**CENTRAL SYNAGOGUE
CONDITIONS & MAINTENANCE OF
DESIGNATED LANDMARK**

LPC PRESENTATION

ADDRESS
652 LEXINGTON AVE
NEW YORK, NY 10022

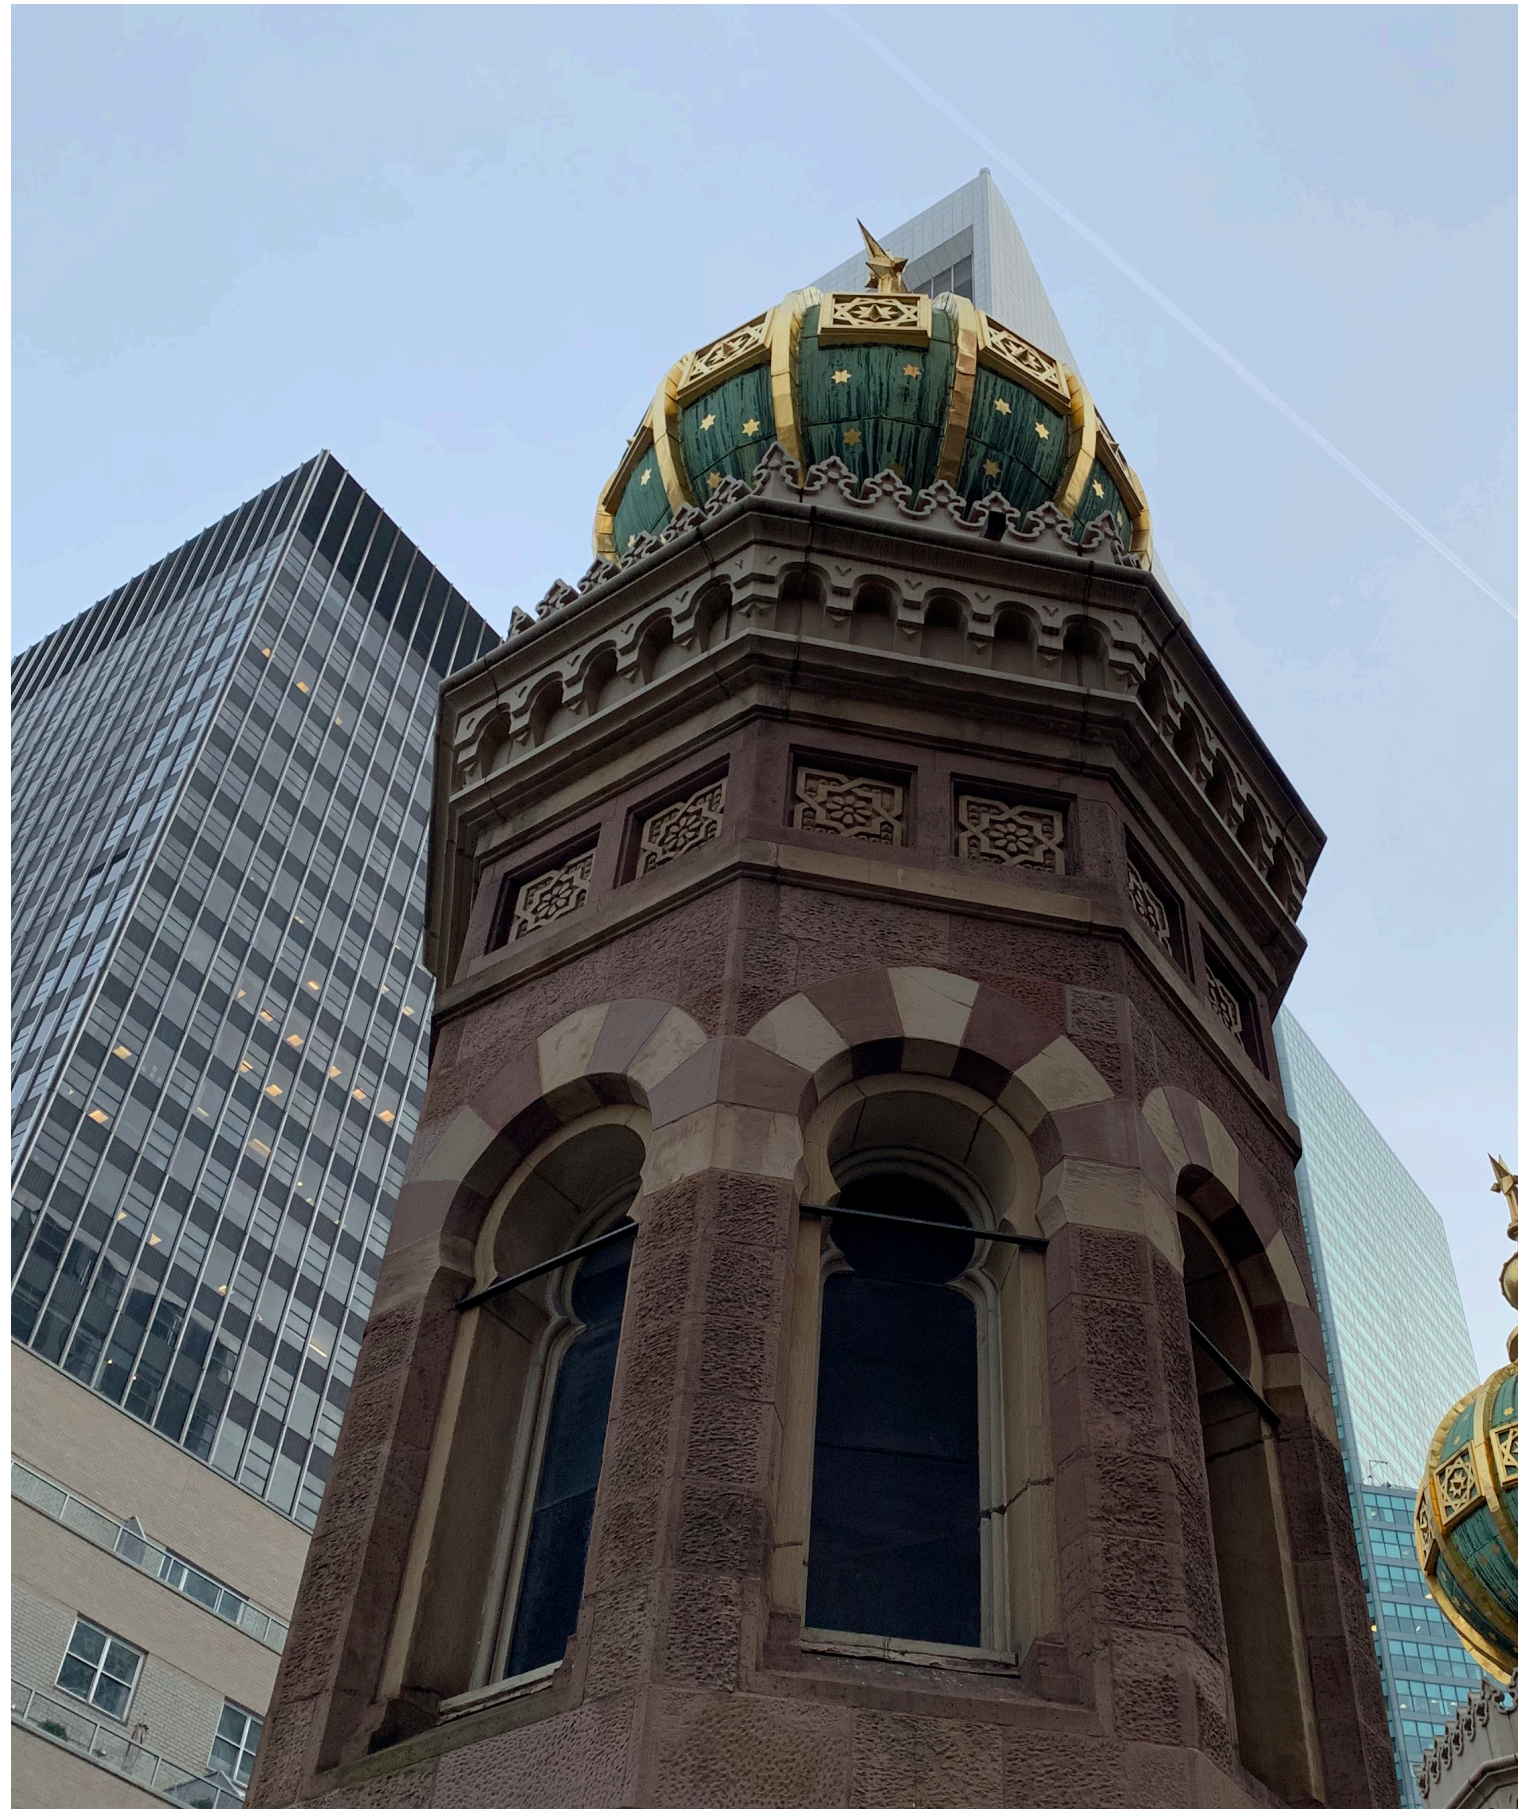
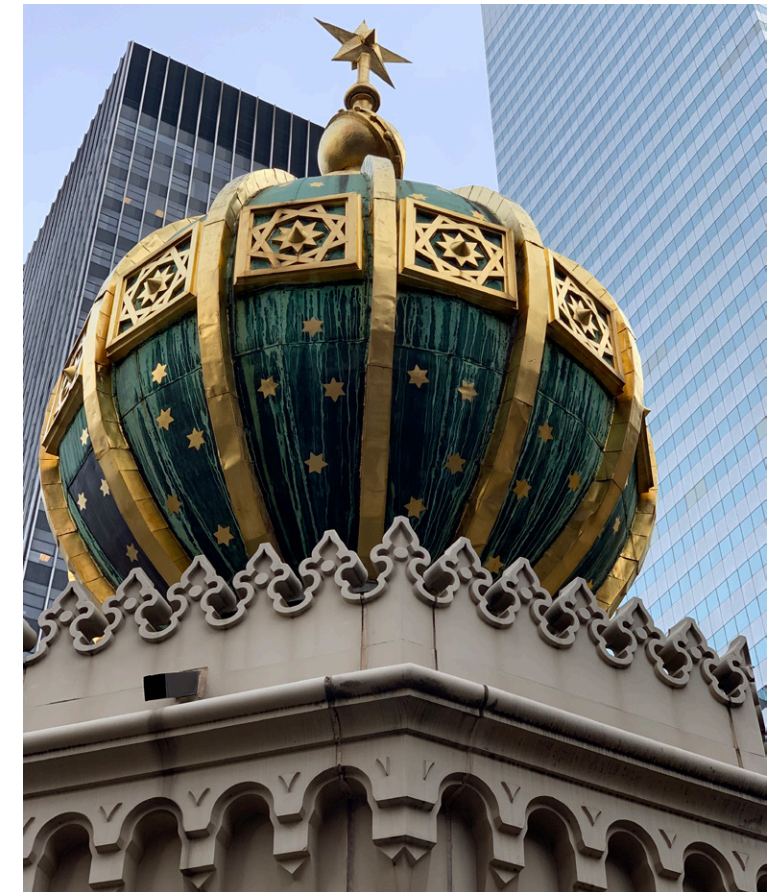
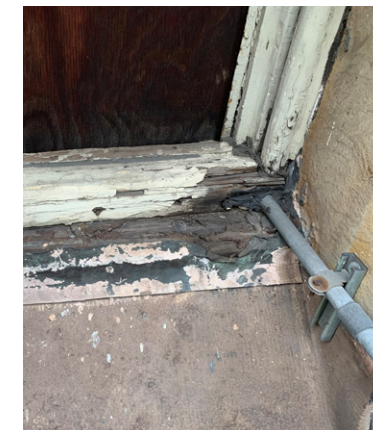
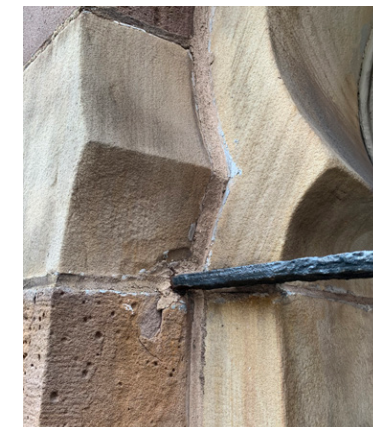
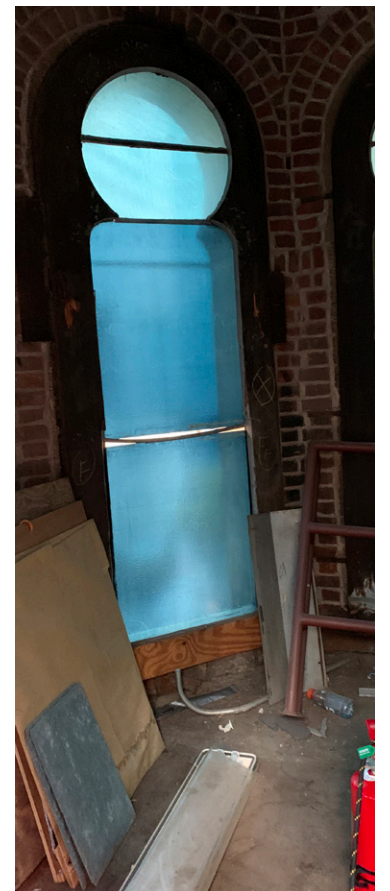
Towers

Condition: Good-to-Fair

- The tower dome paint is cracking; flashing appears to be sound
- Masonry shows areas of weathering and deterioration, with areas of cracked/spalled stone, open/cracked mortar joints, and soiled/stained masonry
- All windows & access doors are deteriorated and should be replaced
- Restoration of gold painted finishes & copper cladding is recommended, as required
