Re: West-Park Presbyterian Church  
165 West 86<sup>th</sup> Street, Manhattan  
(Block 1217, Lot 1) ("Property")

West Park Presbyterian Church  
165 West 86<sup>th</sup> Street, Manhattan  
Block 1217, Lot 1

Application to Landmarks Preservation Commission  
Pursuant to Administrative Code § 25-309 for a Notice to Proceed  
Authorizing Demolition on the Grounds of Insufficient Return

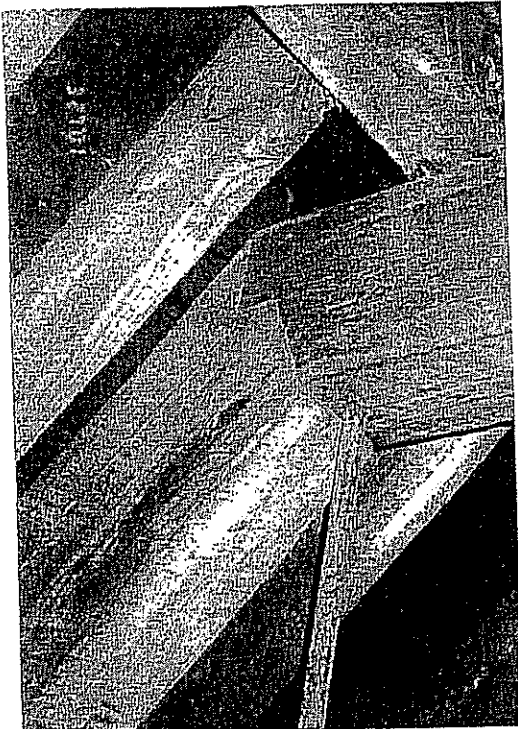
significant structural damage (See Photo S2). The north-south trusses have some minor structural damage at the joints and the upper diagonal chord members. At two joint locations the chord ends are splitting, probably due to the original connection design (See Photo S1). These joints can be repaired by reinforcing the timbers with steel where splitting has occurred. This damage is not an immediate hazard, but needs to be addressed, as the performance of the roof under heavy load (e.g. a heavy snow or wind loads) cannot be predicted. The other damage is longitudinal splitting (checking) along the chords (See Photo S4). The splitting along members is probably due to shrinkage (wood drying out and changing volume) and should not significantly reduce the capacity of the truss. Lastly, while the wood members are embedded in masonry, we have no indication of that any deterioration has occurred in these areas.

Photo S1: Splitting at connection.

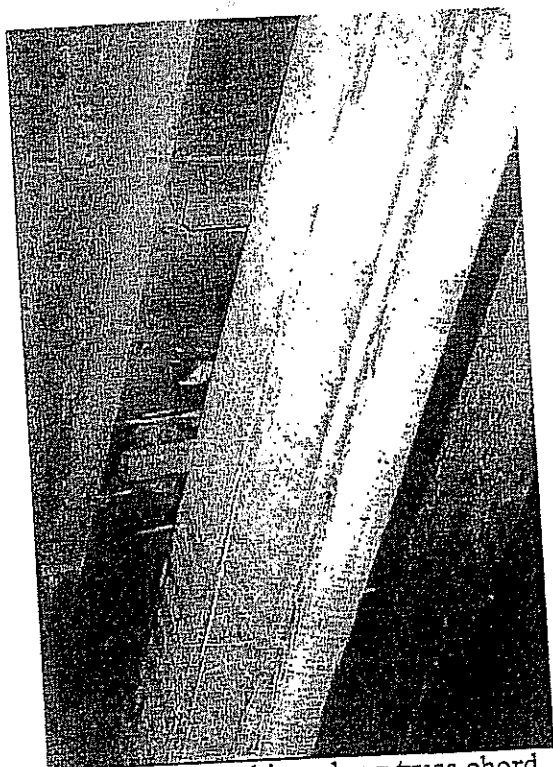
Photo S4: Checking along truss chord.

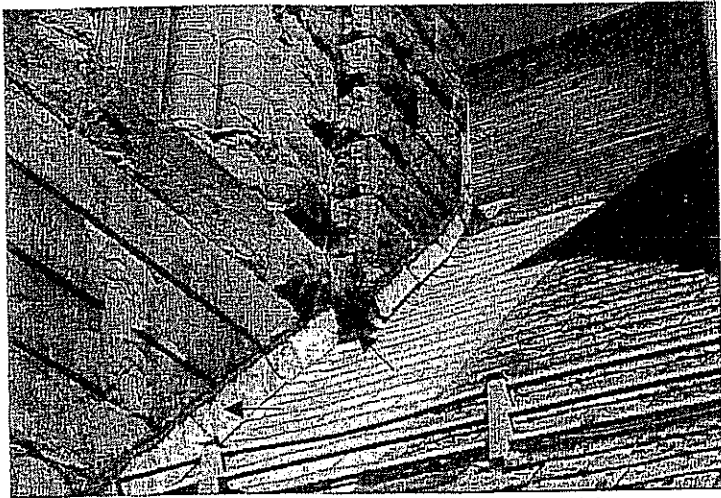
Flashings are in poor condition. Valley flashing between the gable roof and main dormer roof has been partially mopped over with asphalt (See Photo 13). Step flashing and counterflashing at the intersection of the gable roof and all vertical walls (at the bell tower, stair tower, east masonry wall, & gable/dormer parapets) appear to be in poor condition. The counter flashing is bent up, pulled away, exhibits open holes and is missing in many locations. Areas with missing counter flashing have been mopped over with asphalt (See Photos 14, 15, & 16). All counter flashing is attached to the building via reglets cut or built into the stone or masonry joints. Nearly all reglet joints have been mopped over with asphalt (See Photo 17). All mopped asphalt is typically in poor condition, showing cracks, tears and poor pliability.

Photo 14: Damaged and missing counterflashing, mopped over with asphalt.

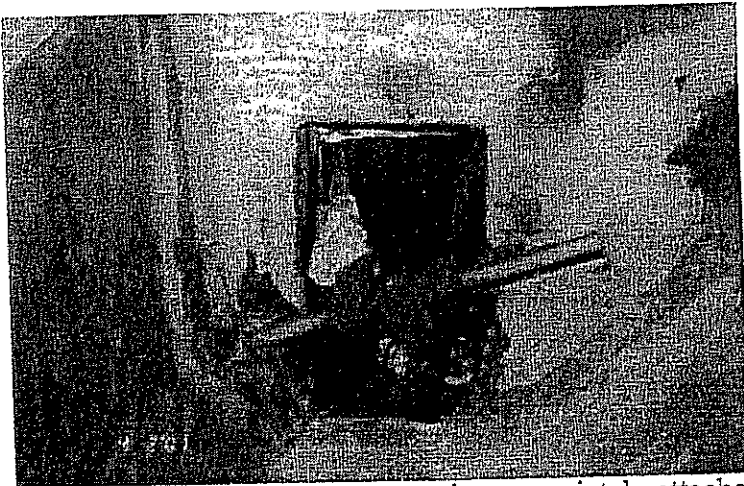
The leader and downspout, at the northeast corner of the gable roof, are inappropriately attached to the building, via bent metal hanging on a metal rod. A poor connection between the scupper through the masonry wall, and the leader creates a place for water to penetrate the roof and run down the masonry wall (See Photo 24). Flashing between the roof membrane, masonry parapet wall, and drain area shows gaps and holes, allowing water to penetrate (See Photo 25). In addition, the drain is clogged with debris.

Photo 24: Leader and downspout inappropriately attached to building; downspout filled with debris.

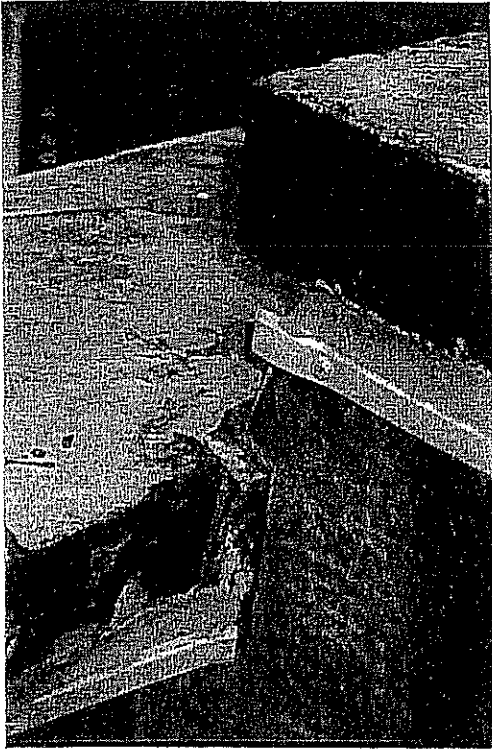
Photo 25: Gaps and holes in flashing, termination bar and sealant.

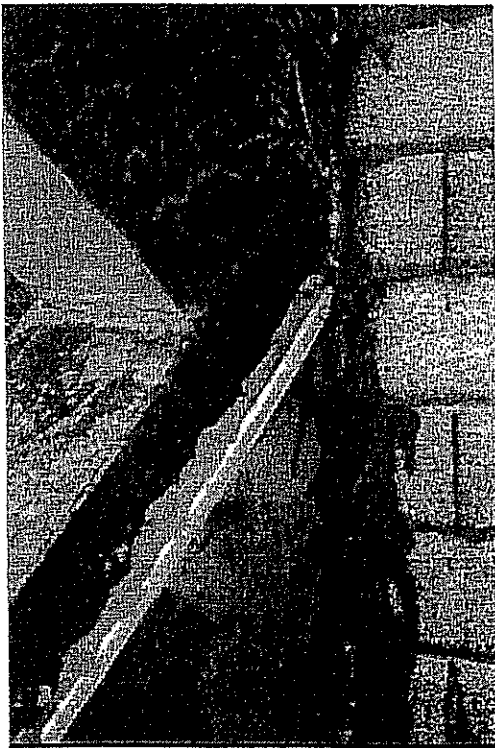
is typically cracked and shows open holes in several locations (See Photos 26 & 27). The stone copings are heavily deteriorated, exhibiting spalls and exfoliation. Open joints exist between stones and between stone and the masonry parapet beneath. In many locations, asphalt has been mopped over the joints, however the asphalt shows open gaps and severe cracking and shrinkage. Please note the exfoliation and spalling of the stone coping presents a fall hazard over the adjacent building's terrace spaces (See Photo 27).

Photo 26: Holes/gaps at intersection of roof and parapet; no flashing or counterflashing.

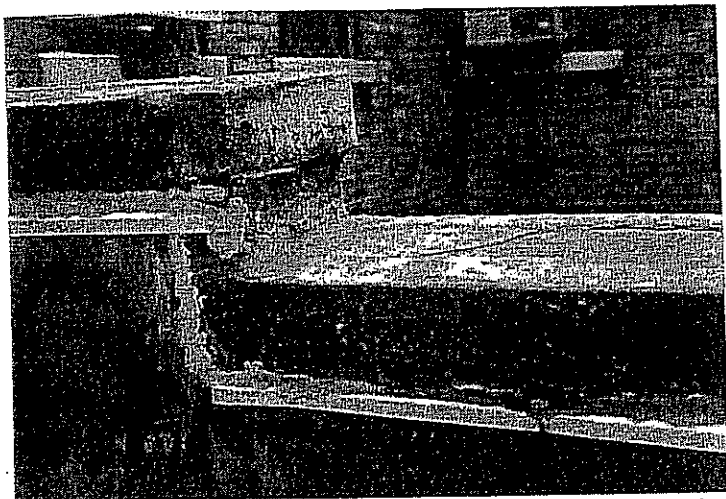
Photo 27: Termination bar/sealant pulled away, deteriorated asphalt, and stone sheeting.

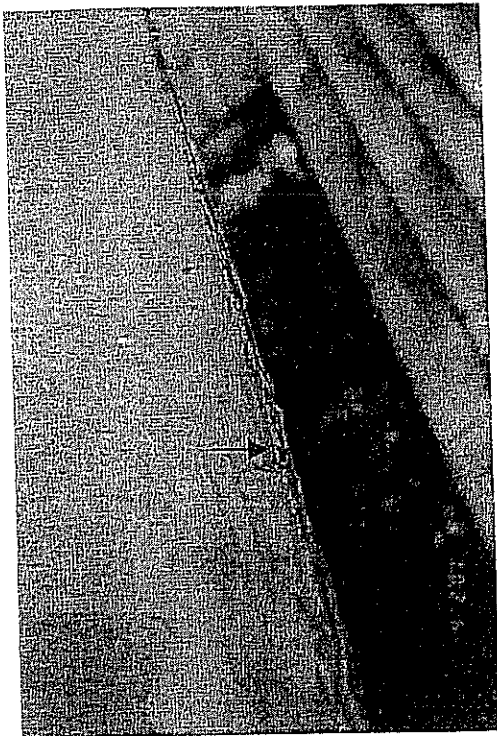
The stair tower roof is flat, covered with an asphaltic membrane, and includes a gutter at the eastern edge. The asphaltic membrane is in poor condition, showing cracking over various areas (See Photo 28). The roof is not sloped appropriately, as evidenced by ponding water on the membrane surface (See Photo 29). At the north edge, the membrane turns up the brick wall of the adjacent building and is held in place with a termination bar and sealant. The sealant along the termination bar is in poor condition, showing cracks and poor pliability. In addition, no cant strip was installed at the edge of the adjacent building, contributing to the poor drainage. Along the south and west edges, the membrane forms a poor seal with sheet metal counter flashing. Although the asphaltic material nearly completely covers the counter flashing, cracks and gaps are present, allowing water to penetrate the roof (See Photo 30).

Photo 30: Holes in flashing.

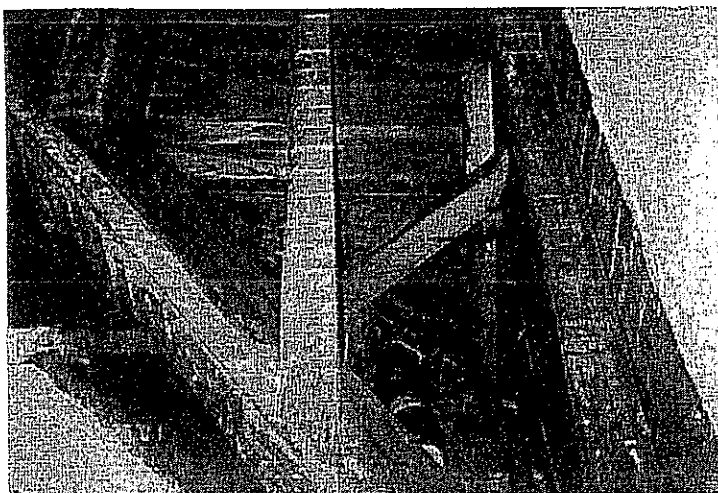
In the southwest corner of the administrative wing the roof framing has deteriorated significantly due to water penetration through the roof. The hip beam has lost approximately half of its section. The surrounding rafters have similar conditions at their ends (See Photo 32). This condition should be repaired within the next six months. The repair would involve sistering the deteriorated members.

Photo 32: Water staining and damage to structural members at dormer cricket.

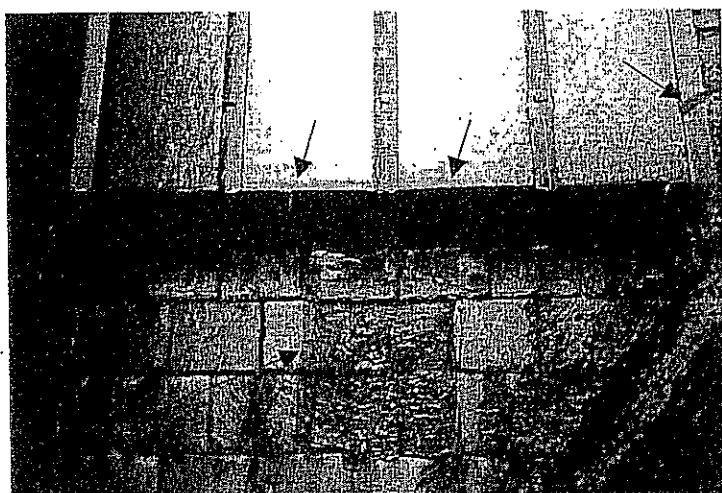
Photo 33: Missing slate tiles mopped over with asphalt.

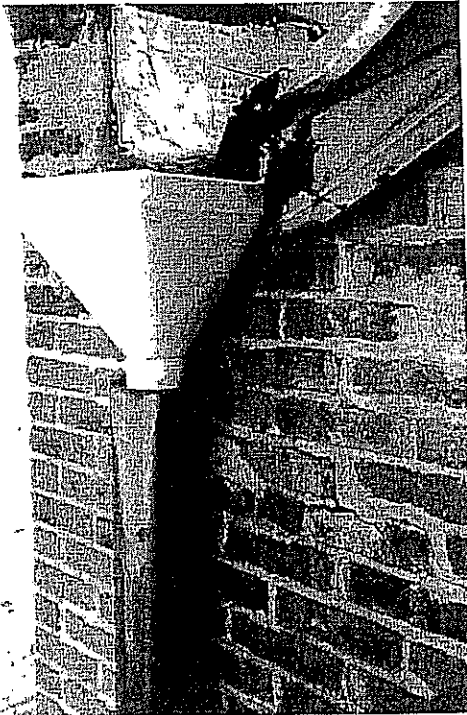
The north facade of the administrative wing is composed of brick masonry, punctured by several monumental windows at the 2<sup>nd</sup>, 3<sup>rd</sup>, and 4<sup>th</sup> floors. The brick masonry is in fair to poor condition, showing small spalls at various locations throughout the facade. The mortar joints, as in other areas, are heavily deteriorated. Along the eastern corner, a downspout runs the height of the wall, that has a poor connection with the leader at the roof level. Moss growth, accelerated mortar joint deterioration, and brick cracking and slight bulging are present throughout the height of the wall, in the area surrounding the downspout (See Photo 40).

Photo 40: Leader and downspout no longer connected at northeast corner.

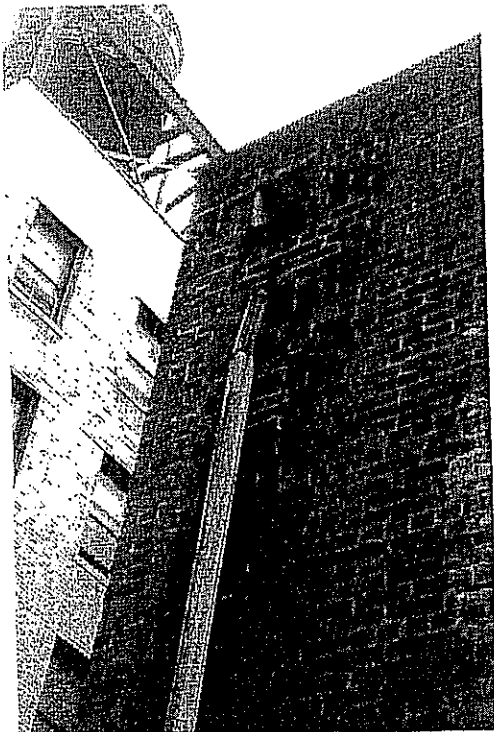
Photo 41: Leader and downspout no longer connected at northwest corner.

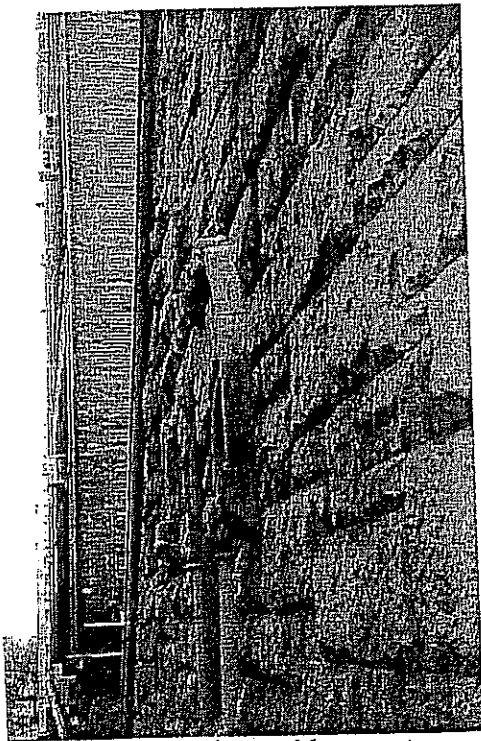
Photo 43: Deteriorated brownstone; note large crack in window eyebrow.

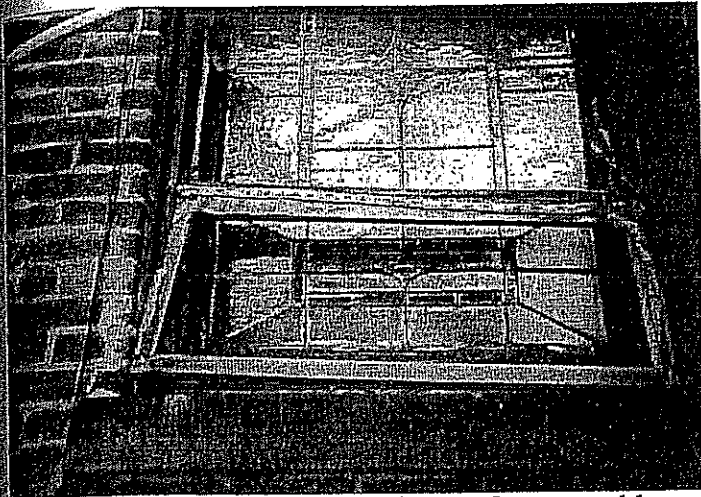
The brownstone bell tower is in particularly poor condition, exhibiting deteriorating structural elements, loose material, and unsafe conditions. Brownstone columns show heavy deterioration from the outside and window frames show undercutting from the inside. Wood window frames are possibly loose within the brownstone and glass pieces, already broken, are certainly loose within the wood frame.

Photo 56: Deteriorated wood window frames and loose members.

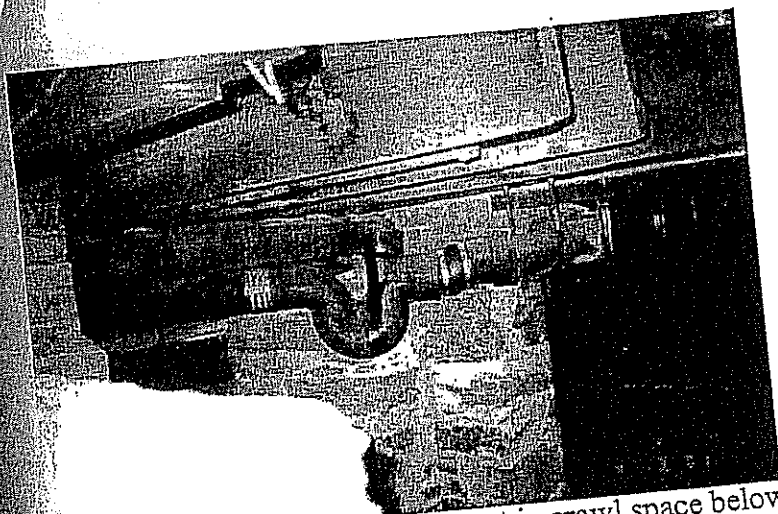
Photo M8: View of waste clean out in crawl space below the church. The purpose of this cleanout must be verified.

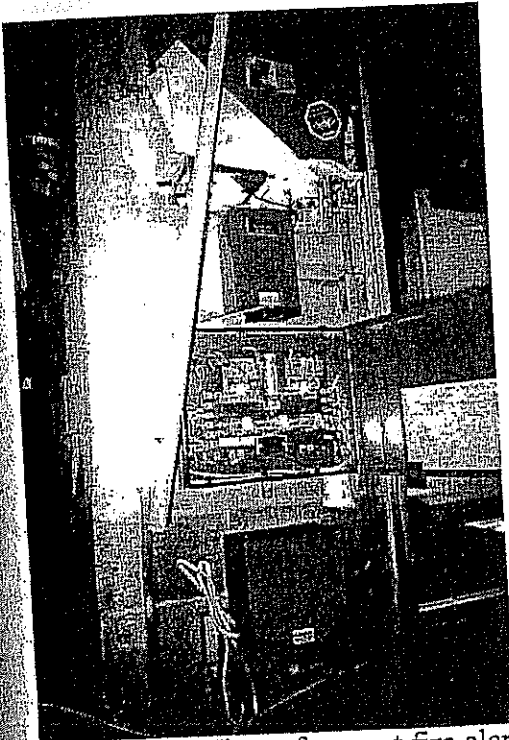
Photo M10: View of current fire alarm system dated from 1955.

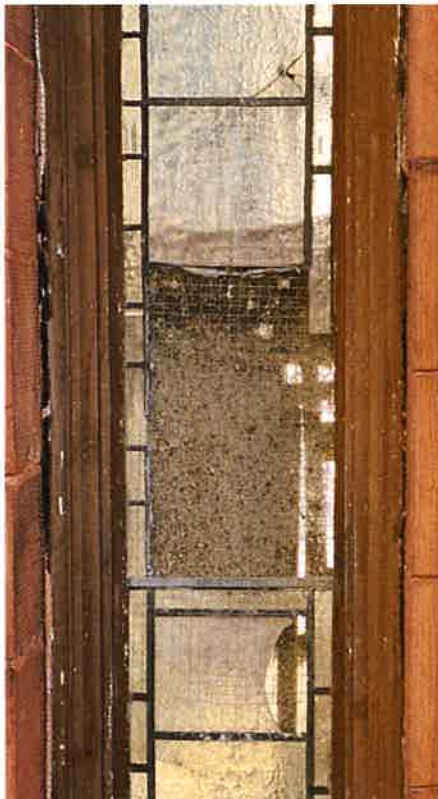
North Tower – Window Deteriorated

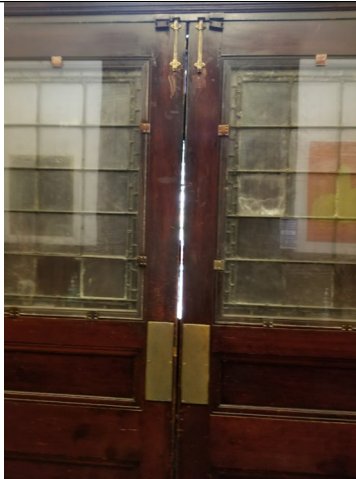
| 7 | | | | 8 | |

| COMMENT | NOTES | PHOTO NUMBER |
|---|---|---|
| <p><b>Locked Egress Doors</b></p> <p>Obstructions or impediments to the means of egress, such as locks on any required egress door, are prohibited (29-1027.3). However, the Department of Buildings (DOB) may approve the electronic locking of specific doors in emergency conditions where it is demonstrated that the contents of such spaces are of “unusual value” (26-288).</p> <p>During the survey a number of locked conditions were identified where the intent was to function as access-control. For example, the Level 3 bathroom had a pad lock to prevent unauthorized use/entry. However, occupants could become locked within the space. Also, the exterior exit doors to Park Avenue and West 86<sup>th</sup> Street are locked or have locked bar assemblies for security purposes; however, these locks also prevent the doors from being used for egress.</p> | <p>All locks must be removed. New access control devices can be provided to limit ingress into a space; however, the devices must always allow for free and unobstructed egress.</p> | <p>1,2,7,26</p> |

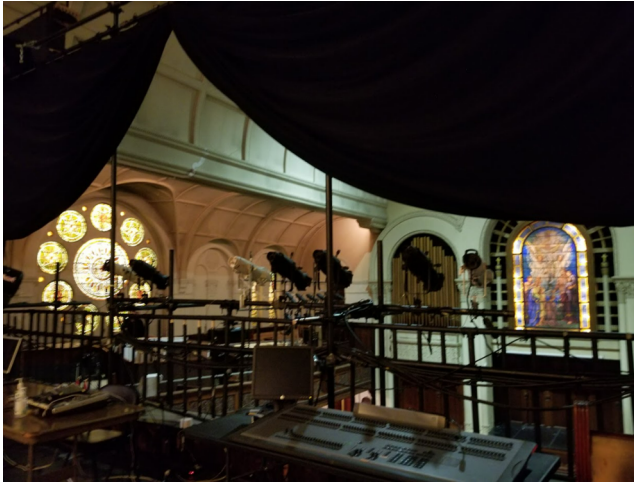
| 11 | | 12 | |

| COMMENT | NOTES | PHOTO NUMBER |
|---|---|---|
| <p><b>Stage Curtains</b></p> <p>NFPA 701 – Standard Methods of Fire Tests for Flame Propagation of Textiles and Films includes methodology (Test Method 1) for flame propagation tests of stage/theater curtains, window drapes, folding shades, and other draperies (NFPA 701 A.1.1.1).</p> <p>The main sanctuary balconies and the chapel include black-out draperies in close proximity to lighting systems that could cause a fire due to heat transfer from the light systems.</p> | <p>It is recommended that sanctuary and chapel curtains be reviewed to confirm that the material is fire retardant or complies with NFPA 701 Test Method 1, or that the material is replaced with a compliant</p> | 11,12 |

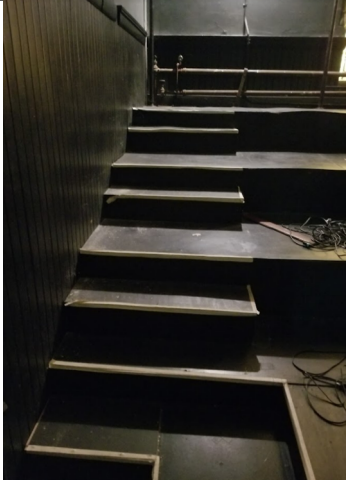
| 13 | | 14 | |

| COMMENT | NOTES | PHOTO NUMBER |
|---|---|---|
| <p><b>Handrails – Sanctuary Balcony Theater</b></p> <p>Handrails are required to comply with the provisions of the 2014 Code where the scope of work includes new stairs/ramps or where the work includes the replacement of an existing stair/ramp (28-101.4.3(13)).</p> <p>The Sanctuary Balcony Theater includes a bleacher-style seating area includes existing stepped aisles to access the assembly seating; however, handrails are not currently provided at the stepped aisles.</p> <p>In new construction, stepped aisles serving assembly seating must have handrails on one side of the aisle (1028.13).</p> | <p>As a standard of care, it is recommended that handrails be provided at the stepped aisles serving the Sanctuary balcony theater.</p> | <p>13</p> |

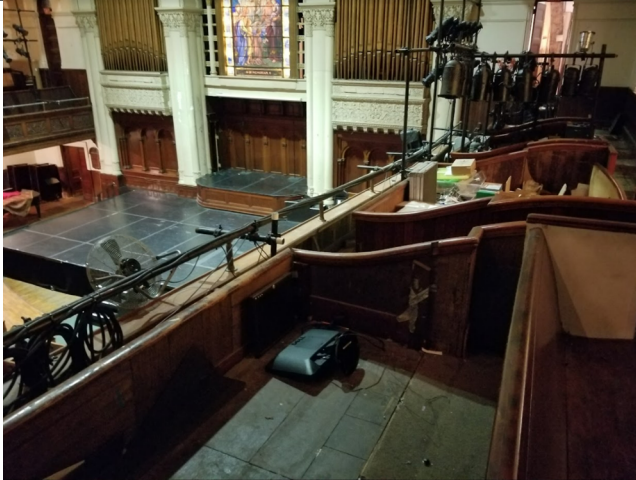
| COMMENT | NOTES | PHOTO NUMBER |
|---|---|---|
| <p><b>Guard Replacements</b></p> <p>Where alteration work includes new or replacement guards, the guards must be designed in accordance with the 2014 Code provisions (28-101.4.3(14)).</p> <p>The 2014 Code requires that guards be provided at walking surfaces that are located more than 30-inches above the floor below. Required guards must have a height of at least 42-inches, and any openings in the guard must be sized to less than 4-inches. Numerous existing guards, including those at the Sanctuary balconies, were identified that have a height of less than 42-inches with openings that were greater than 4-inches. The wood ornate guard at the South stair to Level 3 also has a height of less than 42-inches.</p> | <p>Guard replacement is not required, unless future work includes alterations to the guards or a new condition that requires a guard.</p> <p>However, as a standard of care it is recommended that an analysis be completed to determine which existing guards should be replaced based on the stability or whether they provide sufficient protection.</p> | <p>14,19</p> |

| COMMENT | NOTES | PHOTO NUMBER |
|---|---|---|
| | Also, it is recommended that the analysis identify guards that can be replaced, or adapted, to comply with the guard height and opening limitations of the 2014 Code without affecting the historical nature of the existing condition. Guards within egress stairs and guards at the edges of the Sanctuary balconies should be prioritized. | |

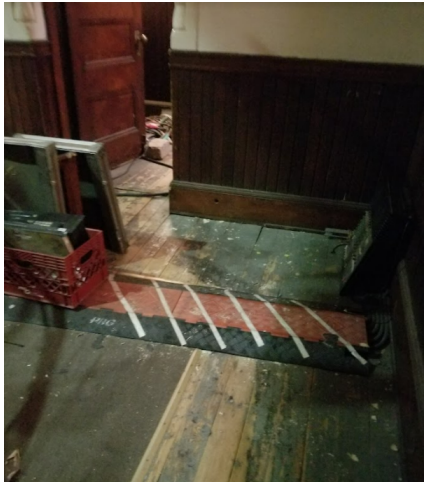
| 15 | | 16 | |

| COMMENT | NOTES | PHOTO NUMBER |
|---|---|---|
| <p><b>Tripping Hazard</b></p> <p>Obstructions or impediments to the means of egress are prohibited (29-1027.3). Obstructions were identified along the path of travel in the Sanctuary balconies, including a covered cable run and various loose extension cords that extend perpendicularly across the exit access path to the South Stair adjacent to Mc Alpin Hall.</p> | <p>All covered cable runs and loose extension cords that are within, or extend through, the egress path.</p> | <p>15, 16</p> |

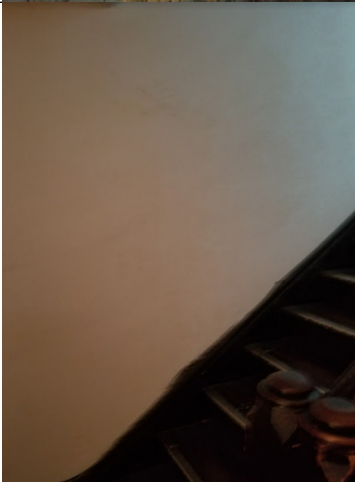
| 19 | | | 20 | |

| COMMENT | NOTES | PHOTO NUMBER |
|---|---|---|
| <p><b>Handrails – General</b></p> <p>Handrails are required to comply with the provisions of the 2014 Code where the scope of work includes new stairs/ramps or where the work includes the replacement of an existing stair/ramp (28-101.4.3(13)).</p> <p>Numerous existing handrails were identified to be noncompliant with the 2014 Code Section 1012 requirements for height, graspability, continuity, and handrail extensions. In addition, most stair runs had handrails on only one side.</p> | <p>Existing handrail replacement is not required unless future work includes a new or replacement stair.</p> <p>However, as a standard of care it is recommended that an analysis be completed to determine which existing handrails should be replaced based on the stability or whether they provide sufficient protection.</p> <p>It is also recommended that the analysis determine which existing handrails can be replaced, or adapted, to comply with the handrail requirements of the 2014 Code without affecting the historical nature of the existing condition.</p> <p>It should be noted that additional code-compliant handrails can be provided for egress purposes while the existing handrails be maintained for aesthetics purposes.</p> | 20 |

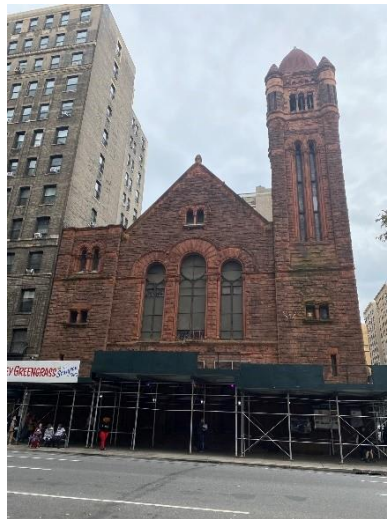
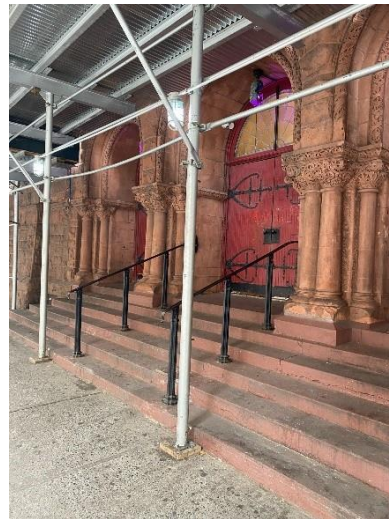
*Amsterdam Ave.* The front entrance off Amsterdam Avenue was not accessible due to several steps at the entrance. Steps and stairs are not allowed in an accessible route (NYCBC 1104.1, ANSI 402.2; 2010

Standards 402.2).

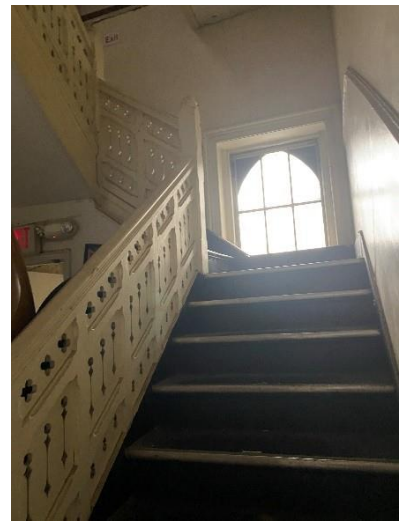
**Accessible Route.** At least one accessible route must connect accessible building or facility entrances with all accessible spaces and elements within the building or facility which are otherwise connected by a circulation path (NYCBC 1104.1; 2010 Standards 206.2.4). Accessible routes must consist of one or more of the following components: walking surfaces with a running slope not steeper than 1:20, doorways, ramps, curb ramps excluding the flared sides, and elevators. Platform lifts are allowed in limited applications. Steps and stairs are not allowed in an accessible route (ANSI 402.2; 2010 Standards 402.2).

Once inside the building, no accessible route connects the sanctuary to any other levels of the building, including the other half of the first floor.

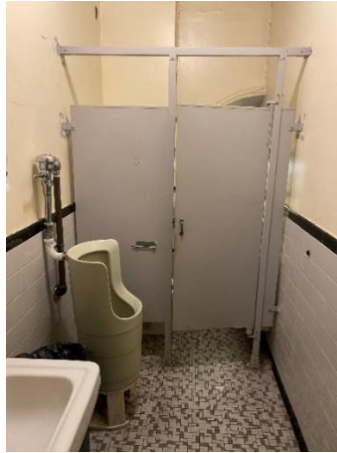
**Toilet Rooms.** No toilet rooms in the building were accessible. All toilet and bathing rooms are located up or down a flight of stairs from the 86<sup>th</sup> Street entry level. Where toilet or bathing rooms are provided, each toilet or bathing room must be accessible (NYCBC 1109.2; 2010 Standards 213.2). In alterations, the ADA allows, where it is technically infeasible to provide an accessible toilet room or bathing room, altering existing toilet or bathing rooms is not required where a single accessible unisex toilet room or bathing room is provided and located in the same area and on the same floor as existing inaccessible toilet or bathing rooms (2010 Standards 213.2 Exception 1). Please be aware that the NYCBC does not include a similar alternative. In CCI's experience, the DOB has allowed the use of single unisex toilet room or bathing room in some existing conditions. If the design team plans on using the 2010 Standards alternative, we recommend discussing this compliance method with your building official to confirm their approval. We also recommend documenting the factors that make compliance of the altered toilet or bathing rooms technically infeasible. None of the existing toilet rooms were currently designed as accessible.

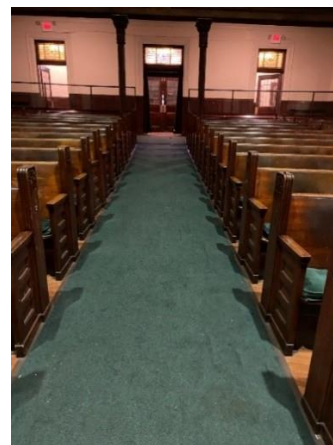
*Sanctuary.* The Sanctuary, that is often used as a theater and event space, did not provide any wheelchair spaces. Wheelchair space locations must be an integral part of any assembly seating area. The requirement that wheelchair spaces be an integral part of the seating plan means that wheelchair spaces must be placed within the footprint of the seating area. Wheelchair spaces cannot be segregated from seating areas. Wheelchair spaces must provide spectators with choices of seating locations and viewing angles that are substantially equivalent to, or better than, the choices of seating locations and viewing angles available to all other spectators. (NYCBC 1108.2.4, ANSI 802.10.1; 2010 Standards 221.2.3) Wheelchair spaces must adjoin accessible routes but must not overlap the required width of an aisle. Slopes must not exceed 1:48 in the floor surface of wheelchair spaces (NYCBC 1108.2.2, ANSI 802.3; 2010 Standards 802.1).

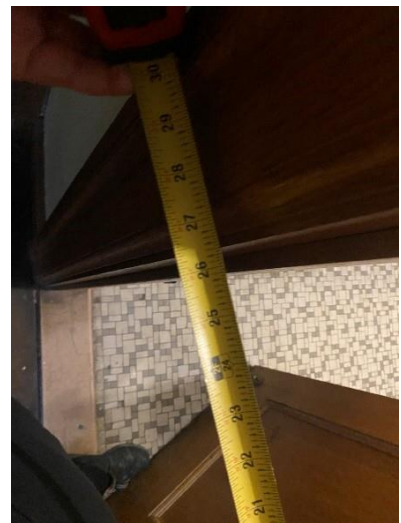
**Thresholds.** Thresholds in this project could also be considered a barrier removal item. Most thresholds in this project are an issue due to the required bevel not being provided or the threshold being too high, especially at locations where the floor material changes. Thresholds must not exceed 1/2 inch maximum in height. The bottom 1/4 inch is allowed to be vertical and the uppermost 1/4 inch must be beveled at a slope not to exceed 1:2. (ANSI 404.2.4; 2010 Standards 404.2.5)
