**Preservation Department – Item 9, LPC-22-02413**

**231-233 West 74th Street – West End - Collegiate Historic  
District Extension  
Borough of Manhattan**

# **Façade Reconstruction 231 & 233 West 74<sup>th</sup> Streets**

**This presentation seeks to demonstrate that the deterioration of the primary (south) facades of the above buildings is so advanced that restoration work is not be possible to perform safely or effectively. MVN therefore seeks permission from LPC to perform reconstruction of the primary facades using salvaged original masonry brick and stone units to the greatest extent possible, and new materials to match the existing, where existing materials are not able to be salvaged.**

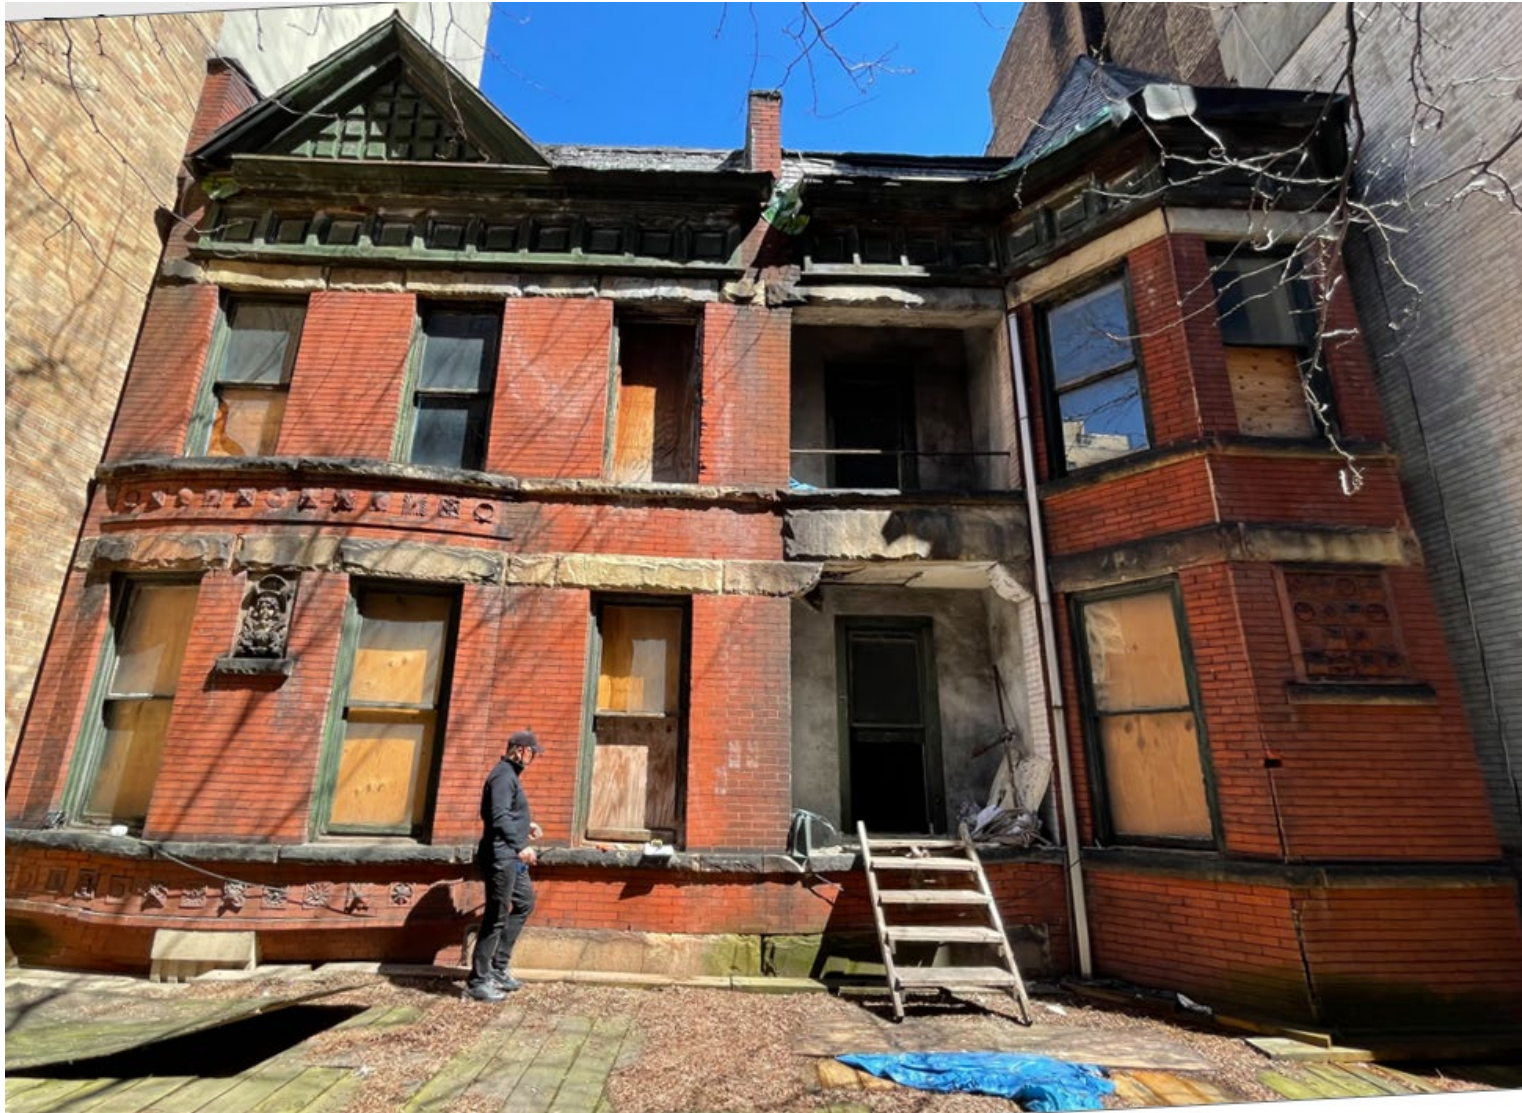
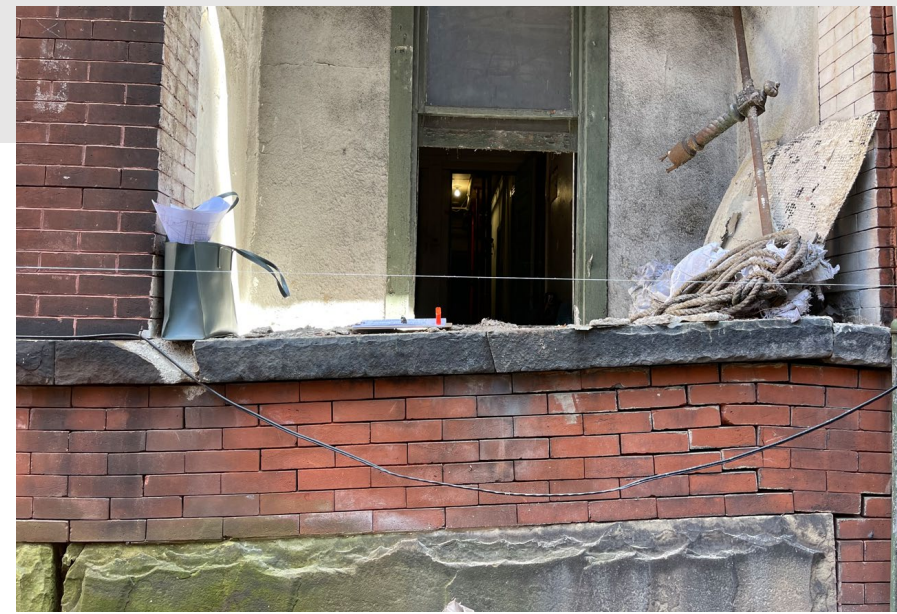
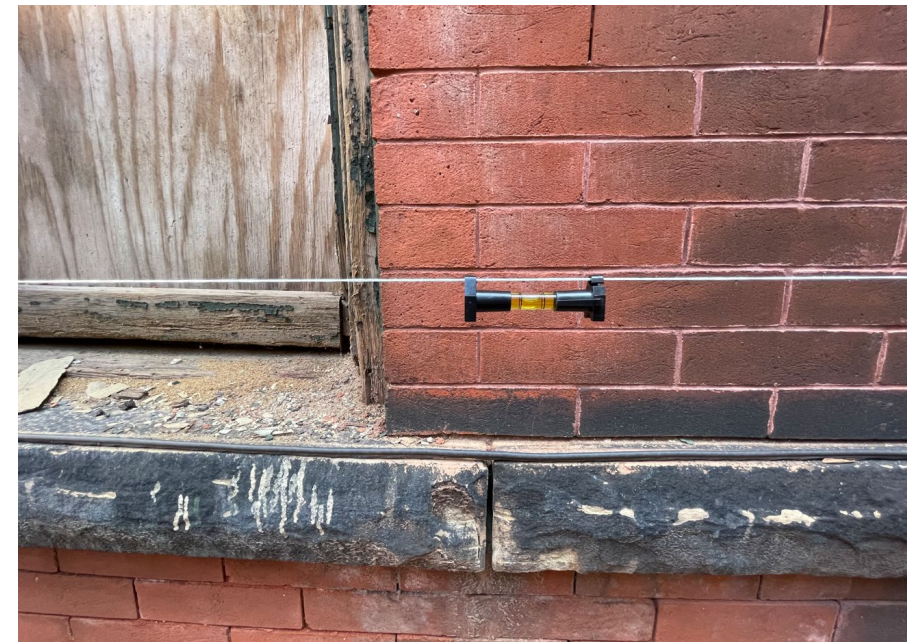
# Existing Displacement & Deterioration

**231 West 75<sup>th</sup> Street (Bay window segment coming apart at corner and cracked vertically from settlement.)**

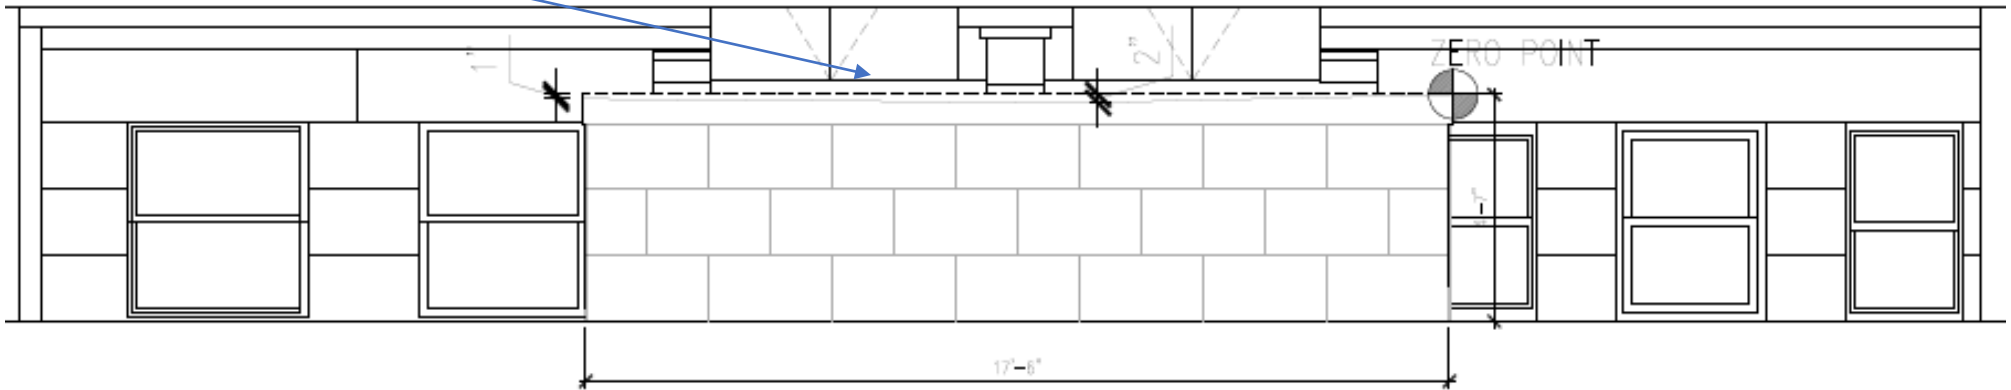
2" displacement
