Preservation Department – Item 1, LPC-22-02413

231-233 West 74th Street – West End - Collegiate Historic

Façade Reconstruction

231 & 233 West 74th Streets

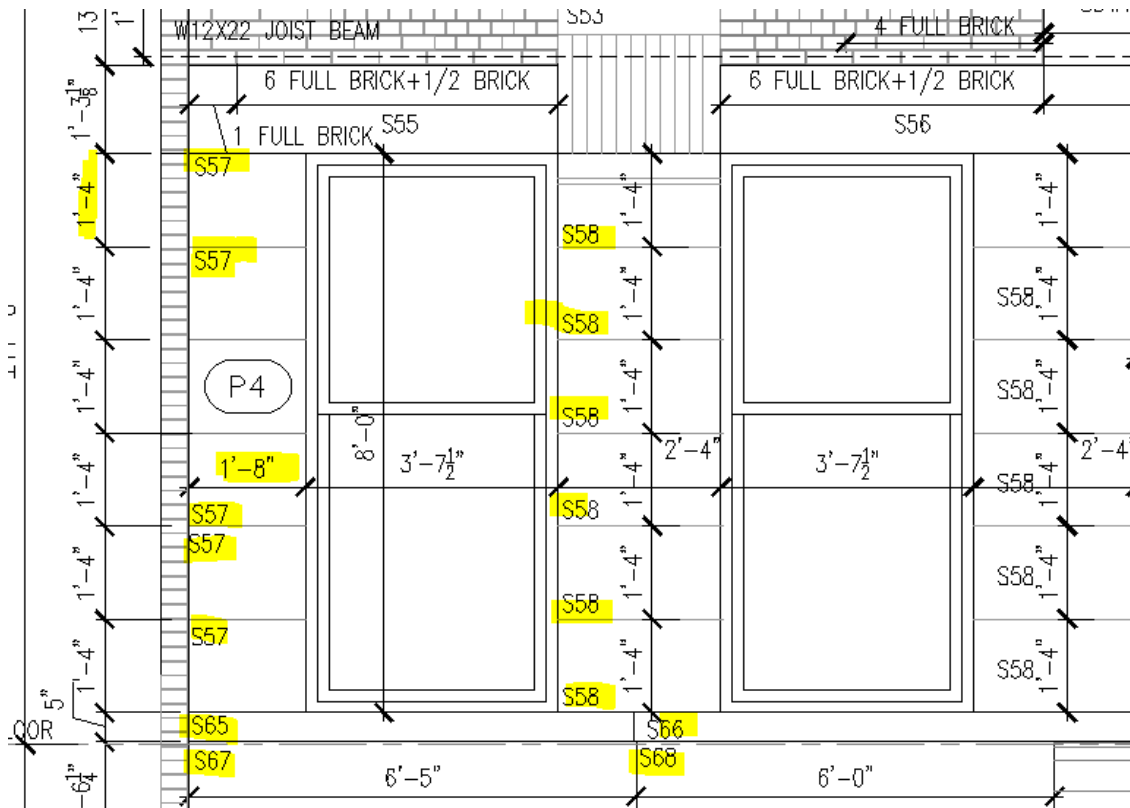
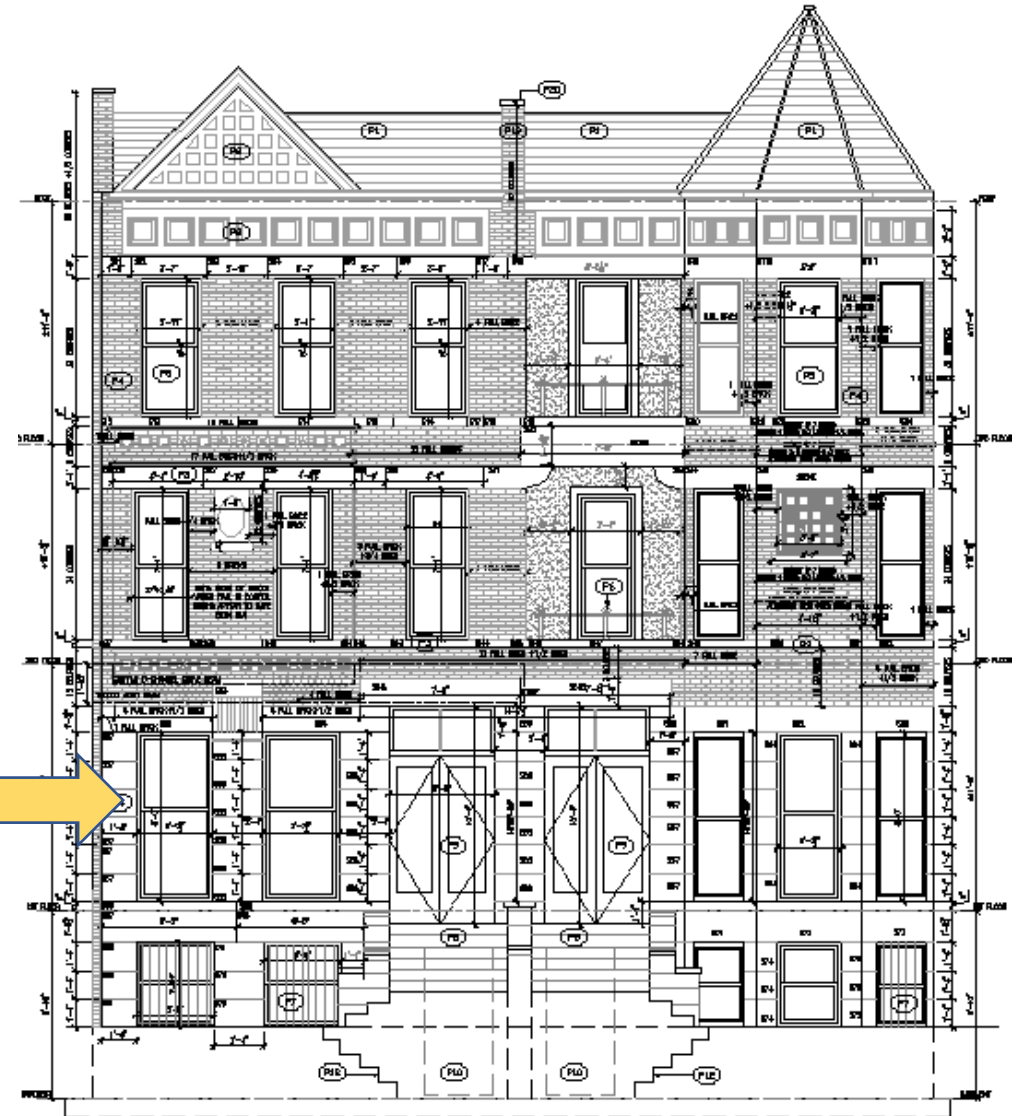
Reconstruction of the Façade

Mortar at facebrick throughout has lost its tensile strength and is easily dislodged making restoration infeasible and reconstruction necessary.

Reinstall salvaged stone: Every unit will be catalogued and installed in its original location. Units that are not able to be salvaged will be replaced with like materials.

During reconstruction, façade materials to be stored in secure watertight locations both offsite & at the rear yard.

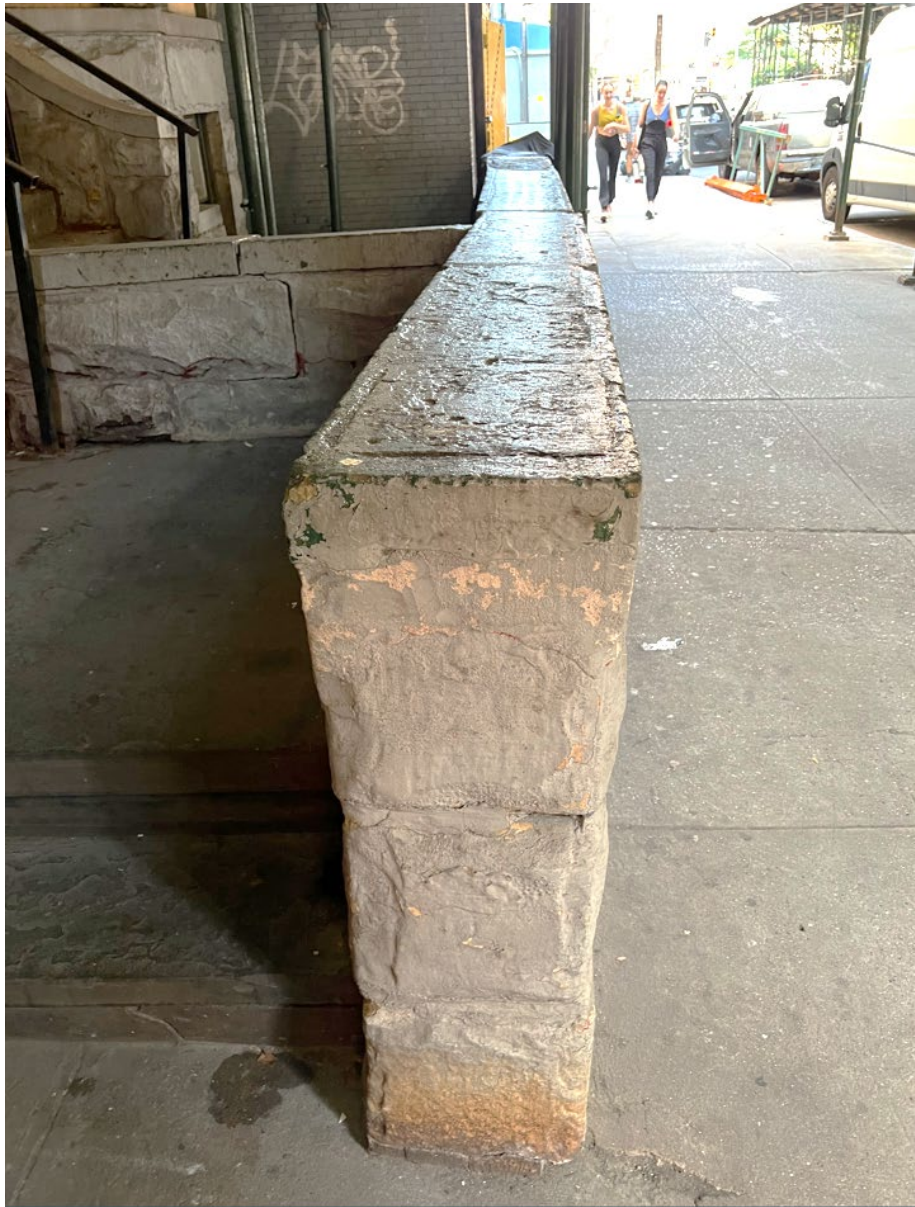
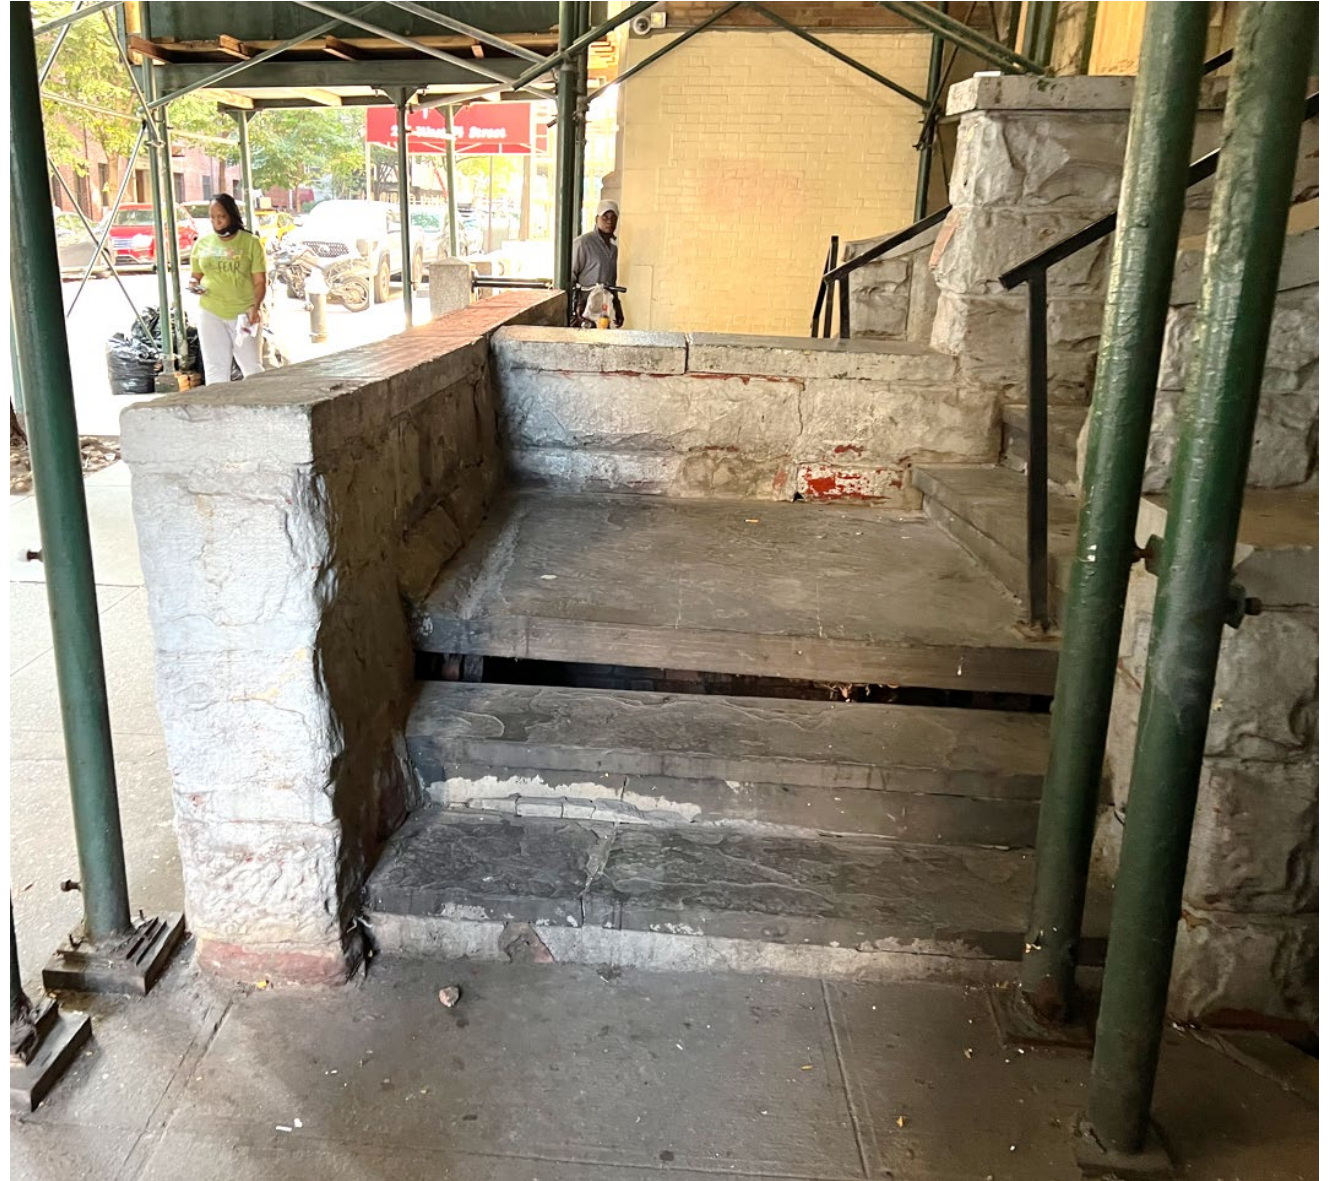
Front Street Wall-Existing reconstruction. New material indicated.

231 W 75th St
(Displacement at street
wall fronting steps)-
Photo taken 2022
reconstruction of this
wall will be necessary.

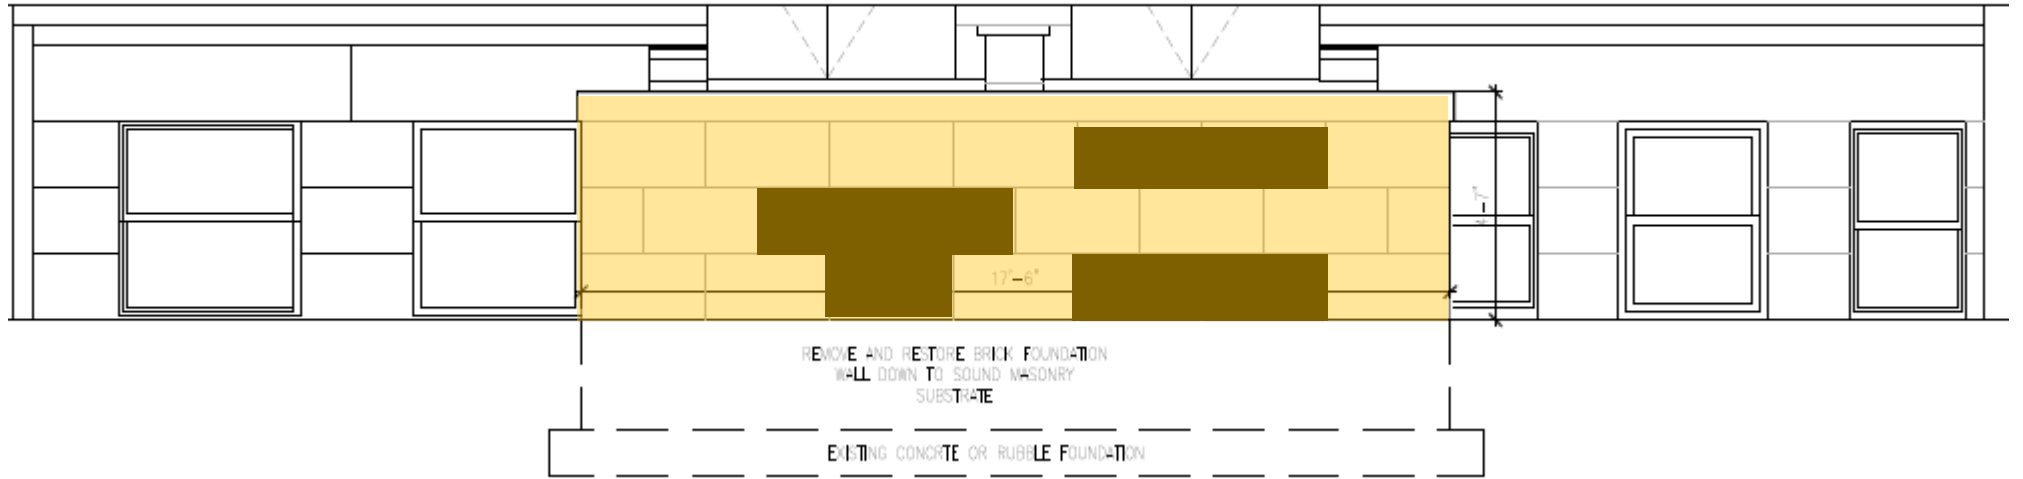
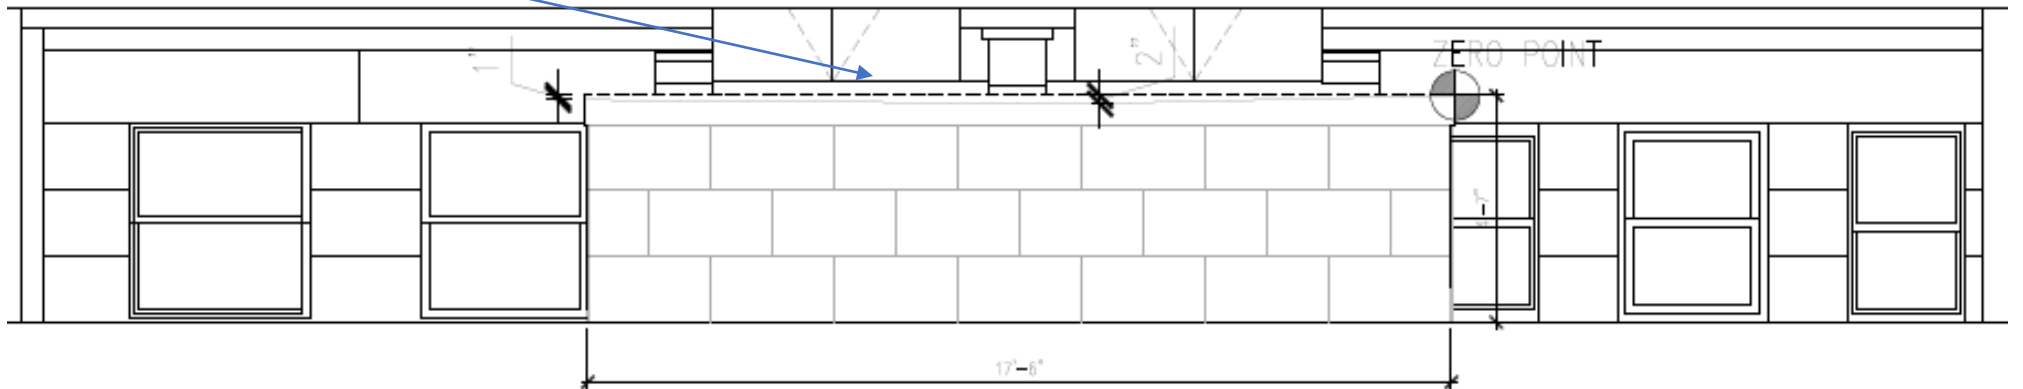
2" displacement
