Preservation Department – Item 3, LPC-23-02975

112 2nd Avenue – East Village/Lower East Side Historic District Borough of Manhattan

MIDDLE COLLEGIATE CHURCH

STRUCTURAL SAFETY ASSESMENT

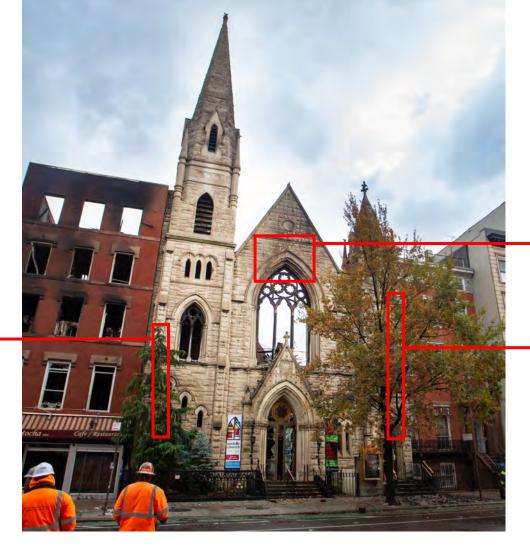
VIEW OF 2ND Ave. FACADE

9. GABLE ARCH

8. SOUTH TOWER CRACK

7. NORTH TOWER CRACK •

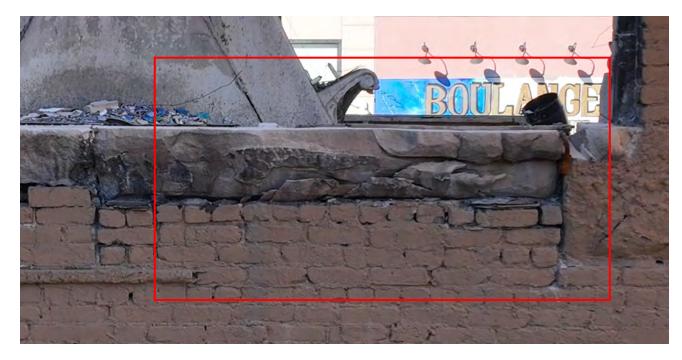
2. BACK OF 2ND Ave. ENTRANCE

DIMENSIONAL STONE FRACTURED

MORTAR MISSING

MASONRY DAMAGED BY THERMAL SHOCK

BRONZE ENTRANCE WARPED AND BUCKLING

RUBBLE BERM AGAINST FOUNDATION WALL

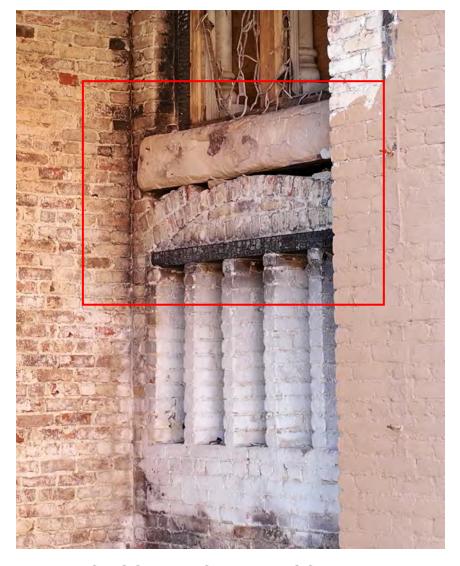
3. VIEW OF SOUTH TOWER MASONRY

SPALLING BRICK DUE TO THERMAL SHOCK

MISSING MORTAR

MISSING BRICKS

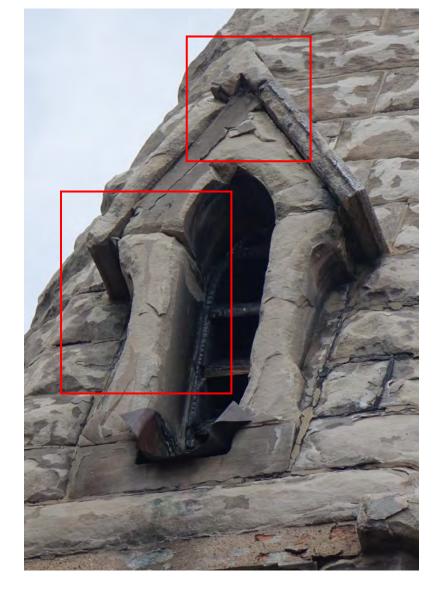
5. SOUTH SPIRE POST-FIRE

LIMESTONE SPALLING FROM THERMAL SHOCK

LIMESTONE FRACTURED

LIMESTONE LOOSE

FINIALS DAMAGED

LIMESTONE HELD IN PLACE BY GRAVITY AND/OR FRICTION

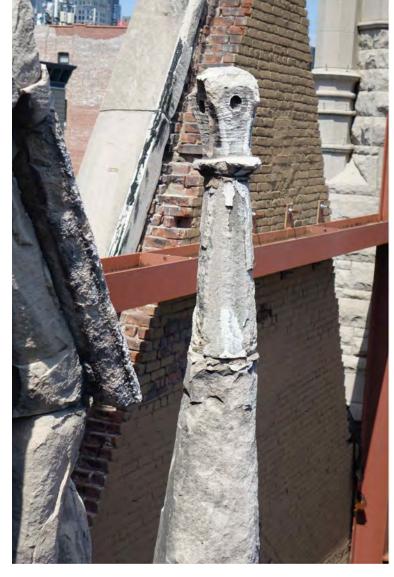
5. SOUTH SPIRE 5. SOUTH SPIRE

LIMESTONE SPALLING FROM THERMAL SHOCK

LIMESTONE FRACTURED

LIMESTONE LOOSE

FINIALS DAMAGED

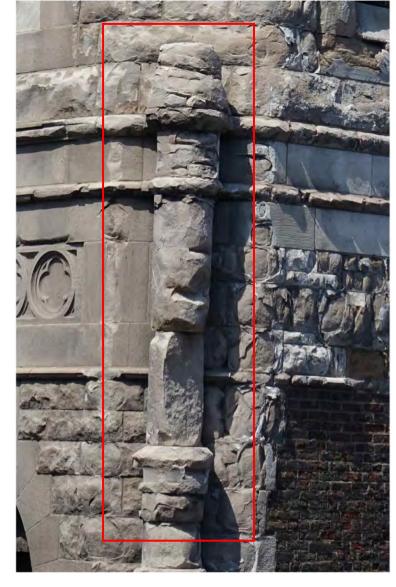
6. NORTH TOWER FINIAL

LIMESTONE SPALLING FROM THERMAL SHOCK

LIMESTONE FRACTURED

LIMESTONE LOOSE

FINIALS DESTROYED

LIMESTONE HELD IN PLACE BY GRAVITY AND/OR FRICTION

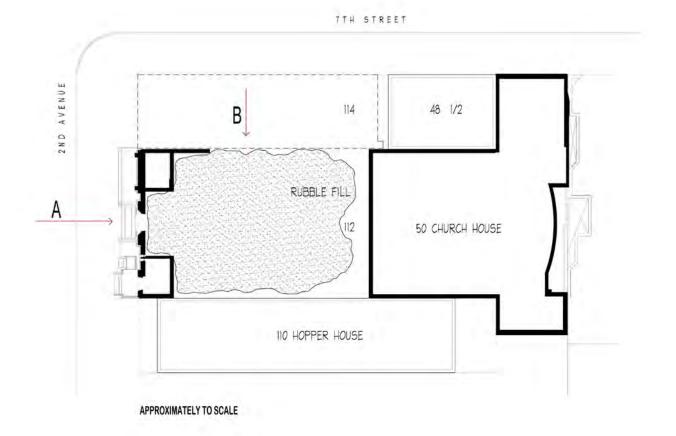
SITE ACCESS CONSTRAINTS

SITE ACCESS CONTRAINTS

- A. CHURCH ONLY HAS ACCESS THRU 2ND AVENUE
- B. NO ACCESS THRU CORNER LOT
- C. HEAVY EQUIPMENT CAN'T ACCESS SITE THRU OR OVER FACADE

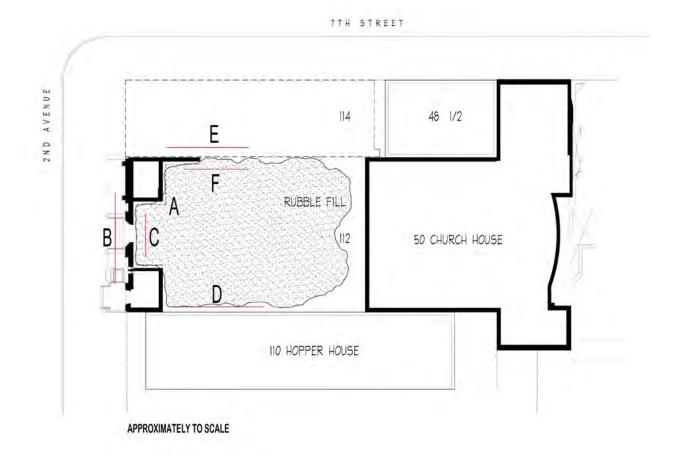
TEMPORARY BRACING CONSTRAINTS

MEASURES TO BRACE FROM 2ND AVE. COULD CAUSE DAMAGE OR COLLAPSE

- A. EXISTING TEMPORARY BRACING NEEDS TO BE MODIFIED TO ALLOW ACCESSS TO THE SITE
- B. REMOVAL OF GABLE COULD DESTABILIZE THE FACADE
- C. RUBBLE BERM IS BRACING EXISTING FOUNDATION
- D. CANNOT BRACE ONTO SOUTH NEIGHBORS BUILDING
- E. CANNOT BRACE ONTO NORTH NEIGHBORS SITE
- F. CANNOT BRACE ONTO NORTH WALL REMNANT AS THAT WILL BE DEMOLISHED TO CLEAR THE SITE

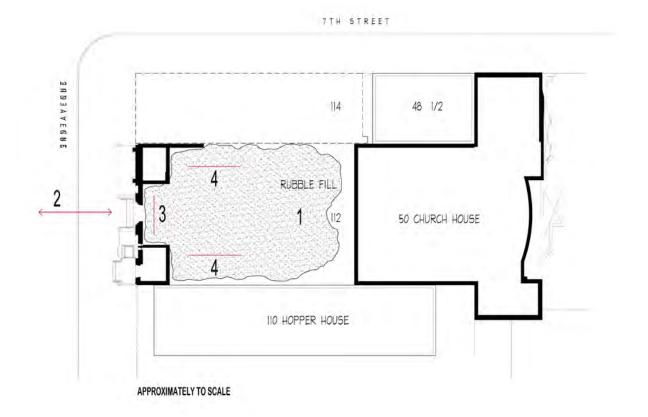
CONSTRUCTION SEQUENCE CONSTRAINTS

ADDITIONAL STABILIZATION CANNOT BE INSTALLED TO ALLOW THE REMOVAL OF THE GABLE

- 1. NEED TO REMOVE RUBBLE DEBRIS FROM SITE TO PROVIDE STABLE PLATFORM TO BRACE FAÇADE FROM
- 2. HEAVY EQUIPMENT NEEDED TO CLEAR DEBRIS CANNOT ACCESS SITE THRU 2^{ND} AVE FAÇADE OPENING
- 3. NEED TO PROVIDE ADDITIONAL BRACING TO FAÇADE TO WIDEN OPENING FOR HEAVY EQUIPMENT ACCESS
- 4. CANNOT INSTALL BRACING ON UNSTABLE DEBRIS
- 5. SEE #1
