Preservation Department – Item 5, LPC-23-02975

**112 2nd Avenue – East Village/Lower East Side Historic District
Borough of Manhattan**

MIDDLE COLLEGIATE CHURCH
112 SECOND AVENUE, NEW YORK, NY 10003

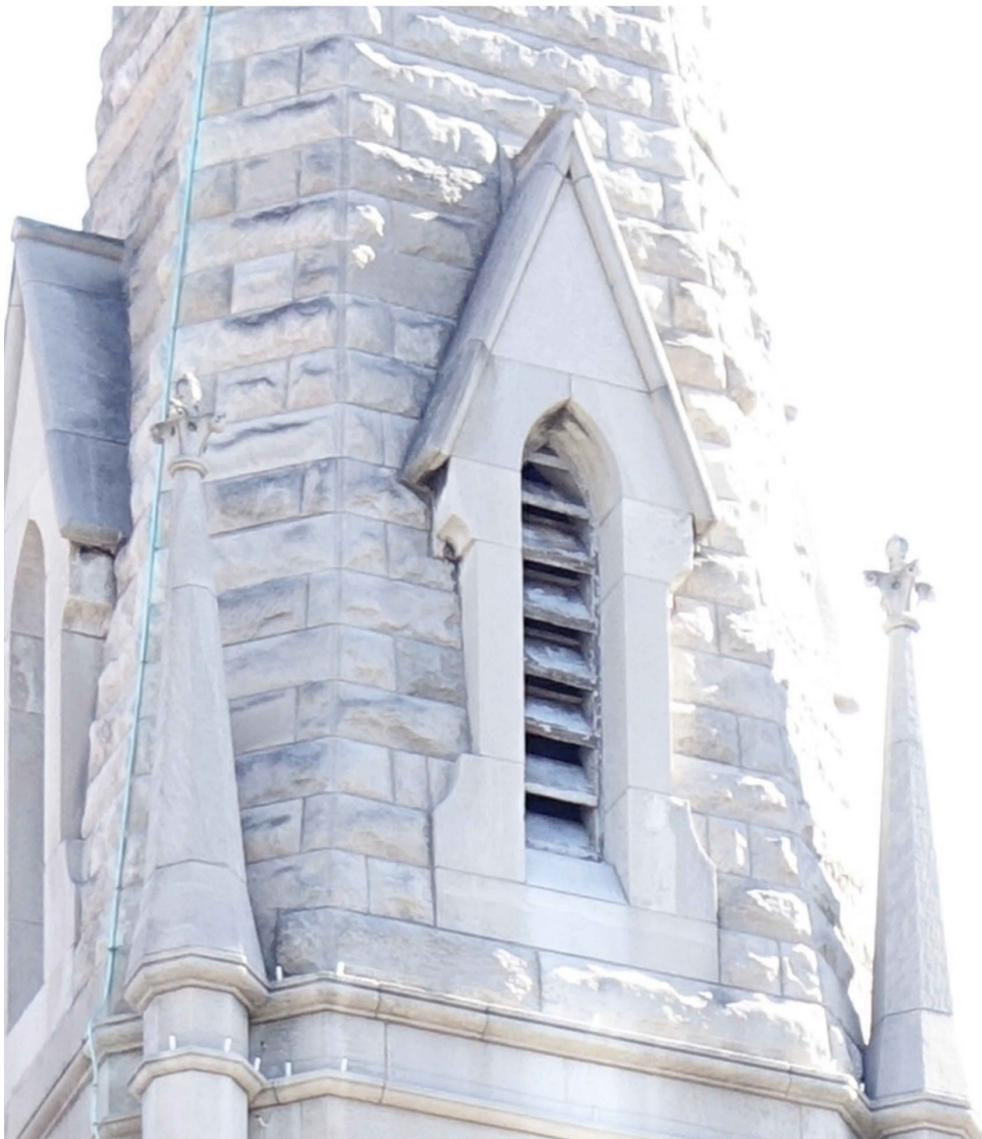
SOUTH SPIRE PRE-FIRE

LOCALIZED DESTABILIZATION

LIMESTONE SPALLING FROM
THERMAL SHOCK

LIMESTONE FRACTURED

LIMESTONE LOOSE

FINIALS DAMAGED

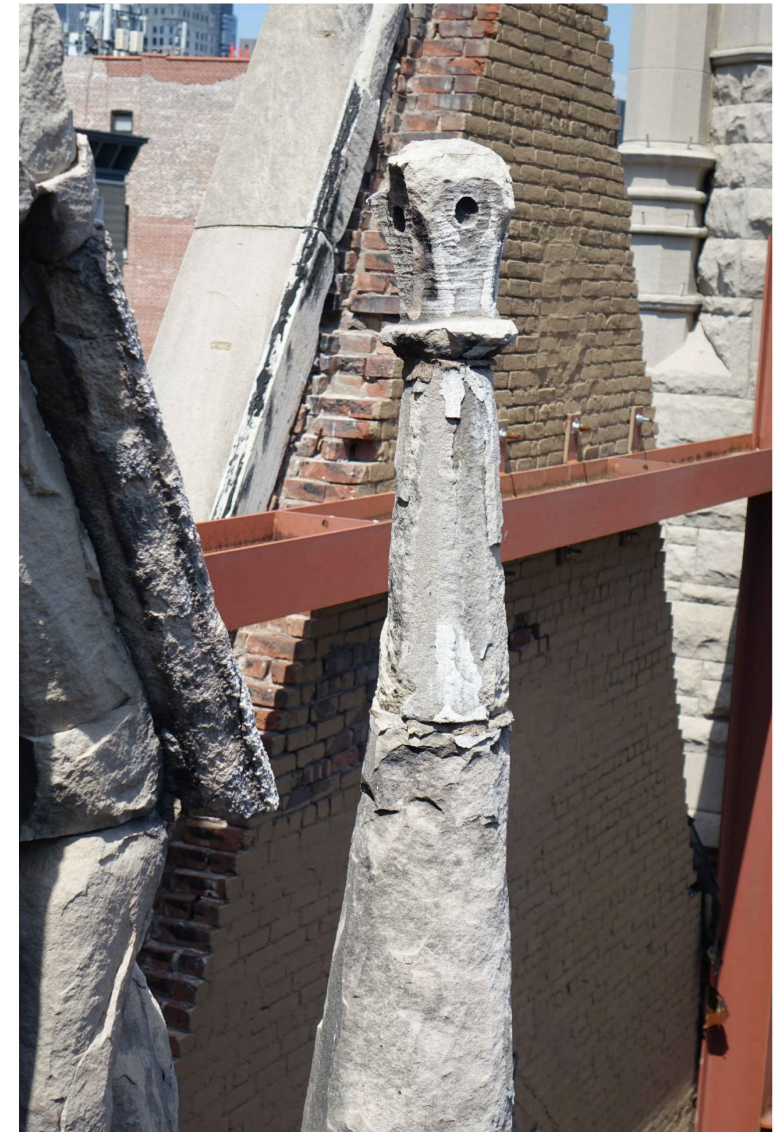
SOUTH SPIRE

LIMESTONE SPALLING FROM
THERMAL SHOCK

LIMESTONE FRACTURED

LIMESTONE LOOSE

FINIALS DAMAGED

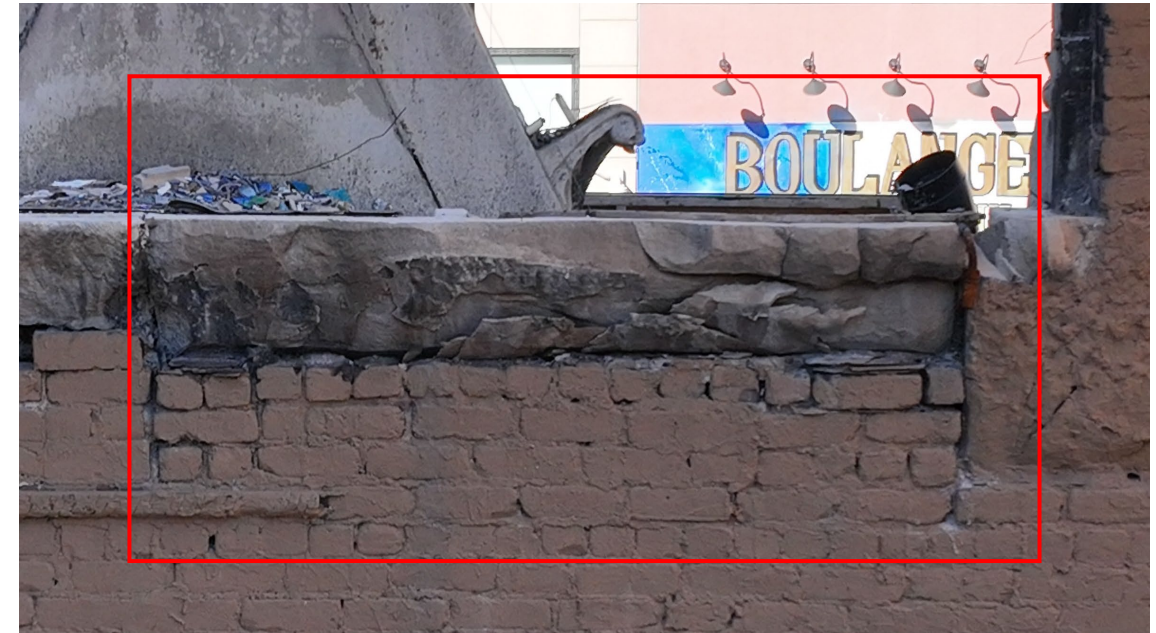
BACK OF GABLE SILL

DIMENSIONAL STONE
FRACTURED

MORTAR MISSING

MASONRY DAMAGED BY
THERMAL SHOCK

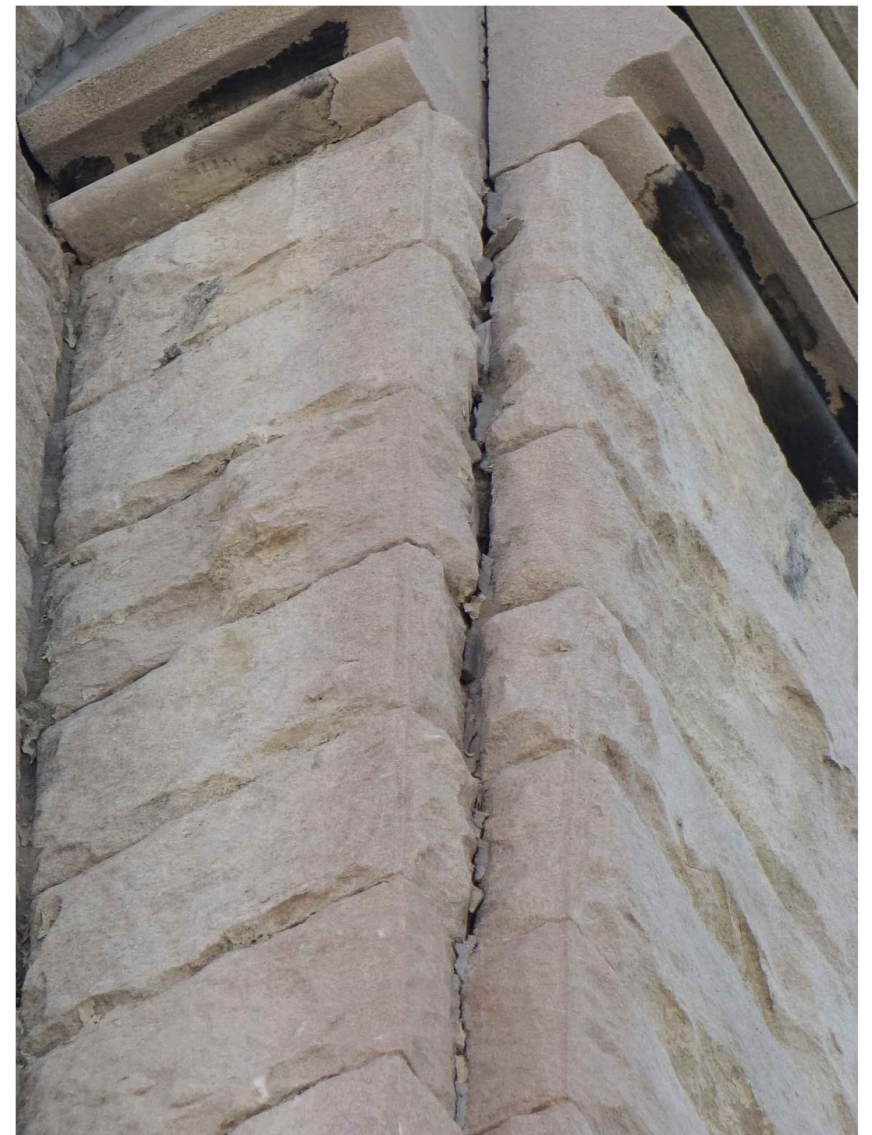
7. NORTH TOWER – LIMESTONE CRACK ENLARGED

LIMESTONE SEPARATING AT BUTRESS

WATER INFILTRATION AND FREEZE THAW LIKELYHOOD
