Preservation Department – Item 2, LPC-23-02975

**112 2nd Avenue – East Village/Lower East Side Historic District  
Borough of Manhattan**

SUPPLEMENTAL PRESENTATION IN SUPPORT OF MCC APPLICATION

MIDDLE COLLEGIATE CHURCH

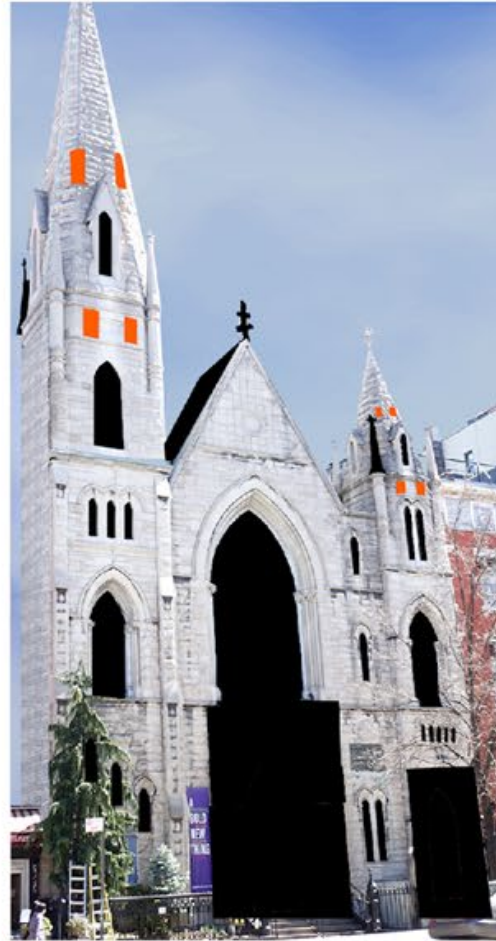
MINIMUM OF MATERIALS DESTROYED IN FIRE OR REQUIRED TO BE REMOVED FOR EGRESS AND SITE ACCESS OF EQUIPMENT

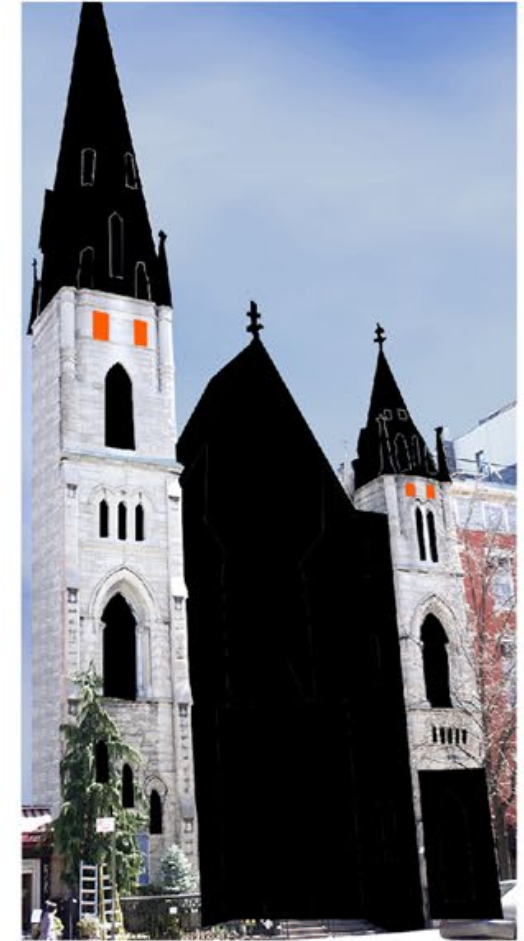
MINIMUM OF MATERIALS DAMAGED OR TO BE REMOVED FOR SAFETY

- DAMAGED/REMOVED MATERIAL
- NEEDLE BEAMS FOR OVERHEAD PROTECTION

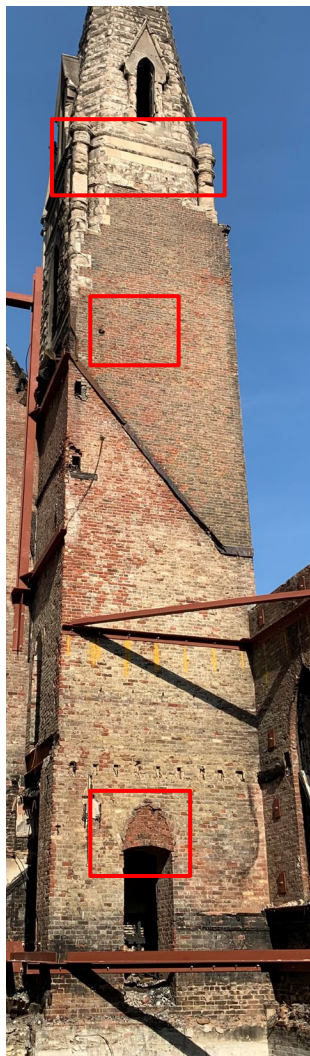
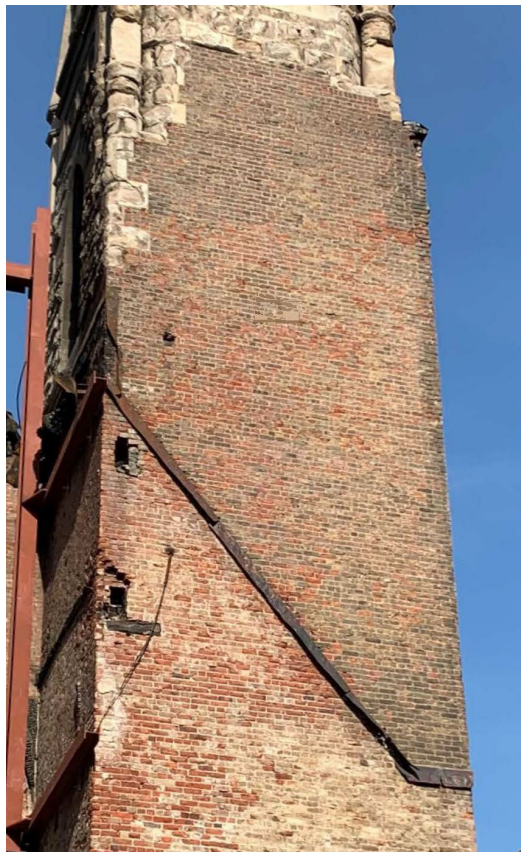
NORTH TOWER

- 35 BRICKS WITHOUT VISIBLE SURFACE DAMAGE
- 386 DAMAGED BRICKS
- 88% DAMAGED BRICKS

IMAGE IS APPROXIMATELY 15% OF TOWER FACE

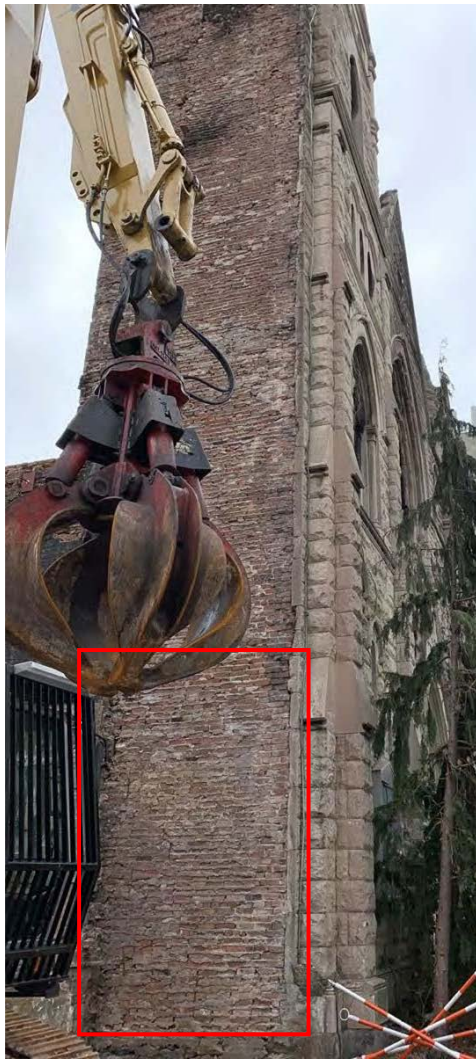
NORTH TOWER – NORTH WALL

CRACKS

VISIBLE MASONRY CRACKS

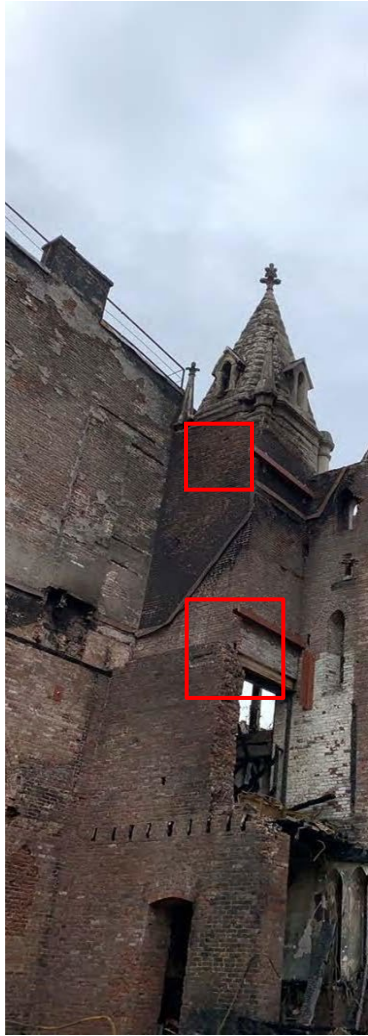
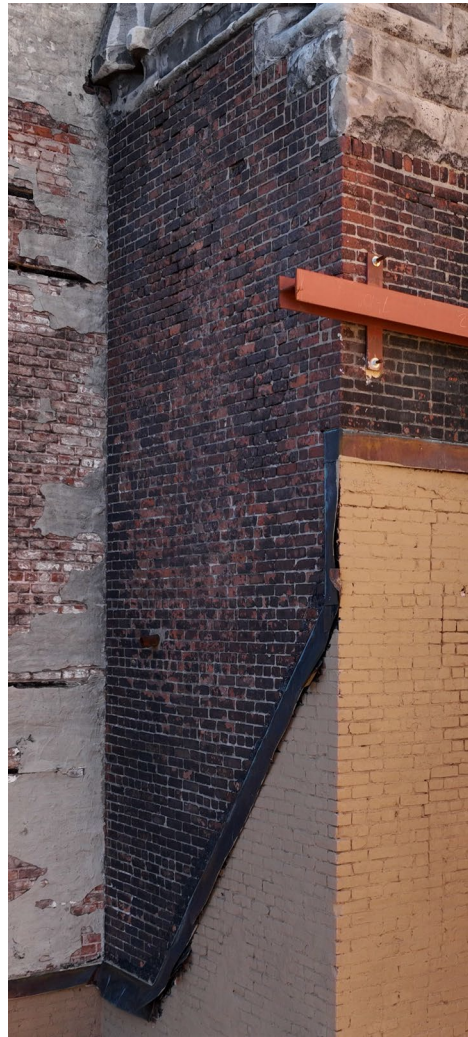
SOUTH TOWER

CRACK AT STEEL TRANSFER

35 BRICKS WITHOUT VISIBLE SURFACE DAMAGE

322 DAMAGED BRICKS

90% DAMAGED BRICKS

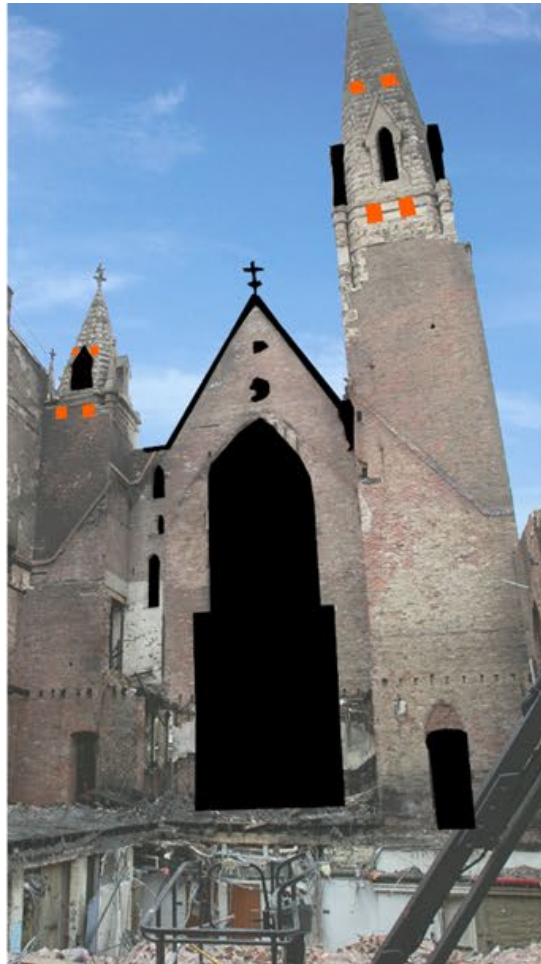
ORIGINAL MATERIALS LOST IN FIRE  
OR REMOVED FOR EGRESS  
& SITE ACCESS

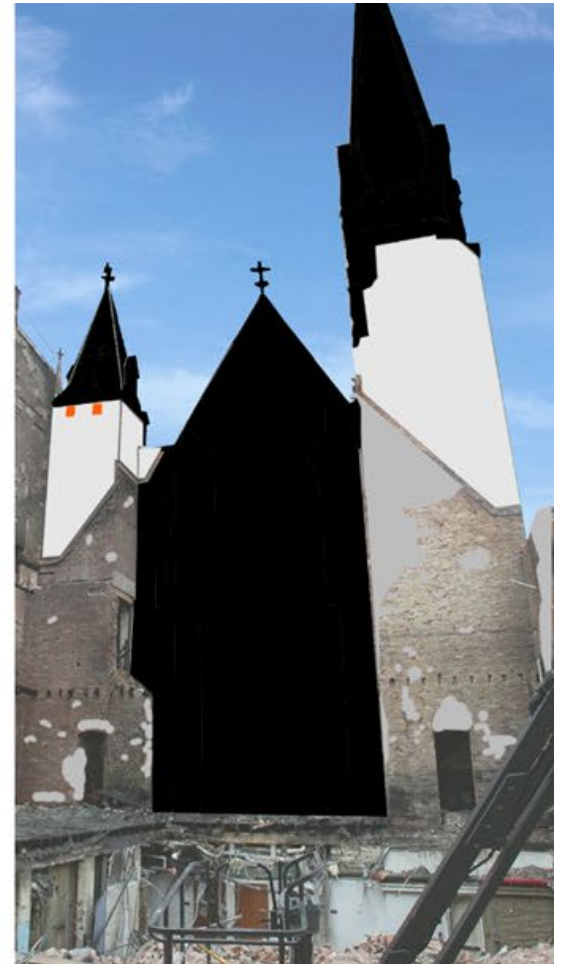
MINIMUM OF MATERIALS DAMAGED OR TO  
BE REMOVED FOR SAFETY

DAMAGED/REMOVED MATERIAL

INTERIOR SPALLING BRICK TO BE REMOVED

EXTERIOR SPALLING BRICK TO BE REMOVED

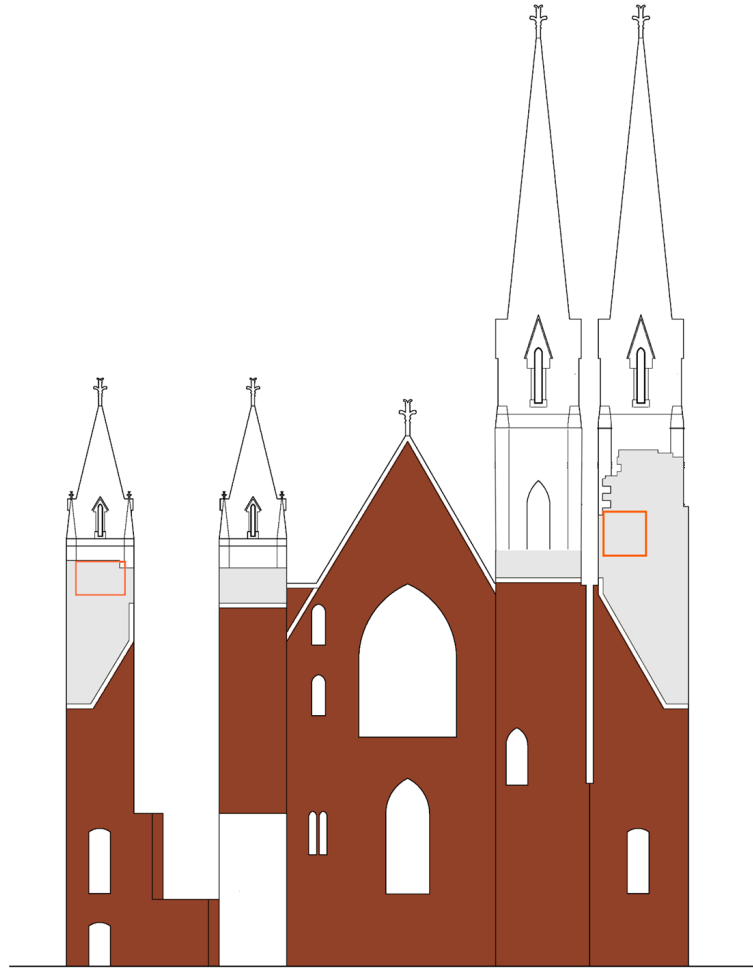
**EXTERIOR BRICK**

**CALCULATED AREAS OF DAMAGED BRICK**

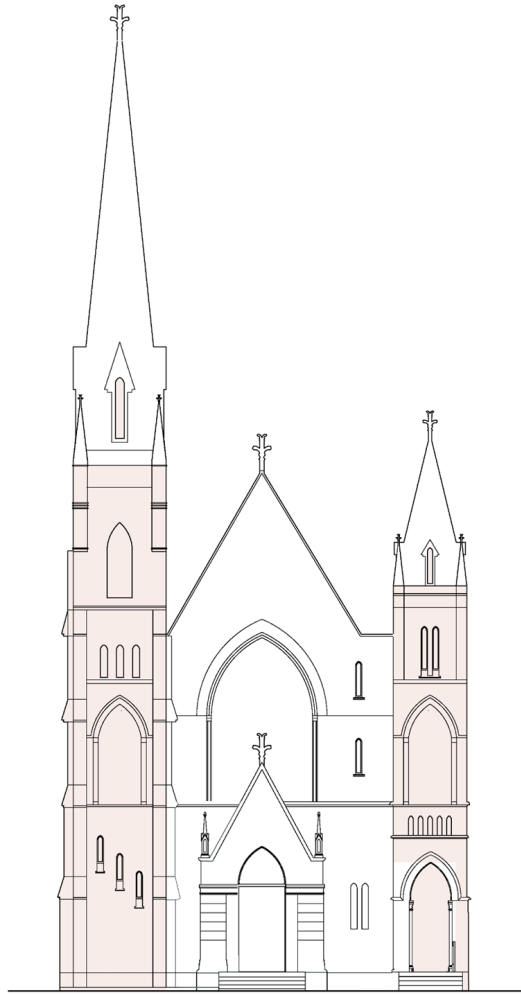
**FRONT ELEVATION**

**LIMESTONE DAMAGED OR TO BE REMOVED**

<b>TOTAL LIMESTONE AREA</b>	<b>3,900 SF</b>
<b>TOTAL DAMAGED / TO BE REMOVED</b>	<b>2,815 SF (72%)</b>
<b>TOTAL REMAINING</b>	<b>1,085 SF (28%)</b>

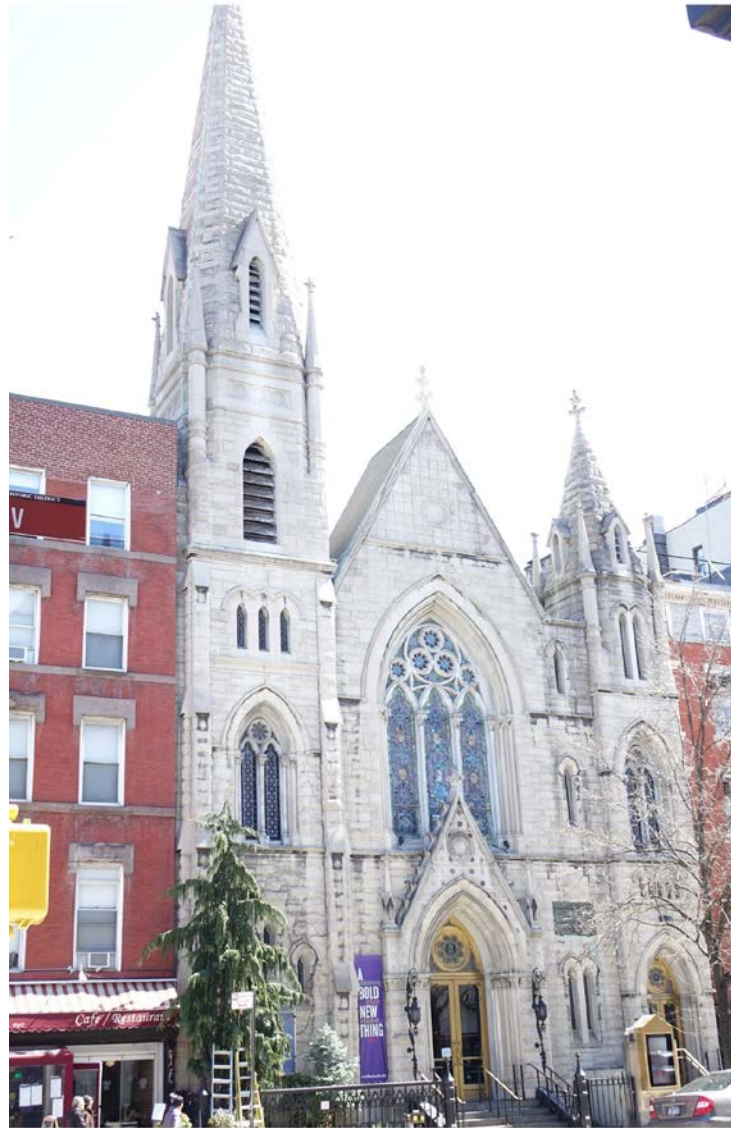
2<sup>nd</sup> Ave. FAÇADE – PRE FIRE

INDIANA LIMESTONE FAÇADE – *DAMAGED AND LOCALLY DESTABILIZED*

LIMESTONE BUTTRESSES – *CRACKS FORMED*

LIMESTONE FINIALS – *DAMAGED AND DESTROYED*

STAINED GLASS WINDOWS (POSSIBLY TIFFANY GLASS) – *DESTROYED*

WOOD AND BRONZE TRACERY – *DAMAGED, AND REMOVED BY ORDER NYC DOB*

GABLED CENTRAL BAY – *DAMAGED AND LOCALLY DESTABILIZED*

NORTHERN TOWER AND SPIRE – *MASONRY DAMAGED, LIMESTONE FRACTURED AND LOCALLY DESTABILIZED*

SOUTHERN TOWER AND SPIRE – *MASONRY DAMAGED, LIMESTONE FRACTURED AND LOCALLY DESTABILIZED*

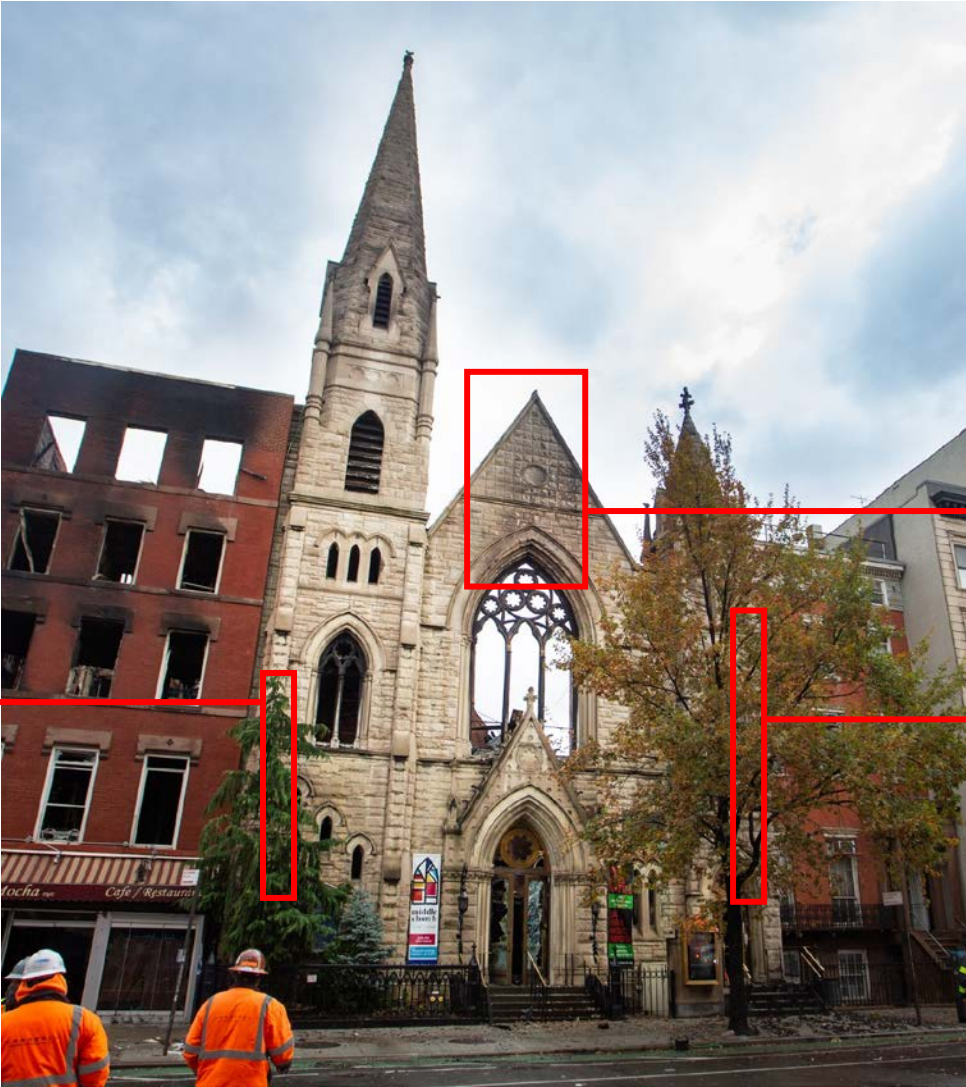
LPC-7

NORTH TOWER CRACK

GABLE ARCH

SOUTH TOWER CRACK

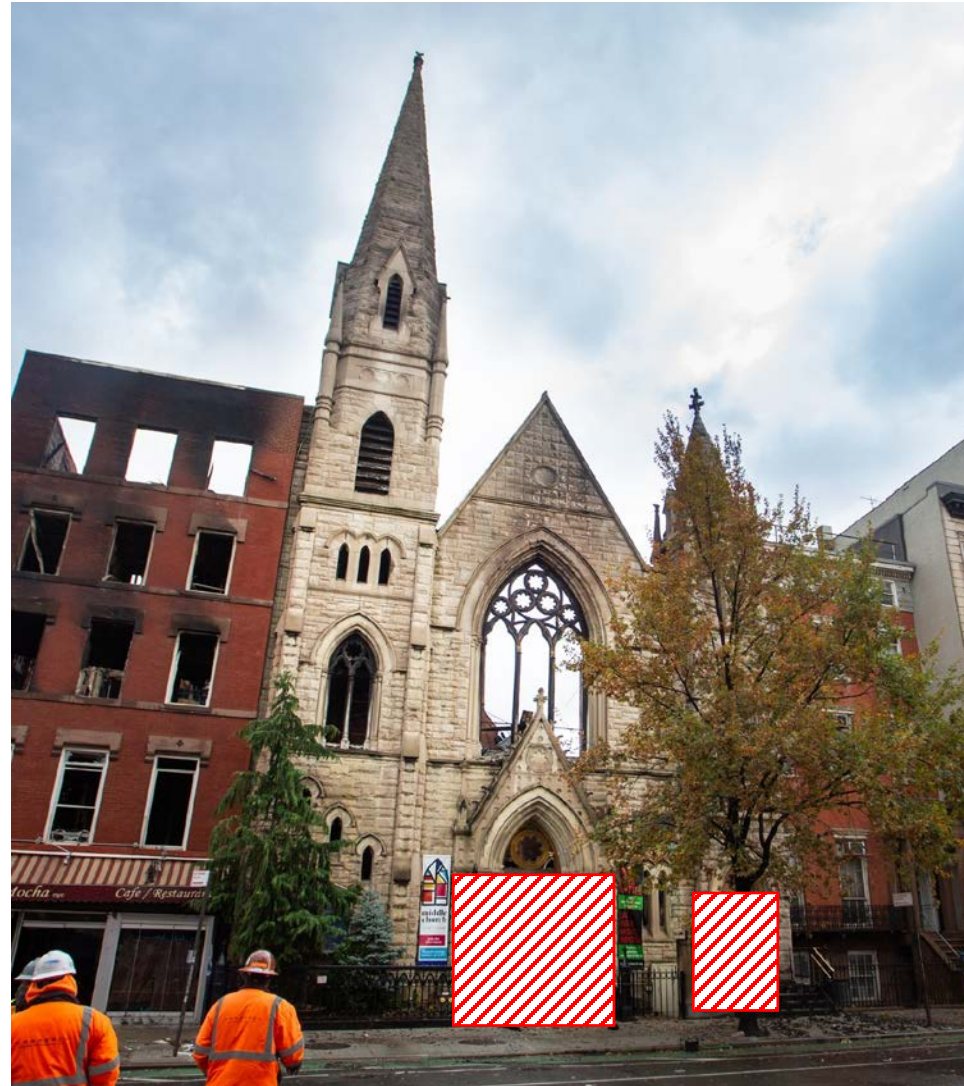
LPC-8

HISTORIC FABRIC TO BE REMOVED

2<sup>ND</sup> Ave. FAÇADE MODIFICATIONS REQUIRED FOR EGRESS BY NYC CODE

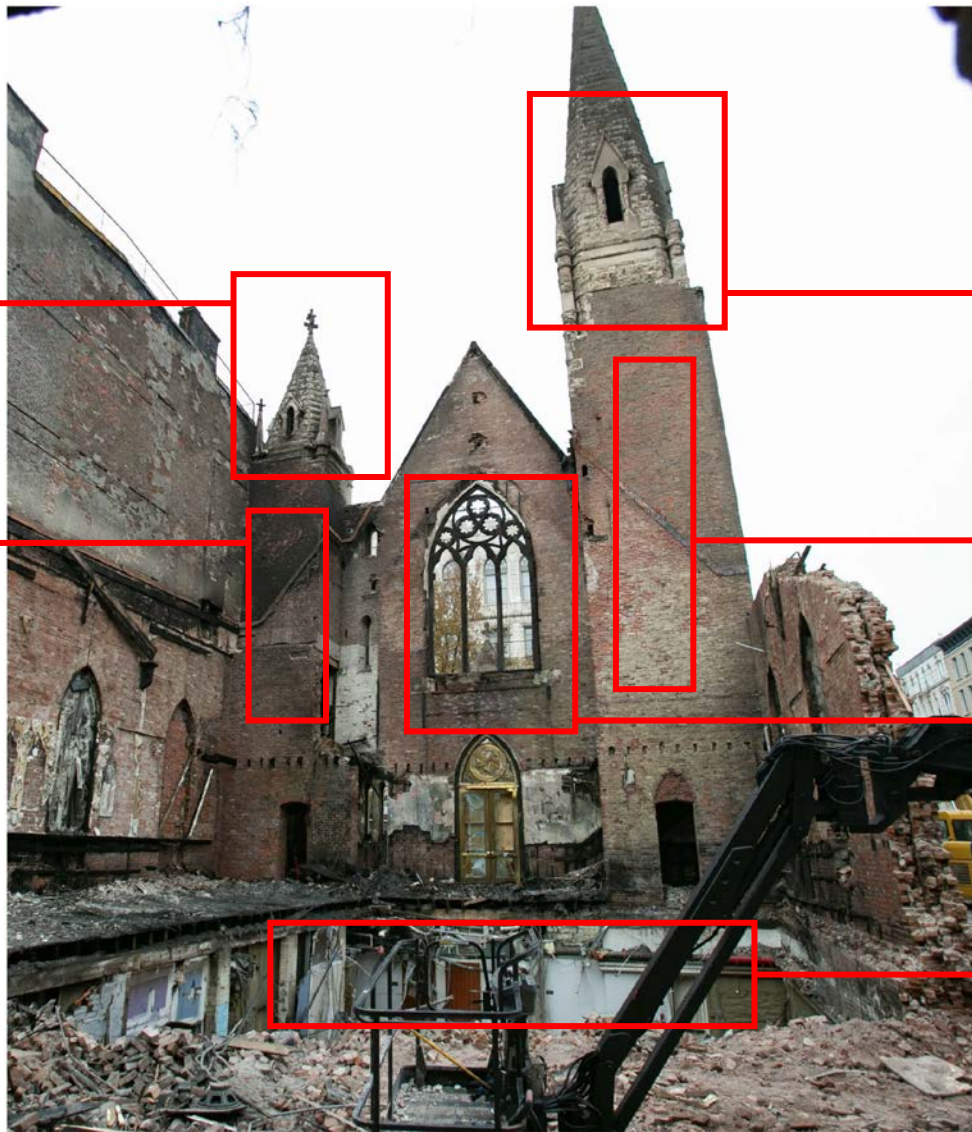
SOUTH SPIRE LIMESTONE

NORTH SPIRE LIMESTONE

FOUNDATION WALL

SPALLING BRICK DUE TO  
THERMAL SHOCK

MISSING MORTAR

MISSING BRICKS

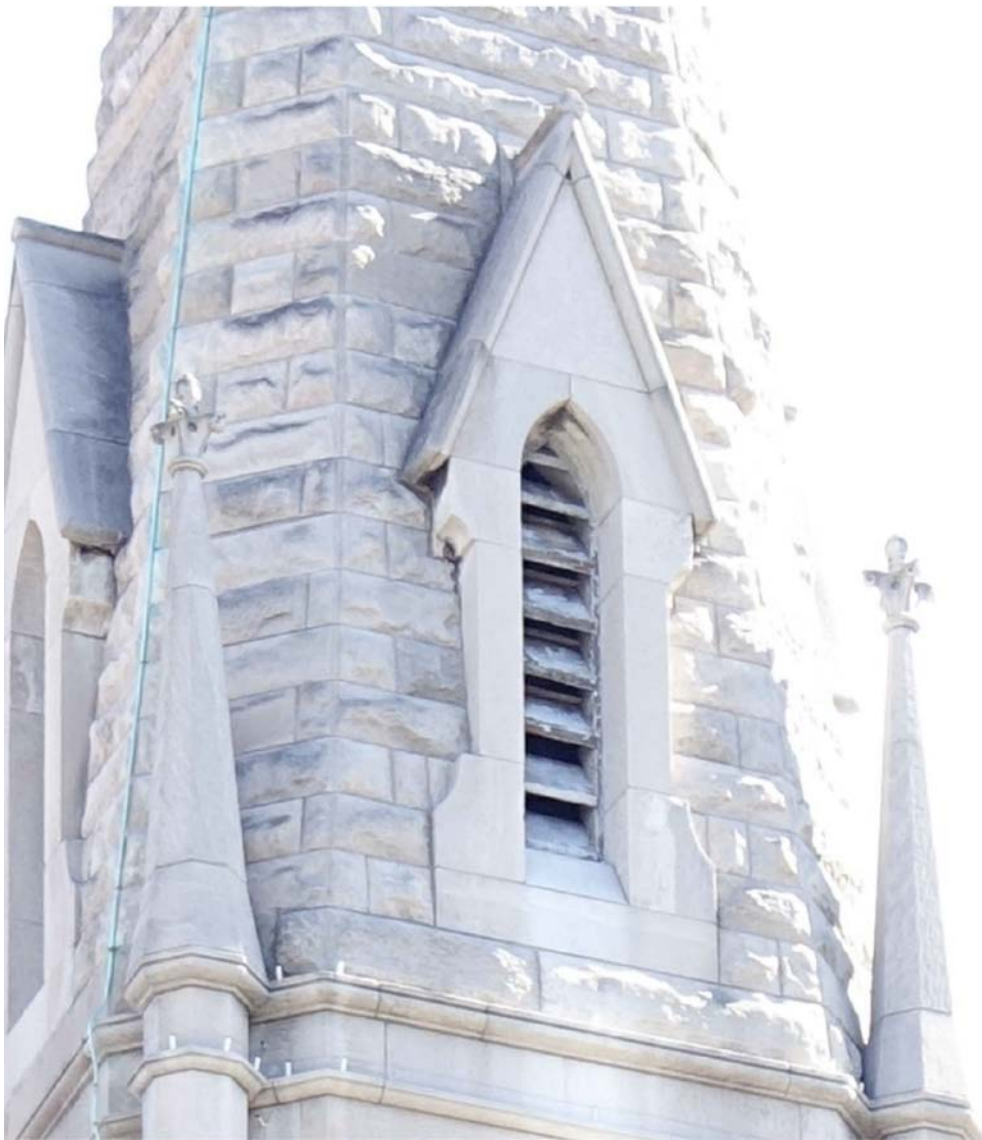
SOUTH SPIRE PRE-FIRE

**LOCALIZED DESTABILIZATION**

LIMESTONE SPALLING FROM THERMAL SHOCK

LIMESTONE FRACTURED

LIMESTONE LOOSE

FINIALS DAMAGED

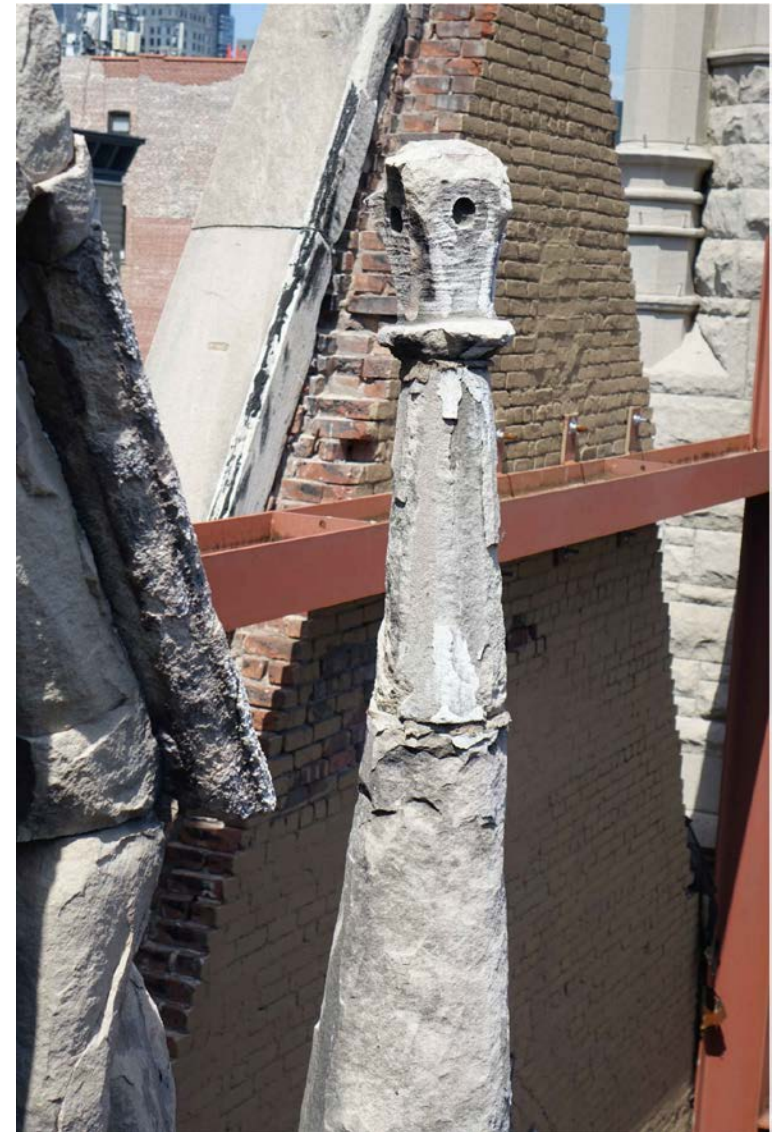
SOUTH SPIRE

LIMESTONE SPALLING FROM THERMAL SHOCK

LIMESTONE FRACTURED

LIMESTONE LOOSE

FINIALS DESTROYED

LIMESTONE HELD IN PLACE BY GRAVITY AND/OR FRICTION

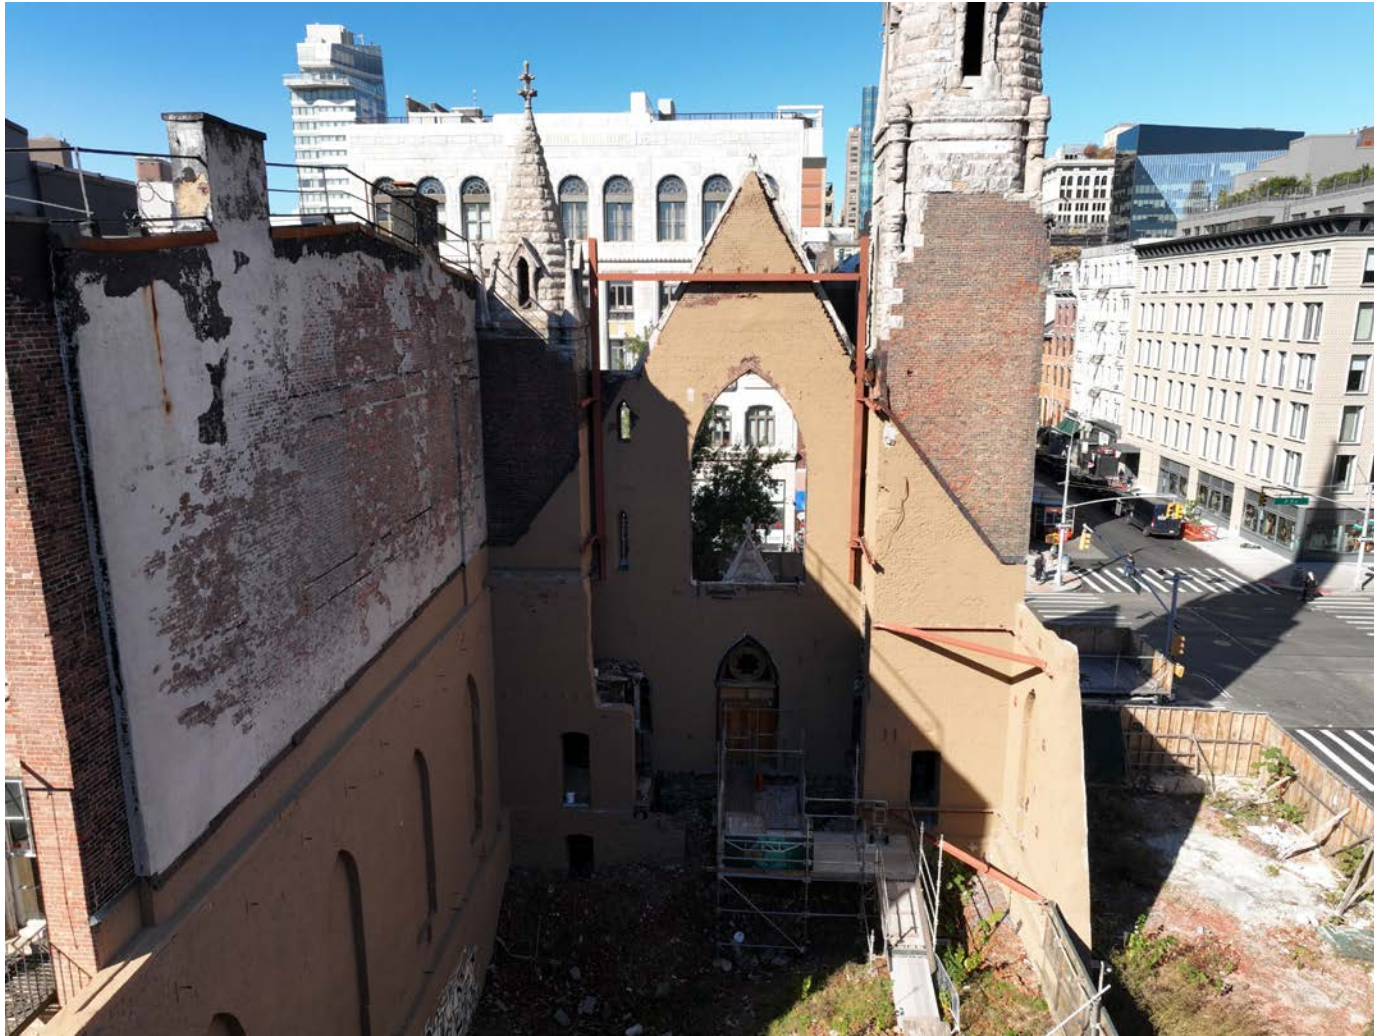
LPC-15

CORNER SITE CLEARED

FAÇADE TEMPORARILY BRACED

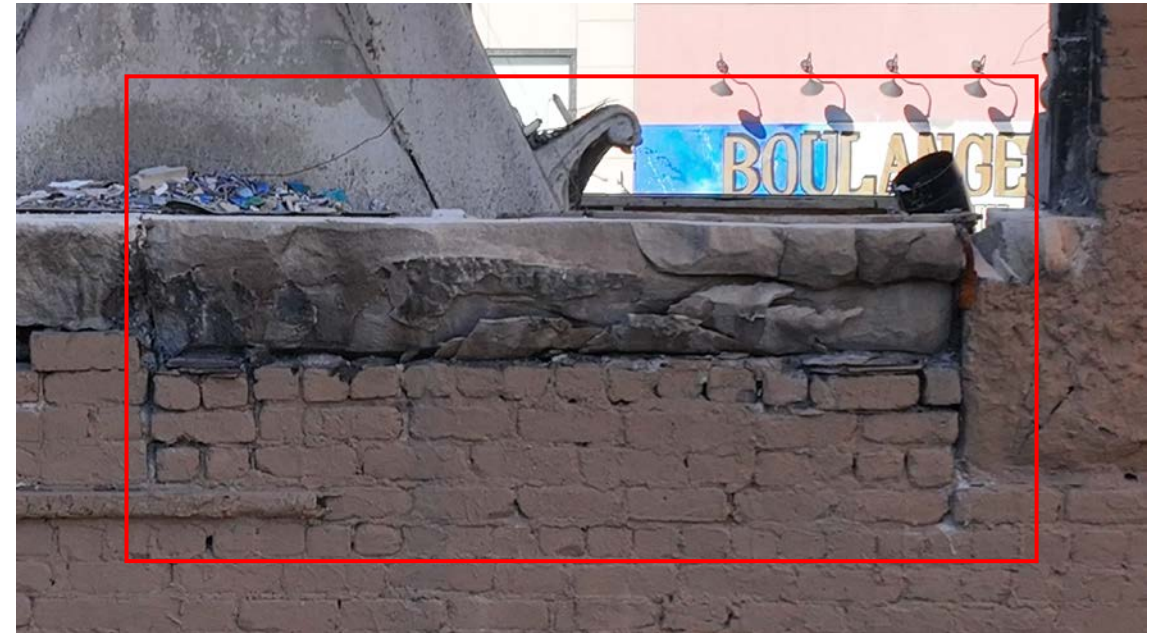
GABLE ARCH

DIMENSIONAL STONE  
FRACTURED

MORTAR MISSING

MASONRY DAMAGED BY  
THERMAL SHOCK

BACK OF GABLE SILL

SPALLING LIMESTONE DUE TO  
THERMAL SHOCK

MISSING MASONRY

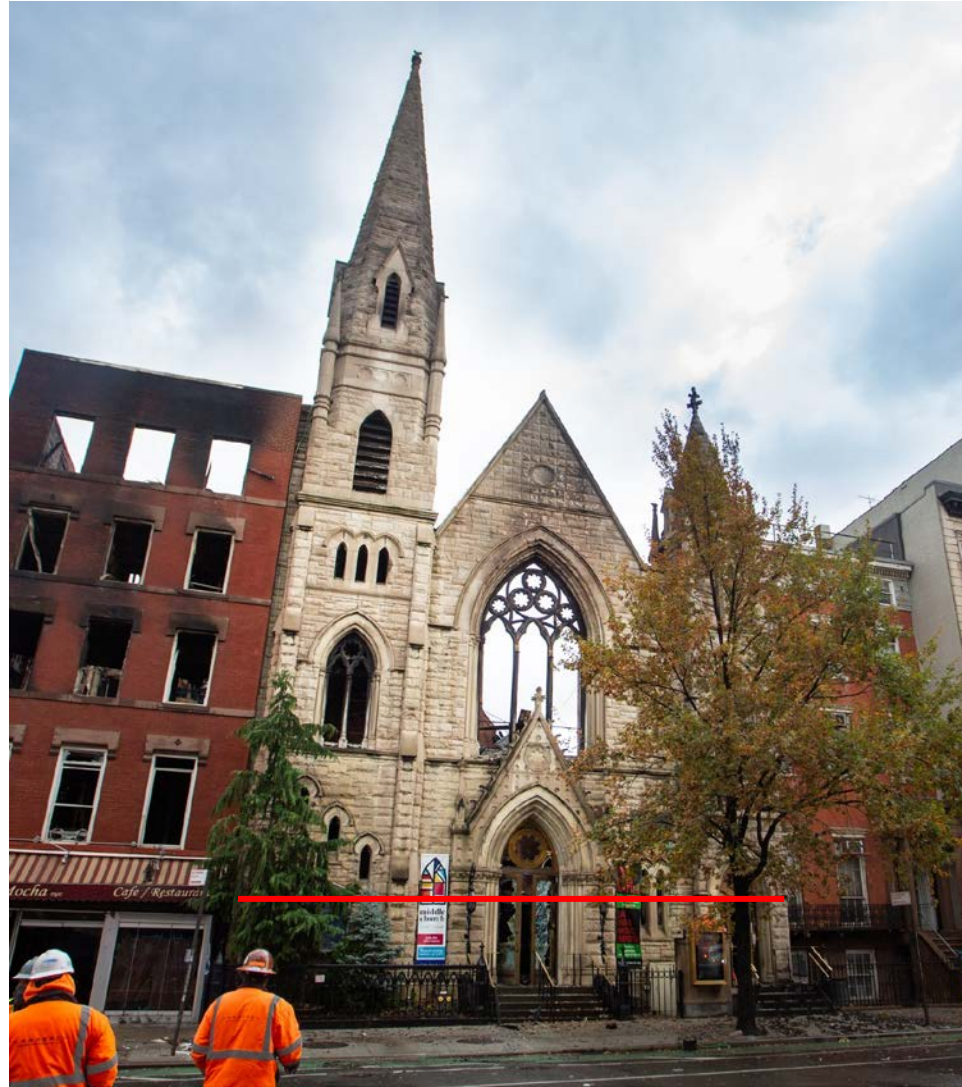
POSSIBLE SALVAGE OF STONE BELOW 8'-0"

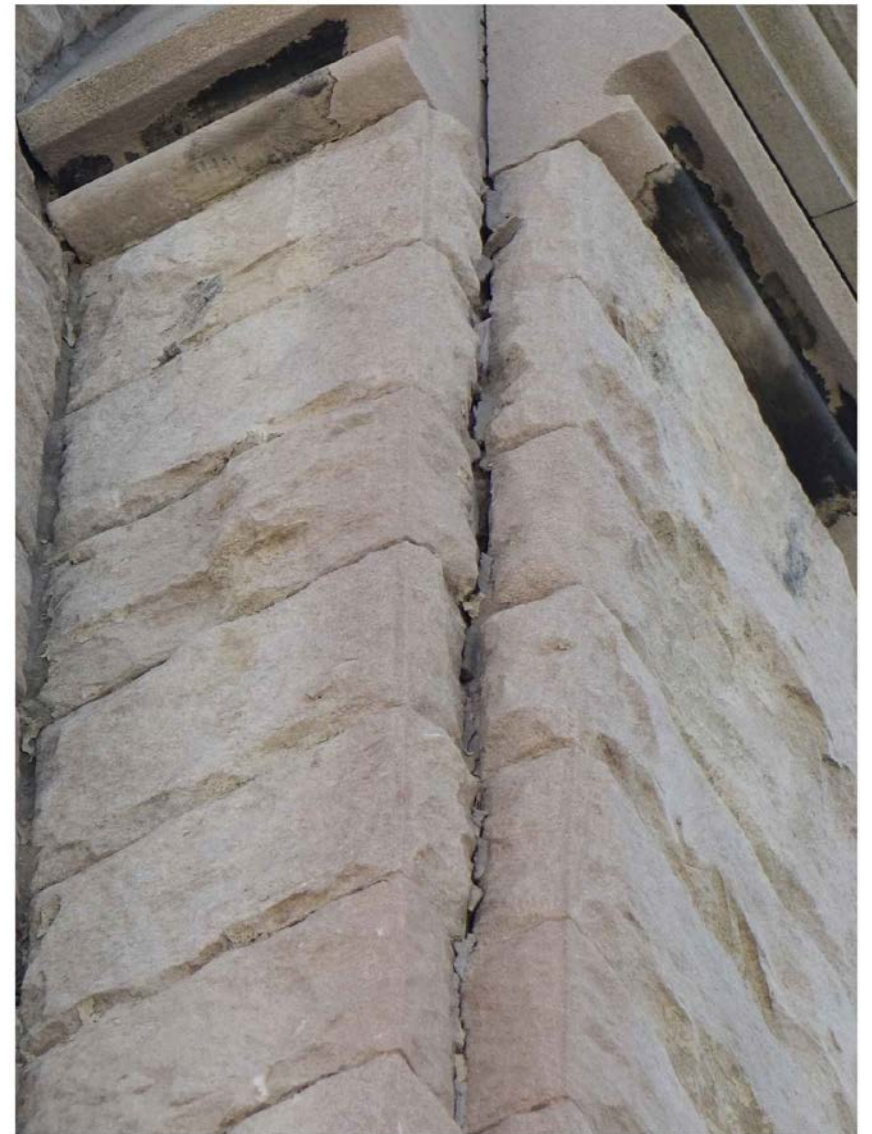
7. NORTH TOWER – LIMESTONE CRACK ENLARGED

LIMESTONE SEPARATING AT BUTRESS

WATER INFILTRATION AND FREEZE THAW LIKELYHOOD

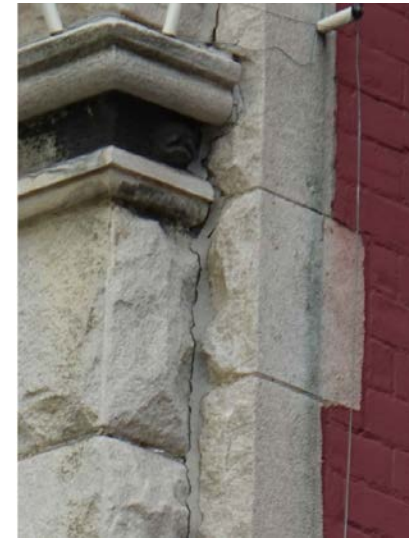
8. SOUTH TOWER – CRACK ENLARGED

LIMESTONE SEPARATING AT SOUTH WALL

WATER INFILTRATION AND FREEZE THAW LIKELYHOOD
