Cary Building  
105 Chambers Street Façade Restoration

Localized Cast Iron Replacement

NYC Landmarks Preservation Commission Presentation

August 29<sup>th</sup>, 2023

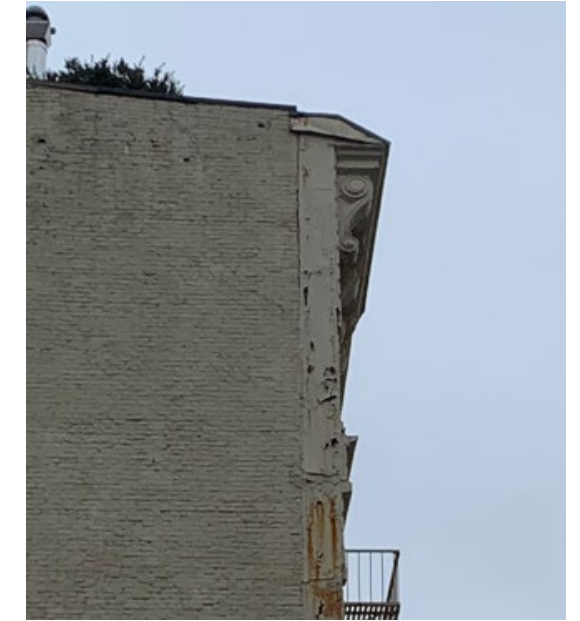
Church St - Northeast corner

Church St - Southeast corner missing cast iron element . Replacement to match Northeast corner design.

Proposed fiberglass to match existing cast iron elements in color, design and dimension.

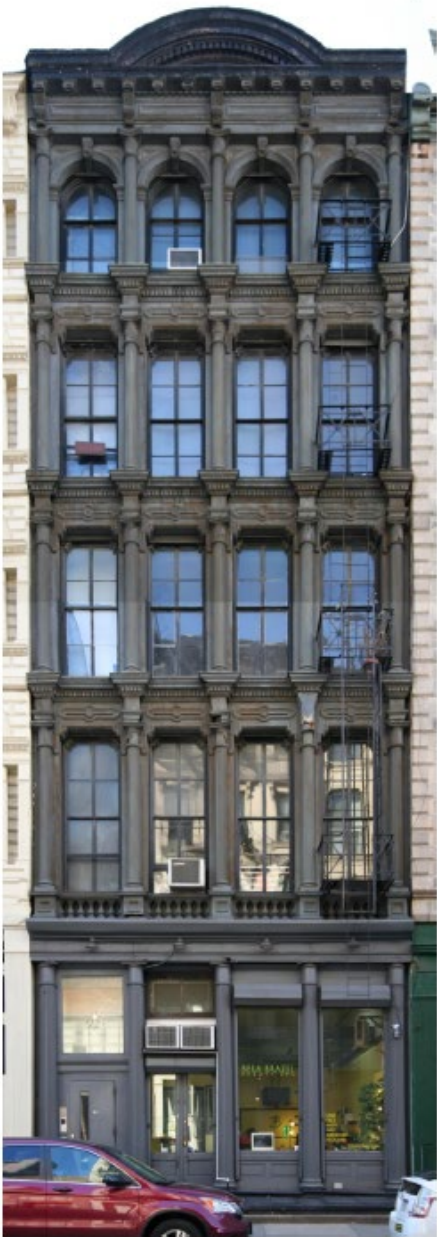
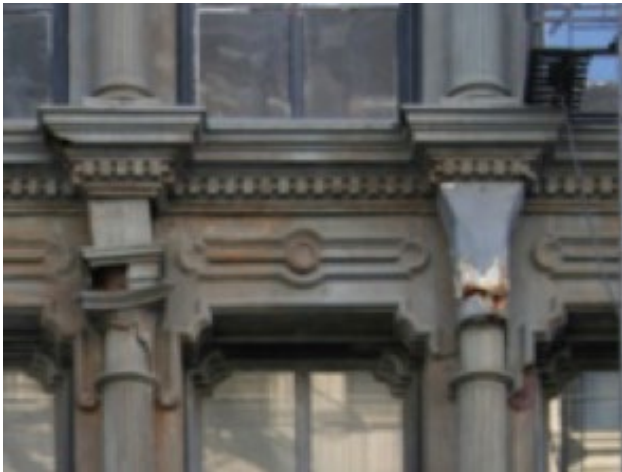
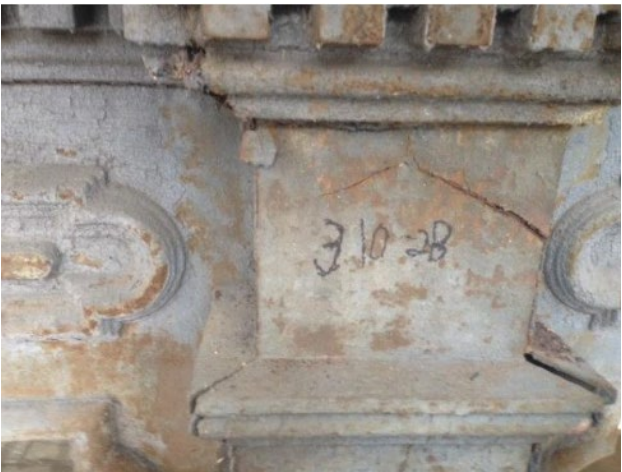
Before: Deteriorated cast iron capitals.
