Preservation Department – Item 9, LPC-25-08773

1466 Broadway – Knickerbocker Hotel – Individual Landmark Borough of Manhattan

Scope of Work Statement and Conditions Assessment for the Knickerbocker Hotel

Request for Terra Cotta Unit Replacement in Cast Stone

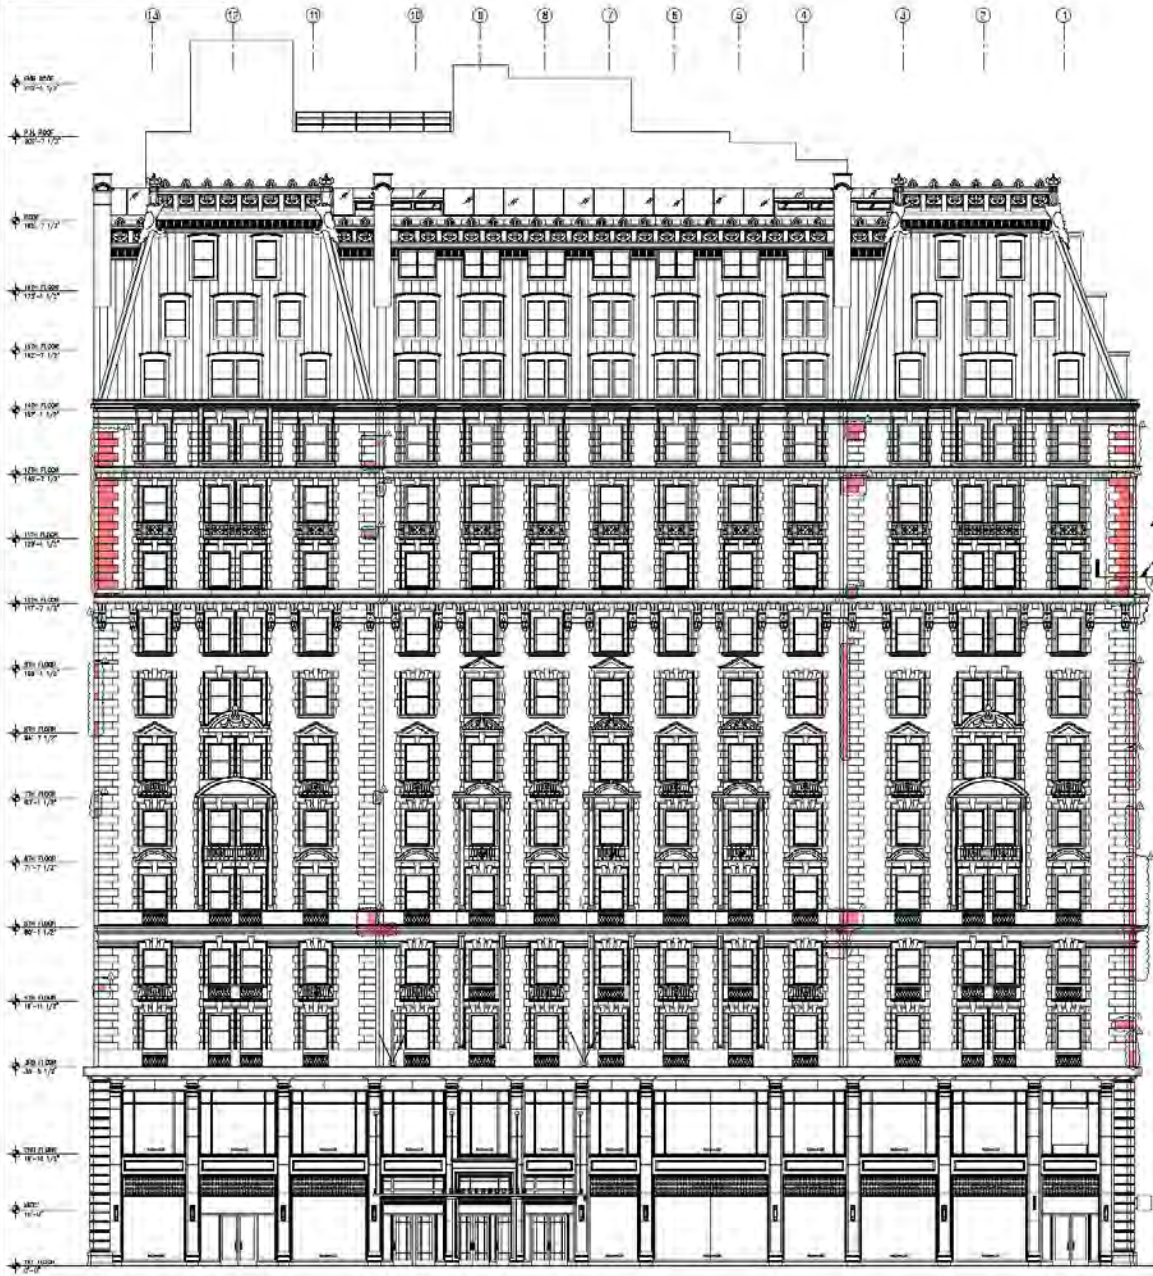
1 NORTH ELEVATION - STREET FACING FACADE
DATE: 10-17-17

Locations of requested
terra cotta replacement
in cast stone.

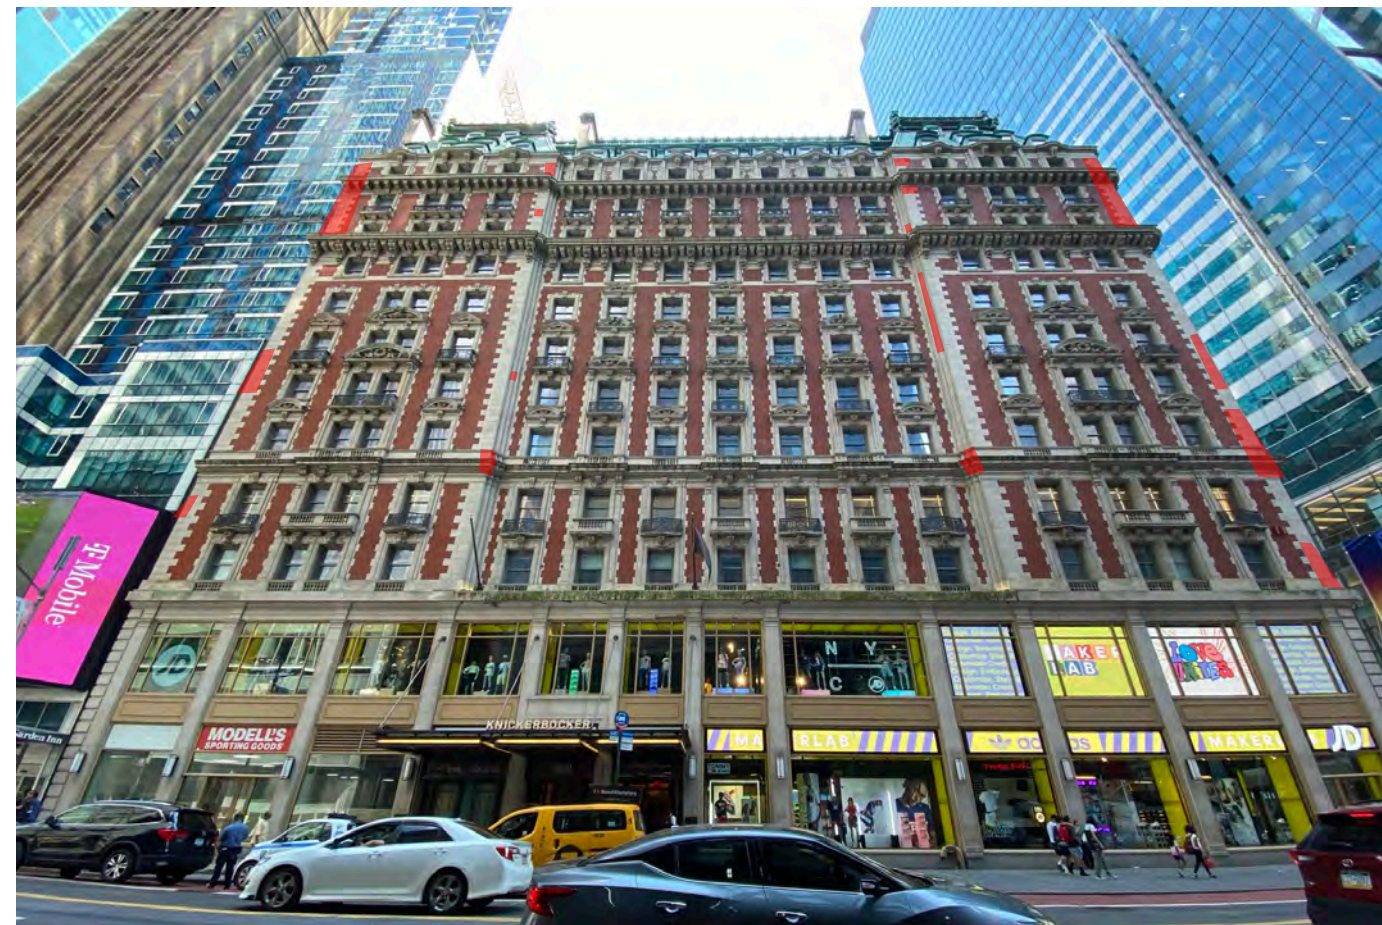
1. North Elevation

Locations of requested
terra cotta replacement
in cast stone.

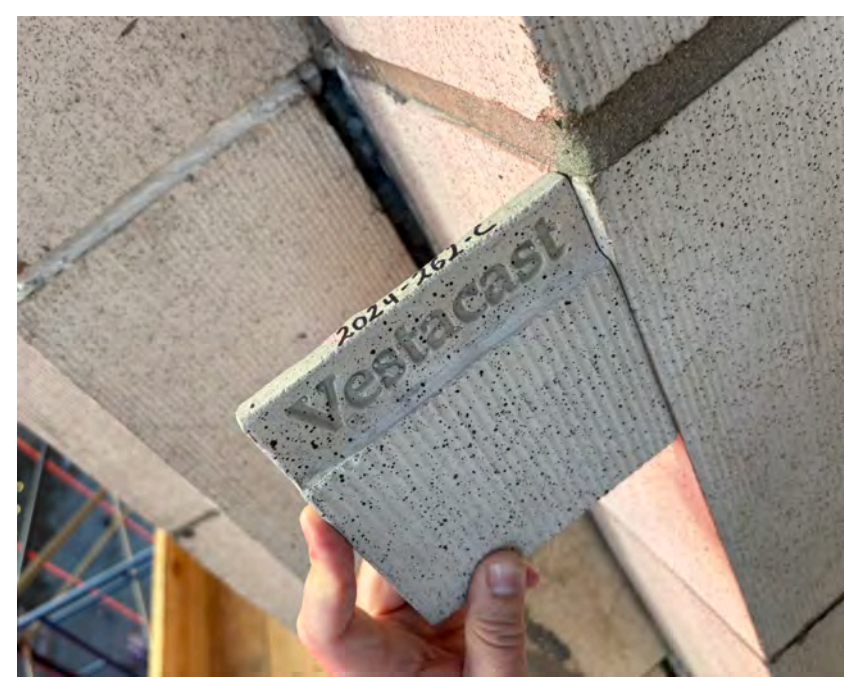
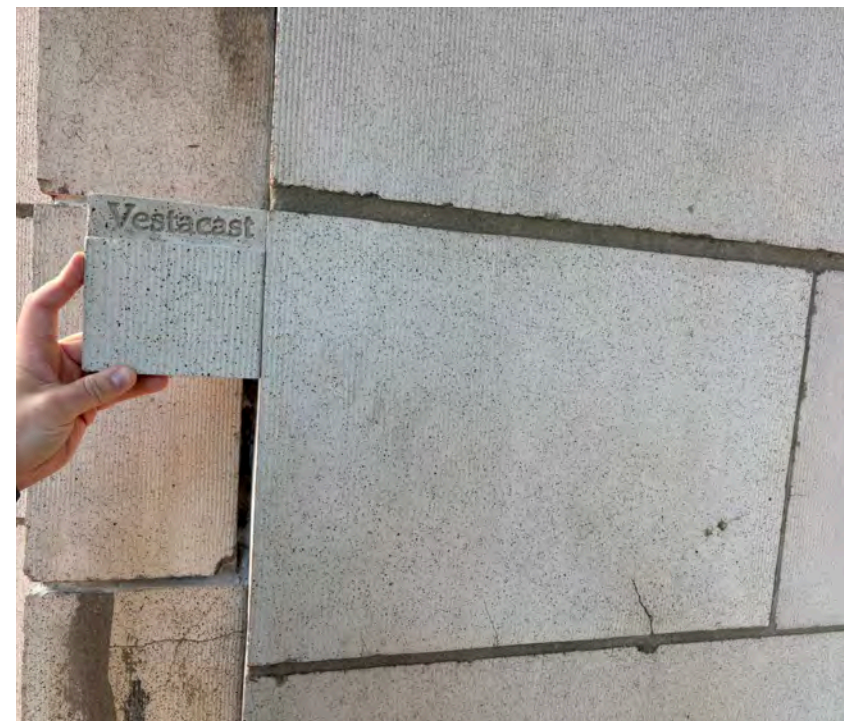
Photo: 1

North Elevation: 10/18/2024
 Northeast Corner.
 Overall view: **Type 1, 2A, 2B, 3A, and 3B.**
 Replacement in Cast Stone.

North Elevation: 2/26/2025
 Northeast Corner.
 Close-up view: **Type 1, 2A, 2B, 3A, and 3B.**
 Replacement in Cast Stone.

Terra Cotta Unit
 Existing conditions
 Northeast Corner

- Prior crack or patch repair failures
- New cracks at terra cotta
- Multiple repairs per unit
- Open mortar joints

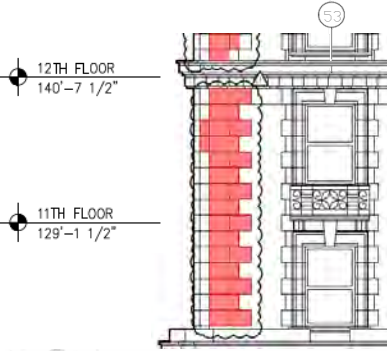
Key Plan: West Elevation

Terra Cotta Unit
Existing Conditions
Northwest corner

- Prior crack or patch repair failures
- New cracks at terra cotta
- Multiple repairs per unit
- Open mortar joints

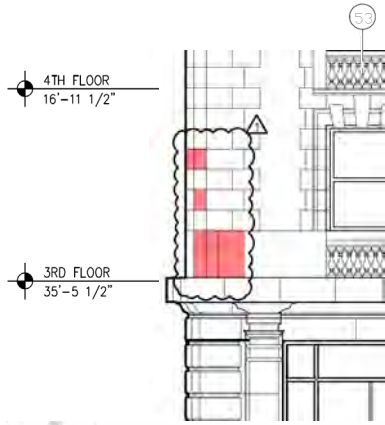
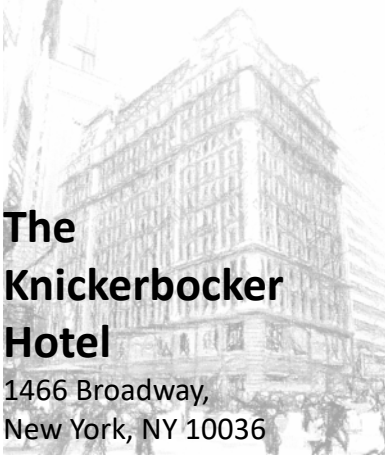
Photo: 5
 North Elevation: 2/26/2025
 Northwest Corner.
 Overall view: **Type 5 and 6.**
 Replacement in Cast Stone.

Photo: 6
 North Elevation: 2/26/2025
 Northwest Corner.
 Close-up view: **Type 5.**
 Replacement in Cast Stone.

Terra Cotta Unit
 Existing conditions
 Northwest Elevation

- Cracked terra cotta
- Spalled patch
- Unsound unit

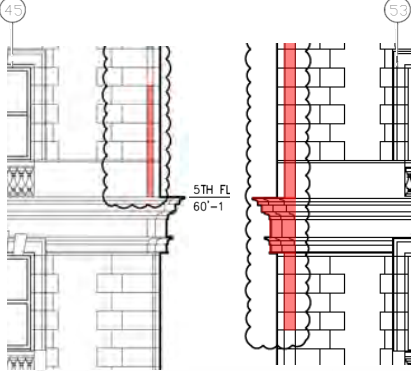
Terra Cotta Unit
Existing condition
West Elevation

- Prior crack repair failures
- New cracks at terra cotta
- Separating vertical cracks

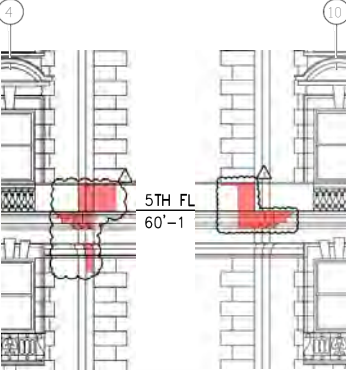
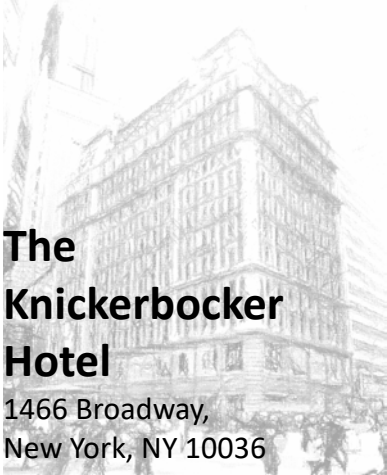
Key Plan: North & West
Photo: 9 **Photo: 10**

Photo: 9
 North Elevation: 10/21/2024
 North Setback Corner.
 Overall view: Type 9D, 9E, and 9F.
 Replacement in Cast Stone.

Photo: 10
 North Elevation: 10/21/2024
 North Setback Corner.
 Overall view: Type 10, 11, 12A, 12B, 13A, and 13B.
 Replacement in Cast Stone.

Photos:
 Terra Cotta Unit
 Existing condition
 West Elevation

- Conditions:**
- Prior crack repair failures
 - New cracks at terra cotta
 - Separating vertical cracks

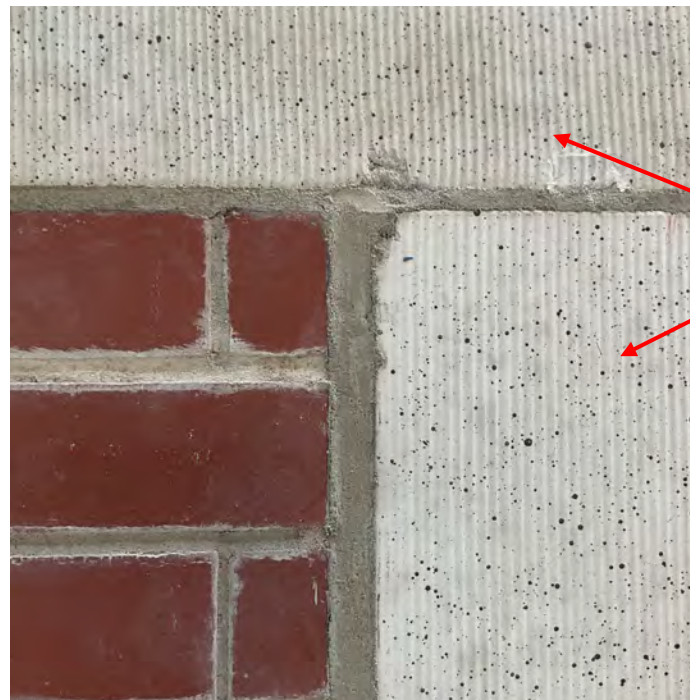
Ashlar Cladded Units
South Elevation.

Existing historic terra cotta unit.

Previously replaced cast stone unit.

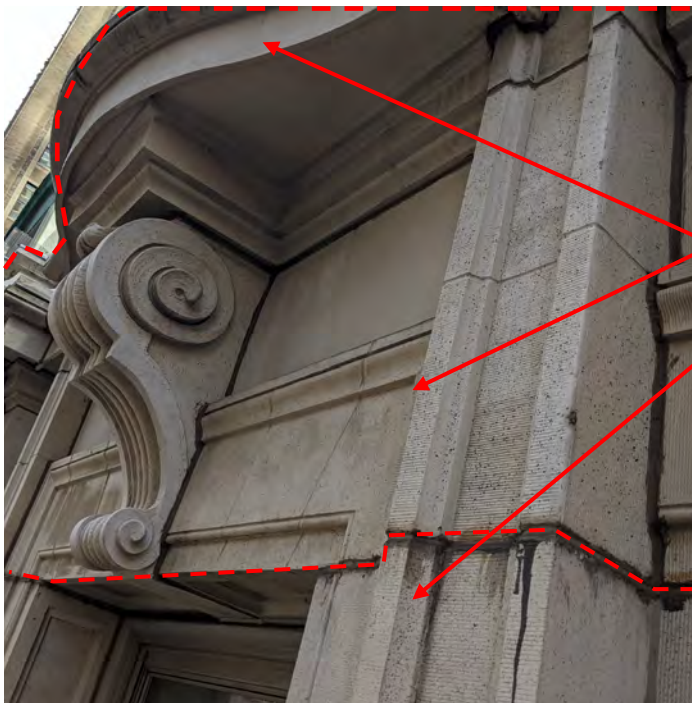
Water-Table and Window Head Units
North Elevation.

Previously replaced fiberglass units.

Existing historic terra cotta unit.

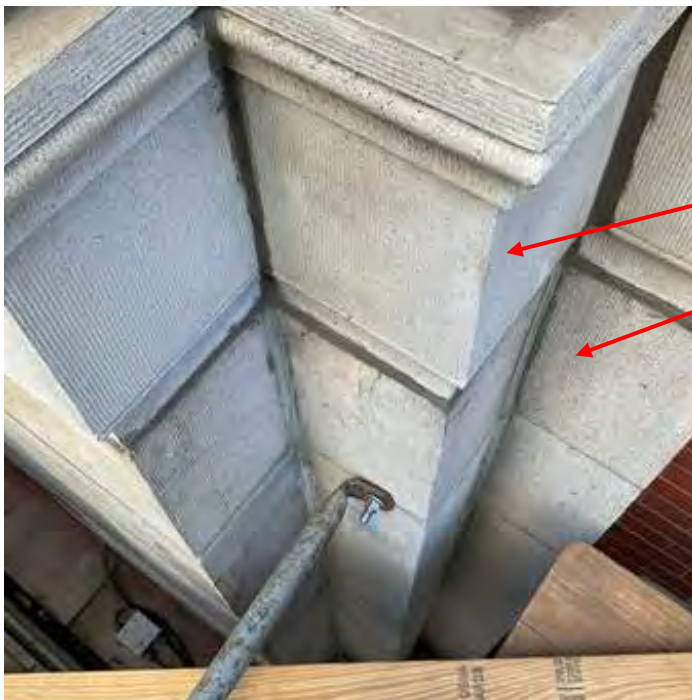
Water-Table Corner Units
North Elevation.

Previously replaced fiberglass unit.

Existing historic terra cotta unit.
