**1 East 60th Street – Upper East Side Historic District
Borough of Manhattan**

The Metropolitan Club

Presentation for Landmark Restoration and Proposed Capital Work

4.0 Appendix A: Existing Conditions Report

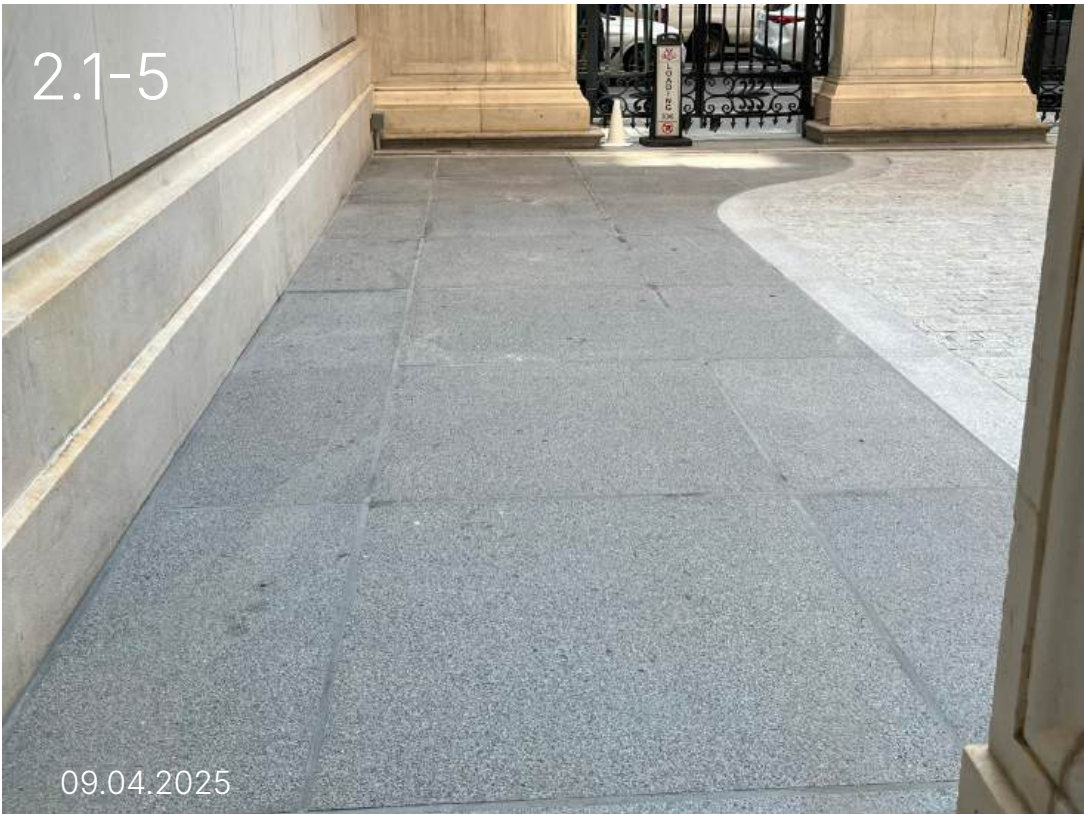
- 2.1-5 Courtyard Path Pavement**
- Removed deteriorated concrete and non-matching concrete patching.
 - Re-introduced historic granite paving.
 - Entire courtyard graded to eliminate changes in level to entrances.

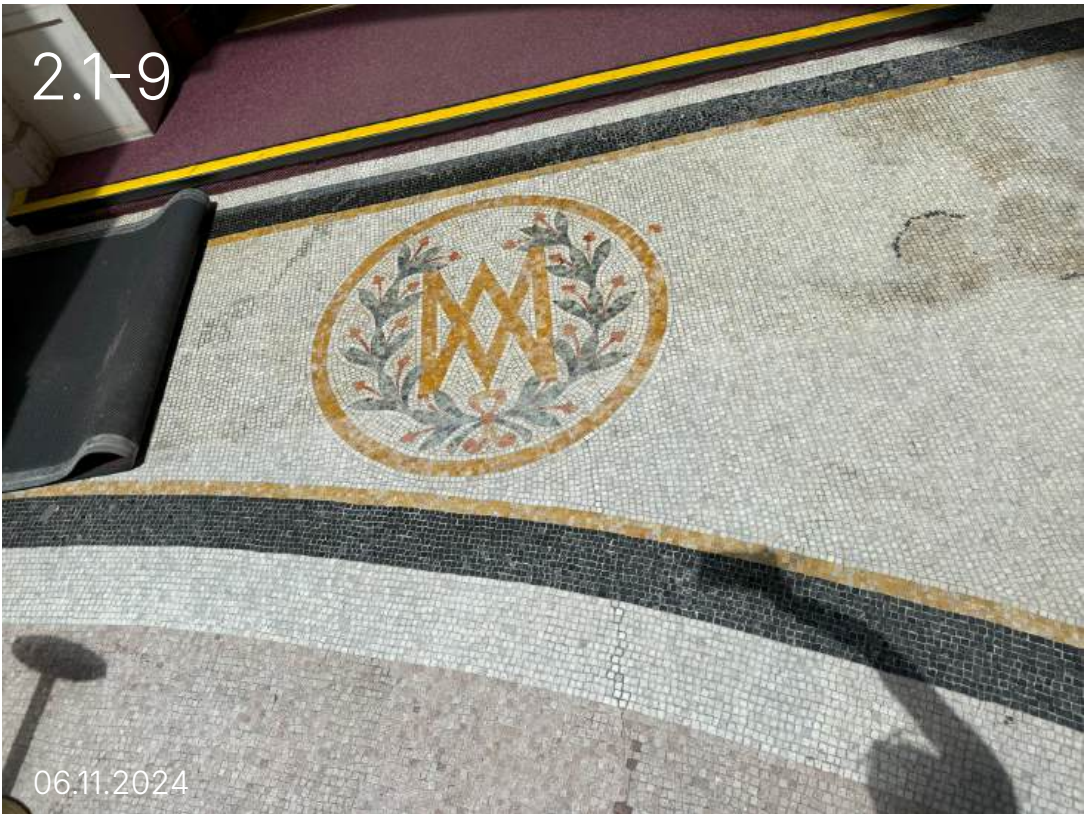
- 2.1-9 West Porch**
- Stained tiles to be cleaned.
 - Cracking to be repaired.
 - Non-matching replacement tiles to be removed and replaced with matching tiles.
 - Restoration currently before LPC and Department of Buildings.

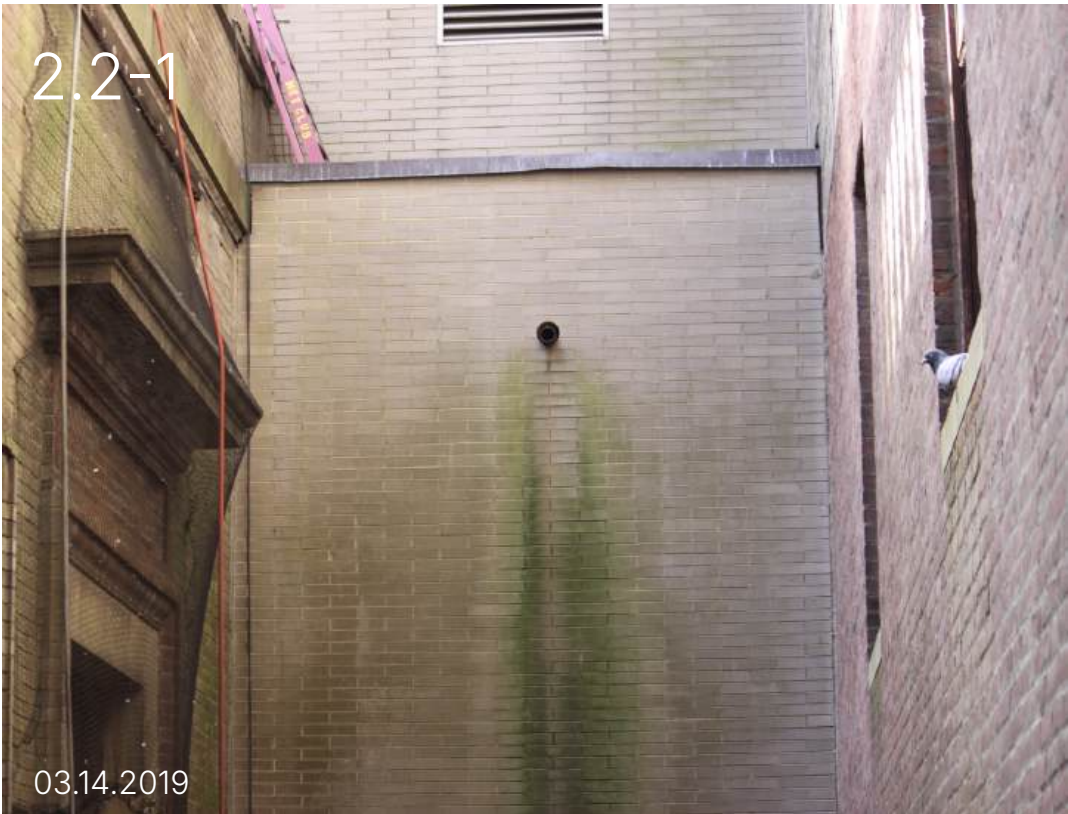
- 2.2-1 Library Wing Rear Facade**
- Incomplete drainage system. Integrate into building drainage system and replace deteriorated parts as required.
 - Remove organic growth on brick.
 - Augment insufficient bird mitigation.
 - Repair raised flashing.
 - Needs immediate attention.

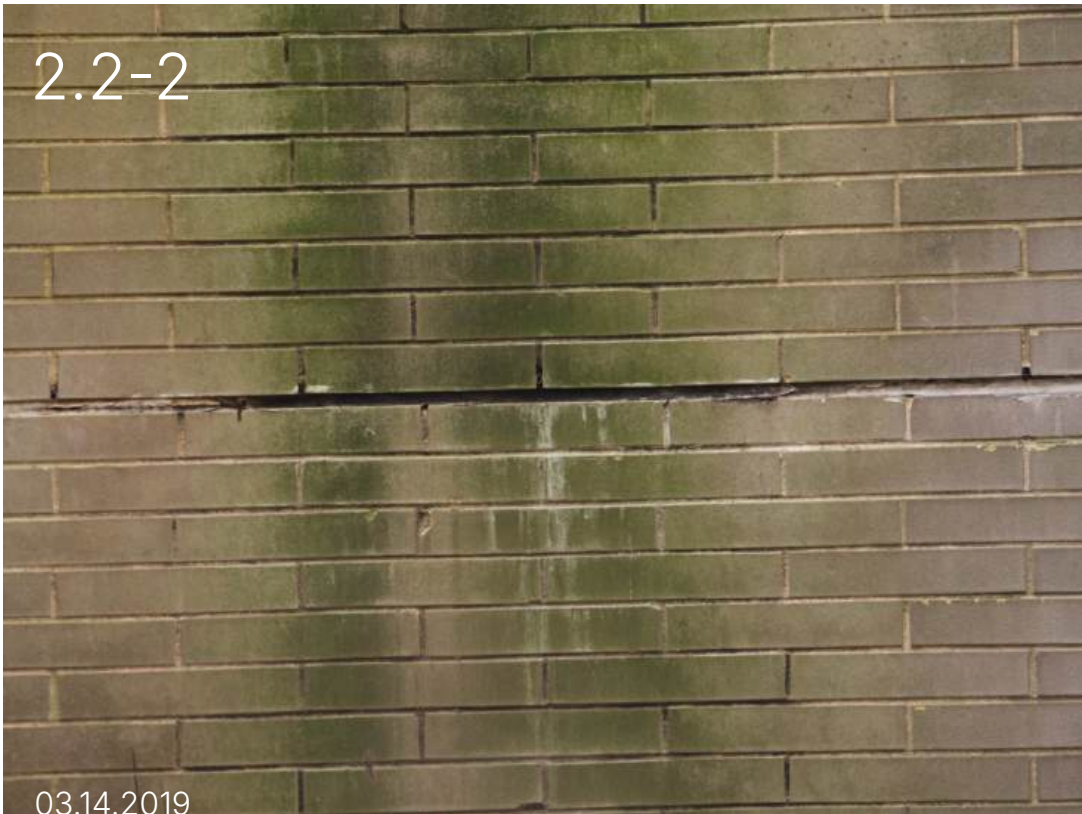
- 2.2-2 Library Wing Rear Facade**
- Repair and/or restore spalled brick.
 - Insufficient pointing.Repoint as required.
 - Needs immediate attention.

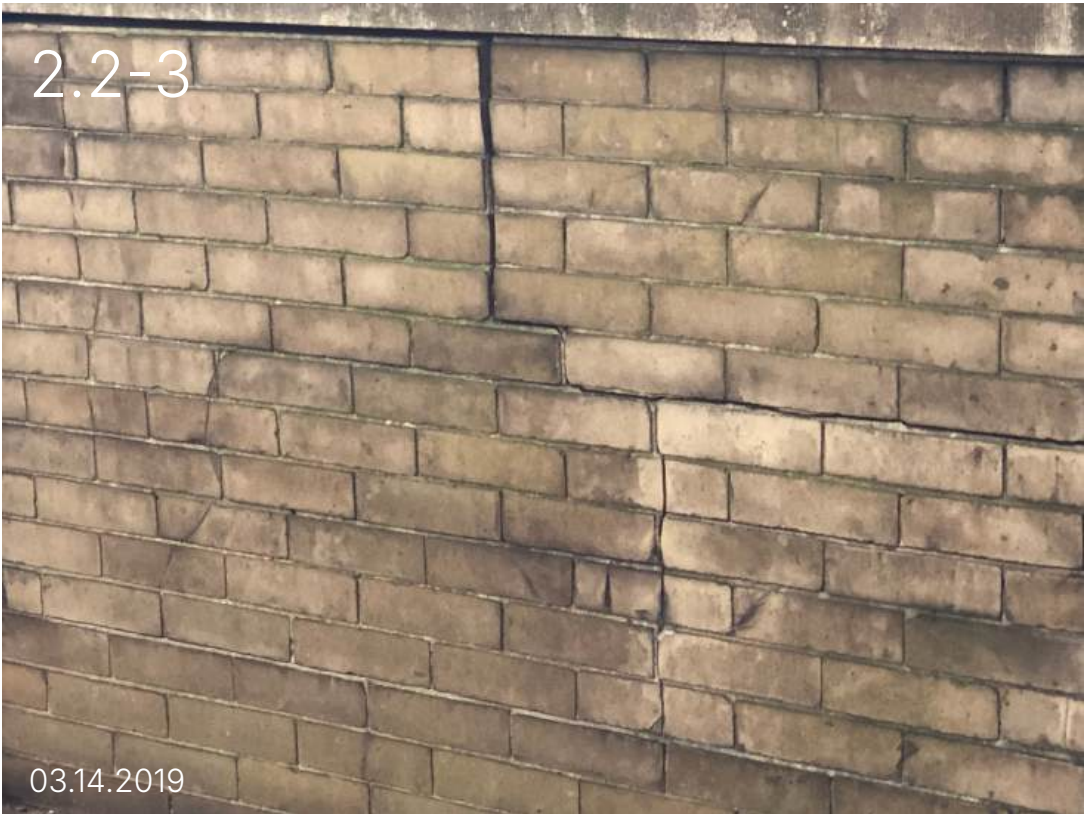
- 2.2-3 Library Wing Rear Facade**
- Step cracking. To be repaired as required.
 - Brick face cracking. To be repaired as required.
 - Repair and/or restore spalled brick.
 - Remove organic growth.
 - Needs immediate attention.

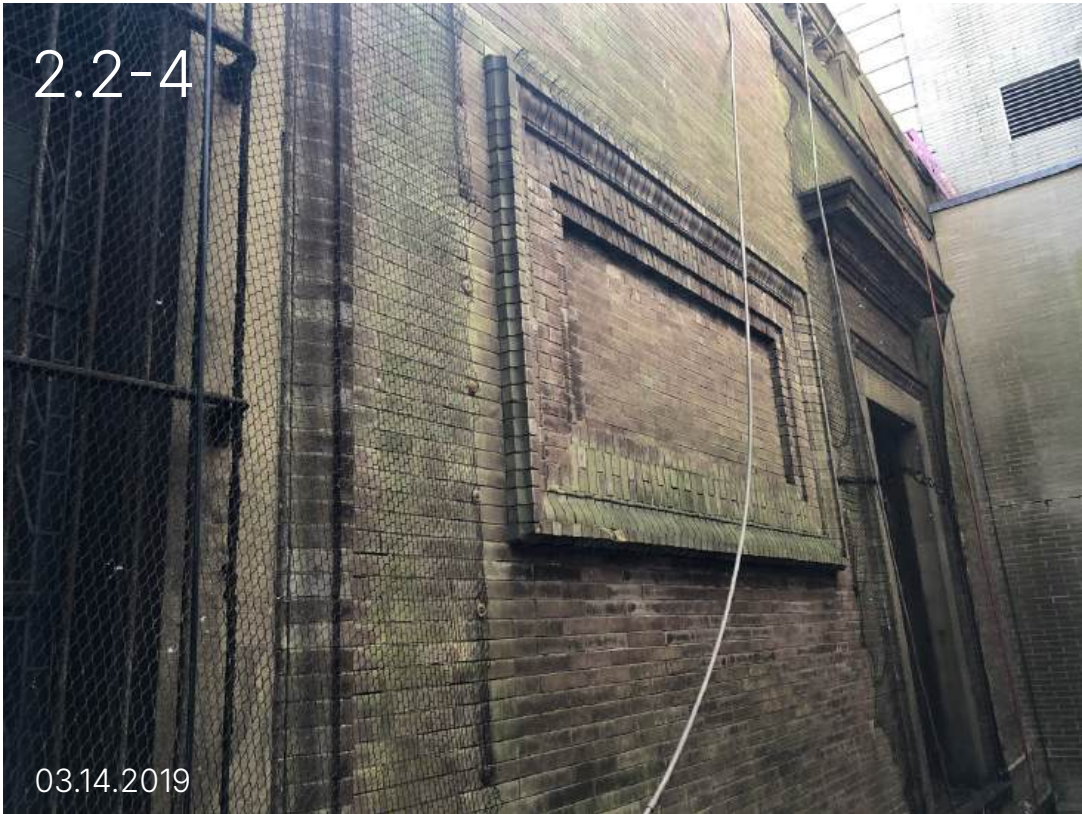
- 2.2-4 Library Wing Rear Facade**
- Remove organic growth.
 - Repair and/or restore cracked and spalled brick.
 - Insufficient bird mitigation.
 - Needs immediate attention.

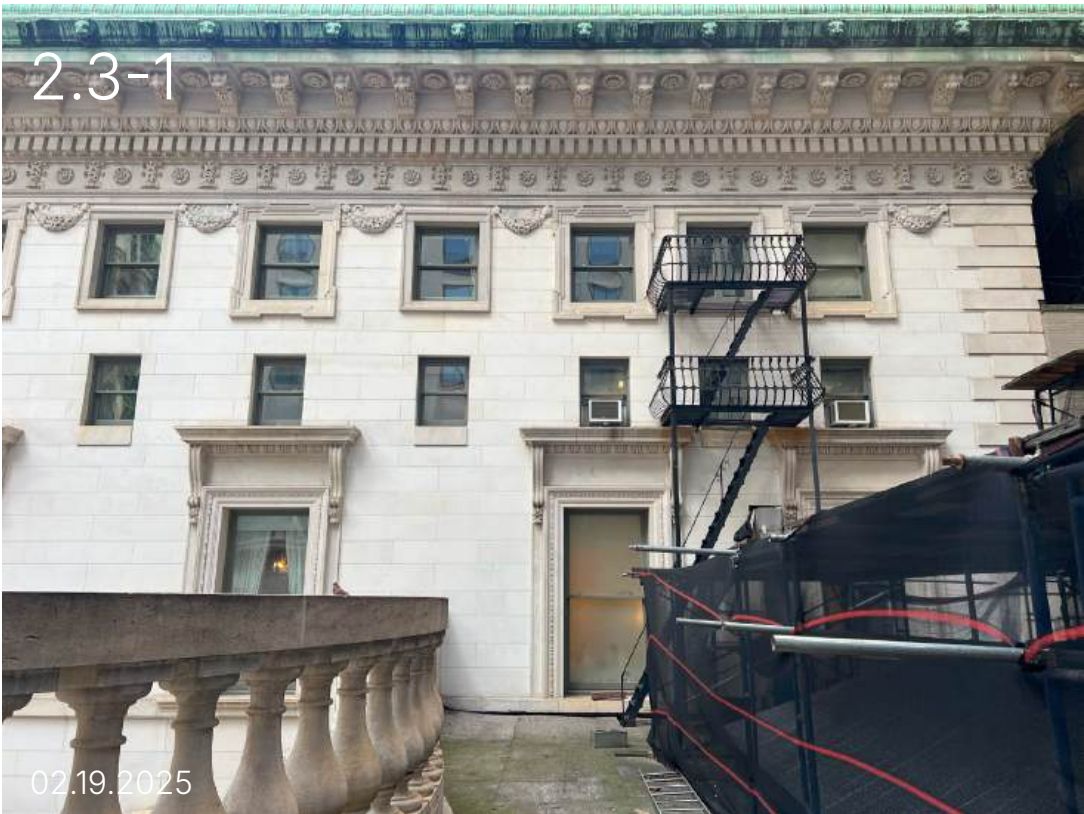
- 2.3-1 Library Roof**
- Library roof under temporary protection due to ongoing work at the adjacent Hotel Pierre.
 - Condition of roofing to be assessed once it is safe and possible.

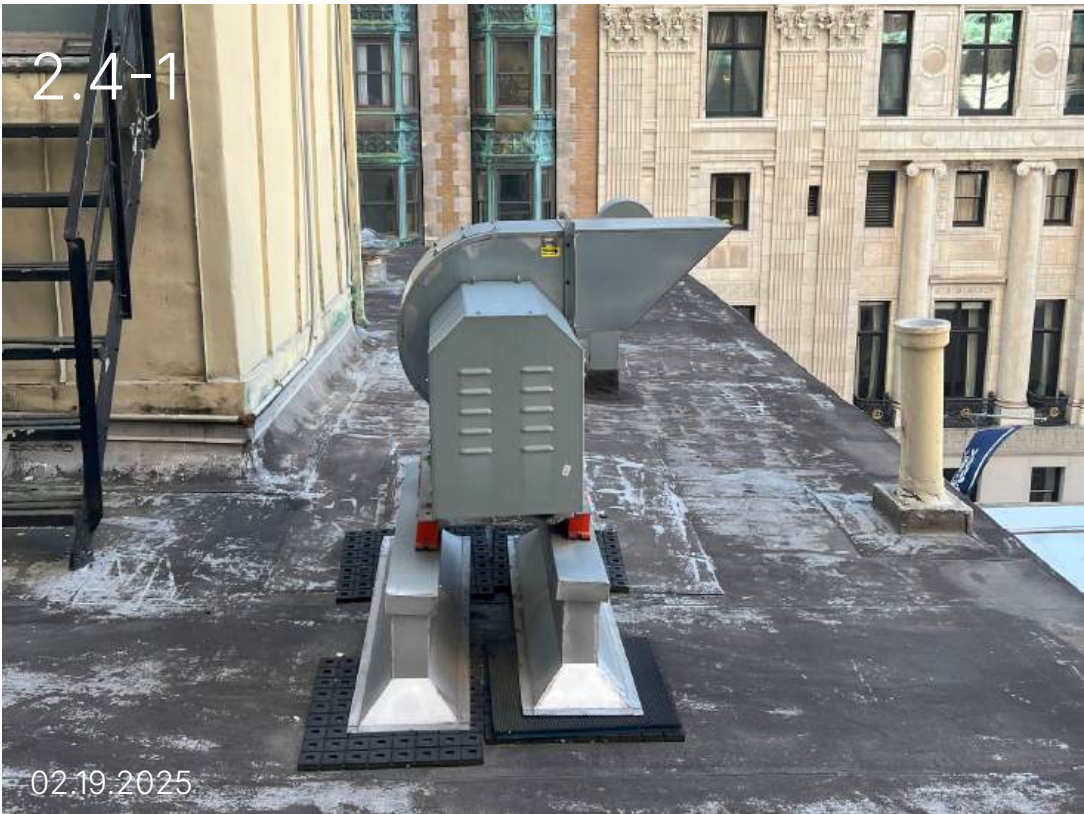
- 2.4-1 Roof
- General condition of flat roof is good.
 - Waterproofing in fair condition.
 - HVAC and plumbing equipment in good condition and is accessible.
 - Install guard rail as required by code

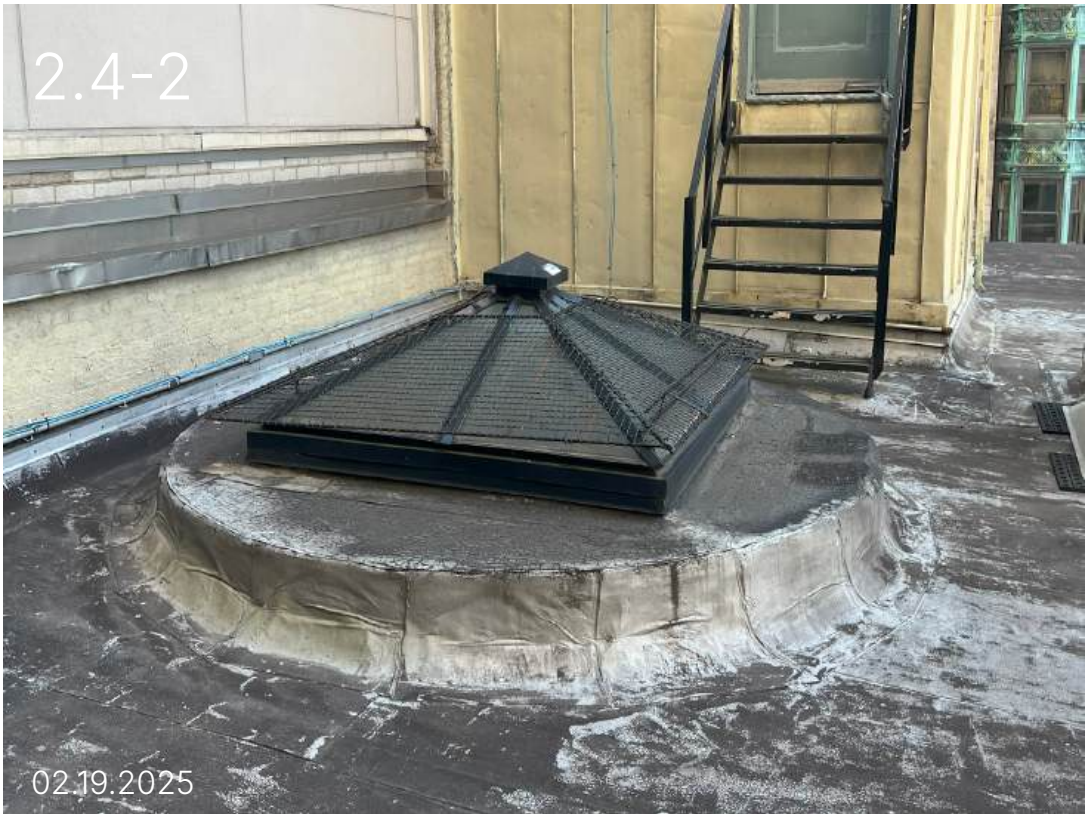
- 2.4-2 Roof - Skylight
- Skylight glazing and frame in good condition.
 - Waterproofing and flashing in good condition.

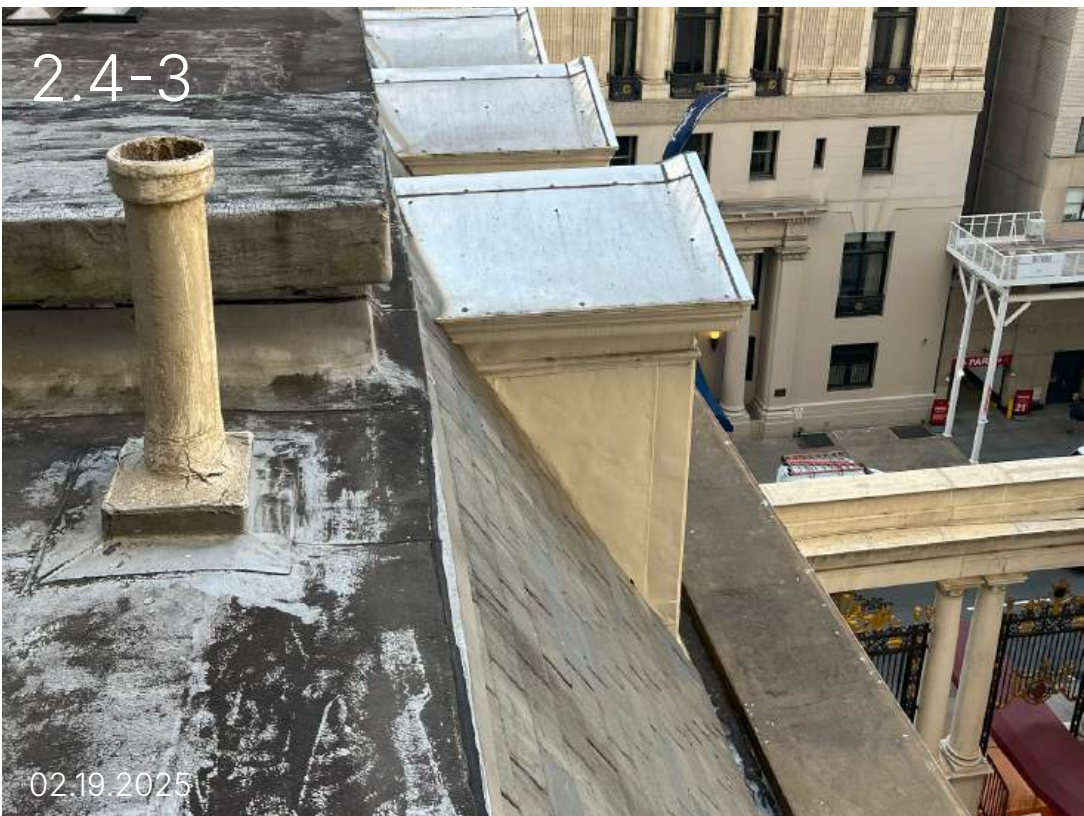
- 2.4-3 Roof - Dormers
- Slate in good condition.
 - Metal dormer roofs and cladding in good condition.
 - Cornice and waterproofing in good condition.

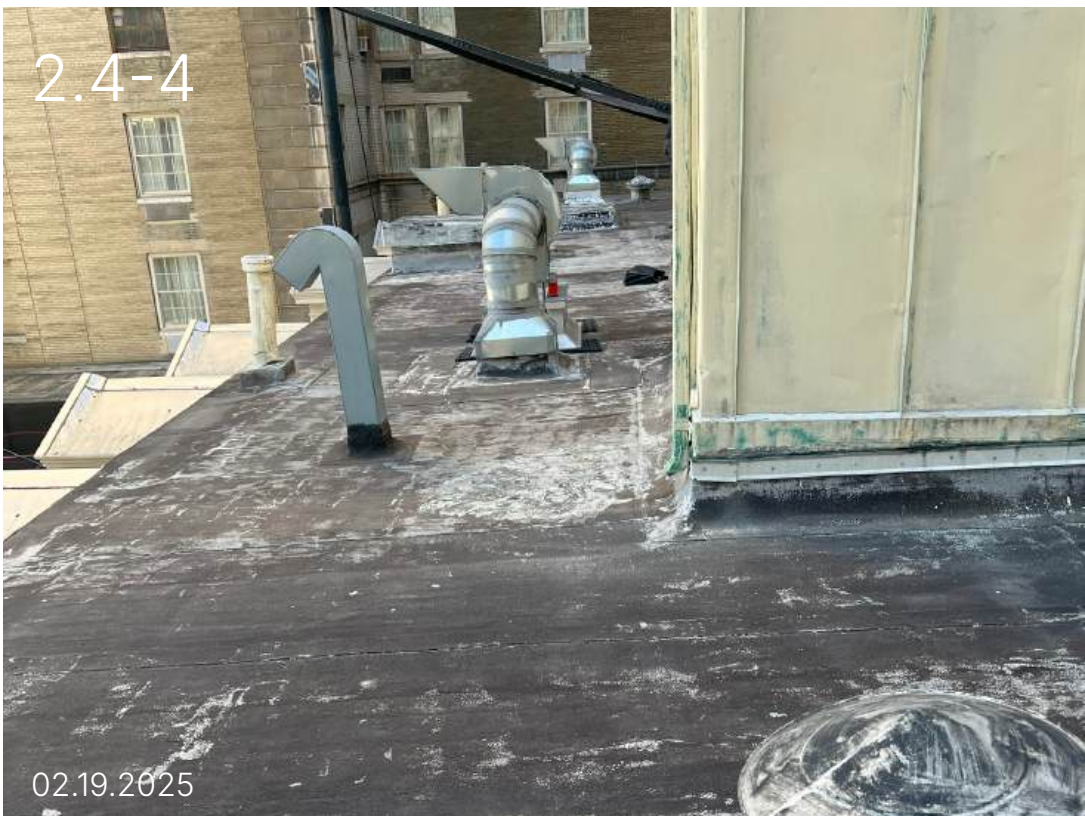
- 2.4-4 Roof - HVAC
- Waterproofing in fair condition.
 - HVAC & penetration waterproofing in good condition.
 - Metal dormers in good condition but will be made historically appropriate with leaded copper in next restorative repair.

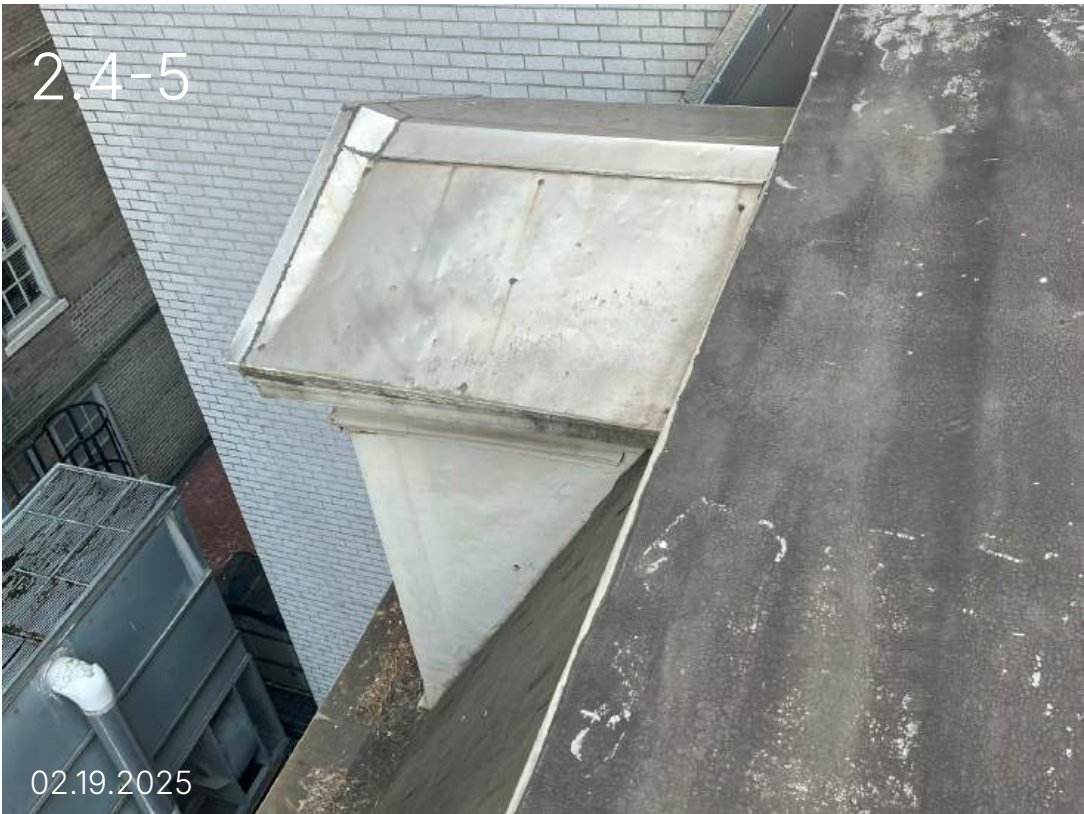
- 2.4-5 Roof - Typical Dormer**
- General condition of dormer roof and cladding is good.
 - Rust stains at selective locations to be removed.
 - Joints with roof are in good condition.

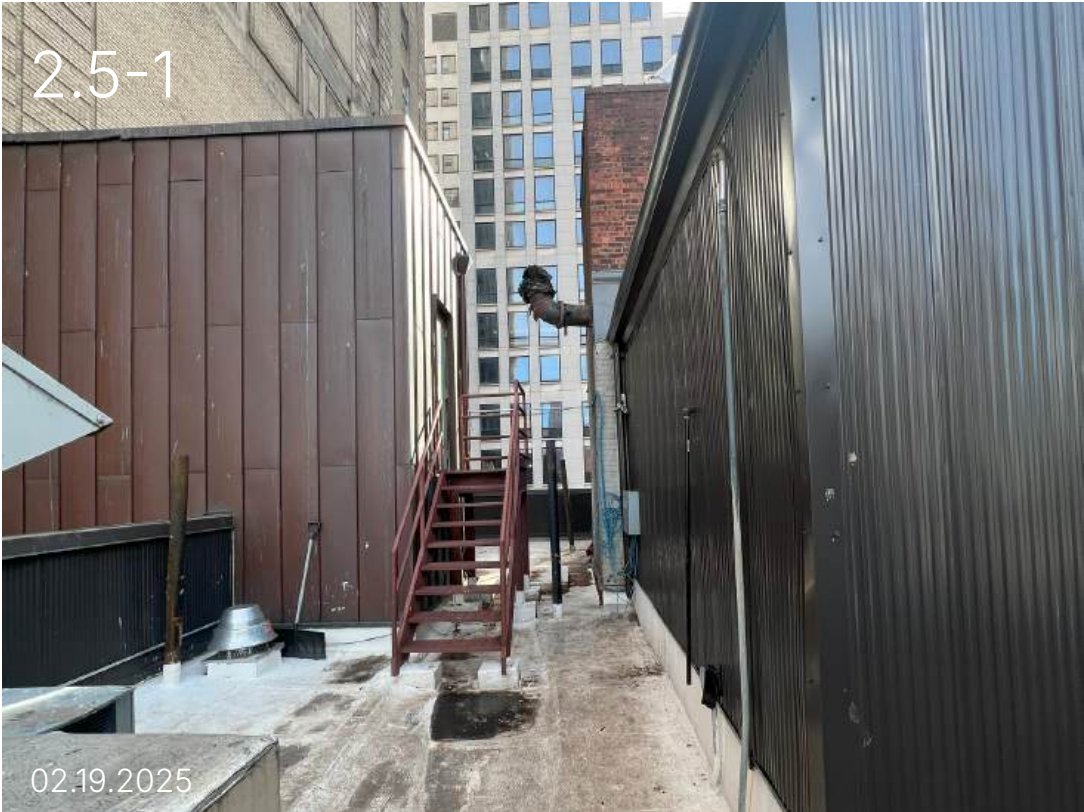
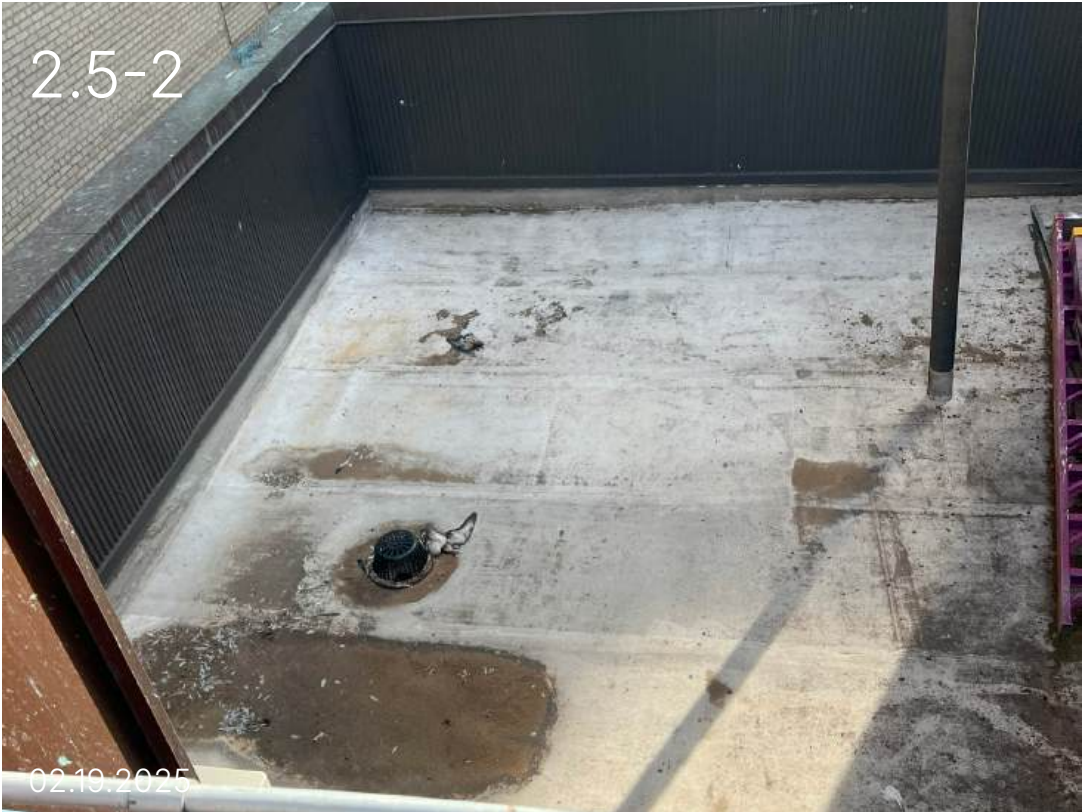
- 2.5-1 Roof
- Waterproofing in serviceable condition.
 - 6th Floor Cladding in good condition.

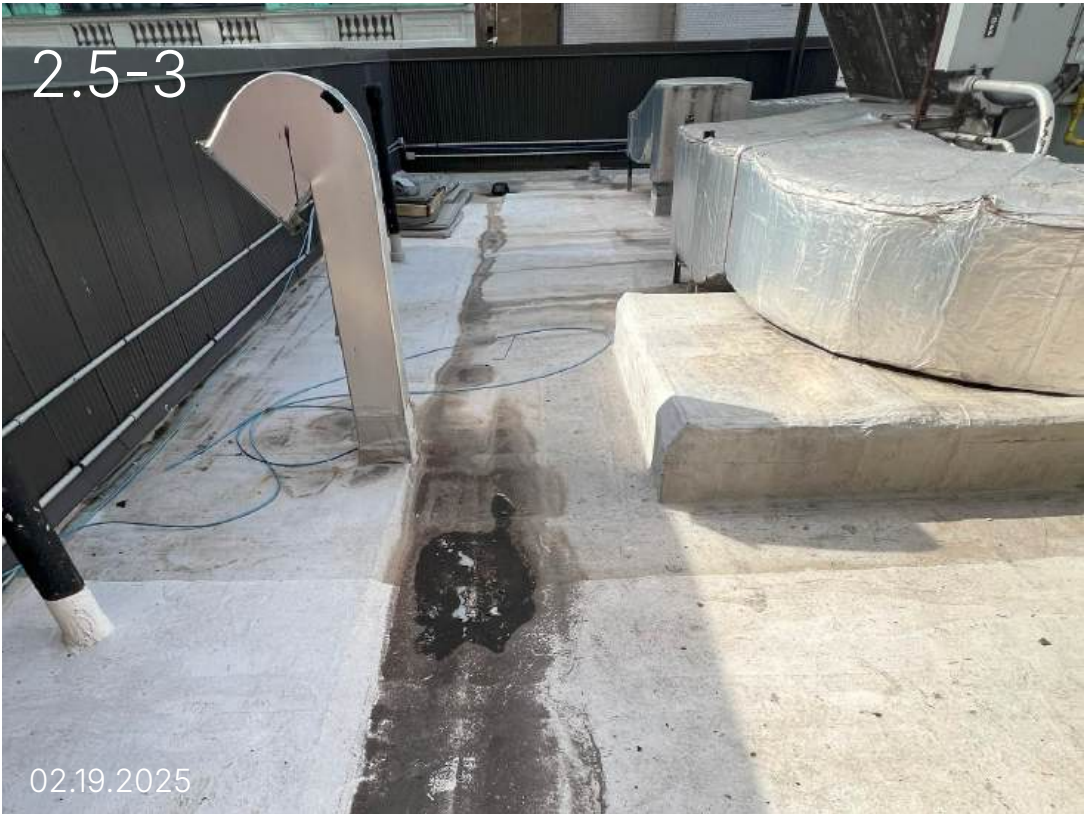
- 2.5-2 Roof
- Drains in working order, typical throughout.
 - Waterproofing in serviceable condition.
 - Some ponding in selective areas.

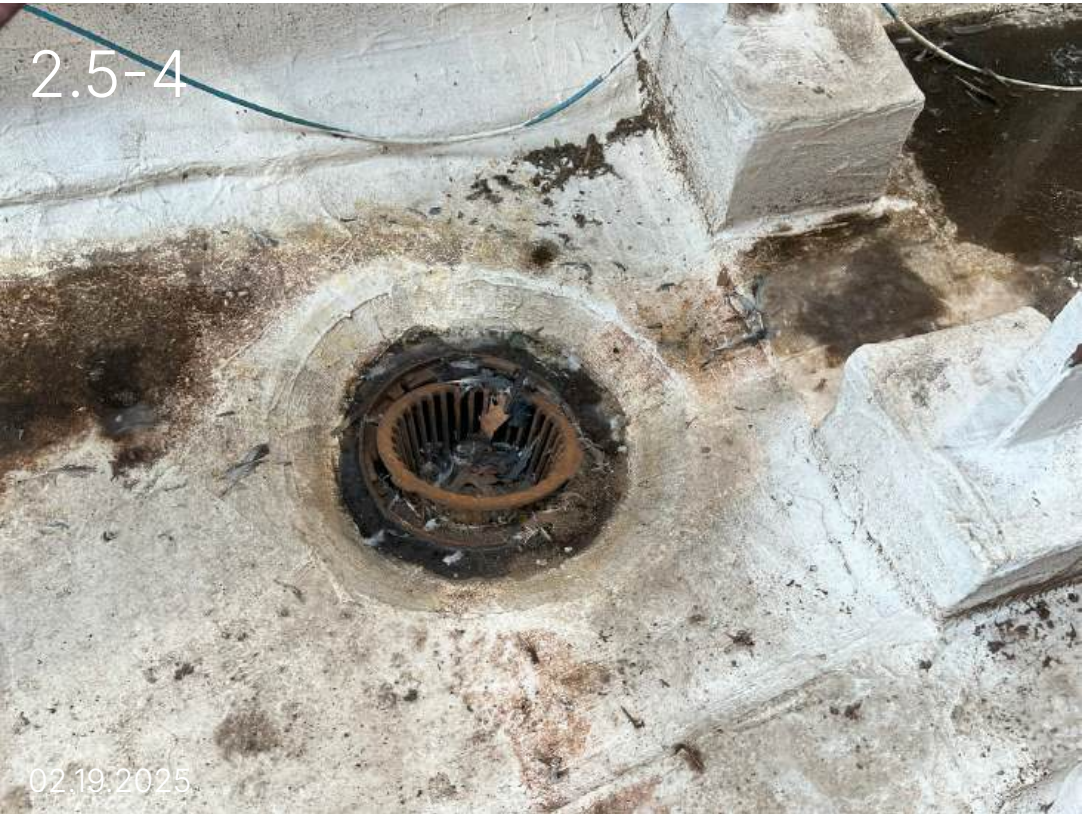
- 2.5-3 Roof
- Waterproofing and HVAC equipment in good condition.
 - Some ponding along direction to drain. Investigate and repair underlayment as required.

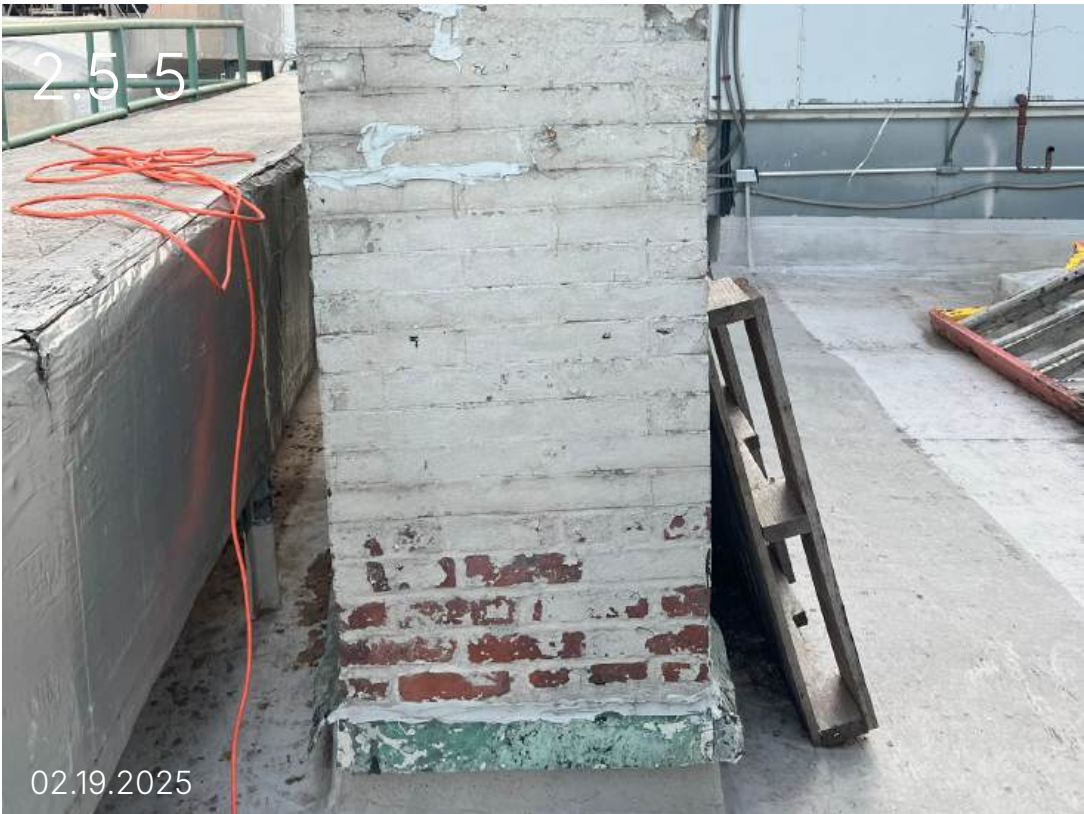
- 2.5-5 Chimney**
- Flashing in somewhat deteriorated condition. To be repaired.
 - Peeling paint. Repaint as required.
 - Waterproofing up to flashing in good condition.
 - Coping in good condition.

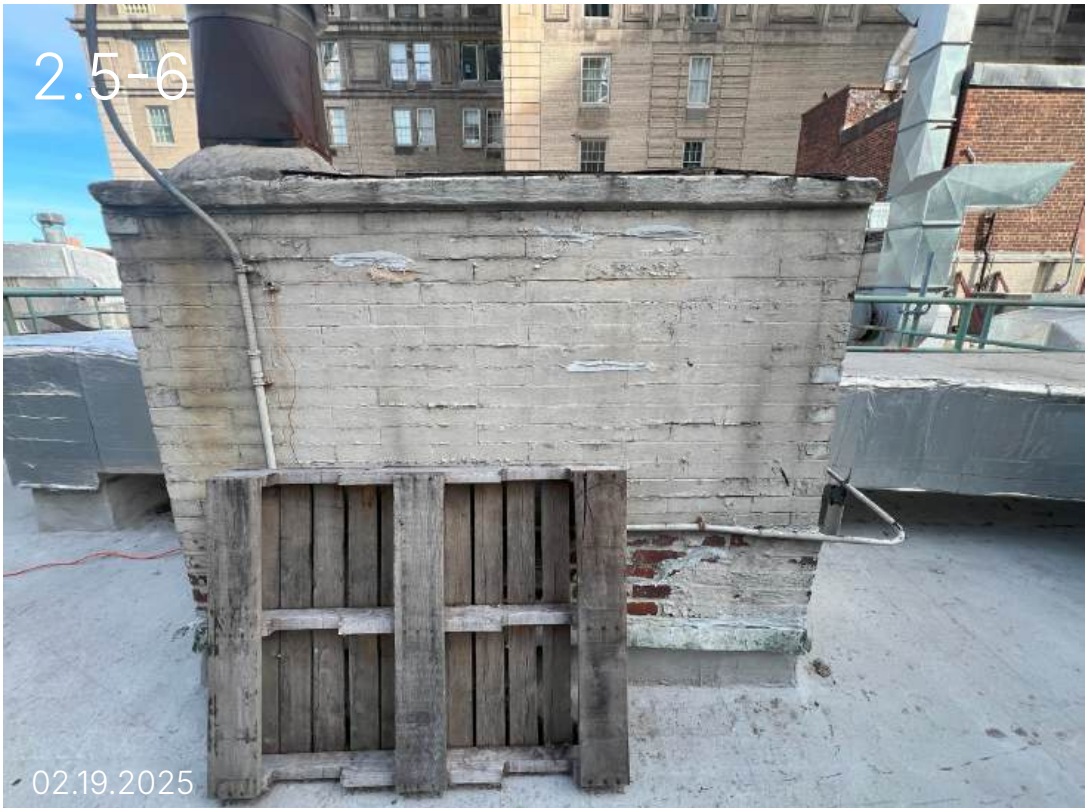
- 2.5-6 Chimney Bulkhead**
- Peeling paint. Repaint as required.
 - Waterproofing up to flashing in serviceable condition.
 - Coping in generally good condition. Some spalls along the edges. Repair as required.
 - HVAC equipment in serviceable condition.

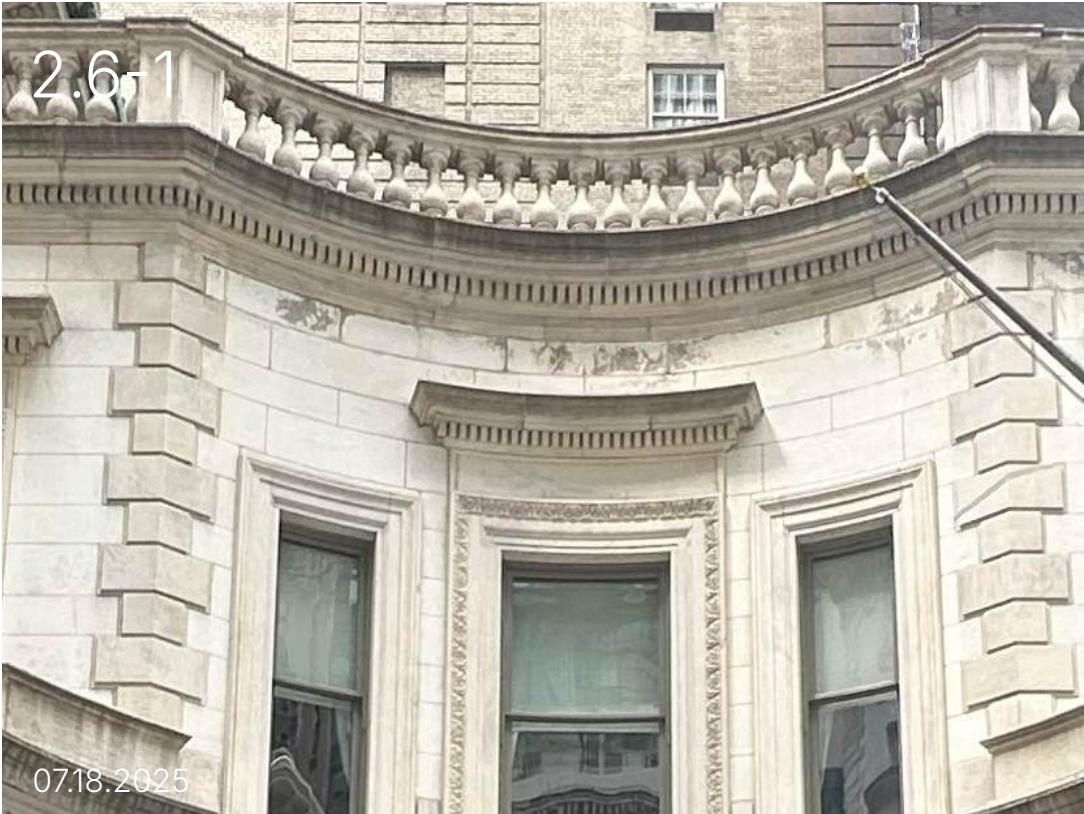
- 2.6-1 Library Wing Facade**
- Upper facade blackened with dirt. To be cleaned.
 - Repoint masonry as required.

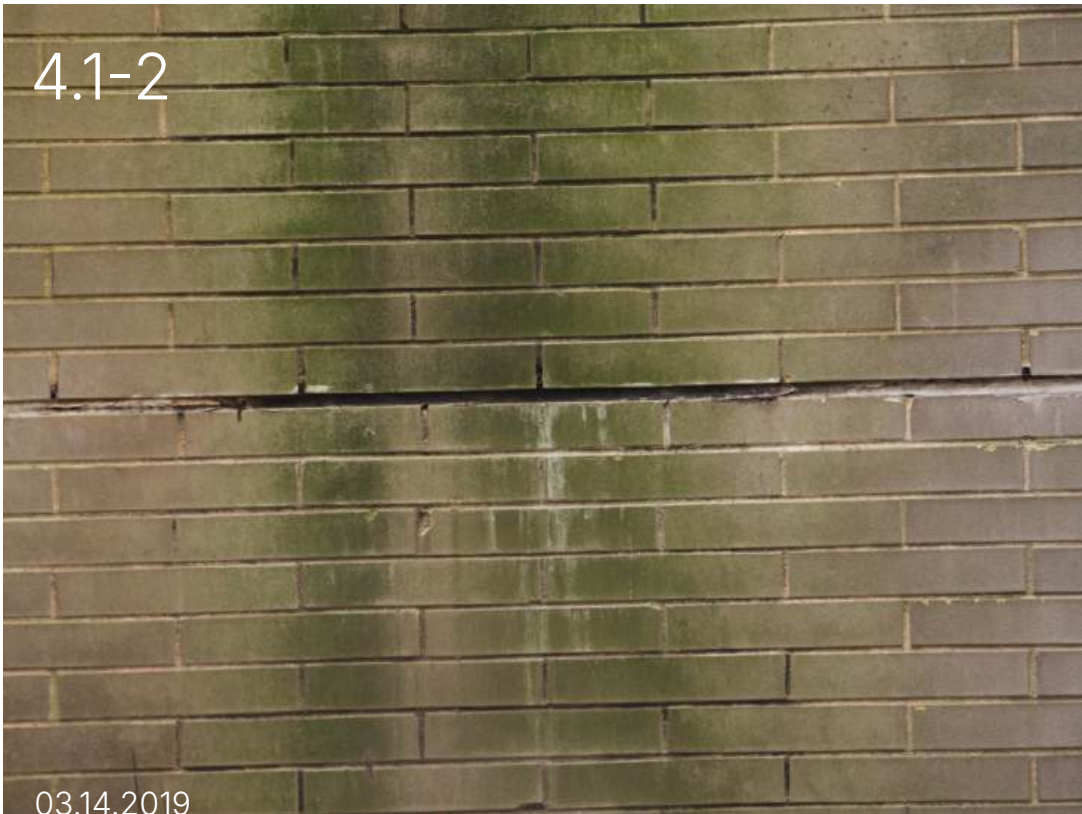
- Spalled brick.
- Insufficient pointing.
- Needs immediate attention.

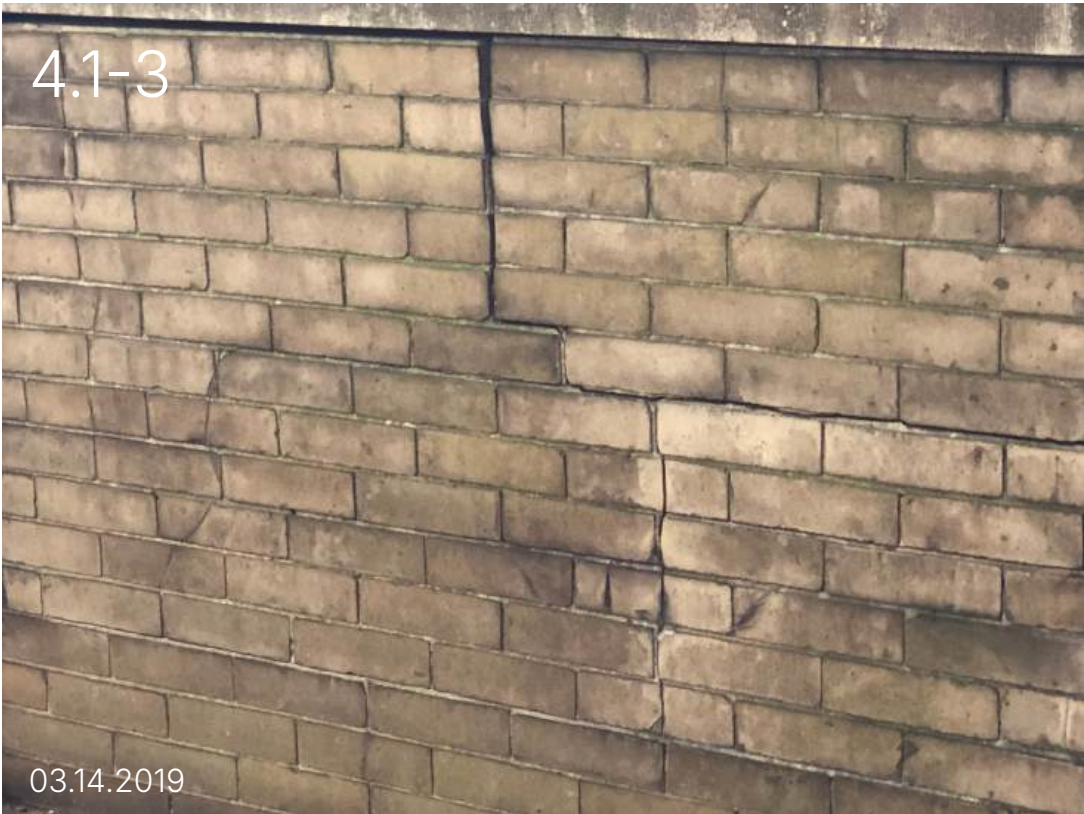
4.1-3 Library Wing Rear Facade

- Step cracking.
- Brick face cracking.
- Brick spalling.
- Organic growth.
- Needs immediate attention.

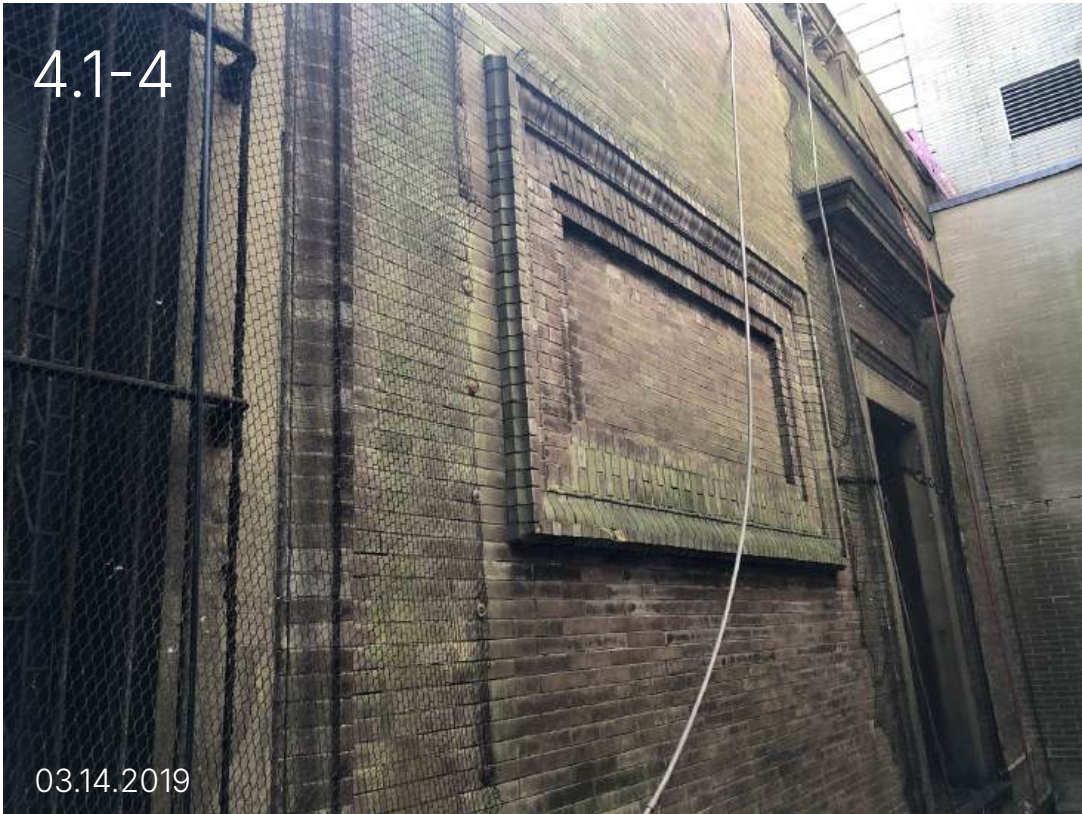
- Organic growth.
- Cracked and spalled brick.
- Insufficient bird mitigation.
- Needs immediate attention.

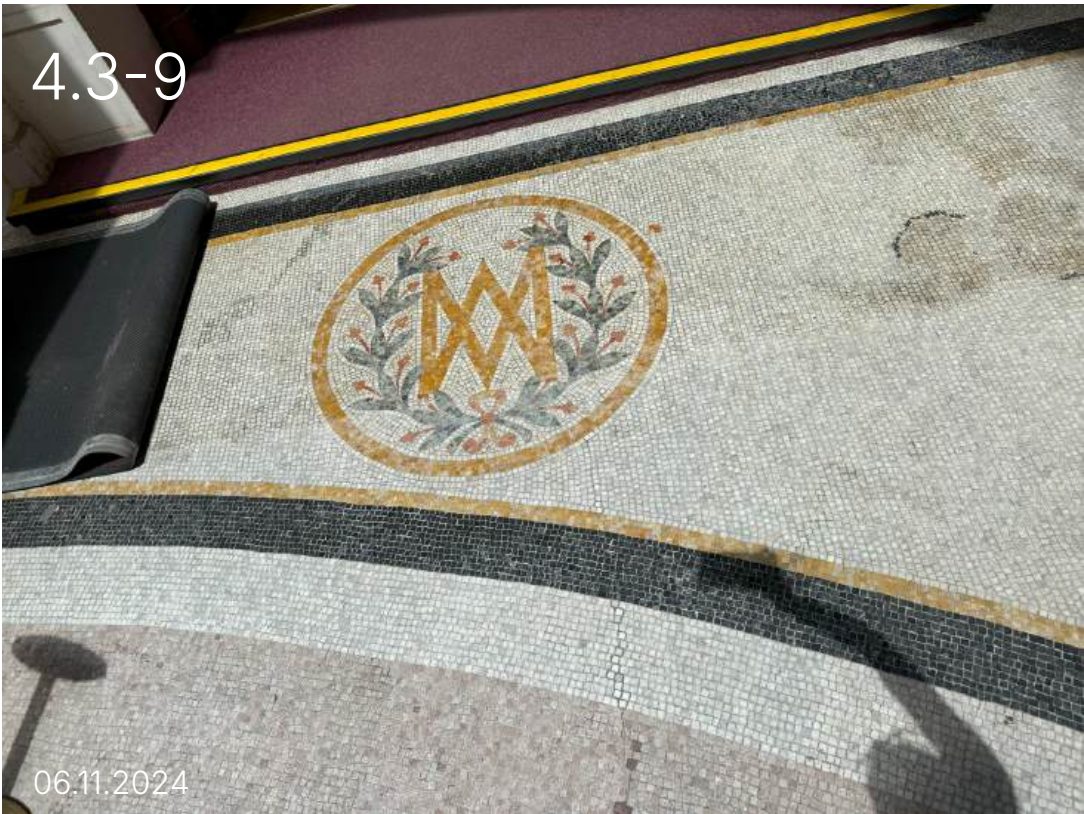
- 4.3-9 West Porch**
- Stained tiles
 - Cracking.
 - Non-matching replacement tiles.
 - Restoration currently before LPC and Department of Buildings.

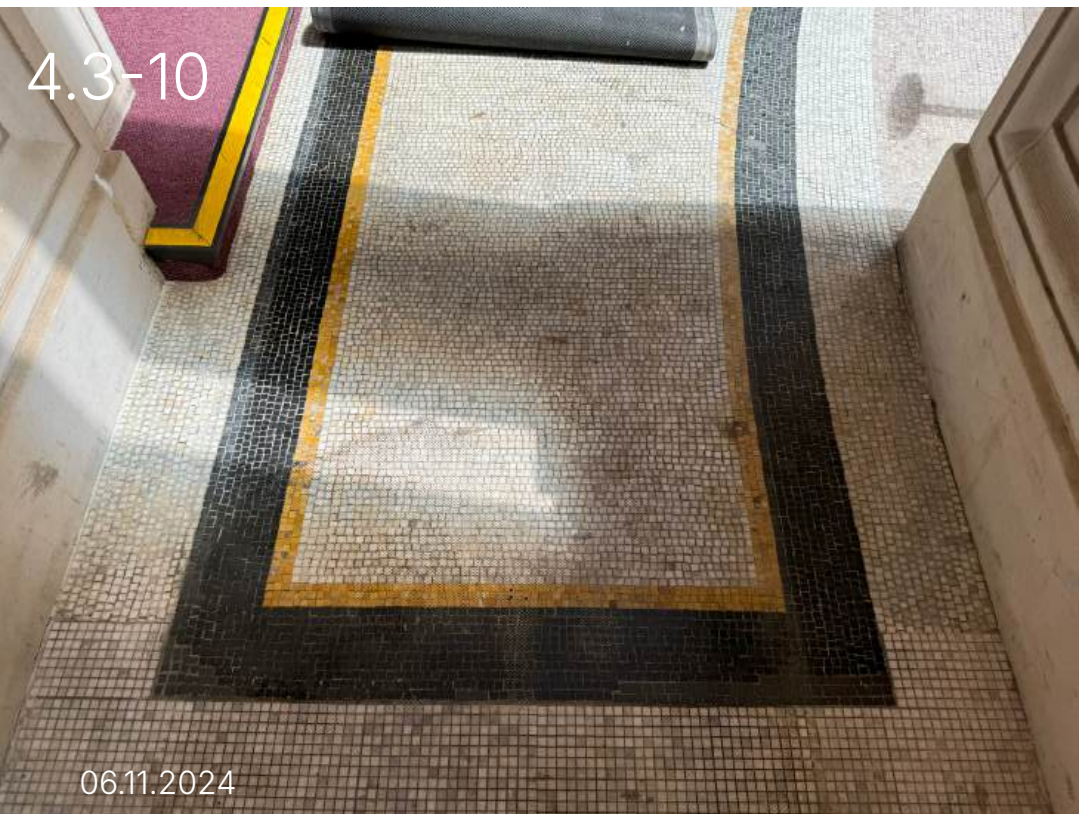
- 4.3-10 West Porch**
- Stained tiles.
 - Cracking.
 - Missing/damaged tiles.
 - Restoration currently before LPC and Department of Buildings.

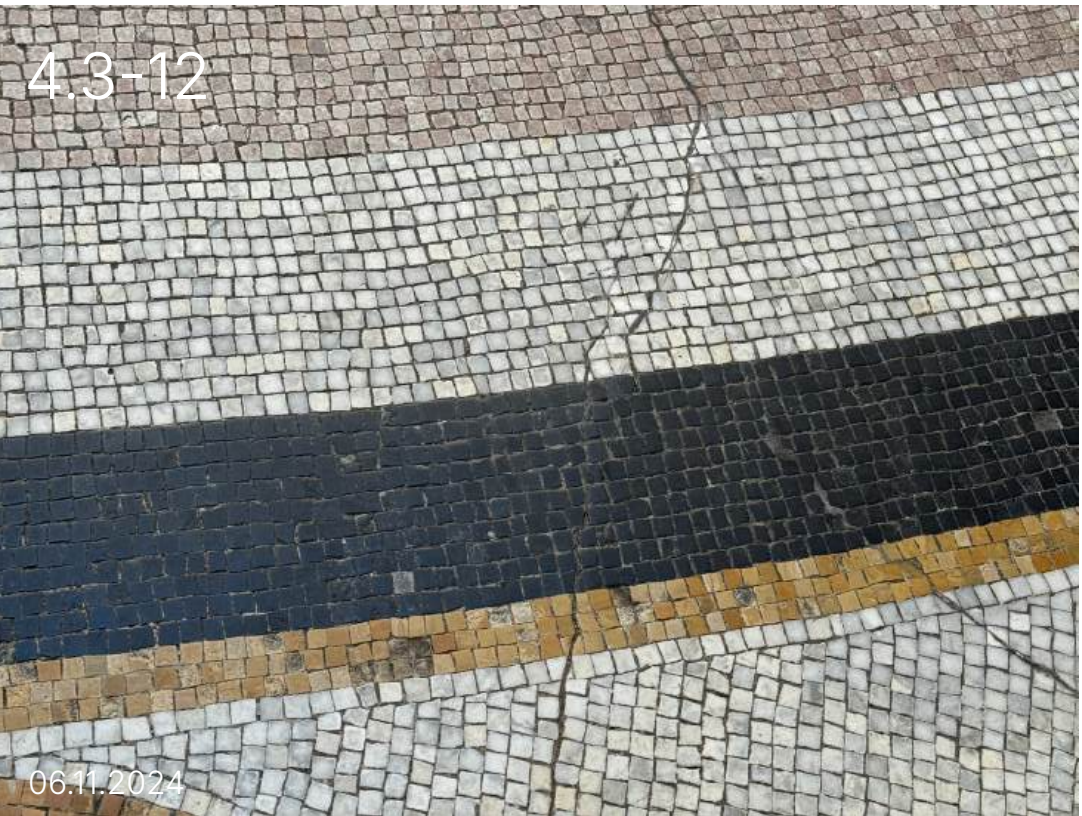
- 4.3-12 East Porch**
- Significant cracking throughout.
 - Missing tiles.
 - Restoration currently before LPC and Department of Buildings.
