**1 East 60th Street – Upper East Side Historic District
Borough of Manhattan**

The Metropolitan Club

Presentation for Landmark Restoration and Proposed Capital Work

4.0 Appendix A: Existing Conditions Report

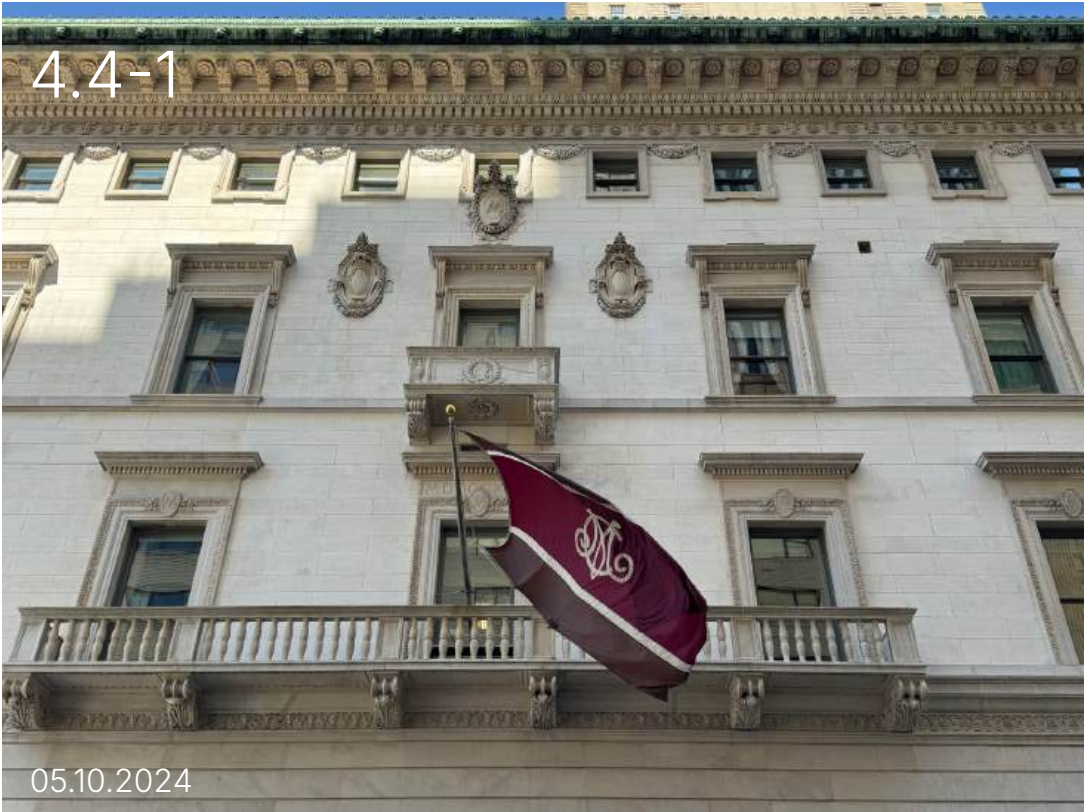
4.4-1 5th Avenue Facade

- Cleaned and Restored in 2023.

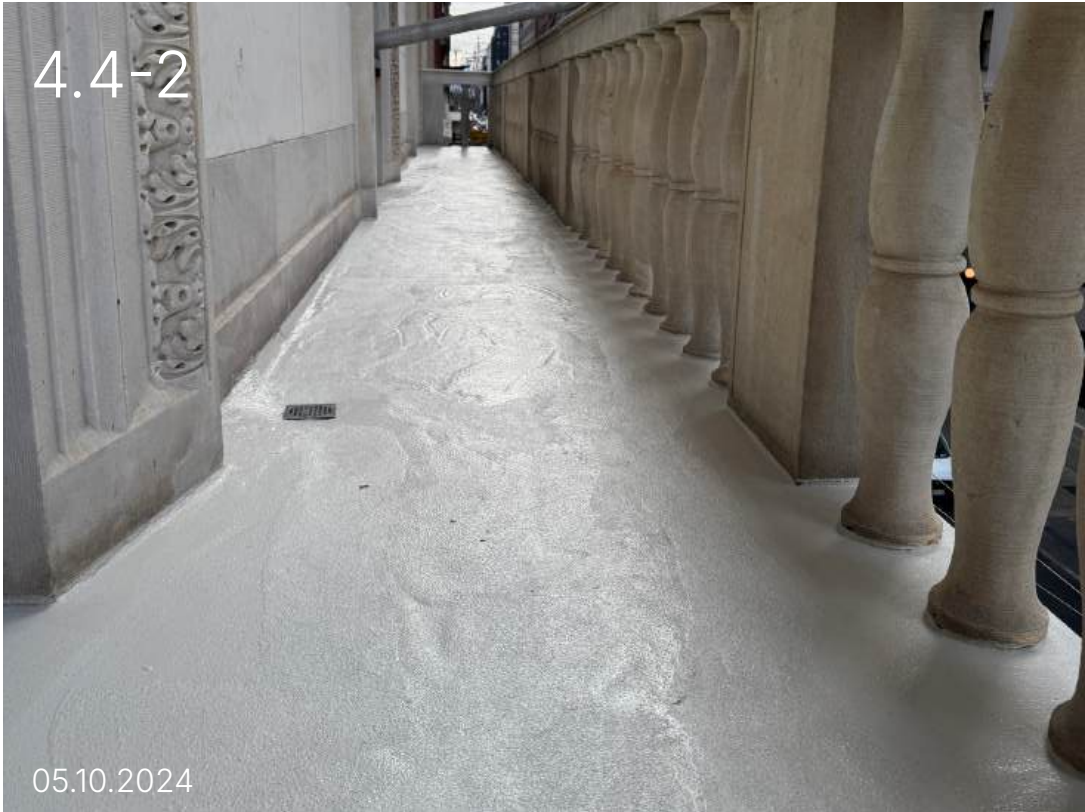
4.4-2 5th Avenue Balcony

- Marble cleaned and restored in 2023.
- New drainage installed in 2023.

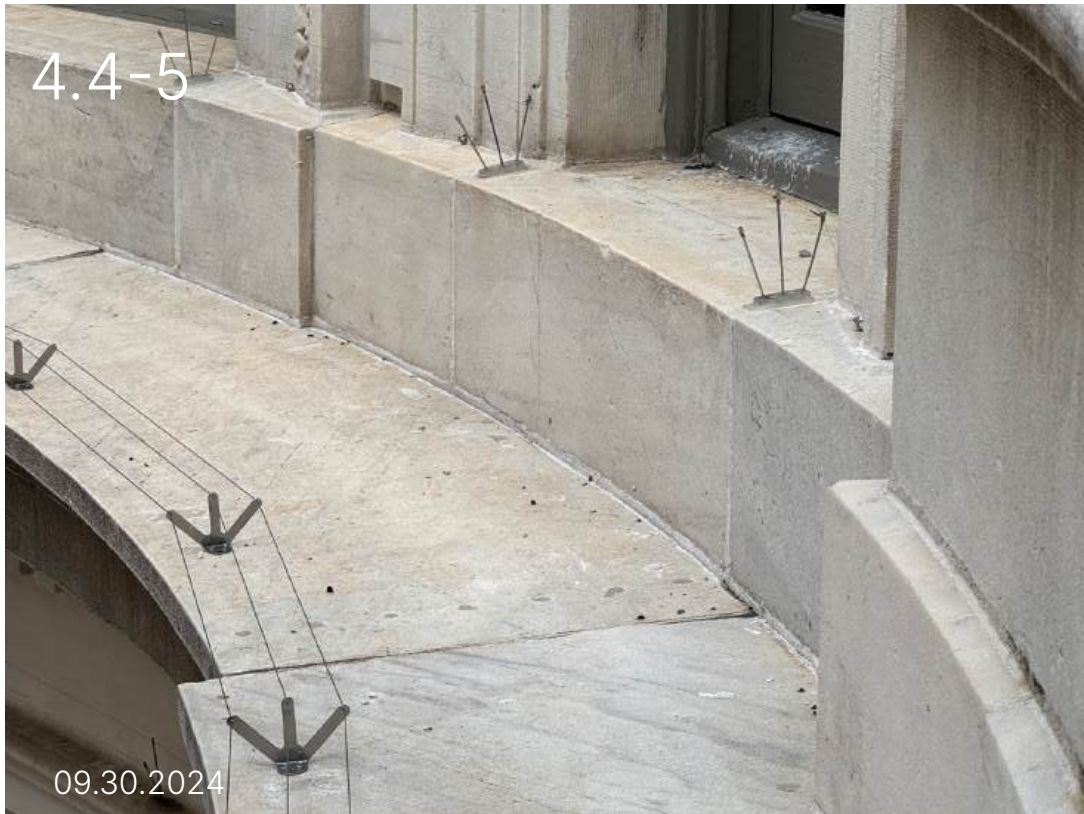
4.4-5 Bird Mitigation
• Electrified and non-electrified bird mitigation strategies deployed across entire facade.

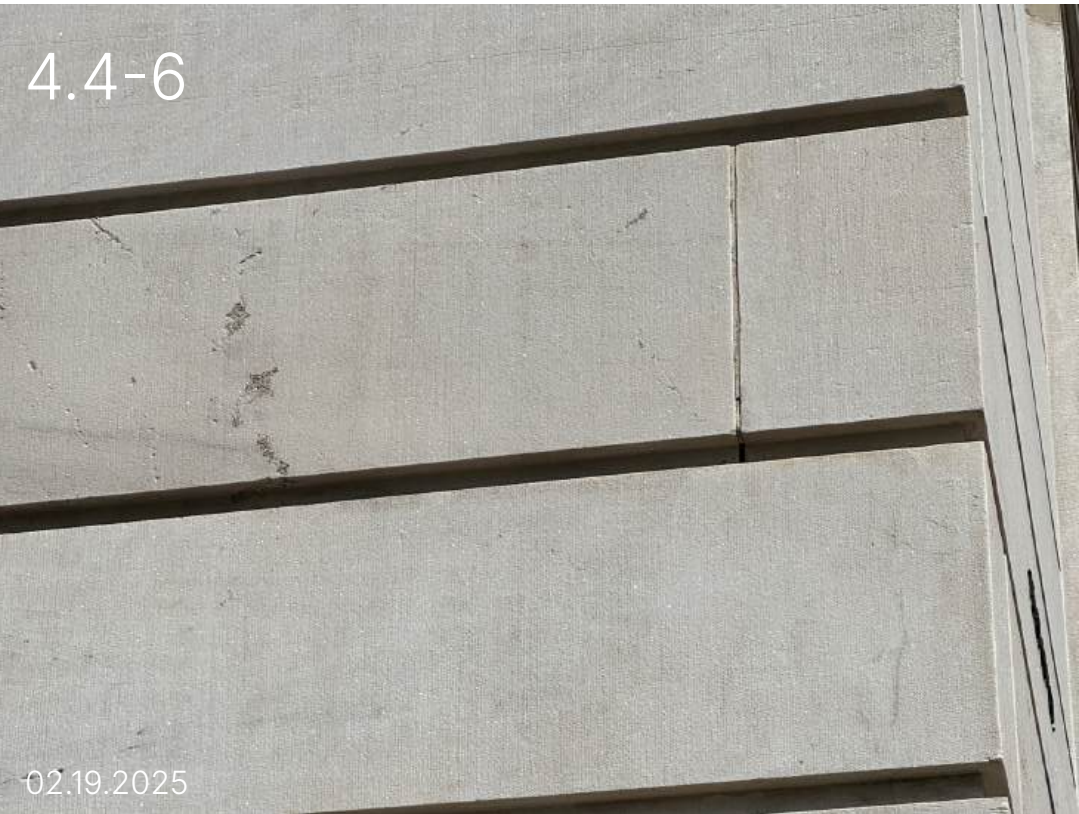
4.4-6 5th Avenue Facade
• Marble cleaned in 2023.
• Selective areas of slight spalling.

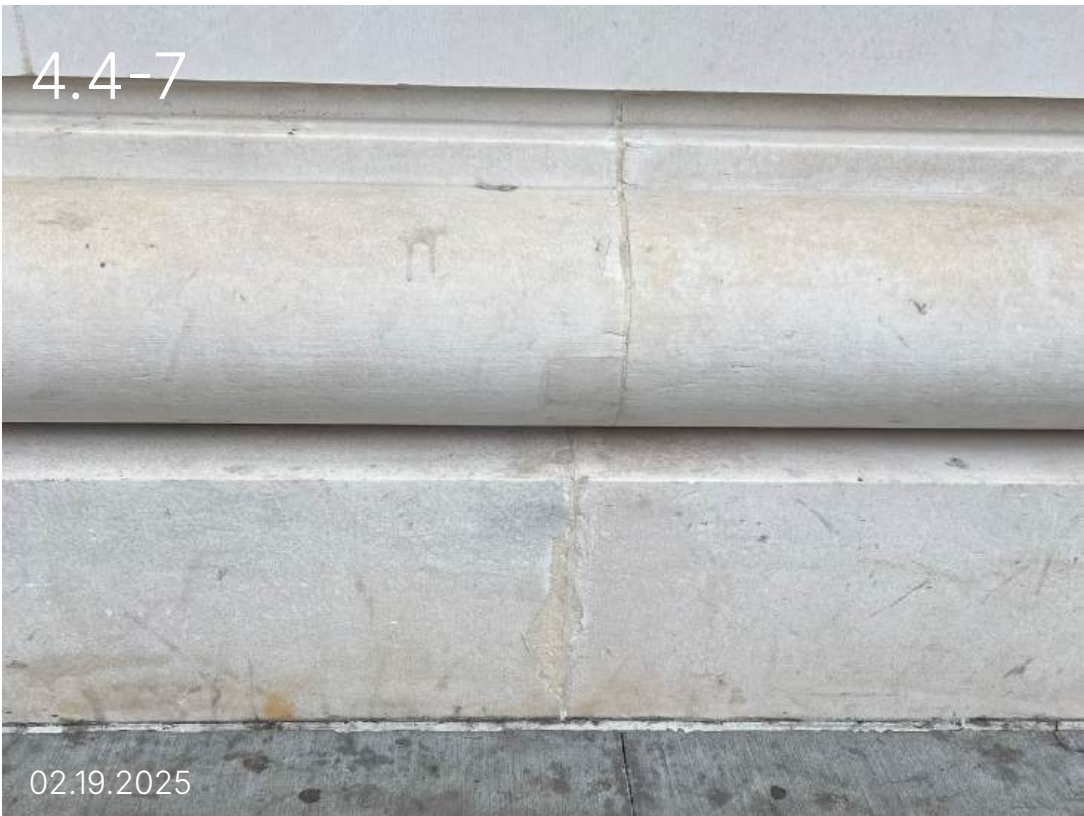
4.4-7 Facades
• Dutchman repairs to select areas made in 2023.

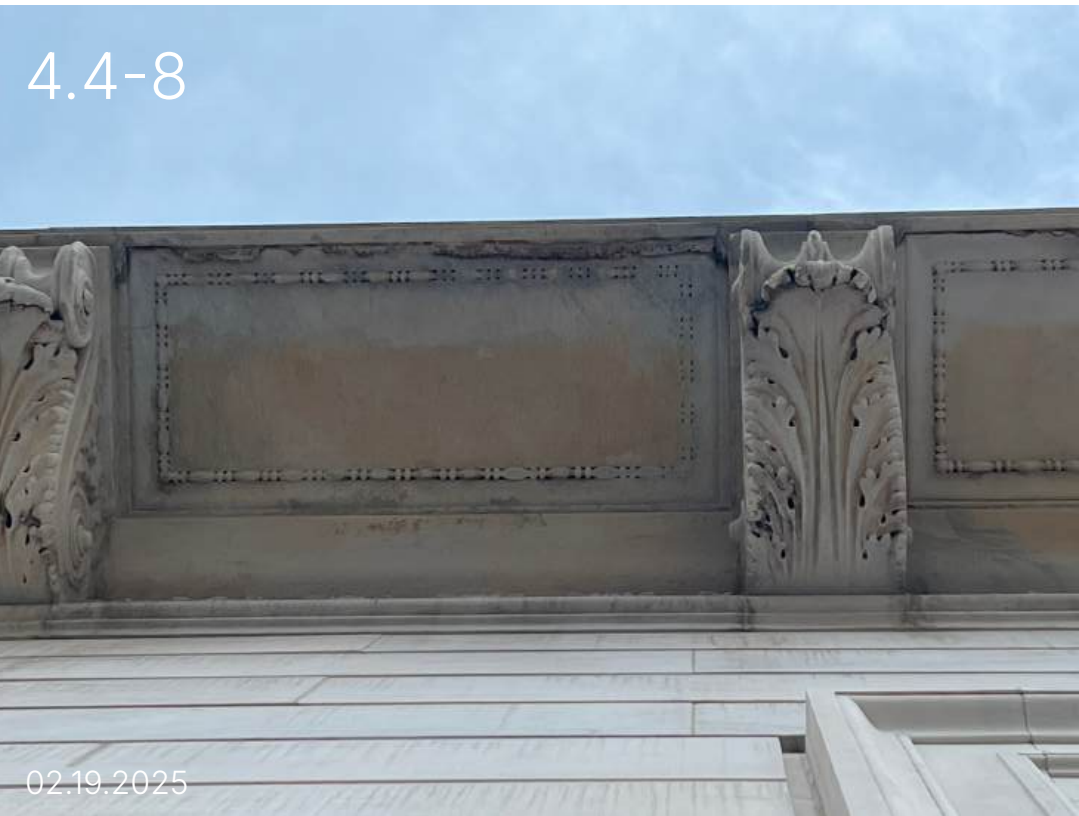
4.4-8 Cornice
• Cleaned in 2023.
• Generally good condition. Selective areas of deterioration (e.g., bead and reel as shown).

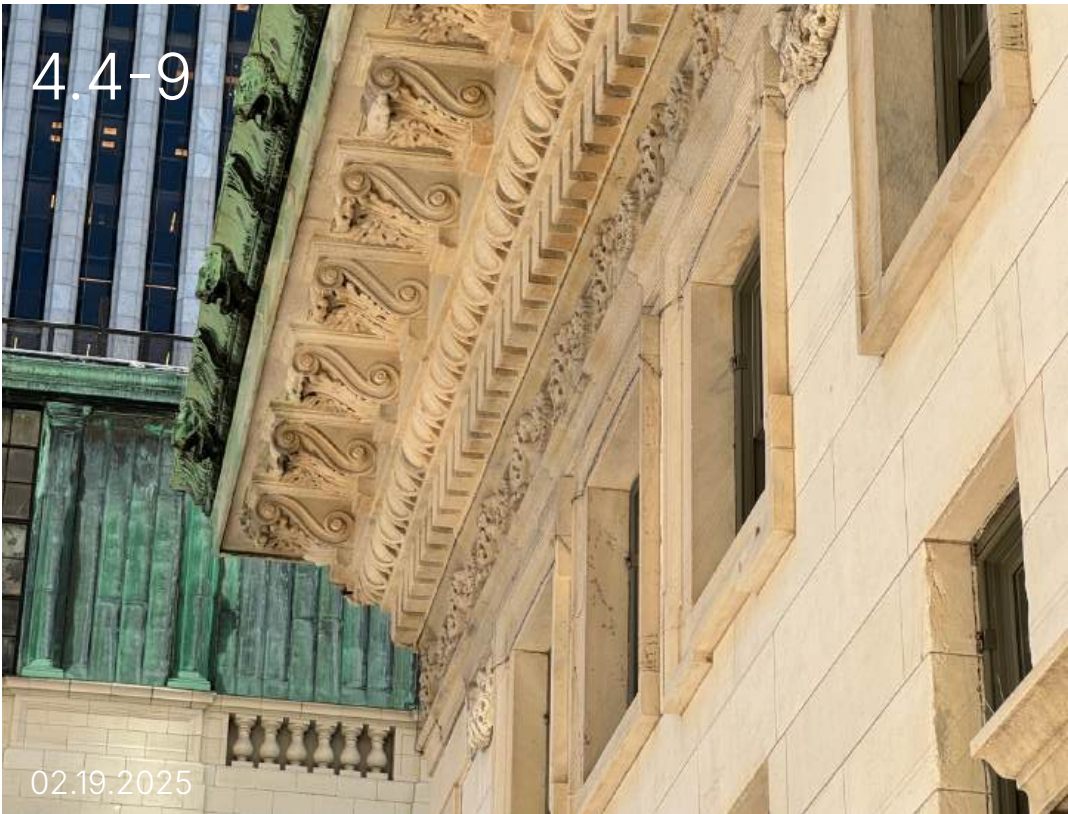
- 4.4-9 Courtyard Facade**
- Marble and copper cornice cleaned and restored in 2023.
 - Slight erosion around blank window openings.
 - Attic story architraves in good condition.

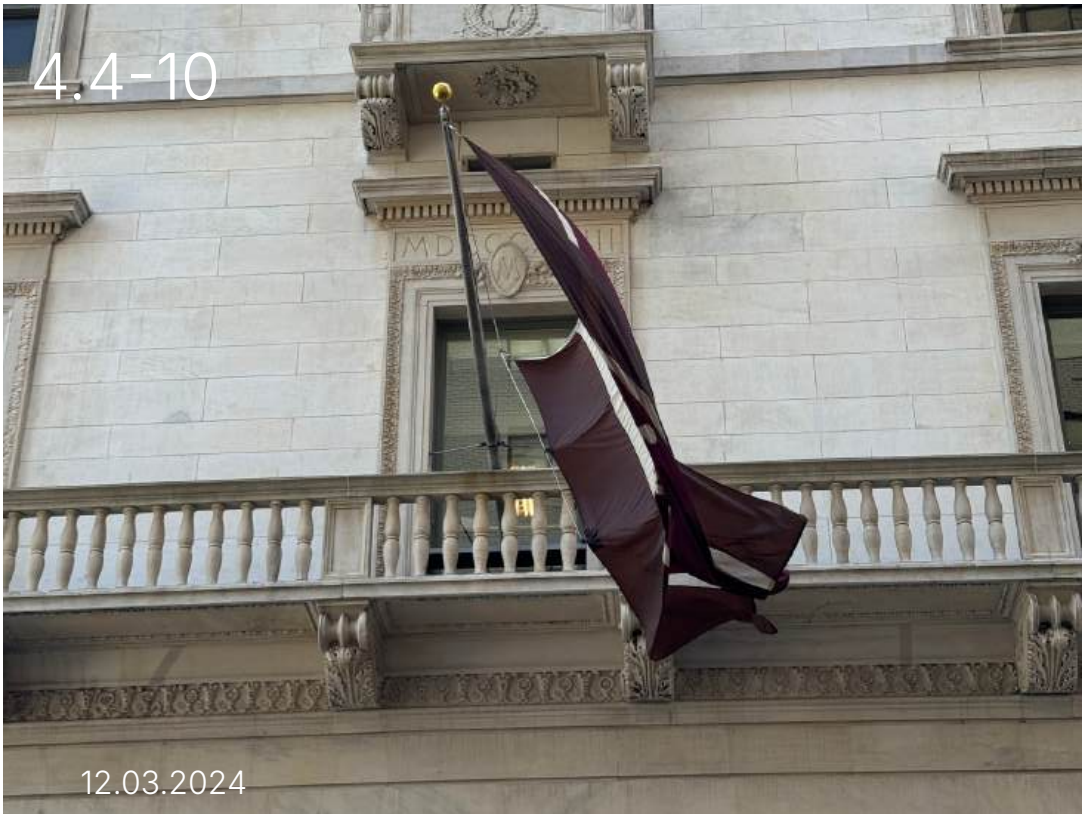
- 4.4-10 5th Avenue Balconies**
- Marble cleaned and restored in 2023.
 - Generally very good condition.

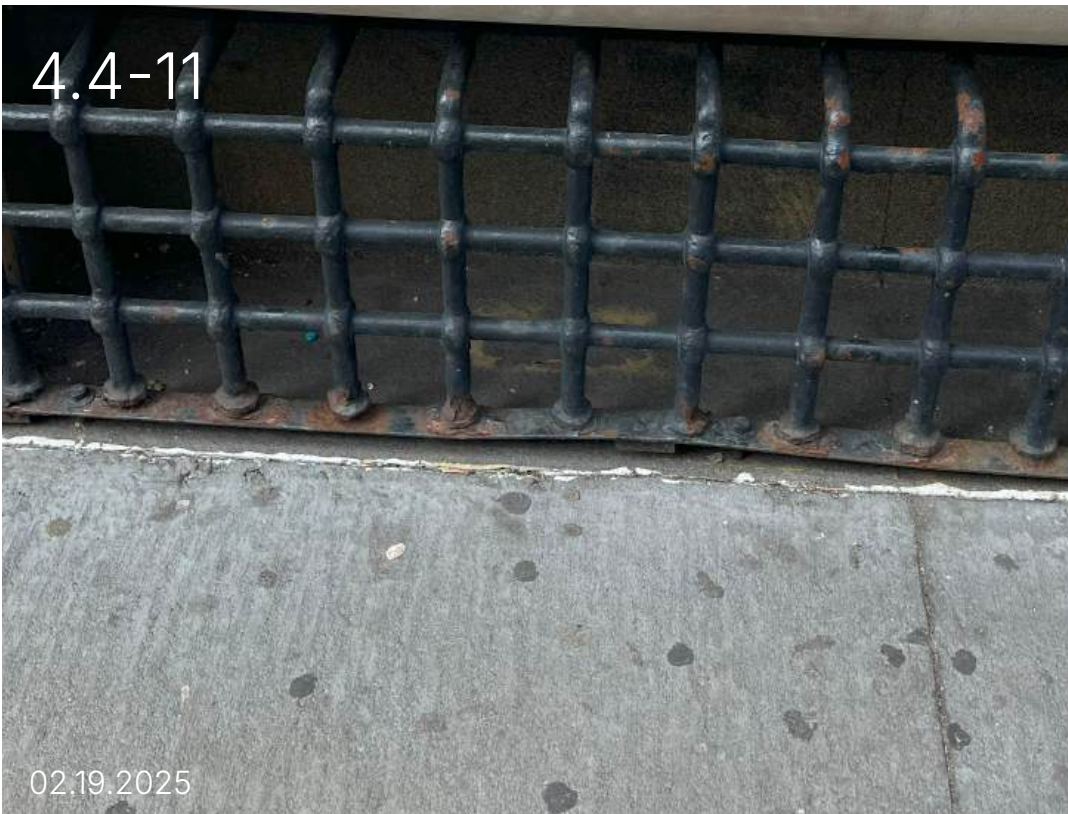
- 4.4-11 Facades**
- Rust at ground-level opening grates.

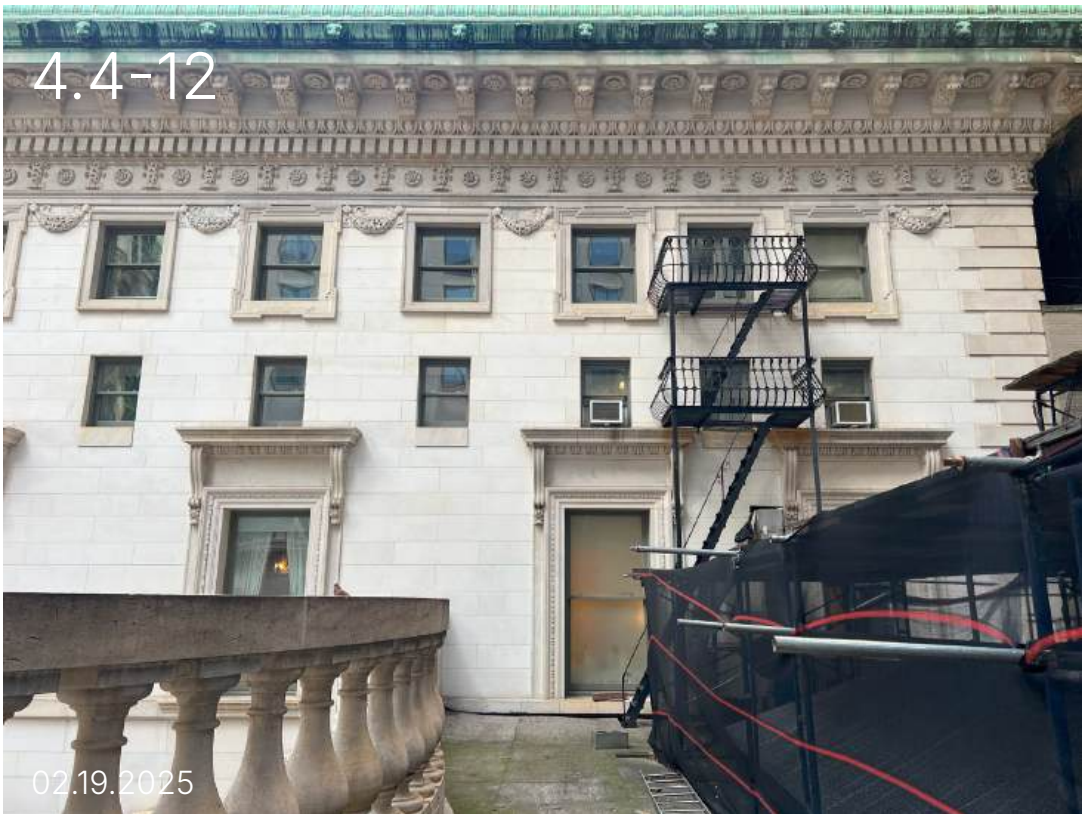
- 4.4-12 Courtyard Facade**
- Cleaned in 2023.
 - Generally good condition.
 - Historic fire escape in good condition.

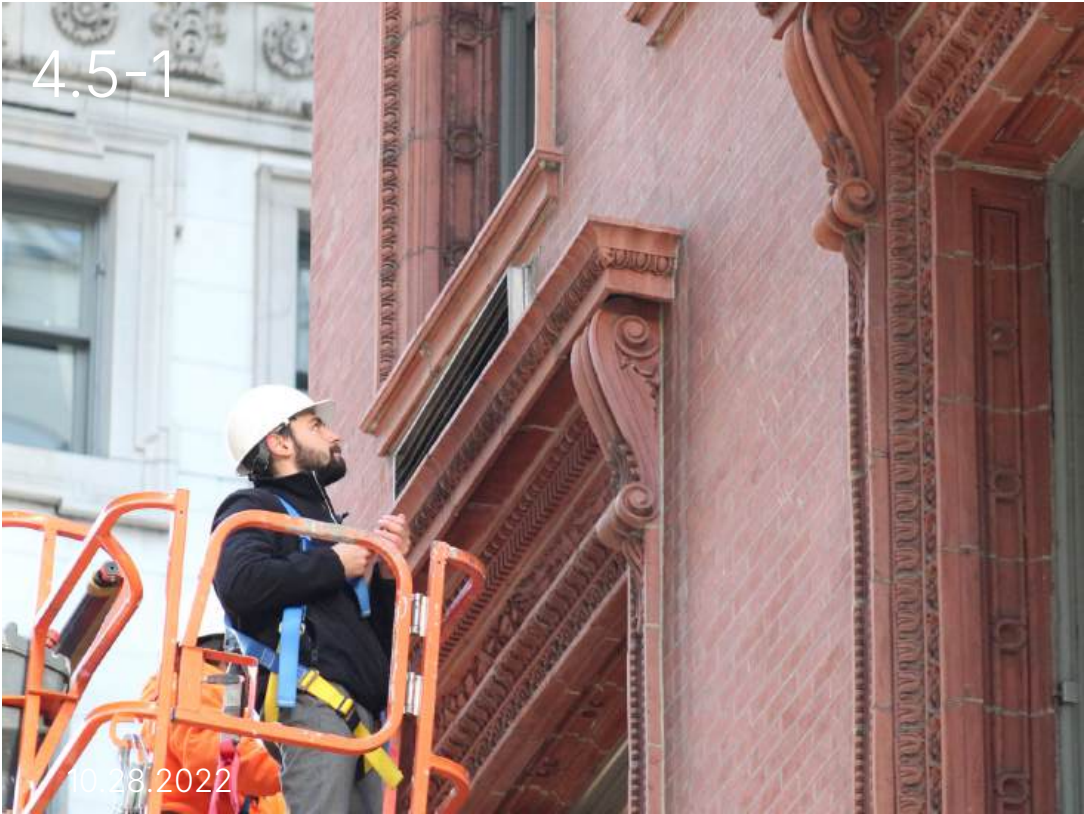
4.5-1 Terracotta Architraves

- Sounded and cleaned in 2023.

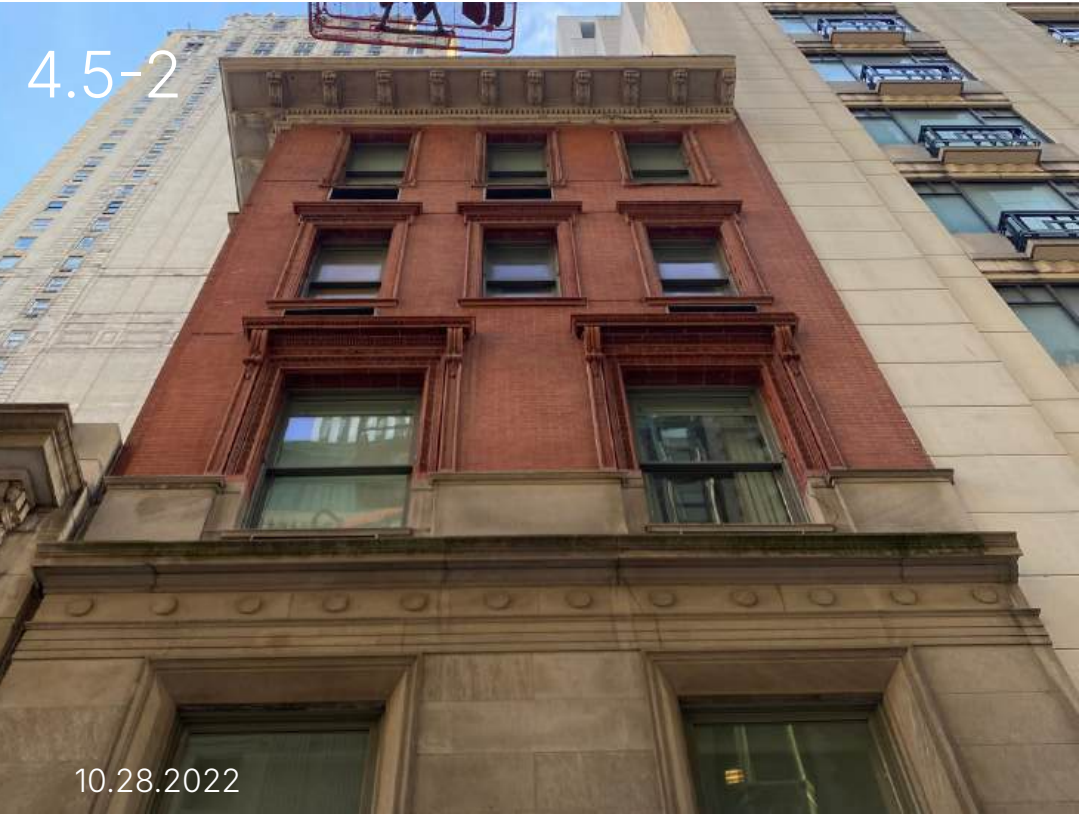
4.5-2 E 60th Street Facade

- Brick and stone cleaned and restored in 2023.

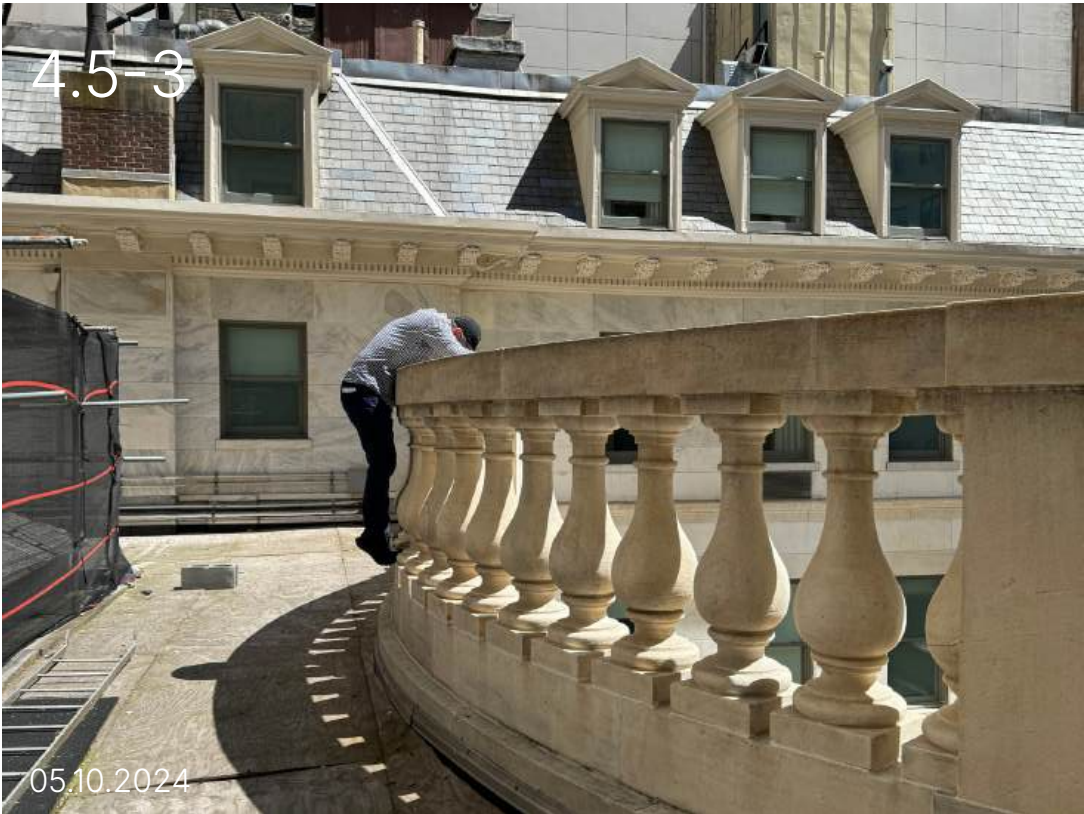
4.5-3 Courtyard Facade

- Stone cleaned and restored in 2023

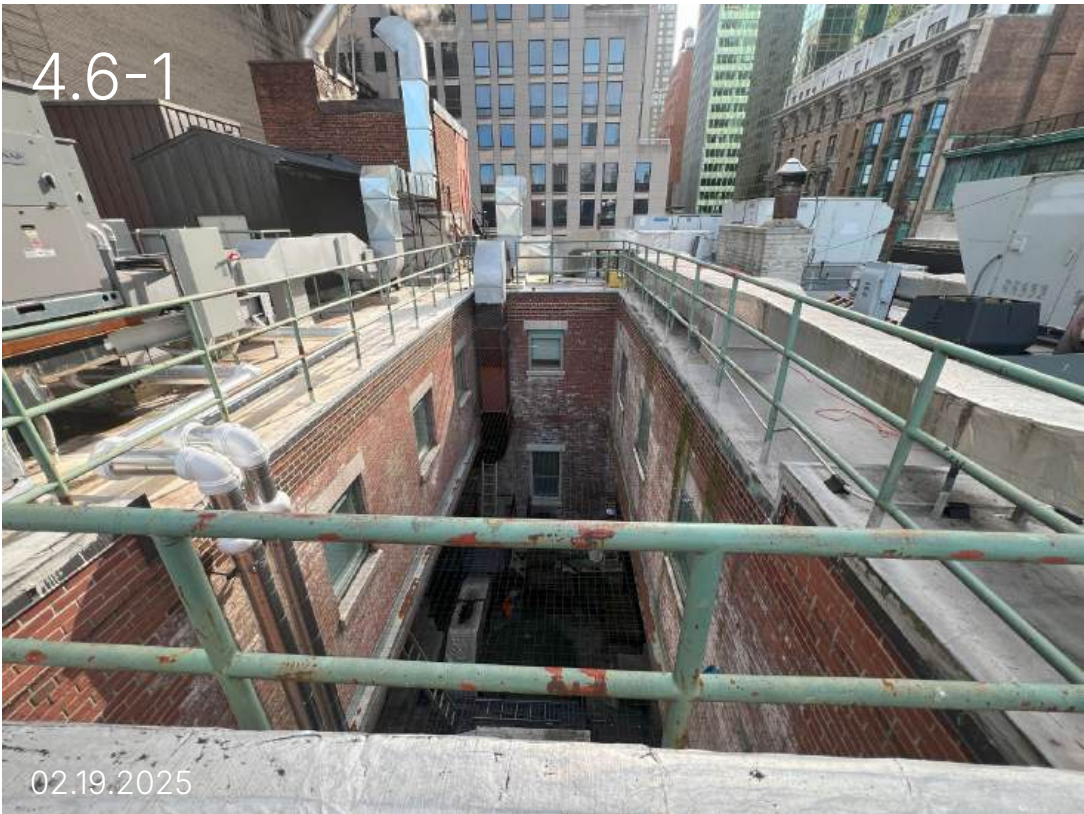
- 4.6-1 Light well Facade
- Efflorescence
 - Selective repointing required.
 - Railing repainting required.

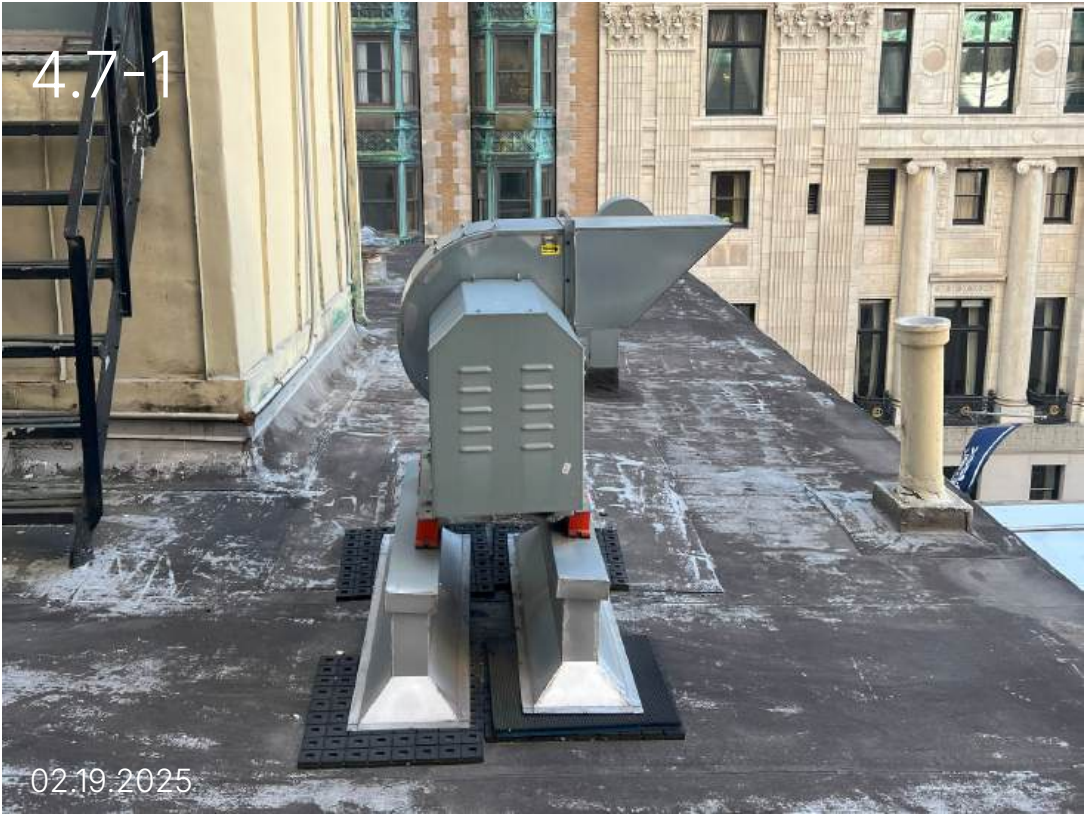
- 4.7-1 Roof**
- General condition of flat roof is good.
 - Waterproofing in fair condition.
 - HVAC and plumbing equipment in good condition and is accessible.
 - Install guard rail as required by code

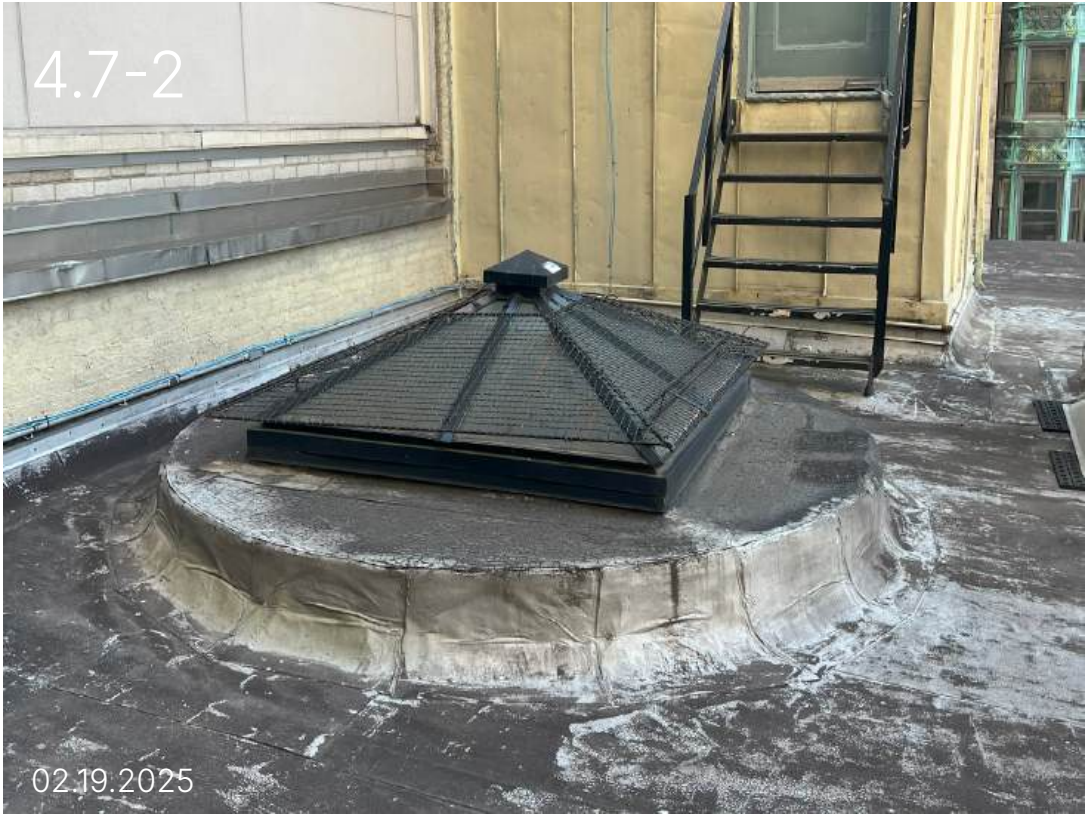
- 4.7-2 Roof - Skylight**
- Skylight glazing and frame in good condition.
 - Waterproofing and flashing in good condition.

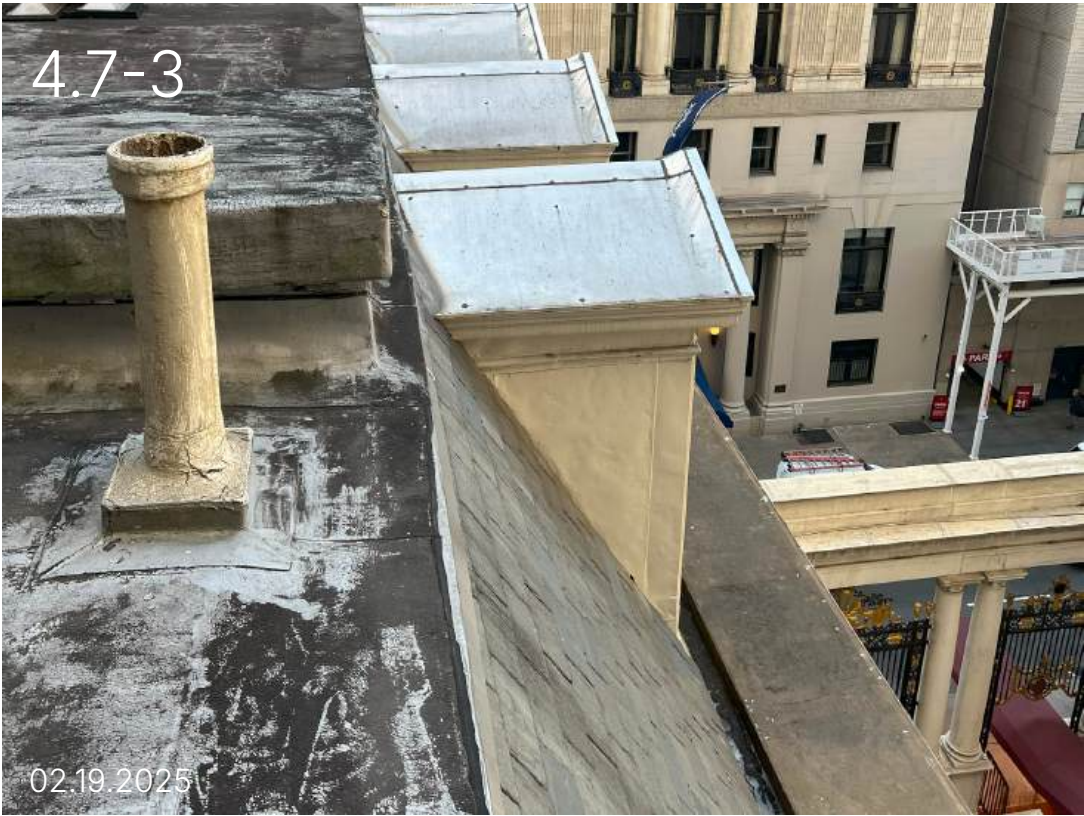
- 4.7-3 Roof - Dormers**
- Slate in good condition.
 - Metal dormer roofs and cladding in good condition.
 - Cornice and waterproofing in good condition.

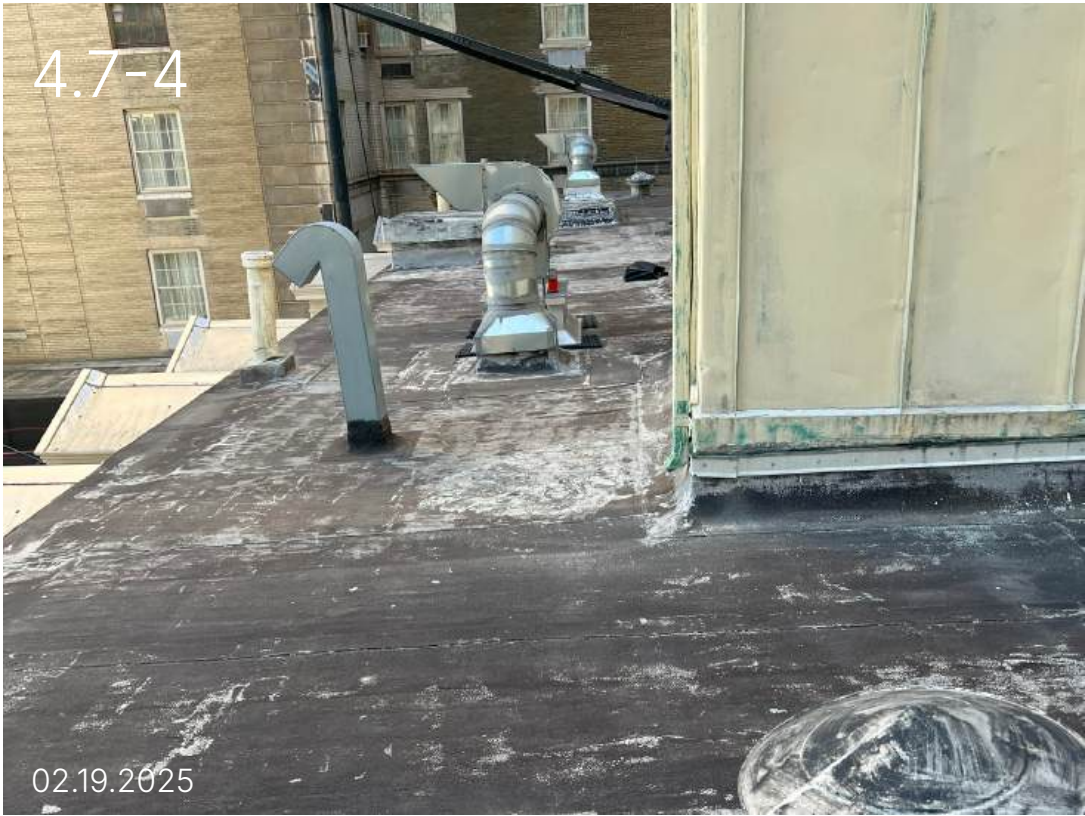
- 4.7-4 Roof - HVAC**
- Waterproofing in fair condition.
 - HVAC & penetration waterproofing in good condition.
 - Metal dormers in good condition but will be made historically appropriate with leaded copper in next restorative repair.

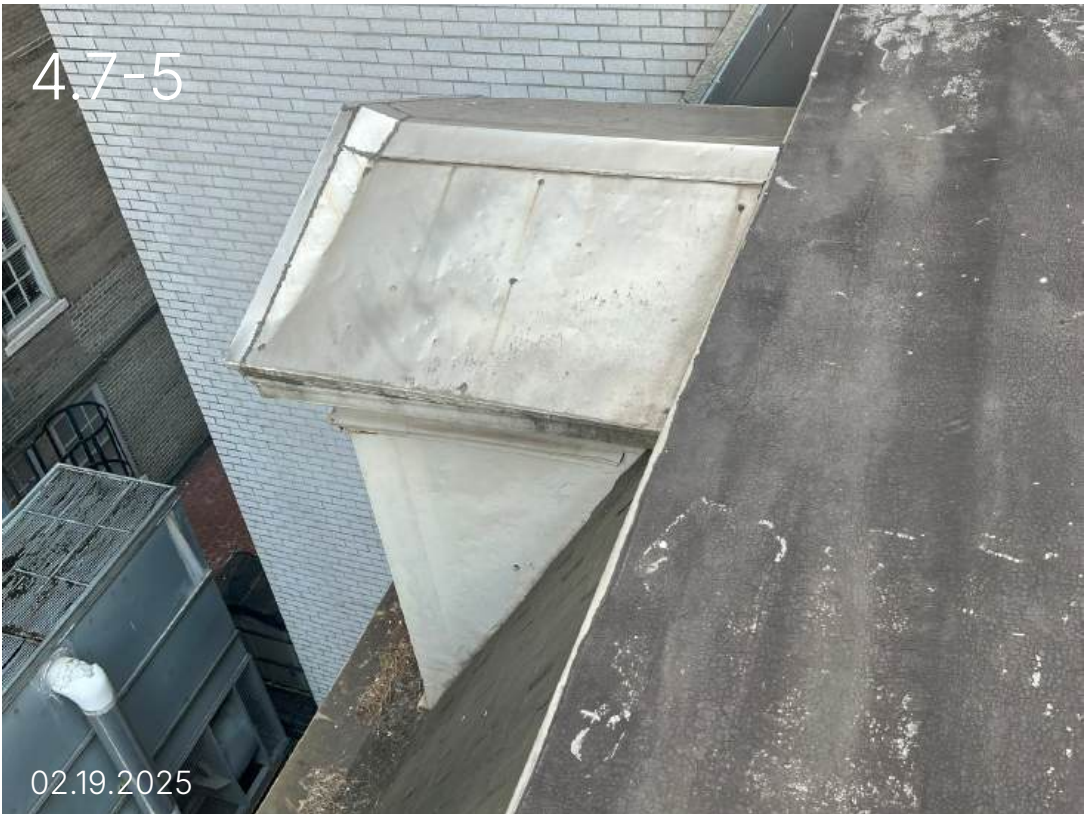
- 4.7-5 Roof - Typical Dormer**
- General condition of dormer roof and cladding is good.
 - Rust stains at selective locations.
 - Joints with roof are in good condition.

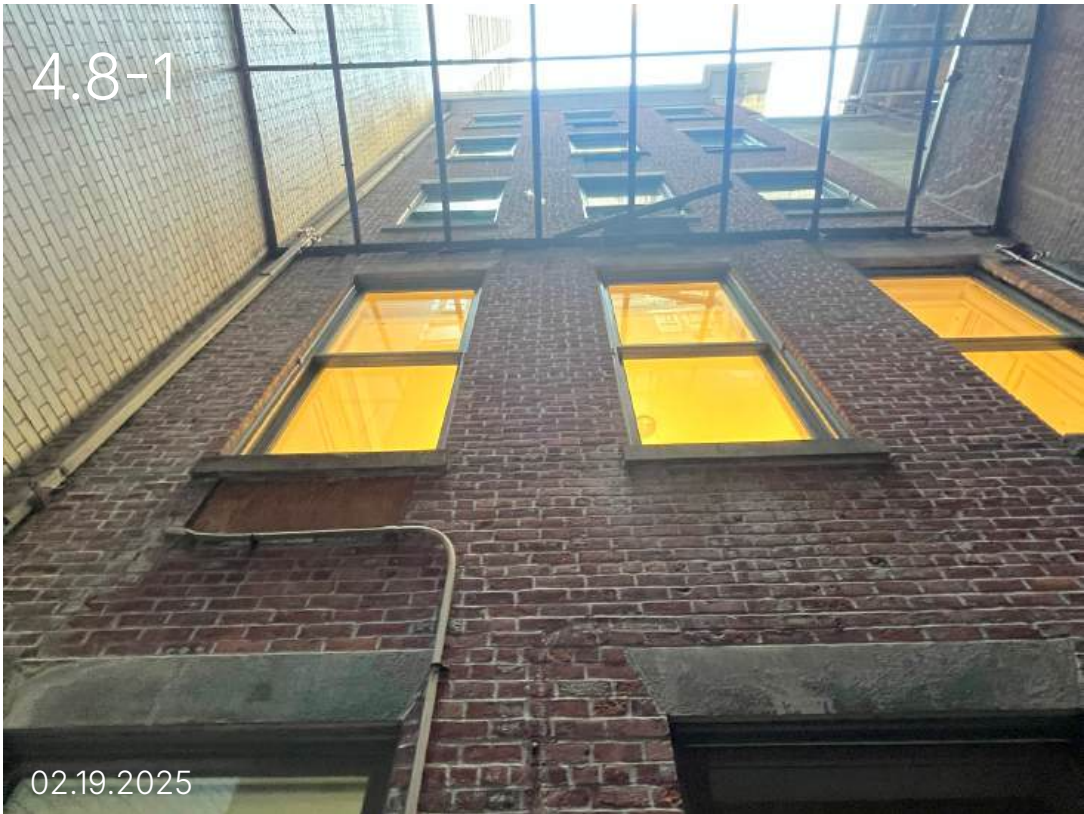
- 4.8-1 Annex Wing Rear Facade
- Reasonable condition.
 - Selective areas in need of repointing.
 - Efflorescence
 - Reasonable bird mitigation.

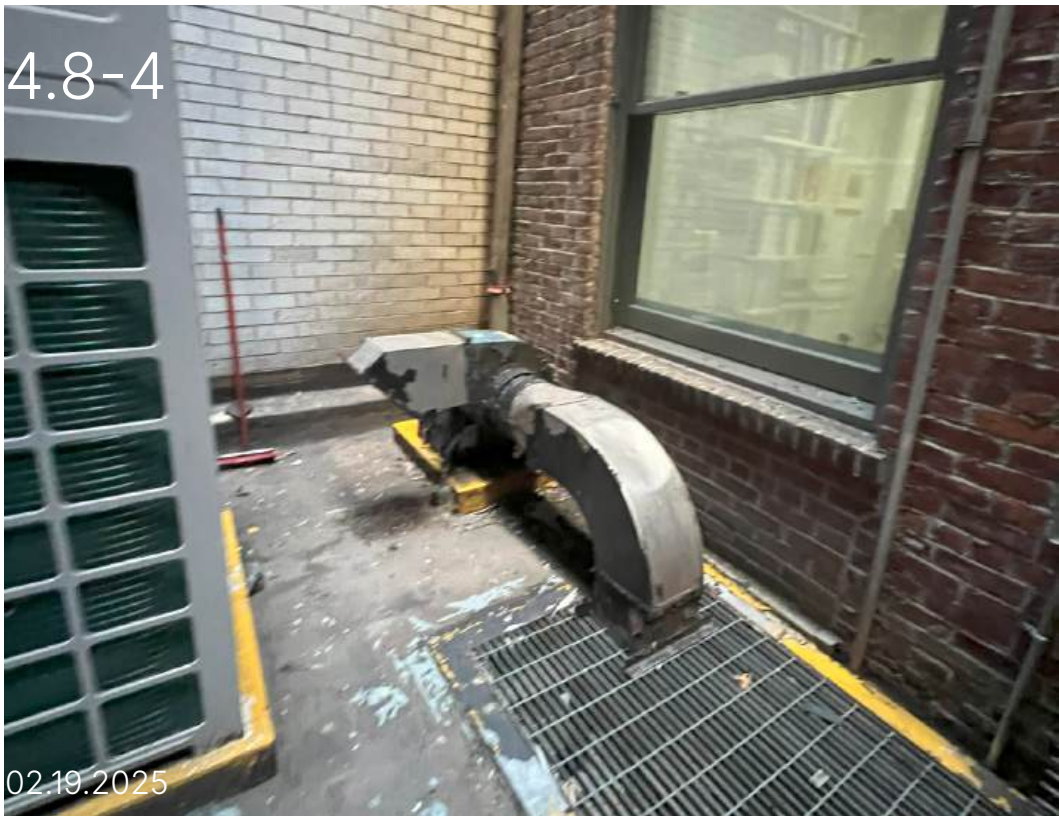
- 4.8-4 Annex Wing Rear Facade
- Back areaway in reasonable condition.
 - Mechanical equipment in good condition.

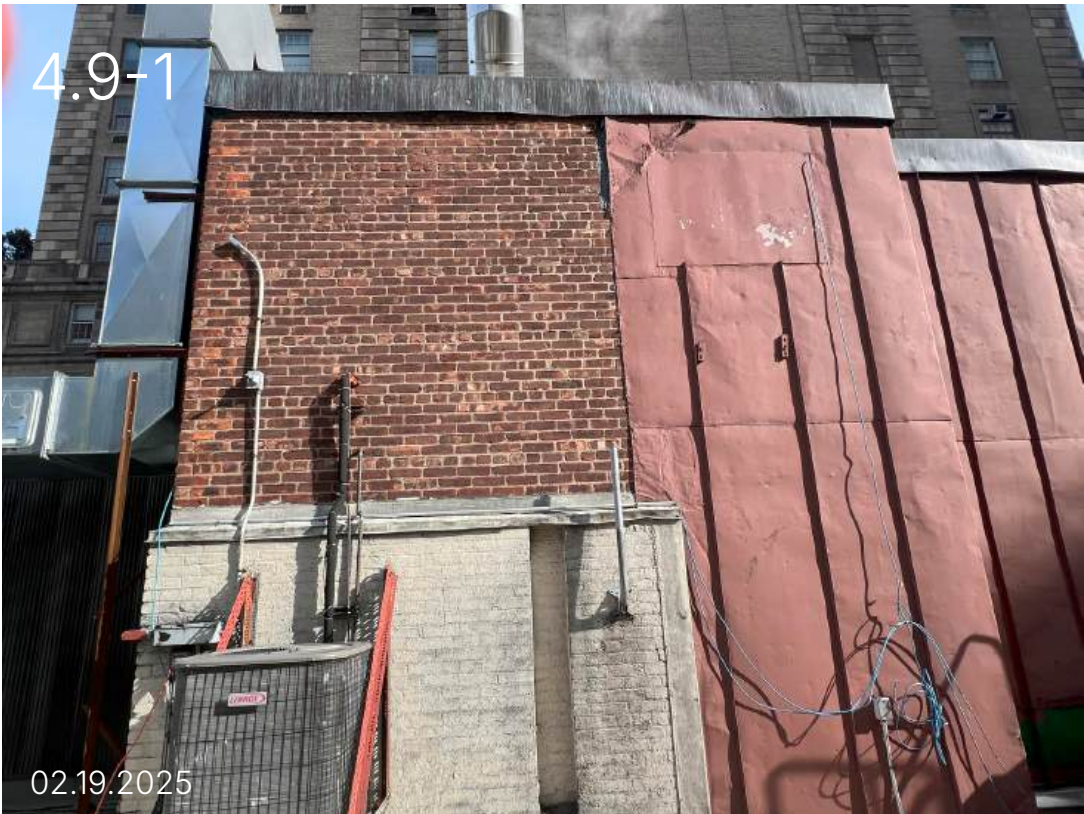
- 4.9-1 Bulkhead
- Brick appears to be in relatively good condition, selective repointing and cleaning recommended.
 - Flashing and Metal cladding in serviceable condition.

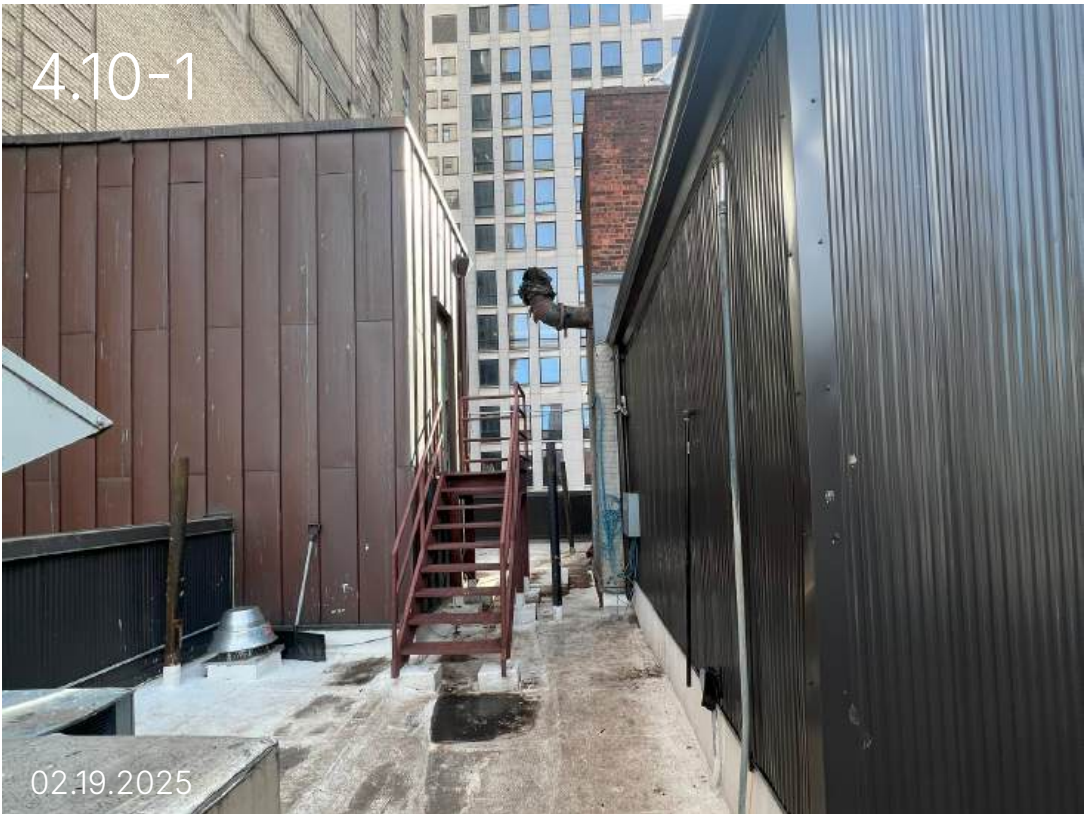
- 4.10-1 Roof
- Waterproofing in serviceable condition.
 - 6th Floor Cladding in good condition.

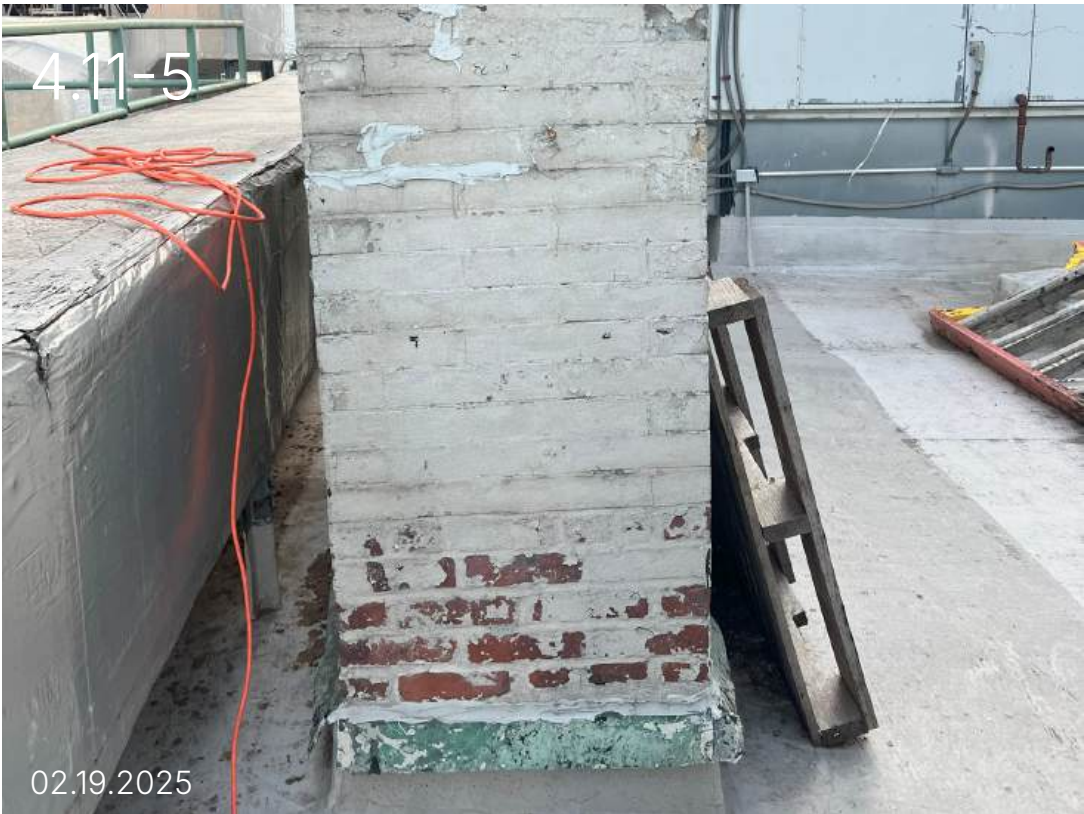
- 4.11-5 Chimney**
- Flashing in somewhat deteriorated condition.
 - Peeling paint
 - Waterproofing up to flashing in good condition.
 - Coping in good condition.

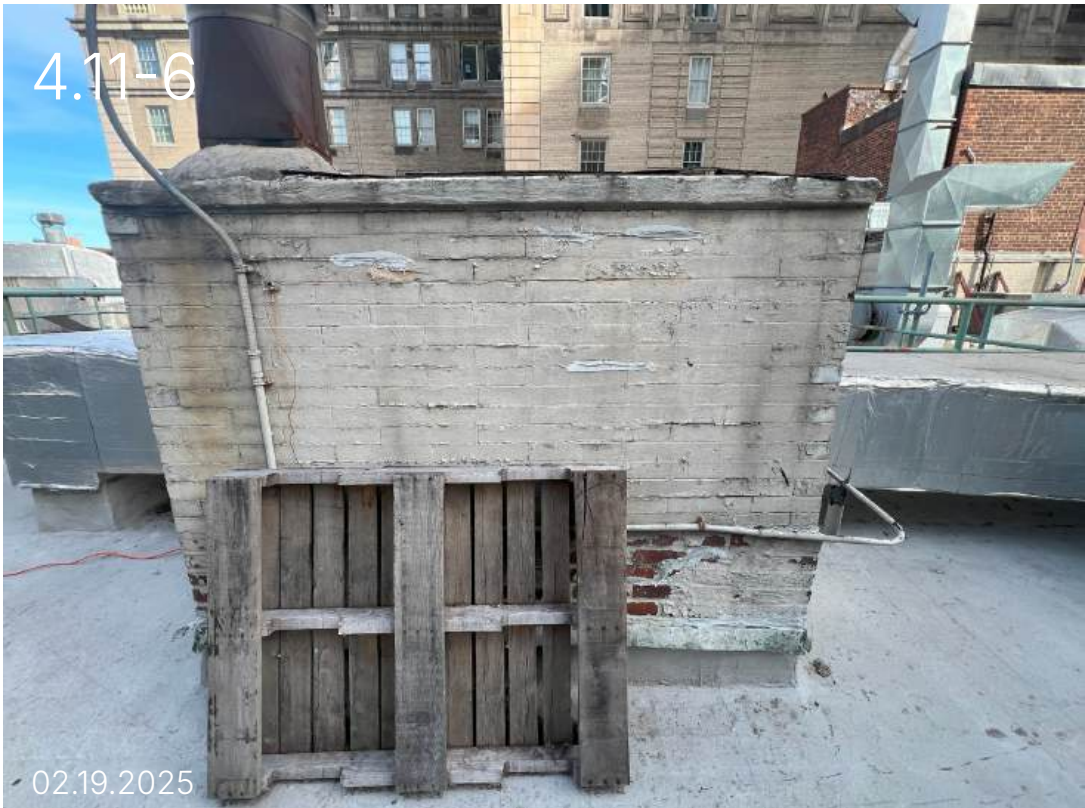
- 4.11-6 Chimney Bulkhead**
- Peeling paint.
 - Waterproofing up to flashing in serviceable condition.
 - Coping in generally good condition. Some spalls along the edges.
 - HVAC equipment in serviceable condition.
