**1 East 60th Street – Upper East Side Historic District
Borough of Manhattan**

The Metropolitan Club

Presentation for Landmark Restoration and Proposed Capital Work

4.0 Appendix A: Existing Conditions Report

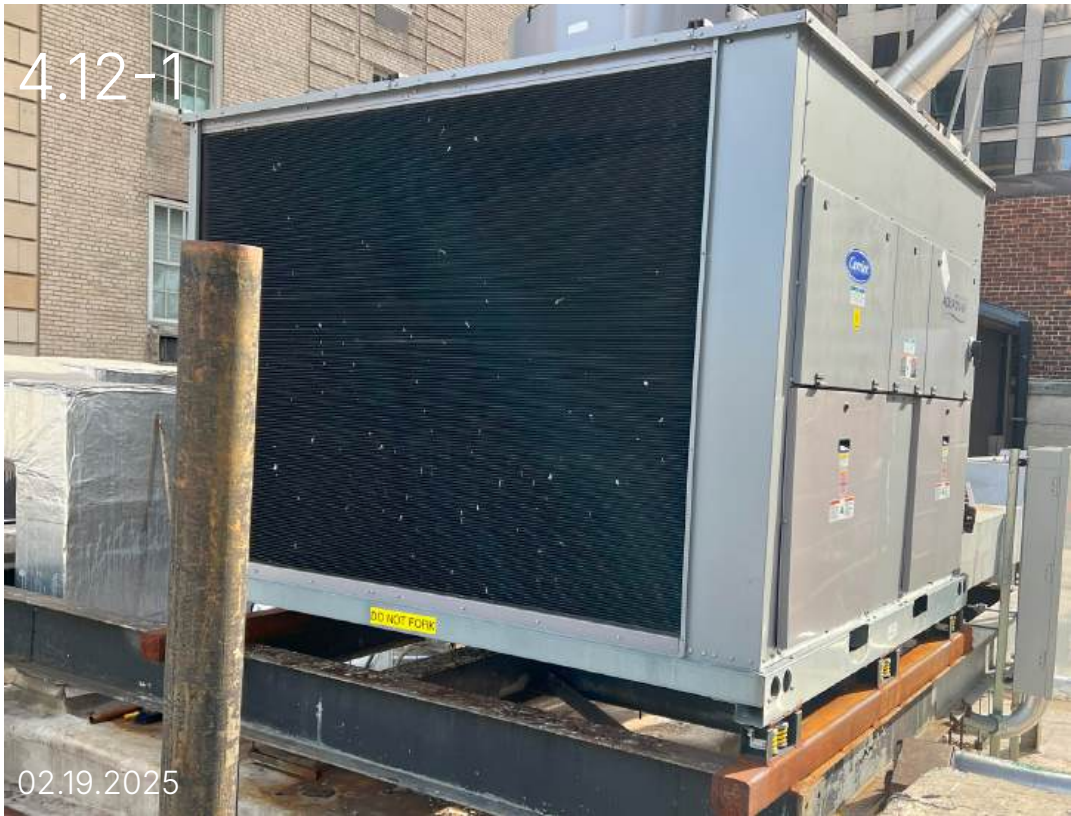
- 4.12-1 HVAC
- Chiller and dunnage in good condition.
 - Ductwork in good condition and accessible.

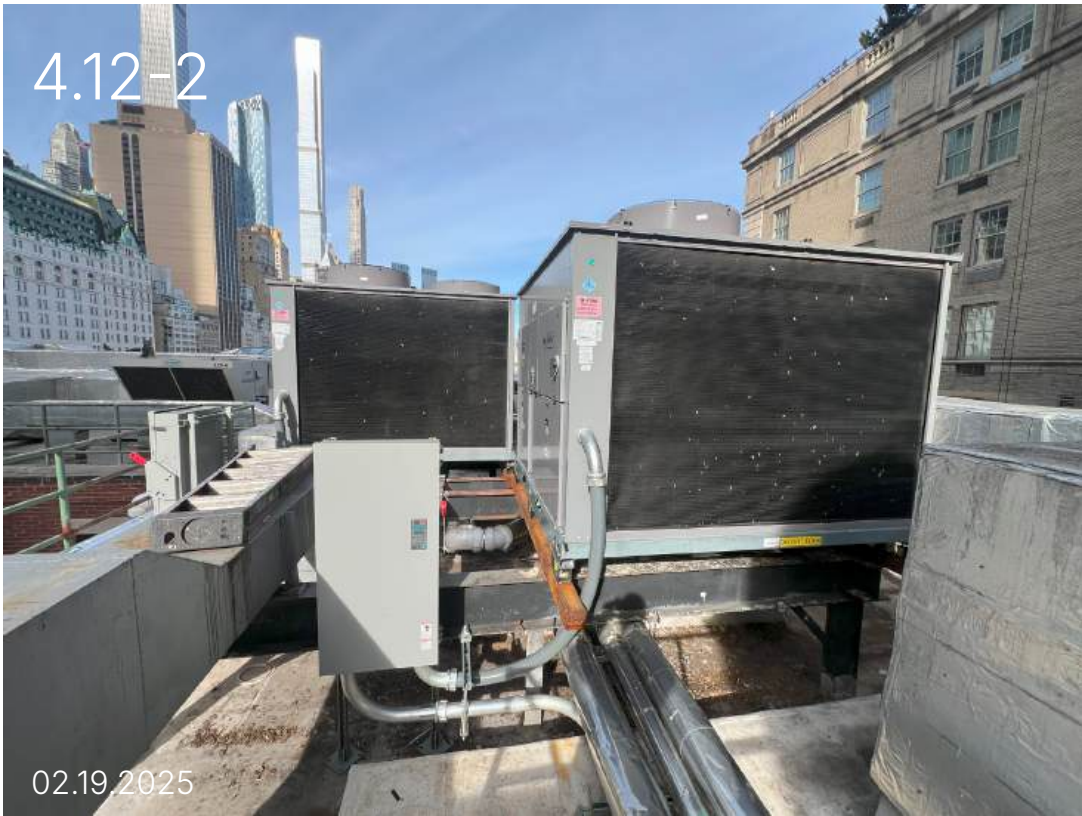
- 4.12-2 HVAC
- Equipment and dunnage in good condition and accessible.

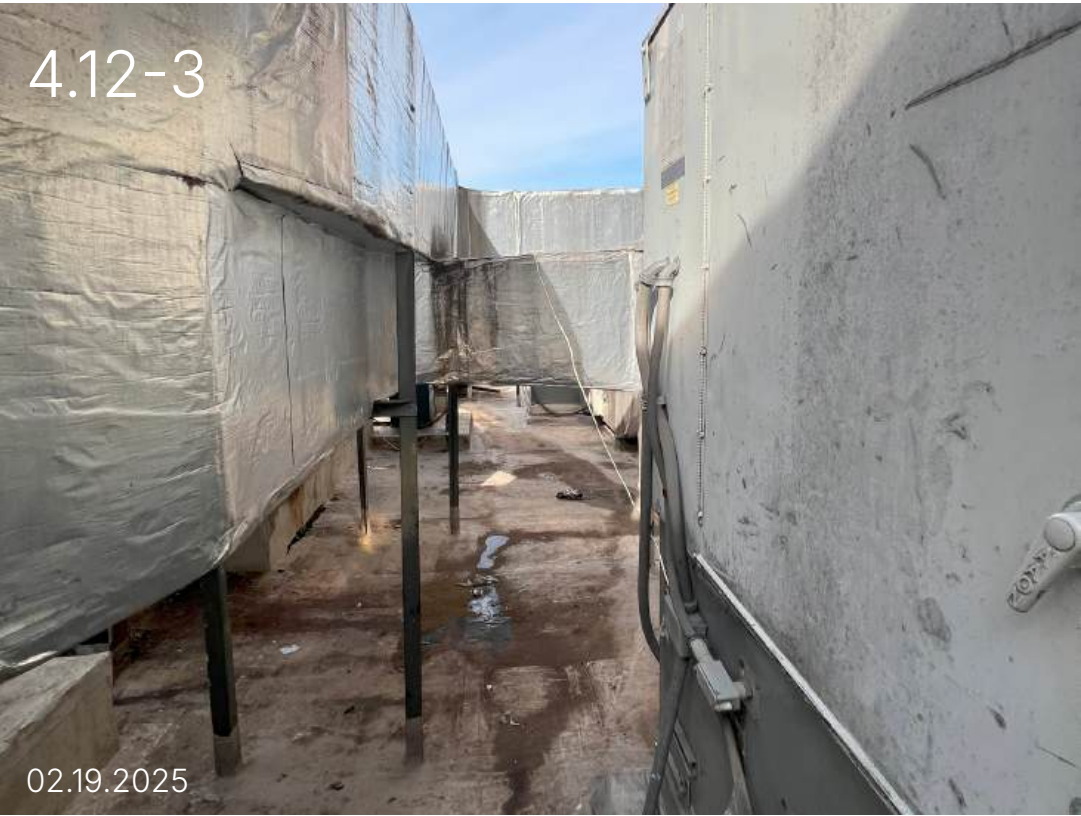
- 4.12-3 HVAC
- Ductwork, conduit, and dunnage in good condition and accessible.

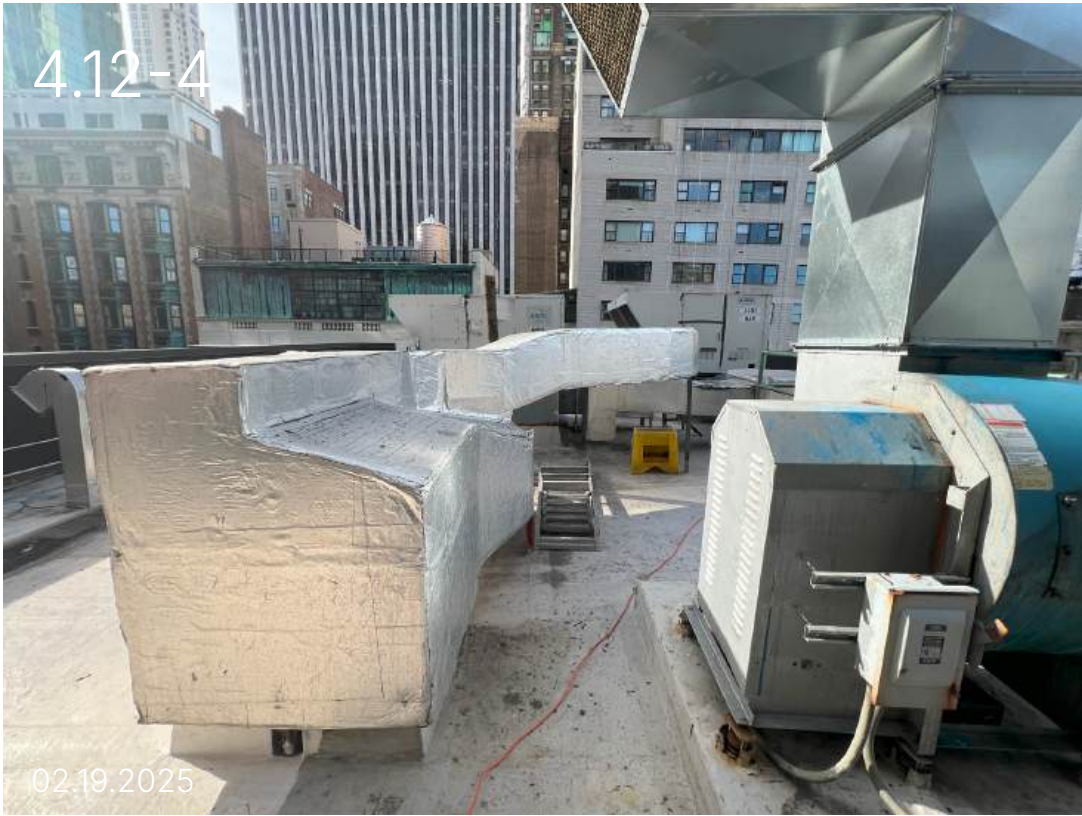
- 4.12-4 HVAC
- Ductwork, conduit, and dunnage in good condition and accessible.

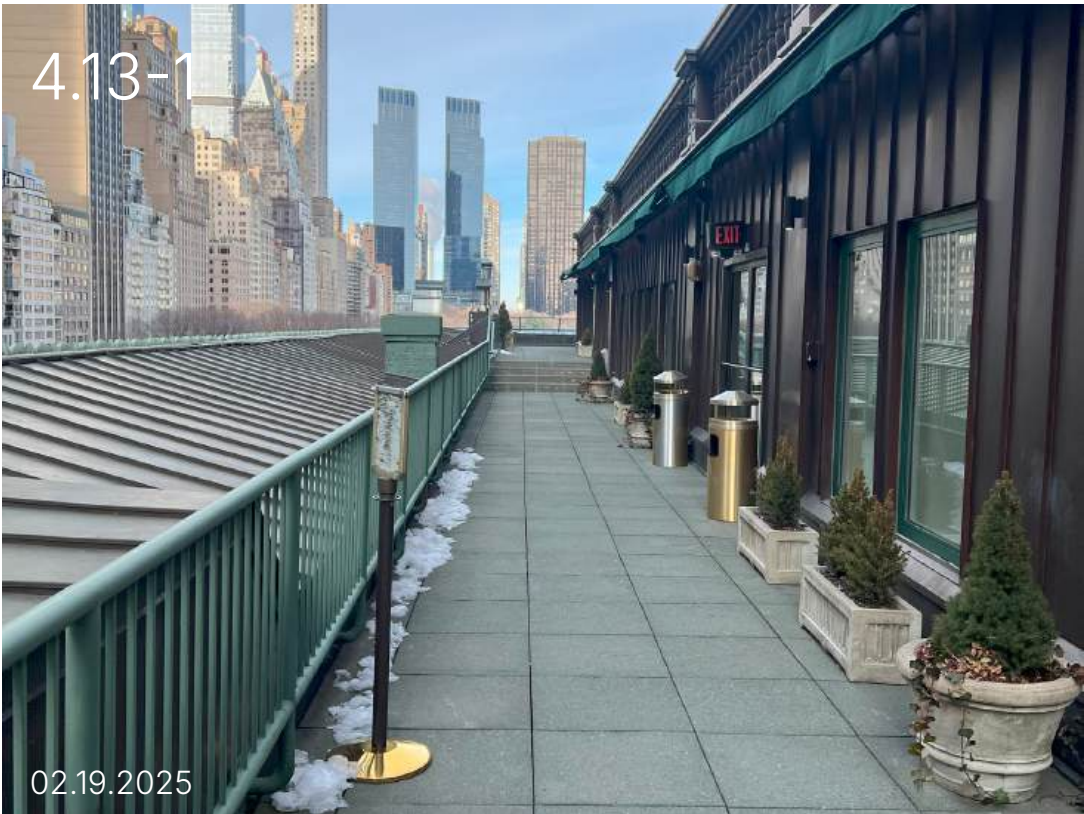
- 4.13-1 6th Floor Terrace**
- Pavers, guard rail, and cornice observed to be in good condition.
 - Organic growth on pavers at select locations.
 - Cladding in good condition.
 - Select areas candidates for future light cleaning.
 - Metal coping generally in good condition.

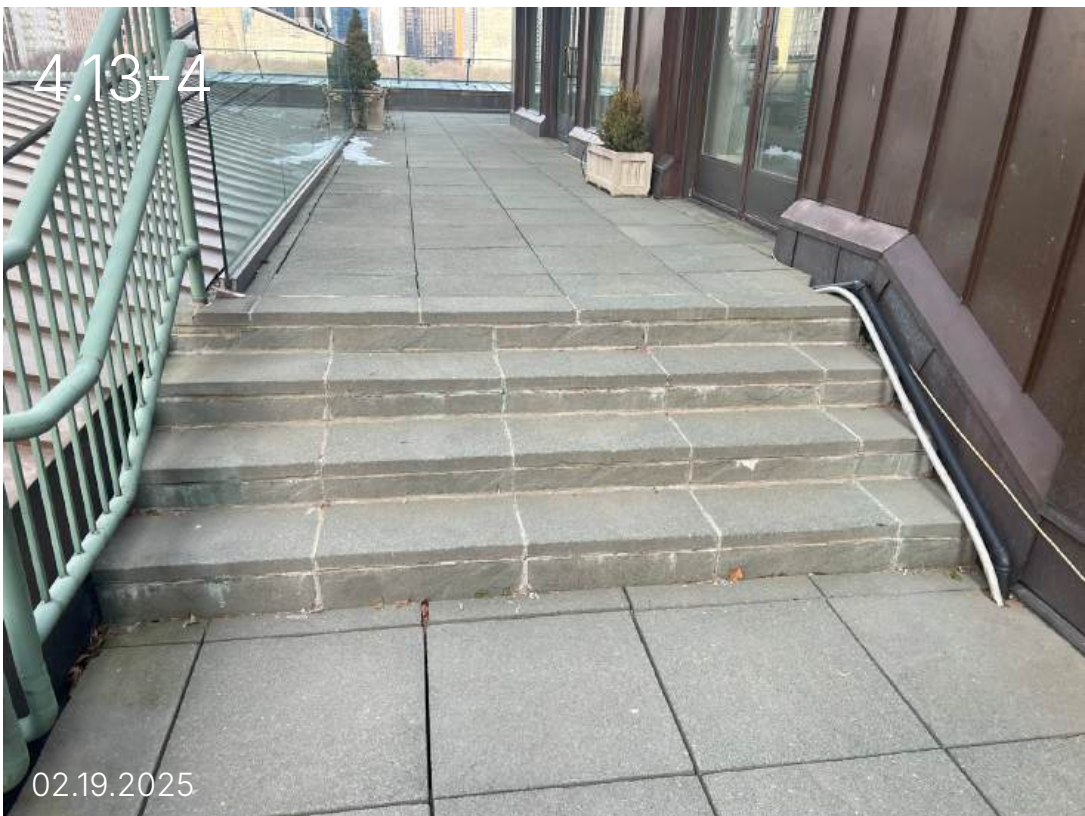
- 4.13-4 6th Floor Terrace**
- Stone stairs and pavers in good condition.
 - Waterproofing in good condition but needs constant monitoring and localized repairs.
 - Conduit and piping in good condition.

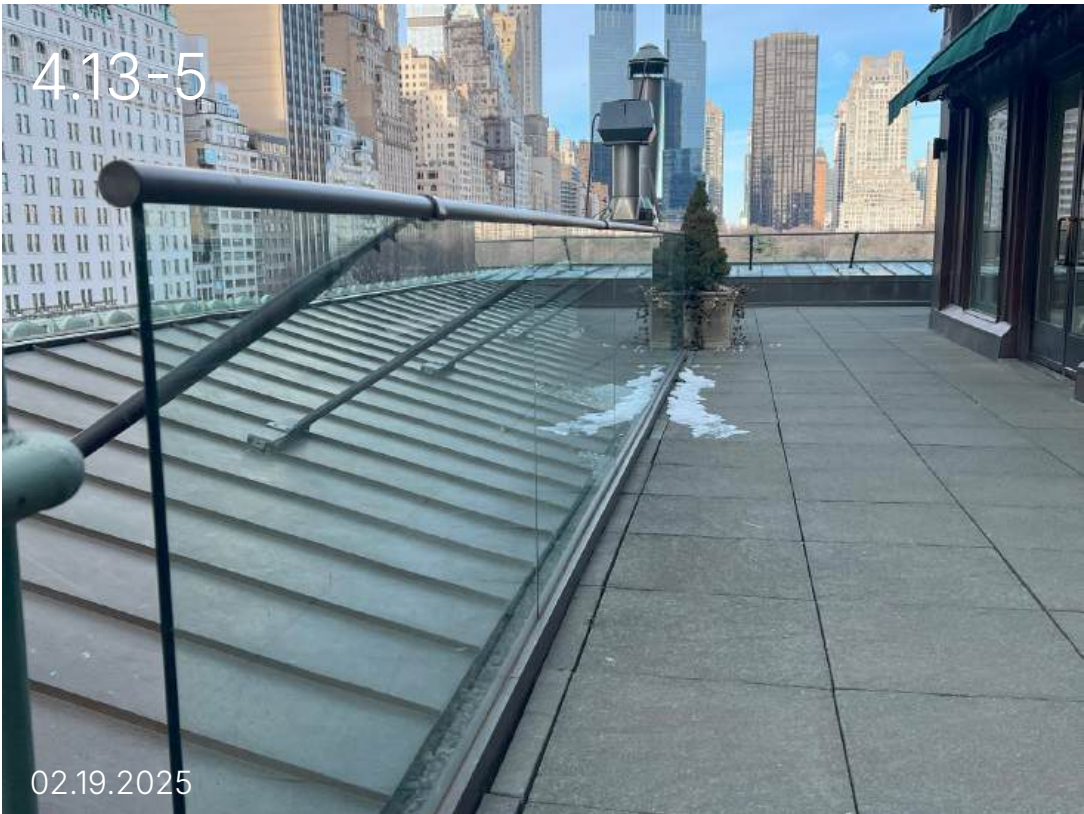
4.13-5 6th Floor Terrace

• Glass railing and supports in good condition.

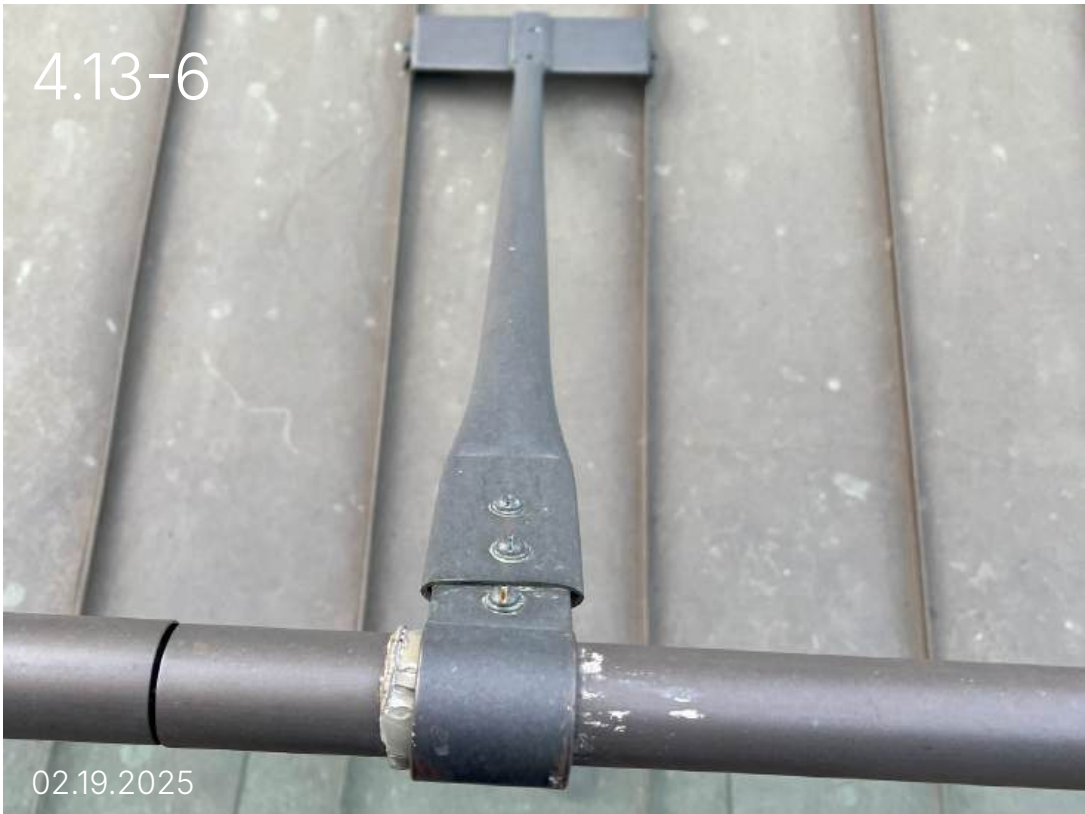
4.13-6 6th Floor Terrace

• Typical glass railing support. No insecure locations observed as repairs and reinforcing are part of continued maintenance.

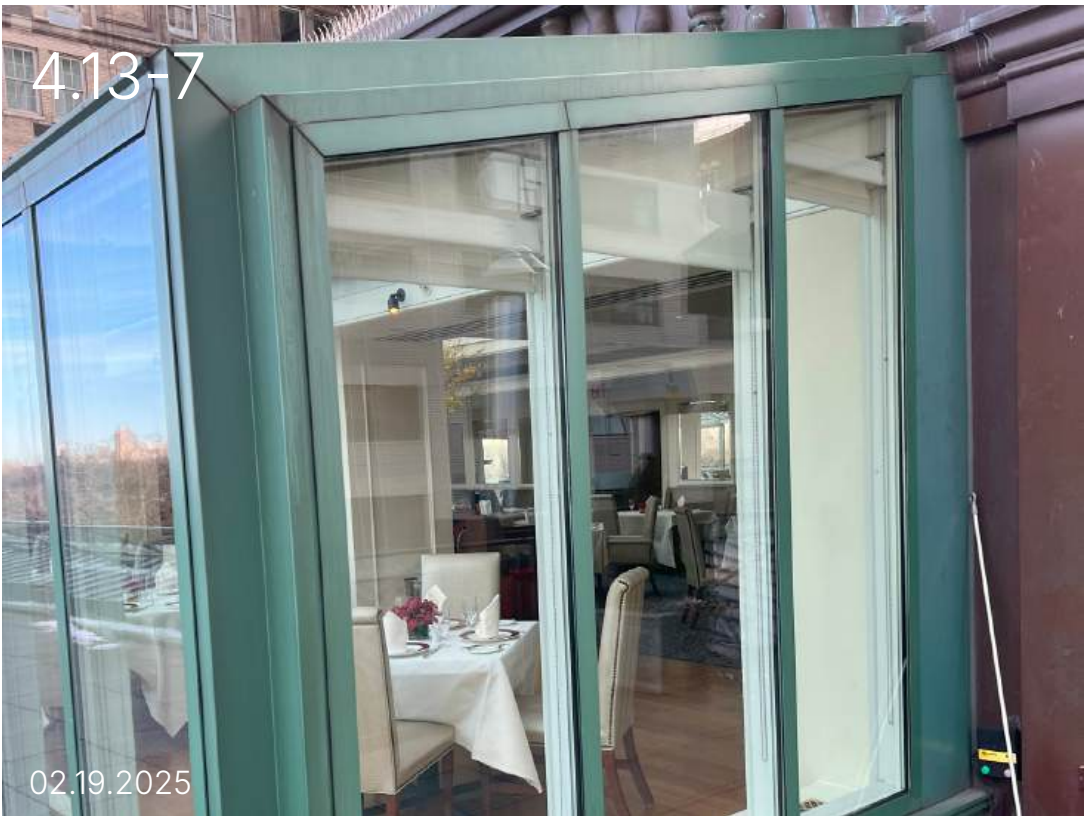
4.13-7 6th Floor Facade

• Greenhouse glazing, flashing, and cladding observed to be in good condition.

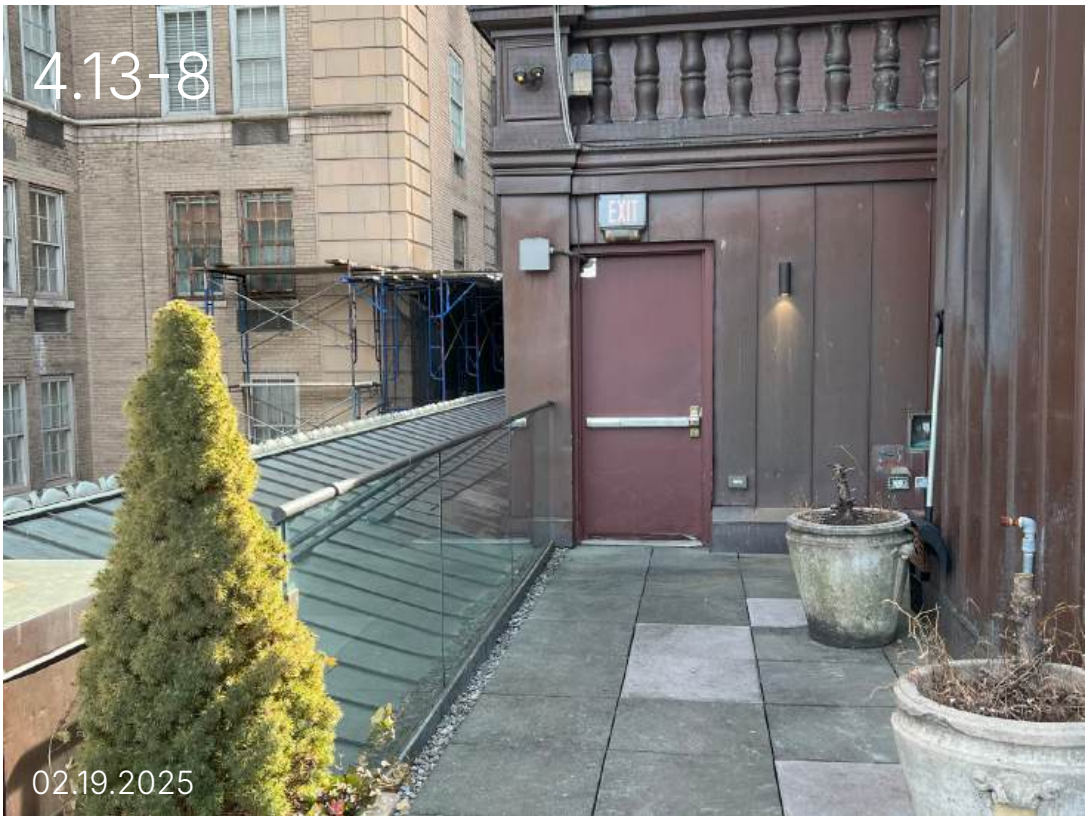
• Egress systems in working order.
• MEP systems in good condition.
• Cladding in good condition. Minor cleaning could be affected in selective areas.
• Sealing at windows and joints on facade need upgrades and monitoring.

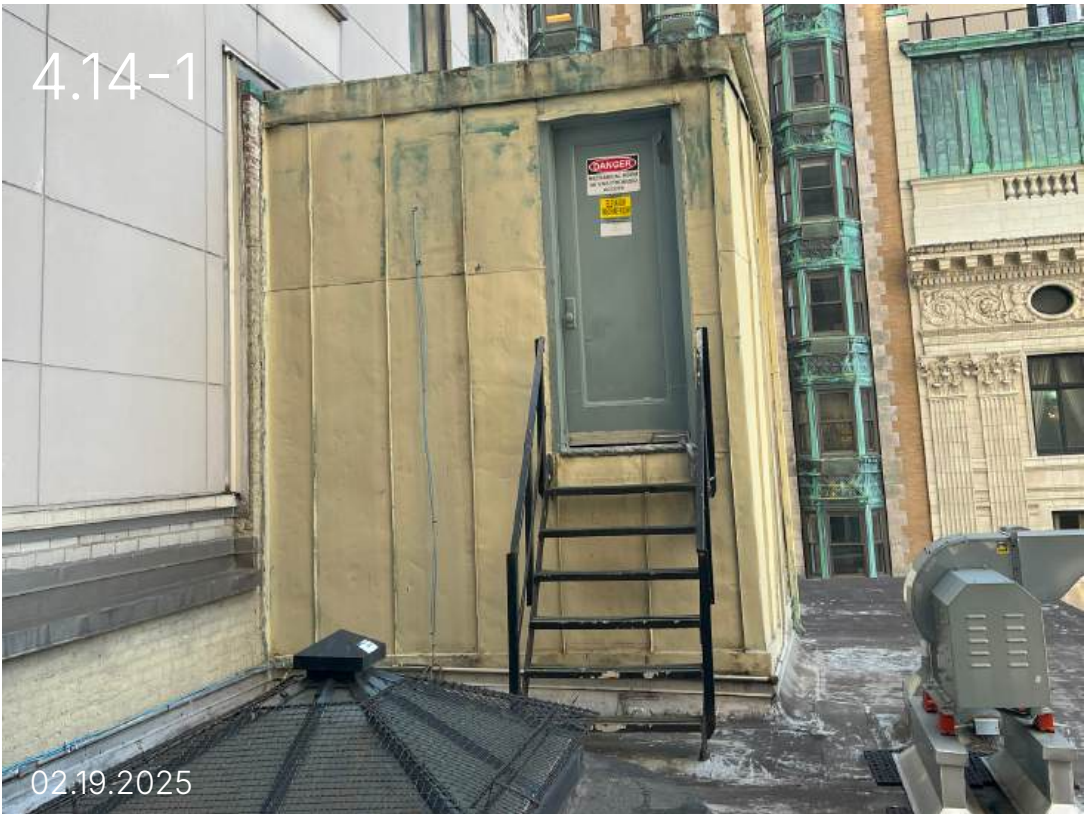
- 4.12-1 Elevator Bulkhead**
- Cladding in fair condition.
 - Metal coping deformed at select locations.
 - Parapet wall, flashing, and waterproofing observed to be in fair condition.
 - Access stairs in good condition.

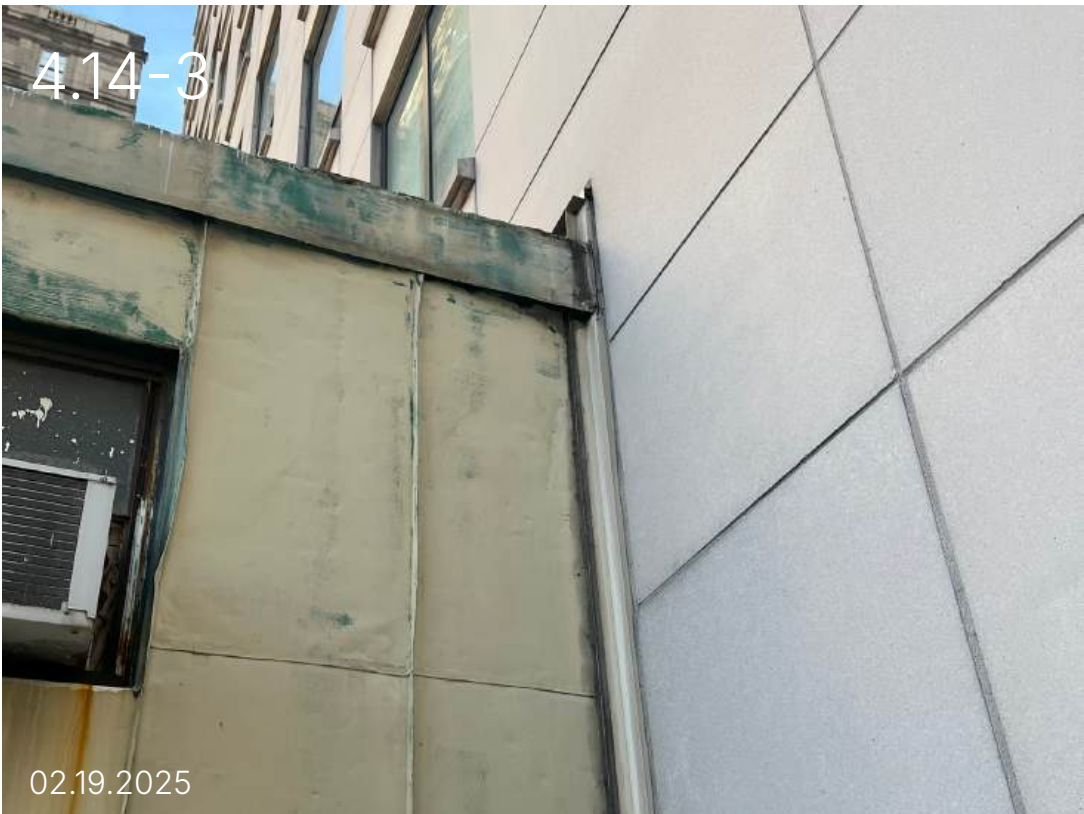
- 4.12-3 Elevator Bulkhead**
- Vertical flashing in good condition.
 - Horizontal coping deformed at select locations.
 - Future repainting.

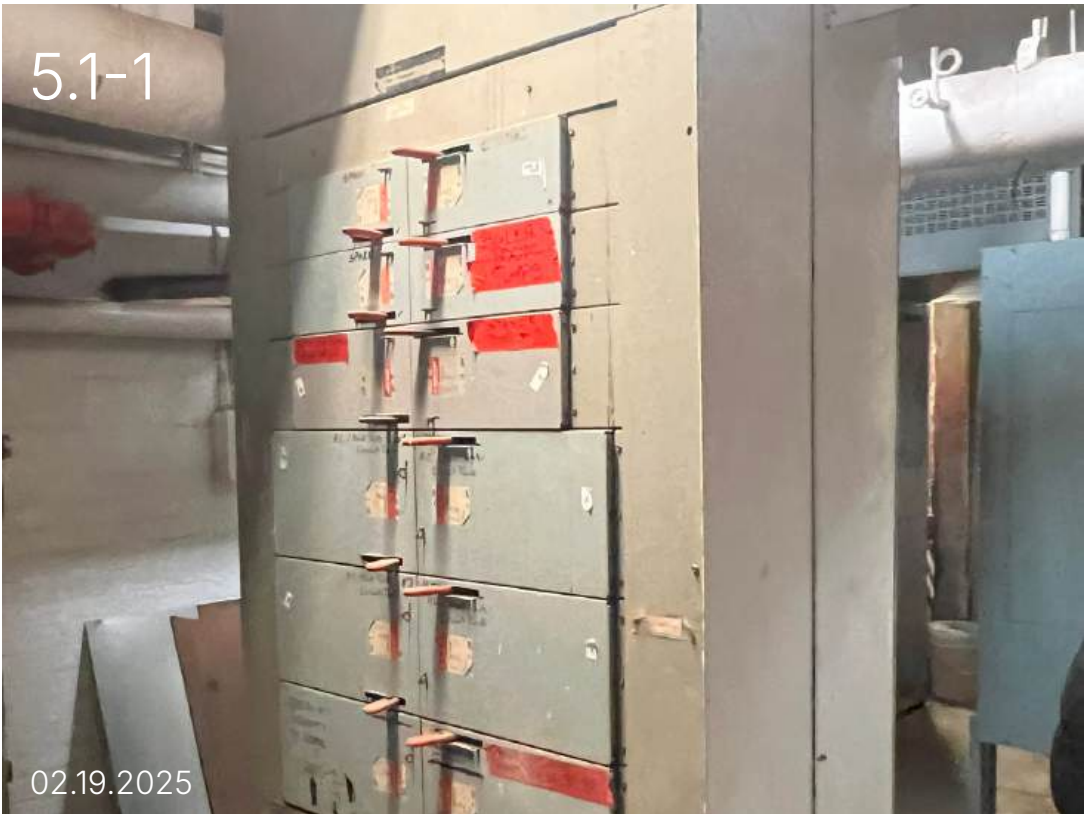
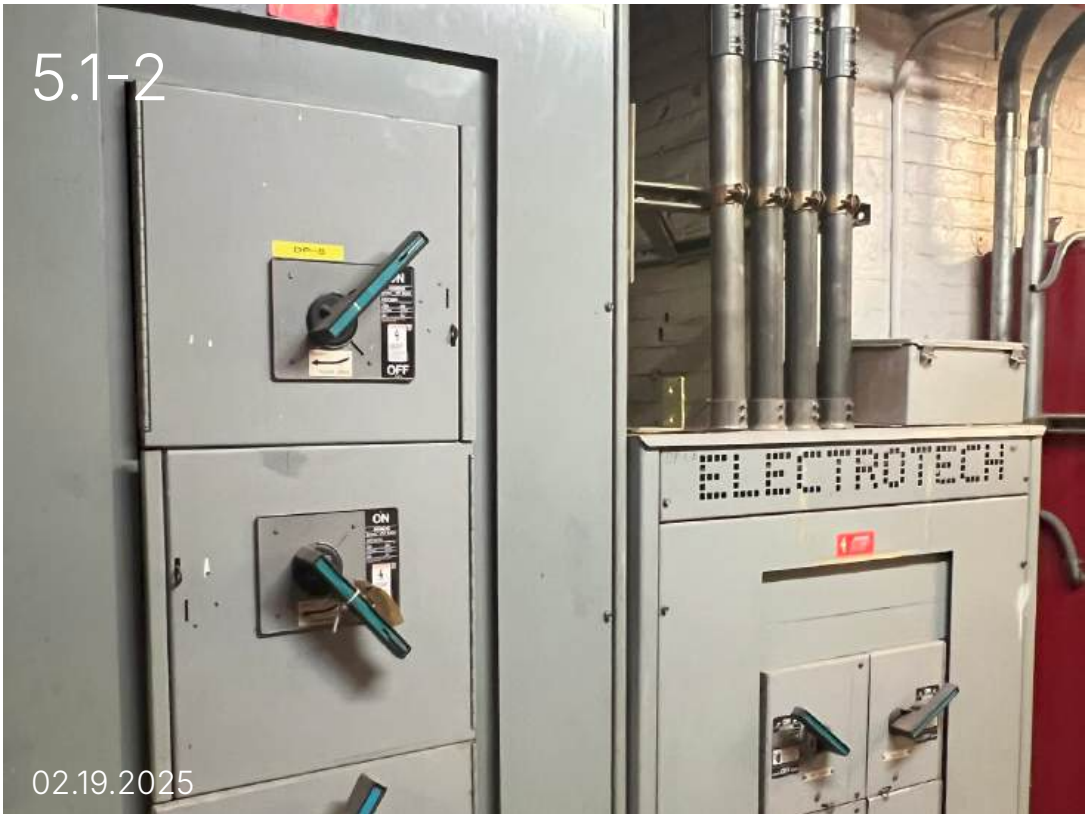
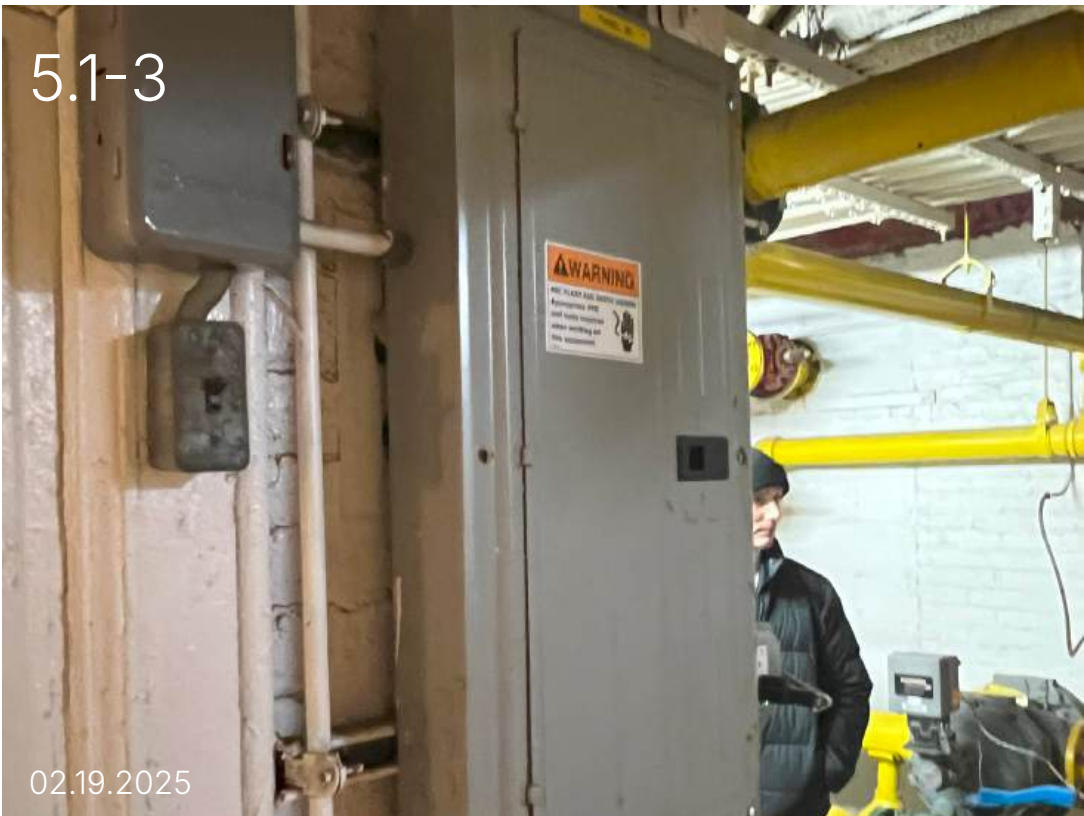
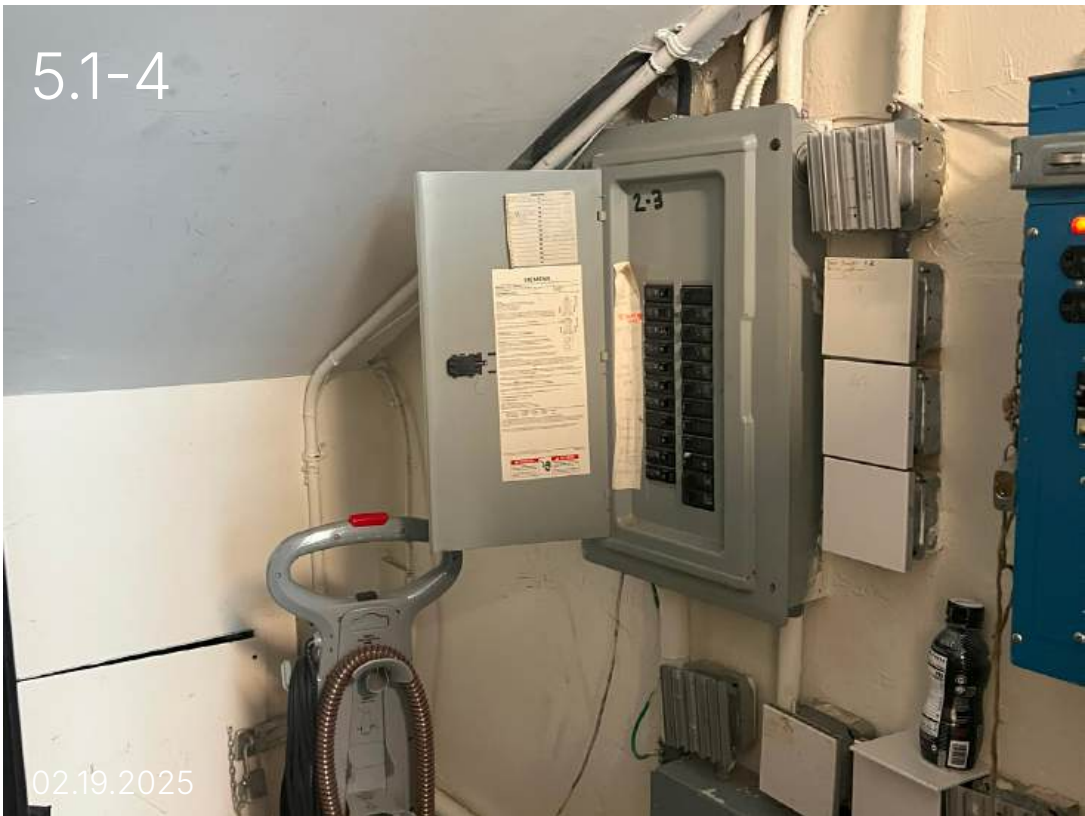
- The electrical service for the Metropolitan Club enters the main Club House through the cellar level. The Club has upgraded its electrical systems in a phased fashion as various renovations have been made over the decades.
- Electrical service for the current uses of the Club is adequate and serviceable.
- Sub-metering to monitor usage is not available.
- Branch circuit wiring, distribution panels, and devices are in need of upgrades. Power has been distributed throughout the Club on an ad hoc basis as required. Rationalization of power sourcing, runs, and plans for the connection of future systems is required in compliance with Local Law 87 mandates.

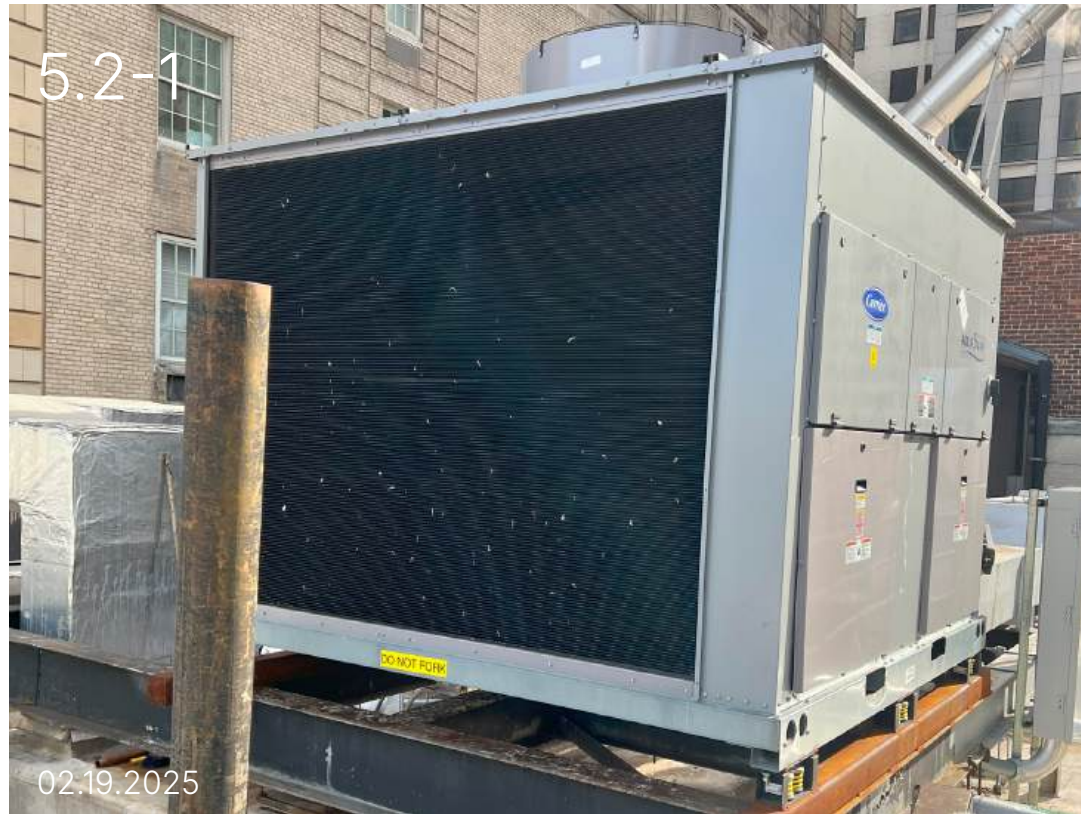
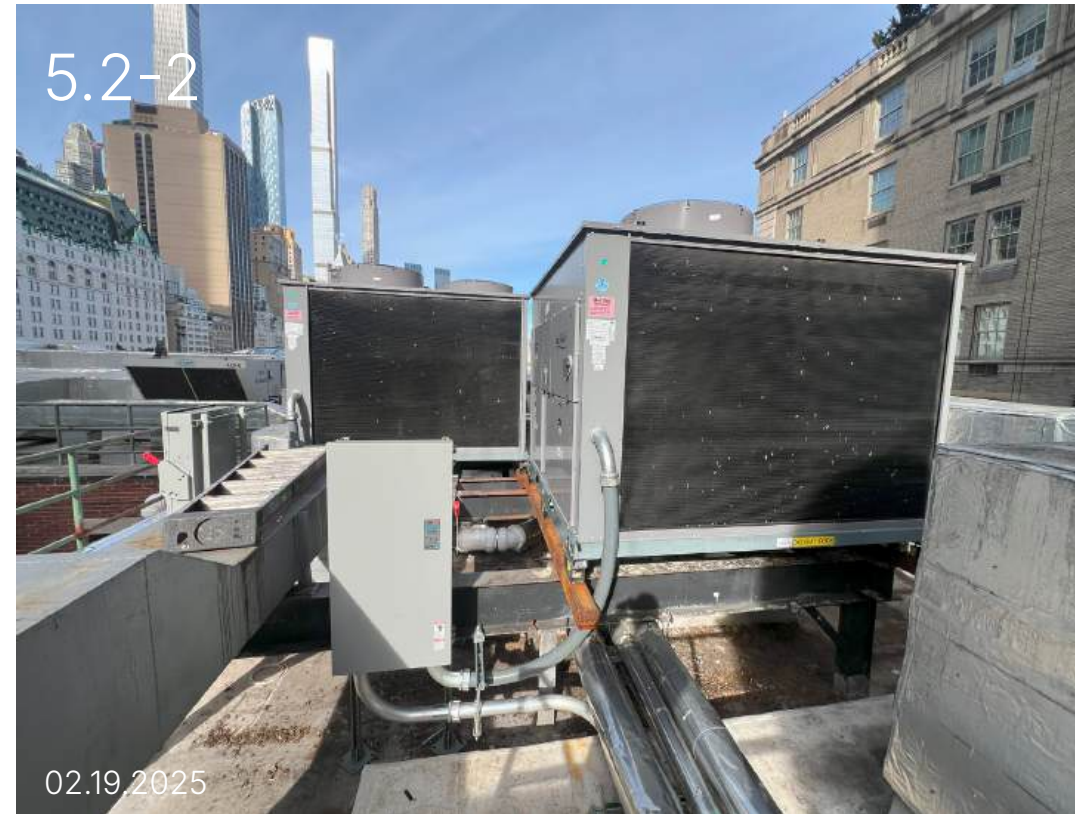
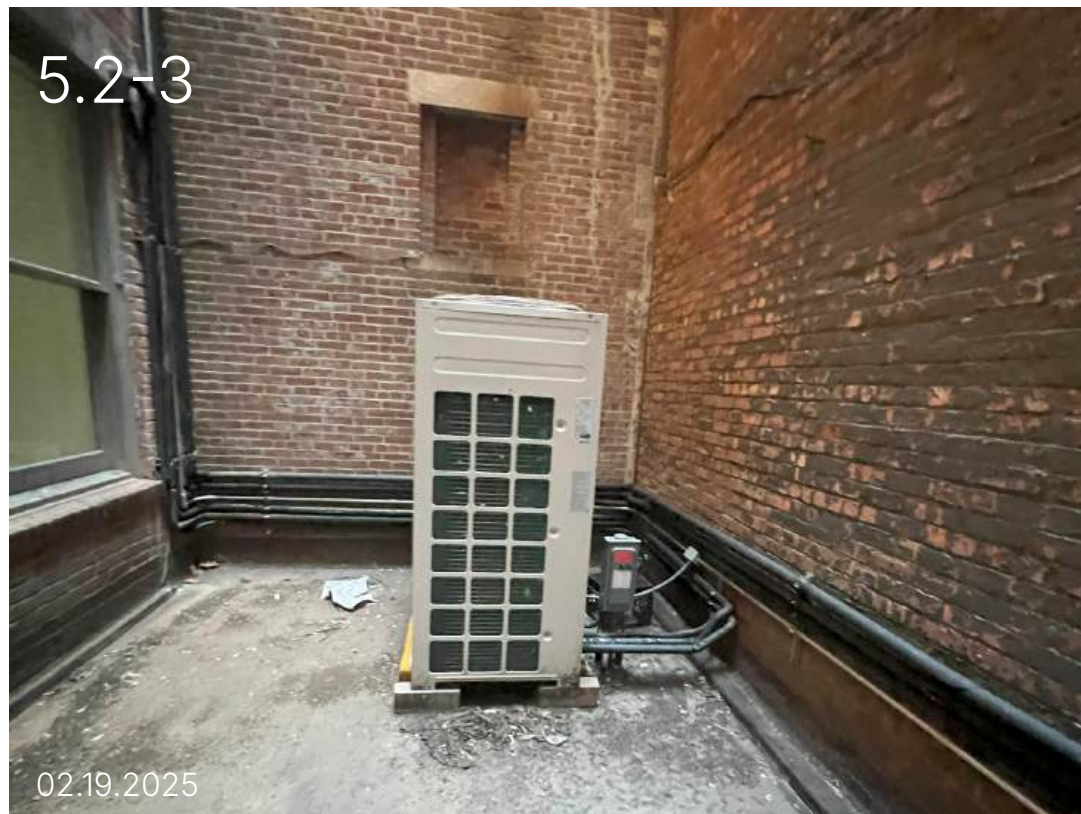
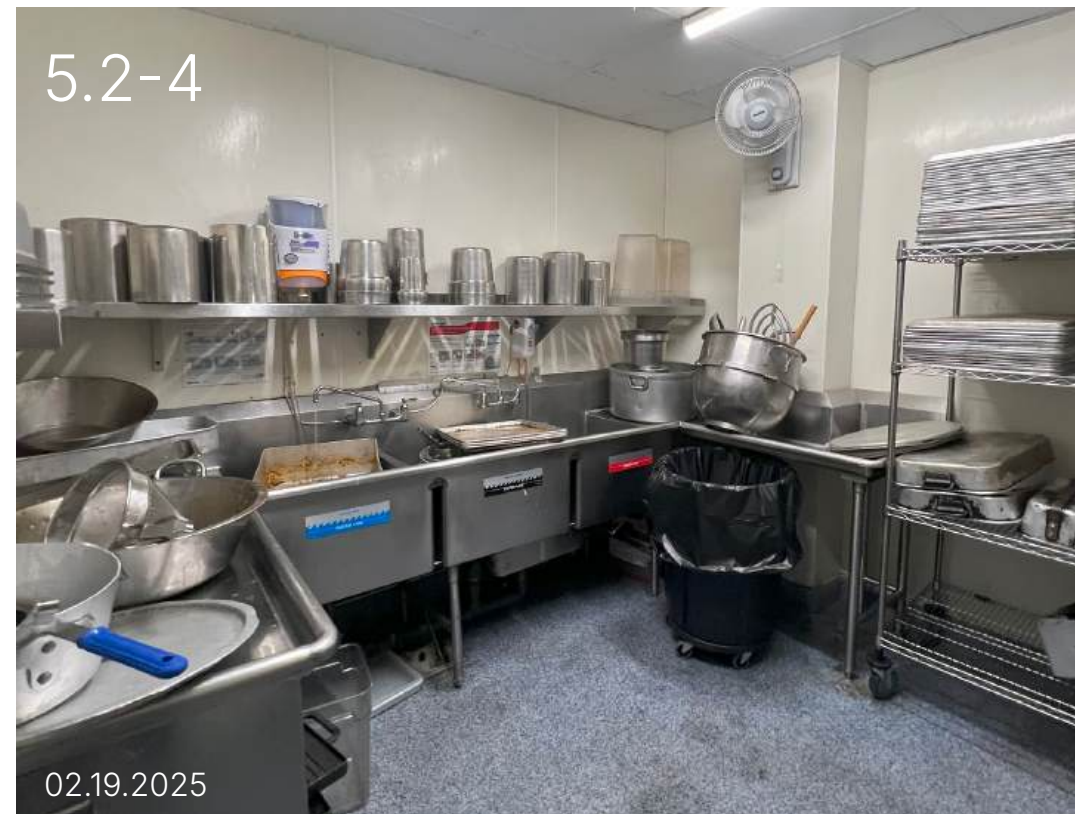
- Central air conditioning is distributed to the Main Club's principal spaces via metal ductwork introduced to the Club post original 1894 construction. Observable ductwork appeared to be in good condition.

- The rooftop chiller was replaced in 2024 and is in good condition and is serviceable.
- Central air conditioning is distributed to the Annex via metal ductwork, introduced after the Annex's initial construction and 1910 renovations post-Club ownership.

- Air conditioning is provided to the Annex guest rooms via VRV Heat Pumps, introduced in 2016. Units are reported to be in serviceable condition. Units recommended for replacement in the near-medium term as they near the end of their useful life.

- Air conditioning to Annex tenant spaces is provided by two air conditioning units (Image 5.2-3), located on the Annex rear yard setback. Condition is reported as serviceable.

- 3rd Floor Main Club Kitchen not integrated into Club air conditioning system. Introduction of a dedicated air conditioning system for the kitchen planned for the near future. Image 5.2-4 shows one of the fans distributed throughout the kitchen as part of an ad hoc solution. New systems will assist balancing of air/humidity control to adjacent.

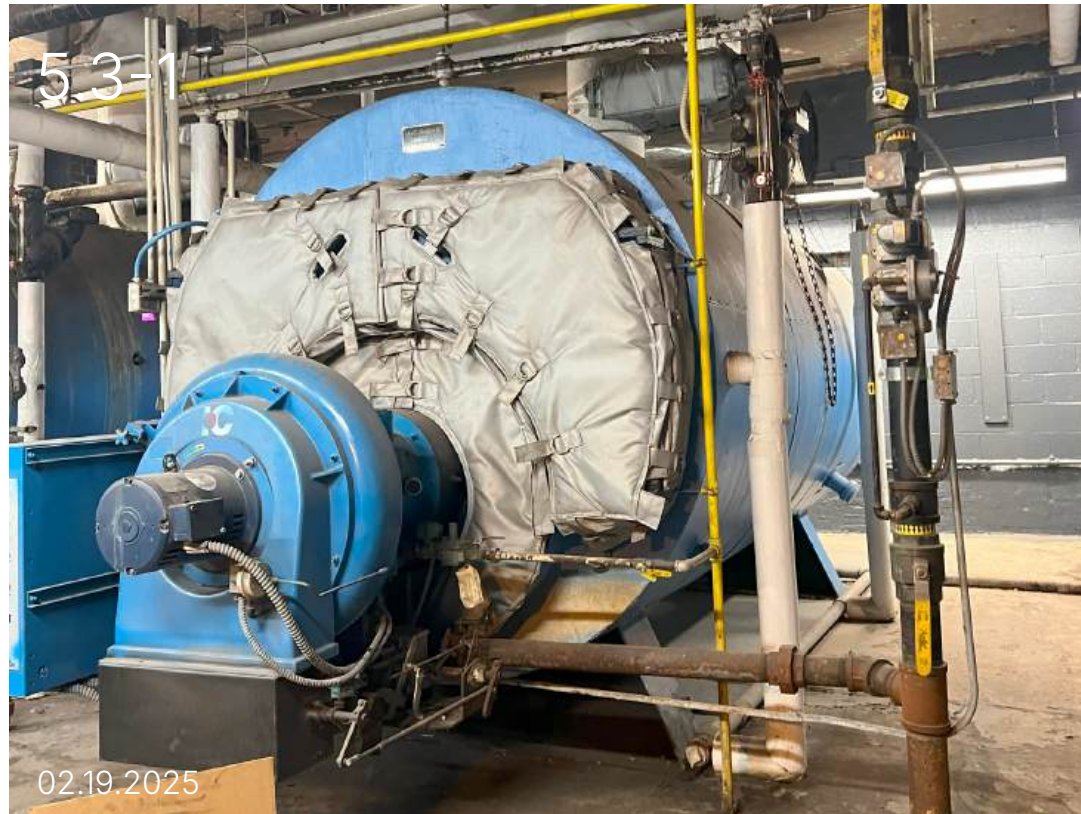
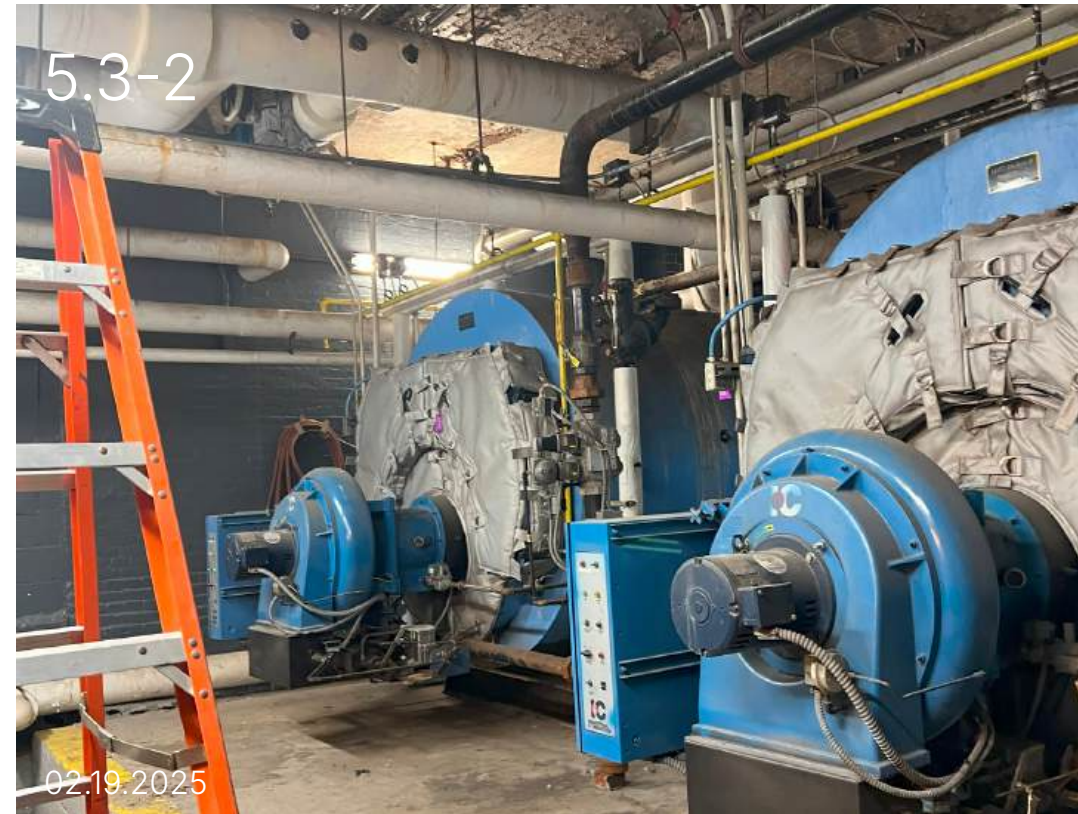
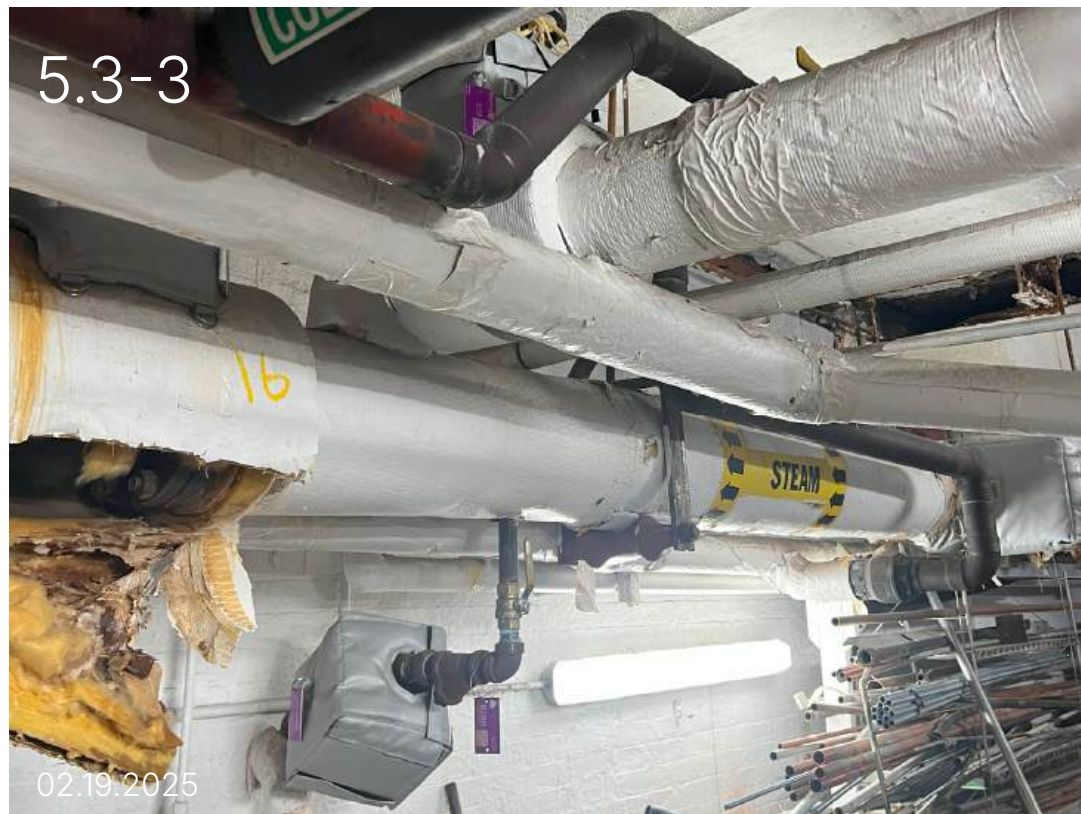
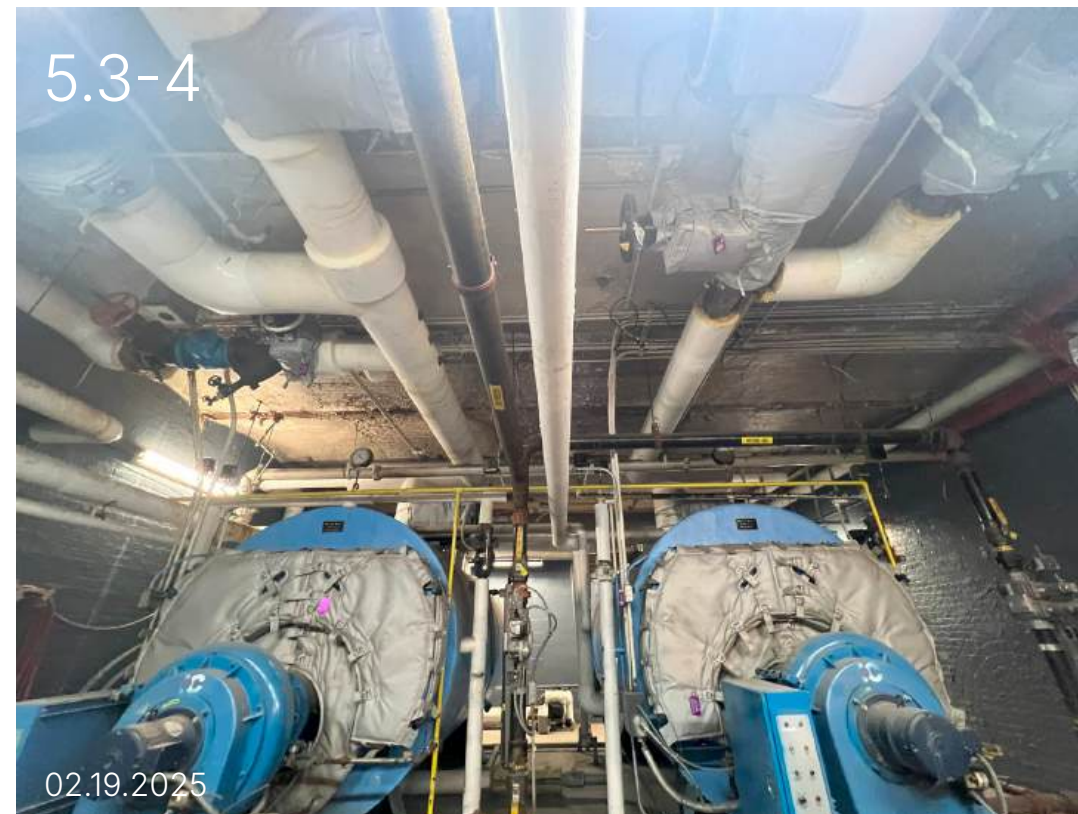
- Heat is provided to the Main Club Building and Annex Building via two natural gas powered boilers.
- Heat is distributed throughout the buildings via metal ductwork. The ductwork and steam piping has been maintained and replaced as required throughout the Club's history.
- Steam pipes largely follow the same runs as the original steam pipes.
- Registers and radiators are largely original to the buildings. Some radiators in main Club Building have been replaced by fan coil units circa 1998.
- The insulation around steam pipes was observed to be deteriorated at select locations. To be replaced on an ongoing basis as required.
