**1 East 60th Street – Upper East Side Historic District
Borough of Manhattan**

The Metropolitan Club

Presentation for Landmark Restoration and Proposed Capital Work

4.0 Appendix A: Existing Conditions Report

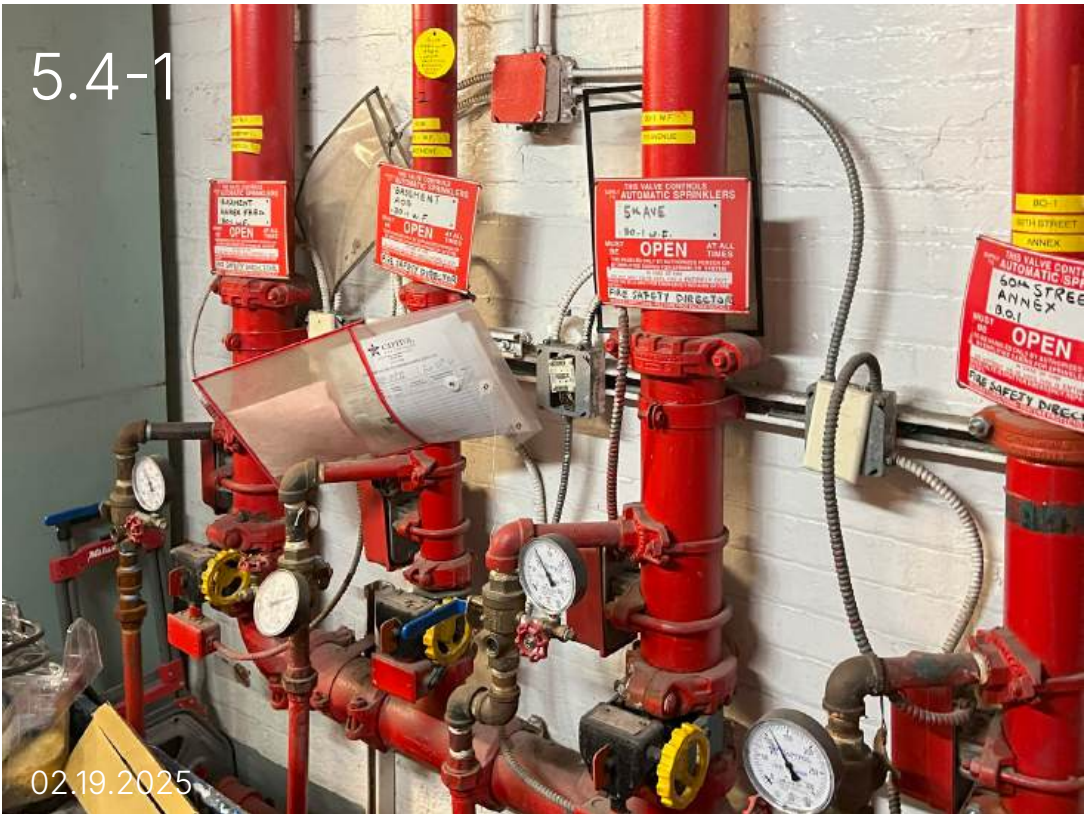
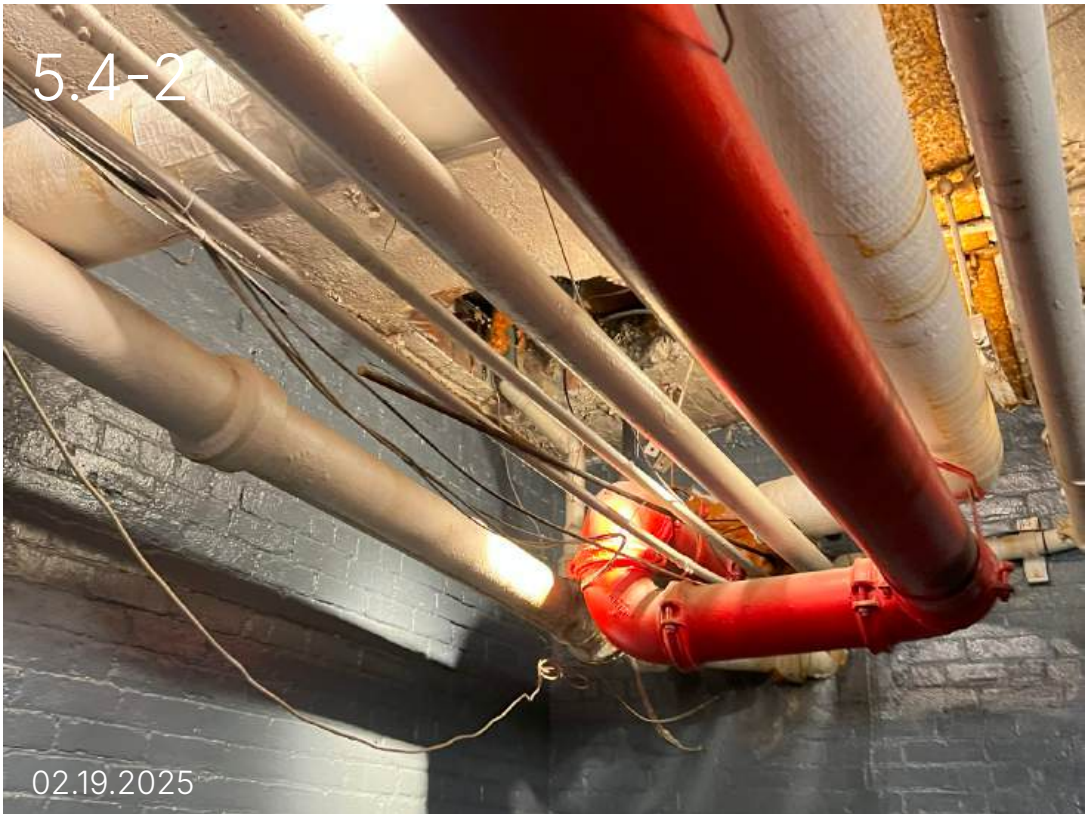
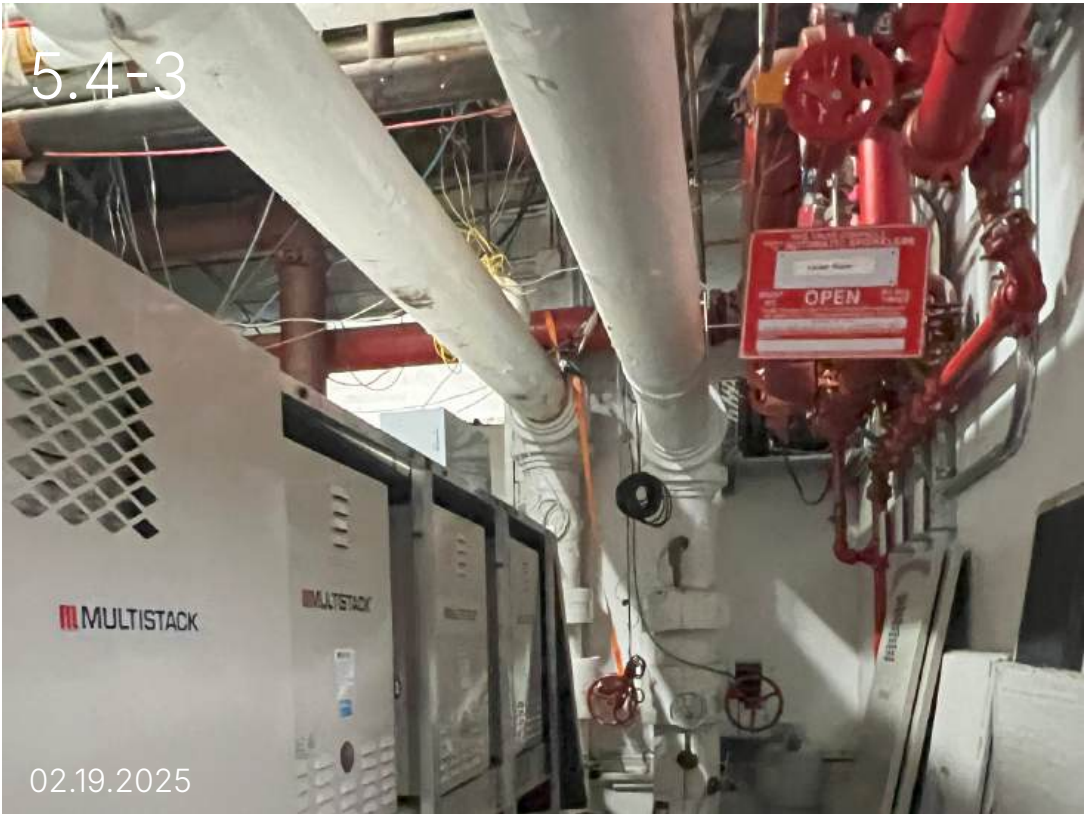
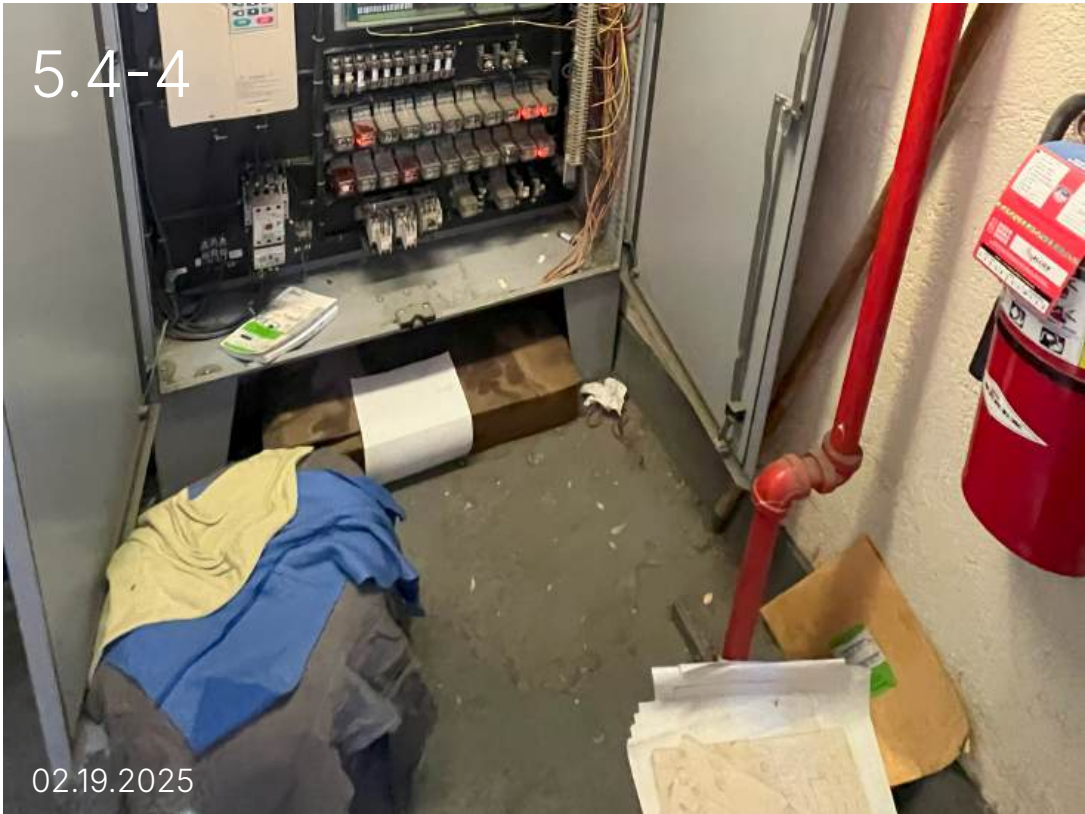
- 5.4 Sprinkler System
- The Club and Annex Buildings are fully sprinklered and integrated as one system.
 - The sprinkler system's standpipes, mains, and distribution lines were observed to be inspected regularly and reported to be maintained in good condition.
 - Individual sprinkler heads were observed in the spaces surveyed, from the cellar to the bulkheads on both the Main Club's and Annex roofs.

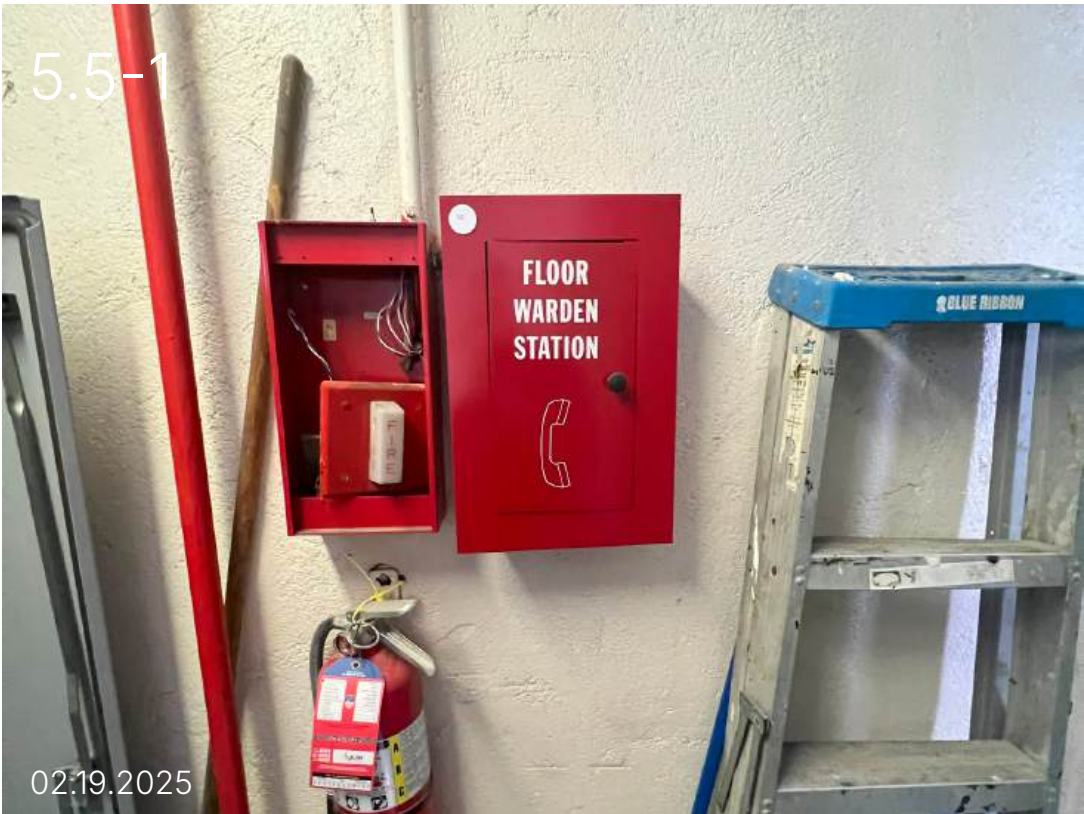
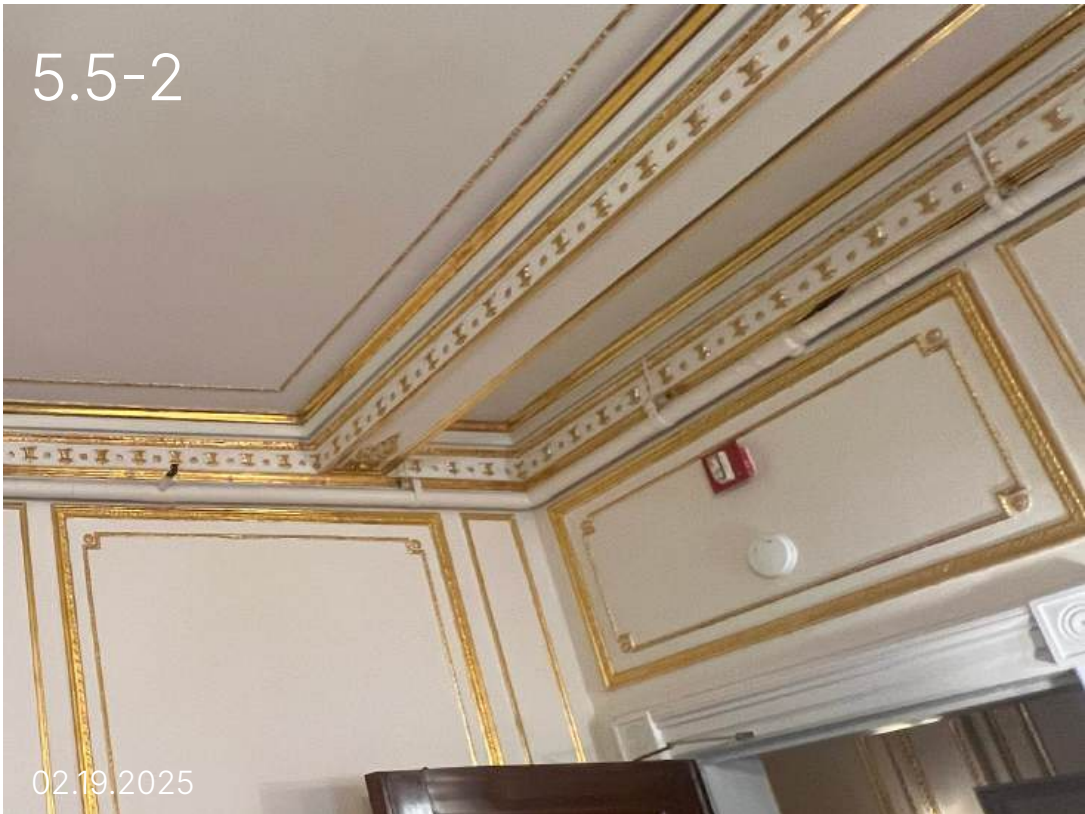
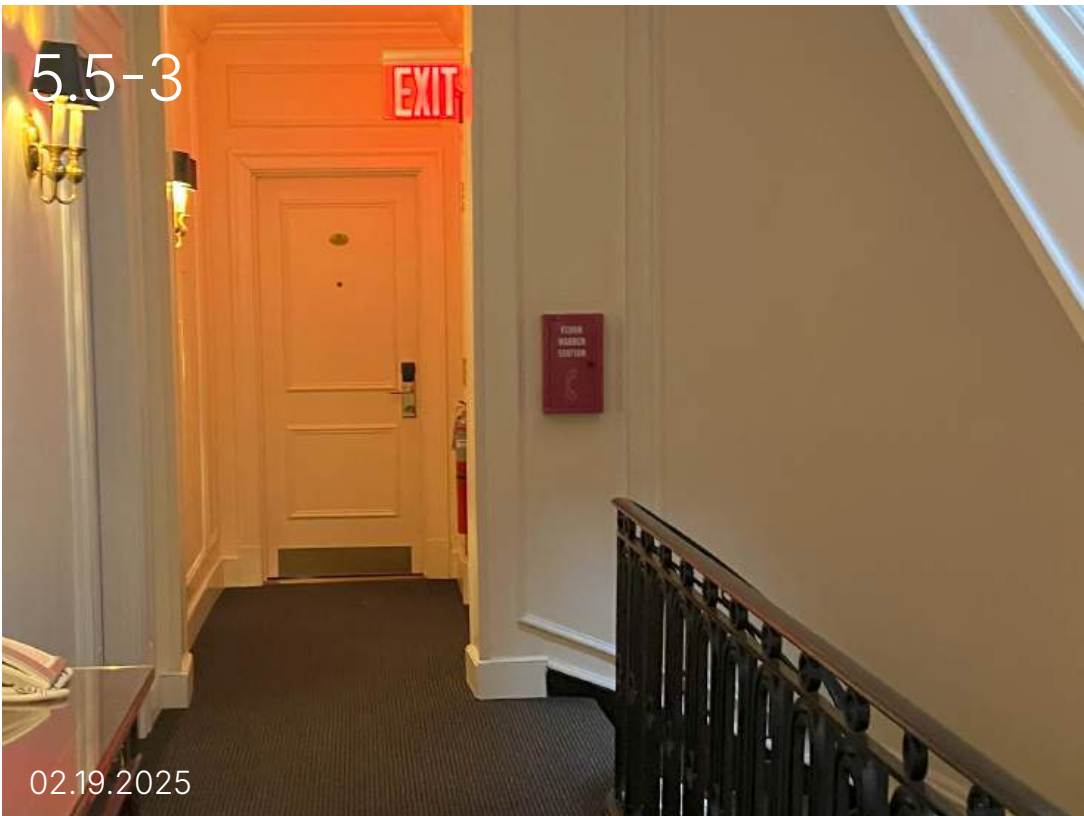
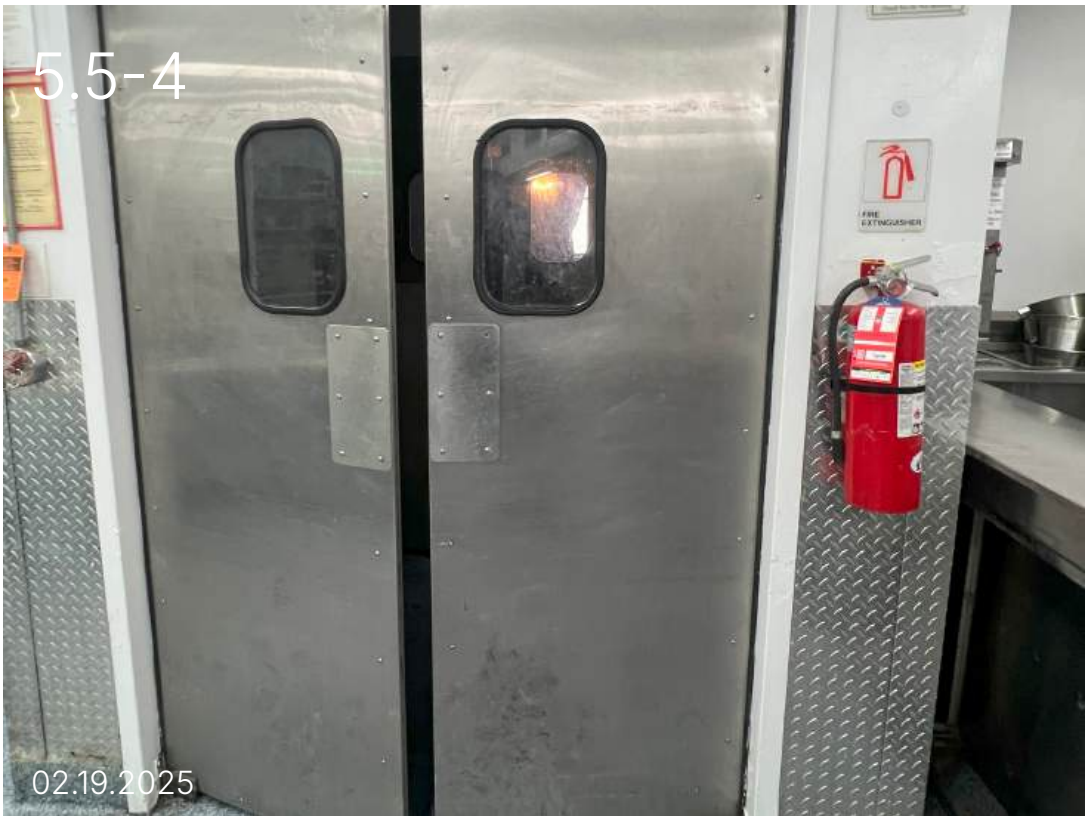
- 5.5 Fire Alarm System
- All Club and Annex spaces are served by a building-wide fire alarm system which is currently fully-approved by the FDNY.
 - Smoke detectors observed in all surveyed spaces.
 - Fire extinguishers observed in all required locations at all floors.
 - Fire extinguishers reported to be inspected regularly as required.

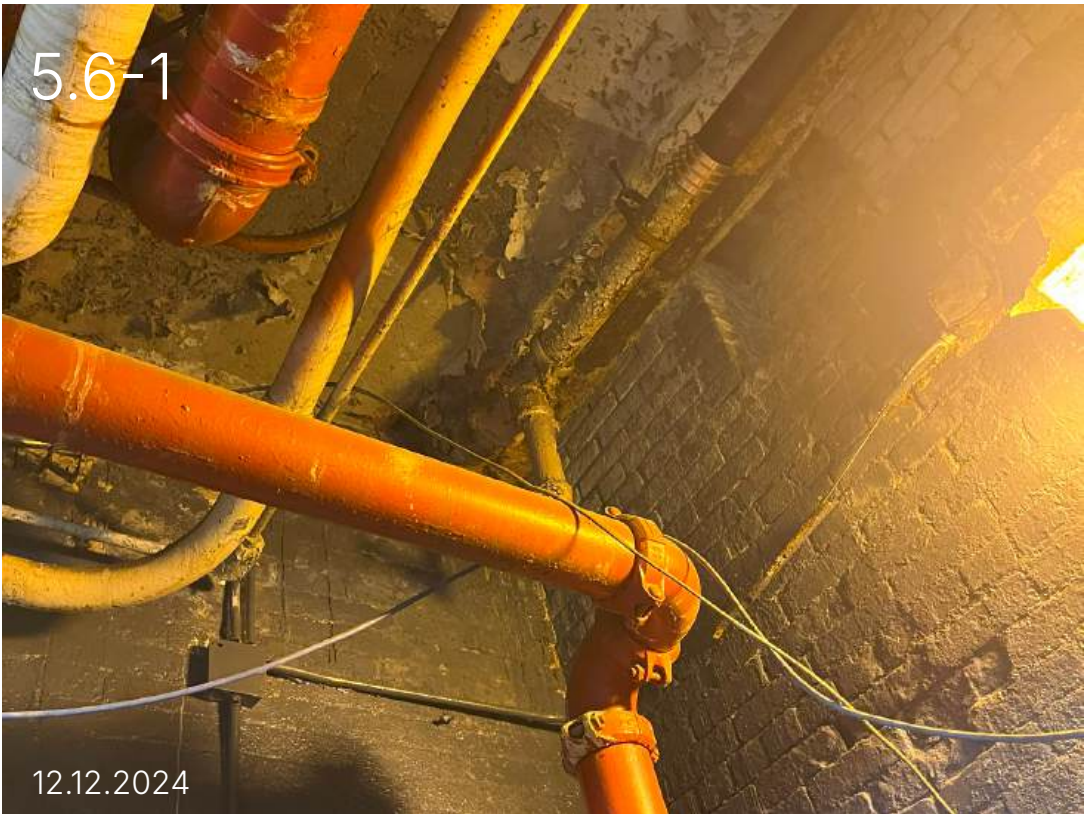
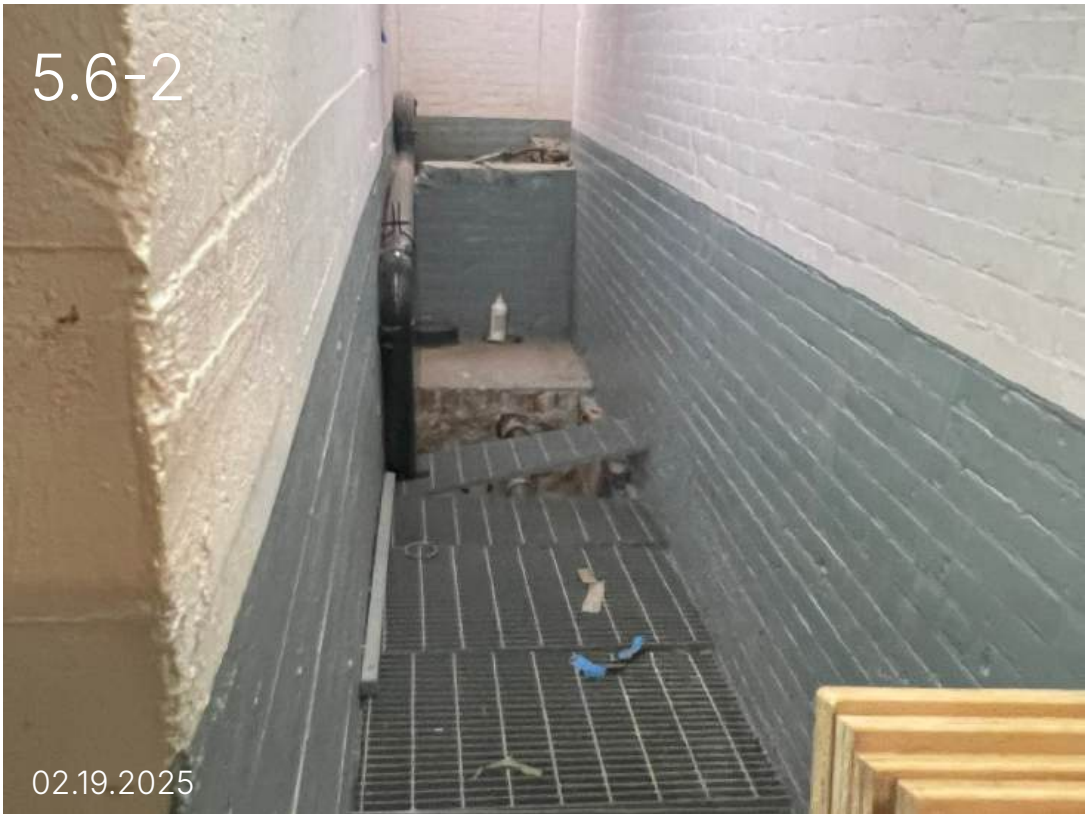
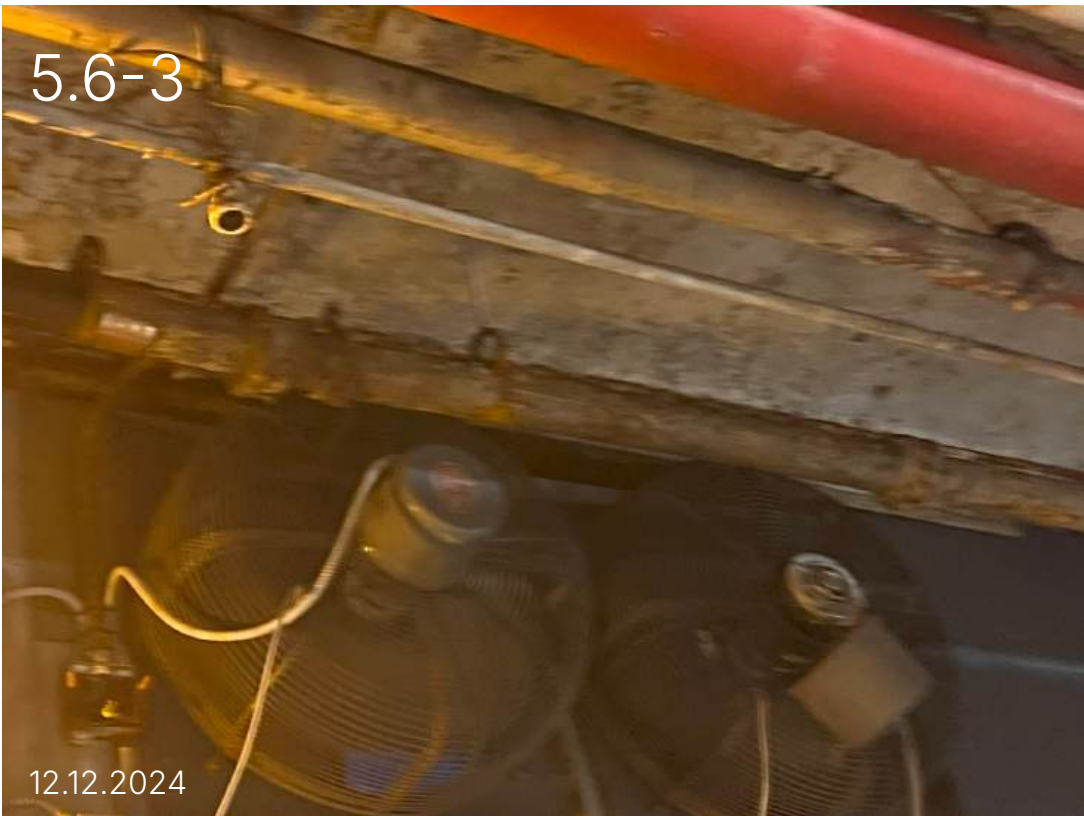
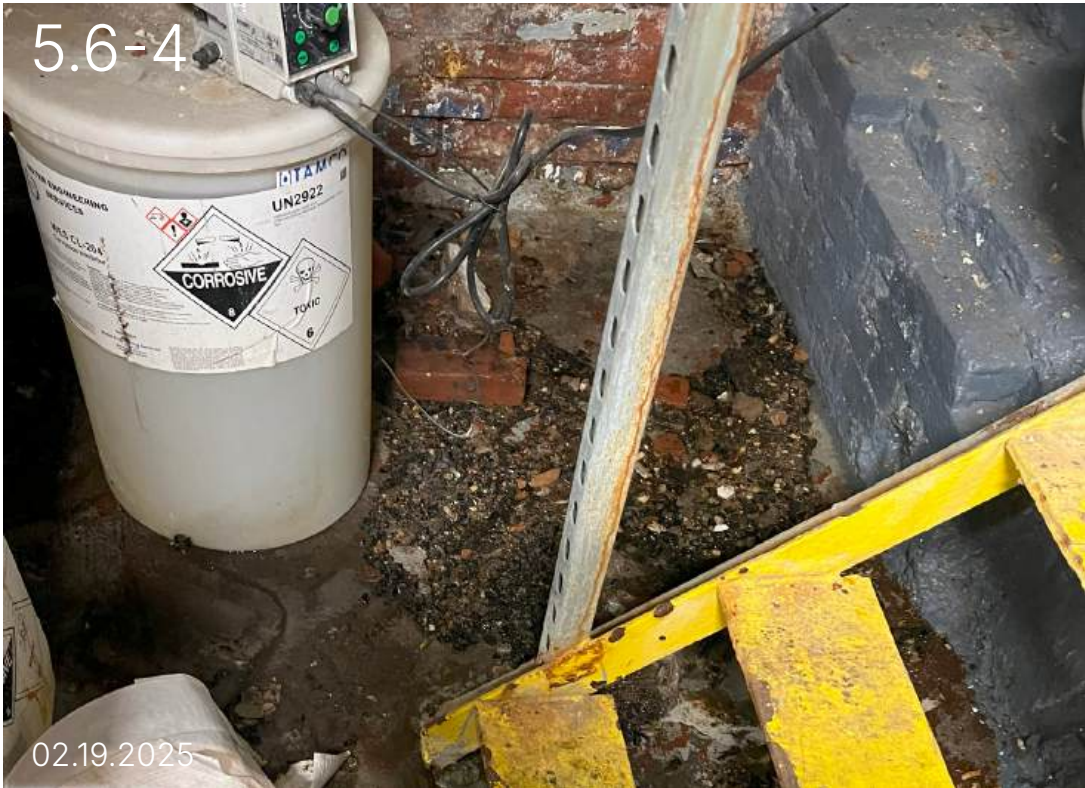
- Roof drainage at the Club and Annex buildings is accomplished via a series of roof drains and internal gutters and drainpipes. No issues were reported or observed at the time of the survey.
- Courtyard drainage consists of two drains at the south end of the courtyard. The drains (5.5-1 & 5.5-3) tie into the main drainage outlet in the cellar (5.5-2), which then exists the Club building towards the direction of 5th Avenue.
- The capacity of the Courtyard drainage system is planned to be increased as part of the Courtyard pavement restoration work, currently before the LPC and the DOB.
- Water infiltration/leaks reported in cellar under courtyard (5.5-4). Courtyard pavement restoration scope includes new waterproofing and repairs to make the courtyard watertight. Drainage and infrastructure continue to be monitored through the exterior as a major concern and effort.

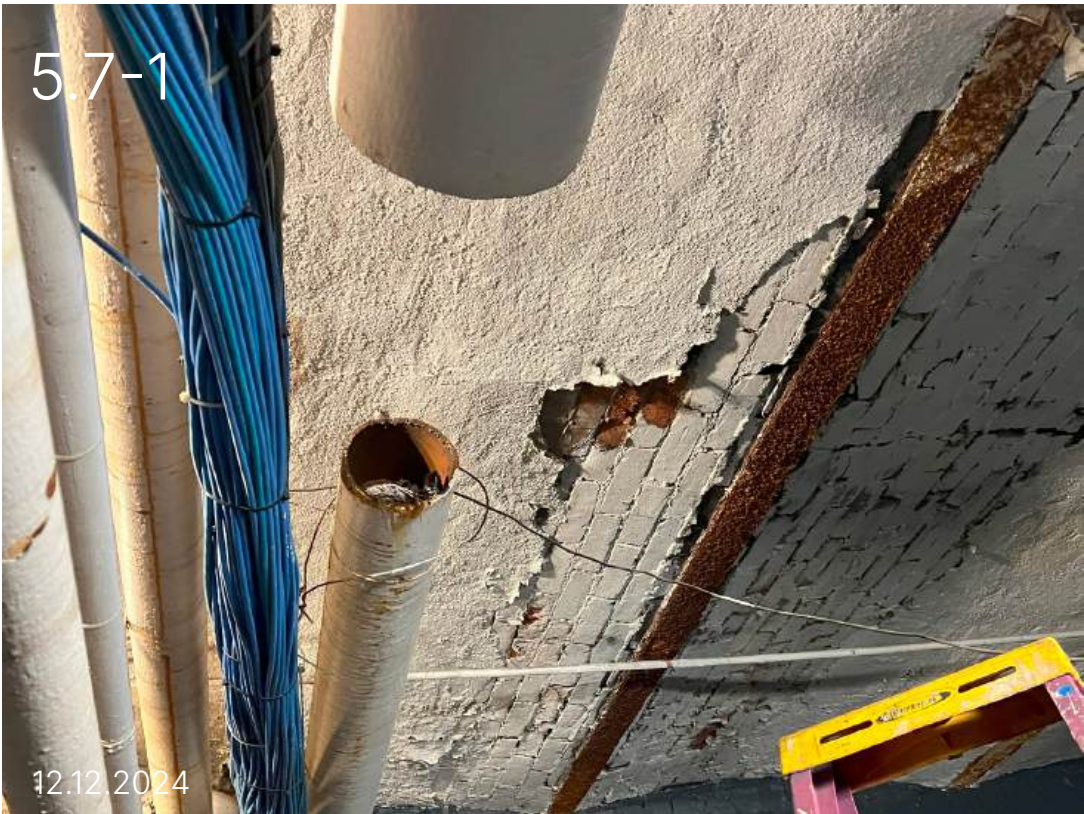
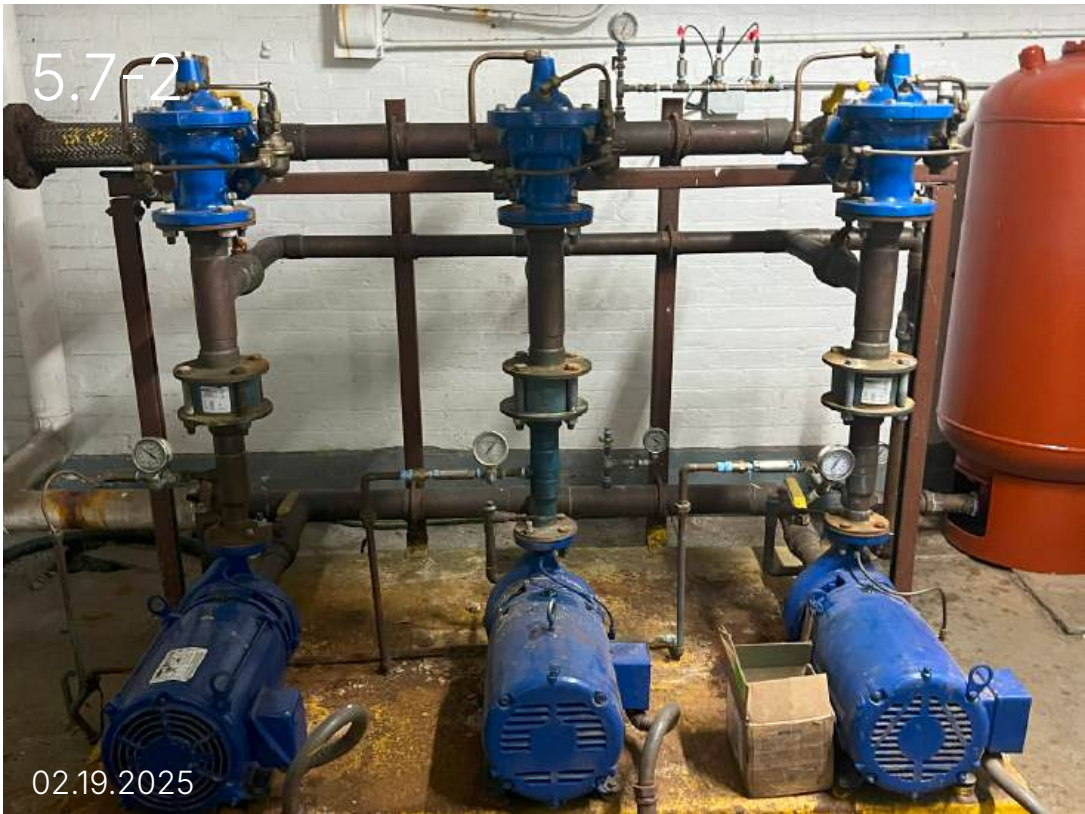
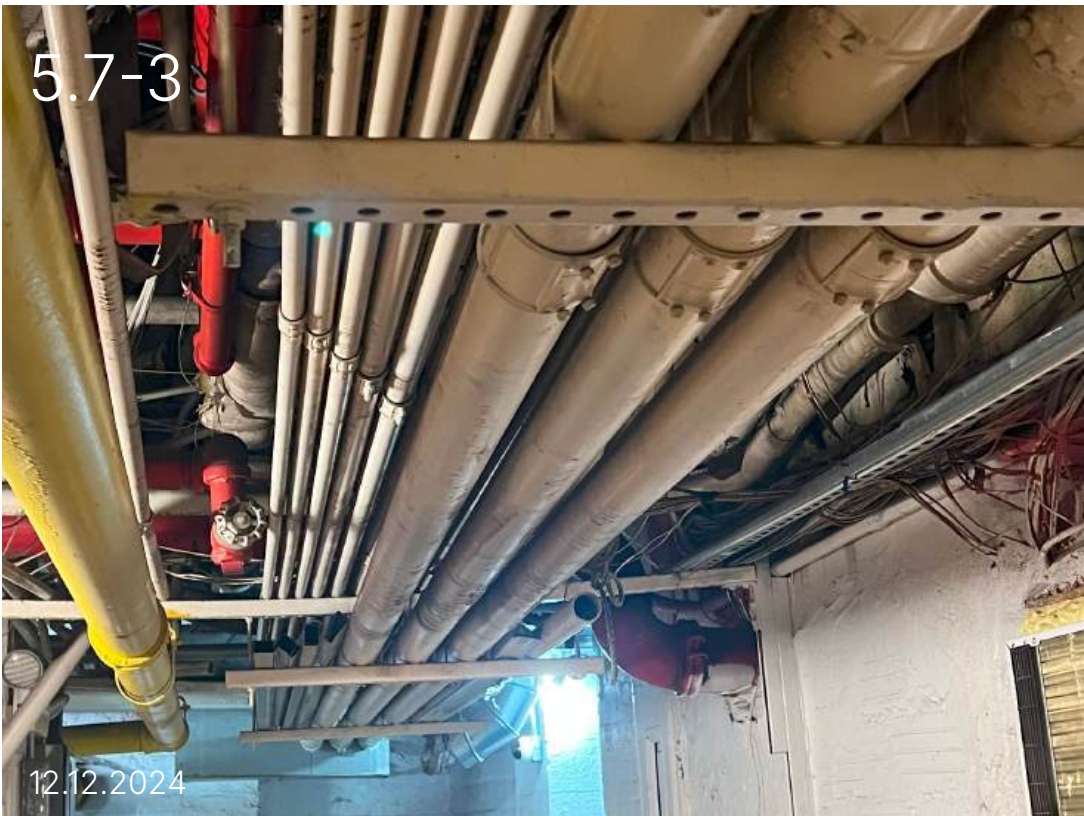
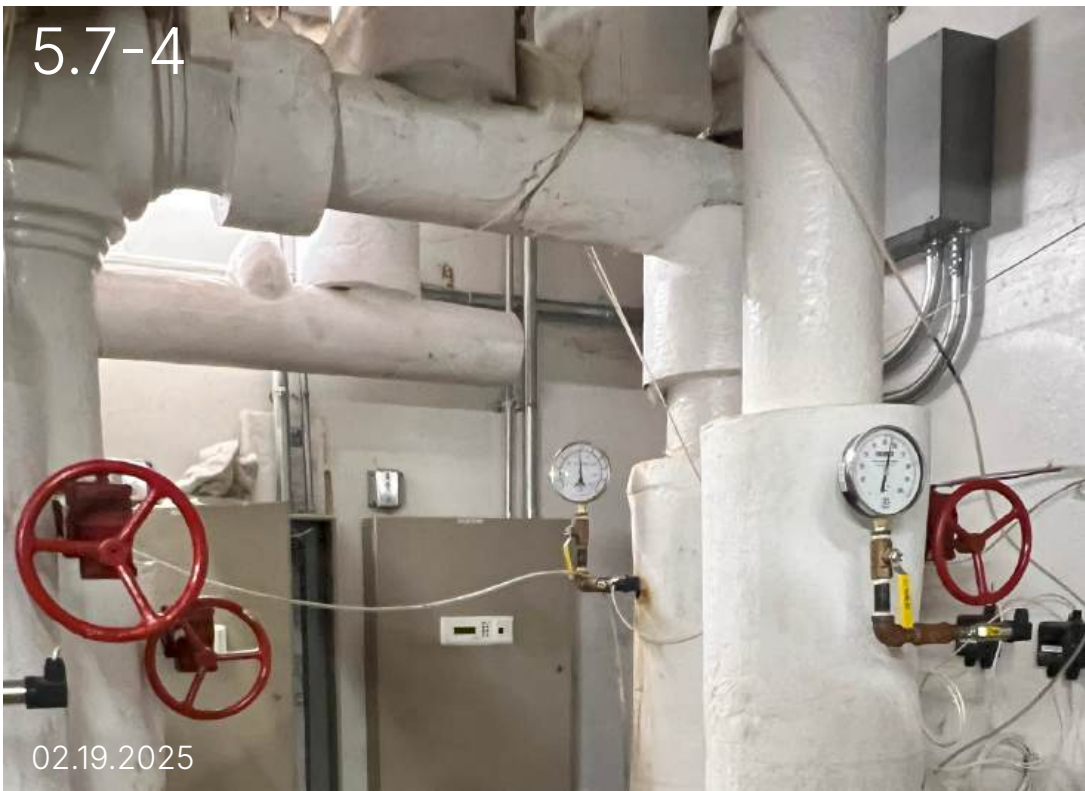
- 5.7 General Plumbing**
- The various plumbing systems (e.g. steam, domestic hot and cold water, waste water, pumps, sewage, roof drainage, etc.) have been subject to repairs and modernizations on an as-needed basis throughout the decades. The overall condition of the plumbing systems is good and no major issues are reported.
 - However, there are select instances of rusted or broken pipes (5.6-1). These are largely the result of age or temperature fluctuations on uninsulated pipes. The Club is in the process of repairing and replacing these pipes on an as-needed basis.
