138-154 St. Felix Street, aka 11-21 Hanson Place – Brooklyn

Academy of Music Historic District

ADAPTIVE-REUSE & ENLARGEMENT

LPC Certificate of Appropriateness Presentation

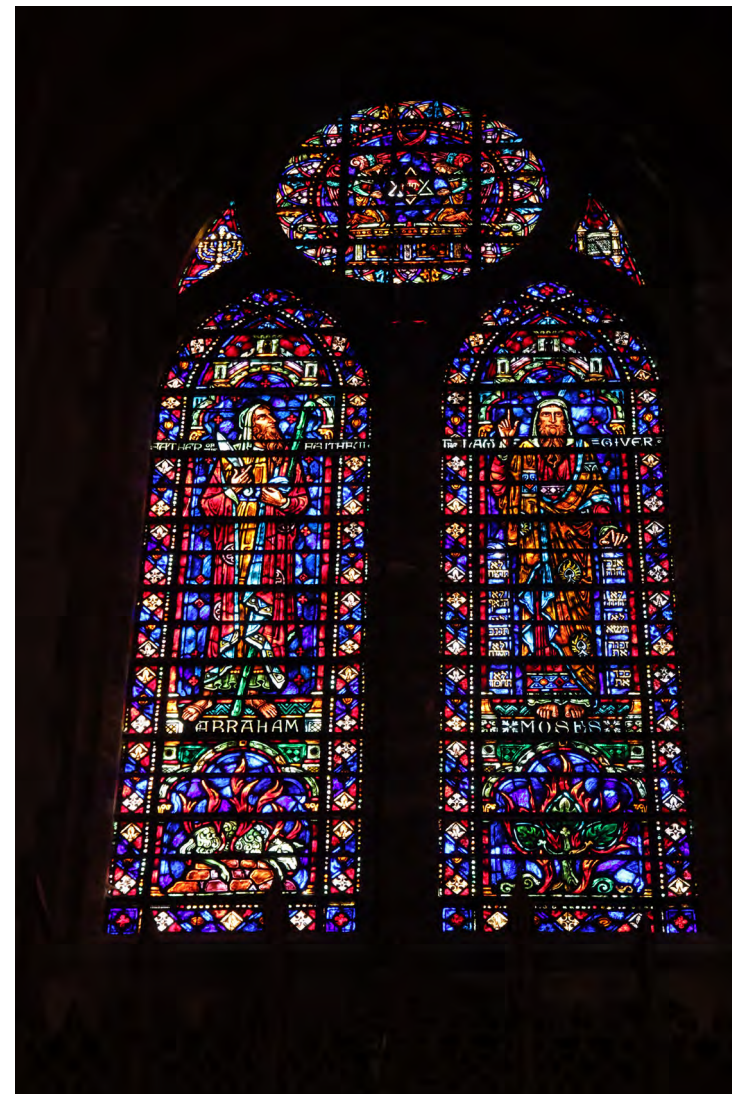
A.1.4: Image of Moses, “The Law Giver”

- Moses is known in the Christian faith as a prophet who received the Ten Commandments from God on Mount Sinai.
- Condition is fair

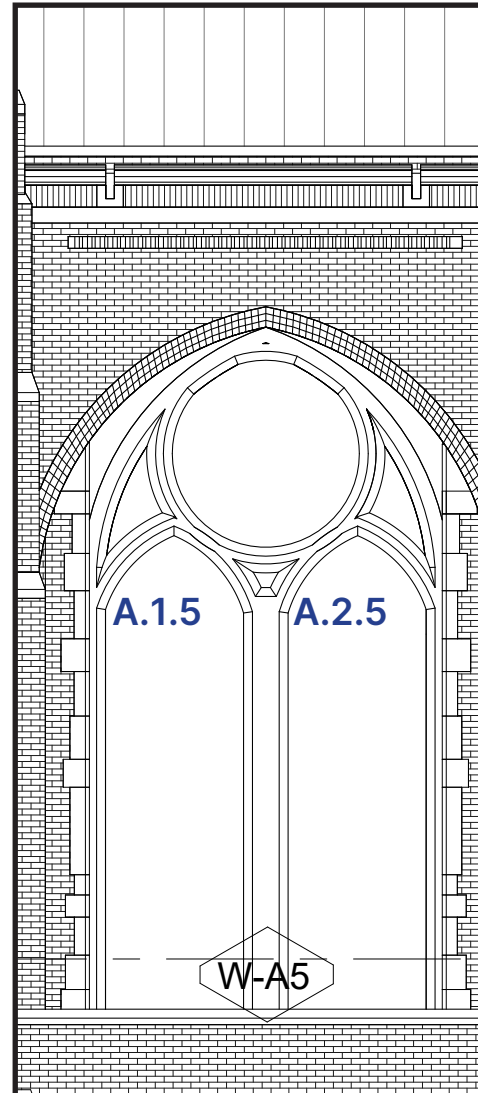
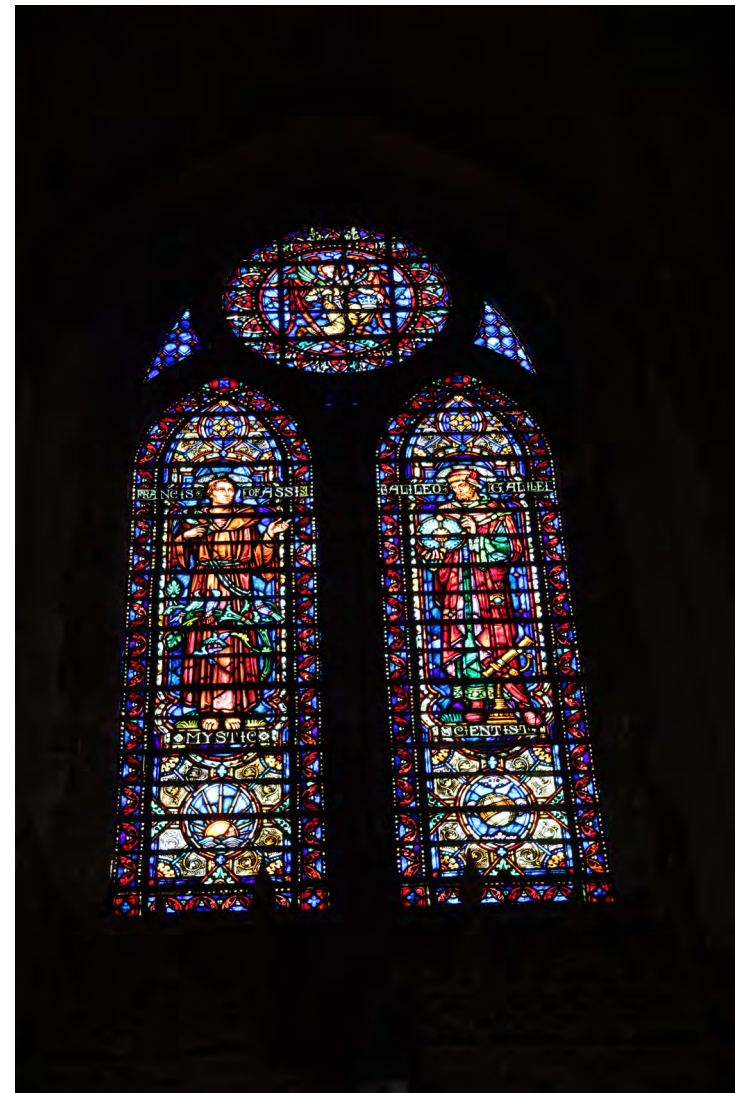
A.1.5: Image of Scientist, “Galileo Galilei”

- Galileo serves as a controversial religious figure who opposed the Church’s idea that the Earth was at the center of the universe. Galileo is celebrated here for his contributions to science.
- Condition is fair

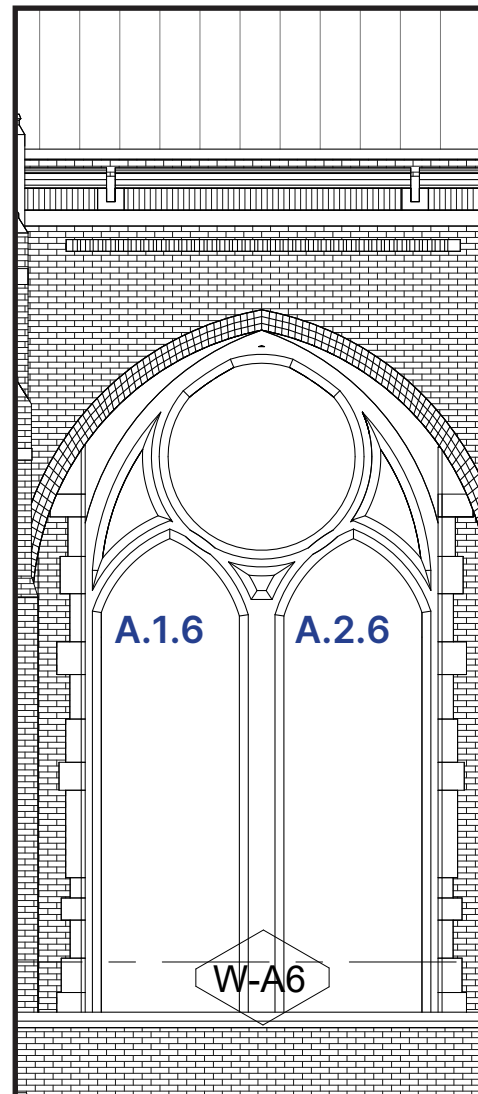
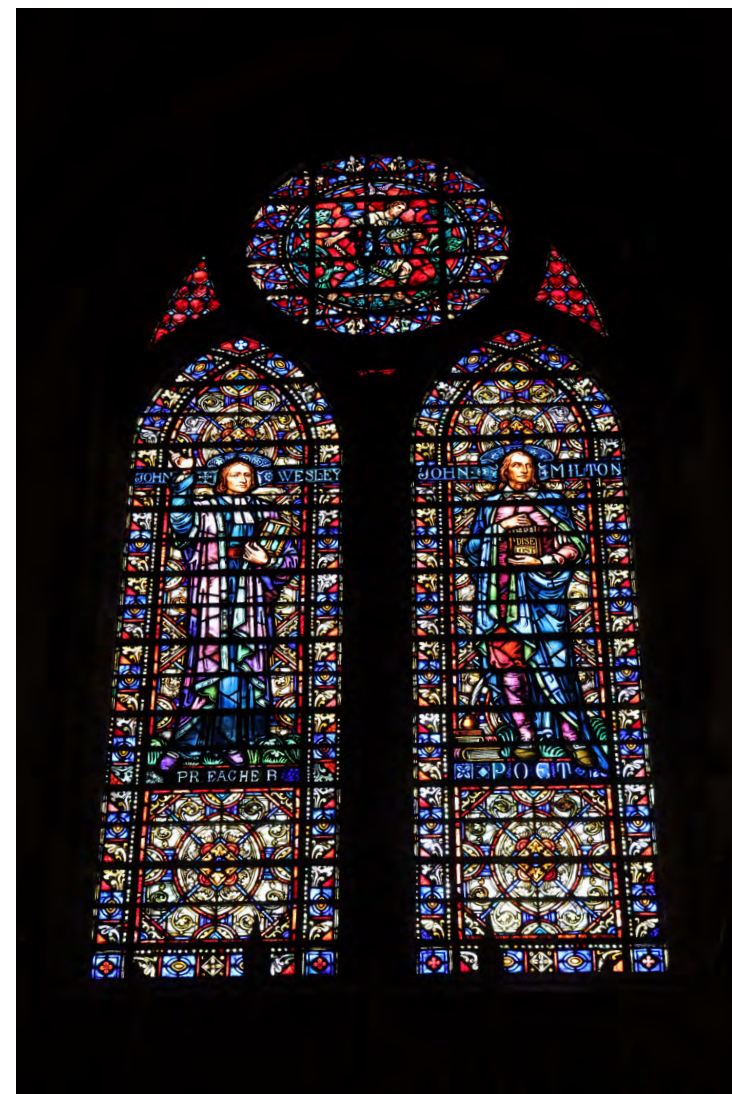
A.1.6: Image of Poet, “John Milton”

- John Milton was an English poet and civil servant. His work “Paradise Lost” addressed the fall of man, including the story of Adam and Eve.
- Condition is fair

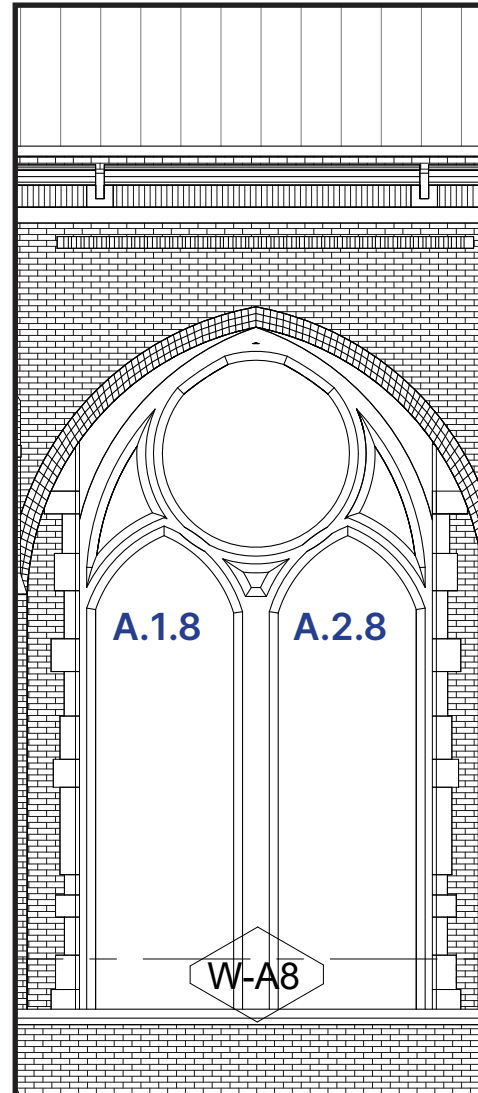
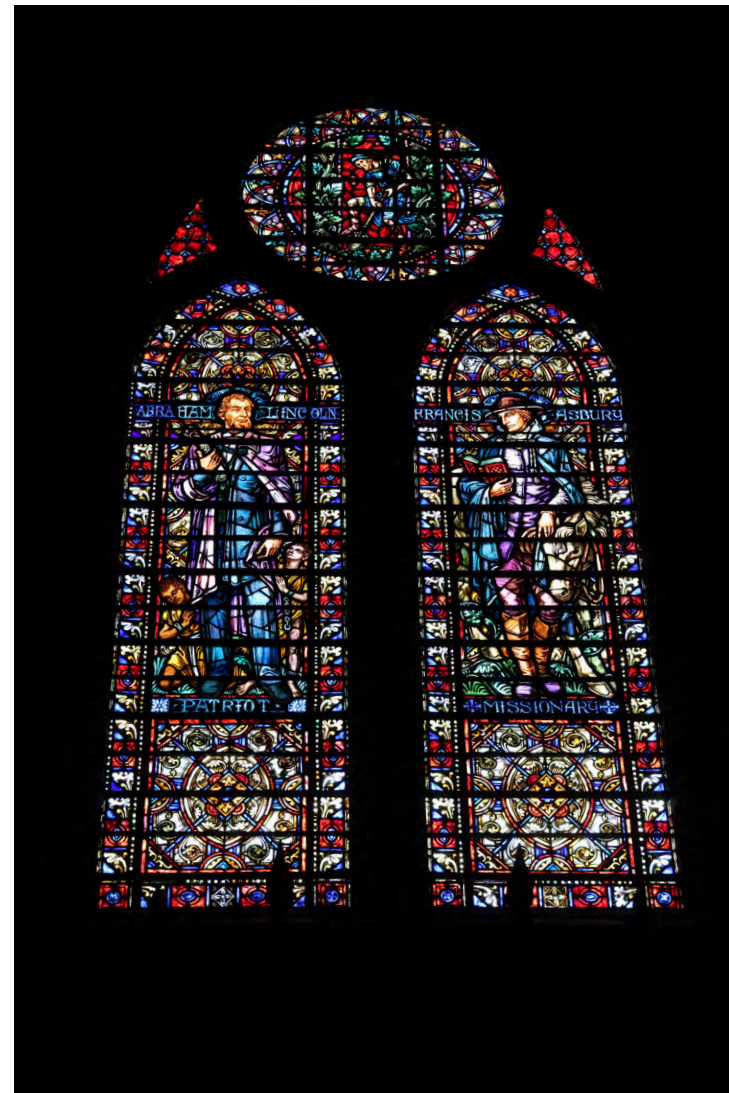
A.1.8: Image of Missionary, "Francis Asbury"

- Francis Asbury was a British-American Methodist minister known as one of the first two bishops of the Methodist Church in the United States.
- Condition is fair

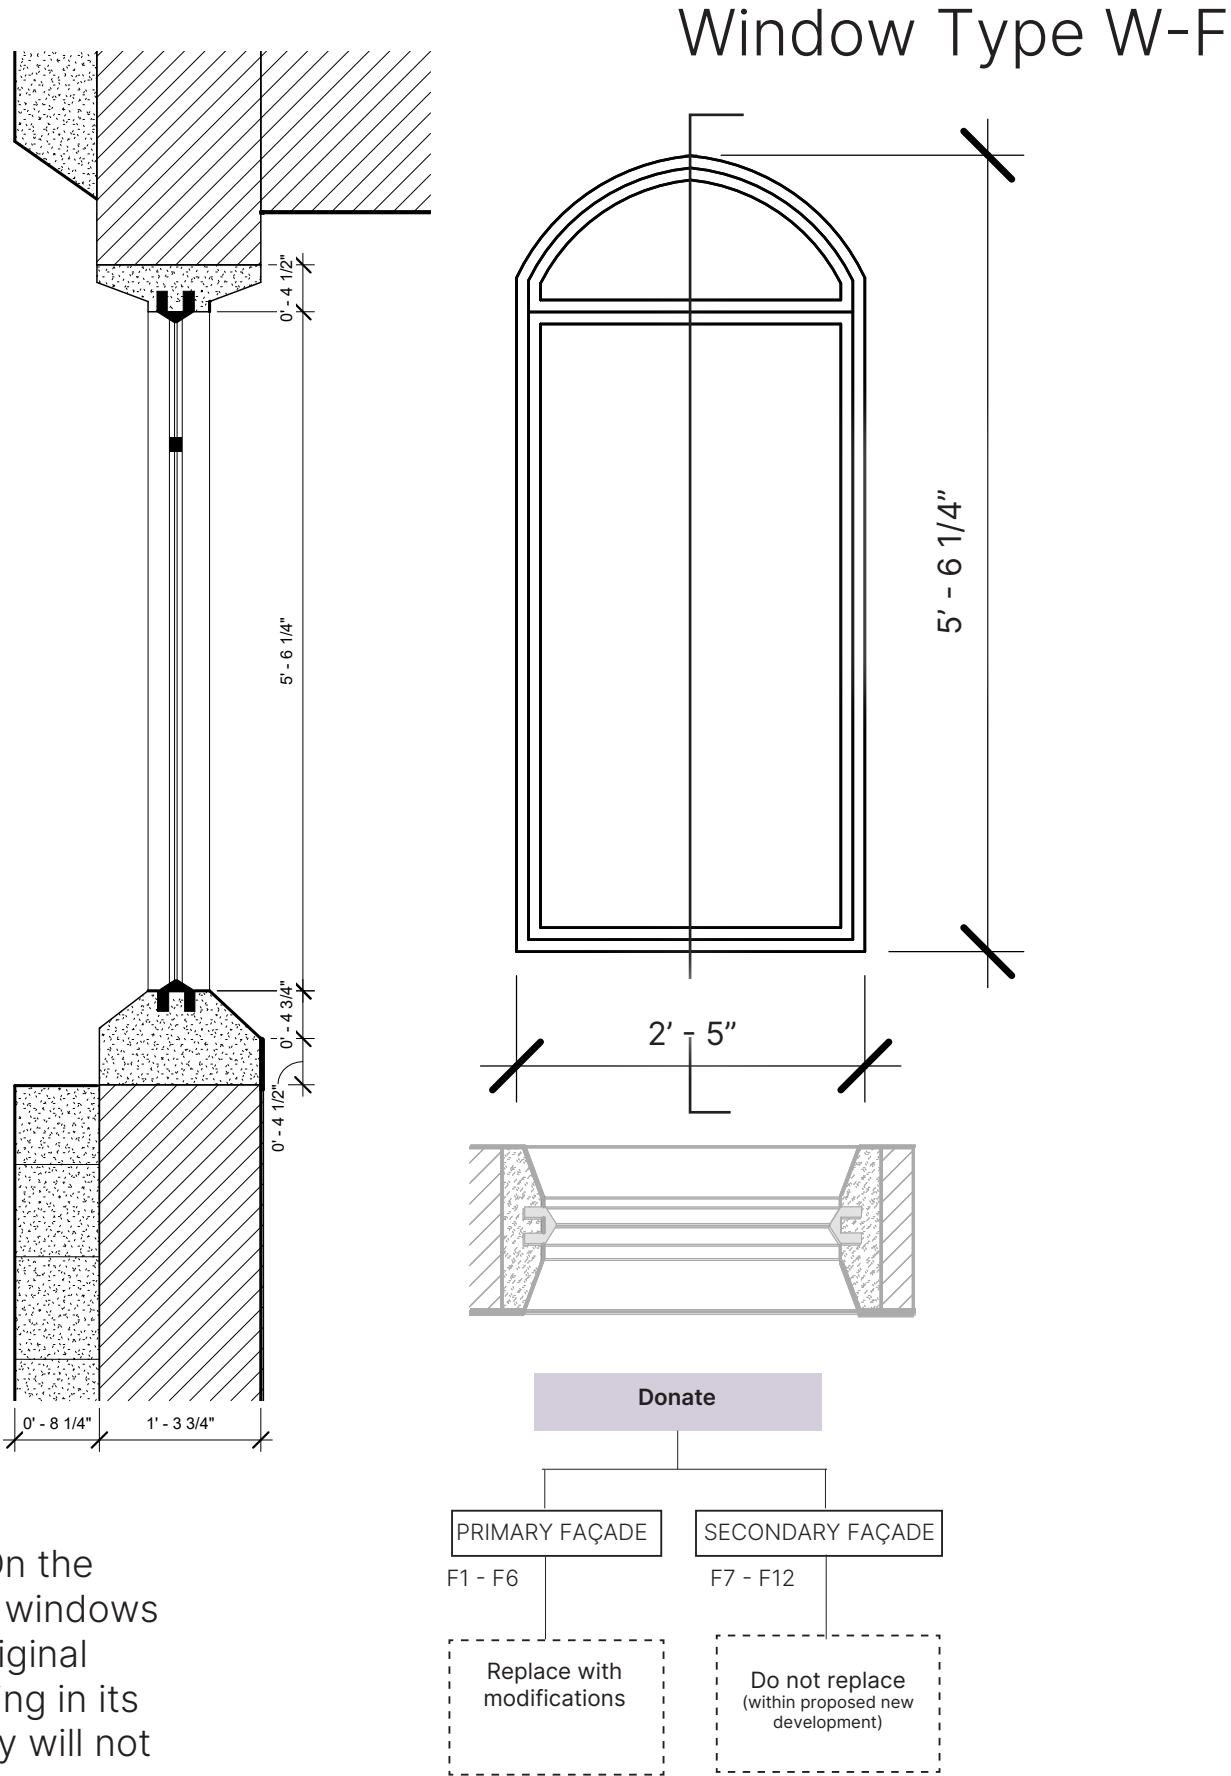
- Pane separation from steel frame
- Water leakage due to shattered panes
- Select windows wrapped in waterproofing plastic
- Minor rusting on interior frame and operator
- Protective glazing was added to the exterior of select windows
- Panels display religious iconography

Historic value of windows dates back to church completion in 1931 and Brooklyn Academy of Music Historic District Designation in 1978. While the stained glass is in fair condition, religious iconography makes them unsuitable for present day and future use.

Windows shall be salvaged and donated/returned to the church due to fair condition and historic value. On the primary façade facing St. Felix Street, windows shall be donated and replaced with new, clear fixed steel windows to allow light into the new community space. The new windows shall have lowered sills, but reflect the original design intent to retain the historic context of the neighborhood and pay tribute to the history of the building in its new construction. On the west secondary façade, windows shall be donated/returned to the church. They will not be replaced due to the proposal to demolish this area of the building to accomodate new development.

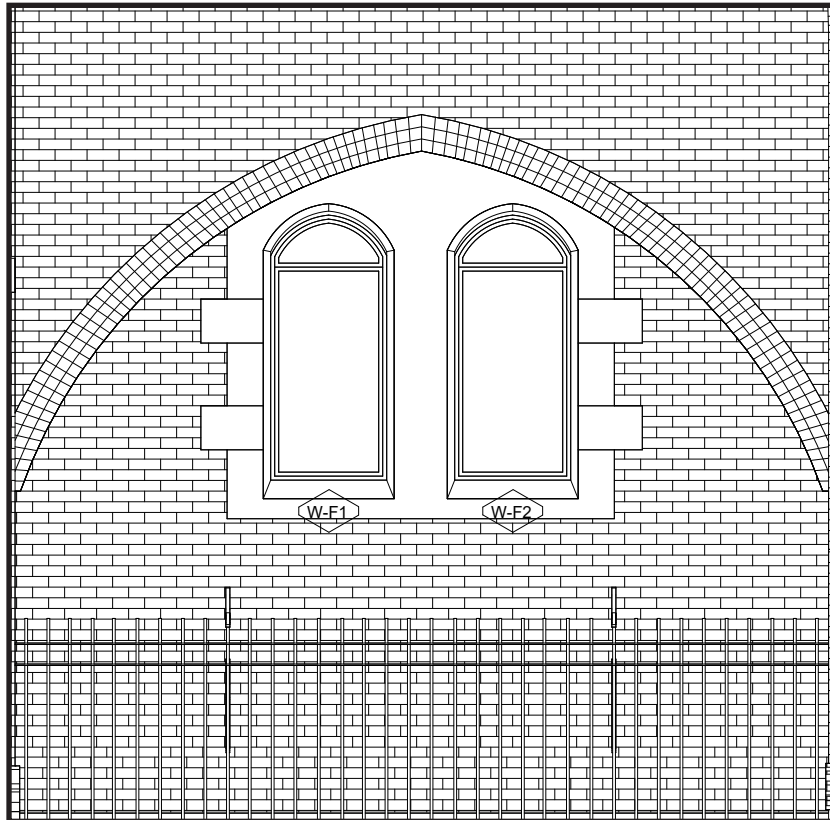
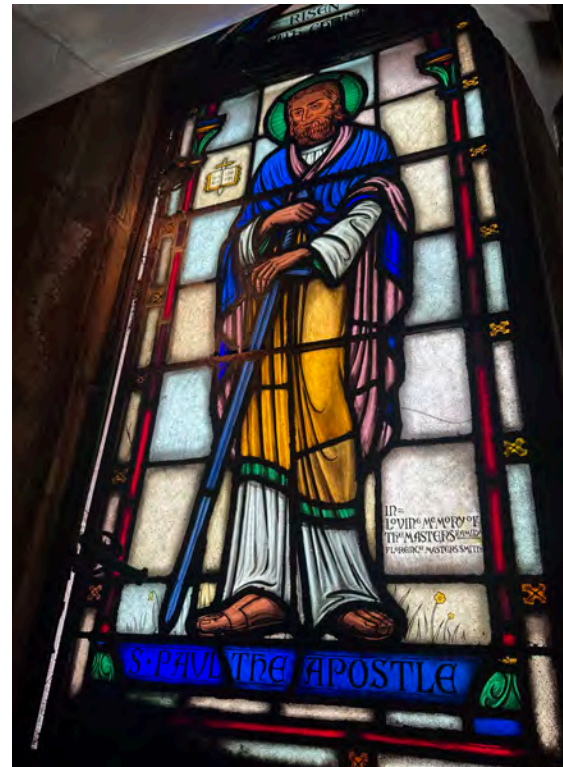
W-F1

- Paul the Apostle is known for spreading Christian teachings and his contributions to the New Testament
- Dedicated to the Masters Family
- Condition is fair

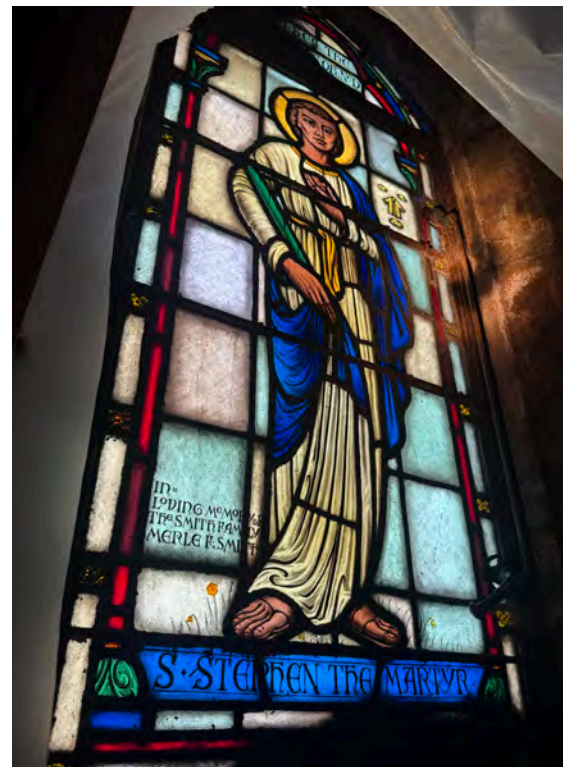
W-F2: S. Stephen the Martyr

- Known for being a deacon in Jerusalem and for his charitable acts
- Dedicated to the Smith Family
- Condition is fair

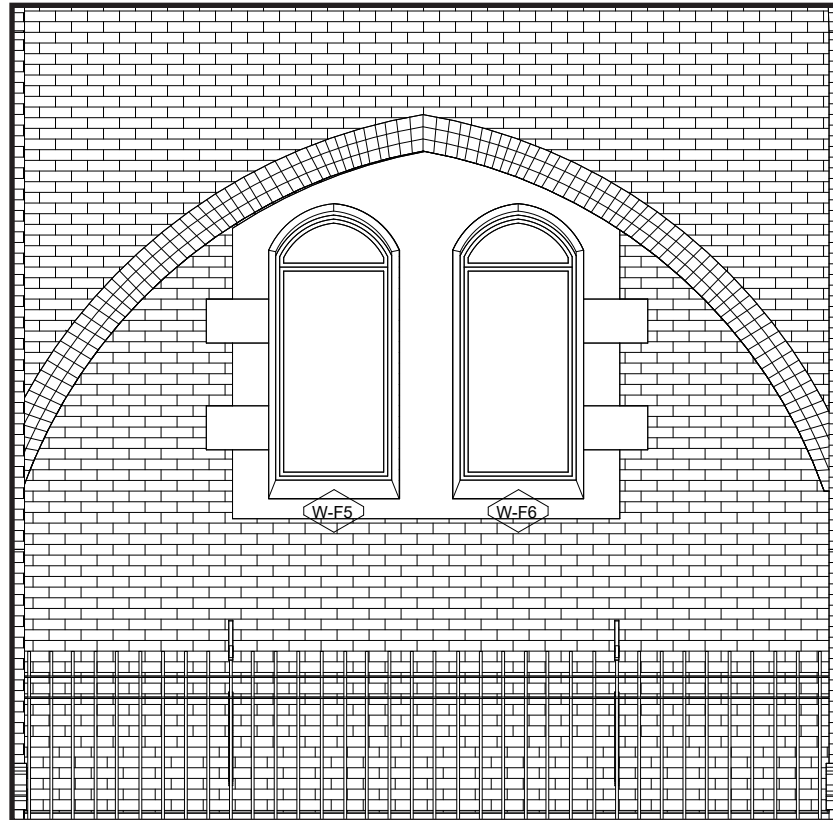
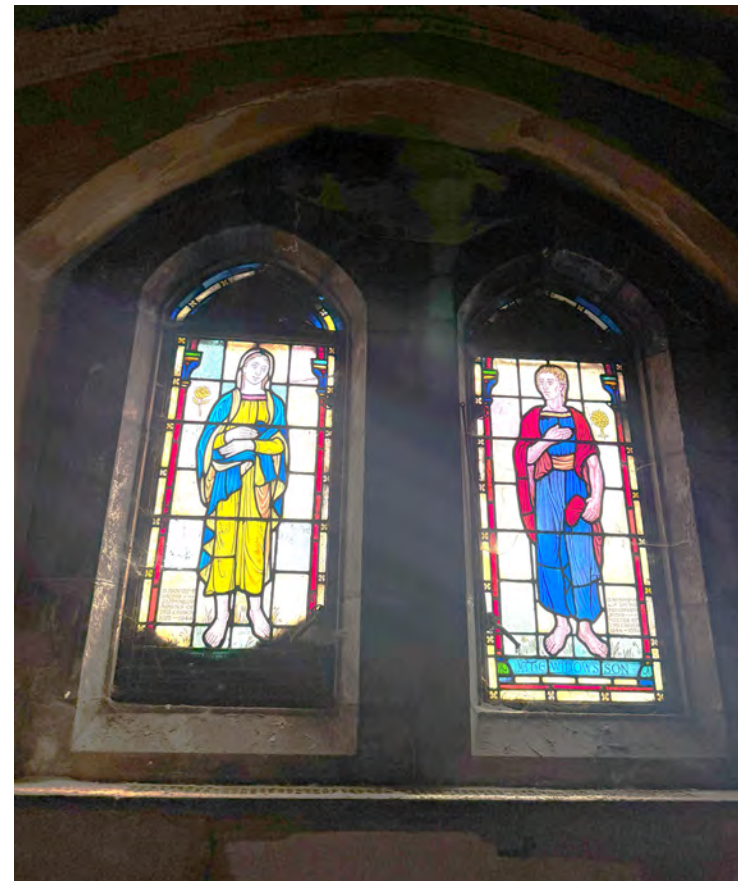
W-F5: The Widow's Son

- Dedicated to Doctor John Emerson Zeiter, the minister of the Church from 1944-1956
- Condition is fair

- Dedicated to Doctor J. Lane Miller, the minister of the Church from 1922-1944
- Condition is fair

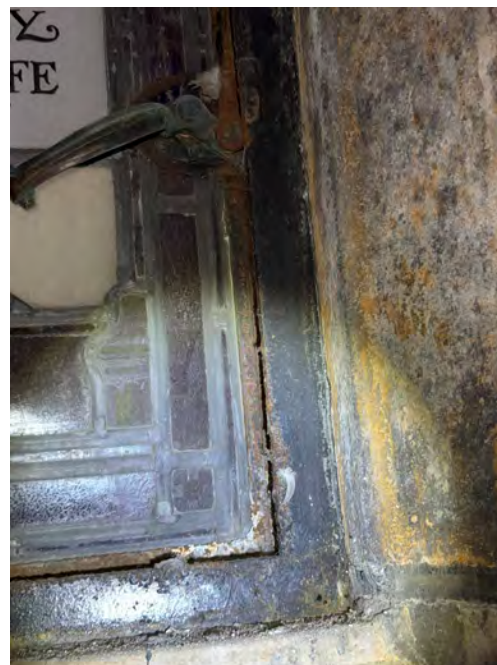
Rusting Frame

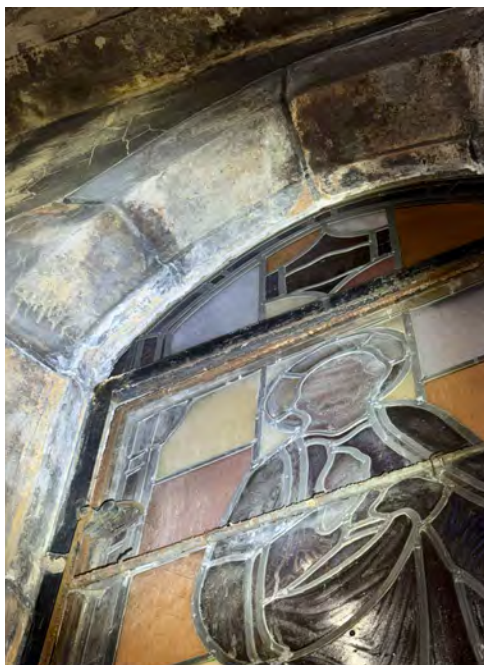
Pane Separation

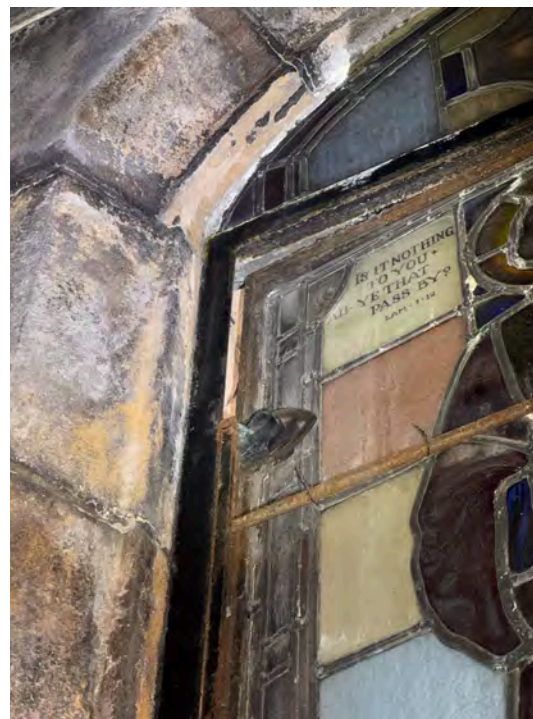
Pane Separation

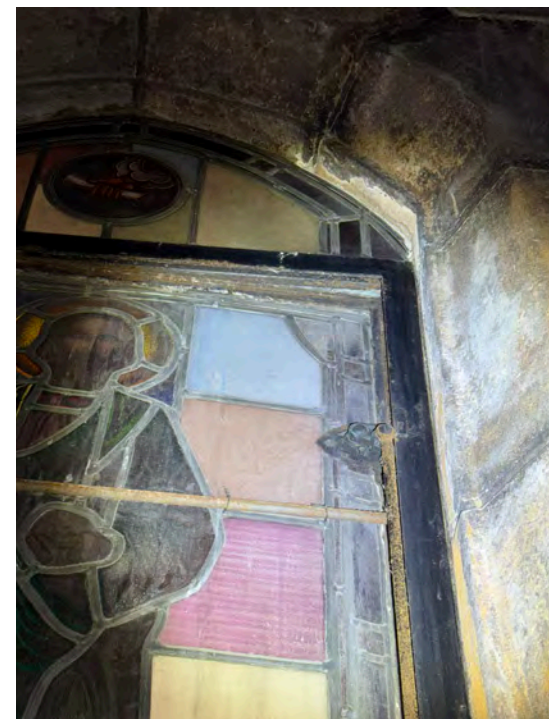
Pane Separation

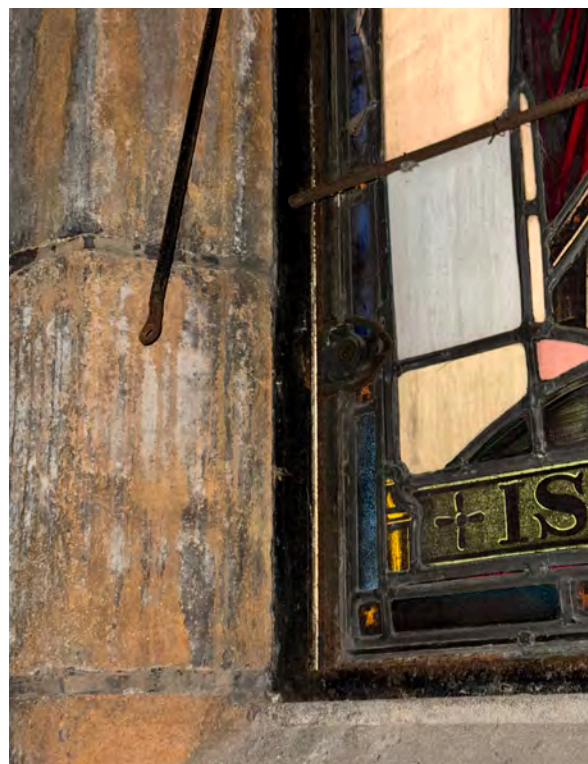
Broken Closure

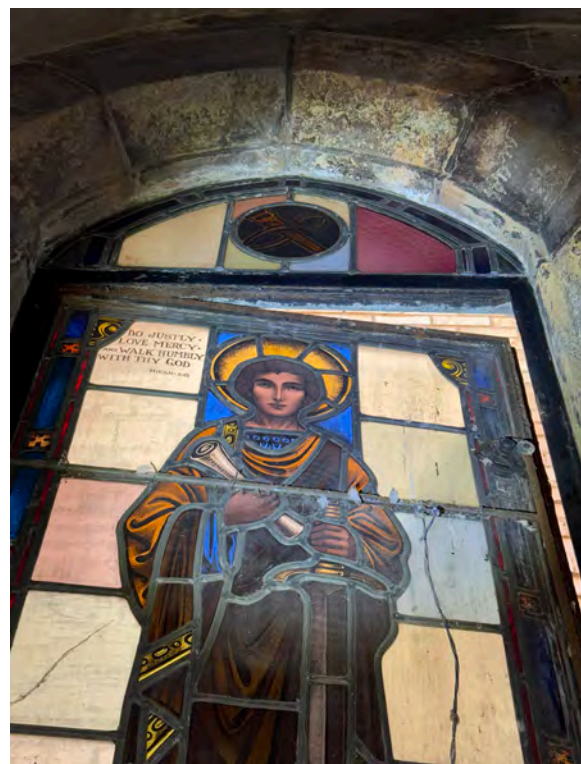
Pane Cracking and Separation

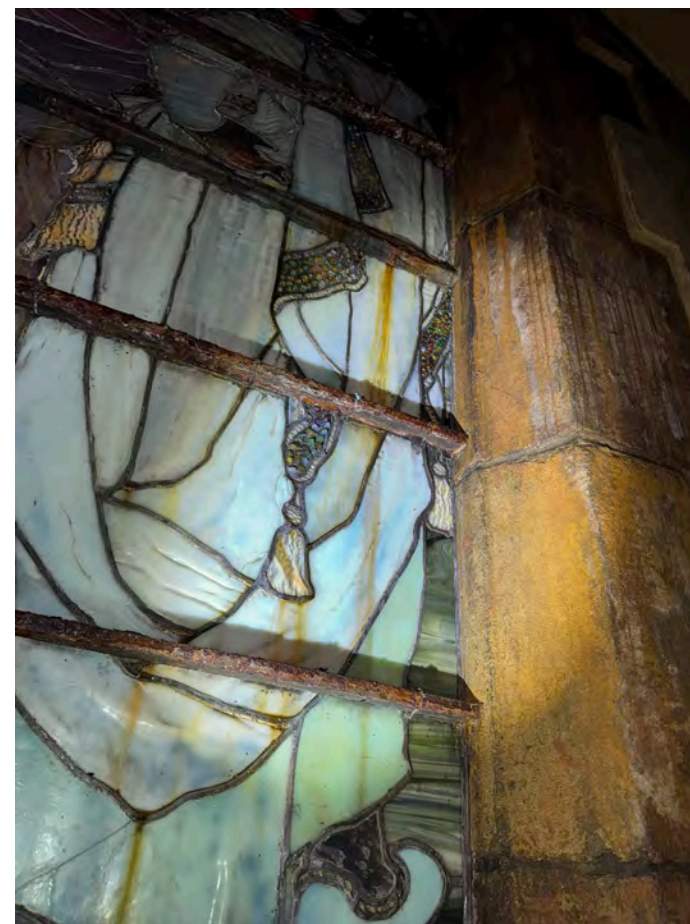
- Minor rusting on steel framing and mullions
- Panels containing religious iconography

Rusting Mullions

Window shall be salvaged and donated/returned to the church due to good condition and historic value from the original school that was founded in 1858. Since the window is a historic Tiffany window, it could instead be sold to a Tiffany collection. On the west secondary façade, windows shall be donated and not replaced because of the proposal to demolish this area of the building to accomodate new development.

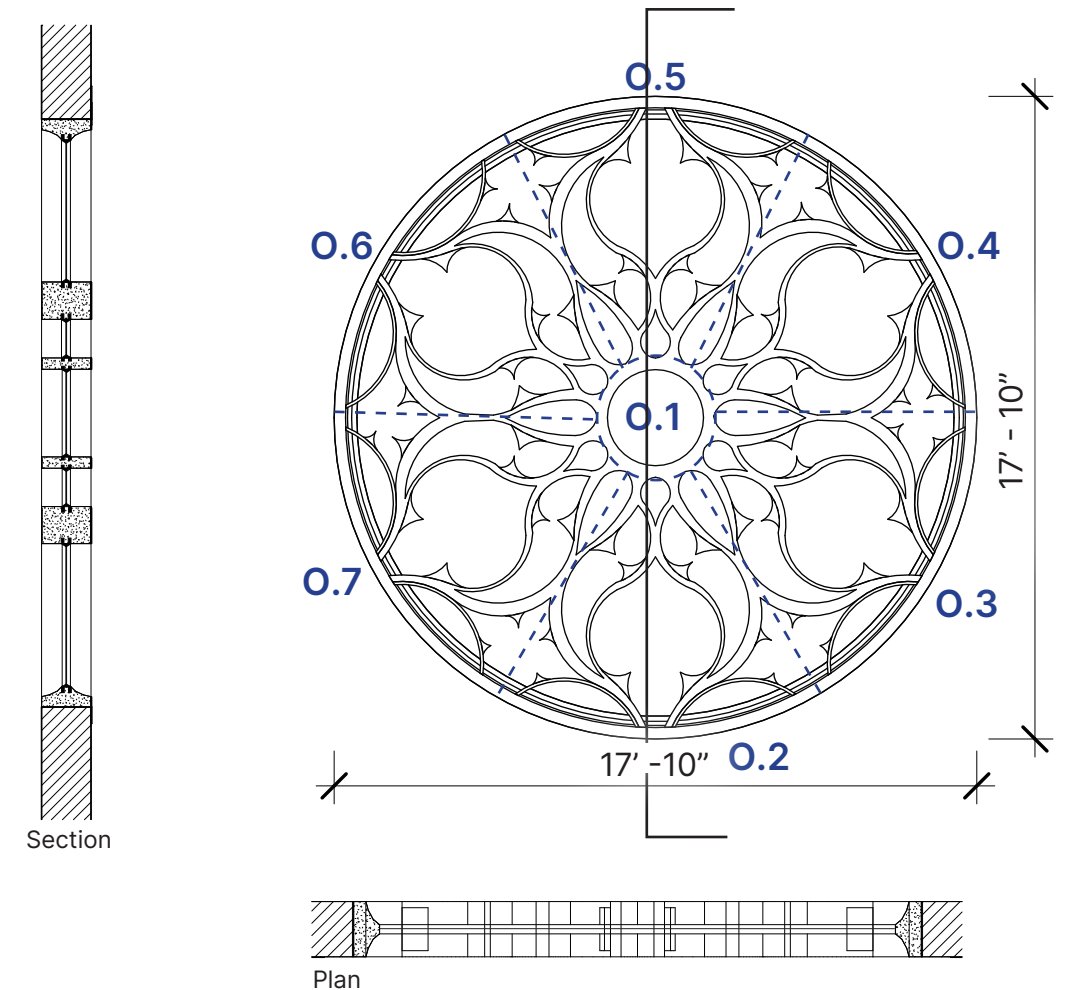
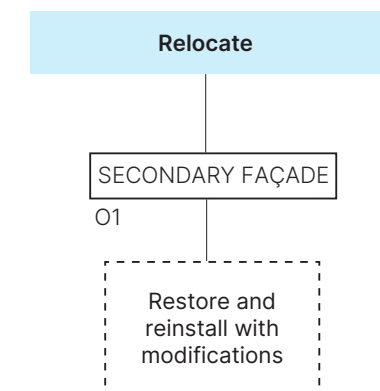
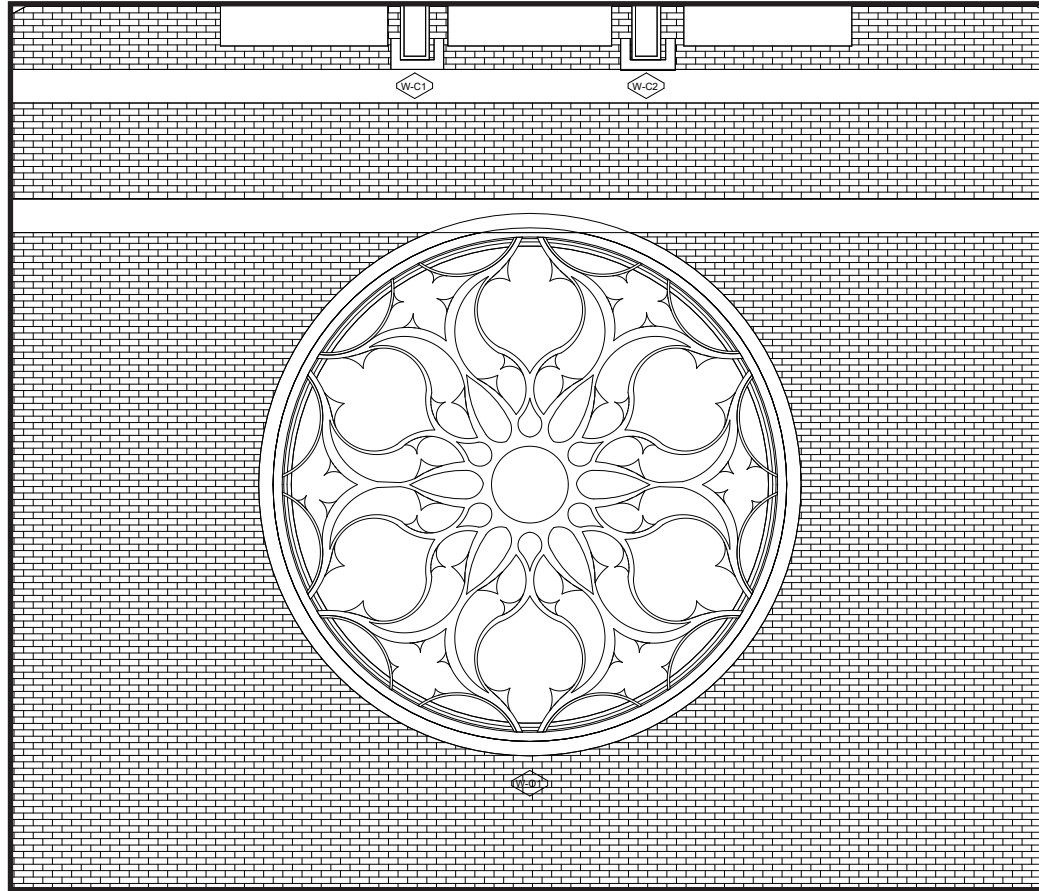
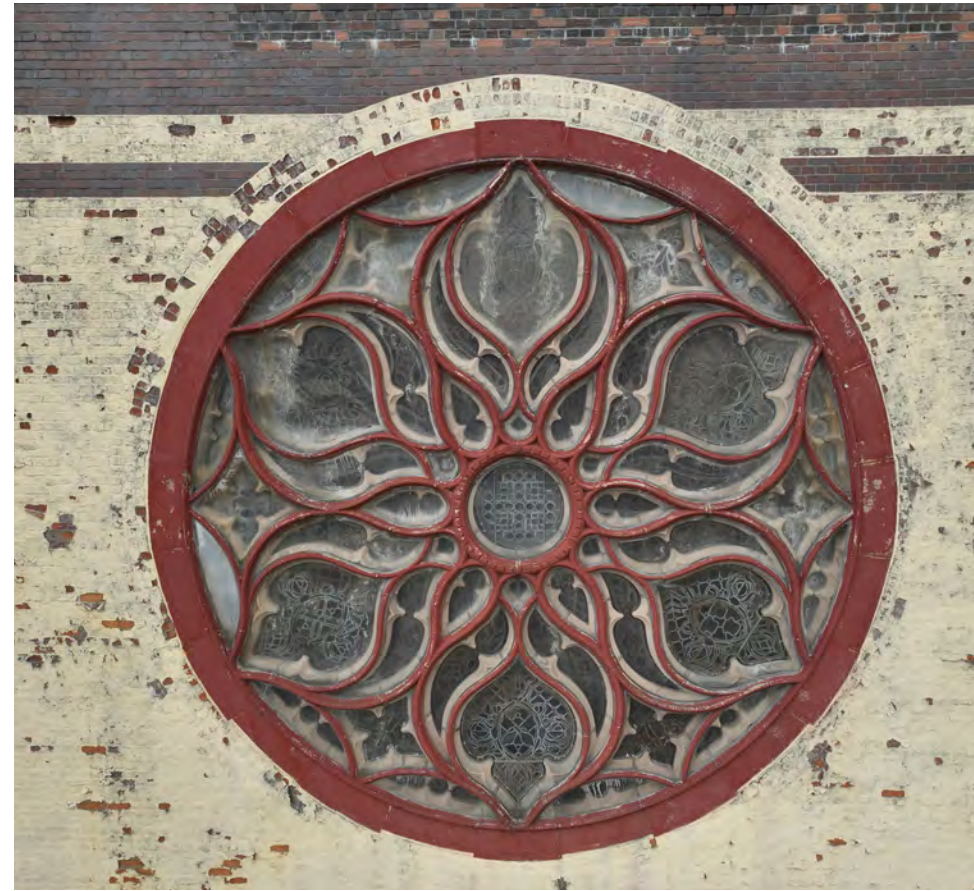
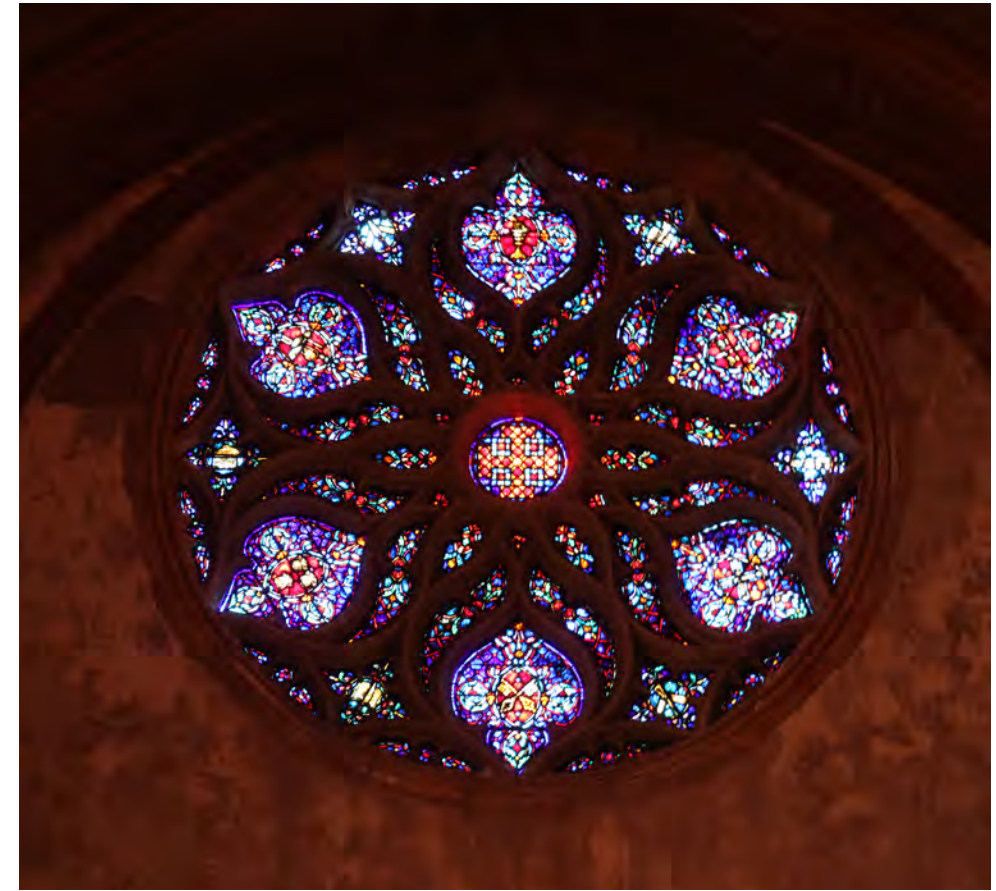
NORTH ELEVATION (SECONDARY FAÇADE)

- Minor rusting on steel framing and mullions
- Stained glass in good condition
- Panel O.1 displays religious iconography

The Rose Window has historic value that dates back to church completion in 1931 and to the Brooklyn Academy of Music Historic District designation in 1978. The stained glass is in good condition and can be reused for the building's restoration and adaptation.

Window shall be salvaged, restored and reused at the interior of the new residential lobby removing it from the lot line of the building to a location where it can be visible to residents of the new building. Tracery shall be salvaged and restored as a part of the window relocation. The window shall not be reinstalled at the same location on the exterior due to the proposed demolition of the north façade and proposed new construction.

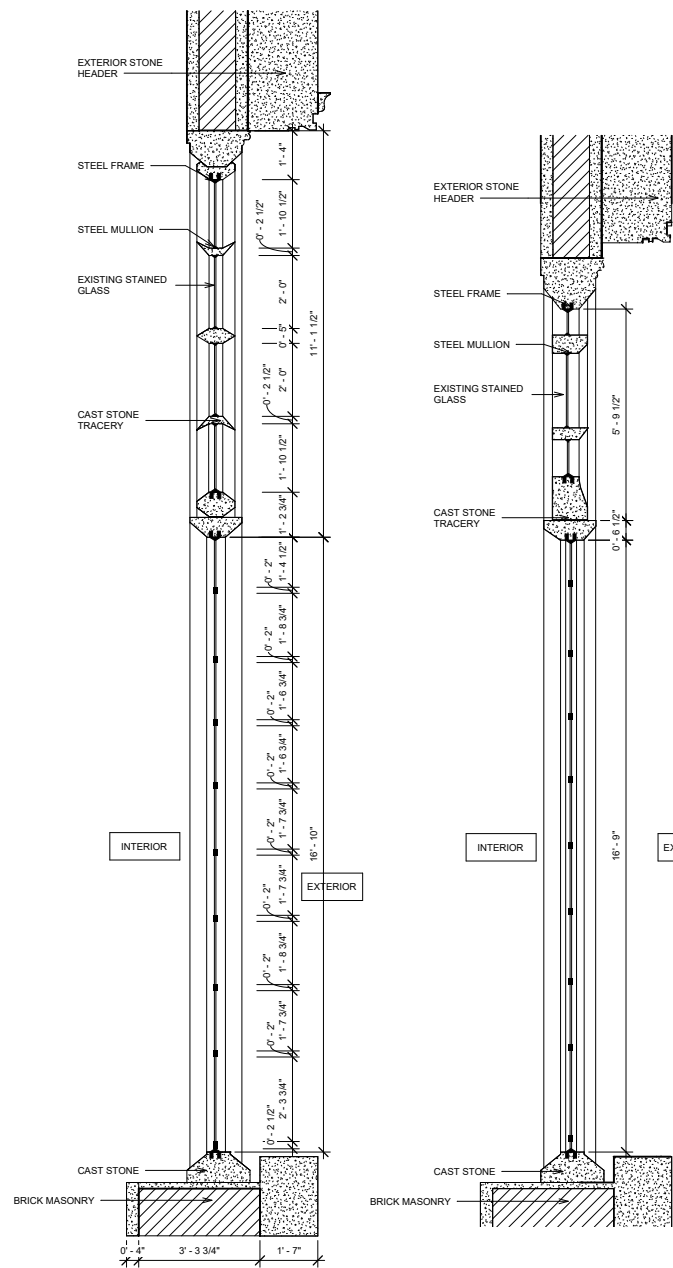
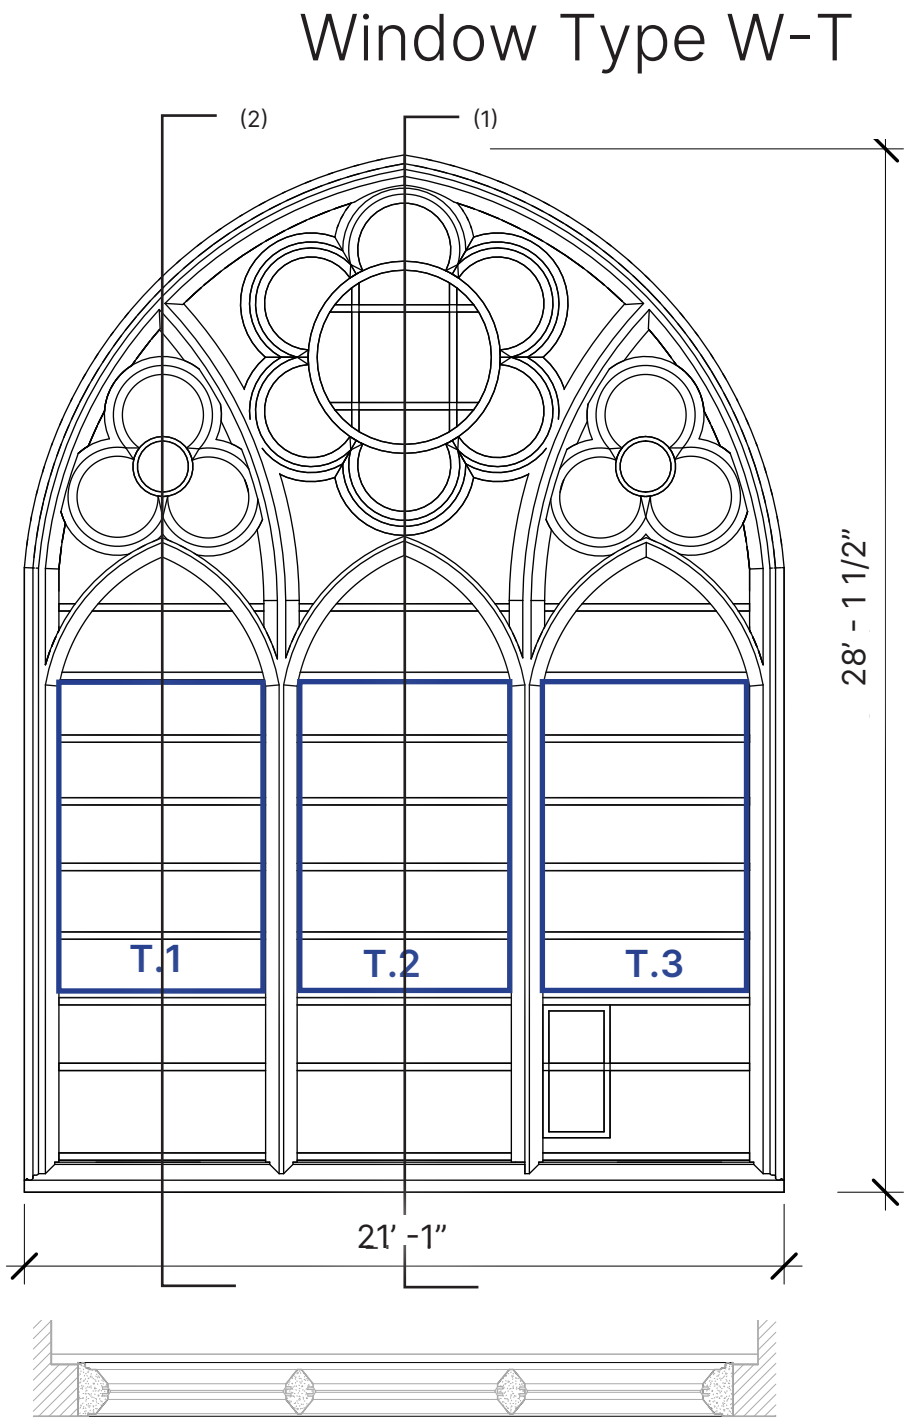
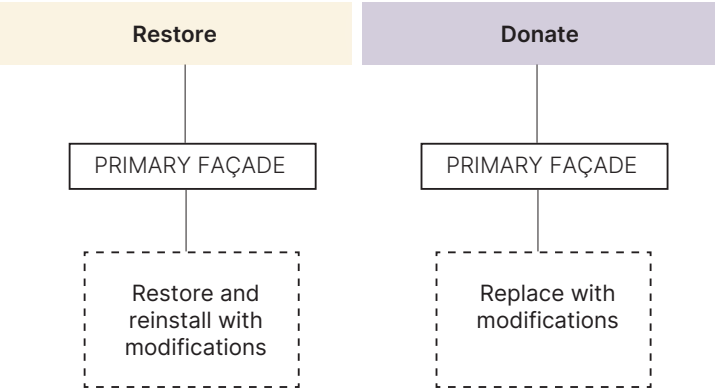
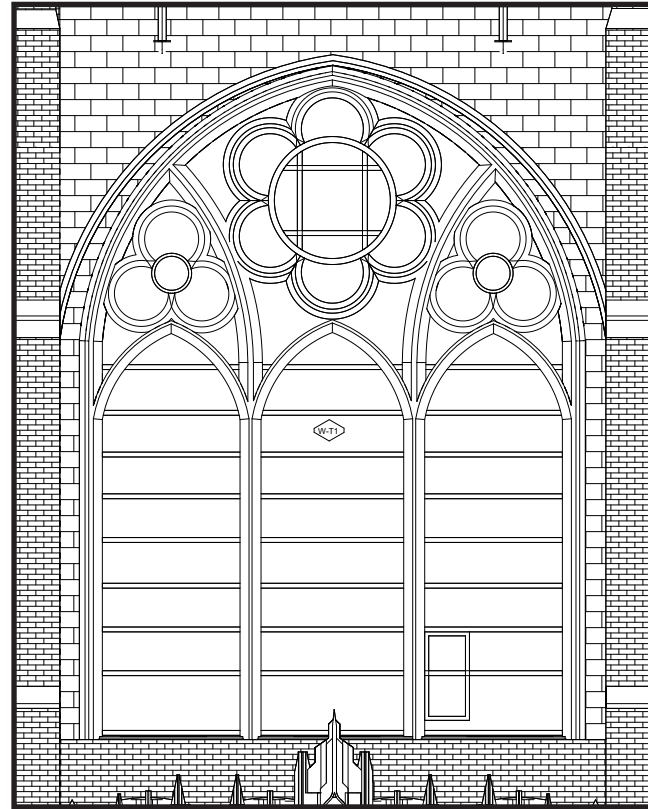
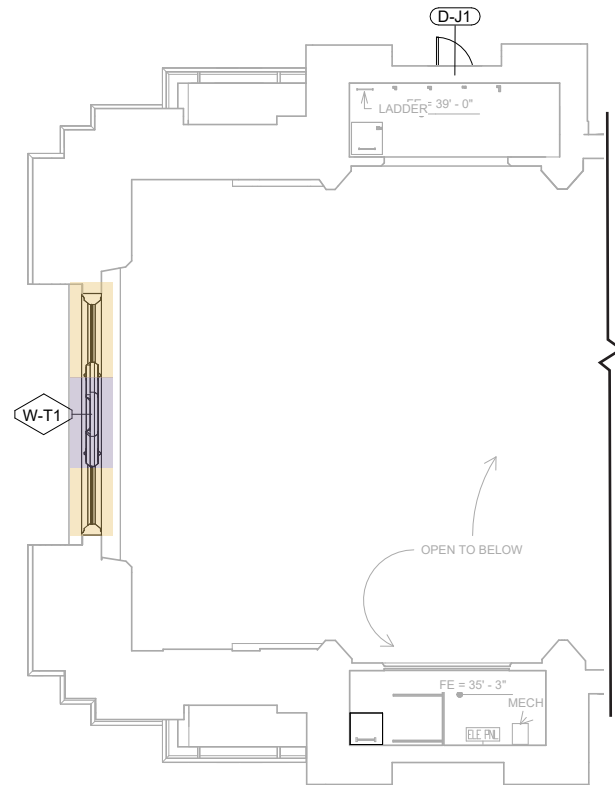
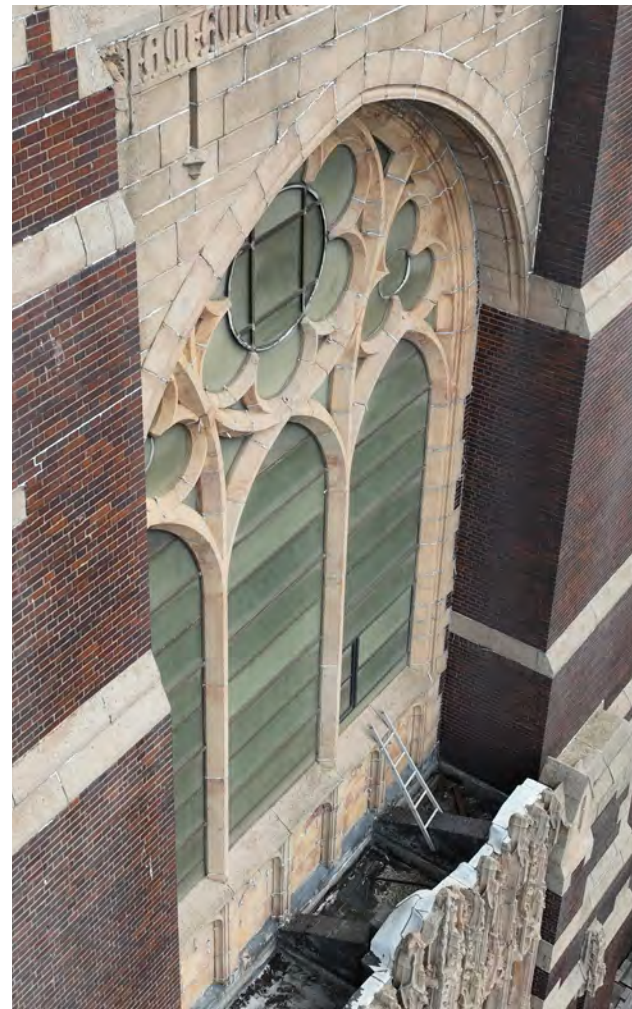
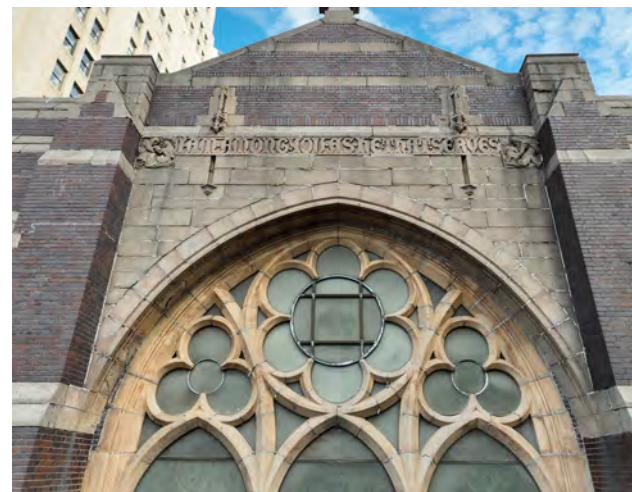
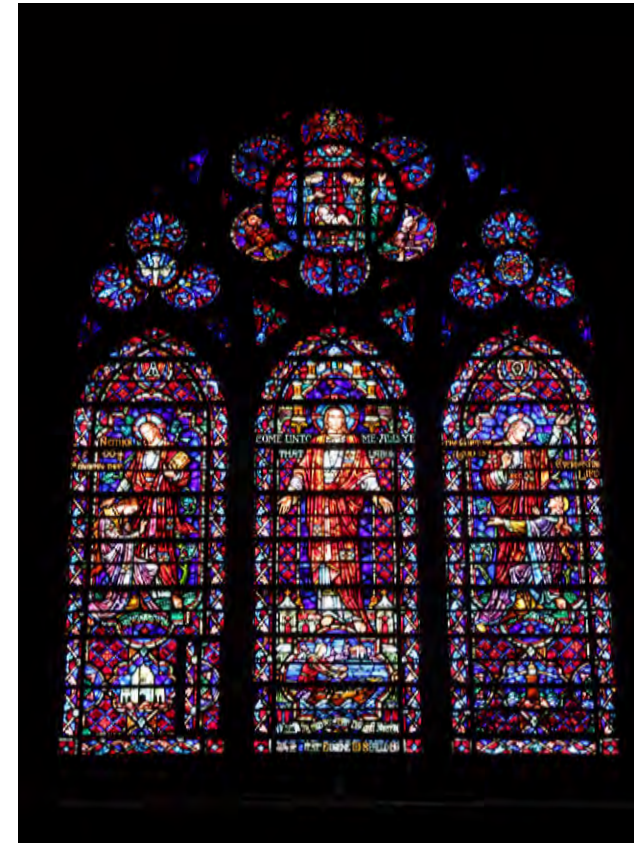
SOUTH ELEVATION (PRIMARY FAÇADE)

- Window was gifted by Eugene W. Spaulding
- Exterior is covered in non-original protective glazing
- Small operable window was added later in building’s history to provide roof access
- Stained glass is in good condition
- Minor rusting of steel window frame
- Separation of cast-stone surround creates breaks in insulation continuity
- Glazing panels T.1, T.2, T.3 and T.5 display religious iconography including the Three Kings and the Nativity scene

The large stained glass window at the south façade has historic value that dates back to church completion in 1931 and to the Brooklyn Academy of Music Historic District designation in 1978. The stained glass is in good condition and can be reused for the building’s restoration and adaptation.

Window shall be salvaged, restored, modified and reinstalled in the existing location for use in the new building amenity space. Panels T.1, T.2, and T.3 shall be removed and donated/returned to the church. The design proposes to replace these panels with salvaged stained glass from the secular panels on the West facade of the church, pending review from stained glass artisan. Tracery shall be salvaged to create casts for new tracery to retain the historic context of the neighborhood and pay tribute to the history of the building in its new construction.
