138-154 St. Felix Street, aka 11-21 Hanson Place – Brooklyn

Academy of Music Historic District

ADAPTIVE-REUSE & ENLARGEMENT

LPC Certificate of Appropriateness Presentation

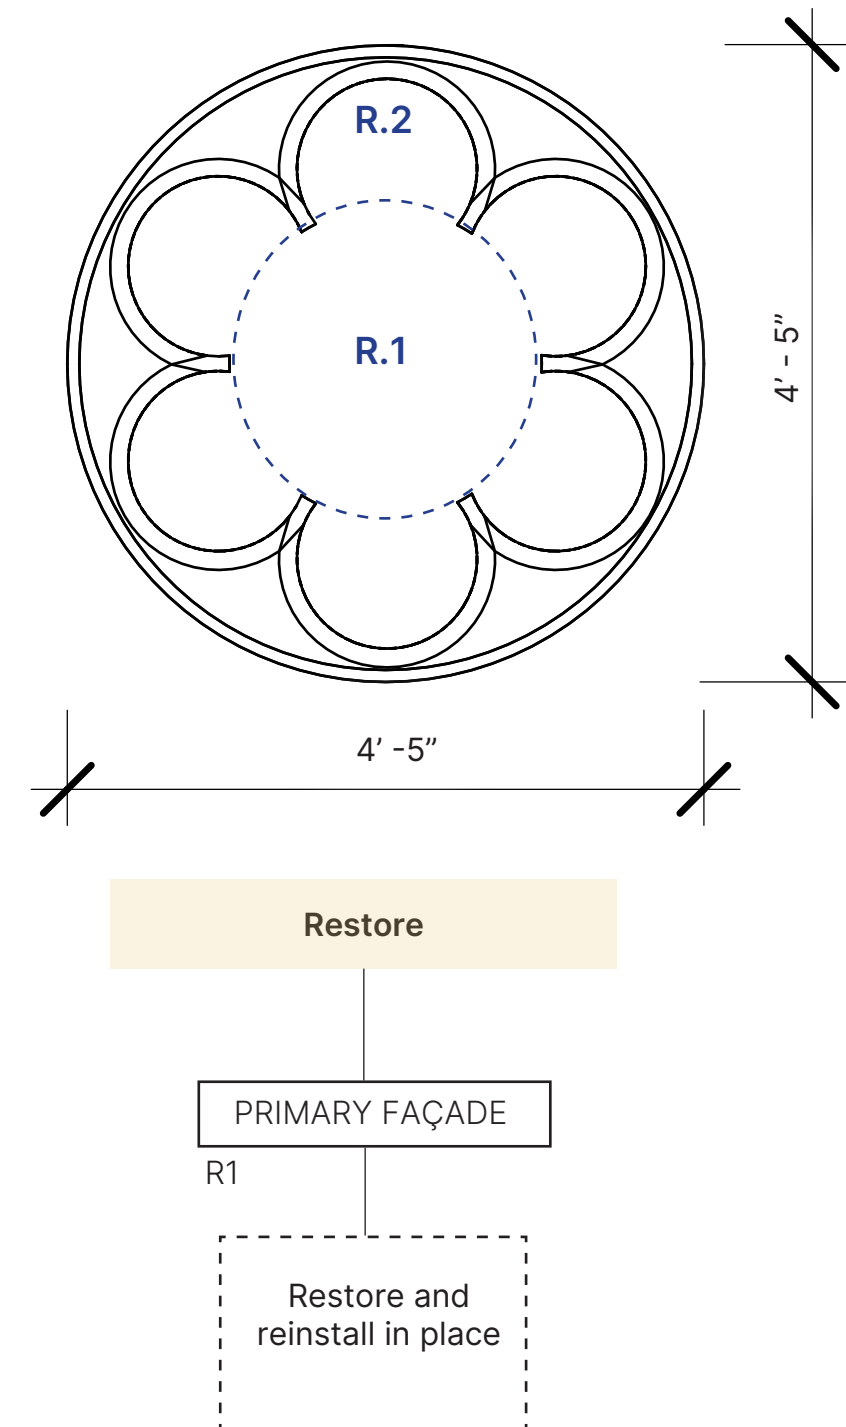
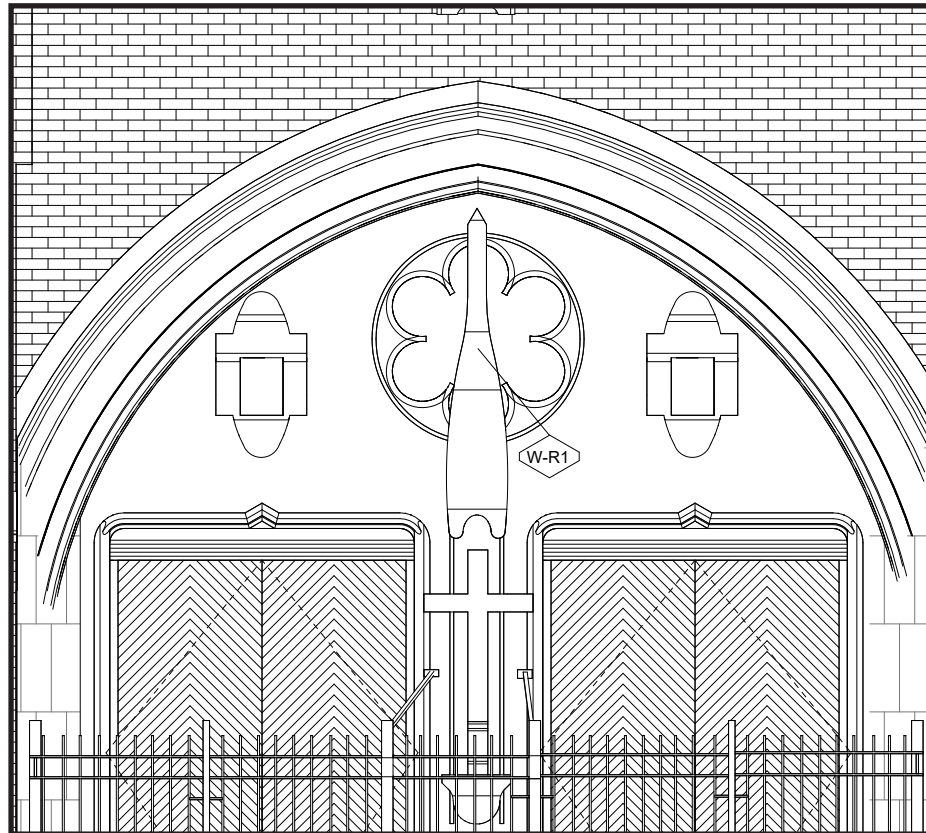
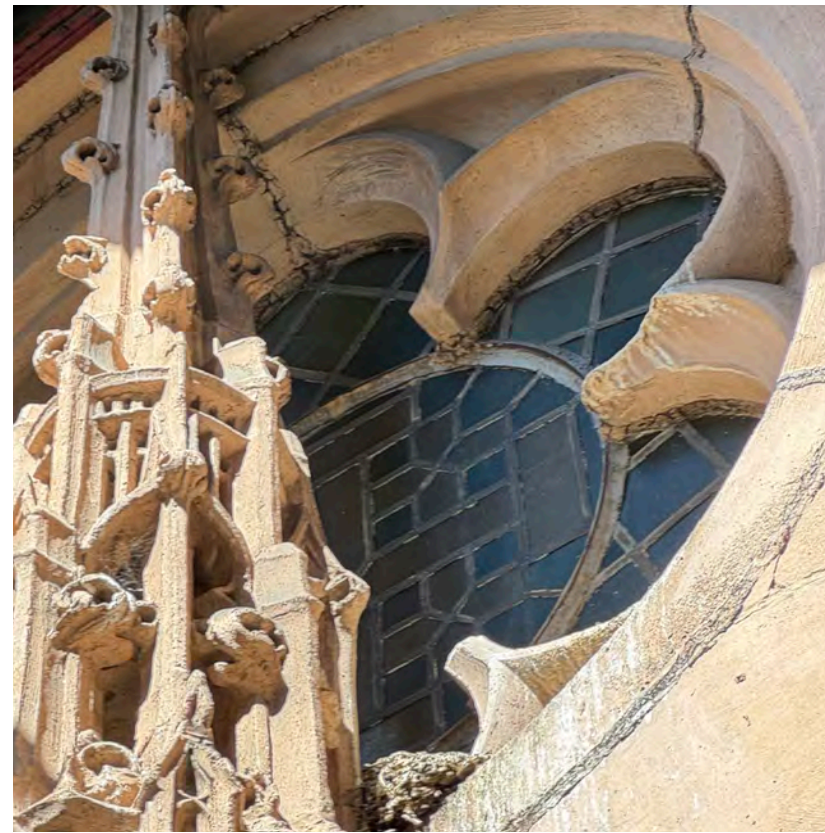
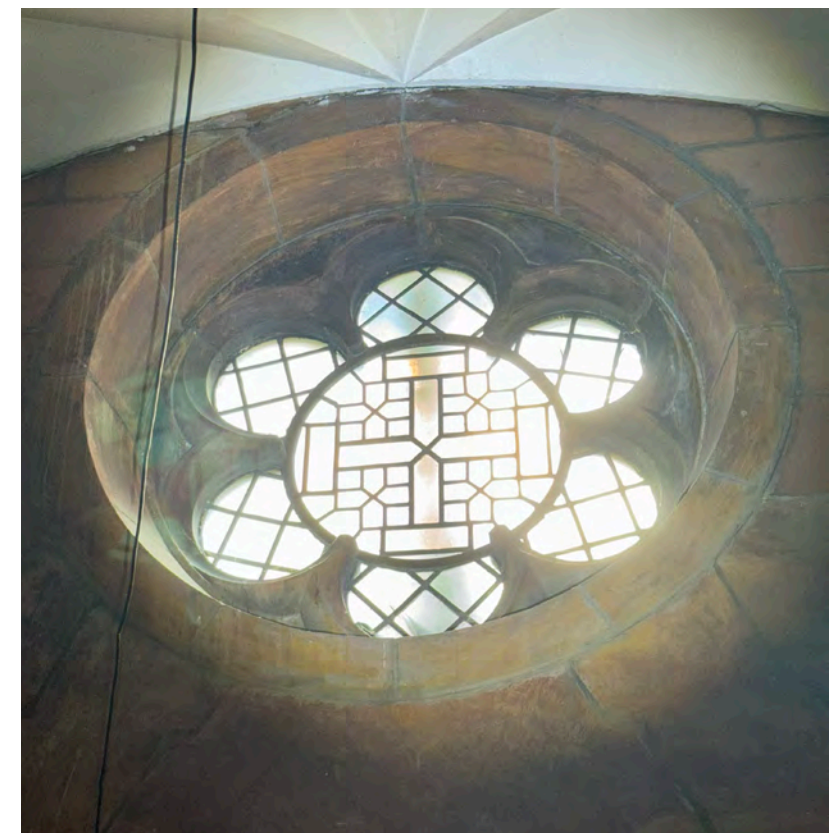
SOUTH ELEVATION (PRIMARY FAÇADE)

- Stained glass is in good condition without cracks or damage
- Pane R.1 displays religious iconography

Historic value of the window dates back to the church completion in 1931 and to the Brooklyn Academy of Music Historic District designation in 1978. The stained glass is in good condition and can be reused for the building's restoration and adaptation.

Window shall be salvaged, restored and reinstalled in the existing location for the future use of the building. Tracery shall be salvaged to create casts for new tracery to retain the historic context of the neighborhood and pay tribute to the history of the building in its new construction.

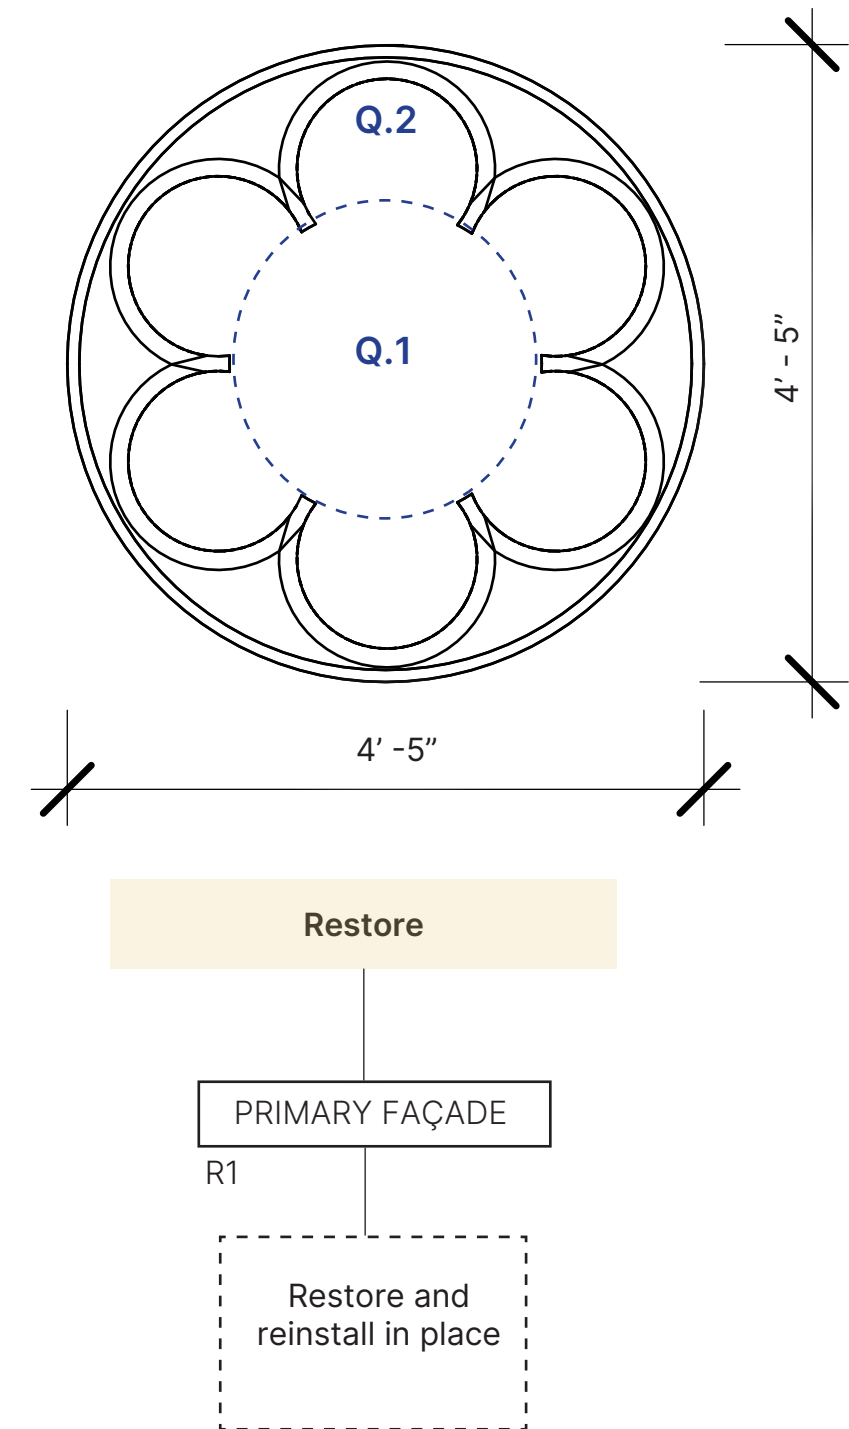
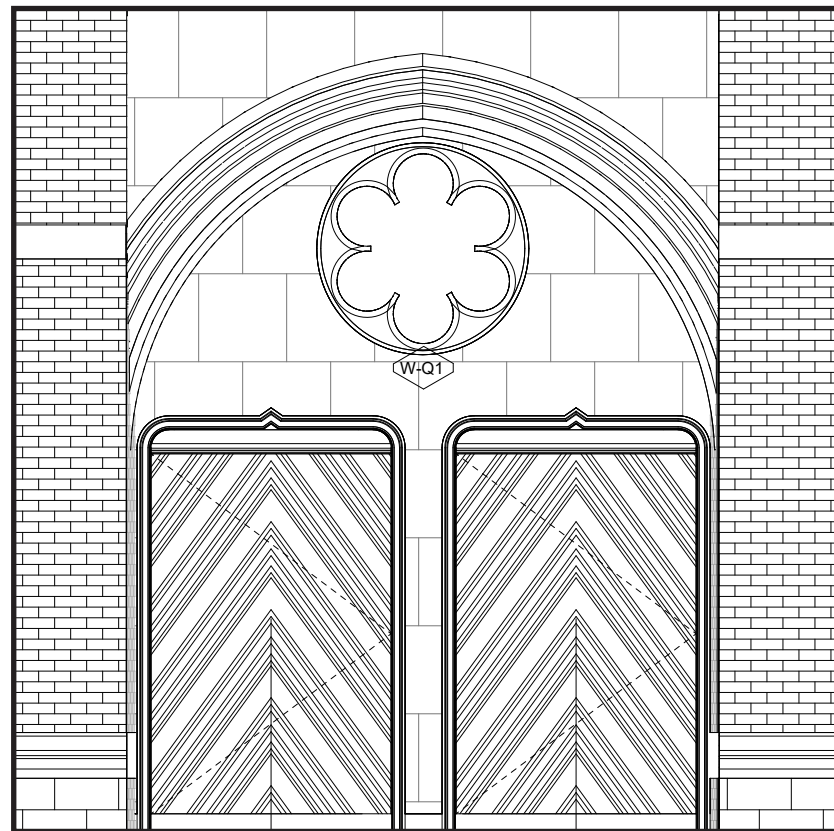
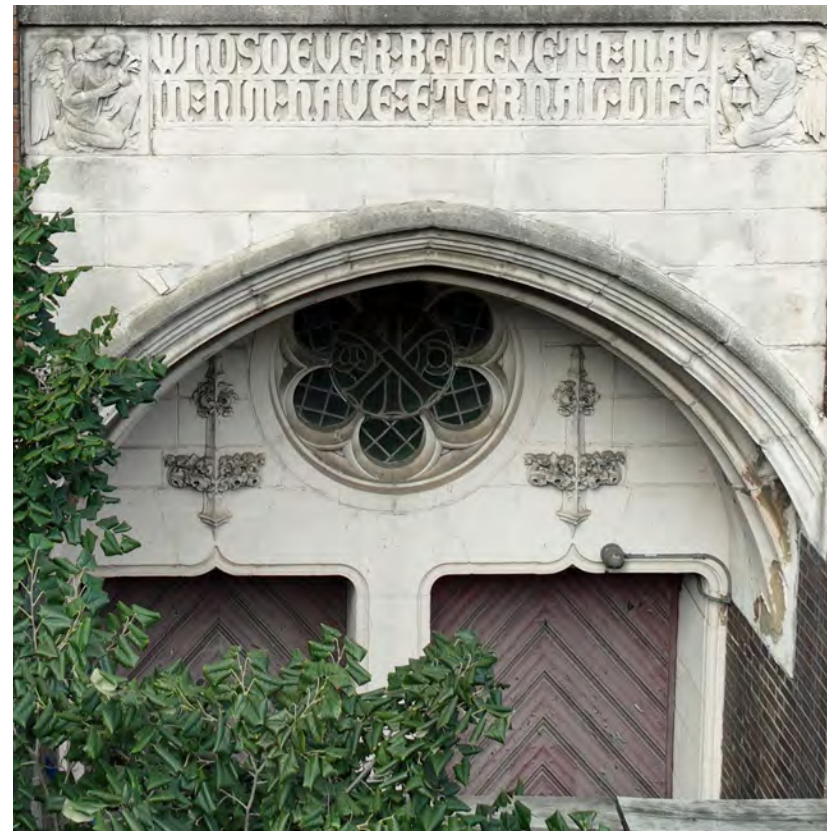
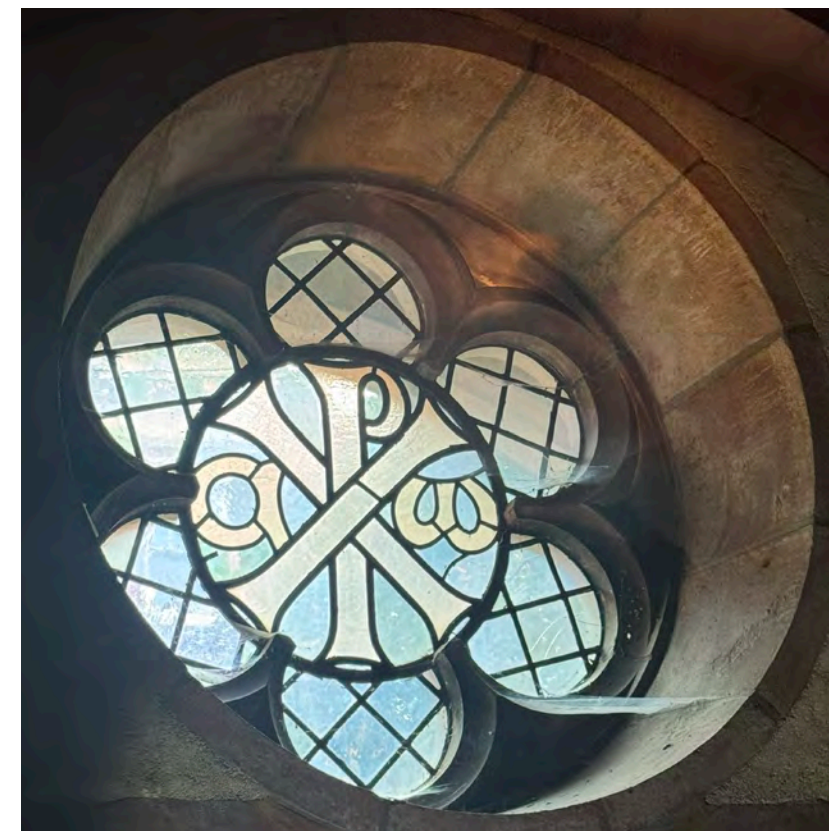
EAST ELEVATION (PRIMARY FAÇADE)

- Stained glass is in good condition without cracks or damage
- Pane Q.1 displays religious iconography

Historic value of the window dates back to the church completion in 1931 and to the Brooklyn Academy of Music Historic District designation in 1978. The stained glass is in good condition and can be reused for the building's restoration and adaptation.

Window shall be salvaged, restored and reinstalled in the existing location for the future use of the building. Tracery shall be salvaged to create casts for new tracery to retain the historic context of the neighborhood and pay tribute to the history of the building in its new construction.

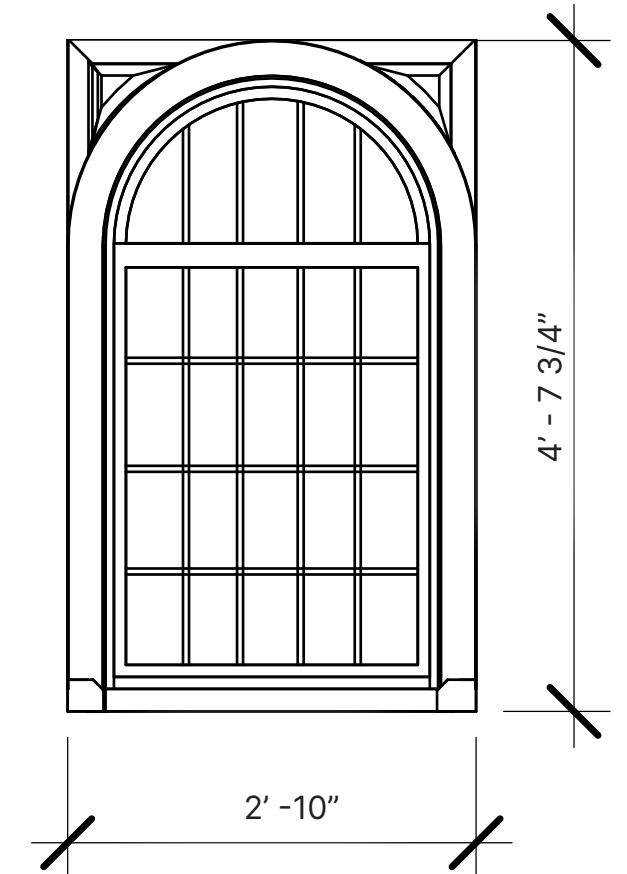
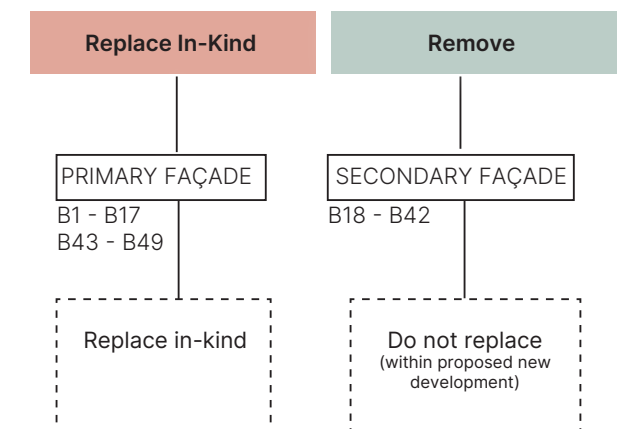
- Generally in poor condition
- Bowing at top and bottom panes
- Rusting along window sills
- No longer operable
- Broken panes

These are standard windows found on several floors of the church. Major damage was observed, windows are inoperable, and susceptible to the elements.

BOWING

MISSING ELEMENTS

BROKEN PANES

Windows shall be removed and replaced based on proposed design. Windows on the south and east primary façades shall be replaced in-kind with steel, operable windows to retain the historic context of the neighborhood. Windows on the west secondary façade shall not be replaced because of the proposal to demolish this area of the building to accomodate new development.

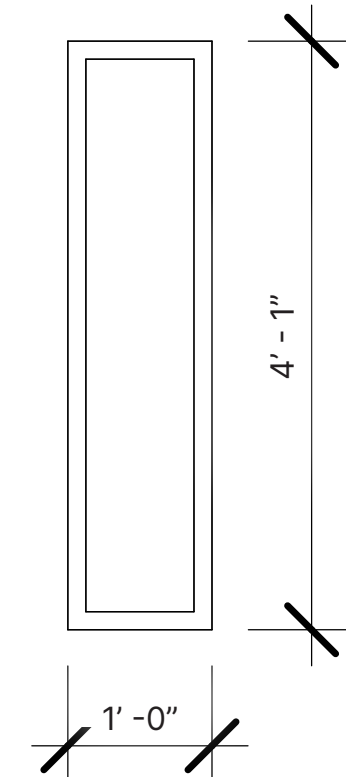
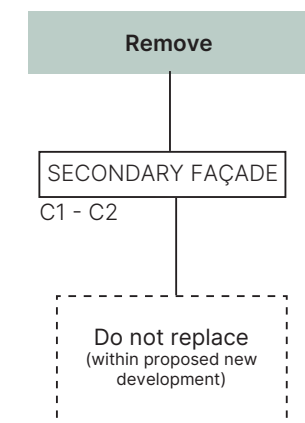
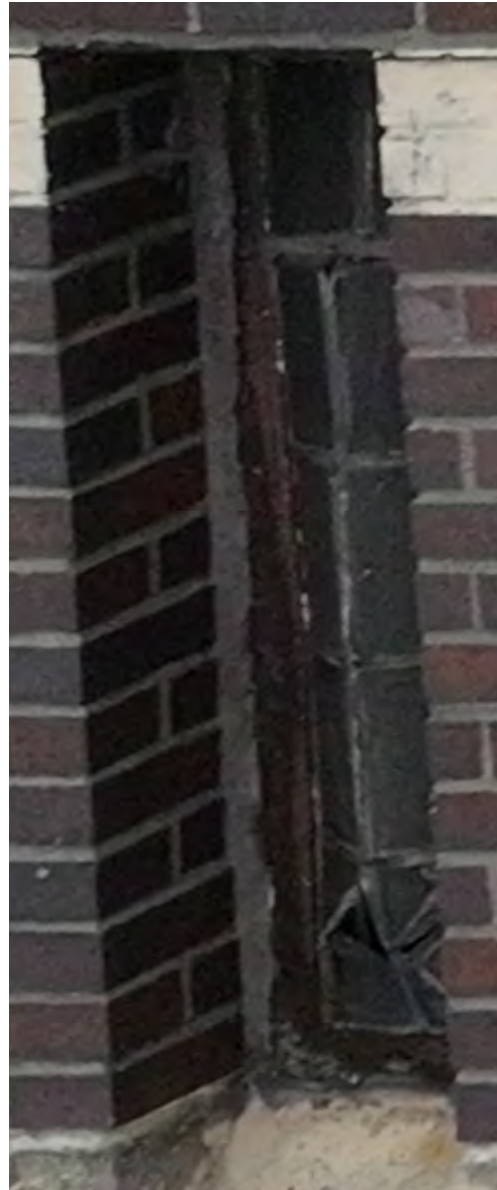
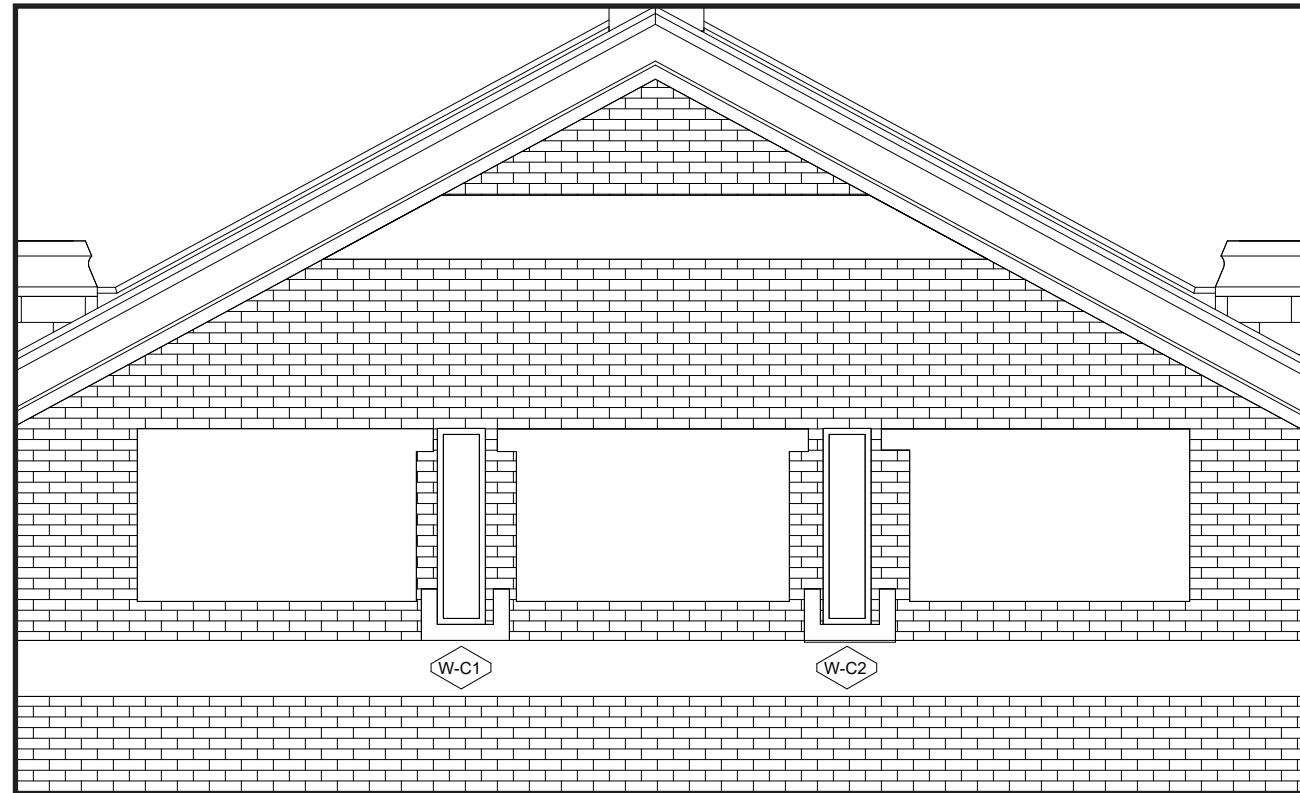
W-C1

- Generally in poor condition
- Bowing throughout
- Rusting along window sills
- Broken panes

Major damage appears to be typical, windows are broken and susceptible to the elements.

Windows on the north secondary façade shall be removed based on proposed design. Windows shall not be replaced because of the proposal to demolish this area of the building to accomodate new development.

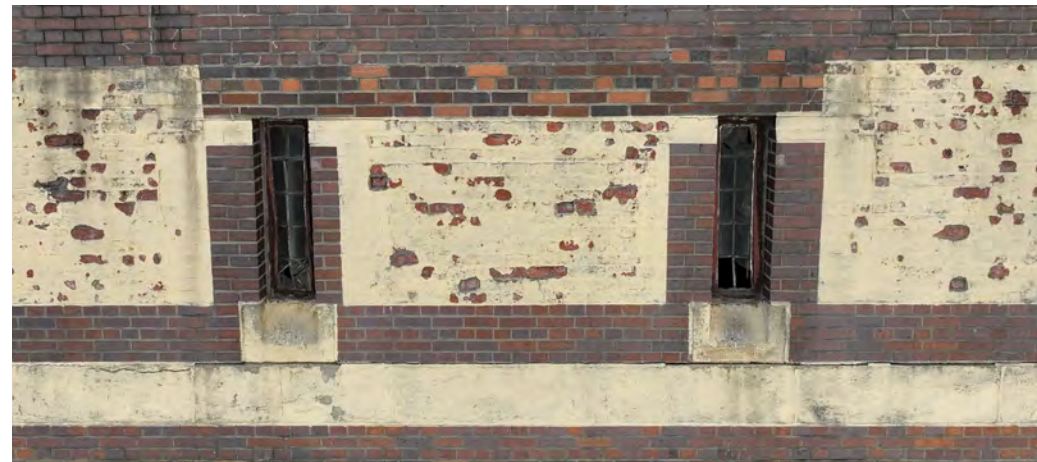
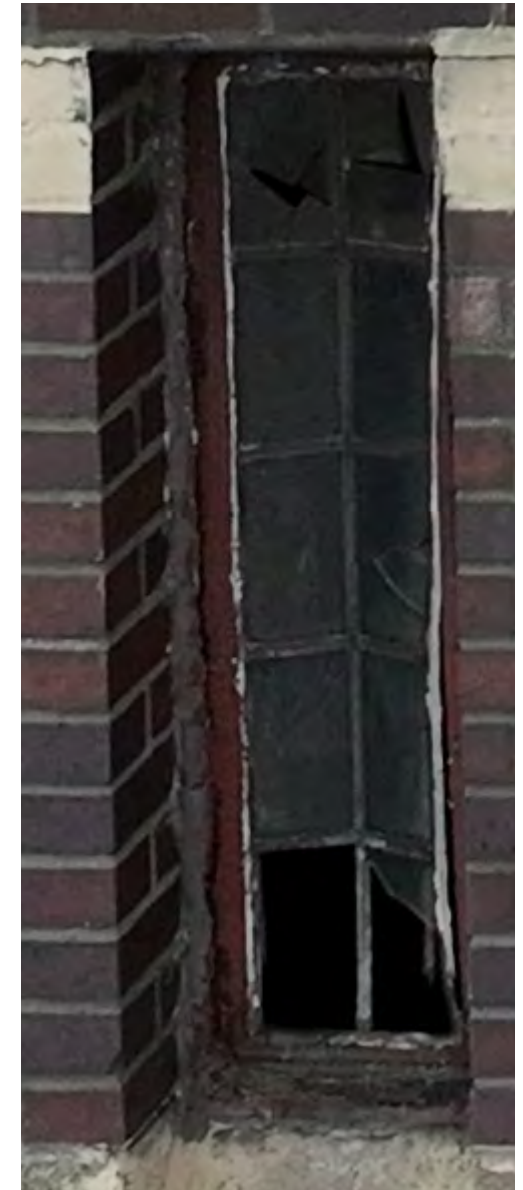
W-C2

- Major deterioration on interior
- No longer operable
- Rusting along window sills
- Frames detaching on exterior

Major damage appears to be typical, windows are broken and susceptible to the elements.

Windows on the east primary façade shall be removed and replaced in-kind with steel, operable windows meeting all light and air standards based on proposed design and retaining the historic context of the neighborhood.

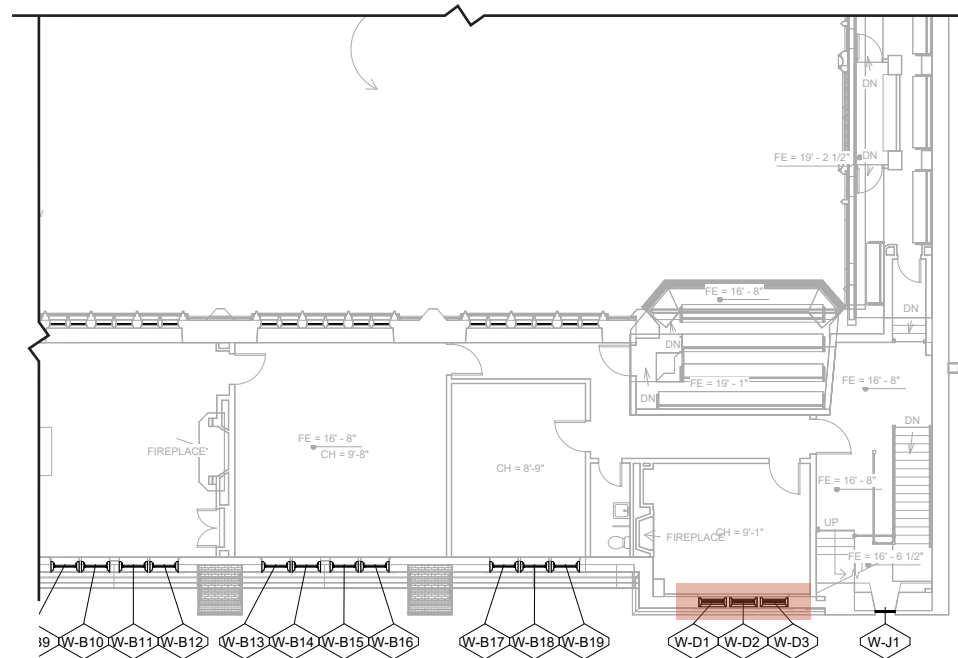
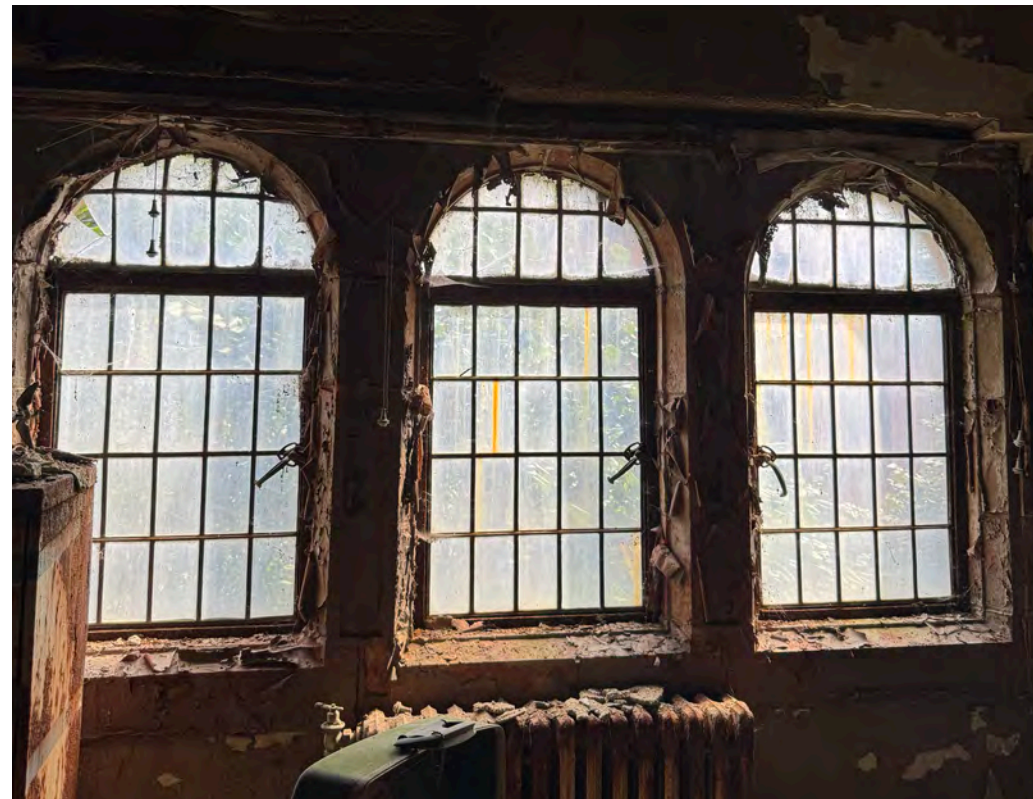
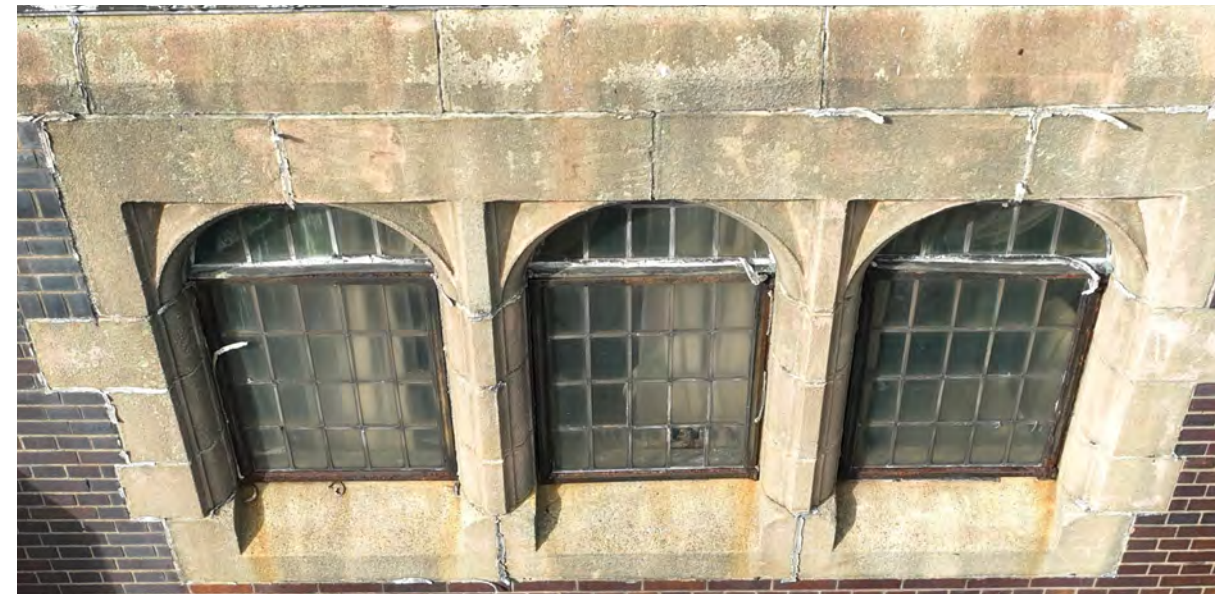
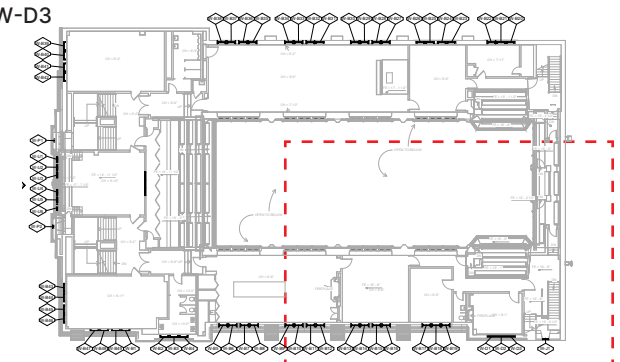
Window Type W-D

- Major deterioration on interior
- No longer operable
- Rusting along window sills
- Frames are detaching on exterior
- Broken panes

Major damage appears to be typical, windows are broken and susceptible to the elements.

Windows shall be removed and replaced based on proposed design. Windows on the south and east façades shall be replaced in-kind with steel, operable windows meeting all light and air standards, retaining the historic context of the neighborhood.

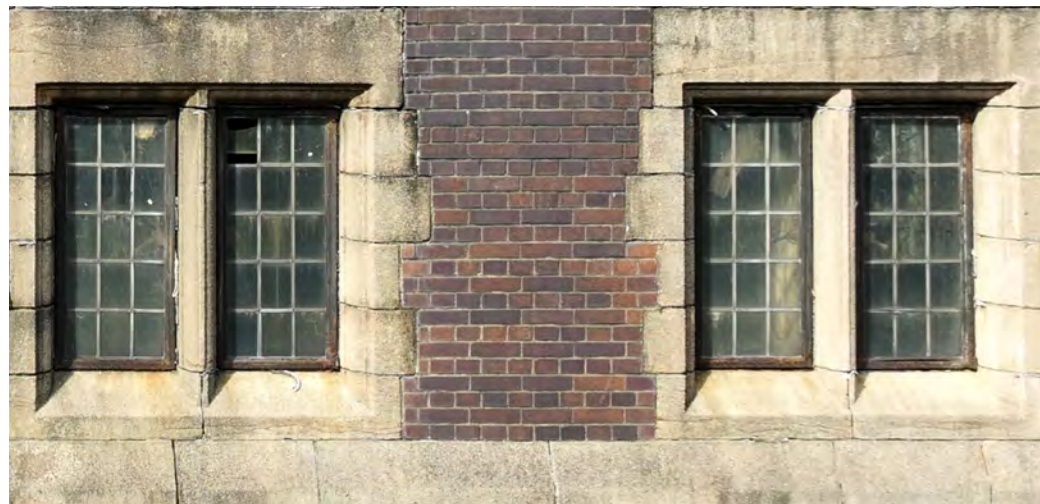
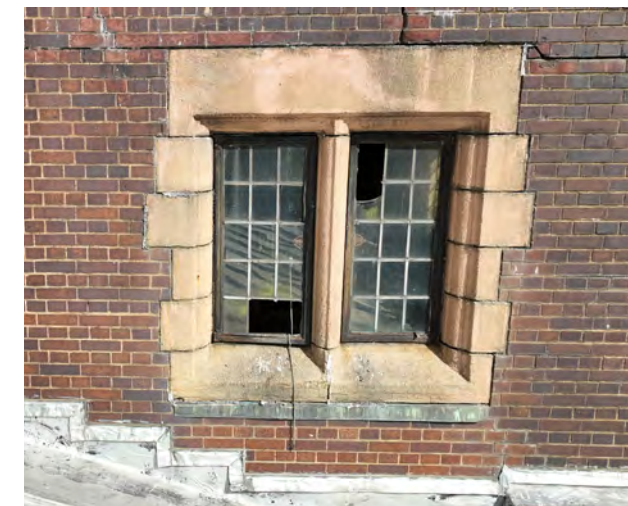
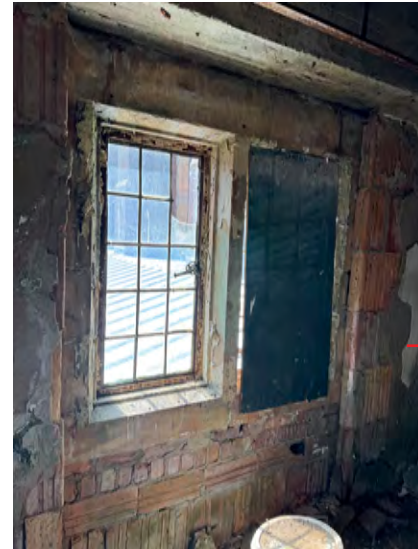
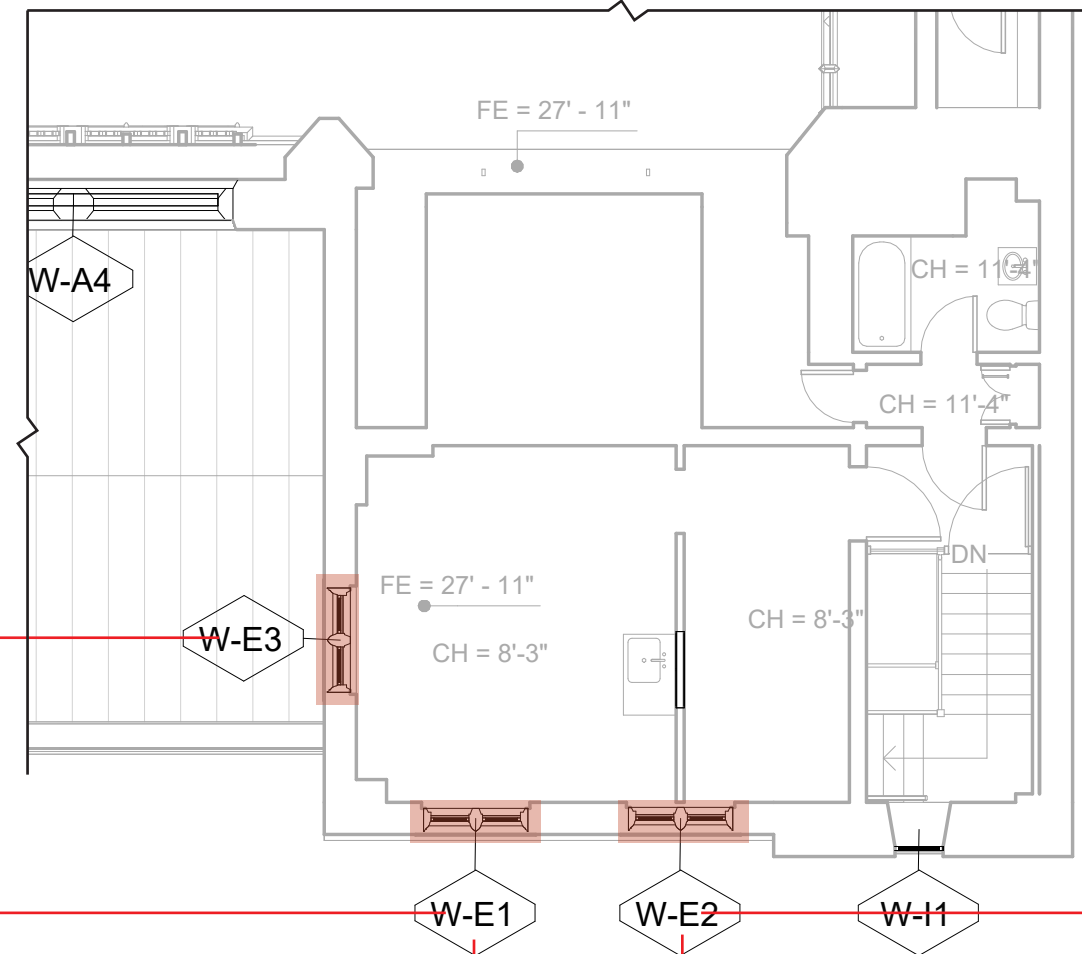
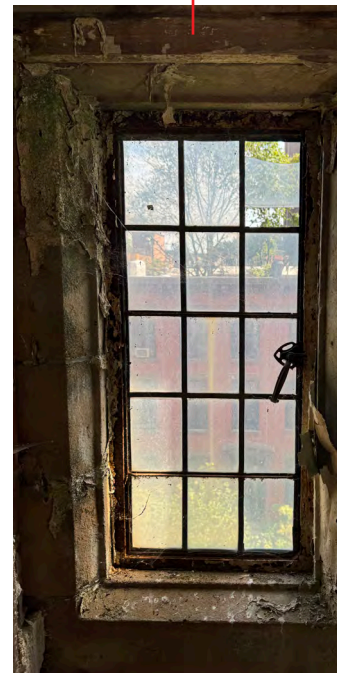
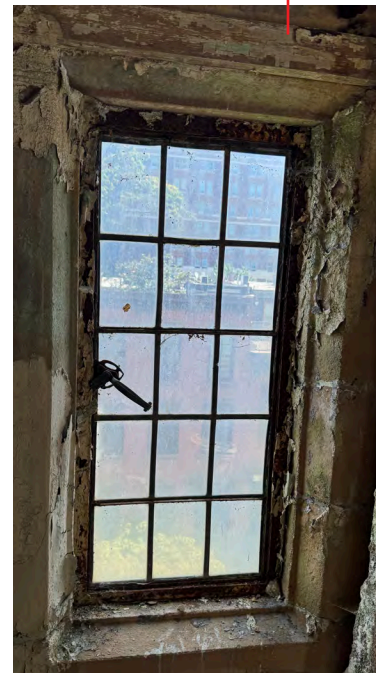
Window Type W-E

- Major deterioration on interior
- No longer operable
- Rusting along window sills
- Frames are detaching on exterior
- Broken and warping panes

Major damage appears to be typical, windows are broken and susceptible to the elements.

Windows shall be removed and replaced based on proposed design. This window shall be replaced with a new, modified, steel storefront to accomodate the new entrance into the proposed residential development.

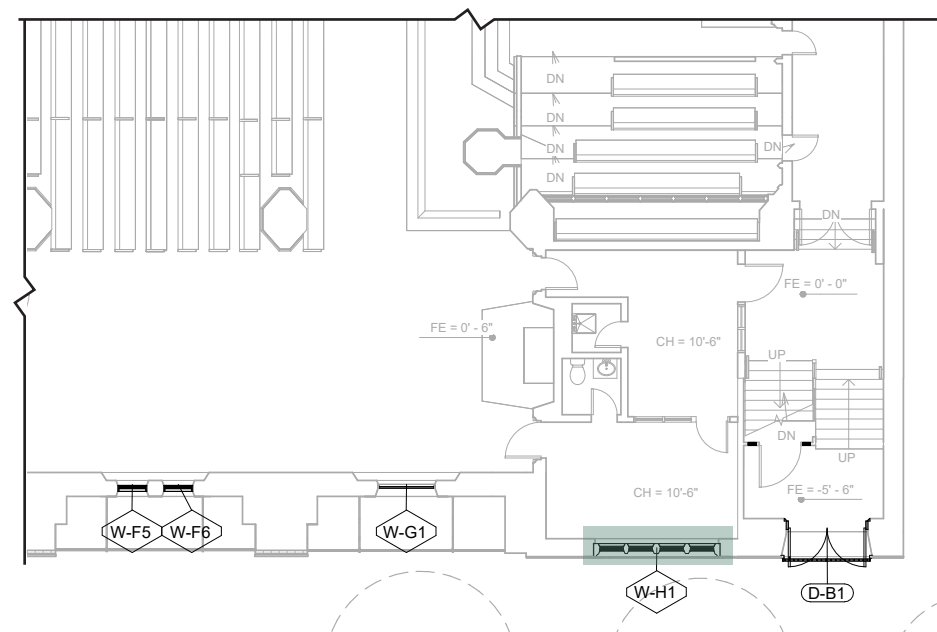
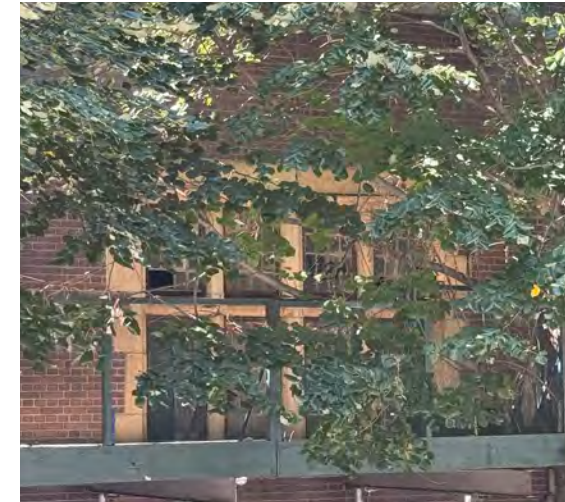
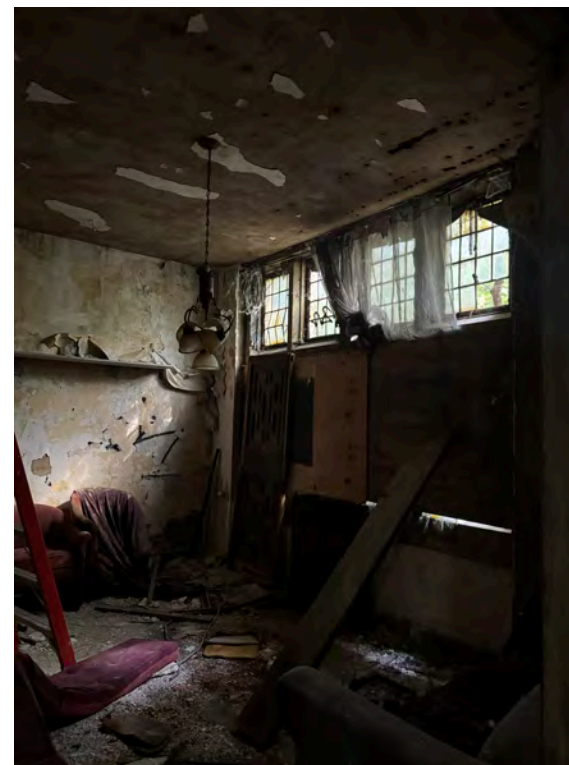
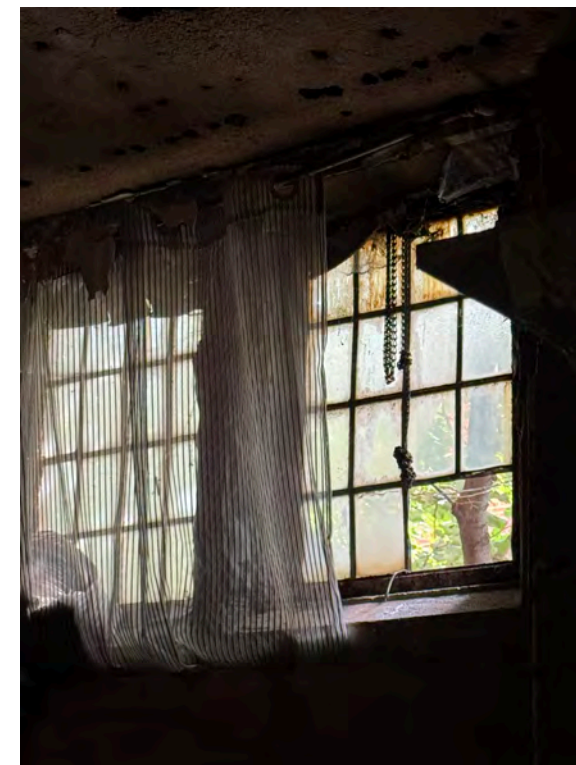
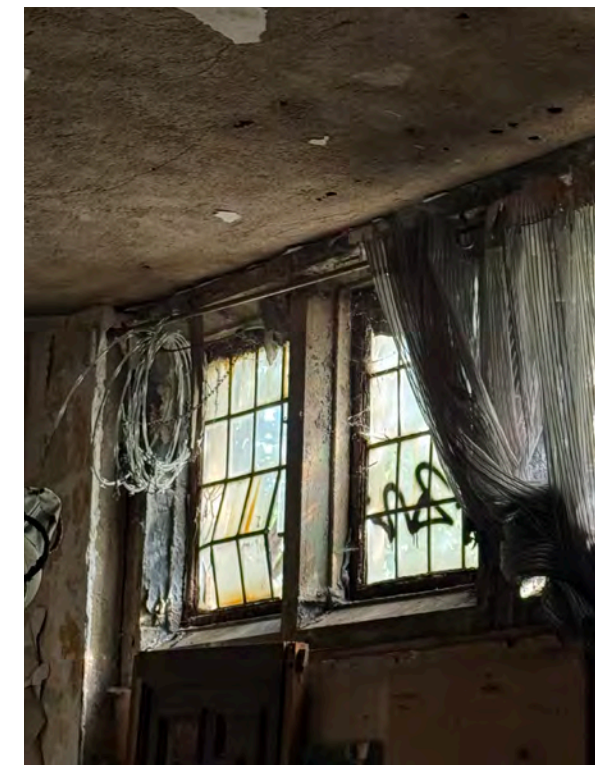
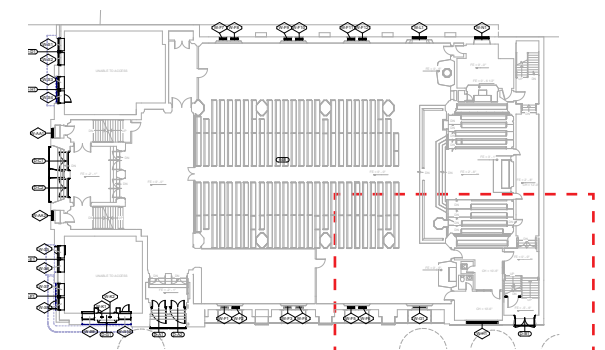
Window Type W-H

- Major deterioration on interior
- No longer operable
- Rusting along window sills
- Frames are detaching on exterior
- Broken and warping panes

Major damage appears to be typical, windows are broken and susceptible to the elements.

Windows shall be removed and replaced based on proposed design. Windows on the east façade shall be replaced in-kind with steel, operable windows to retain the historic context of the neighborhood.

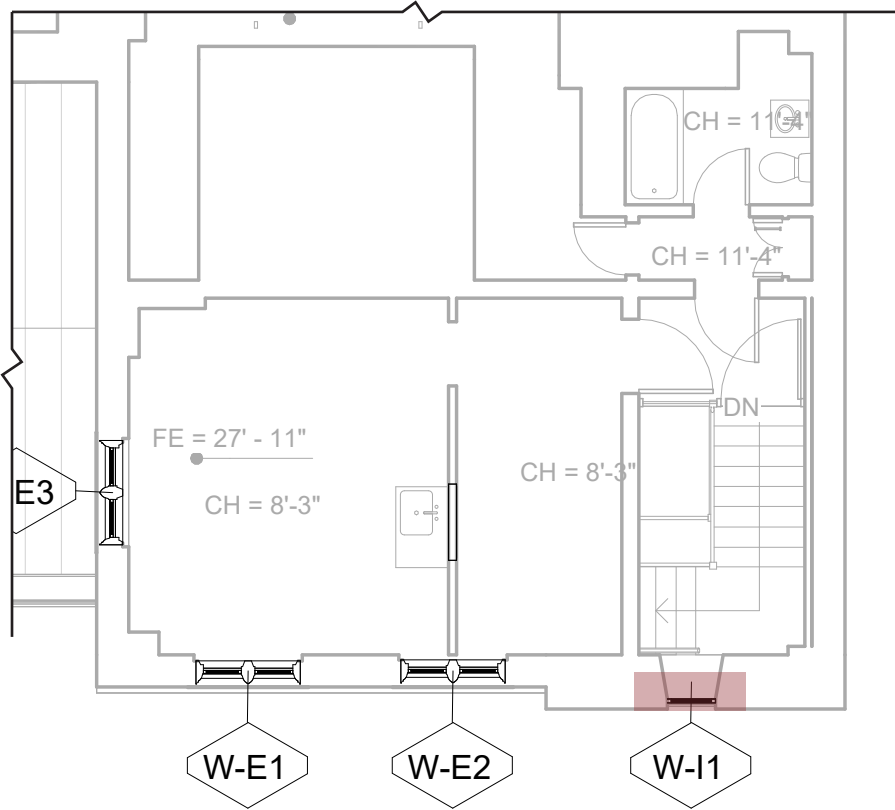
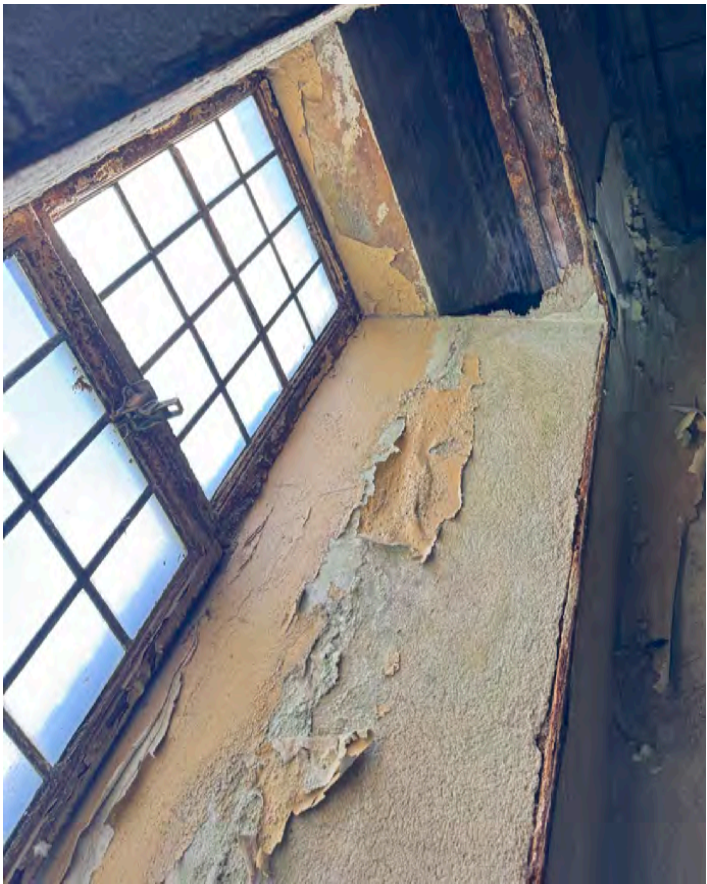
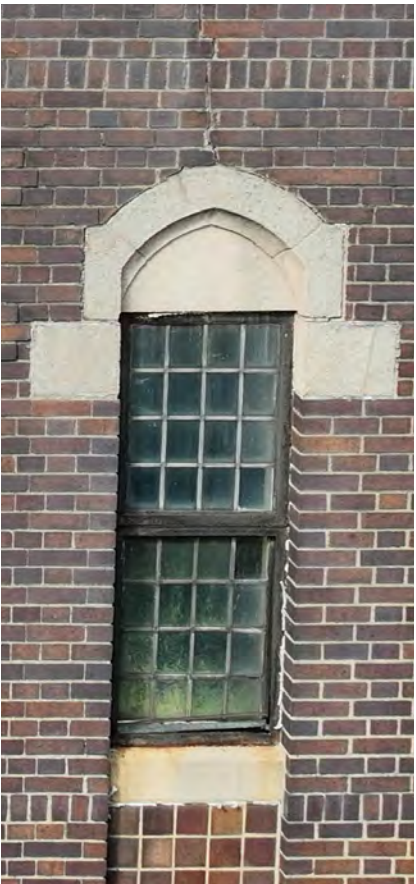
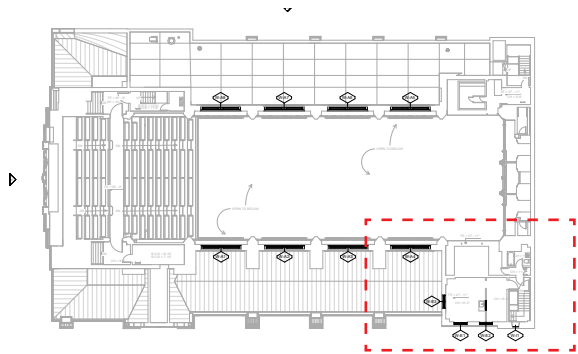
- Major deterioration on interior
- No longer operable
- Rusting along window sills
- Frames detaching on exterior
- Broken and warping panes

Major damage appears to be typical, windows are broken and susceptible to the elements.

Windows shall be removed and replaced based on proposed design. This window on the east façade shall be replaced with a steel, operable window that is similar to the existing window, but shifted up half of a story to align with windows on the third floor and the revised floor plate.
