138-154 St. Felix Street, aka 11-21 Hanson Place – Brooklyn

Academy of Music Historic District

ADAPTIVE-REUSE & ENLARGEMENT

LPC Certificate of Appropriateness Presentation

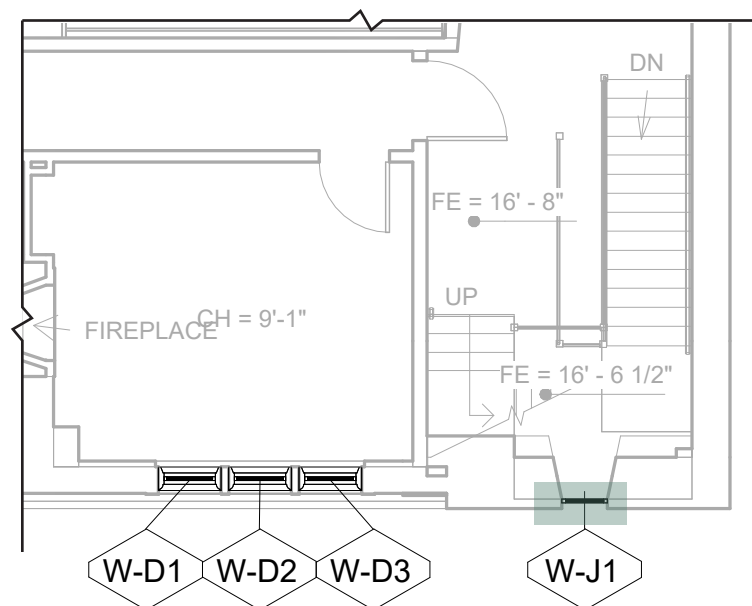
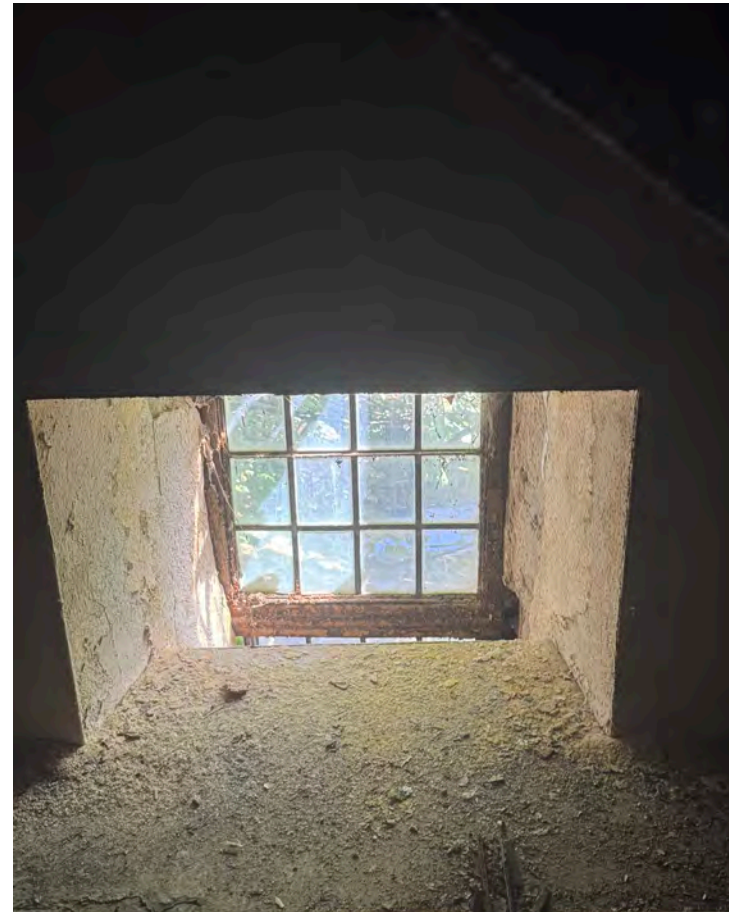
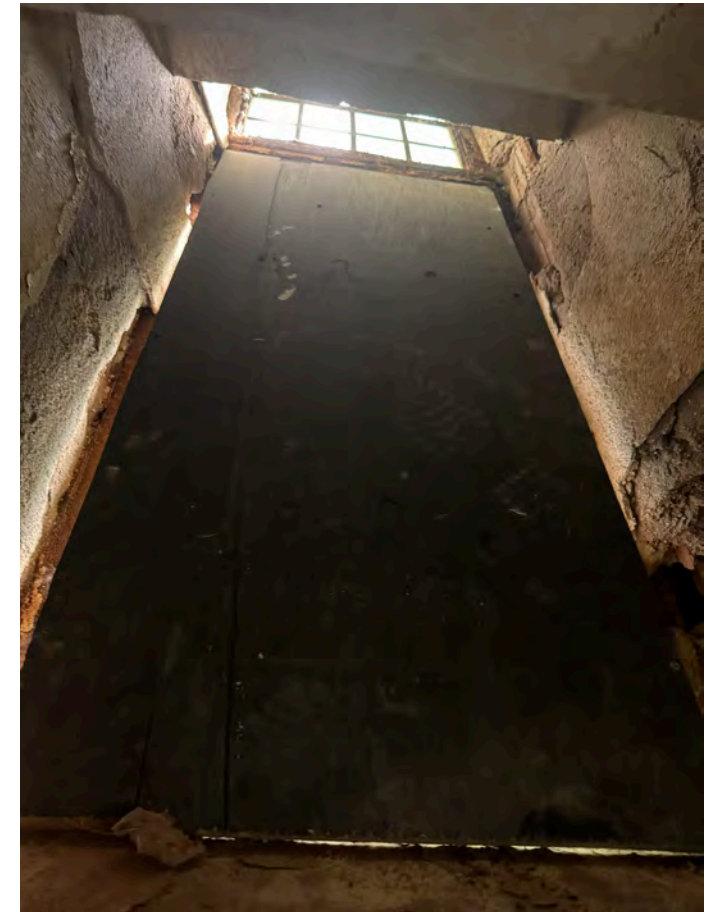
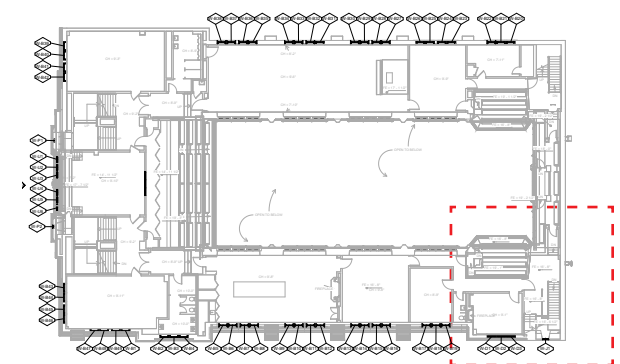
- Broken and warped panes
- One window entirely missing
- Rusted window sills
- Operability impaired

Major damage appears to be typical, windows are broken and susceptible to the elements.

Windows shall be removed and replaced based on proposed design. Windows on the east façade shall be replaced in-kind with steel, fixed windows to retain the historic context of the neighborhood.

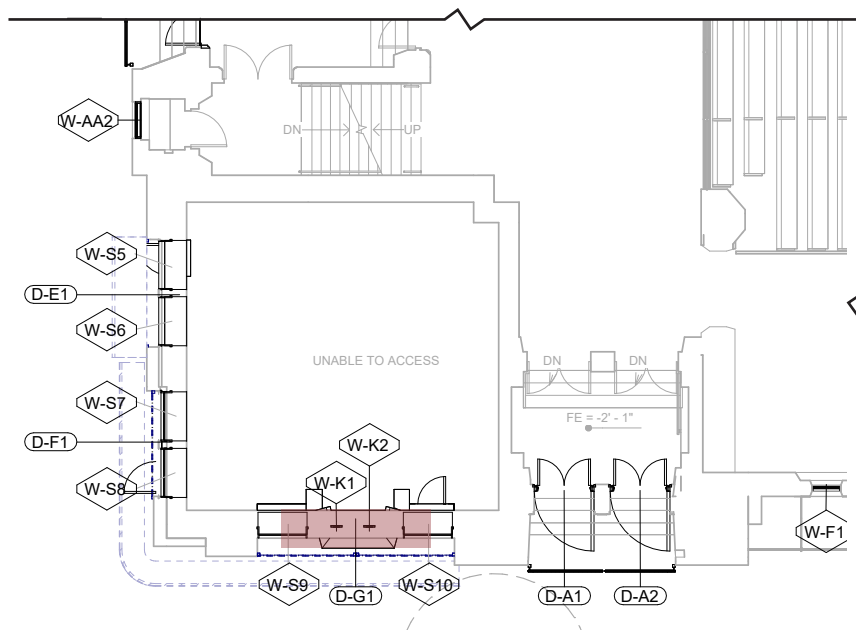
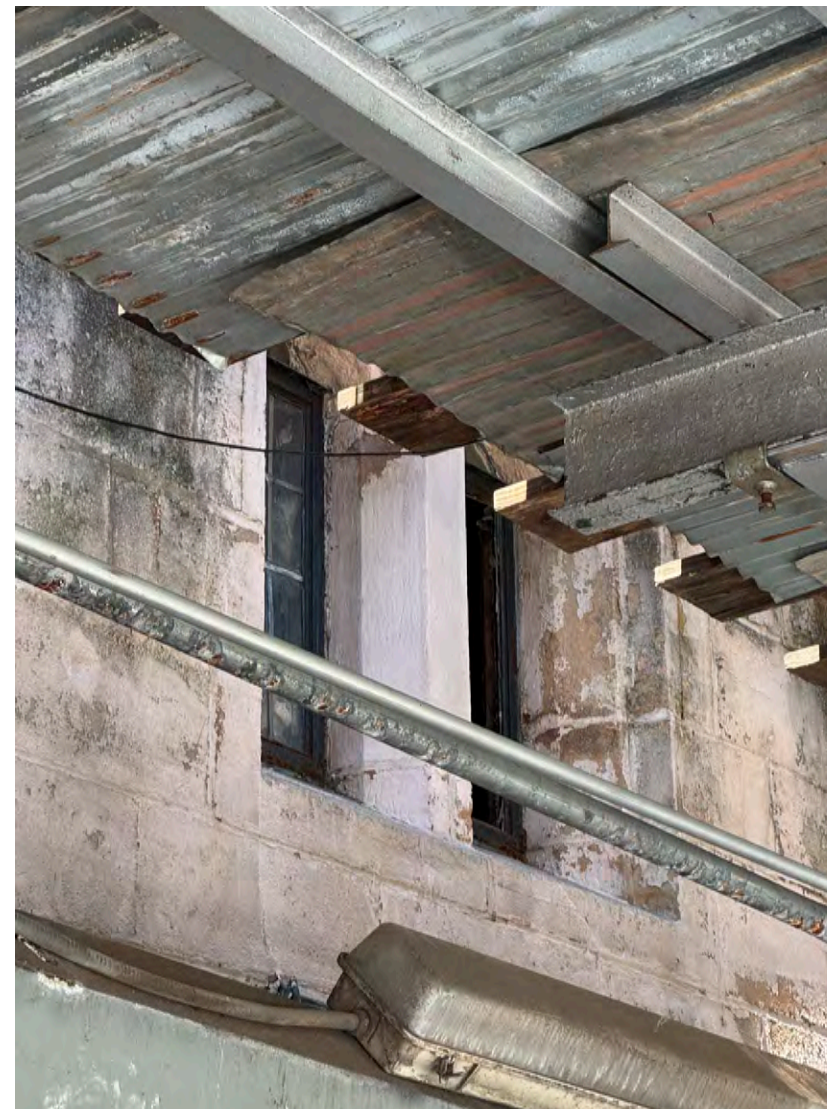
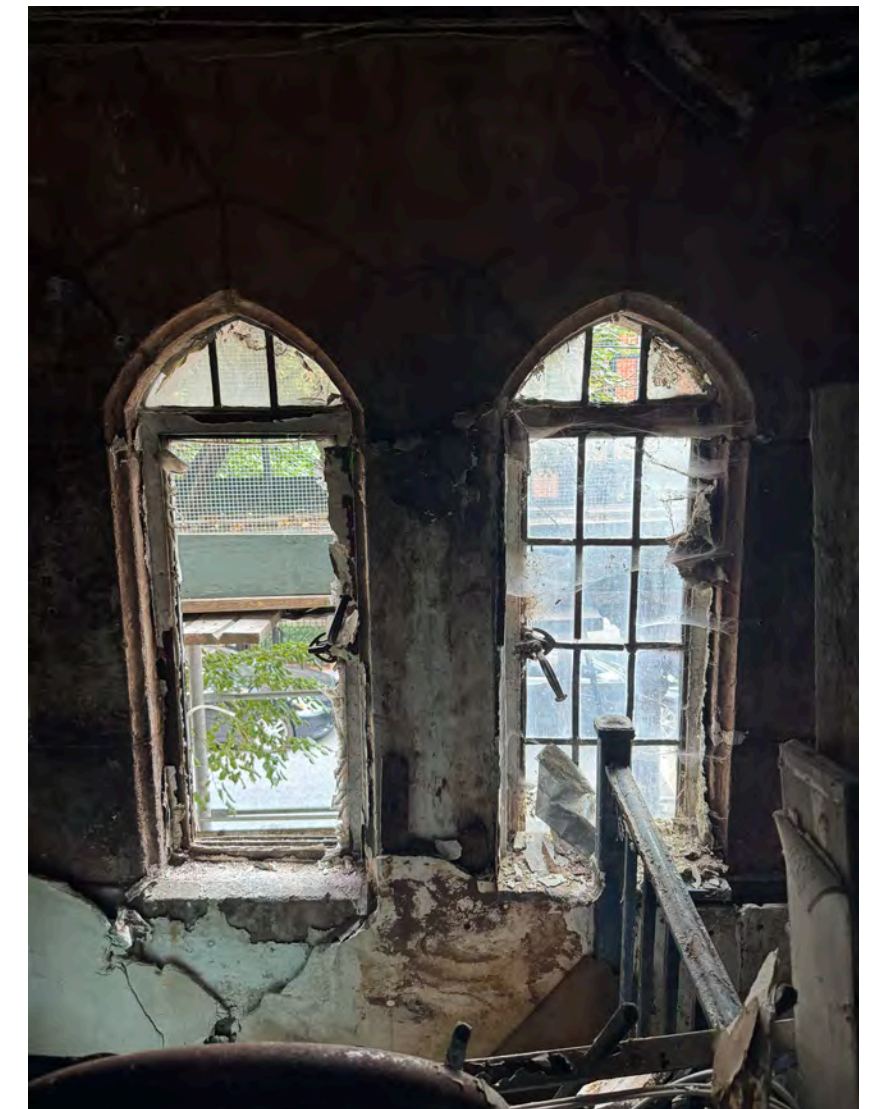
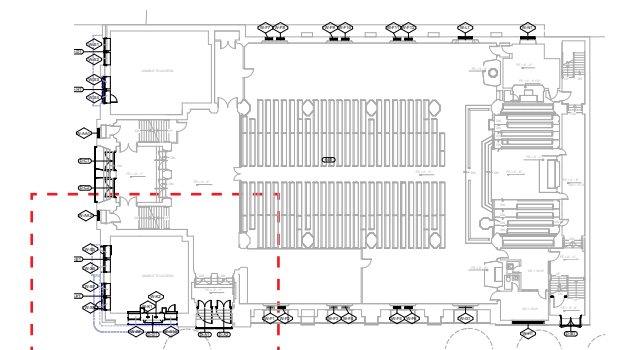
- Major deterioration on interior
- No longer operable
- Rusting along window sills
- Frames detaching on exterior
- Broken and bowing panes

Major damage appears to be typical, windows are broken and susceptible to the elements.

Windows shall be removed and replaced based on proposed design. Windows on the east primary façade shall be replaced in-kind with steel, operable windows to retain the historic context of the neighborhood. Windows on the west secondary façade shall not be replaced because of the proposal to demolish this area of the building to accomodate new development.

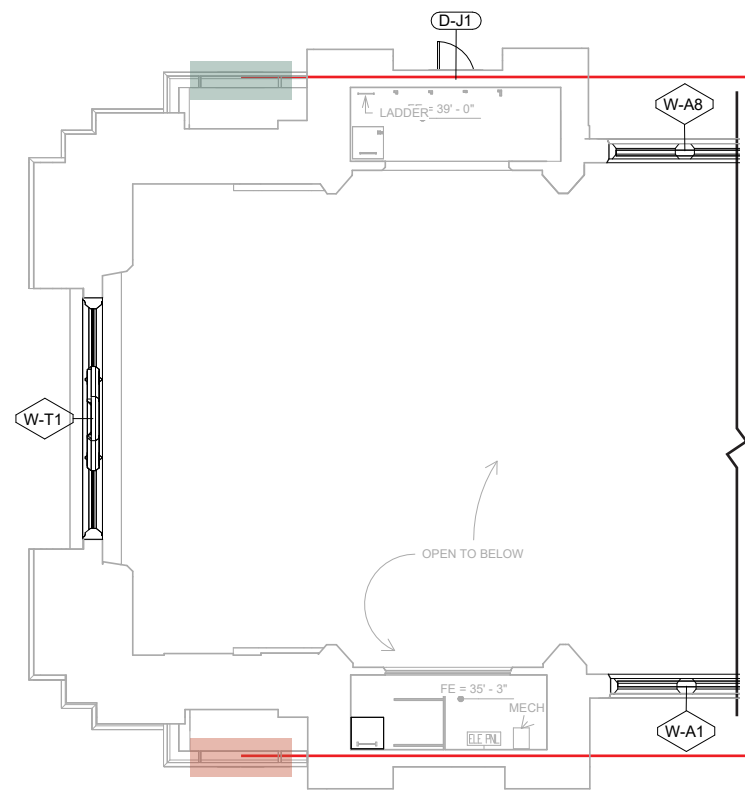
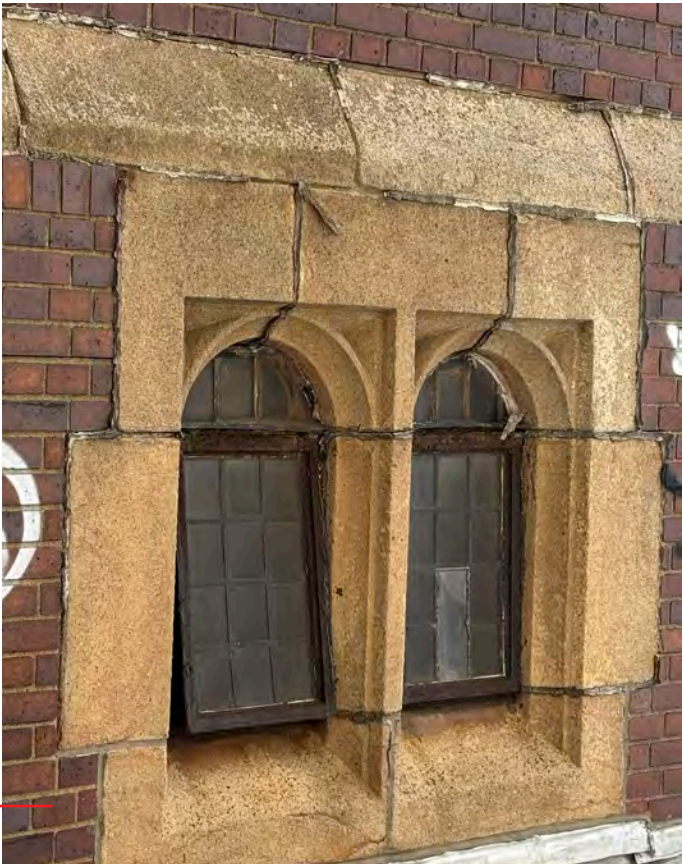
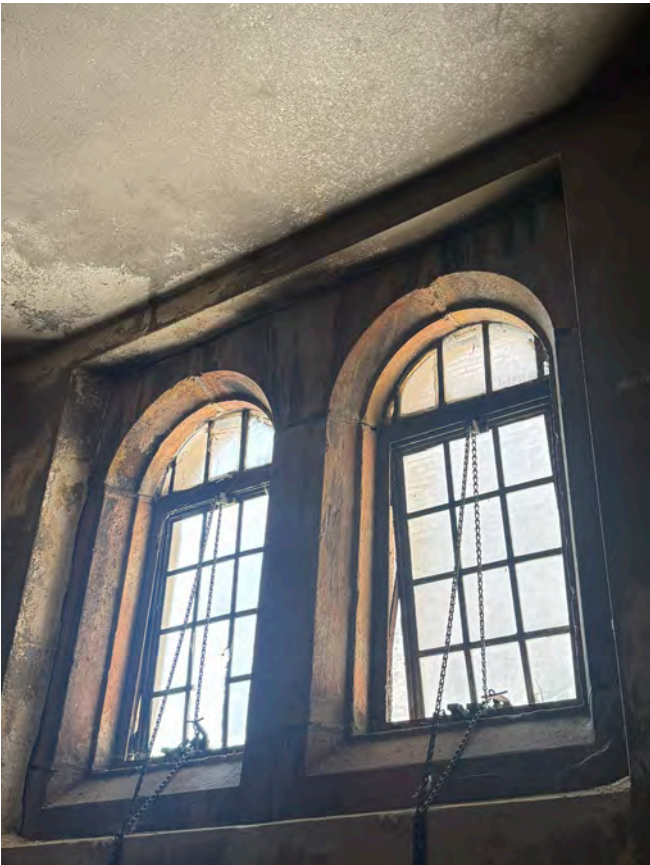
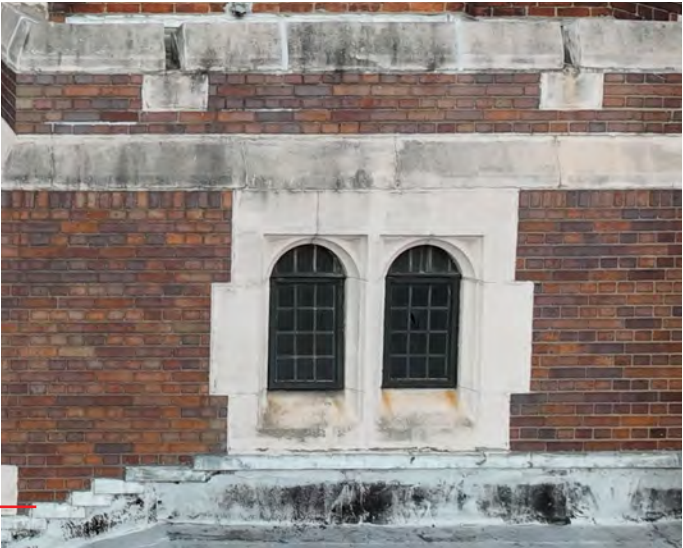
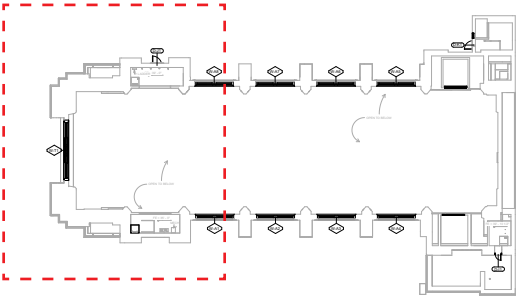
Window Type W-M

- Major deterioration on interior
- Rusting along window sills
- Frames detaching on exterior
- Boarded up on interior to prevent additional water damage
- Broken and warping panes

Major damage appears to be typical, windows are broken and susceptible to the elements.

Windows shall be removed and replaced based on proposed design. Windows on the south façade shall be replaced in-kind with steel, fixed windows to retain the historic context of the neighborhood.

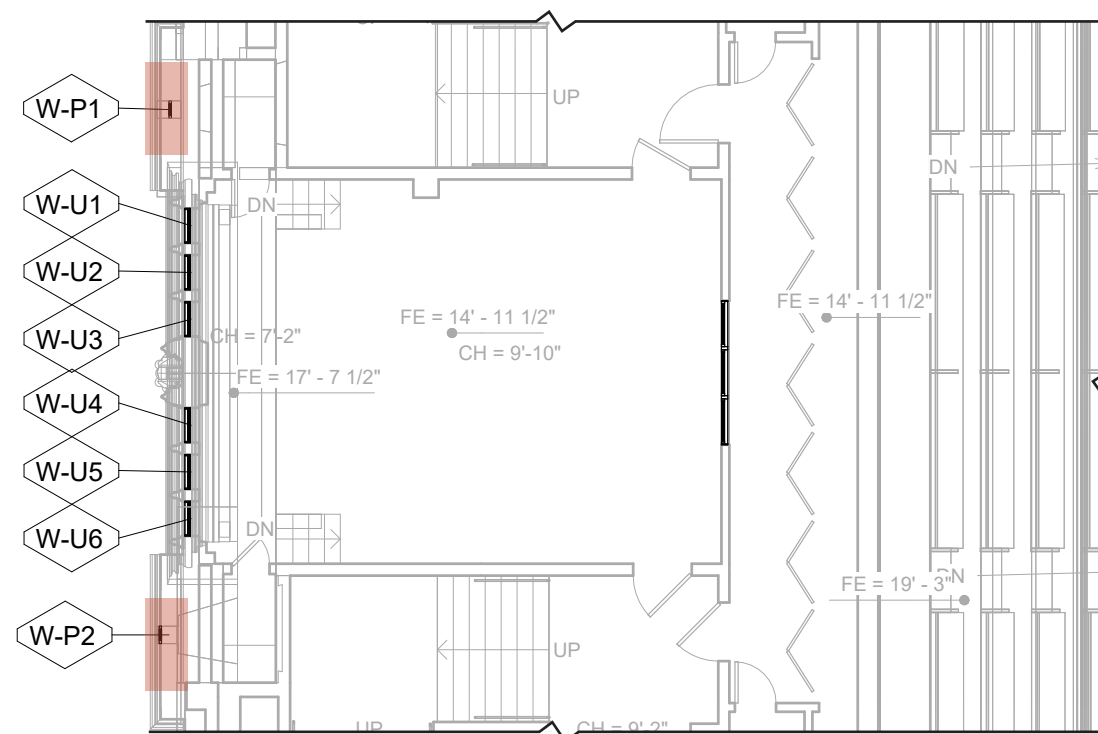
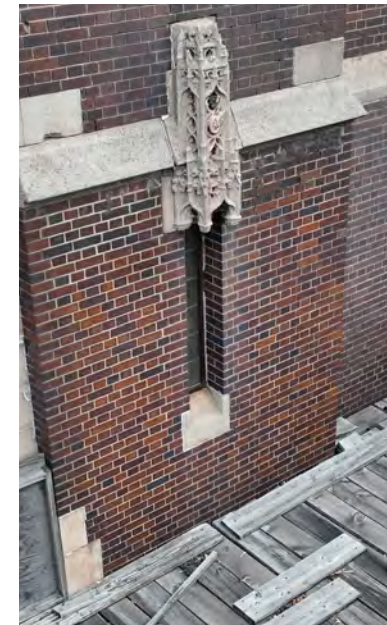
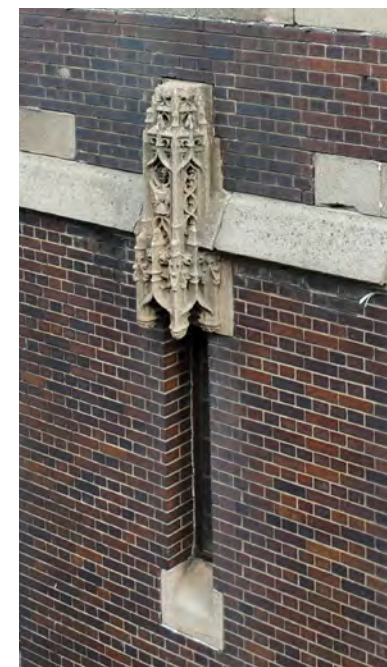
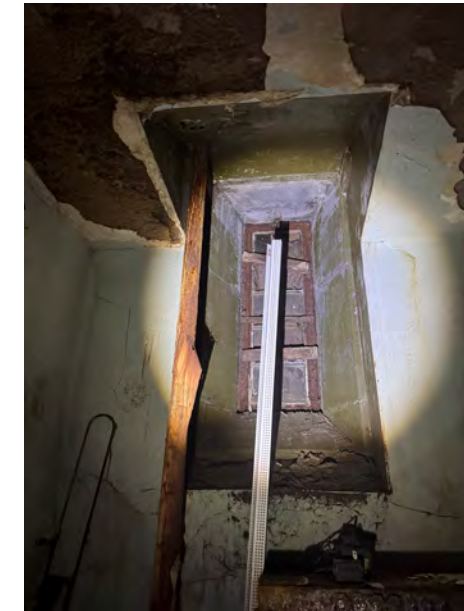
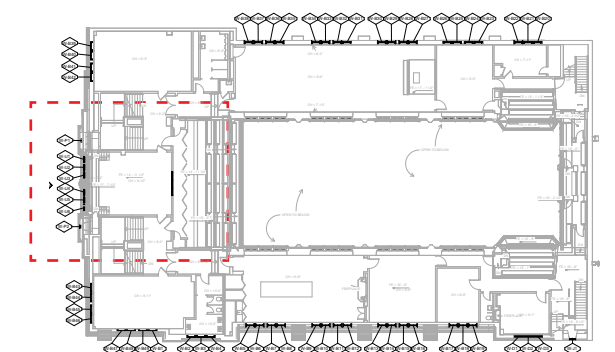
- Panels removed to install air conditioning units
- Rusting along window sills
- Warping and broken panes

Major damage appears to be typical, windows are blocked by mechanical equipment, and are no longer functioning as originally intended.

Windows shall be removed and replaced based on proposed design. Window openings shall accomodate new decorative aluminum ventilation screens for the storefronts similar to what was replaced in certain locations of the building.

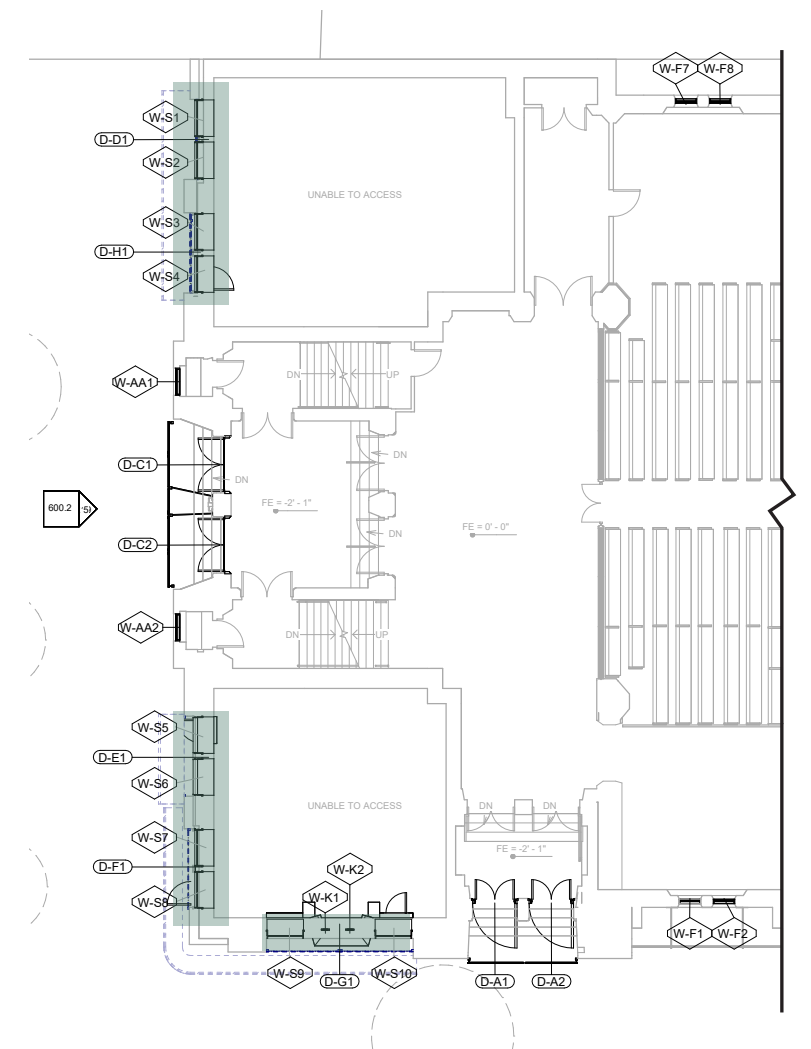
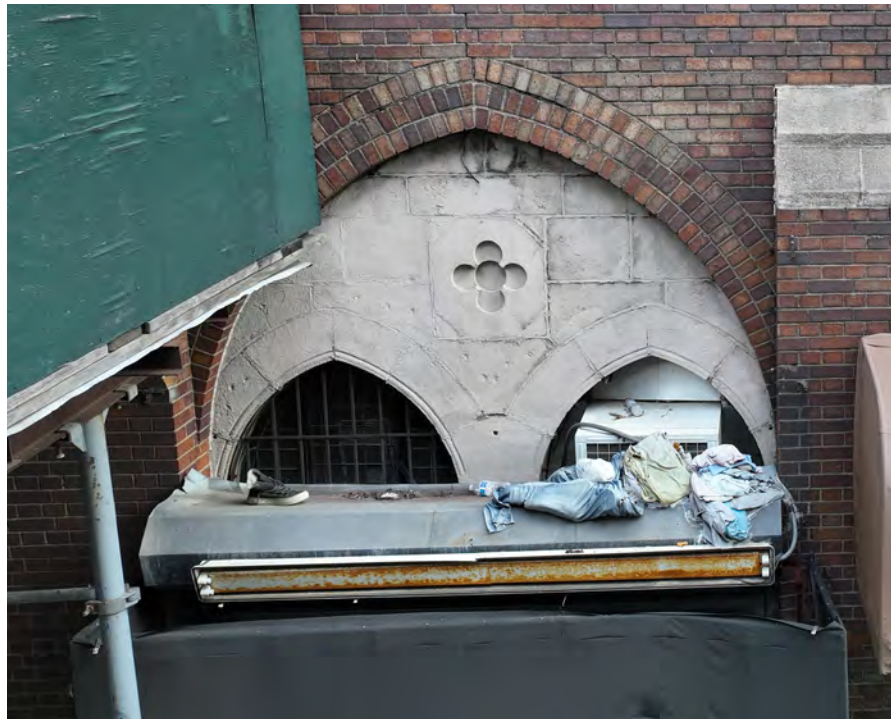
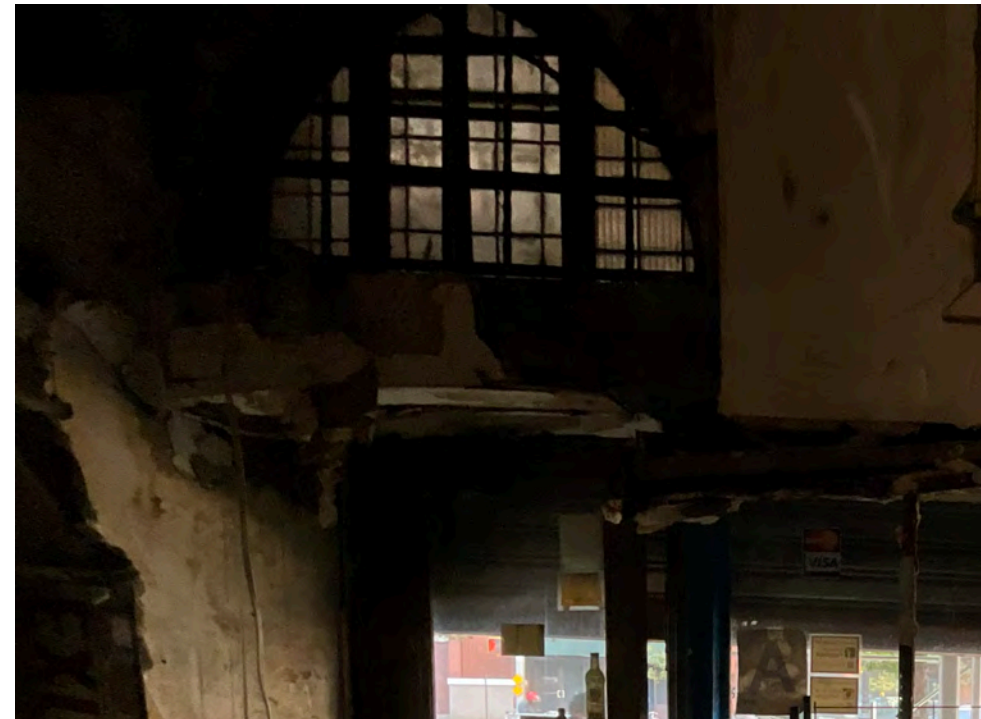
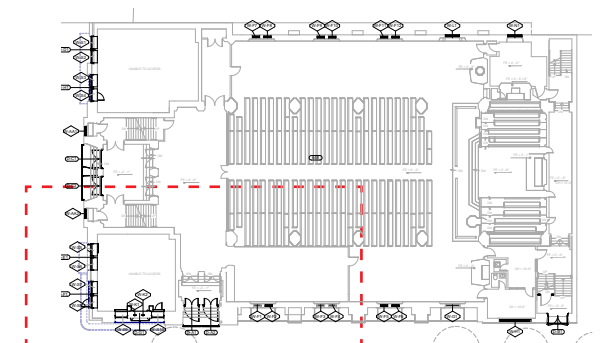
Window Type W-S

- Broken and bowing panes
- Rusting along window sill
- No longer operable

Major damage appears to be typical, windows are broken and susceptible to the elements.

Windows shall be removed and replaced based on new design. Windows on the south façade shall be replaced in-kind with steel, operable windows, meeting all light and air requirements, to retain the historic context of the neighborhood.

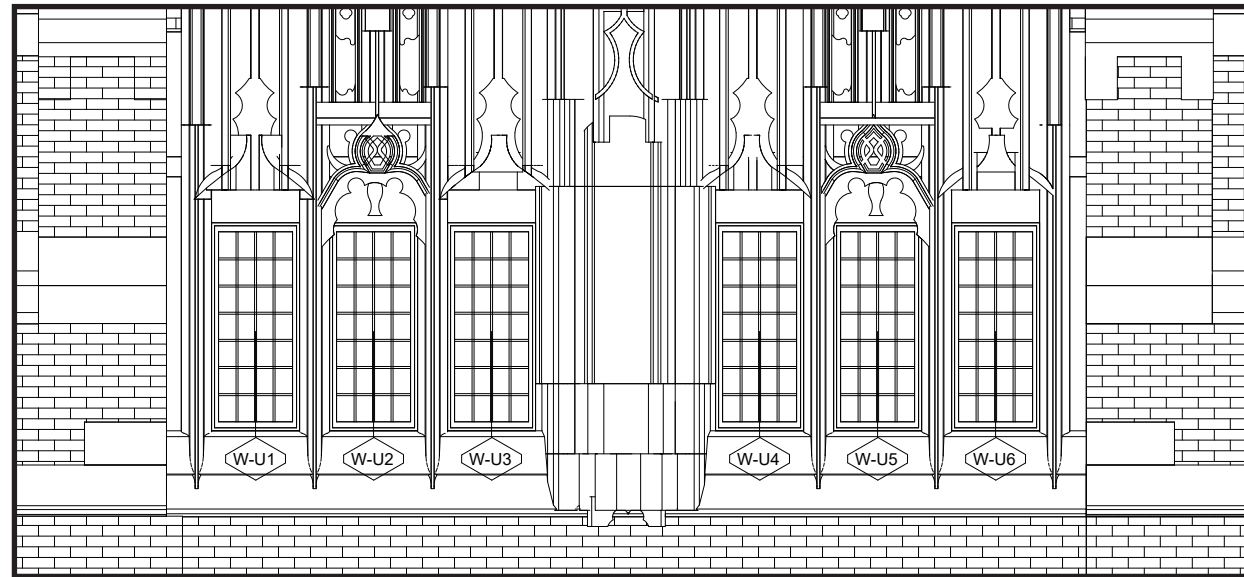
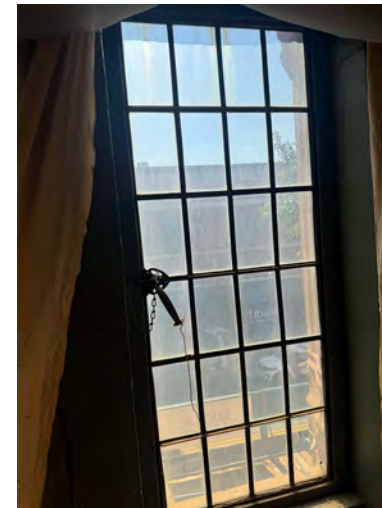
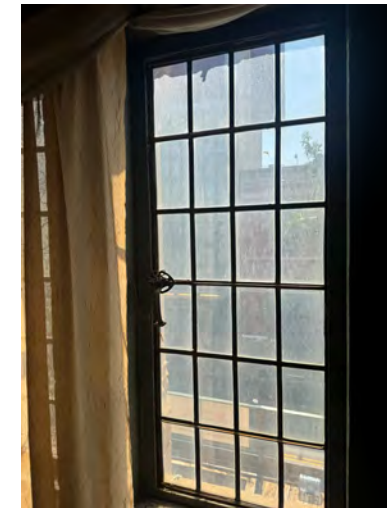
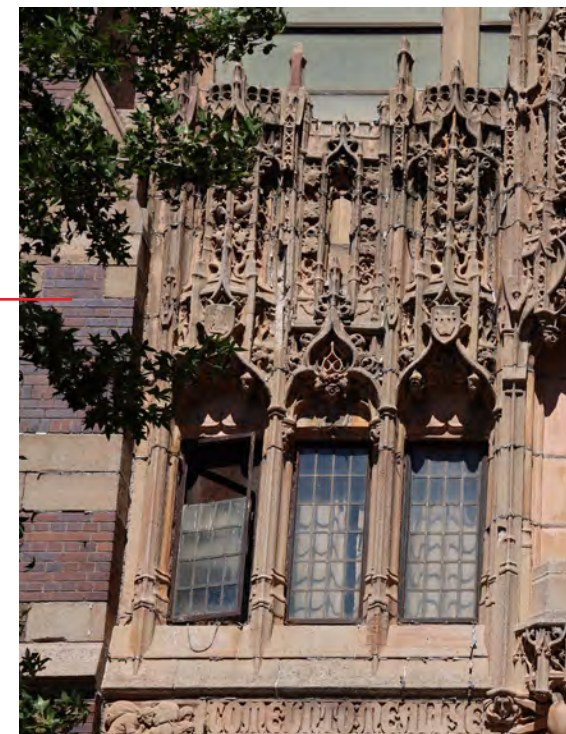
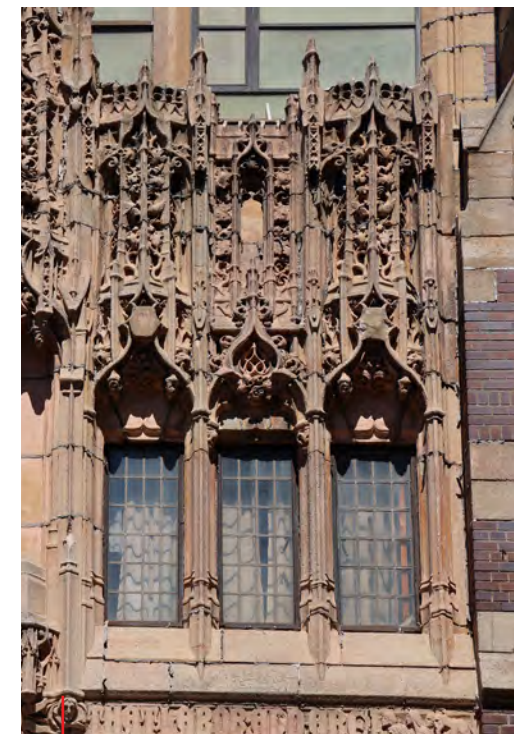
SOUTH ELEVATION (PRIMARY FAÇADE)

- Quantity: 33
- Operable
- Visibility from street: No
- Date: 1931 (Original)
- Condition: Poor

VISUAL INSPECTION & CURRENT CONDITION

- Standard windows built in lightwells
- Broken and warped panes
- Rusted window sills
- Operability impaired
- Mold growth and water damage observed in select locations at lower levels
- Panes removed for air conditioner installation
- Non-original interior grille added for security

Major damage appears to be typical, windows are broken and susceptible to the elements.

Windows on the south and east primary façades shall be removed and replaced in-kind and meeting all light and air requirements based on proposed design. Thorough repairs shall be made to remove mold and other damage caused by water. Windows on the west secondary façade shall not be replaced because of the proposal to demolish this area of the building to accomodate new development.

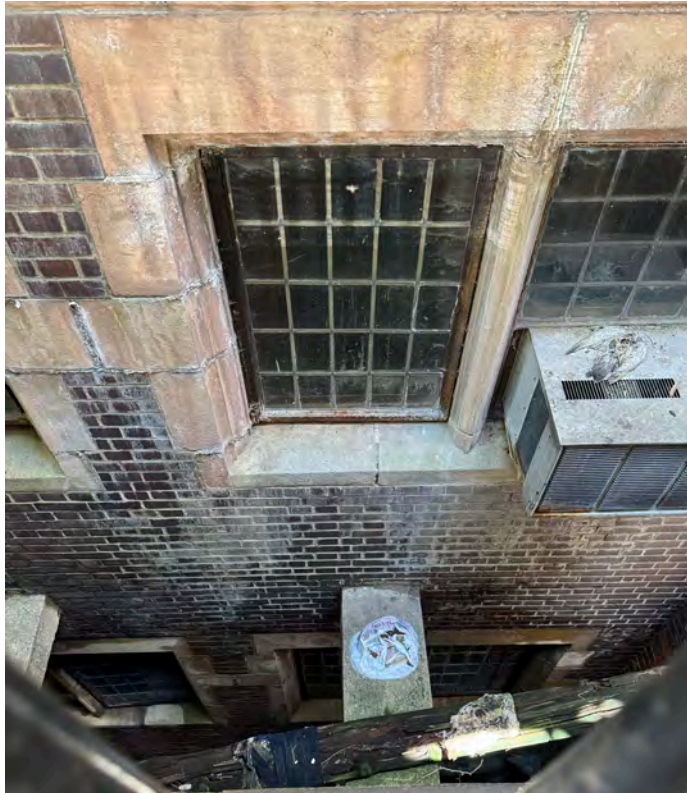
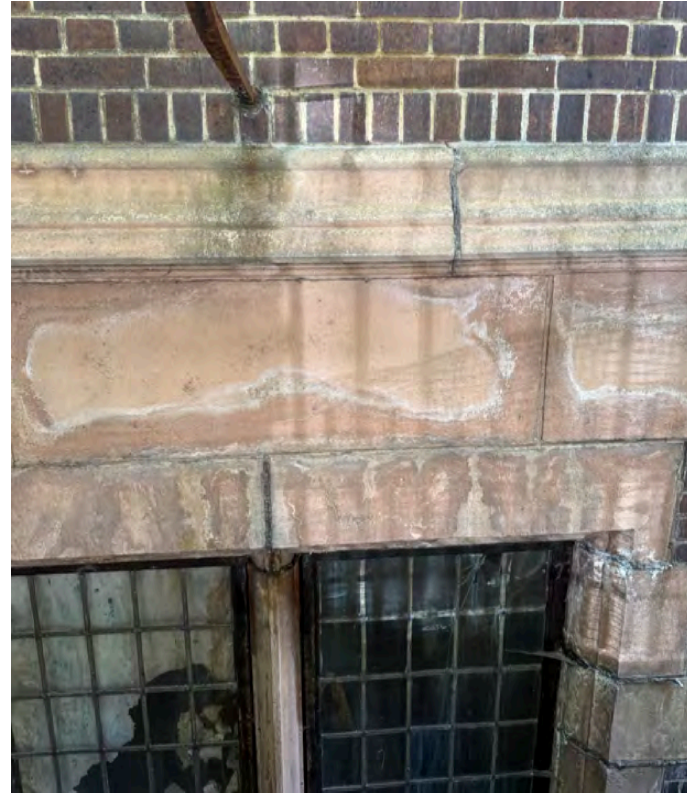
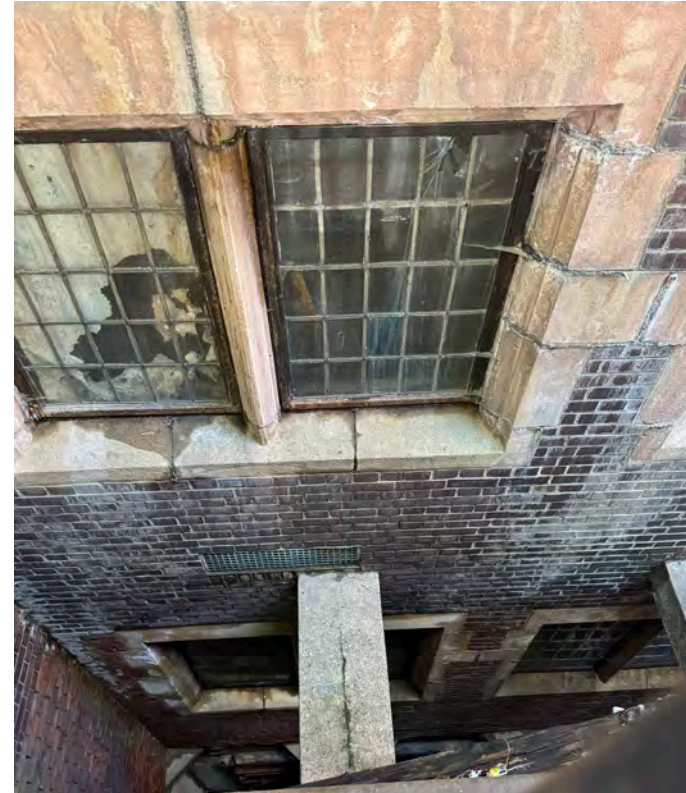
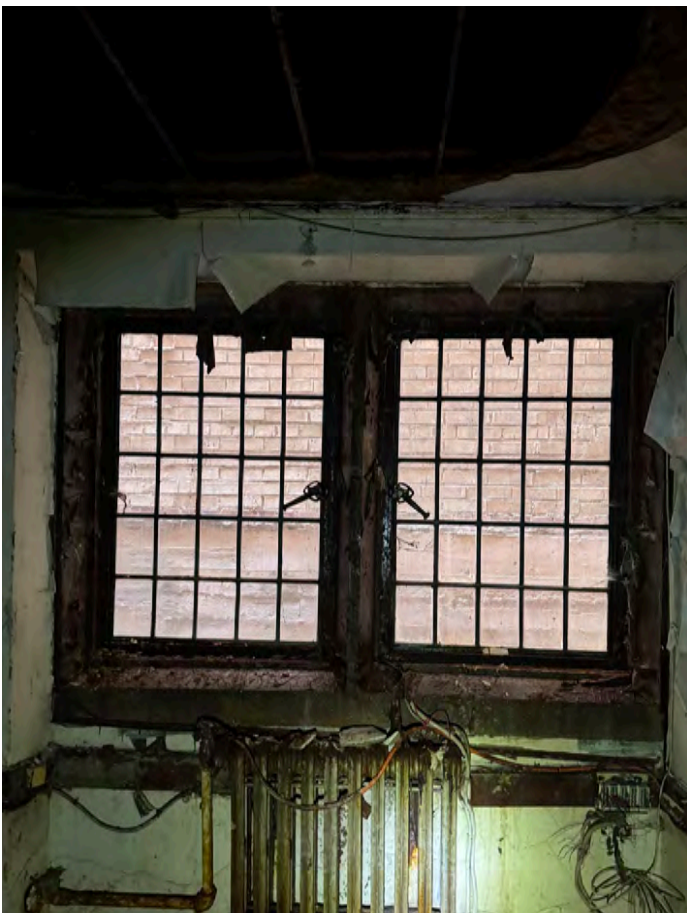
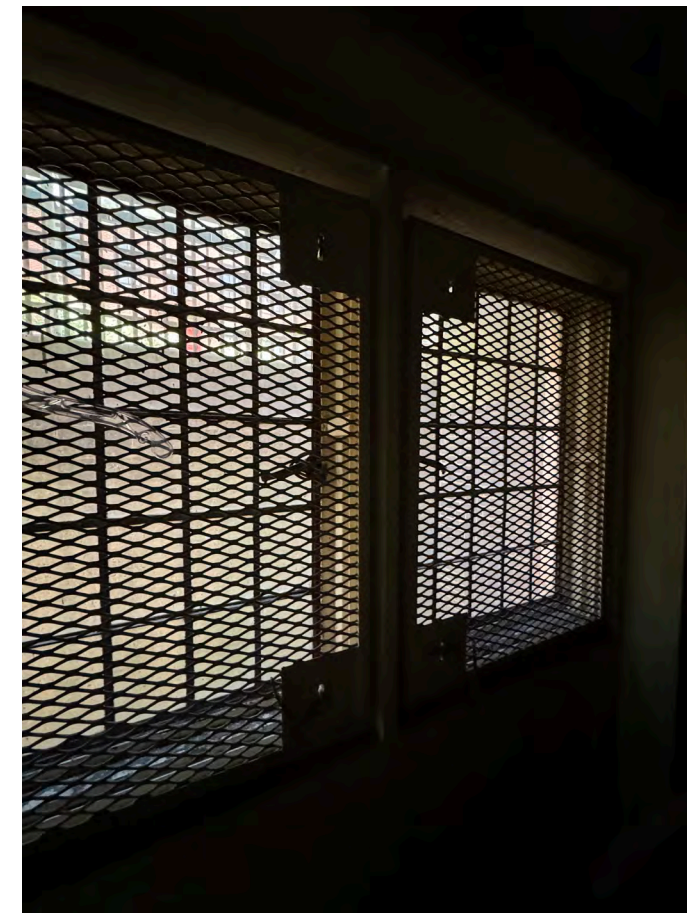
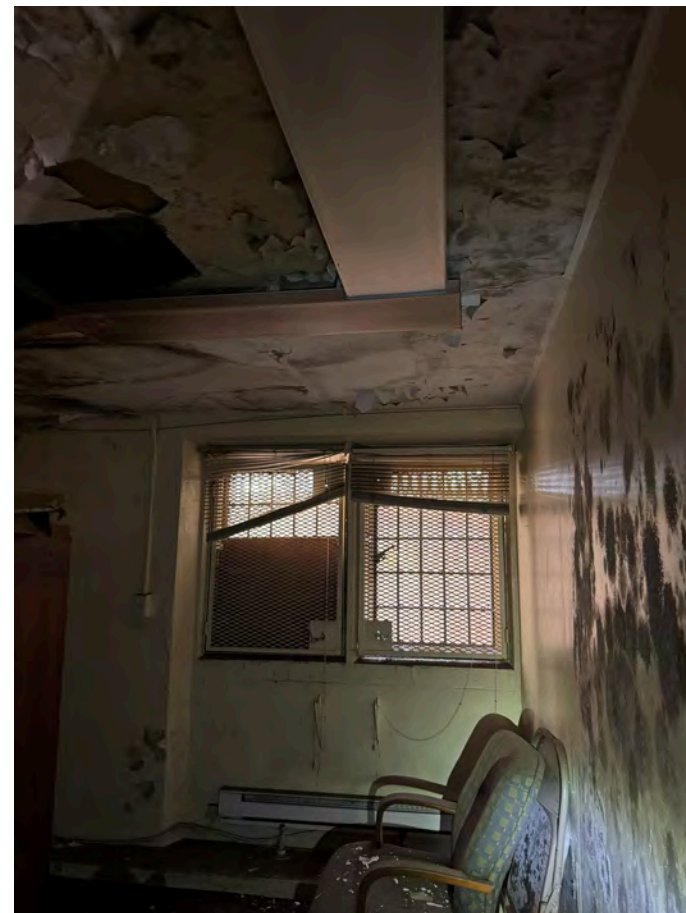
- Standard window built in stairwell
- Rusting along window sill
- Boarded up from the interior due to security risk

Windows shall be removed and replaced based on proposed design. Windows on the east primary facade shall be replaced with a new, modified, steel storefront to accomodate the new entrance into the proposed residential development.

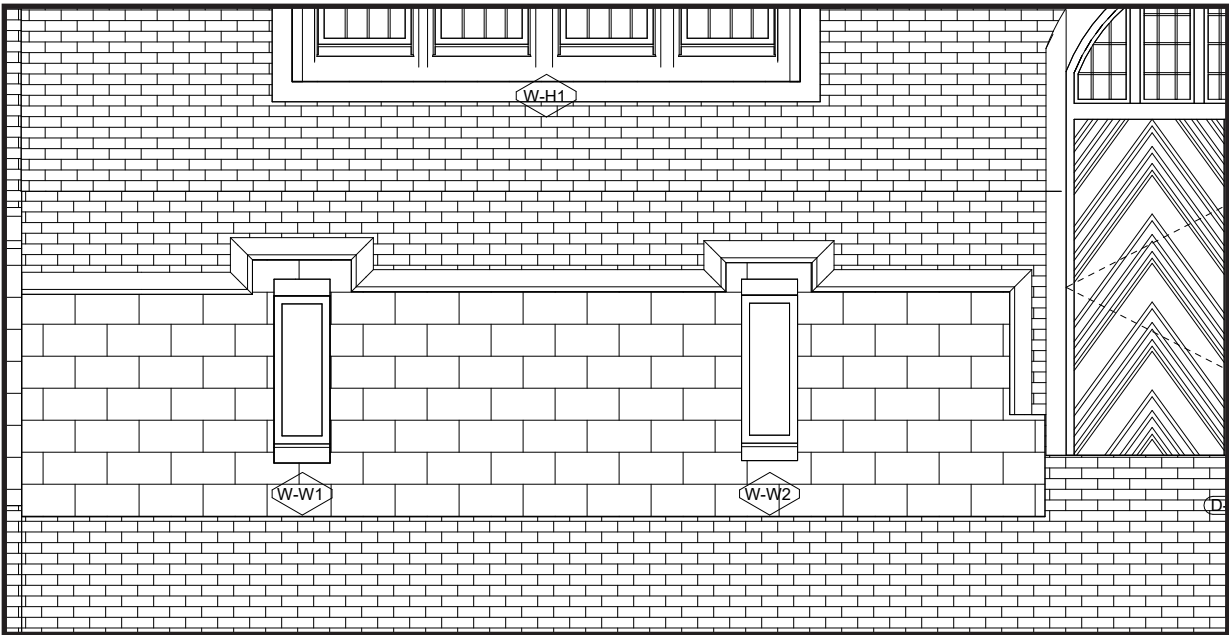
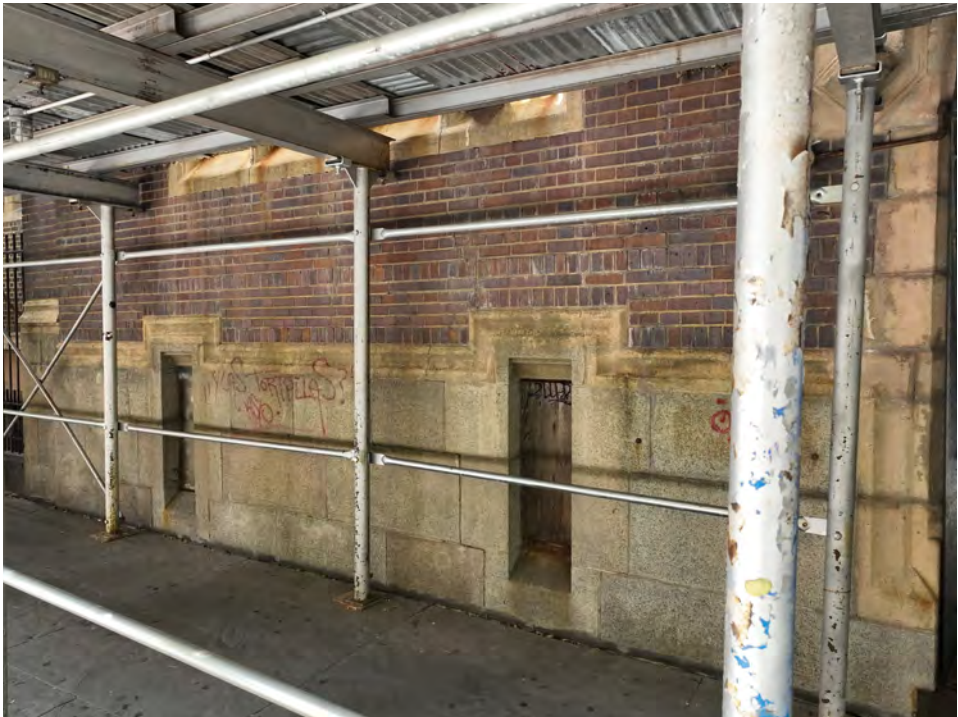
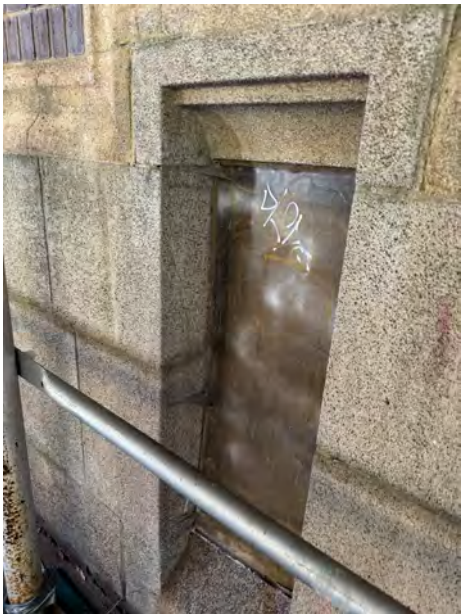
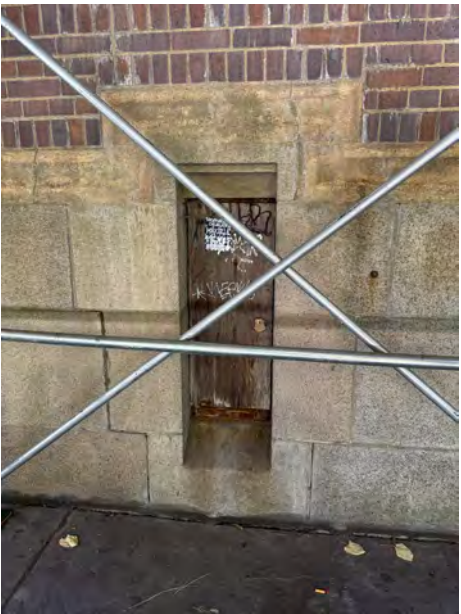
EAST ELEVATION (PRIMARY FAÇADE)

- Rusting along window sills
- Bowing frame on exterior

Major damage appears to be typical, windows are broken and susceptible to the elements.

Window shall be removed and replaced based on proposed design. Window on the east façade shall be replaced, meeting all light and air requirements, with a new clear operable steel window with tracery to match the adjacent existing windows retaining the historic context of the neighborhood.

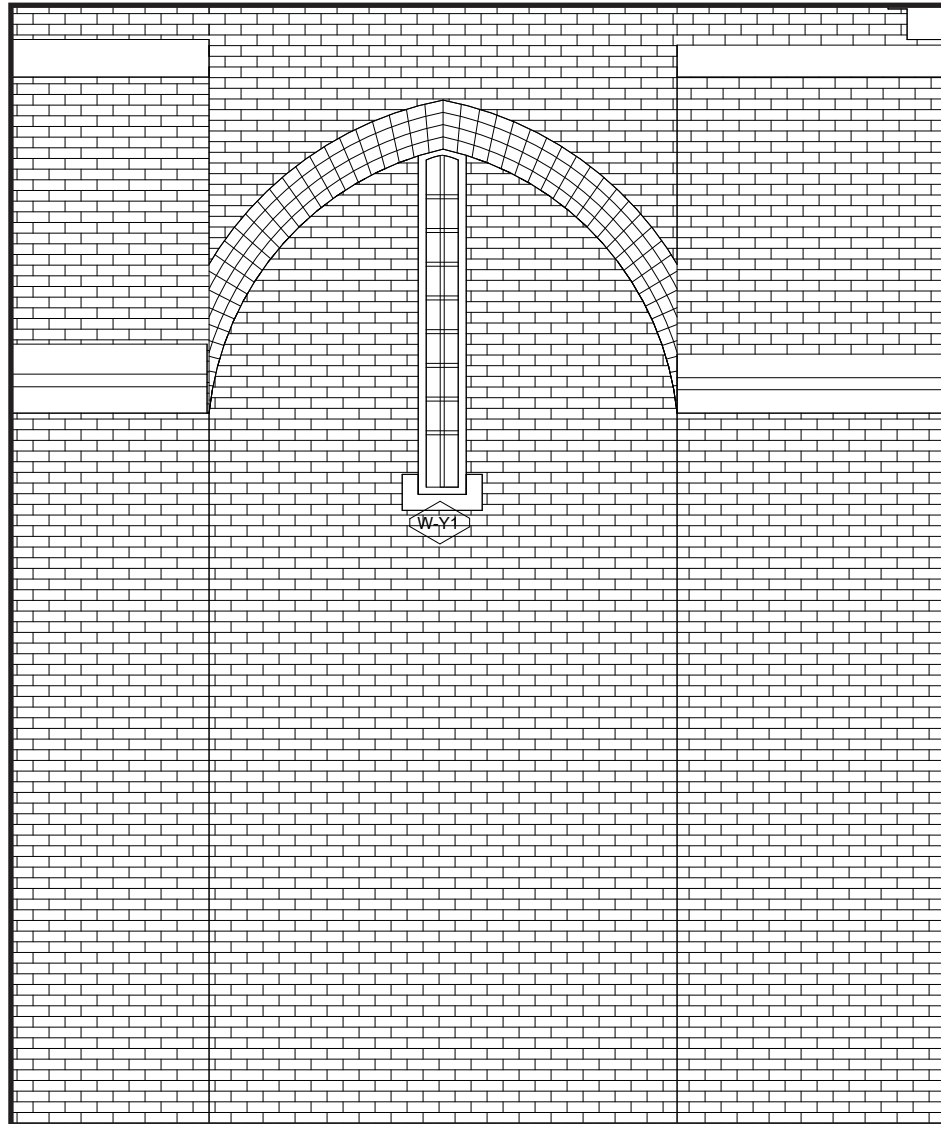
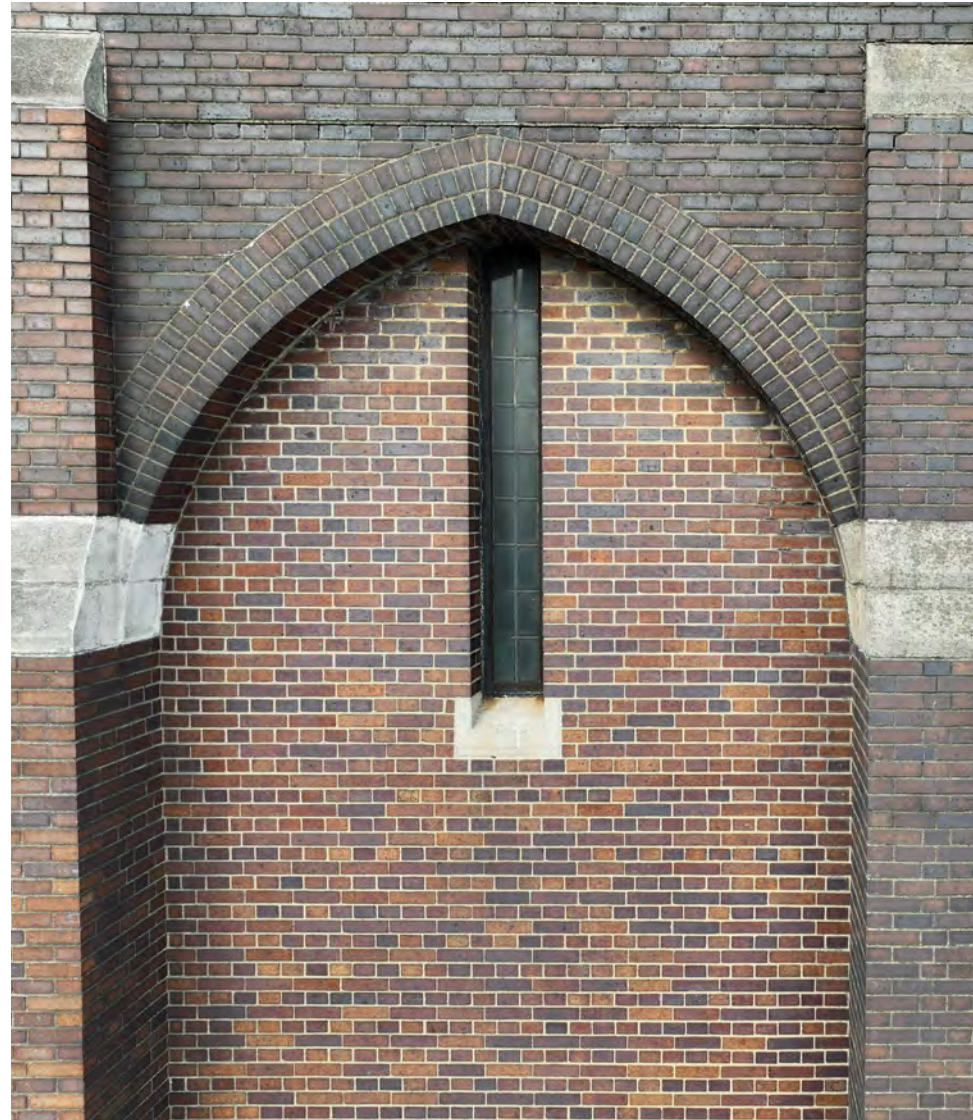
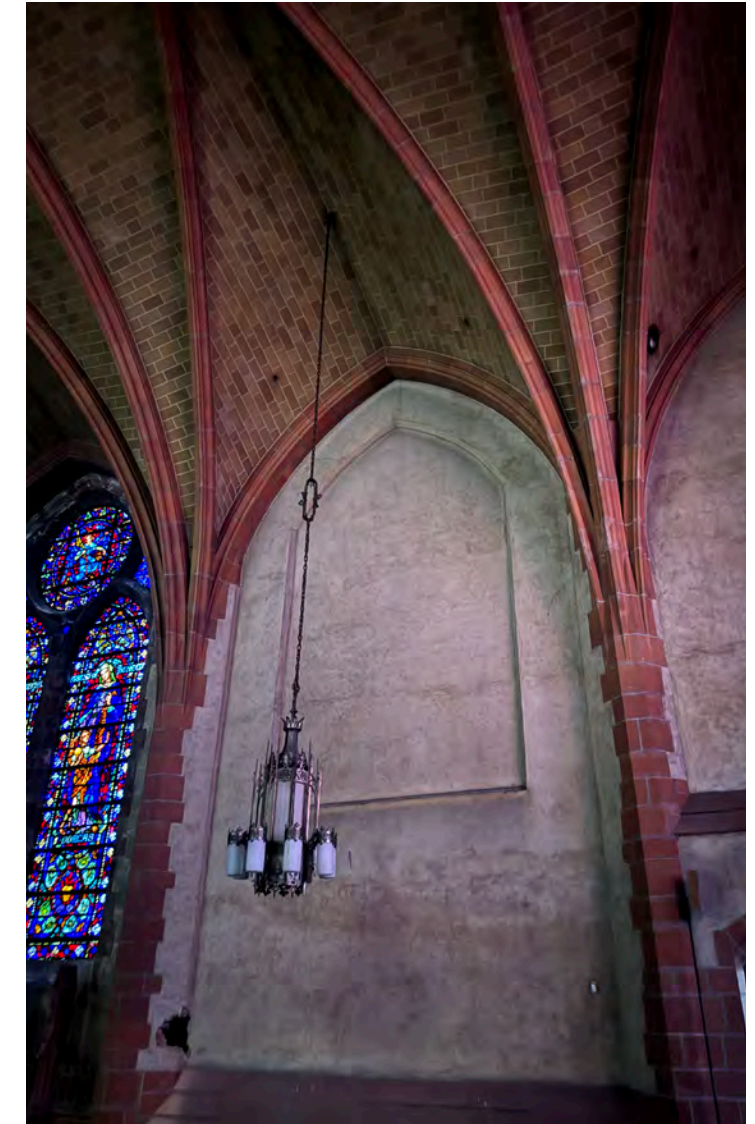
EAST ELEVATION (PRIMARY FAÇADE)

- Window built in lightwells
- Broken and warped panes
- Rusted window sills
- Operability impaired
- Mold growth and water damage observed in select locations at lower levels
- Panes removed for air conditioner installation

Major damage appears to be typical, windows are broken and susceptible to the elements.

Window shall be removed based on proposed design. Thorough repairs shall be made to remove mold and other damage caused by water in the existing openings. Windows on the west secondary façade shall not be replaced because of the proposal to demolish this area of the building to accomodate new development.
