138-154 St. Felix Street, aka 11-21 Hanson Place – Brooklyn

Academy of Music Historic District

ADAPTIVE-REUSE & ENLARGEMENT

LPC Certificate of Appropriateness Presentation

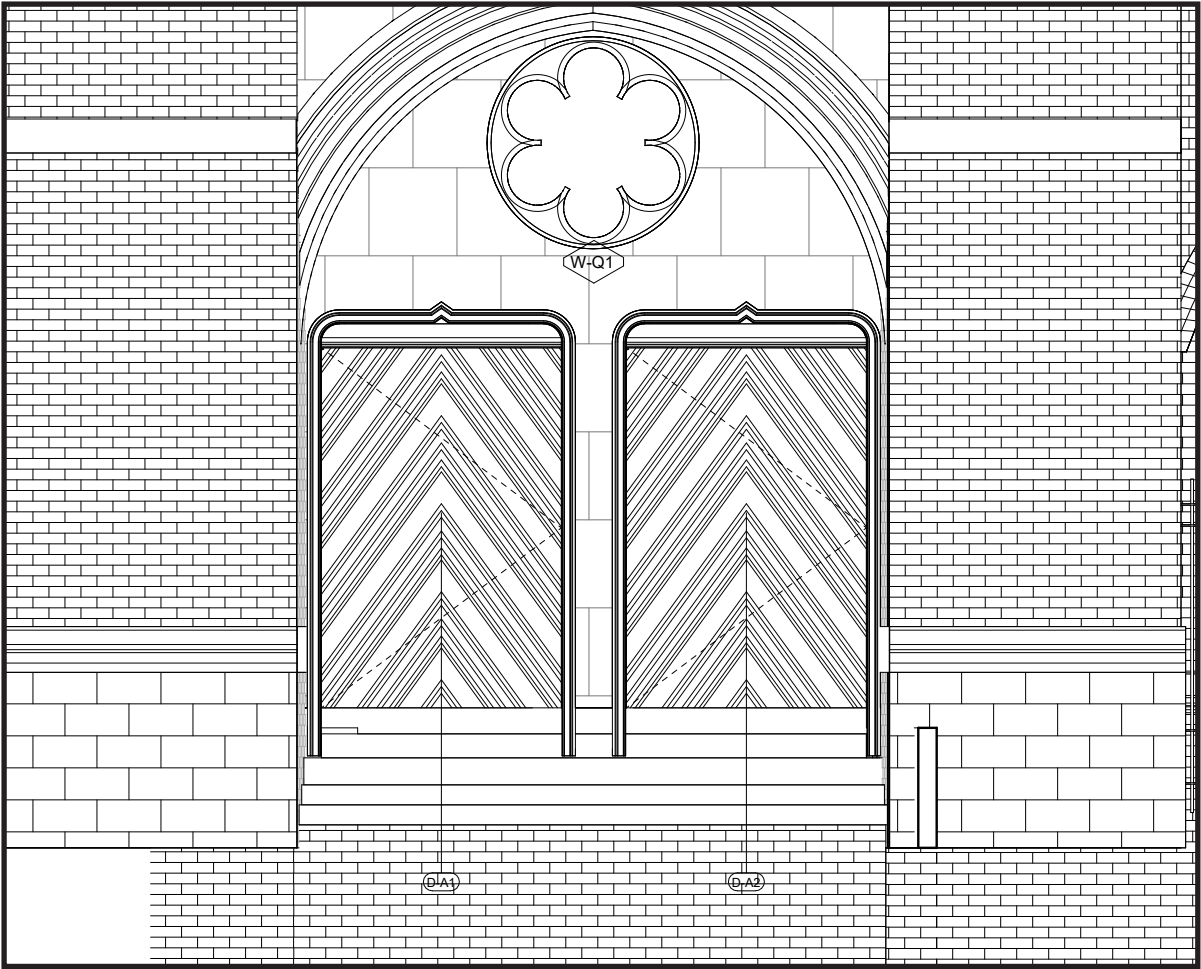
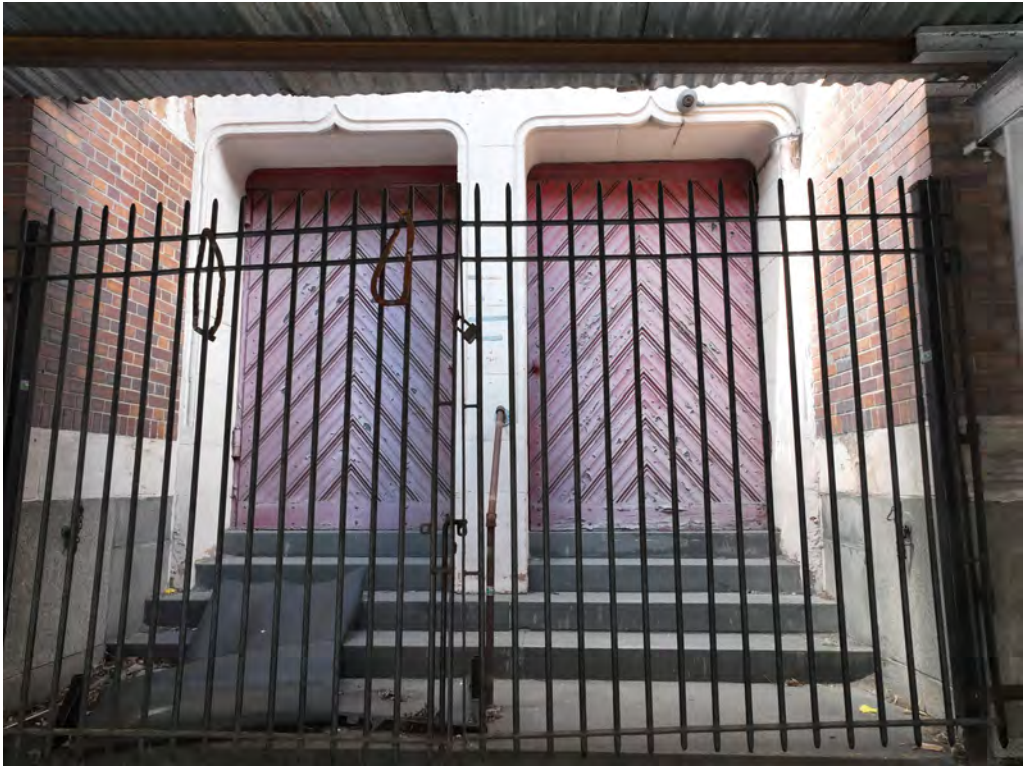
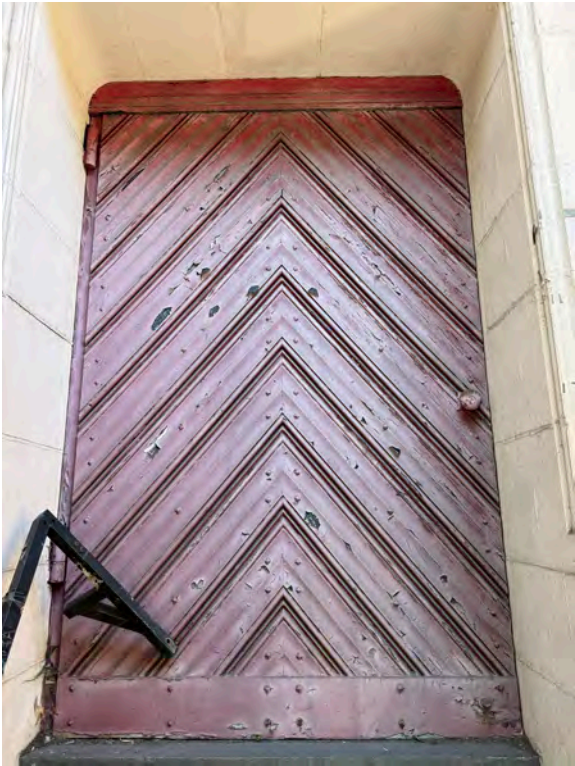
EAST ELEVATION (PRIMARY FAÇADE)

Major damage appears to be typical, doors are broken and susceptible to the elements.

Doors shall be salvaged and restored. Doors on the east primary façade shall be reinstalled and used for egress purposes only to retain the historic context of the neighborhood.

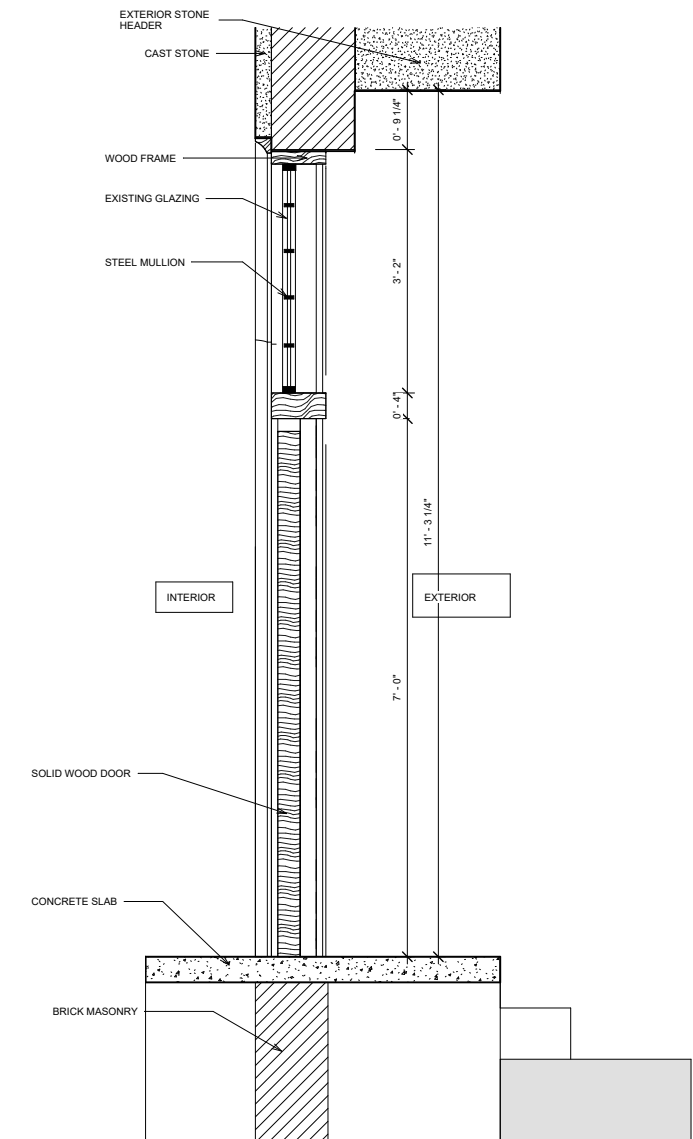
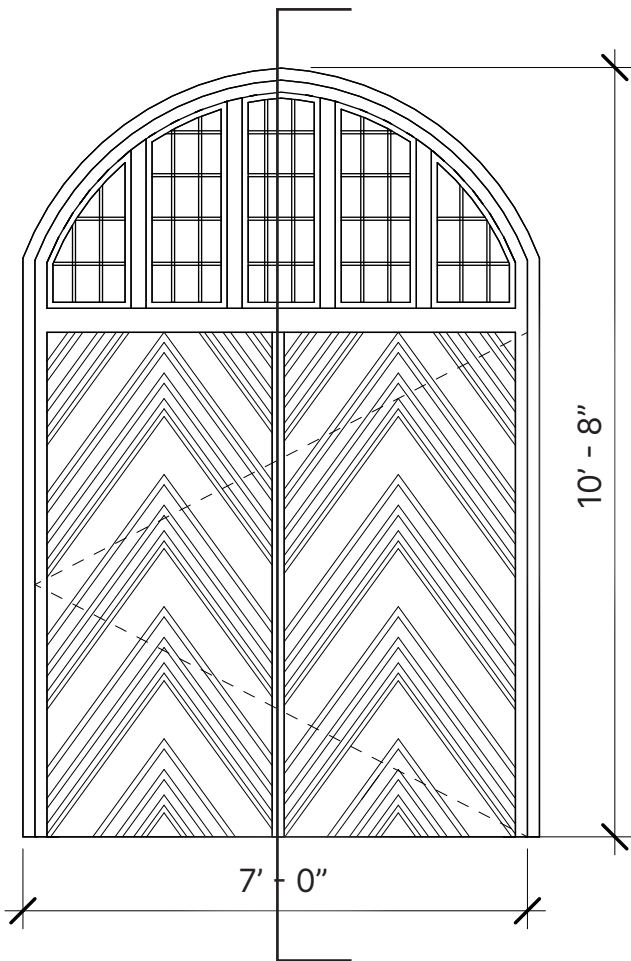
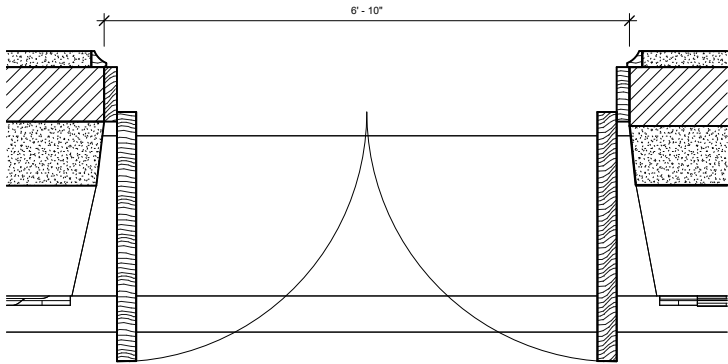
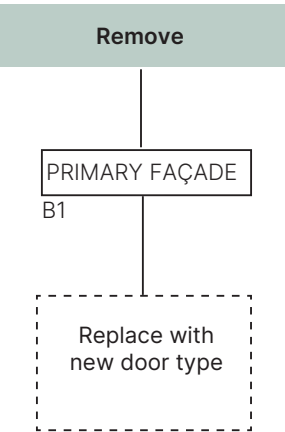
Major damage appears to be typical, doors are broken and susceptible to the elements.

Doors shall be removed and replaced based on proposed design. Door on the east primary façade shall be replaced with a new storefront to accomodate new proposed entry to residential development.

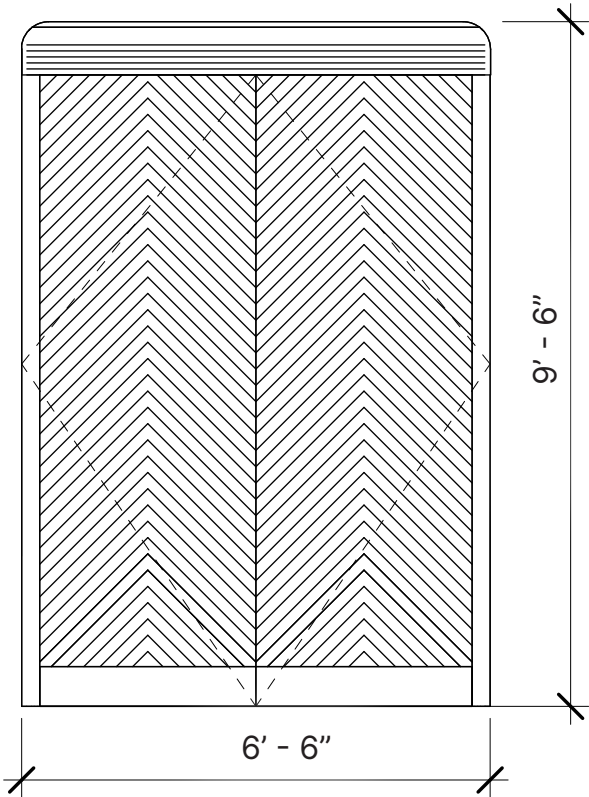
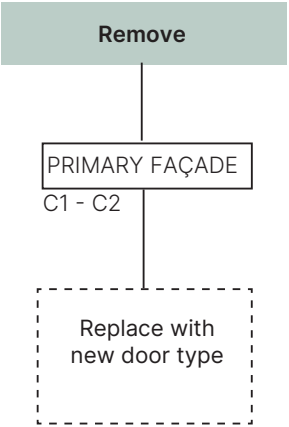
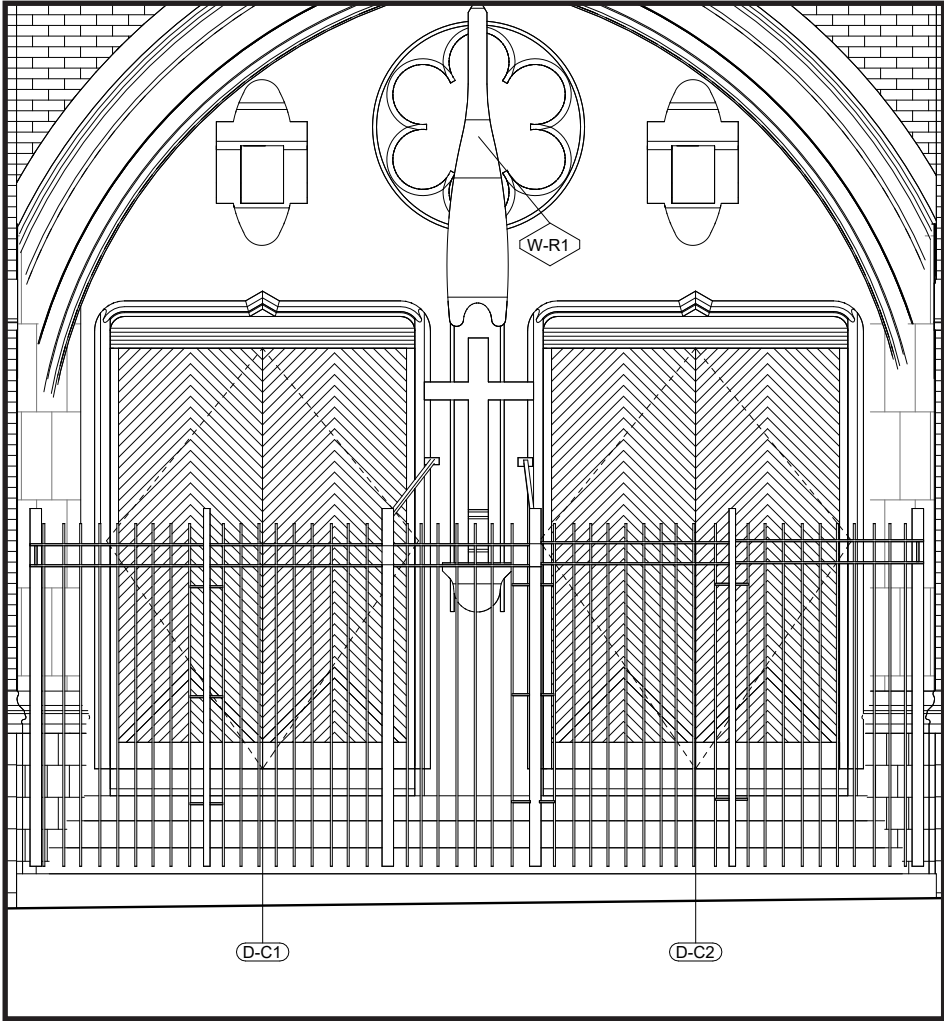
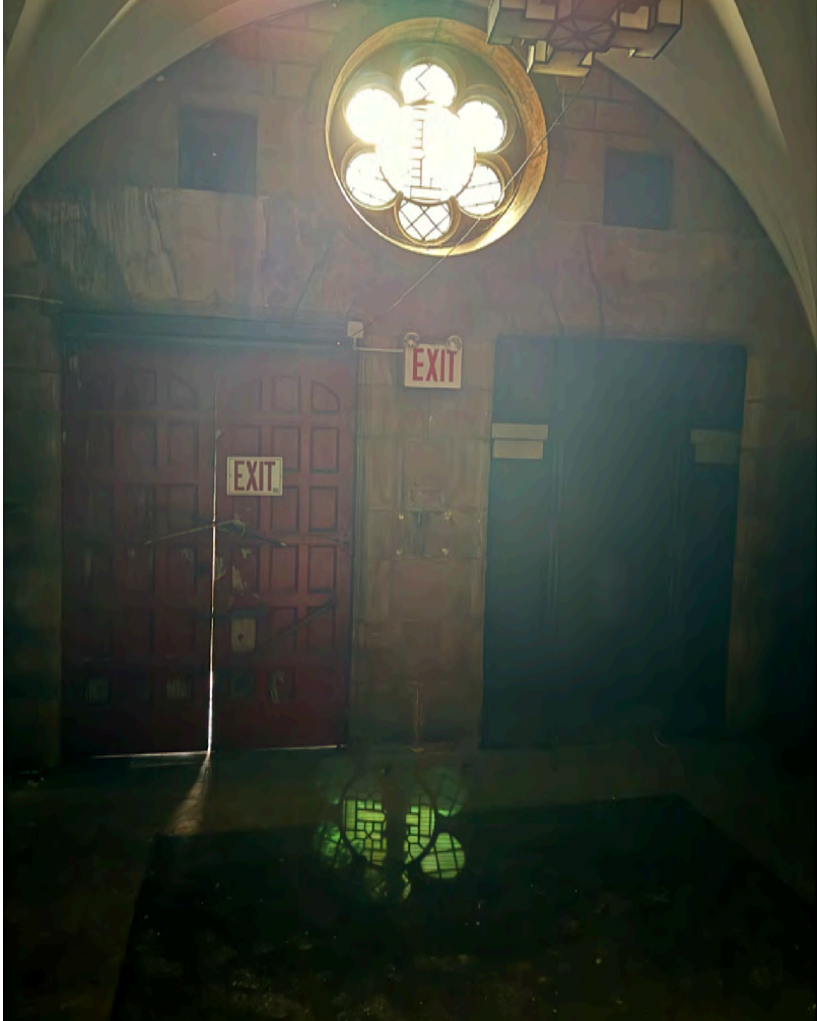
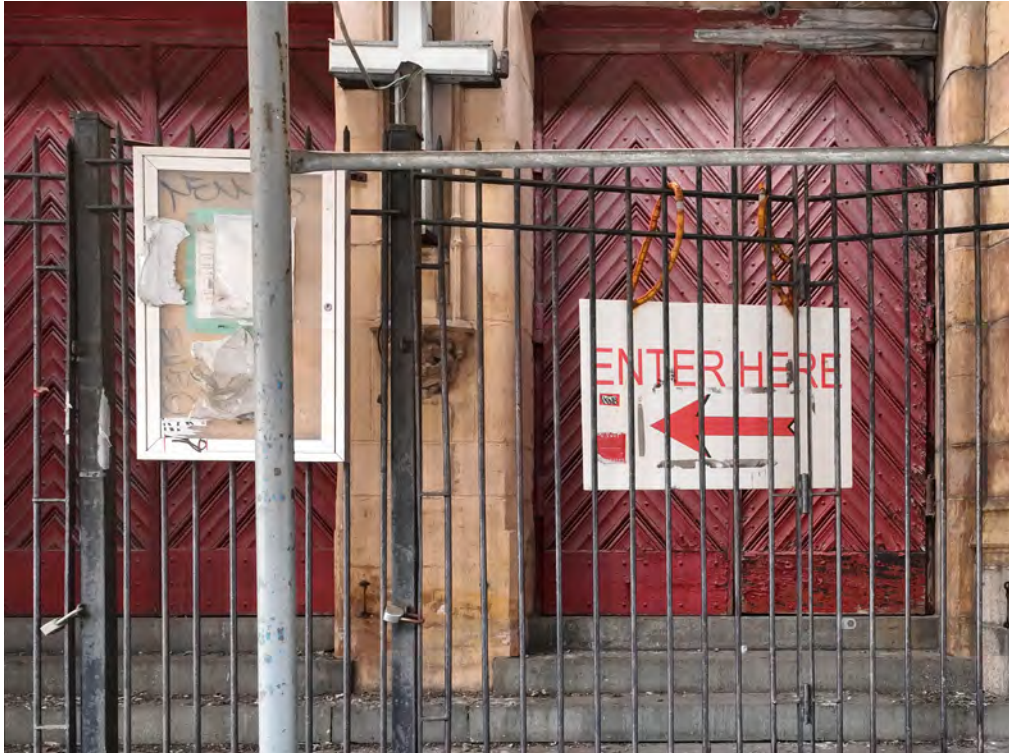
- Warping causes door to no longer shut properly
- Chipping paint
- Doors boarded up from the interior

Major damage appears to be typical, doors are broken and susceptible to the elements.

Doors shall be removed and replaced based on proposed design. Doors on the south primary façade shall be replaced with new storefront to accomodate proposed new community main entrance.

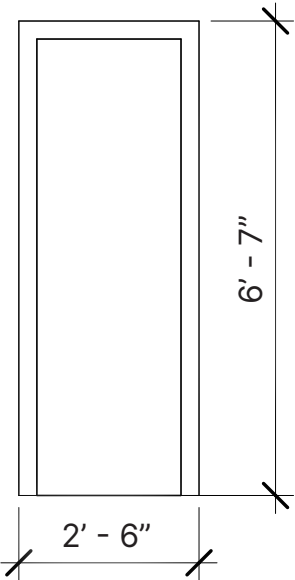
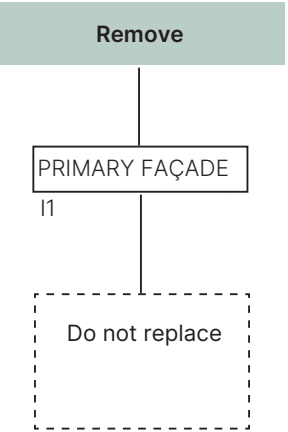
Major damage appears to be typical, doors are broken and susceptible to the elements.

Door shall be removed based on proposed design. Door on the east primary façade shall not be replaced because of the proposal to demolish this area of the building to accomodate new development.

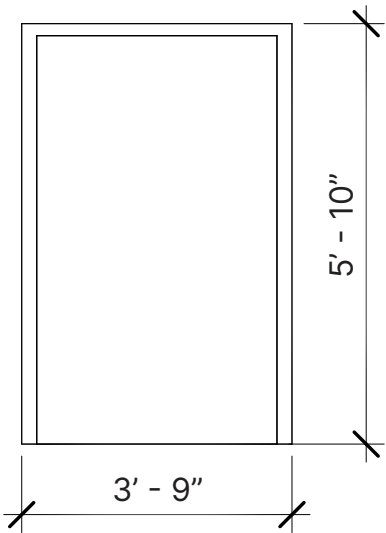
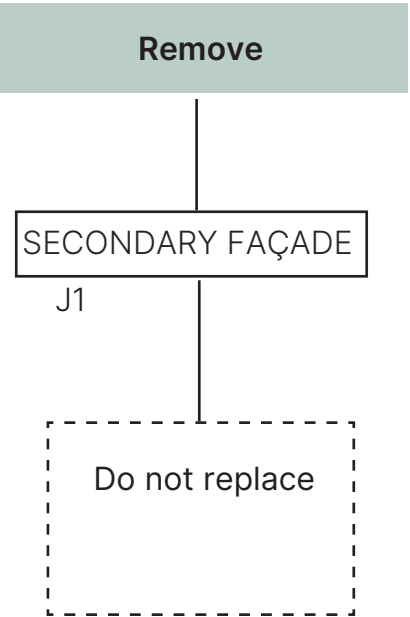
Major damage appears to be typical, doors are broken and susceptible to the elements.

Door shall be removed based on proposed design. Door on the west secondary façade shall not be replaced because of the proposal to demolish this area of the building to accomodate new development.

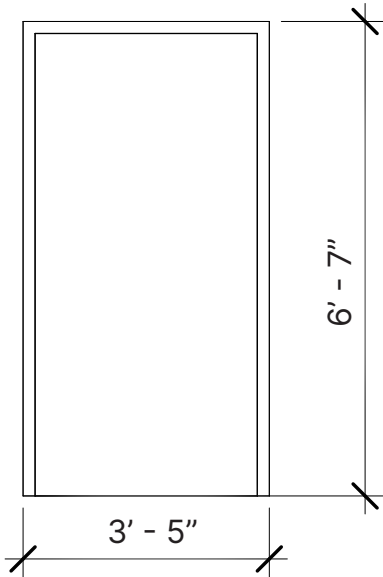
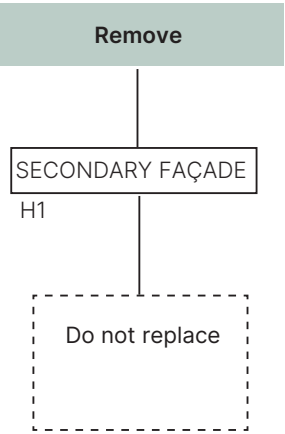
Major damage appears to be typical, doors are broken and susceptible to the elements.

Door shall be removed based on proposed design. Door shall not be replaced because of the proposal to demolish this area of the building to accomodate new development.

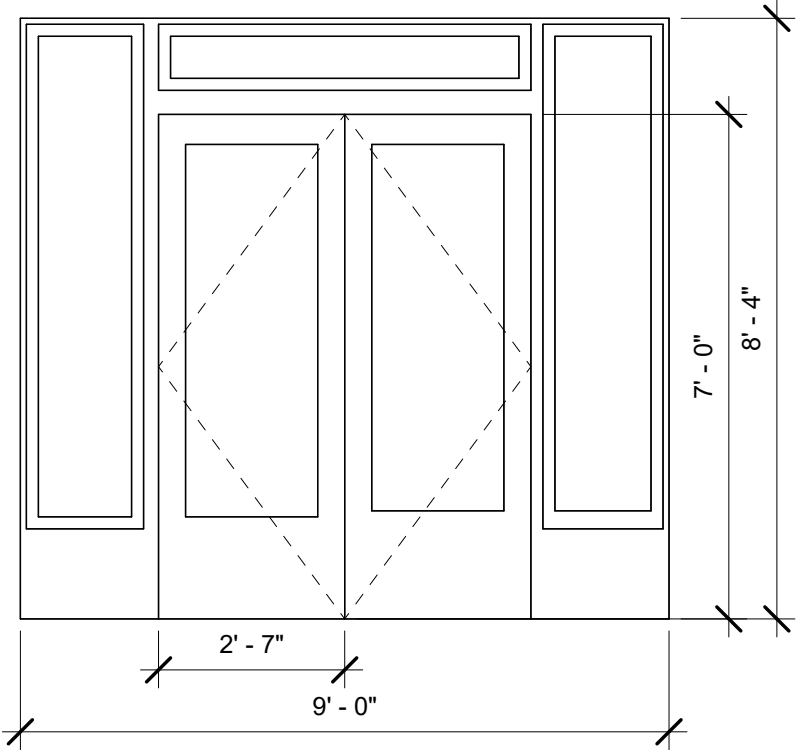
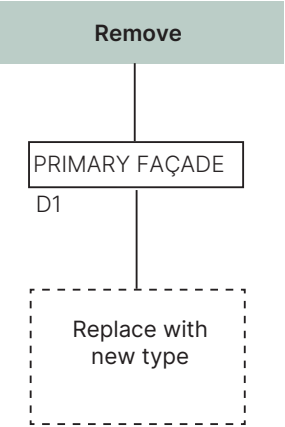
- Installed infront of original storefronts
- Fine condition

- Framing system is rusted
- Glazing is damaged

Security grille is generally in good condition but shall not be required for proposed storefronts at ground level in future design.

Security grilles and existing storefronts shall be removed. Existing security grilles shall not be replaced to accomodate new proposed storefronts. New storefront material shall be similar to existing and include double doors.

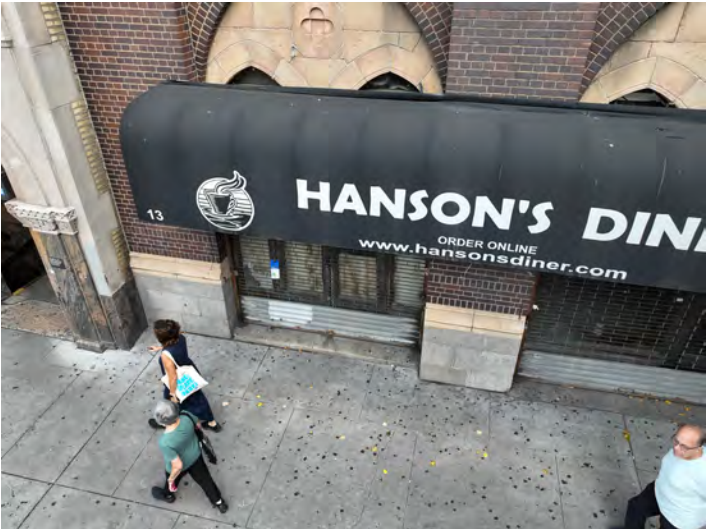
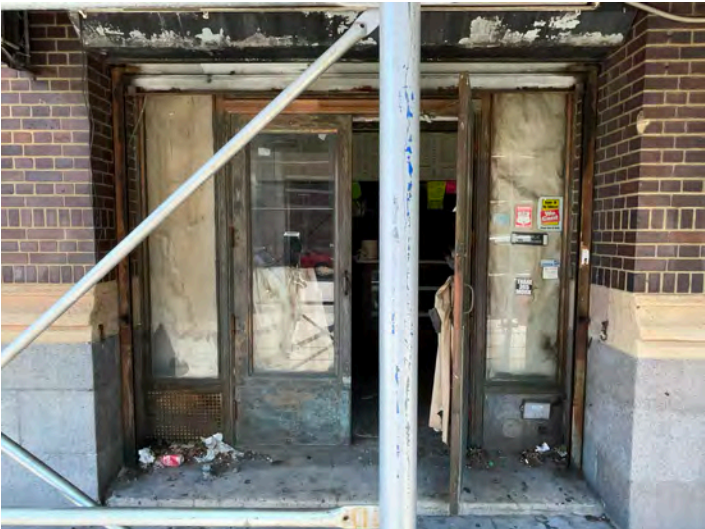
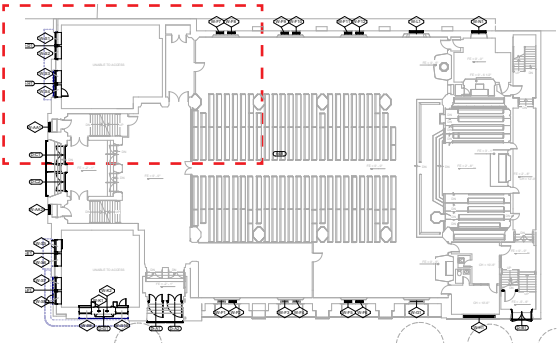
D-D1

- Quantity: 1
- Visibility from street: Yes
- Date: Unknown (Non-original)
- Condition: Fair

- Installed infront of original storefronts
- Fine condition

- Framing system is rusted
- Glazing is damaged

Security grille is generally in good condition but shall not be required for proposed storefronts at ground level in future design.

Security grilles and existing storefronts shall be removed. Existing security grilles shall not be replaced to accomodate new proposed storefronts. New storefront material shall be similar to existing and include double doors.

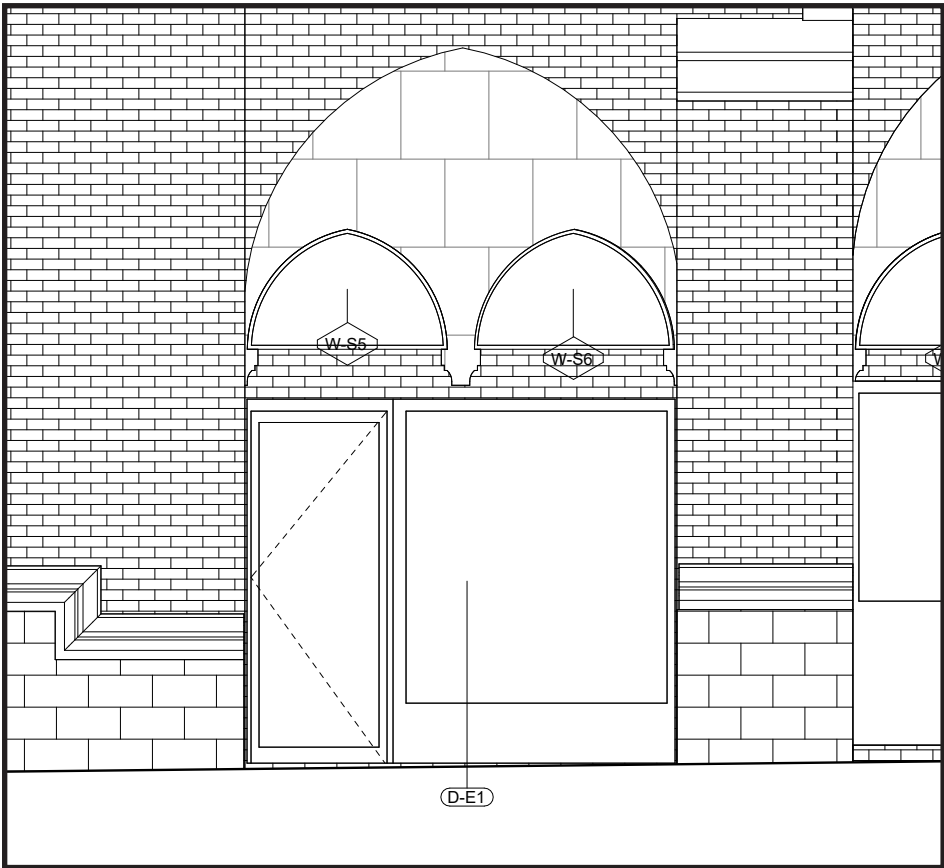
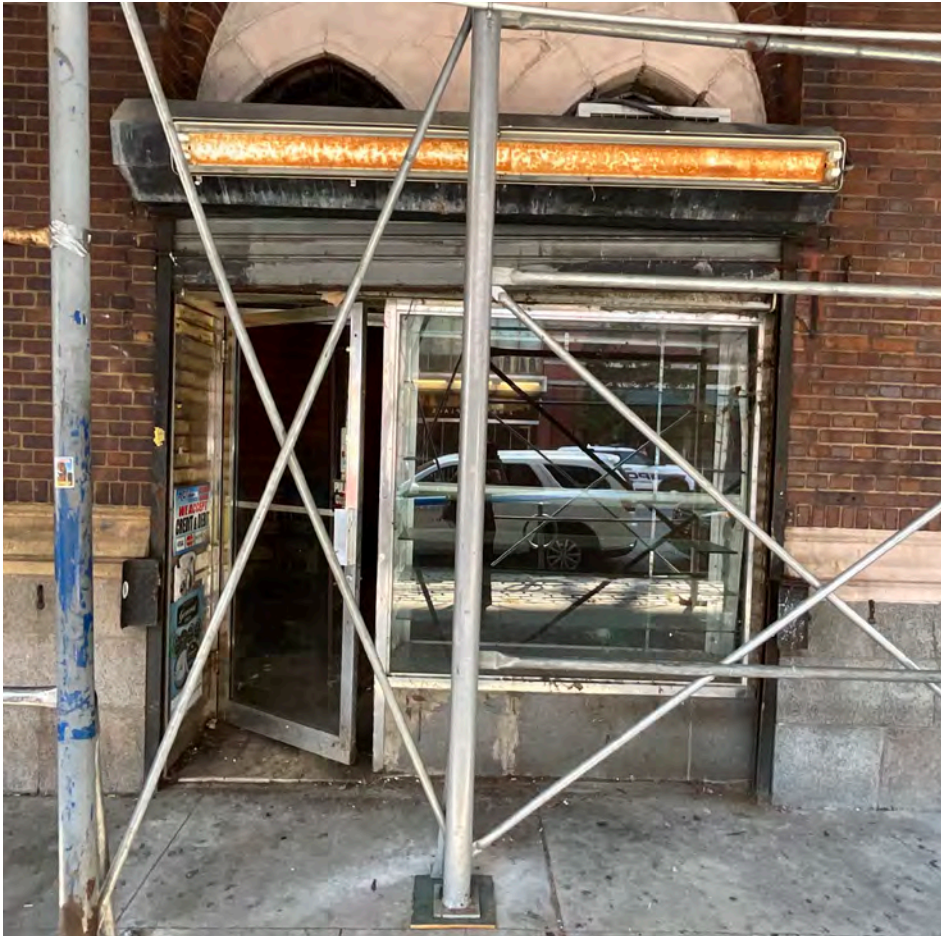
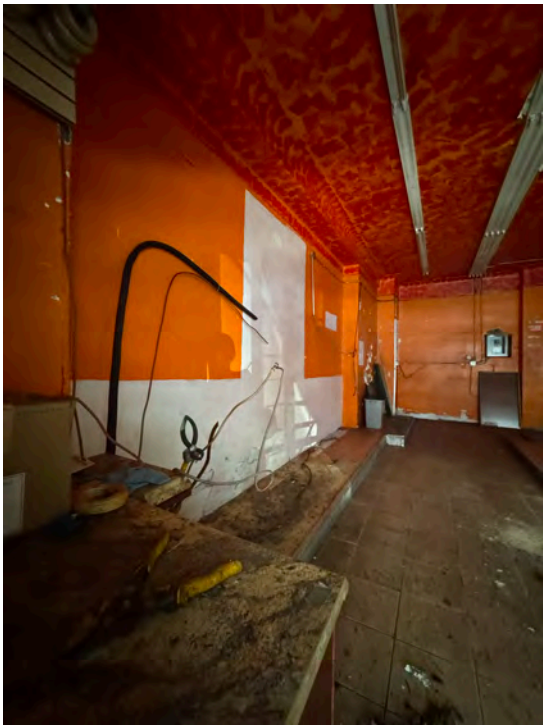
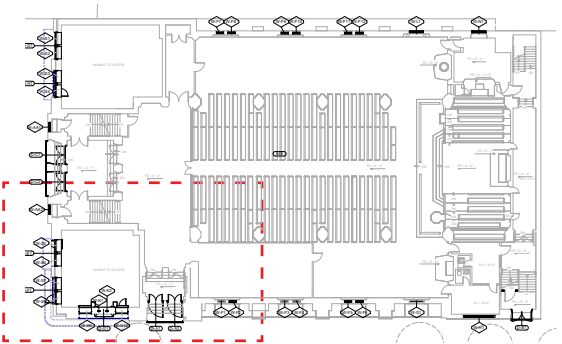
- Quantity: 1
- Visibility from street: Yes
- Date: 1931 (Original)
- Condition: Fair

- Installed infront of original storefronts
- Fine condition

- Framing system is rusted
- Glazing is damaged

Security grille is generally in good condition but shall not be required for proposed storefronts at ground level in future design.

Security grilles and existing storefronts shall be removed. Existing security grilles shall not be replaced to accomodate new proposed storefronts. New storefront material shall be similar to existing and include double doors.

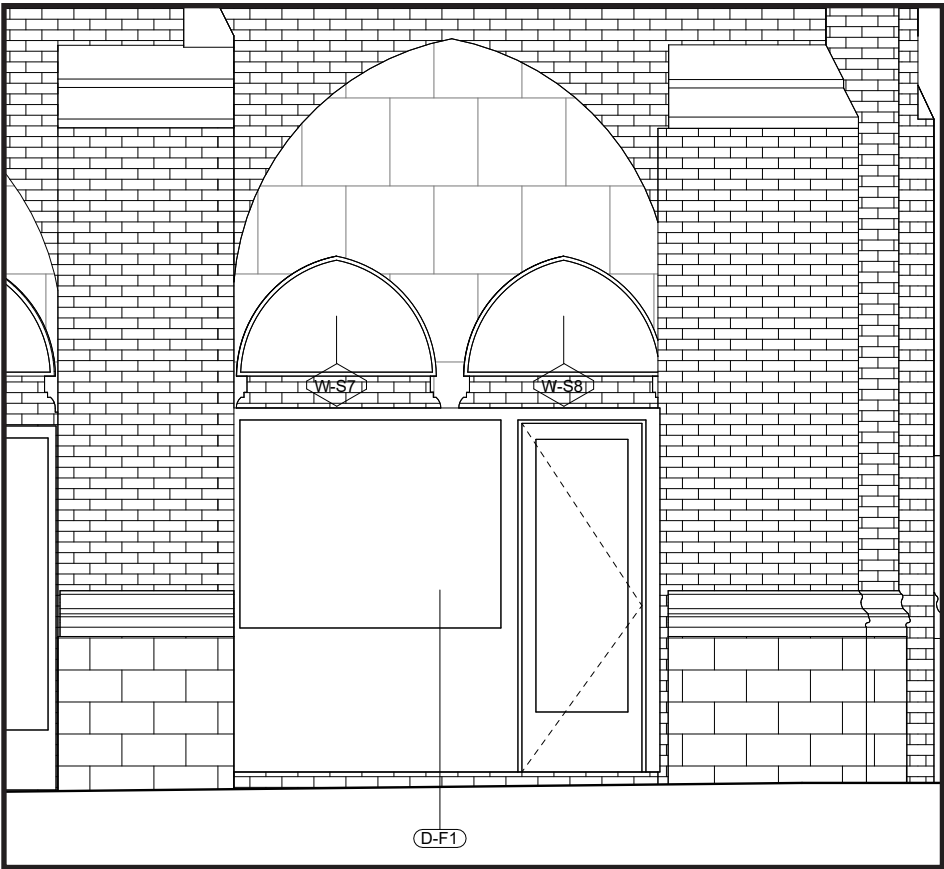
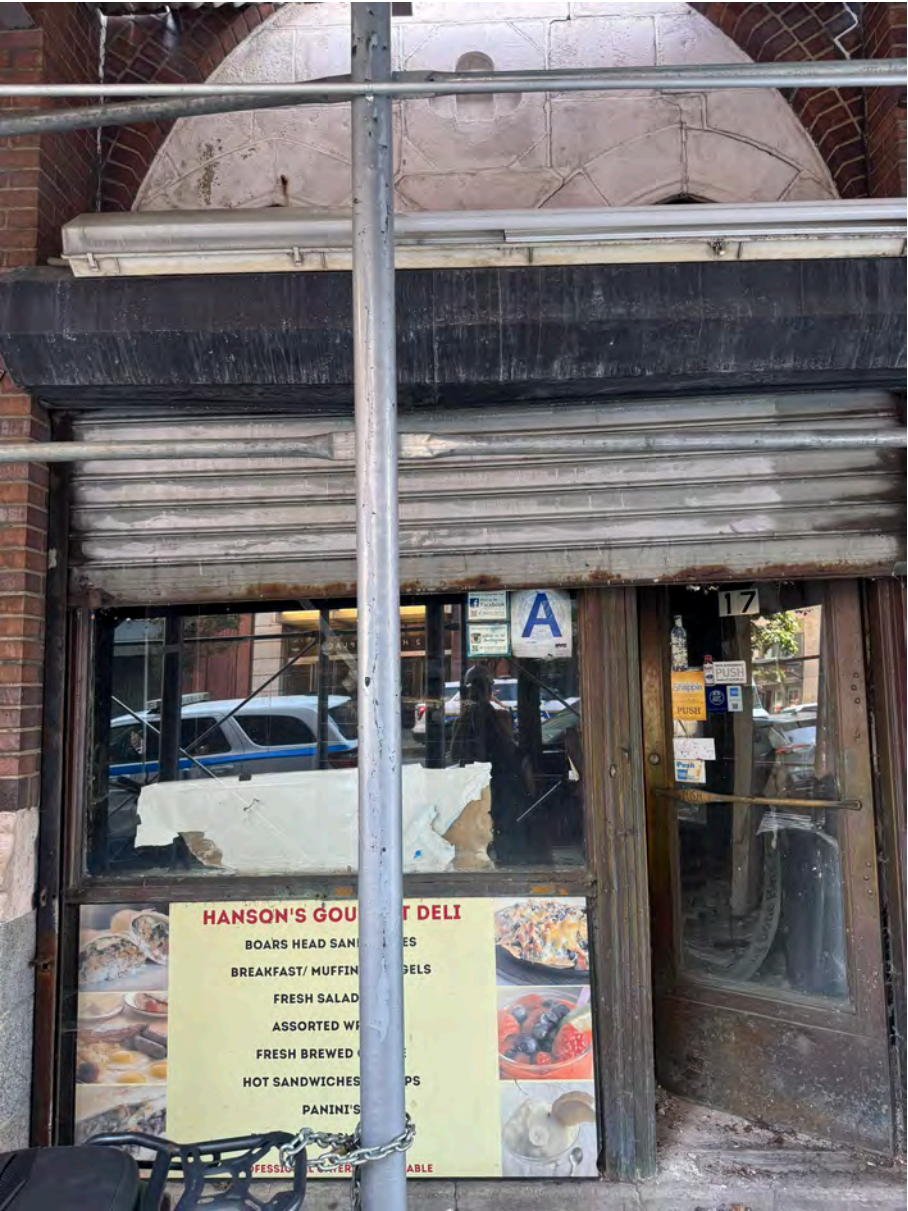
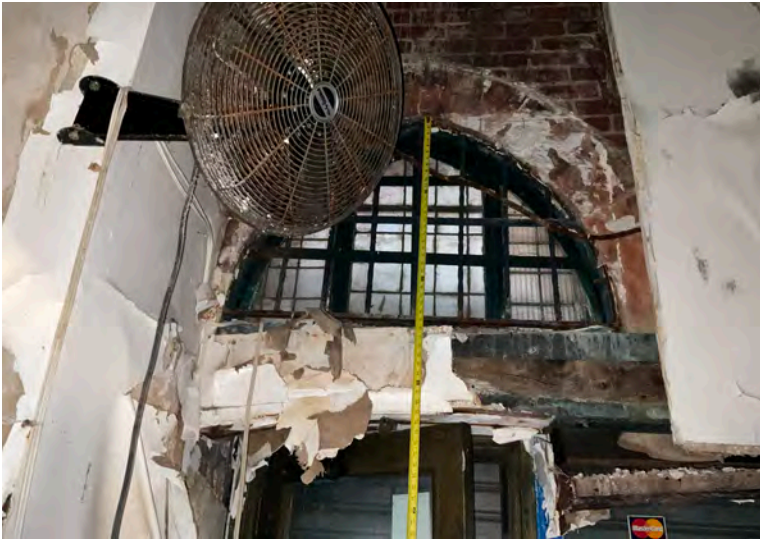
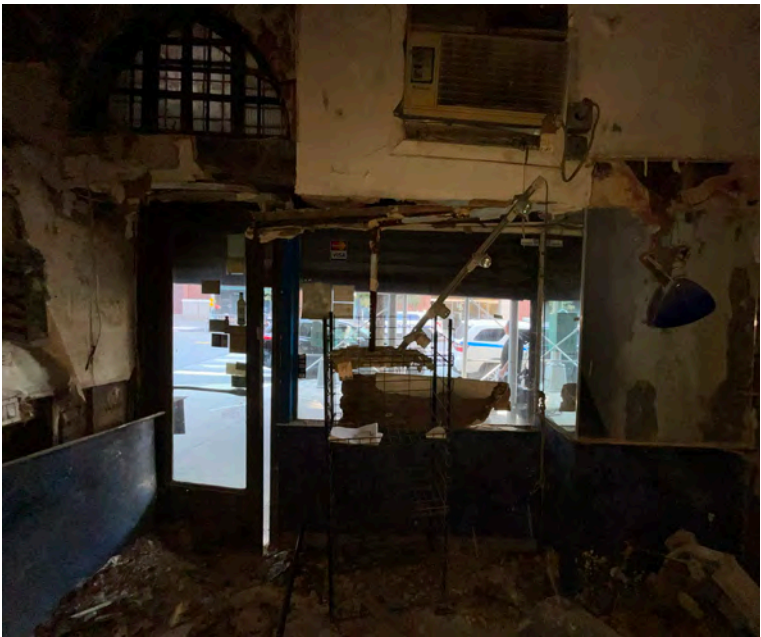
- Quantity: 1
- Visibility from street: Yes
- Date: 1931 (Original)
- Condition: Fair

- Installed infront of original storefronts
- Fine condition

- Framing system is rusted
- Glazing is damaged

Security grille is generally in good condition but shall not be required for proposed storefronts at ground level in future design.

Security grilles and existing storefronts shall be removed. Existing security grilles shall not be replaced to accomodate new proposed storefronts. New storefront material shall be similar to existing and include double doors.

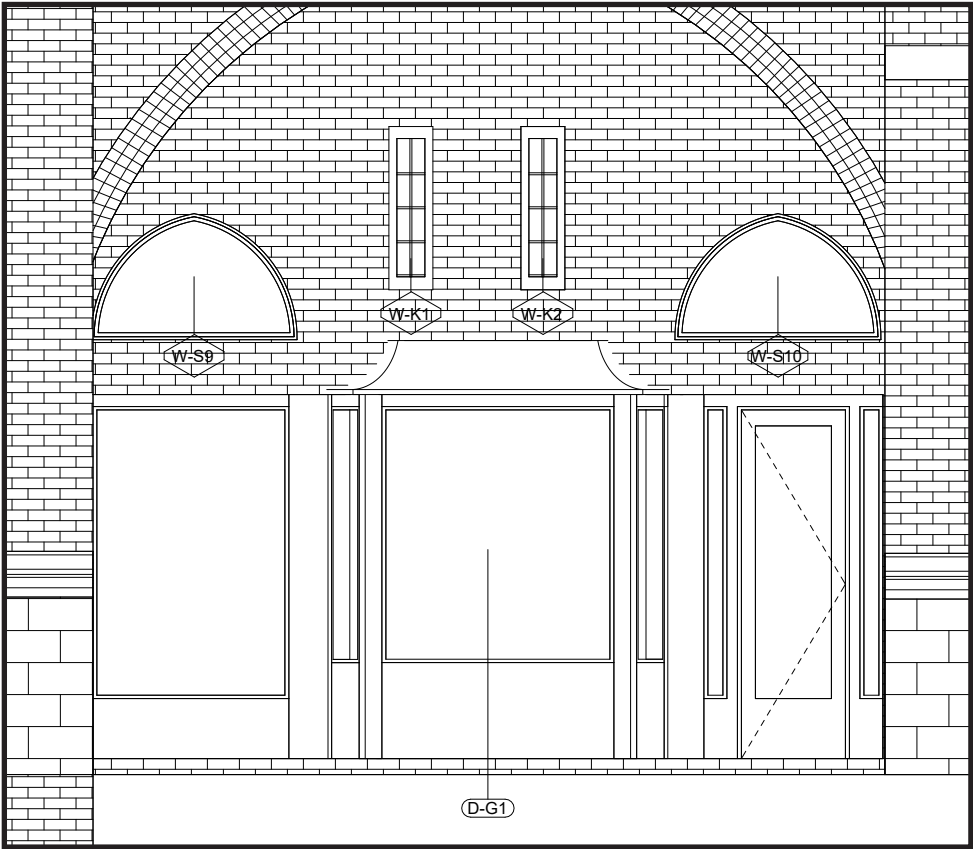
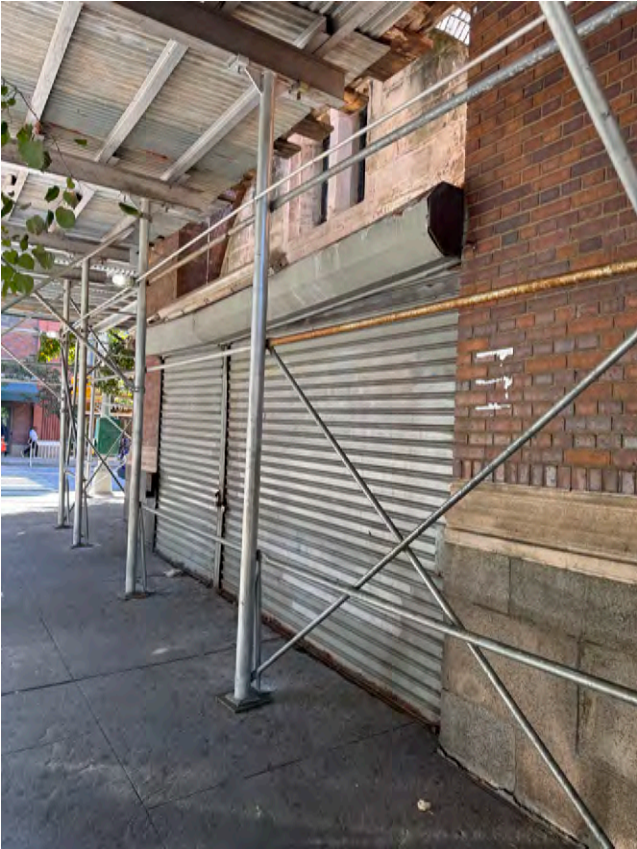
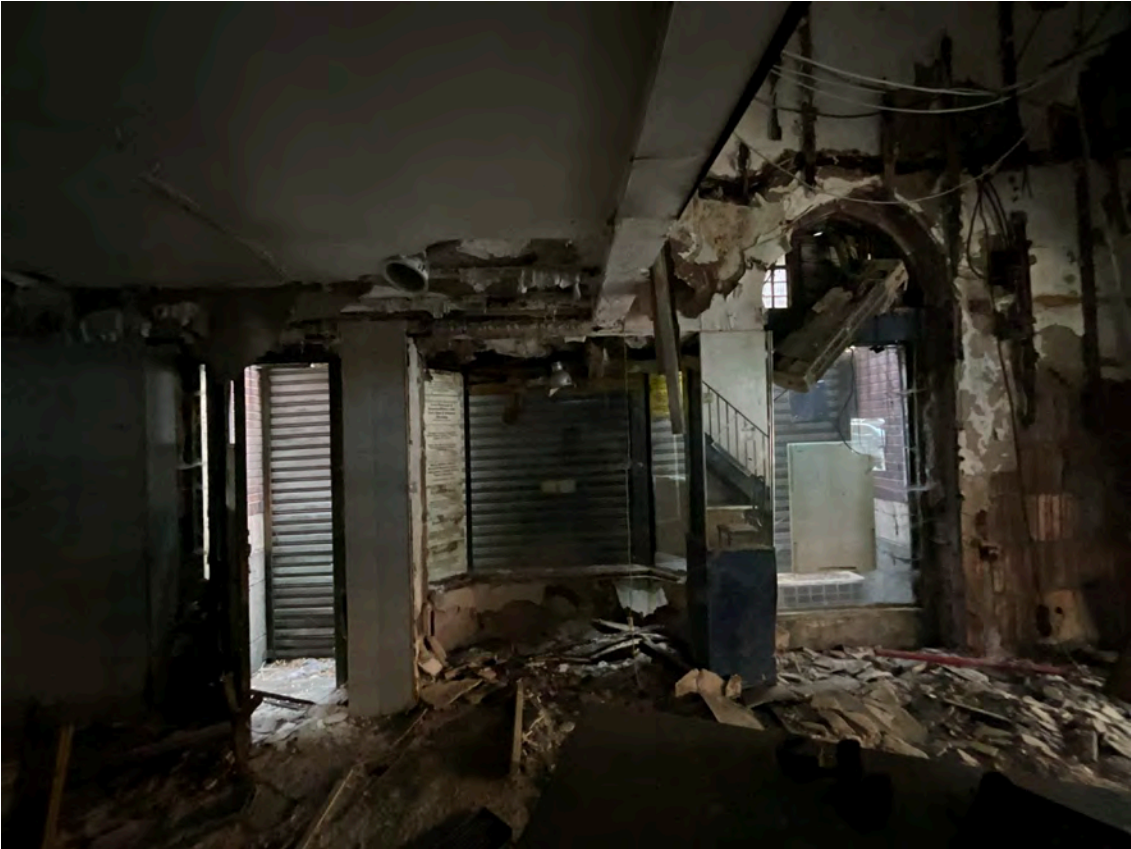
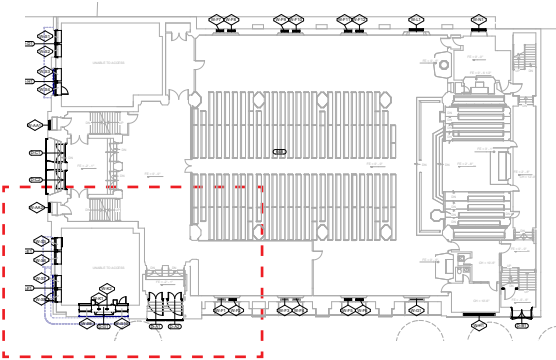
- Quantity: 1
- Visibility from street: Yes
- Date: 1931 (Original)
- Condition: Fair

- Installed infront of original storefronts
- Fine condition

- Framing system is rusted
- Glazing is damaged

Security grille is generally in good condition but shall not be required for proposed storefronts at ground level in future design.

Security grilles and existing storefronts shall be removed. Existing security grilles shall not be replaced to accomodate new proposed storefronts. New storefront material shall be similar to existing and include double doors.
