April 21, 2026
Public Meeting

Preservation Department – Item 5, LPC-25-09125

139 Thompson Street – Sullivan-Thompson Historic District Borough of Manhattan

Front Facade Inspection

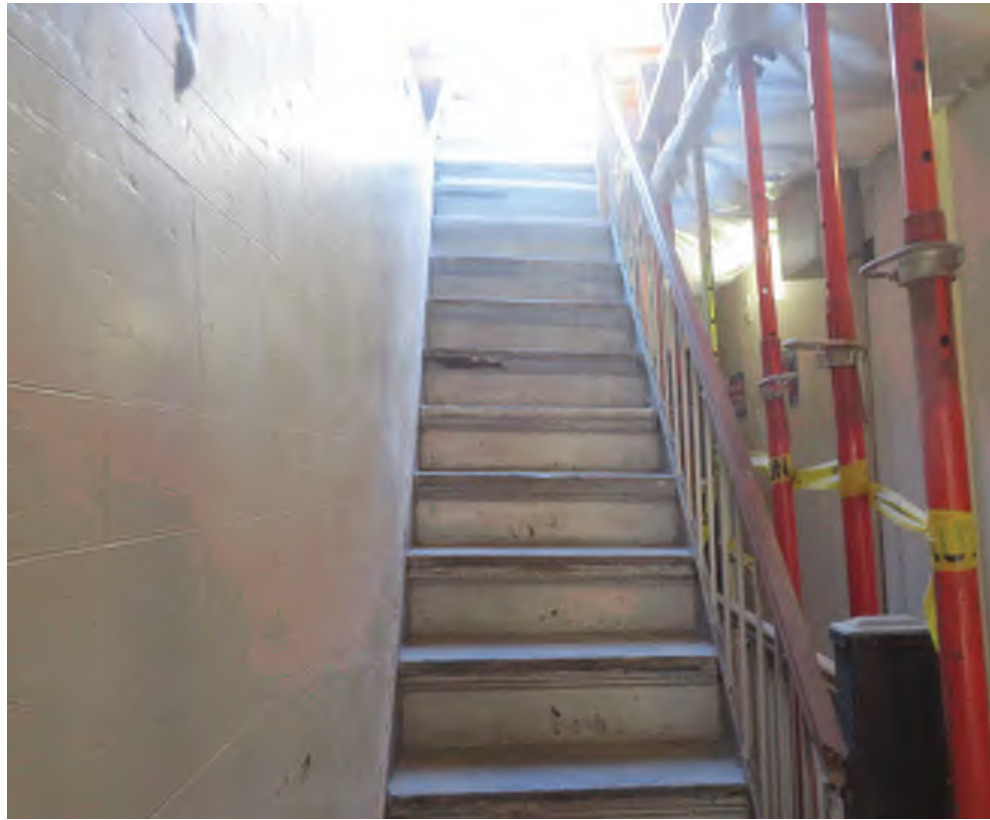
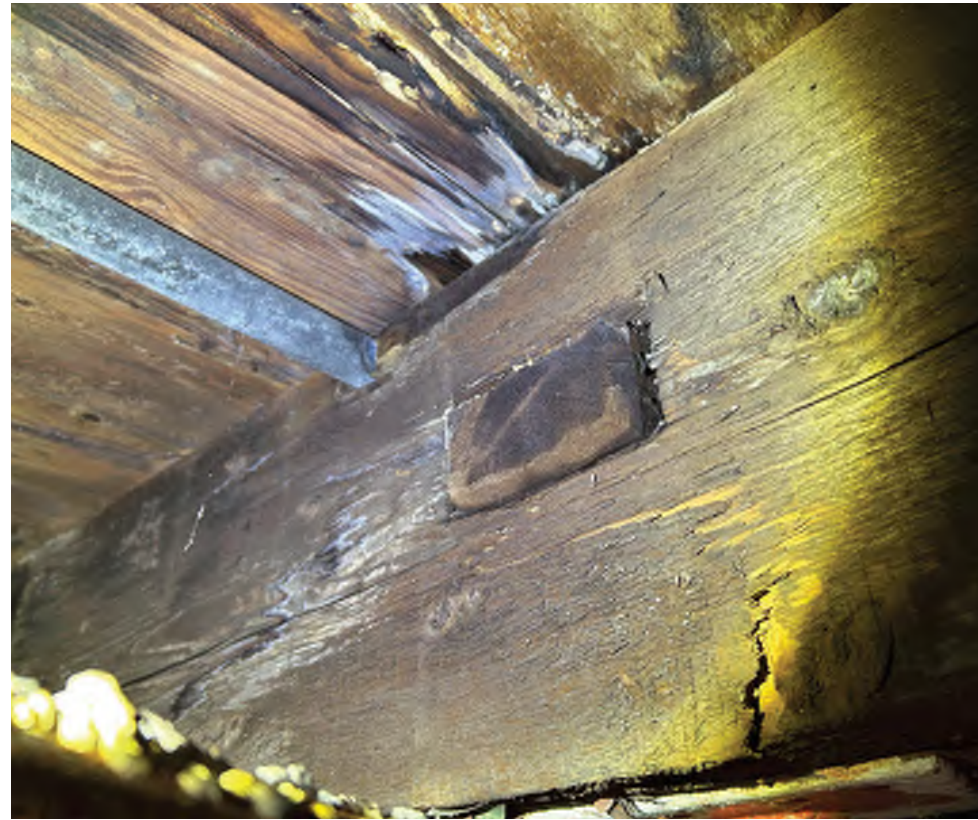
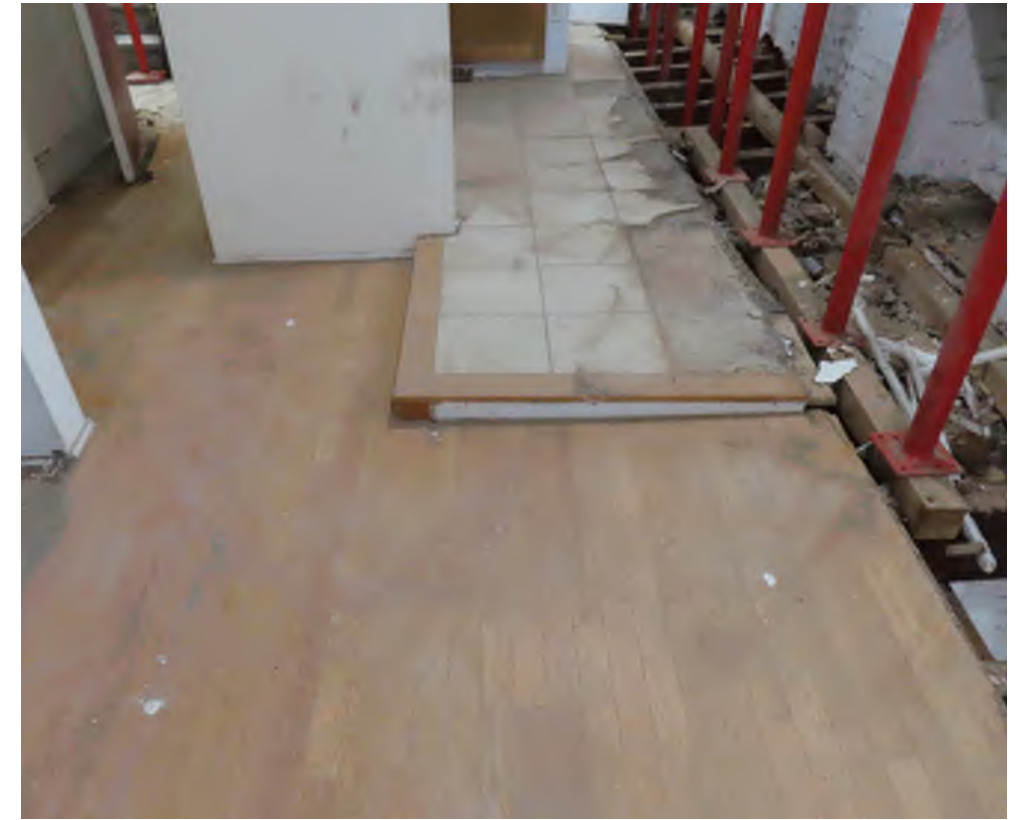
TILTED STAIRS DUE TO EXCESSIVE FLOOR JOIST DEFLECTIONS

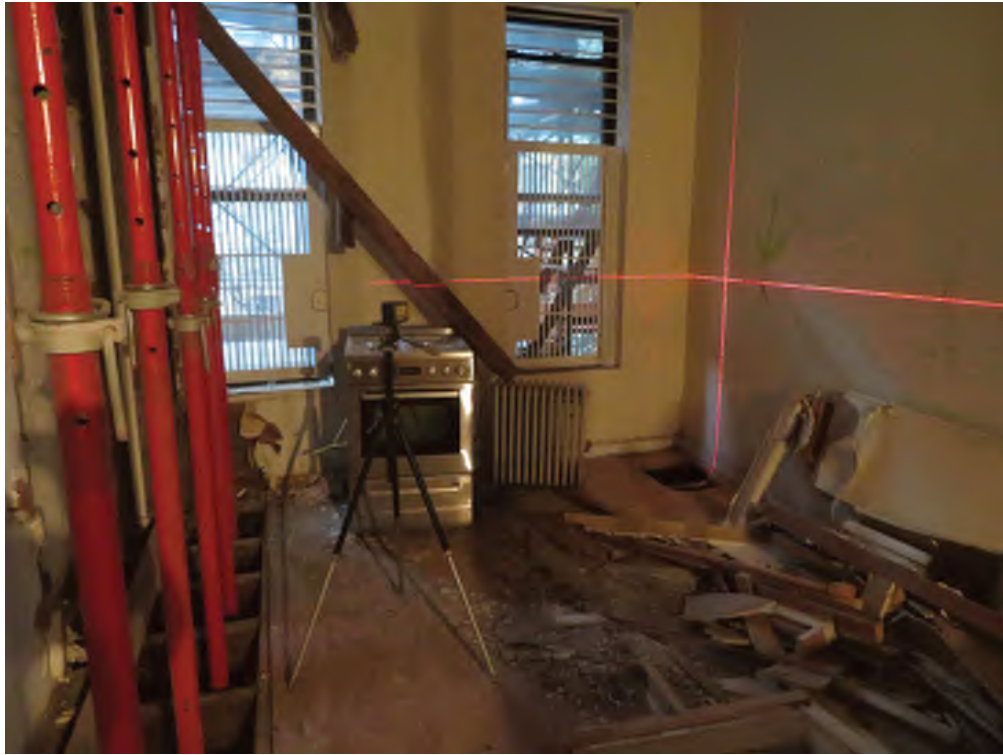
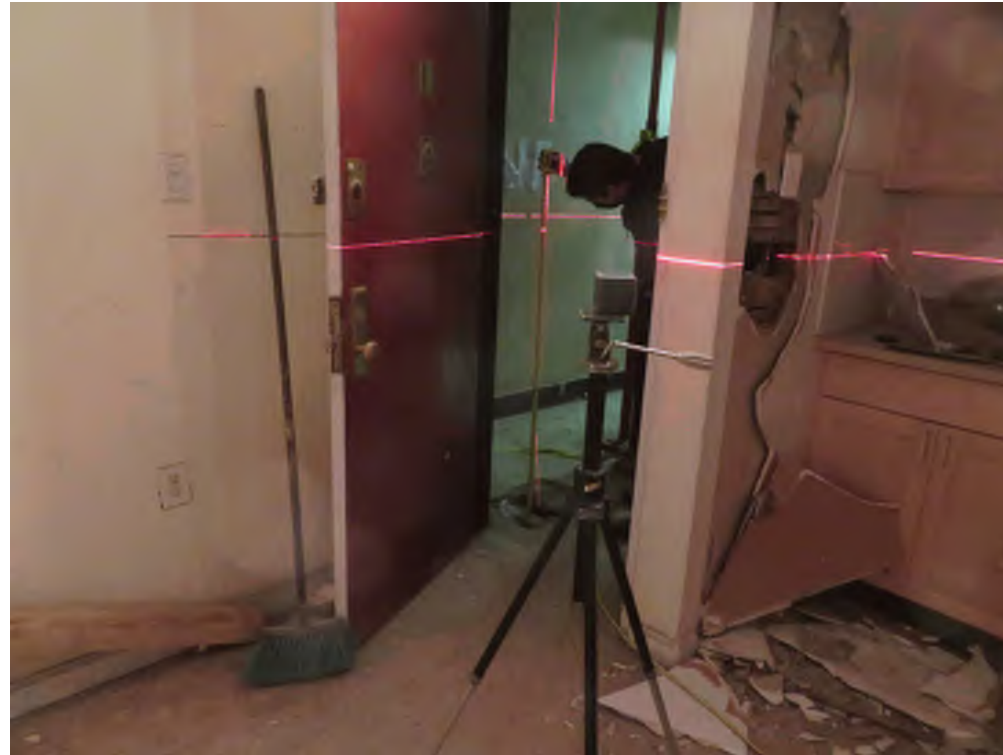
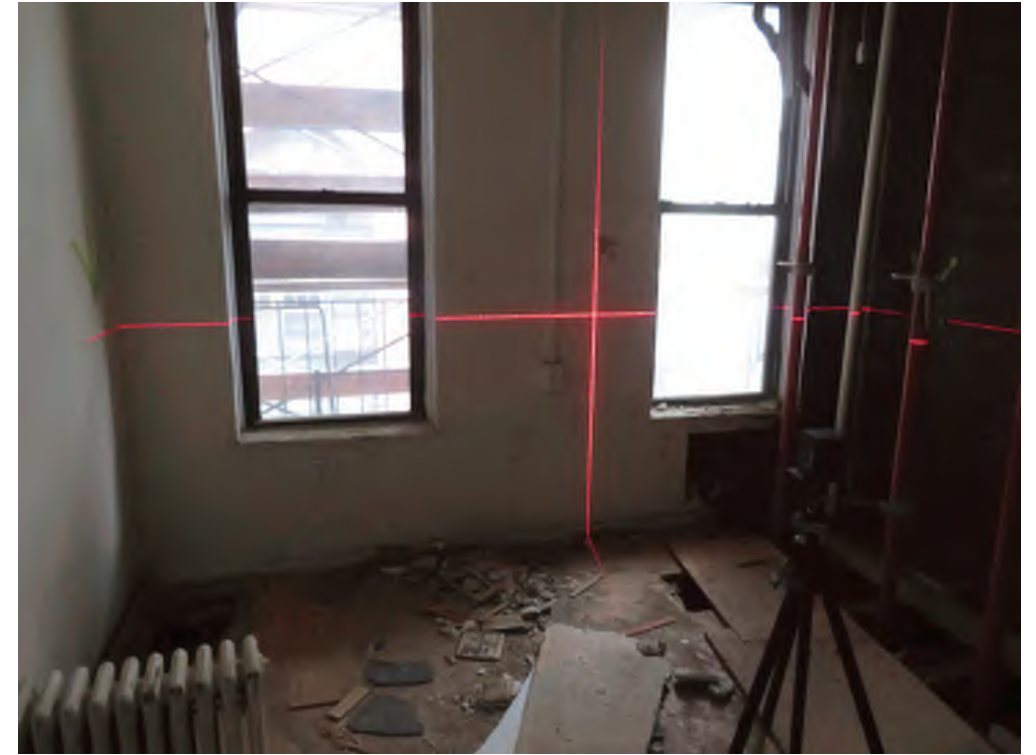
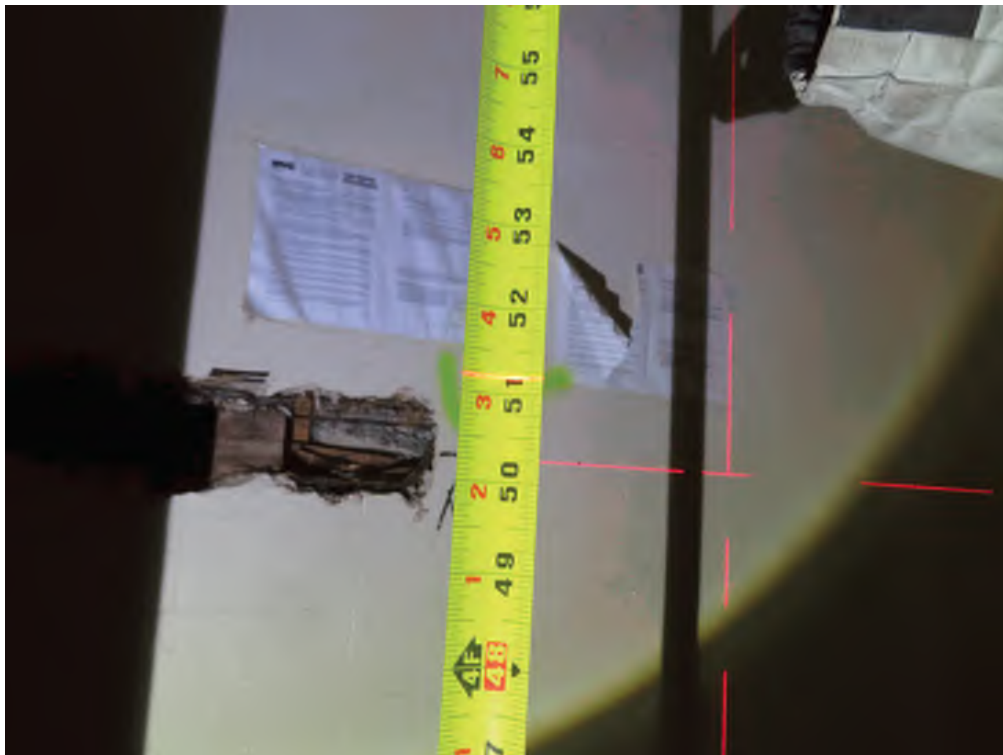
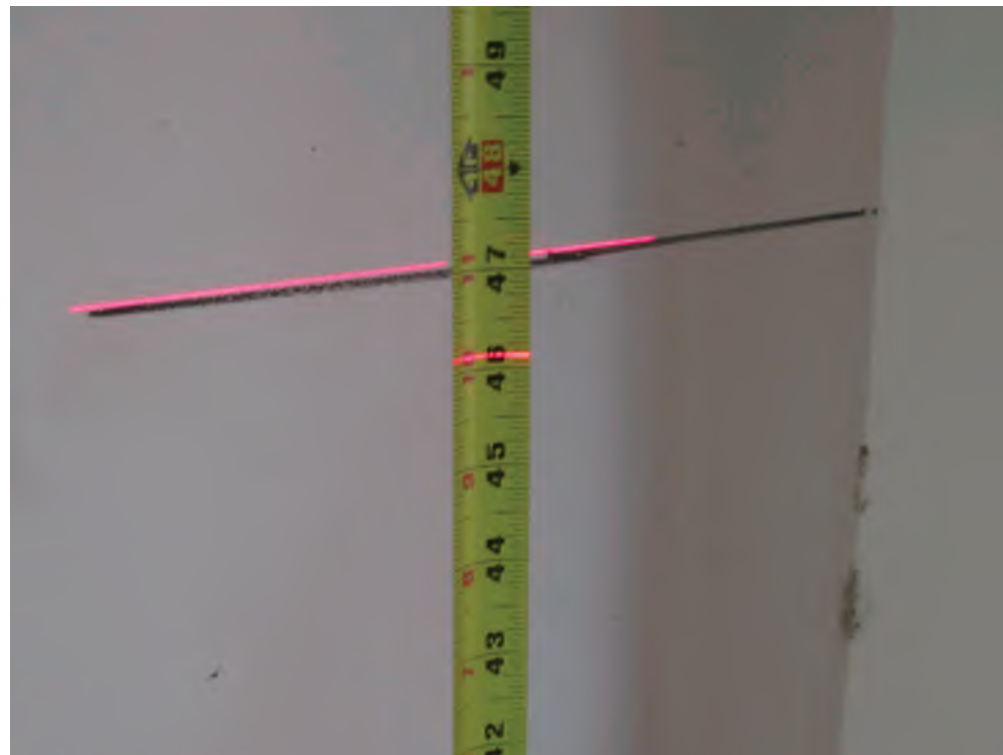
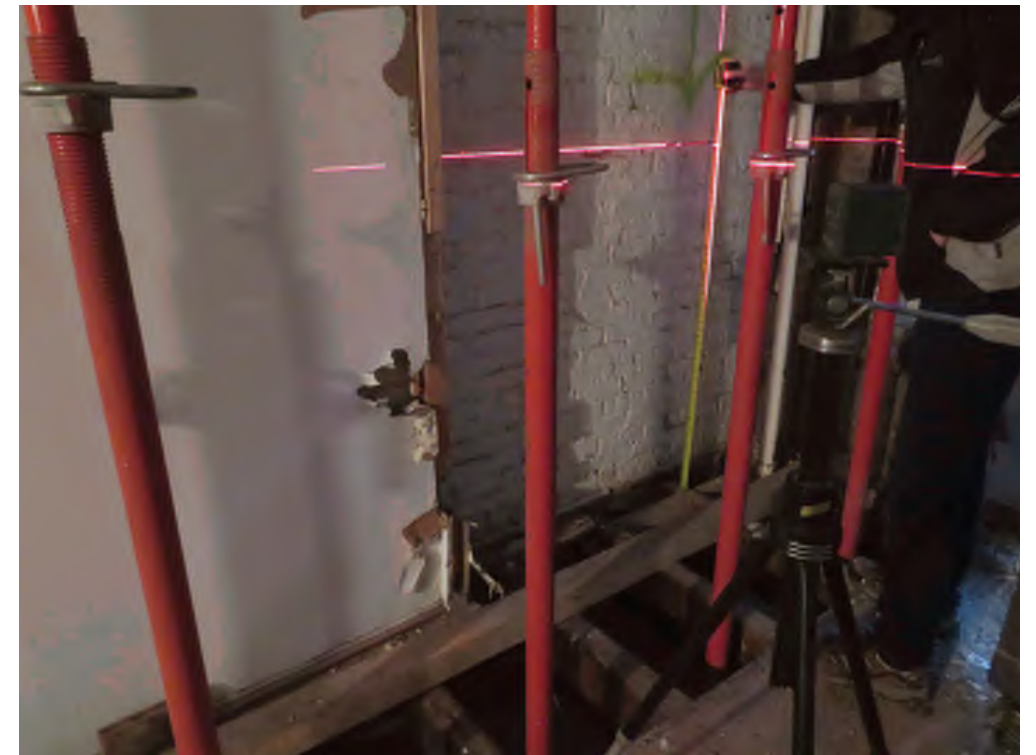
FLOOR JOIST DEFLECTION

Existing Conditions

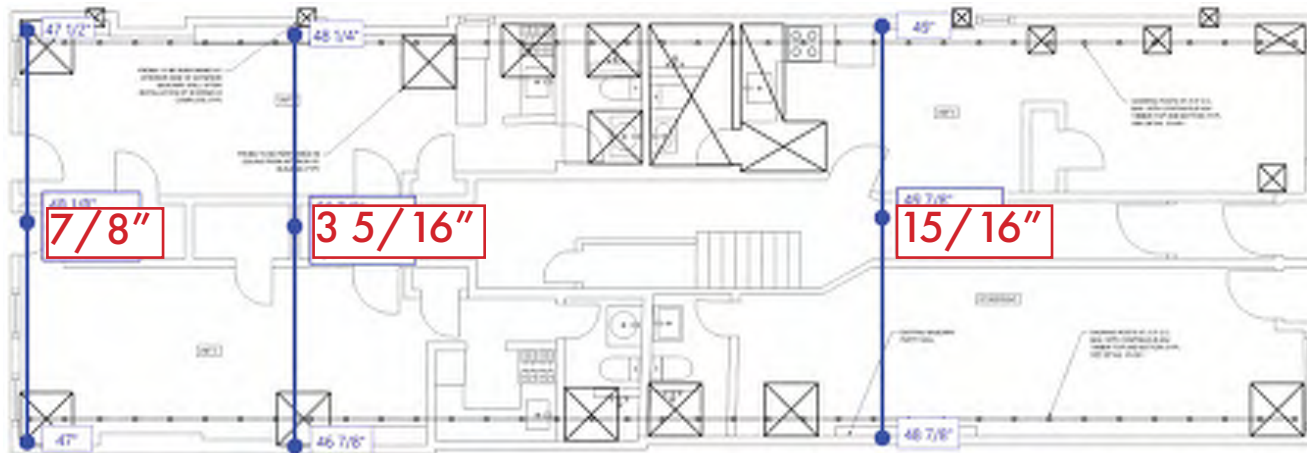
1ST FLOOR JOIST DEFLECTION MEASUREMENTS

FIRST FLOOR						
LOCATION #	NORTH (IN)	SOUTH (IN)	N,S AVERAGE (IN)	MIDSPAN (IN)	MID Δ (IN)	L/x
1	47 1/2	47	47 1/4	48 1/8	7/8	319
2	48 1/4	46 7/8	47 9/16	50 7/8	3 5/16	84
3	49	48 7/8	48 15/16	49 7/8	15/16	298
SECOND FLOOR						
LOCATION #	NORTH (IN)	SOUTH (IN)	N,S AVERAGE (IN)	MIDSPAN (IN)	MID Δ (IN)	L/x
1	48 3/8	48 3/8	48 3/8	48 7/8	1/2	558
2	48 1/4	47 1/4	47 3/4	51 1/4	3 1/2	80
3	47 1/2	47	47 1/4	50 1/4	3	93
4	47 3/4	47 1/4	47 1/2	48 3/8	7/8	319
THIRD FLOOR						
LOCATION #	NORTH (IN)	SOUTH (IN)	N,S AVERAGE (IN)	MIDSPAN (IN)	MID Δ (IN)	L/x
1	47	47 3/8	47 3/16	48 1/2	1 5/16	213
2	46 1/2	45 7/8	46 3/16	50 1/2	4 5/16	65
3	45 3/4	44 5/8	45 3/16	49 5/8	4 7/16	63
4	45 1/4	44 3/4	45	46 1/8	1 1/8	248
FOURTH FLOOR						
LOCATION #	NORTH (IN)	SOUTH (IN)	N,S AVERAGE (IN)	MIDSPAN (IN)	MID Δ (IN)	L/x
1	46 1/8	47 3/4	46 15/16	47 1/4	5/16	893
2	46 1/4	47	46 5/8	51 1/4	4 5/8	60
3	45 1/4	46 3/8	45 13/16	51 1/8	5 5/16	53
4	45 1/4	45 1/2	45 3/8	46 1/2	1 1/8	248

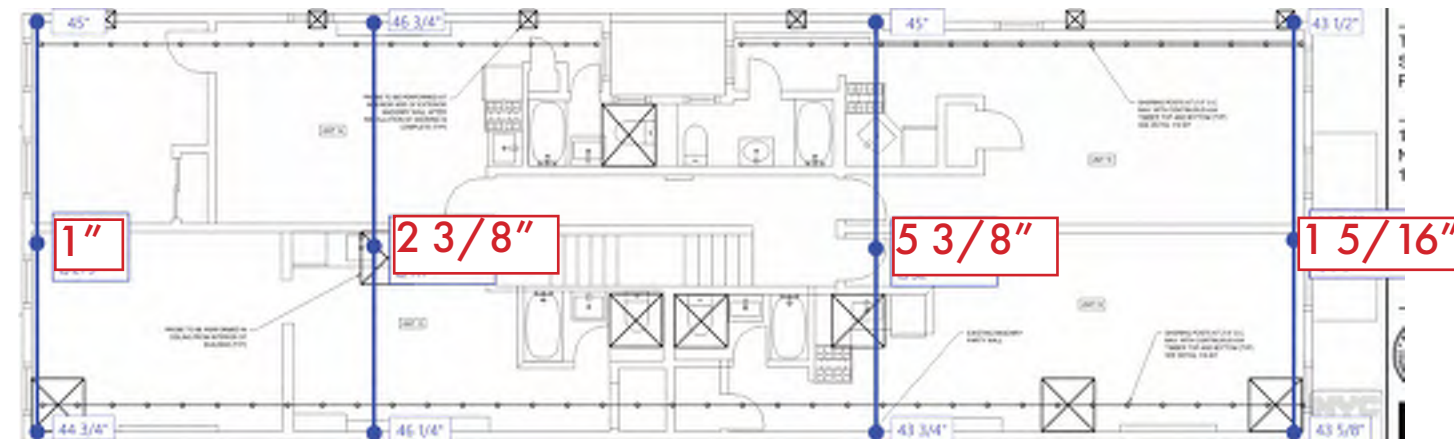
5TH FLOOR JOIST DEFLECTION MEASUREMENTS

FIFTH FLOOR						
LOCATION #	NORTH (IN)	SOUTH (IN)	N,S AVERAGE (IN)	MIDSPAN (IN)	MID Δ (IN)	L/x
1	45	44 3/4	44 7/8	45 7/8	1	279
2	46 3/4	46 1/4	46 1/2	48 7/8	2 3/8	117
3	45	43 3/4	44 3/8	49 3/4	5 3/8	52
4	43 1/2	43 5/8	43 9/16	44 7/8	1 5/16	213

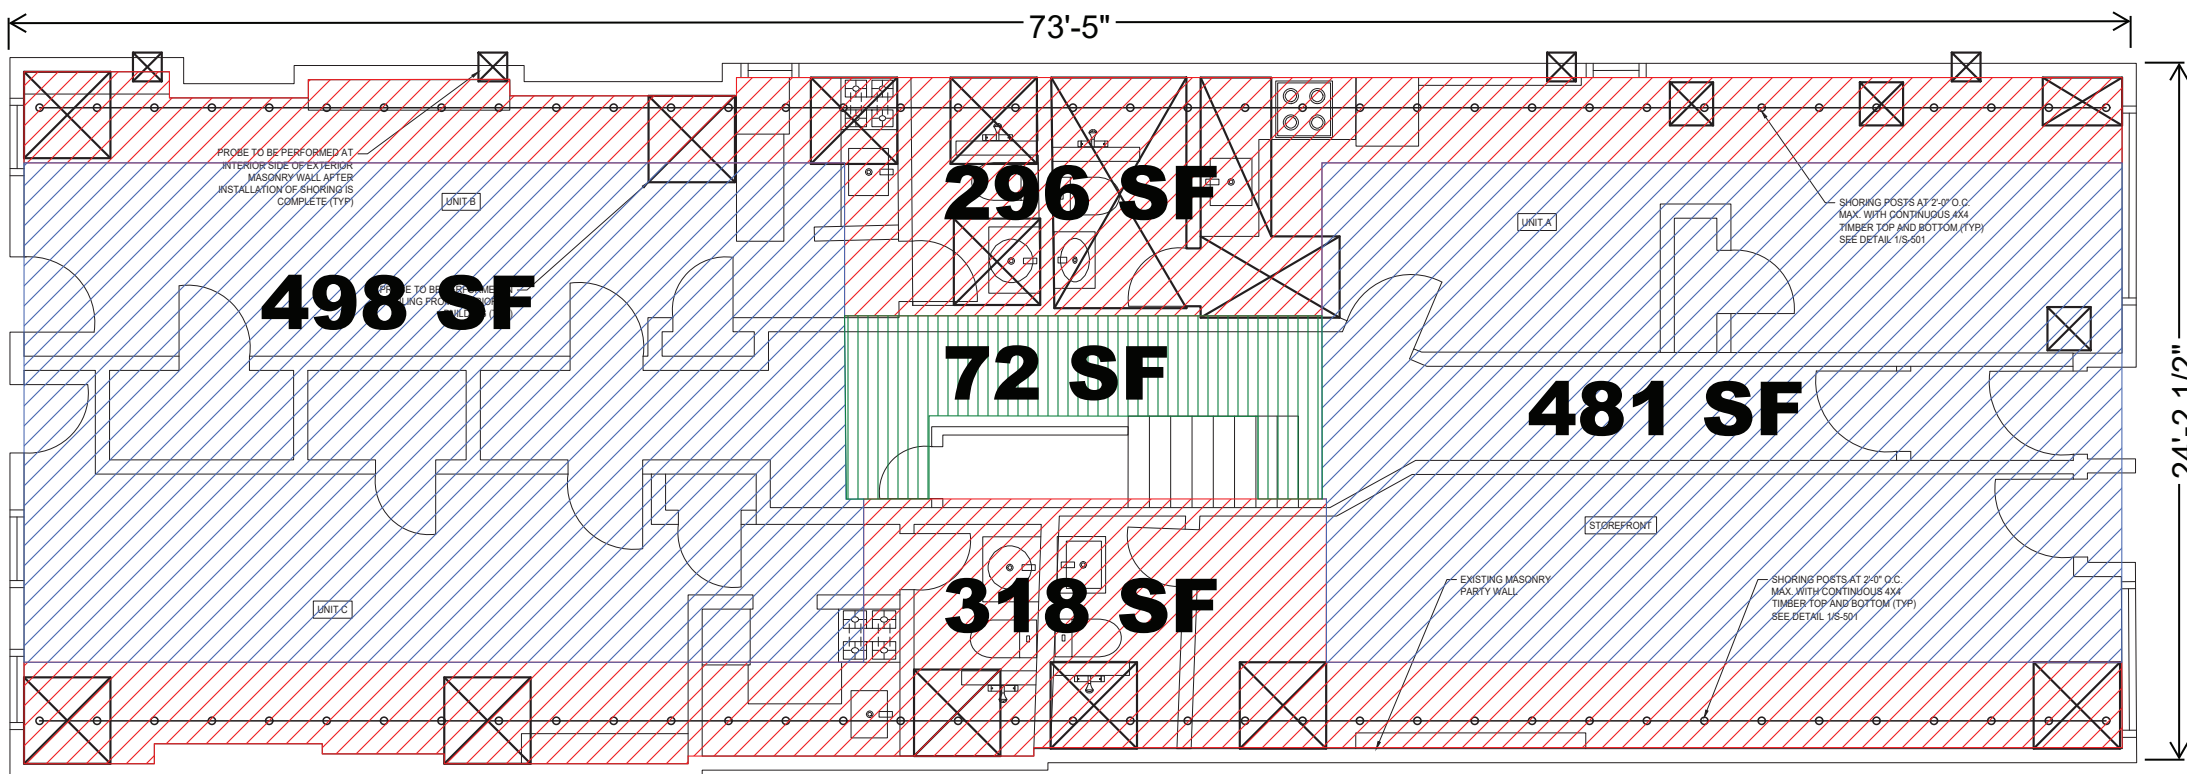
1ST FLOOR

- EXISTING FLOOR AREA TO REMAIN**
-

EXISTING JOIST TO REMAIN
- REPLACED FLOOR AREA**
-

EXISTING STAIRWELL TO BE REMOVED AND REPLACED

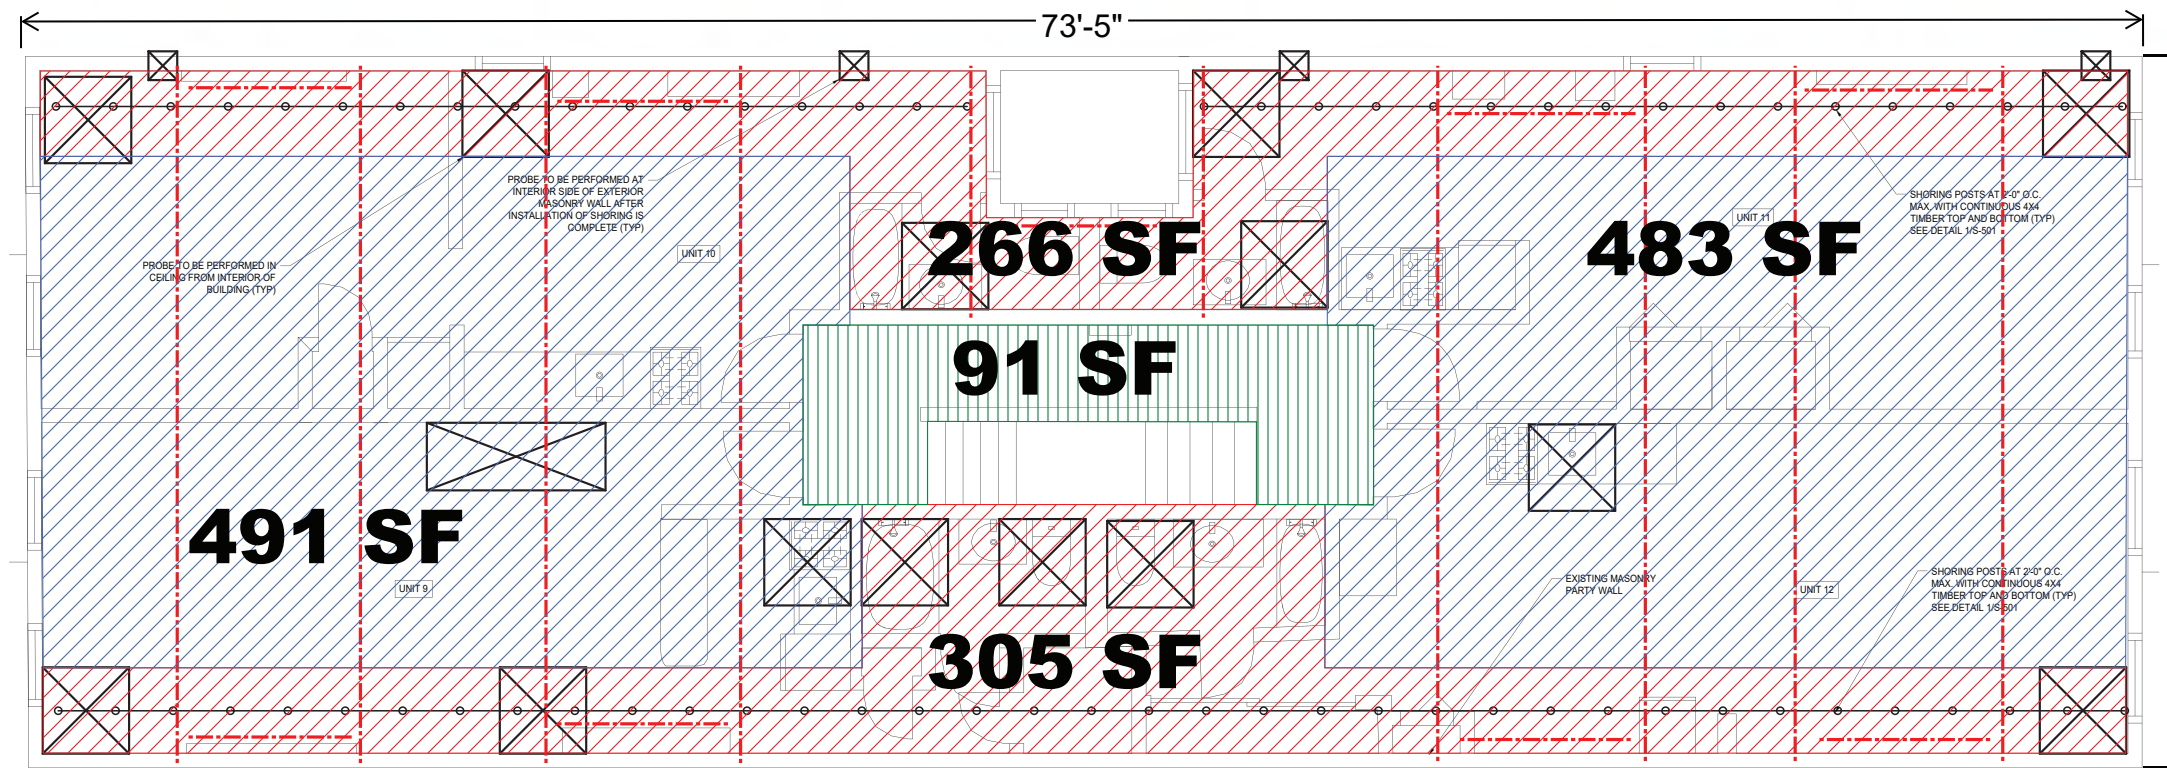
TYPICAL FLOOR (2-5)

- EXISTING FLOOR AREA TO REMAIN**
- NO EXISTING FLOOR AREA TO REMAIN ON TYPICAL FLOOR
- REPLACED FLOOR AREA**
- AREA OF FLOOR REMOVED FOR SHORING INSTALLATION
 - EXISTING JOISTS TO BE REMOVED AND REPLACED
 - EXISTING STAIRWELL TO BE REMOVED AND REPLACED

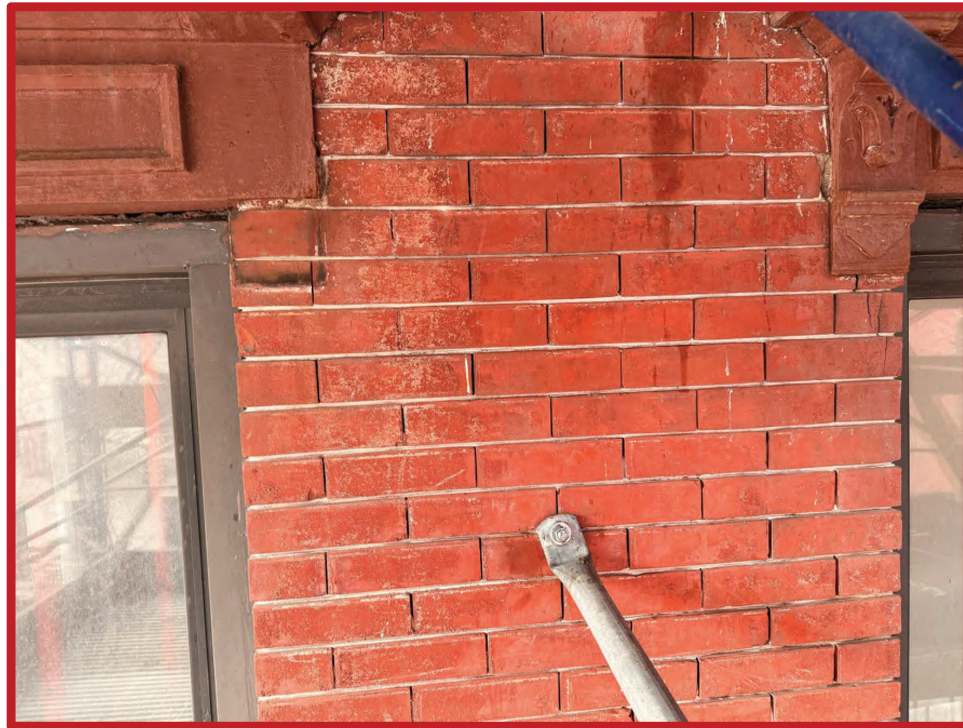
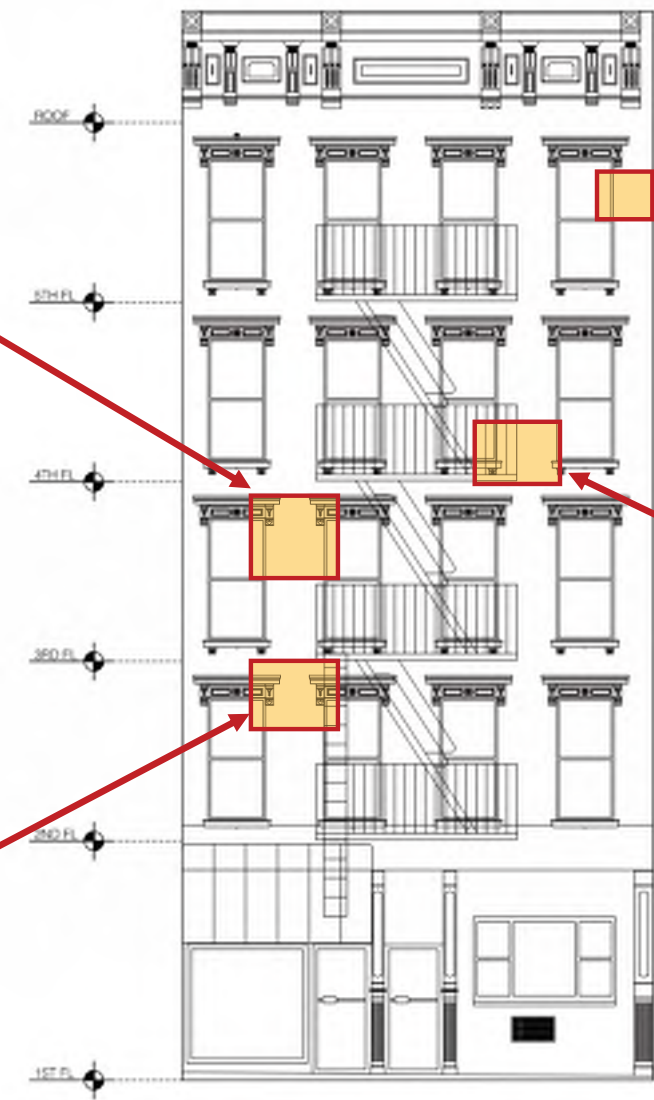
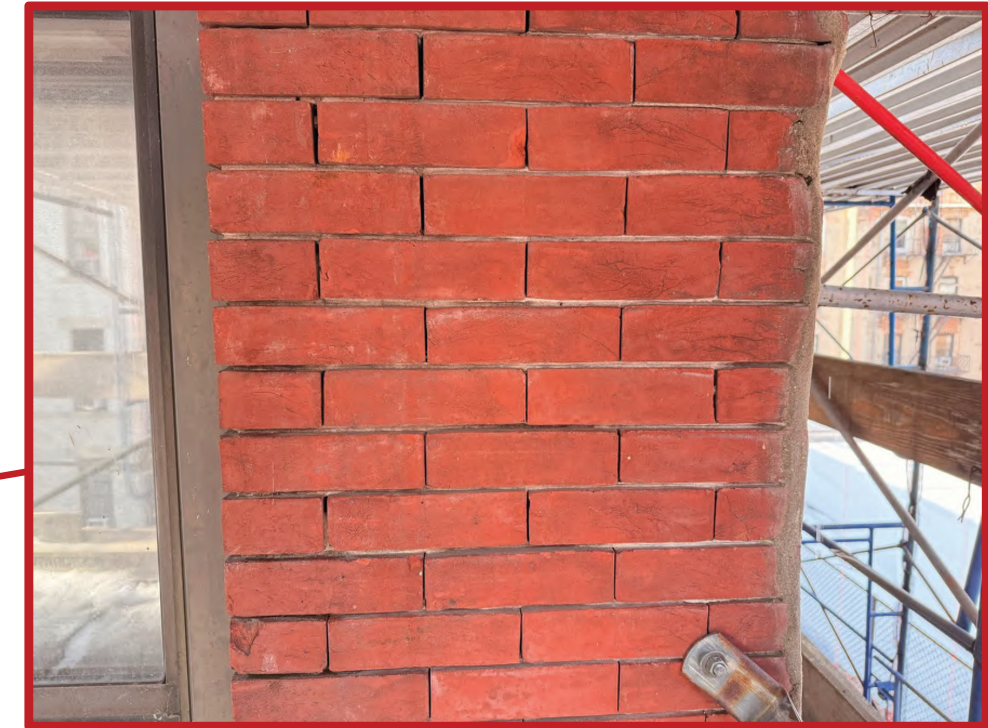
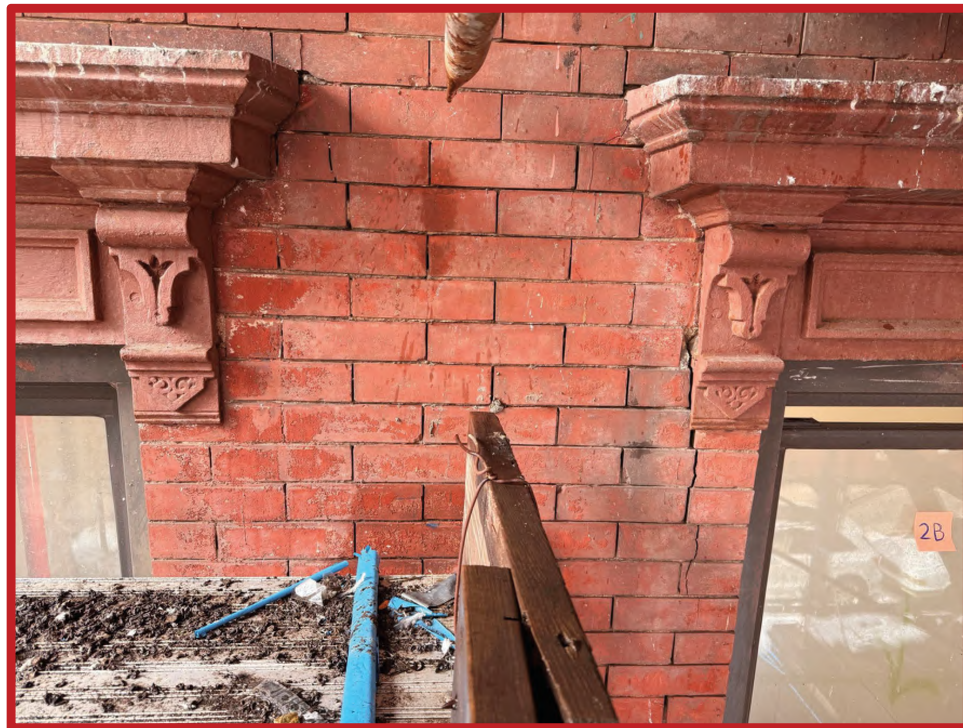
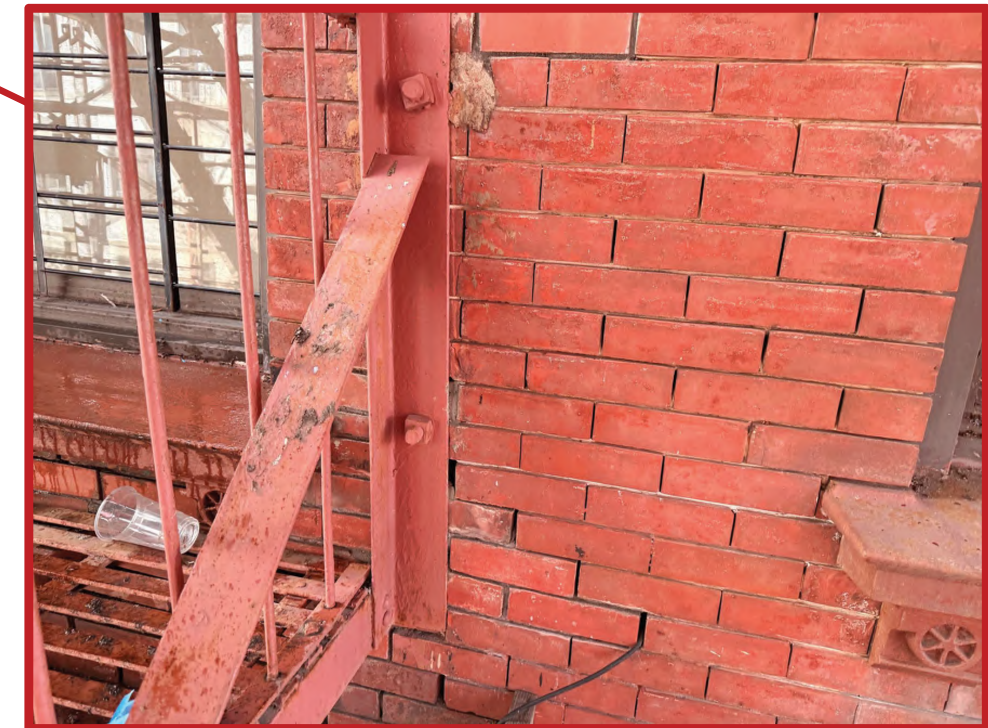
2. BRICK SPALL

3. BRICK CRACK

4. MISSING/
DAMAGED BRICK

5. VERTICAL BRICK
CRACK

7. FORMER COATING
DAMAGE

8. ORGANIC GROWTH
