**131 East 10th Street – St. Mark's-in-the-Bowery Church –  
Individual Landmark – Borough of Manhattan**

# St. Mark's Church in-the-Bowery

75-42  
Continuing  
Maintenance Plan

21 JULY 2026

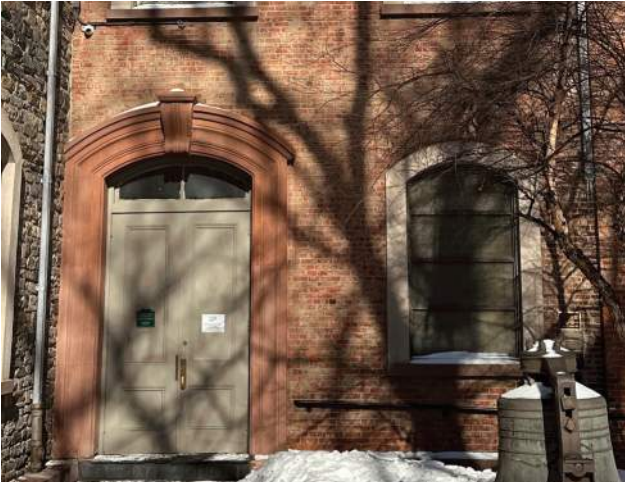
**BRICK WALLS**

The east facade showcases the gable end of the stone wall and brick walls that are in good condition. Wood windows on both buildings are replacements.

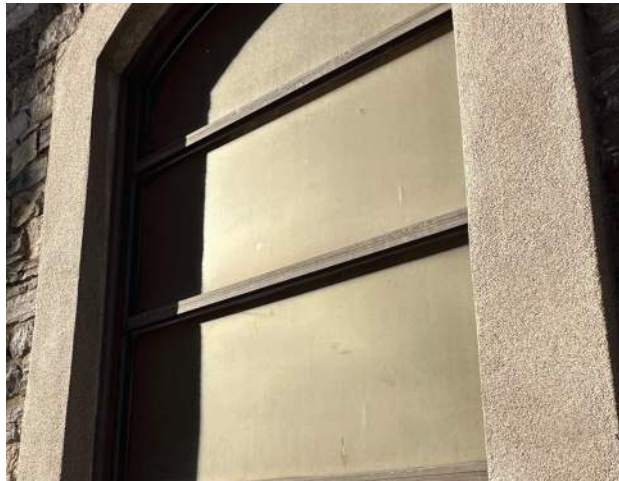
#### PROTECTIVE GLAZING

The typical protective glazing has heavy muntins that do not relate to the existing window frames, plastic glazing that has discolored and darkened, and does not allow ventilation.

**A32** - REPLACE STAINED GLASS PROTECTIVE GLAZING WITH VENTED GLAZING

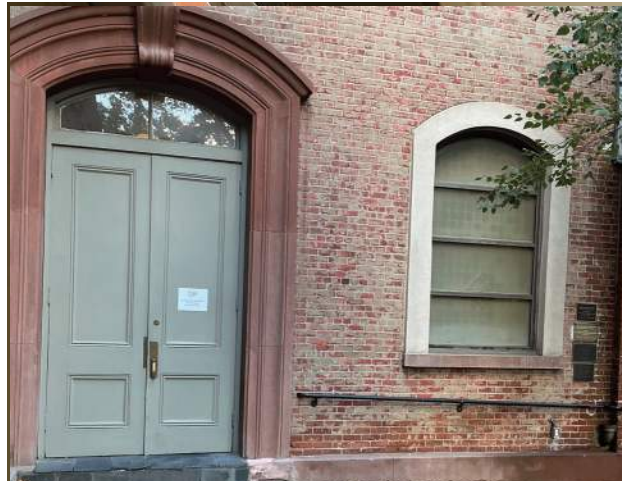
#### WOOD DOORS

Parish Hall entry doors are solid wood, operate soundly, and have functional hardware.

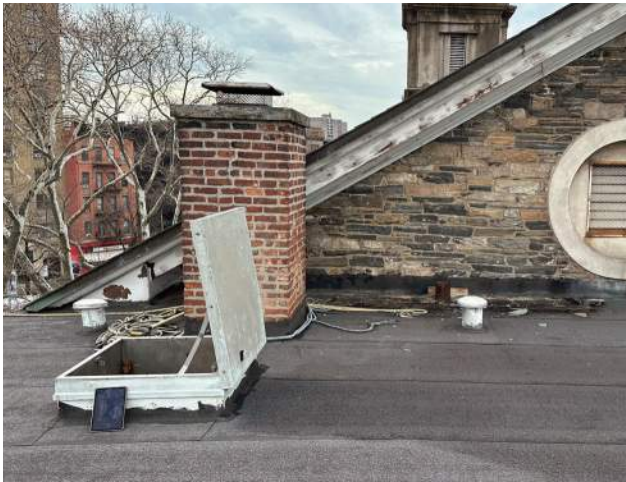
ROOF ACCESS

A hatch opens from the 2FL ballet studio balcony onto the low-slope roof.

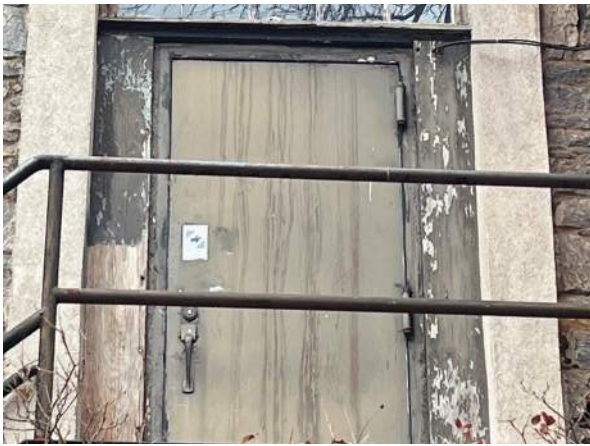
The Parish Hall first floor exit door is mismatched to the historic character of the building, and has deteriorated.

**A16-2** - REPLACE PARISH HALL EGRESS DOOR WITH NEW TO MATCH HISTORIC CHARACTER

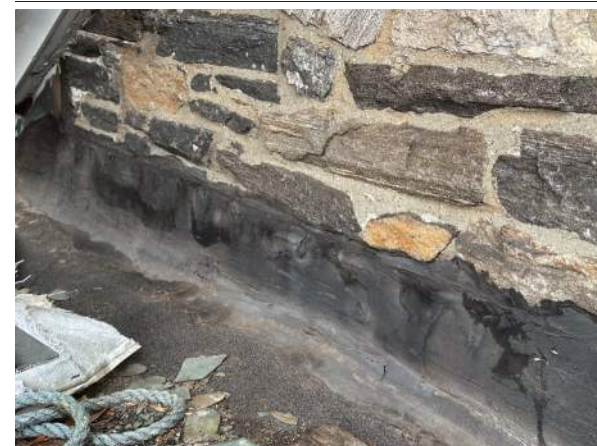
Open seams or other defects were not observed in the low slope membrane, however, water collected at edges and did not have scuppers to direct runoff.

**A15-1** - REPLACE PARISH HALL ROOFING MEMBRANE AT FLAT ROOF

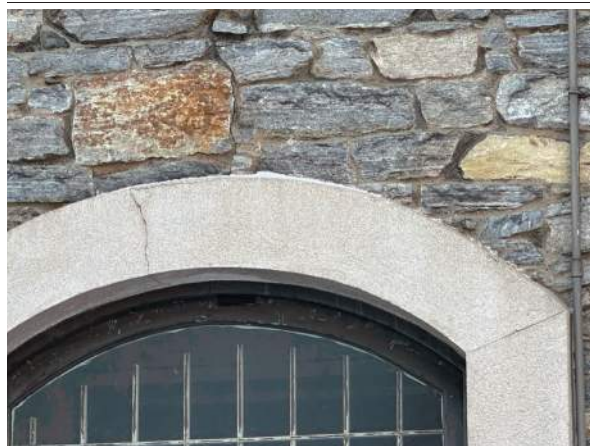
Surrounds have typically cracked at the top of the arch, and horizontally cracked at sills, at both nave and mezzanine level windows.

**A11-1** - REPAIR CRACKS AT STONE MASONRY  
AND AT WINDOW SURROUNDS
