STONE STREET HISTORIC DISTRICT STOREFRONT MASTER PLAN

STONE STREET MASTER PLAN

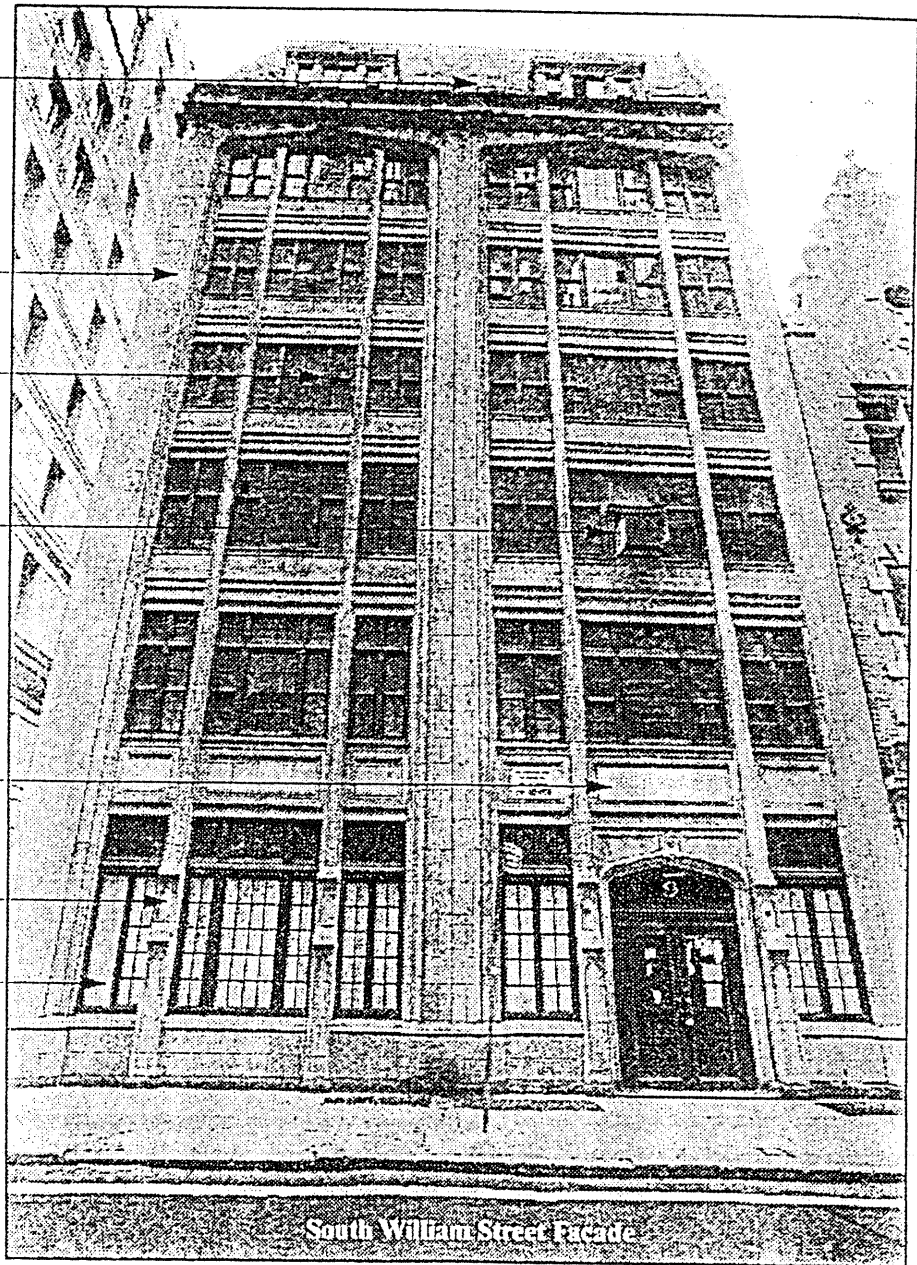
South William Street Facade

- Slate mansard roof
- Limestone veneer
- Wood framed, leaded-glass windows (typical)
- Window-mounted air-conditioning units
- Carved marble panel: "Lehman Brothers"
- Missing light fixture in recessed niche (typical)
- Missing window panes

In 1836, two brick store and loft structures were built on this site and occupied by various importers and merchants. They still exist under the current facades. The southern portion of the Stone Street facade still retains the Greek Revival character of the original building. The neo-Gothic limestone facades on South William Street, Mill Lane, and part of Stone Street date from the extensive 1920's alterations done by William H. McGee to create offices for his marine insurance firm. In 1961, Lehman Brothers expanded from 1 William Street into this building. The firm vacated the building in the 1980's. Remaining over the South William Street entrance is a marble plaque that reads "Lehman Brothers". The existing condition of this facade is very good and most of the original 1920's features remain.

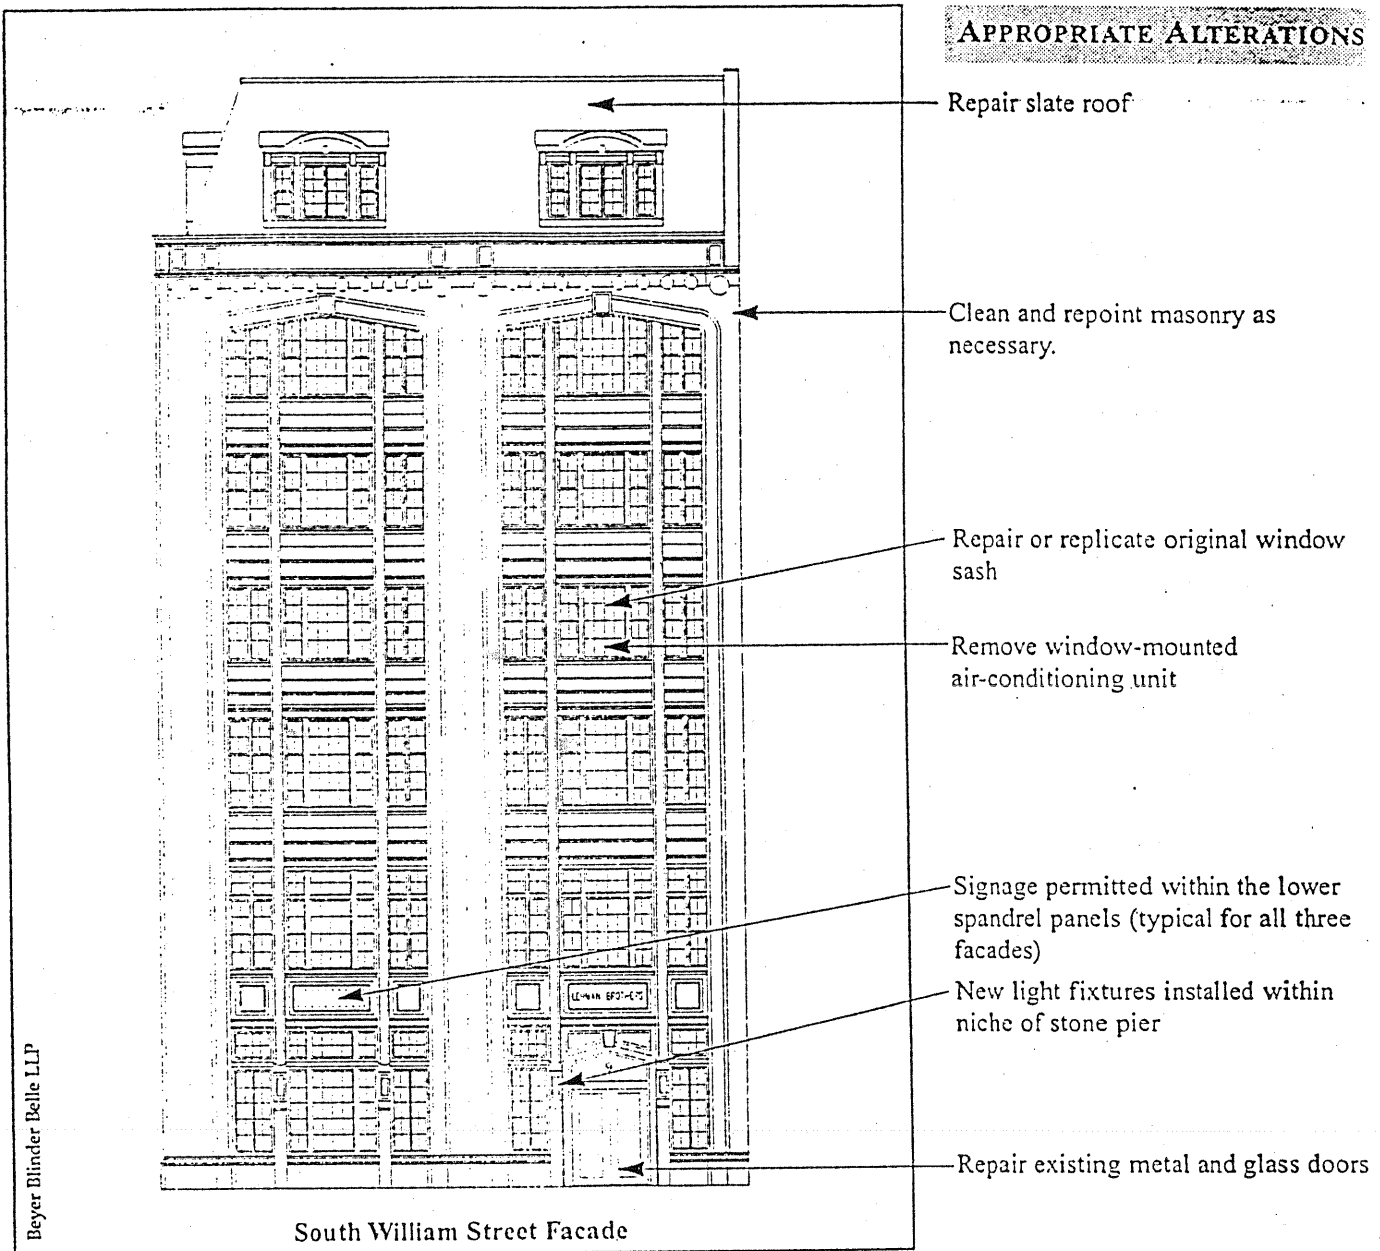
9-11 South William Street/59-61 Stone Street/
1 Mill Lane; Lehman Brothers Building

The existing condition of this facade is very good and most of the original 1920's features remain. The stone piers along street level appear to have accommodated light fixtures, which have since been removed. The painted wood storefront bulkheads beneath the ground floor windows have deteriorated and should be repaired or replicated. There are two vault panels with glass lenses in the sidewalk centered on the building. They are in good condition and should be retained.

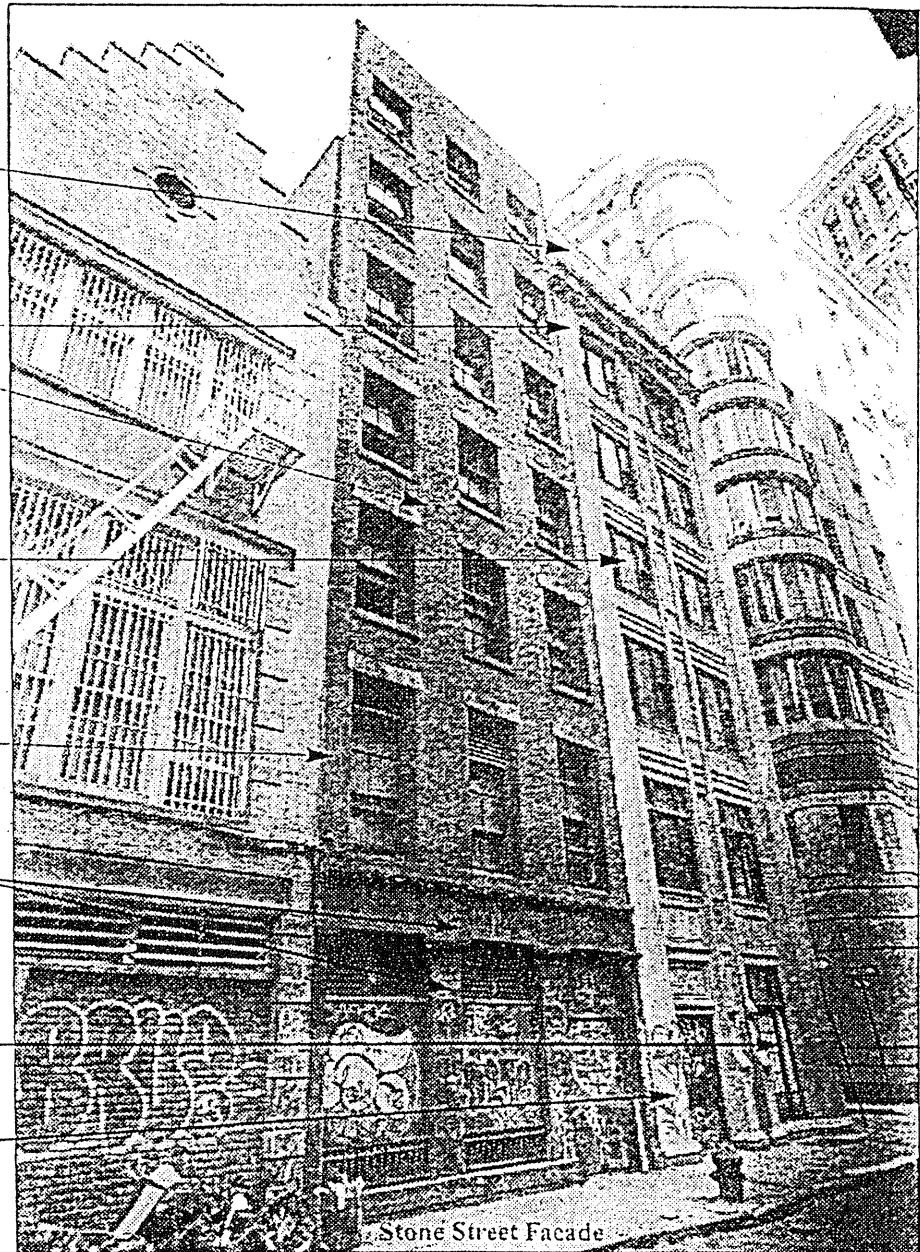
9-11 South William Street/59-61 Stone Street/ 1 Mill Lane; Lehman Brothers Building

- Slate mansard roof
- Limestone veneer
- Missing decorative tie-rod plates
- Painted wood window frames and sash with multi-paned leaded clear glass
- Painted brick and stone facade
- Original granite piers and lintel
- Missing window sash
- Graffiti stained stone

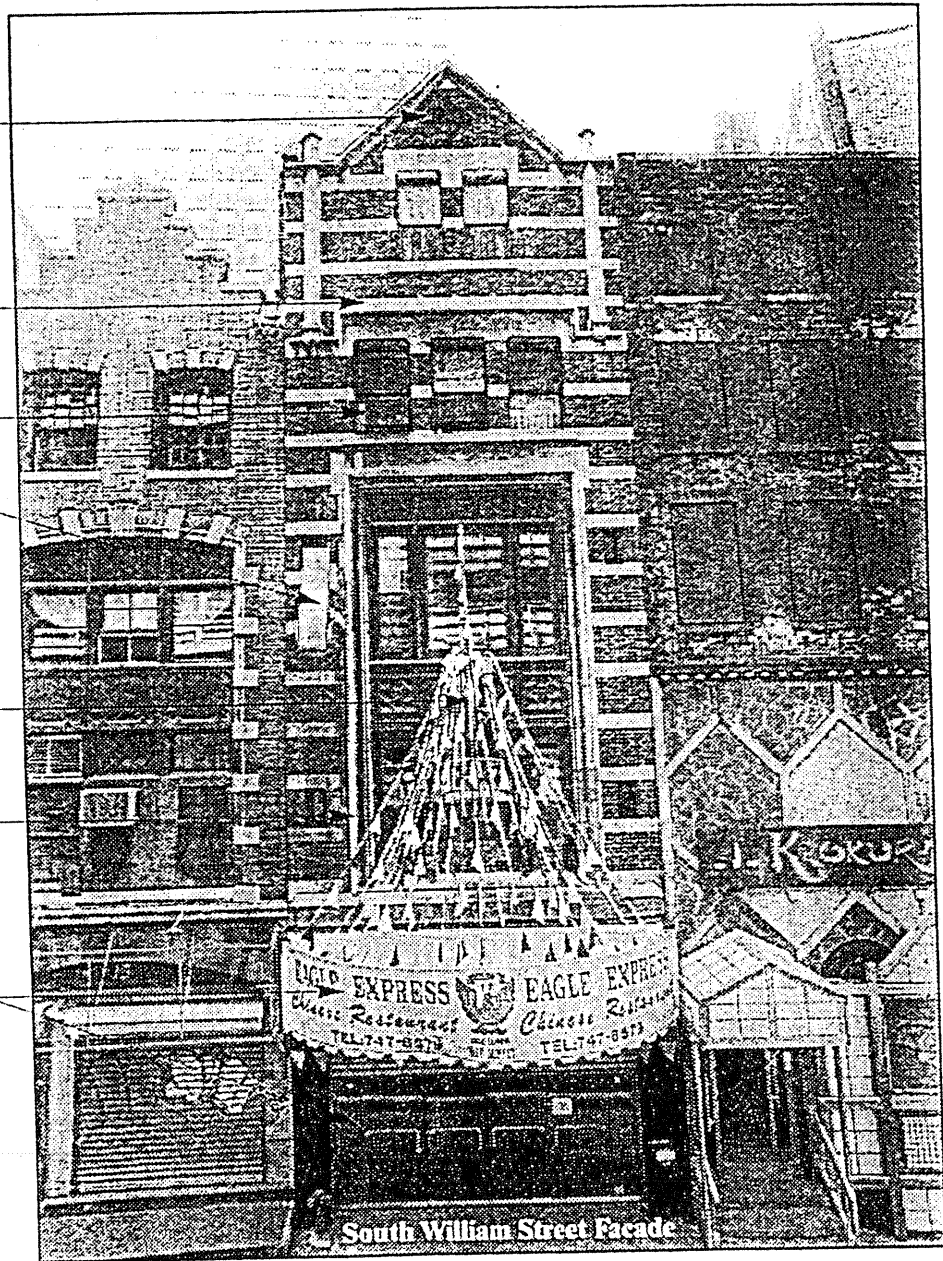
17 South William Street/53 Stone Street

- Iron ornament at gable
- Flemish bond brick and limestone banding
- Window-mounted air conditioning unit
- Modern projecting illuminated signbox
- Carved wood spandrels with date '1905' in center panel
- Molded stone window surround
- Modern storefront and awning

By 1839, this Greek Revival store and loft building was erected and occupied by importing firms. In 1905 the site was acquired by Henry Schaefer, who commissioned architect Edward L. Tilton to remodel the building. The 1839 South William Street facade was replaced with a neo-Renaissance style facade, which remains today on the upper floors. The modern storefront is a recent modification to the facade. The general condition of the facade is good.

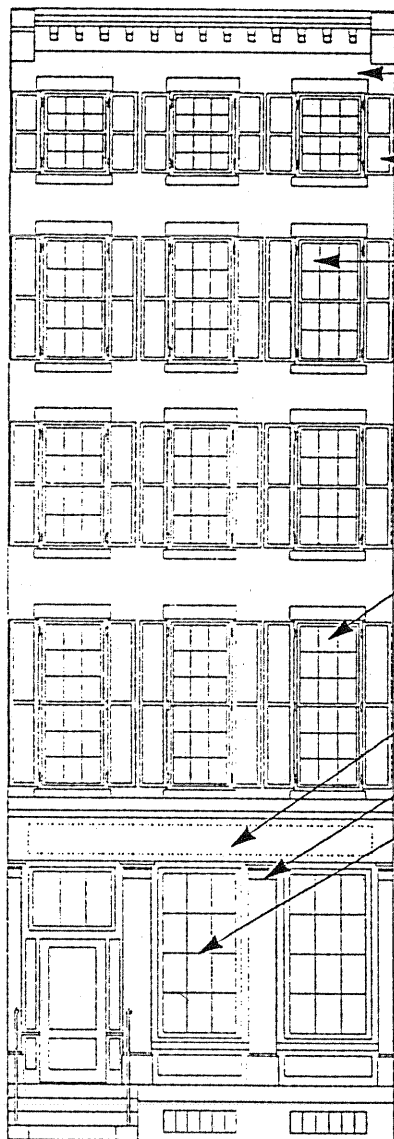
South William Street Facade

By 1839, this Greek Revival store and loft building was erected and occupied by importing and publishing firms. In 1905, the building was owned by Amos F. Eno and contained a wholesale wine store and offices above. Restaurants have occupied the site for many years. Both the South William Street and the Stone Street facades retain their original Greek Revival character at the upper stories. The existing condition of the facade is poor due to extensive alterations made to the lower floors.

- Remove paint, clean, and repair brick and stone facade
- Install new metal fire shutters at windows (typical)
- Install new double-hung windows (typical)
- Remove existing two-story storefront and signage; restore original second floor window openings
- Permitted surface-mounted sign location
- Install new granite piers and lintel
- Install new storefront and entrance steps

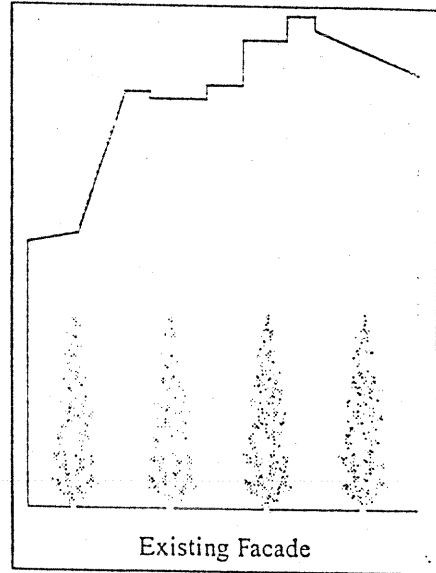
Existing Facade

This facade, once a party wall, was exposed during the demolition of the adjoining building and construction of the Goldman Sachs development. The blank brick wall is a dominant presence on the plaza, and detracts from the overall quality of the plaza and streetscape. The existing condition of the wall is fair.

Alternative improvement:

1. English columnar oak trees and ivy planted along base of the party wall, as shown below (easement needed);

It should be noted that since these are lot-line windows, a NYC Building Department variance is required and/or an easement must be procured from the owner of the adjoining property, Goldman Sachs, before these windows can be installed.

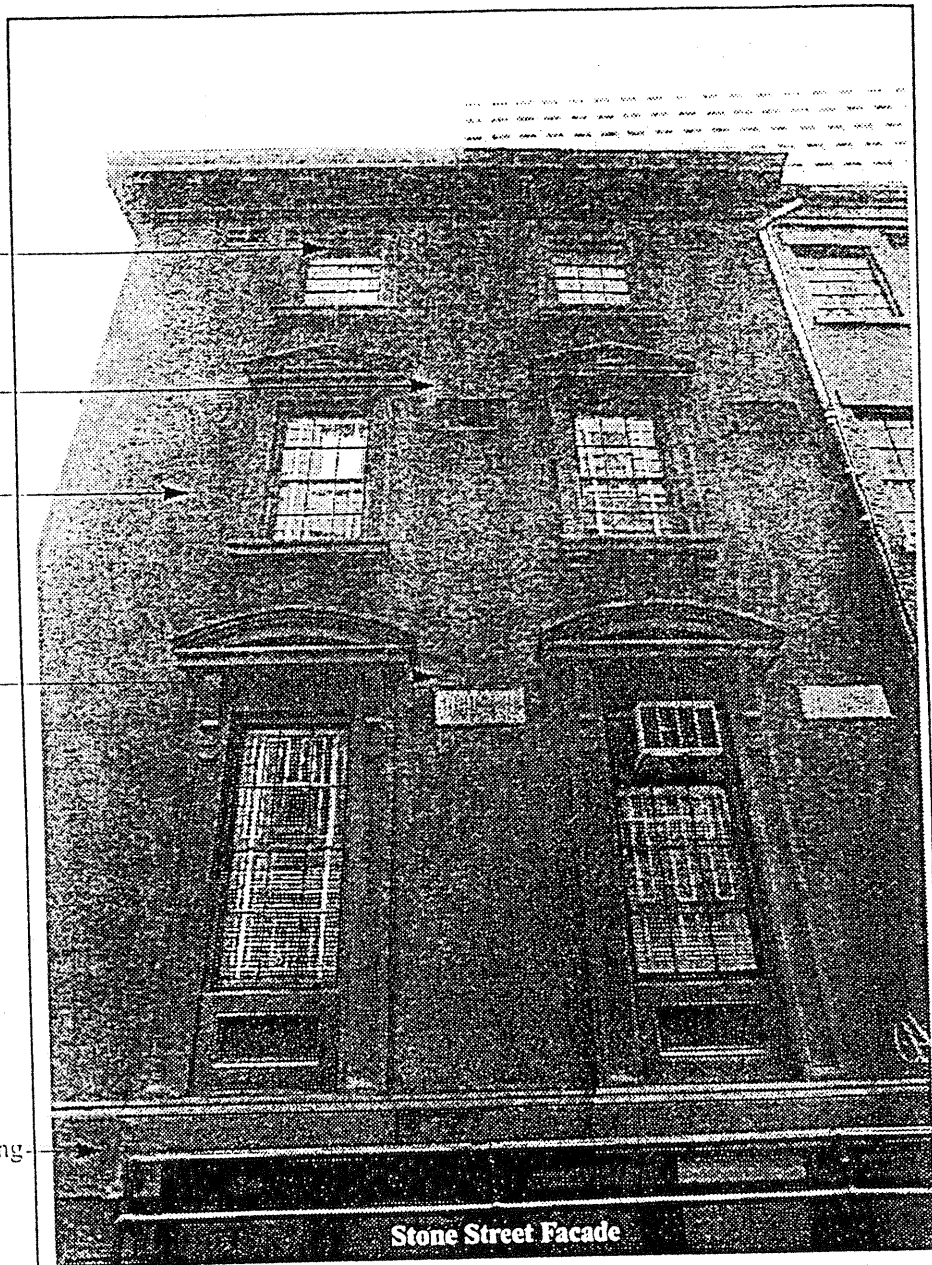
1 Hanover Square/66 Stone Street/101 Pearl Street India House

Through-the-wall
air-conditioning units (typical)

Patching at location of
removed through-the-wall
air conditioning units (typical)

Alterations to the original facade include: applied dark brown elastomeric wall coating, removal of original parapet, installation of through-the-wall air-conditioning units, and replacement of the original double-hung wood windows. The existing condition of the exterior wall surface is poor.

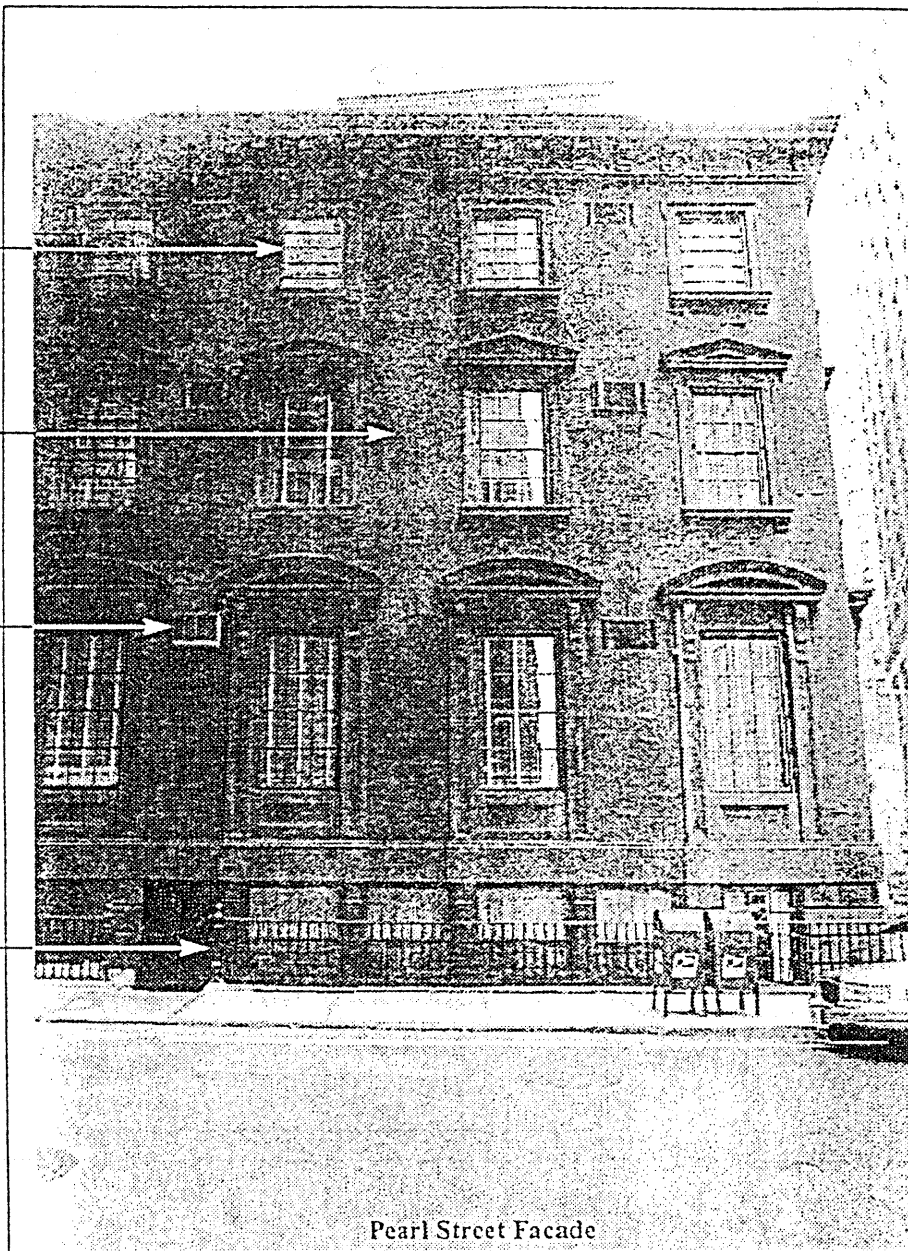
1 Hanover Square/66 Stone Street/101 Pearl Street India House

Upper floor windows replaced
with fixed aluminum windows

Through-the-wall
air-conditioning units (typical)

Alterations to the original facade include: applied dark brown elastomeric wall coating, removal of original parapet, installation of through-the-wall air-conditioning units, and replacement of original double-hung wood windows.

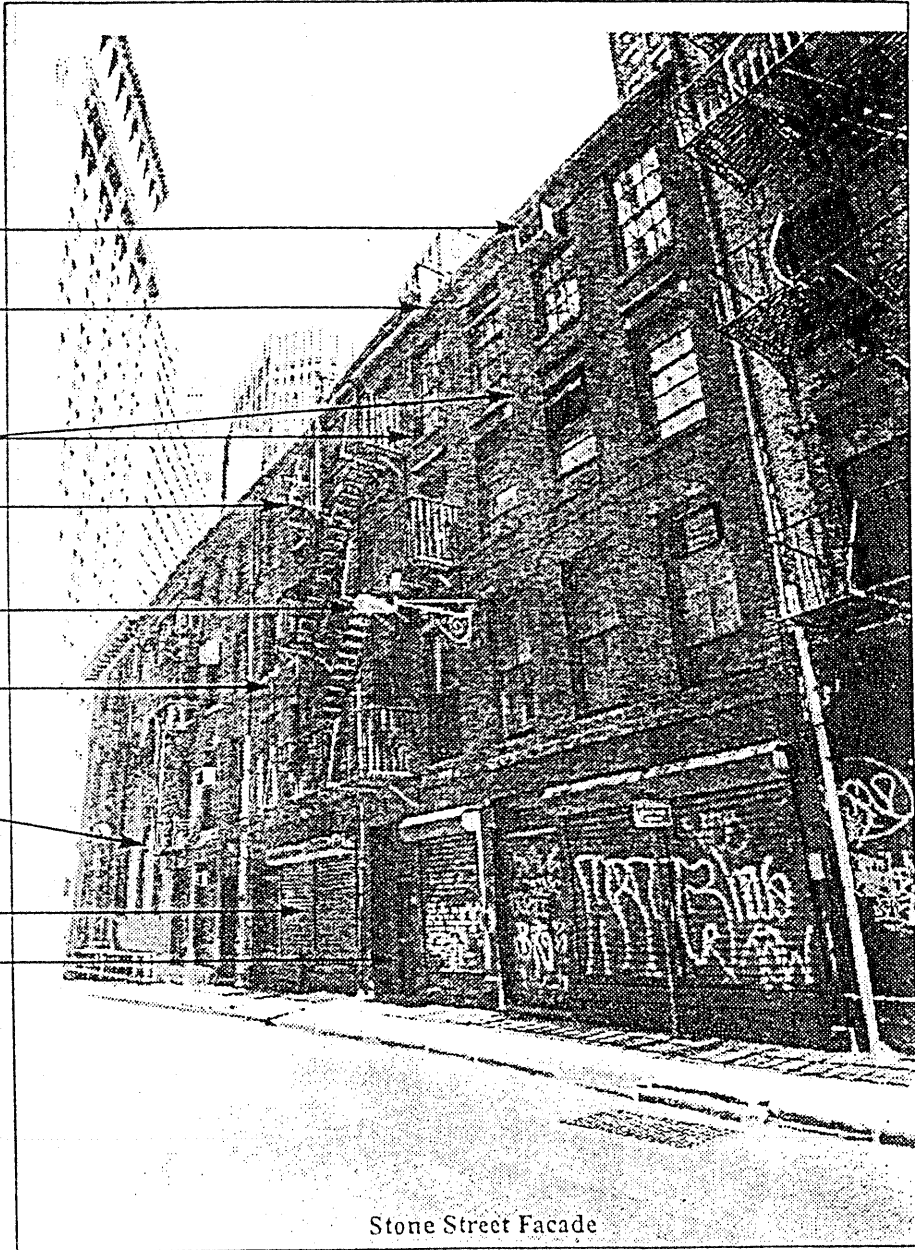
Stone Street Facade

- Window-mounted air-conditioning units
- Corbeled brick cornice
- Original window shutter pintles (hinges) and star-shaped tie-rods
- Painted metal fire escape
- Historic black painted metal 'Westchester bracket' streetlight (altered)
- Painted brick facade
- Historic metal sign bracket
- Security grilles and housing
- Altered original wood paneled doors

Repair existing historic
fire escape

Repair existing historic
Westchester light bracket

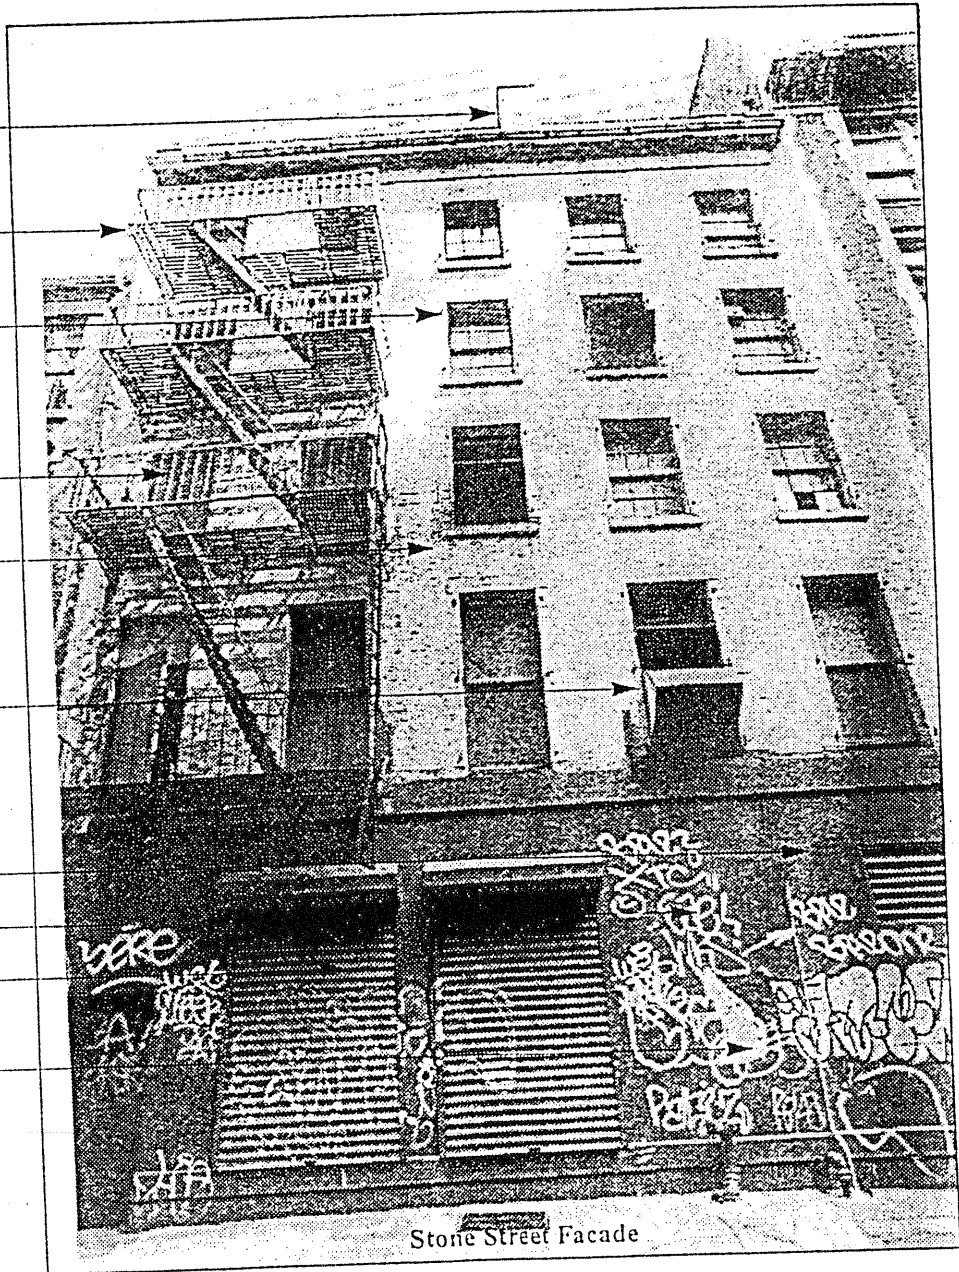
Stone Street Facade

Security grilles and exposed housing

Graffiti

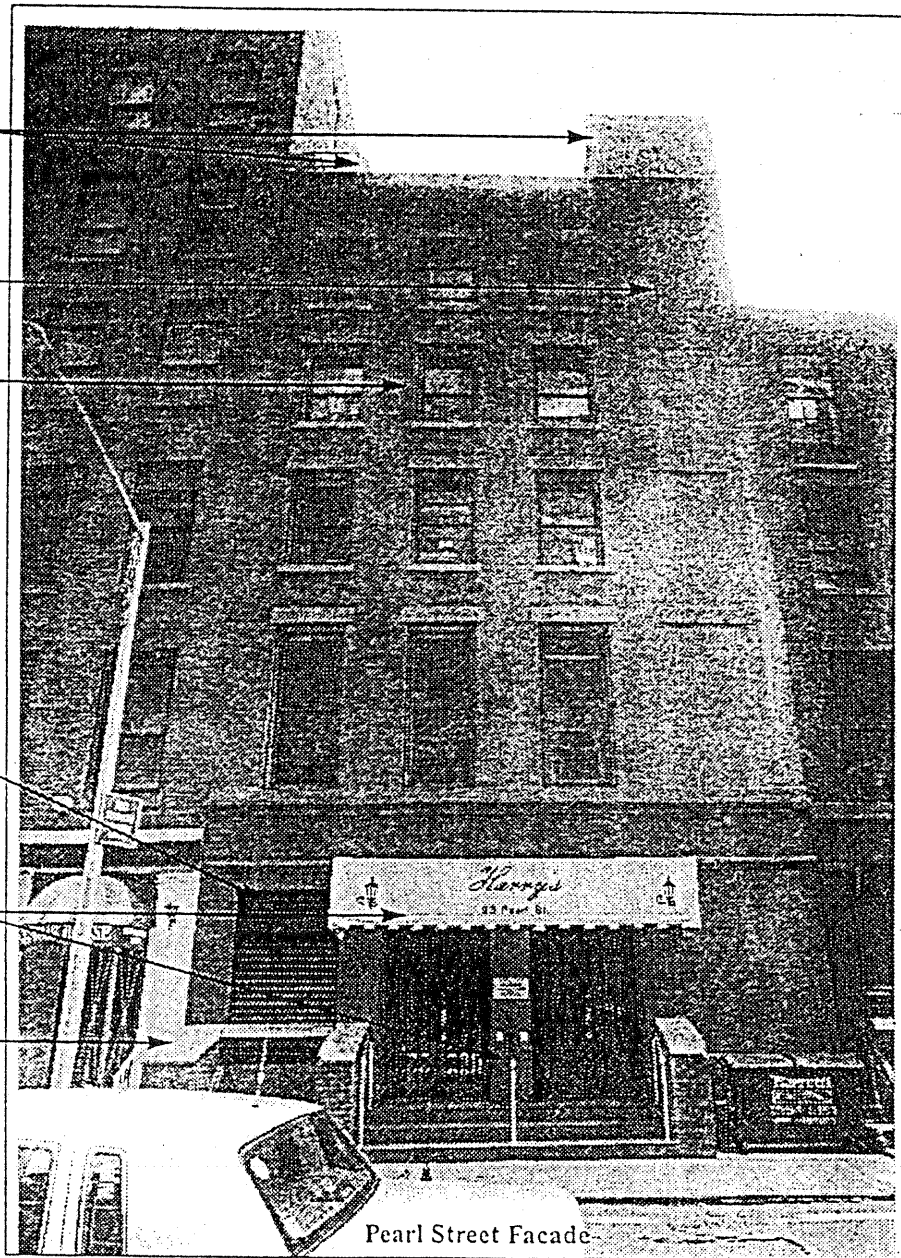
91-93 Pearl Street/58 Stone Street

Modern tiled entrance stairs; metal railings and awning

Modern brick wing walls at cellar and entrance stairs

Modifications to this facade over the years include new brick wing walls at the secondary entrance to the ground floor commercial space. The northern end bay of windows has been blocked and a new roof bulkhead is visible from the street level. The original brick facade has been stuccoed over.

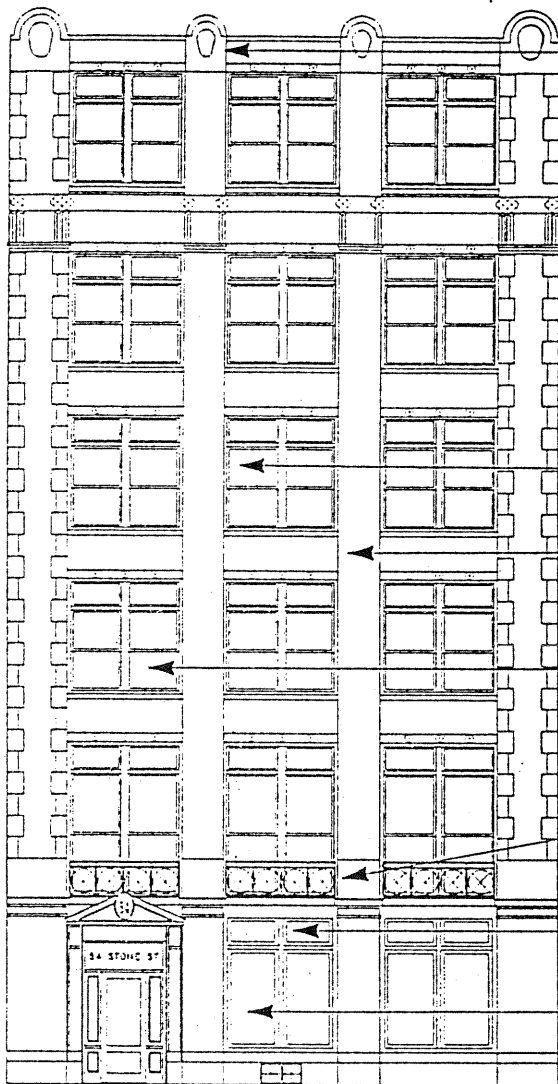
Stone Street Facade

- Cracks indicating structural movement of parapet
- Altered original windows
- Modern metal flagpole
- 1919 brick and limestone facade
- Flood lights and exposed conduit
- Historic ironwork
- Exposed security grille housing
- Modern entrance doors
- Paint and graffiti-marred stone piers

In 1919, Percy Chubb bought and altered the property to accommodate his marine underwriters firm. The Stone Street facade was rebuilt in the neo-Renaissance style while the Pearl Street facade was not renovated as extensively. These alterations by architect A.C. Jackson still remain today. More modern alterations have since occurred at the storefront level on both street facades.

Investigate structural movement of parapet; repair as necessary

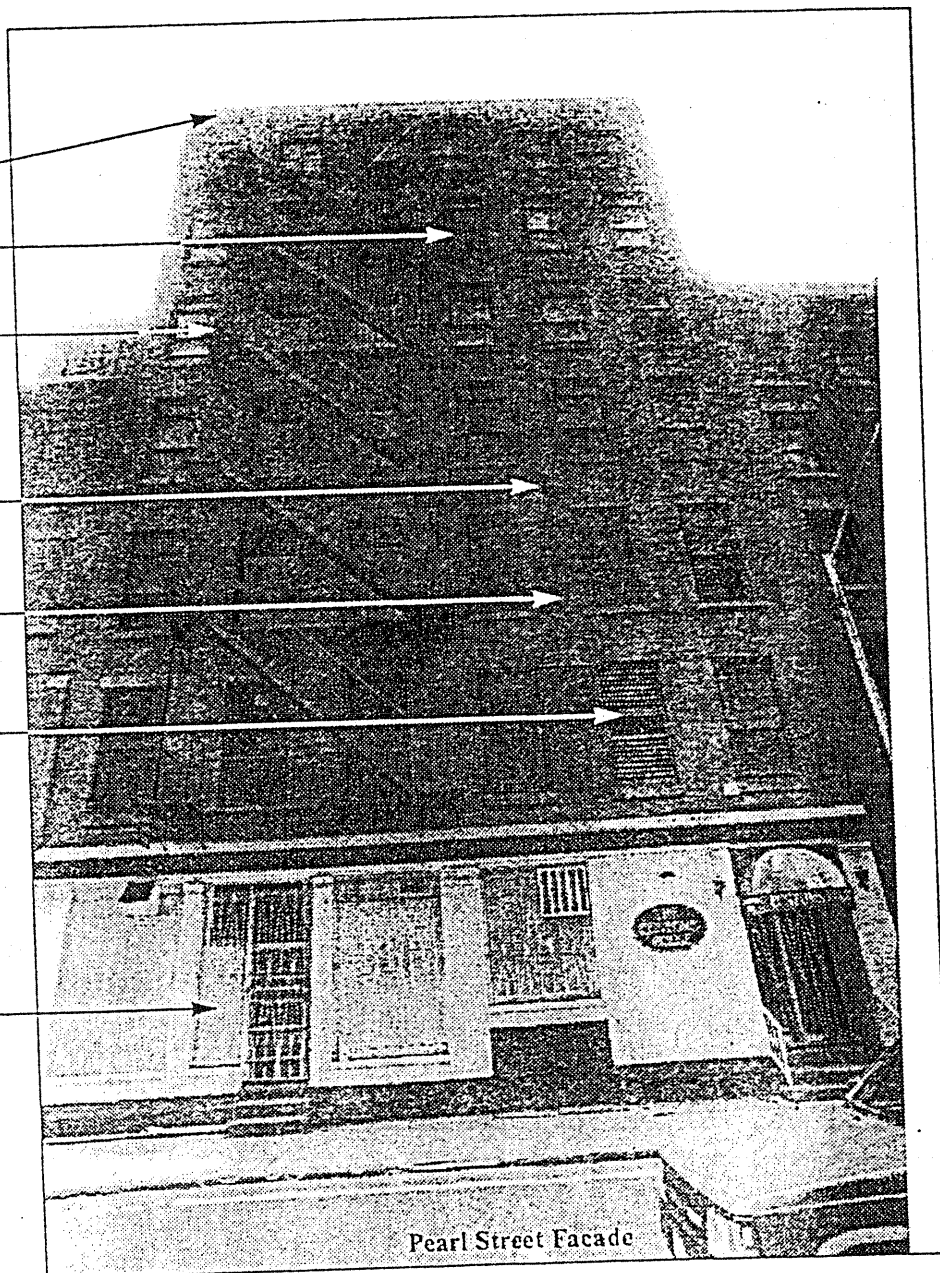
89 Pearl Street/54 Stone Street

Louvered window opening

Extensive storefront alterations

This facade retains some of its original facade elements but extensive alterations at the storefront level have eliminated much of its original Greek Revival character. The 1919 alteration included adding a seventh floor with window openings not aligned with the lower floor windows. The existing condition of the facade is good.

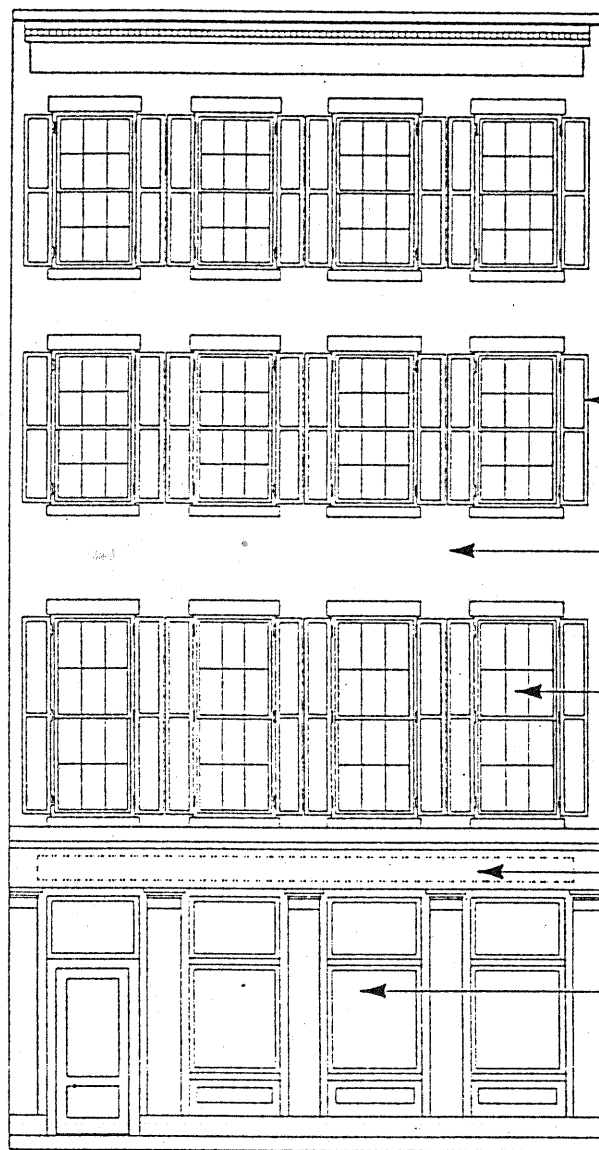
- Denticulated brick cornice
- Damaged brick (typical)
- Original window shutter pintles (hinges)
- Painted and soiled facade
- Blocked window openings with vents
- Exposed security grille and housing
- Blocked and stuccoed storefront

Install new painted metal shutters

Clean and repair damaged brick facade

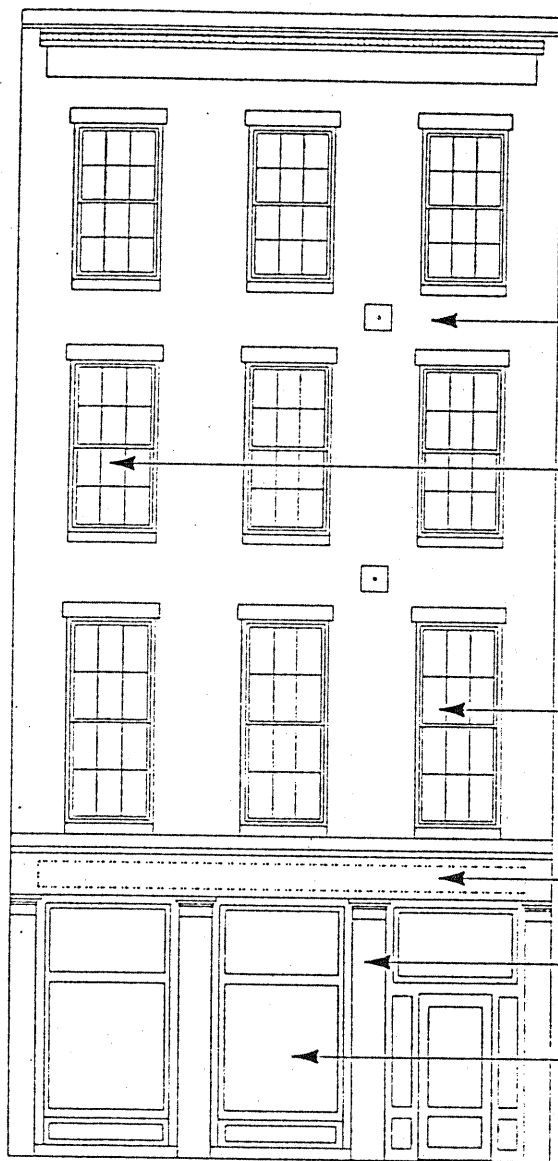
The Stone Street facade still retains its original Greek Revival elements on the upper stories. The storefront has been extensively altered, with the windows blocked and the surfaces covered in stucco. A modern metal fire escape further detracts from the facade. Probes should be made to verify if any of the original storefront elements remain.

Clean and repair brick facade

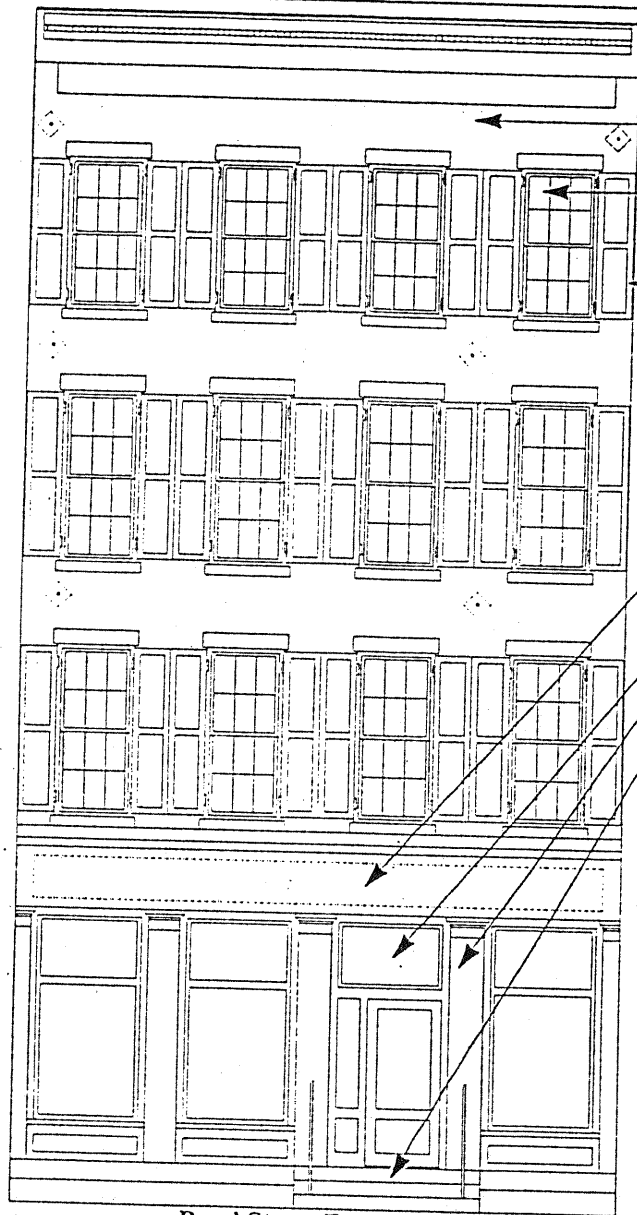
Pearl Street Facade

The original Greek Revival character remains only on the upper two floors. The lower two floors, including the storefront entrance, have been extensively altered. Probes should be made to verify if any of the original facade and storefront elements remain.

- Clean and repair brick and stone facade
- Restore original window openings and install double-hung windows (typical)
- Install new metal window shutters
- Permitted surface-mounted sign location
- Install new storefront; Remove existing stairs and replace with stone/metal stairs parallel with street and building facade; Restore granite lintel and piers.

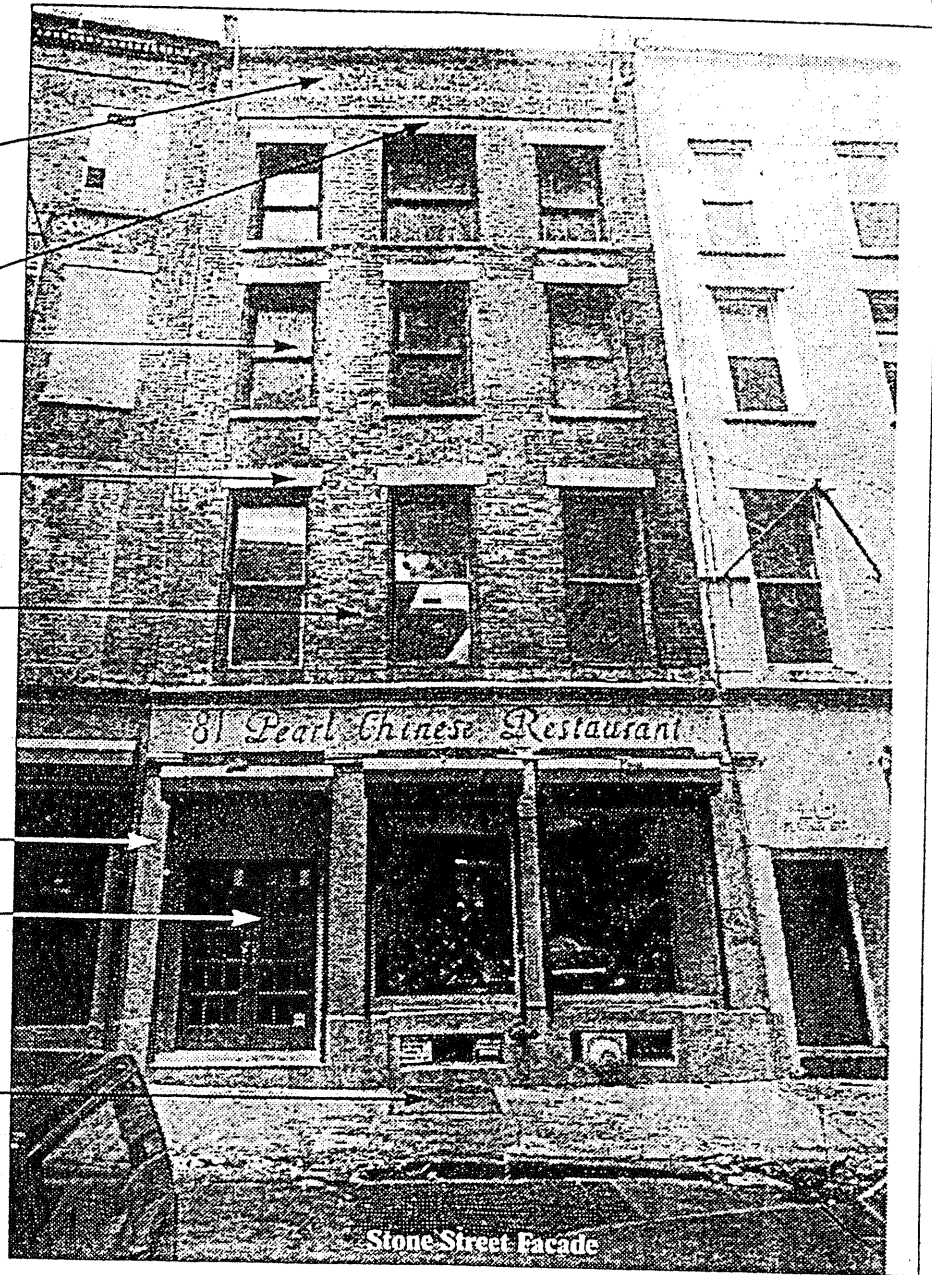
Stone Street Facade

Modern storefront and entrance

Metal access door in sidewalk

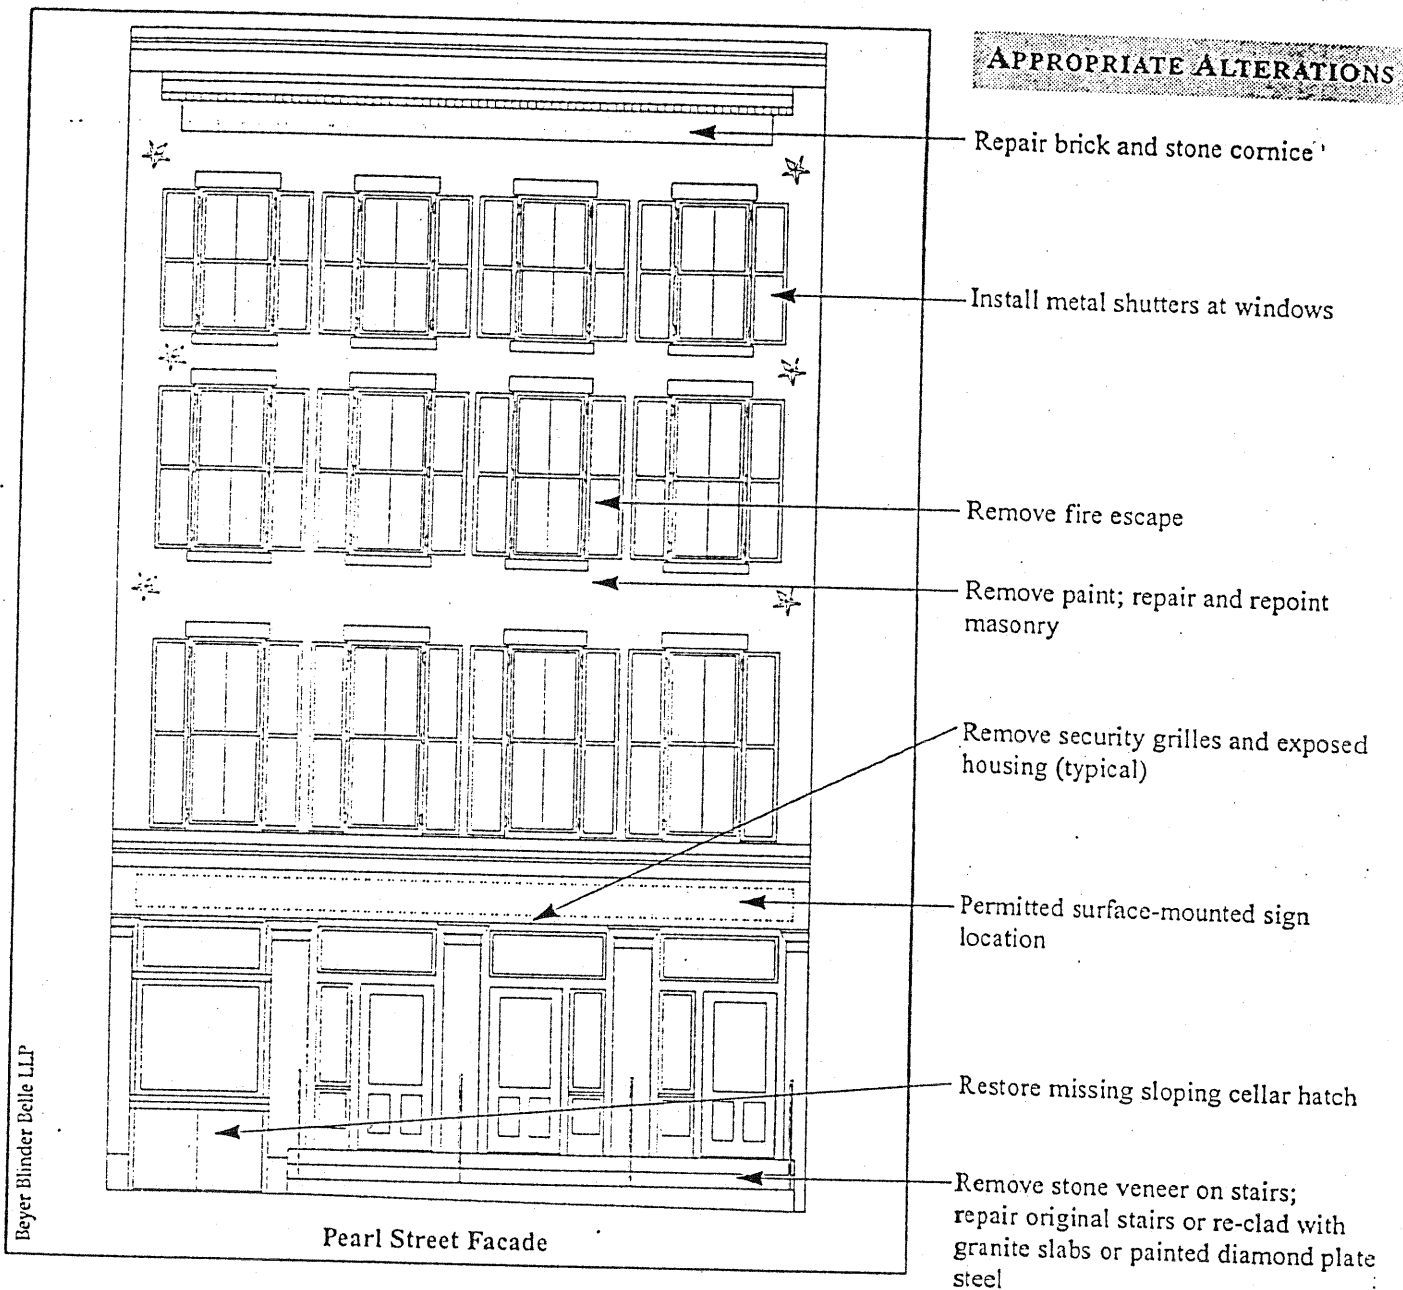
81 Pearl Street/48 Stone Street

The Pearl Street facade retains most of the original Greek Revival elements. The storefront has been altered but the original granite piers and lintel remain. The modern metal fire escape detracts from the facade.

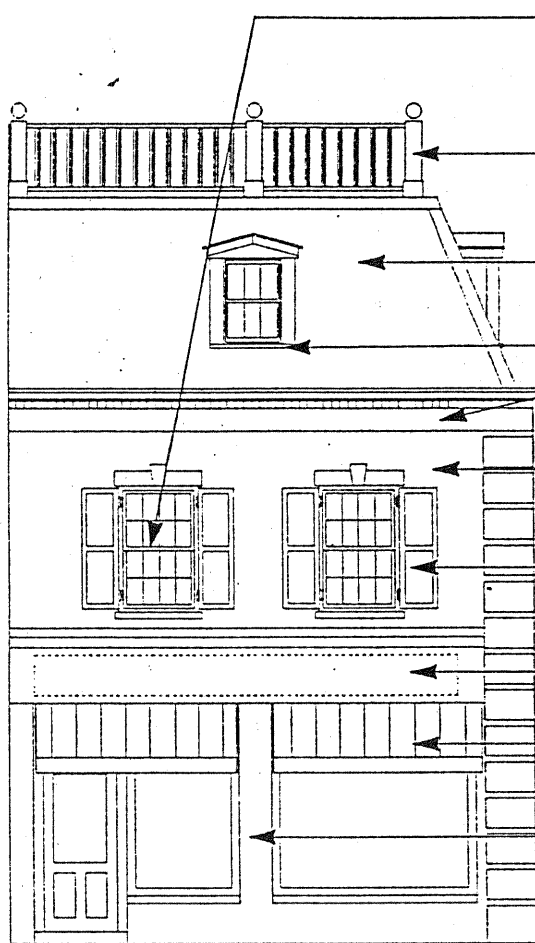
Stone Street Facade

This building was built in 1836, as were 79 and 81 Pearl Street. In 1982, in response to an Unsafe Building Notice issued by the Buildings Department, the upper floors were removed, making the former five-story building a two and one-half story building. During this alteration, the three facades were extensively remodeled. This work included installation of new brick veneer, new window openings, and new mansard roof. The condition of the facade is good, but the materials and detailing do not relate to the building's original Greek Revival design, nor are they compatible with the surrounding historic buildings.

- Remove fire escape, second floor door, and awning; install double-hung window
- Replace existing metal bar railing with a white-painted milled wood balustrade with finial posts
- Replace asphalt roofing shingles with slate or quality simulated slate shingle
- Replace aluminum trim with painted wood trim; remove awning; add wider architrave under dentil course
- Paint the brick veneer to reduce the wide color range present
- Install new wood or metal shutters at second floor window openings
- Install new storefront cornice and signage band; remove existing signage
- Install new awnings between building piers
- Install new piers centered on second floor window openings

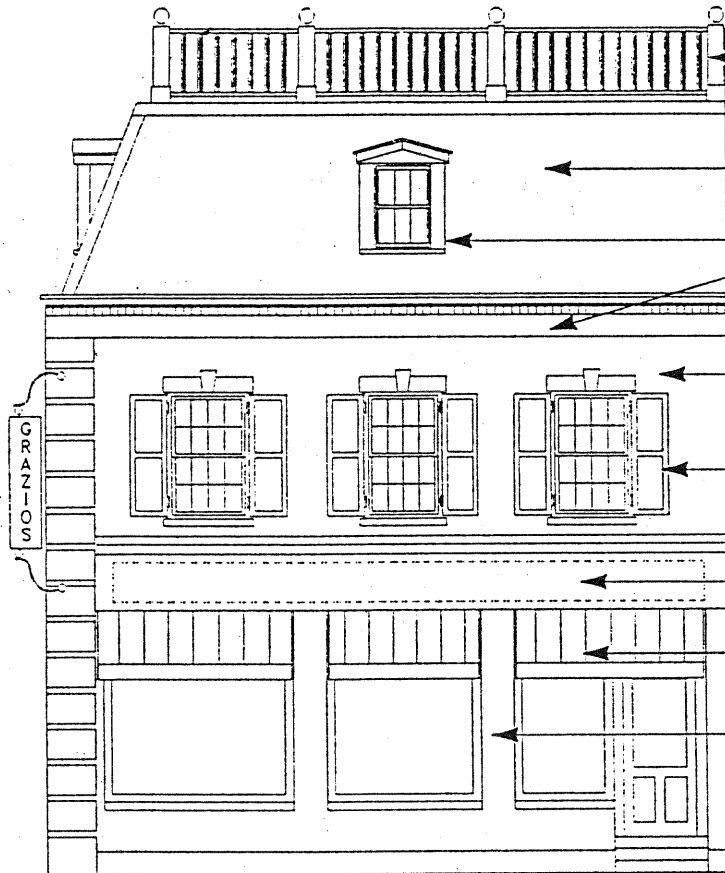
This Pearl Street facade, like the other street facades, dates to 1982. The condition of the facade is good, but the materials and detailing do not relate to the building's original Greek Revival design, nor are they compatible with the surrounding historic buildings.

- Replace existing metal bar railing with a white-painted milled wood balustrade with finial posts
- Replace asphalt roofing shingles with slate or quality simulated slate shingle
- Replace aluminum trim with painted wood trim; add wider architrave under dentil course
- Paint the brick veneer to reduce the wide color range present
- Install new wood or metal shutters at second floor window openings
- Install new storefront cornice and signage band; remove existing signage
- Install new awnings between building piers
- Install new piers centered on second floor window openings
