STONE STREET HISTORIC DISTRICT STOREFRONT MASTER PLAN

STONE STREET MASTER PLAN

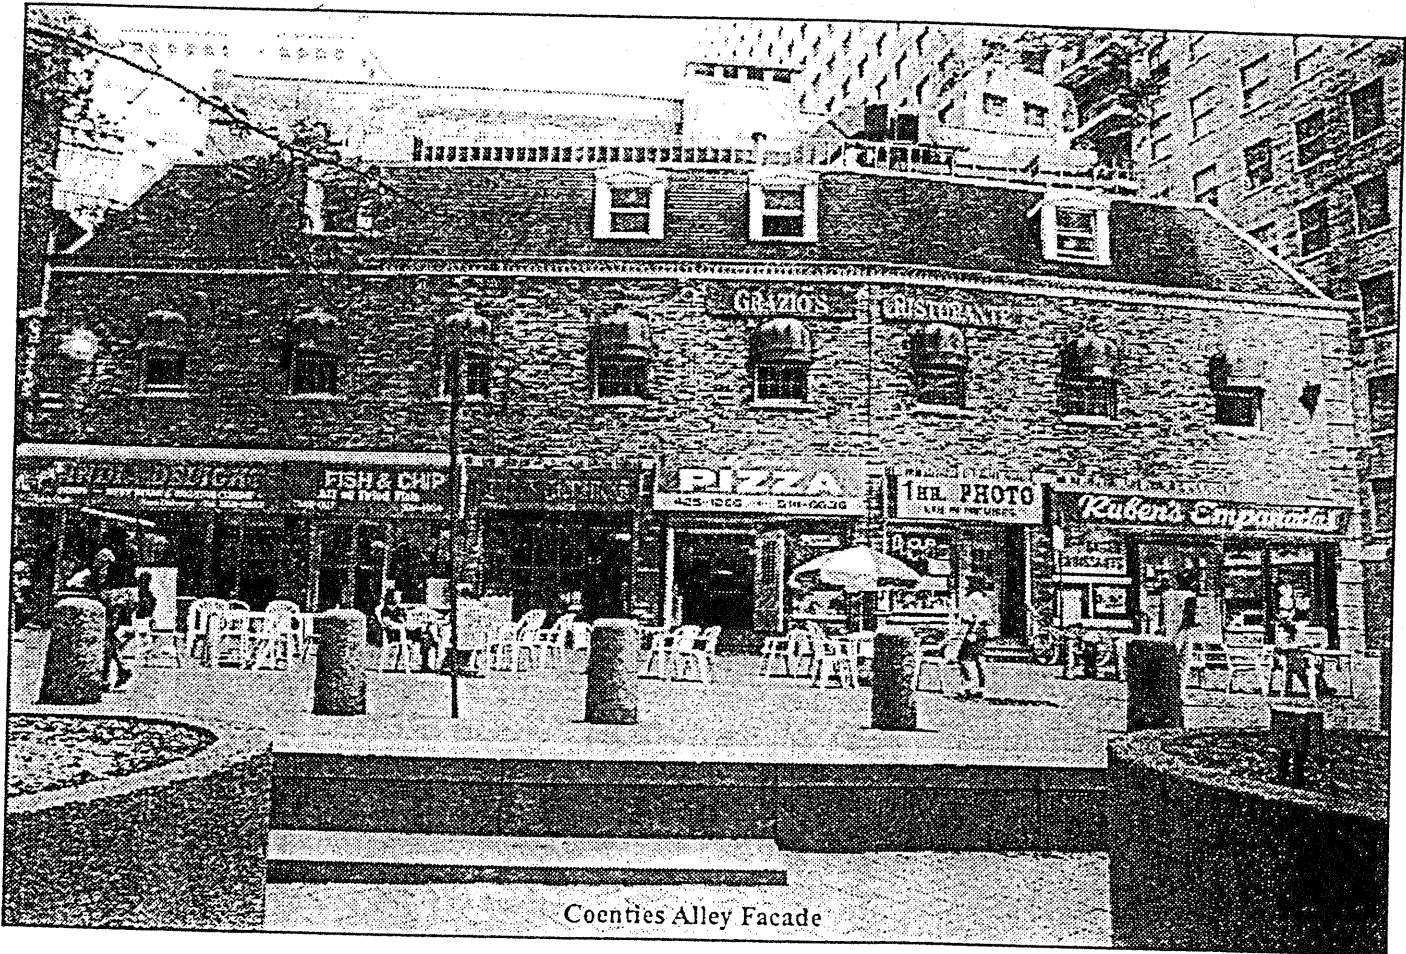
Coenties Alley Facade

The condition of the existing facade is good, but the materials and detailing do not relate to the building's original Greek Revival design, nor are they compatible with the surrounding historic buildings.
