EXHIBITS TO APPLICATION STATEMENT

West Park Presbyterian Church
165 West 86th Street, Manhattan
Block 1217, Lot 1

Application to Landmarks Preservation Commission
Pursuant to Administrative Code § 25-309 for a Notice to Proceed
Authorizing Demolition on the Grounds of Insufficient Return

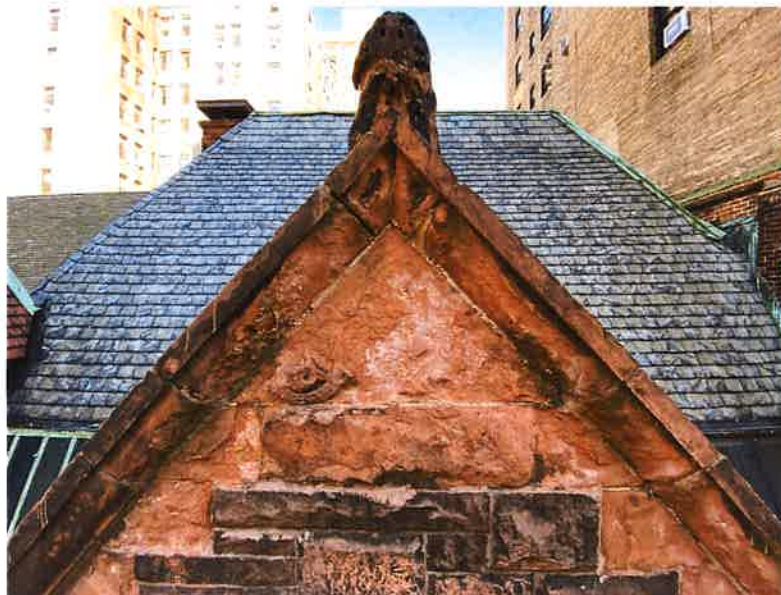
- Façade MD visited the site on November 9th, 10th and 11th and reviewed the façade and roofs from the basket of a lift. We reviewed the south façade of the chapel and noted that there is an ornamental sandstone, located at the top of the of the façade, at the end of the roof ridge beam, which is cracked and spalled. The stone is approximately 2' wide, 2' deep and 36" tall.

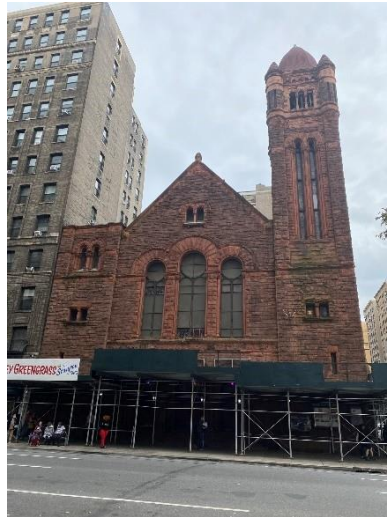
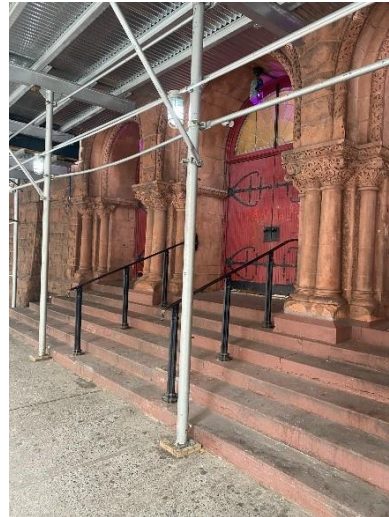
Amsterdam Ave. The front entrance off Amsterdam Avenue was not accessible due to several steps at the entrance. Steps and stairs are not allowed in an accessible route (NYCBC 1104.1, ANSI 402.2; 2010

Standards 402.2).

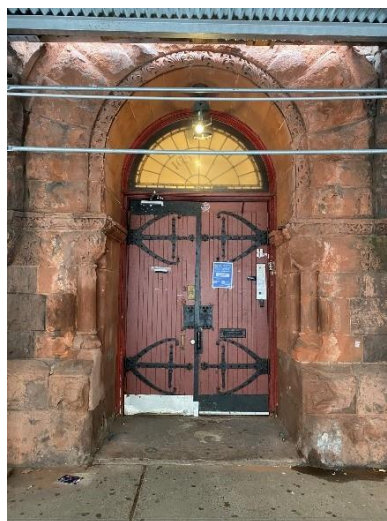
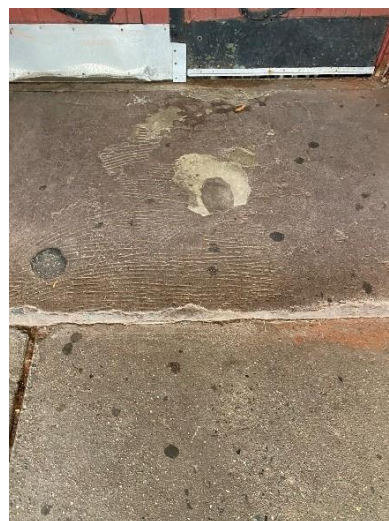
West 86th Street. The side entrance off W 86th was not accessible due to the door clear width and threshold. While this entrance was at the same elevation as the corner entrance to the Sanctuary, the double doors and thresholds were not compliant. Door openings intended for user passage must provide a clear width of 32 inches minimum measured between the face of the door and the stop, with the door open 90 degrees (ANSI 404.2.2; 2010 Standards 404.2.3). Threshold and changes in level must not exceed 1/2 inch maximum in height. The bottom 1/4 inch is allowed to be vertical and the uppermost 1/4 inch must be beveled at a slope not to exceed 1:2. (ANSI 404.2.4; 2010 Standards 404.2.5)

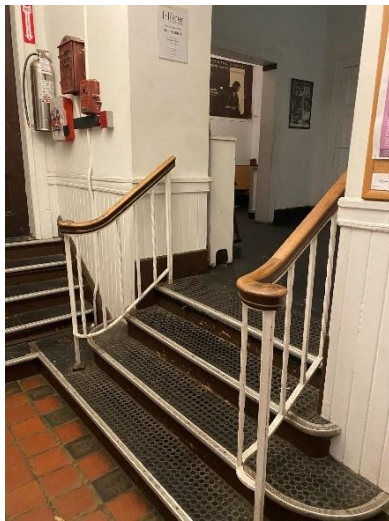
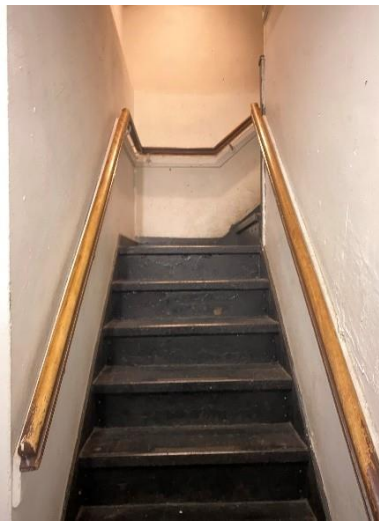
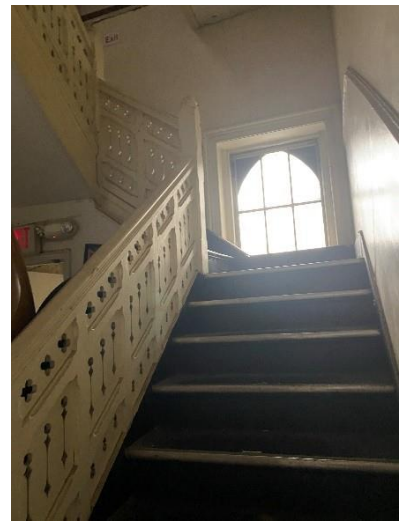
Accessible Route. At least one accessible route must connect accessible building or facility entrances with all accessible spaces and elements within the building or facility which are otherwise connected by a circulation path (NYCBC 1104.1; 2010 Standards 206.2.4). Accessible routes must consist of one or more of the following components: walking surfaces with a running slope not steeper than 1:20, doorways, ramps, curb ramps excluding the flared sides, and elevators. Platform lifts are allowed in limited applications. Steps and stairs are not allowed in an accessible route (ANSI 402.2; 2010 Standards 402.2).

Once inside the building, no accessible route connects the sanctuary to any other levels of the building, including the other half of the first floor.

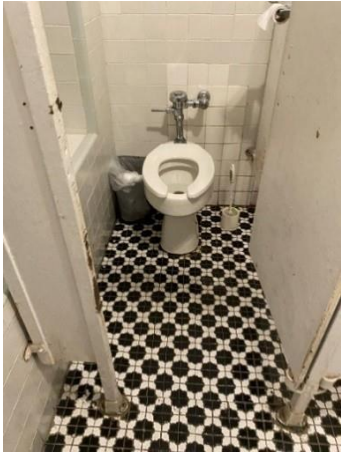
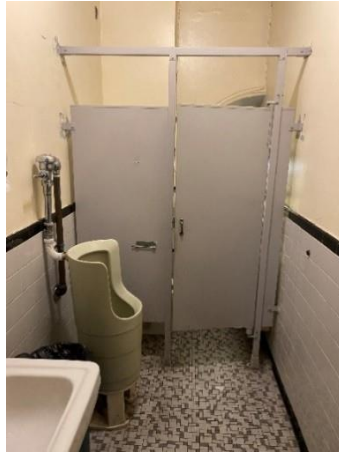
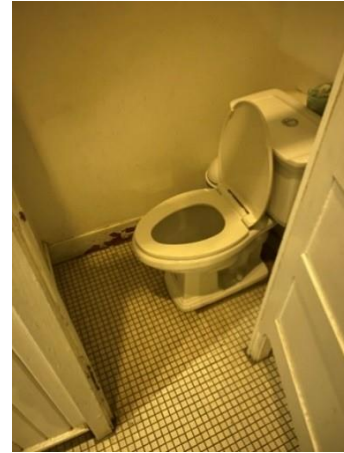
Toilet Rooms. No toilet rooms in the building were accessible. All toilet and bathing rooms are located up or down a flight of stairs from the 86th Street entry level. Where toilet or bathing rooms are provided, each toilet or bathing room must be accessible (NYCBC 1109.2; 2010 Standards 213.2). In alterations, the ADA allows, where it is technically infeasible to provide an accessible toilet room or bathing room, altering existing toilet or bathing rooms is not required where a single accessible unisex toilet room or bathing room is provided and located in the same area and on the same floor as existing inaccessible toilet or bathing rooms (2010 Standards 213.2 Exception 1). Please be aware that the NYCBC does not include a similar alternative. In CCI's experience, the DOB has allowed the use of single unisex toilet room or bathing room in some existing conditions. If the design team plans on using the 2010 Standards alternative, we recommend discussing this compliance method with your building official to confirm their approval. We also recommend documenting the factors that make compliance of the altered toilet or bathing rooms technically infeasible. None of the existing toilet rooms were currently designed as accessible.

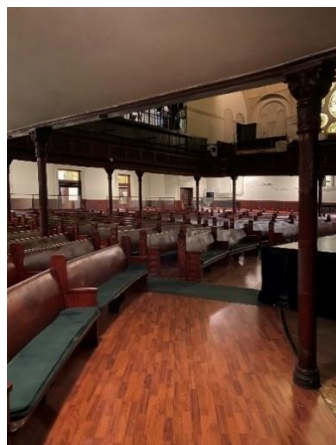
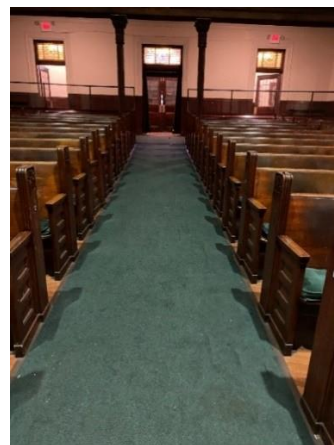
Sanctuary. The Sanctuary, that is often used as a theater and event space, did not provide any wheelchair spaces. Wheelchair space locations must be an integral part of any assembly seating area. The requirement that wheelchair spaces be an integral part of the seating plan means that wheelchair spaces must be placed within the footprint of the seating area. Wheelchair spaces cannot be segregated from seating areas. Wheelchair spaces must provide spectators with choices of seating locations and viewing angles that are substantially equivalent to, or better than, the choices of seating locations and viewing angles available to all other spectators. (NYCBC 1108.2.4, ANSI 802.10.1; 2010 Standards 221.2.3) Wheelchair spaces must adjoin accessible routes but must not overlap the required width of an aisle. Slopes must not exceed 1:48 in the floor surface of wheelchair spaces (NYCBC 1108.2.2, ANSI 802.3; 2010 Standards 802.1).

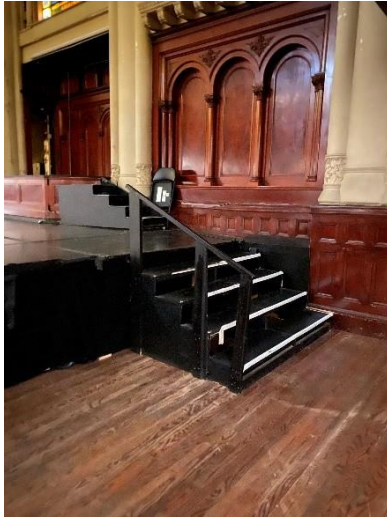
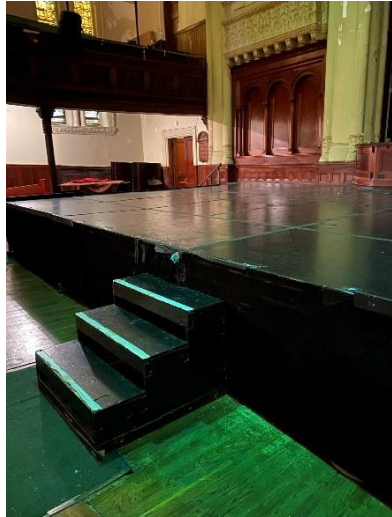
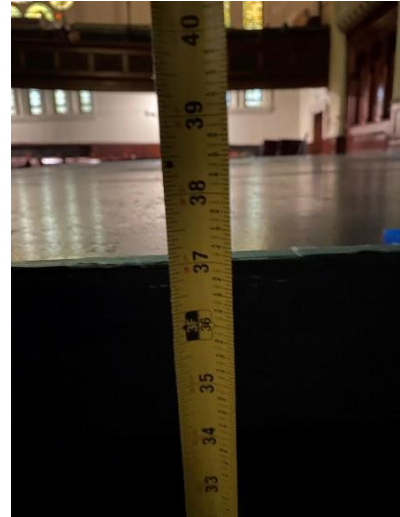
The large stage was raised 37 inches above the finish floor and did not provide an accessible route. Where a circulation path directly connects a performance area to an assembly seating area, an accessible route must directly connect the assembly seating area with the performance area (NYCBC 1108.2.8; 2010 Standards 206.2.6).

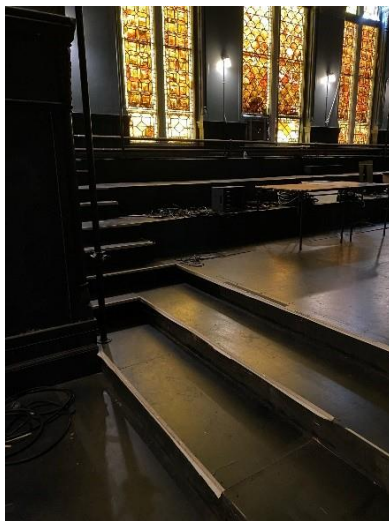
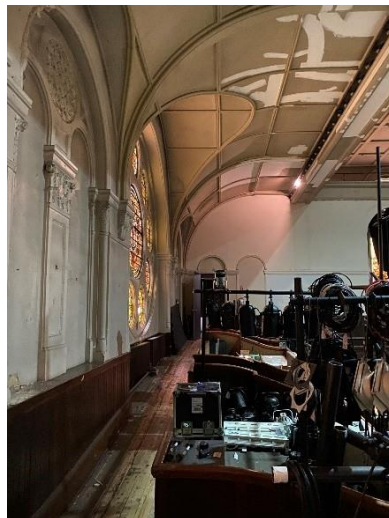
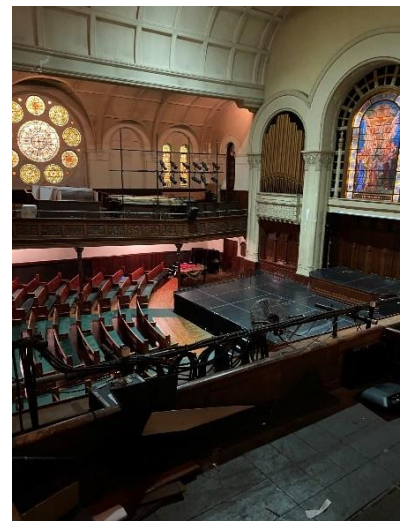
The Sanctuary balcony and choir loft were not connected to the Sanctuary by an accessible route, and an accessible route was not provided through the balcony itself.

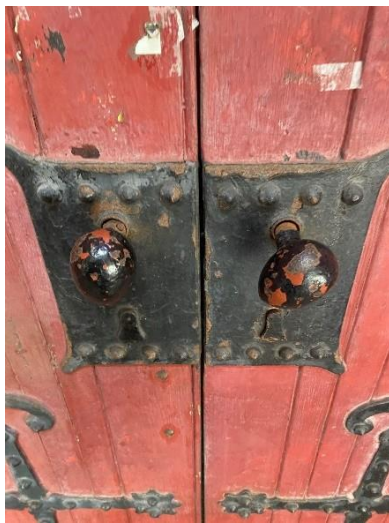
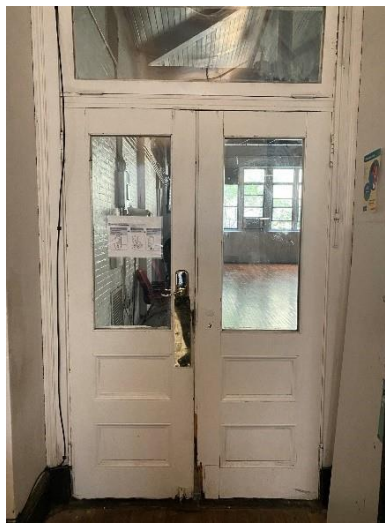
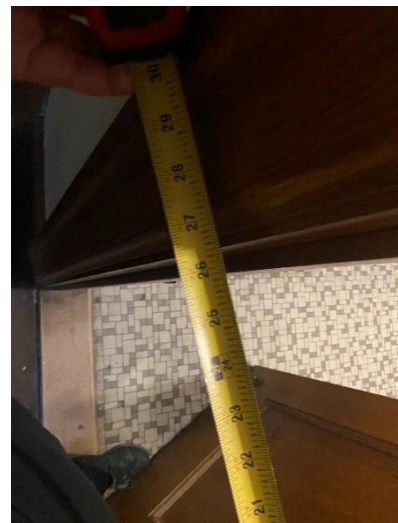
Thresholds. Thresholds in this project could also be considered a barrier removal item. Most thresholds in this project are an issue due to the required bevel not being provided or the threshold being too high, especially at locations where the floor material changes. Thresholds must not exceed 1/2 inch maximum in height. The bottom 1/4 inch is allowed to be vertical and the uppermost 1/4 inch must be beveled at a slope not to exceed 1:2. (ANSI 404.2.4; 2010 Standards 404.2.5)

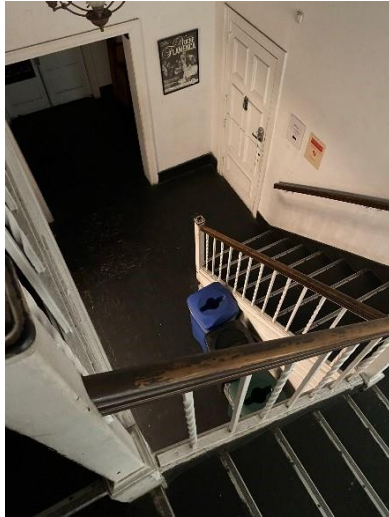
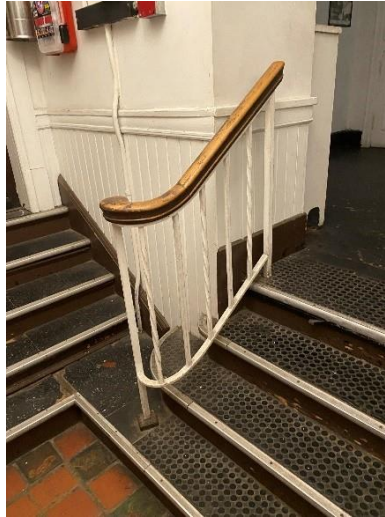
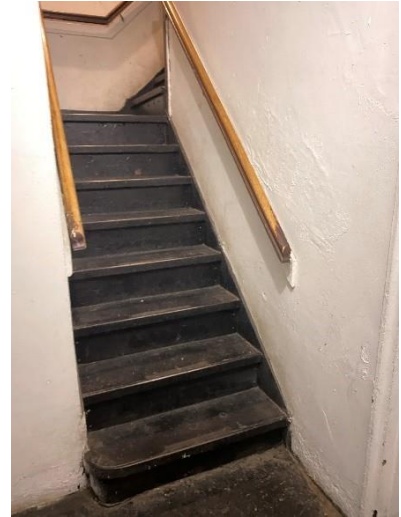
Handrails. Interior and exterior stairs that are part of a means of egress must have compliant handrails. (2010 Standards 210.1, 504.6) Most stair handrails in this project were NOT accessible, due to lack of extensions and returns. At the top of a stair flight, handrails must extend horizontally above the landing for 12 inches minimum beginning directly above the first riser nosing (or must be continuous to the handrail of an adjacent stair flight). At the bottom of a stair flight, handrails must extend at the slope of the stair flight for a horizontal distance at least equal to one tread depth beyond the last riser nosing (or must be continuous to the handrail of an adjacent stair flight). After extending the minimum dimension, extensions must return to a wall, guard, or the landing surface (2010 Standards 505.10). While the NYCBC does not specifically address handrails in Chapter 11 Accessibility, similar requirements exist in Chapter 10 Means of Egress.

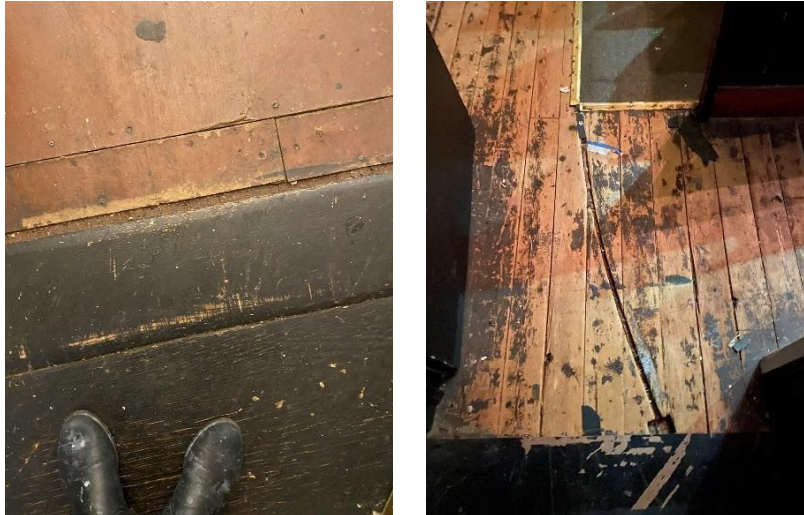
Floor Material. There were several locations in the existing wood floor, where the changes in level exceeded 1/4 of an inch. Changes in level of 1/4 inch high maximum are allowed to be vertical. Changes in level greater than 1/4 inch in height and not more than 1/2 inch maximum in height must be beveled with a slope not steeper than 1:2. Changes in level greater than 1/2 inch in height must be ramped with landings (ANSI 303; 2010 Standards 303).
