**The City of New York
Department of Environmental Protection**

**ENVIRONMENTAL ASSESSMENT
ATTACHMENT 2**

ENVIRONMENTAL ASSESSMENT

CAT 211 | Engineering Design Services and Design During Construction
for the Reconstruction of Catskill Watershed Dams and Associated Facilities

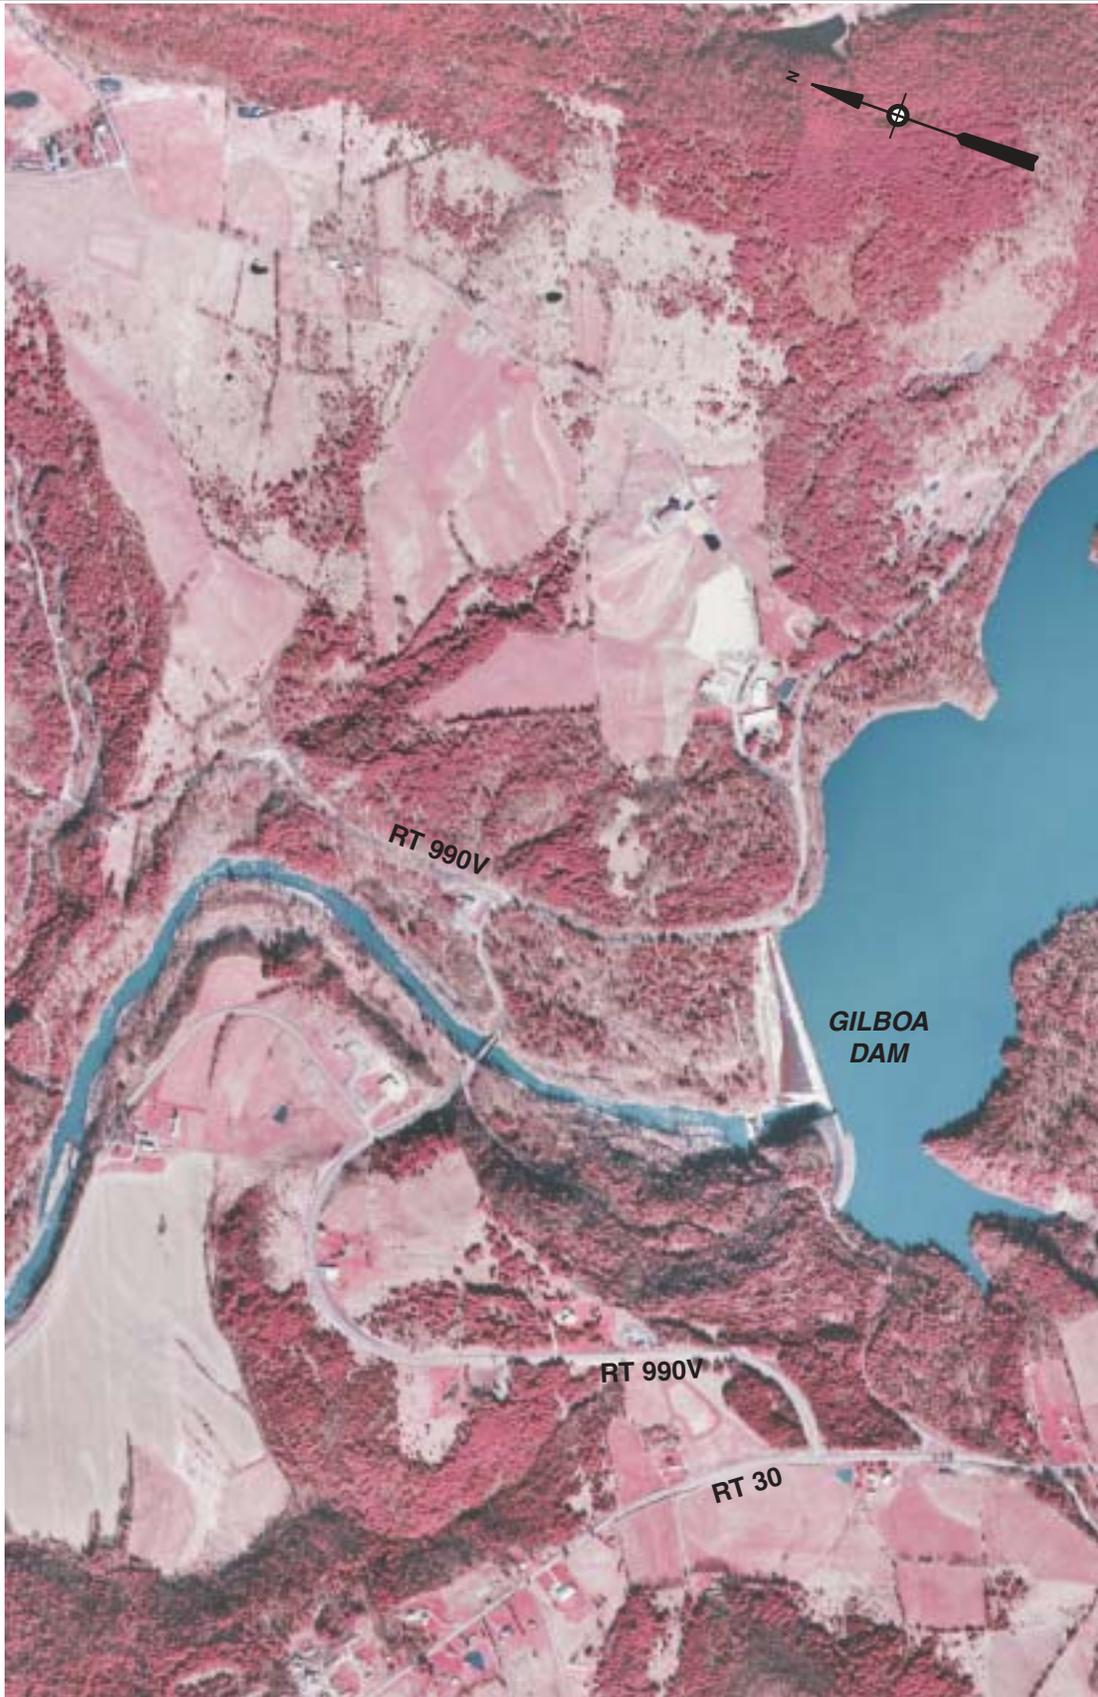
Figure 2.1-1

Project Area Vicinity

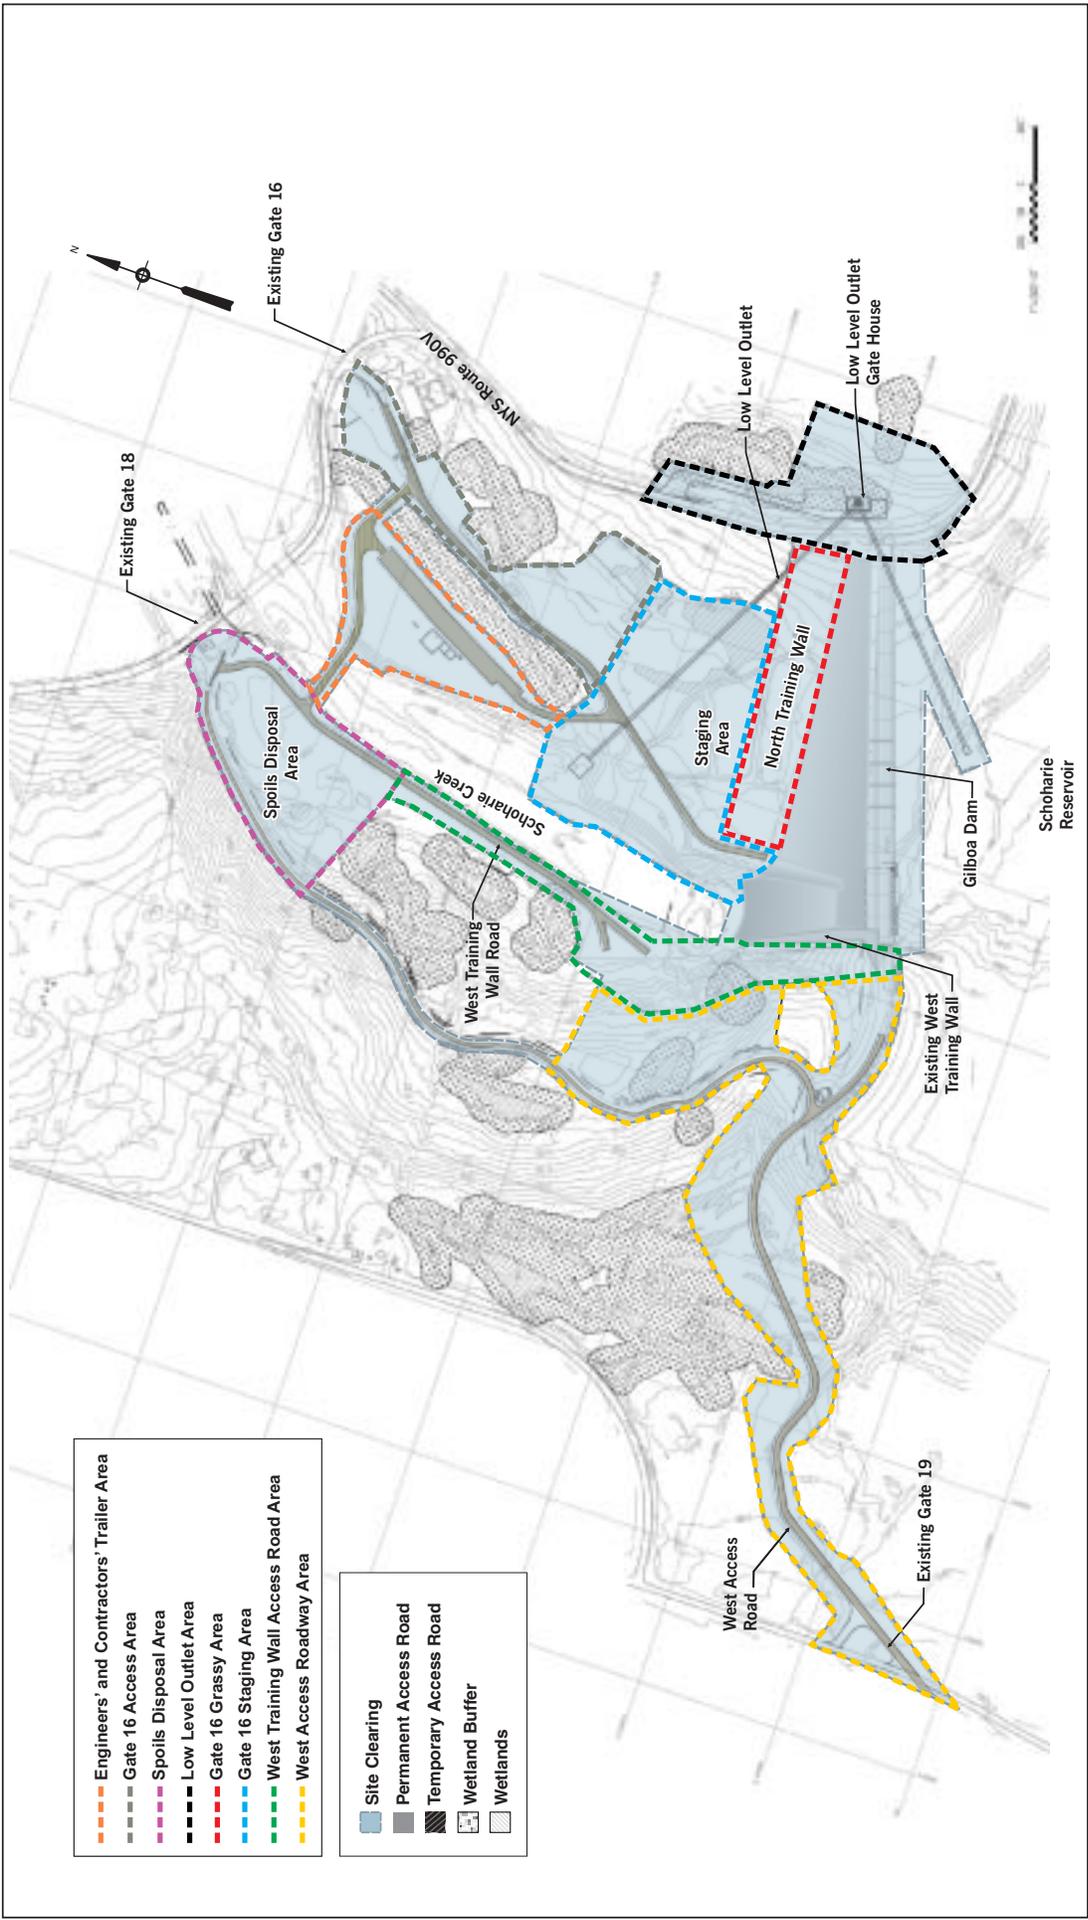
Figure 2.1-1-2

- Engineers' and Contractors' Trailer Area
- Gate 16 Access Area
- Spoils Disposal Area
- Low Level Outlet Area
- Gate 16 Grassy Area
- Gate 16 Staging Area
- West Training Wall Access Road Area
- West Access Roadway Area

- Site Clearing
- Permanent Access Road
- Temporary Access Road
- Wetland Buffer
- Wetlands

In order to temporarily accommodate heavy reconstruction equipment, trees and land would need to be cleared and graded to the clearing limits illustrated in Figure 2.1-2 to establish a staging area from which all work for the Dam reconstruction would be organized and executed. Following the completion of land disturbance activities as a result of reconstruction in different portions of the project site (i.e., the West Access Road), these areas would be restored with natural vegetation. Please refer to The Natural Resources Restoration Plan in Section 2.6, Natural Resources.

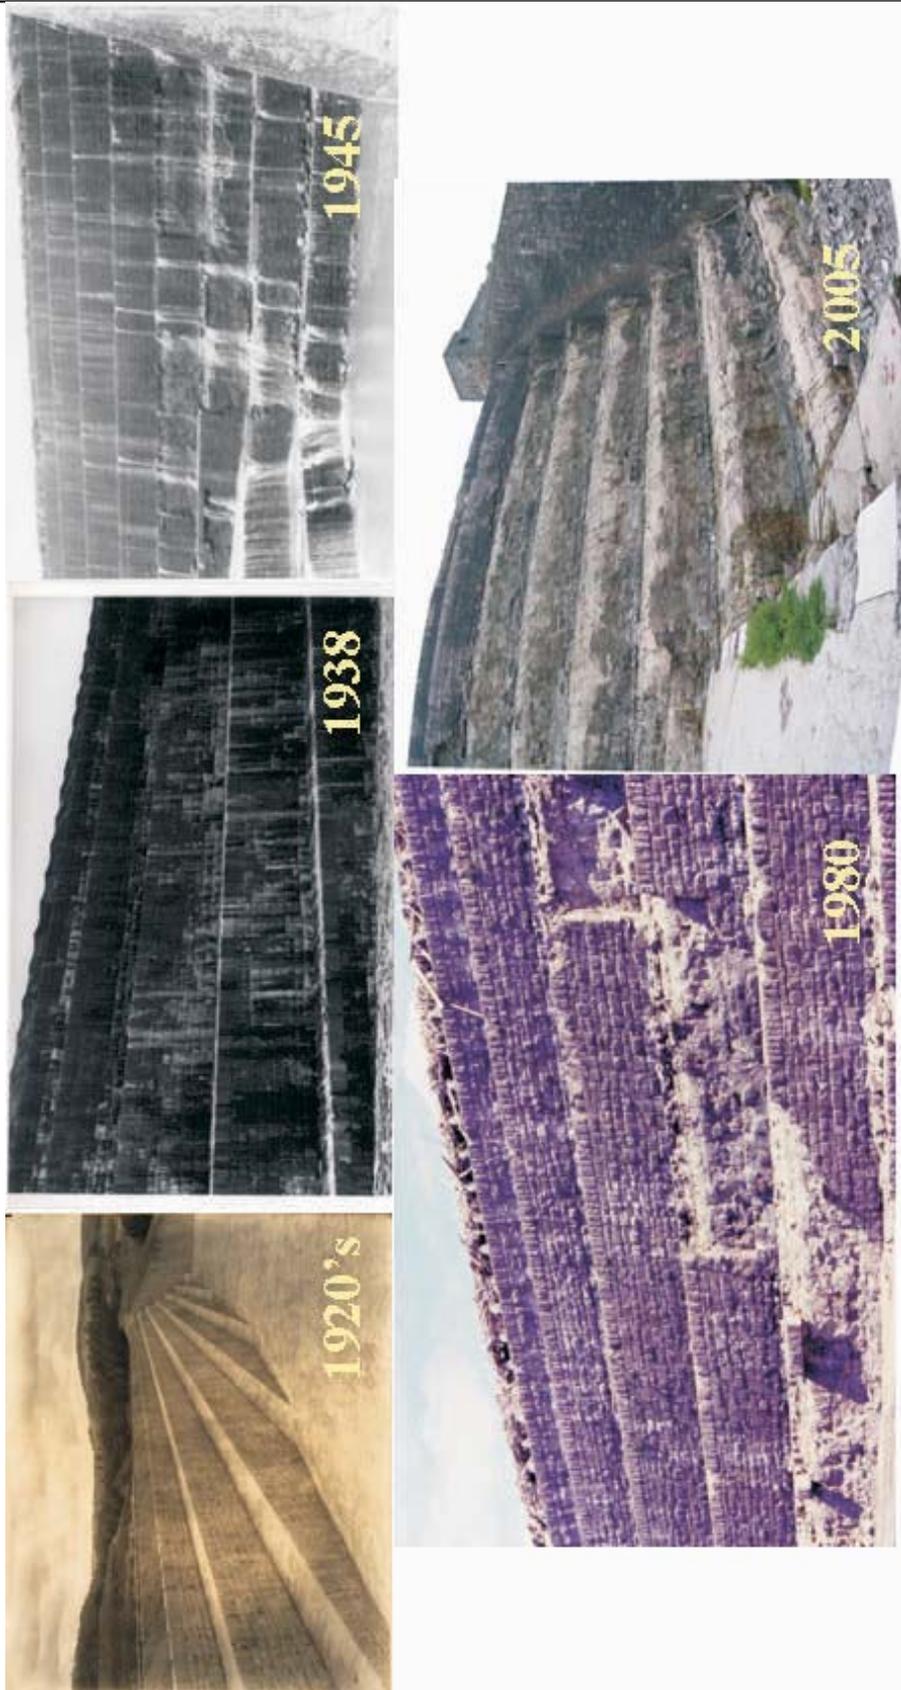
Figure 2.3-1

Facade Deterioration

Over the past 30 years, increasing amounts of the stone façade have been lost due to erosion. Currently the majority of the stone façade on the Stair-Stepped overflow structure has been delaminated or lost entirely; exposing approximately 50 percent of the cyclopean concrete substructure, which has dramatically reduced the aesthetic quality of the Dam (see [Figure 2.3-1](#)). Further damage from water, erosion and weather can also be seen in other areas of the Dam including the Side Channel and the West Training Wall. This further damage has reduced the hydraulic energy dissipating capability of the spillway.

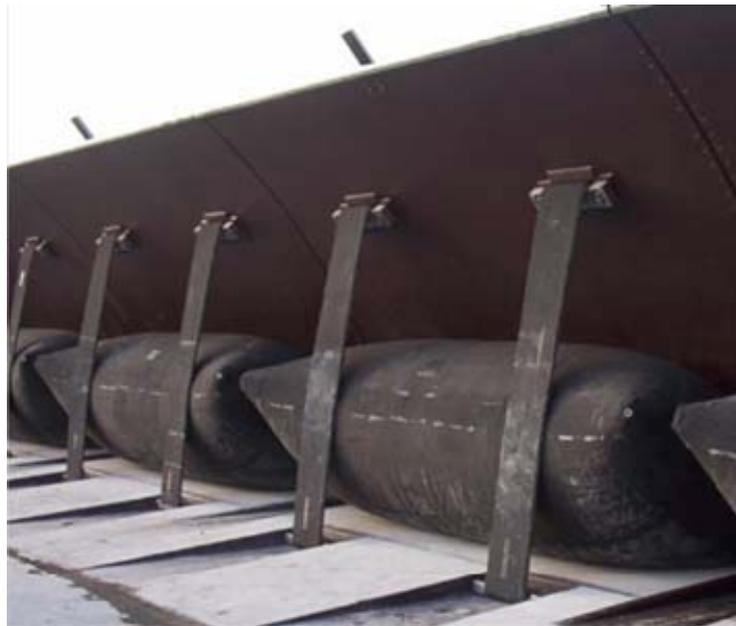
FIGURE 2.3-4. TYPICAL INSTALLATION OF CREST GATES

As part of the proposed project, crest gates would be installed in the existing spillway notch and would slightly alter the physical appearance of the Dam. The crest gates could be described as a row of stainless steel gate panels supported on their downstream side by inflatable air bladders (Figure 2.3-4). The dimensions of the crest gates would be 5.5 feet high in the vertical direction when fully inflated and 220 feet long. When upright with the air bladders fully inflated, the crest gates would be flush with the top of the spillway. When fully deflated, the crest gates would rest flat on the notch invert. The crest gates could also be positioned at any point between these two extremes, depending on the desired pool elevation within the Reservoir. A conceptual rendering of crest gates is presented in Figure 2.3-5. Figure 2.3-6 illustrates the extent of the existing spillway notch where the crest gates would be installed. Although the visual appearance of the Dam from the Scenic Public Overlook Area (a distance of approximately 1,200 ft) would be modified somewhat by the installation of the crest gates, the visual impact would be minimal and confined to a 220-foot long area of the western most portion of the 1,326-foot spillway.

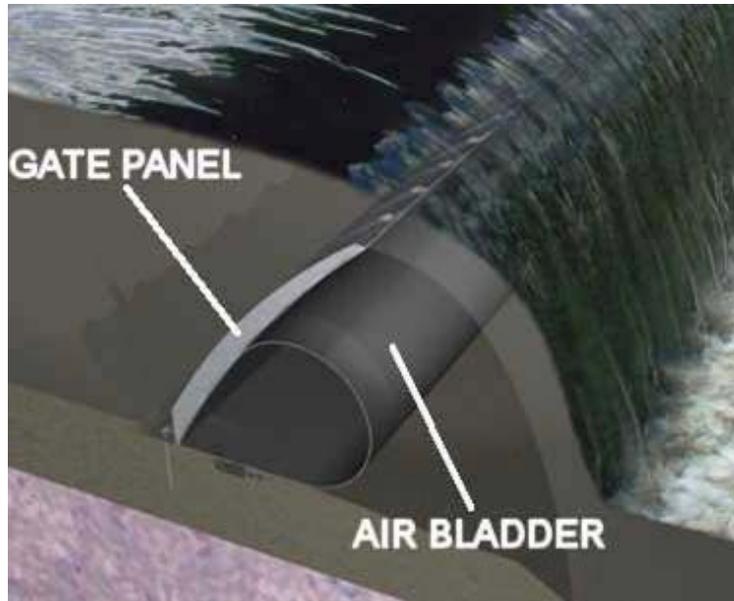
FIGURE 2.3-5. CONCEPTUAL RENDERING OF THE PROPOSED CREST GATES

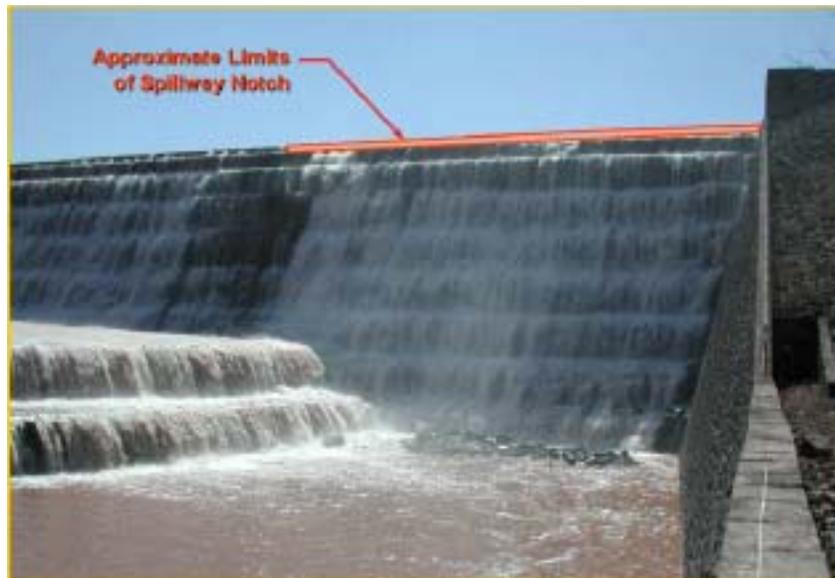
FIGURE 2.3-6. PROPOSED CREST GATES INSTALLATION AT GILBOA DAM

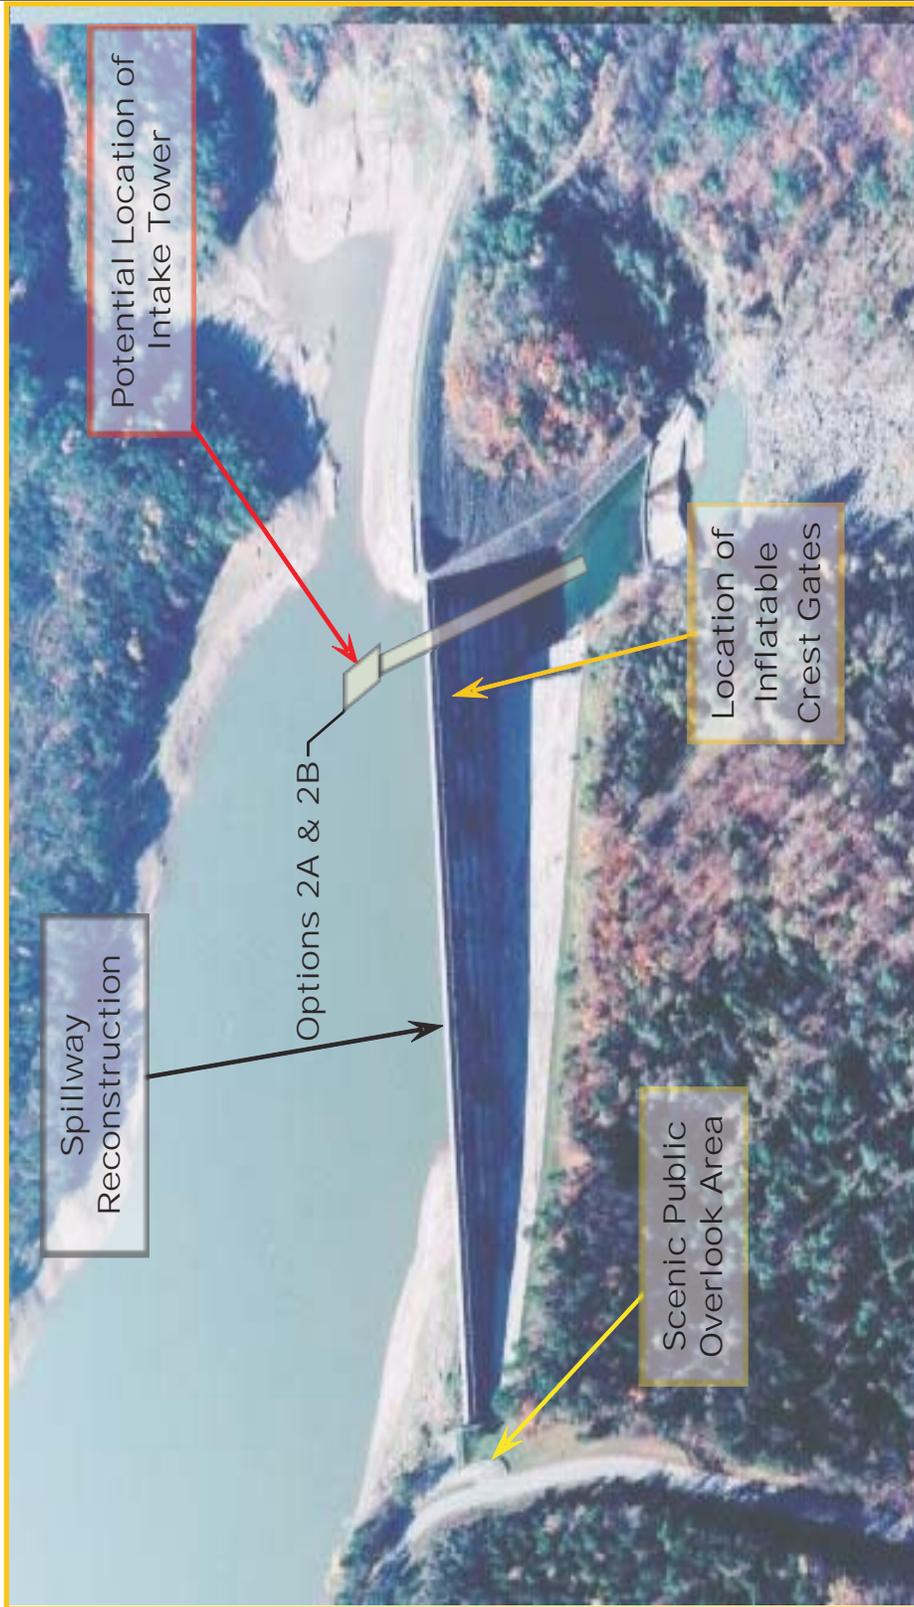
Low Level Outlet Options 2A & 2B

The final design of the LLO is incomplete at the issuing of this EA and is dependent on the results of a continuing boring program. There are currently six options being considered for the placement of the new LLO (see [Section 1.5.1.2.3, Project Description](#)) for the Reservoir. The options that would have the greatest effect on the area's aesthetic resources are assessed in this section. Options 2A and 2B of LLO installation consist of constructing a new intake tower within the Reservoir on the upstream side of the Dam and would potentially have the greatest visual influence of all six alternatives under consideration (see [Figure 2.3-7](#)). These options would necessitate the installation of an intake tower located close to the Dam that would be visible from the Scenic Public Overlook Area, creating a visual change from this vantage point. Because the intake tower would be consistent with the architecture of the surrounding structures the change is anticipated to be minimal. In addition, when the Reservoir is at full capacity, only the upper-most portion of the tower would be visible from the Scenic Public Overlook Area. Under options 2A and 2B, a small control building would be provided to house the controls of the LLO. In addition, a concrete basin-like structure would be installed at the LLO discharge into Schoharie Creek. The building's design shall be consistent with surrounding NYCDEP architecture and views would not be considered adverse to aesthetic resources since they would fit the context of the surrounding area.
