**PHASE I ENVIRONMENTAL SITE ASSESSMENT
FOR SHAFT 33B
E. 59th STREET / SECOND AVENUE SHAFT SITE**

**OCTOBER 2005
Revised DECEMBER 2005**

Prepared By: Malcolm Pirnie, Inc.

**NEW YORK CITY DEPARTMENT OF ENVIRONMENTAL PROTECTION
CITY WATER TUNNEL NO. 3, STAGE 2
SHAFT 33B
E. 59TH STREET / SECOND AVENUE SHAFT SITE**

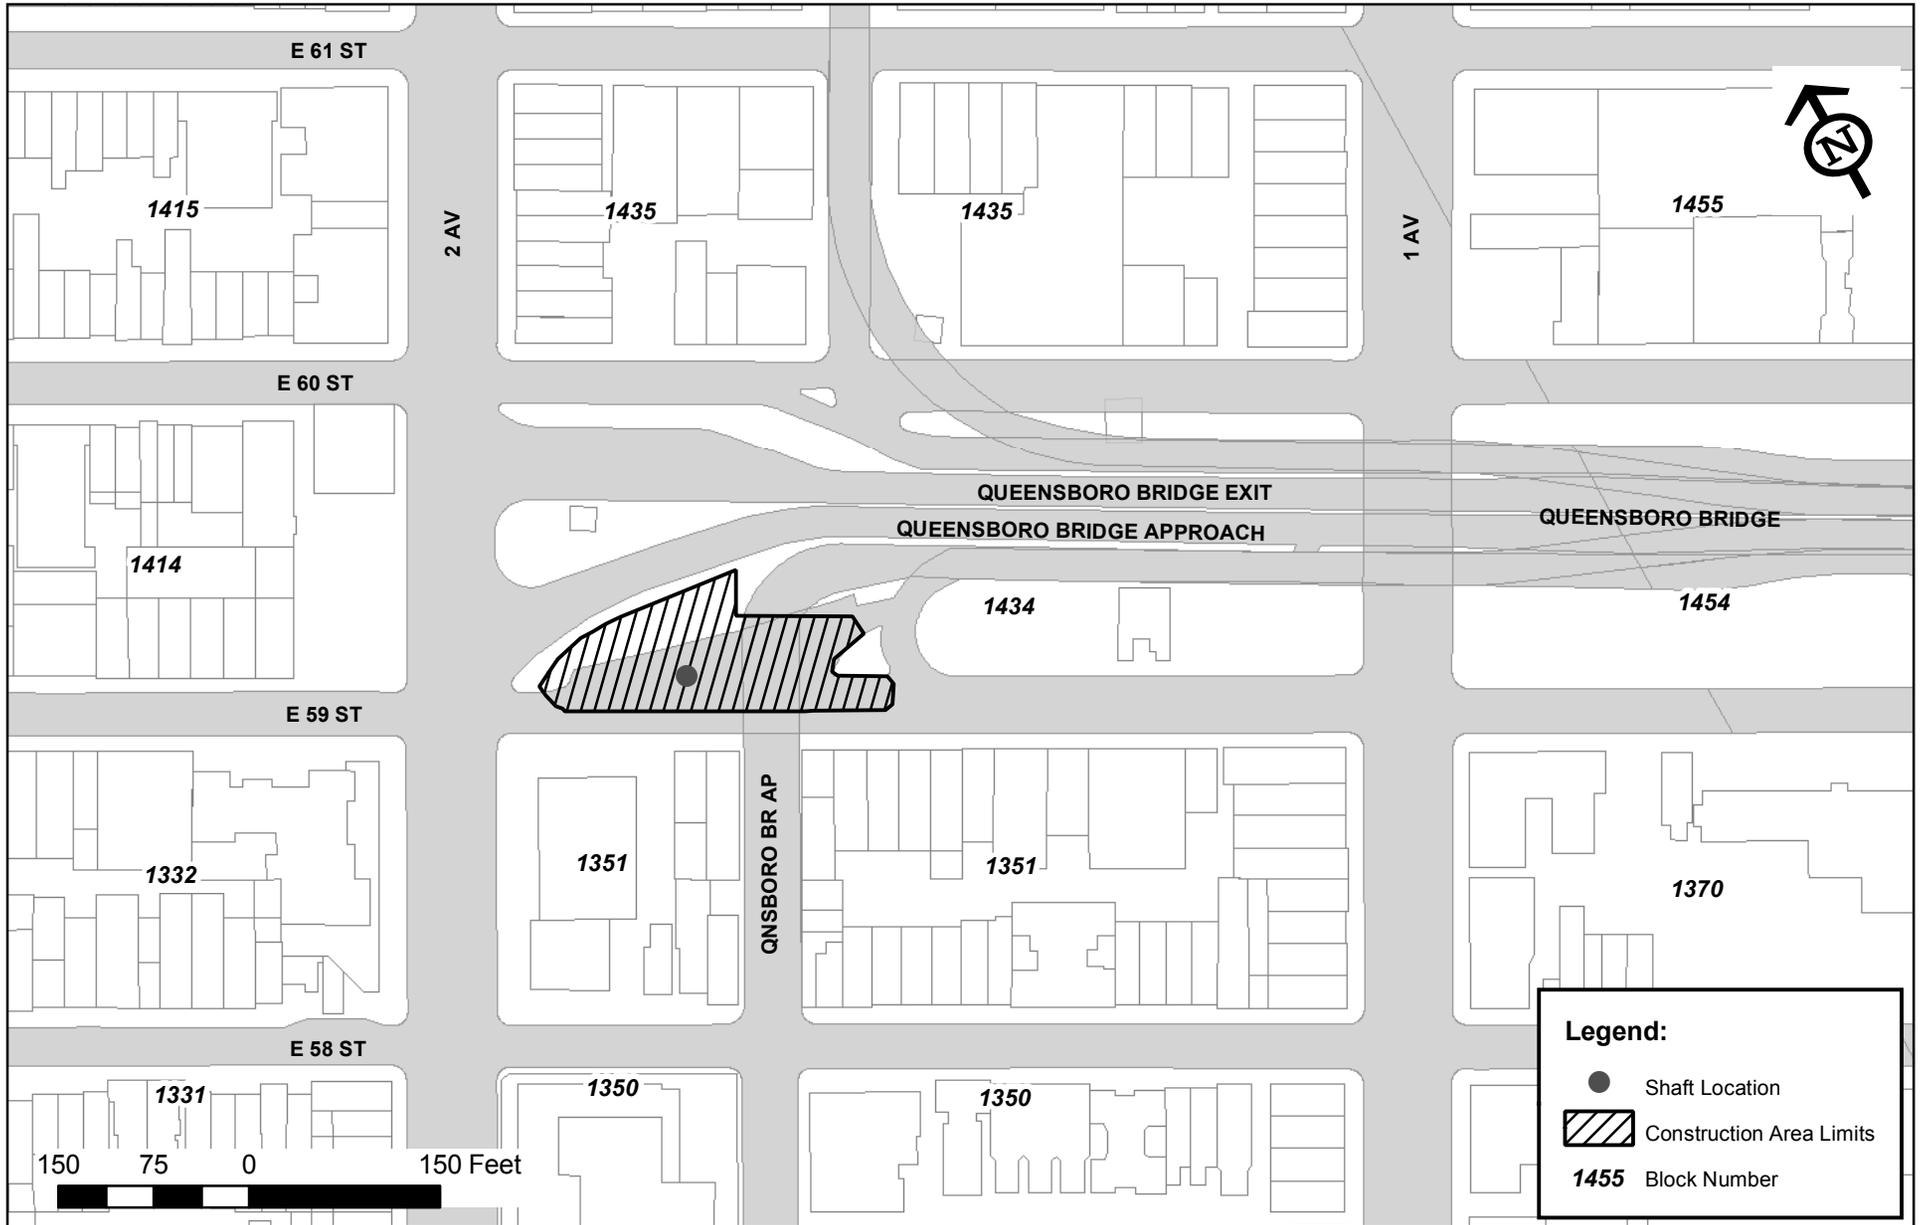
FIGURE 1

The Site, as shown in Figure 1, consists of approximately 15,500 square feet of vacant property located on the north side of E. 59th Street between the Queensboro Bridge approach and Second Avenue in New York, New York. The area around the Site is zoned for a variety of commercial and retail uses, residential development, personal services, infrastructure, and open space. Occupied commercial space consists predominantly of small, independently-owned businesses at ground level with residential space above.

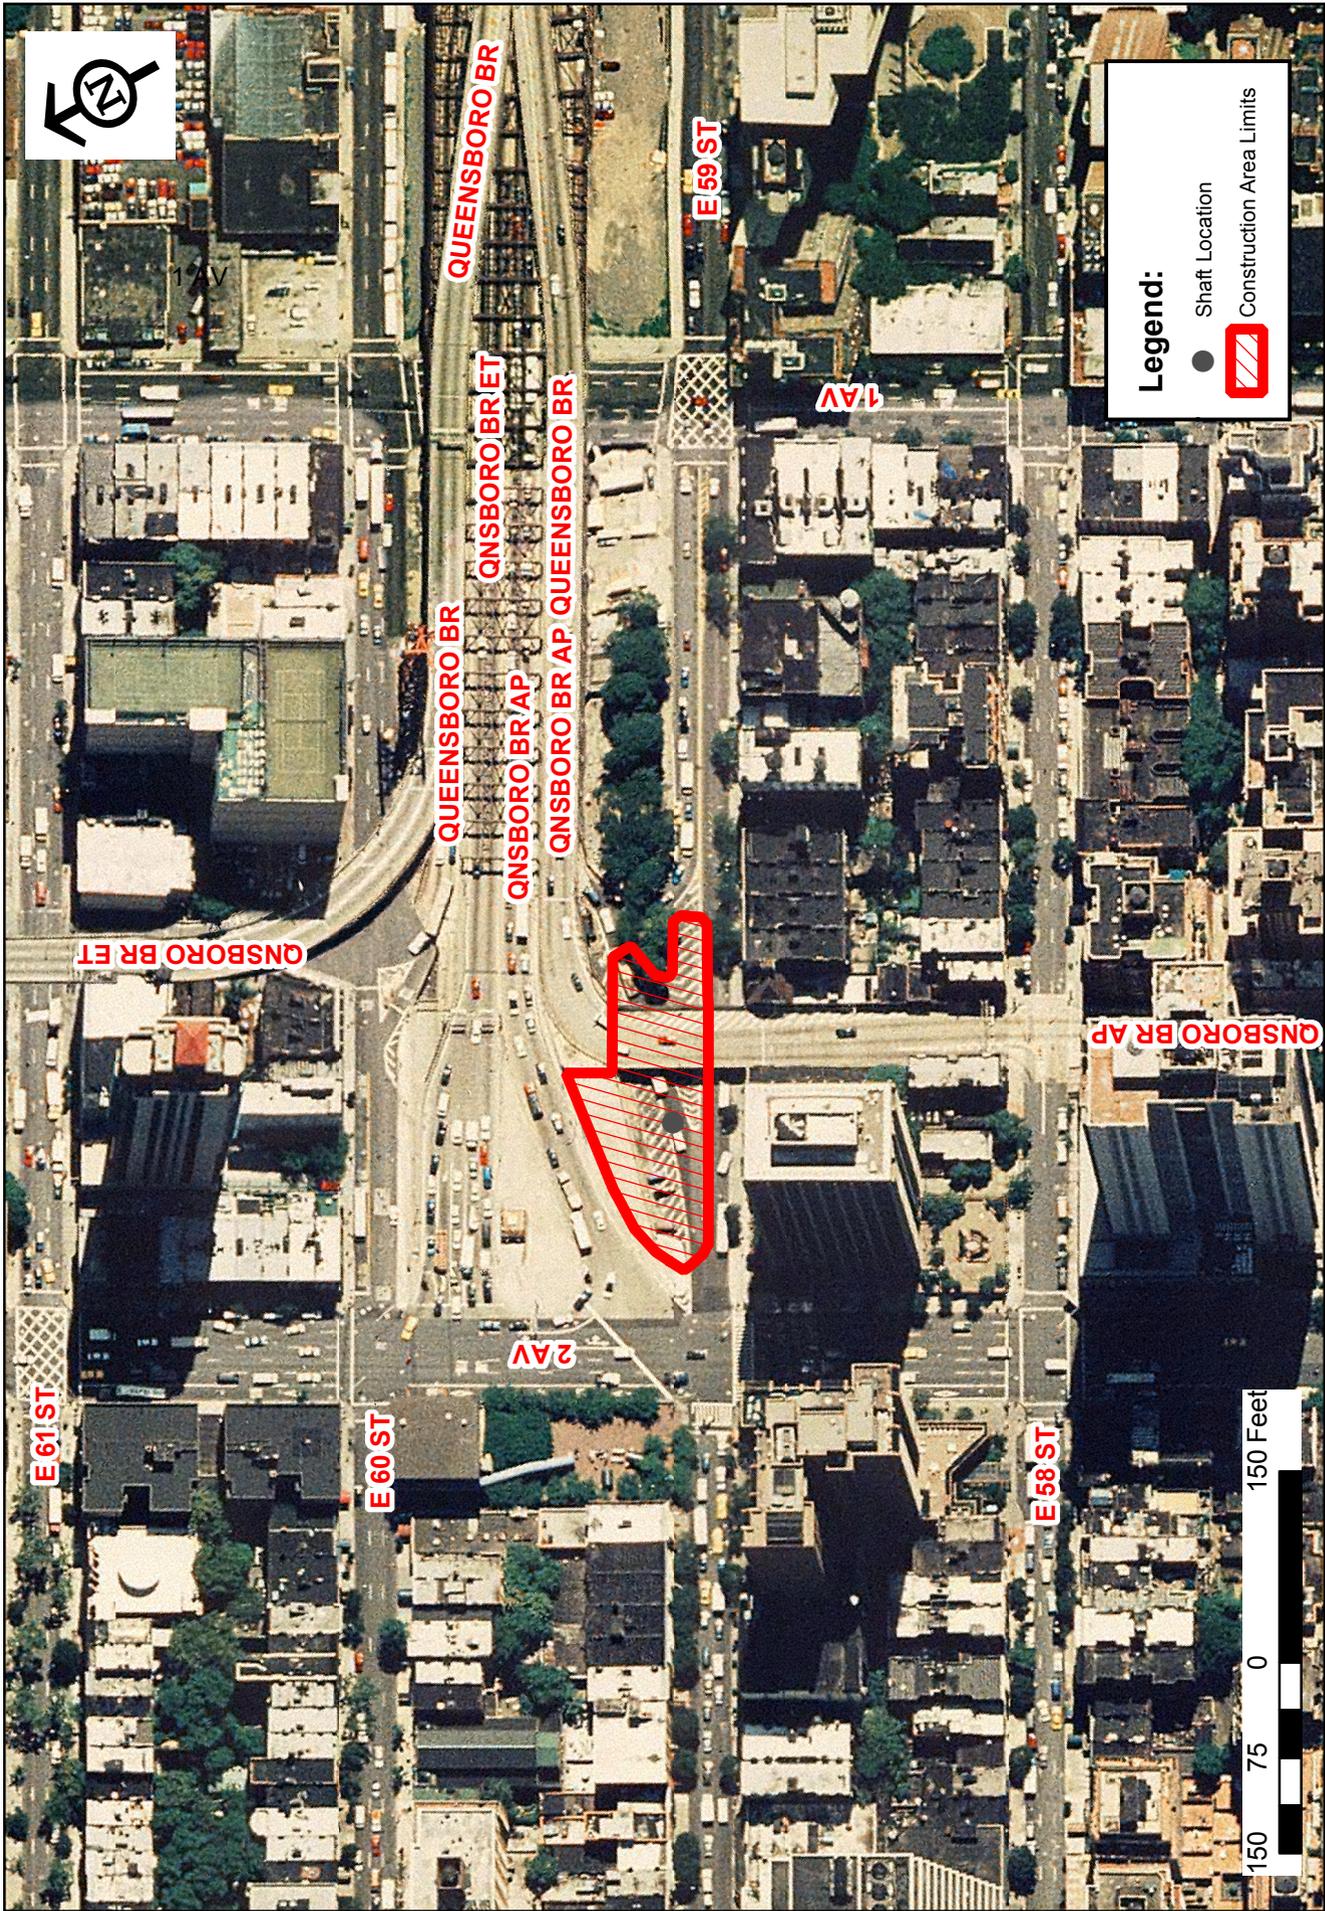
AERIAL PHOTOGRAPH

- Shaft Location
- ▨ Construction Area Limits
