422 WEST BROADWAY, MANHATTAN

PROPOSAL FOR A MODIFICATION OF USE AND BULK

Condi Building
Restoration
422 West Broadway
New York, NY

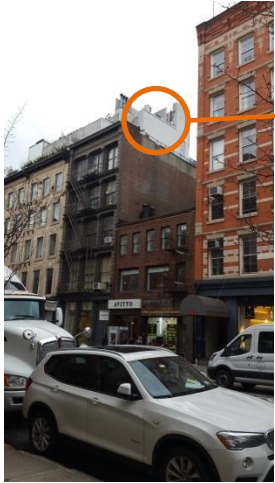
North Corner – First Set-Back

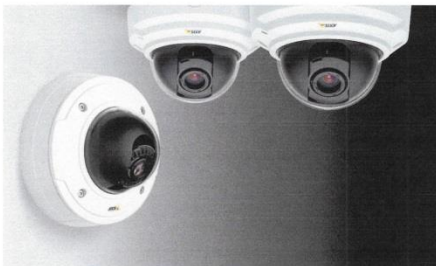
AXIS P33 Network Camera Series

Fixed domes for any environment with remote focus and zoom.

- > Superb video quality including HDTV 1080p
- > Multiple H.264 video streams
- > Remote focus and zoom
- > Outdoor ready
- > Digital PTZ and multi-view streaming
- > P-Iris control

AXIS P33 Network Cameras constitute a series of indoor and outdoor-ready fixed domes. These cameras are ideal for unobtrusive video surveillance in exposed areas such as airports, subways, retail stores, schools and university campuses.
