University Village: NYU 2031 Landscape Presentation

Existing Conditions

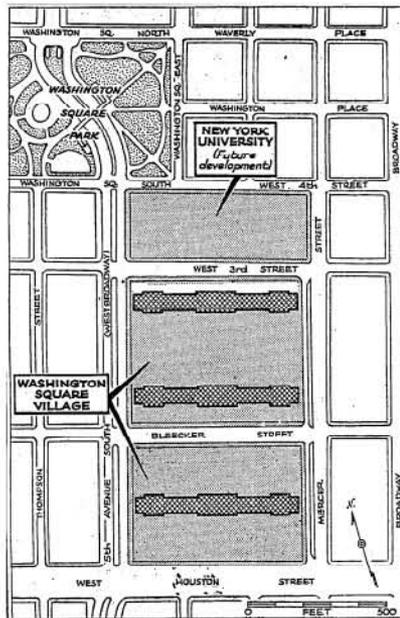
Washington Square Village Plan, c. 1957

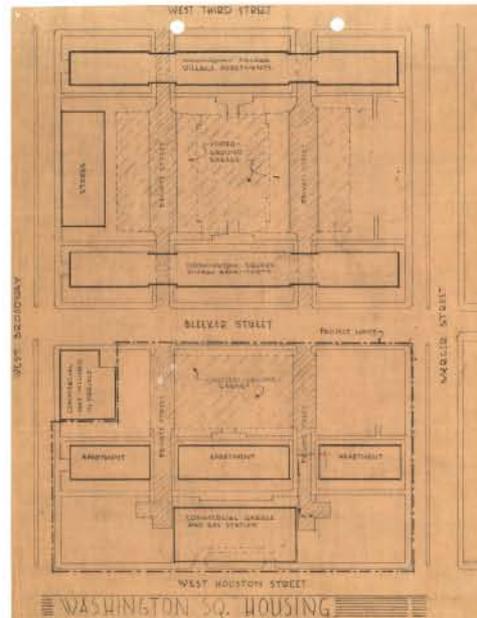
Washington Square Housing Plan Showing South Block to be Released for Sale, c. 1960

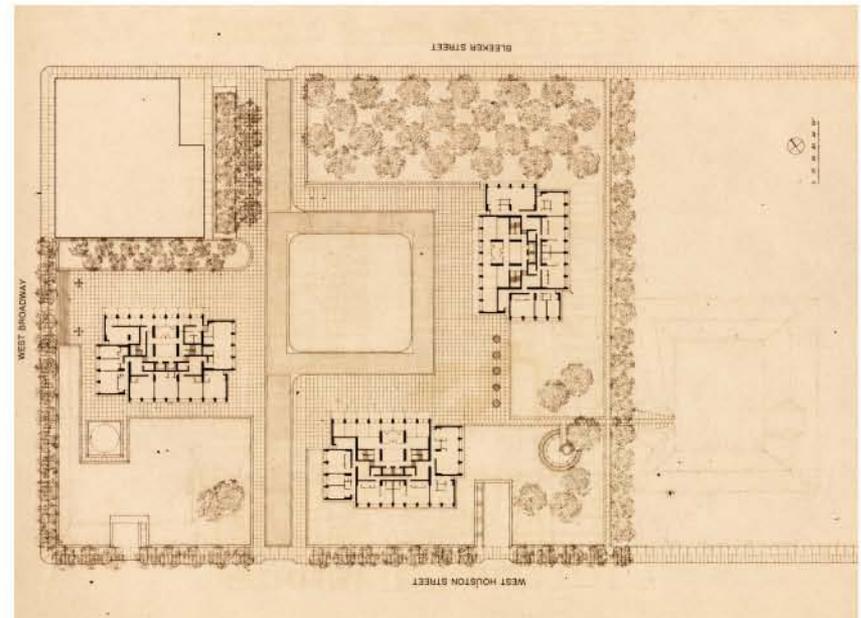
Archived University Village Site Plan, c. 1966

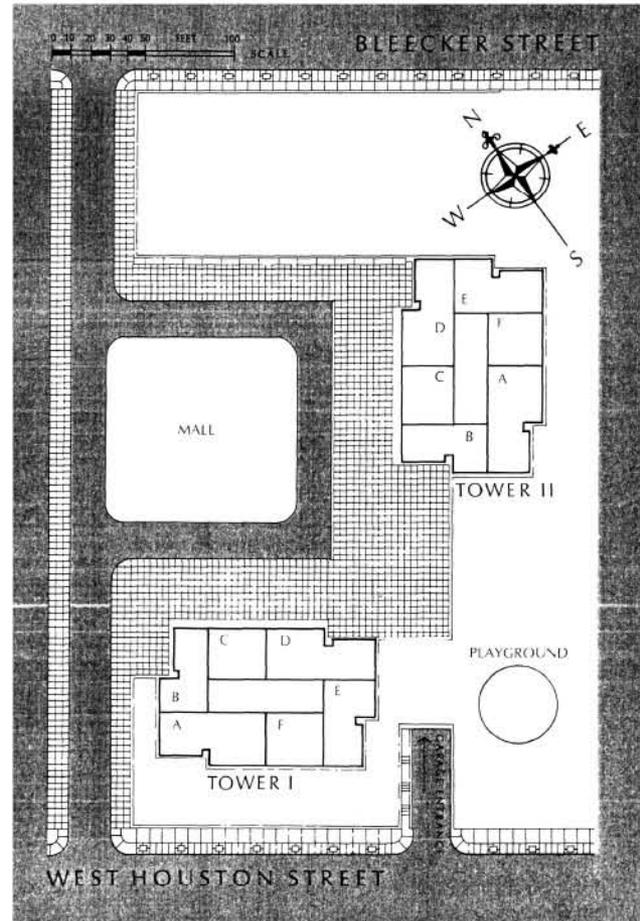
Site plan from University Plaza Apartments Real Estate Brochure, c. 1966 (NYU Archives)

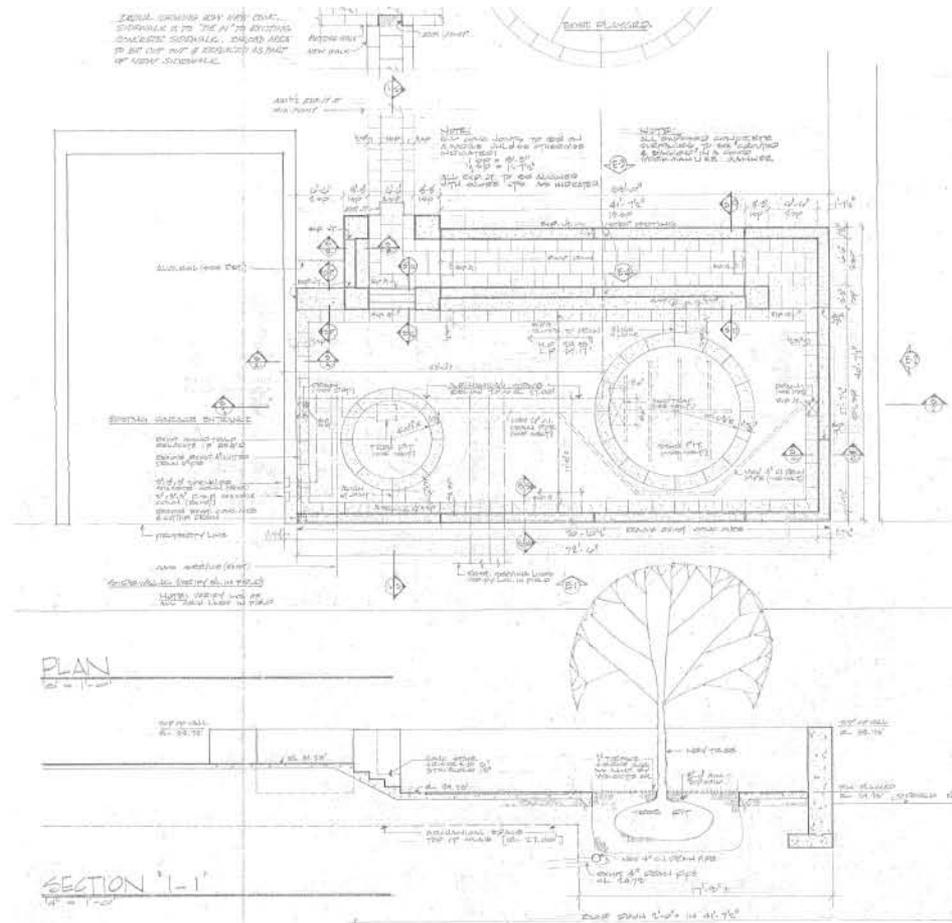
Children's Playground, I.M. Pei & Partners, Architects,
11 September 1967

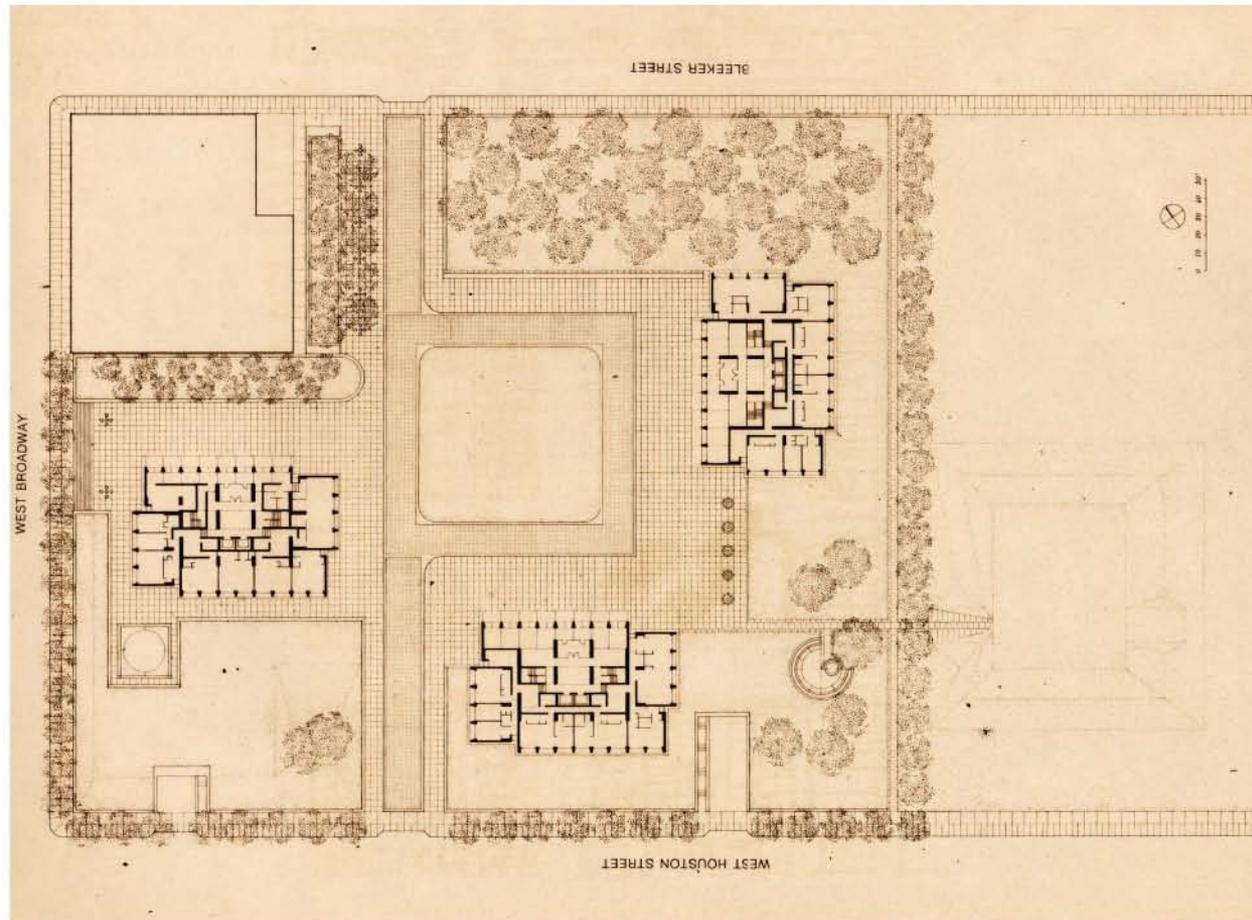
Archived University Village Site Plan, c.1966

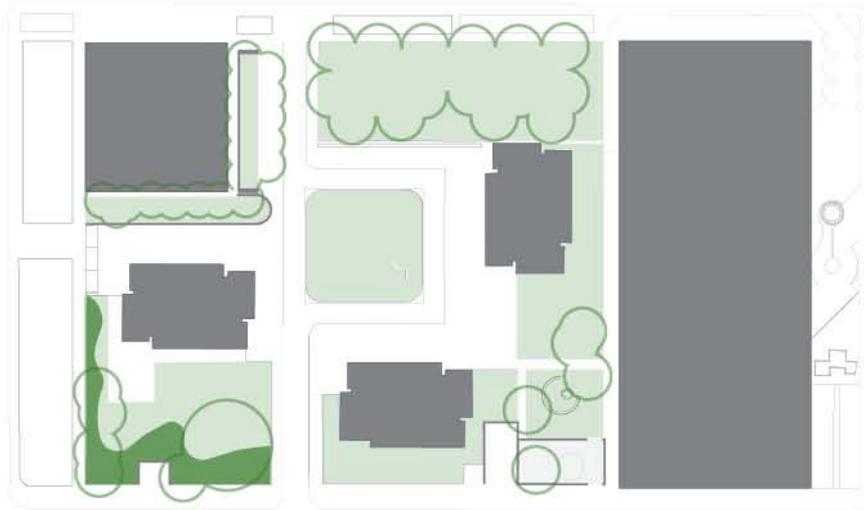
Existing

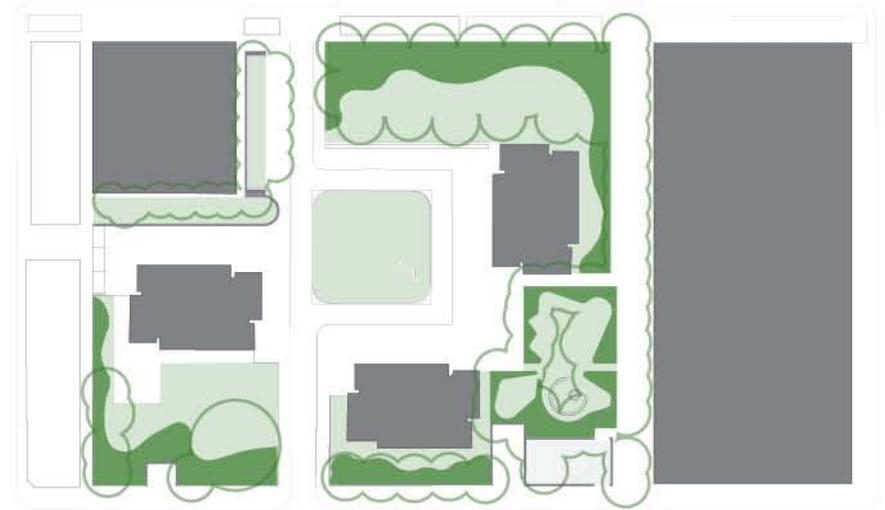
Proposed - Definition of the Edge

- Edge Definition
- Augmentation of Play Program
- Horticultural Enhancement
- Restoration of Historic Features

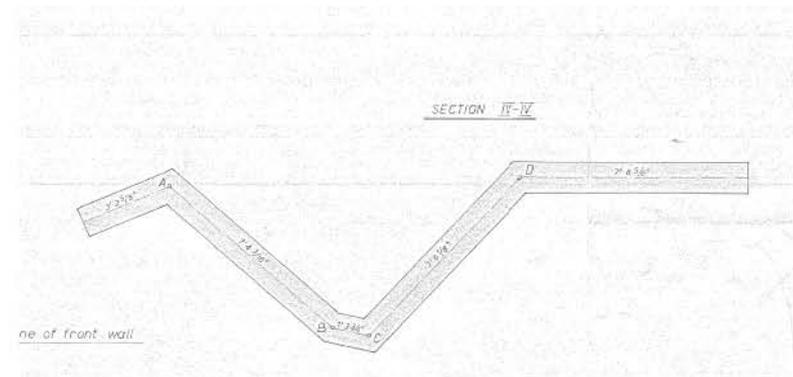
Section through Sylvette

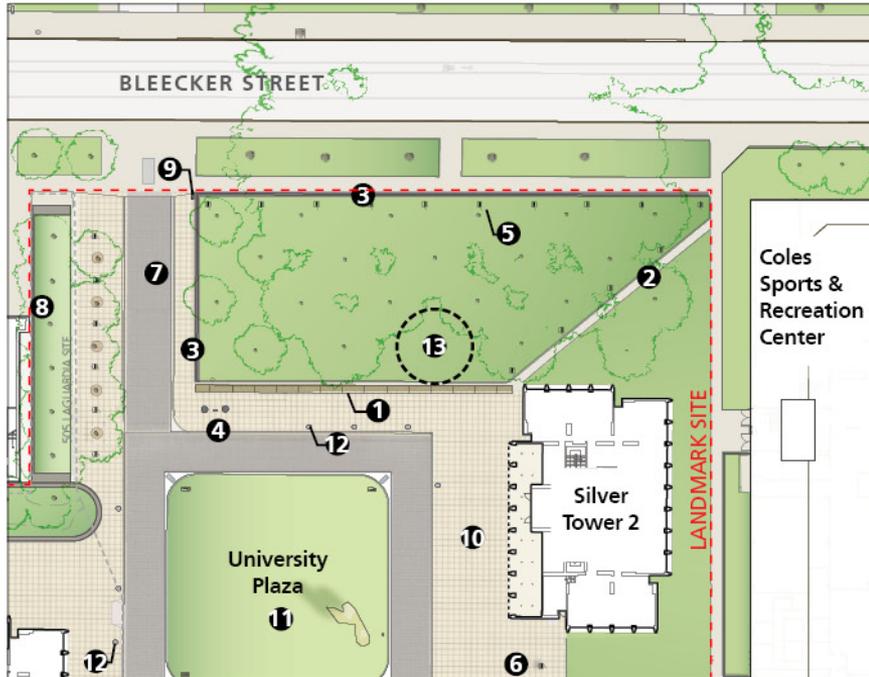
Existing Conditions Plan

| 1. Original Concrete Bench | 8. Original Concrete Site Wall |
| 2. Existing Non-Original Sidewalk | 9. Original Taxi Call Light |
| 3. Original Concrete Gutter and Non-Original Fence | 10. Concrete Pavement |
| 4. Flag Poles (2) and Signage | 11. Lawn |
| 5. Existing Light Pole (Non-Original), Typ. | 12. Existing Bollards, Typ. |
| 6. Existing Light Pole (Non-Original) | 13. Missing Tree (1) |
| 7. Original Driveway | |

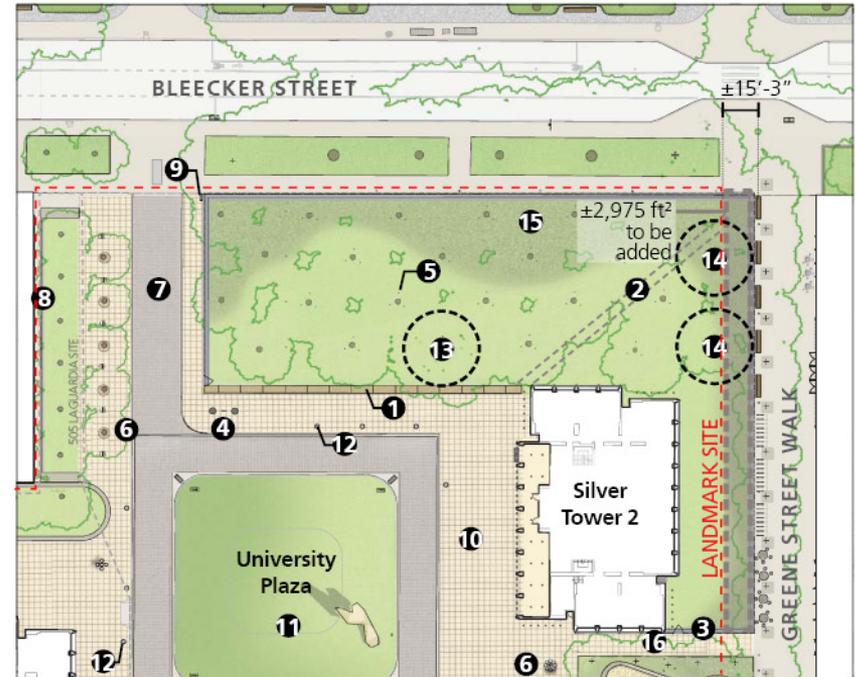
Proposed Plan

| 1. Original Concrete Bench to be Repaired as Required | 8. Original Concrete Site Wall to Remain |
| 2. Existing Non-Original Sidewalk to be Removed and Replaced with Plant Bed | 9. Original Taxi Call Light to be Repaired |
| 3. New Concrete Gutter to Match Original and New Railing on Side | 10. Concrete Pavement to be Repaired as Required |
| 4. Flag Poles (2) and Signage to be Retained | 11. Lawn |
| 5. New Lighting, Typ. | 12. Bollards, Repair and Return to Original Location, Typ. |
| 6. Replicate to Match Original Light Fixtures | 13. Missing Tree to be Added (1) |
| 7. Original Driveway, Repaired as Required | 14. Trees to be Added (2) |
| | 15. New Understory Planting |
| | 16. New Path to Greene Street Walk |

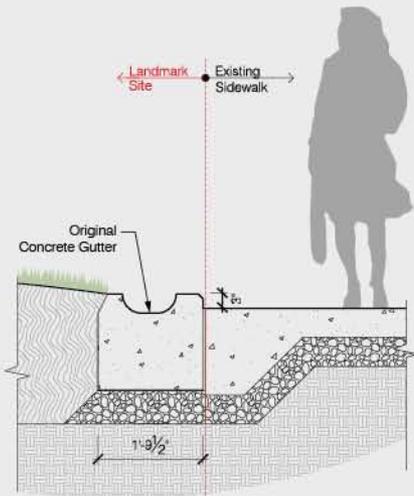
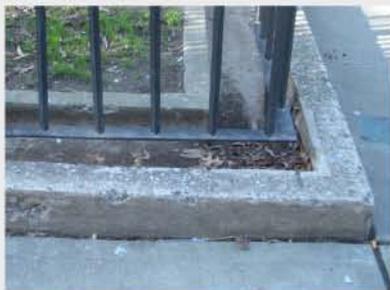
Original Conditions

Original Concrete Gutter, Fence added later

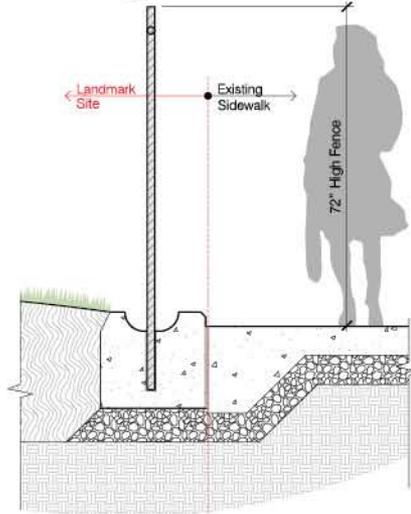
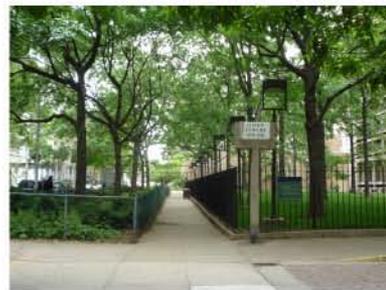
Existing Conditions

Existing Fence

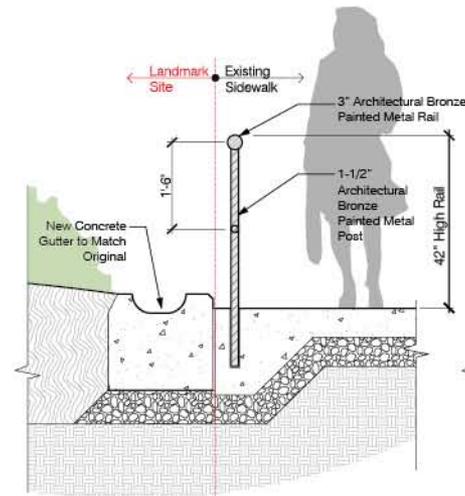
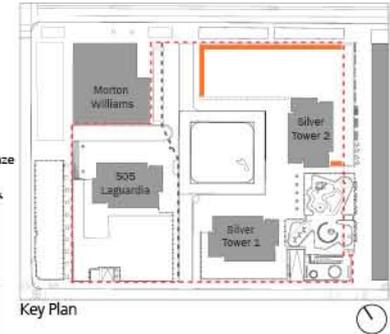
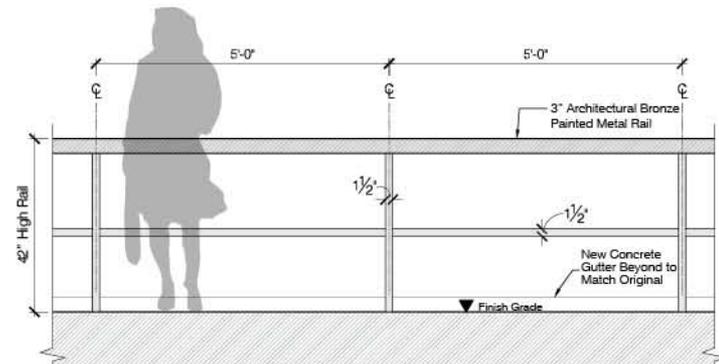
Proposed Conditions

Fencing — 42" High Perimeter Rail at Bleecker Street

Proposed Rail

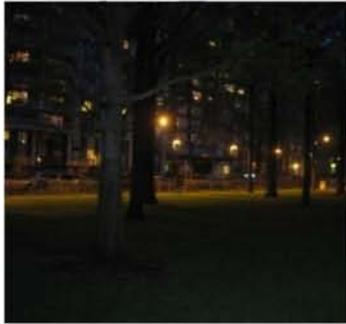
Existing: Poles at Perimeter

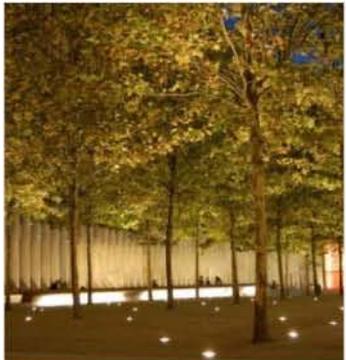
Precedent: Recessed Tree Uplights

Proposed Site Lighting - Oak Grove Tree Uplights

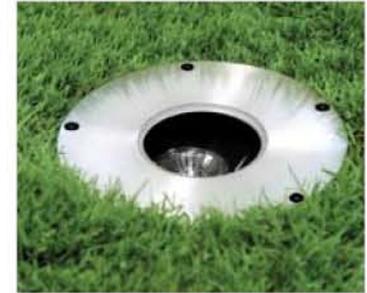
Proposed:
Low Wattage Metal Halide Ingrade
Lensed Uplight Mounted in Grass
Lamp Life: 12,000 – 15,000 hours

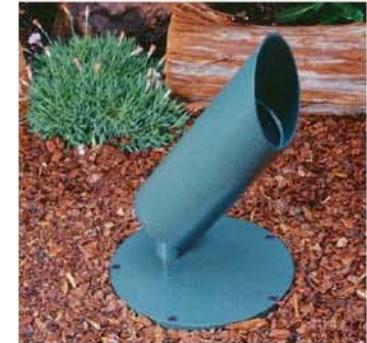
Proposed:
Low Wattage Metal Halide Uplight
Mounted in Ground Cover
Lamp Life: 12,000 – 15,000 hours

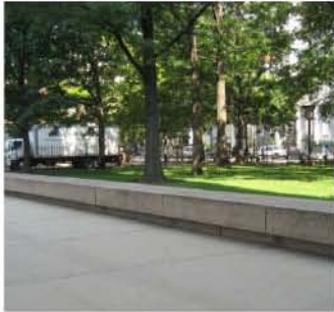
Existing: Front View

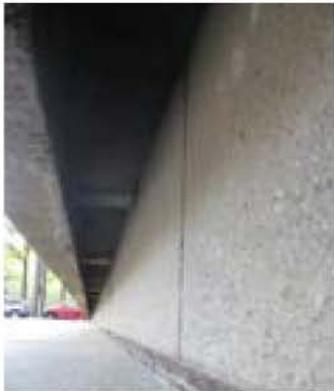
Existing: View From Below

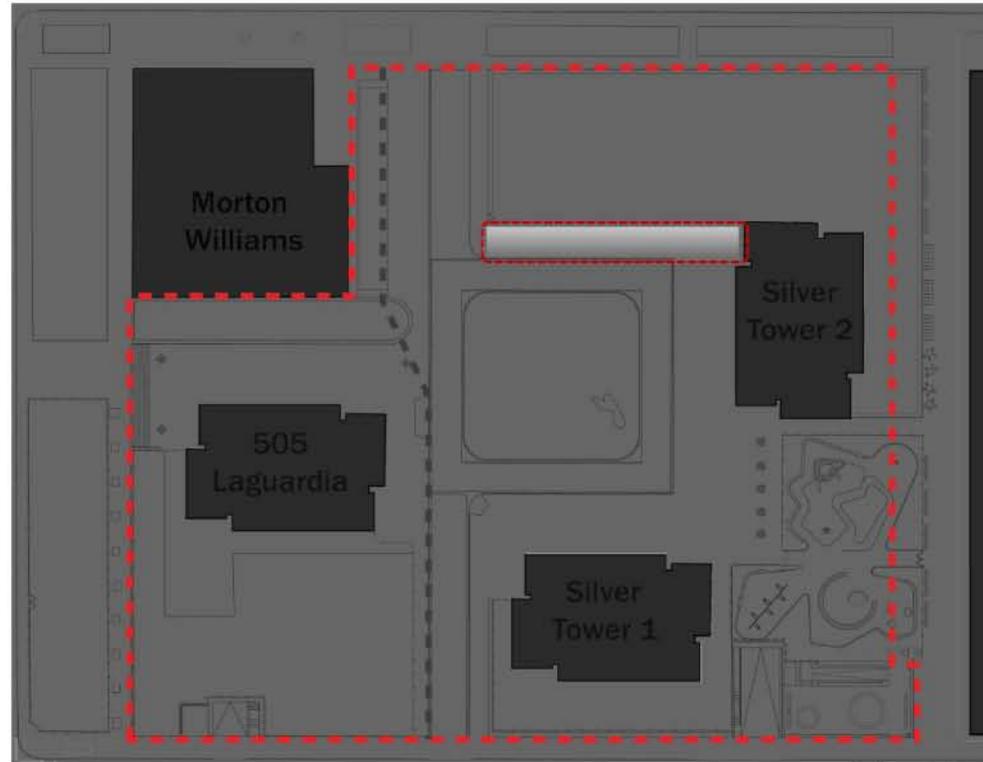
Proposed:
LED continuous strip light with
asymmetric distribution

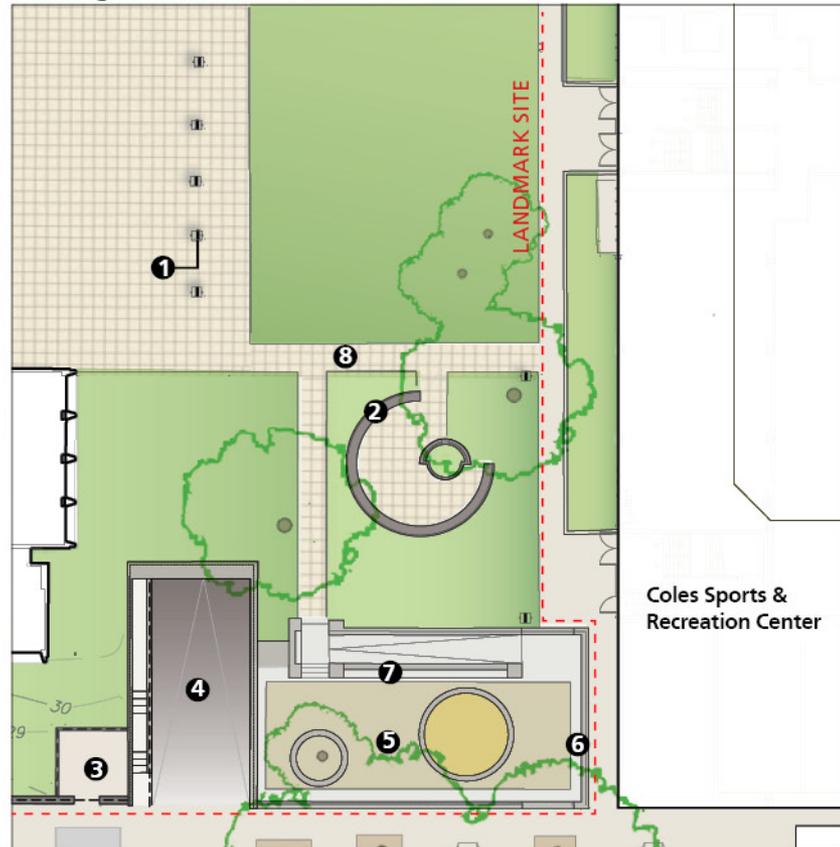
Existing Conditions Plan

| 1. Existing Light Poles (Non-Original) | 5. Original Playground |
| 2. Original Concrete Seating | 6. Original Concrete Wall |
| 3. Existing Dumpster (Non-Original) | 7. Original Concrete Bench |
| 4. Original Garage Entry | 8. Original Concrete Pavement |

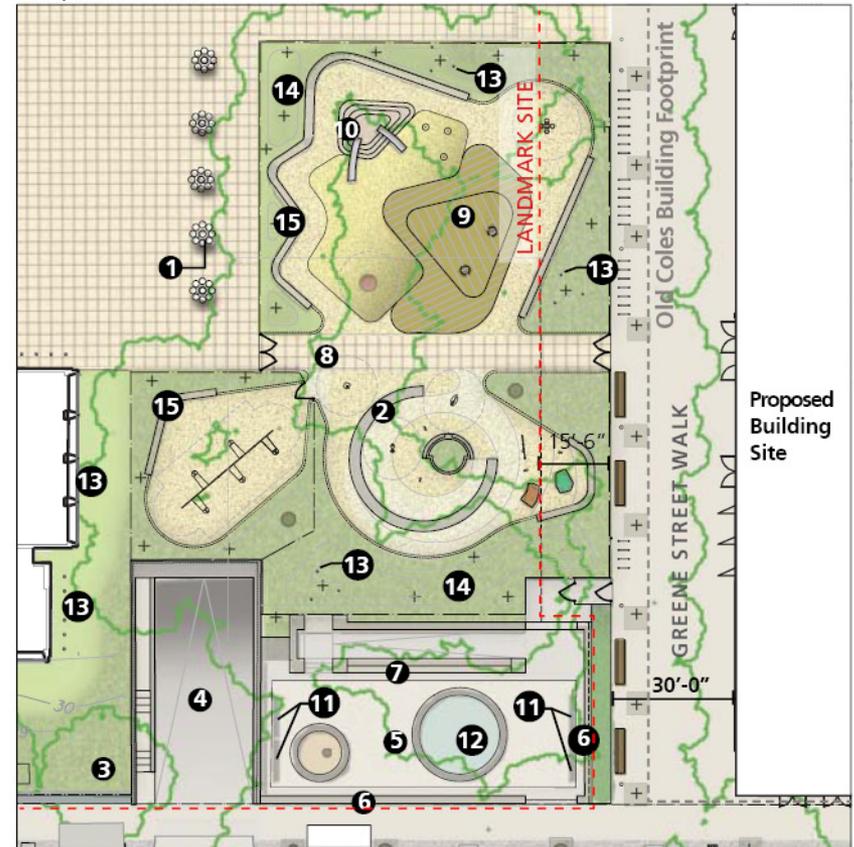
Proposed Plan

| 1. Replicate Historic Light Fixtures Required | 8. Proposed Toddler Playground with Playsurface |
| 2. Repair Original Concrete Seating as Required | 9. Proposed Wood Platform |
| 3. Relocate Dumpster and Replace with Plant Bed | 10. Proposed Slide Hill |
| 4. Original Garage Entry to Remain | 11. Proposed Concrete Benches |
| 5. Proposed Dog Run | 12. Original Sand Box Converted to Dog Run Feature |
| 6. Original Concrete Wall to Remain, Non-Original Existing Fence to be Removed From the Site Wall, Repair as Required | 13. New Lighting |
| 7. Repair Original Concrete Bench as Required | 14. Proposed Plant Bed |
| | 15. Proposed Concrete Seatwall |

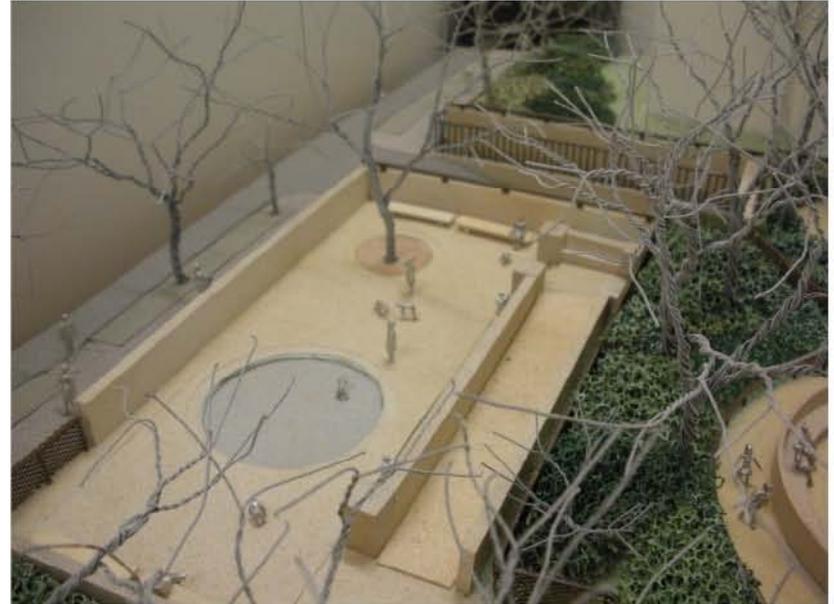
Proposed View of Dog Run

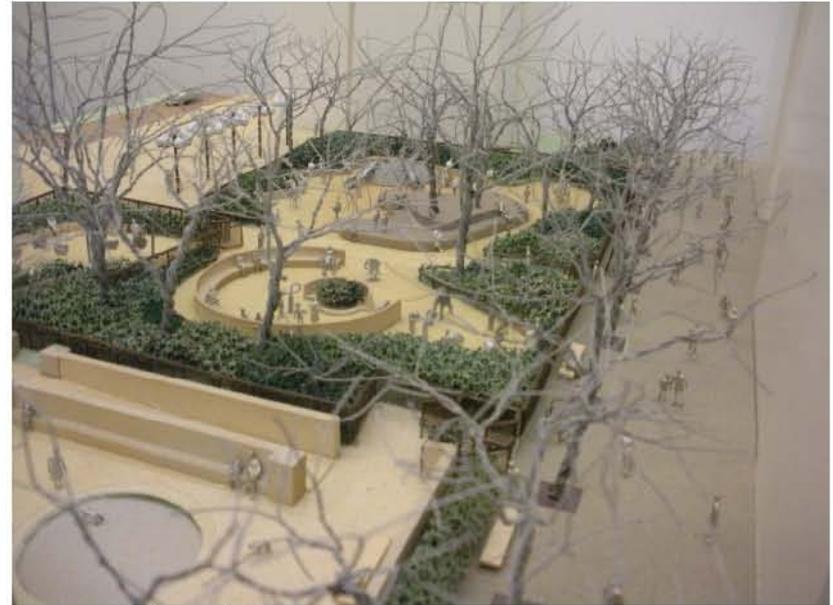
Proposed View of Dog Run

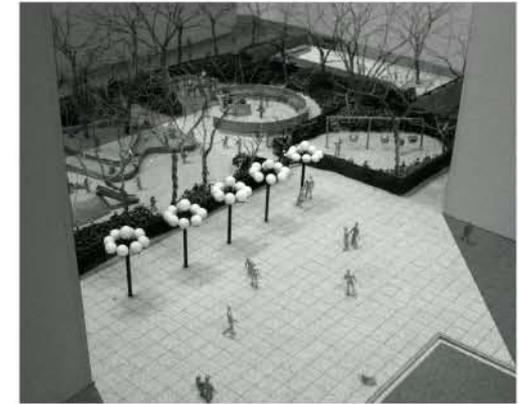
Proposed View of Toddler Playground

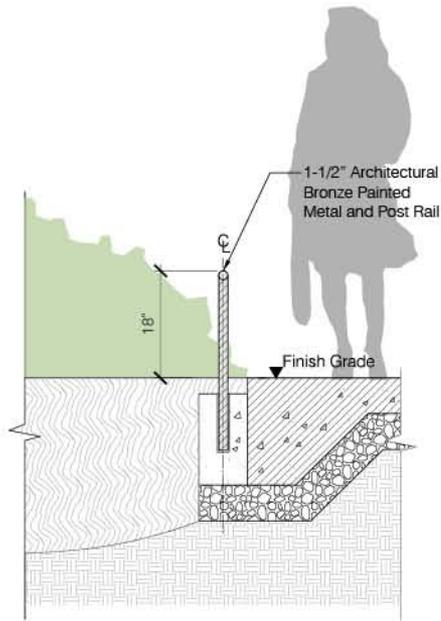
Proposed Section

Fencing — 18"-High Plant Rail (New)

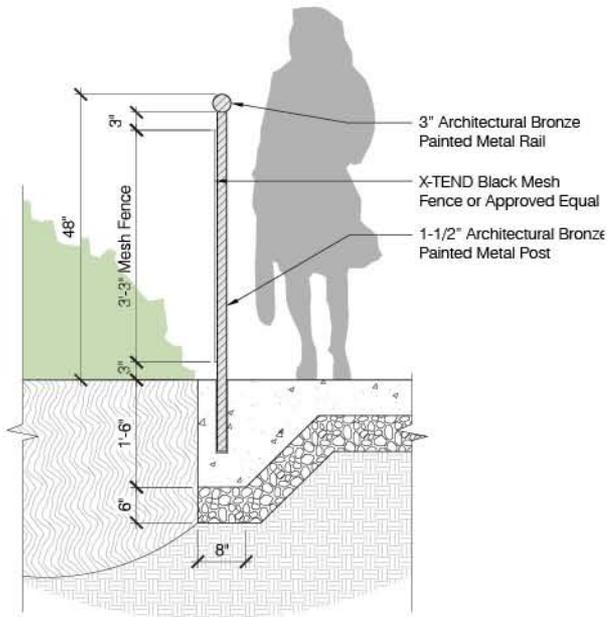
Proposed Section

Fencing — 48"-High Playground Perimeter Fence (New)

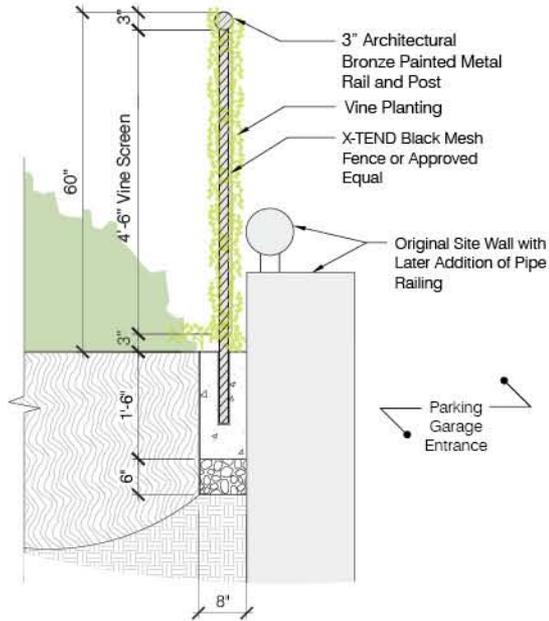
Proposed Section

Fencing — 60"-High Vine Screen (New)

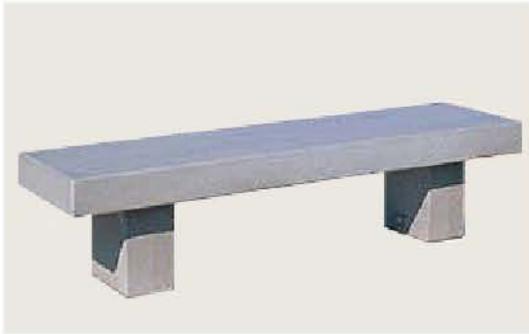
Proposed Concrete Bench
Additional Seating to be Located in Proposed Dog Run

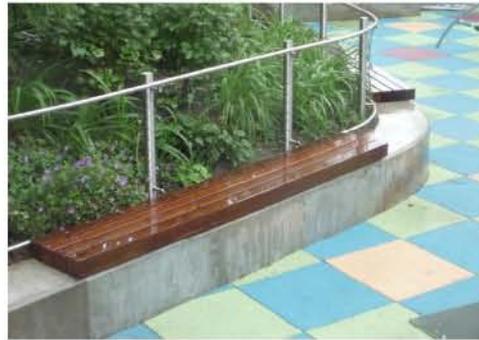
Proposed Concrete Seatwall
Additional Seating to be Located in Proposed Playground

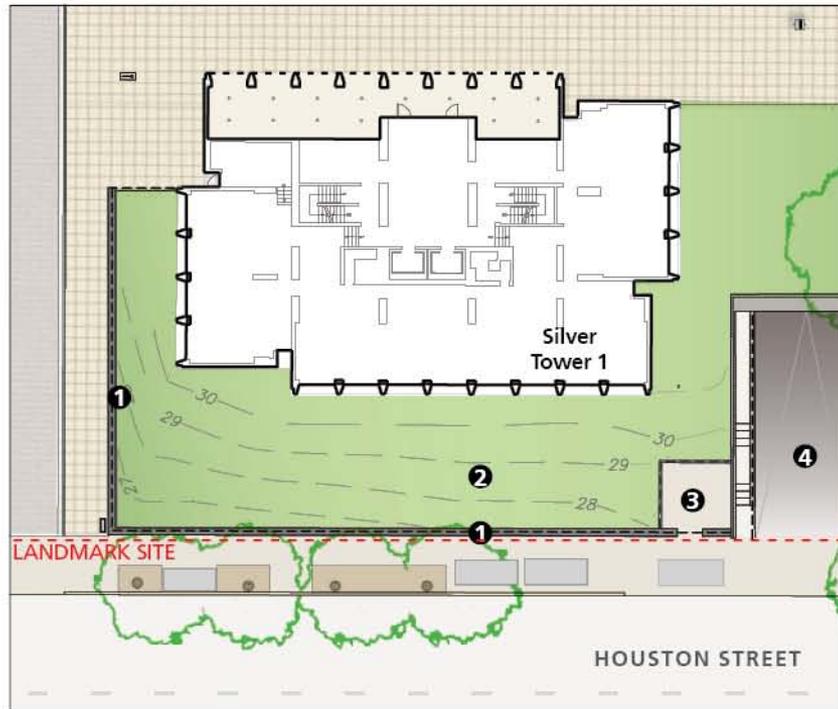
Existing Conditions Plan

1. Original Concrete Concrete Gutter and Non-Original Fence
2. Lawn
3. Non-Original Dumpster Location
4. Original Garage Entry

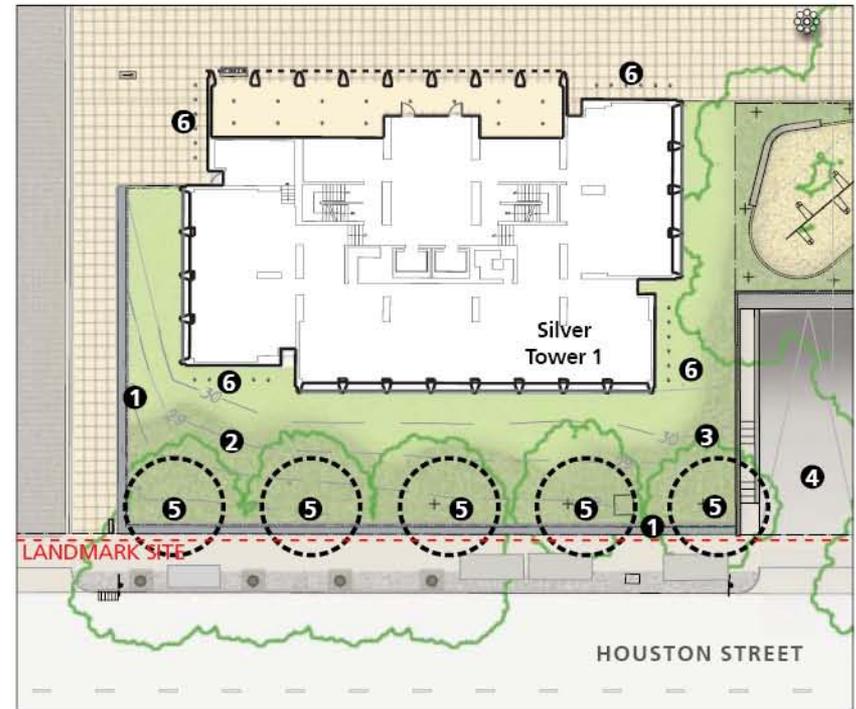
Proposed Plan

1. New Concrete Gutter (To Match Original) and New Fence on Side
2. New Understory Planting
3. Relocated Non-Original Dumpster and Replaced with Plant Bed
4. Original Garage Entry
5. New Trees (5)
6. Proposed Site Lighting

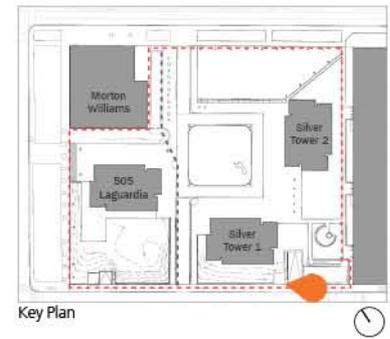
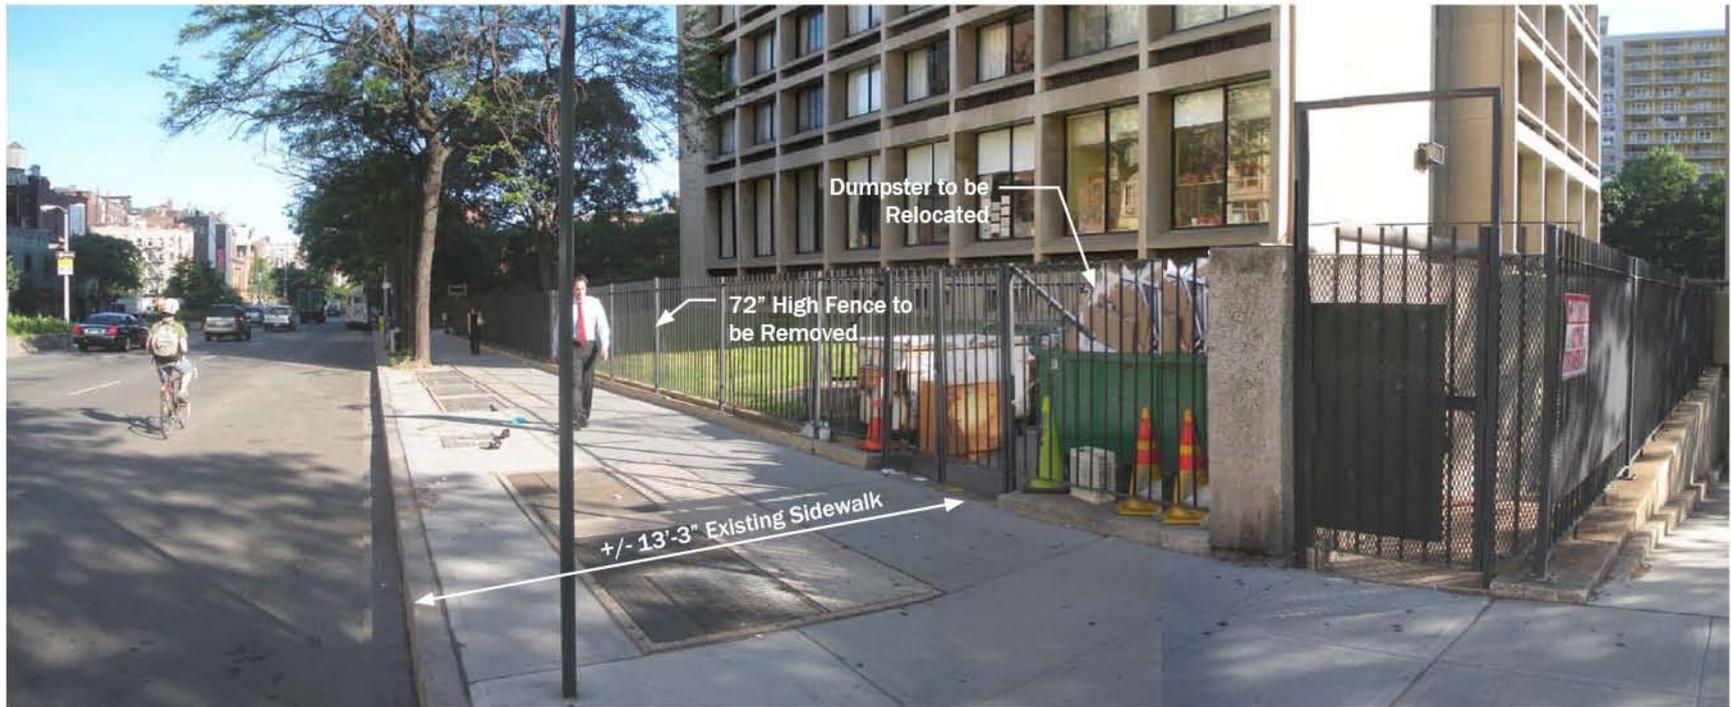
Silver Tower 1 Landscape — Existing

View of Existing Houston Street Sidewalk Looking West

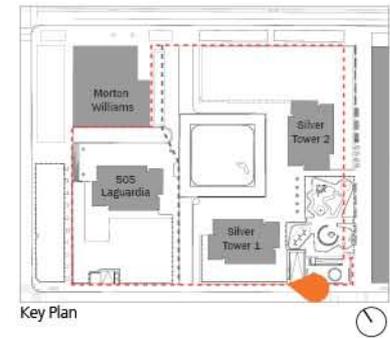
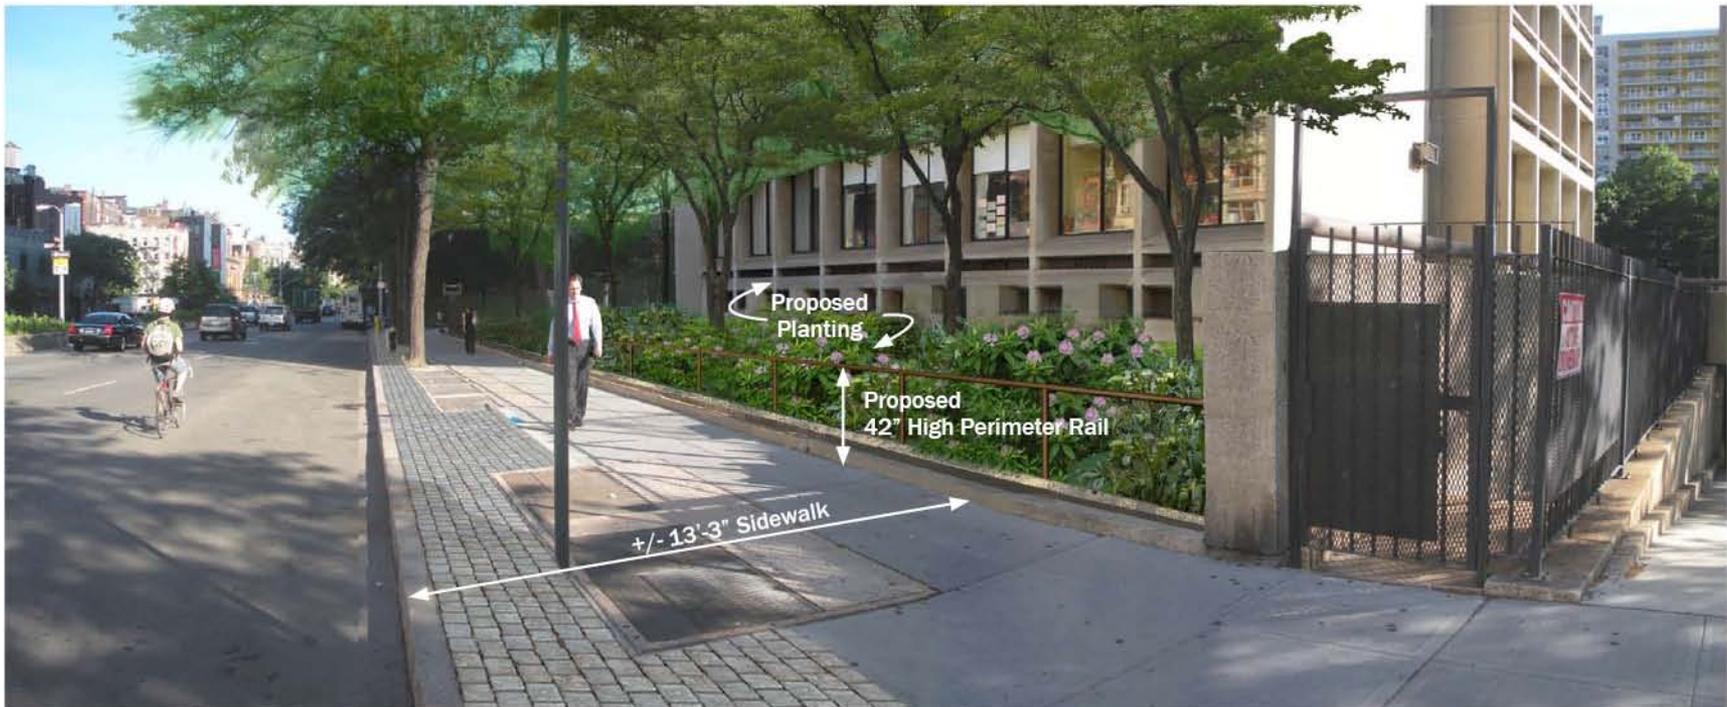
Silver Tower 1 Landscape — Proposed

View of Proposed Houston Street Sidewalk Looking West

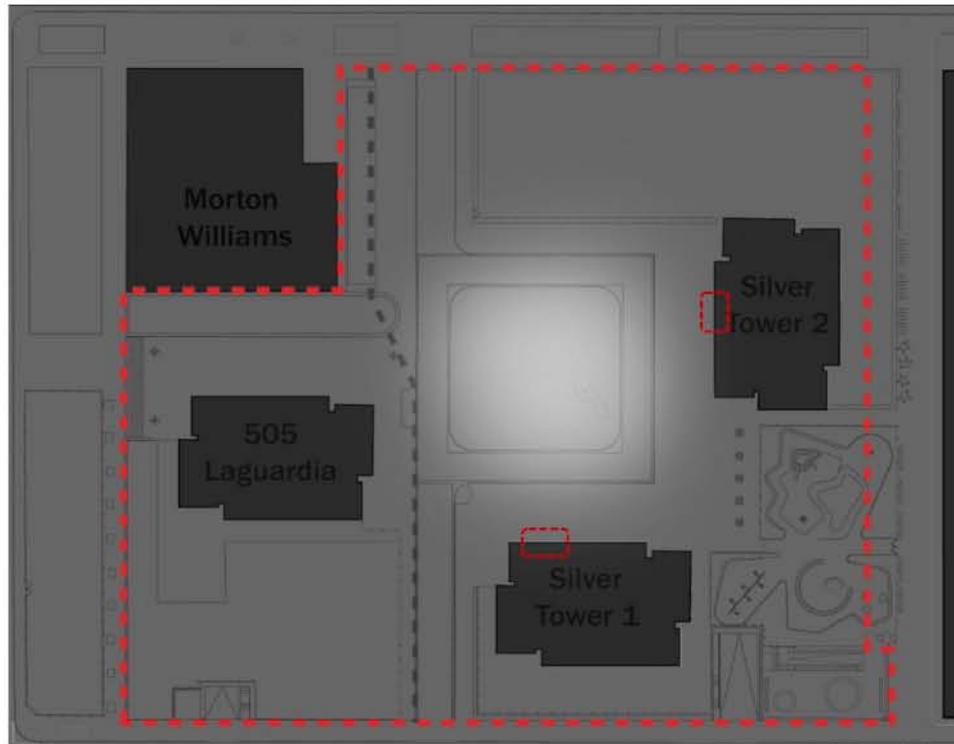
Site Lighting - Moonlighting (Existing Conditions)

(2) Locations, (12) Total Floodlights

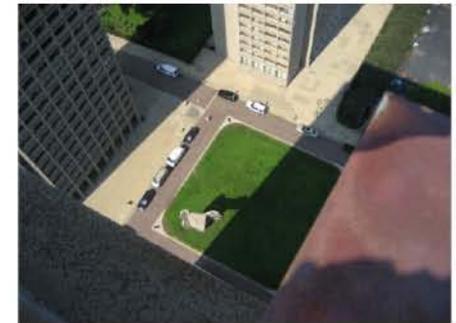
View to Central Green

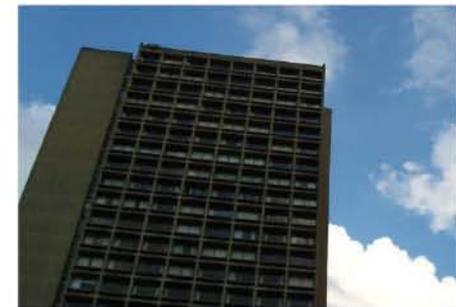
View of Tower Top

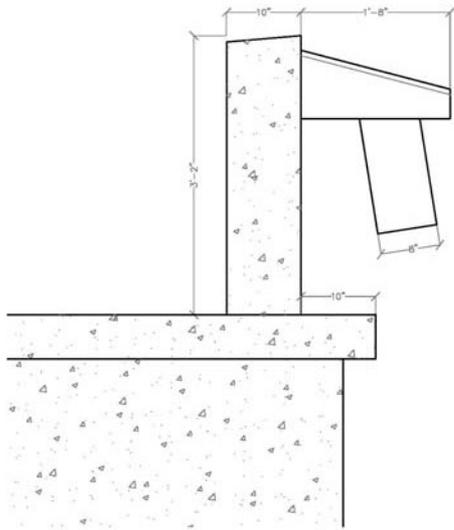
Site Lighting - Moonlighting (Proposed)

Dimensioned Side Elevation
Maintain original design aesthetics

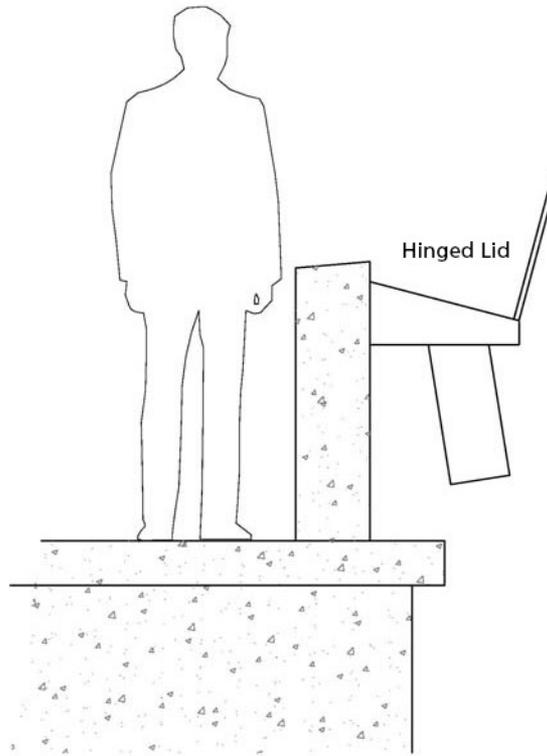
Side Elevation showing hinged door

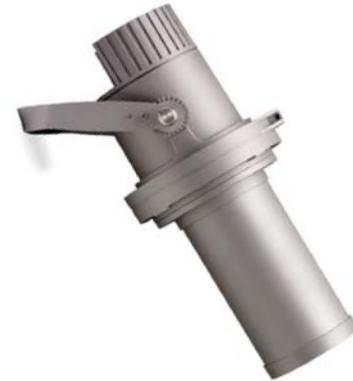
Proposed wet location floodlight to be
integrated into re-designed compartment
box that houses (6) total fixtures

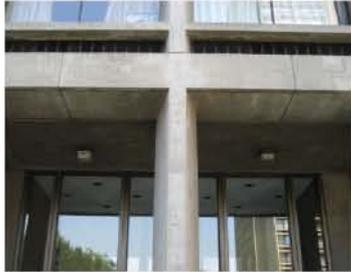
Site Lighting - Downlights at Building Entrances

Existing Conditions:

Surface Mounted Fixtures have Replaced Downlight Locations

Compact Fluorescent Lamps with Poor Optics and Poor Color Rendering Properties have Replaced Some Lamps

Some Downlights are Without Lamps

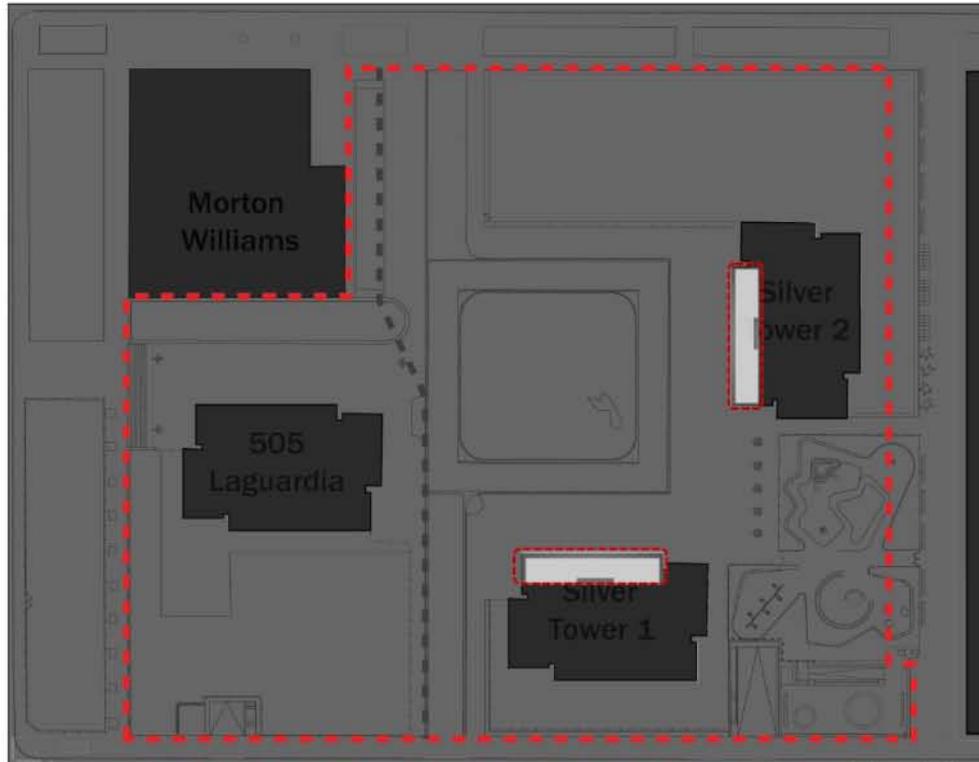
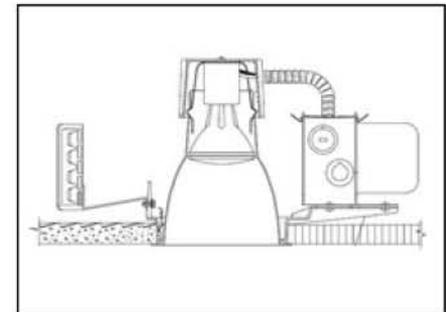
Proposed:
Replace Existing Downlights with Ceramic Metal Halide Downlights to Provide Better Optics, Better Color Rendering, and Better Efficiencies
Lamp Life: 12,000-15,000 hours

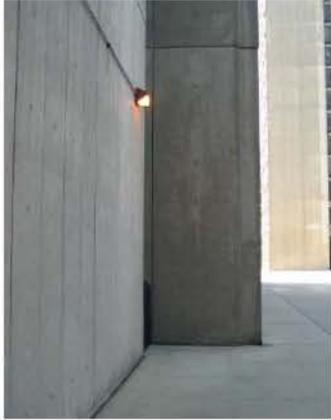
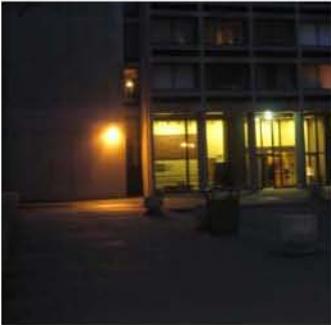
Proposed Site Lighting - Ingrade Facade Uplights

Existing:
Wall Mounted Floodlights

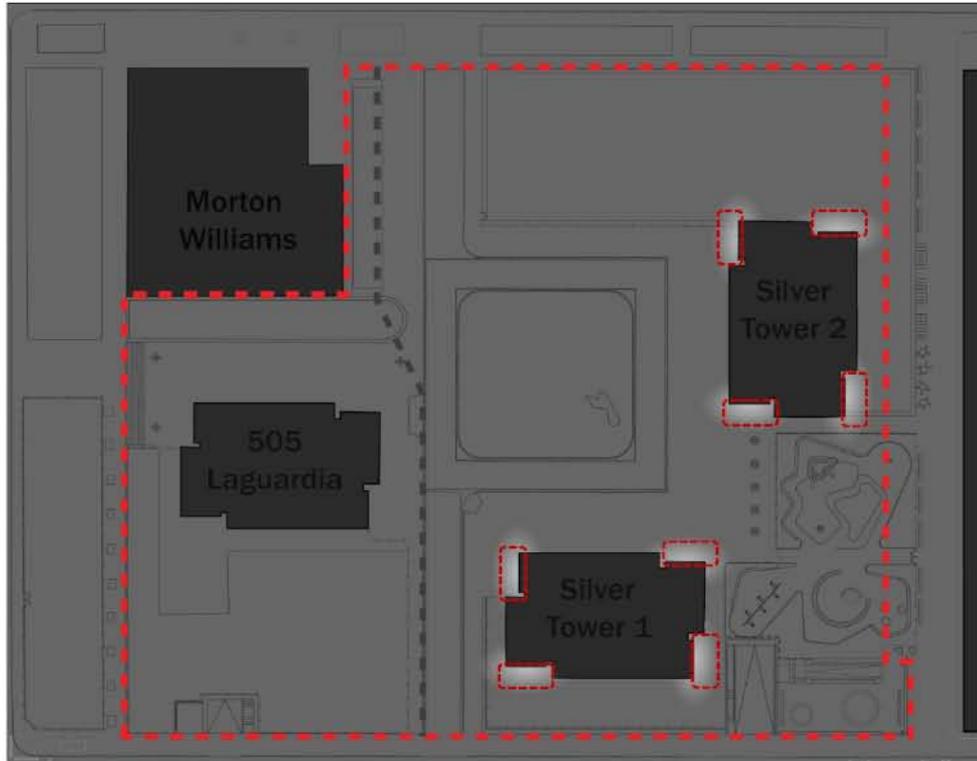
Concept:
Uplighted Facades Offer Bounce Light for Security While Re-enforcing "Pinwheel" arrangement of Building Layout

Proposed:
Low wattage Ingrade Metal Halide Uplight
Lamp Life: 12,000 - 15,000 hours

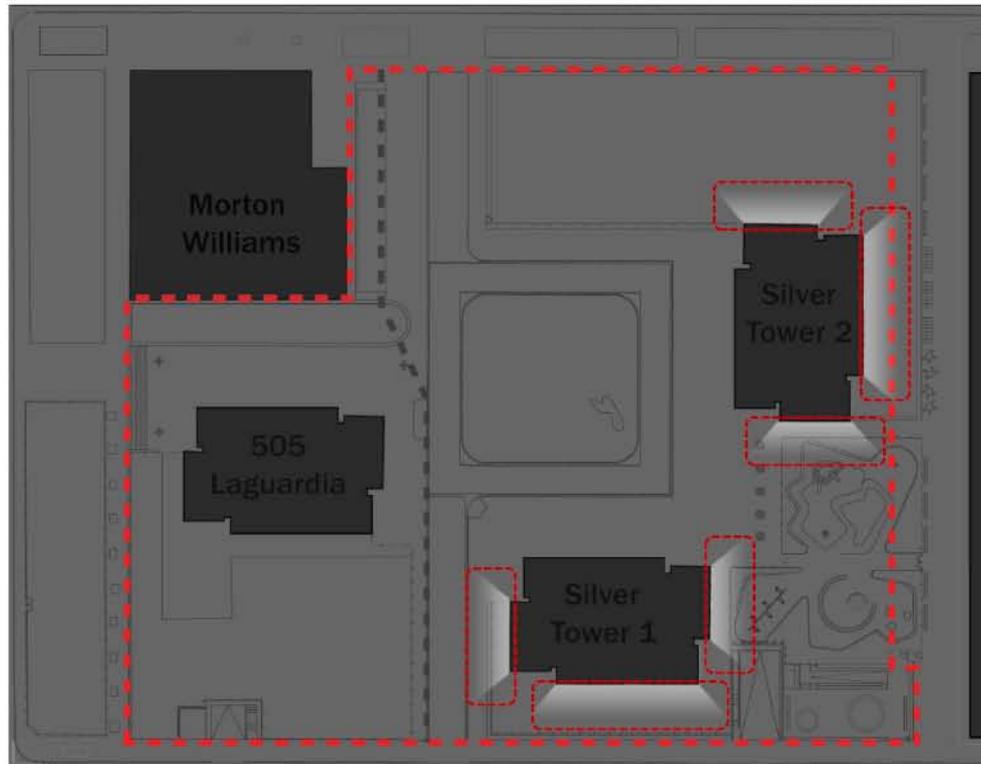
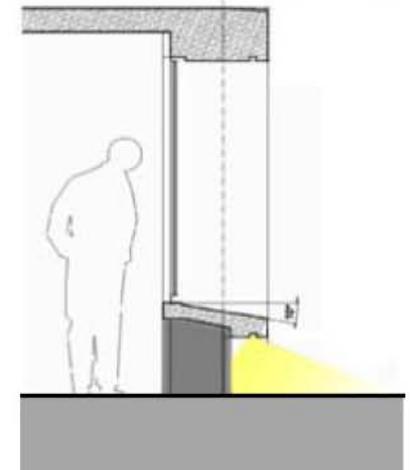
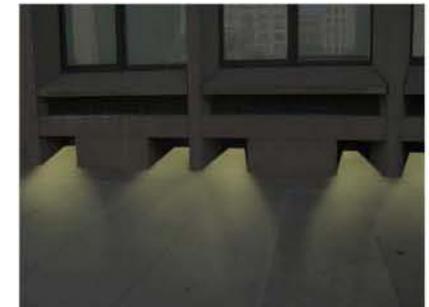
Proposed Site Lighting - LED fixture at Building Lip

Proposed:
LED Fixture Concealed at Building Lip
Lamp Life: 50,000+ hours
