University Village: NYU 2031 Landscape Presentation

Existing Conditions

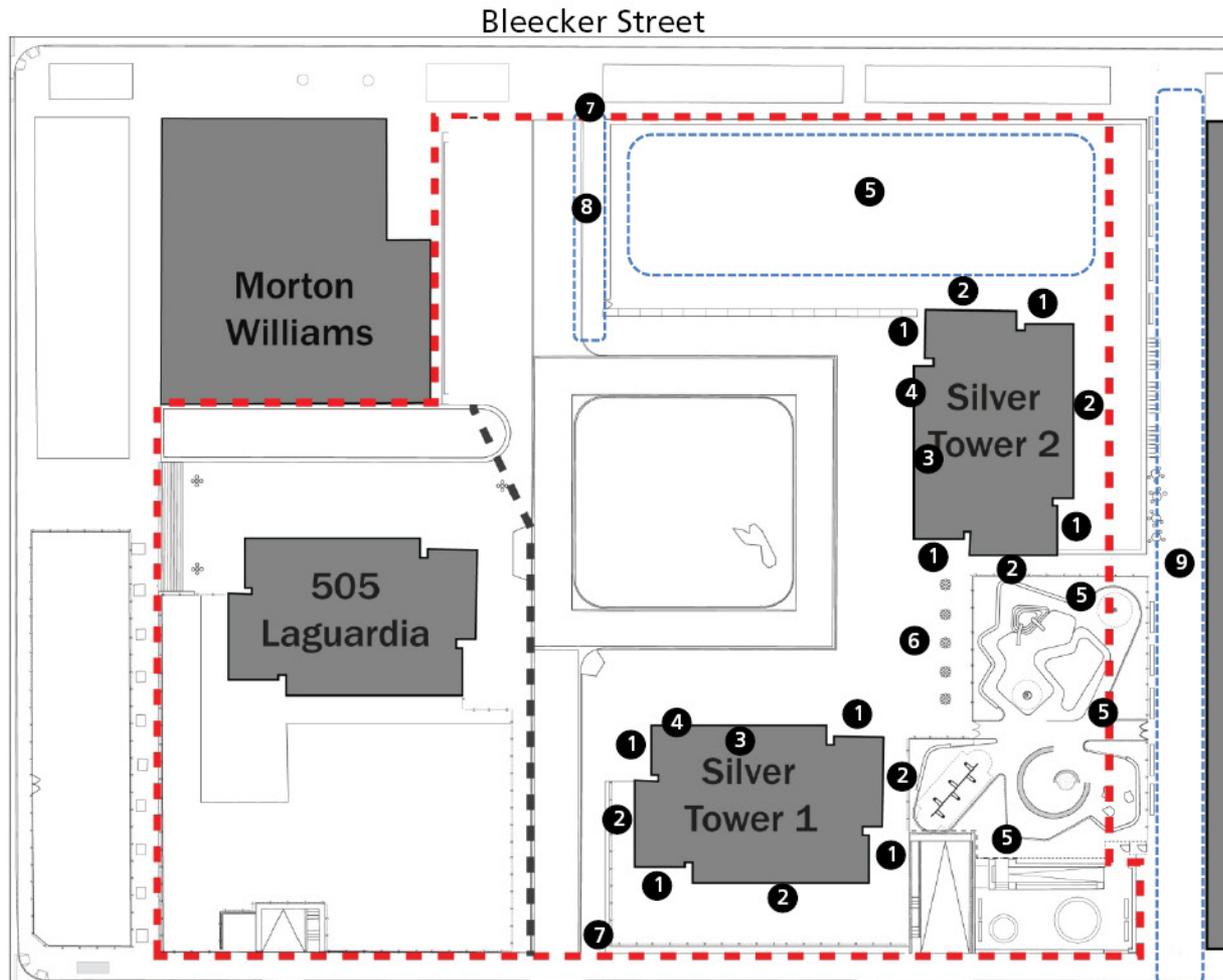
Site Lighting - Proposed Site Lighting Plan

| <ol style="list-style-type: none"> 1. Proposed Ingrade Facade Uplights 2. Proposed Ground Level LED Striplight at Building Lip 3. Replaced Metal Halide Downlights at Building Entries 4. Replaced Moonlighting Floodlights at Roof 5. Proposed Tree Uplights | <ol style="list-style-type: none"> 6. Replicate Historic Multi-Globe Pole Lights 7. Refurbished Taxi Light 8. Proposed Modern Bollard at Entry Walkways of Site 9. Proposed Modern Pole Fixture Along Greene Way |
