**The City of New York  
Department of Environmental Protection**

**ENVIRONMENTAL ASSESSMENT  
ATTACHMENT 1**

**PROJECT DESCRIPTION**

Engineering Design Services and Design During Construction  
for the Reconstruction of Catskill Watershed Dams and Associated Facilities

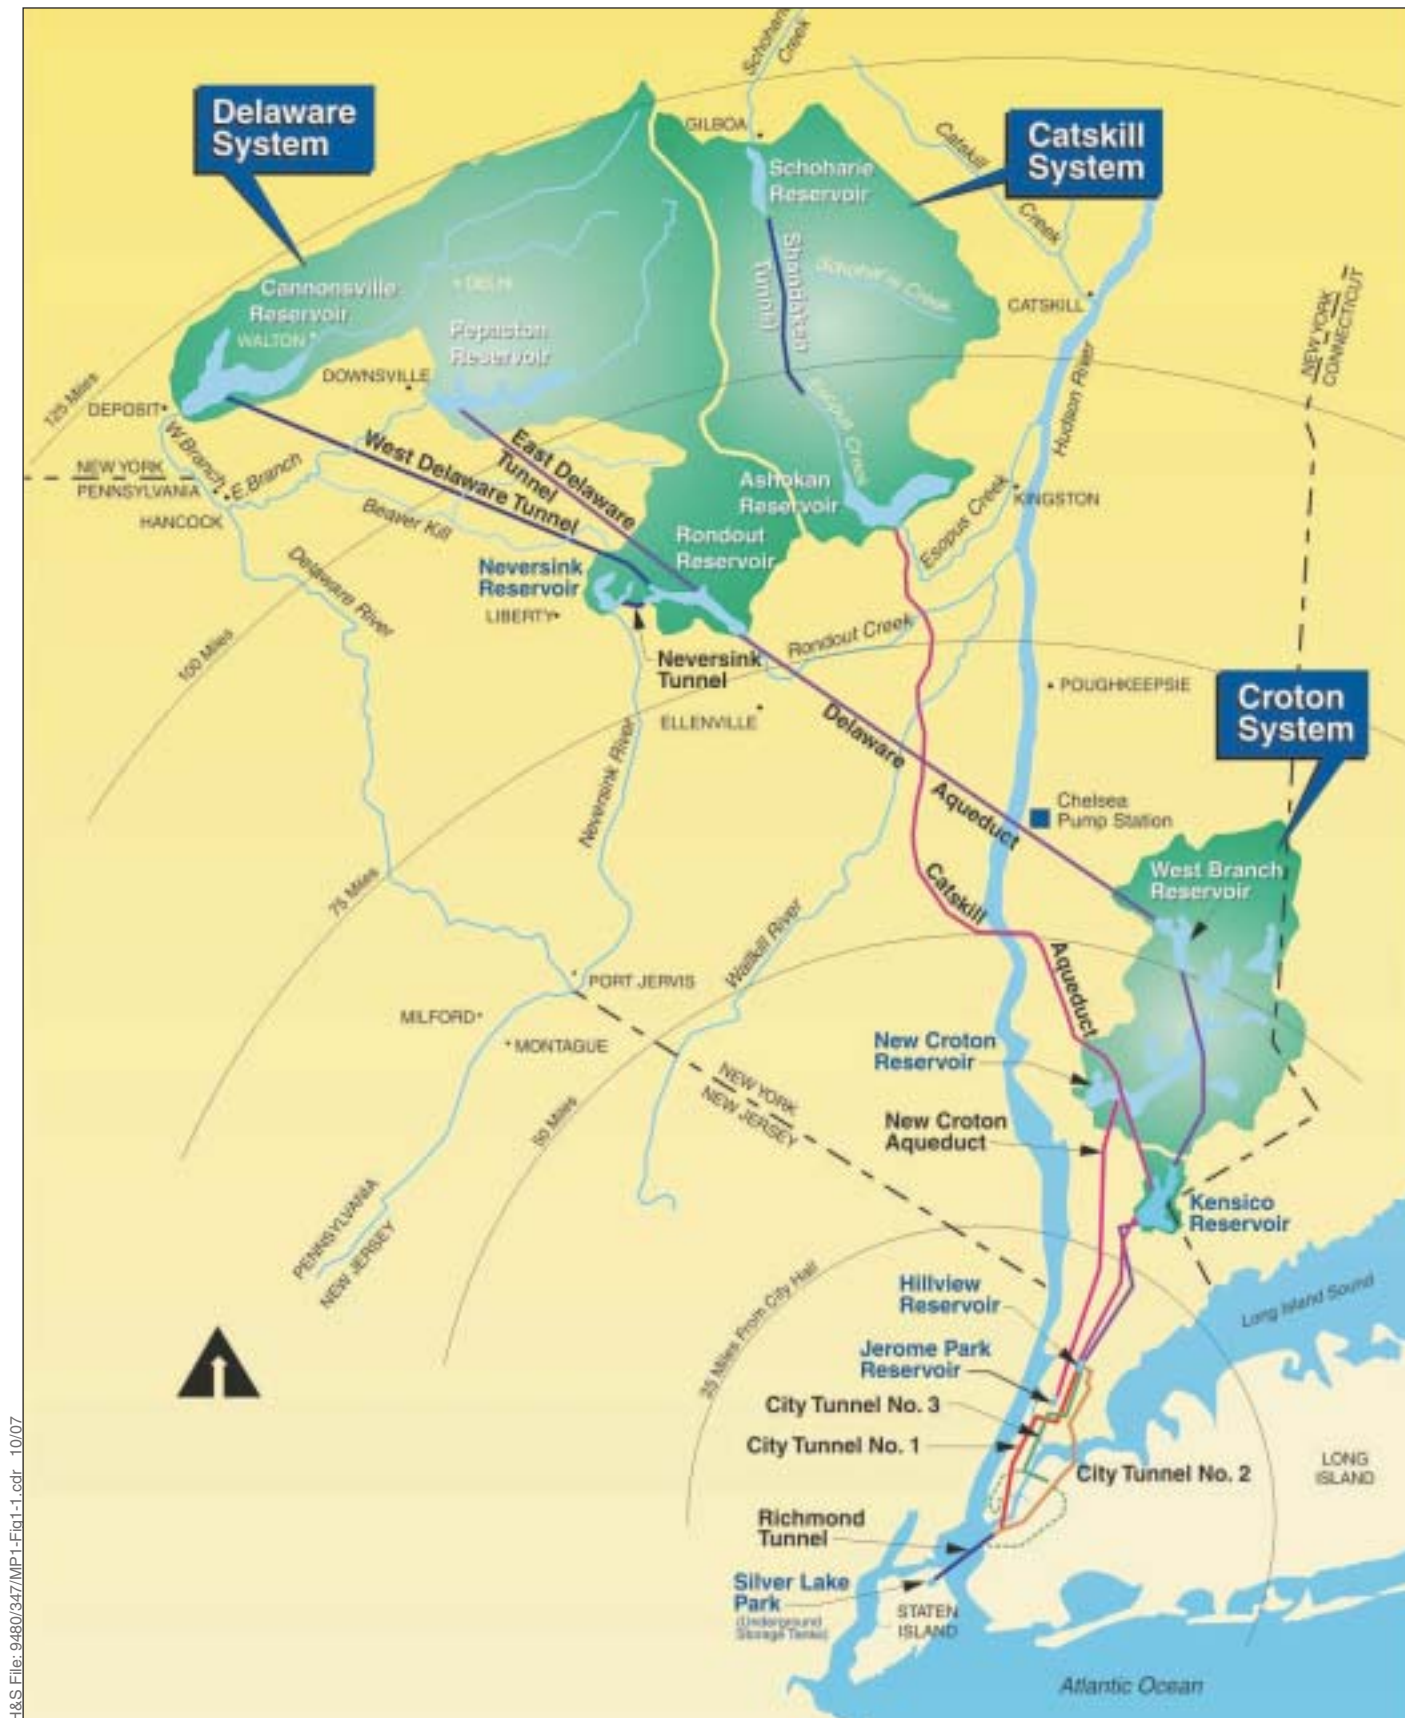
Figure 1-1

## New York City Water Supply System

From the outlet of the tunnel the water travels about 15 miles through Upper Esopus Creek and Ashokan Reservoir to the Catskill Aqueduct, where it travels to the Kensico Reservoir before traveling through either the Catskill or Delaware Aqueduct to the Hillview Reservoir and into the City's distribution system (refer to [Figure 1-1 – City Water Supply Map](#)).

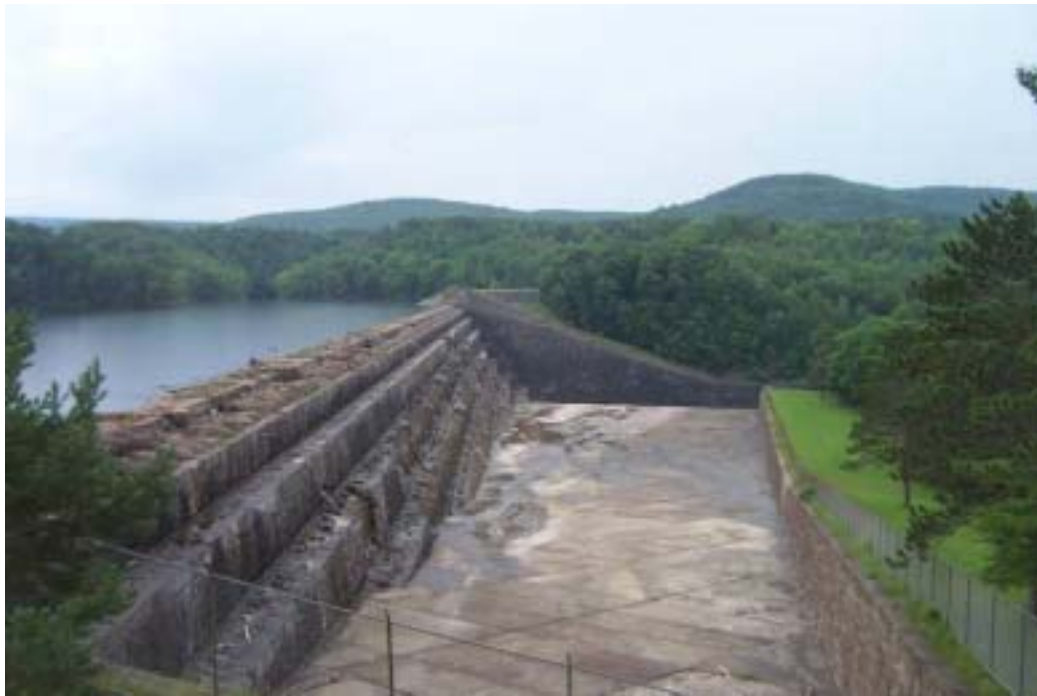
**Figure 1-4: Gilboa Dam**

Gilboa Dam is a classic NYCDEP gravity dam design, consisting of a 160-foot high by 1,326-foot long Spillway constructed of mass cyclopean concrete with a 3-5 foot thick Ashlar masonry façade of mortared quarried stone on the entire downstream face, and a portion of the upstream face (see [Figure 1-4](#)). The Dam is abutted on the west by a 160-foot high by 700-foot long Earthfill Embankment section consisting of homogenous rolled earthfill with a concrete corewall. A stair-stepped overflow structure (Stair-Steps), also constructed of cyclopean concrete with stone veneer facing, cascades water from the Spillway into the Side Channel, which varies from 80 to 270 feet in width. The Stair-Steps consist of 8.5 to 20 feet wide and 6 to 20 feet high steps, with approximately three steps that extend the full length of the Spillway, and is intended to dissipate energy as water overflows the Spillway. An onsite model study performed in the early 1920's after Dam construction had commenced demonstrated that water flowing over the crest of the Dam overshot the upper steps and struck the Stair-Steps at a lower position than anticipated, indicating that the original Spillway configuration provided less energy dissipation than intended. Therefore, a series of cast in place concrete crest vanes were installed at the top of the overflow structure to re-direct flow over the Dam crest at an oblique angle to prevent flow from overshooting the upper steps and therefore provide additional energy dissipation.

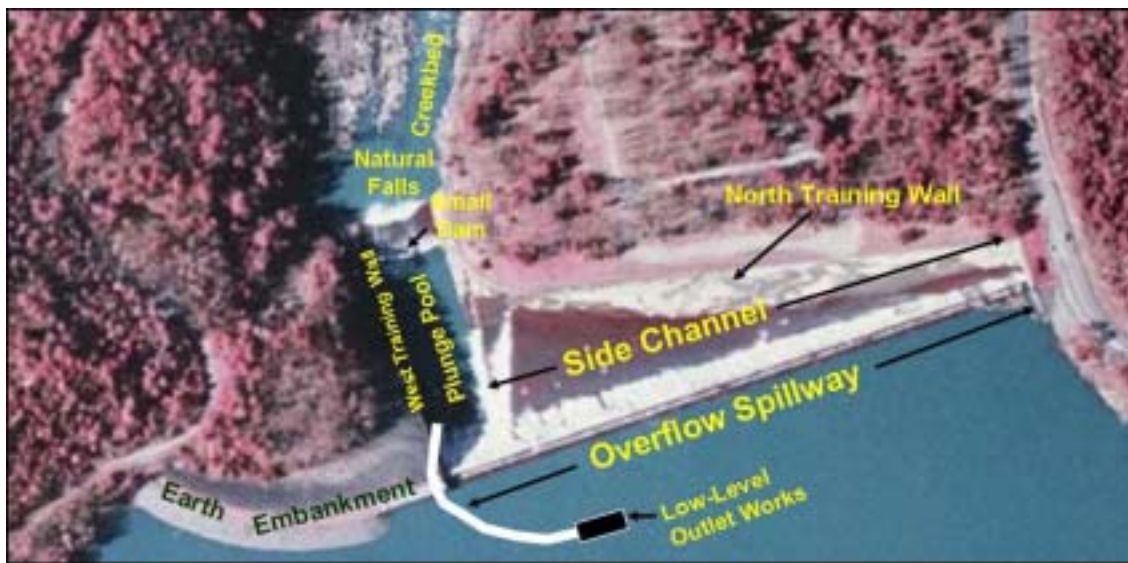
**Figure 1-5: Gilboa Dam**

Water flowing over the crest cascades into to the Side Channel (see [Figure 1-5](#)), which was originally constructed of stone but in 1953 was paved with wire-reinforced concrete to minimize routine maintenance, protect the original stone paving, and prevent damage to the stone joints from water pressure and freeze-thaw cycles during the winter months. Underdrains with 20-foot-deep drainage wells at 25-foot spacing along the underdrains into rock were also installed beneath the slab. To the north of the Side Channel is a stone clad retaining wall that forms the North Training Wall which directs water coursing over

the top of the Dam west where it hits the West Training Wall and is directed north into a 360-foot-long Plunge Pool. The Plunge Pool is bounded on the west by another stone clad retaining wall which again directs water flow north, downstream into the natural streambed for Schoharie Creek. Low level outlet works were provided beneath the western edge (i.e. left abutment) of the Spillway to permit drainage of Schoharie Reservoir into the Plunge Pool for routine inspection and maintenance of normally submerged areas and to provide a method of lowering the reservoir pool during any dam safety emergency. The hydraulic capacity of the Low Level Outlet works is supplemented by the Shandaken Intake Tunnel Chamber which could also be used to dewater the upper portion of Schoharie Reservoir (to elevation 1050 based on the original construction).

As discussed in [Section 1.4.1.3., Gilboa Dam](#), the original outlet for the low level outlet works of the Schoharie Reservoir is situated at the upstream end of the Plunge Pool beneath the western edge (i.e., left abutment) of the Spillway (refer to [Figures 1-5 and 1-12](#)). This structure was originally constructed to provide drainage of the Reservoir during routine inspection and maintenance of normally submerged areas or for emergency drawdown purposes when used in combination with the existing Shandaken Tunnel Intake structure. Since the 1960's, it has not been operated due to the accumulation of sediment over the inlet pipe in the Reservoir. In addition, the existing valving located in the Gate Control Chamber just west of the Spillway is in questionable condition. Therefore, new outlet works have been included in the proposed Gilboa Dam Reconstruction project to facilitate Reservoir drawdown as needed to suitably respond to Dam safety emergencies, and to allow for periodic maintenance of the Dam. As part of this proposed reconstruction of the LLO, NYCDEP is considering the installation of a warning system to notify downstream communities should an emergency release be necessary. A secondary potential use of the new LLO would be as a component of snowpack-based reservoir management (further discussed in [Section 1.5.1.3., Snowpack-Based Reservoir Management/Spillway Notch](#)).

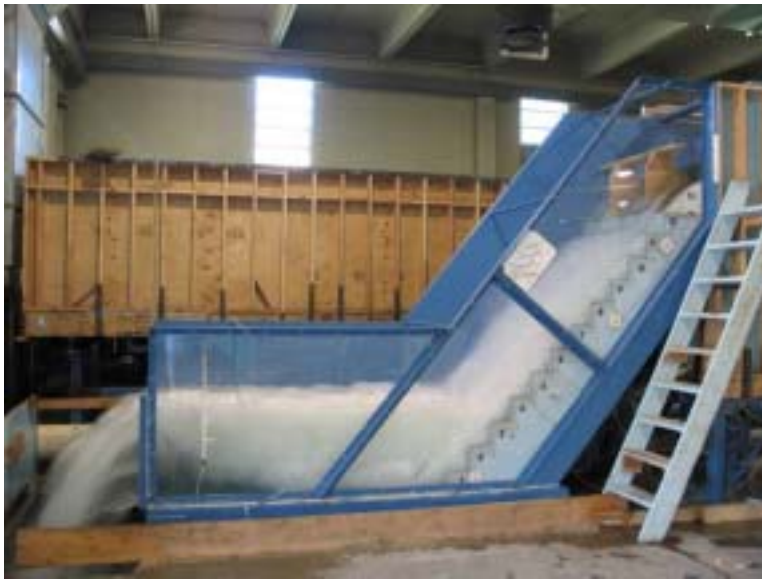
**Figure 1-8: 1:20 Model**

The 1:20 scale sectional three-dimensional model was first assembled to reproduce the existing stepped profile of Gilboa Dam (Figure 1-8) and to study the original crest and Spillway design under the maximum overflow of the original design criteria. The physical modeling results of this reproduction were consistent with the erosion and damage to the Dam which is visible today, thus validating the model for use in the development of a new Spillway configuration. The existing Stair-Step profile was also tested using the updated flow parameters, which crested more than 15 feet above the existing Dam with very little water striking the Dam's horizontal steps. This confirmed that the original Dam design was inadequate to control an overflow of this magnitude.

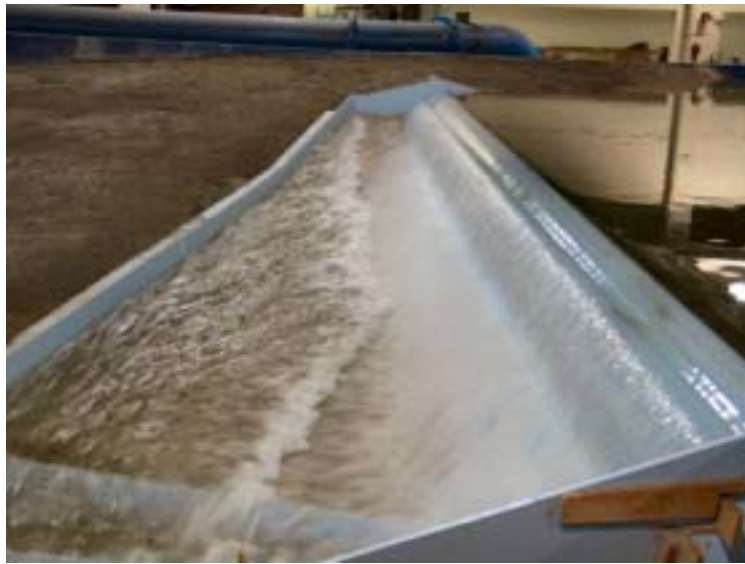
**Figure 1-9: 1:40 Model**

Using the updated flow parameters and optimized Spillway step configuration, a 1:40 scale physical model (Figure 1-9) was built to assess the hydraulic capacity and structural stability of the concrete Spillway as well as the structural stability of the other critical Dam structures including the adjoining Earth Embankment, West Training Wall, and Overflow Structure steps. In addition, channel velocities for flood events with 100-year, 500-year,  $\frac{1}{2}$  PMF return periods were used to evaluate the performance of potential energy dissipation modifications to the concrete Side Channel and Plunge Pool. The physical model was also updated during the emergency work to include the 5.5-foot deep notch to provide additional information on how this modification would affect the overflow. The 1:40 model results demonstrated that the notch, if present in the crest, would have no effect on the Spillway's ability to pass the flow parameters.

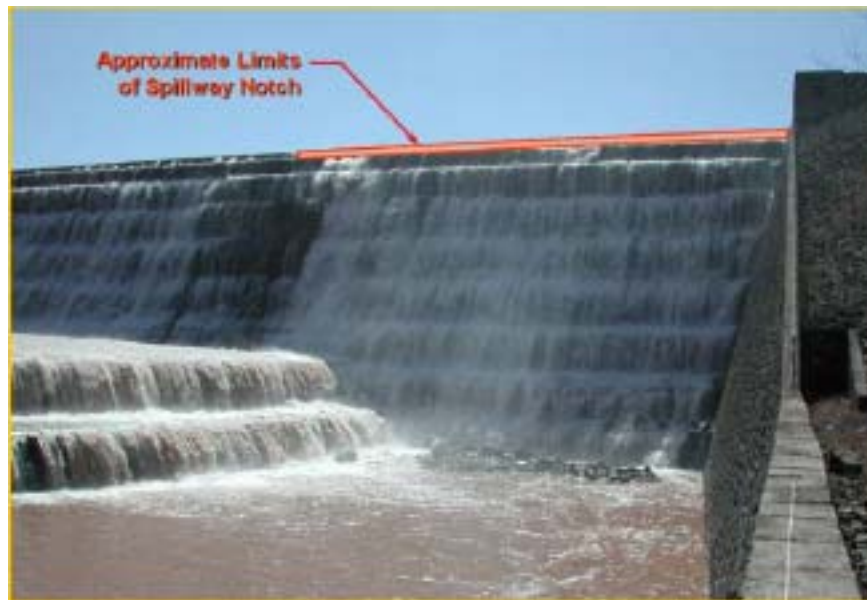
**Figure 1-16: Proposed Crest Gate System Installation at Gilboa Dam**

The dimensions of the entire crest gate system would be 5.5 feet high in the vertical direction when fully inflated and 220 feet long. A conceptual rendering of the pneumatically operated crest gates and a photograph of an existing installation are presented in [Figures 1-14](#) and [1-15](#), respectively. [Figure 1-16](#) illustrates the extent of the existing Spillway notch where the crest gates would be installed.

When the air bladders are fully inflated, the top of the crest gates would be flush with the Spillway at elevation 1130 feet. When the air bladders are fully deflated, the crest gates would rest flat six inches above the existing notch (elevation 1124.5 feet), thus enabling Reservoir drawdown to elevation 1125.0 feet. By controlling the pressure in the air bladders, the crest gates can be maintained in either a fully raised or fully lowered position. Control of the crest gates would be provided by a programmable logic controller (PLC) that offers remote control from NYCDEP's operations center in Grahamsville and onsite manual control.

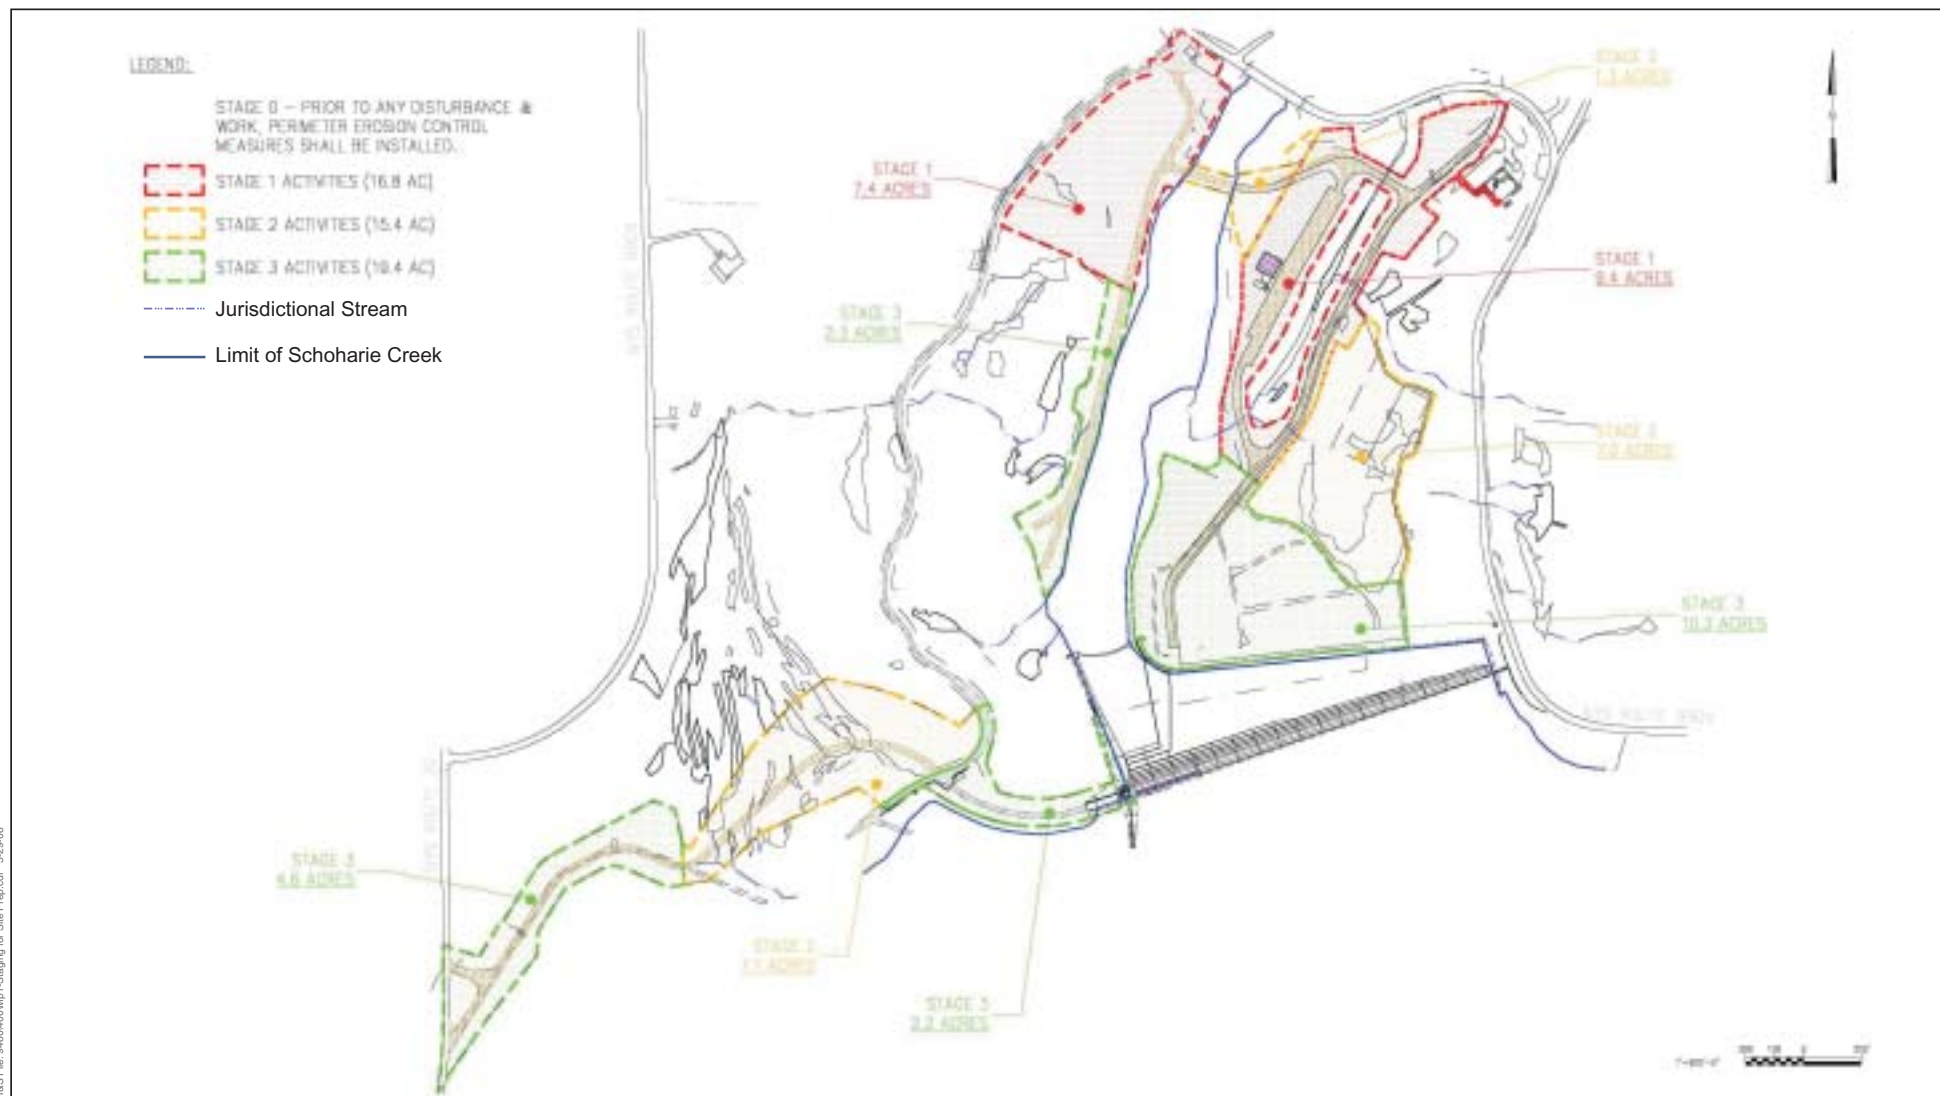
Figure 1-19

**Staging for Site Preparation  
Gilboa Dam and Associated Facilities**

The site preparation work would be performed in three stages, as shown in [Figure 1-19](#), in order to provide a logical and efficient sequence of work as well as to minimize erosion and sedimentation of the work area during clearing and regrading activities.
