Chapter 11: Proposed Rondout-West Branch Tunnel Inspection and Repair

This chapter of the ~~Final Draft~~ Environmental Impact Statement (~~F~~EDEIS) evaluates the proposed Rondout-West Branch Tunnel Inspection and Repair (inspection and repair) that would occur as part of Upstate Water Supply Resiliency:

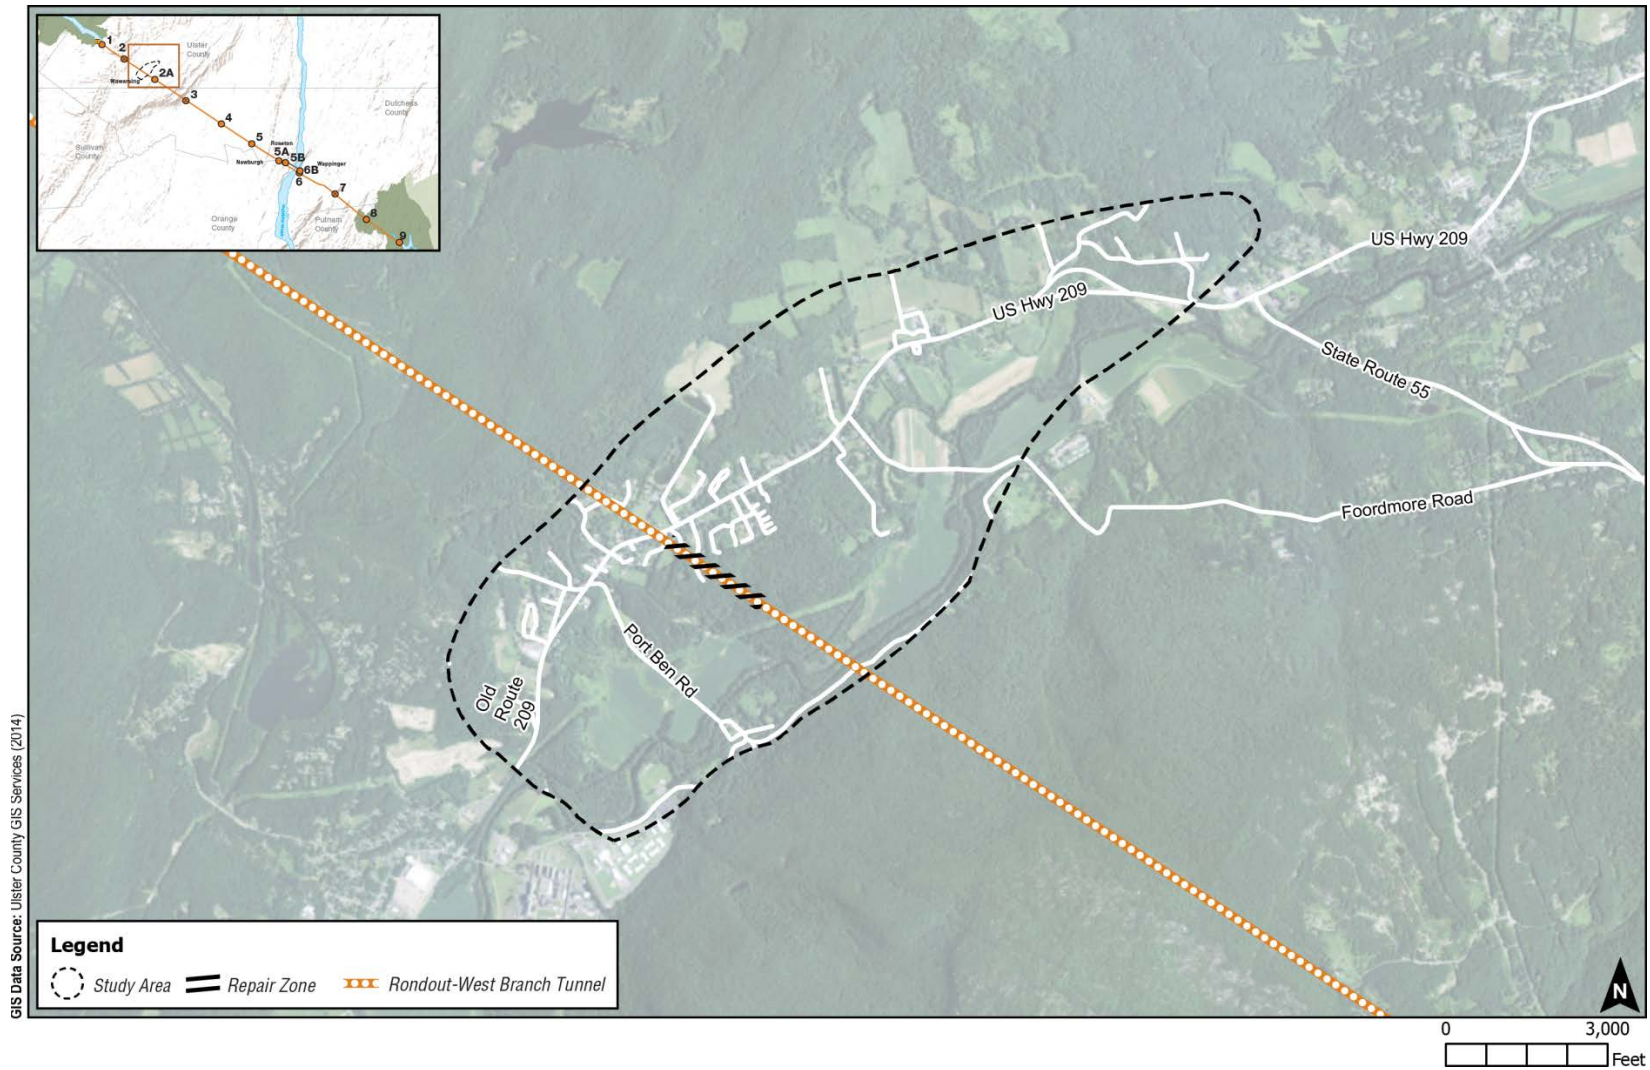
Figure 11.3-2: Leak Repair – Study Area

The Leak Repair Study Area was defined based on these geologic units and water levels measured by the USGS when DEP reduced flow in the RWBT. The northeastern and southwestern boundaries were defined as the areas where parcels are supplied with water from water districts and changes to groundwater levels are likely to be negligible in the bedrock aquifer as a result of reducing flow in the RWBT. The southeastern boundary coincides with a divide in the regional groundwater flow system that extends along and to the east of Rondout Creek. The northwestern boundary of the study area aligns with a change in bedrock from limestone to shale as no inflow of water from this shale into the RWBT was recorded during construction. This boundary also coincides with the location where topography transitions from a valley floor to the surrounding hills to the northwest (see **Figure 11.3-2**).

The groundwater impact analysis was performed for the Leak Repair Study Area shown on **Figure 11.3-2**. Potential impacts to groundwater resources in the Leak Repair Study Area from the inspection and repair was evaluated in Section 11.6.9.1, “Water Resources,” using the methodology described below.

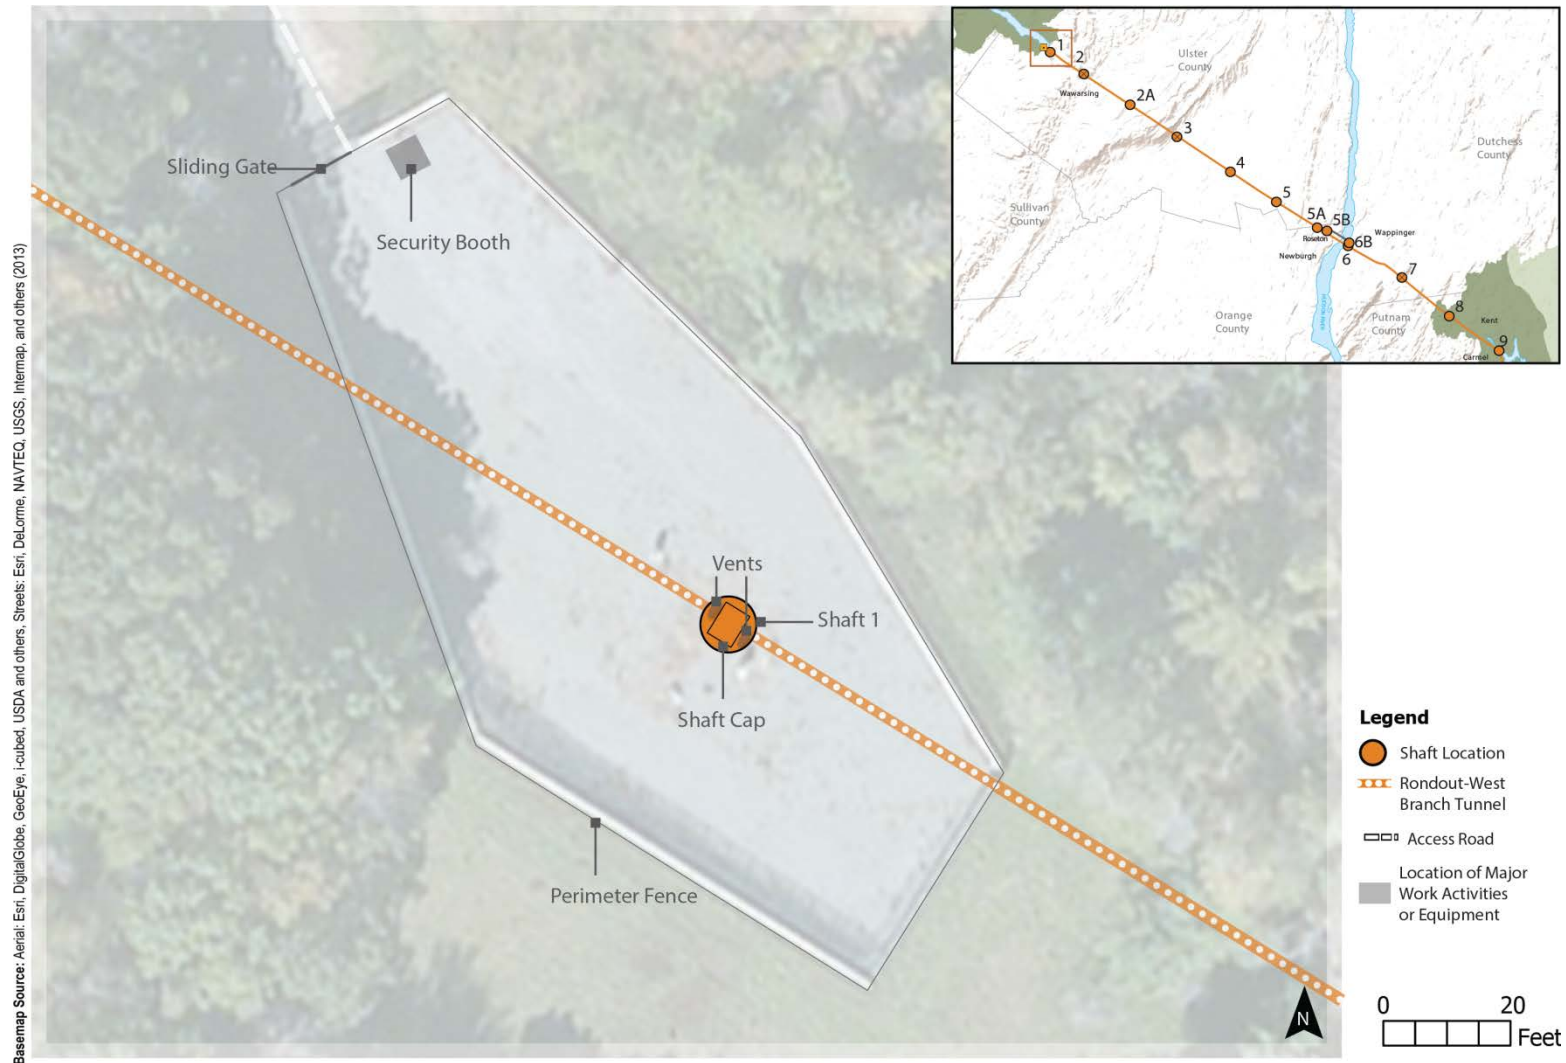
Figure 11.5-4: Shaft 1

Once the inspection and repair begins, work at the Shaft 1 site would occur 7 days a week from 7 AM to 7 PM. At this time, the RWBT would be drained, which is anticipated to take approximately 20 days. At this time, the existing shaft cap would be demolished to eventually allow equipment, materials, and personnel to enter or exit the shaft during the inspection and repair.

Note: The gray lines show the edge of the work area/site and outline other features of the existing shaft site.
