A. INTRODUCTION

The proposed project would involve the installation of a flood protection system generally located within City parkland and streets between Montgomery Street to the south and East 25th Street to the north. The proposed flood protection system would consist of a combination of floodwalls, levees, and closure structures that, together with other infrastructure improvements, would improve the resiliency of this area to coastal flooding while simultaneously improving access and community connectivity to the waterfront. The proposed project would require the demolition or disturbance of existing structures, excavation,² and disturbance and removal of some of the existing fill and soil. Dewatering of groundwater would also be required. A detailed description of the alternatives analyzed in this chapter is provided in Chapter 2, “Project Alternatives.”

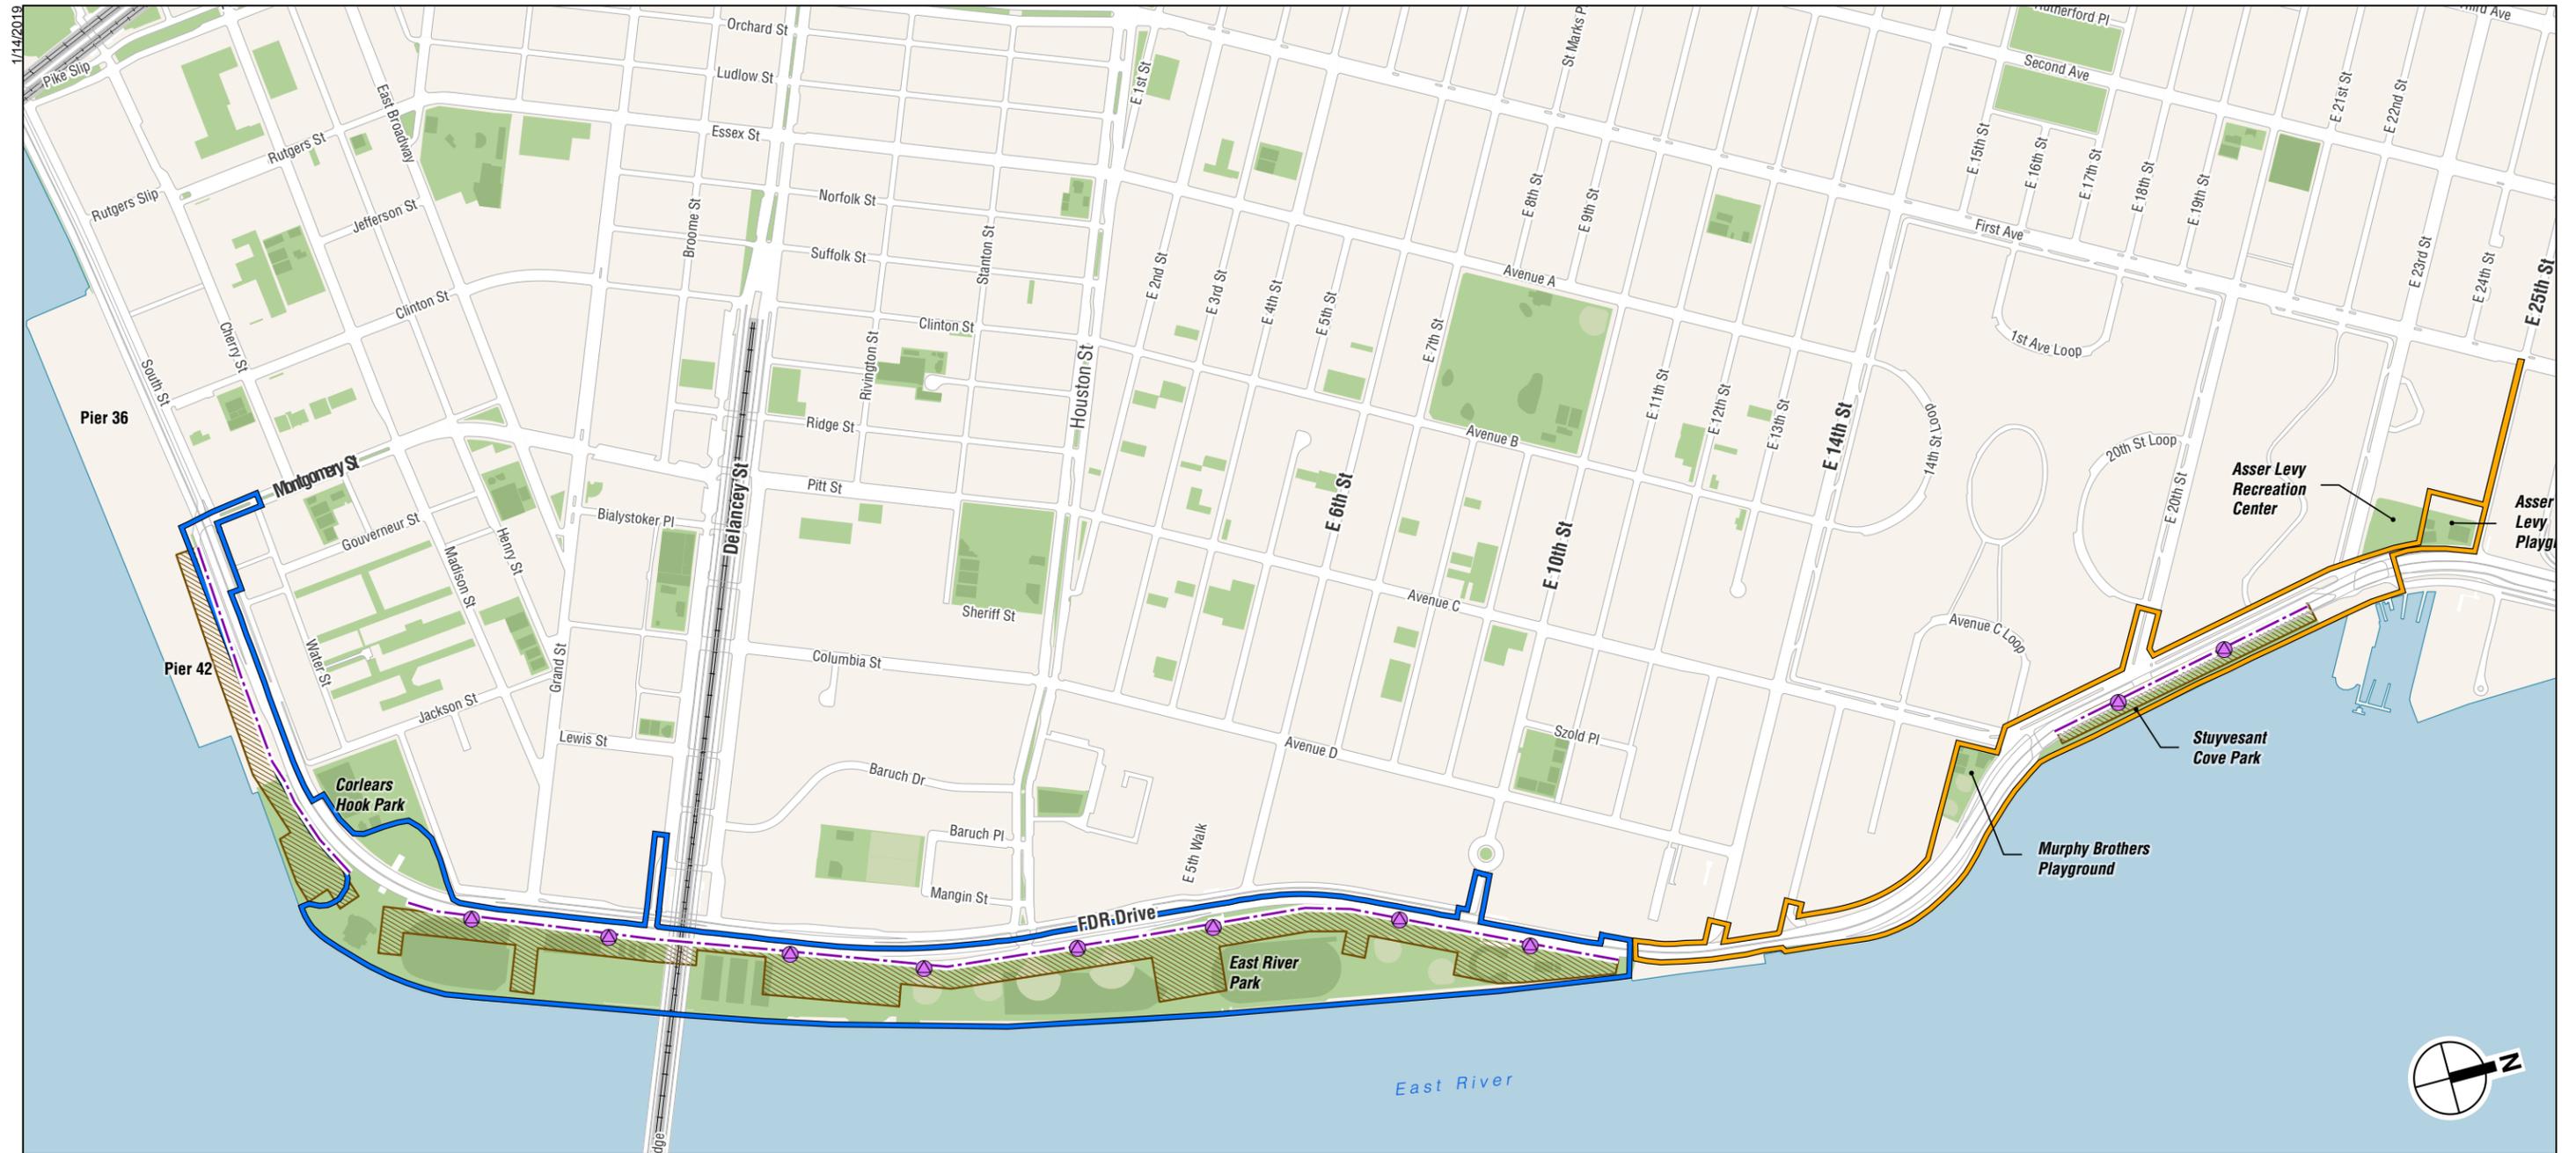
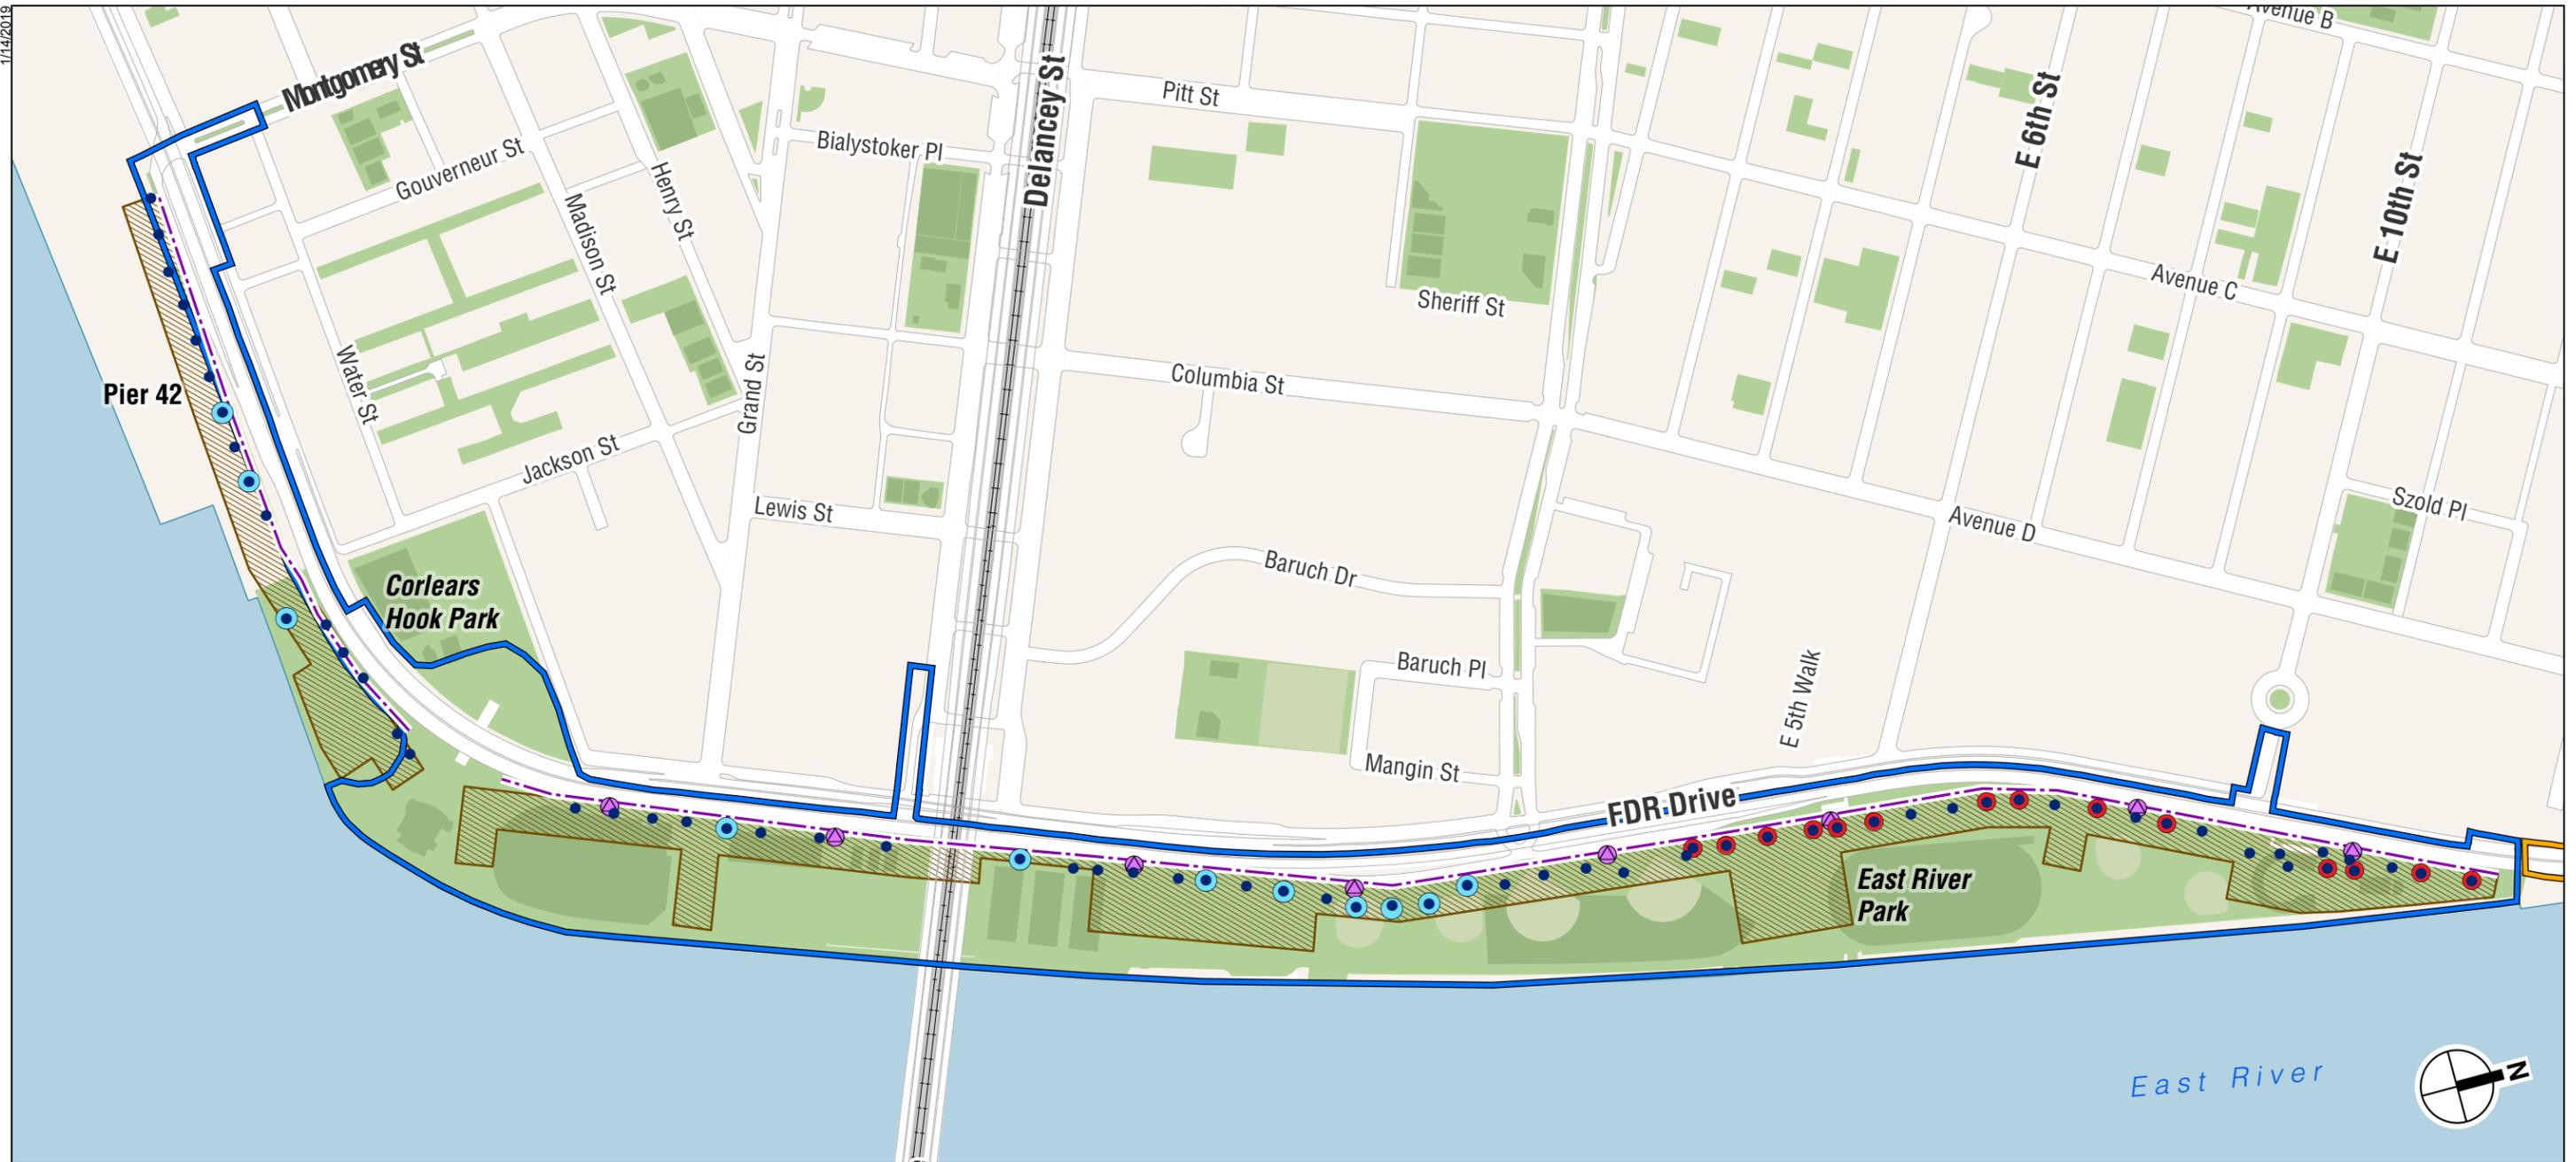
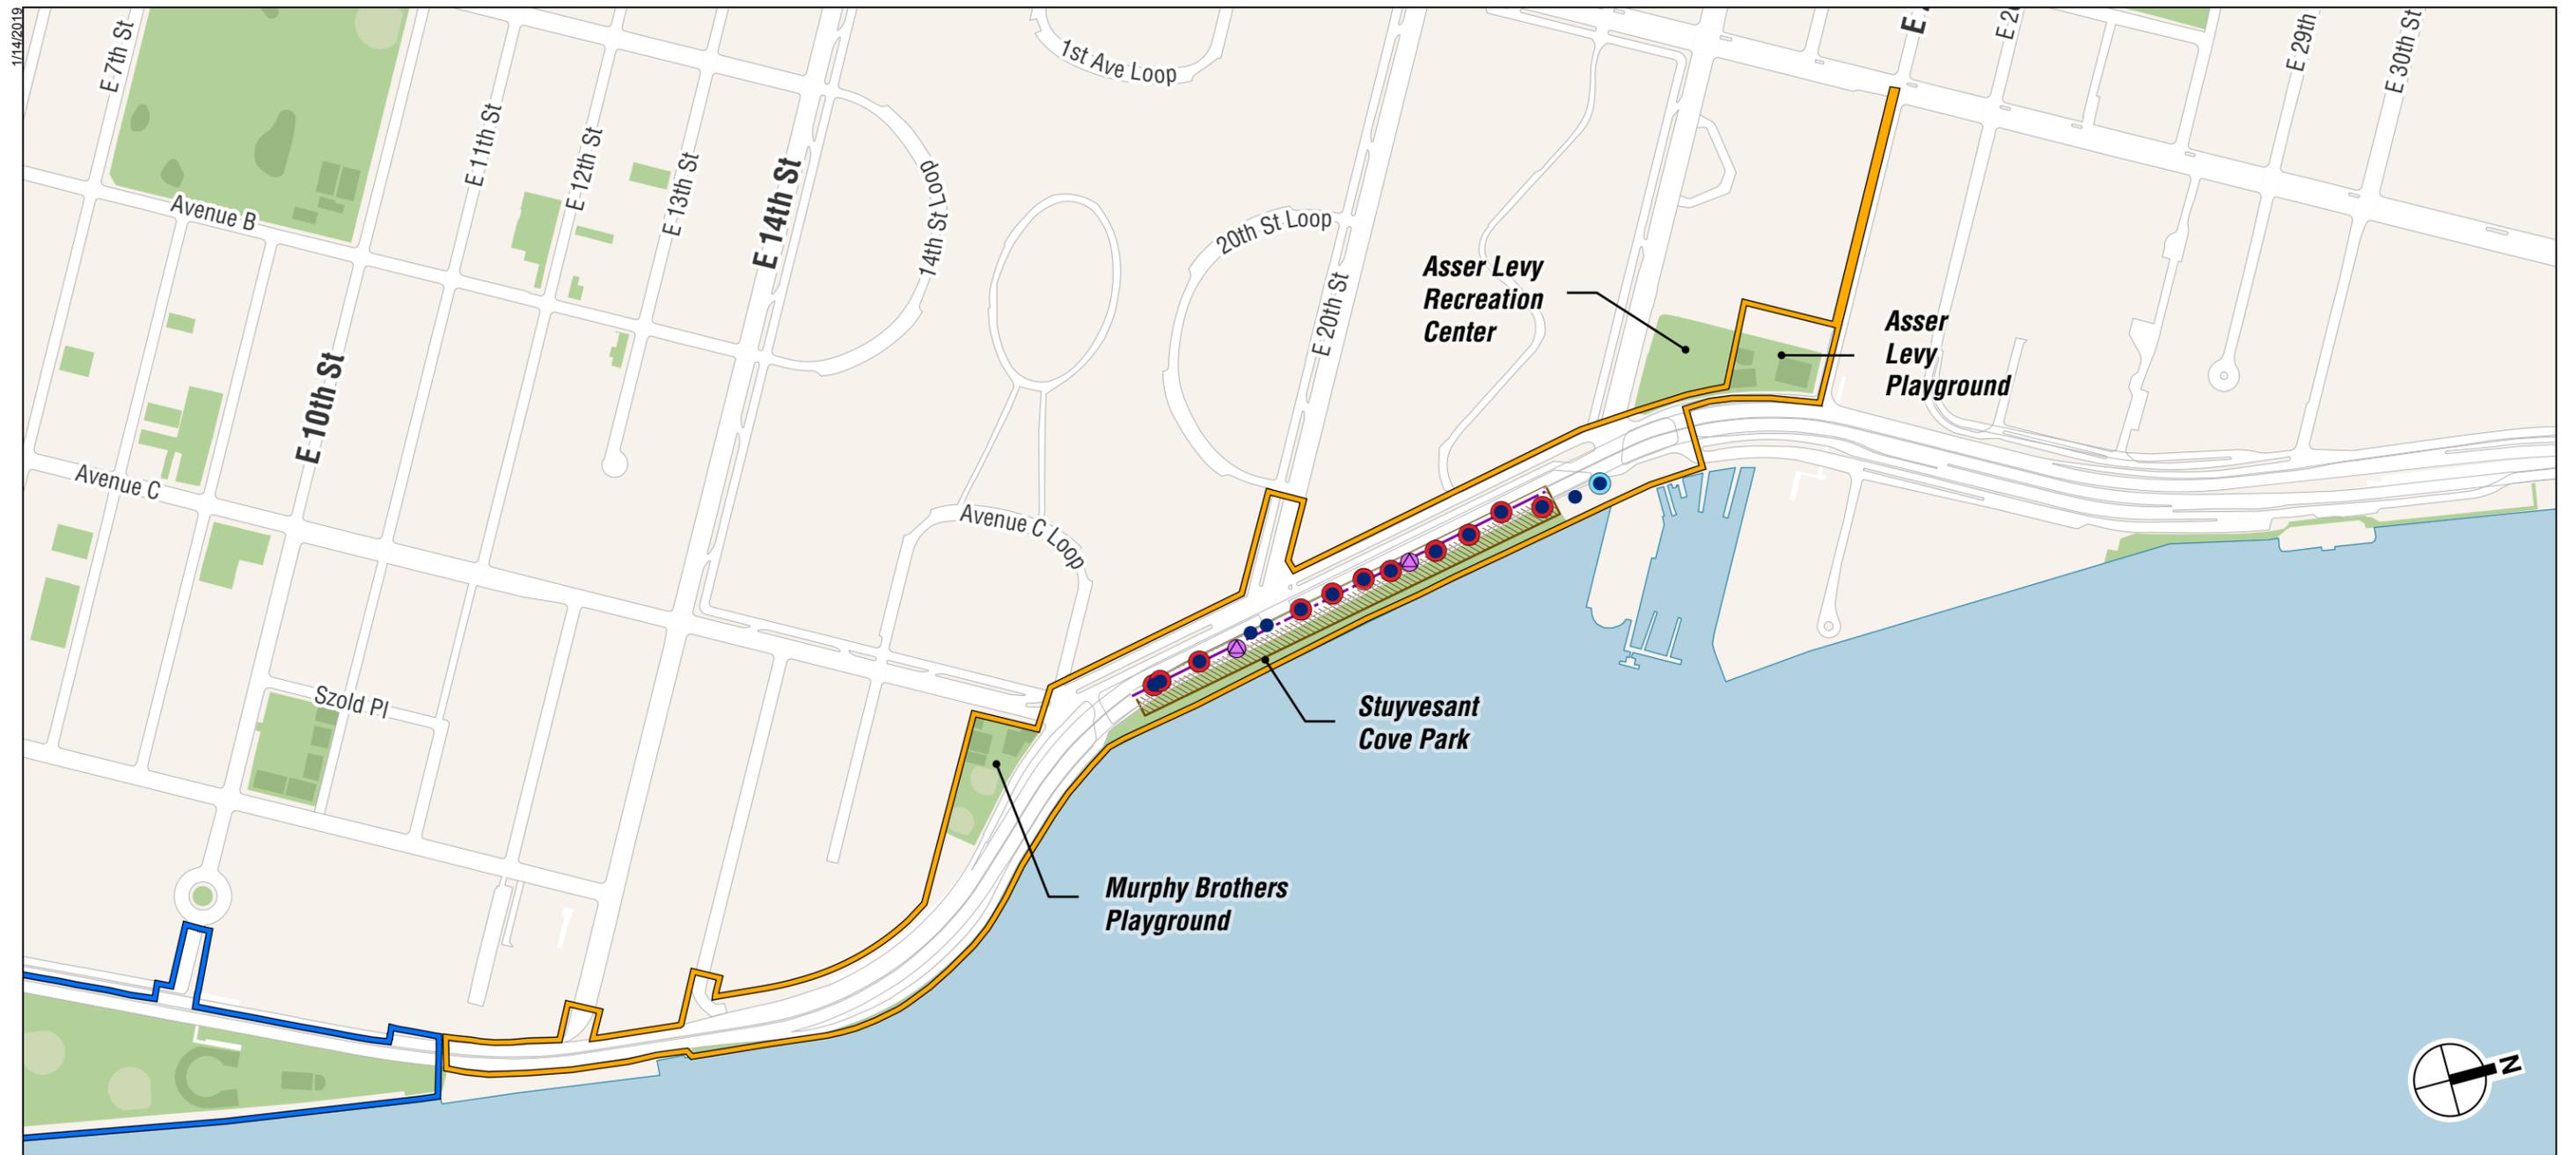
- Project Area One
- Project Area Two
- Deep Boring Alignment
- Shallow Boring Areas
- ▲ Groundwater Sample Locations
- Deep Soil Boring Location & Designation
- Deep Soil Borings with Petroleum-Like Contamination Encountered at Depths
- Deep Soil Borings with Coal Tar-Like Contamination Encountered at Depths

Groundwater during the soil and groundwater investigations was first encountered at approximately 5 to 12 feet below grade; however, more precise groundwater measurements obtained from temporary wells identified the water table at between 5 and 16 feet below grade. While groundwater throughout the project area would be expected to flow toward the East River, local variations are possible due to intervening subsurface structures (such as former or current bulkheads), tidal fluctuation, and past filling. Groundwater in Manhattan is not used as a source of drinking water (see **Figures 5.7-1 through 5.7-3**).

Petroleum-like odors and or low-level photoionization detector (PID) readings, indicating the presence of VOCs, were noted during the field screening of soil from 12 borings as shown on **Figures 5.7-2 and 5.7-3**. However, laboratory data indicated potential petroleum contamination in only three of these borings—one located slightly south of East Houston Street, one just north of the Williamsburg Bridge, and another near the Solar One site.
