20 NOLAN PARK, GOVERNORS ISLAND  
RESTORATION / REHABILITATION  
COMMUNITY BOARD 1 PRESENTATION

MAY 7, 2019

THE TRUST FOR GOVERNORS ISLAND

JAKLITSCH/GARDNER ARCHITECTS PC

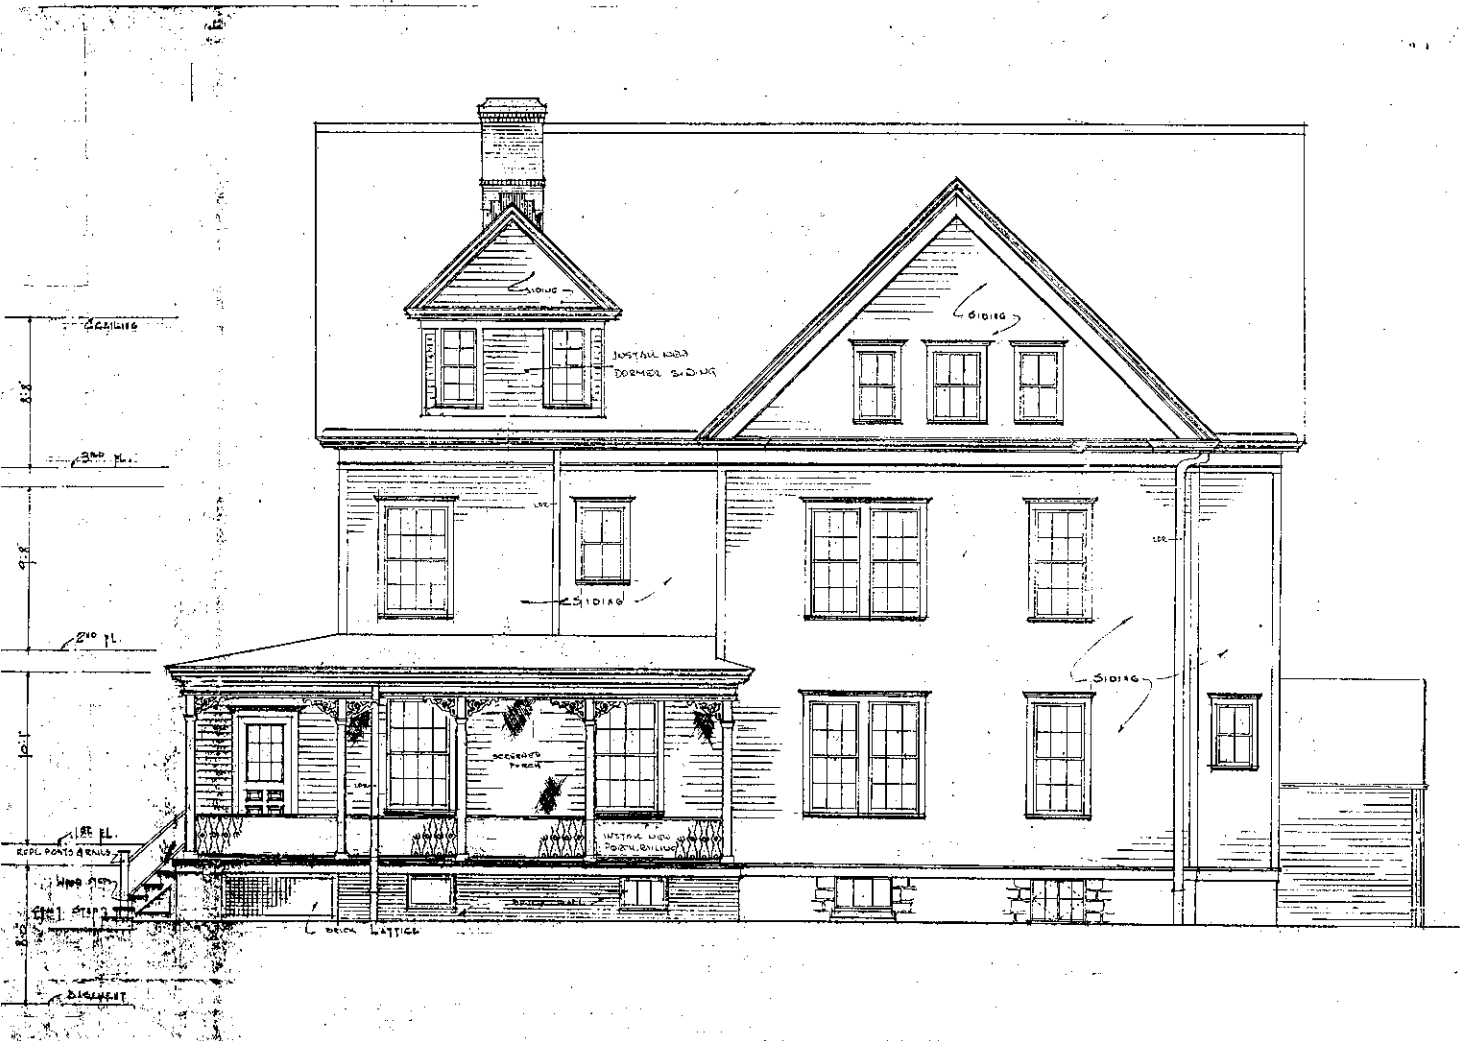
### 1993 CONSTRUCTION DOCUMENTS

- 1. The 1993 renovation altered existing facades by making changes to the siding and front porches.
- 2. Porch enclosures eliminated.
- 3. New columns, balusters and scroll work added.
- 4. Asbestos-cement siding removed.
- 5. Clapboard siding underneath was revealed, repaired and repainted.

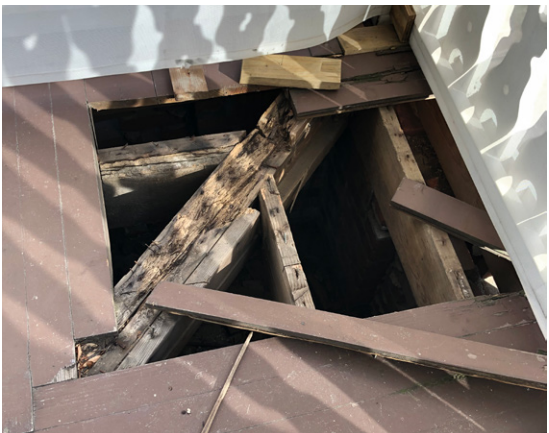
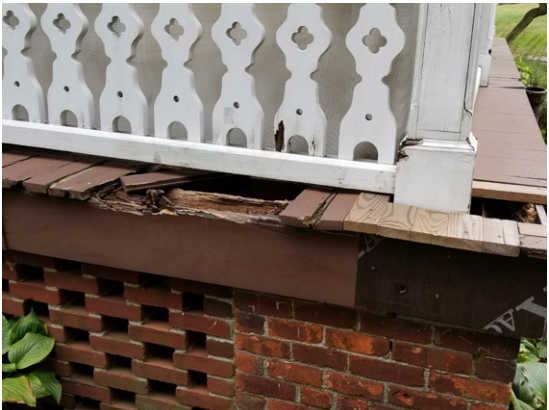
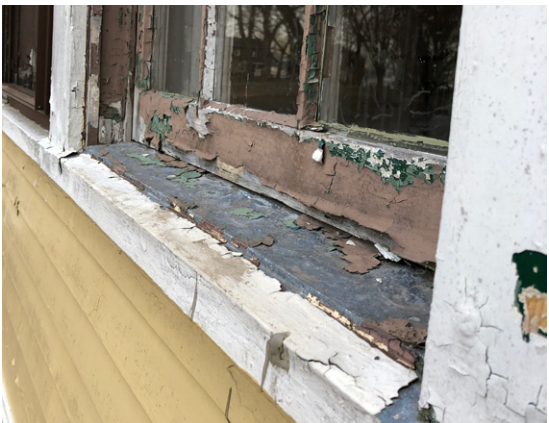
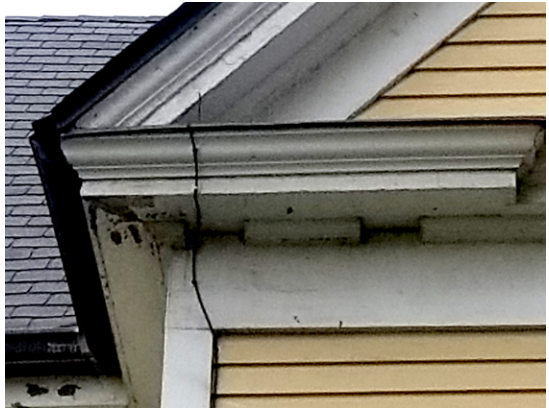
## EAST ELEVATION

- 1. Wood decking and structural joists at front porches are subject to dry rot and termite damage, not structurally safe and need to be replaced.
- 2. Finish floor at interior 6" above current finish decking at porch. ADA access requires 1/2" maximum difference in level.
- 3. Existing wood porch columns and scrollwork not original to the house. Incompatible with the spare Neo-Colonial design of the 1902 original building.
- 4. Current entry vestibules are not original to the building. We recommend restoring the 1902 front elevation design based on historic data.
- 5. Original dentils and eave brackets are missing. We recommend restoring based on historic data and existing material.
- 6. Copper roof at porch is in excellent condition

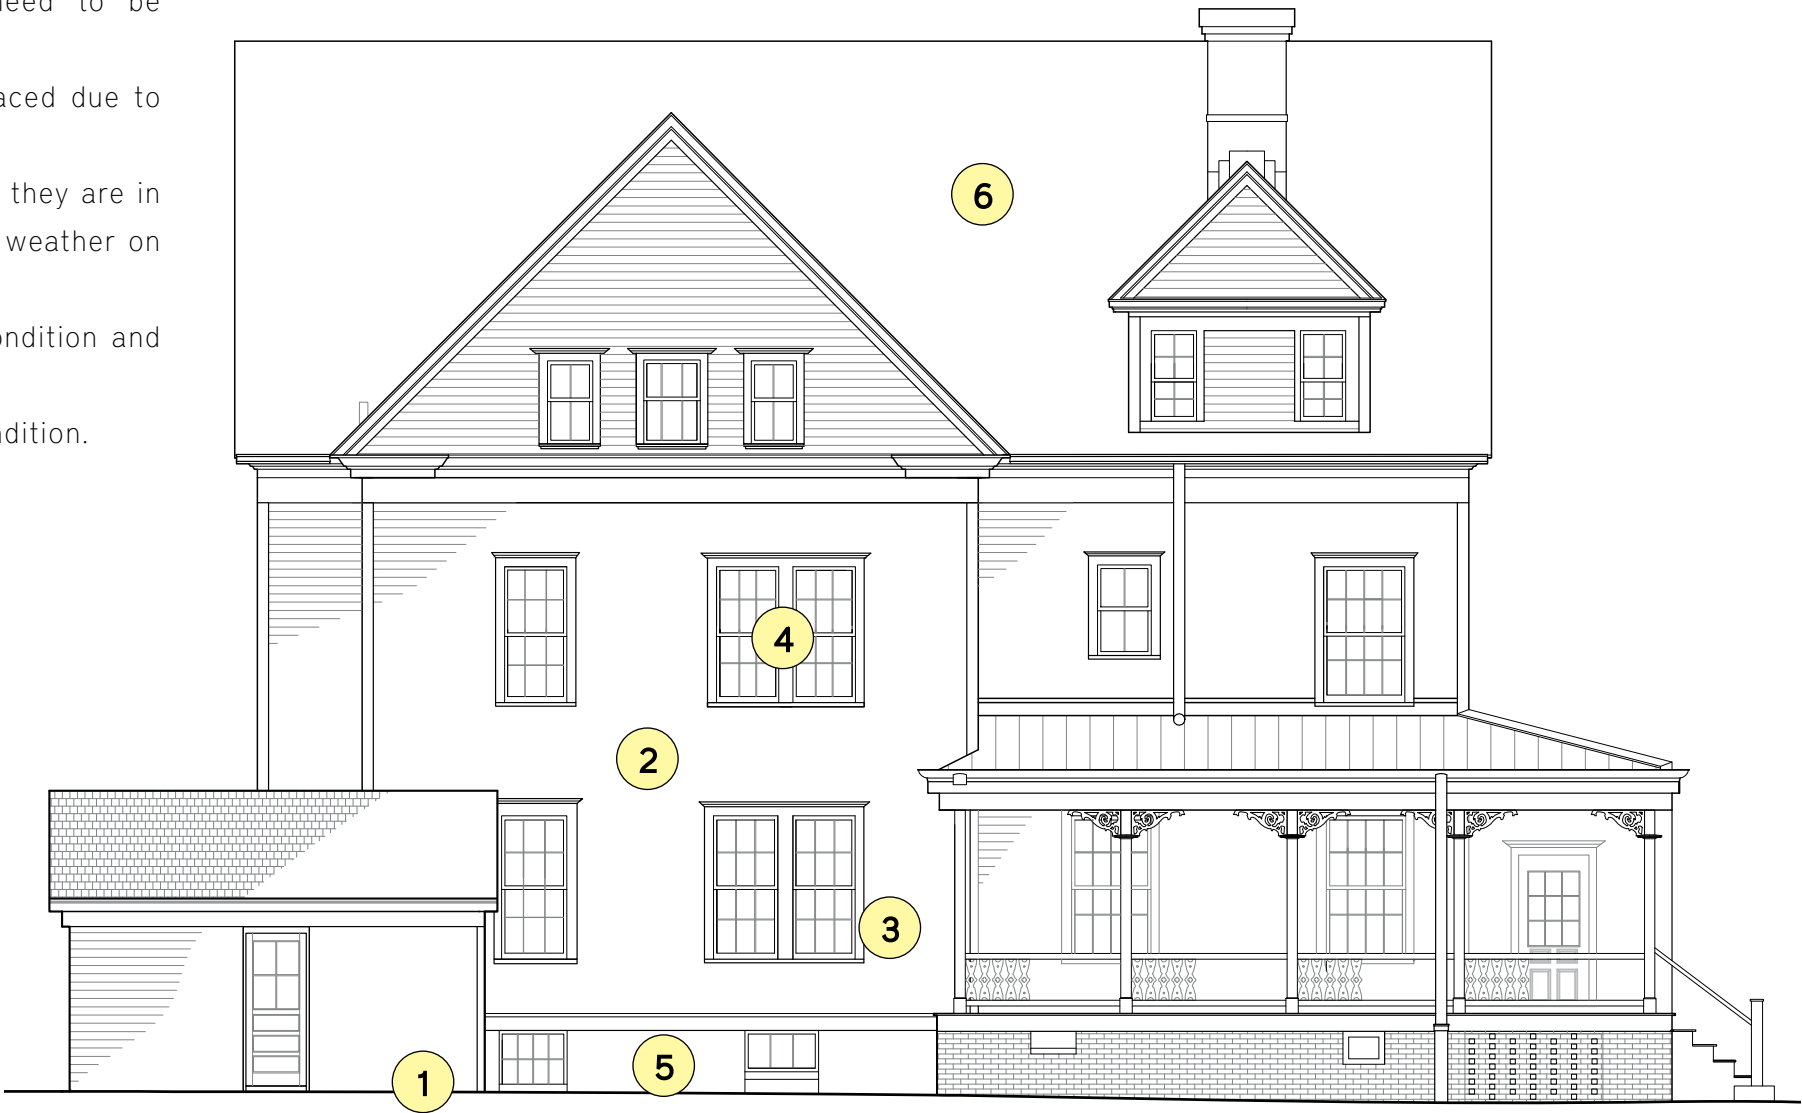
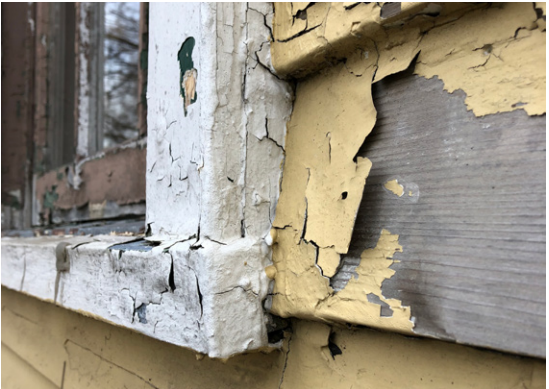
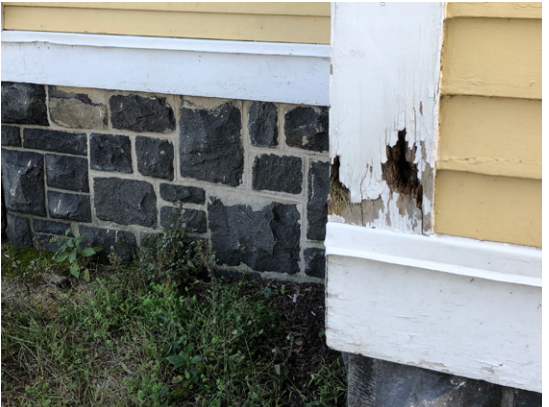
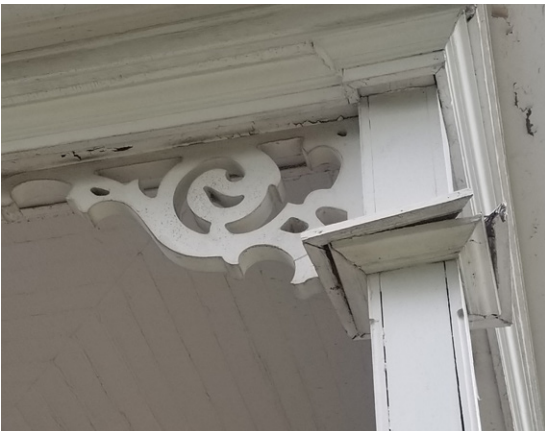
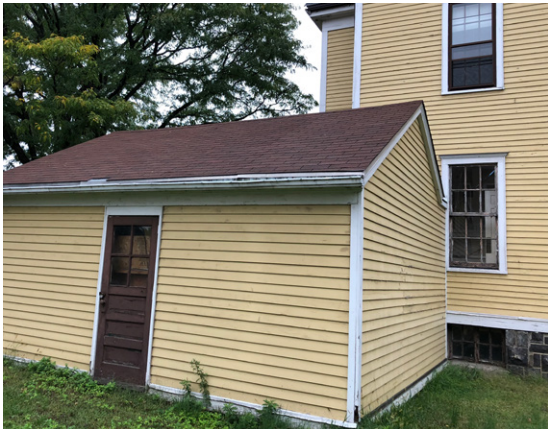
## SOUTH ELEVATION

- 1. Garage concrete slab and wood siding is sitting slightly below grade; subject to water damage and rot. Poor condition.
- 2. Clapboard siding generally in good condition, asbestos residue and lead paint need to be addressed and siding repainted.
- 3. Some exterior trim needs to be replaced due to dry rot.
- 4. Windows date from 1936 renovation; they are in poor condition and subject to severe weather on south, west and north exposures.
- 5. Schist cellar walls are in excellent condition and stable.
- 6. Asphalt shingle roof is in excellent condition.

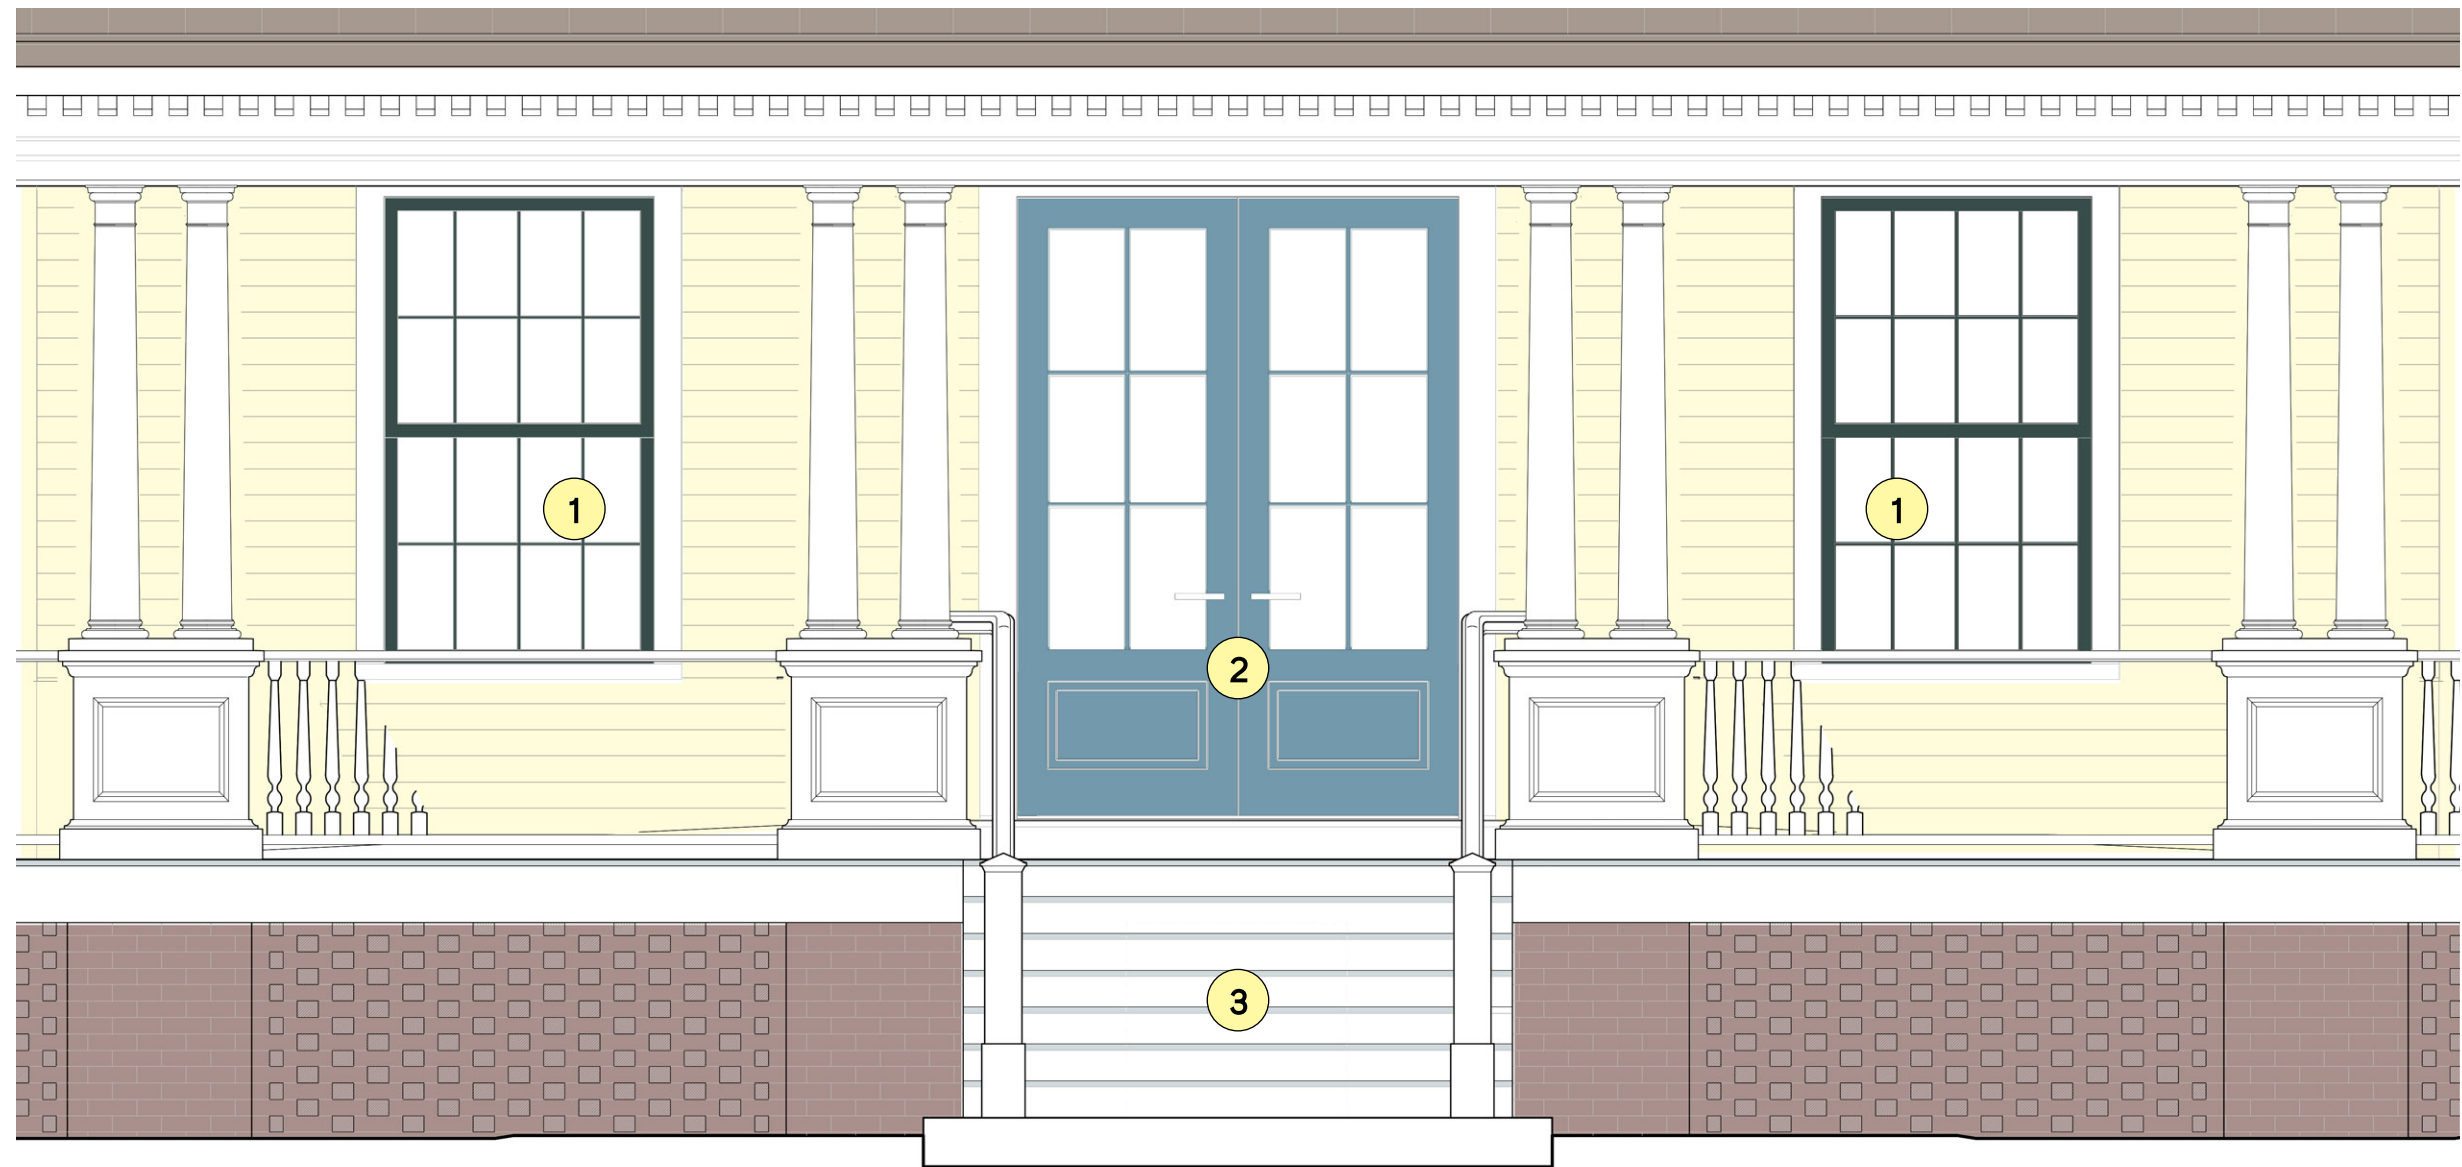
## ENTRY ELEVATION

1. New window centered on porch column
2. New painted wood double door with glass lites
3. New painted wood entrance stair and handrails with granite slab at the bottom of the stair

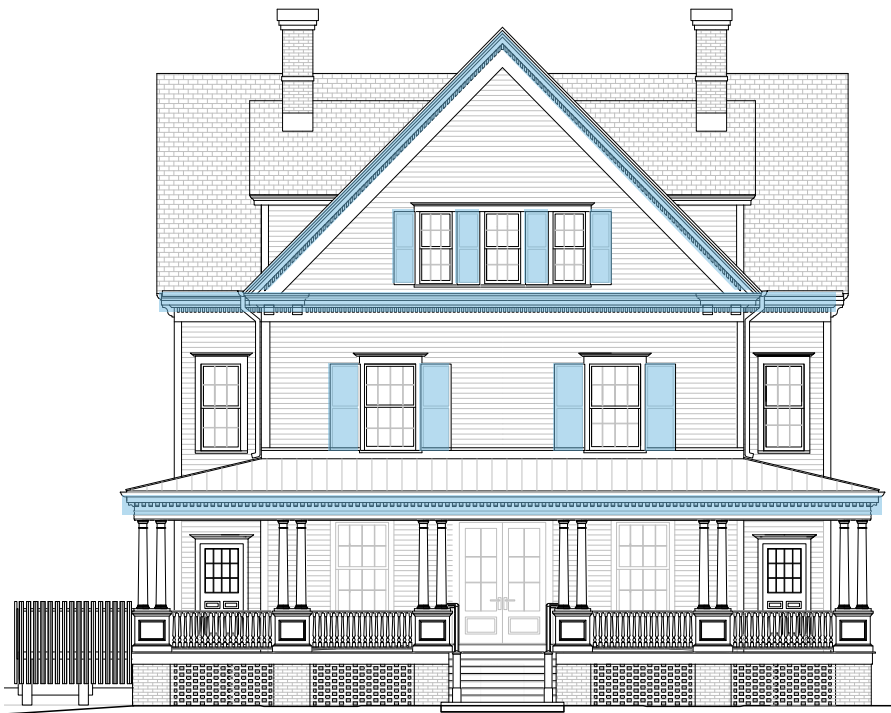
EXISTING CONDITION WITH MISSING BRACKETS AND DENTILS

- 1. Original building had wood dentil molding at roof trim and eaves as well as paired brackets. Portions of original trim remain, showing the original locations and sizes of each. Decorative trim, dentil and brackets to be replaced with duplicates based on historic data and original material.
- 2. New operable wood shutters to be installed.

AREA OF WORK

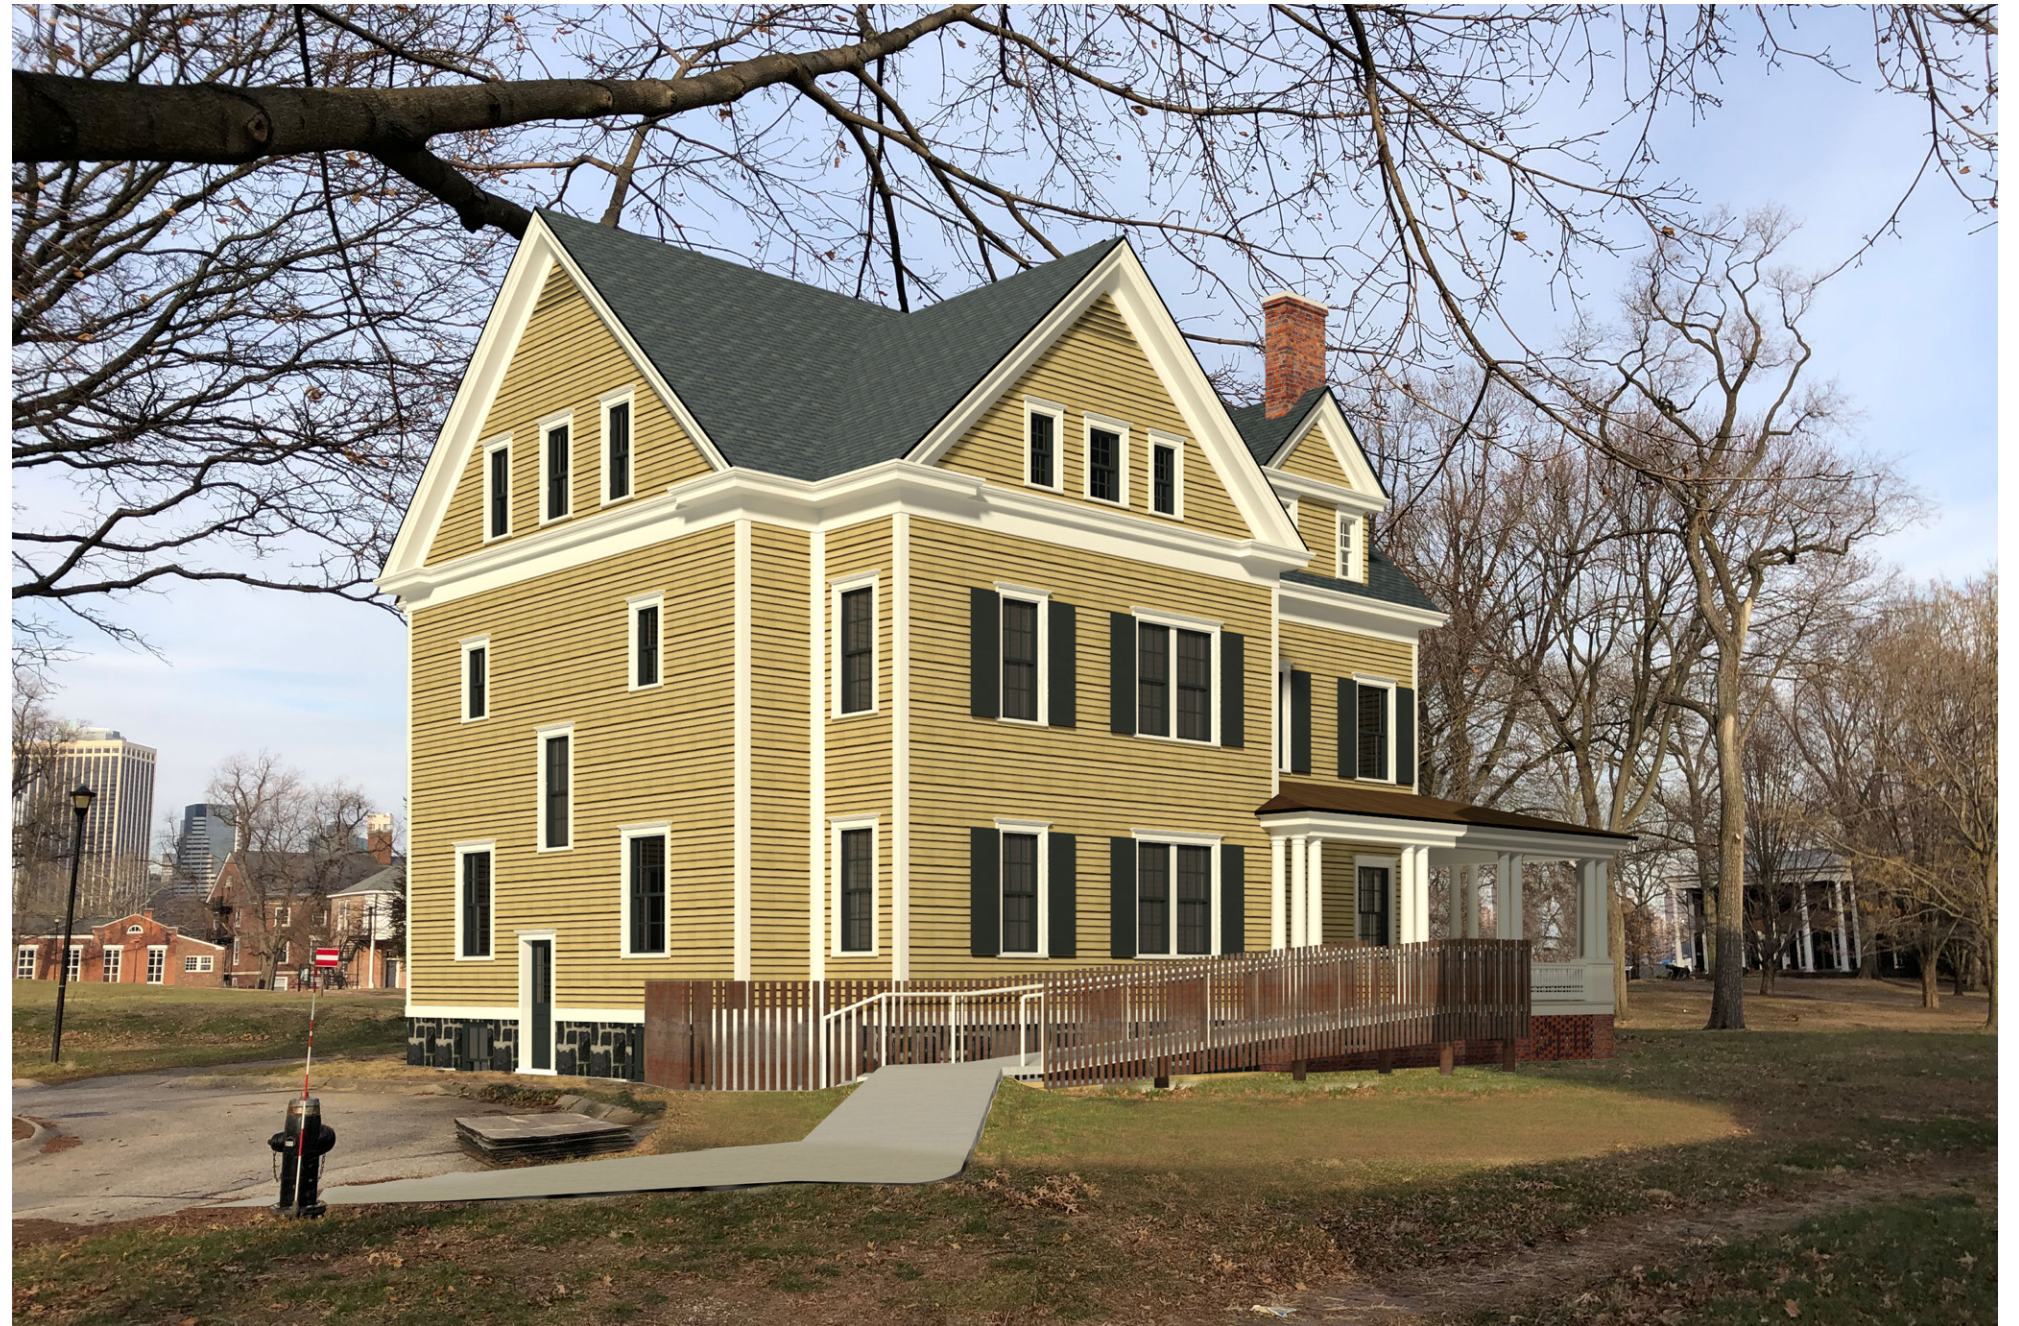
## PROPOSED CONDITION

1. ADA-compliant ramp required for accessibility.
2. Site constraints on the north and west elevation prevent the addition of a new ADA ramp in those locations.
3. Additions to the building, if necessary, recommended to be limited to the west side and the rear portions of the north and south elevations.
4. Garage in poor condition; proposed to be removed.
5. ADA-compliant ramp proposed at rear-most bay of porch at south elevation.

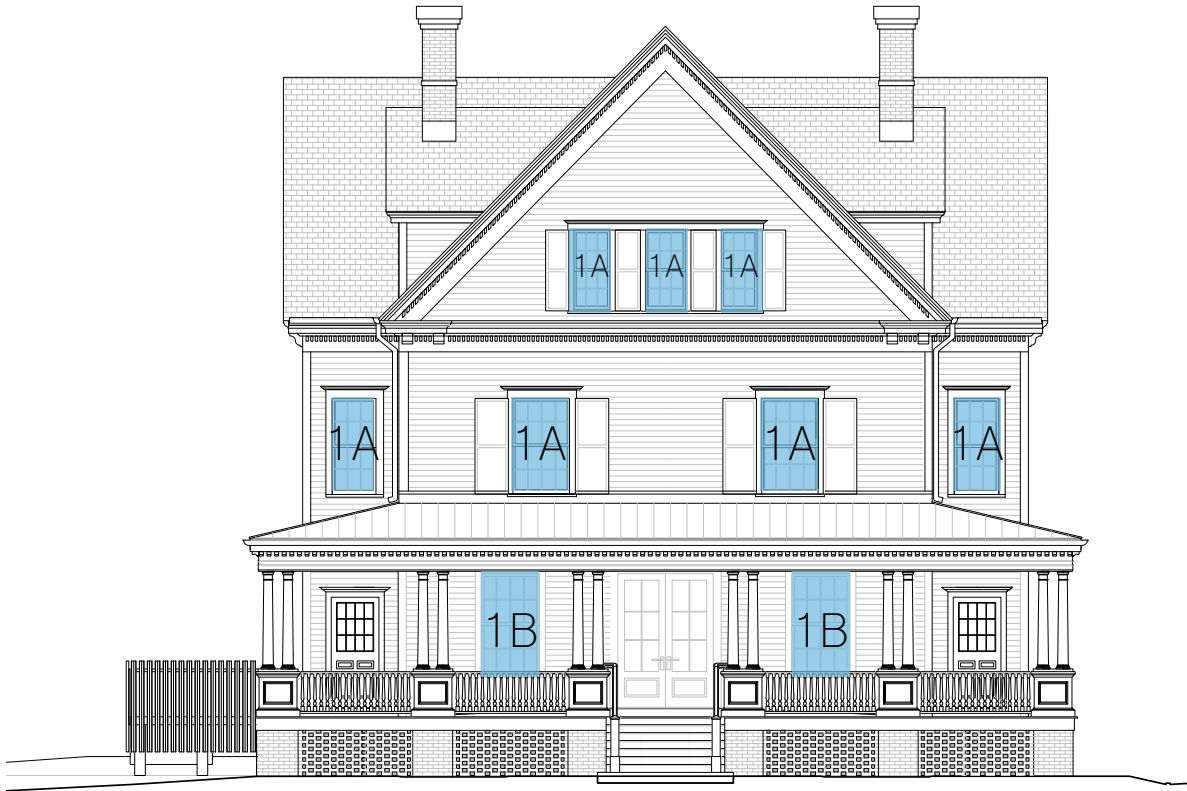
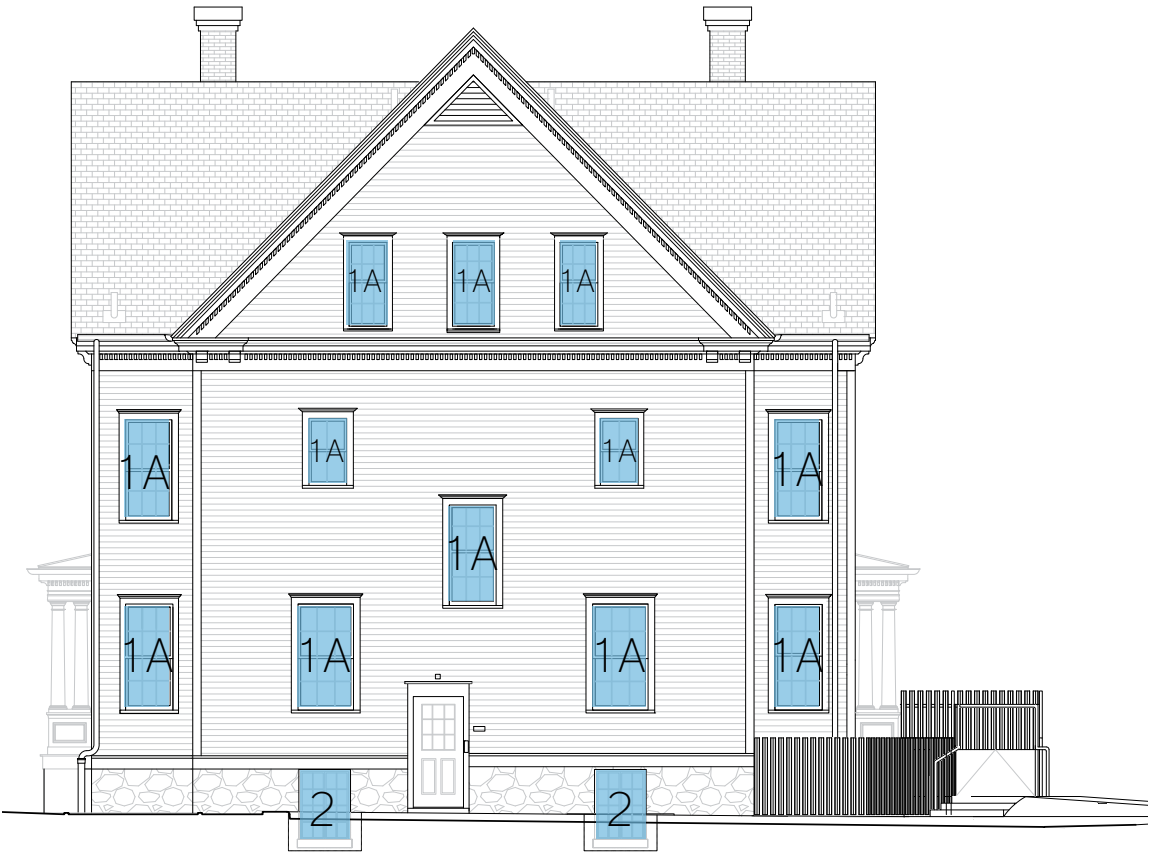
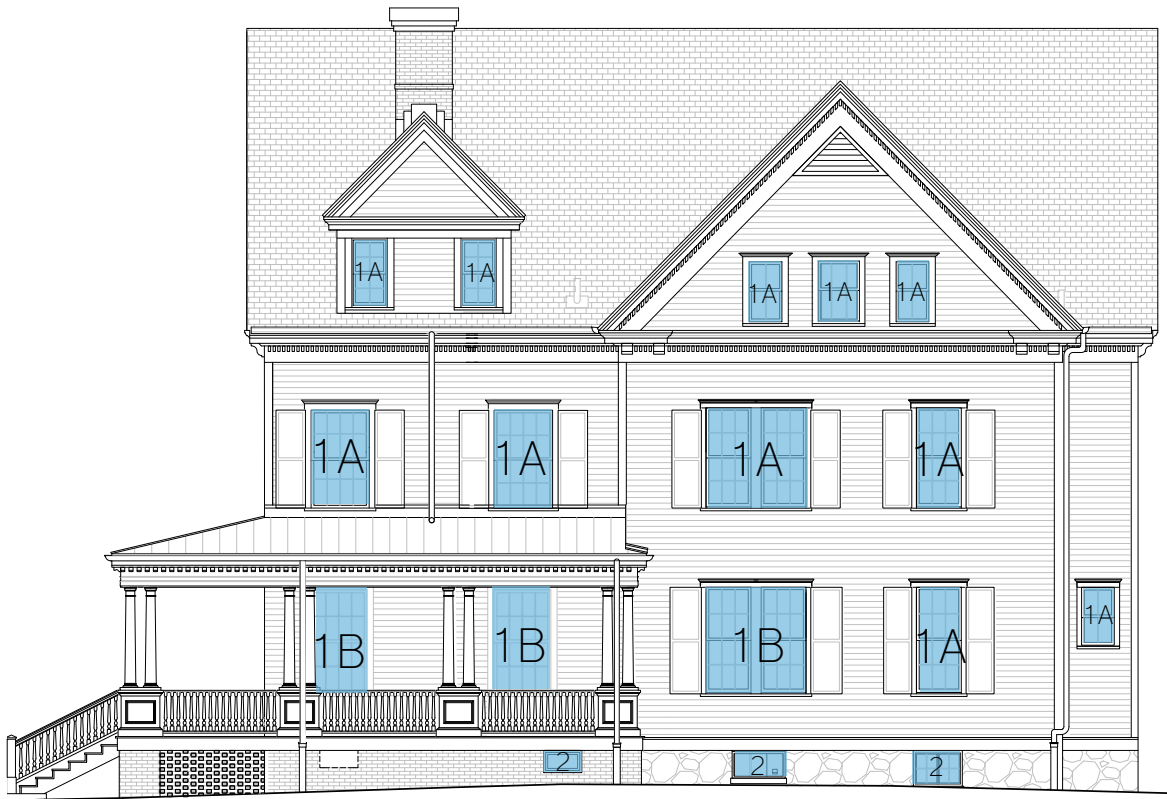
## WINDOW TYPES

- 1A NEW PAINTED WOOD DOUBLE HUNG WINDOW - SPRING LOADED
- 1B NEW PAINTED WOOD DOUBLE HUNG WINDOW - WEIGHT AND CHAIN
- 2 NEW METAL FRAME CASEMENT WINDOW (CELLAR ONLY)

- 14. Replacement of wood double hung windows (1st floor to 3rd floor)
- 15. Replacement of metal casement windows (cellar only)
- 16. New enlarged window at second floor to match original.
