Preservation Department – Item 1, LPC-22-01205

**95 Prospect Park West, Prospect Park - Litchfield Villa -
Individual Landmark
Borough of Brooklyn**

Litchfield Villa Grounds

Main Entrance Ramp

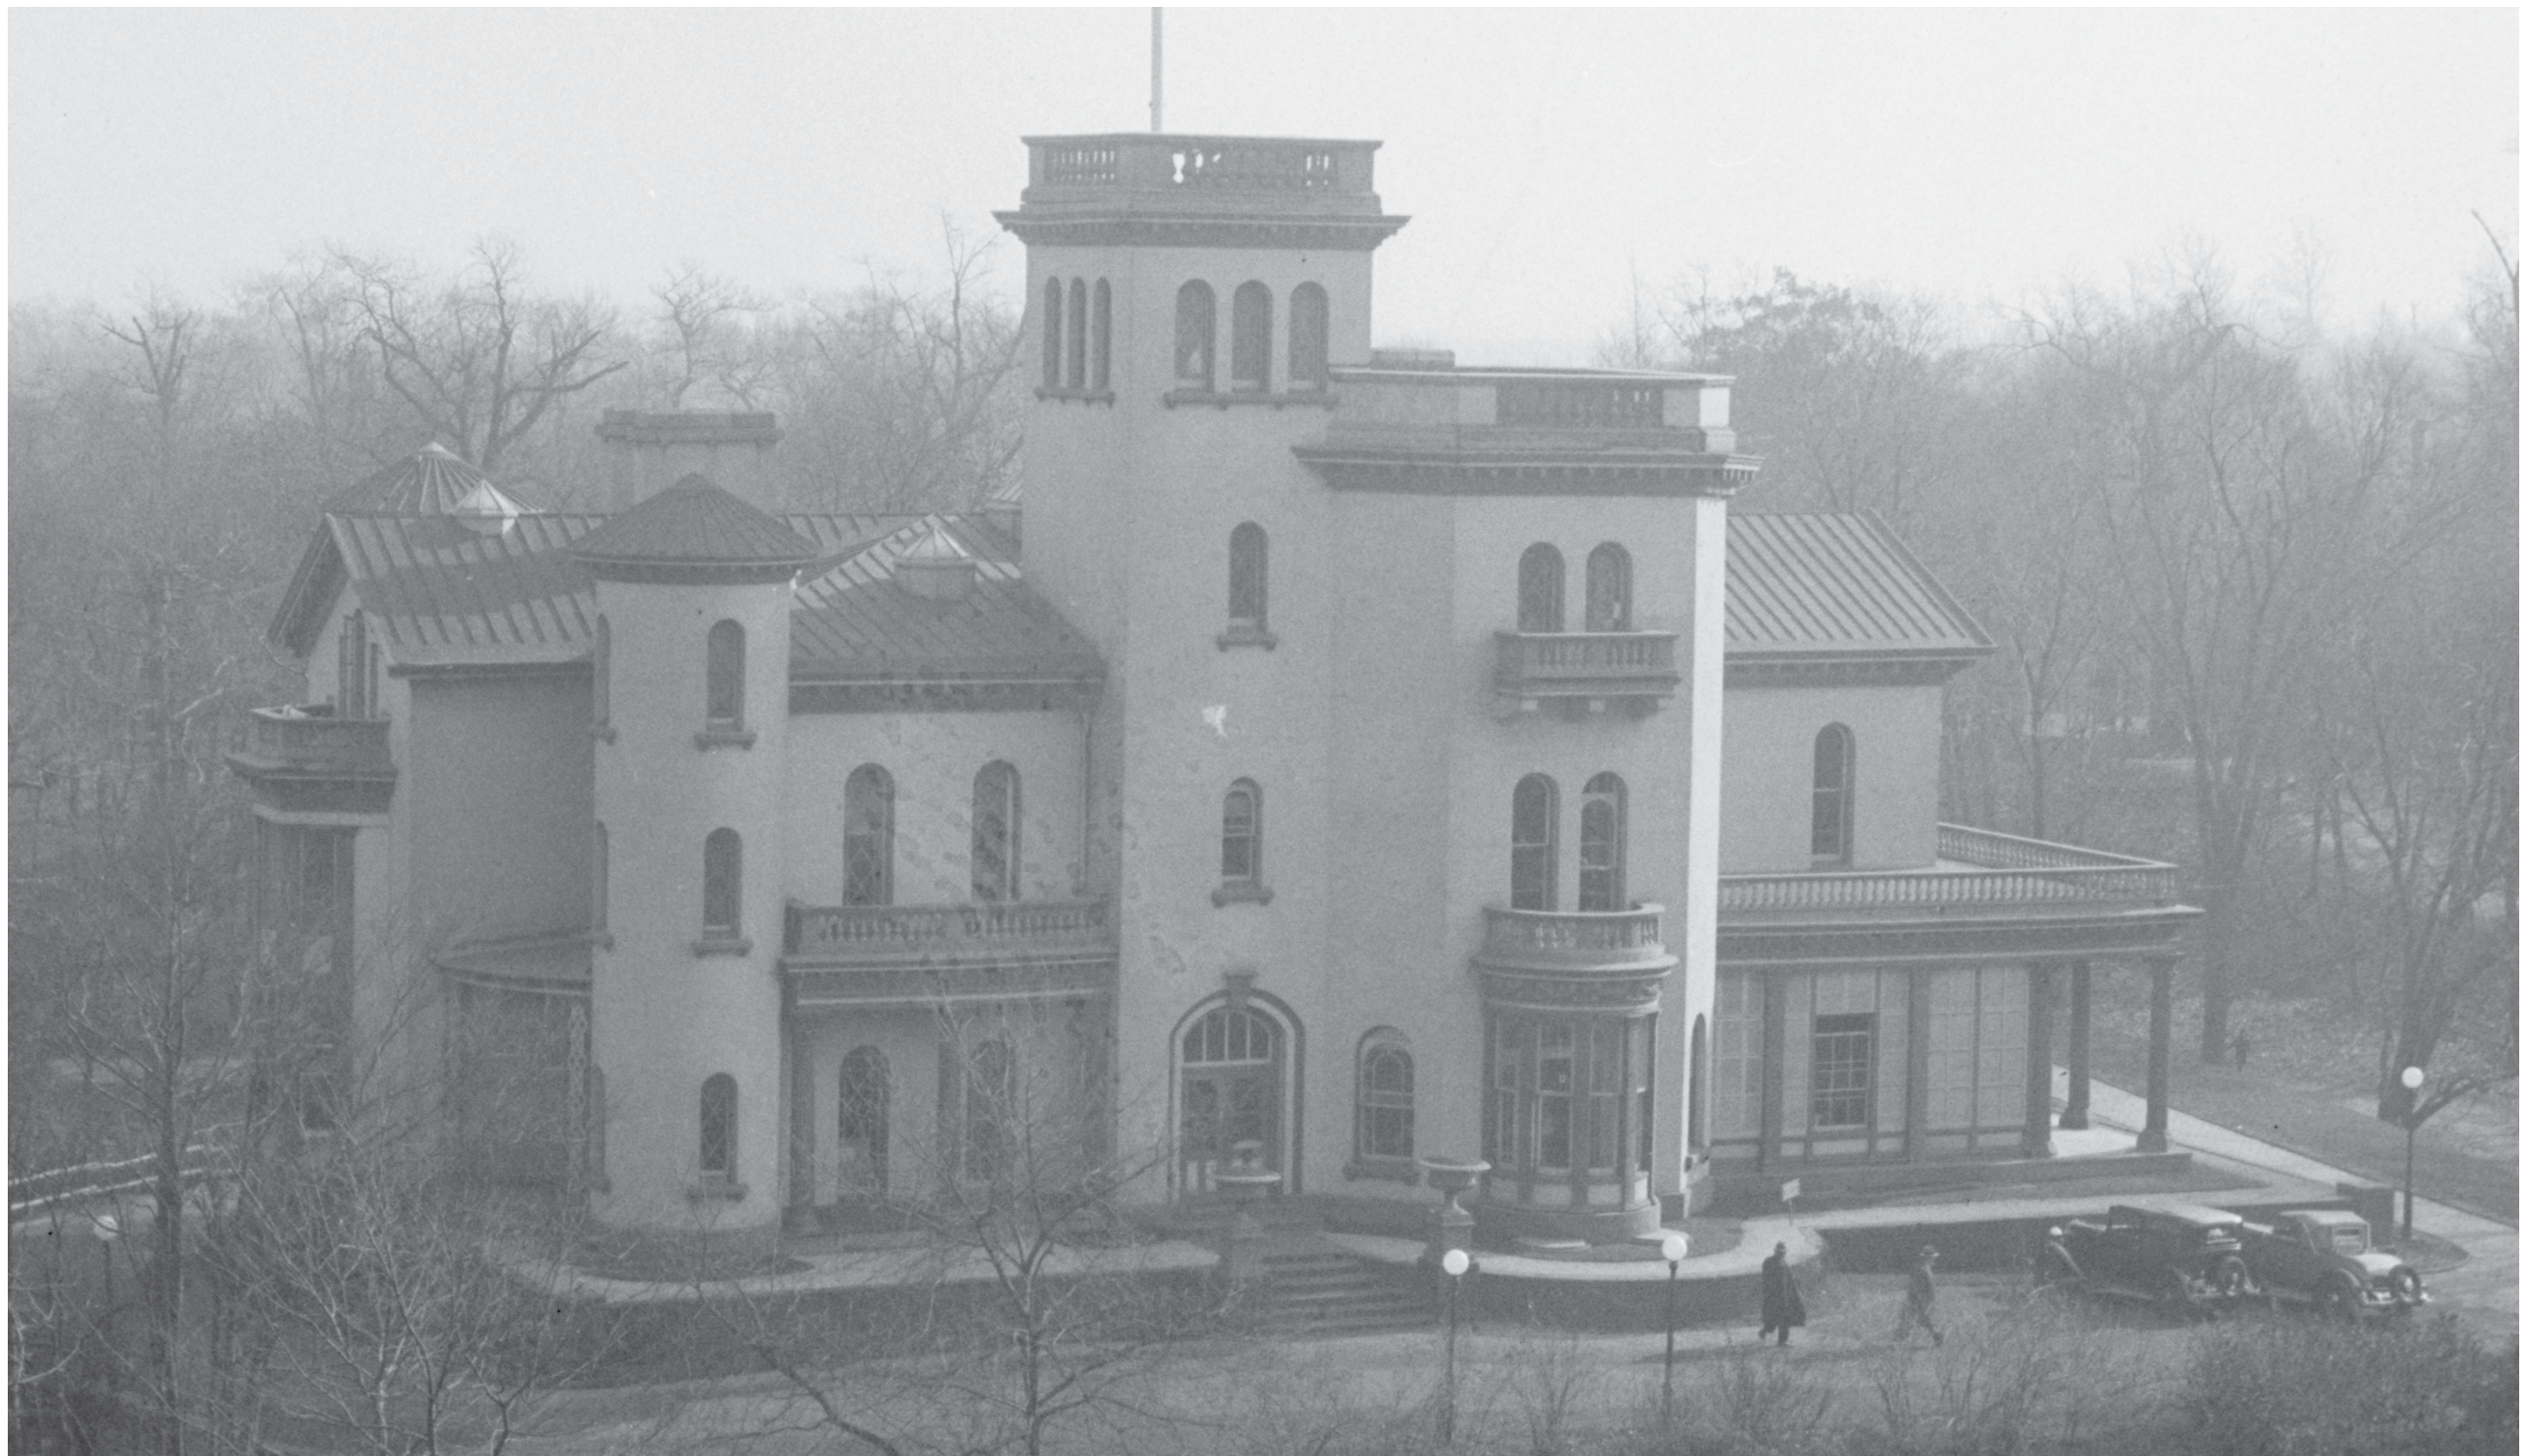
1934 The original facade was stucco before it was removed to show brick. Original double door is present but was removed shortly after. Note the un-vegetated terraces retained by brownstone walls wrapping the building.

Historic 1934 photo of entrance shows paint at door surround matching the color found at the earliest extant finish layer.

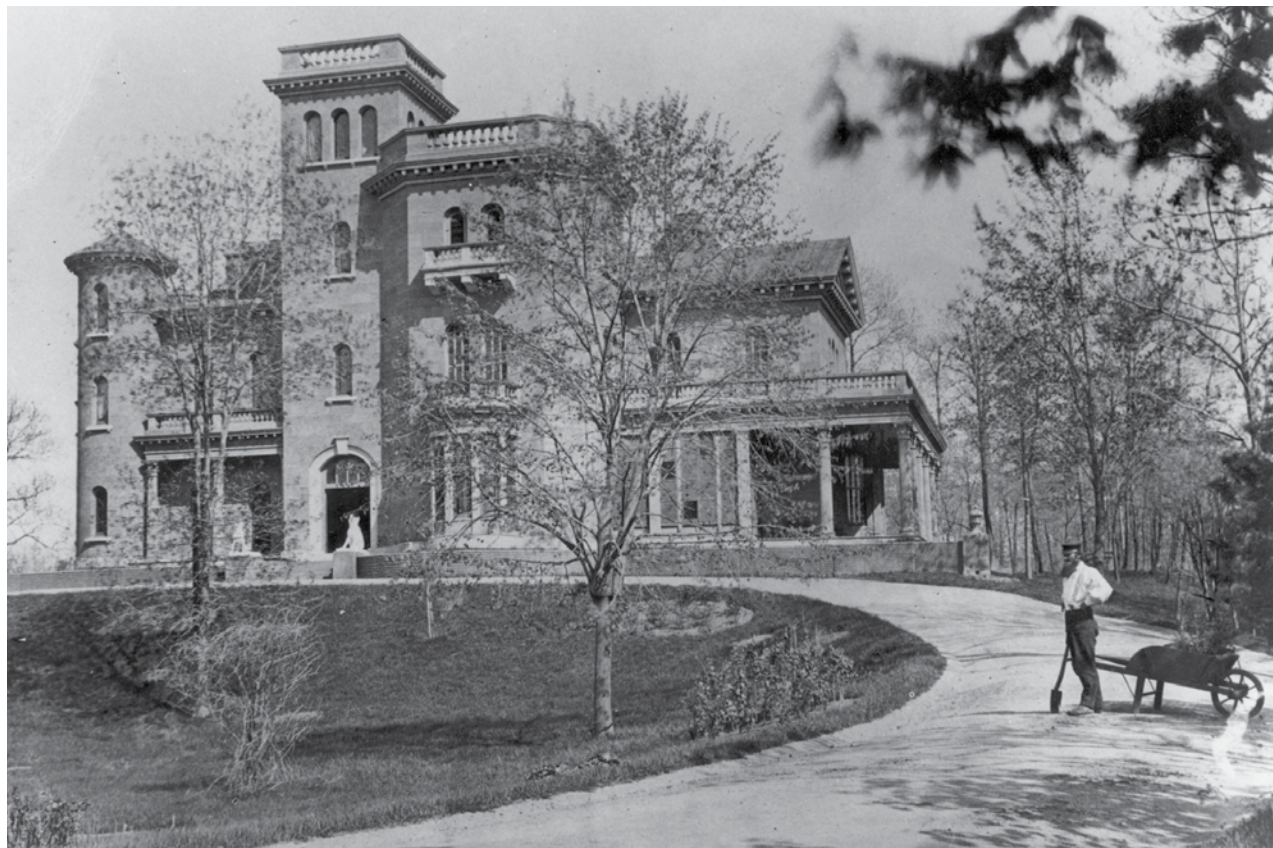
1870 A curved drive led to the front of the building.

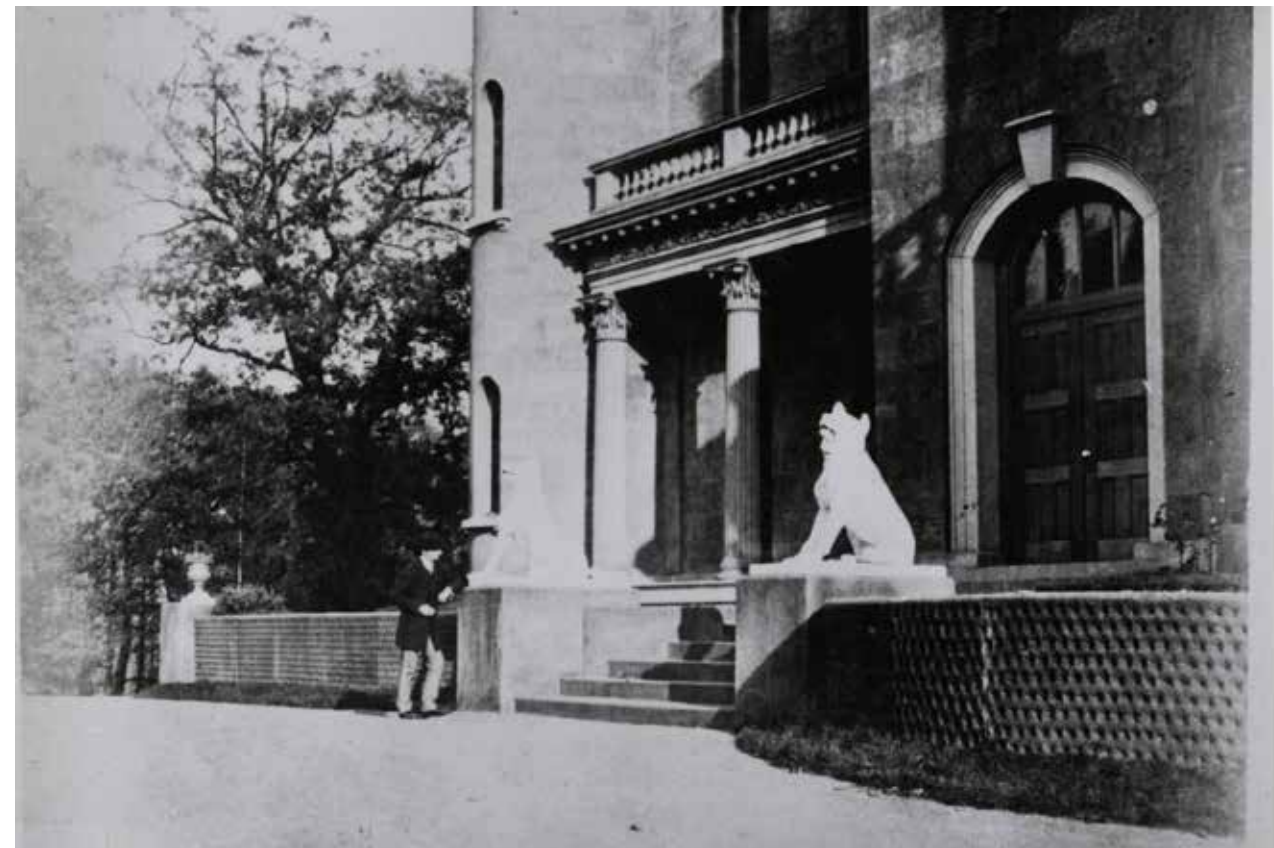
1870 Main entrance; note original double swing door and canines on piers.

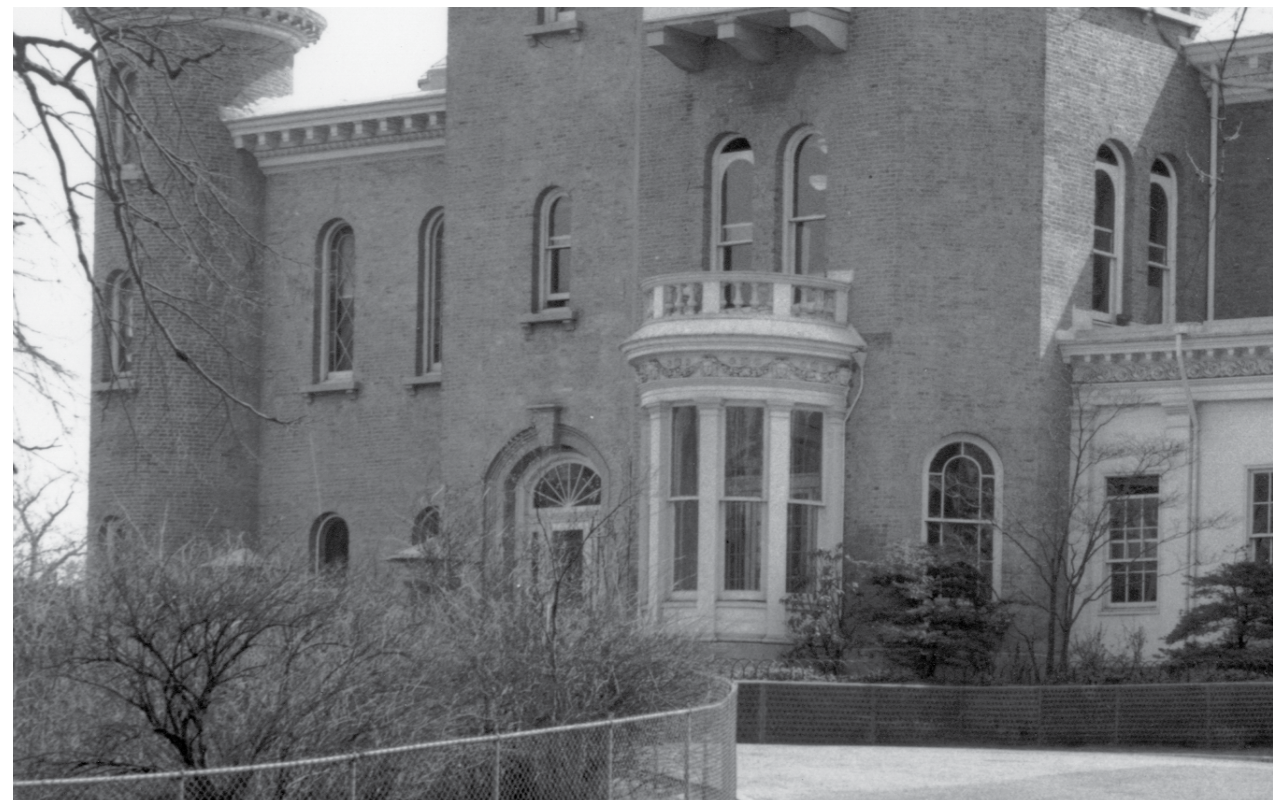
1949 Door has been changed to single swing after the 1930s. Note the door's light color and new exposed brick facade.

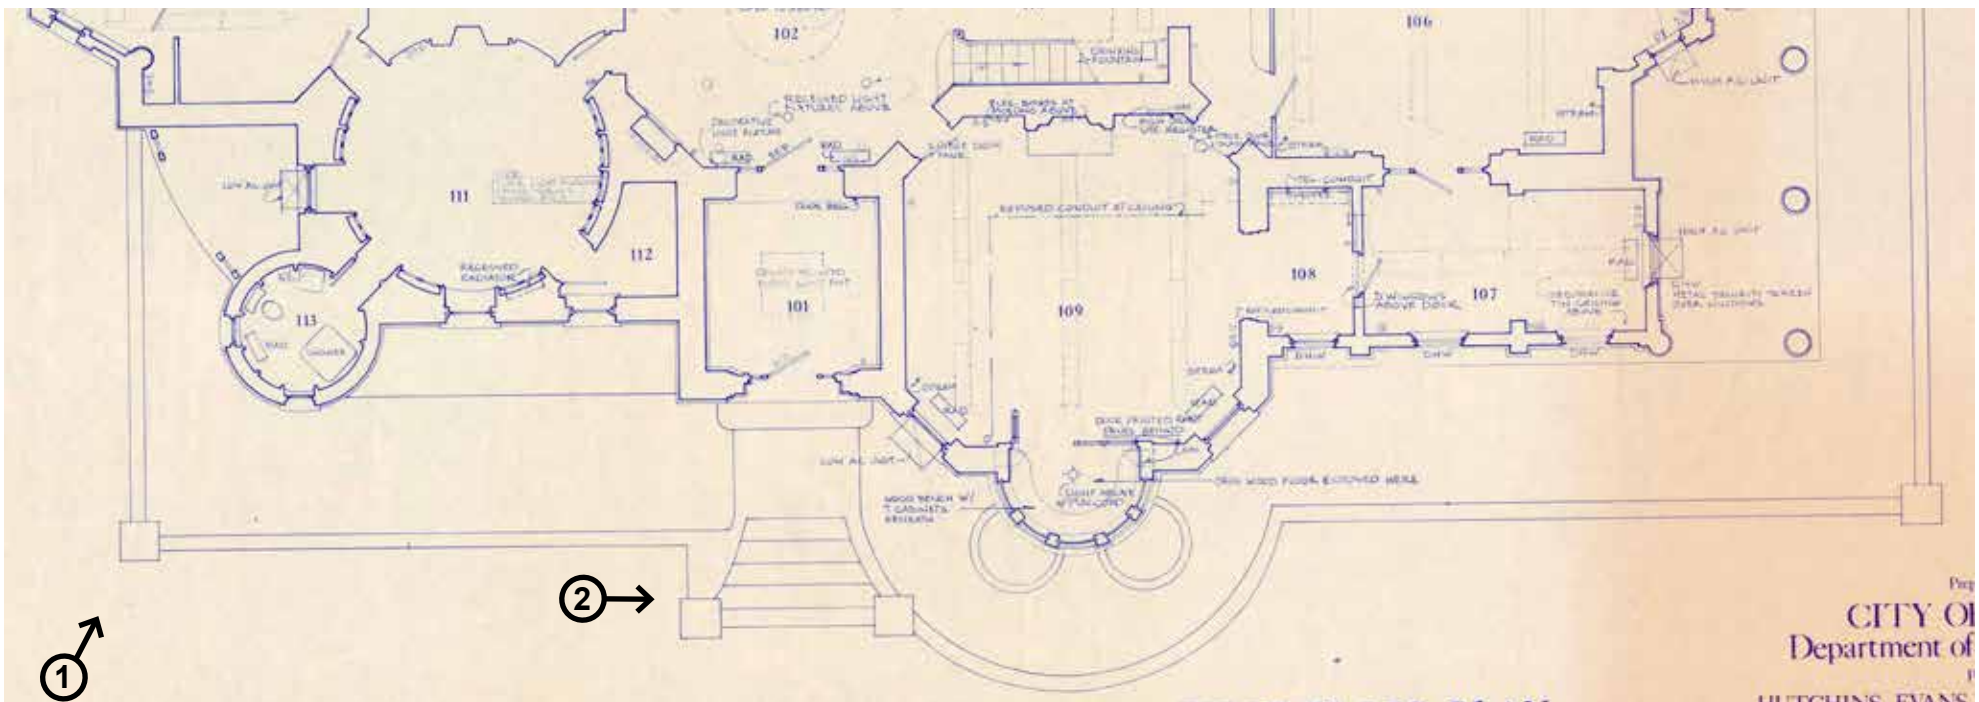
1 Original northwest brownstone wall in storage

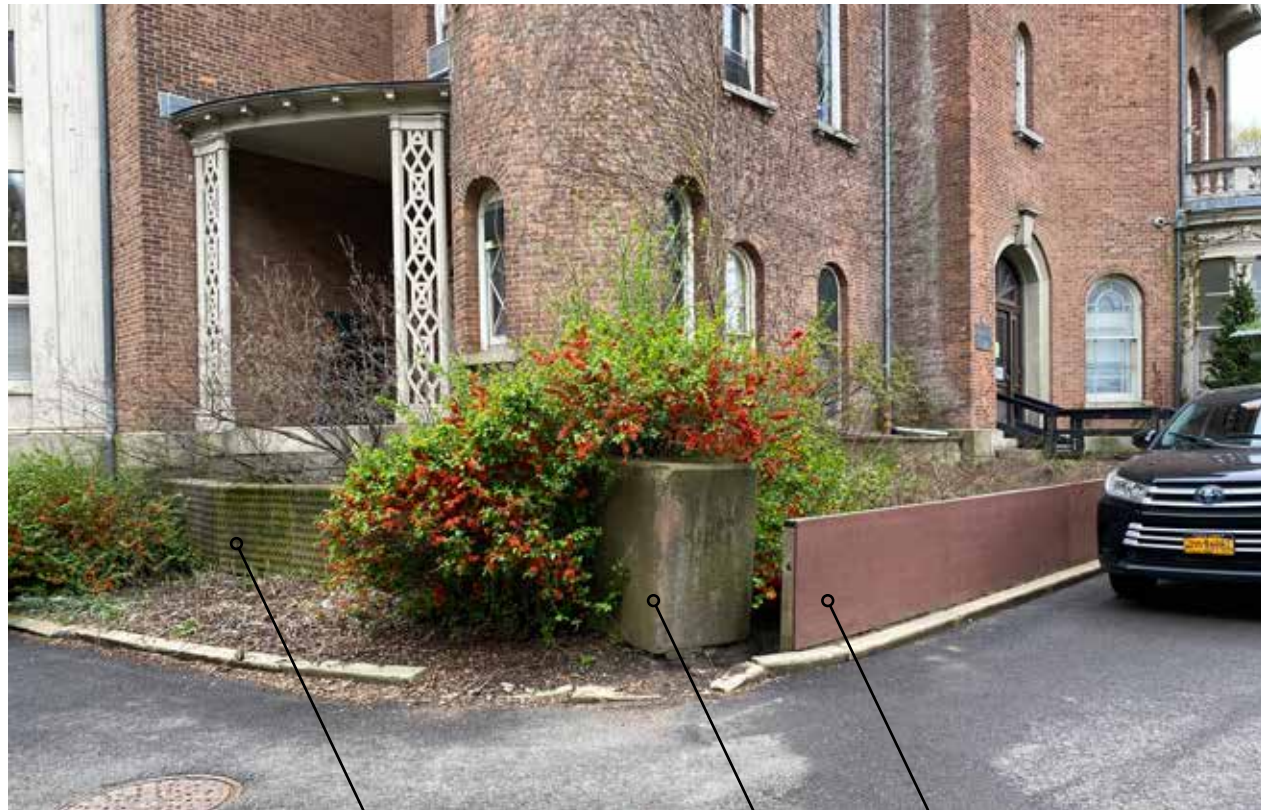
Brownstone wall

Brownstone pier

Temporary Plywood
Brownstone wall in storage

2 Temporary staircase on original brownstone and granite steps

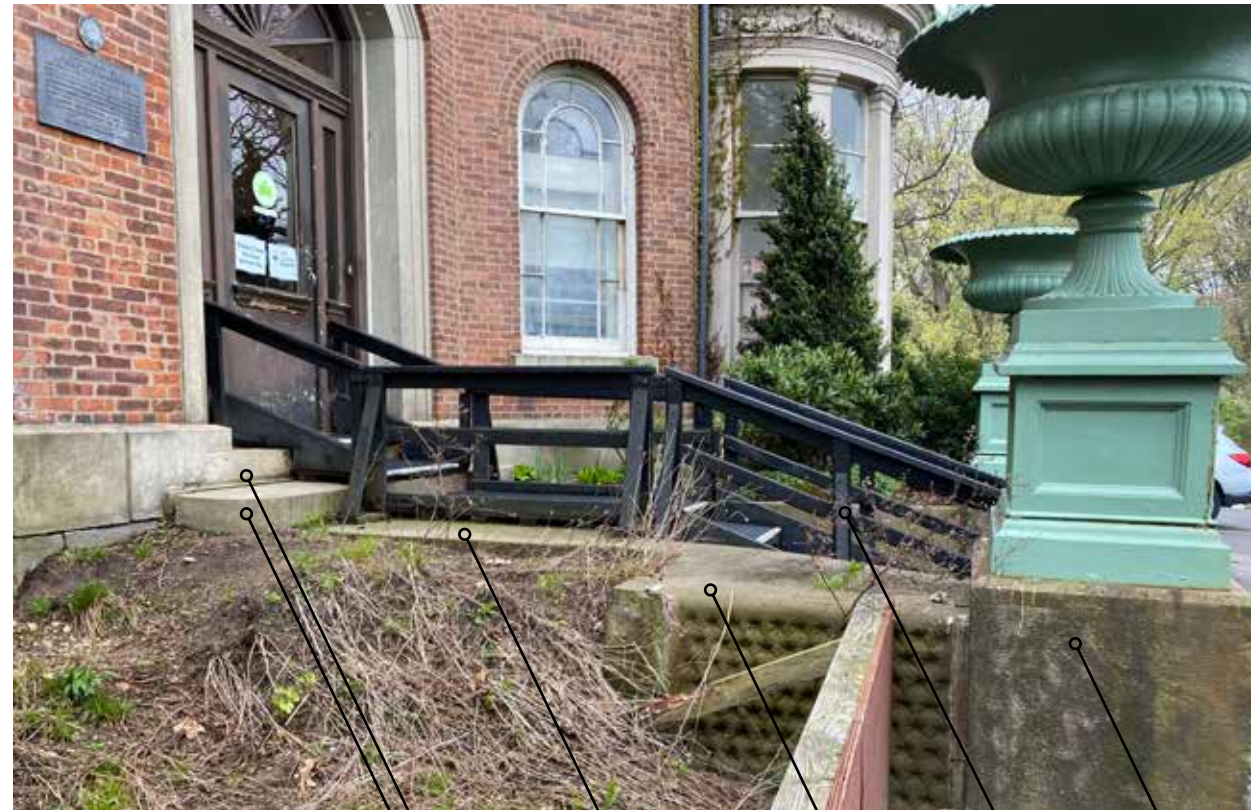
Two granite steps

Brownstone cheek wall

Brownstone landing

Temporary Wood
Stair

Brownstone pier

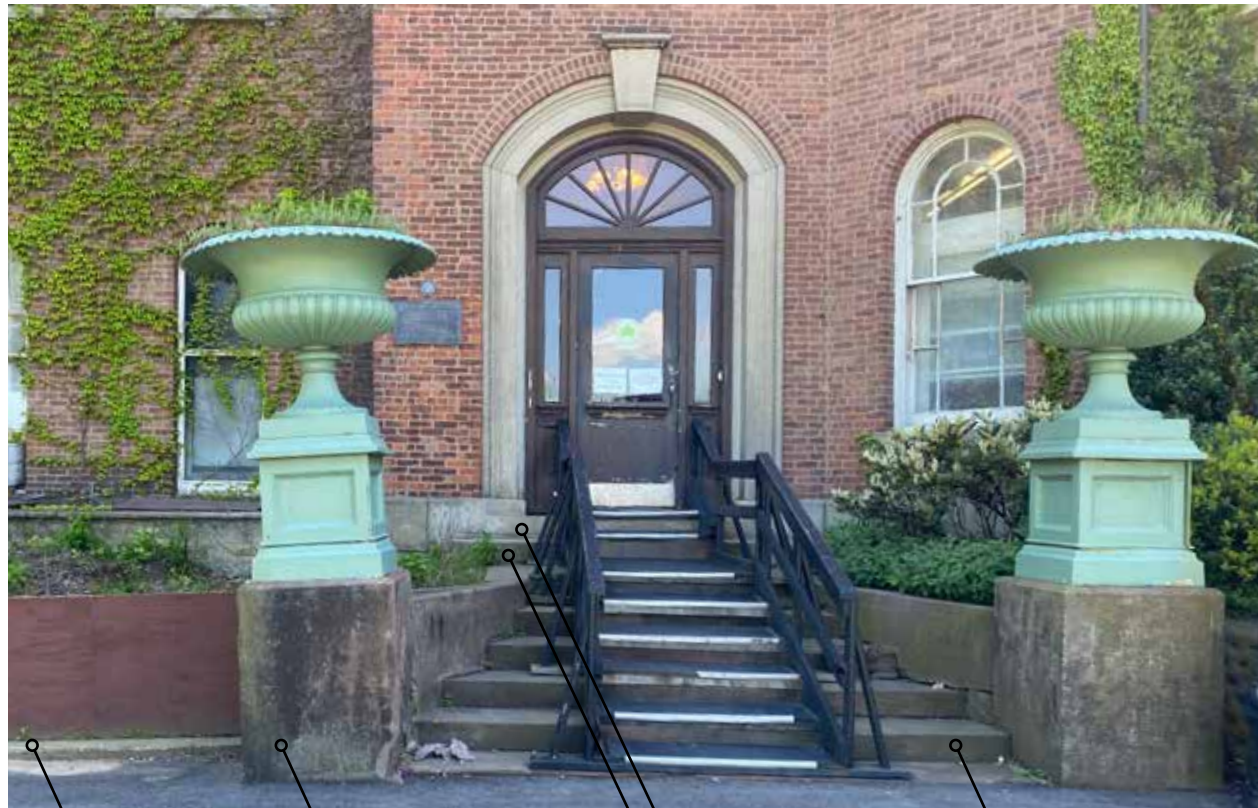
Brownstone wall in storage Brownstone pier 2 Granite steps 5 brownstone steps

4 Top two steps are granite and match the building granite

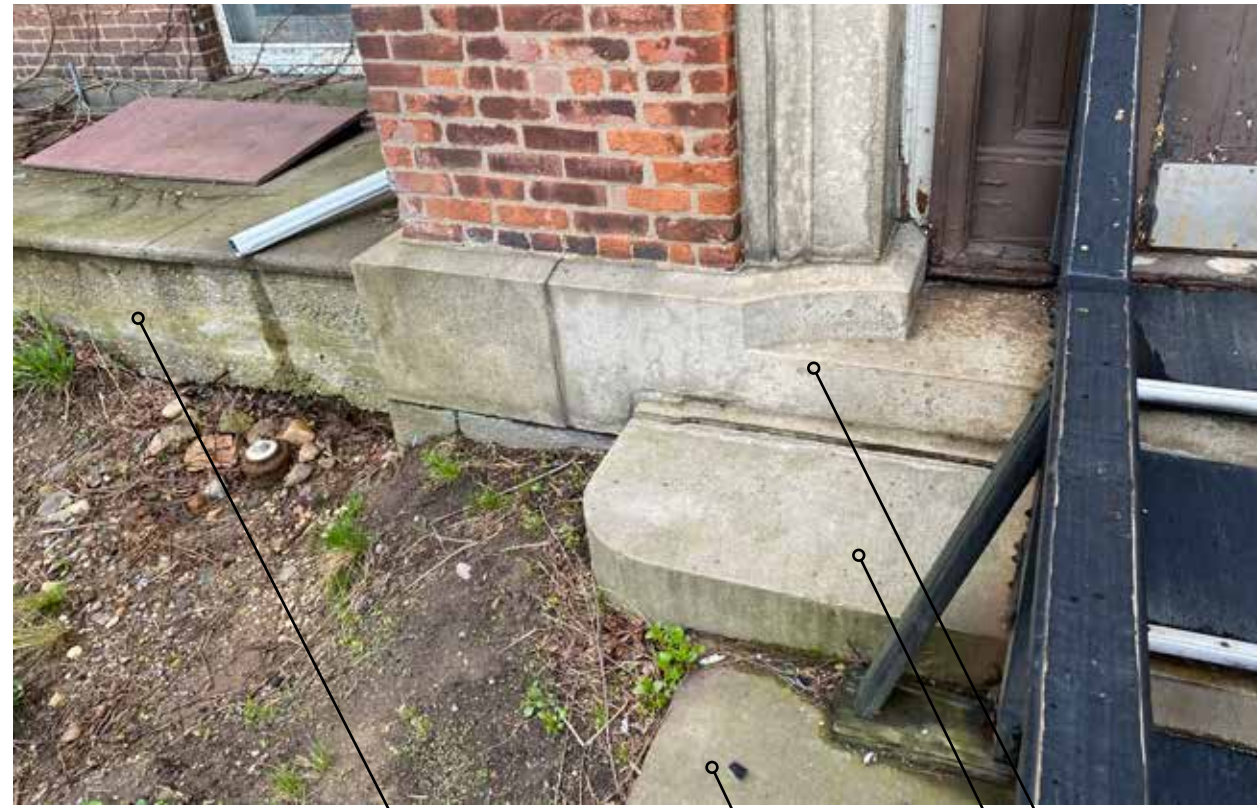
Concrete terrace Brownstone landing 2 Granite steps

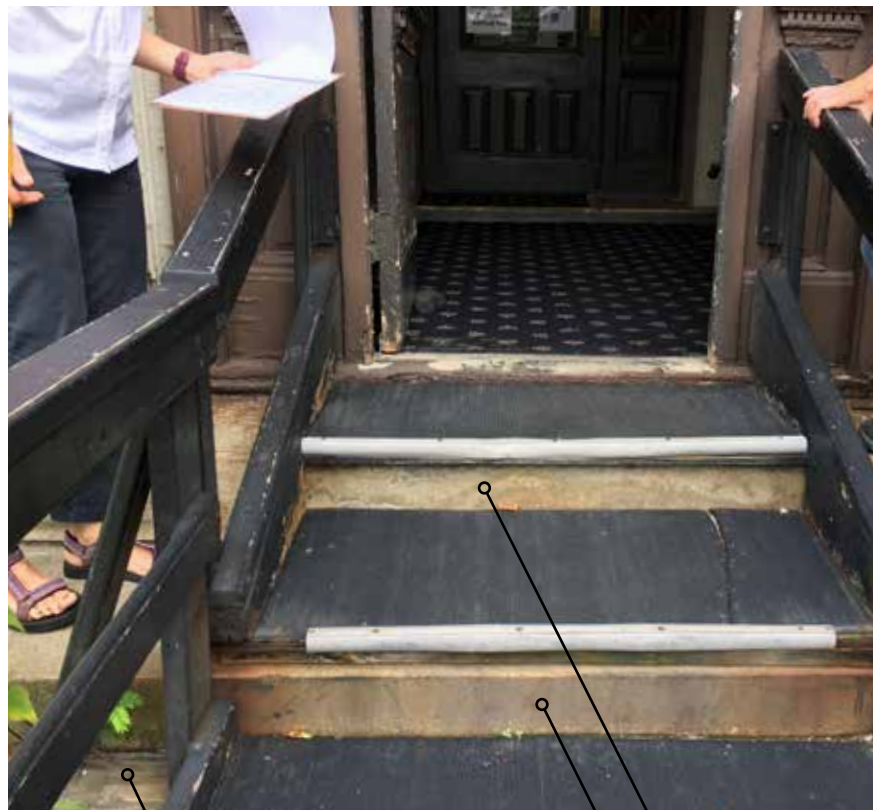
Brownstone landing

2 Granite steps

6 Ramp will be installed between concrete terrace and reset brownstone wall

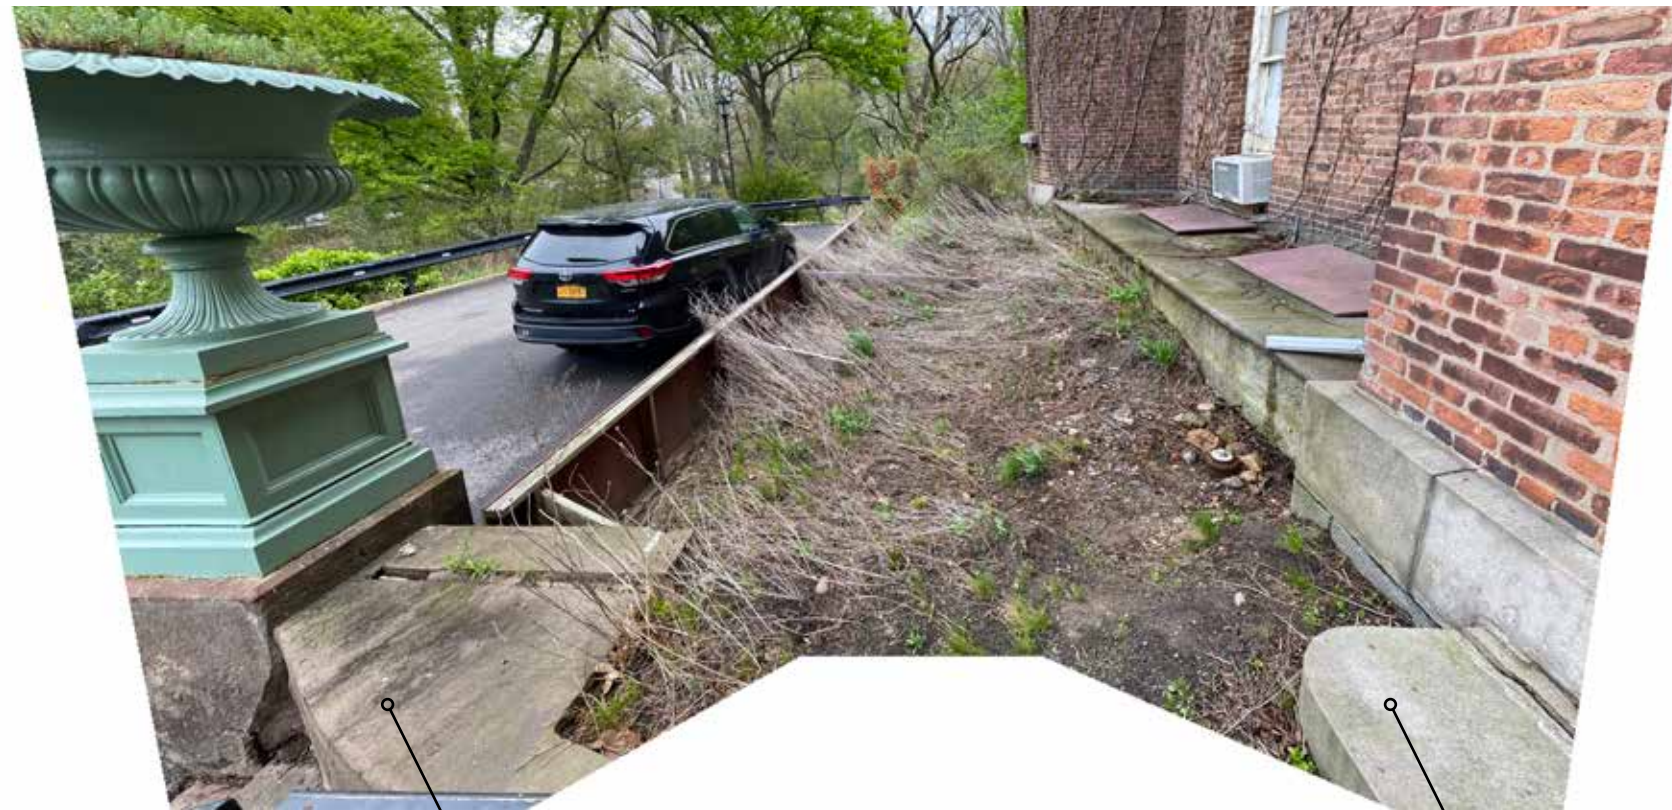
Brownstone cheek wall

Granite steps

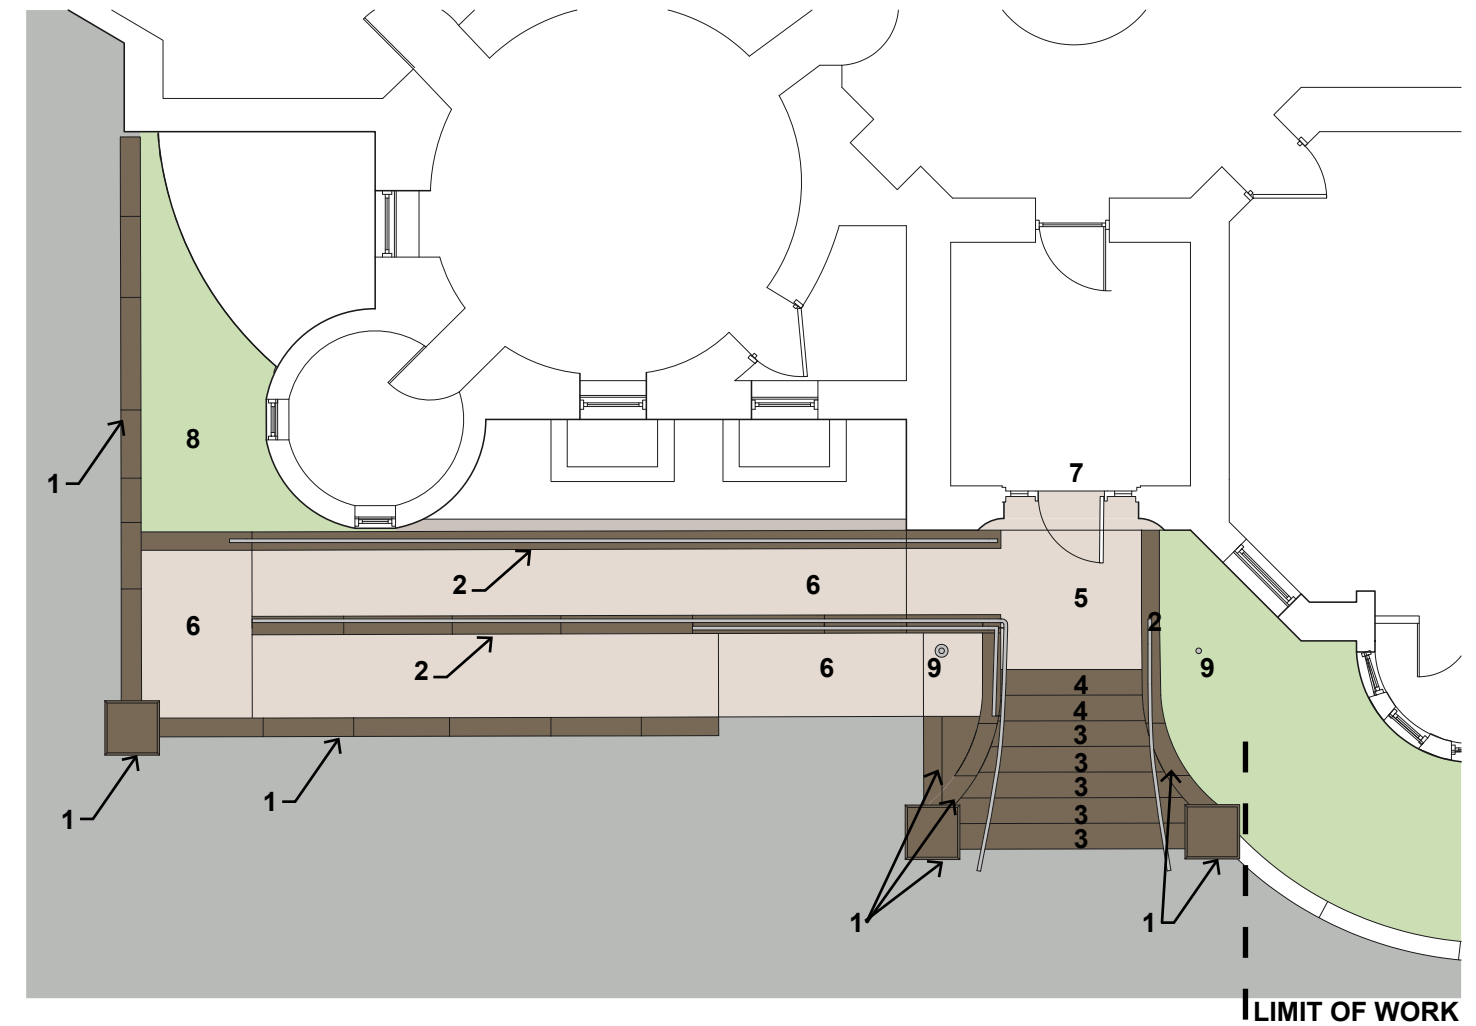
PROPOSED

1. Restore original brownstone wall and piers; set on foundation
2. Install cast stone brownstone ramp wall with railing
3. Reset five original brownstone steps
4. Install two new cast stone brownstone steps
5. Install new granite landing to meet top granite step flush
6. Install new granite pavement
7. Refabricate door, hang on opposite side
8. Slope down existing planting bed to meet ramp landing
9. Install two 15ft tall flagpoles

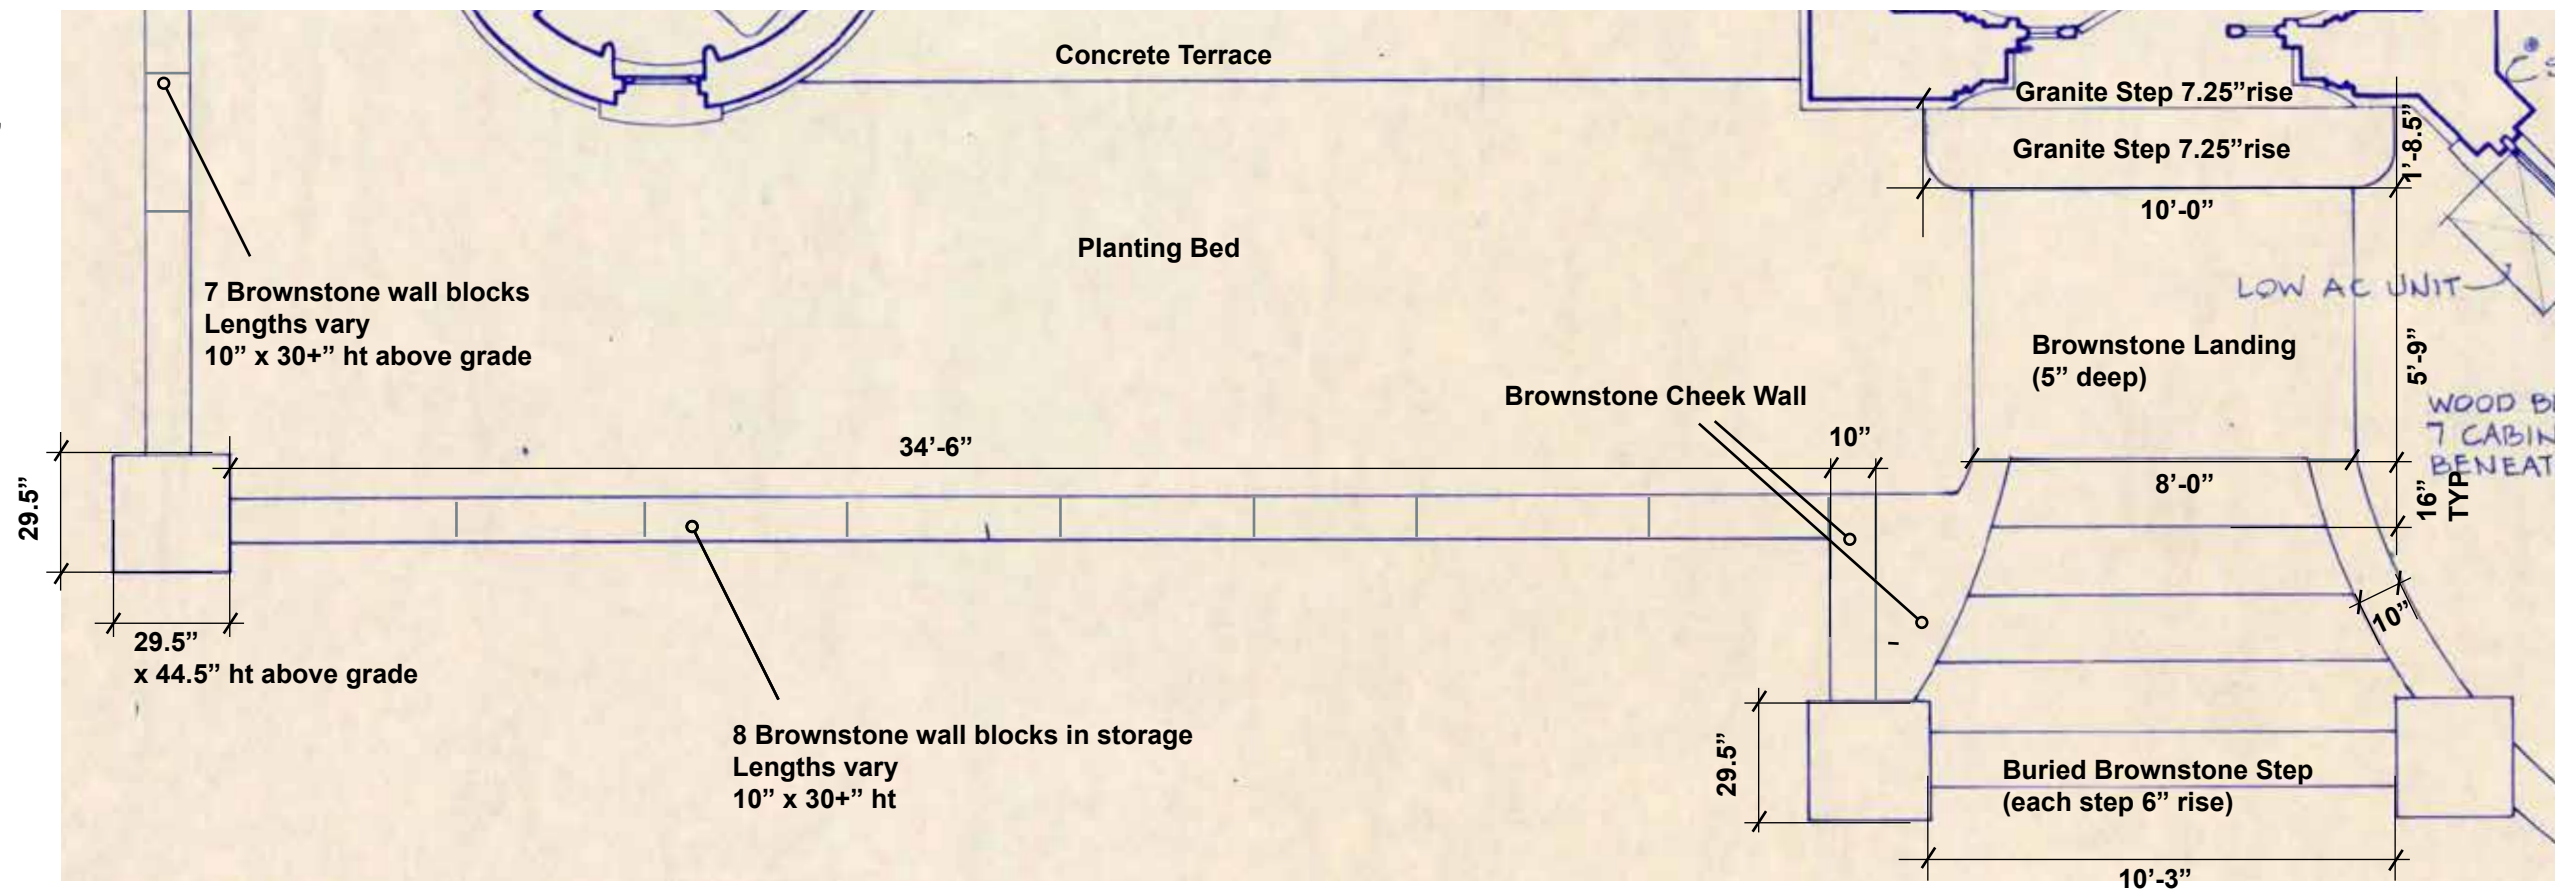
EXISTING

Existing granite:
'North Carolina Mt. Airy'

Existing brownstone:
'Portland'

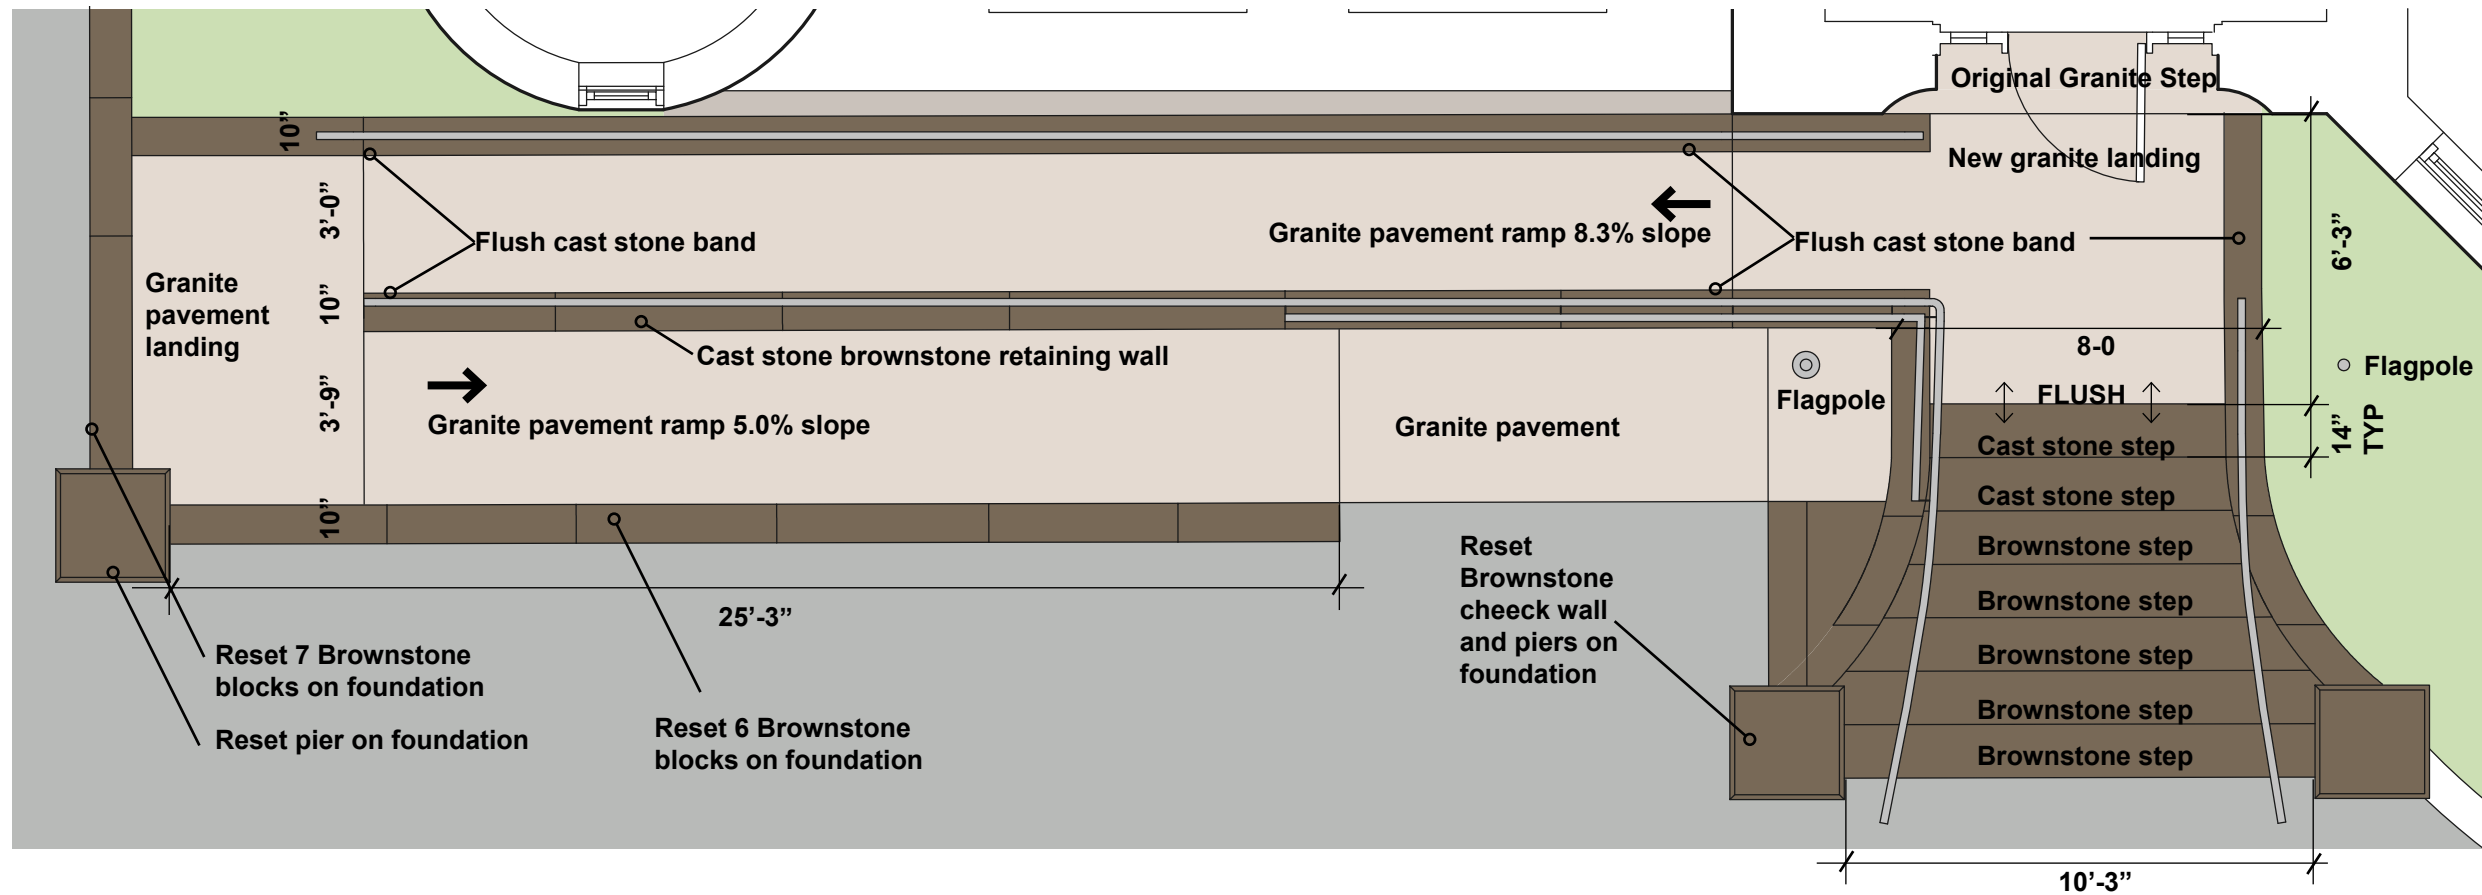
PROPOSED

All new granite:
'BETHEL WHITE'

All new cast stone brownstone:
'FISKE 18'
CORINTHIAN STONE

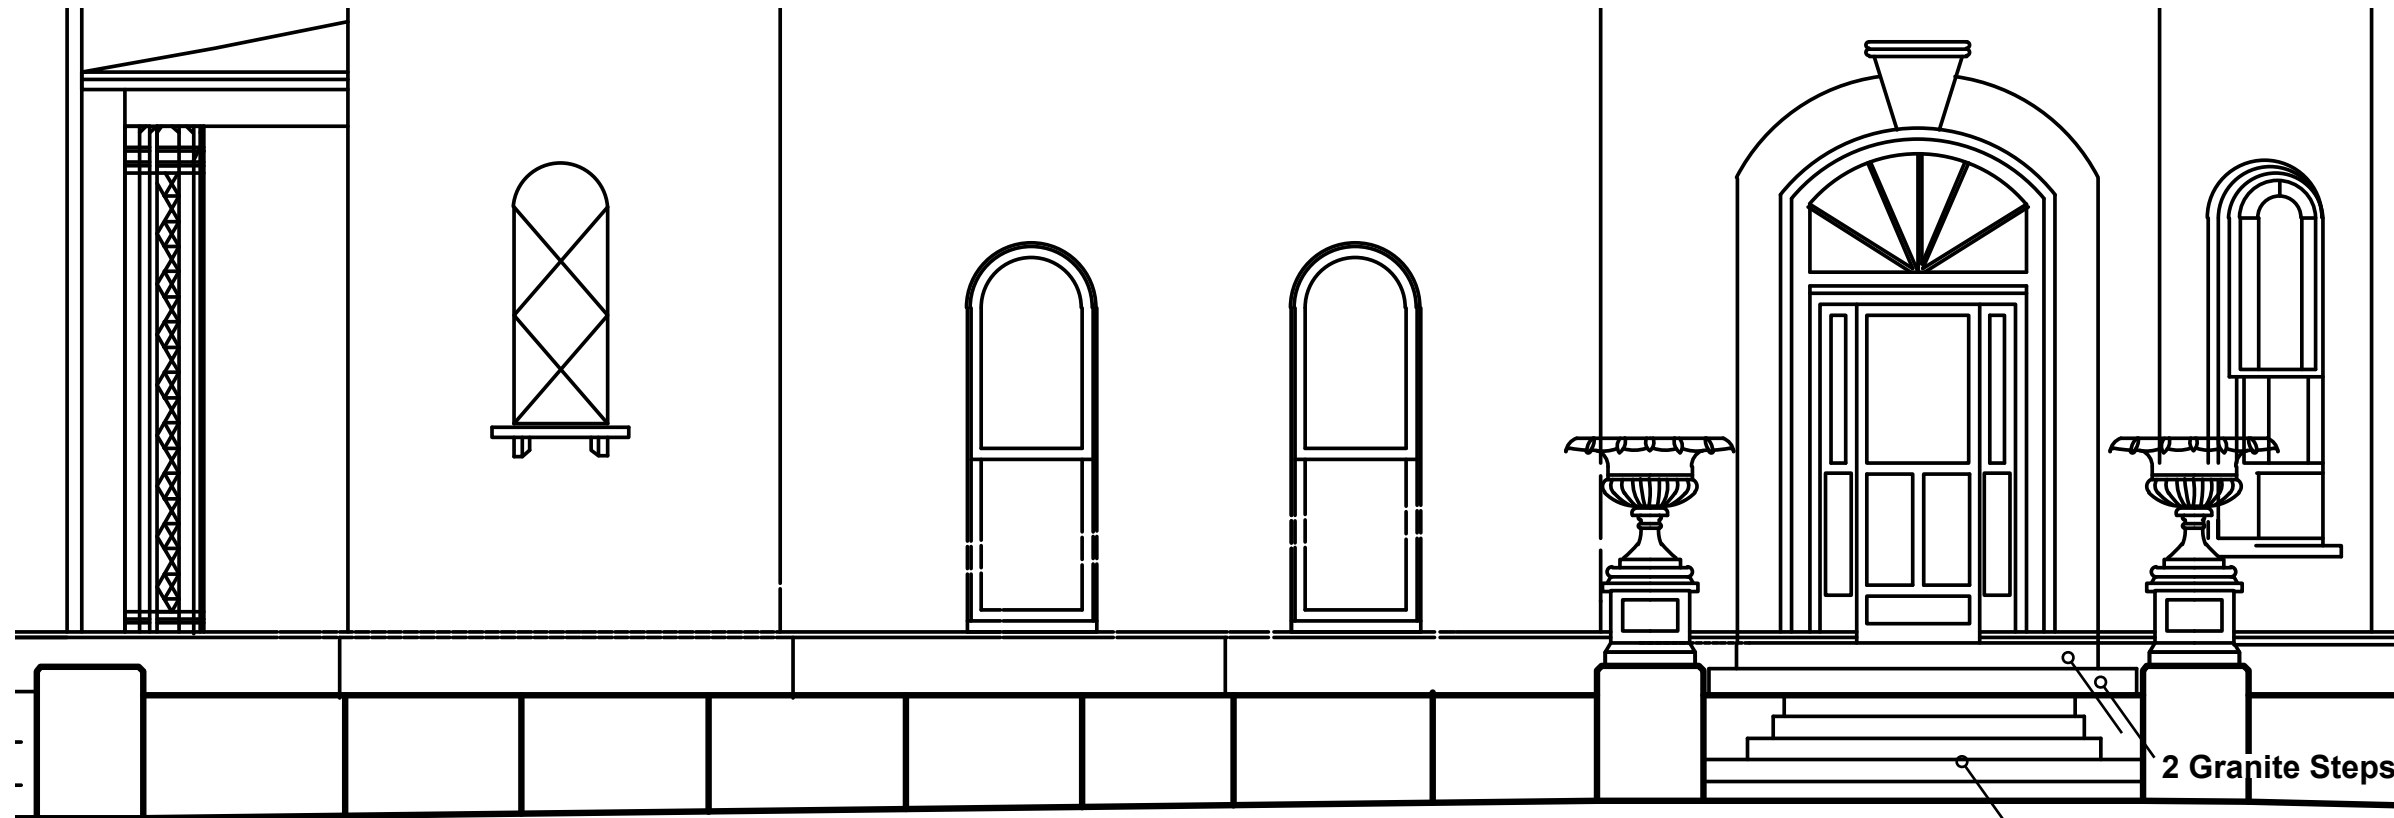
EXISTING

2 Granite Steps
5 Brownstone Steps, Landing, Piers, and Walls

Original Brownstone walls and pier reset on foundation
