Preservation Department – Item 1, LPC-22-01205

**95 Prospect Park West, Prospect Park - Litchfield Villa -
Individual Landmark
Borough of Brooklyn**

Litchfield Villa Grounds

Main Entrance Ramp

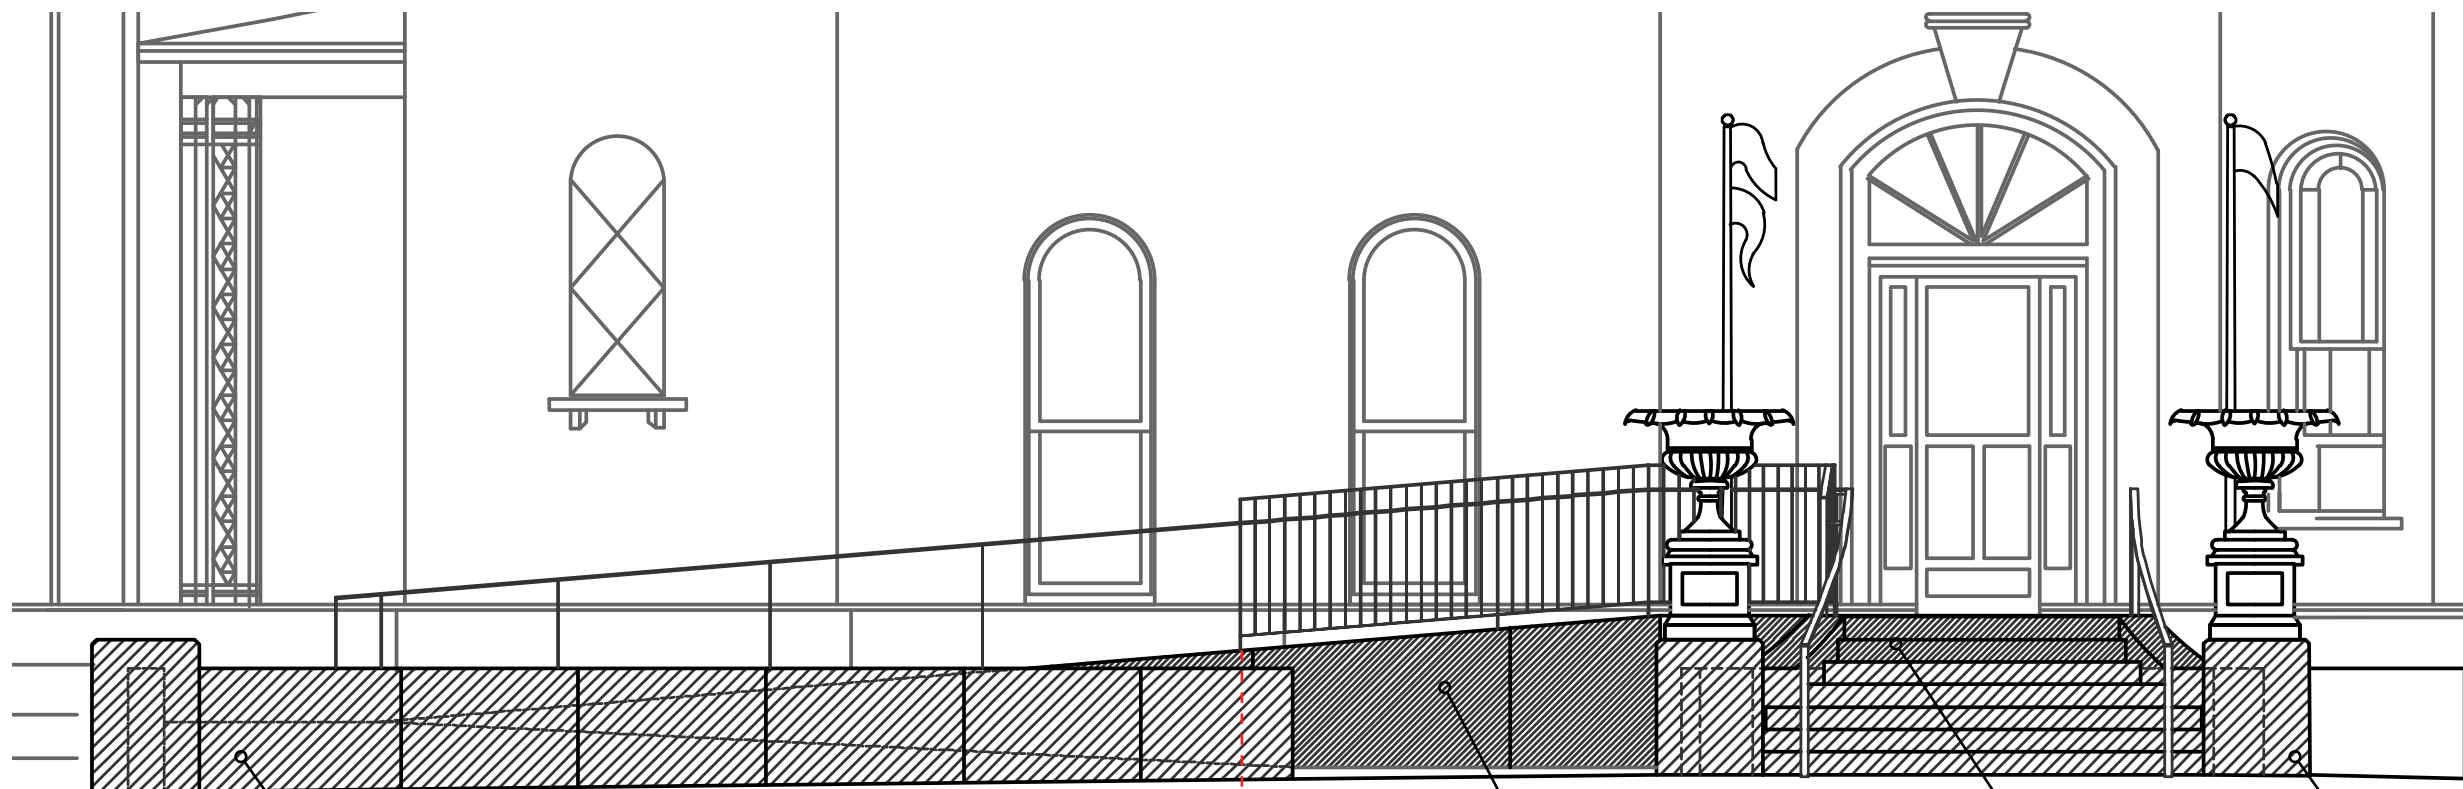
PROPOSED

30" Drop Guards no longer needed

New Cast Stone Brownstone Retaining Wall
Color: Fiske 18 by Corinthian Stone

New Cast Stone Brownstone Steps and Capped Cheek Wall
Color: Fiske 18 by Corinthian Stone

Brownstone Steps, Pier, and Cheek Wall reset on foundation

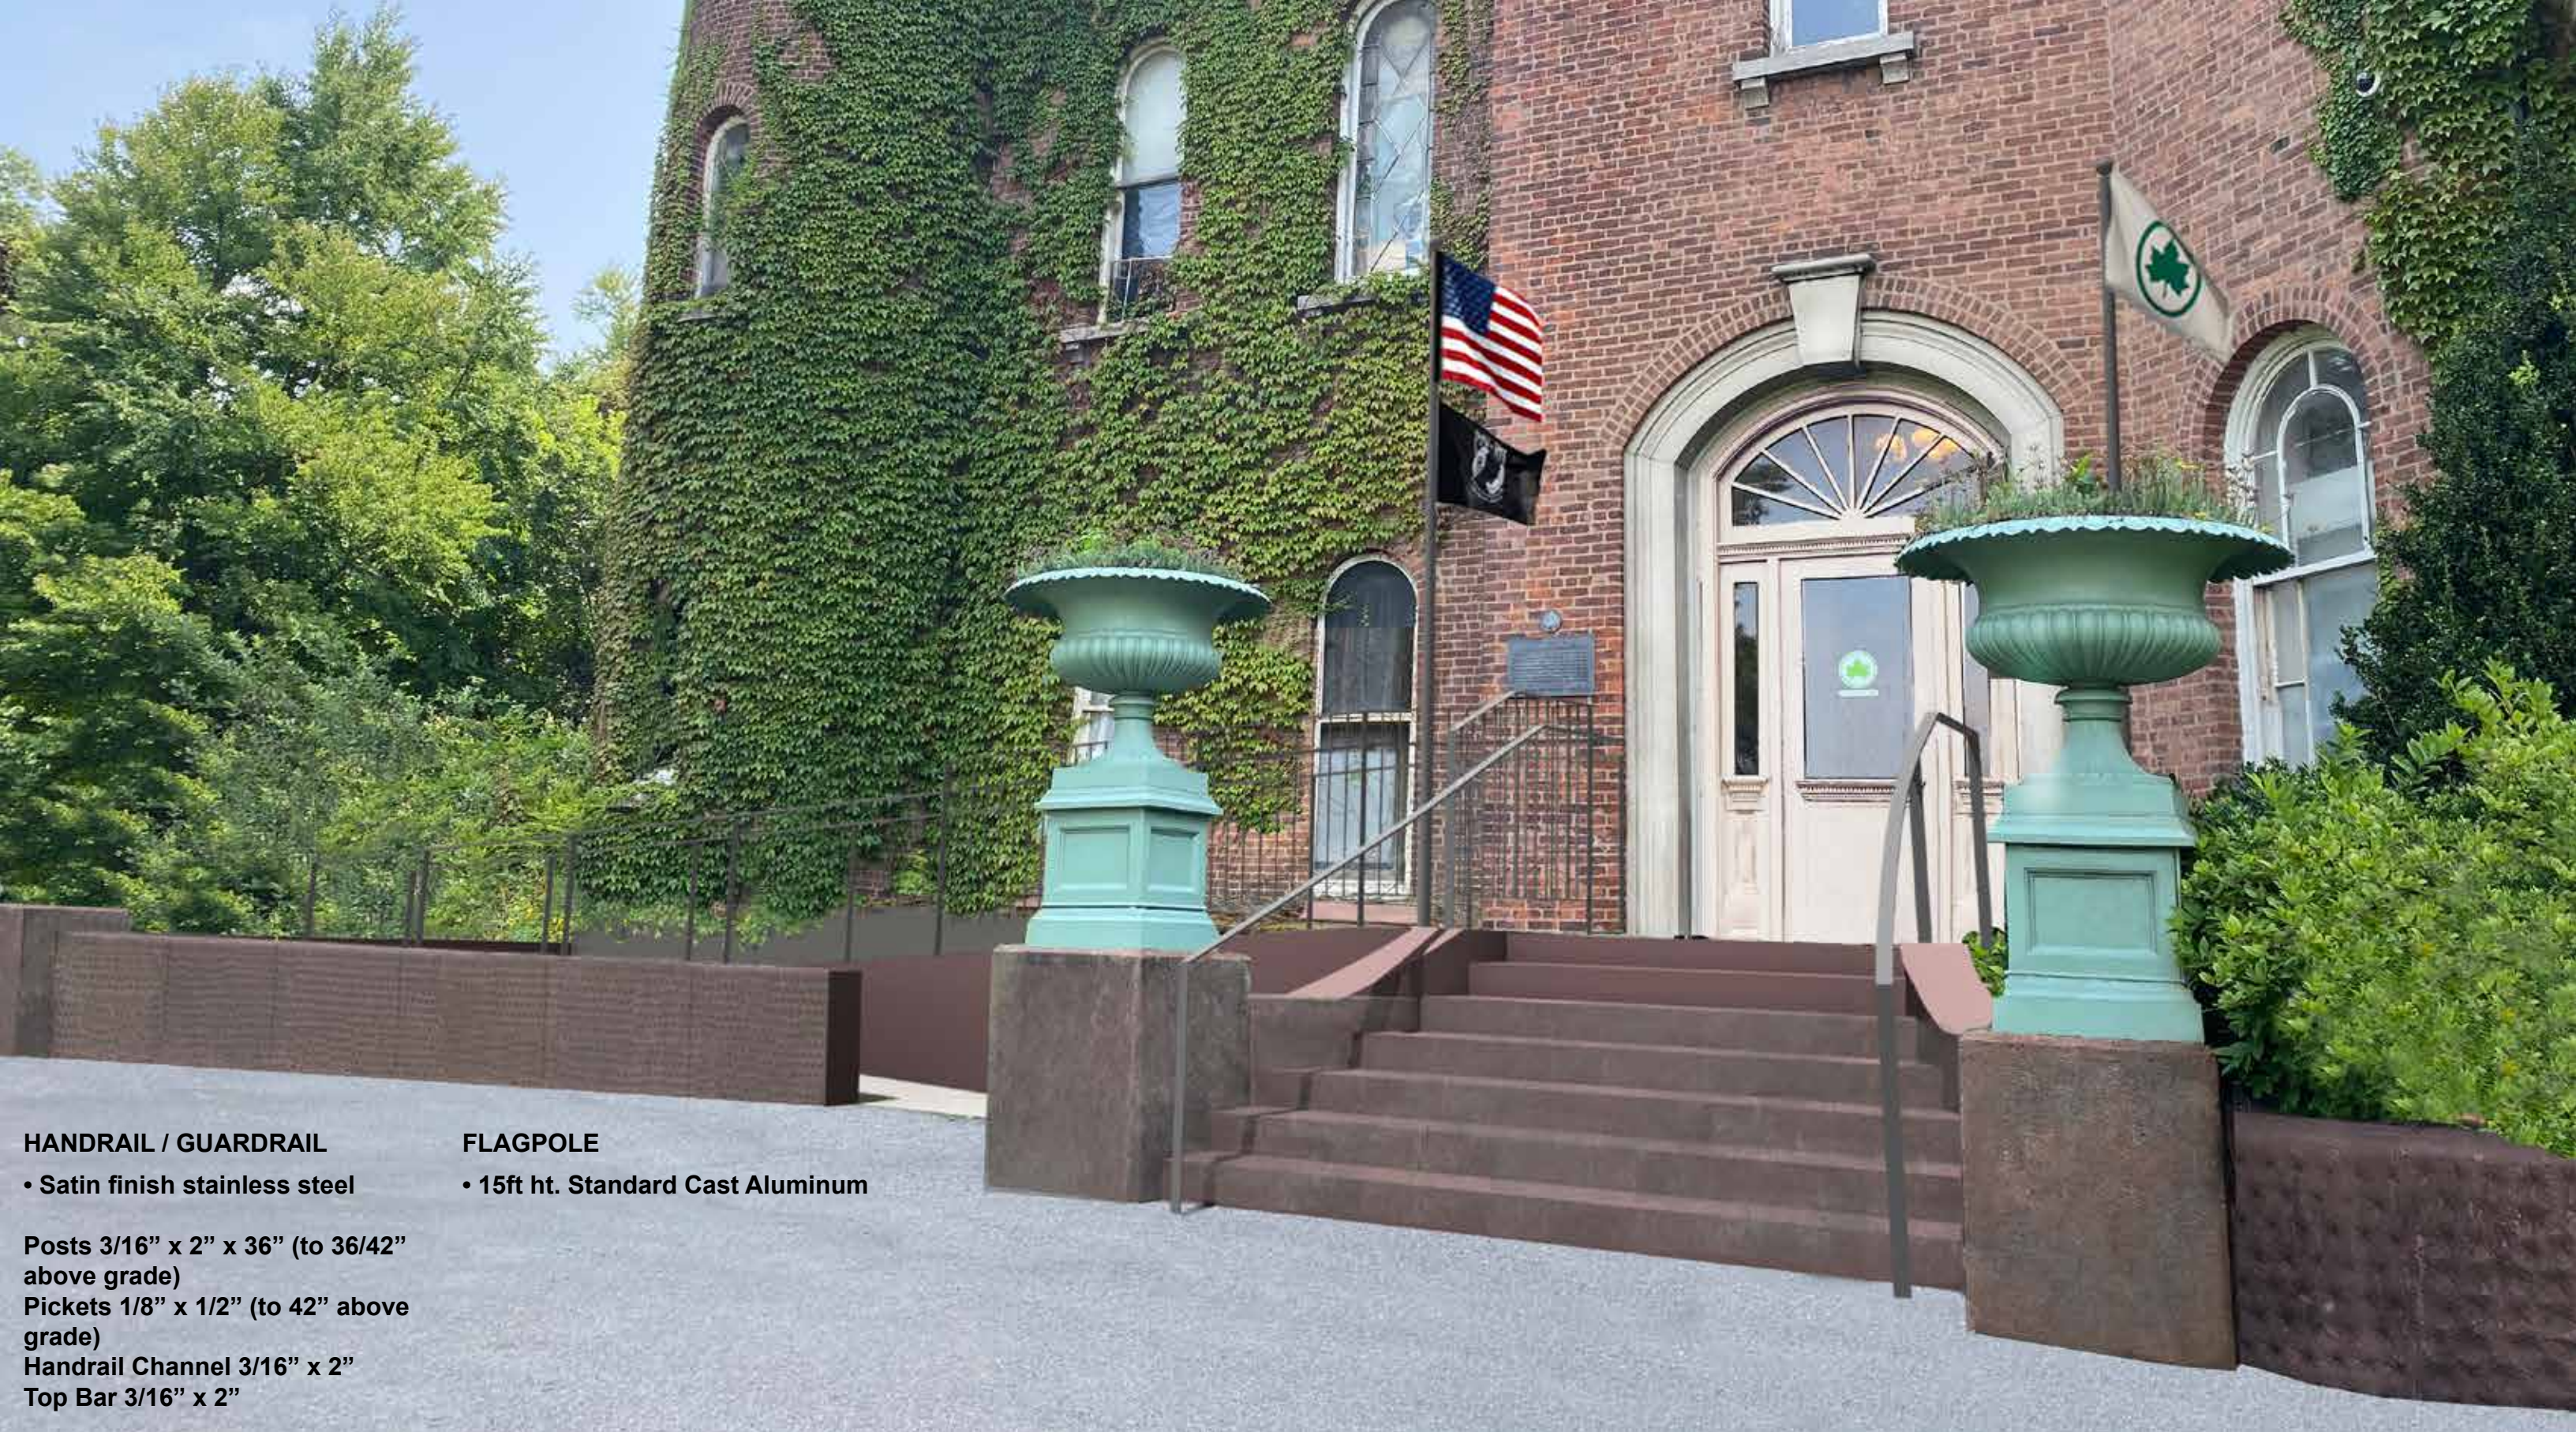
HANDRAIL / GUARDRAIL

- Satin finish stainless steel

Posts 3/16" x 2" x 36" (to 36/42" above grade)
Pickets 1/8" x 1/2" (to 42" above grade)
Handrail Channel 3/16" x 2"
Top Bar 3/16" x 2"

FLAGPOLE

- 15ft ht. Standard Cast Aluminum

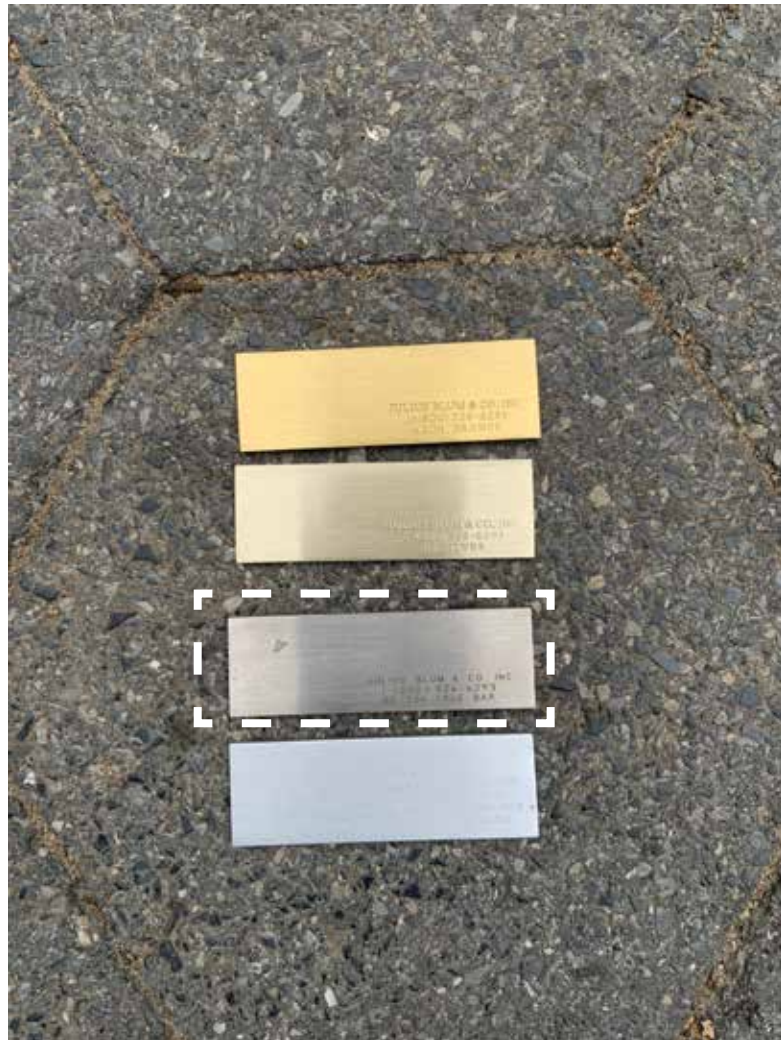
Brushed stainless steel metal railing.

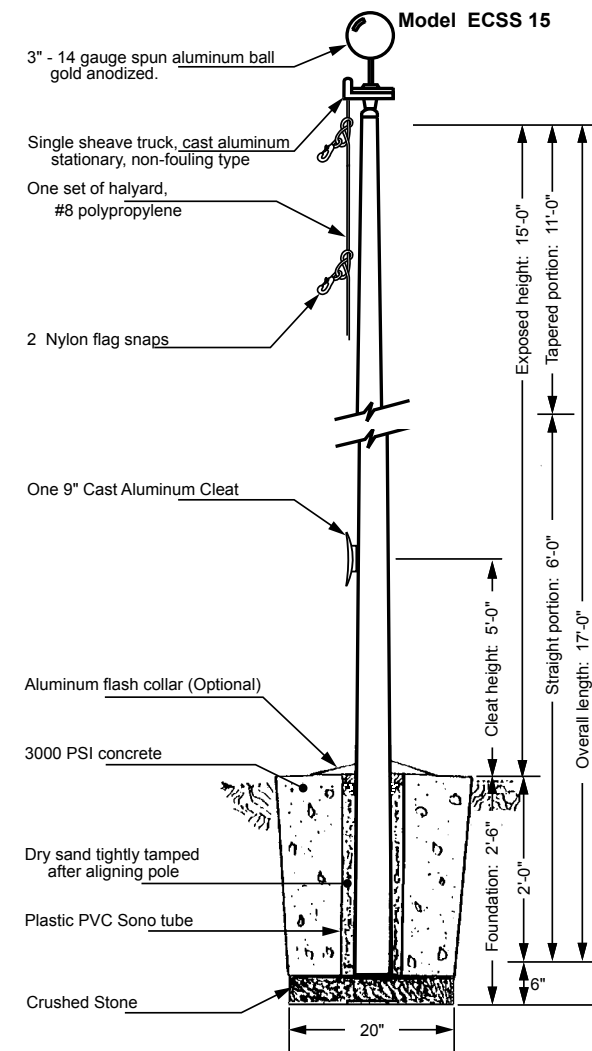
Typical 15ft ht. aluminum rail.

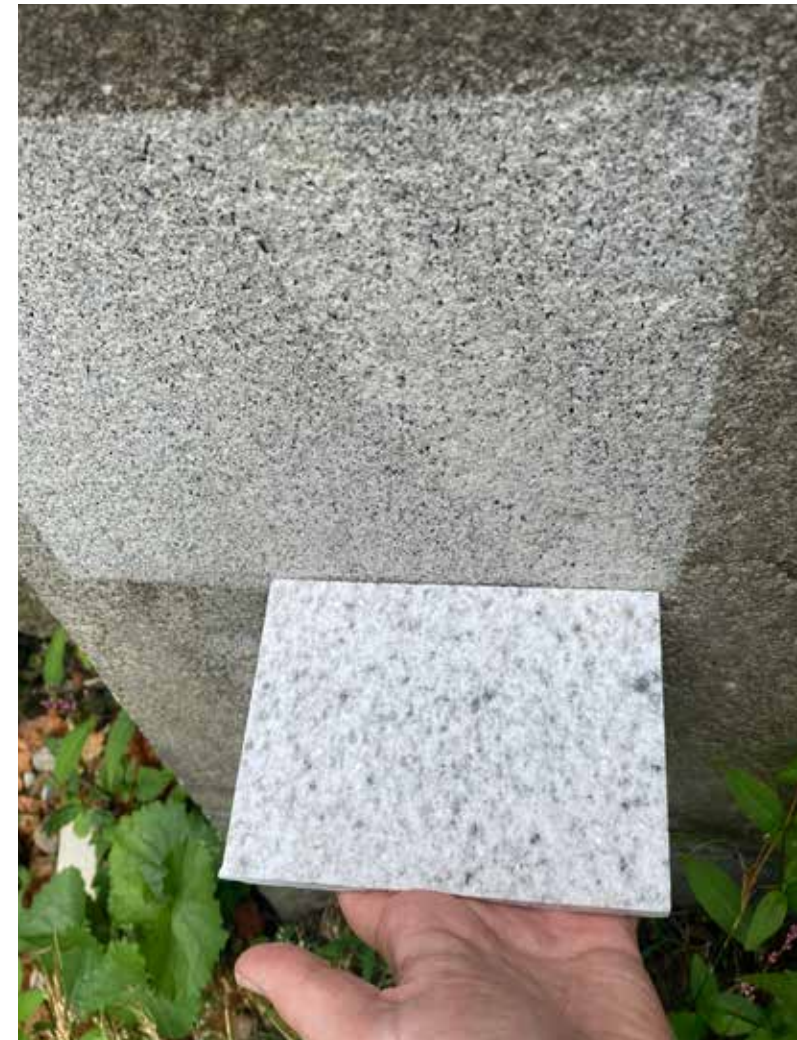
Bethel White granite for ramp surface and landing, as pictured in front of cleaned door surround

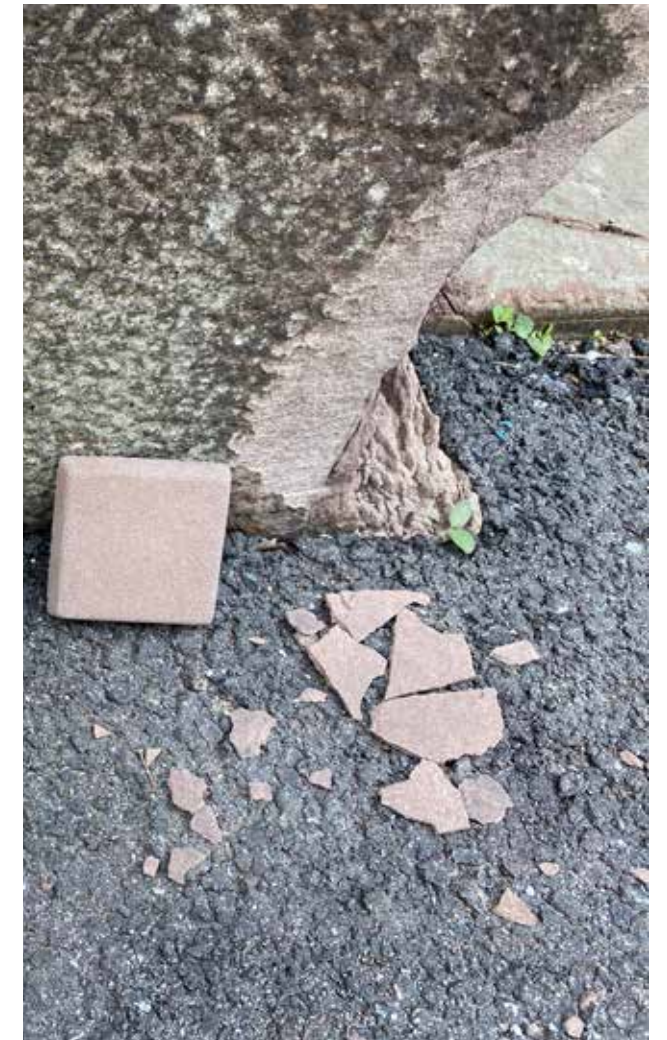
'Fiske 18' Cast stone, as pictured in front of original Portland brownstone pier.

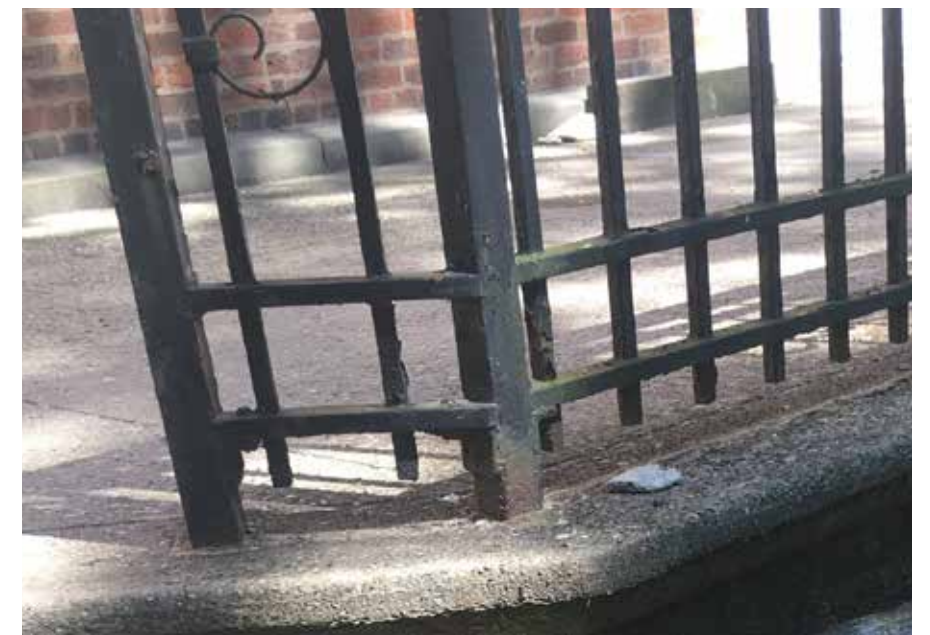
Painted black steel fence is not properly maintained; corroded and chipping.

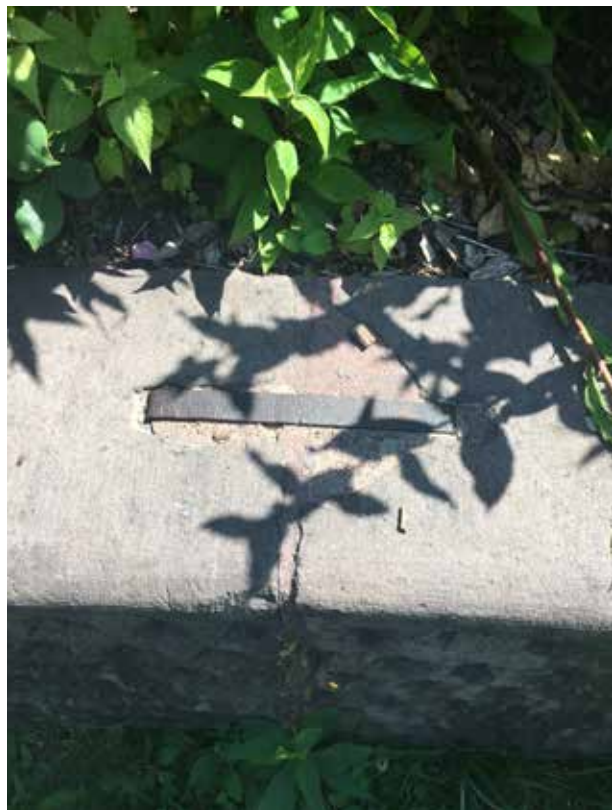
Iron staples on brownstone wall, not original.

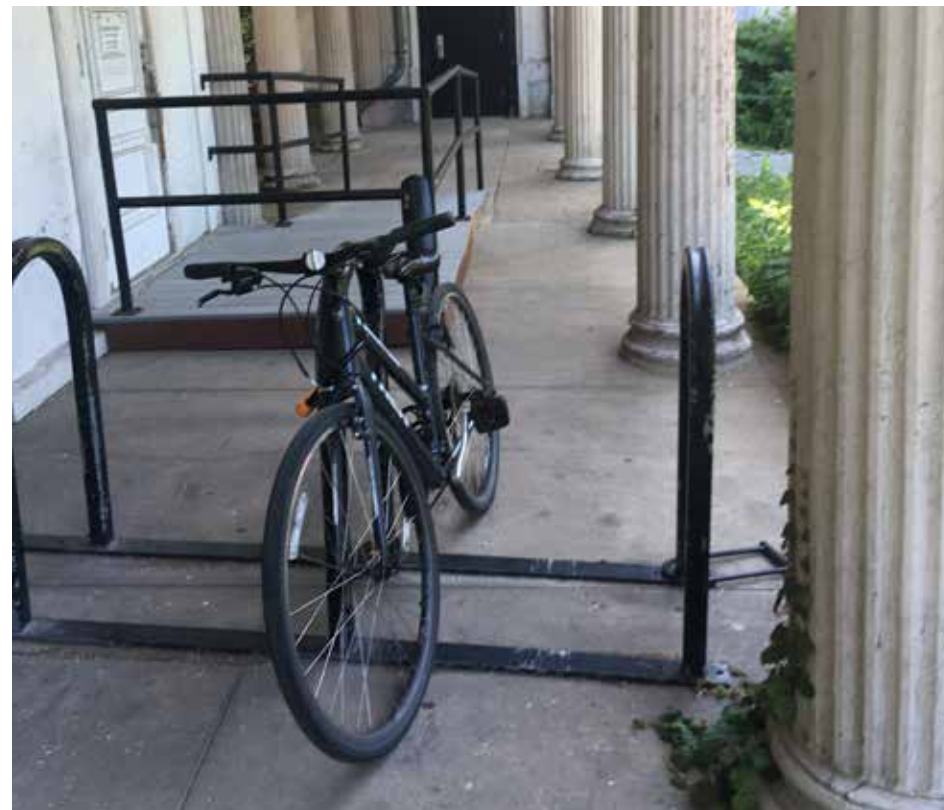
Various black painted rail on portico.

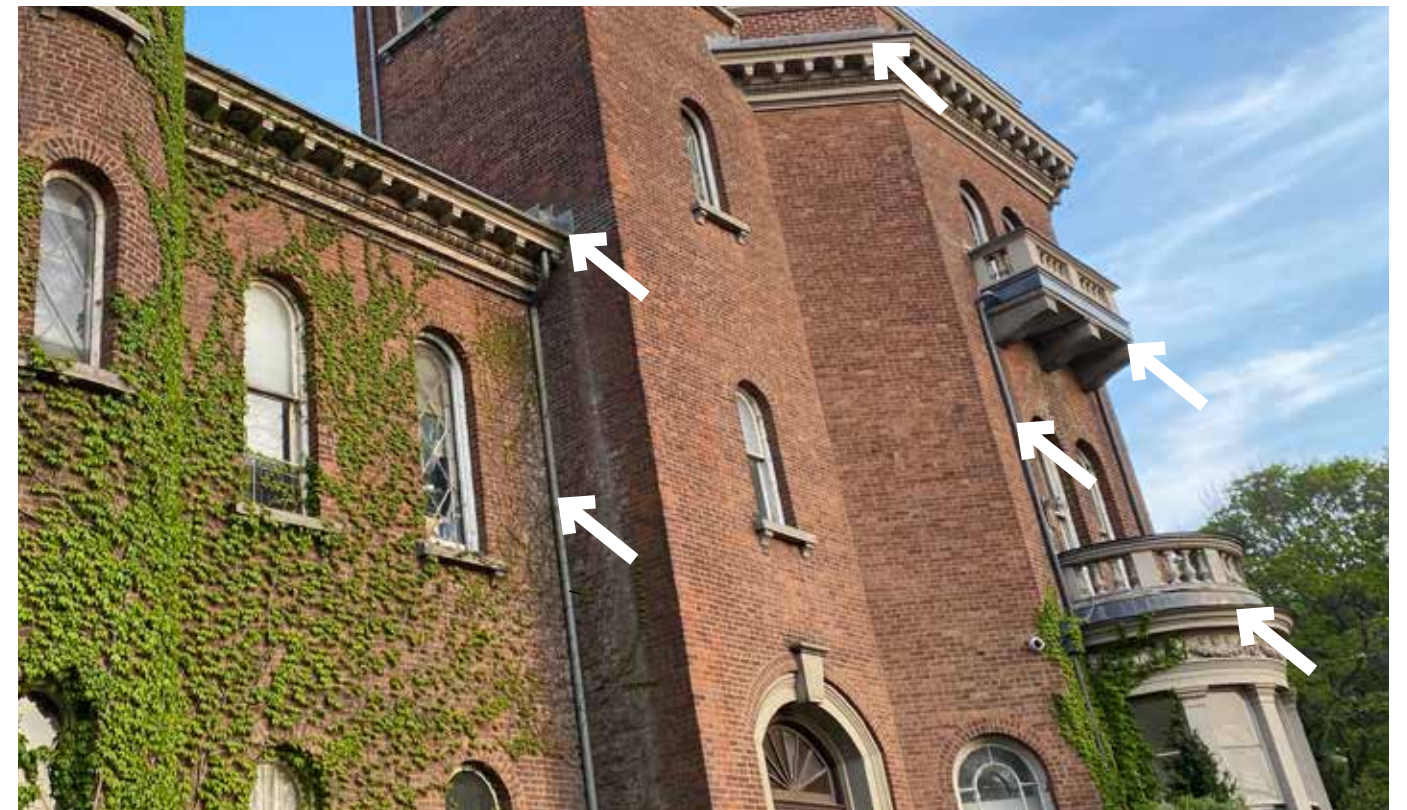
Only lead coated copper elements on front of building.

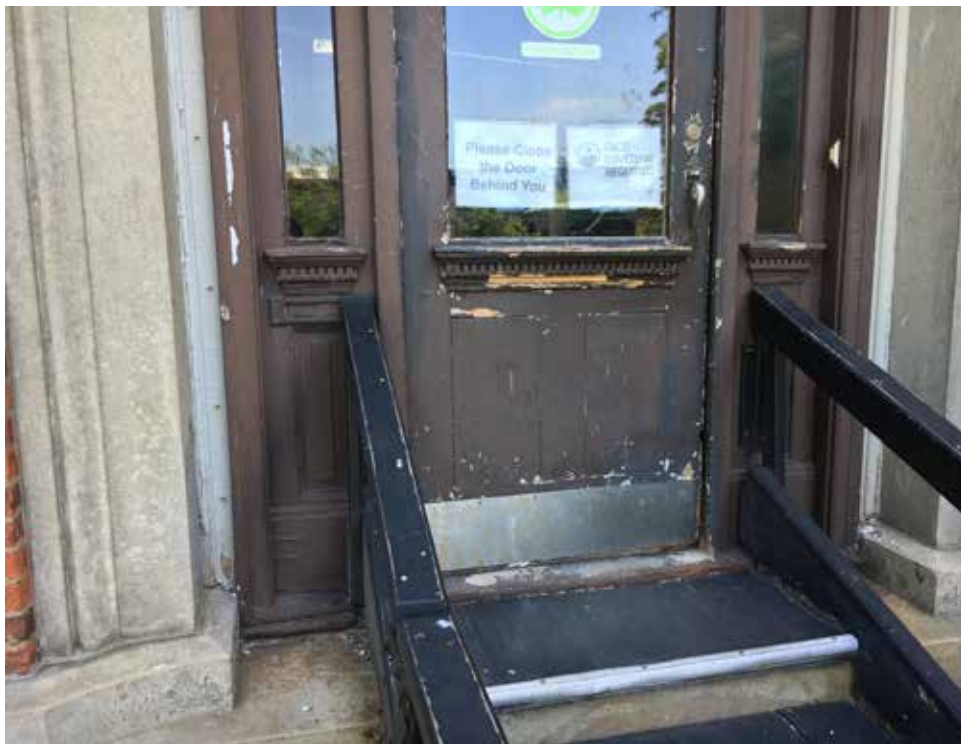
Granite door surround and base exhibiting general soiling.

- Clean granite door surround and base at entrance.
- Remove and reset brownstone steps.
- Repair spalling and delaminating areas of brownstone steps using dutchmen and patching to match adjacent material.

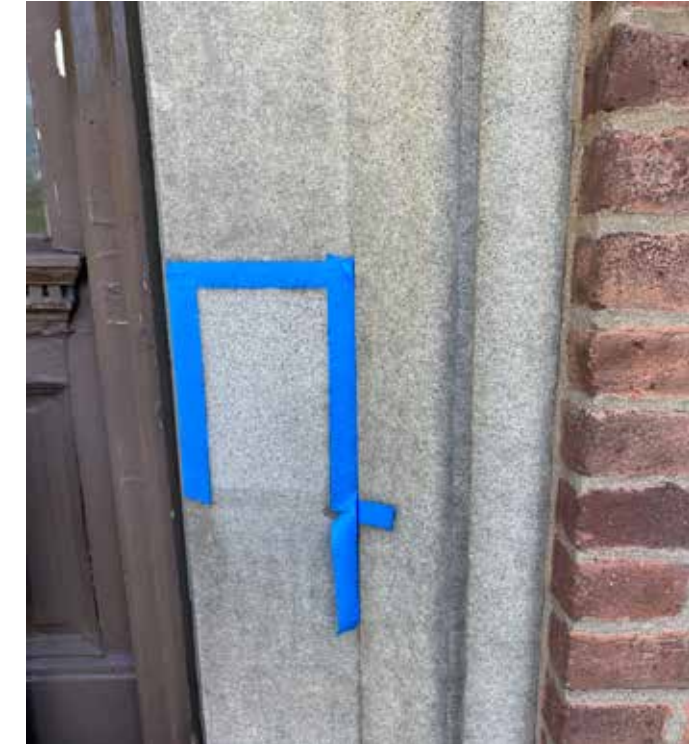
Cleaning test at granite door surround using detergent cleaner.

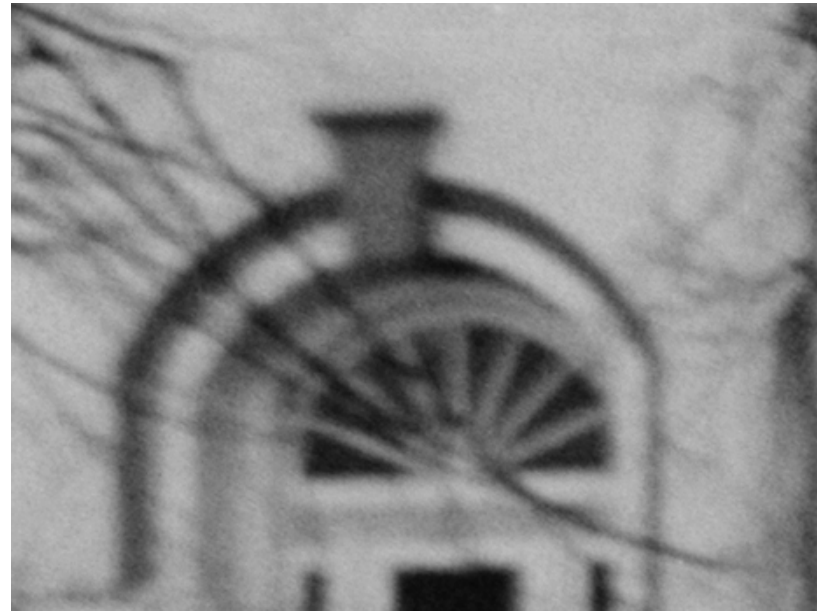
Historic 1934 photo of entrance shows paint at door surround matching the color found at the earliest extant finish layer.

- Remove existing finishes and provide new painted finishes to match original, based on paint analysis and archival research (original color is in the range of off-white to tan, exact color to be confirmed)
- Provide isolated wood putty and dutchman repairs as necessary at deteriorated wood
