Preservation Department – Item 1, LPC-22-08731

**6301 12th Avenue, aka 6301-6323 12th Avenue, 1202-1216 63rd
Street, and 1201-1215 64th Street – Angel Guardian Home –
Individual Landmark
Borough of Brooklyn**

LPC-22-08731: 6301 12th Avenue, Angel Guardian Home - Individual Landmark

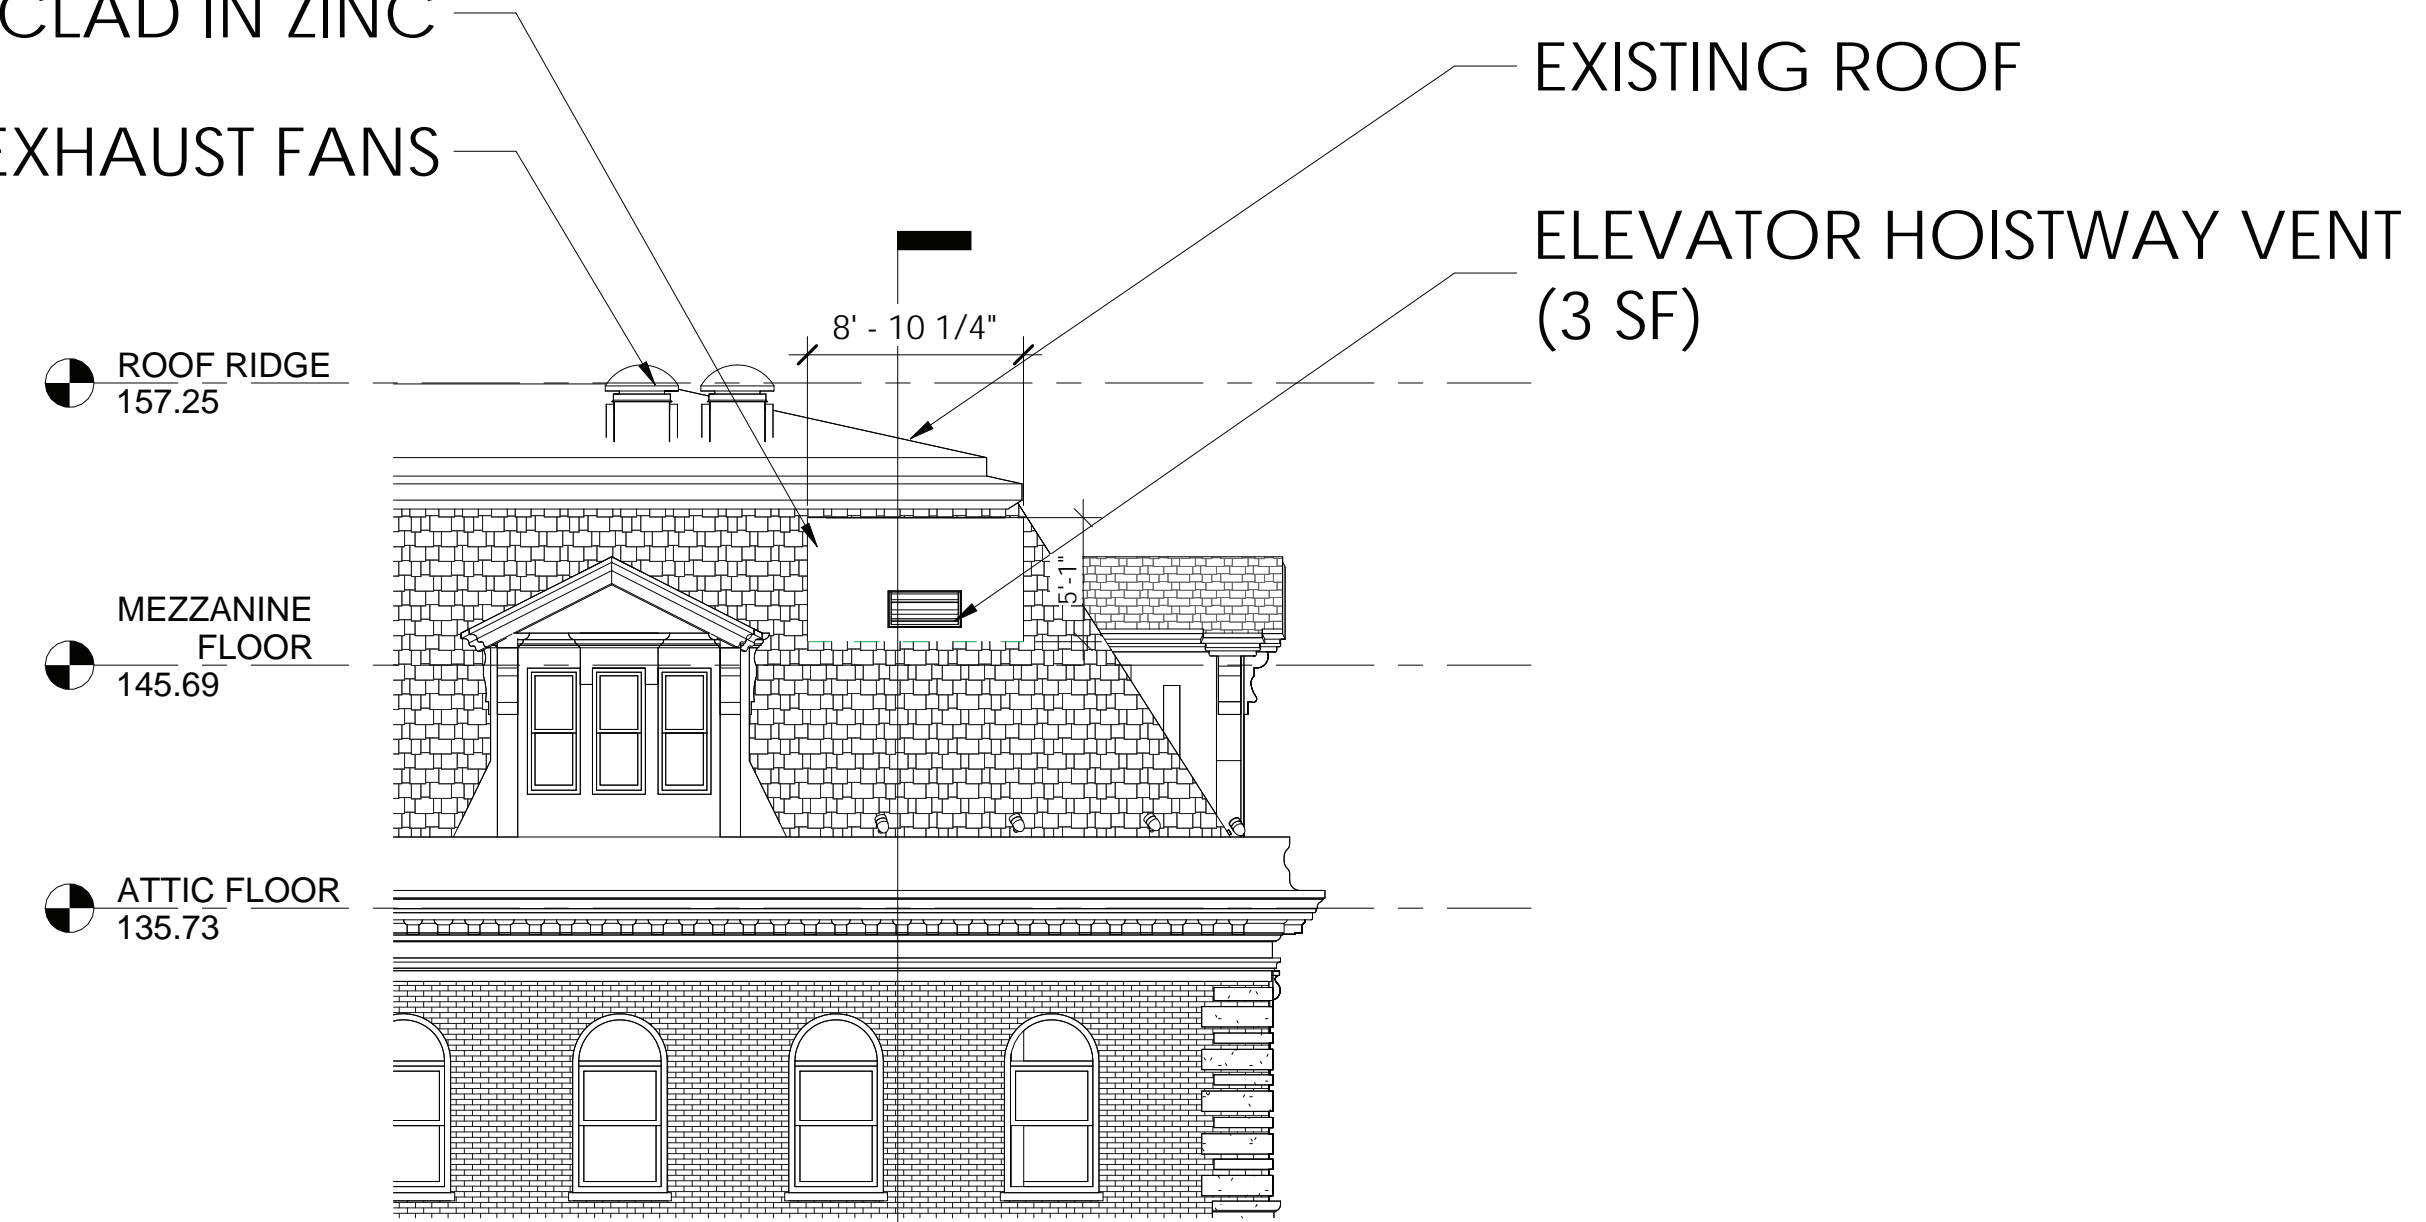
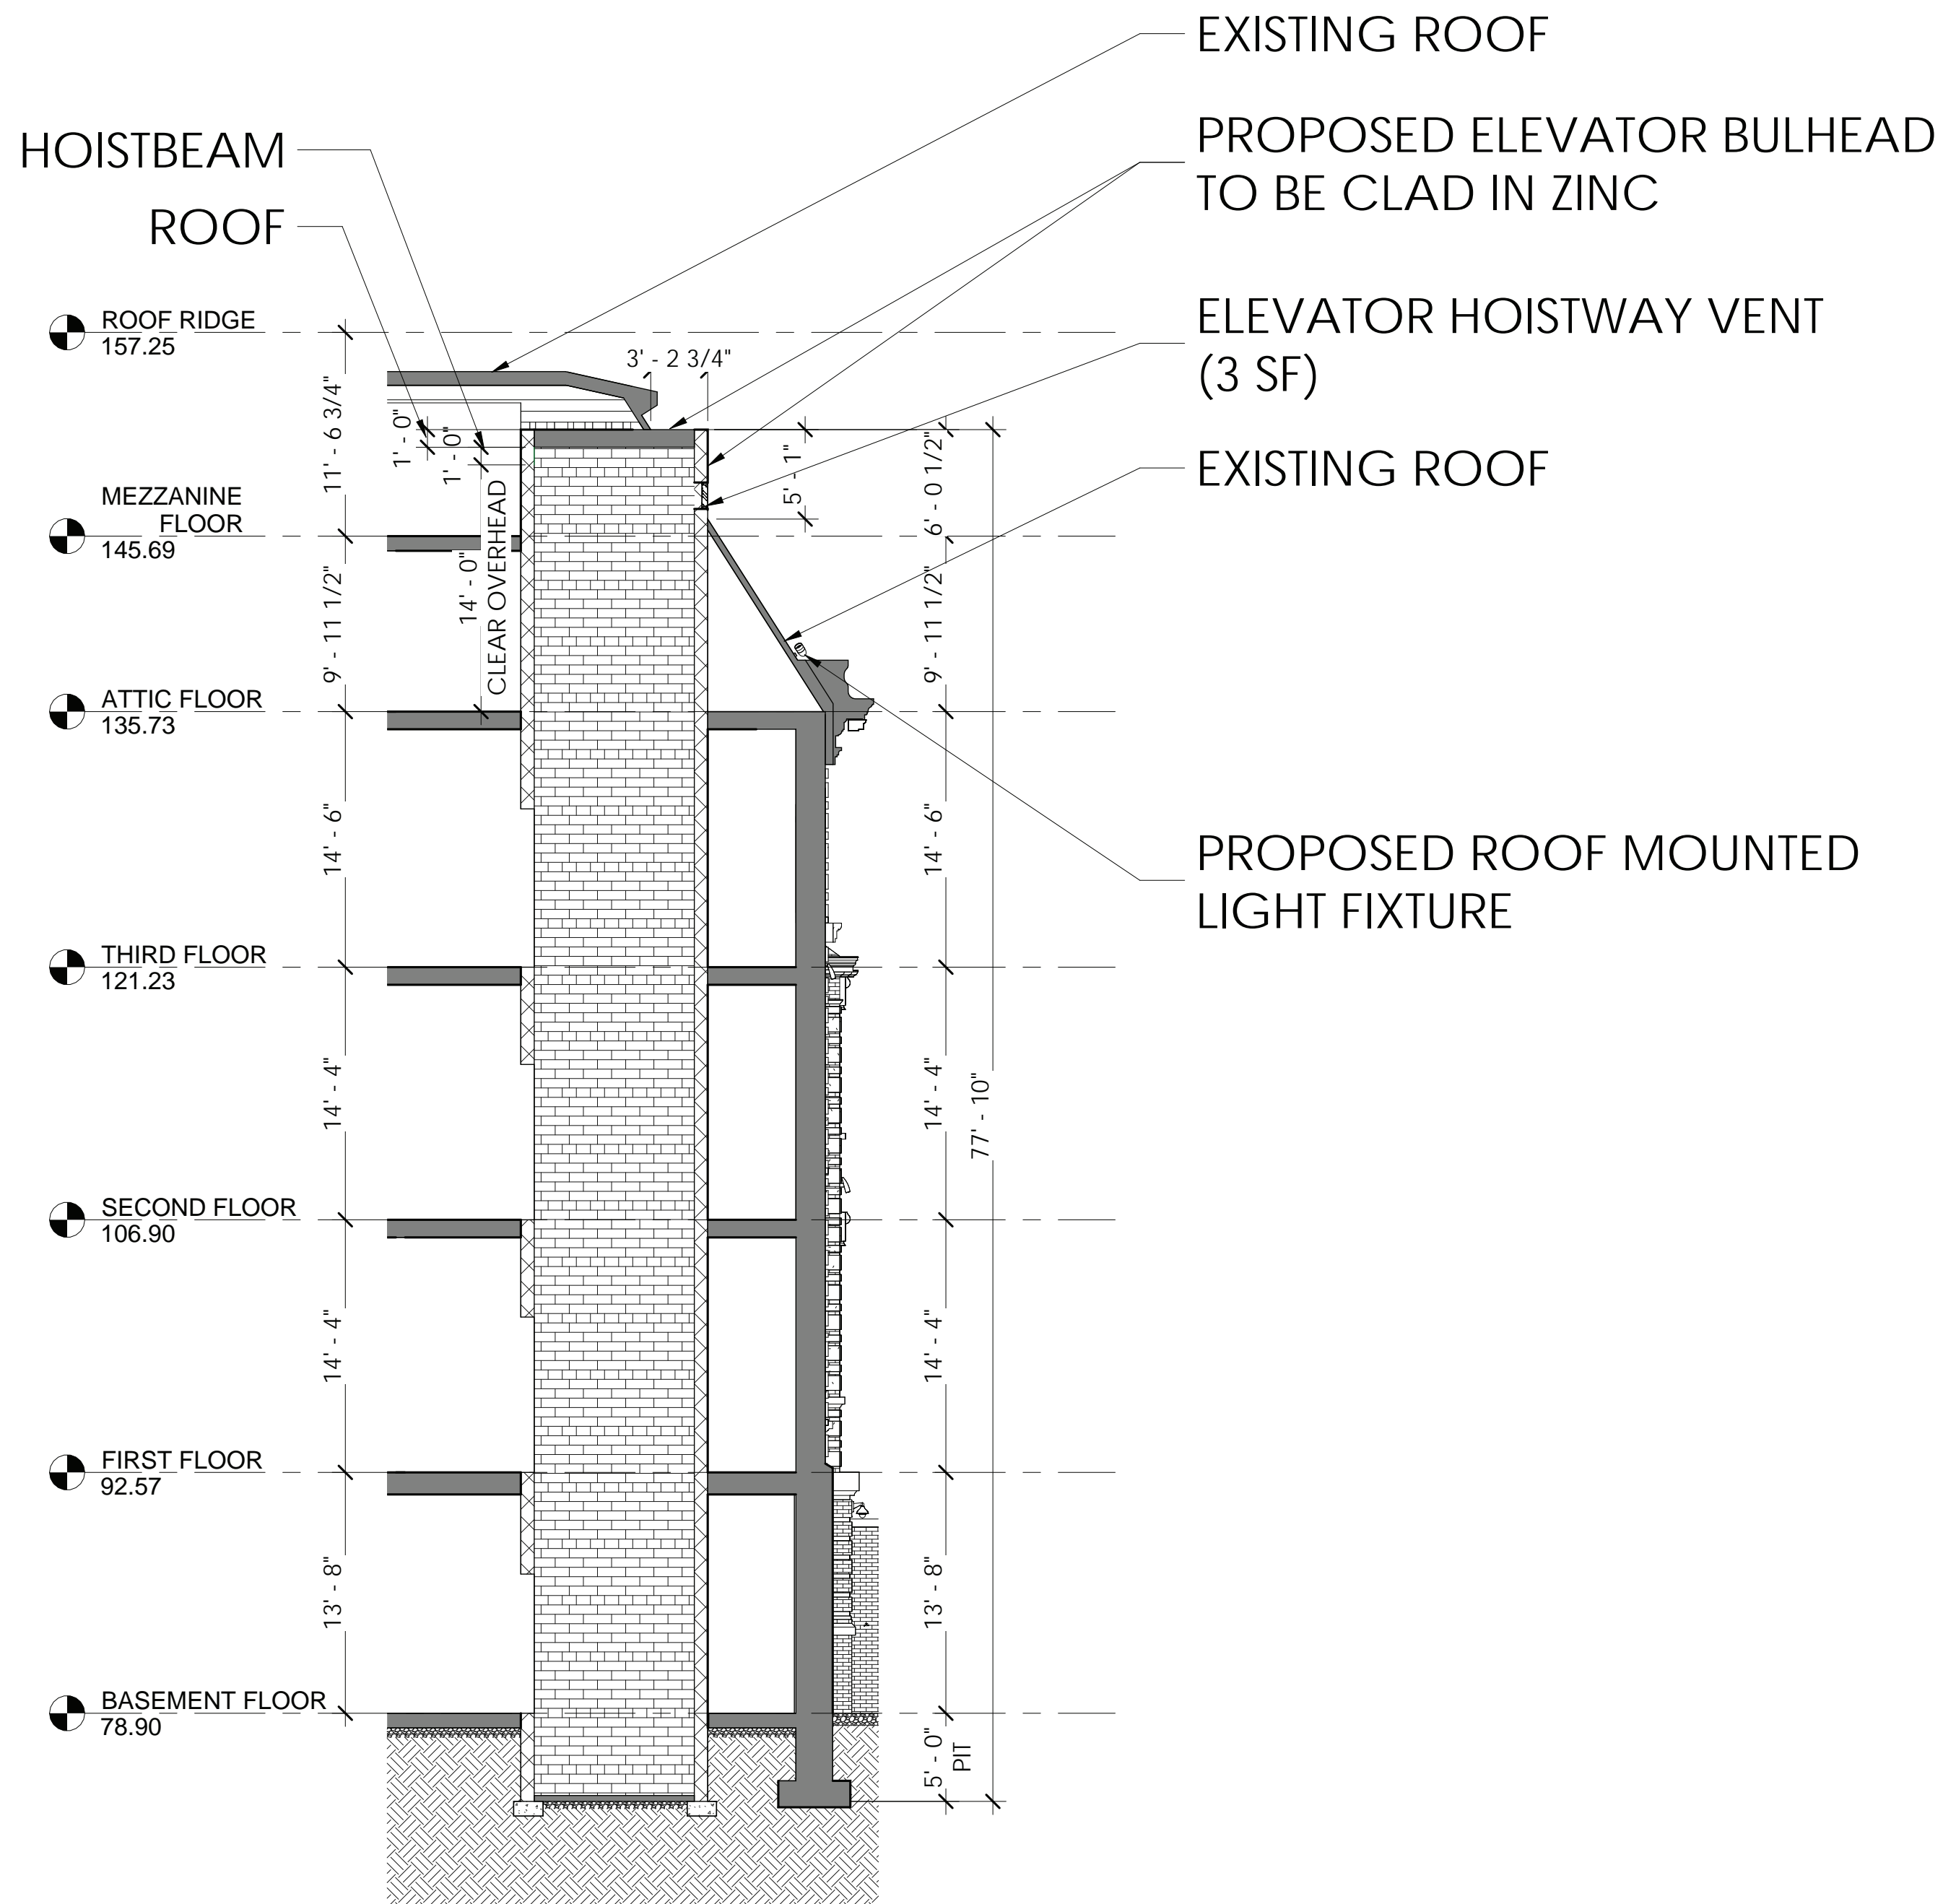
REVISED DESIGN:

PROPOSED ELEVATOR BULHEAD
TO BE CLAD IN ZINC
PROPOSED EXHAUST FANS

- CHANGES:
- ELEVATOR BULKHEAD HEIGHT
 - NEW ELEVATOR HOISTWAY VENT

RE-STUDY SHIFT OR REDUCE ELEVATOR BULKHEAD

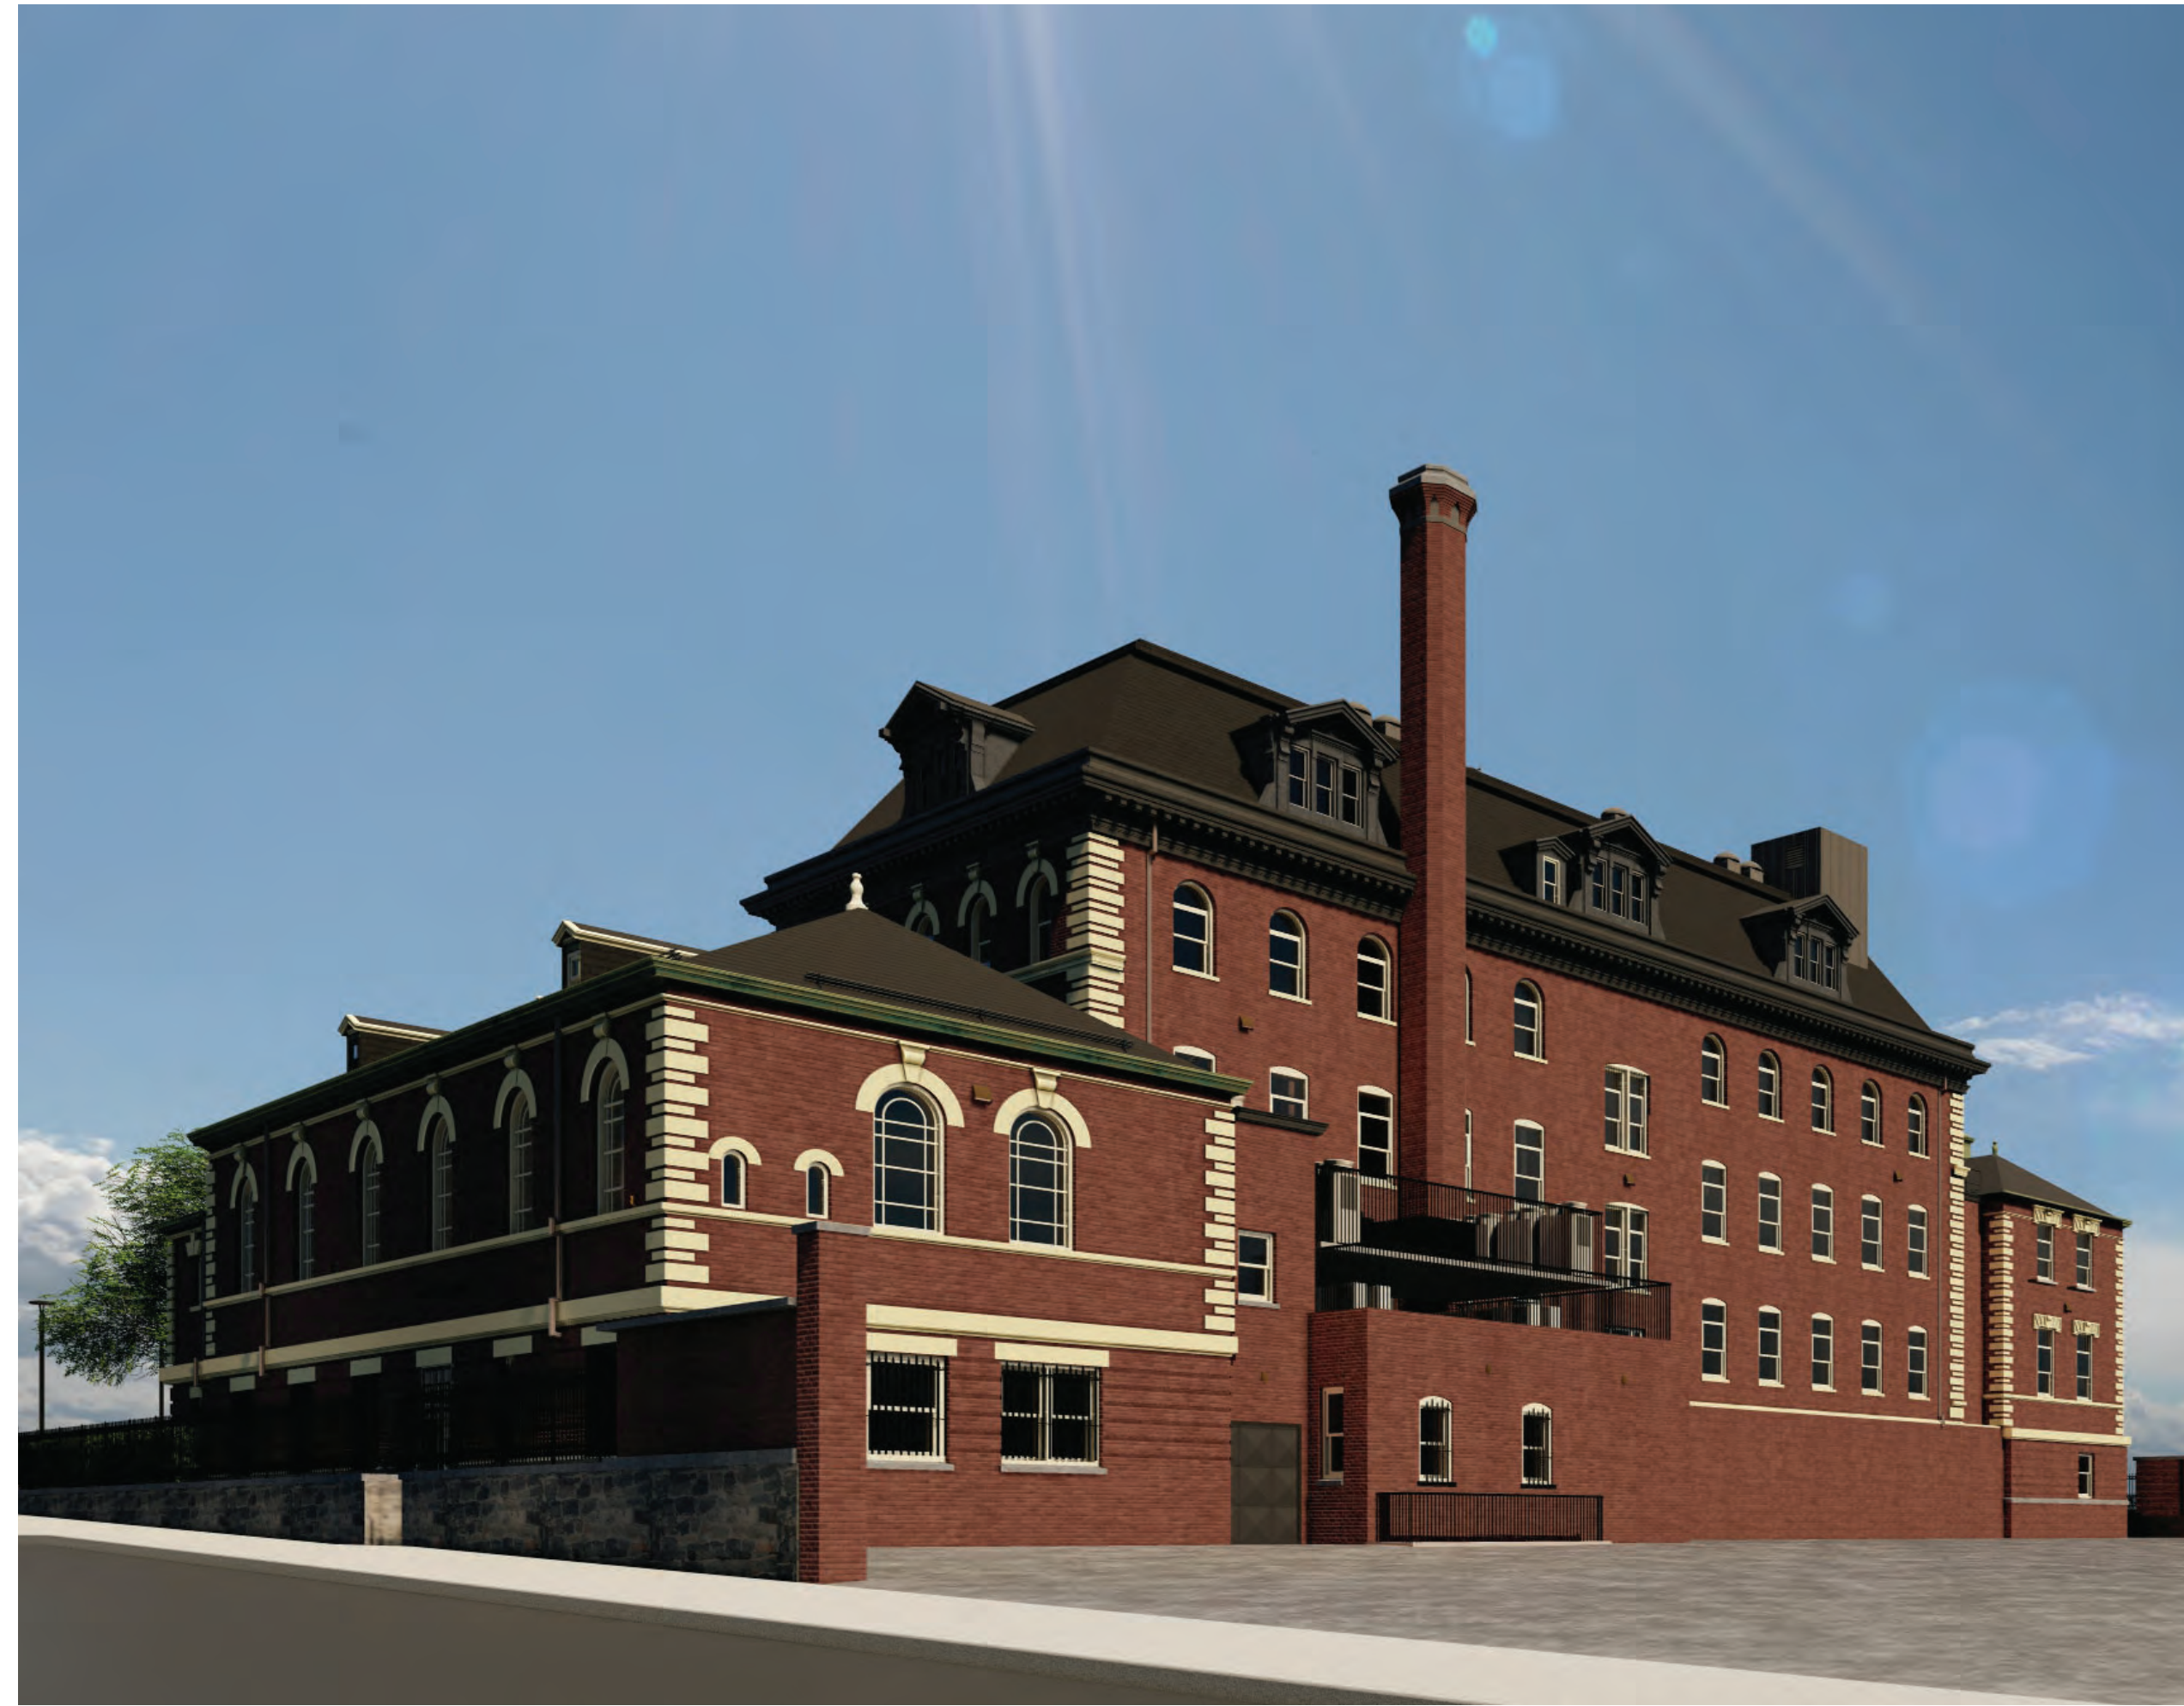
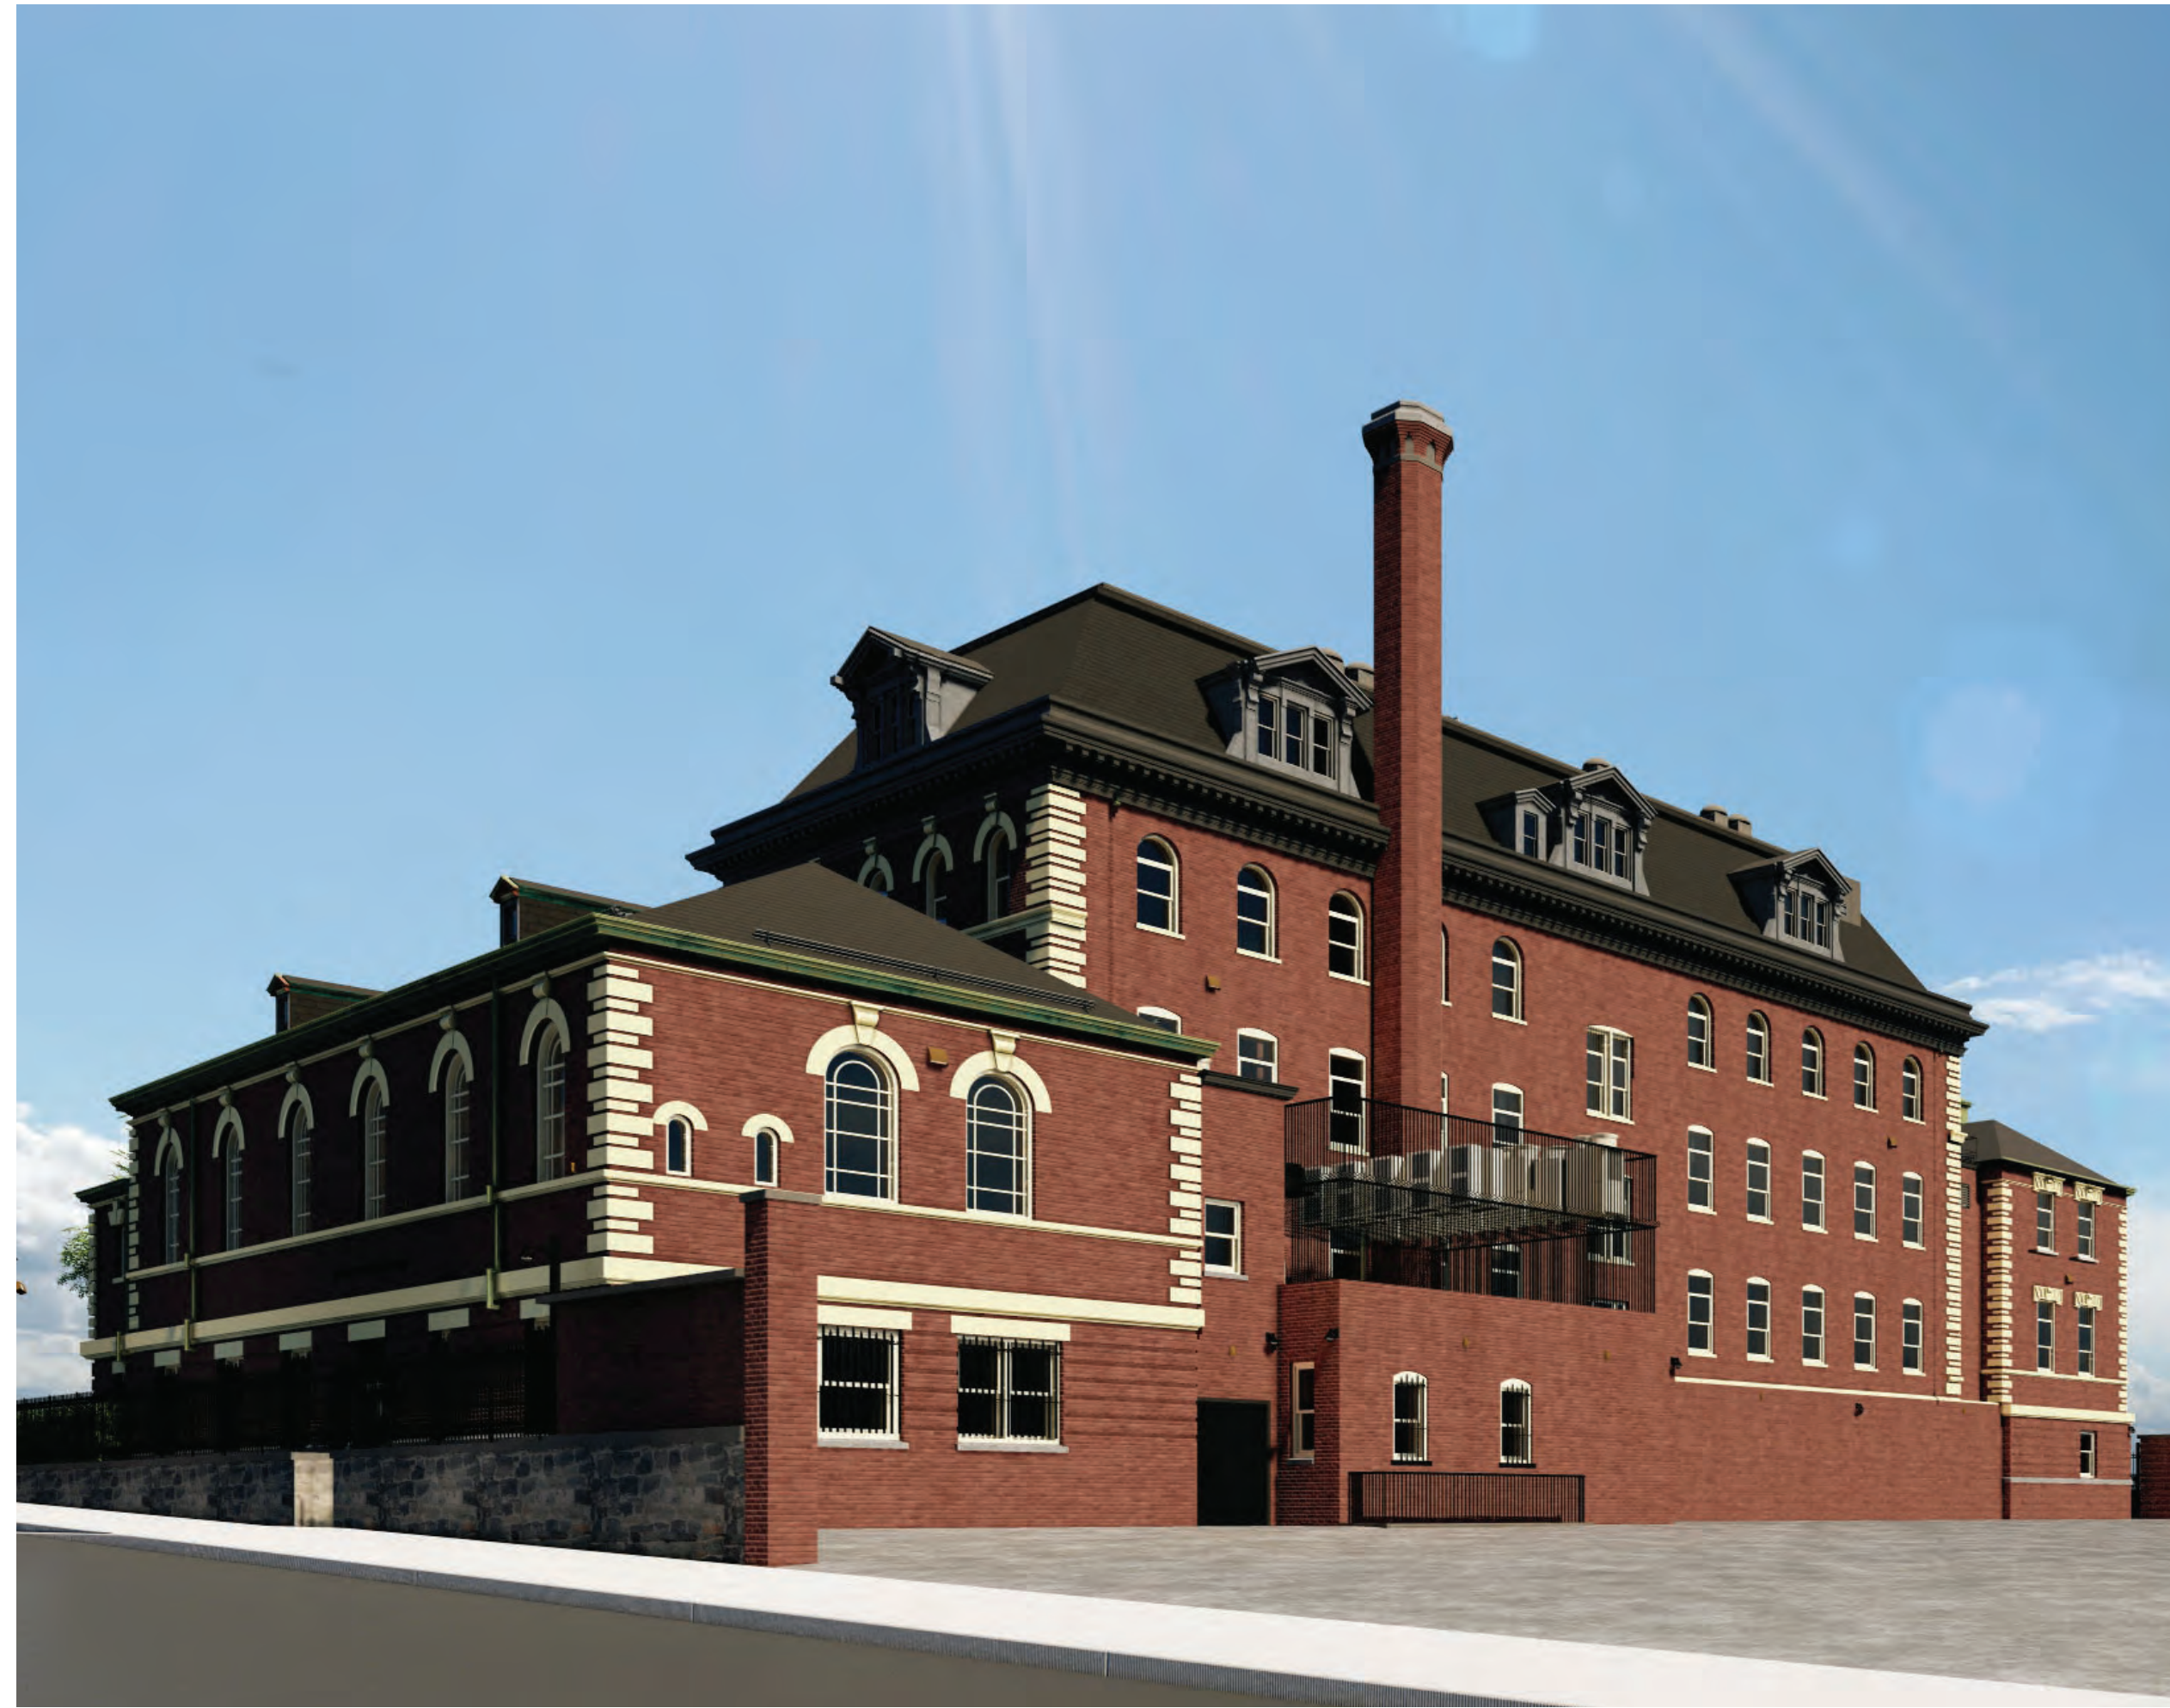
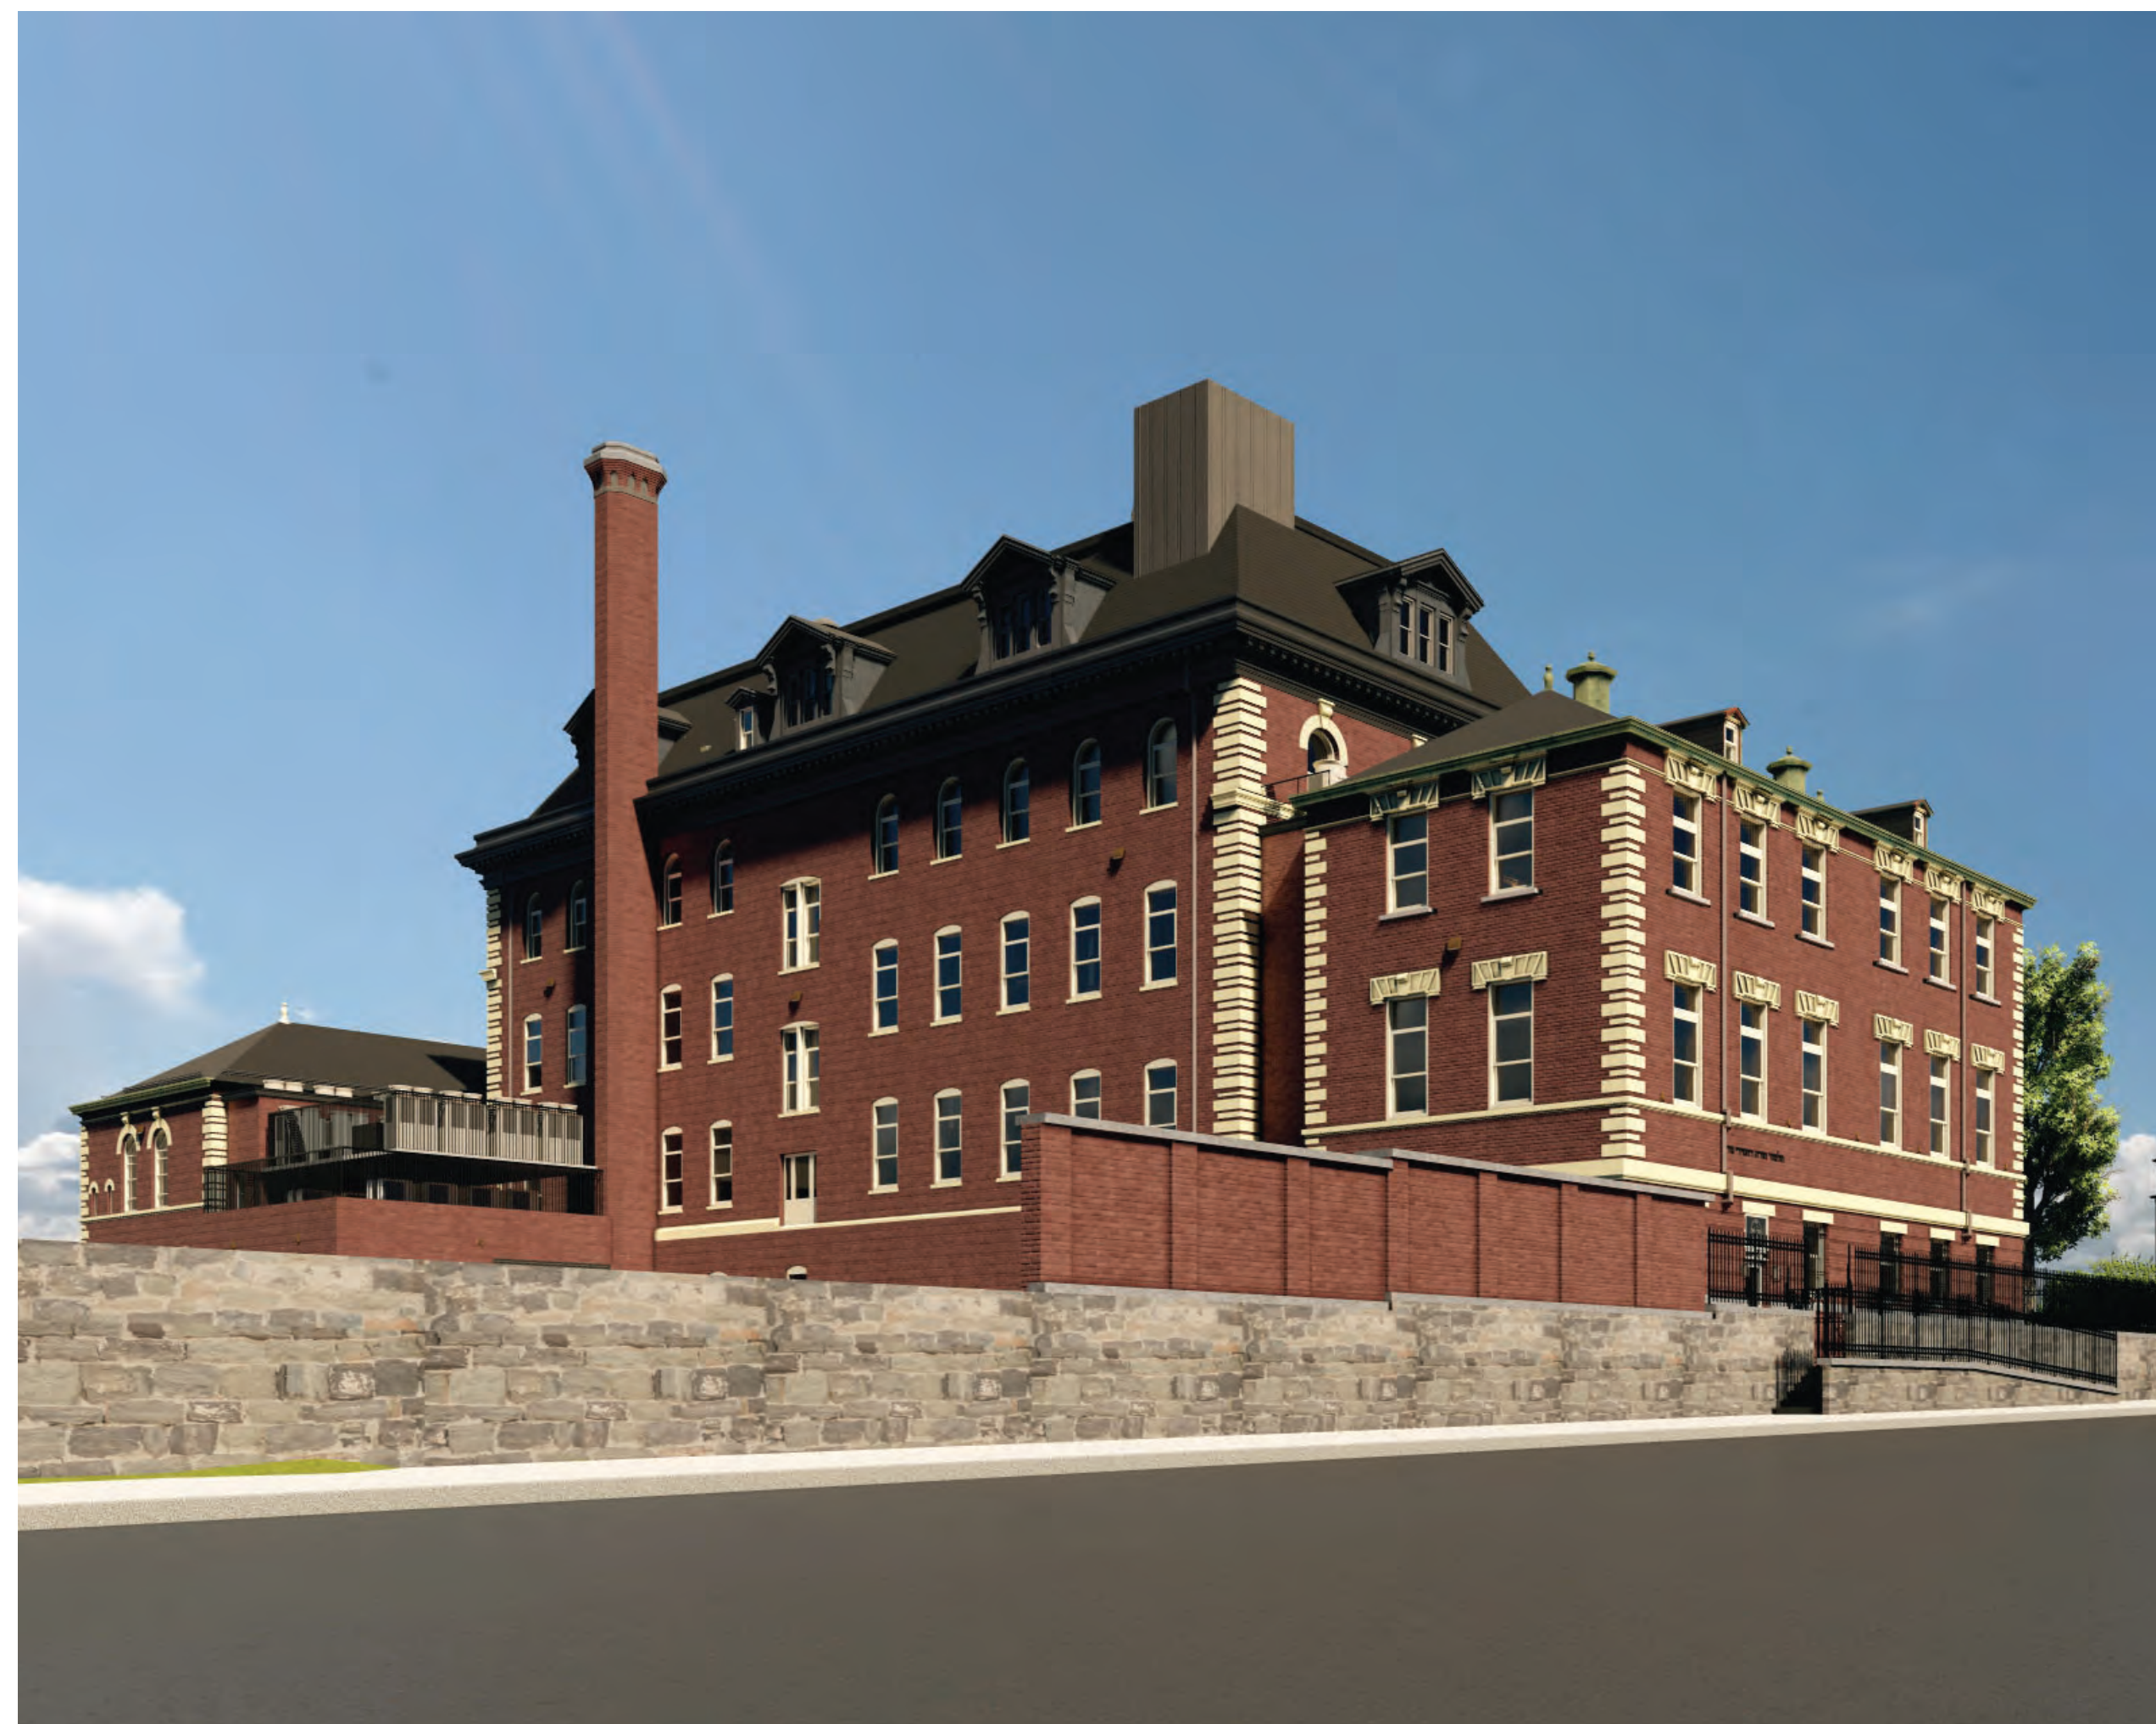
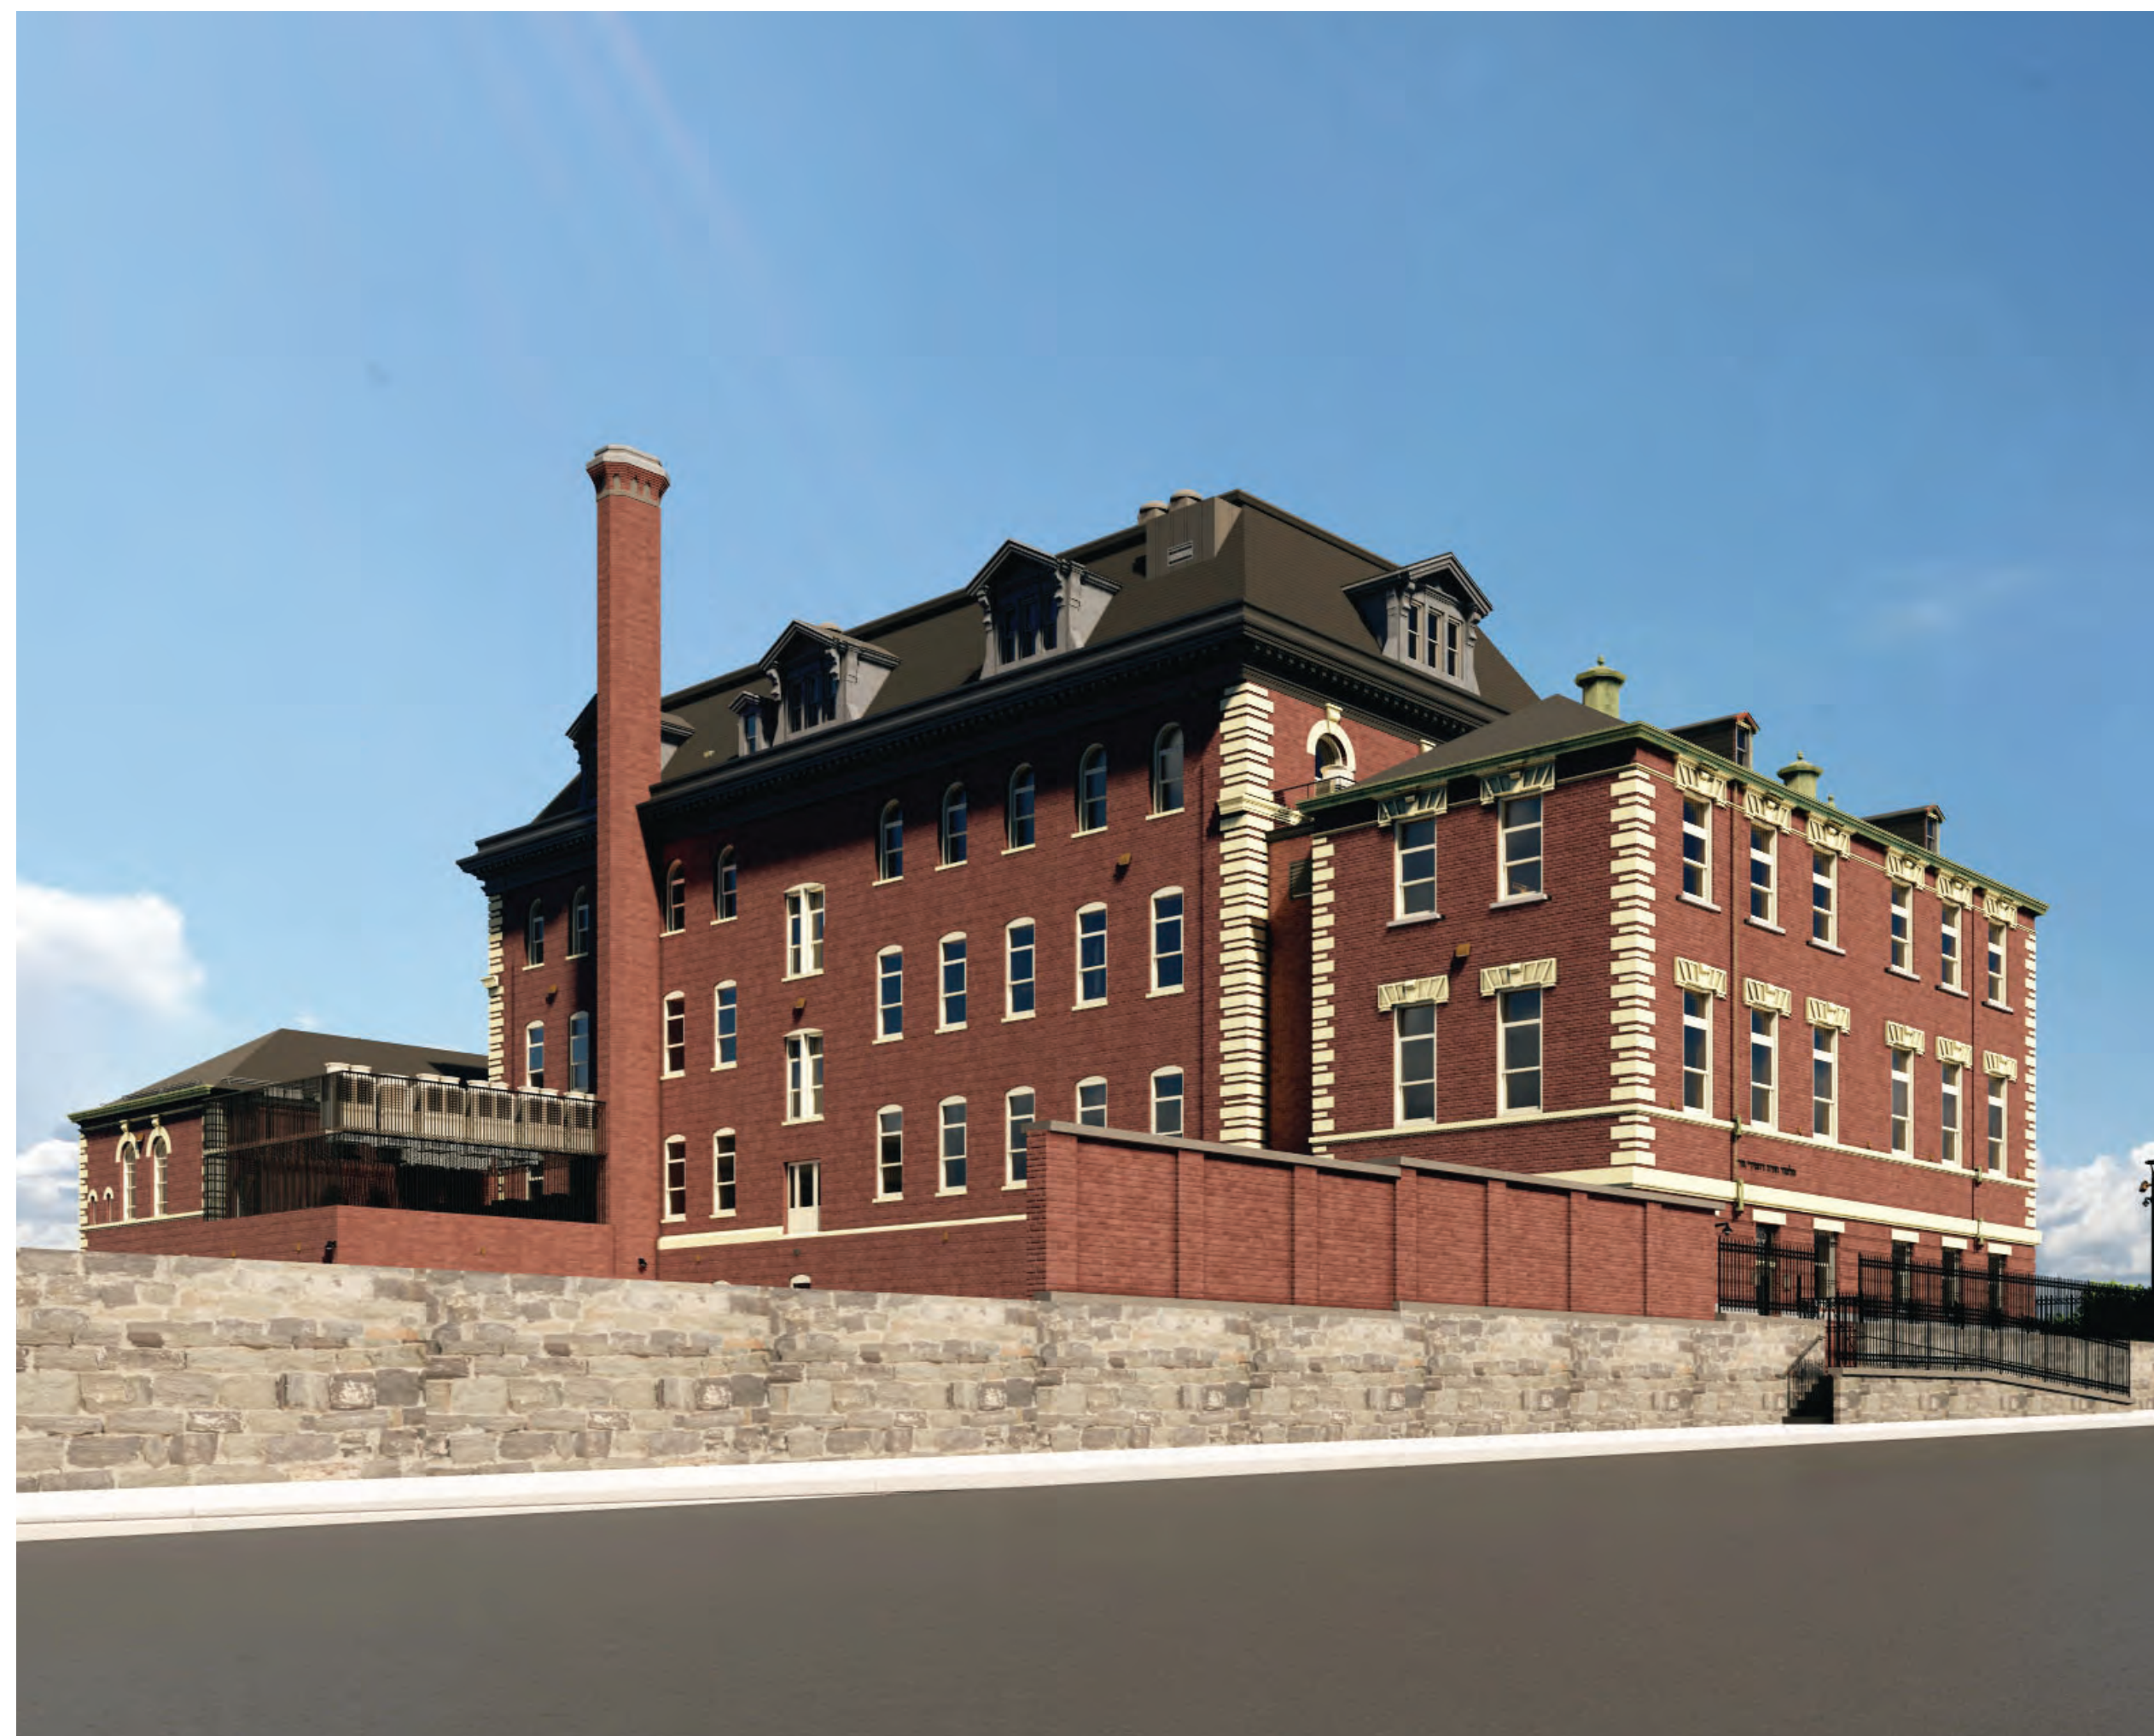
PROPOSED DESIGN:

- CHANGES:
- ELEVATOR BULKHEAD HEIGHT
 - ELEVATOR HOISTWAY VENT
