Preservation Department – Item 1, LPC-22-08731

**6301 12th Avenue, aka 6301-6323 12th Avenue, 1202-1216 63rd
Street, and 1201-1215 64th Street – Angel Guardian Home –
Individual Landmark
Borough of Brooklyn**

LPC-22-08731: 6301 12th Avenue, Angel Guardian Home - Individual Landmark

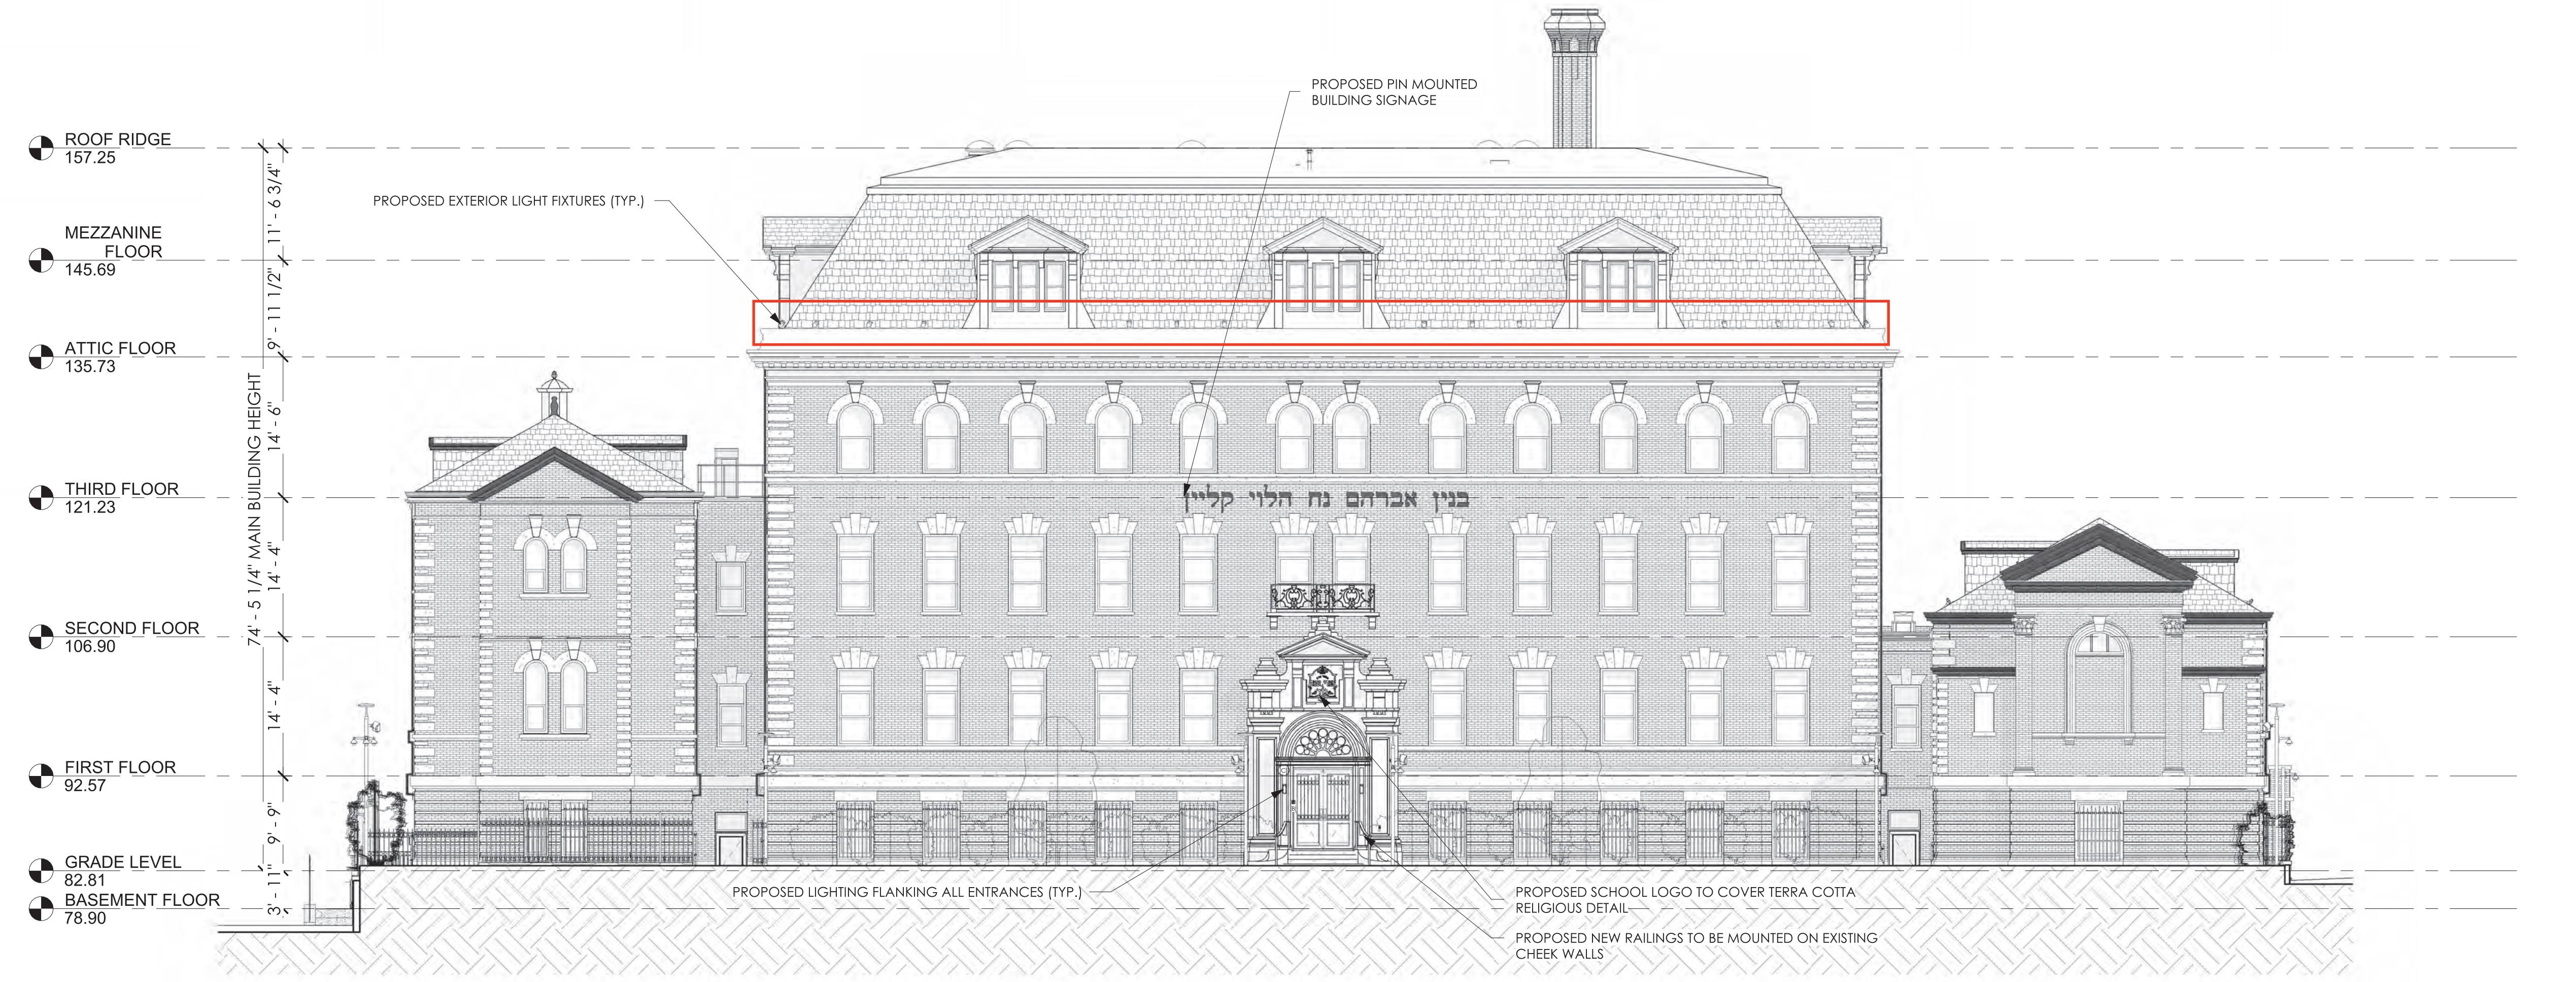
**12TH AVENUE
REVISED ELEVATION**

- CHANGES:**
- LIGHTING, SPEAKER, AND SECURITY CAMERA FIXTURES REMOVED
 - DOORS REVISED TO MATCH HISTORIC IMAGES
 - LETTERING ON ARCH REMOVED
 - LETTERING ON FACADE SHORTENED
 - ELEVATOR BULKHEAD LOWERED

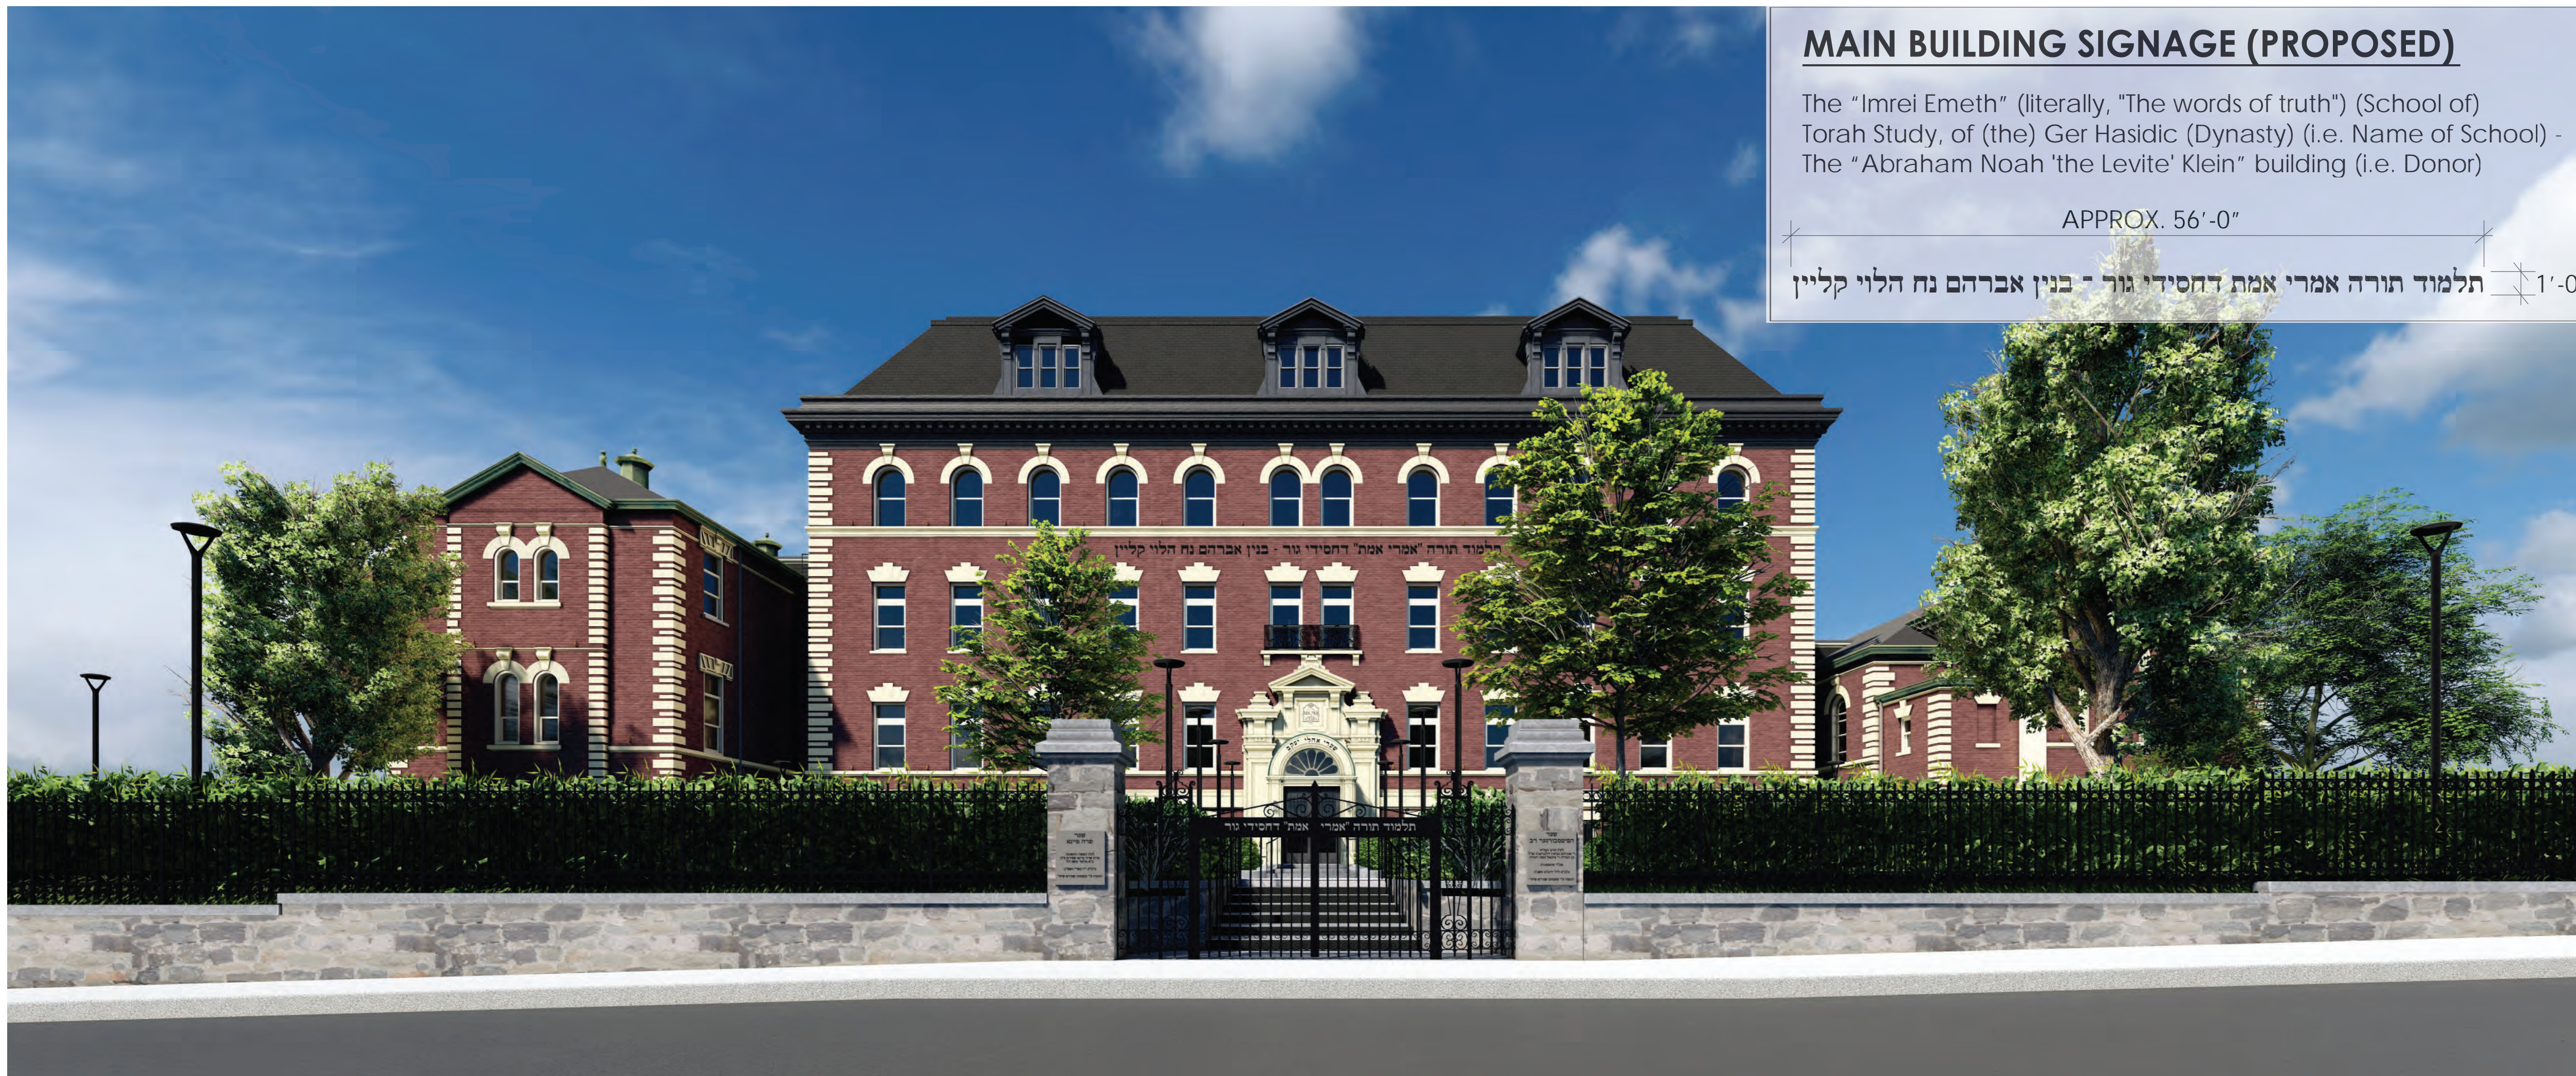
12TH AVENUE
PROPOSED RENDERING

MAIN BUILDING SIGNAGE (PROPOSED)

The "Imrei Emeth" (literally, "The words of truth") (School of Torah Study, of (the) Ger Hasidic (Dynasty) (i.e. Name of School) - The "Abraham Noah 'the Levite' Klein" building (i.e. Donor)

APPROX. 56'-0"
תלמוד תורה אמרי אמת דחסידי גור - בנין אברהם נח הלוי קליין 1'-0"

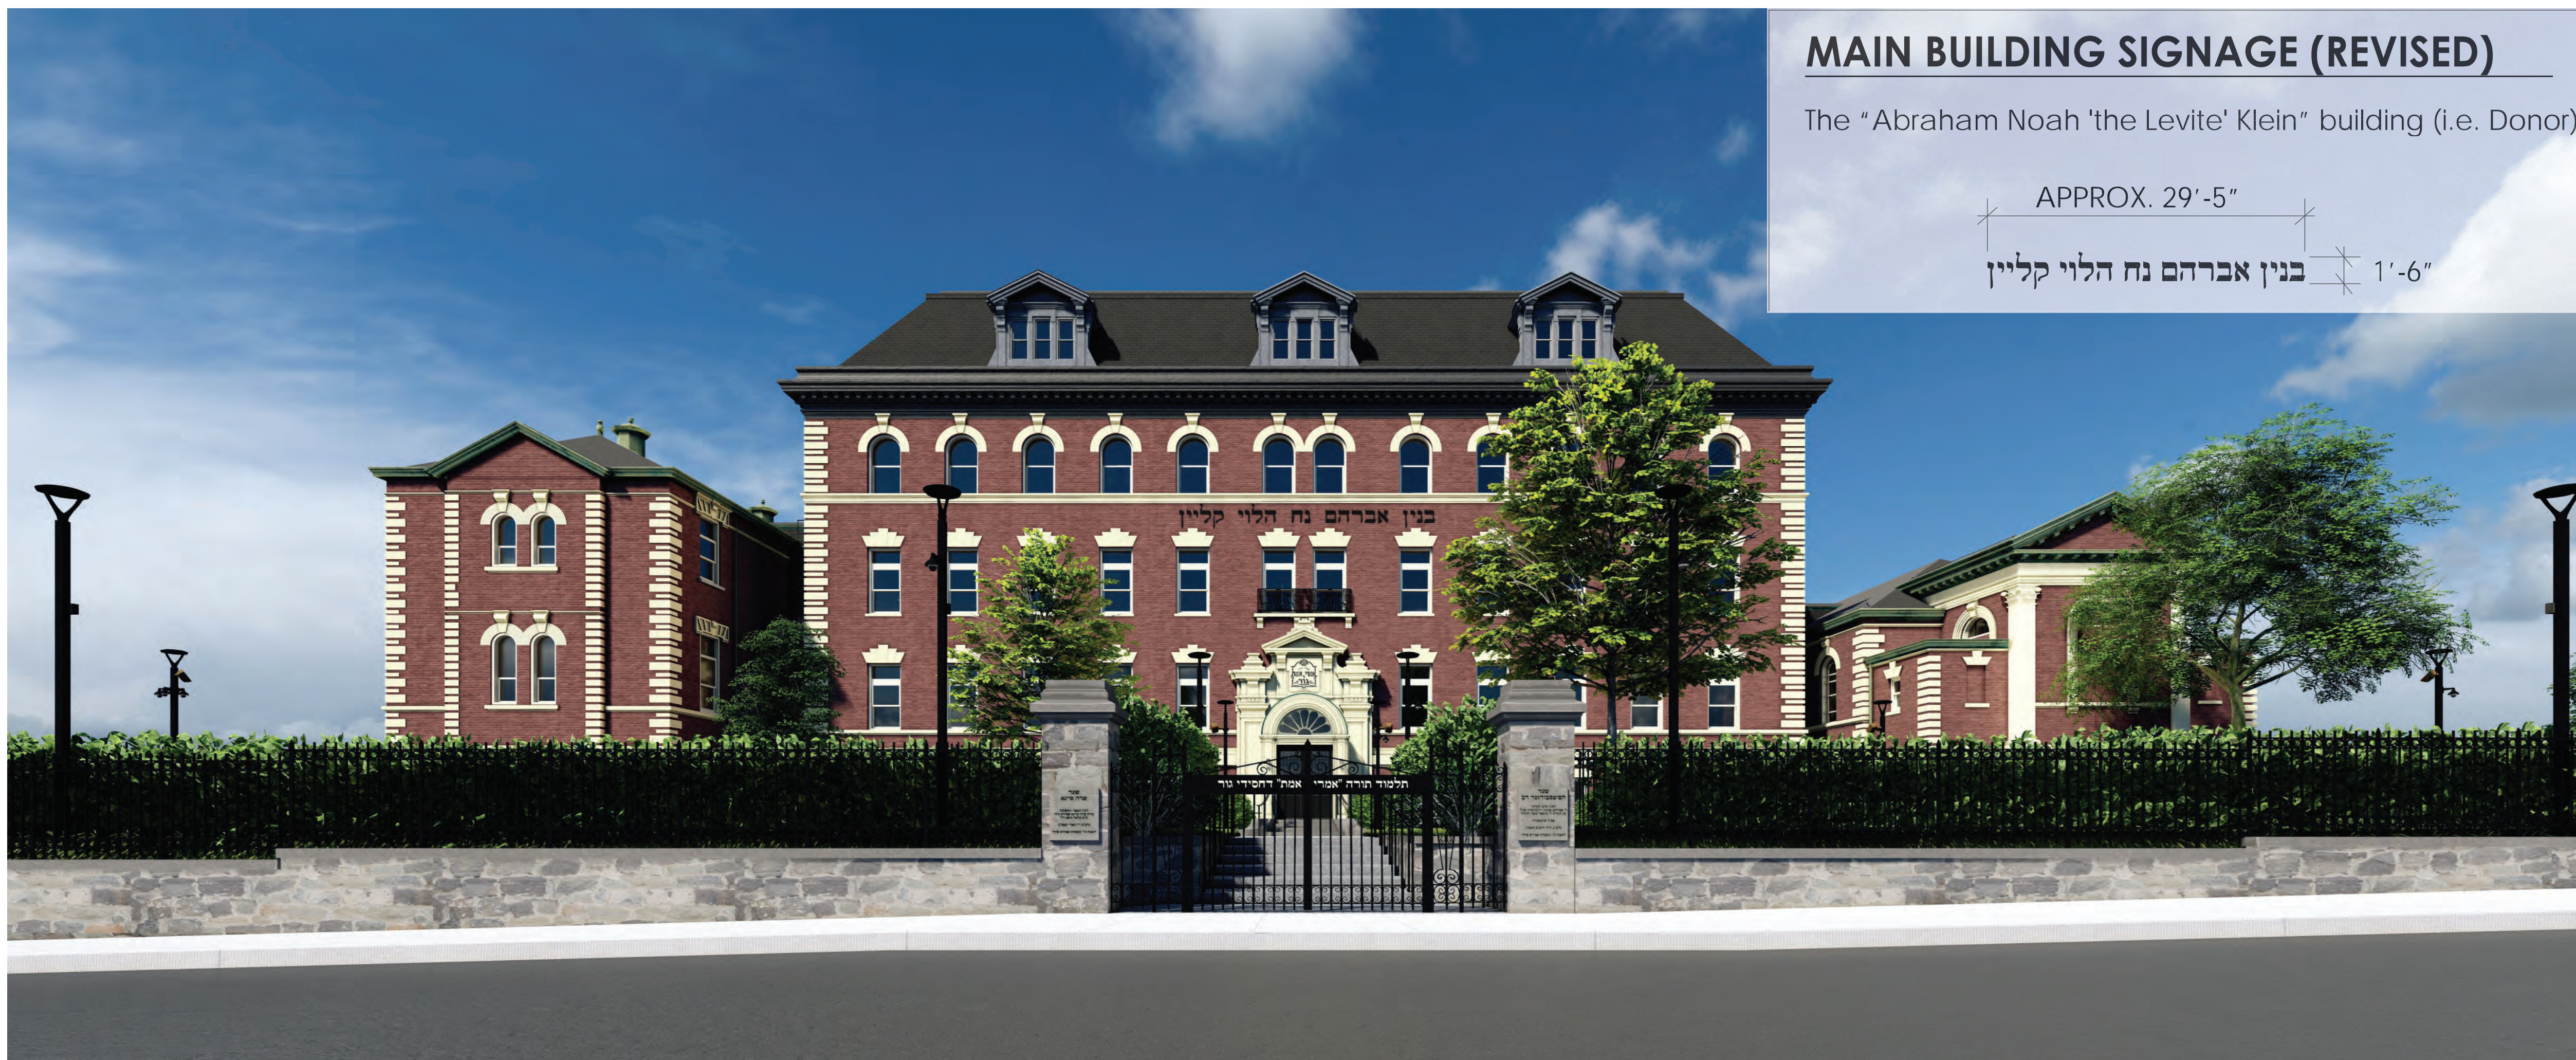
12TH AVENUE
REVISED RENDERING

MAIN BUILDING SIGNAGE (REVISED)

The "Abraham Noah 'the Levite' Klein" building (i.e. Donor)

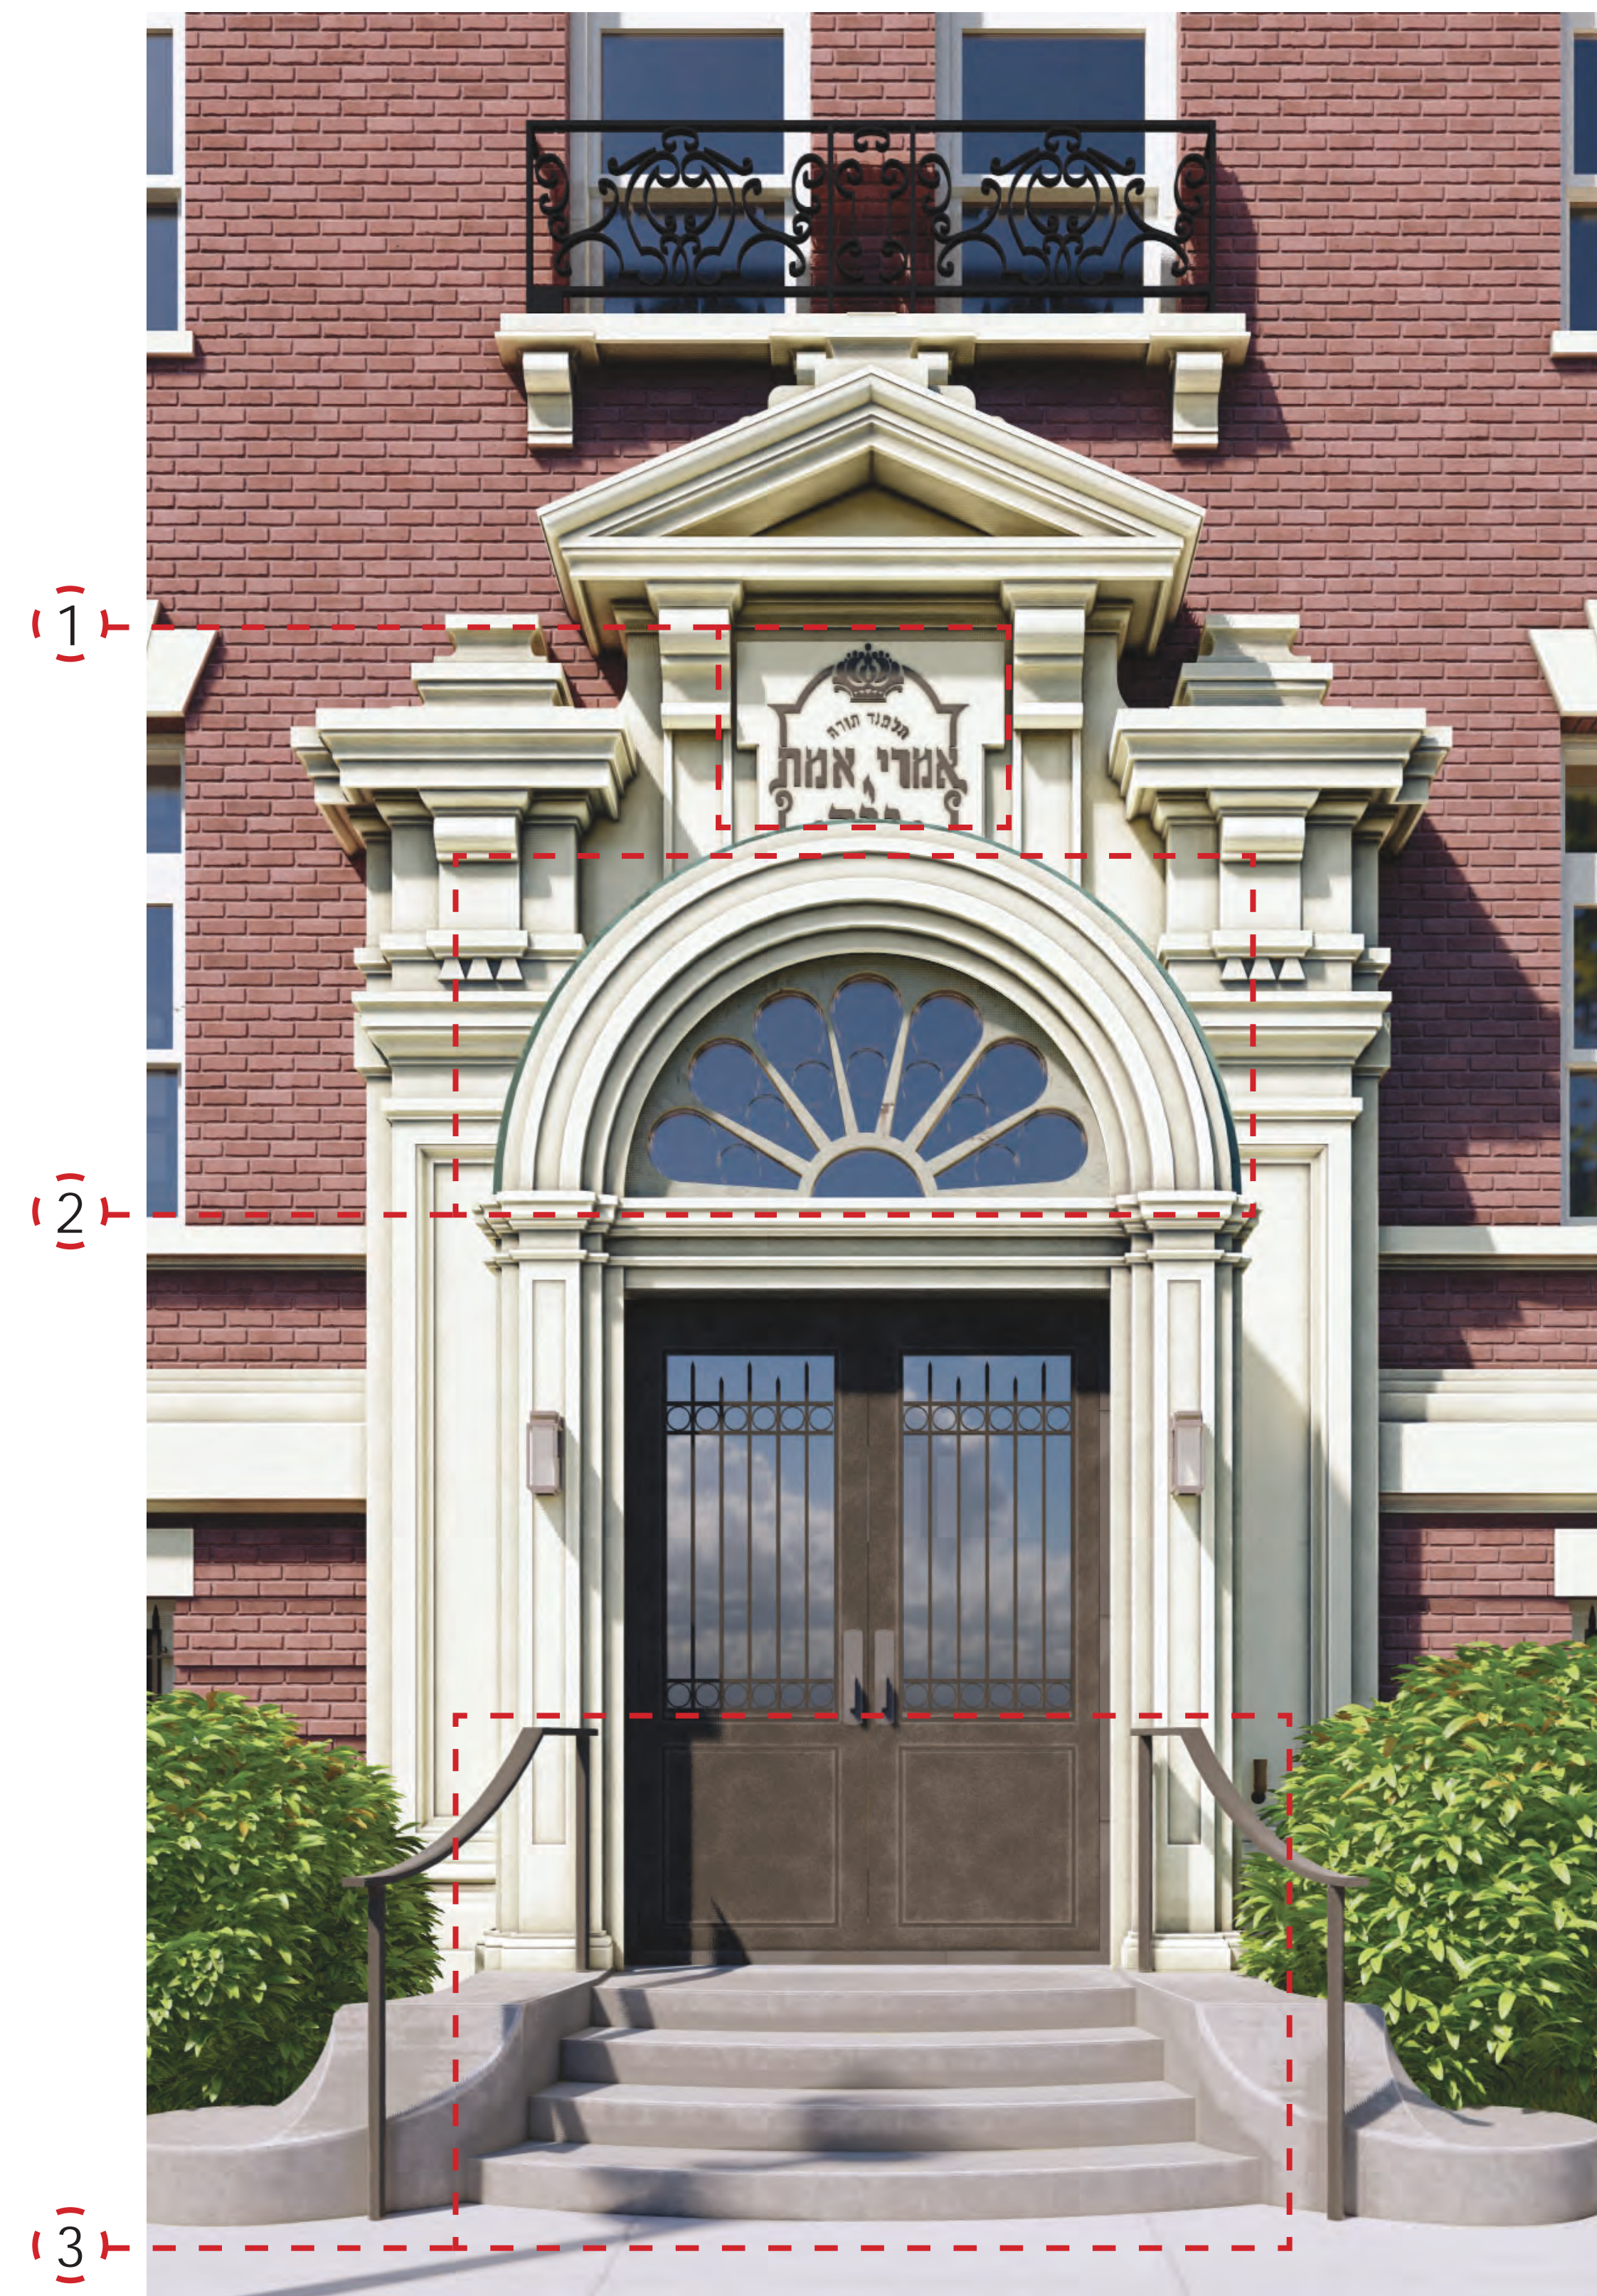
12TH AVE ENTRANCE:

1. SCHOOL LOGO ON FRP PANEL SECURED THROUGH EXISTING MORTAR JOINTS
2. REMOVE LETTERING FROM ARCH
3. NEW BLUESTONE STEPS (ALL RISERS EQUAL) AND TOP OF RAILING IS MOUNTED ON BLUESTONE CHEEK WALL

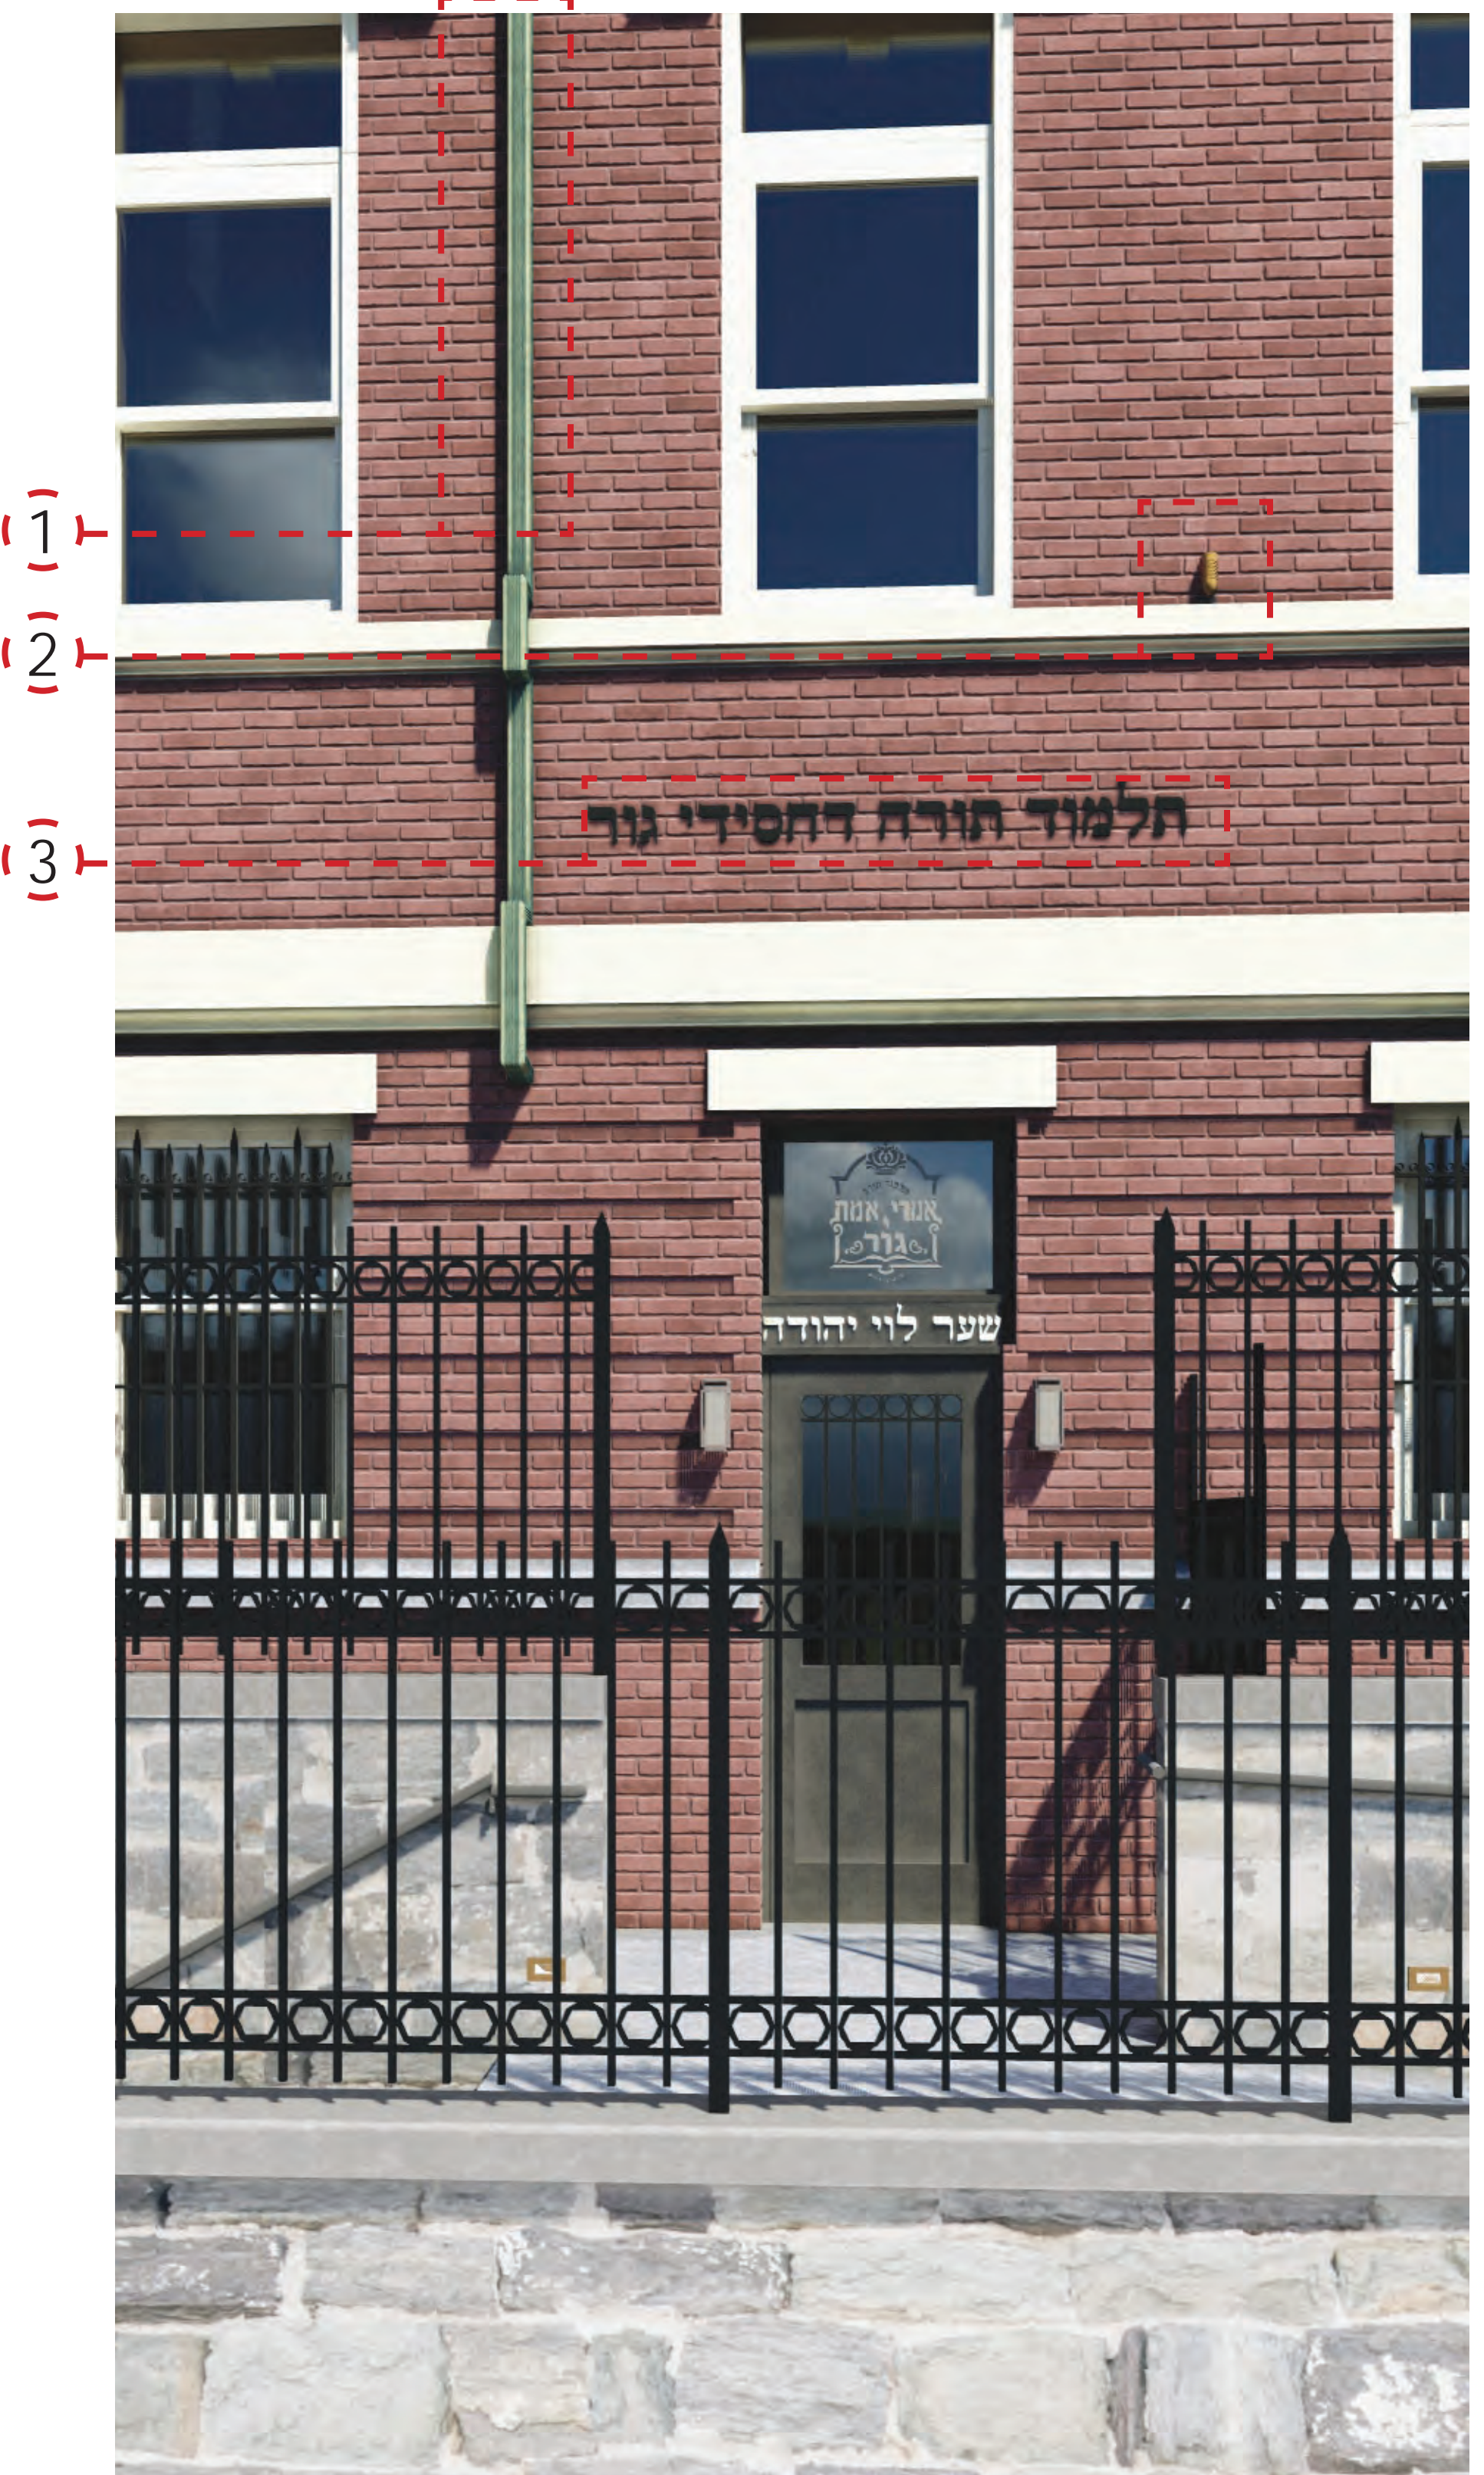
63RD STREET ENTRANCE:

1. ALUMINUM LEADERS PAINTED COPPER
2. LIGHT FIXTURES ON SECONDARY FACADE REMAINS
3. LETTERING ON SECONDARY FACADE REMAINS

- WE REVIEWED EXISTING COPPER DOWNSPOUTS WHICH ARE ALL BROKEN AND DISUSED
- WE PROPOSE ALUMINUM LEADERS PAINTED BRIGHT TO MATCH THE CURRENT COPPER MATERIAL AROUND THE BUILDING

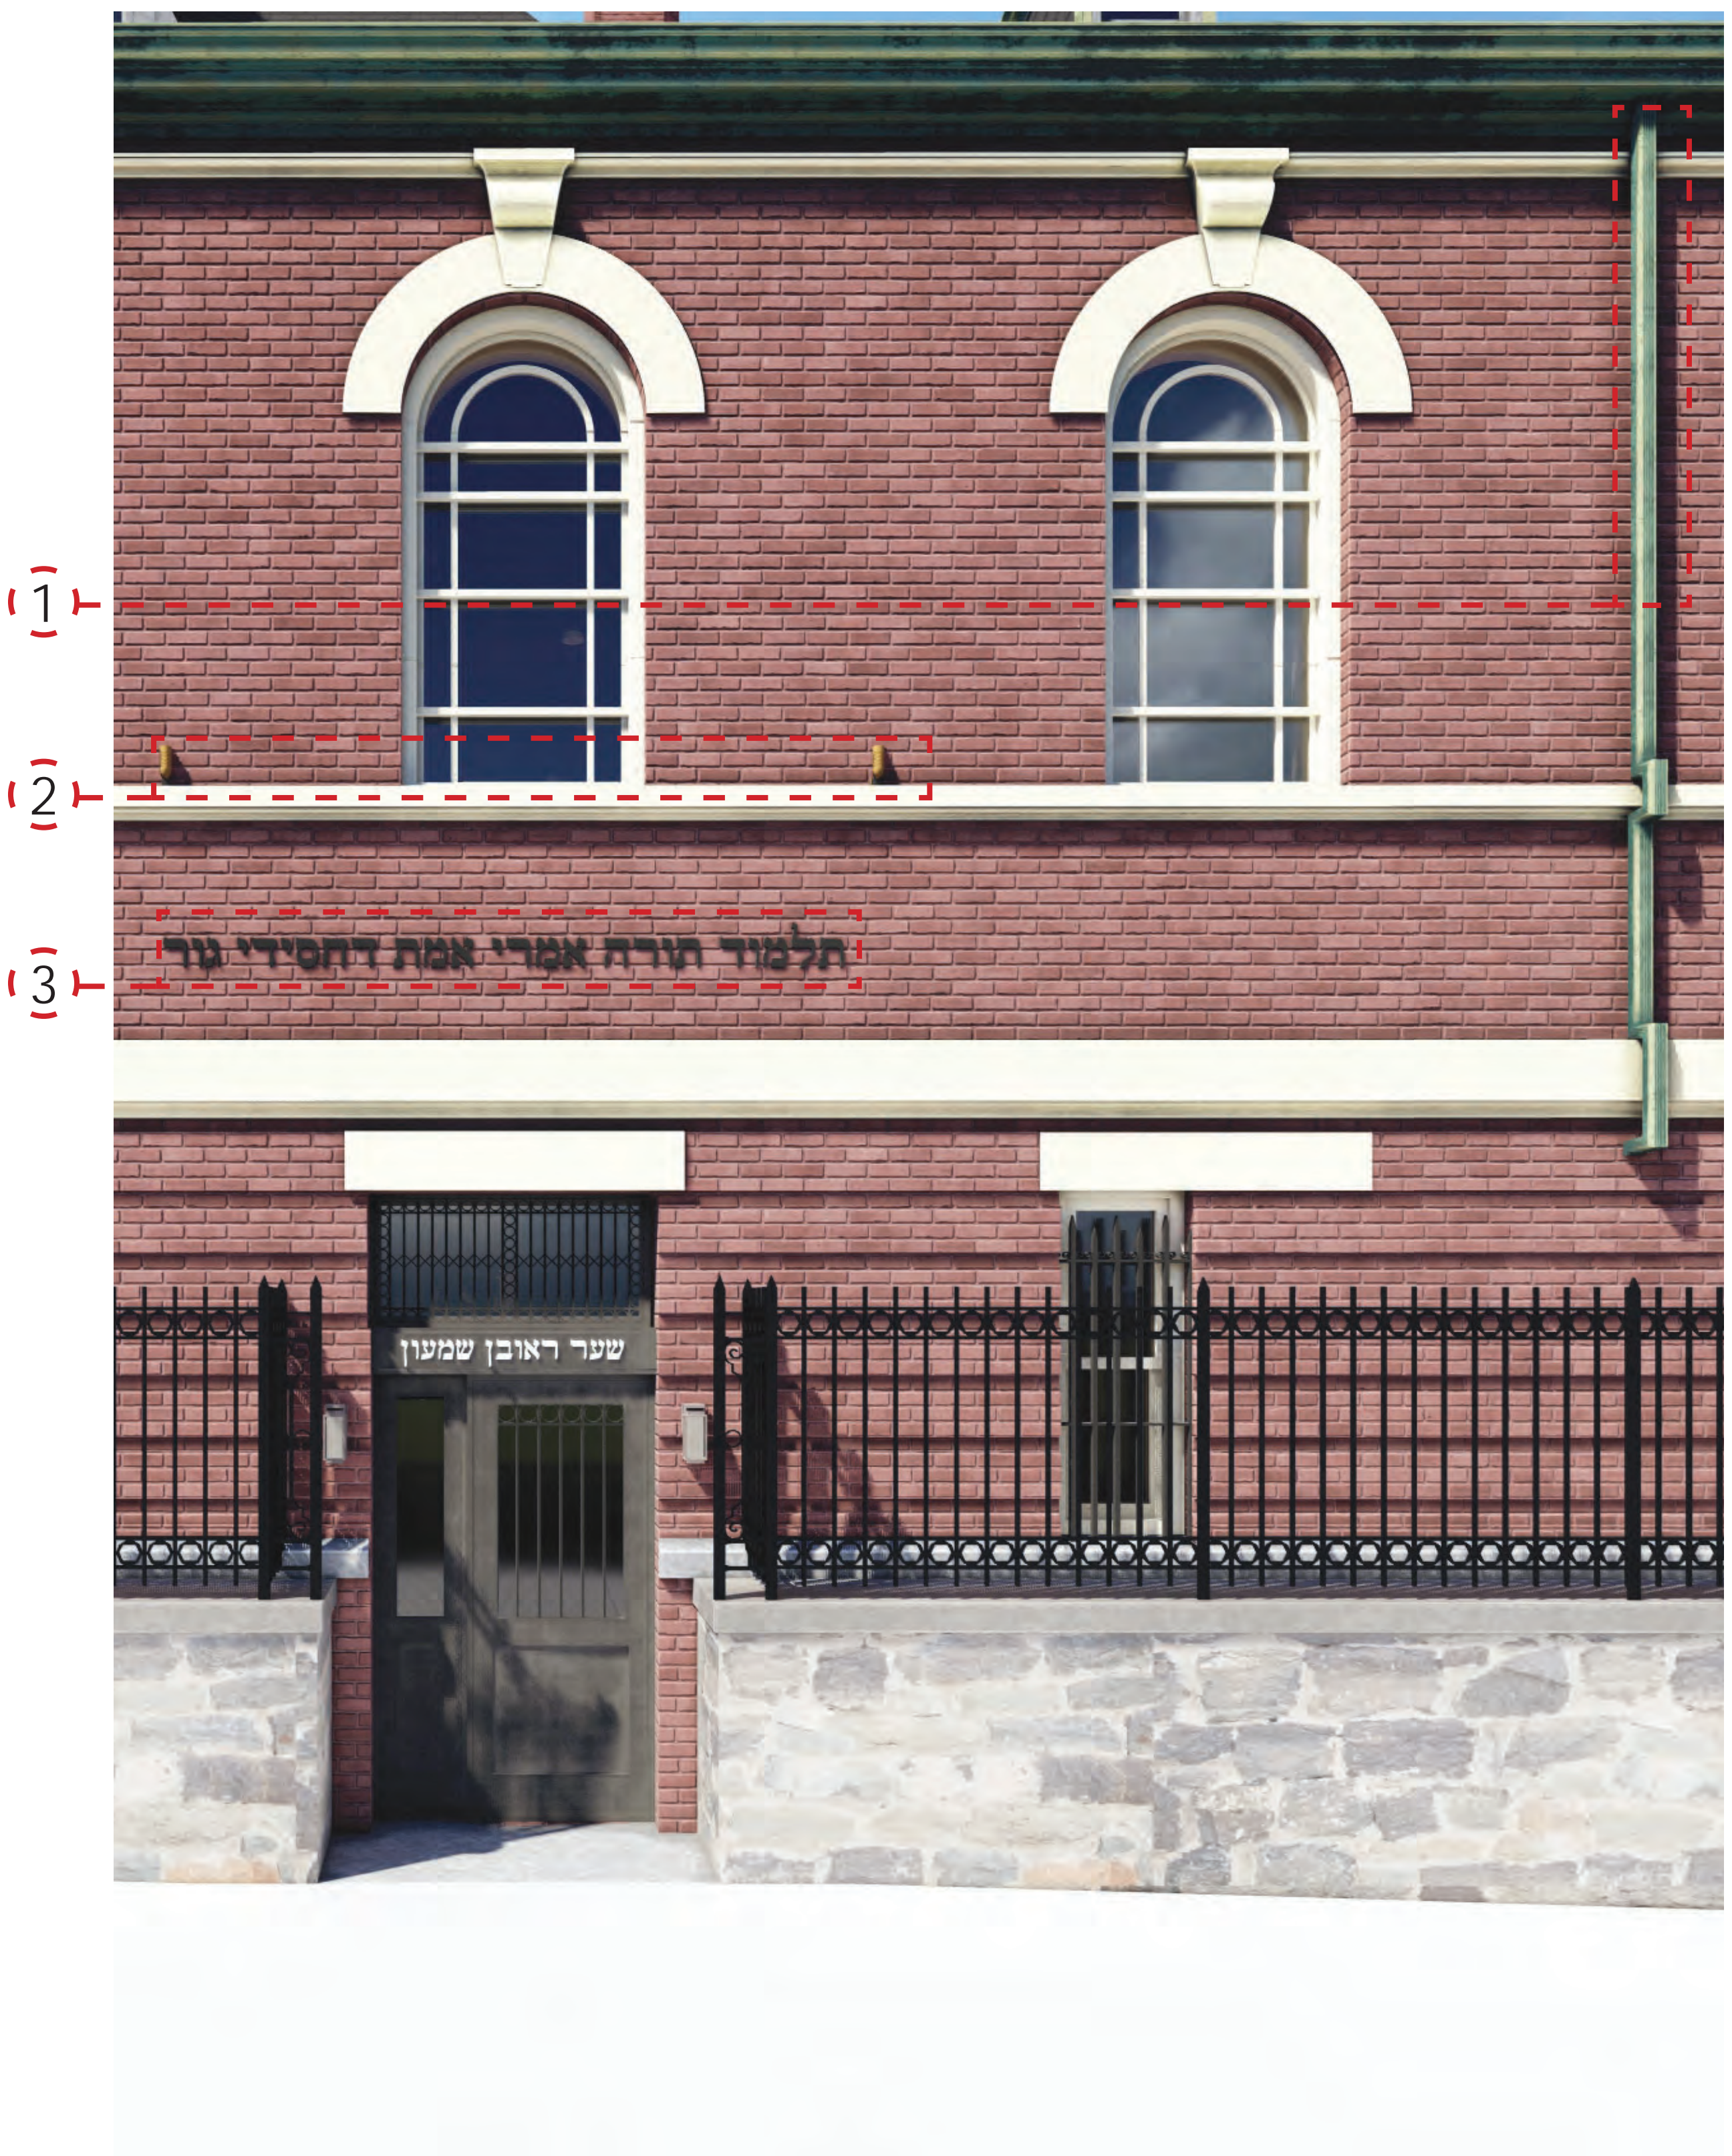
64TH STREET ENTRANCE:

1. ALUMINUM LEADERS PAINTED COPPER
2. LIGHT FIXTURES ON SECONDARY FACADE REMAINS
3. LETTERING ON SECONDARY FACADE REMAINS
