Preservation Department – Item 1, LPC-22-08731

**6301 12th Avenue, aka 6301-6323 12th Avenue, 1202-1216 63rd
Street, and 1201-1215 64th Street – Angel Guardian Home –
Individual Landmark
Borough of Brooklyn**

LPC-22-08731: 6301 12th Avenue, Angel Guardian Home - Individual Landmark

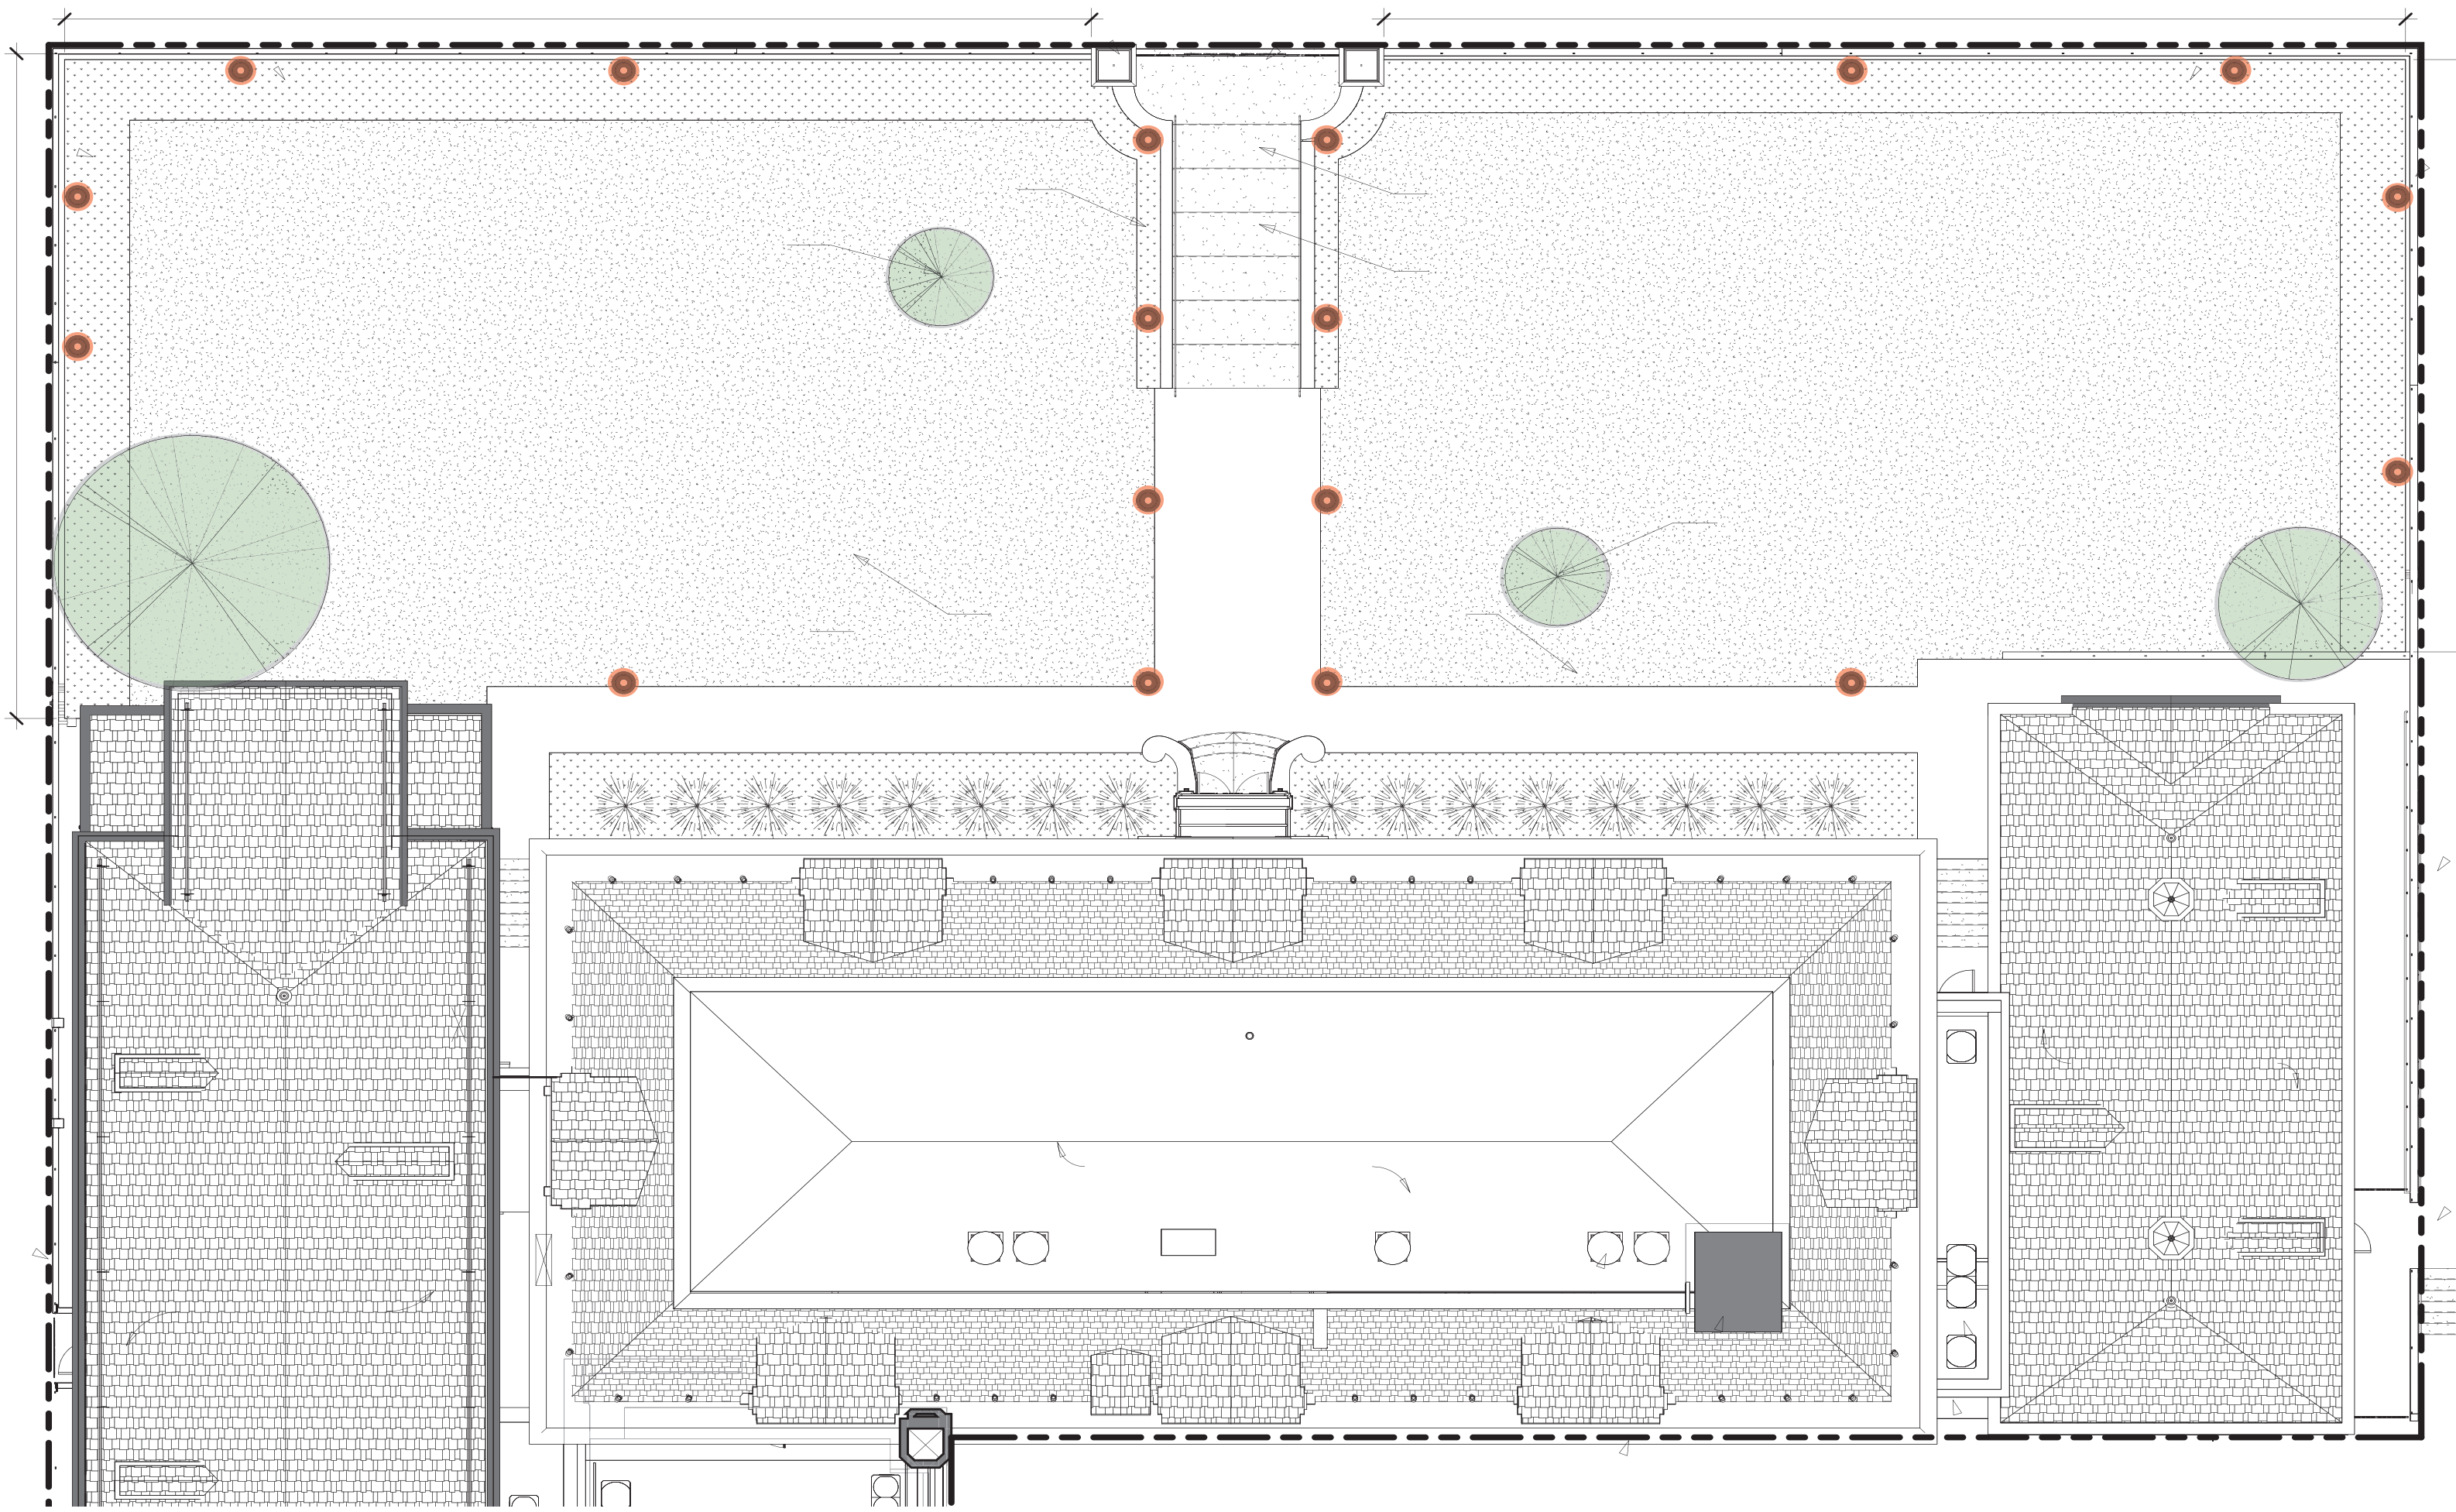
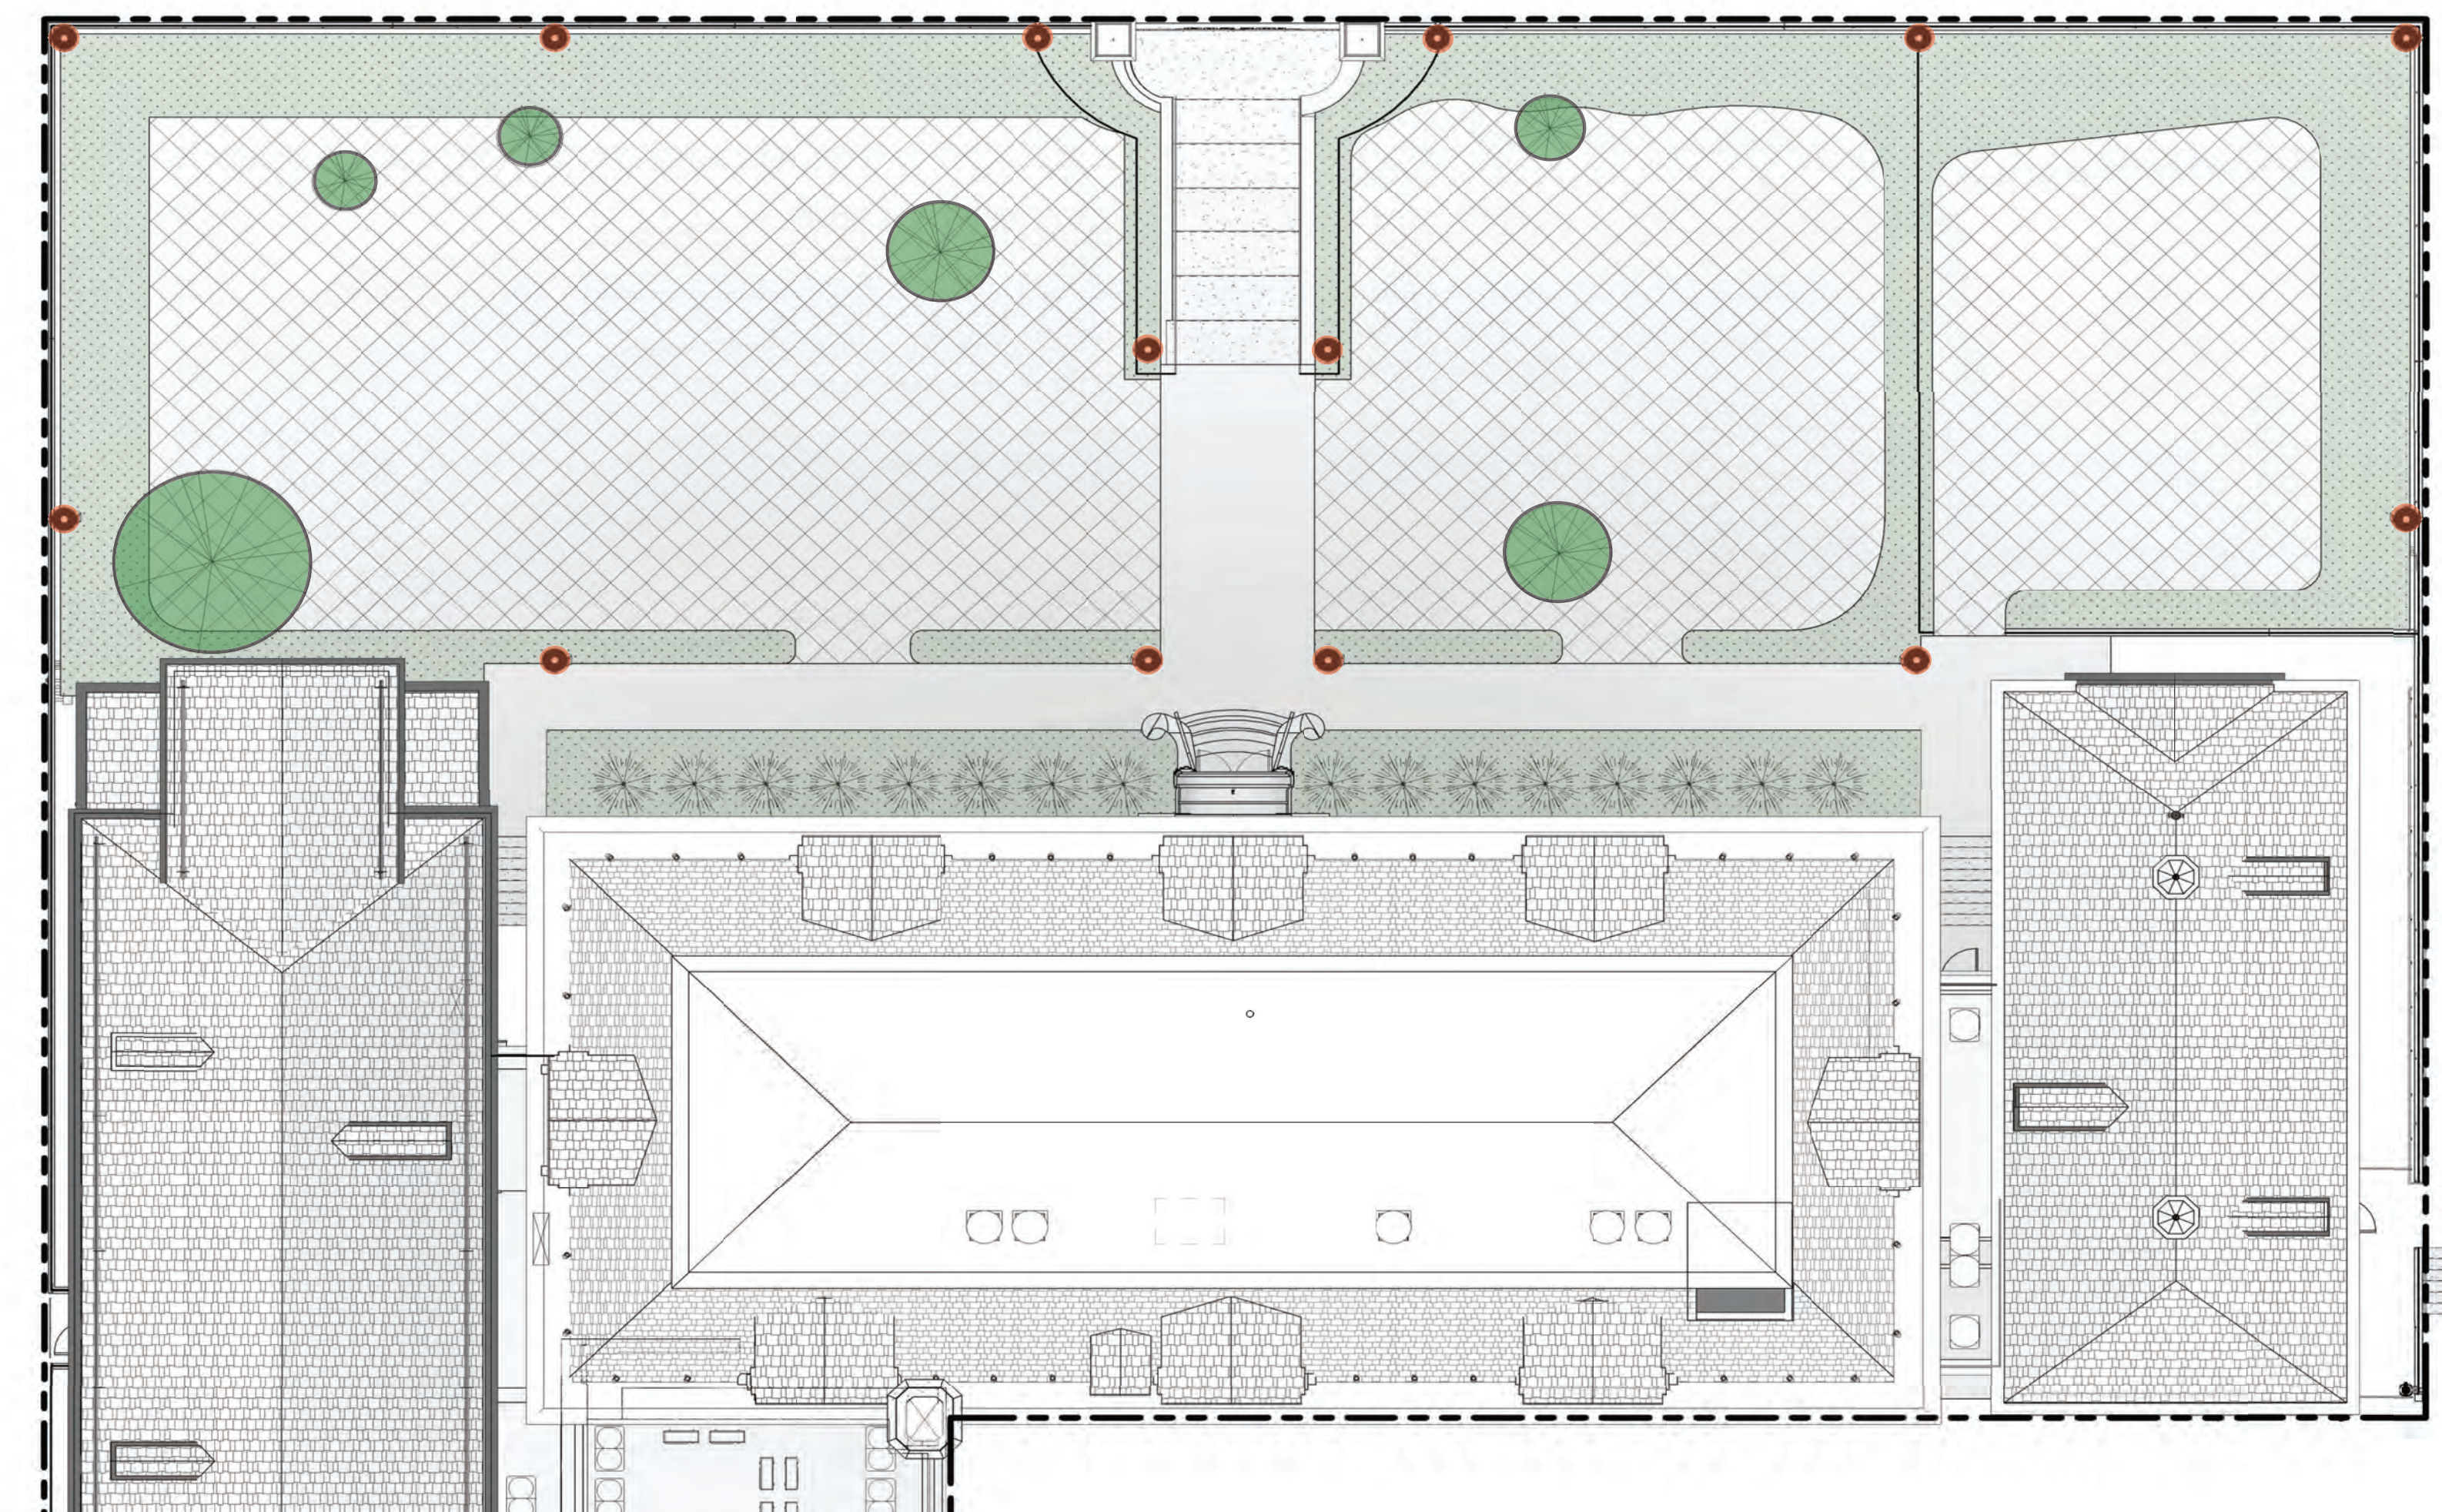
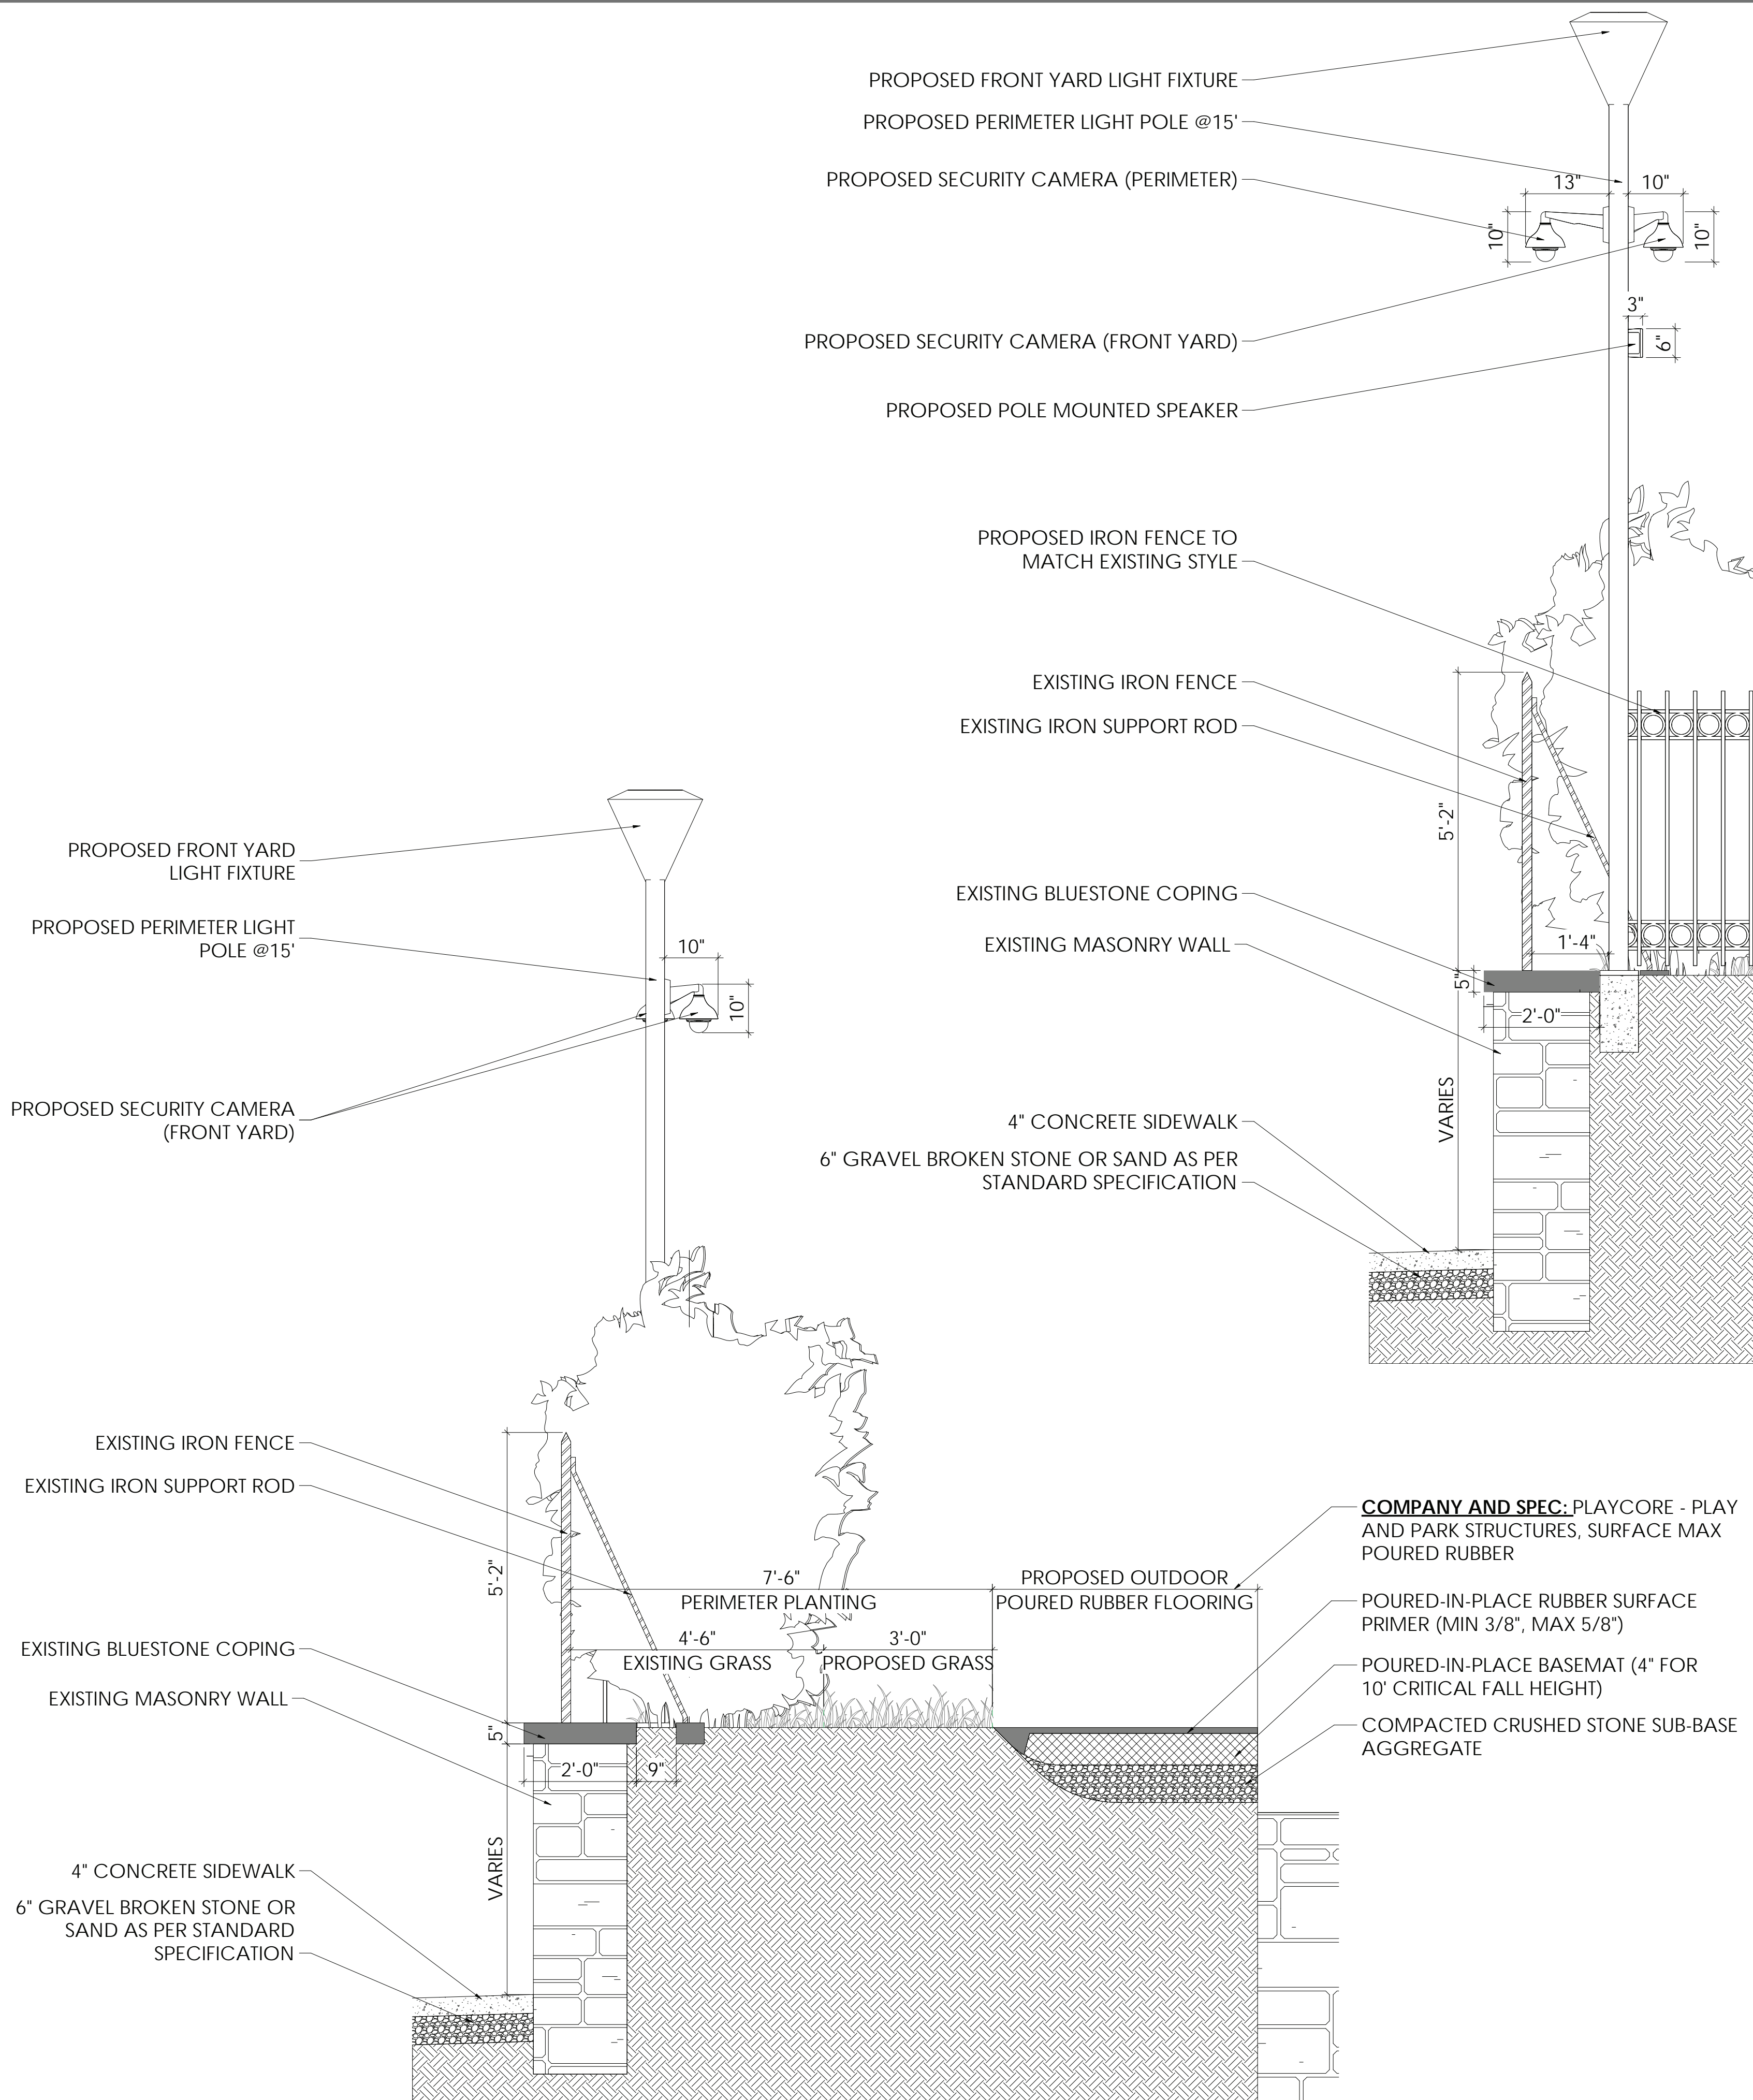
PROPOSED AND REVISED SITE PLAN:

TYPICAL SECTIONS WITH LIGHT POLES:

RE-STUDY TYPE OF FRONT YARD MATERIAL, AMOUNT PROPOSED
