Preservation Department – Item 1, LPC-22-08731

**6301 12th Avenue, aka 6301-6323 12th Avenue, 1202-1216 63rd
Street, and 1201-1215 64th Street – Angel Guardian Home –
Individual Landmark
Borough of Brooklyn**

LPC-22-08731: 6301 12th Avenue, Angel Guardian Home - Individual Landmark

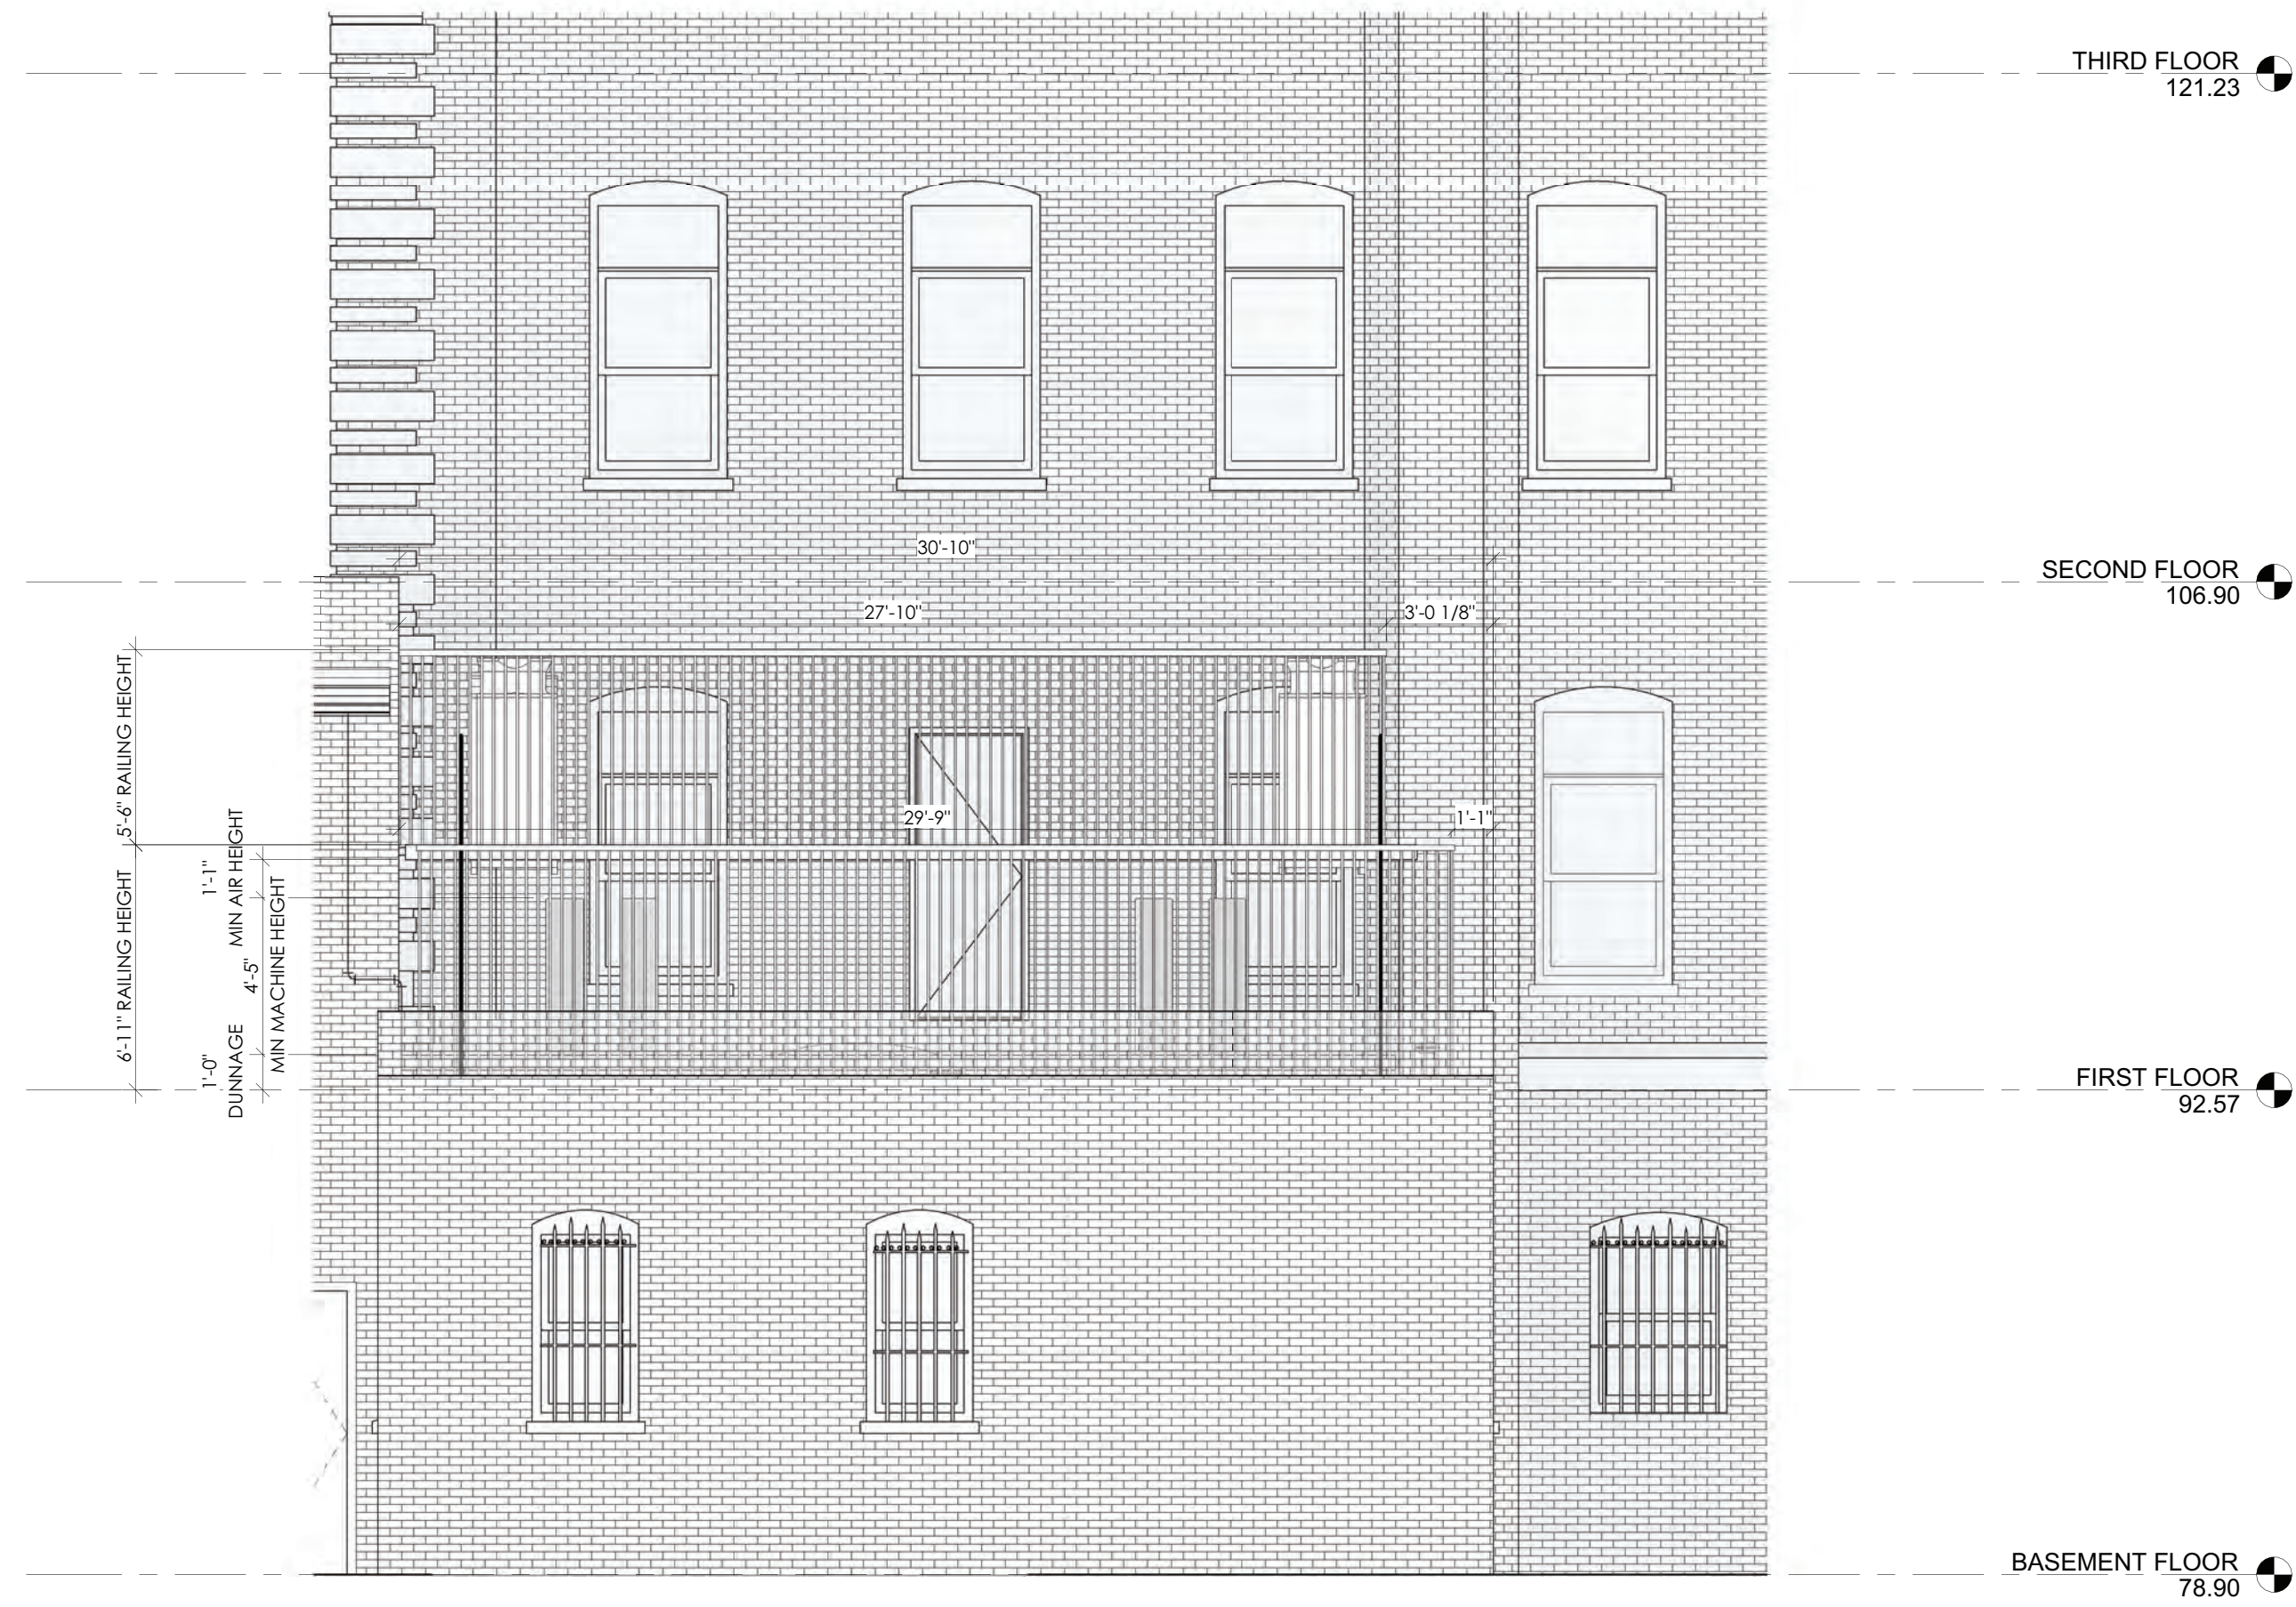
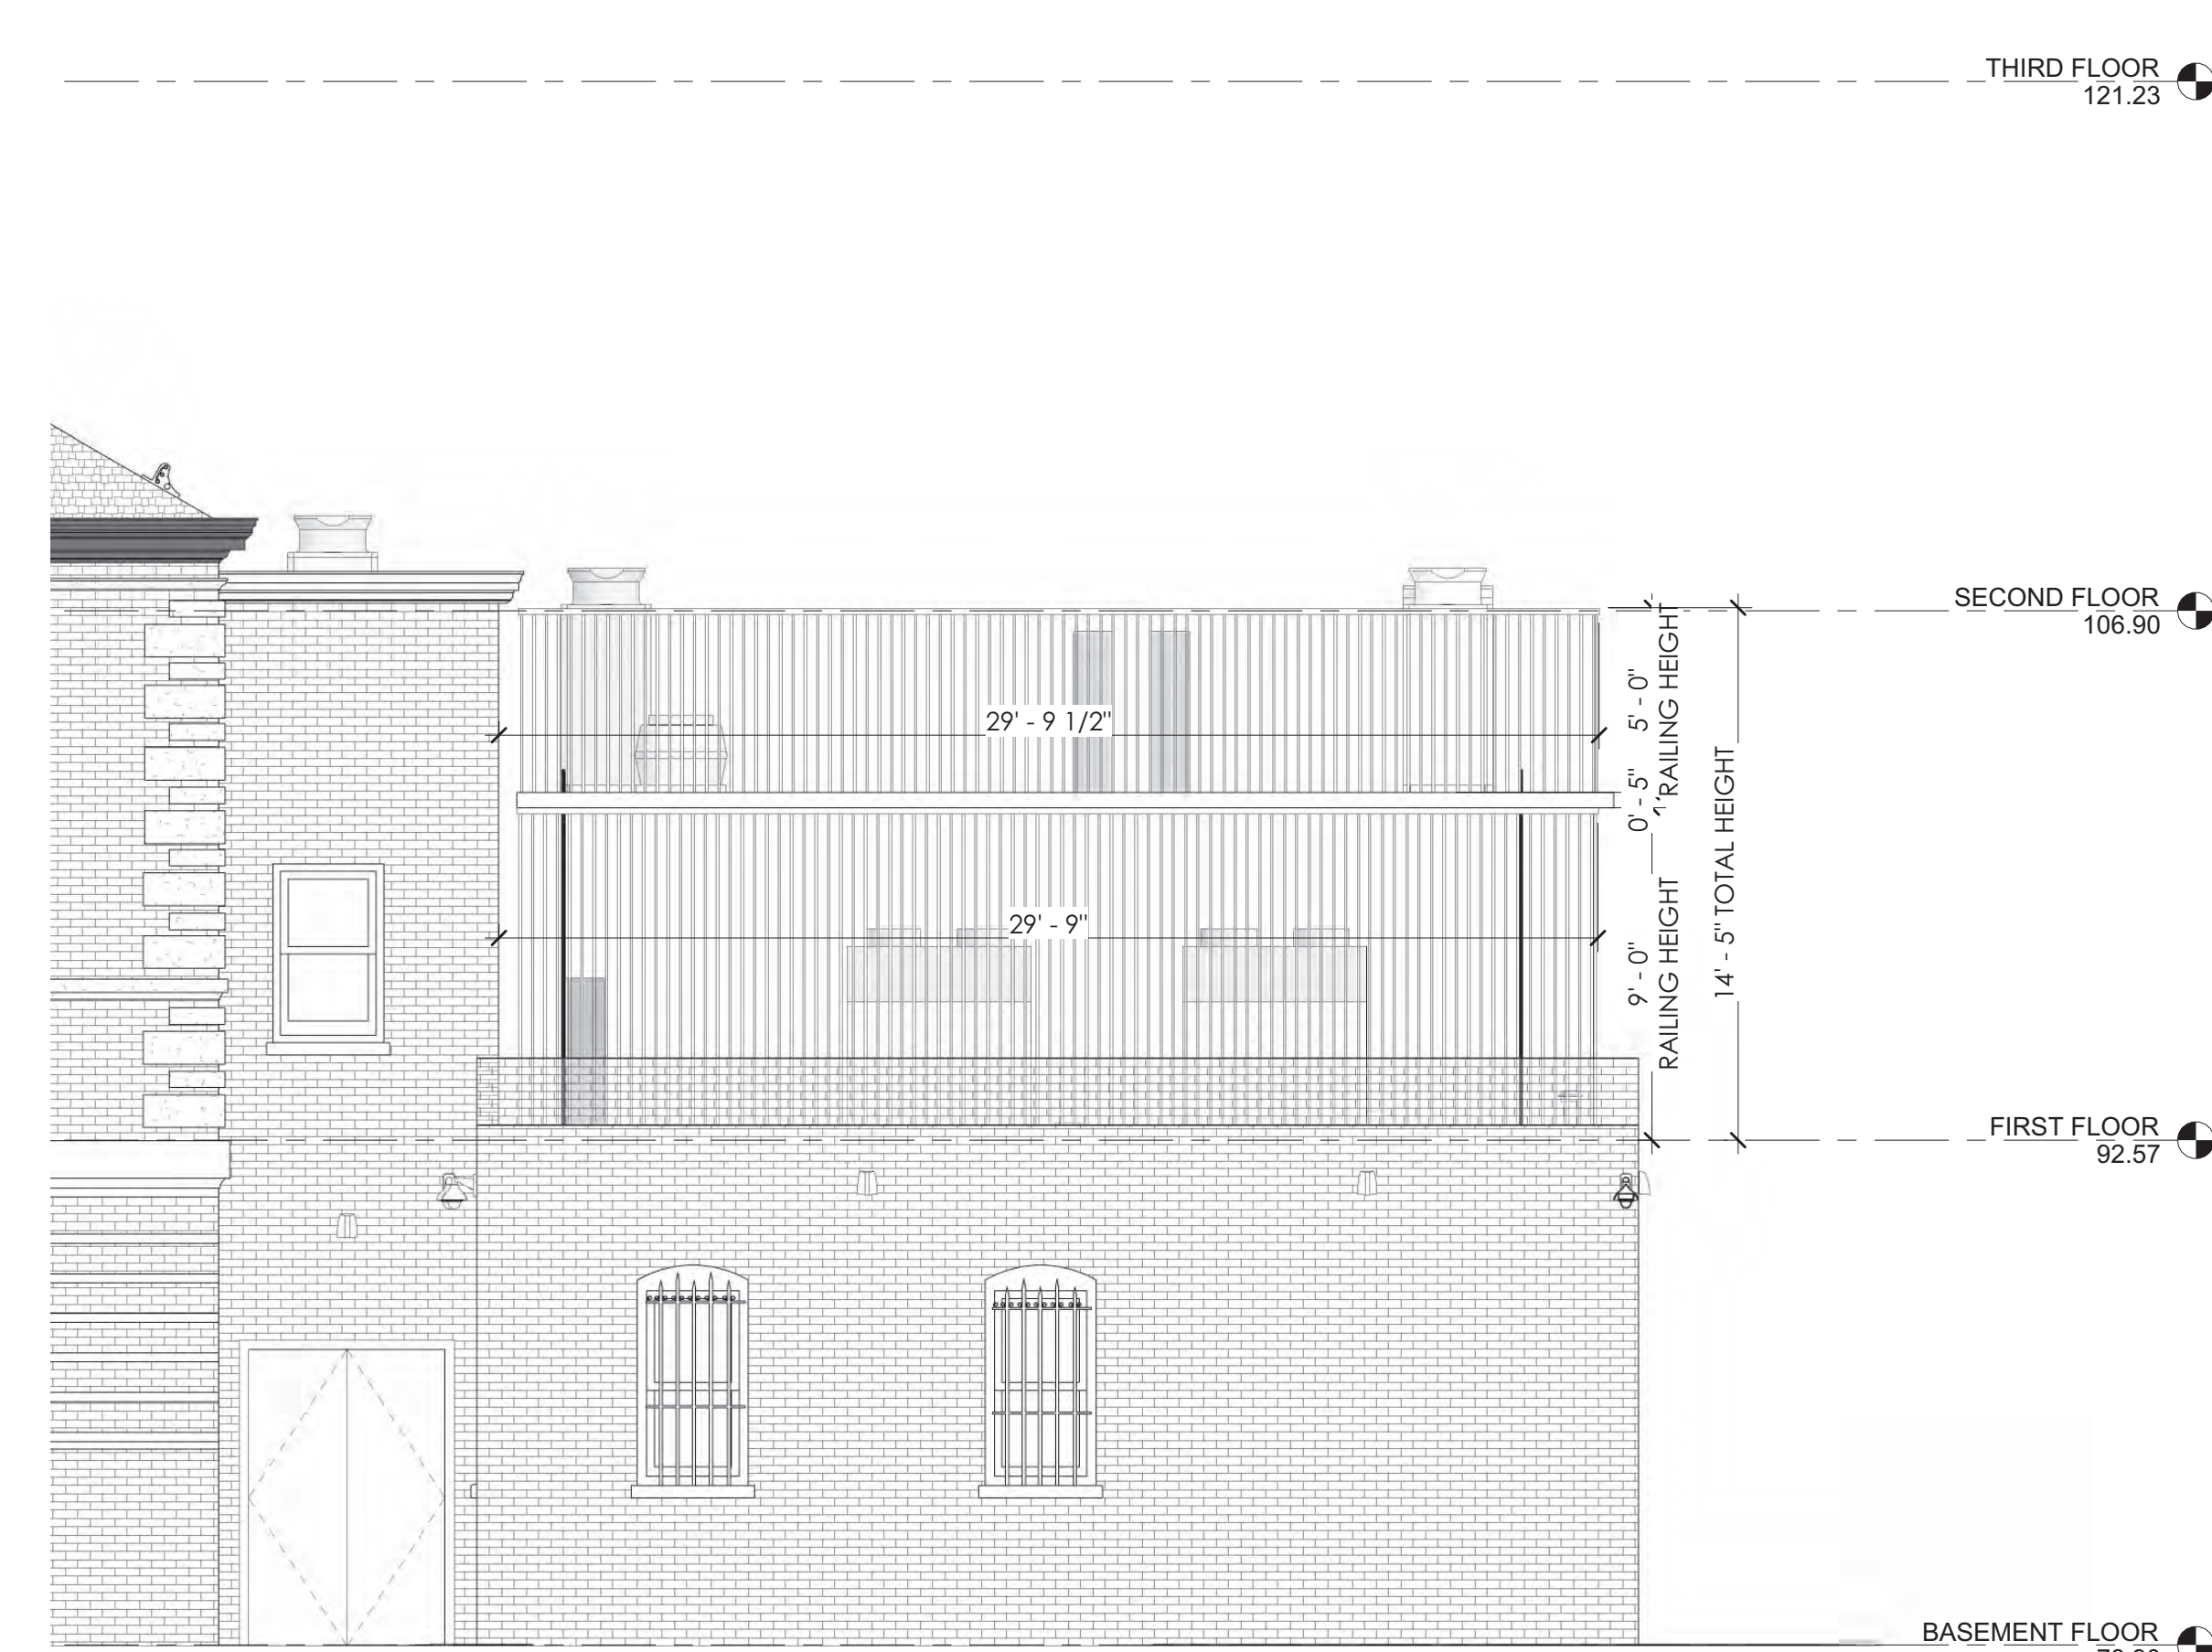
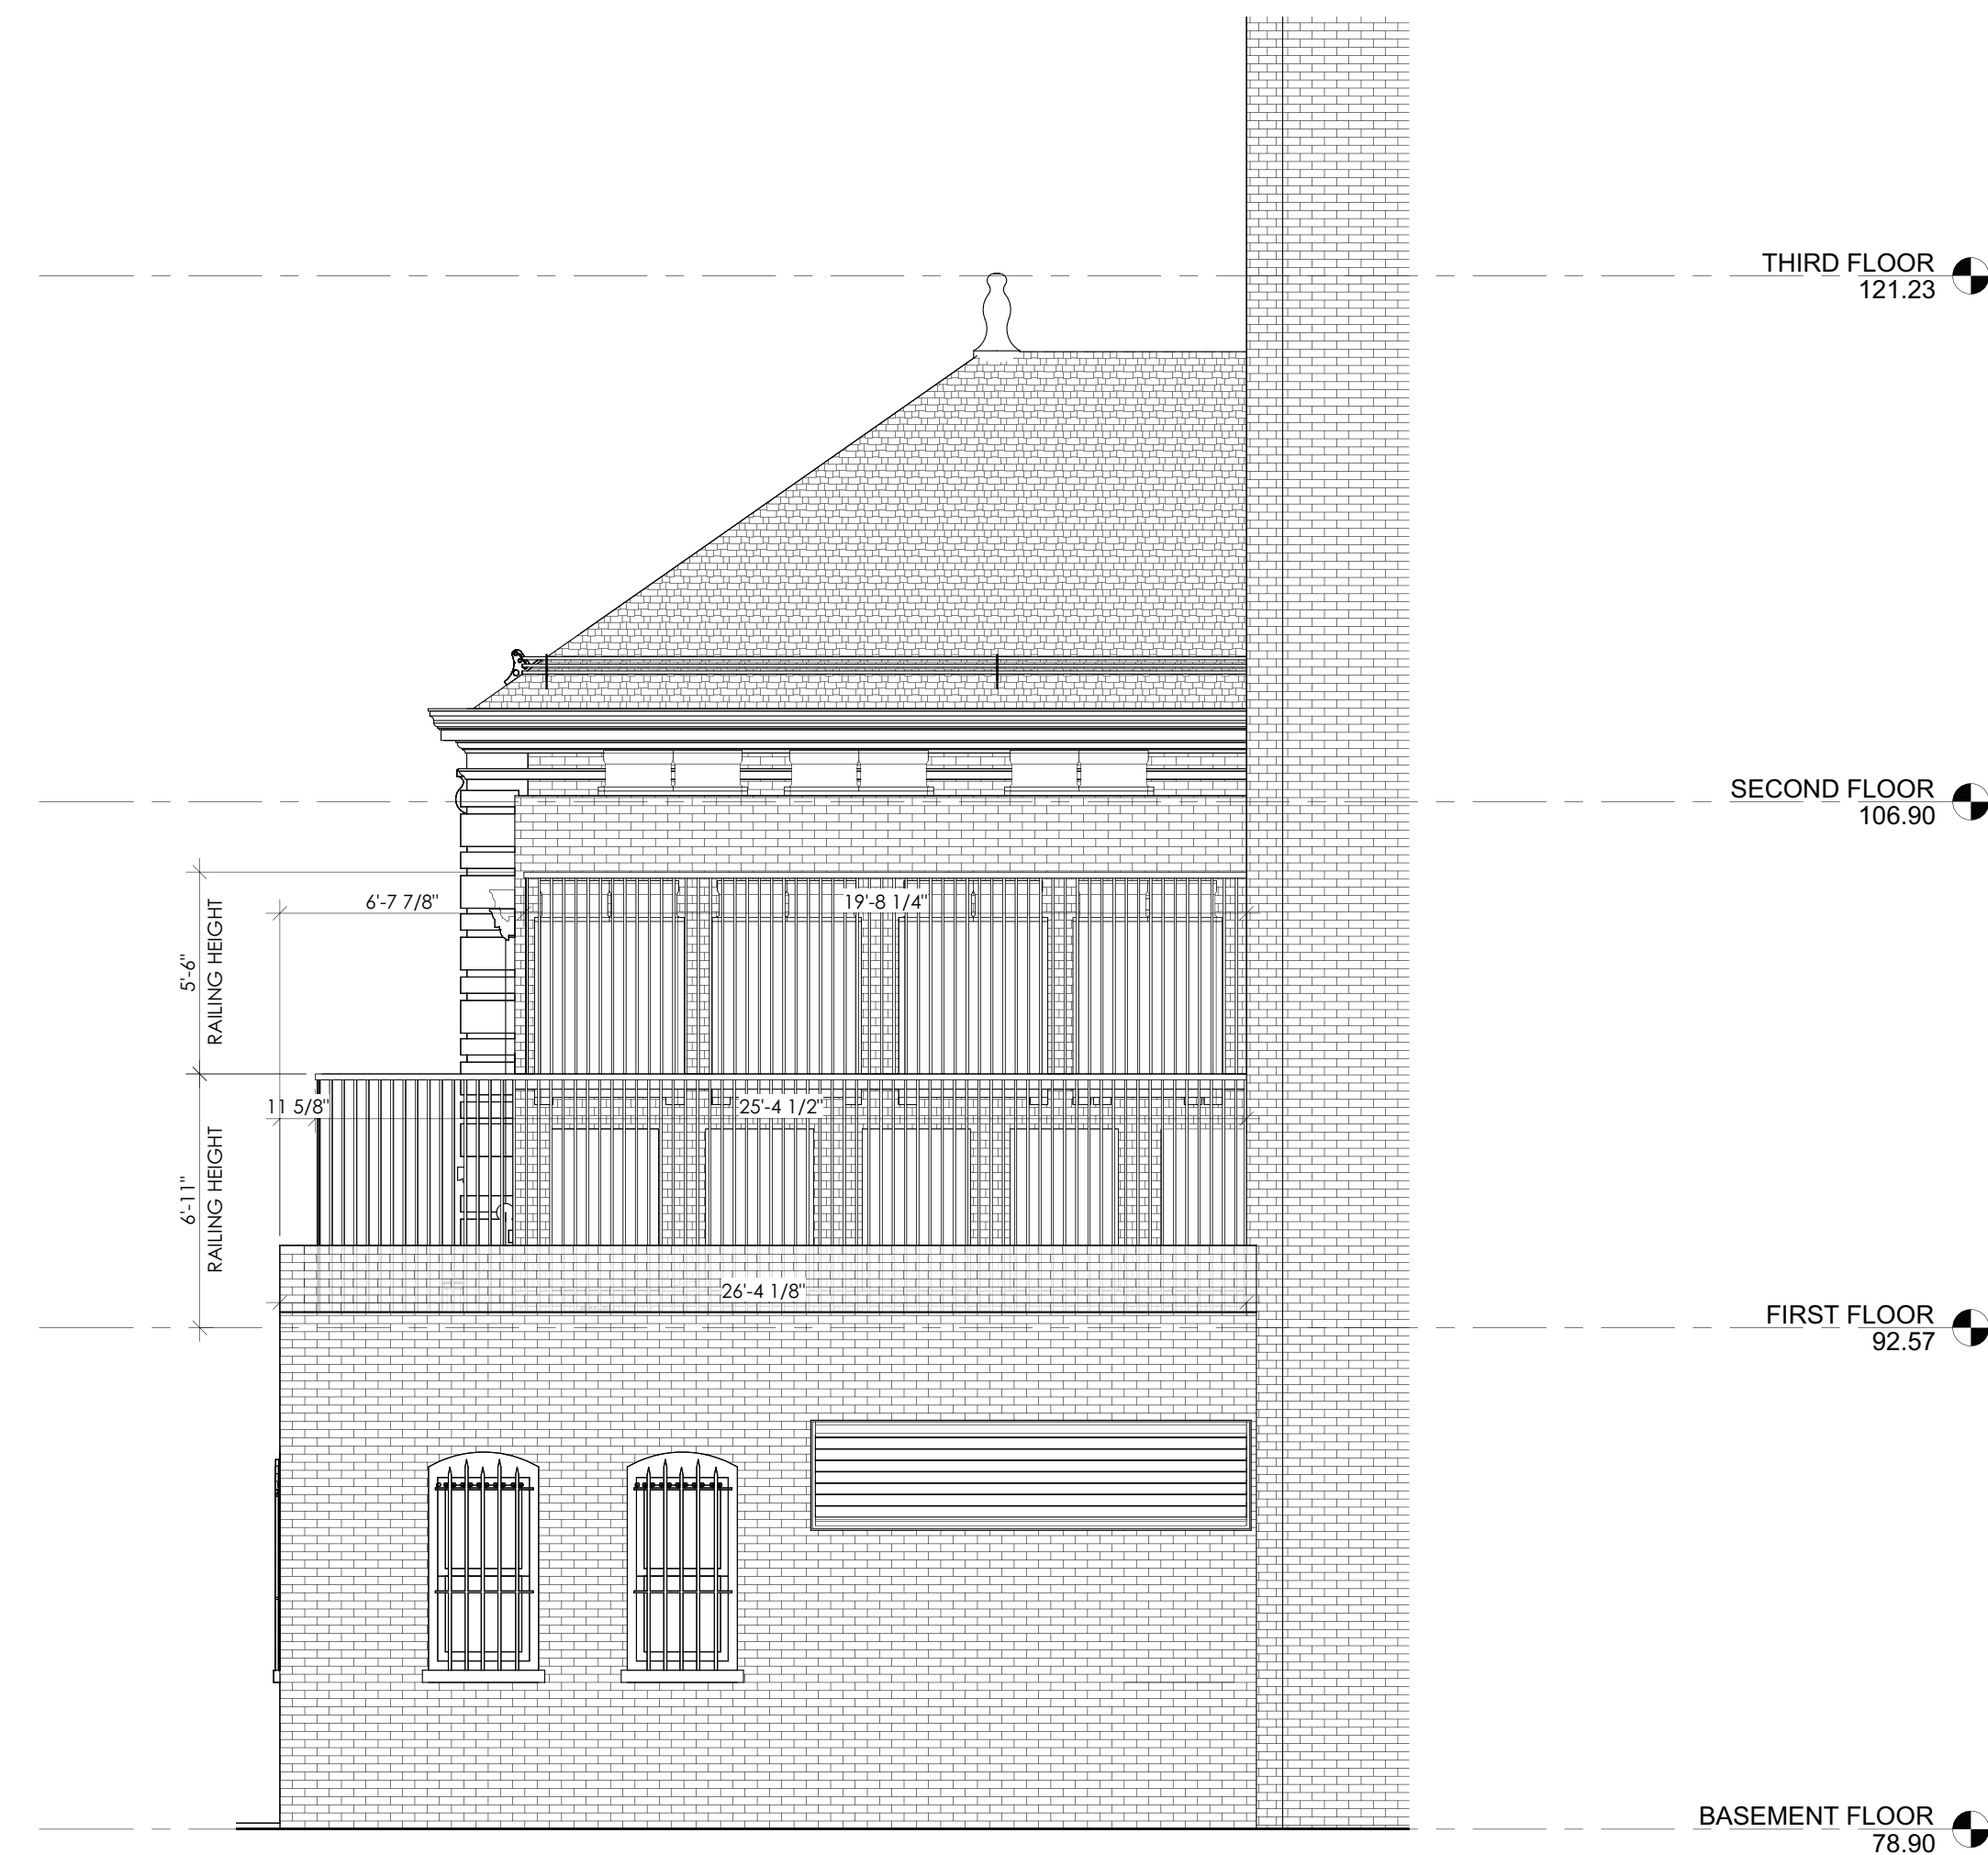
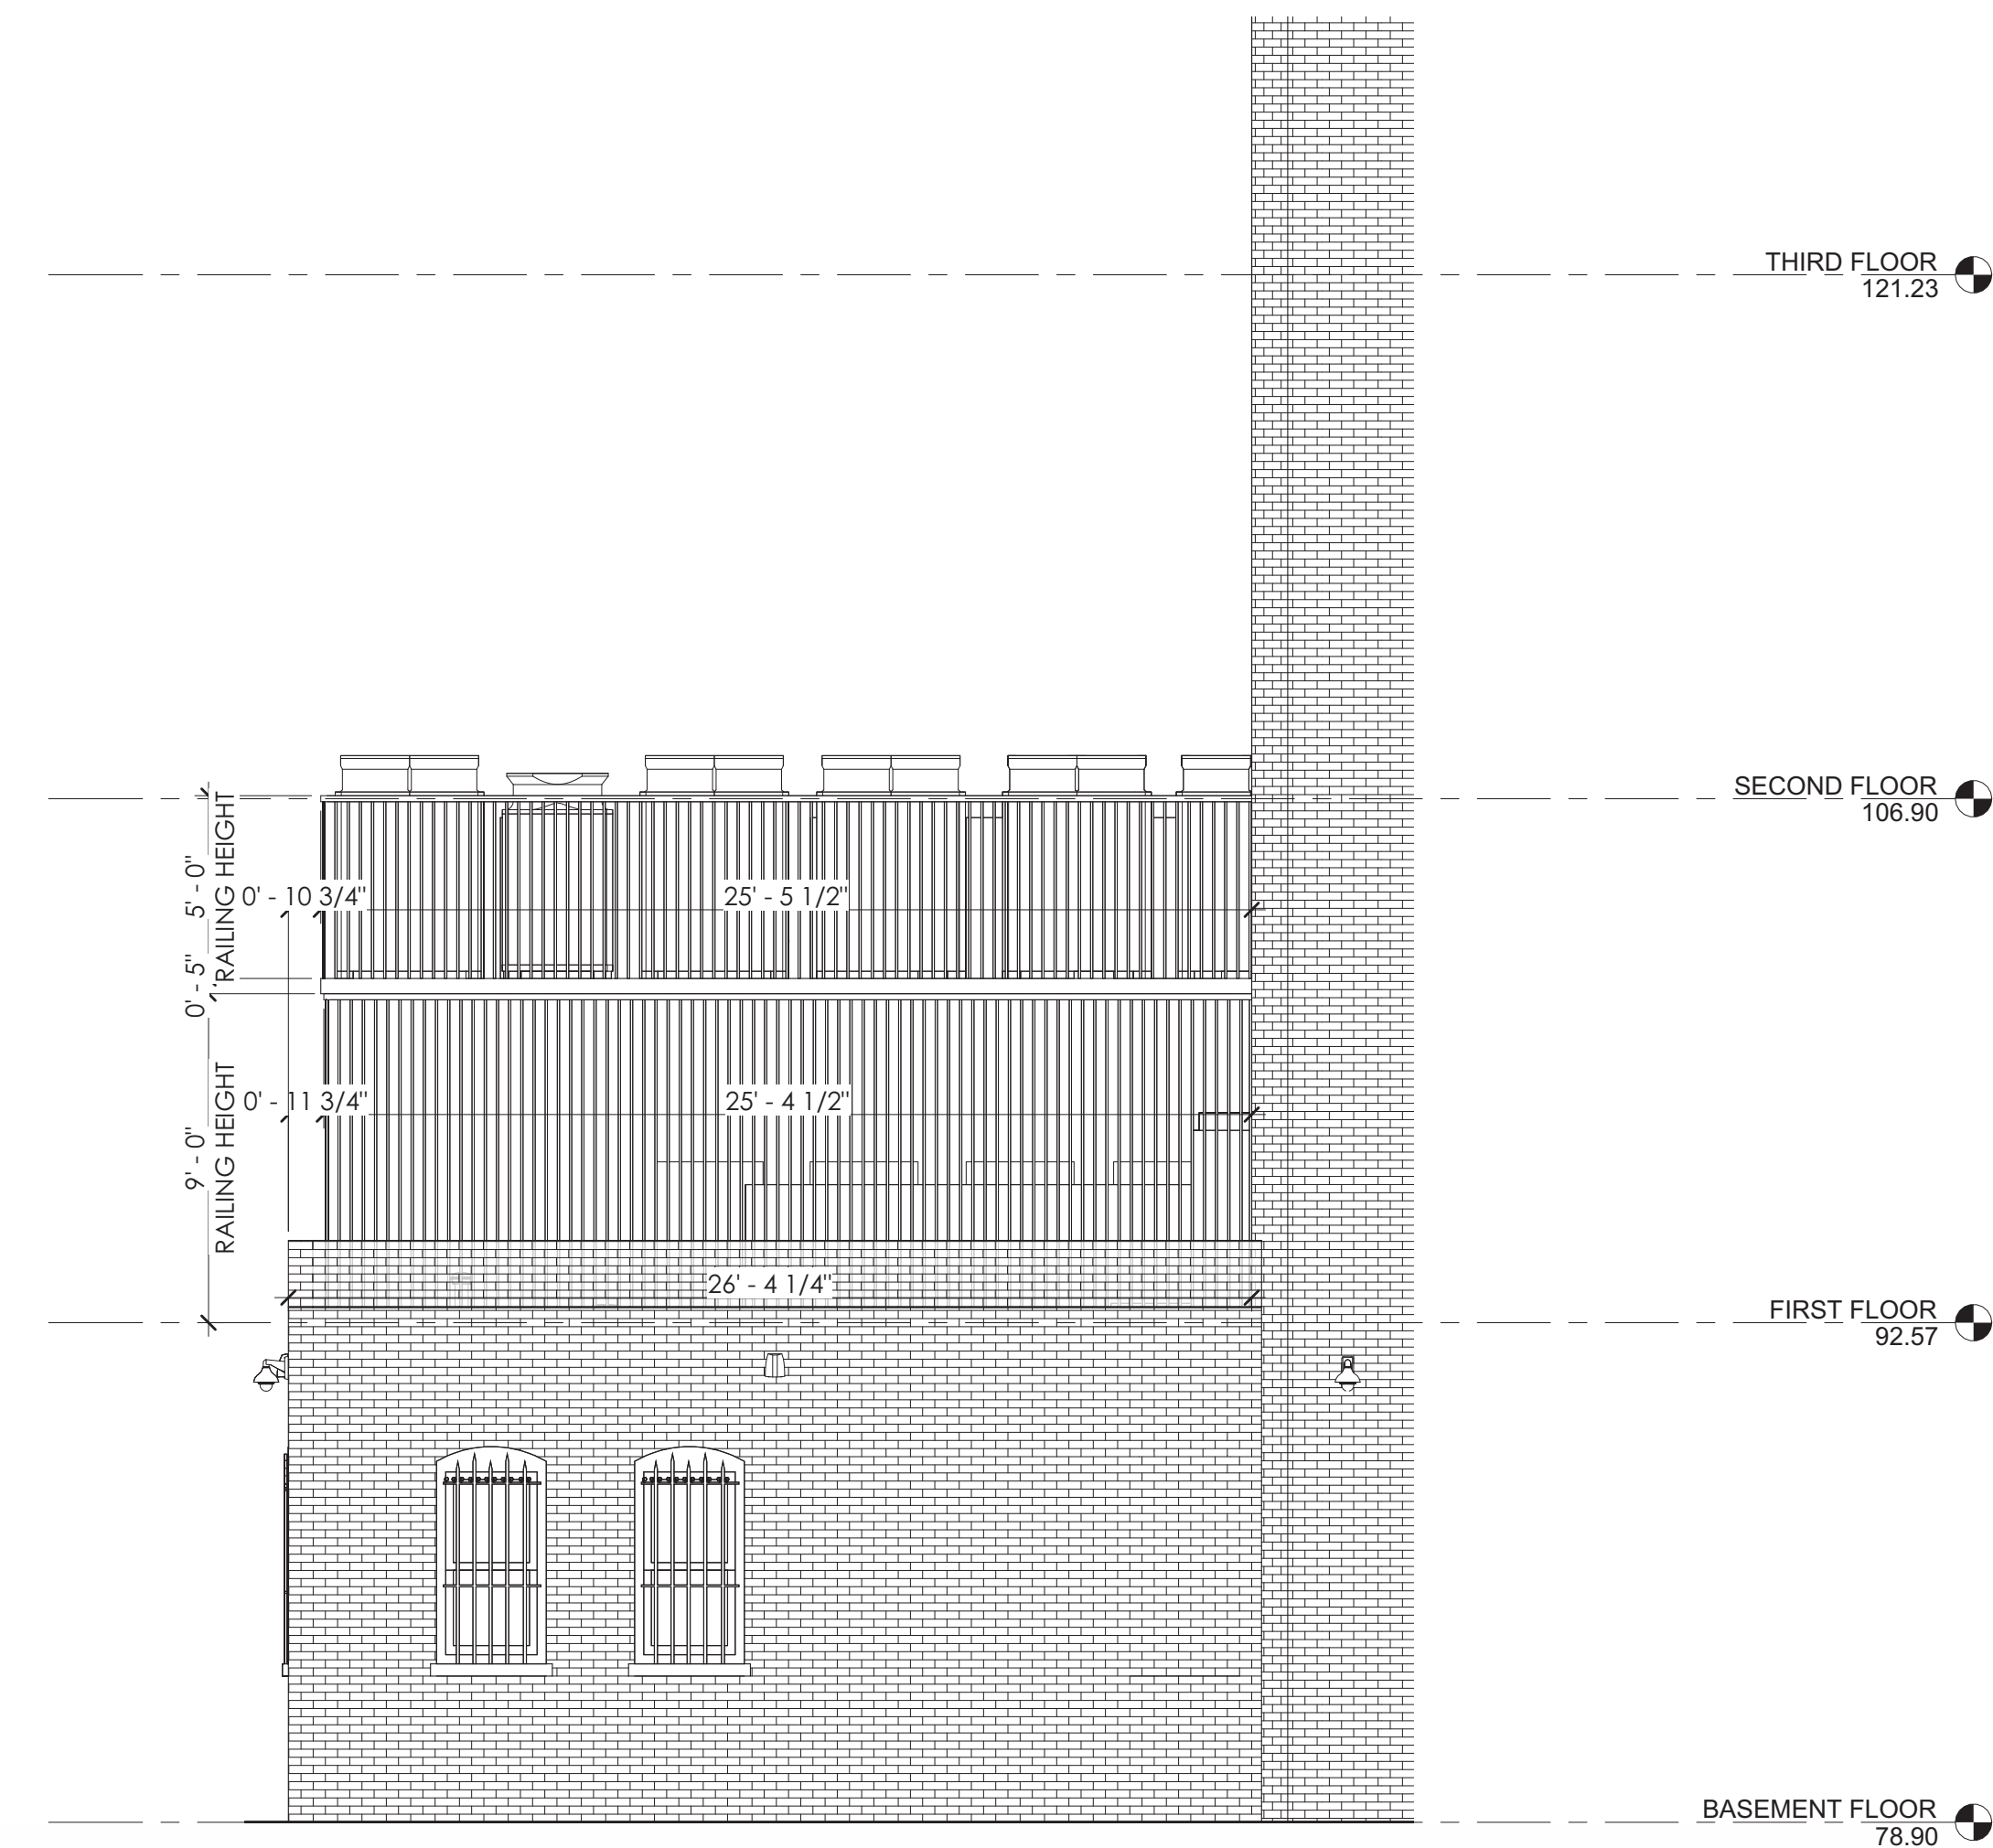
PROPOSED DESIGN:

- CHANGES:**
- RAISED HEIGHT OF FIRST LEVEL DUNNAGE
 - REMOVED SECOND LEVEL DUNNAGE SETBACK
 - WIDE MECHANICAL LOUVRE REMOVED

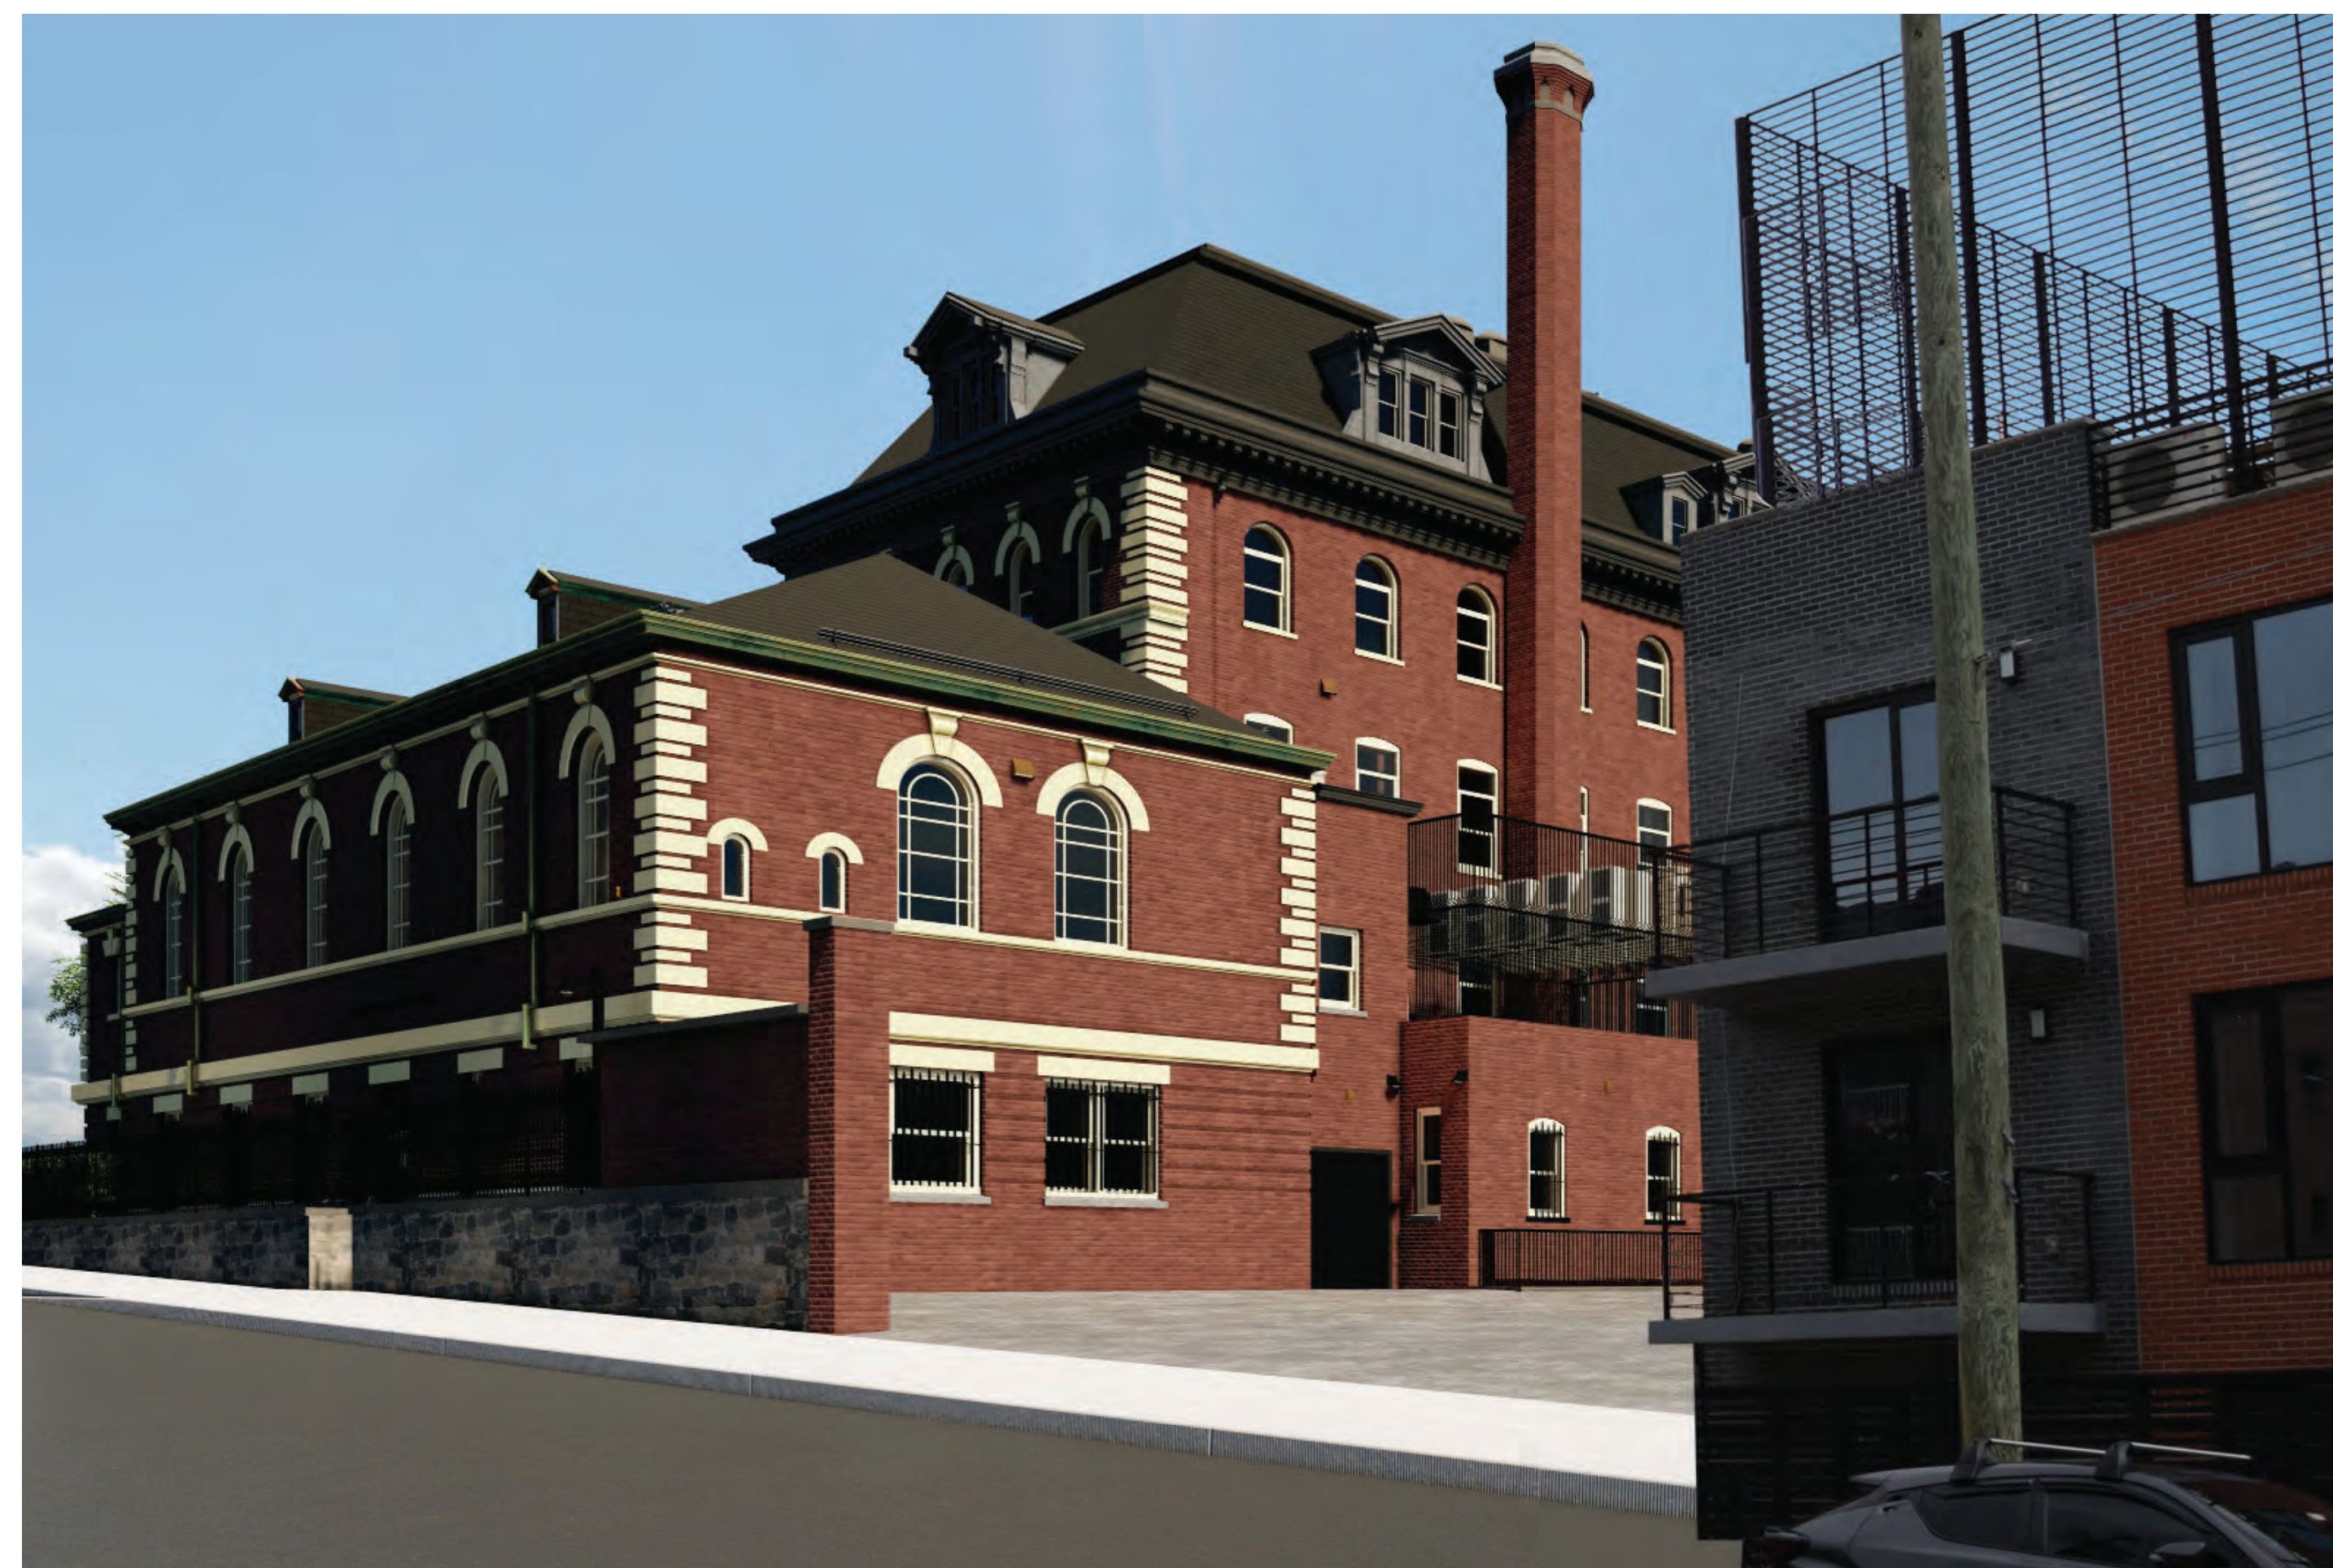
REVISED:

- CHANGES:
- EXPAND DUNNAGE SPACE FOR MORE EQUIPMENT
 - RAISE HEIGHT OF FIRST LEVEL DUNNAGE
 - WIDE MECHANICAL LOUVRE REMOVED
 - ADDITIONAL REAR FACADE LIGHT FIXTURES
 - ADDED REAR FACADE SECURITY CAMERA FIXTURES
