Preservation Department – Item 1, LPC-22-08731

**6301 12th Avenue, aka 6301-6323 12th Avenue, 1202-1216 63rd
Street, and 1201-1215 64th Street – Angel Guardian Home –
Individual Landmark
Borough of Brooklyn**

LPC-22-08731: 6301 12th Avenue, Angel Guardian Home - Individual Landmark

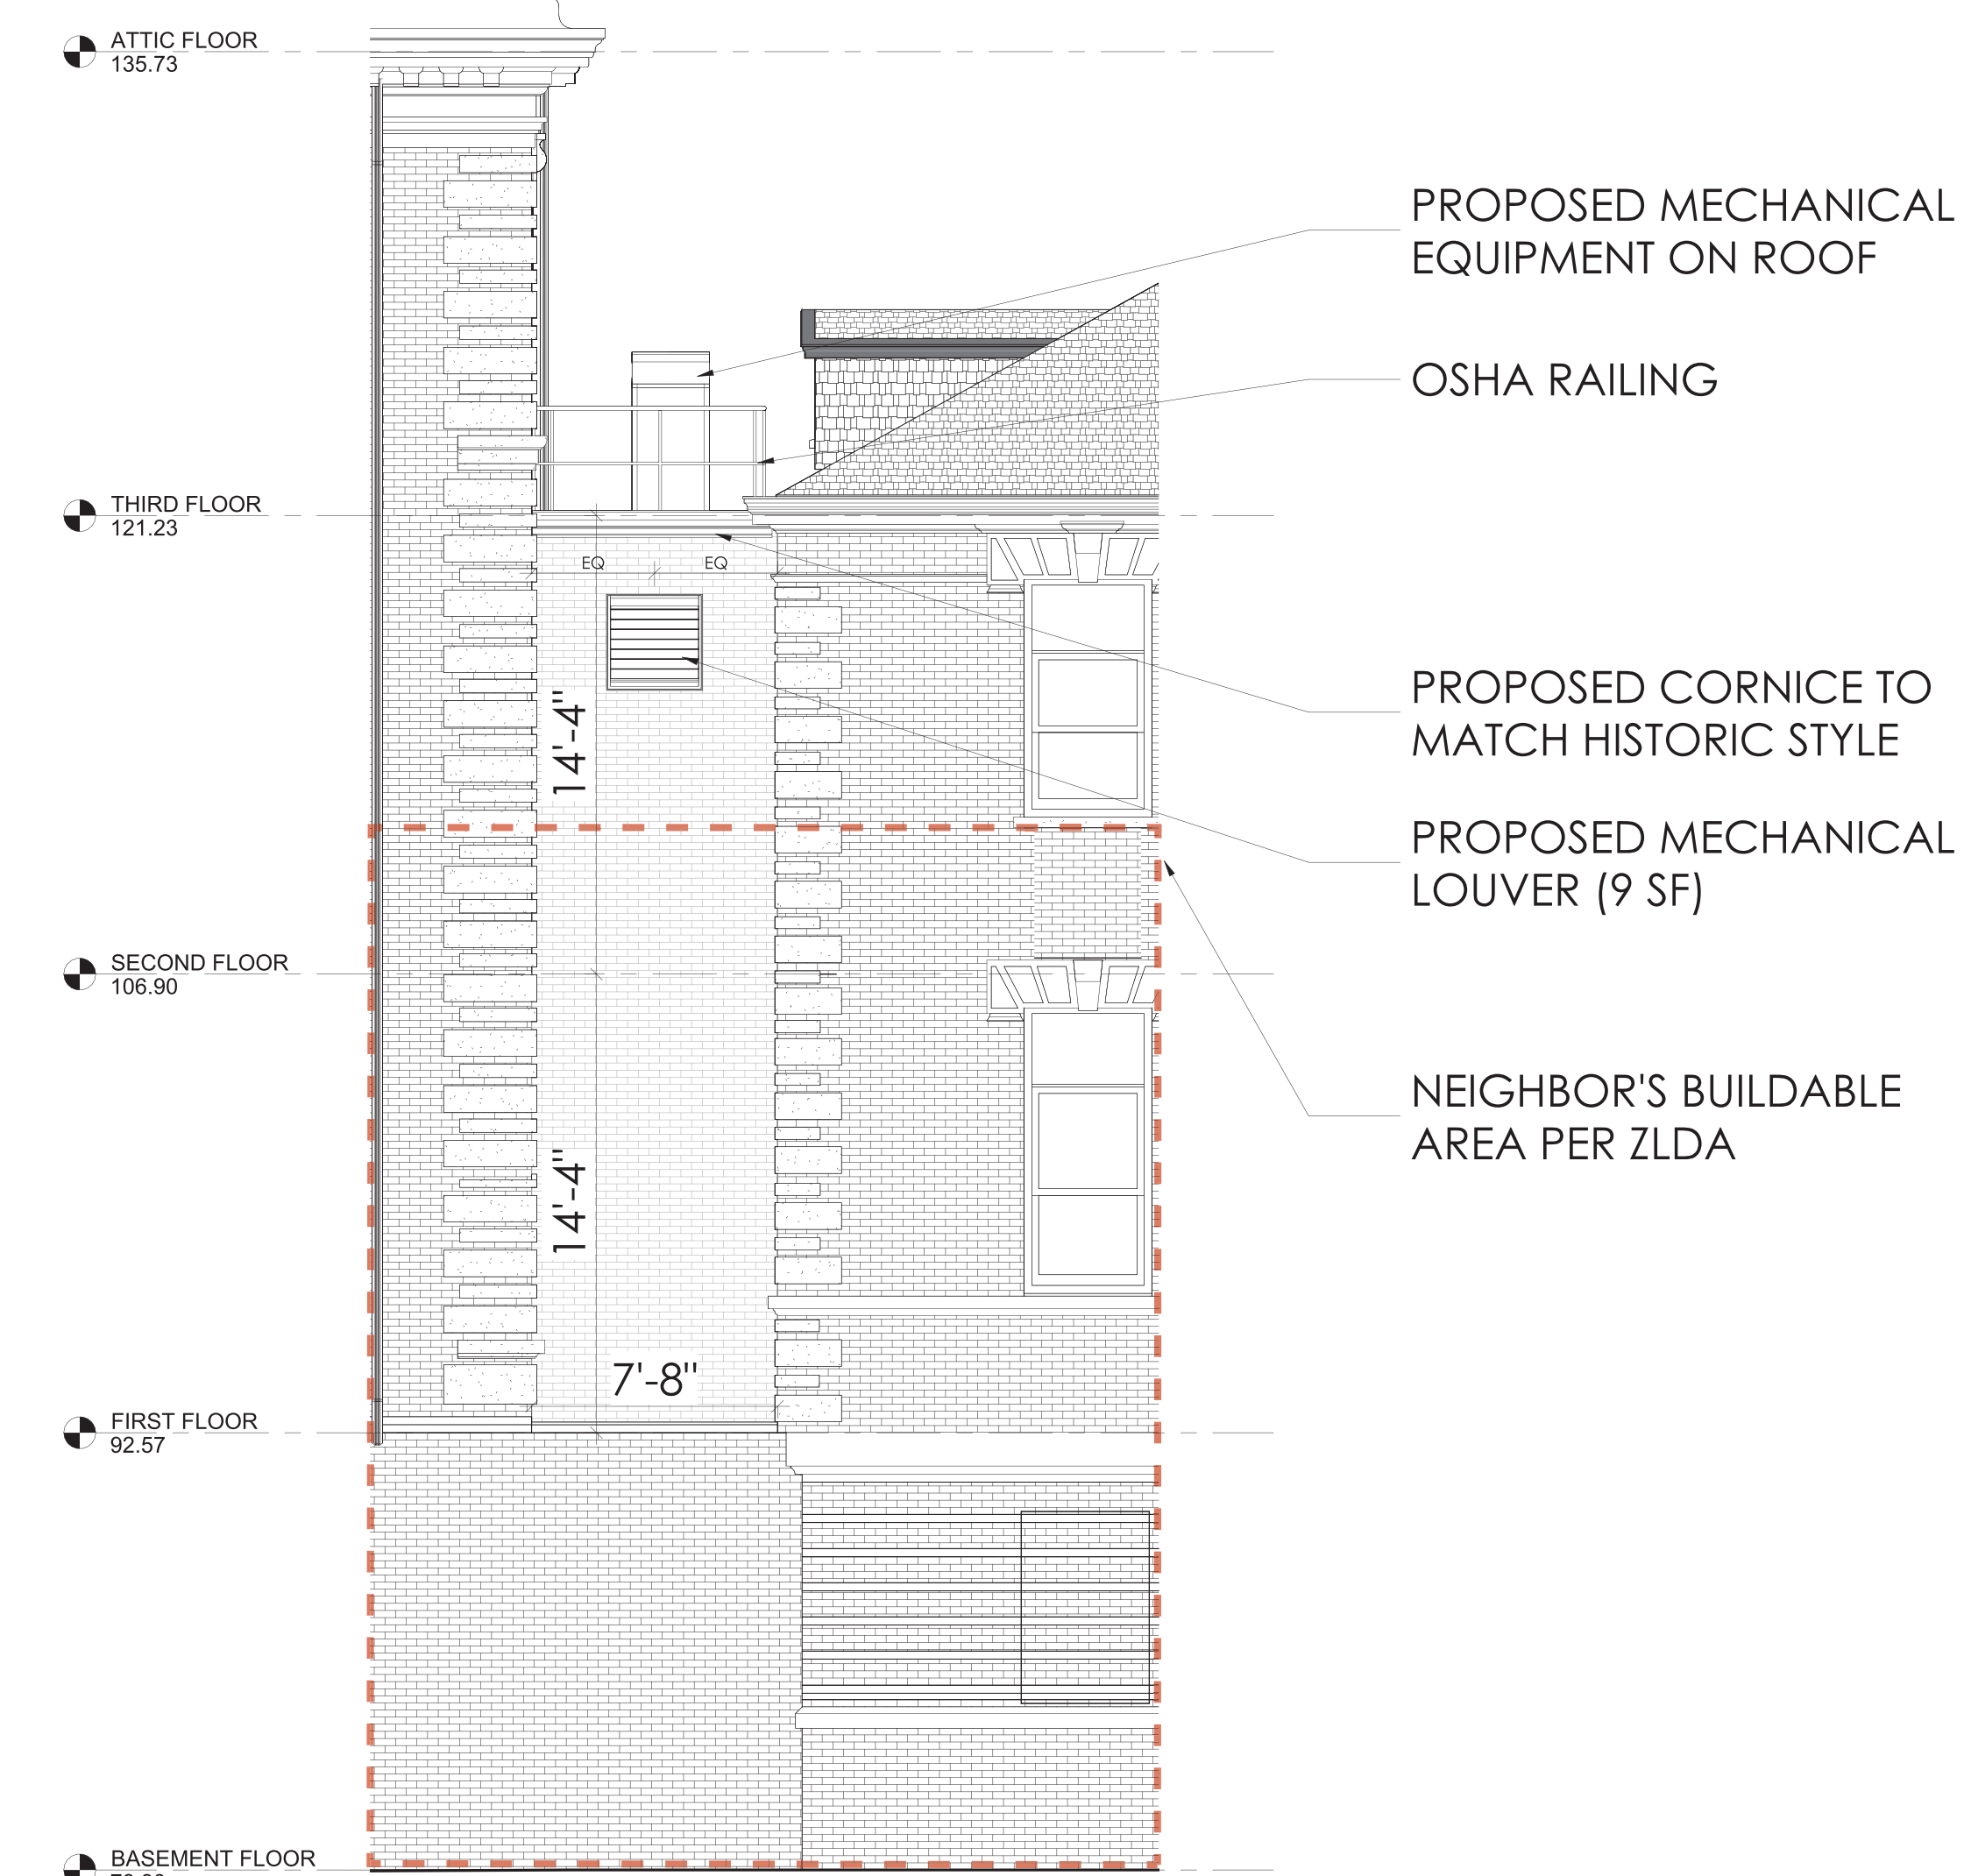
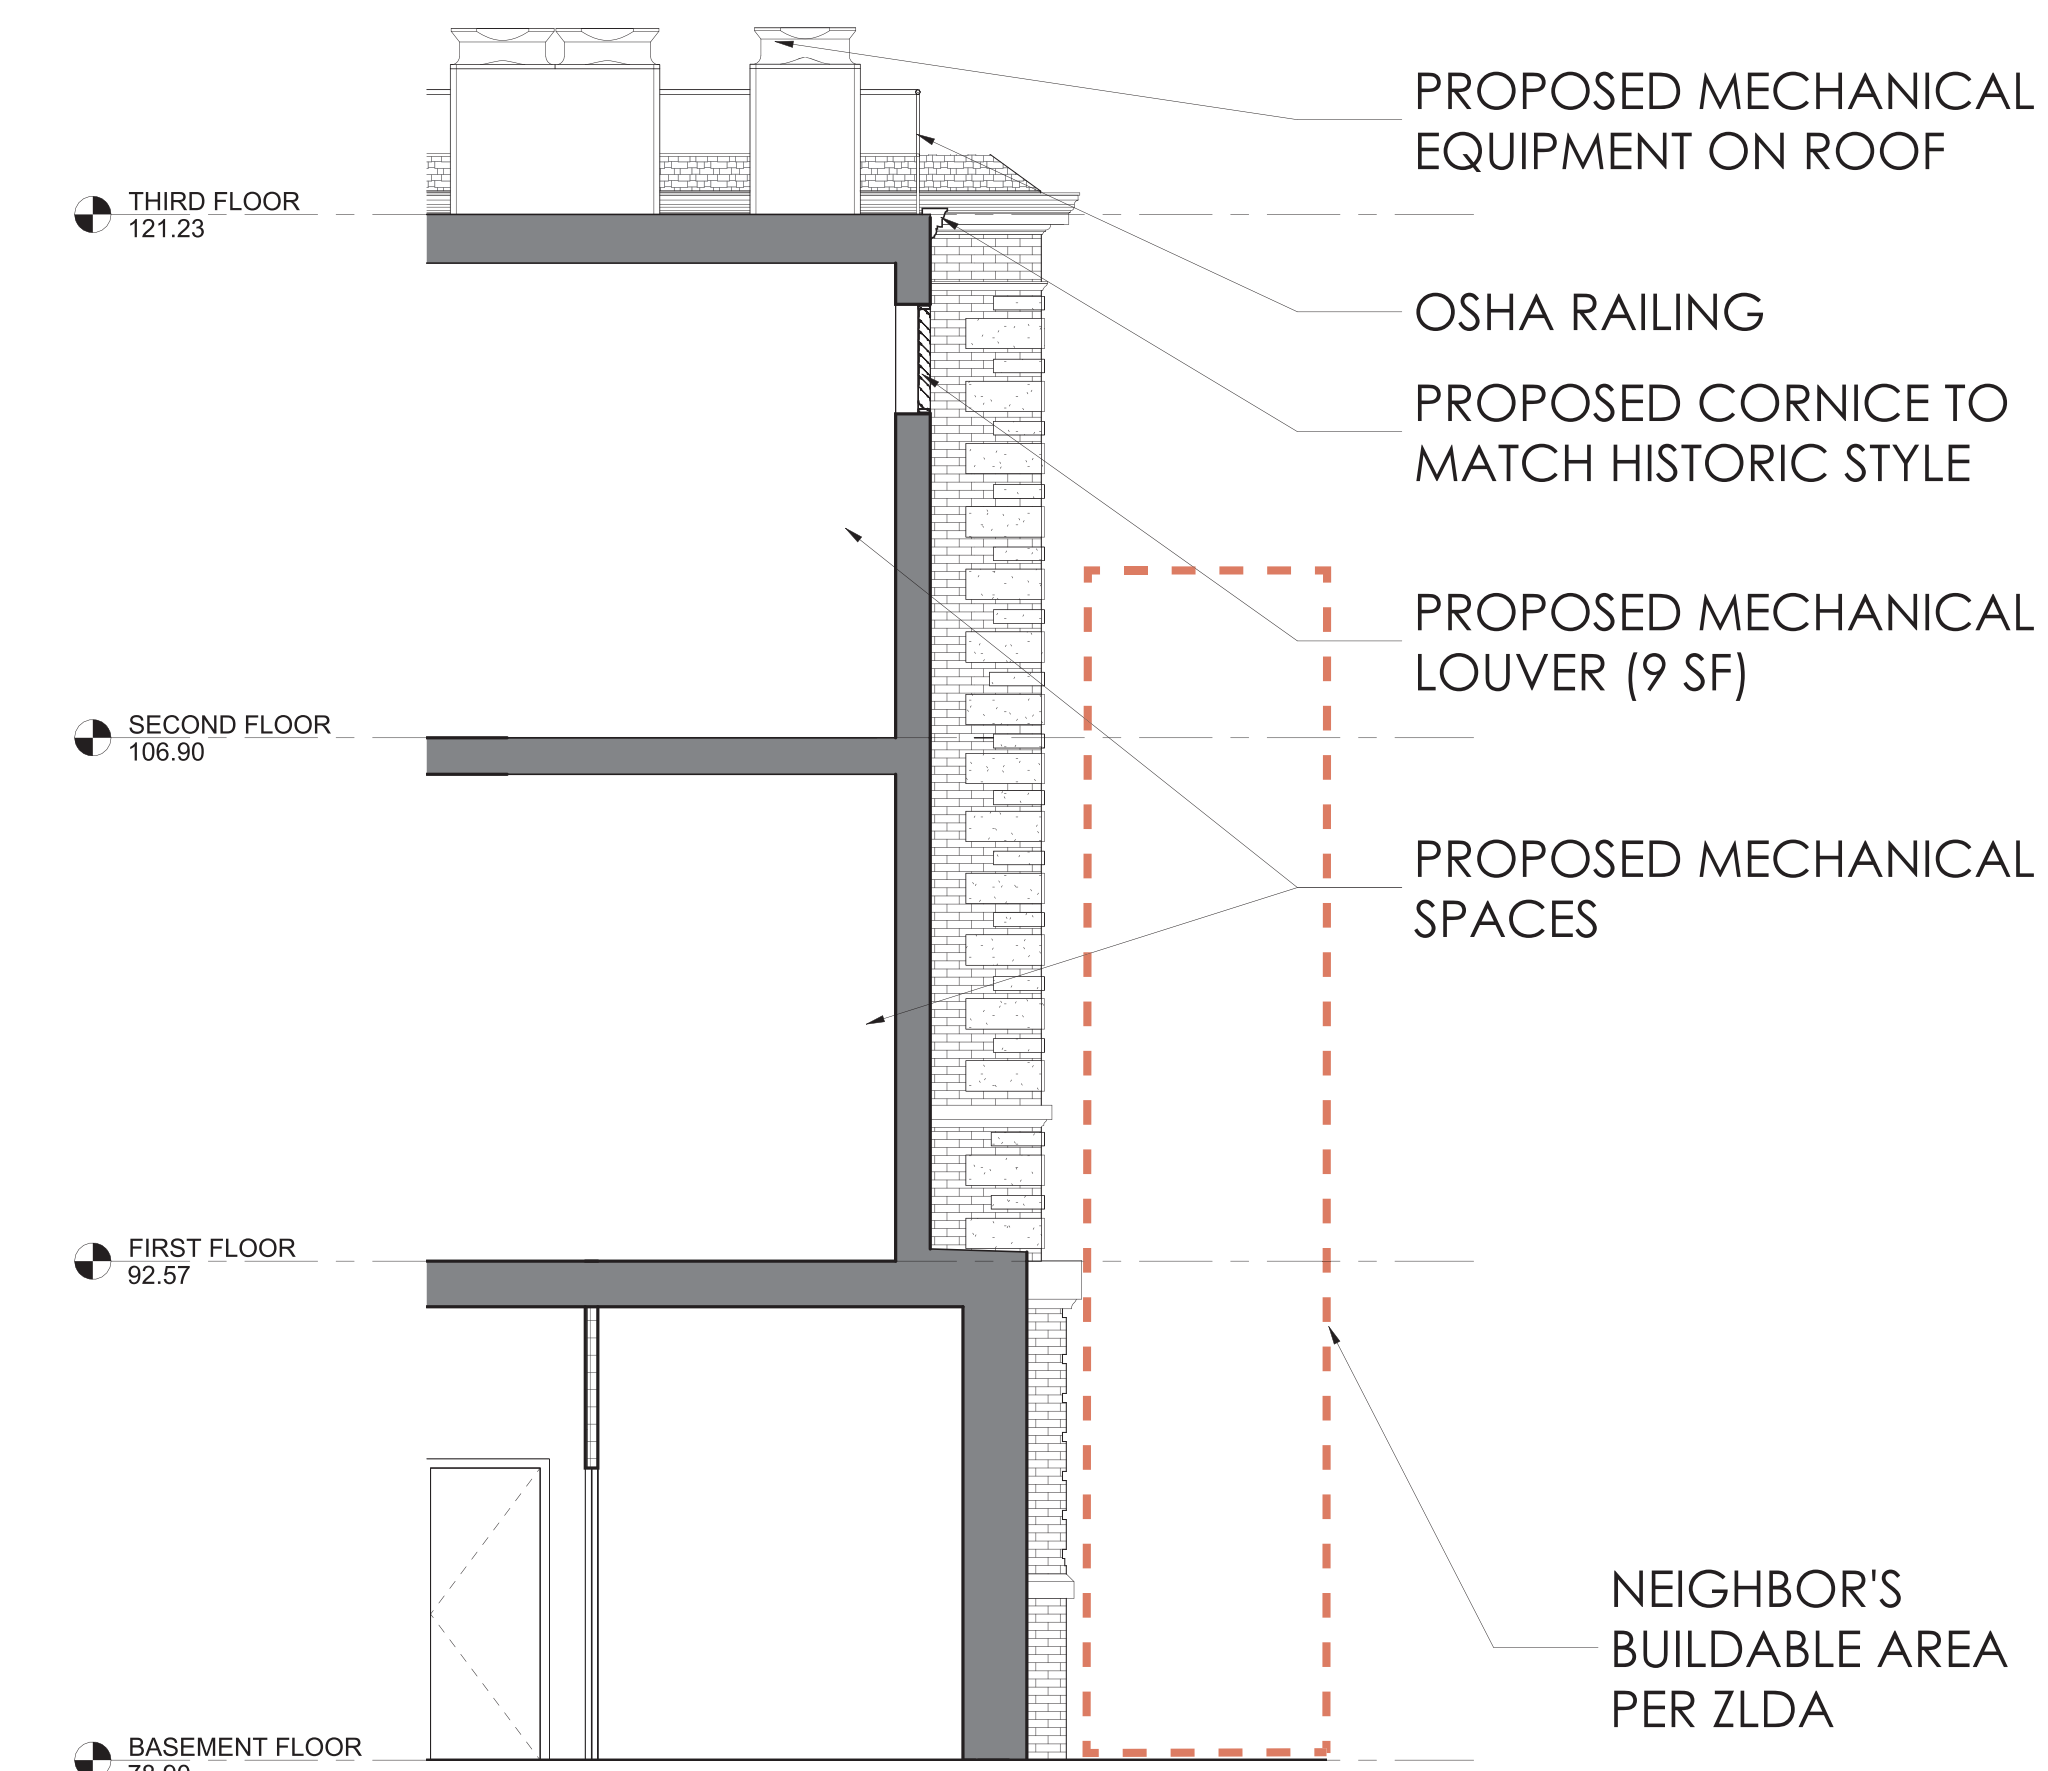
REVISED DESIGN:

CHANGES:
 • NEW MECHANICAL LOUVRE

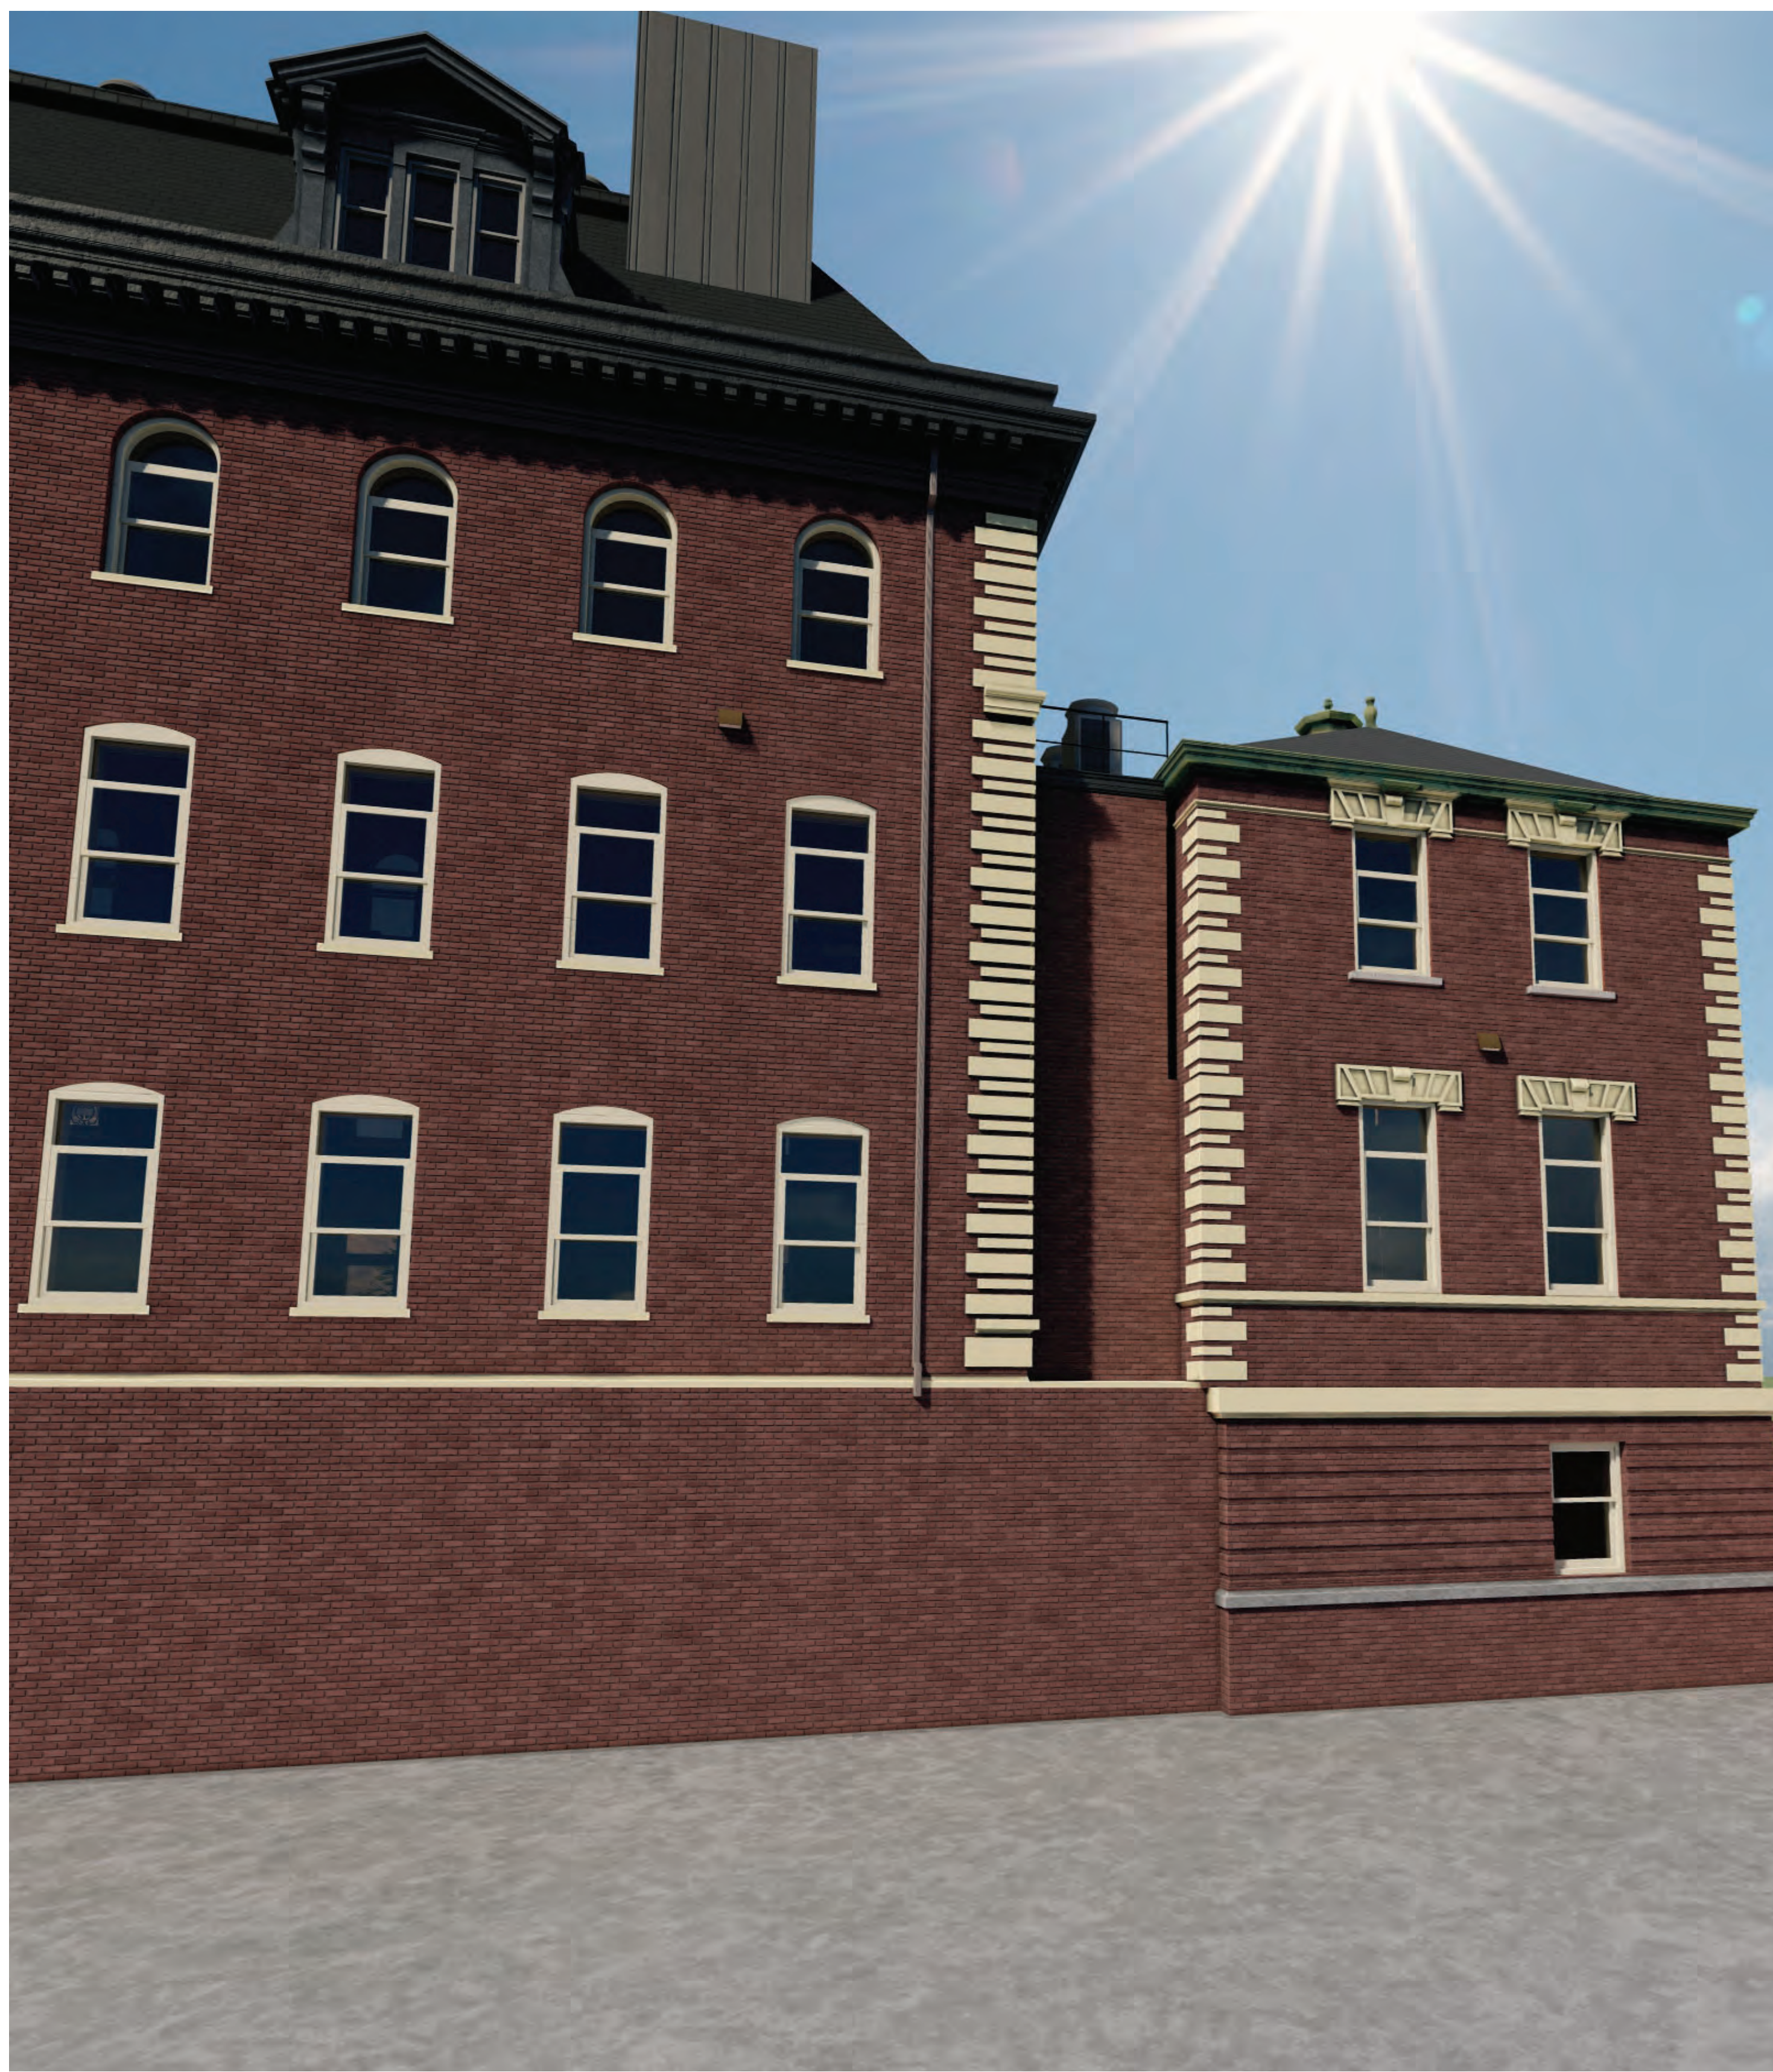
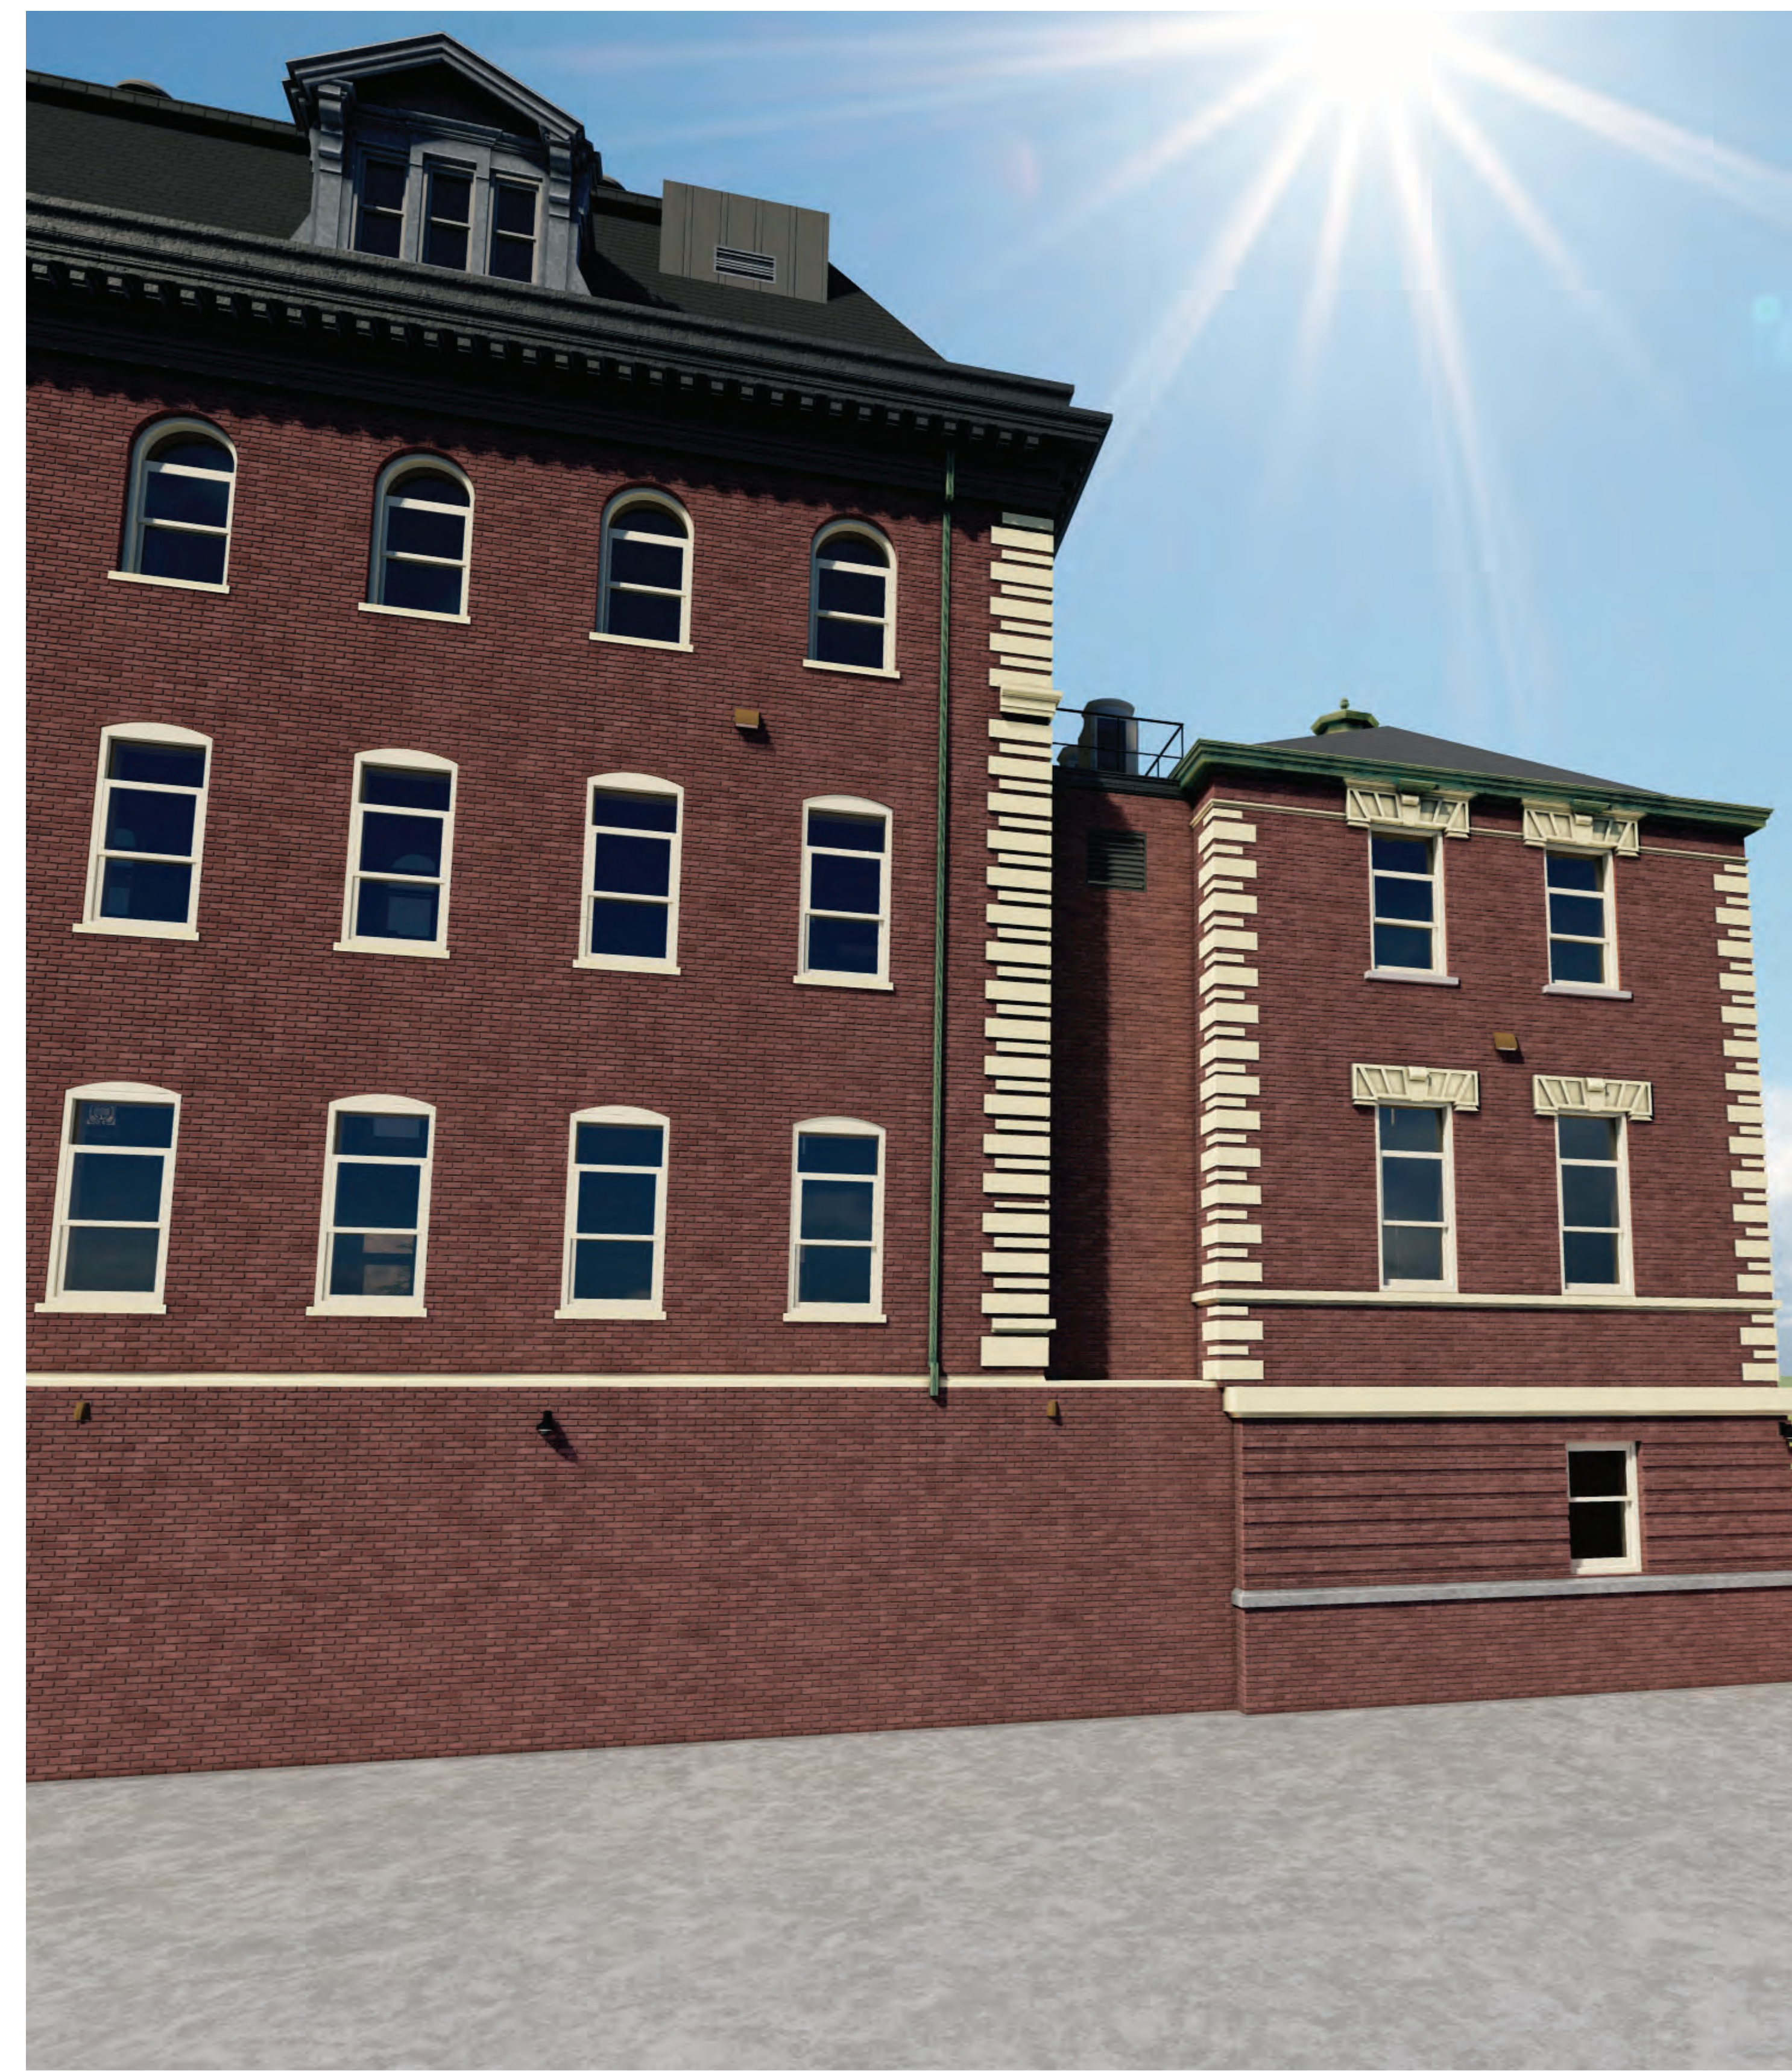
- CHANGES:
- NEW MECHANICAL LOUVRE
 - ELEVATOR BULKHEAD HEIGHT
 - DOWNSPOUTS MATCH COPPER
 - ADDITIONAL REAR FACADE LIGHT FIXTURES
 - REAR FACADE SECURITY CAMERA FIXTURE

- WE REVIEWED EXISTING COPPER DOWNSPOUTS WHICH ARE ALL BROKEN AND DISUSED
- WE PROPOSE ALUMINUM LEADERS PAINTED BRIGHT TO MATCH THE CURRENT COPPER MATERIAL AROUND THE BUILDING

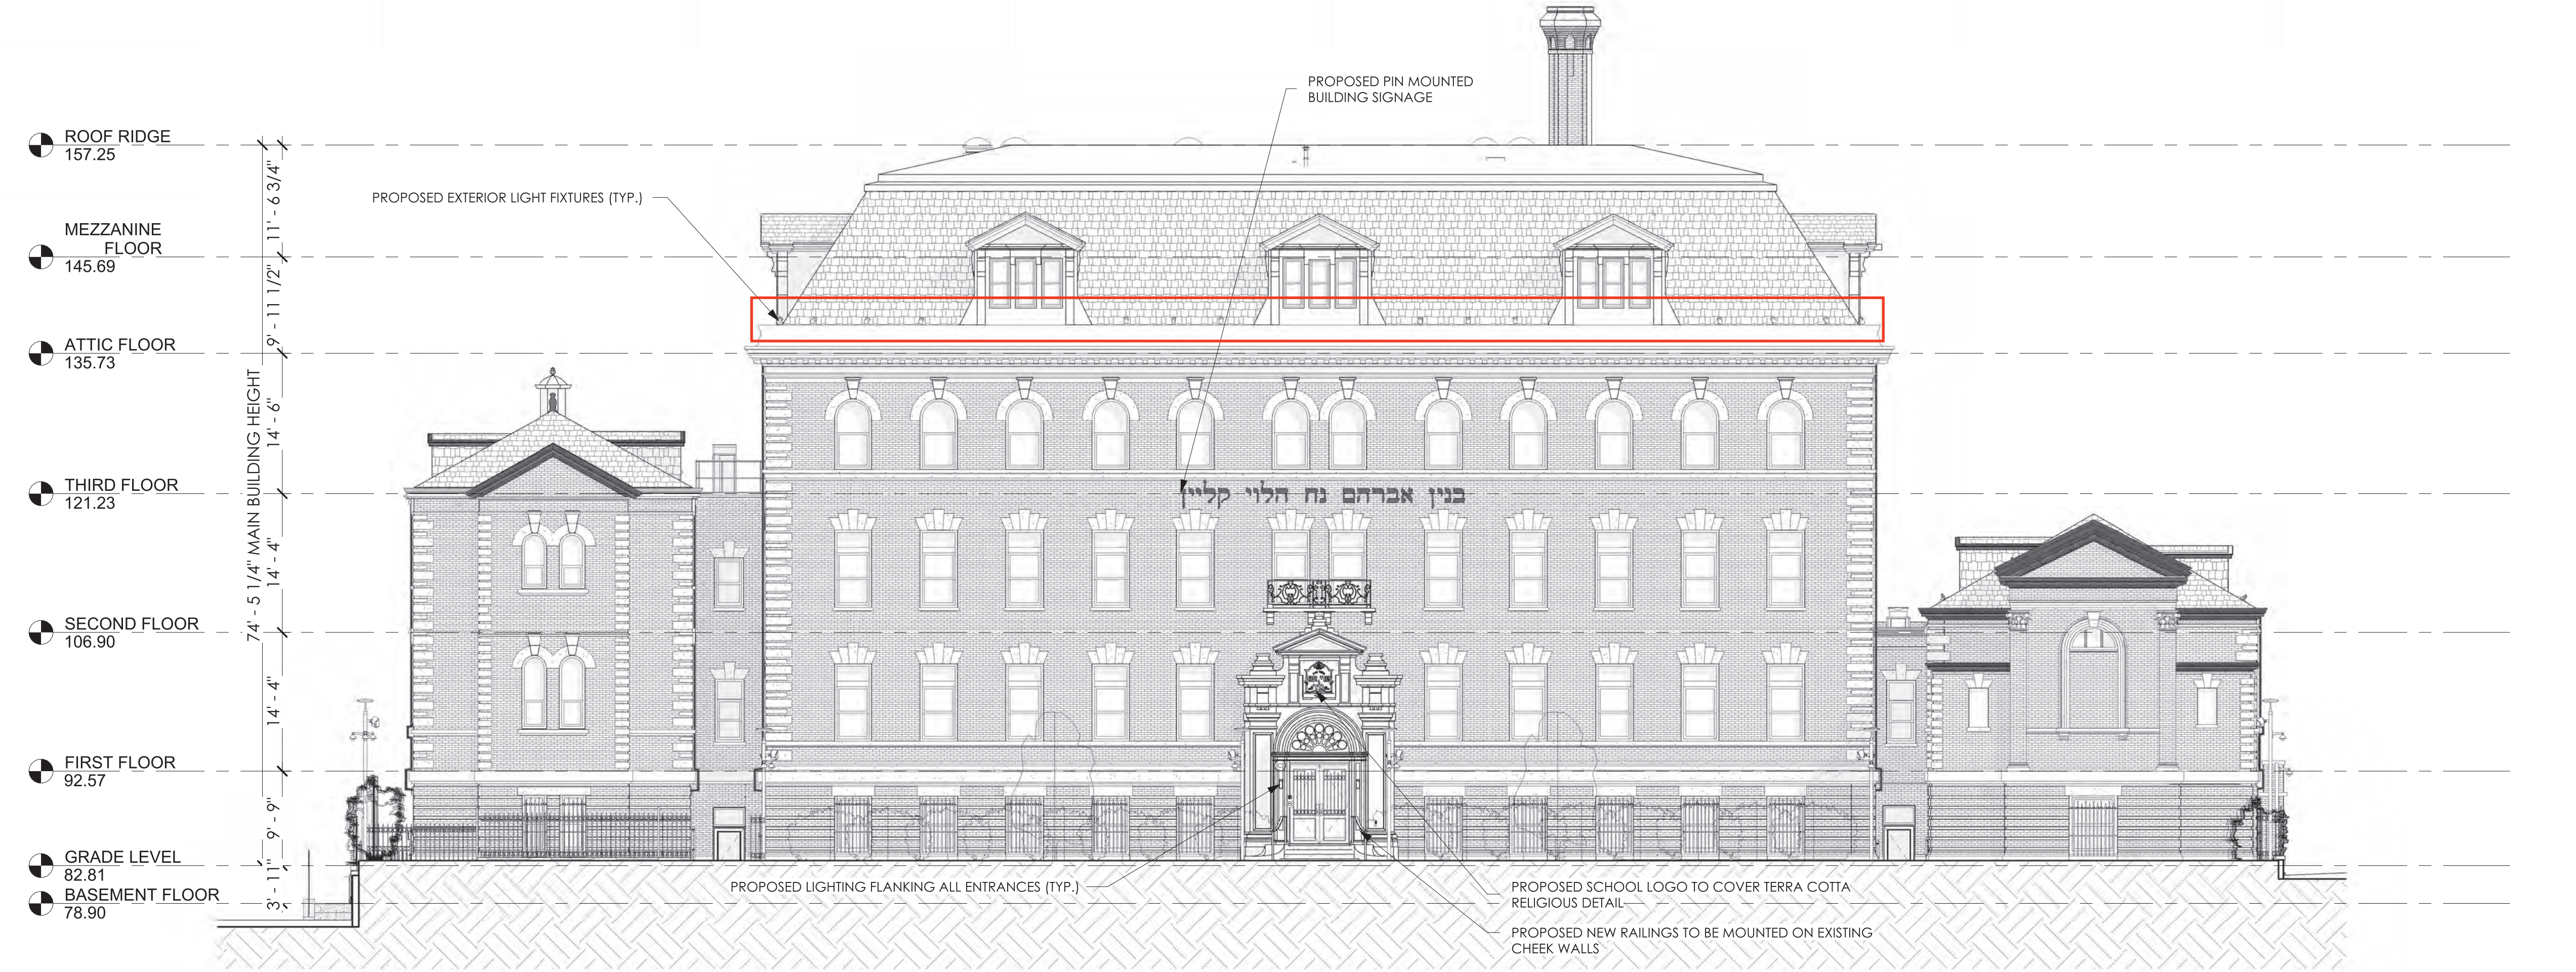
**12TH AVENUE
REVISED ELEVATION**

12 COUNT, HBLED13YA-D10

- CHANGES:**
- LIGHTING, SPEAKER, AND SECURITY CAMERA FIXTURES REMOVED
 - DOORS REVISED TO MATCH HISTORIC IMAGES
 - LETTERING ON ARCH REMOVED
 - LETTERING ON FACADE SHORTENED
 - ELEVATOR BULKHEAD LOWERED

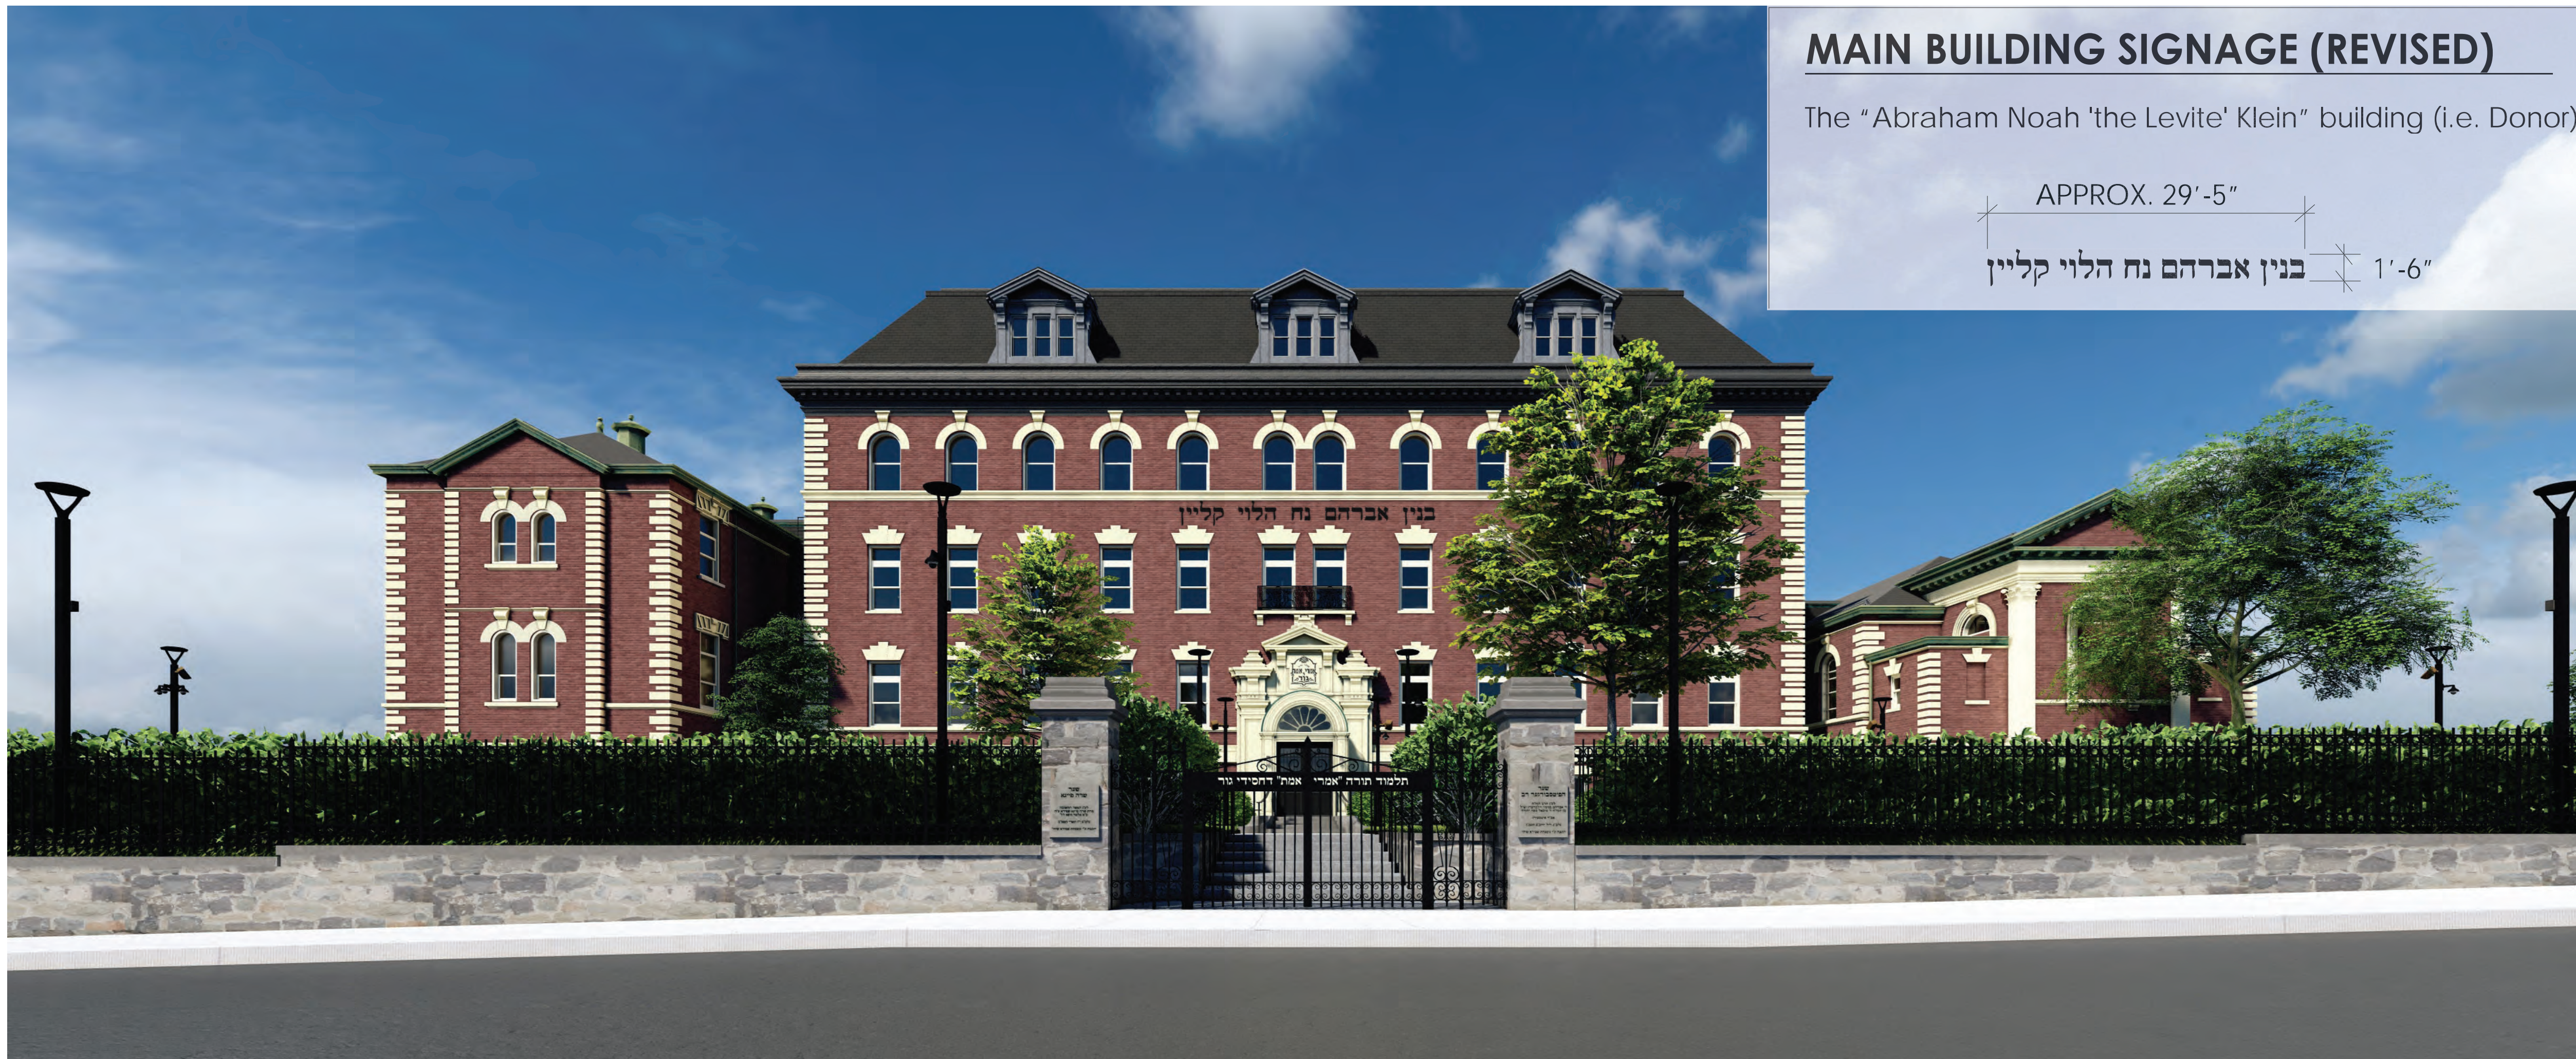
12TH AVENUE
REVISED RENDERING

- CHANGES:**
- TREE IN FRONT OF 63RD ST WING TO BE REMOVED
 - ADDITIONAL TREES TO REMAIN
 - REVISED LIGHT POLE PLACEMENT
 - MAIN BUILDING FACADE LETTERING SHORTENED
 - LETTERING ON ARCH REMOVED

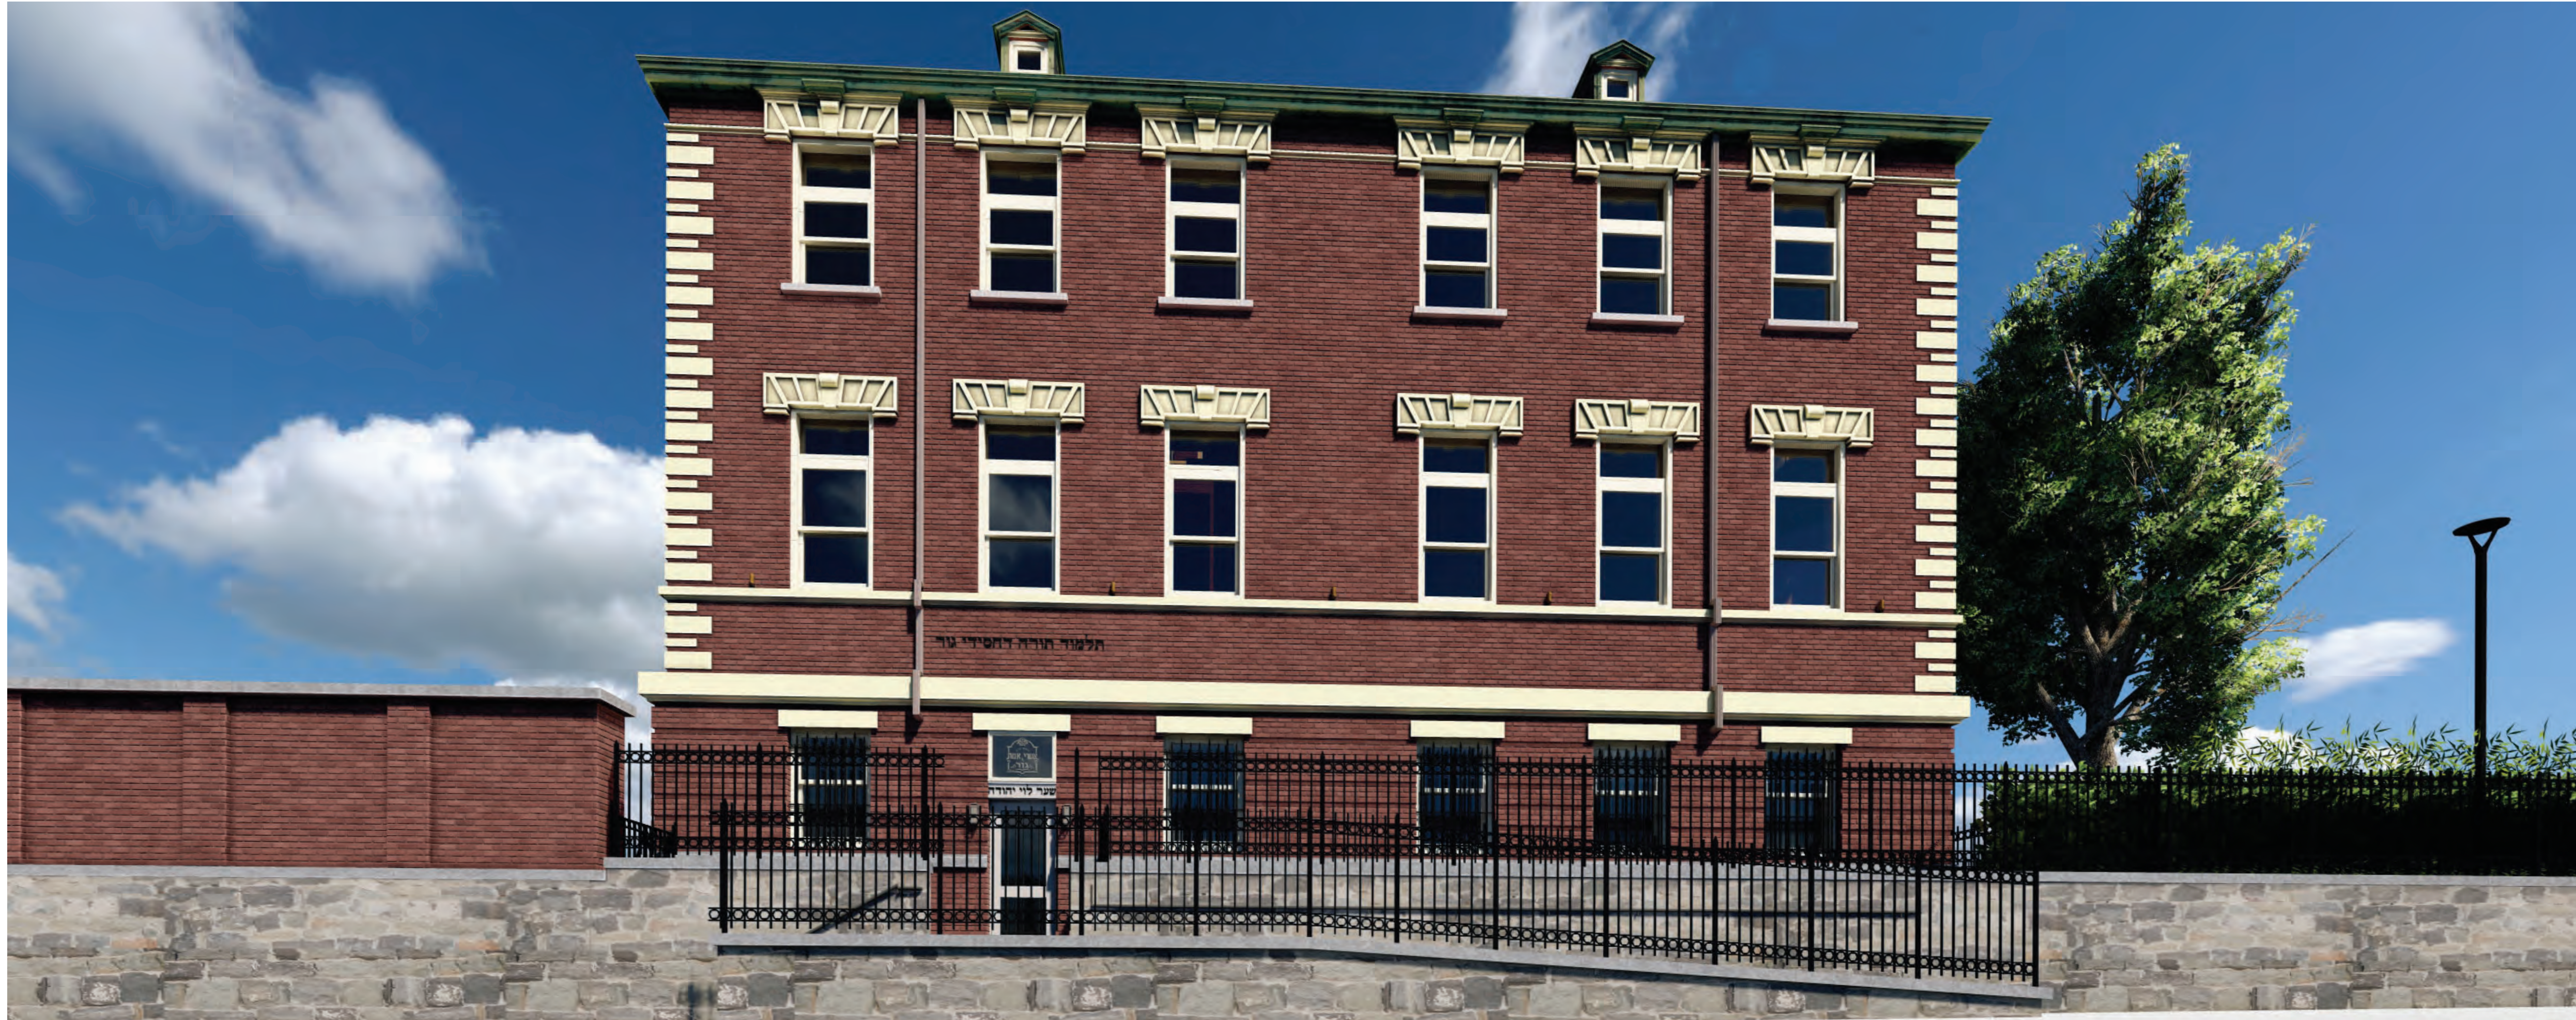
**63RD STREET
REVISED ELEVATION**

**6 COUNT, HBLED13YA-D10
5 COUNT, LFLED8YA**

- CHANGES:**
- LIGHTING, SPEAKER, AND SECURITY CAMERA FIXTURES REMOVED
 - DOORS REVISED TO MATCH HISTORIC IMAGES
 - ELEVATOR BULKHEAD LOWERED
 - MECHANICAL DUNNAGE WIDENED
