Preservation Department – Item 1, LPC-22-08731

**6301 12th Avenue, aka 6301-6323 12th Avenue, 1202-1216 63rd
Street, and 1201-1215 64th Street – Angel Guardian Home –
Individual Landmark
Borough of Brooklyn**

LPC-22-08731: 6301 12th Avenue, Angel Guardian Home - Individual Landmark

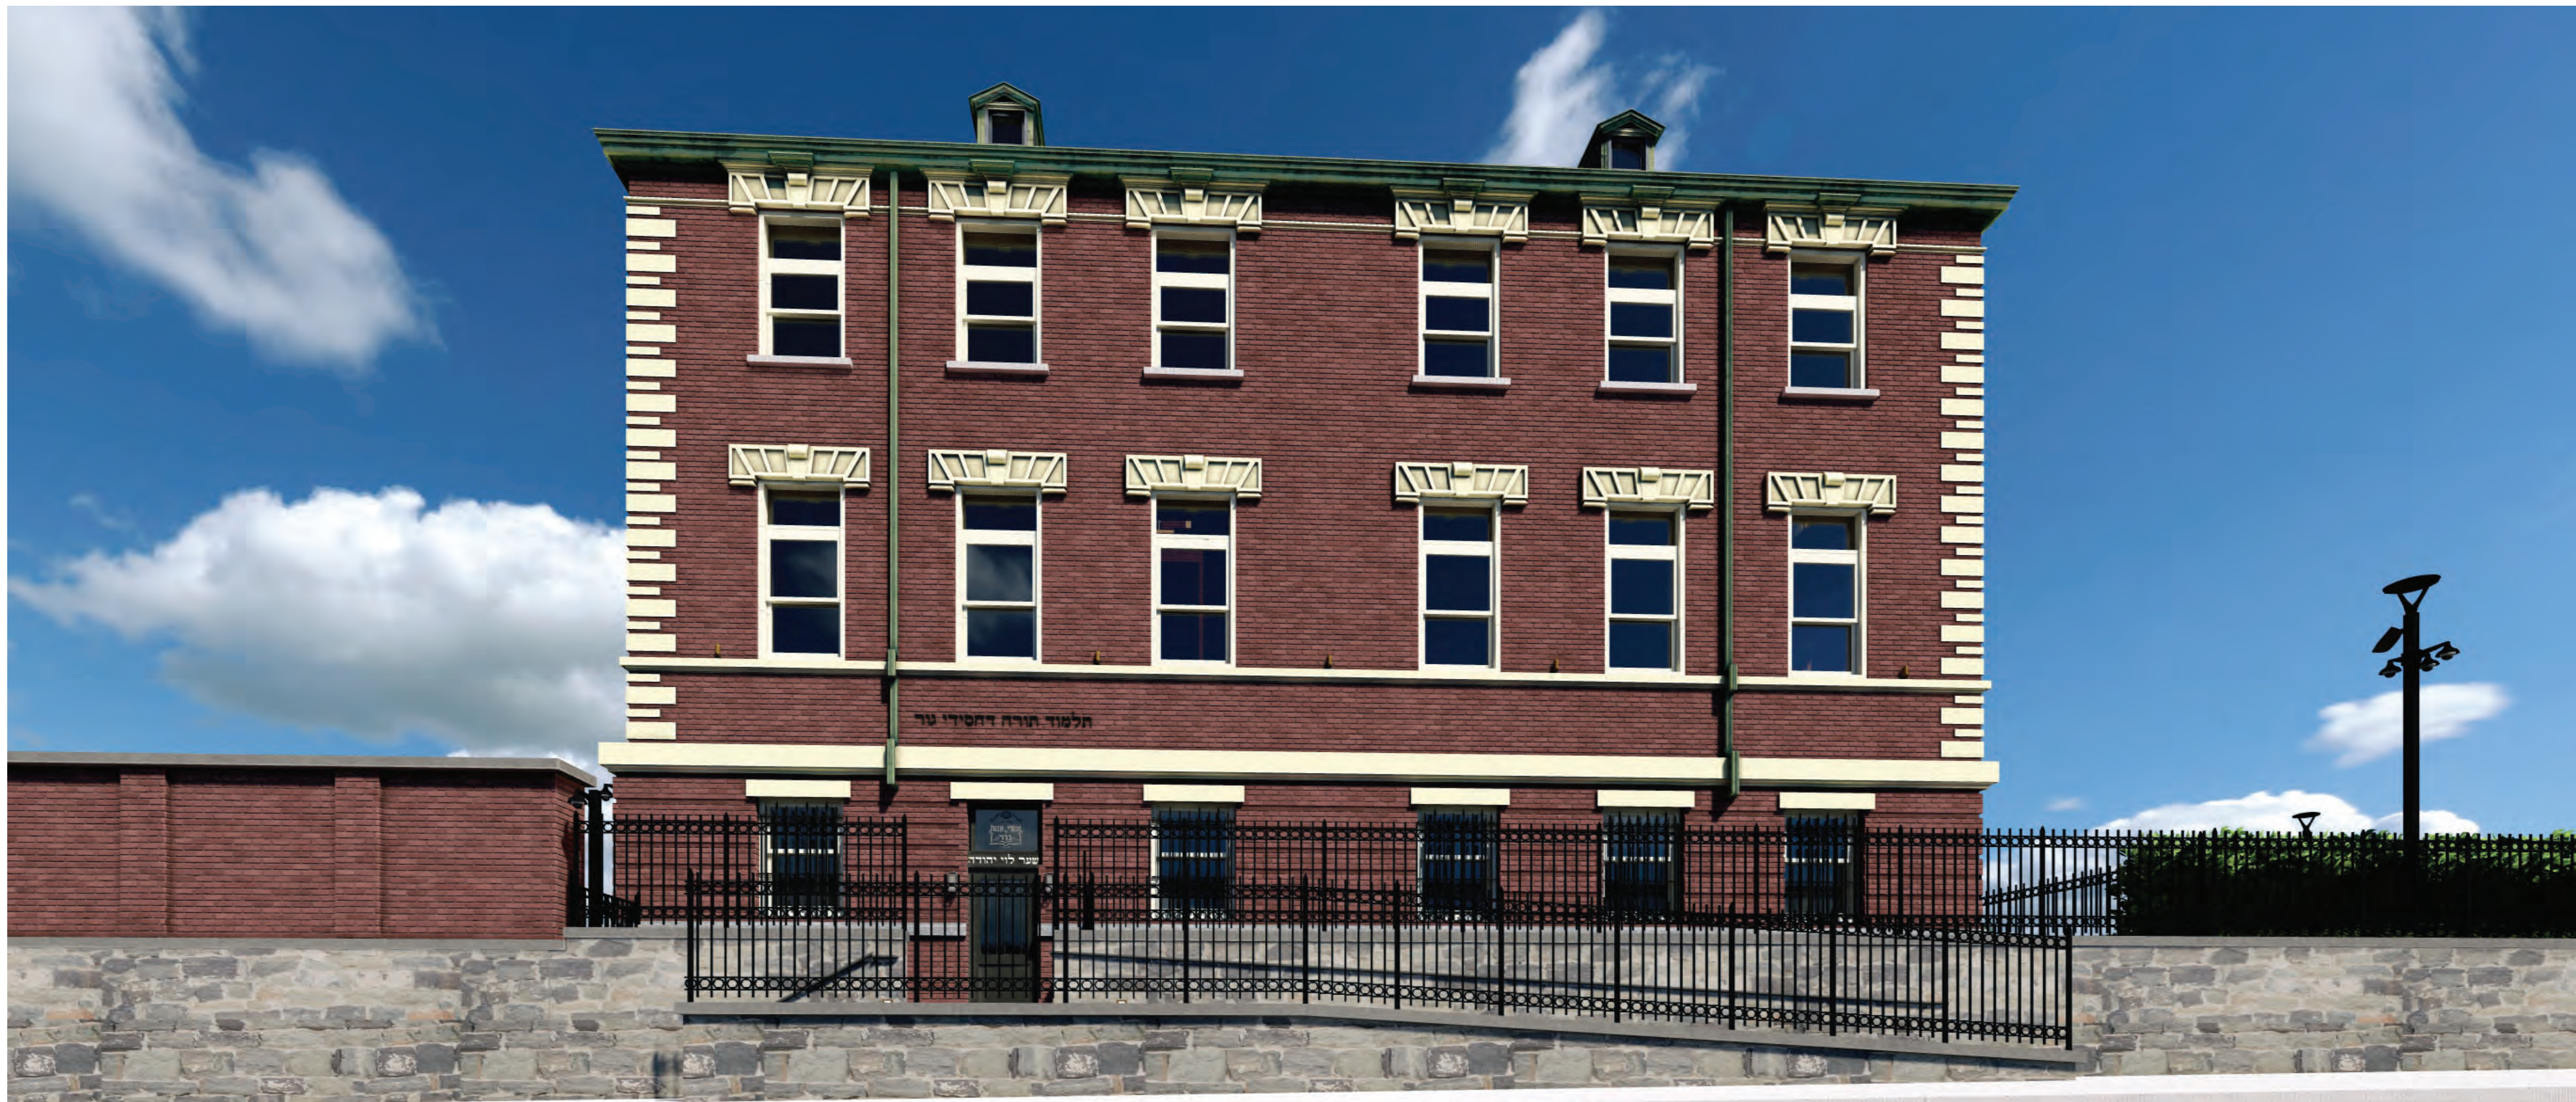
63RD STREET
REVISED RENDERING

- CHANGES:
- TREE IN FRONT OF 63RD ST WING TO BE REMOVED
 - DOWNSPOUTS MATCH COPPER
 - LIGHTING, SPEAKER, AND SECURITY CAMERA FIXTURES MOUNTED ON LIGHT POLES
 - DOORS REVISED TO MATCH HISTORIC IMAGES
 - DOOR AND TRANSOM COLOR REVISED

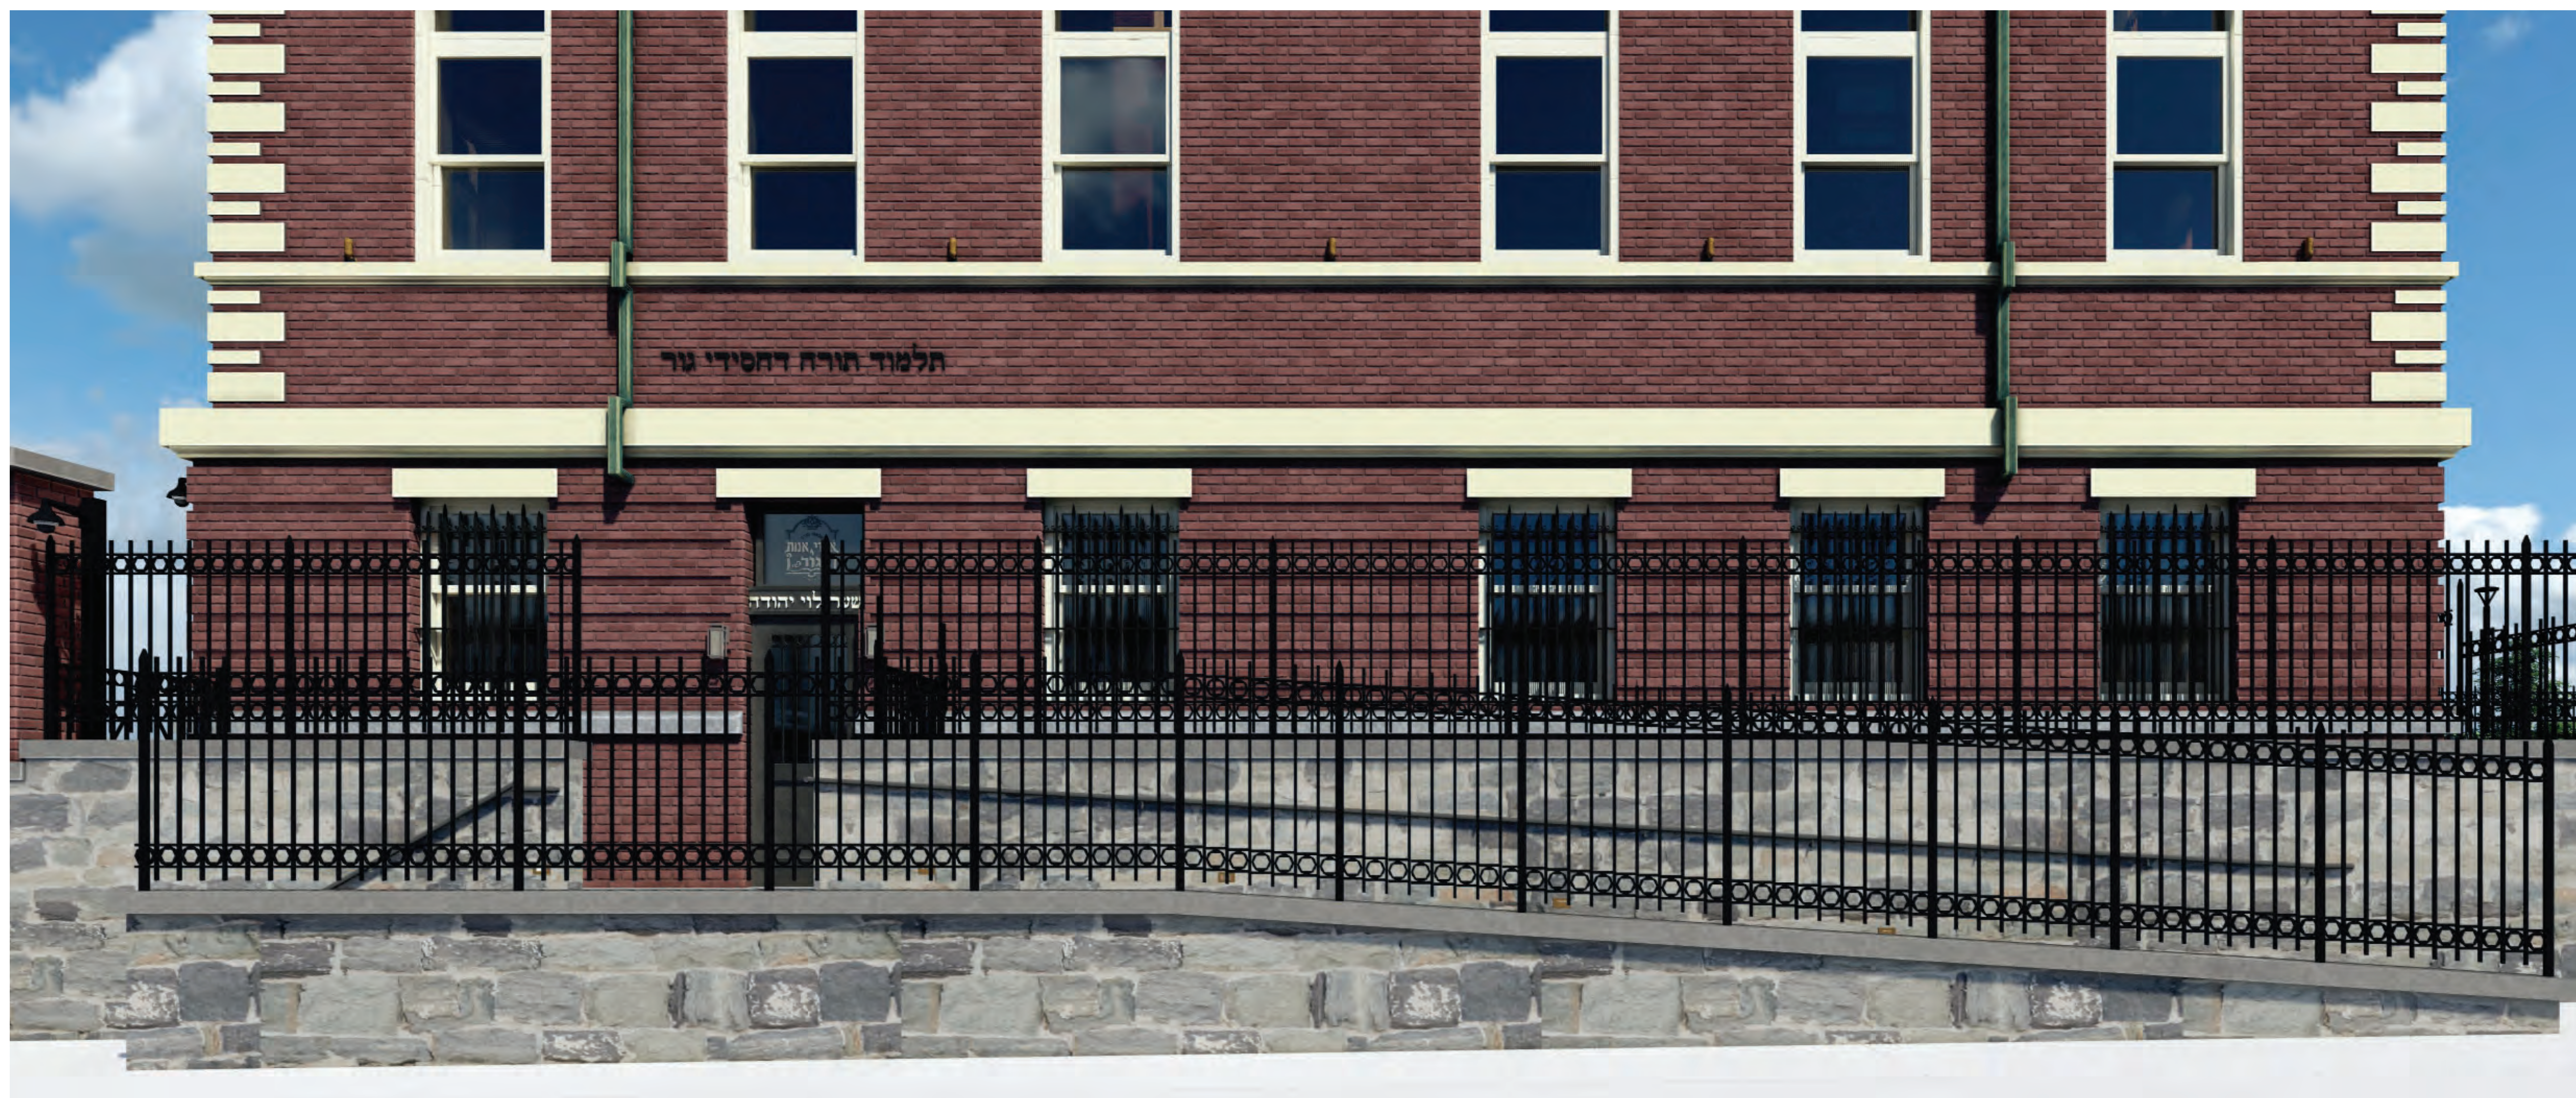
63RD STREET
REVISED RENDERING

- CHANGES:
- TREE IN FRONT OF 63RD ST WING TO BE REMOVED
 - DOWNSPOUTS MATCH COPPER
 - DOORS REVISED TO MATCH HISTORIC IMAGES
 - DOOR AND TRANSOM COLOR REVISED
 - ADDED POLE WITH SECURITY CAMERA

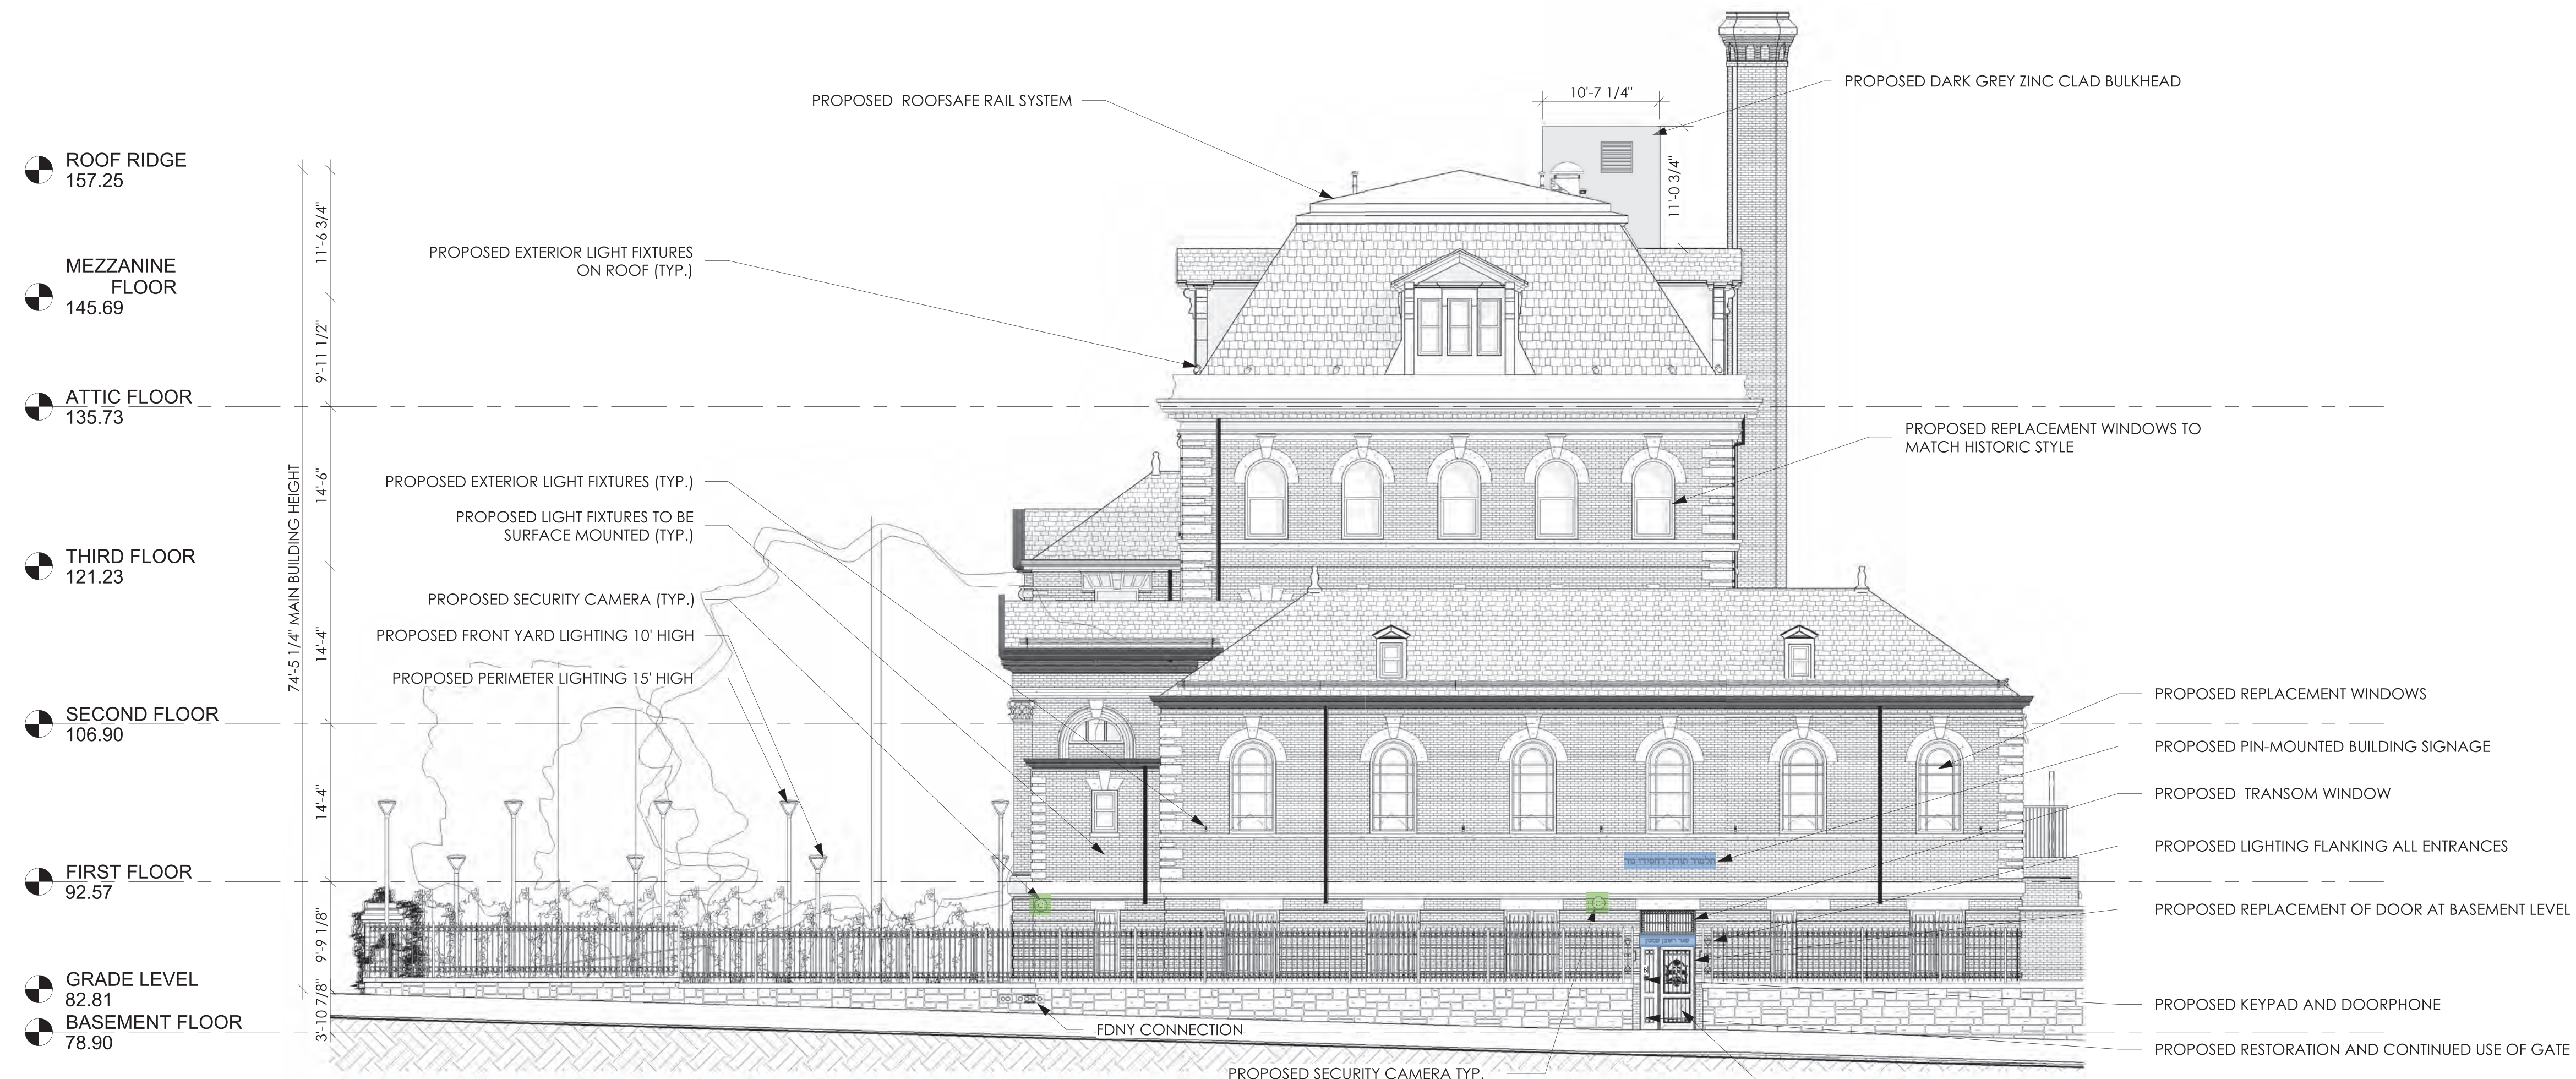
**64TH STREET
PROPOSED ELEVATION**

4 COUNT, HBLED13YA-D10
5 COUNT, LFLED8YA

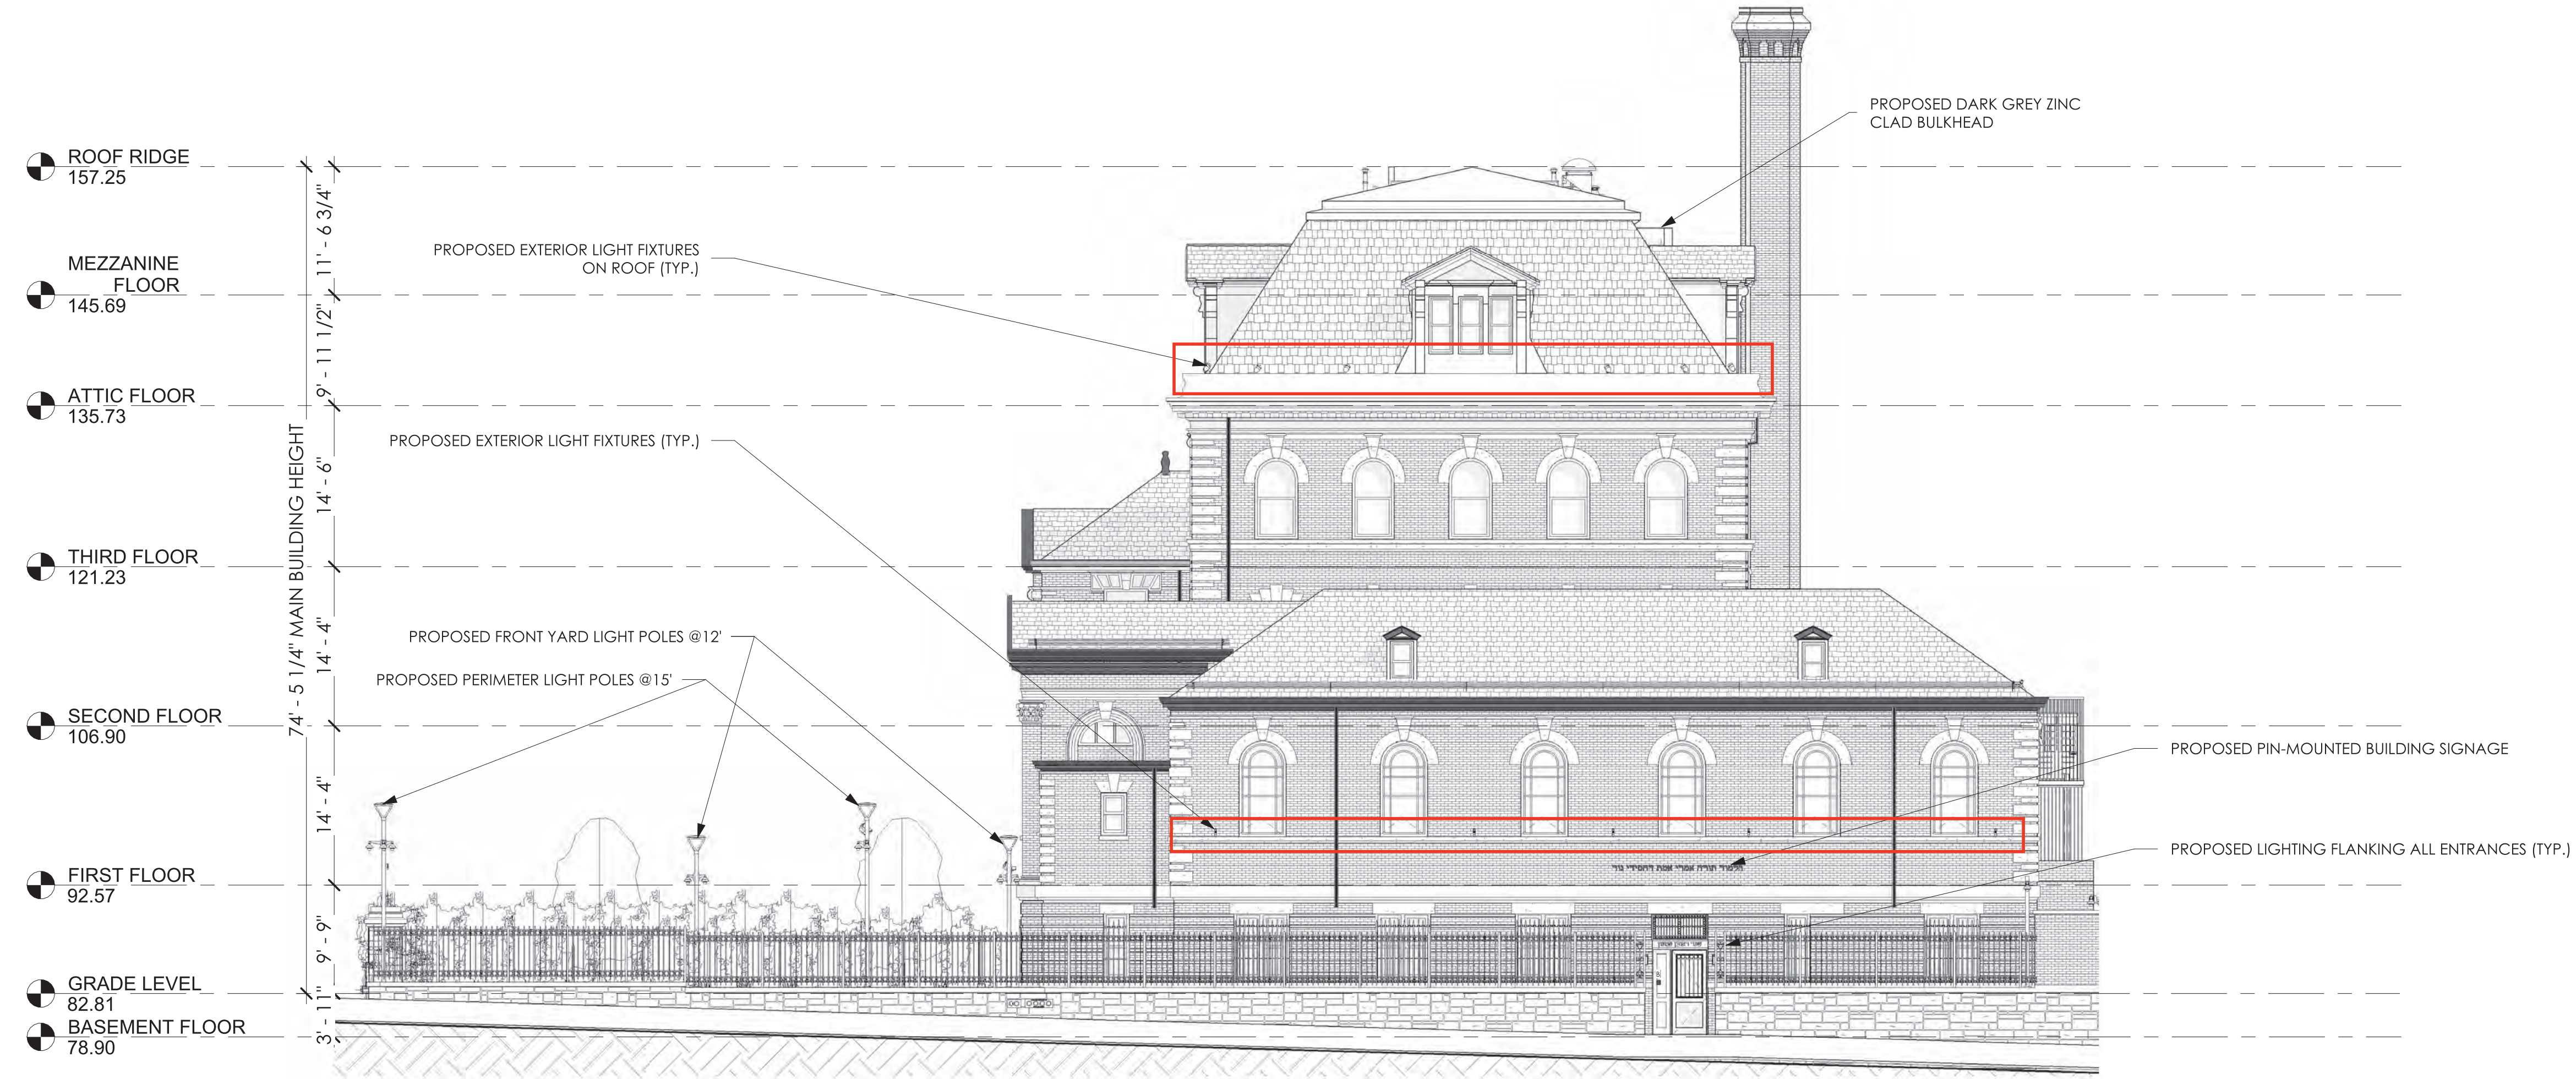
**64TH STREET
REVISED ELEVATION**

- CHANGES:**
- DOORS REVISED TO MATCH HISTORIC IMAGES
 - SECURITY CAMERA FIXTURES REMOVED
 - LIGHTING, SPEAKER, AND SECURITY CAMERA FIXTURES MOUNTED ON LIGHT POLES
 - REVISED LIGHT POLE PLACEMENT
 - ELEVATOR BULKHEAD LOWERED
 - MECHANICAL DUNNAGE WIDENED

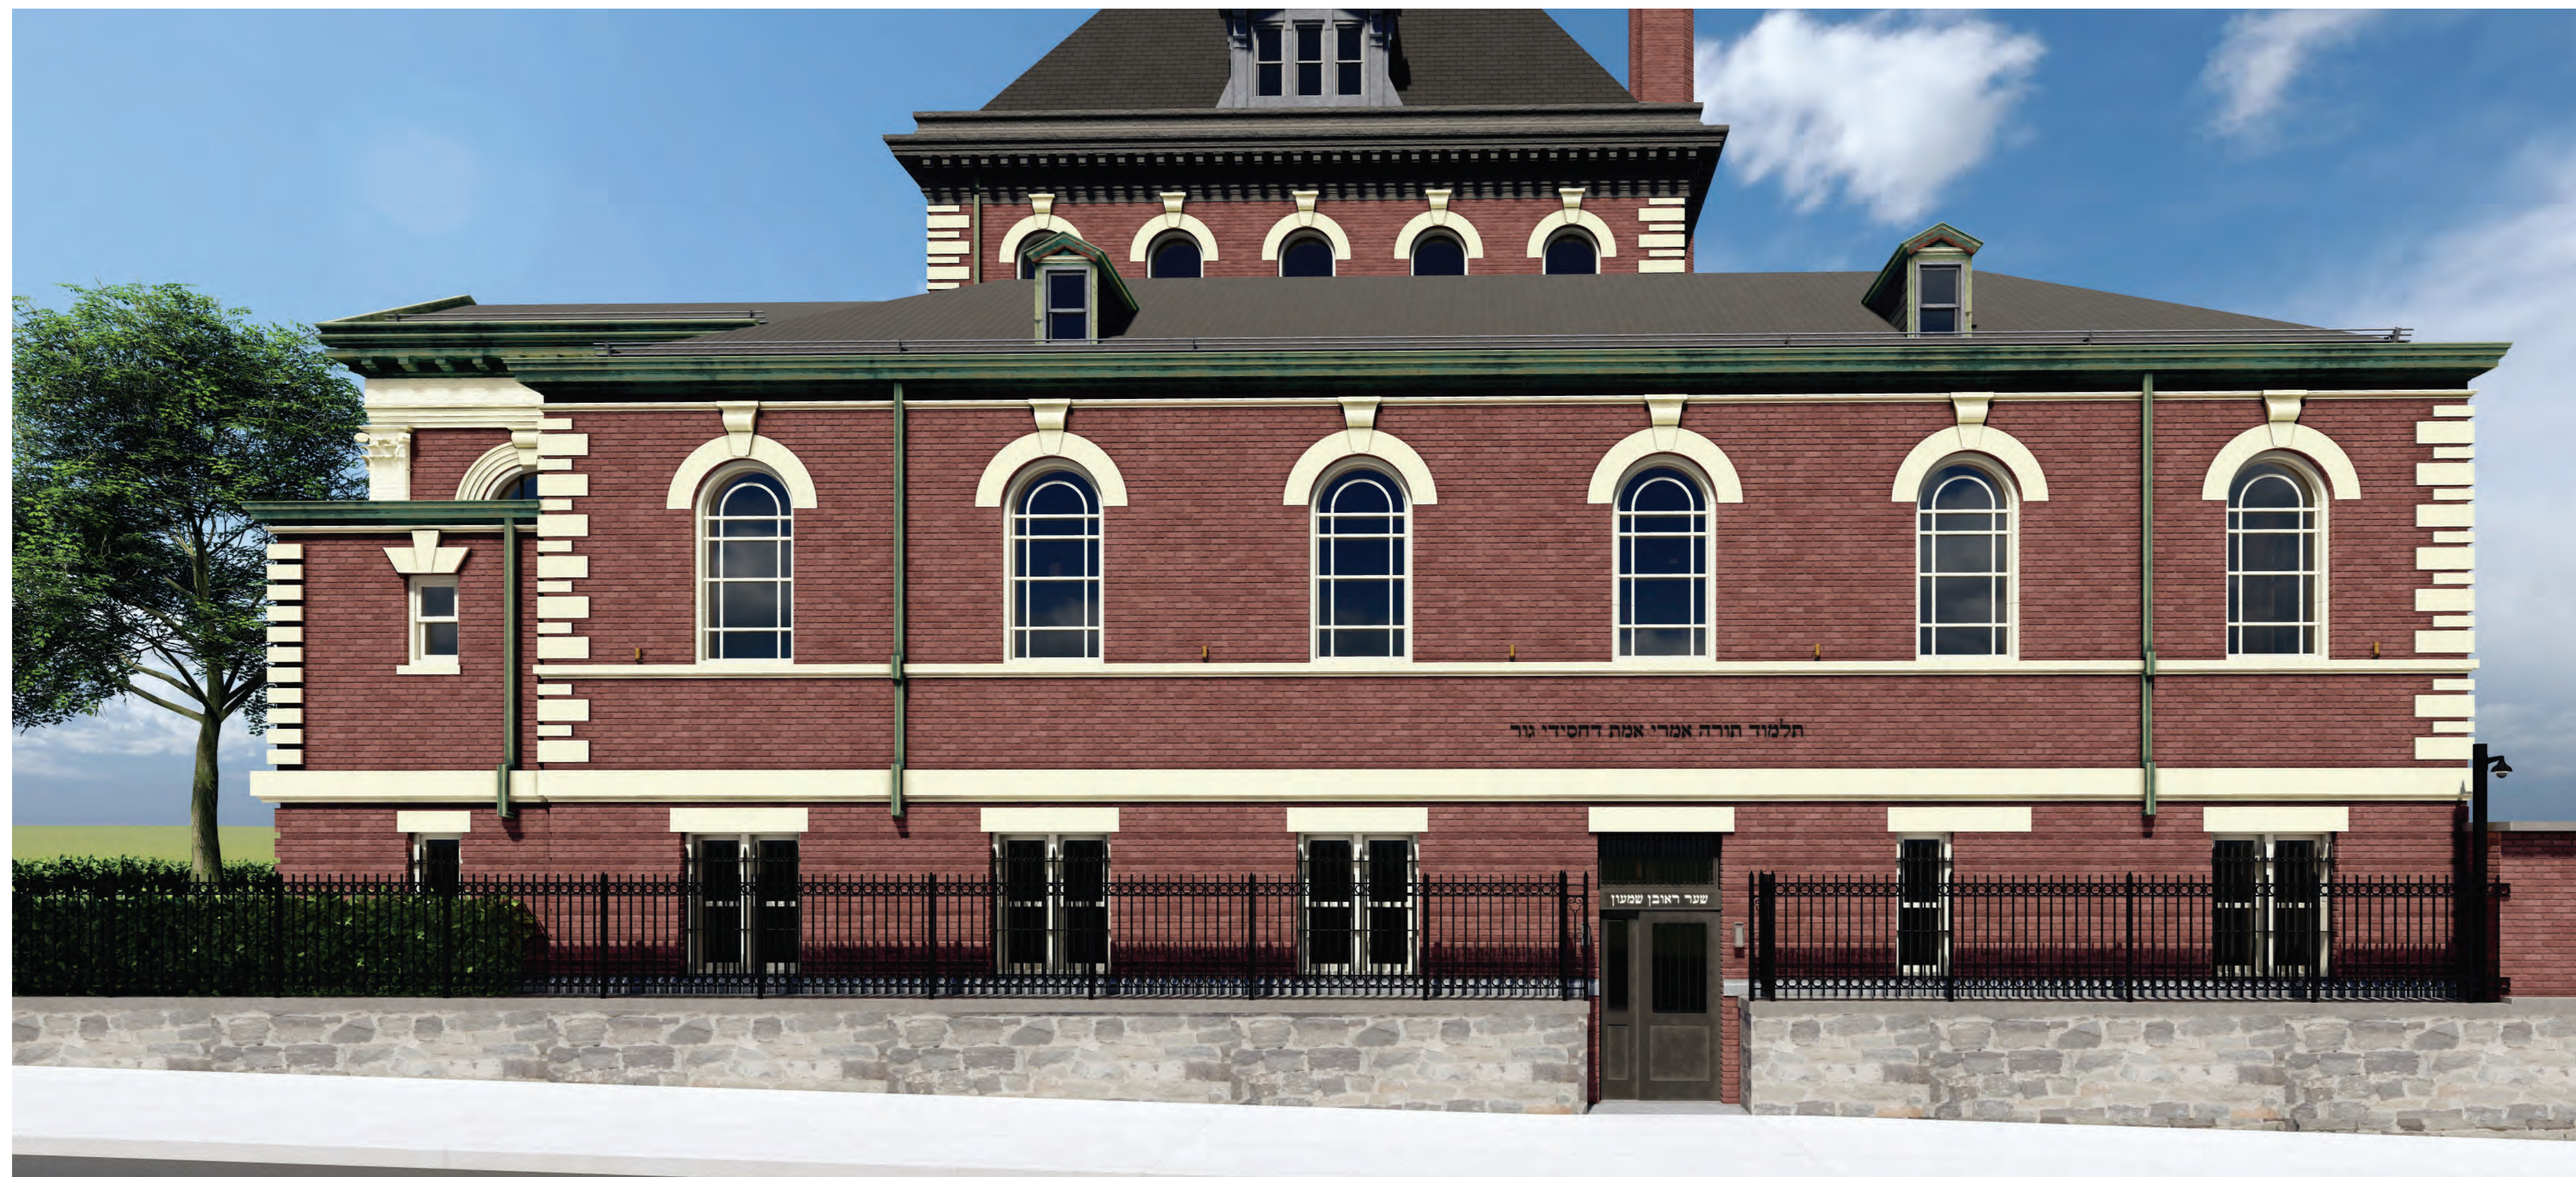
64TH STREET
REVISED RENDERING

- CHANGES:
- DOORS REVISED TO MATCH HISTORIC IMAGES
 - DOOR AND TRANSOM COLOR REVISED
 - DOWNSPOUTS MATCH COPPER
 - FACADE LETTERING EXPANDED TO COMPLETE SCHOOL NAME
 - ADDED POLE WITH SECURITY CAMERA

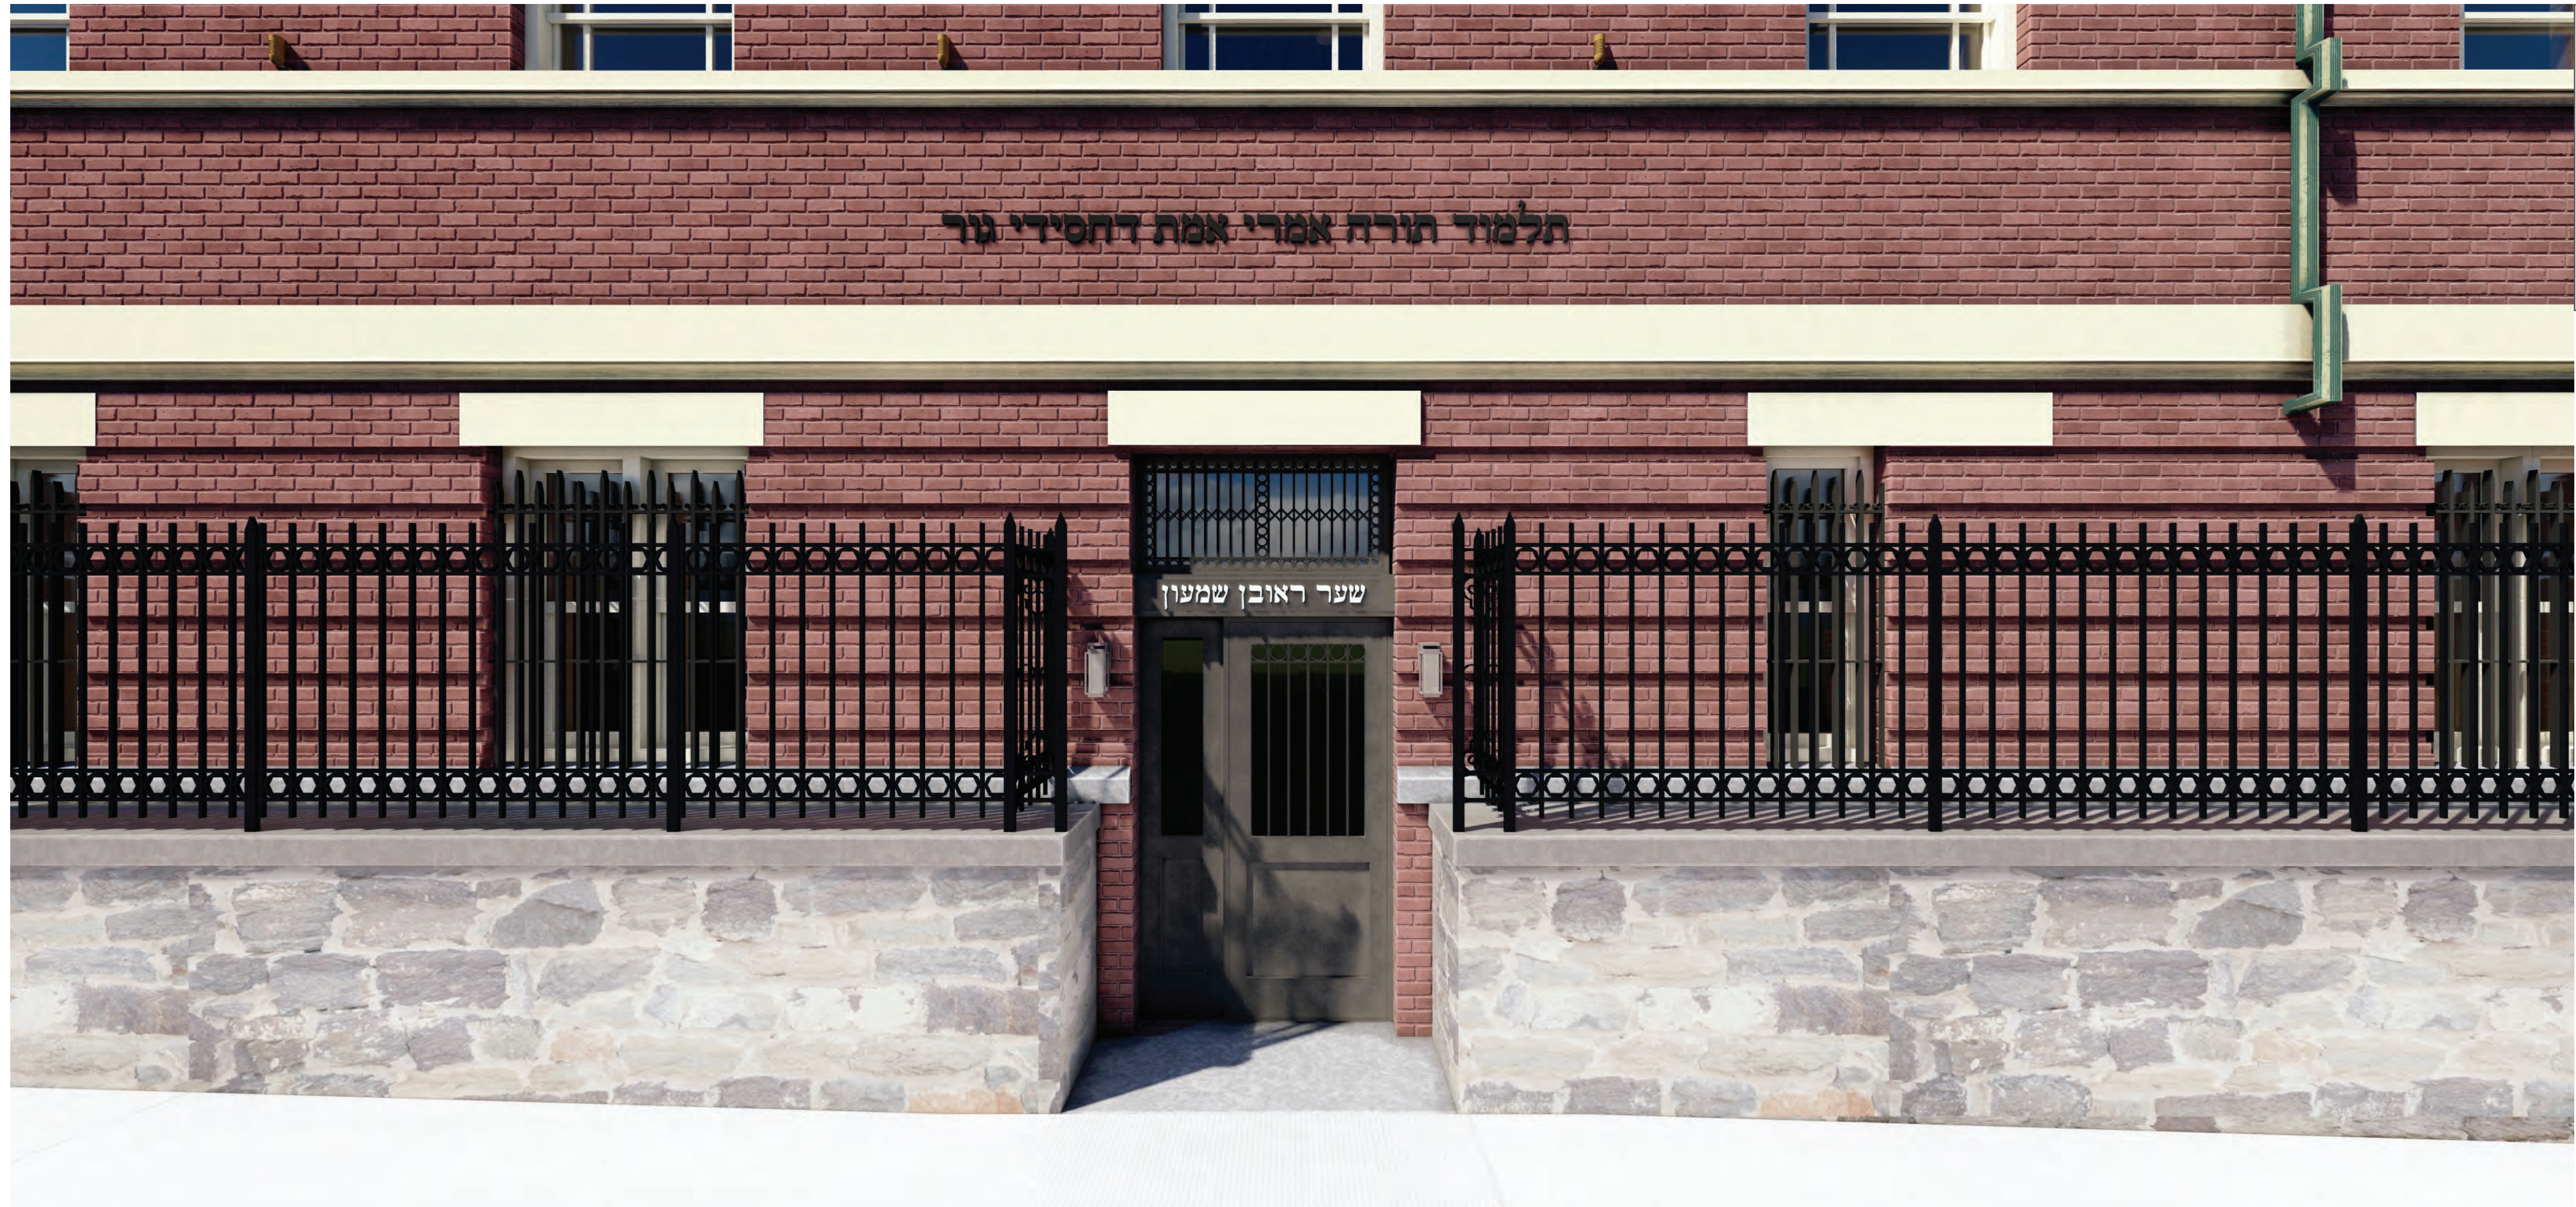
UPPER SIGNAGE ON BUILDING (REVISED)

The "Imrei Emeth" (literally, "The words of truth") (School of) Torah Study, of (the) Ger Hasidic (Dynasty) (i.e. School Name)

- CHANGES:**
- DOORS REVISED TO MATCH HISTORIC IMAGES
 - DOOR AND TRANSOM COLOR REVISED
 - DOWNSPOUTS MATCH COPPER
 - FACADE LETTERING EXPANDED TO COMPLETE SCHOOL NAME

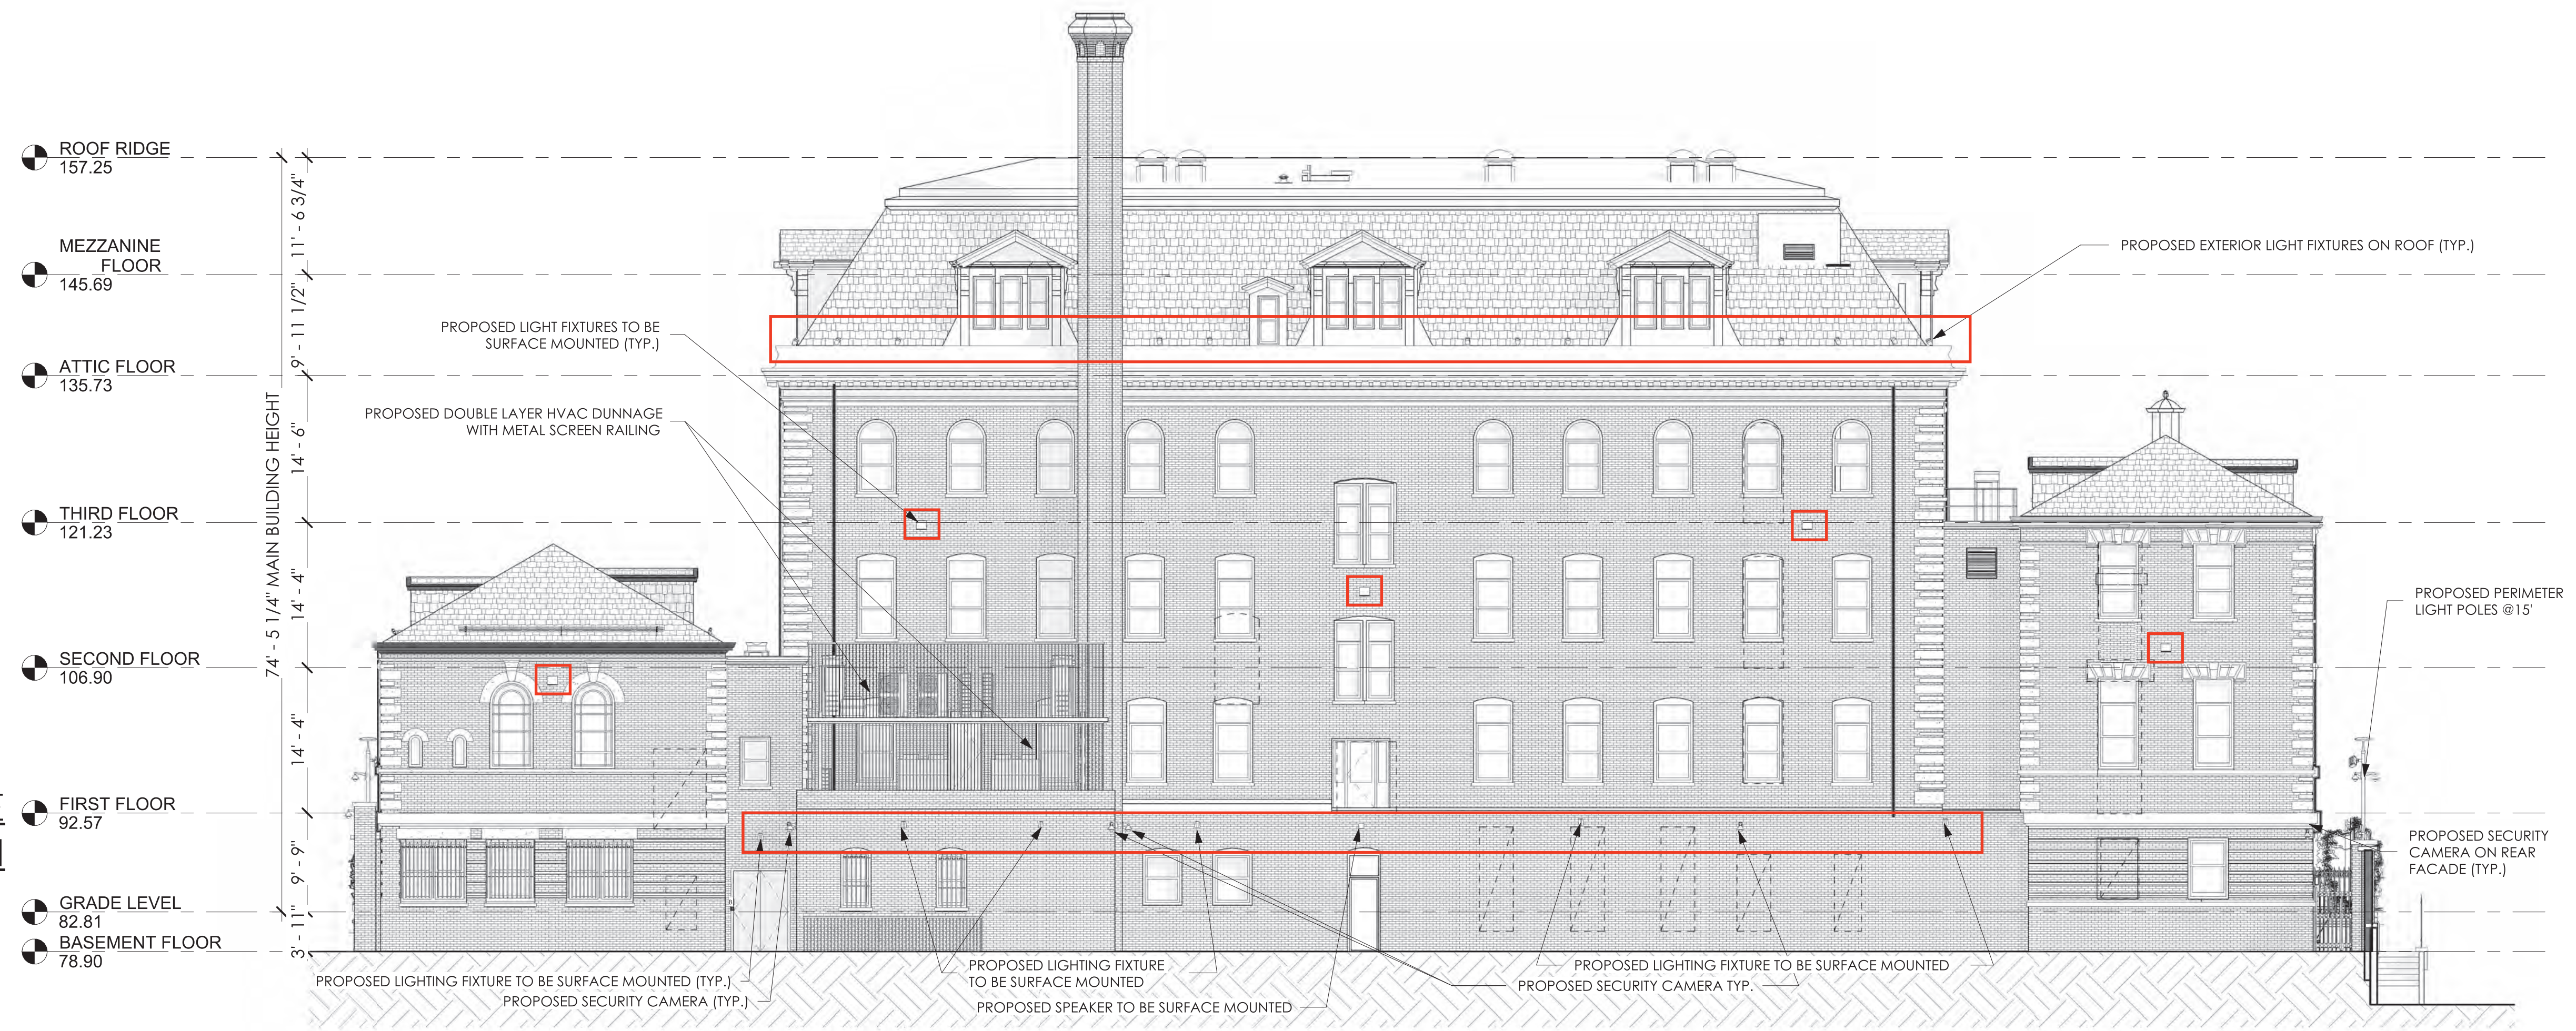
**REAR FACADE
REVISED ELEVATION**

- CHANGES:**
- ELEVATOR BULKHEAD HEIGHT
 - DOWNSPOUTS MATCH COPPER
 - ADDITIONAL REAR FACADE LIGHT AND SECURITY CAMERA FIXTURES
 - NEW MECHANICAL LOUVRE
 - MECHANICAL DUNNAGE WIDENED
