Preservation Department – Item 1, LPC-22-08731

**6301 12th Avenue, aka 6301-6323 12th Avenue, 1202-1216 63rd
Street, and 1201-1215 64th Street – Angel Guardian Home –
Individual Landmark
Borough of Brooklyn**

LPC-22-08731: 6301 12th Avenue, Angel Guardian Home - Individual Landmark

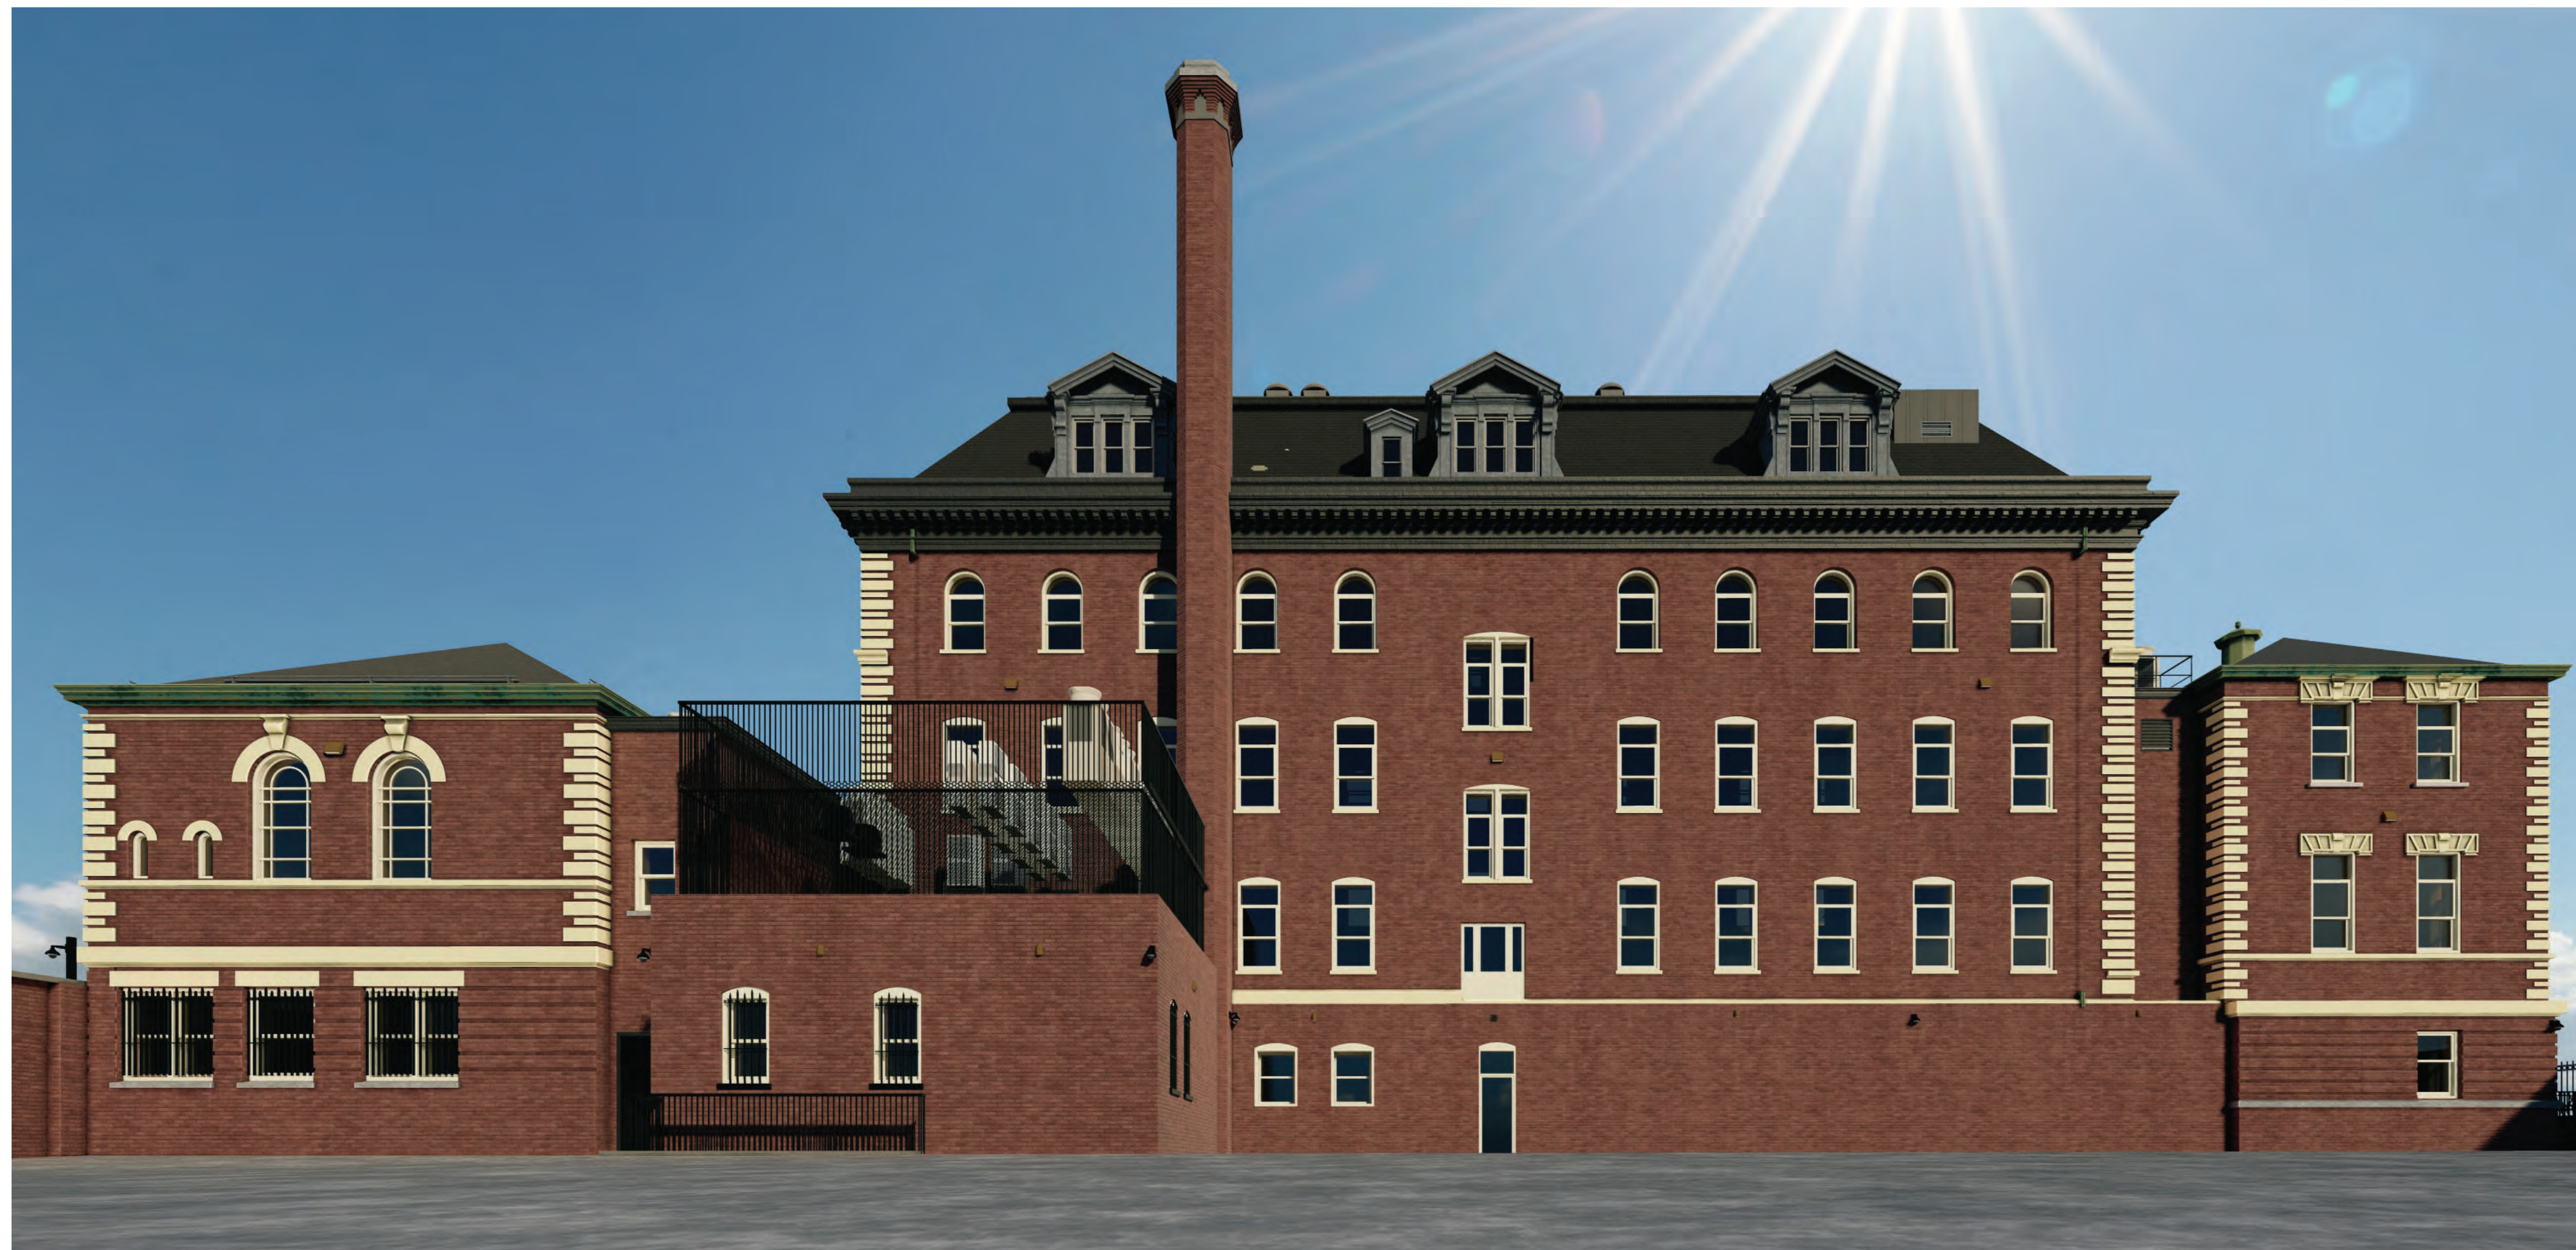
REAR FACADE
REVISED RENDERING

- ELEVATOR BULKHEAD HEIGHT
- DOWNSPOUTS MATCH COPPER
- ADDITIONAL REAR FACADE LIGHT AND SECURITY CAMERA FIXTURES
- NEW MECHANICAL LOUVRE
- MECHANICAL DUNNAGE WIDENED

- WE REVIEWED EXISTING COPPER DOWNSPOUTS WHICH ARE ALL BROKEN AND DISUSED
- WE PROPOSE ALUMINUM LEADERS PAINTED BRIGHT TO MATCH THE CURRENT COPPER MATERIAL AROUND THE BUILDING

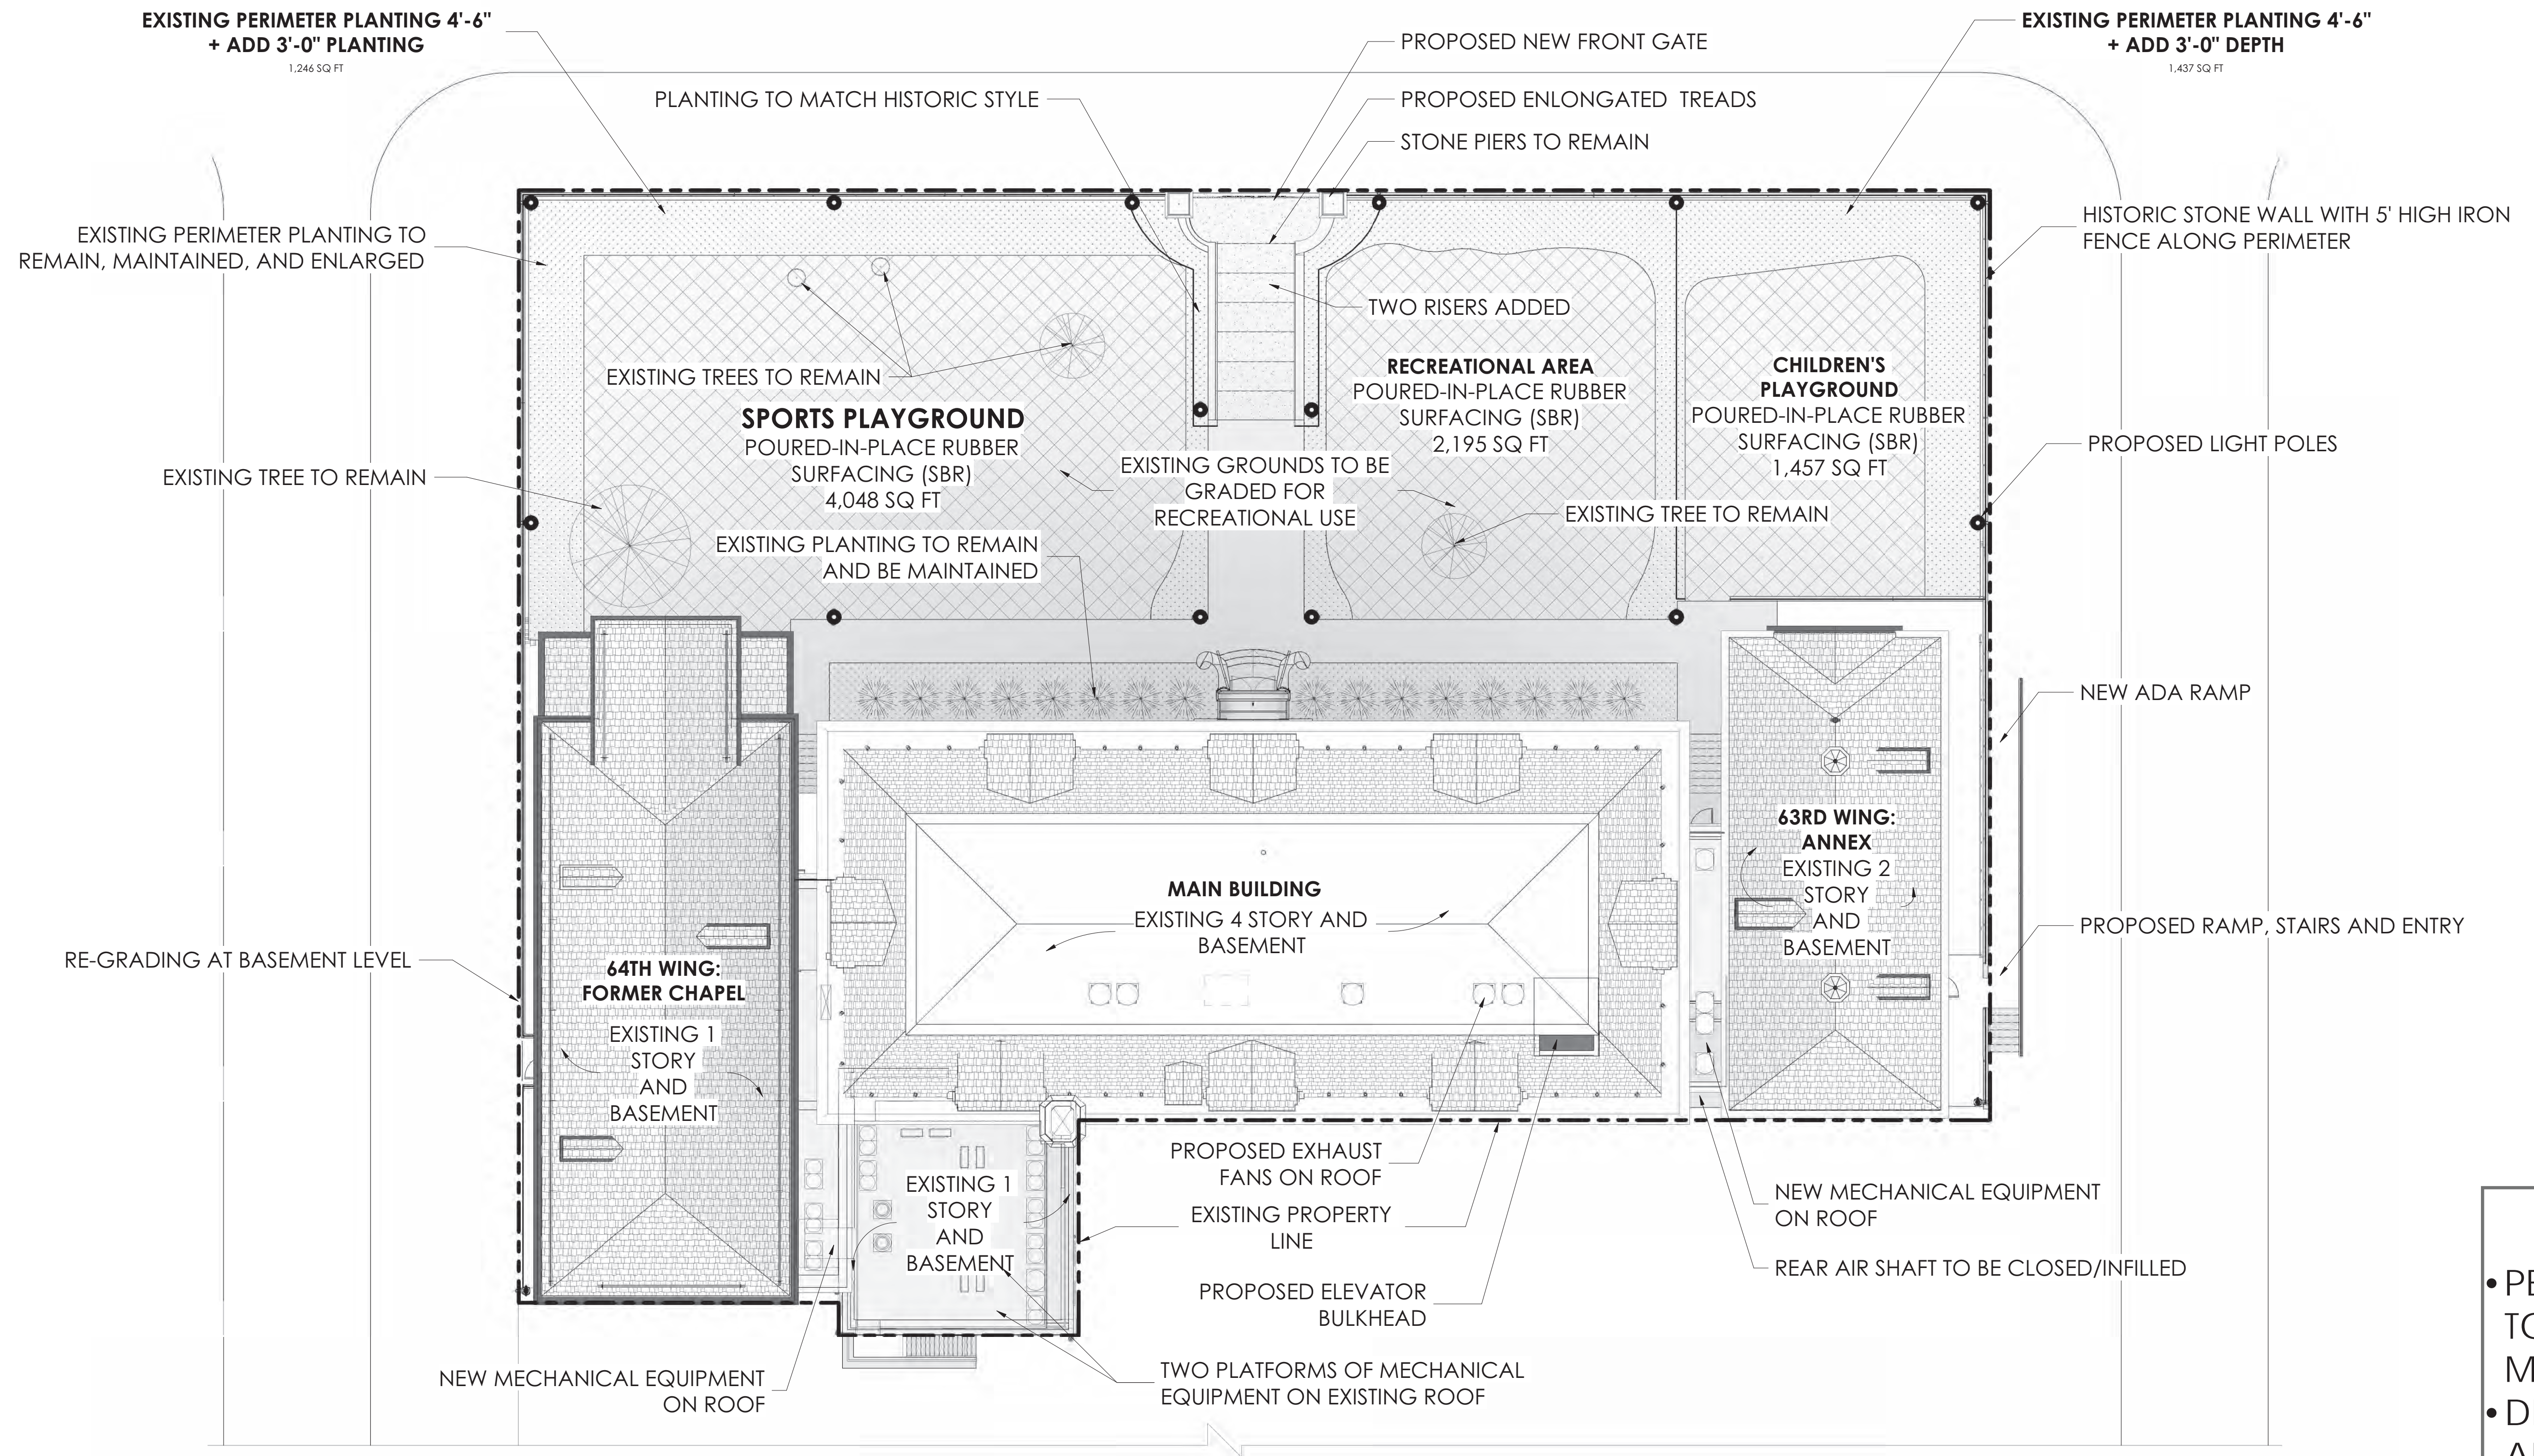
- CHANGES:**
- PERIMETER PLANTING TO BE WIDENED AND MAINTAINED
 - DEVELOPED PLAY AREAS AND DIVIDED UP THE Poured RUBBER PLAY SPACES
 - PLACED GRASS BORDER THROUGHOUT THE PLAY SPACES
 - LESSEned THE AMOUNT OF POLES IN THE FRON YARD

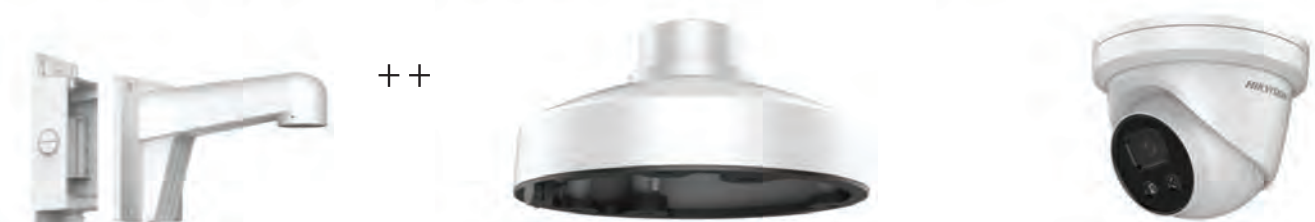
PROPOSED EXTERIOR SECURITY CAMERAS - ALUMINUM ALLOY, WITH SURFACE SPRAY TREATMENT (Hikvision White)

WML Wall Mount with Junction Box - Long
PC140 Pendant cap for dome camera
PCI-T18F4S AcuSense 8 MP IR Fixed Turret Network Camera

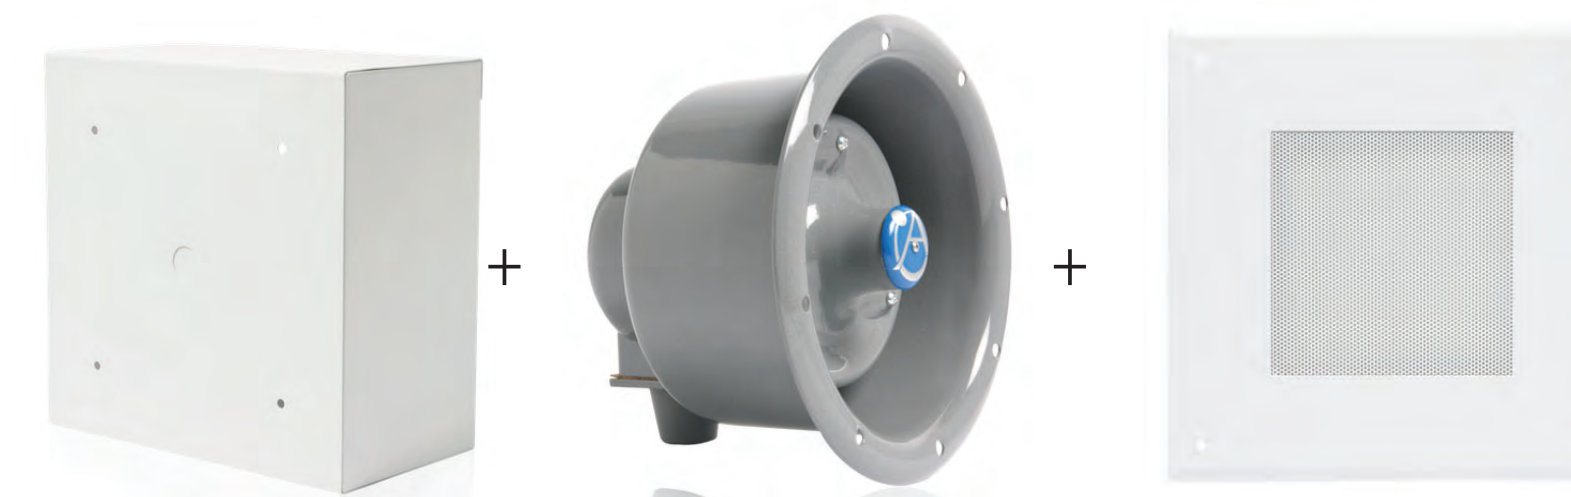
PROPOSED EXTERIOR SPEAKER (WALL MOUNTED)

1. APF Series Square Surface Enclosure 6 inch deep
2. Flanged Emergency Horn Speaker with 15-Watt 25V/70V Transformer
3. APF Series Square Recessed Grille

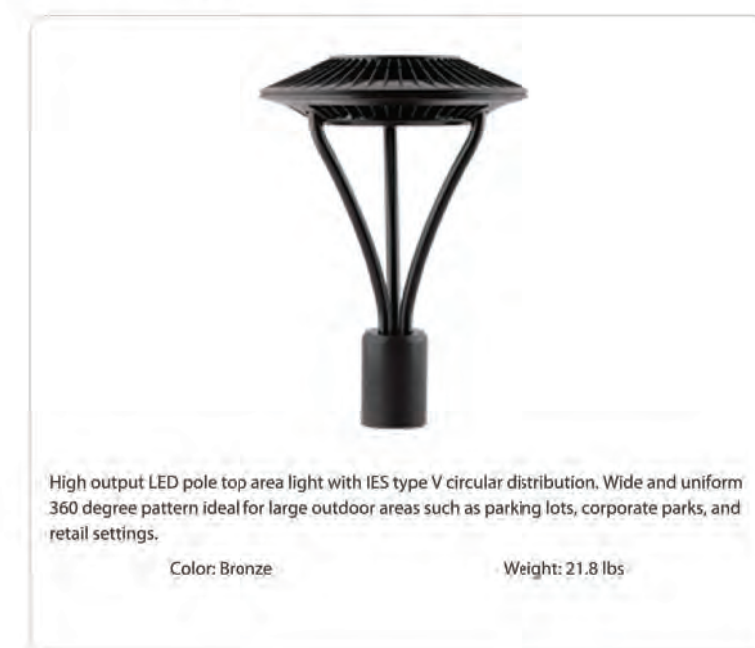
ALED5T78Y/D10

Technical Specifications
Compliance
UL Listed: Suitable for wet locations
IESNA LM-79 & IESNA LM-80 Testing
RAB LED luminaires and LED components have been tested by an independent laboratory in accordance with IESNA LM-79 and LM-80.

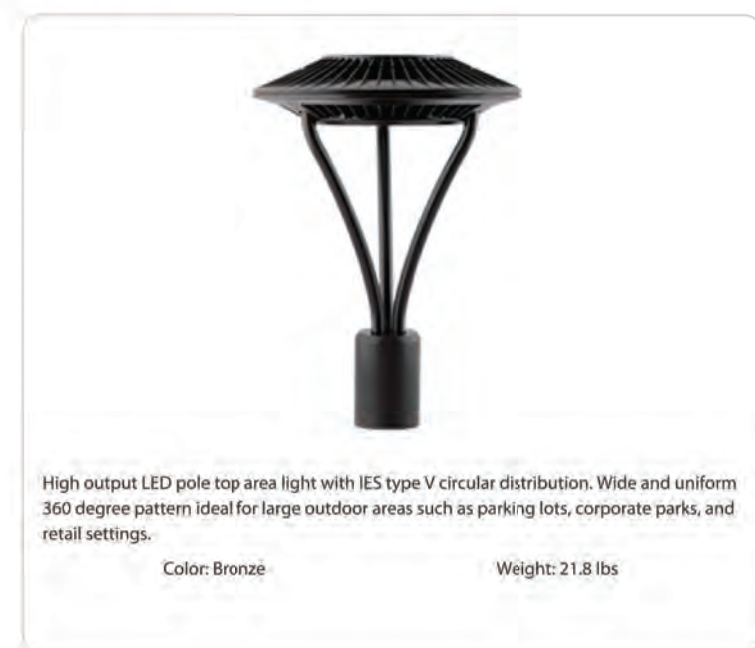
ALED5T26Y/D10

Technical Specifications
Compliance
UL Listed: Suitable for wet locations
IESNA LM-79 & IESNA LM-80 Testing
RAB LED luminaires and LED components have been tested by an independent laboratory in accordance with IESNA LM-79 and LM-80.

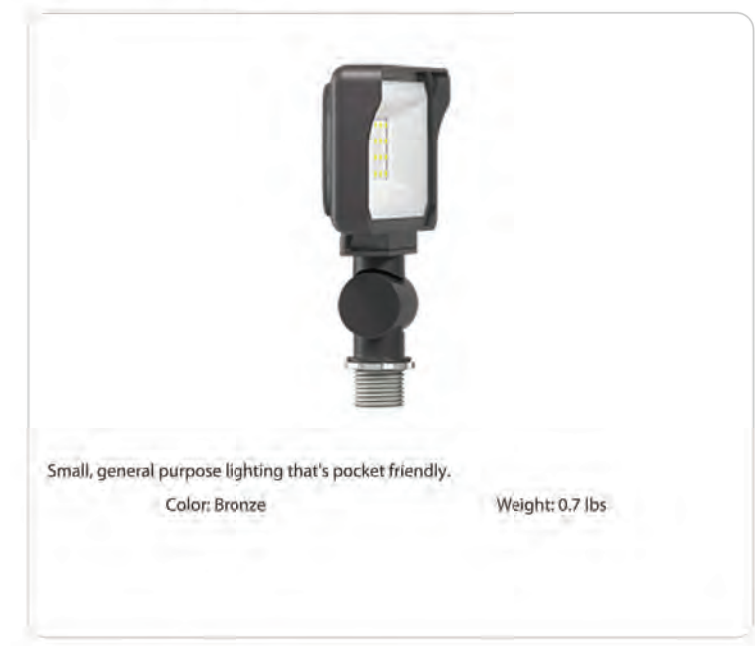
X34-16L-830/120

Technical Specifications
Compliance
UL Listed: Suitable for wet locations. Suitable for ground mounting.
IESNA LM-79 & LM-80 Testing
RAB LED luminaires and LED components have been tested by an independent laboratory in accordance with IESNA LM-79 and LM-80.

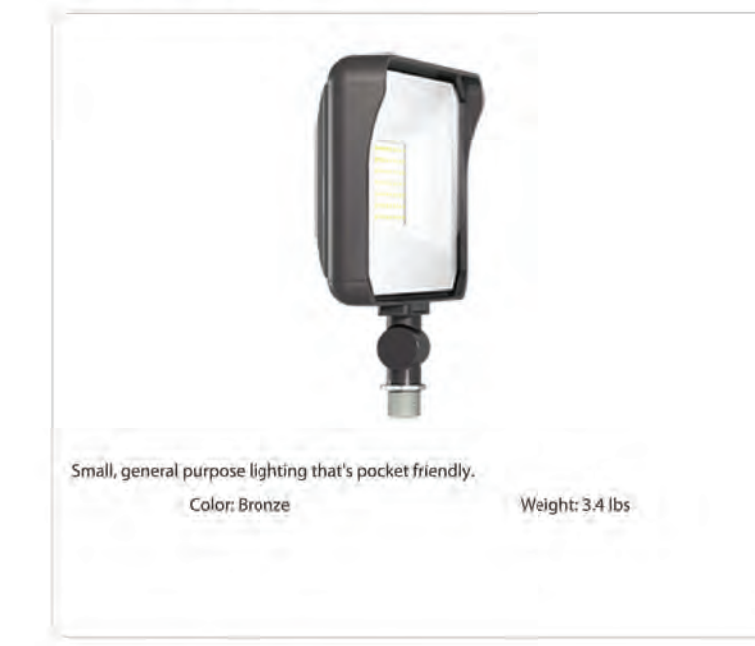
X34-55L-830/120

Technical Specifications
Compliance
UL Listed: Suitable for wet locations. Suitable for ground mounting.
IESNA LM-79 & LM-80 Testing
RAB LED luminaires and LED components have been tested by an independent laboratory in accordance with IESNA LM-79 and LM-80.

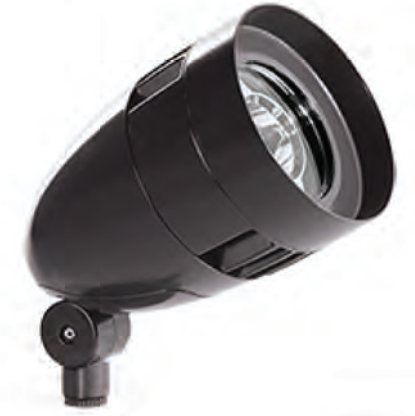
HBLED13YA/D10

Color: Bronze Weight: 4.8 lbs

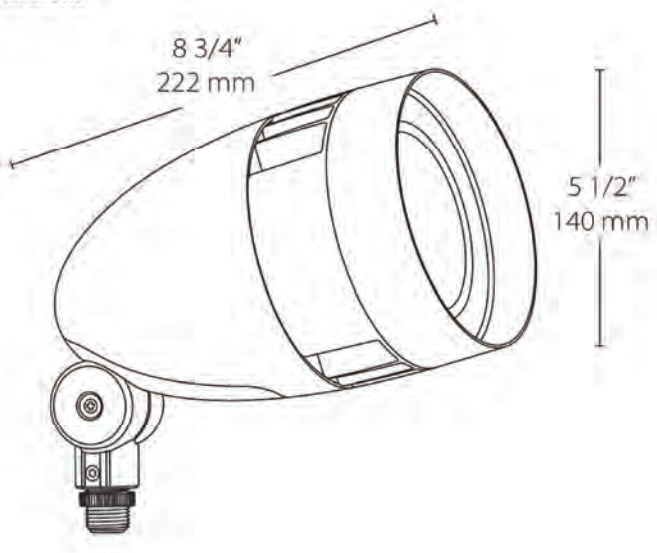
Dimensions

8 3/4" 222 mm
 5 1/2" 140 mm

Features
 80% energy savings vs. PAR floods
 Mount on junction box or on RAB Mighty Post
 Patent-pending "Air-Flow" technology
 5-Year, No-Compromise Warranty

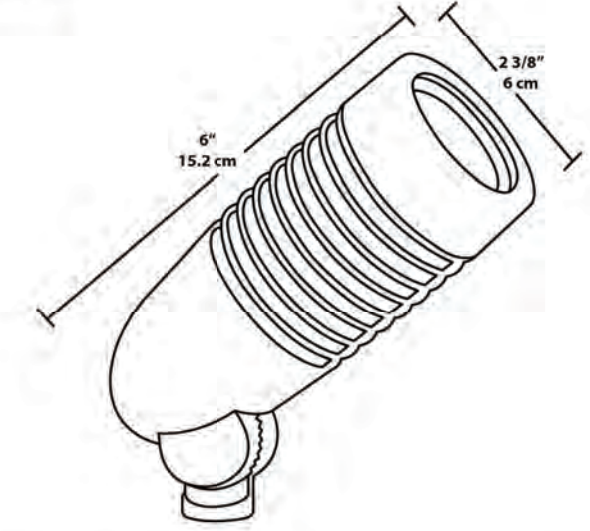
Dimensions

6" 152.4mm
 2.31" 59mm

Features
 Microprismatic diffuser produces a smooth distribution and low glare
 4H x 4V NEMA beam spread
 Optional spot and narrow spot hood reflectors available
 Runs cool; prevents burning foliage or fingers
 5-Year, No-Compromise Warranty

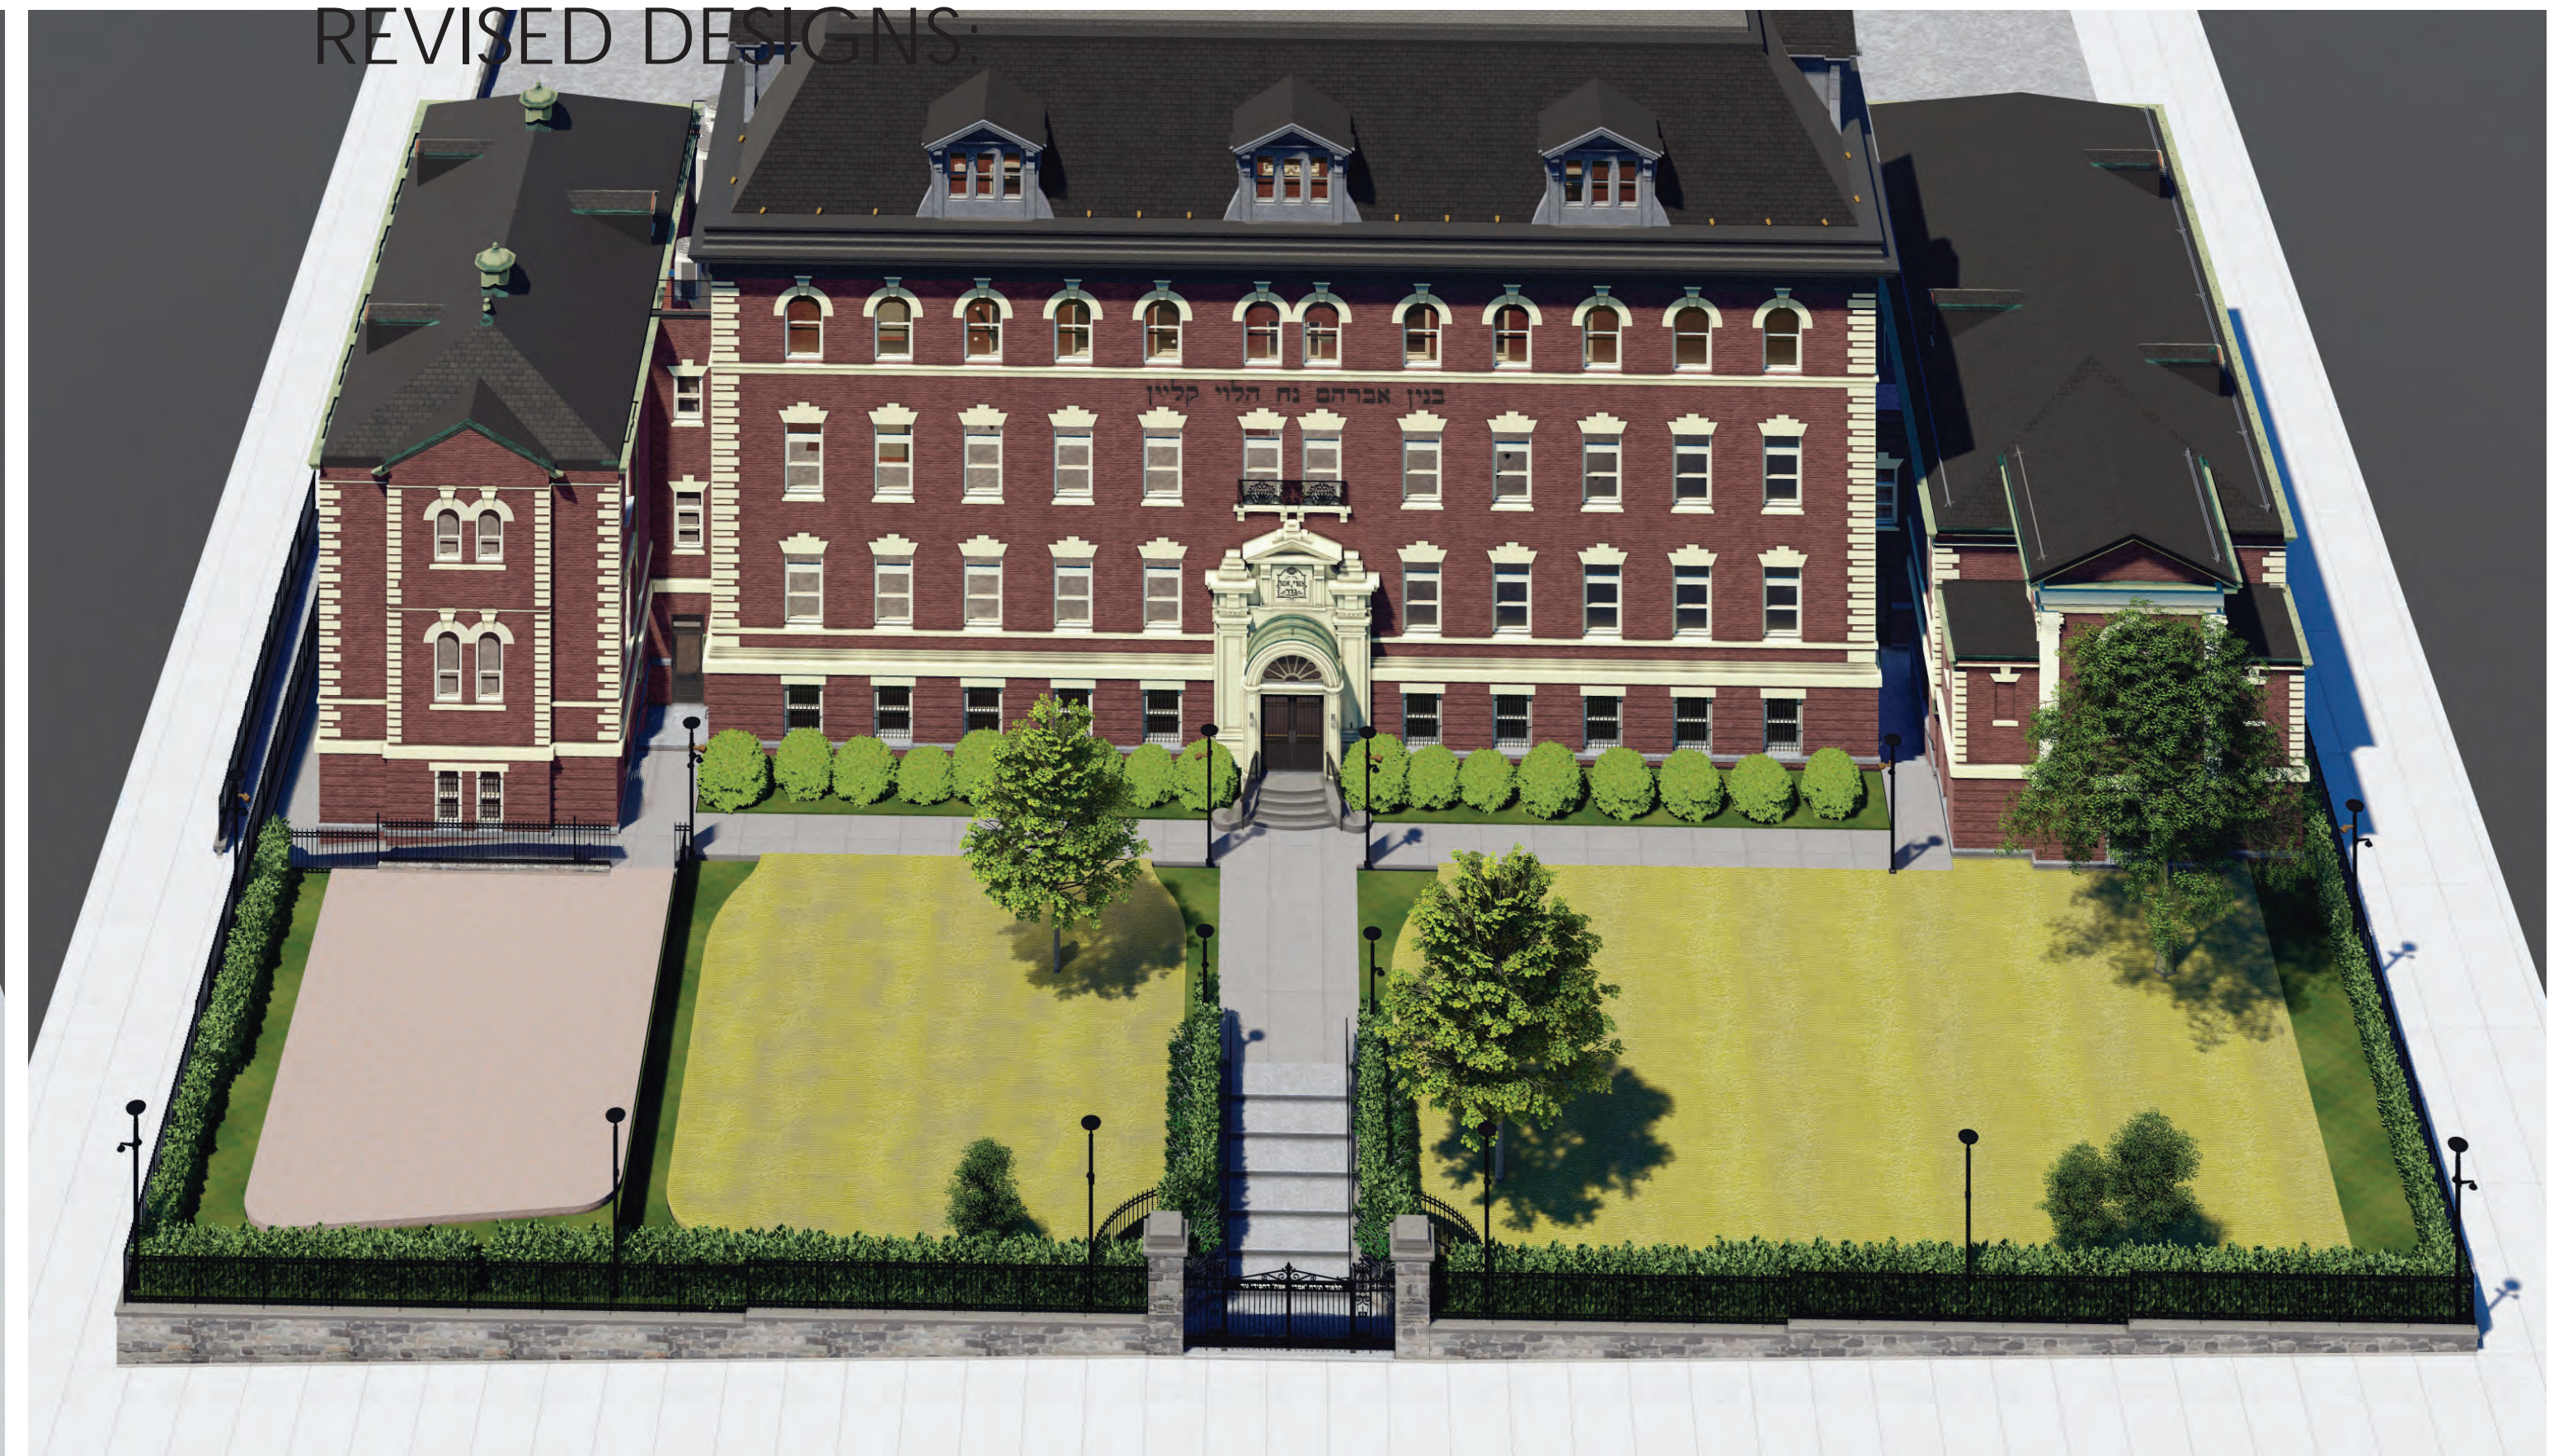
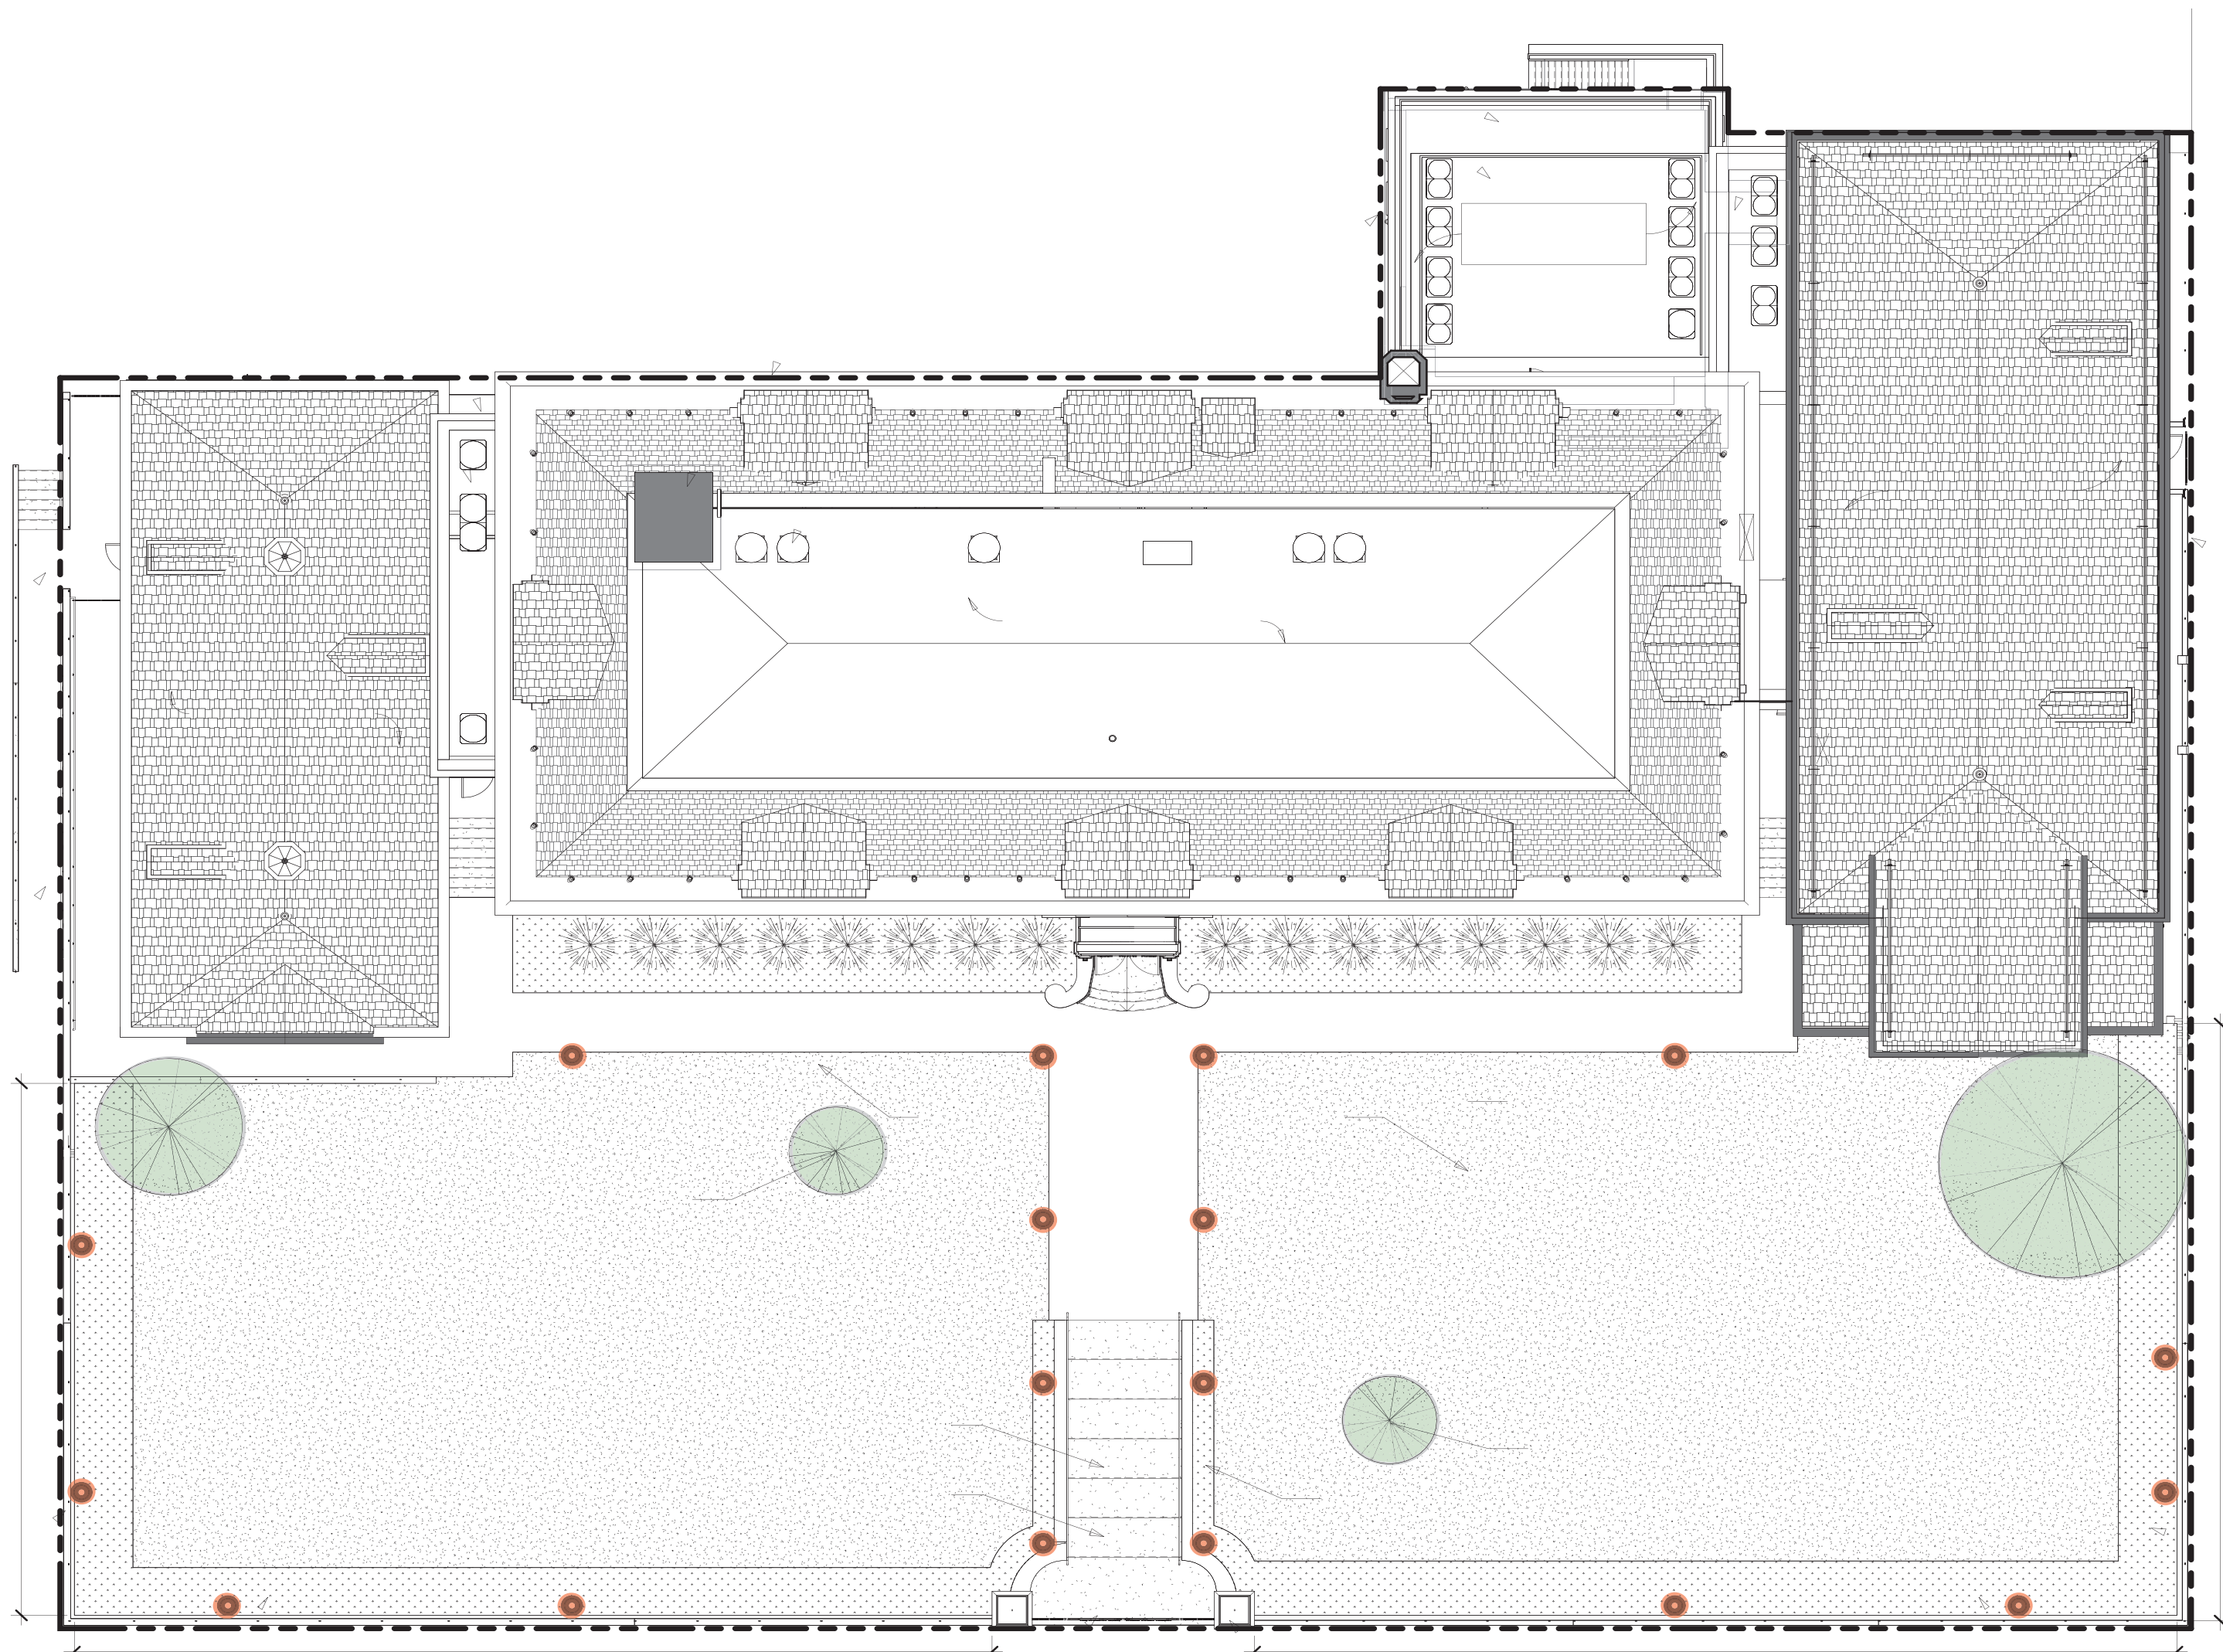
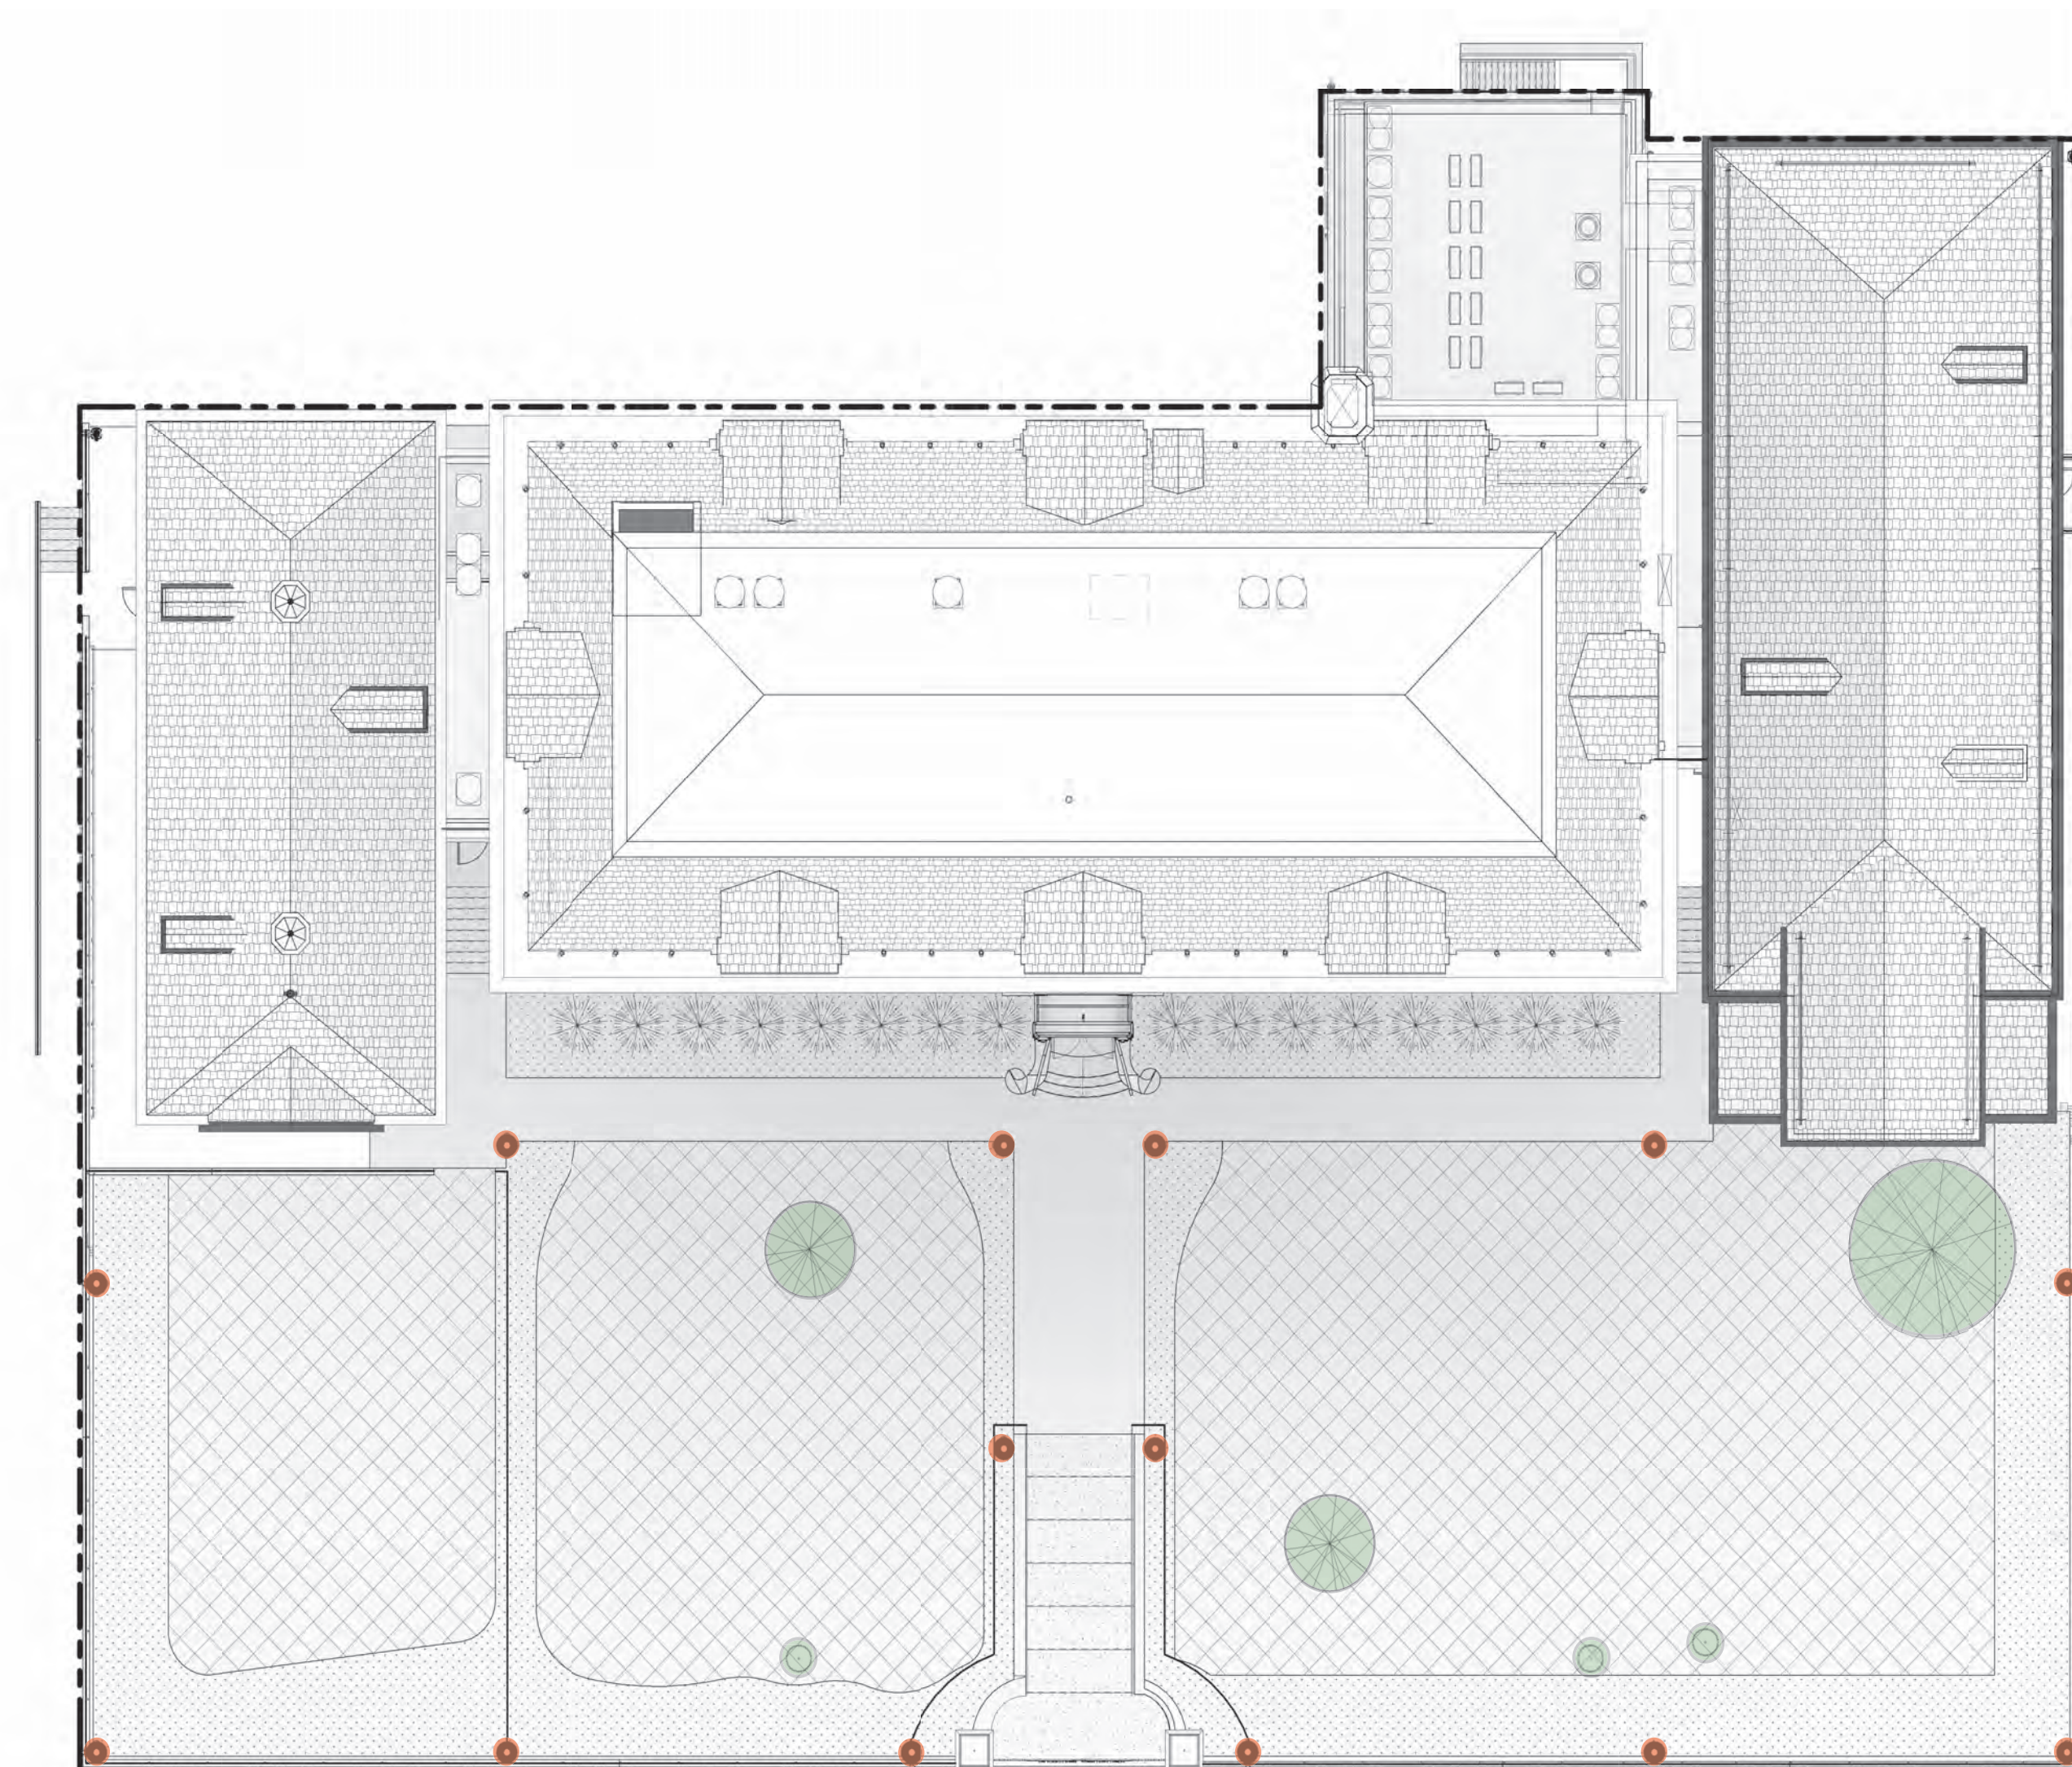
REVISED DESIGNS:

- PERIMETER PLANTING TO BE WIDENED AND MAINTAINED
- DEVELOPED PLAY AREAS AND DIVIDED UP THE POURED RUBBER PLAY SPACES
- PLACED GRASS BORDER THROUGHOUT THE PLAY SPACES
- REVISED LIGHT POLE PLACEMENT
- TREE IN FRONT OF 63RD ST WING TO BE REMOVED
- ADDITIONAL TREES TO REMAIN
