Preservation Department – Item 1, LPC-22-08731

**6301 12th Avenue, aka 6301-6323 12th Avenue, 1202-1216 63rd
Street, and 1201-1215 64th Street – Angel Guardian Home –
Individual Landmark
Borough of Brooklyn**

LPC-22-08731: 6301 12th Avenue, Angel Guardian Home - Individual Landmark

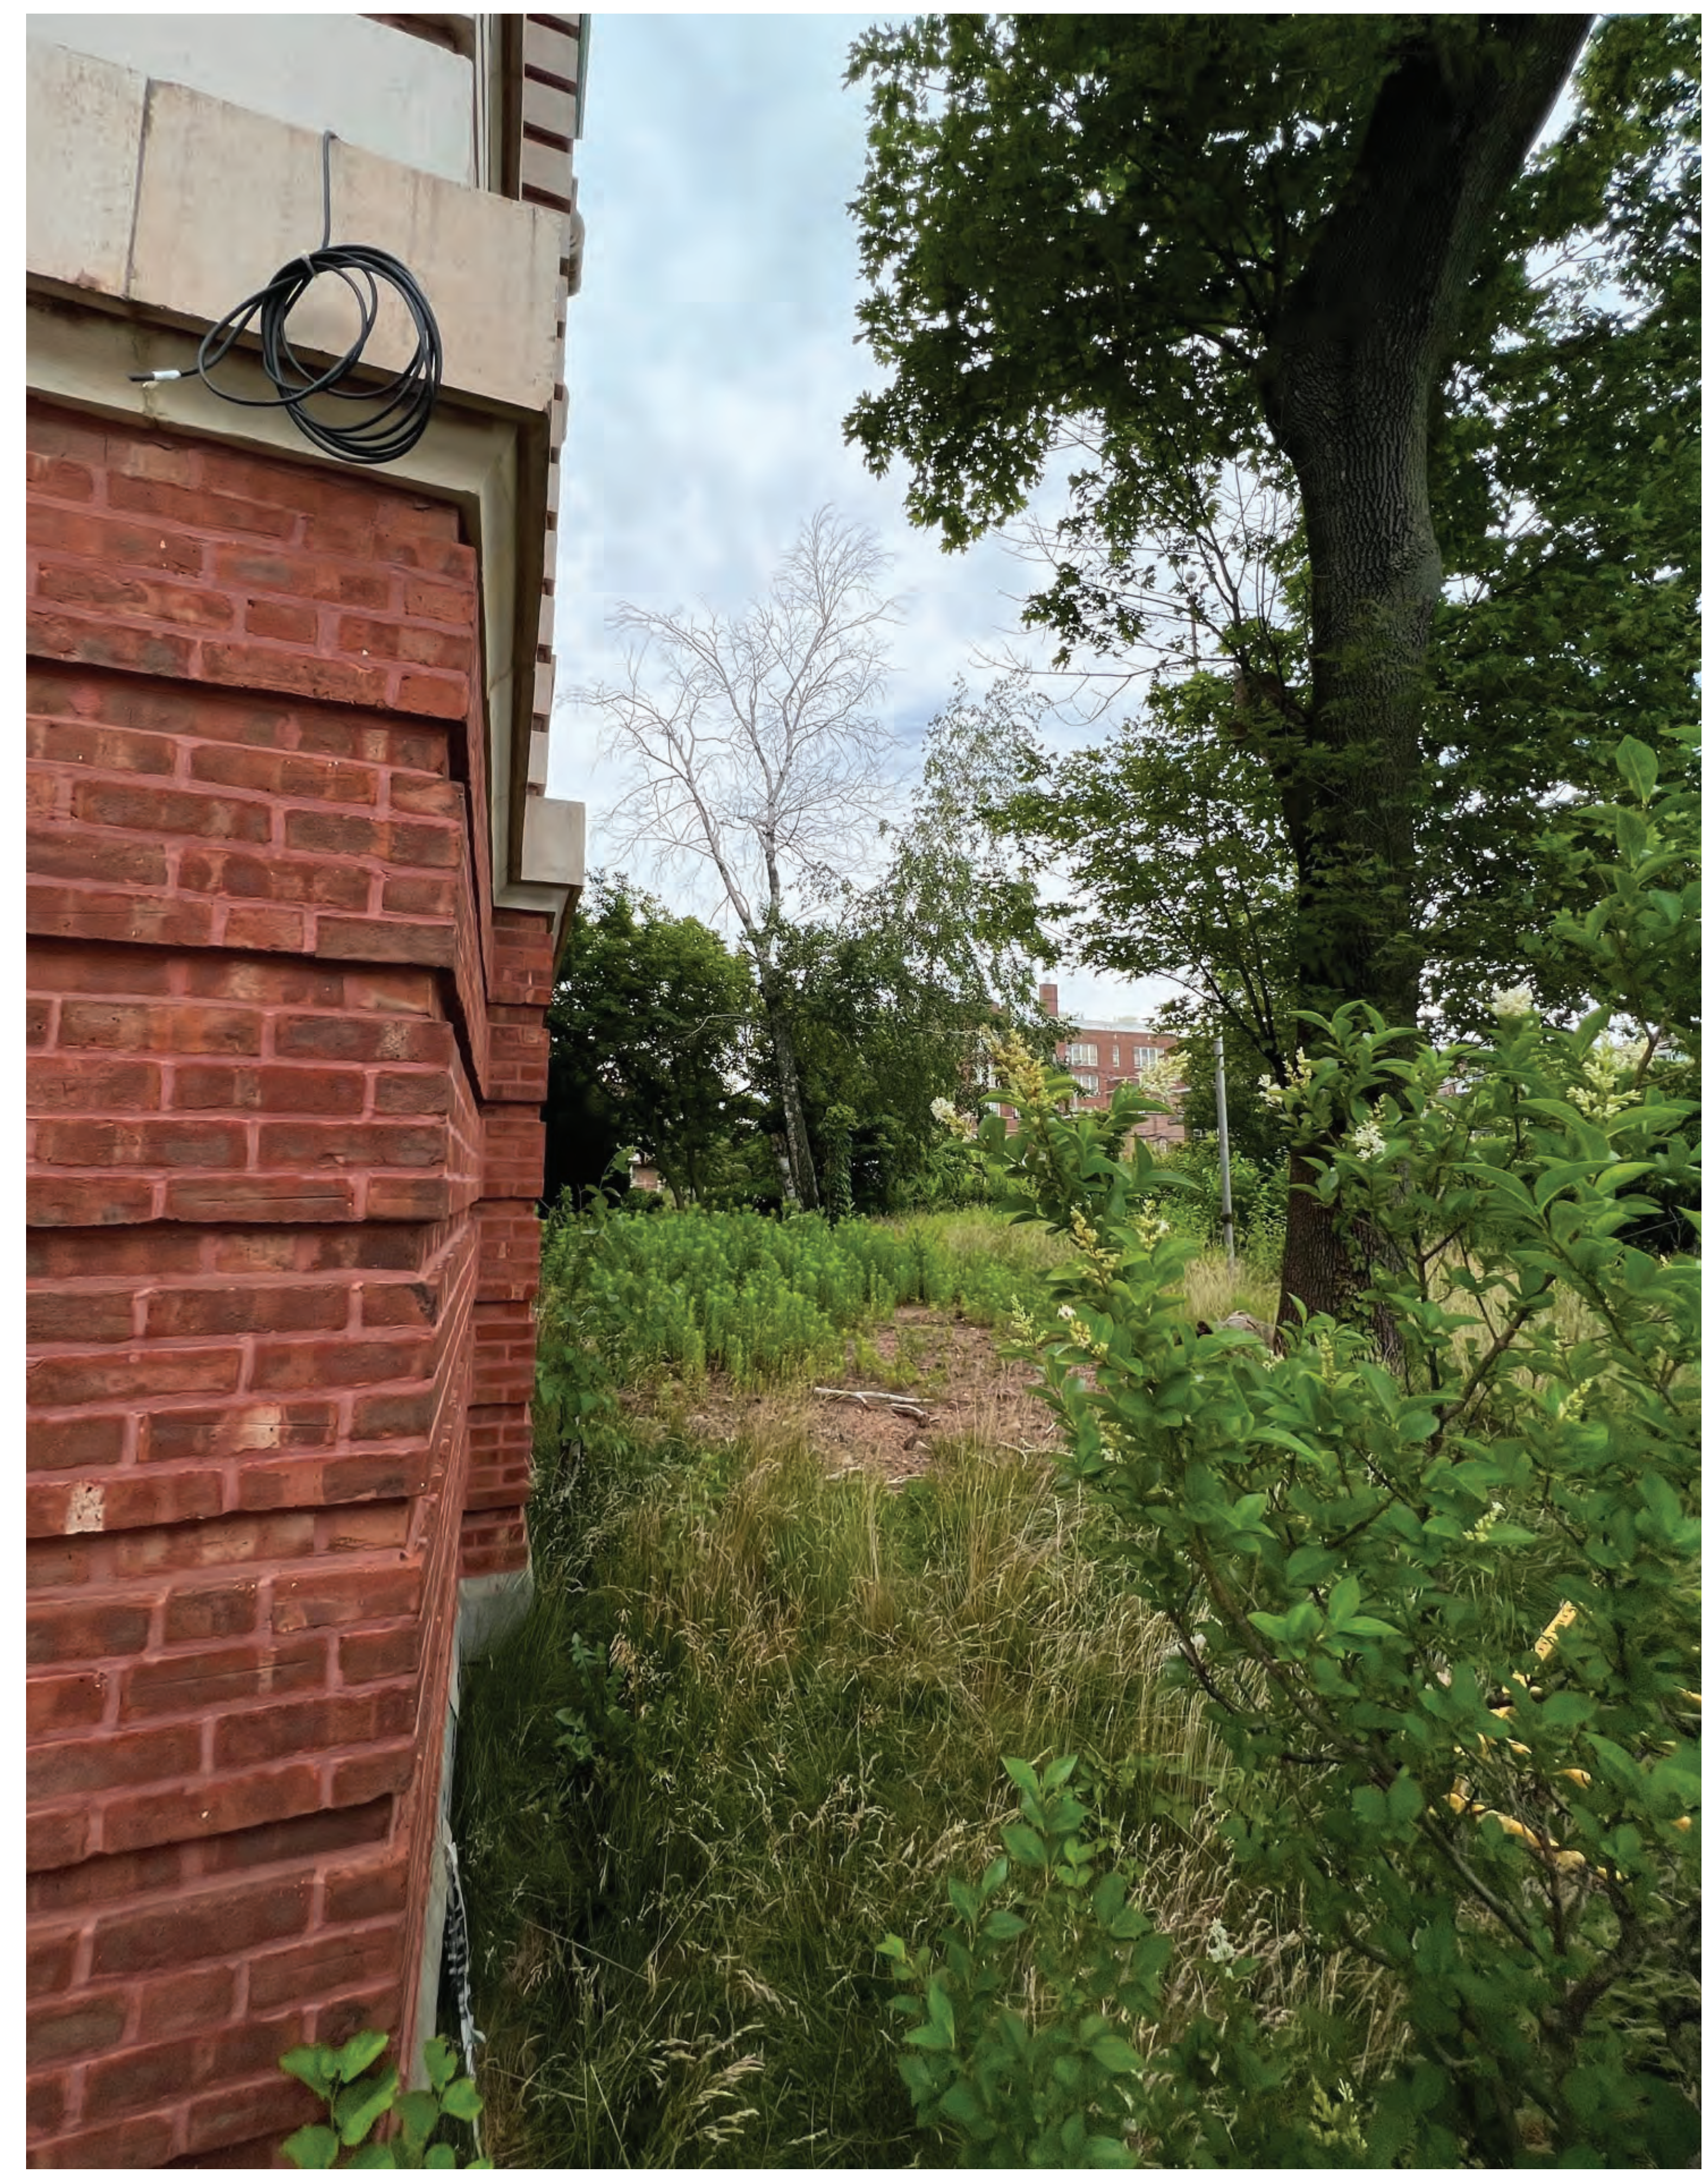
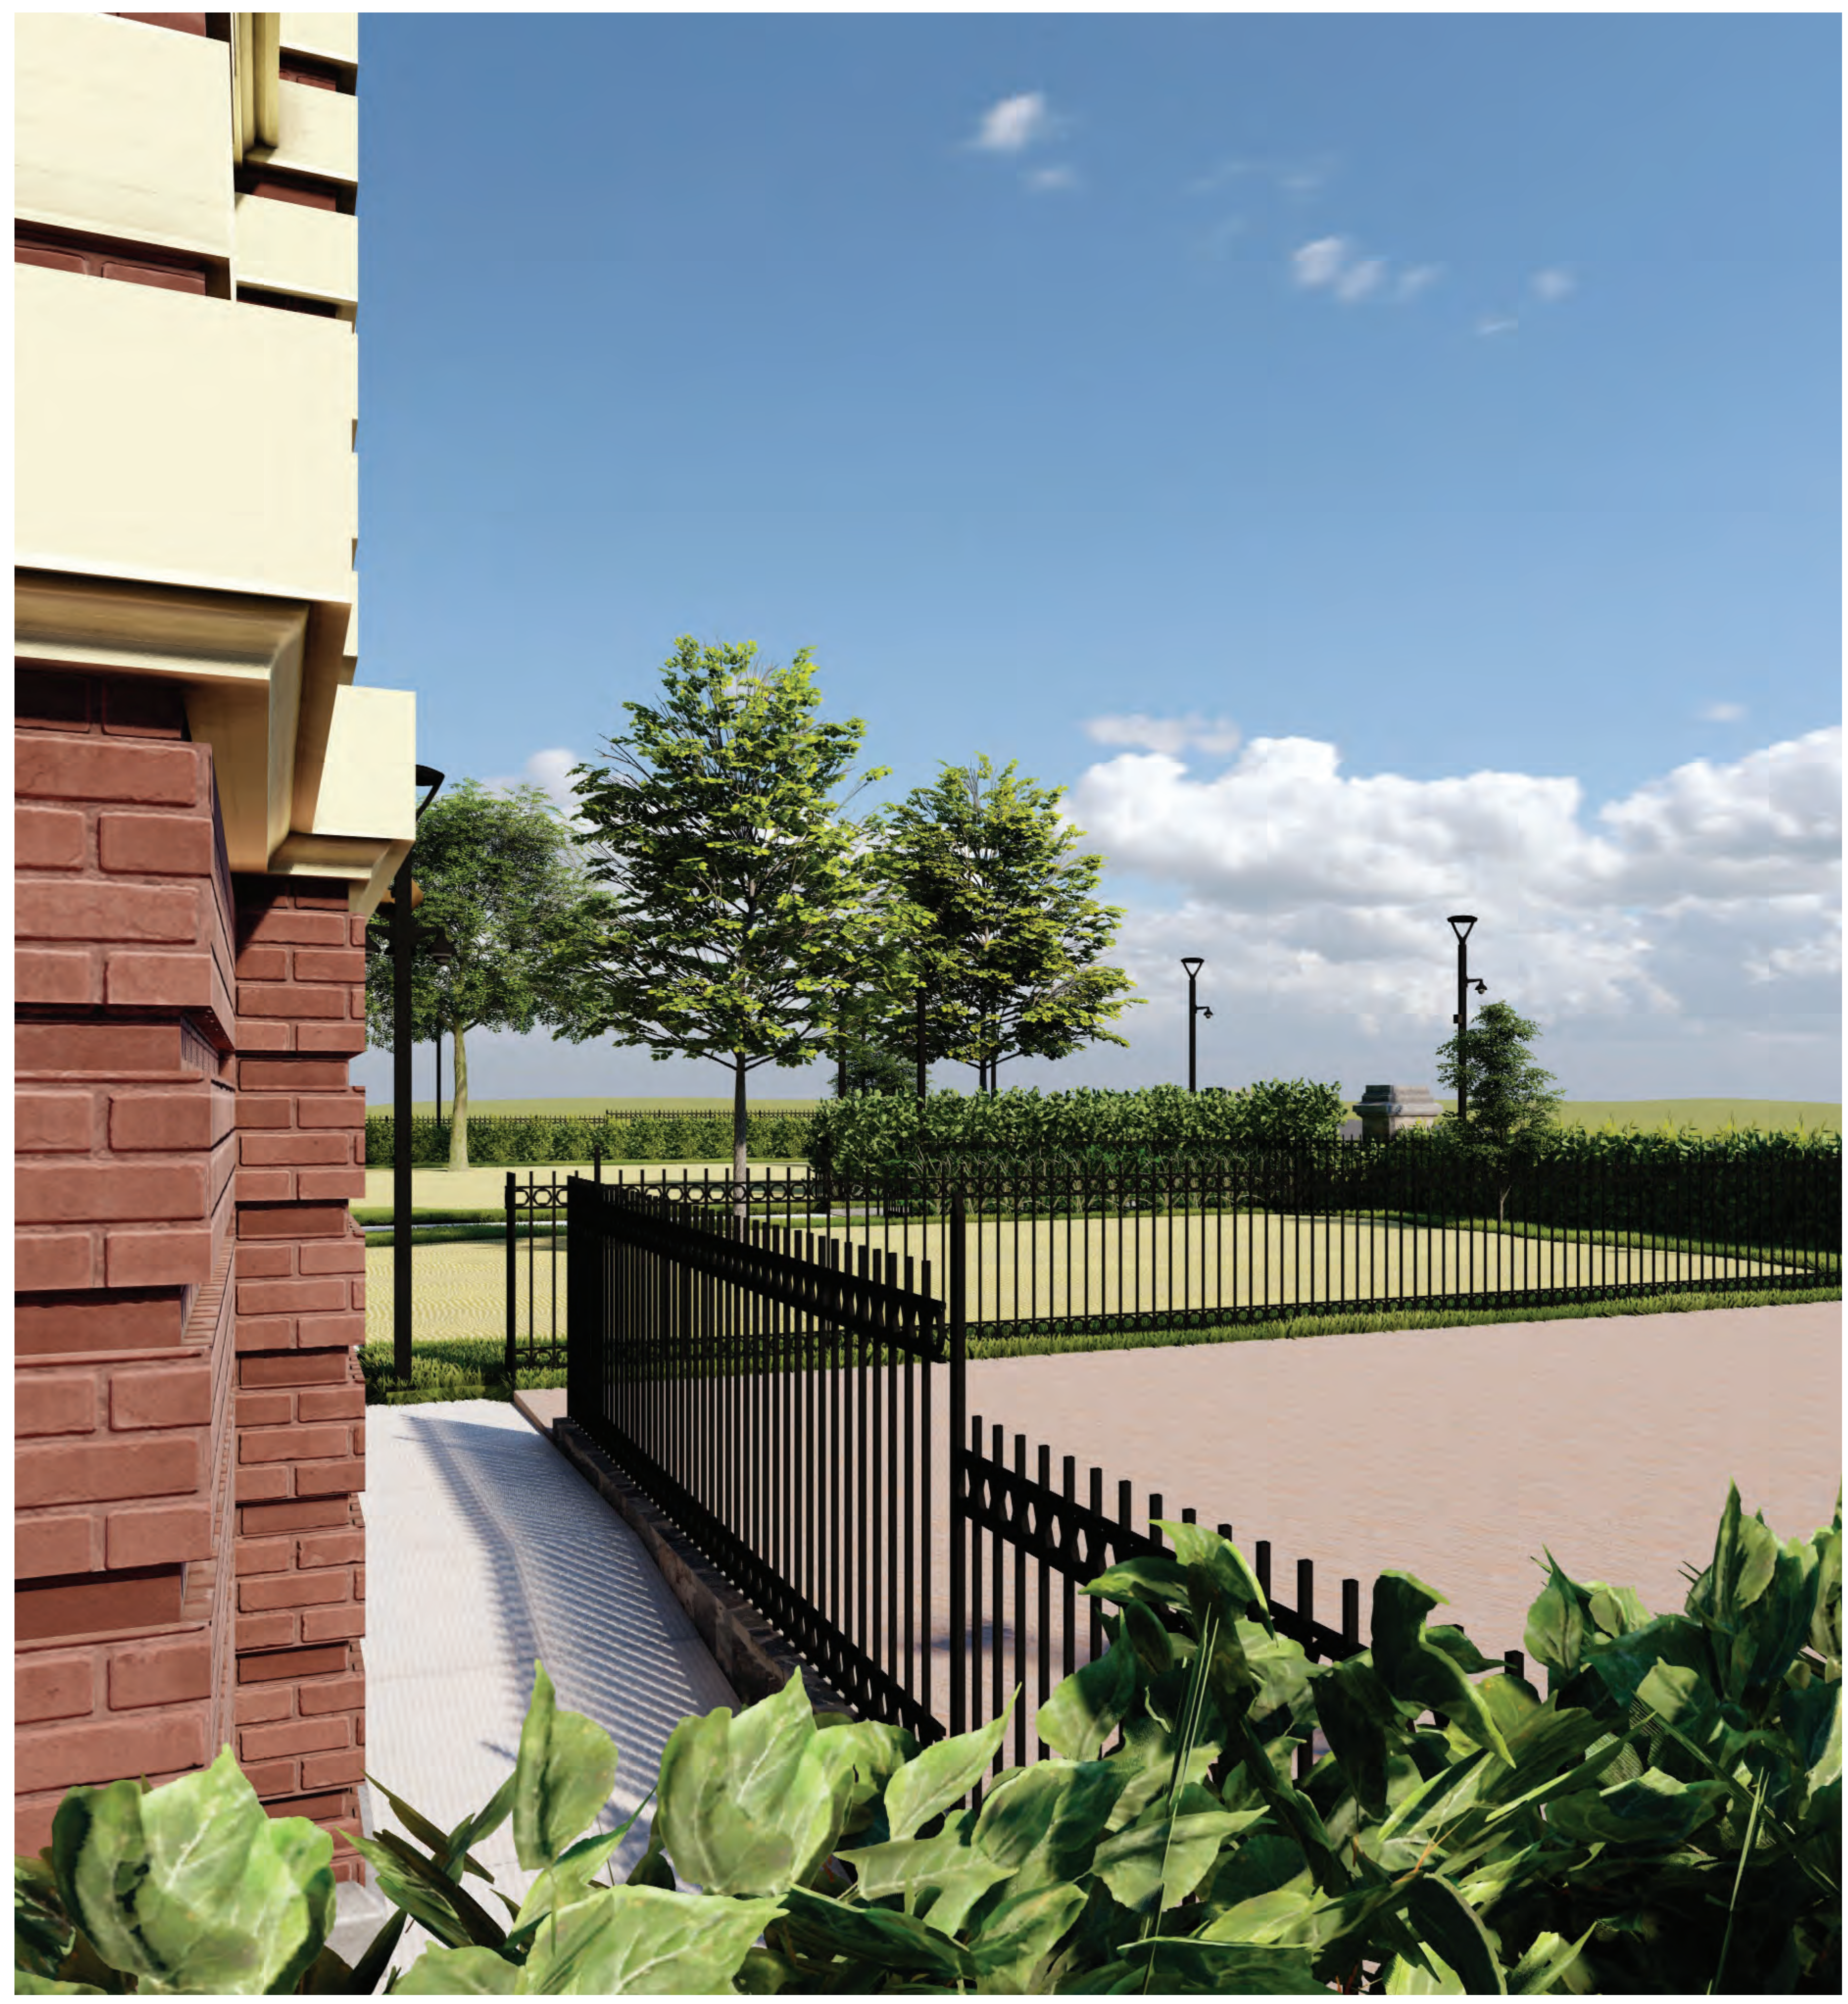
FRONT YARD RENDERINGS

EXISTING:

PROPOSED:

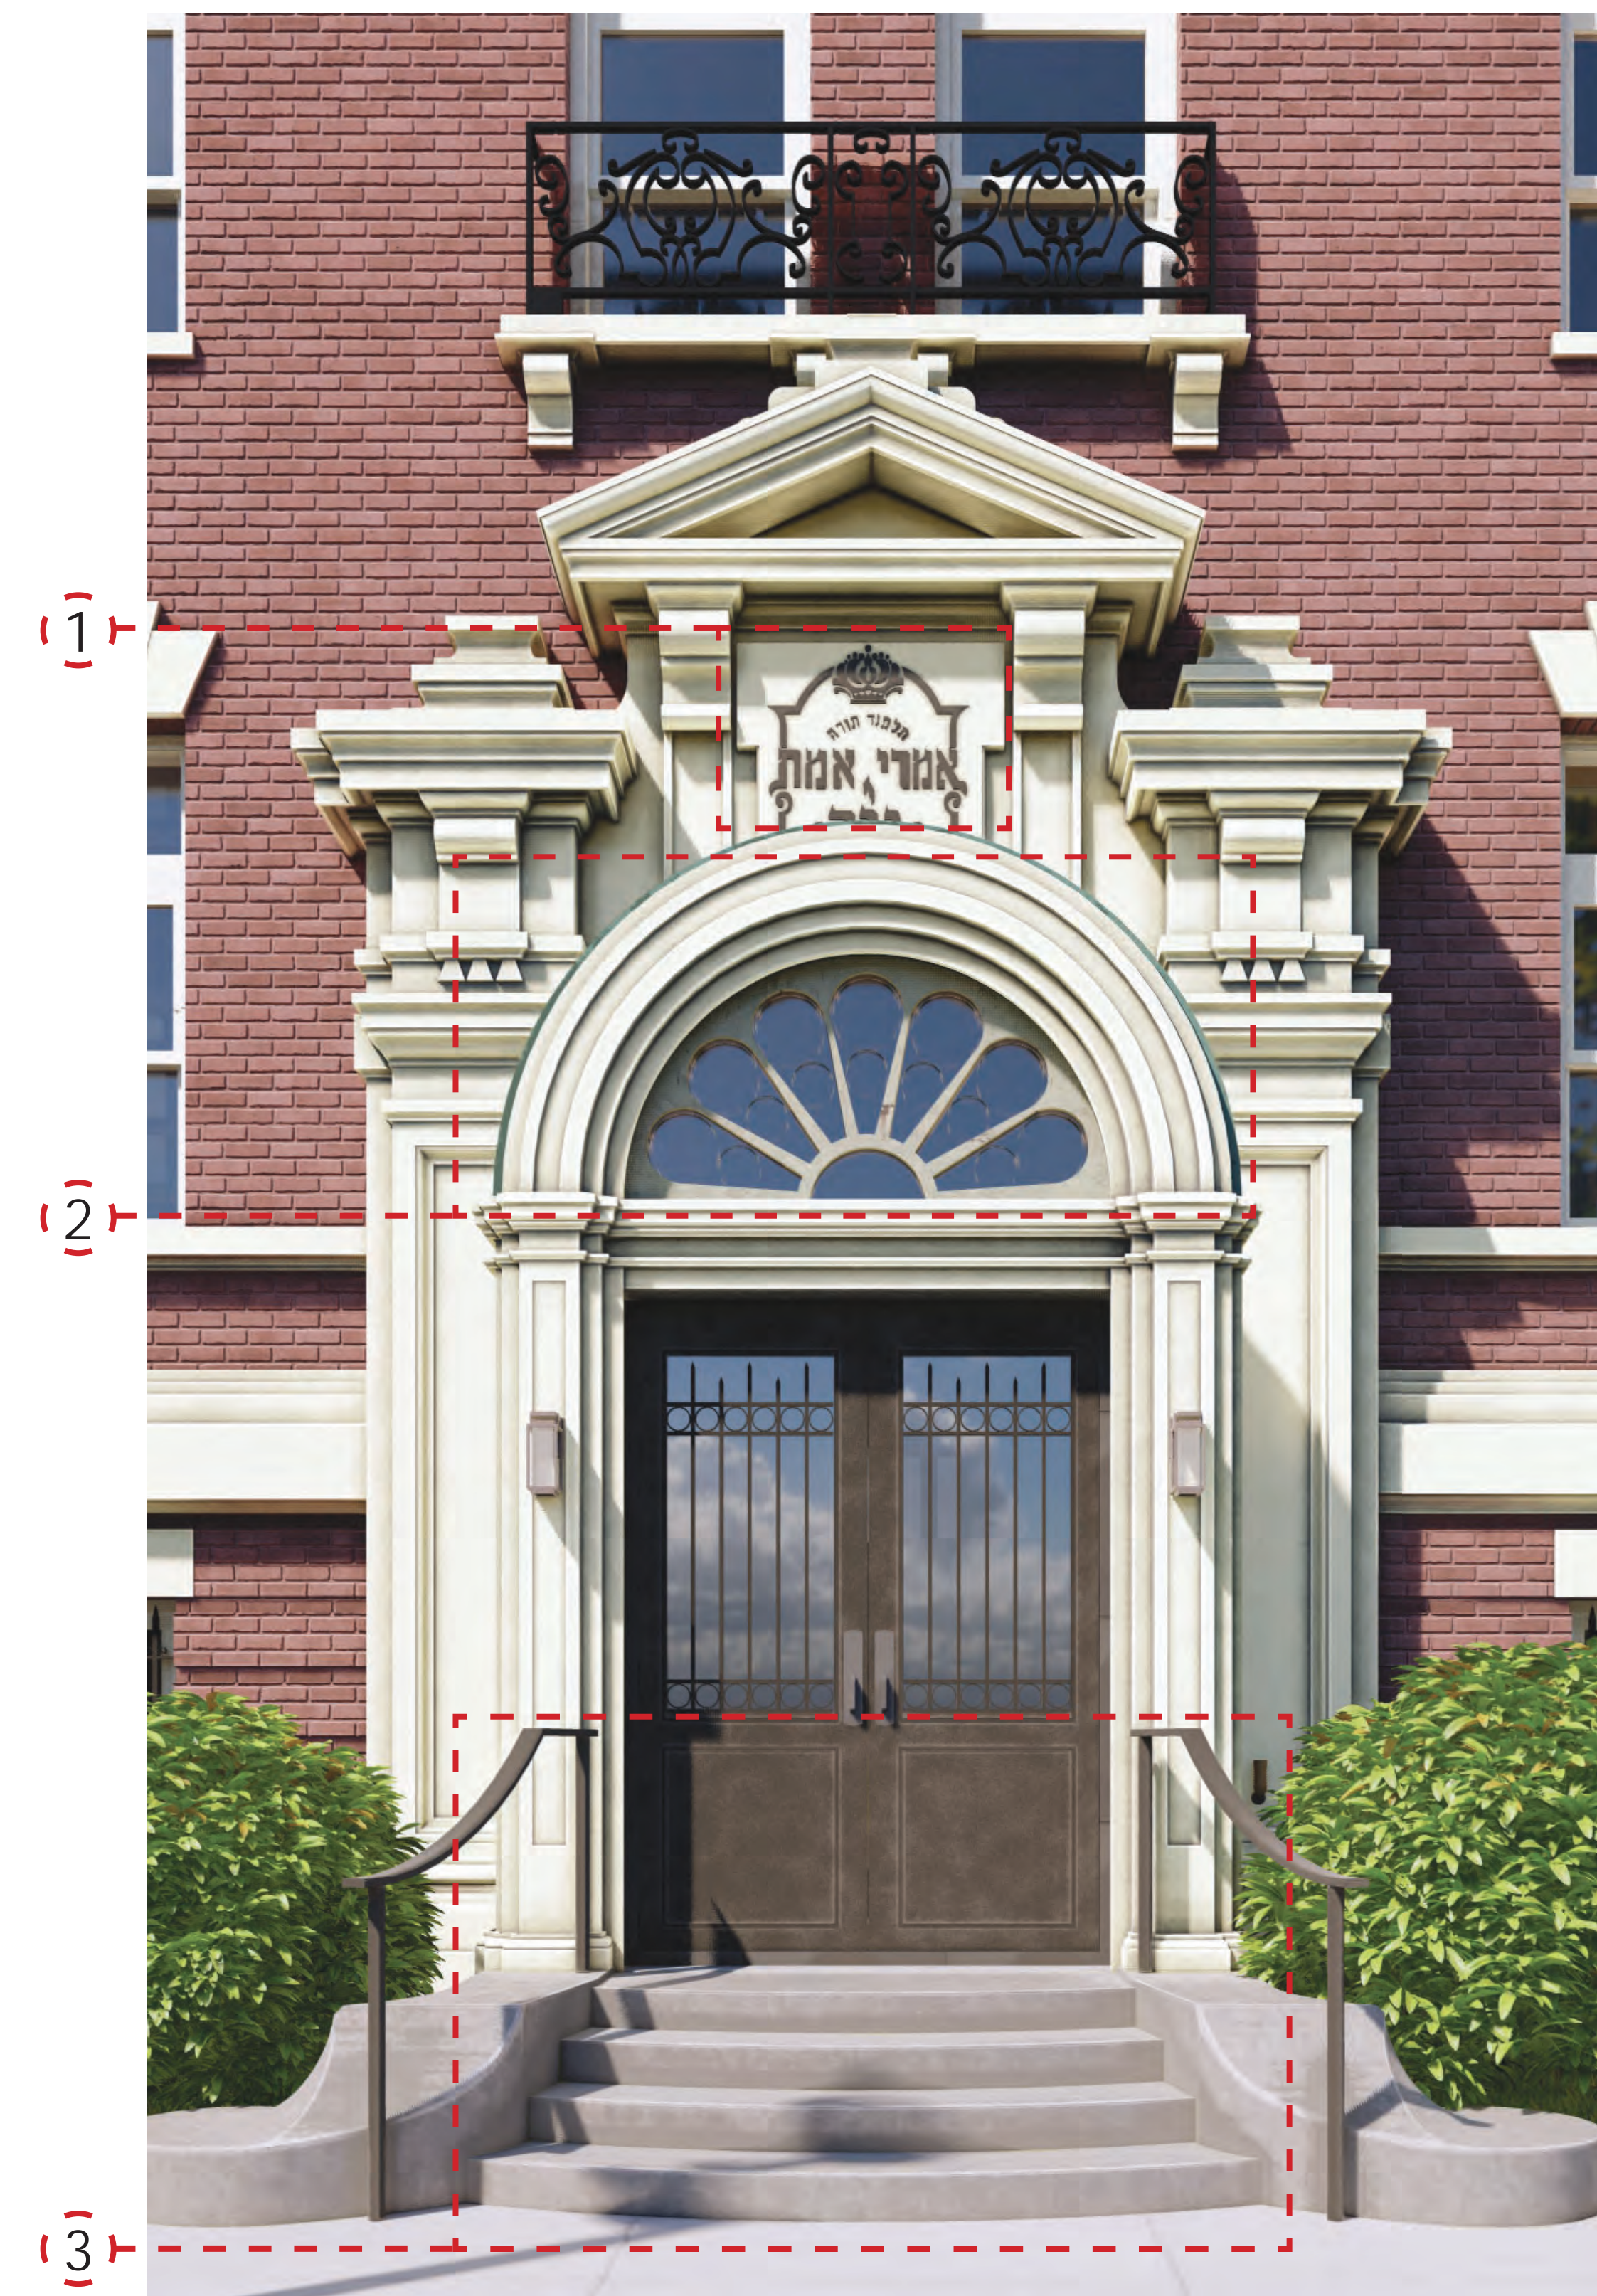
12TH AVE ENTRANCE:

1. SCHOOL LOGO ON FRP PANEL SECURED THROUGH EXISTING MORTAR JOINTS
2. REMOVE LETTERING FROM ARCH
3. NEW BLUESTONE STEPS (ALL RISERS EQUAL) AND TOP OF RAILING IS MOUNTED ON BLUESTONE CHEEK WALL

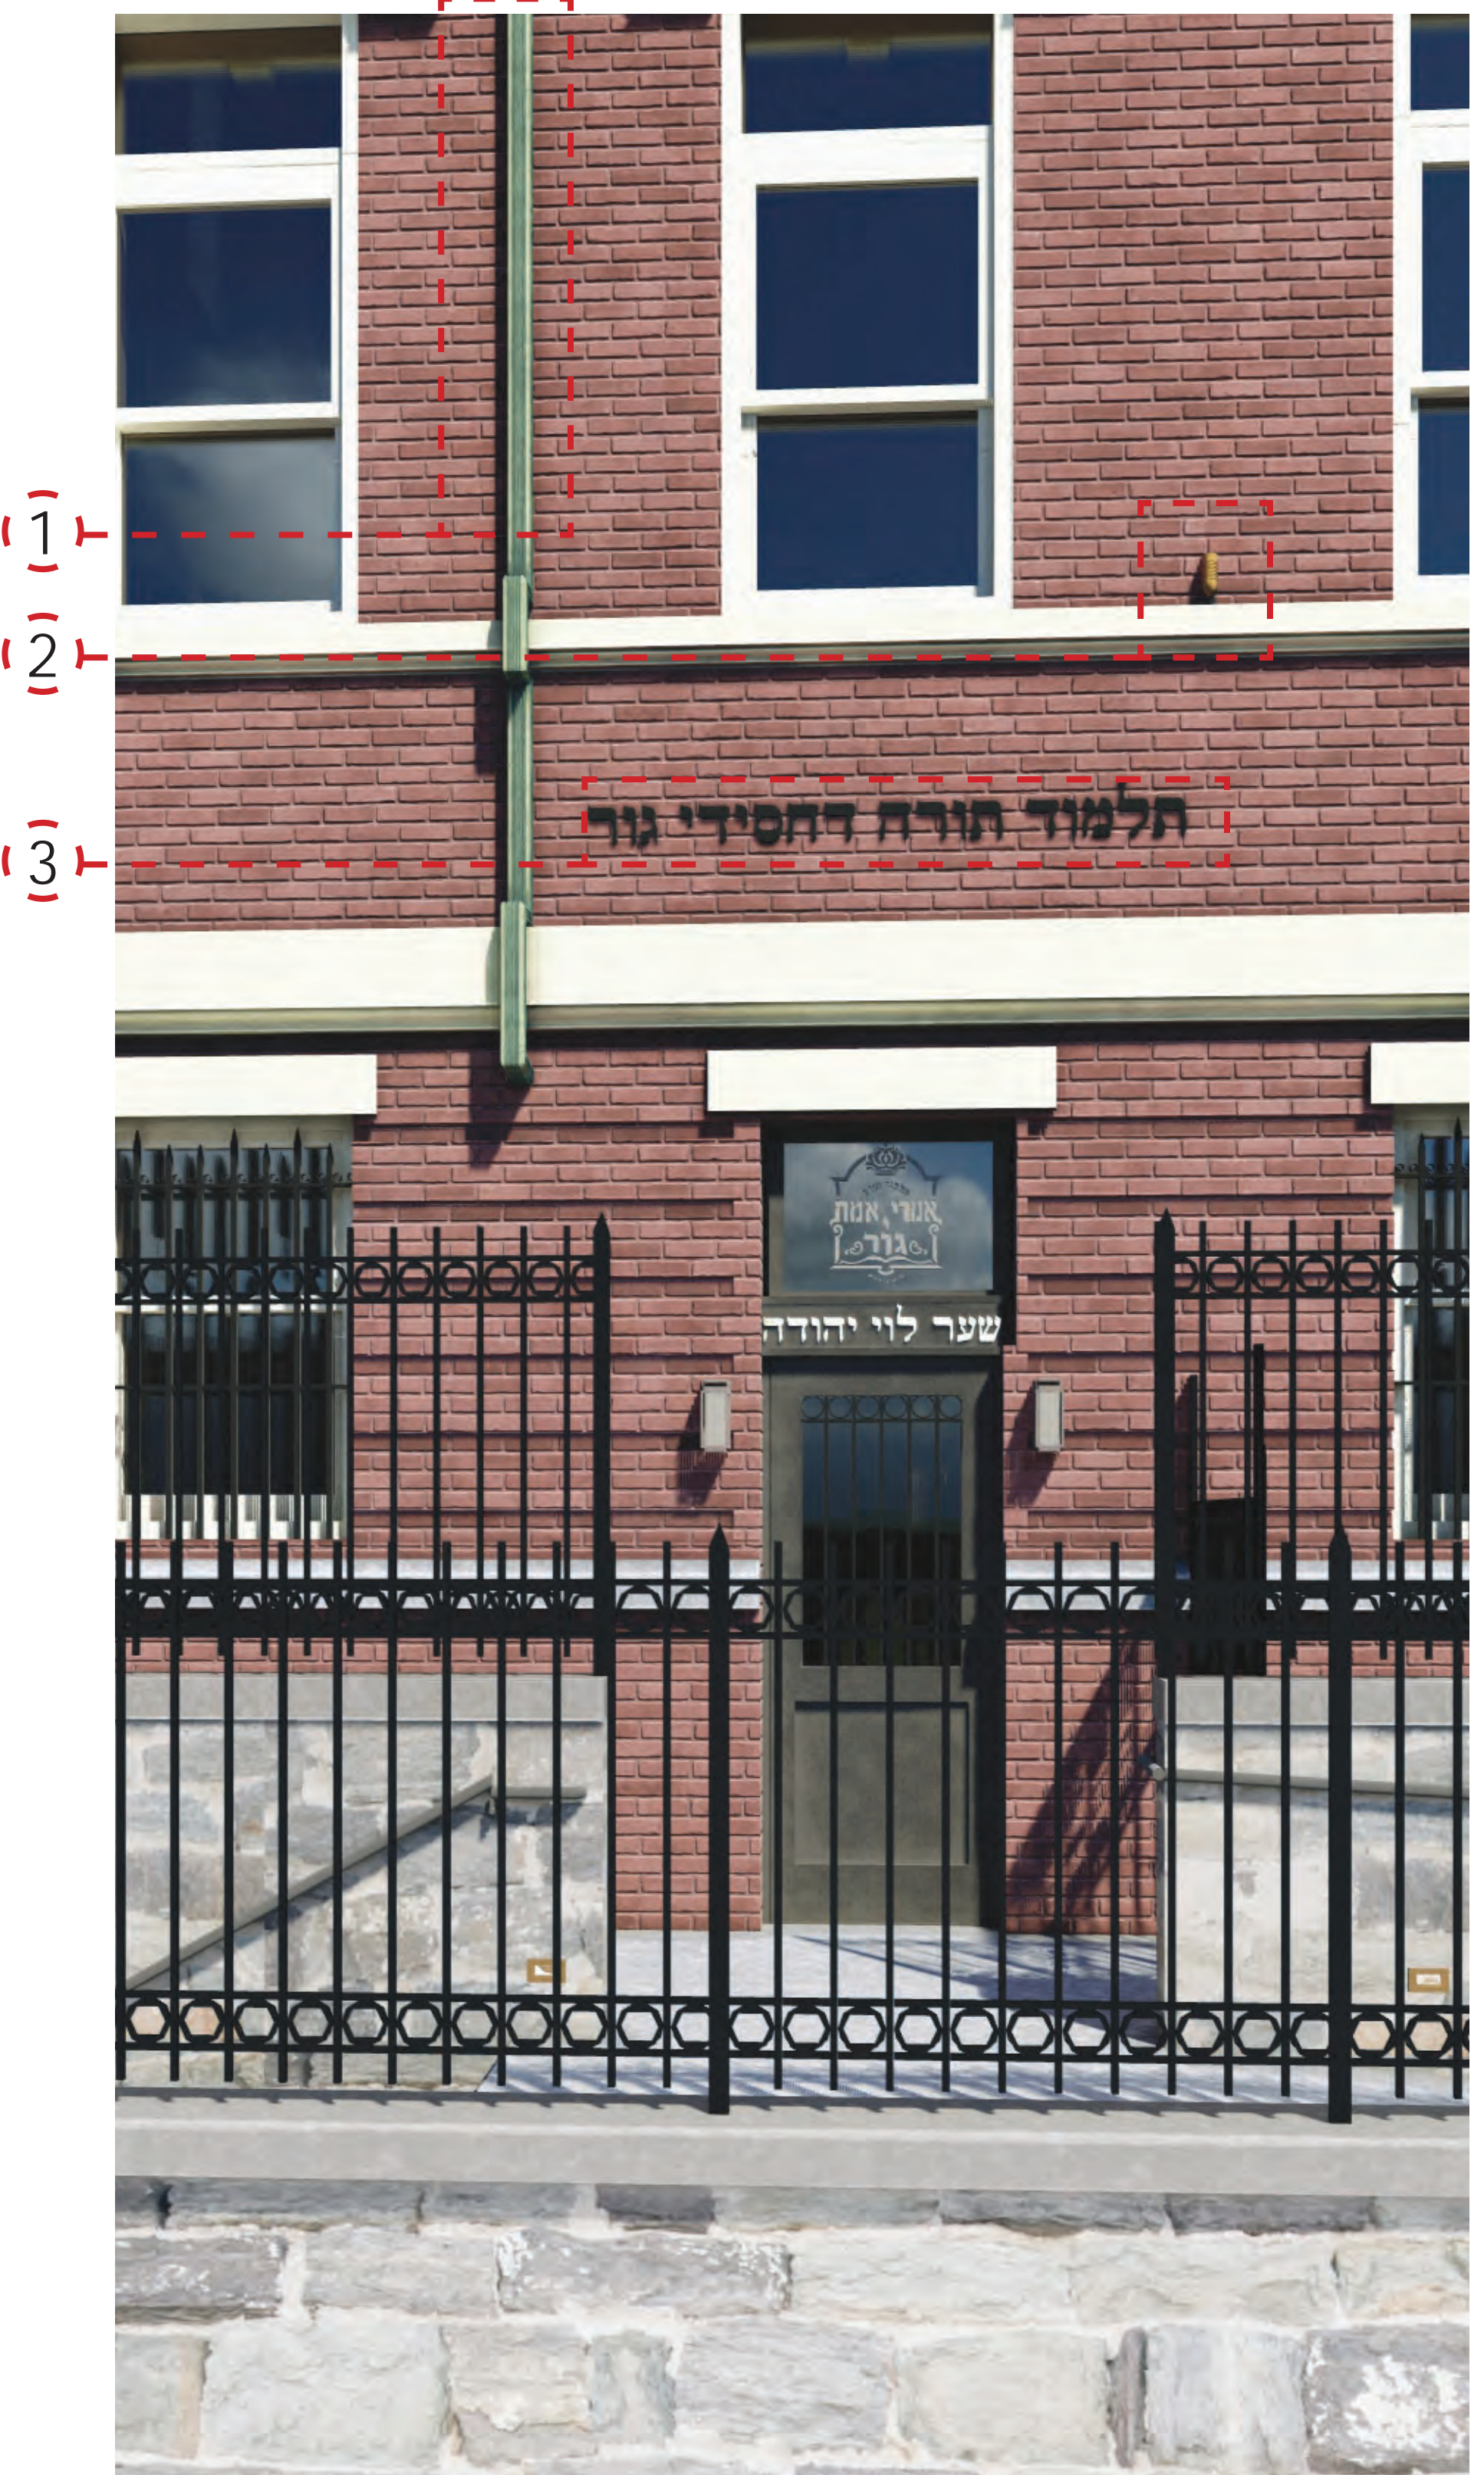
63RD STREET ENTRANCE:

1. ALUMINUM LEADERS PAINTED COPPER
2. LIGHT FIXTURES ON SECONDARY FACADE REMAINS
3. LETTERING ON SECONDARY FACADE REMAINS

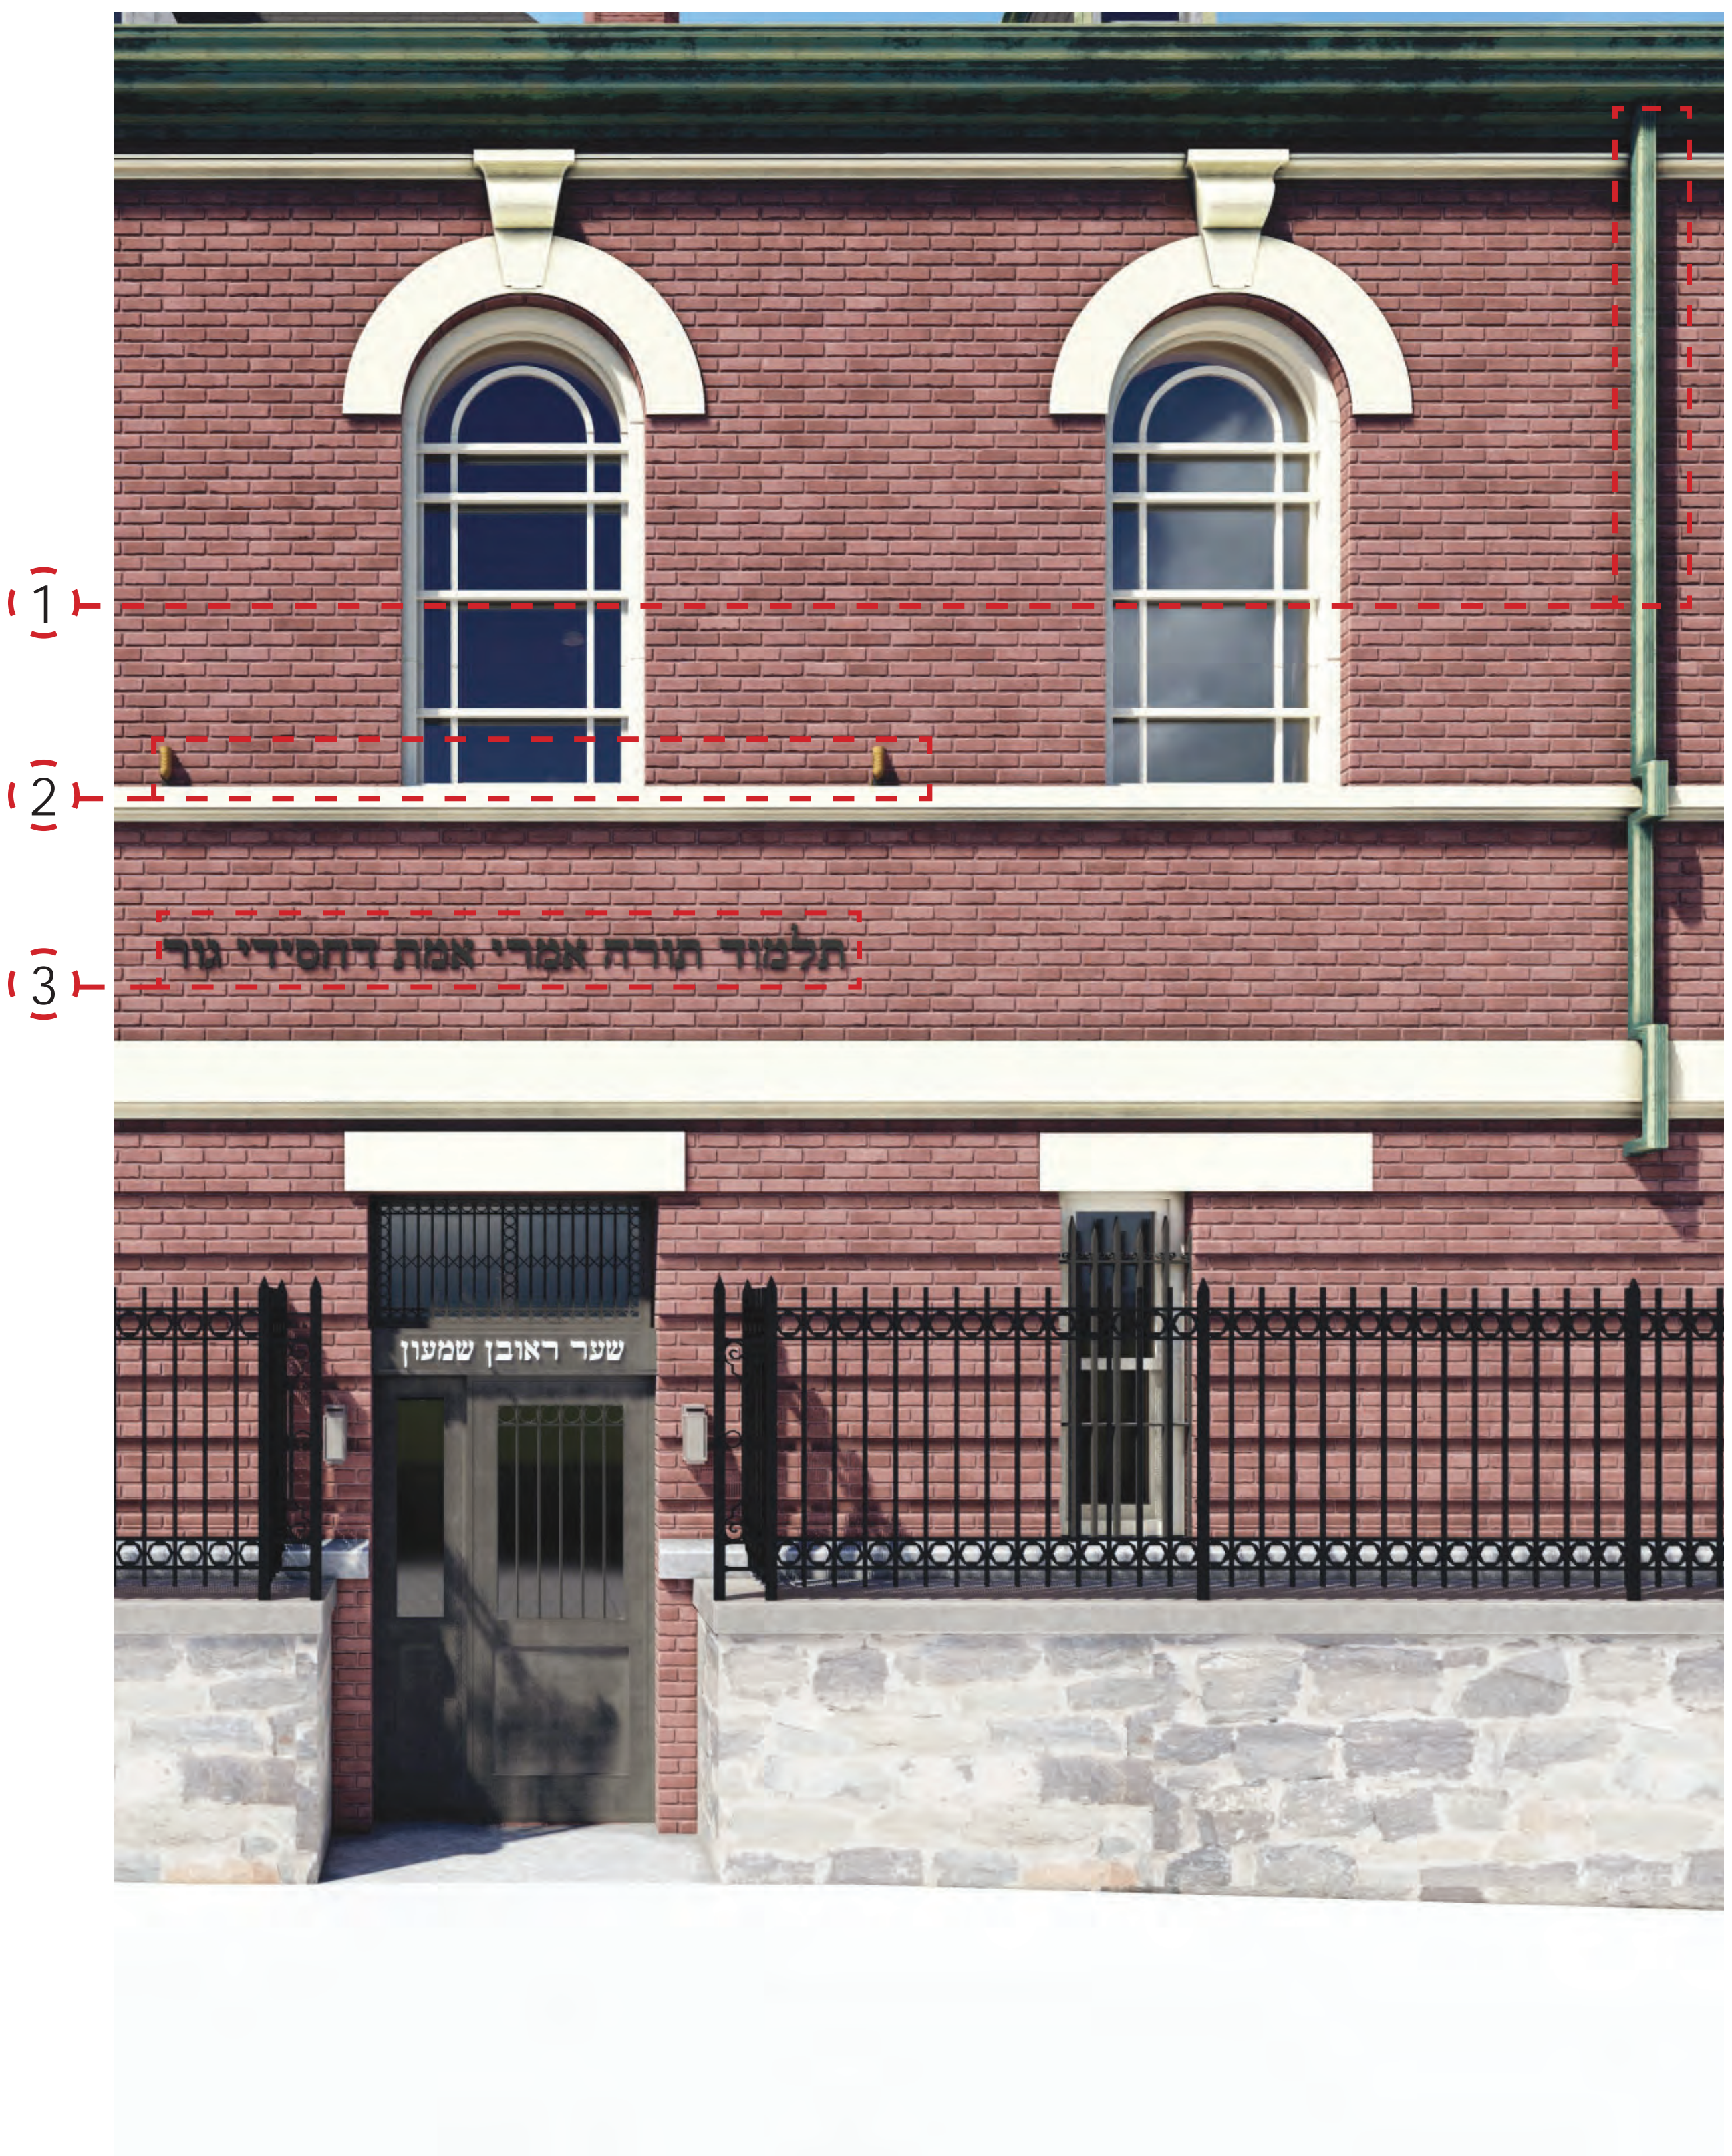
REVISION TO ALL ENTRANCE DOORS
GUR YESHIVA, 6301 12TH AVENUE BROOKLYN, NY

64TH STREET ENTRANCE:

1. ALUMINUM LEADERS PAINTED COPPER
2. LIGHT FIXTURES ON SECONDARY FACADE REMAINS
3. LETTERING ON SECONDARY FACADE REMAINS
