Preservation Department – Item 6, LPC-25-11198

**257-263 Washington Avenue and 230-236 Hall Street –
Clinton Hill Historic District
Borough of Brooklyn**

APPLICATION TO THE NYC LANDMARKS PRESERVATION COMMISSION
257 WASHINGTON AVE, BOROUGH OF BROOKLYN

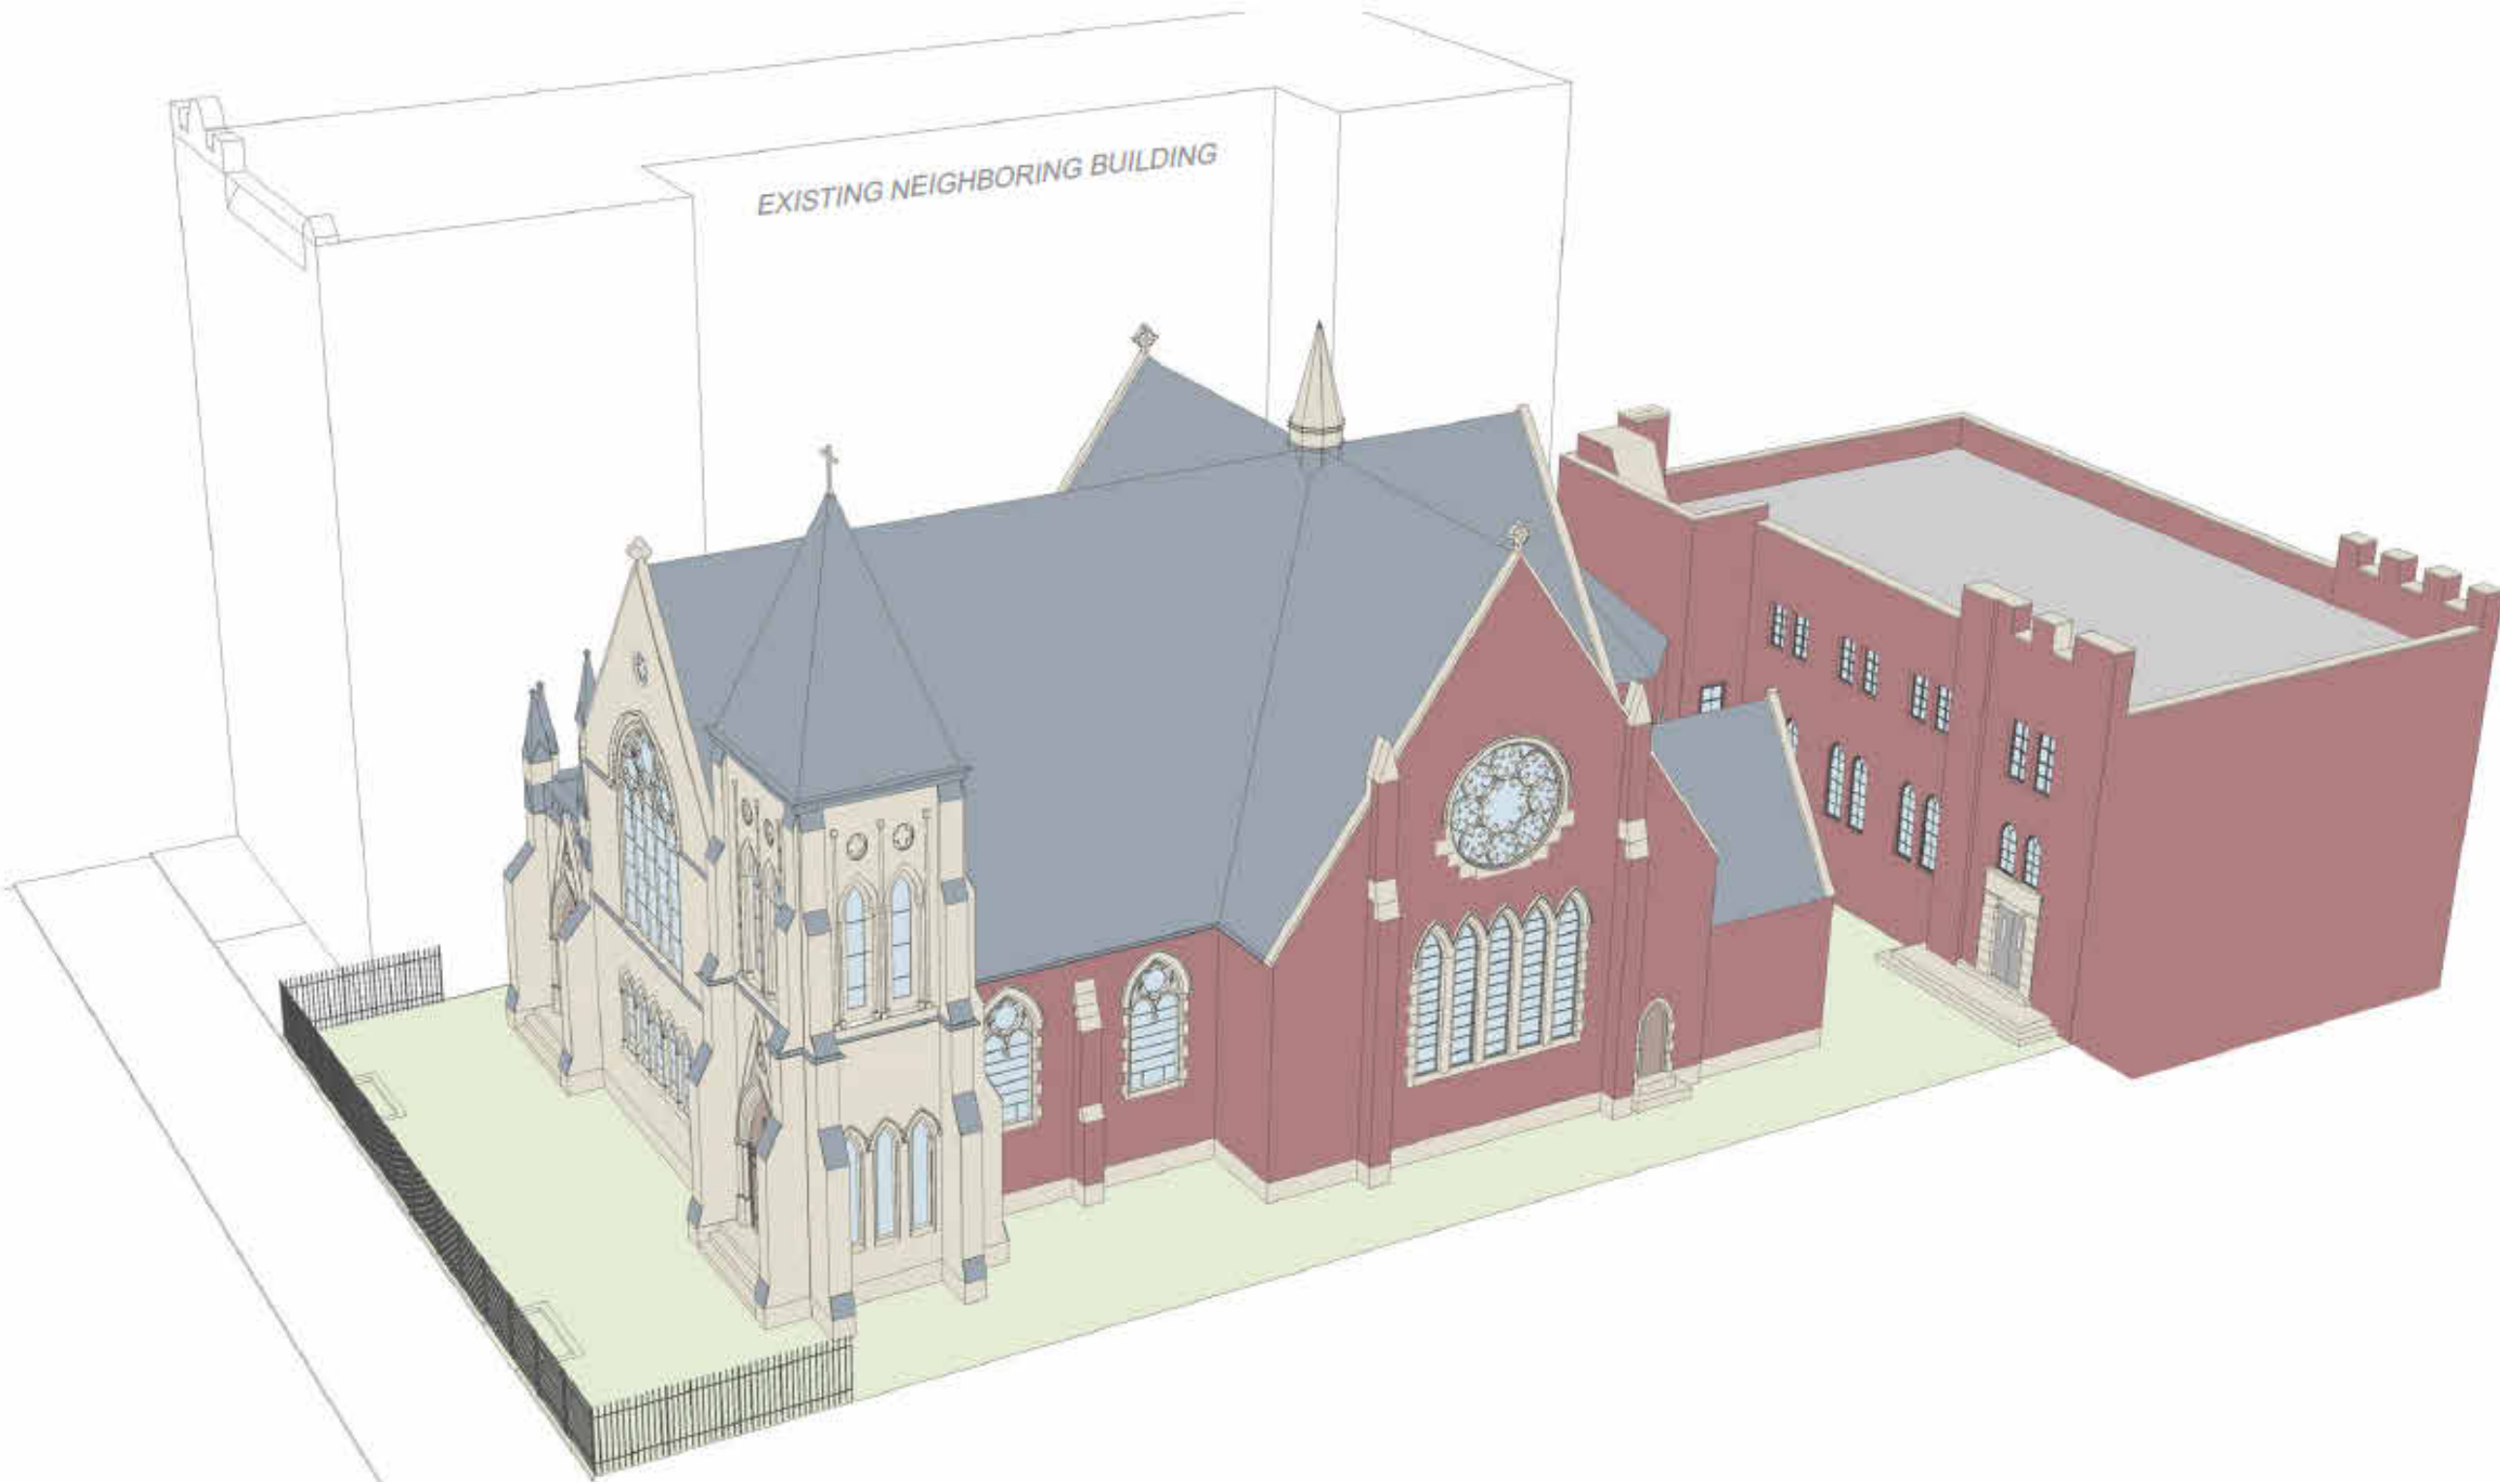
BIRD'S EYE VIEW OF PROPERTY
EXISTING CONDITIONS

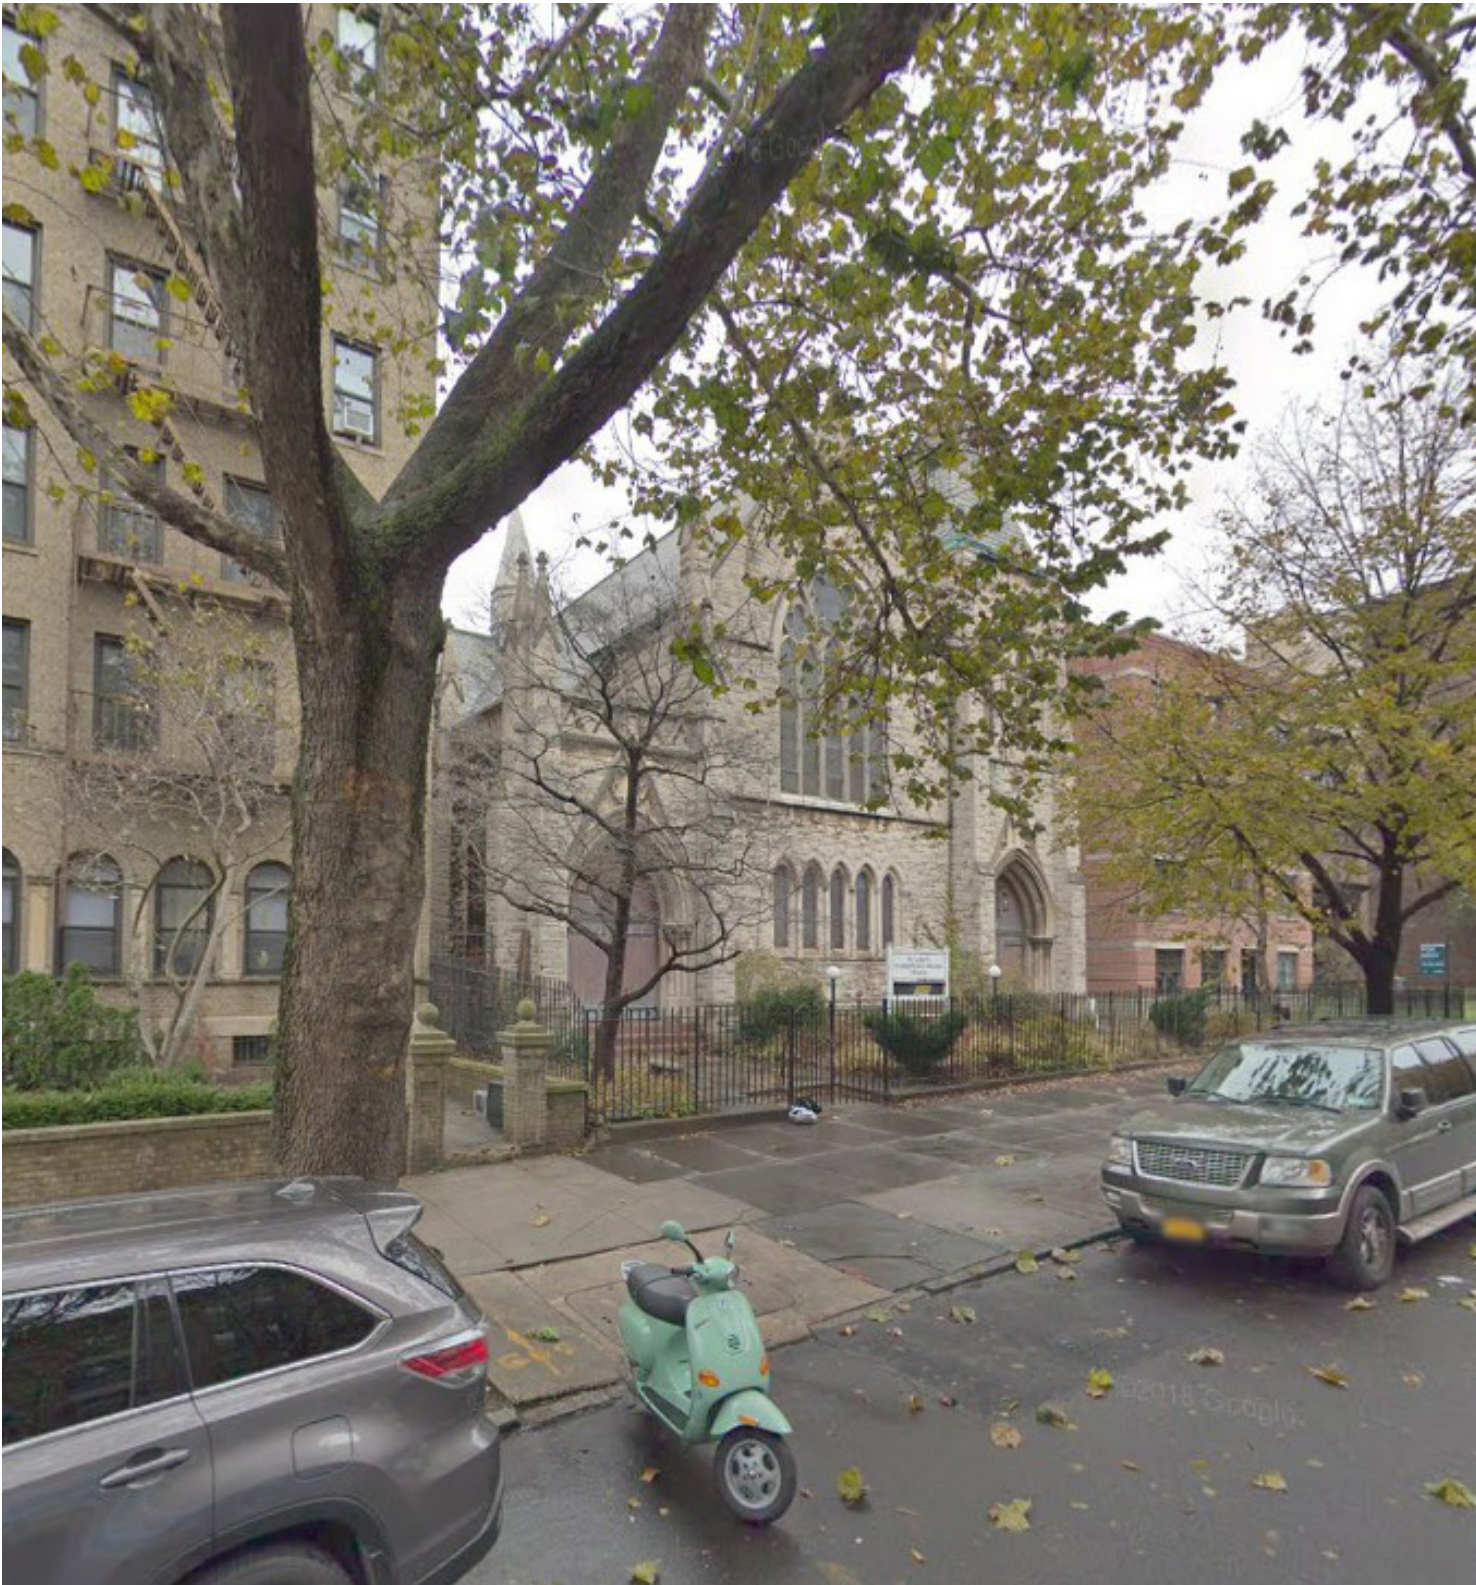
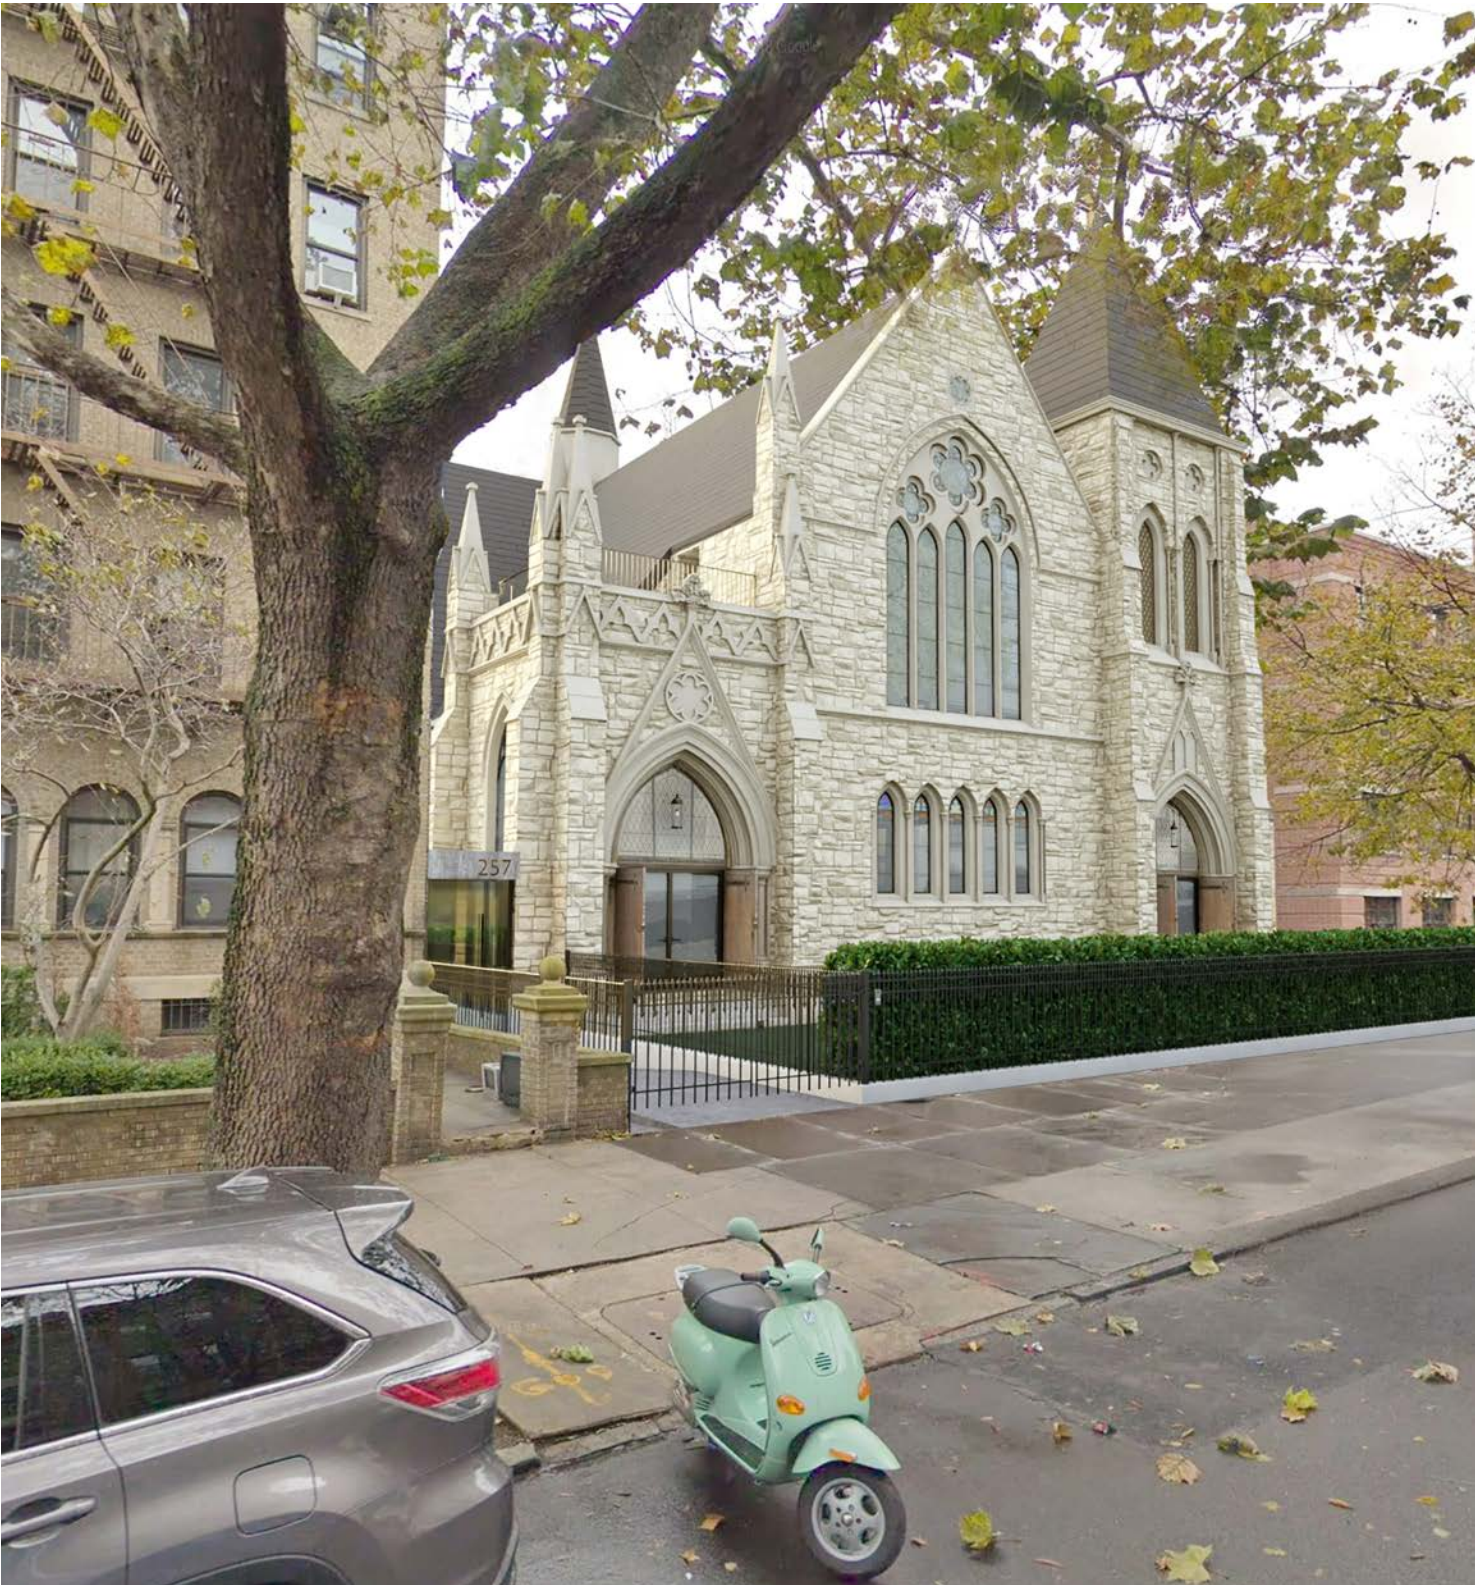
PROPOSED ENTRY AT WASHINGTON AVE

EXISTING (NOVEMBER 2017)

PROPOSED

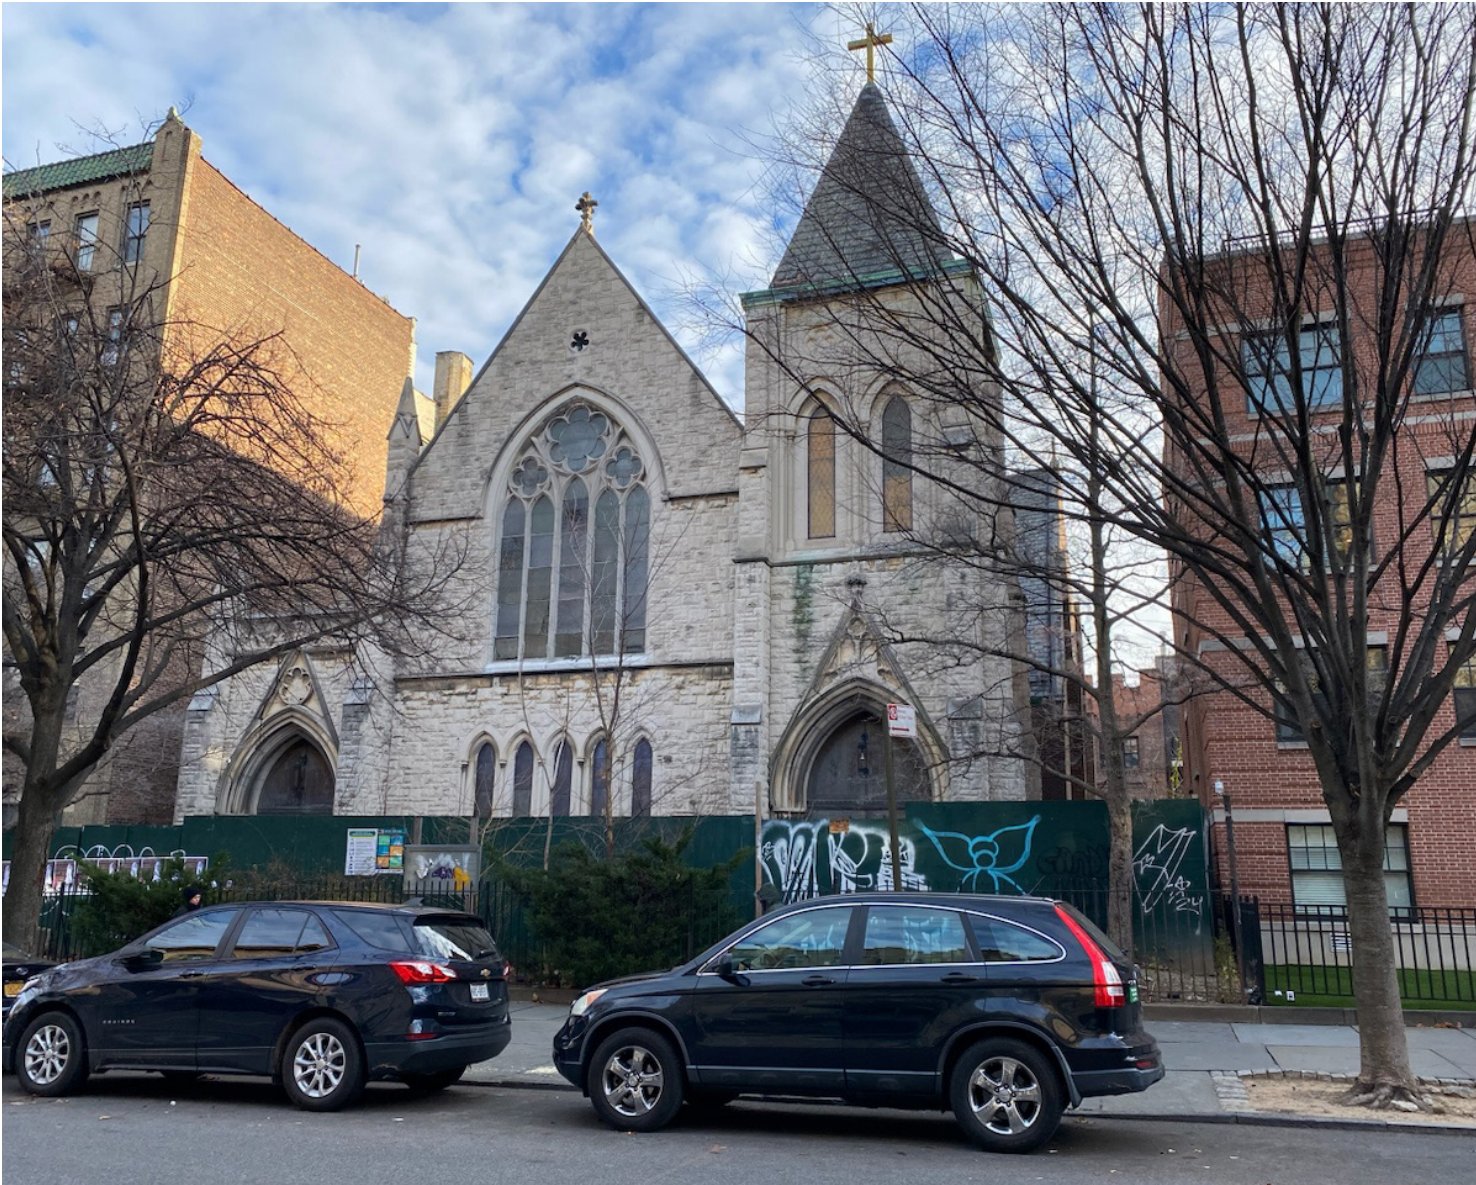
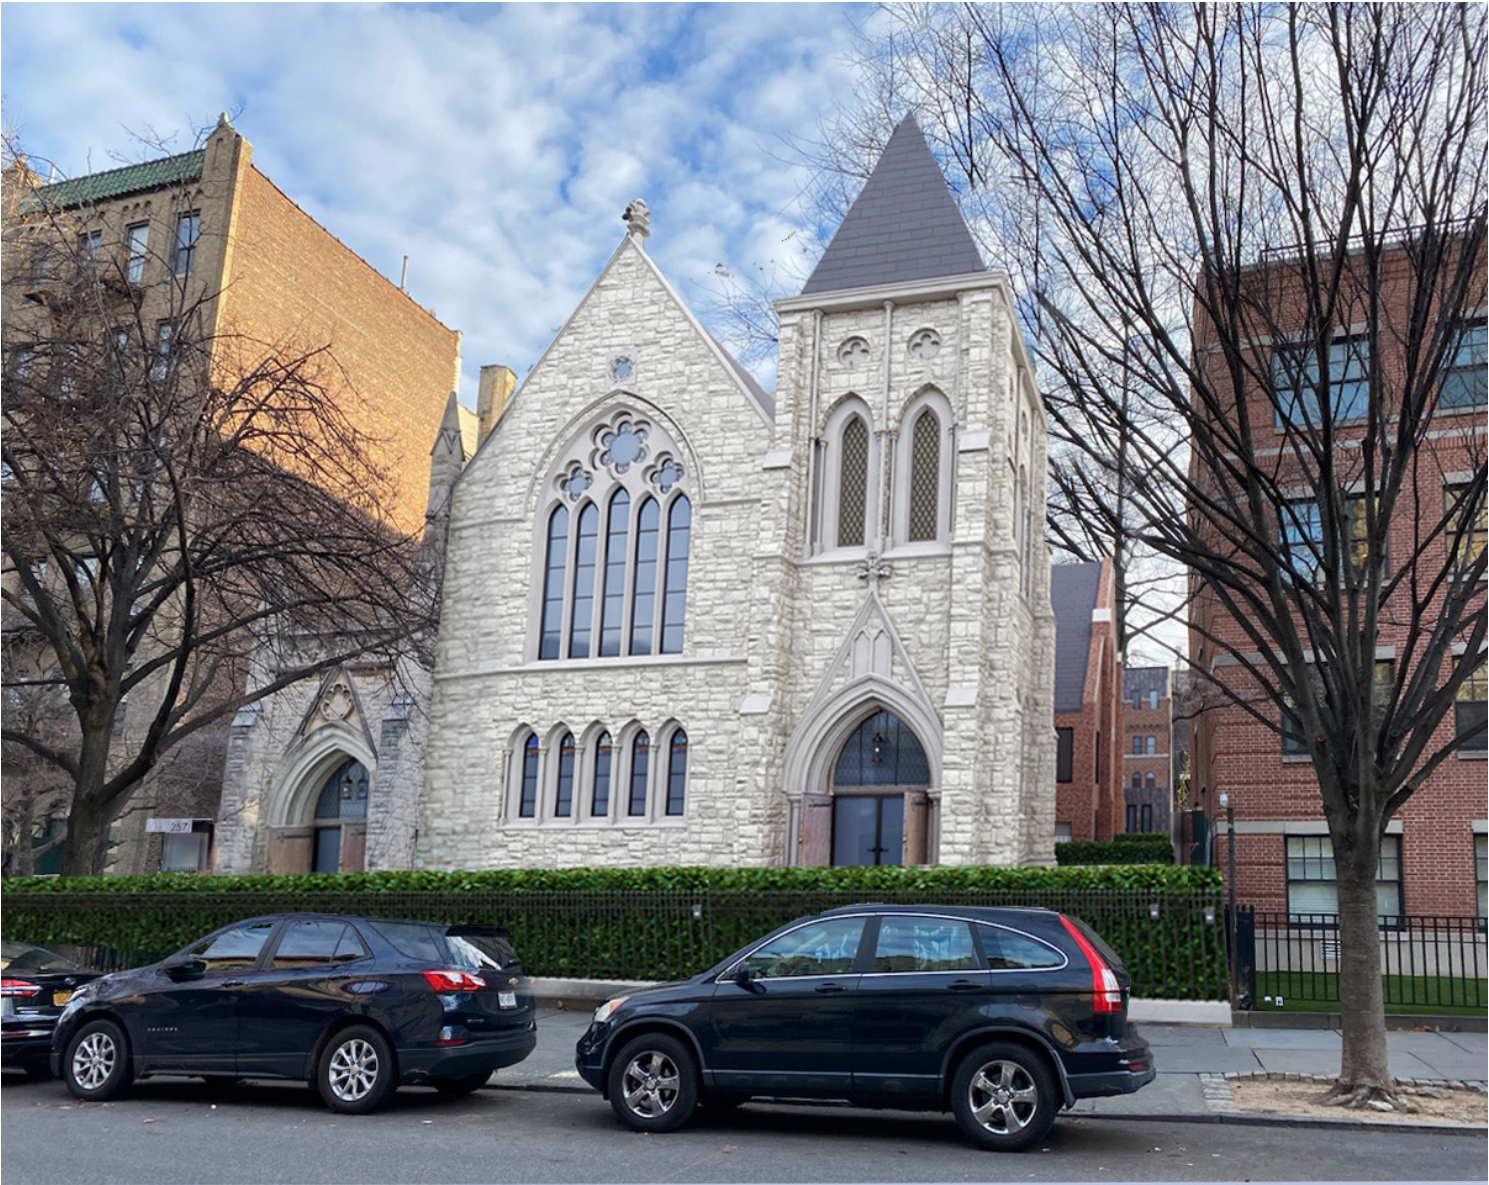
PROPOSED ALLEY AT WASHINGTON AVE

EXISTING (NOVEMBER 2024)

PROPOSED

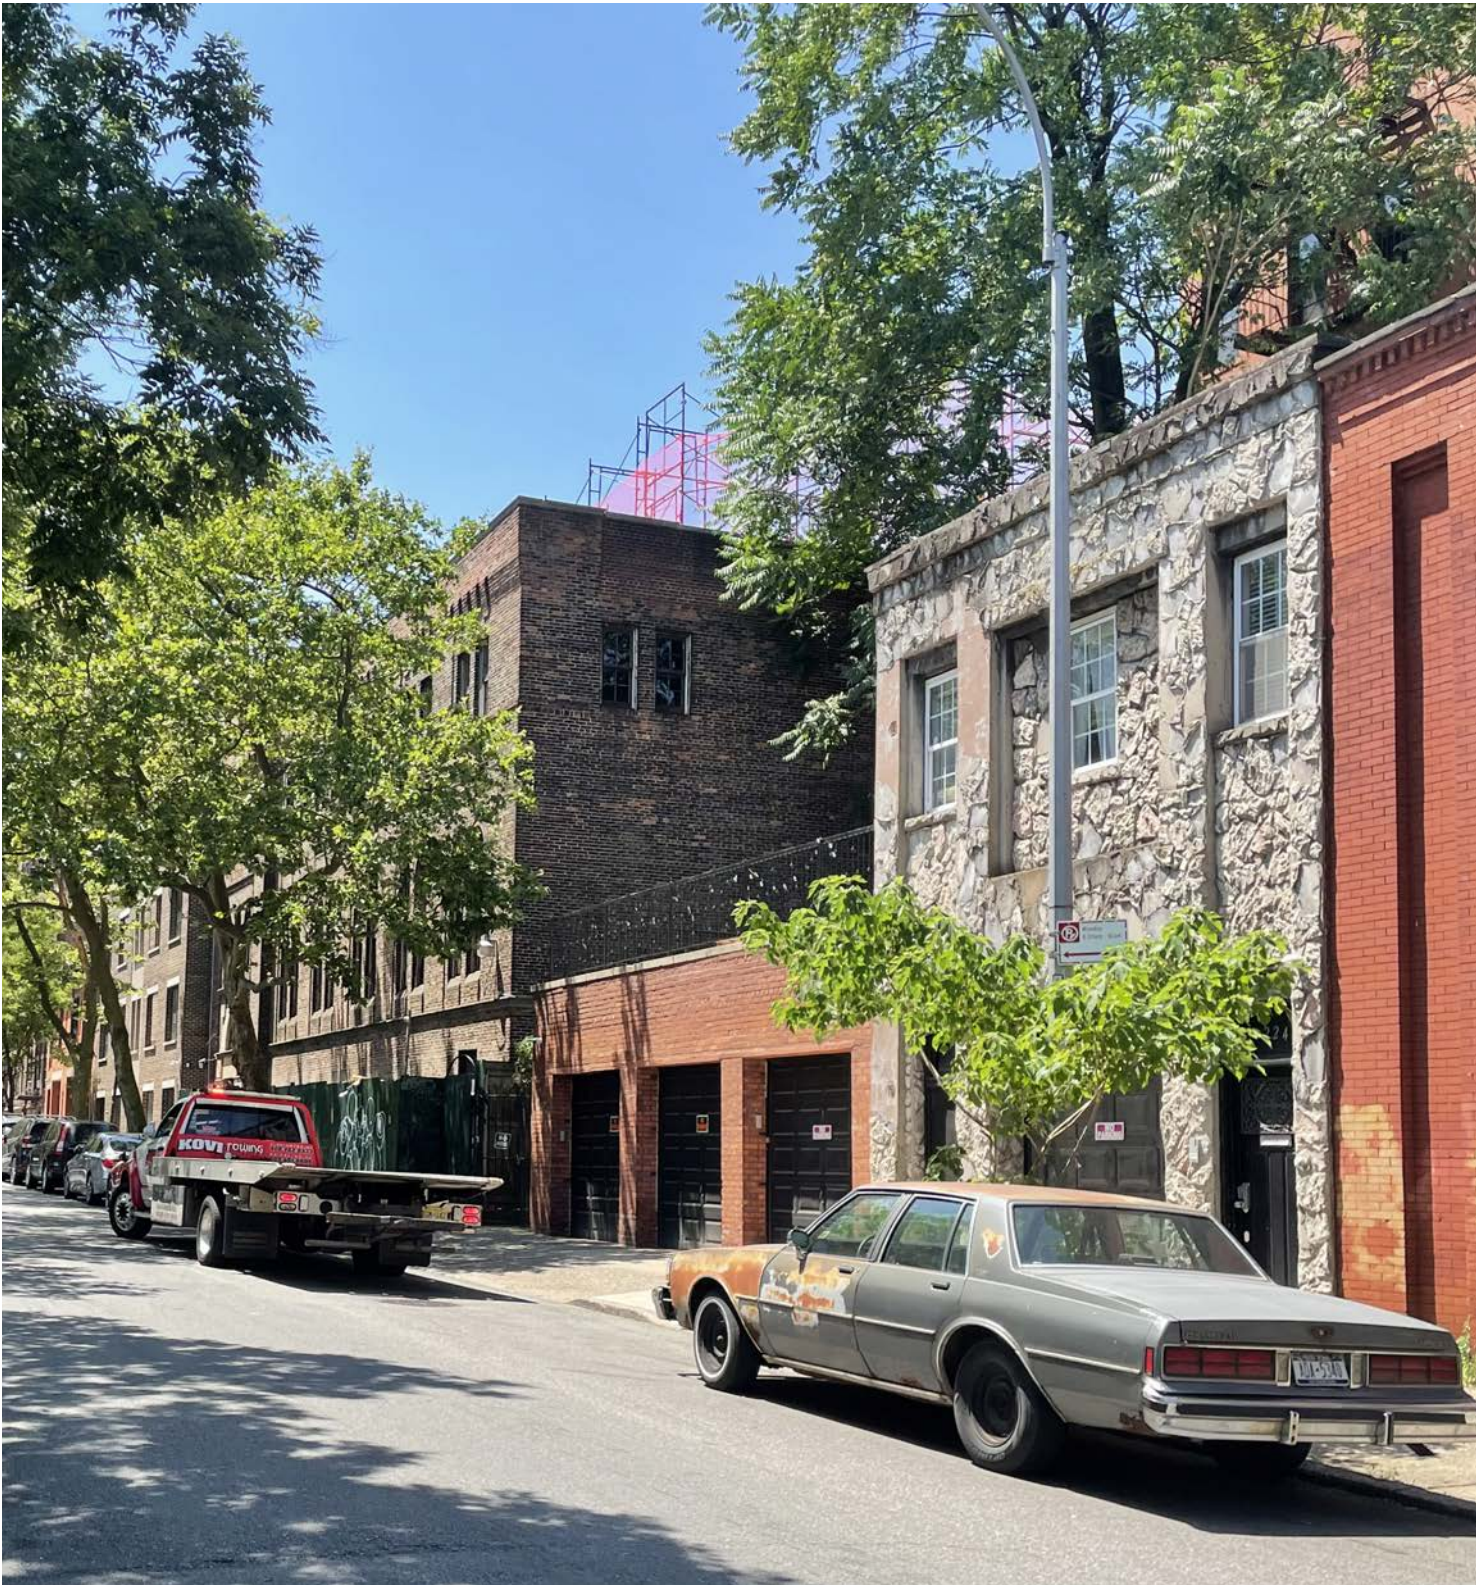
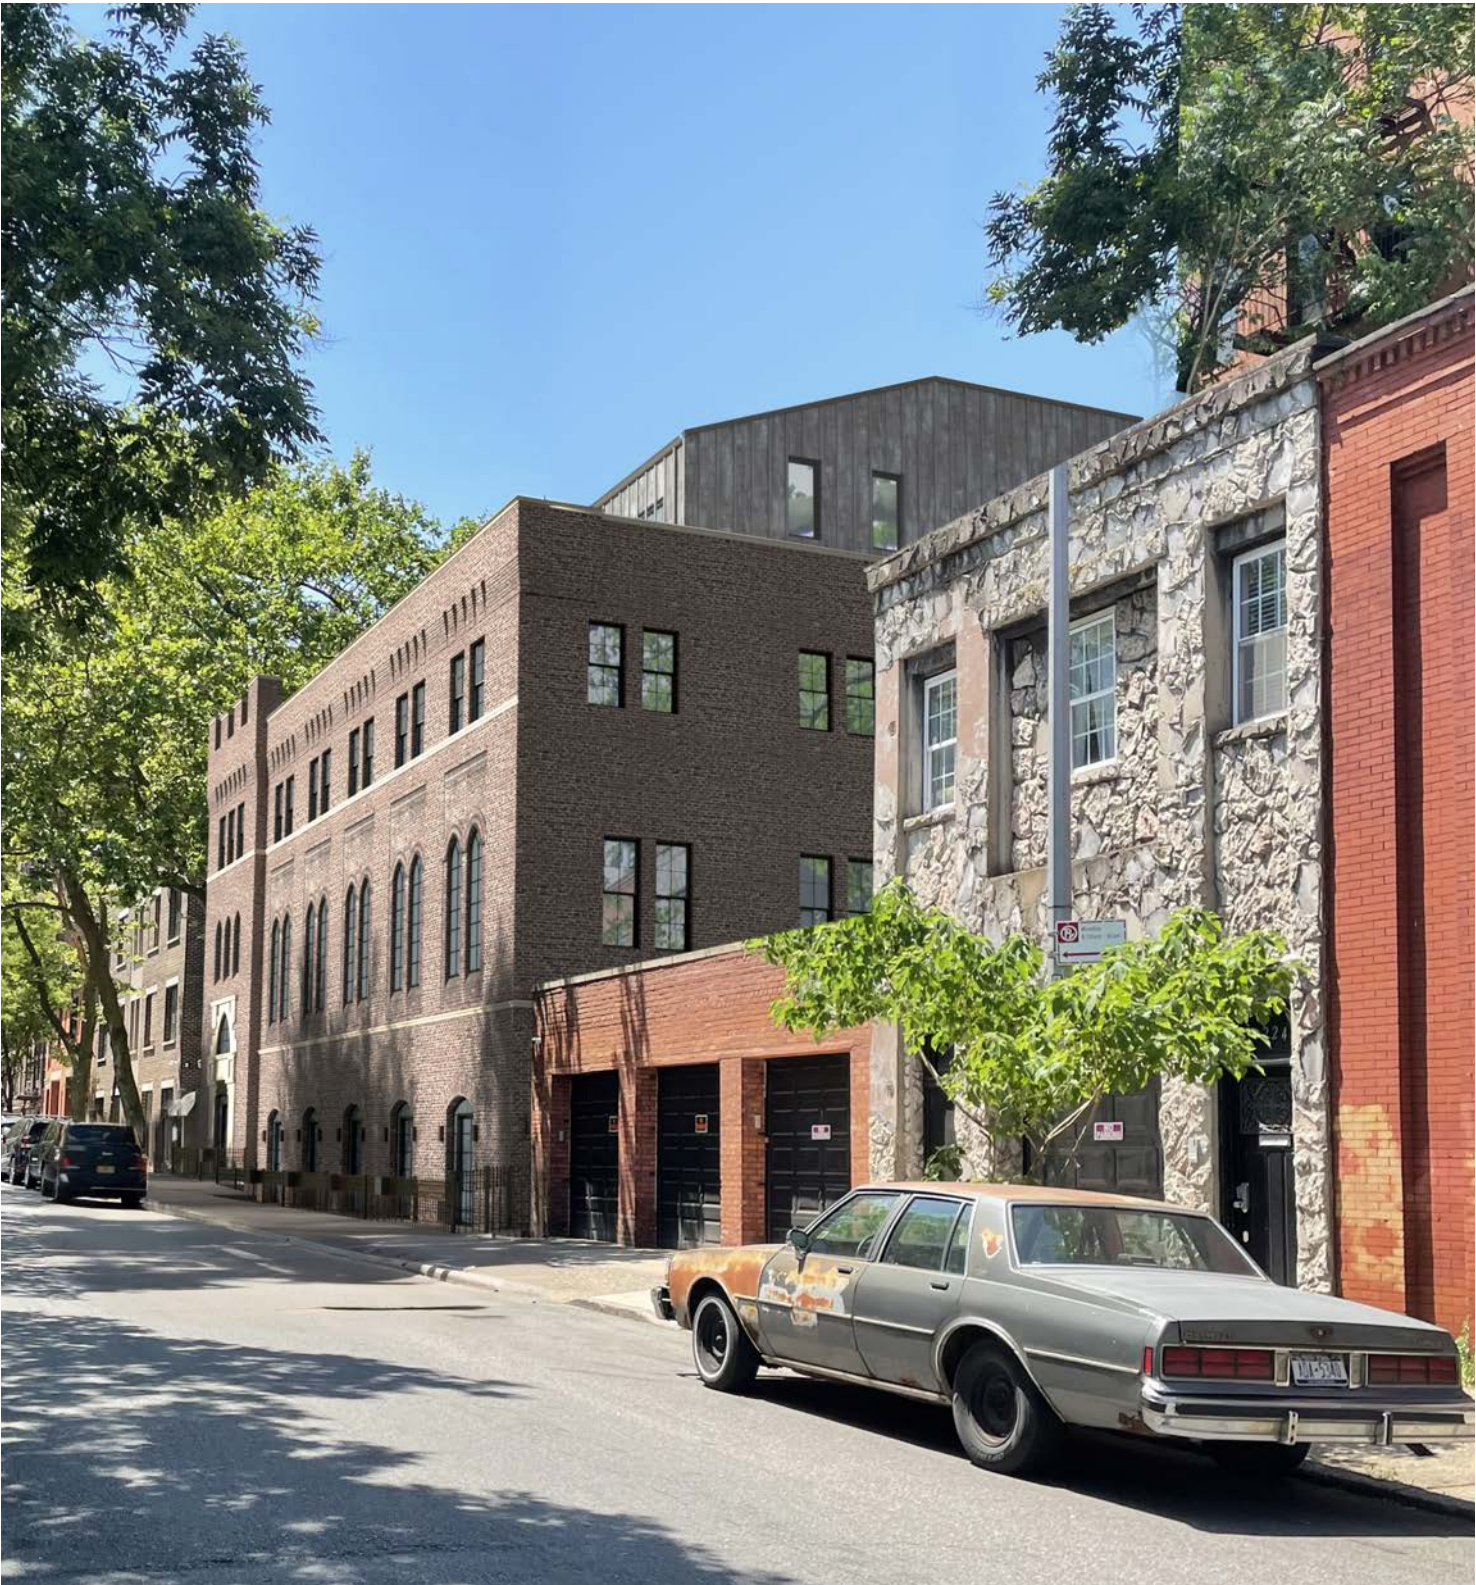
STREET VIEW ON HALL STREET

EXISTING (JUNE 2025)

PROPOSED

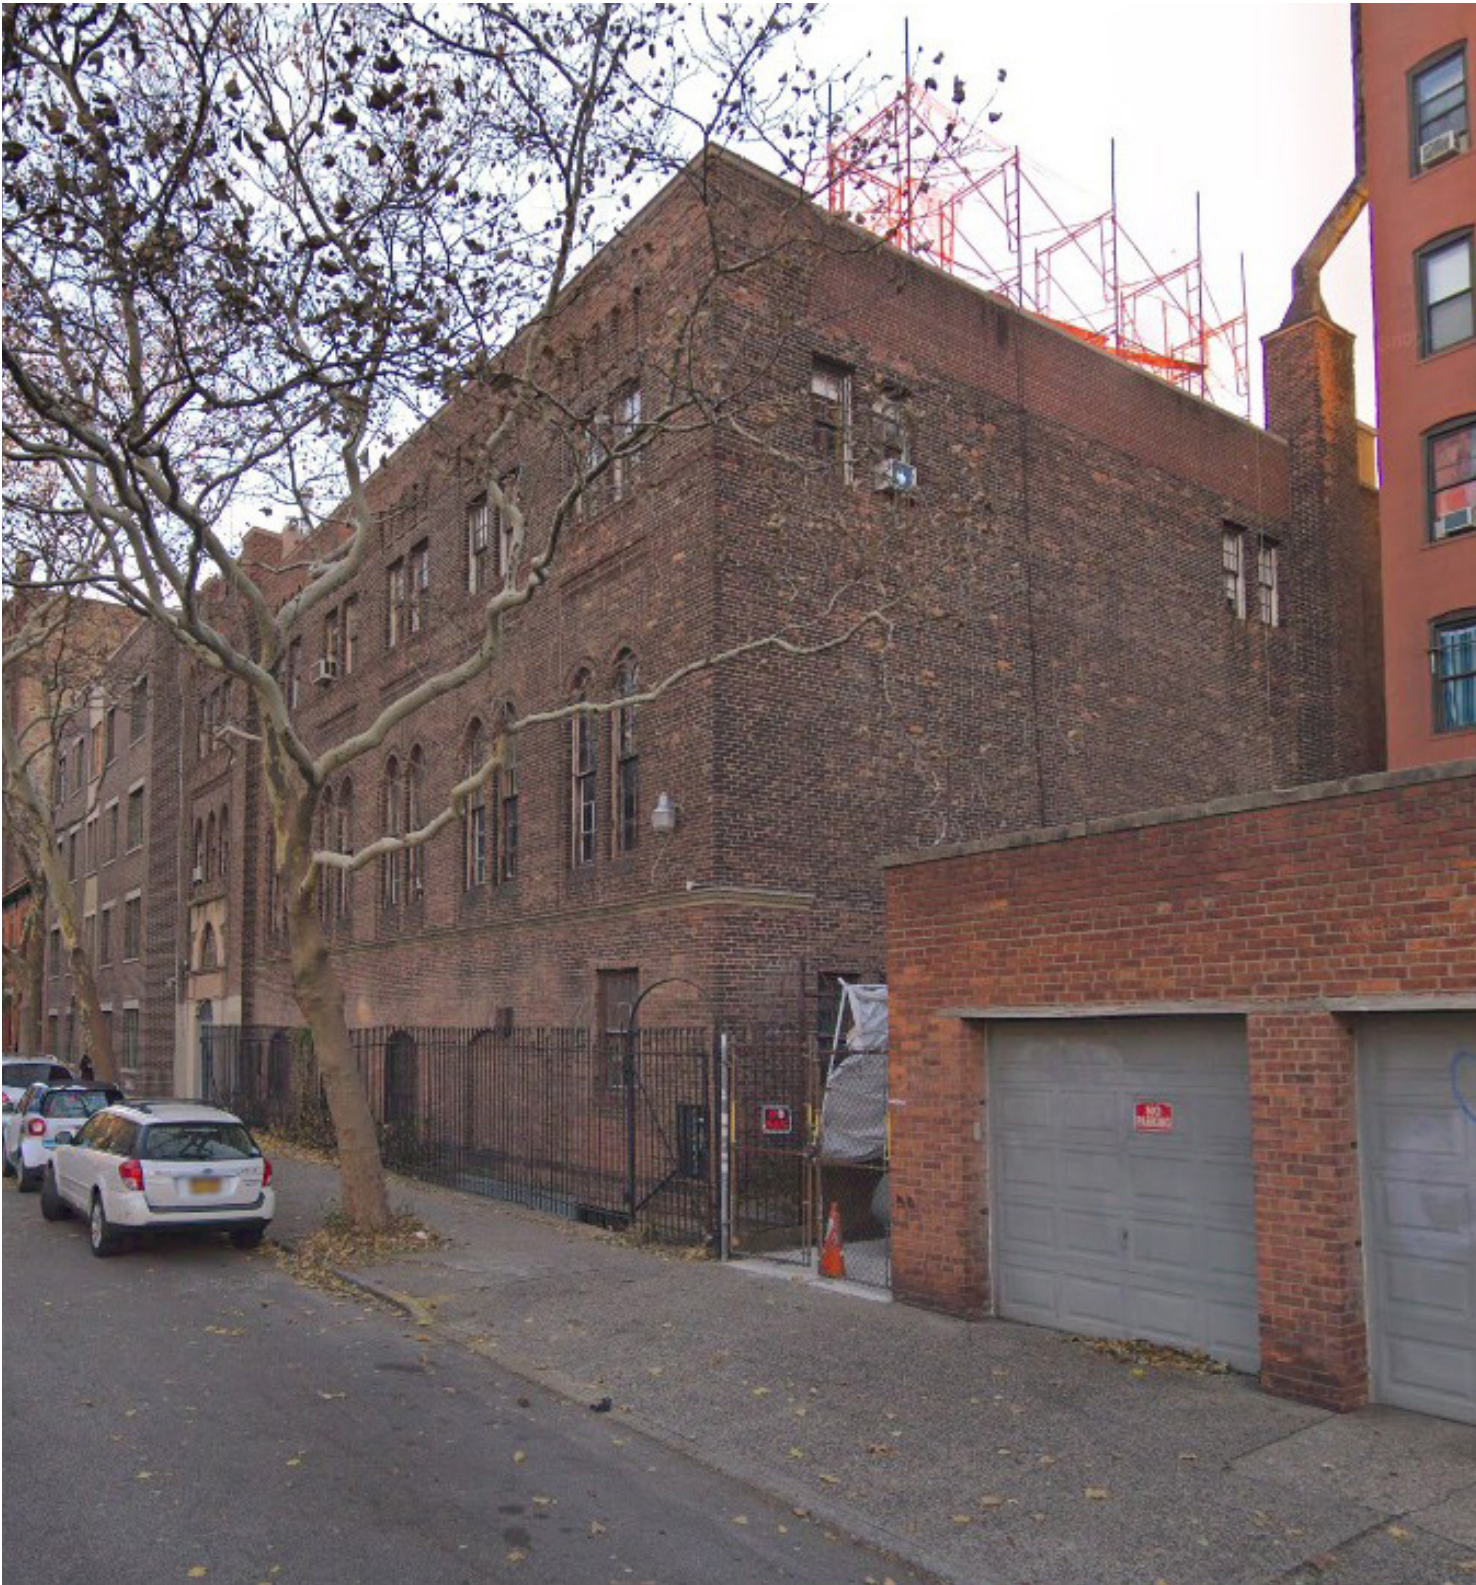
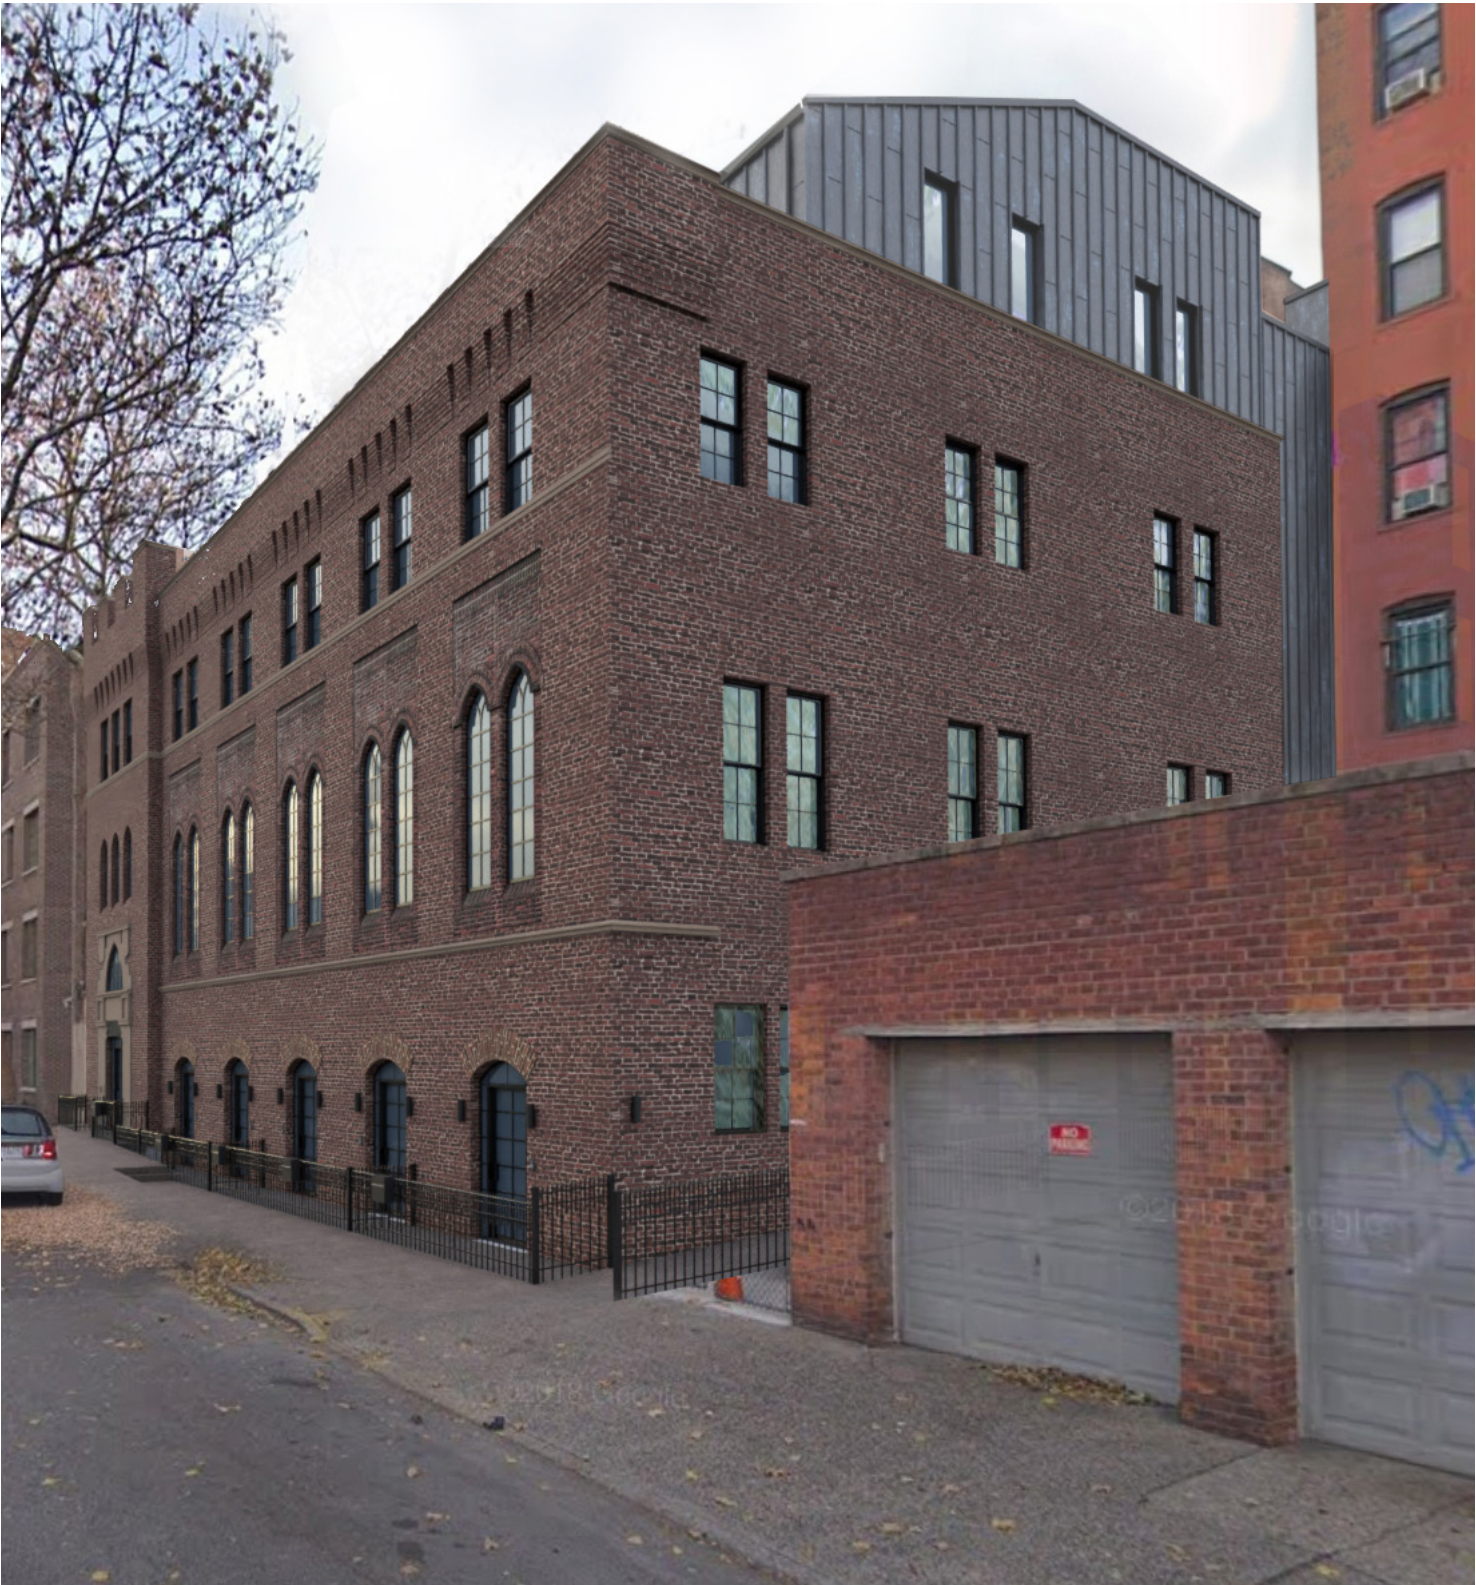
PROPOSED PENTHOUSE ADDITION ON HALL STREET

EXISTING (NOVEMBER 2017)

PROPOSED
