Preservation Department – Item 6, LPC-25-11198

**257-263 Washington Avenue and 230-236 Hall Street –
Clinton Hill Historic District
Borough of Brooklyn**

APPLICATION TO THE NYC LANDMARKS PRESERVATION COMMISSION
257 WASHINGTON AVE, BOROUGH OF BROOKLYN

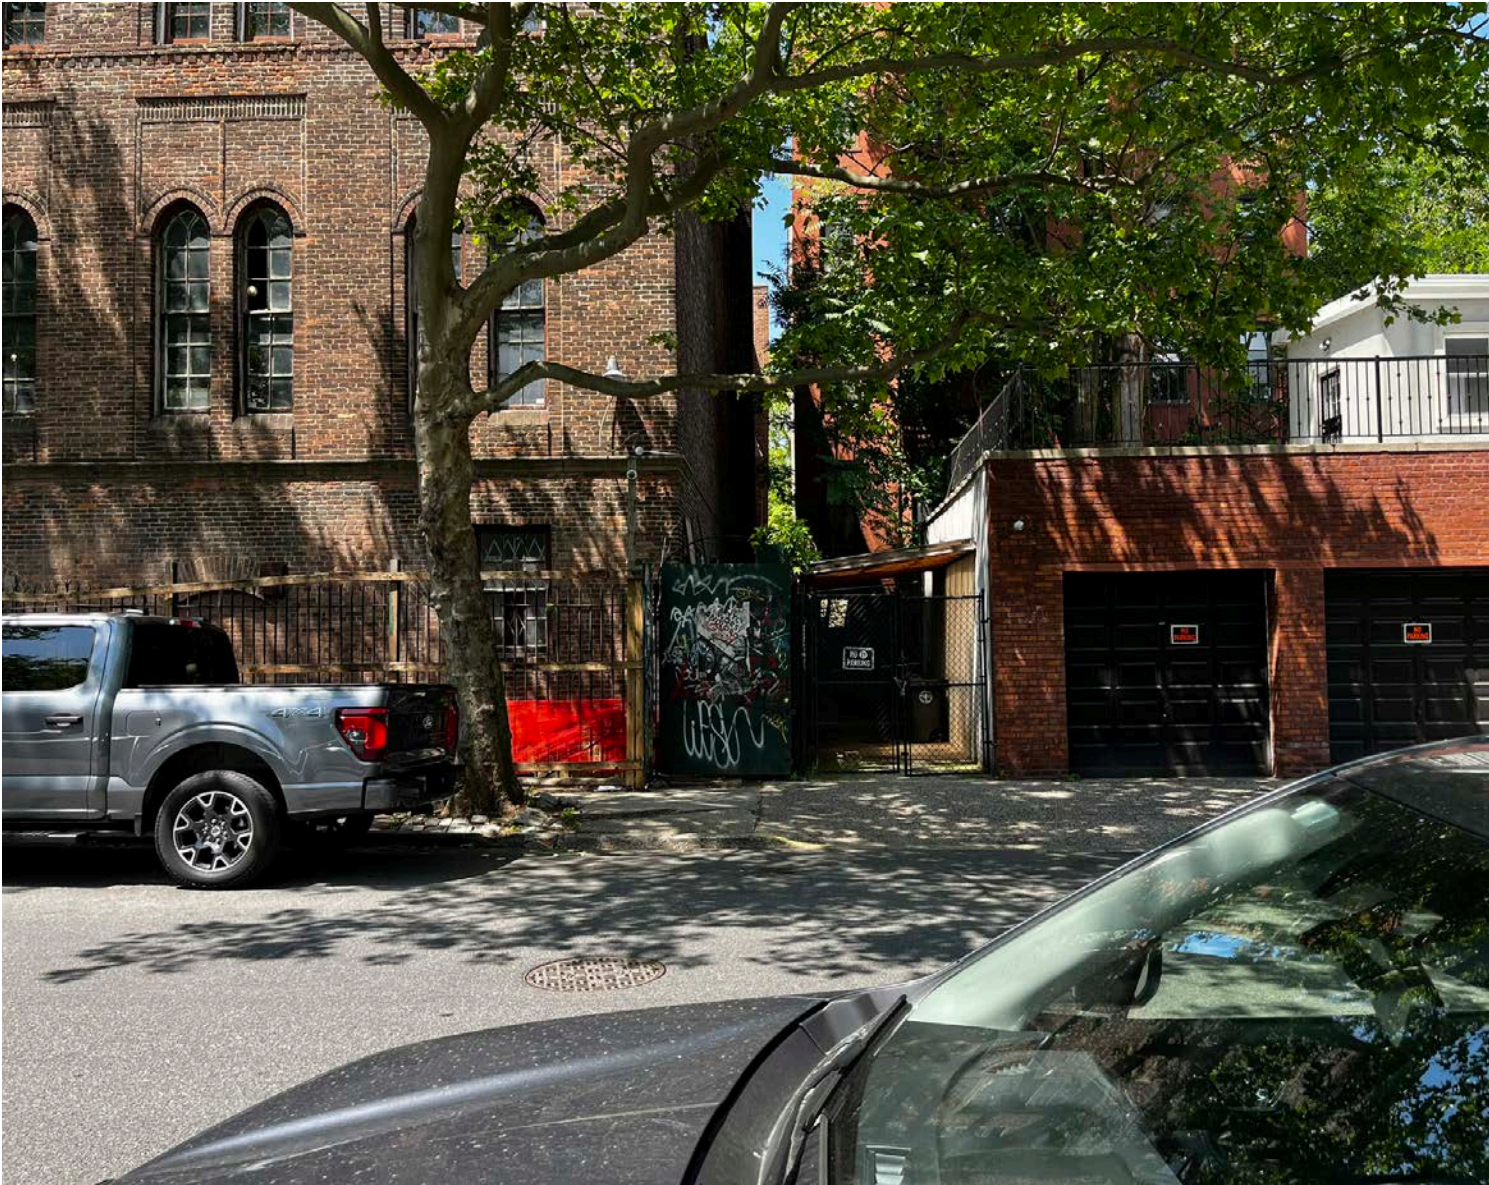
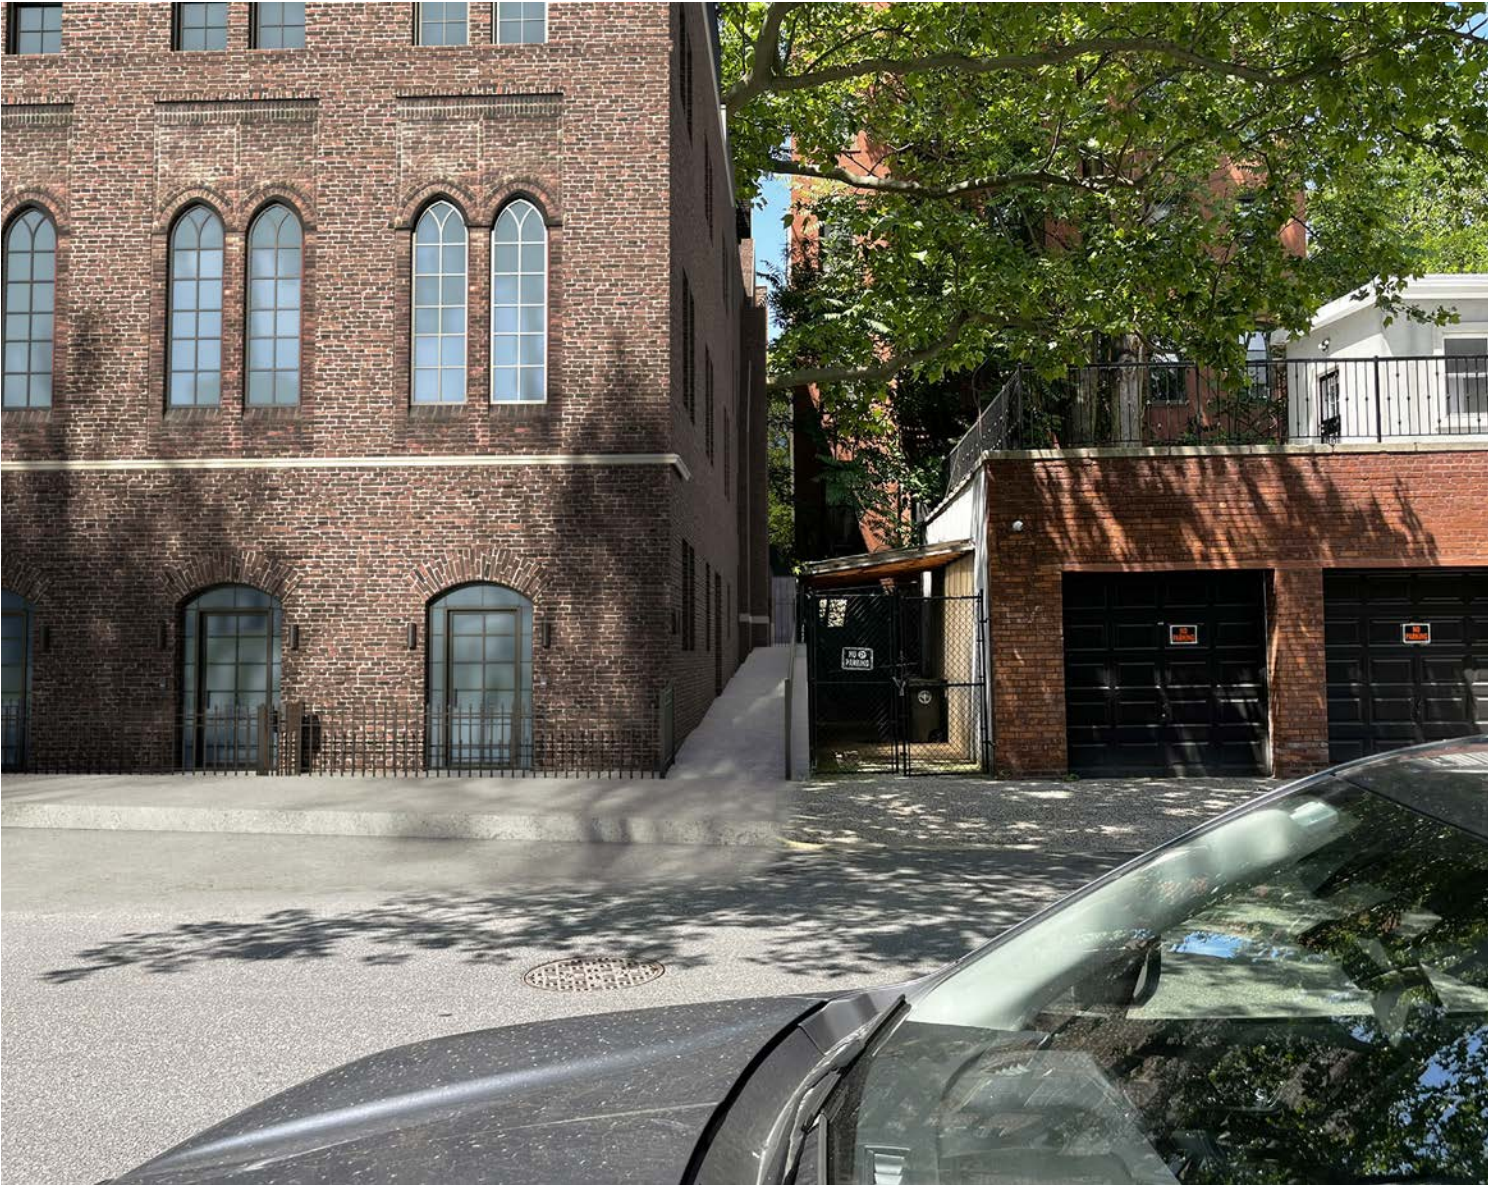
PROPOSED ALLEY AT HALL STREET

EXISTING (JUNE 2025)

PROPOSED

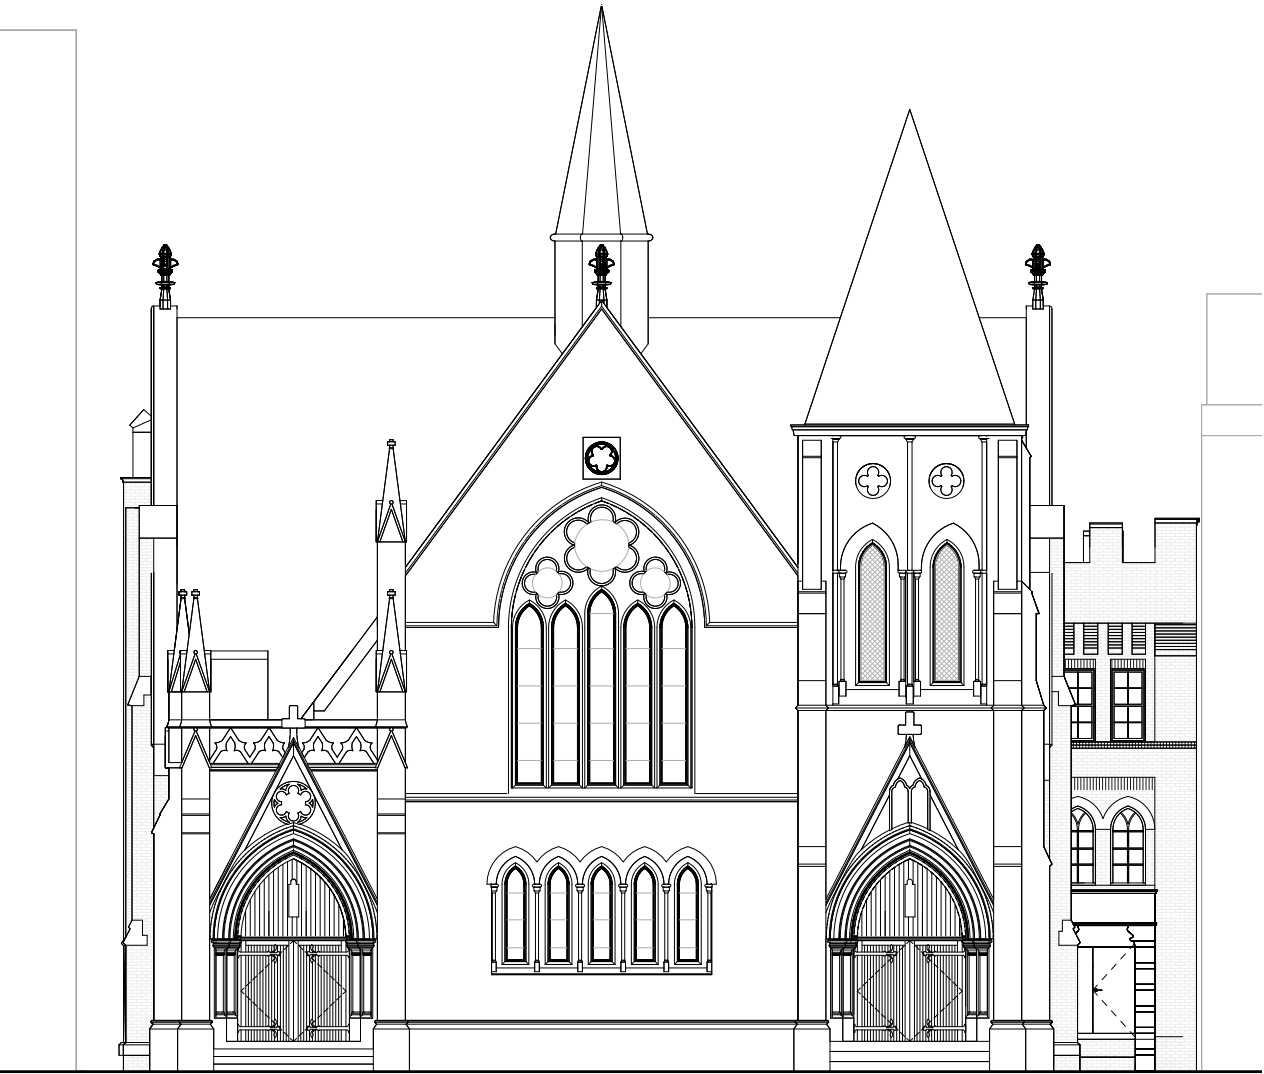
WASHINGTON AVE ELEVATION

EXISTING

PROPOSED

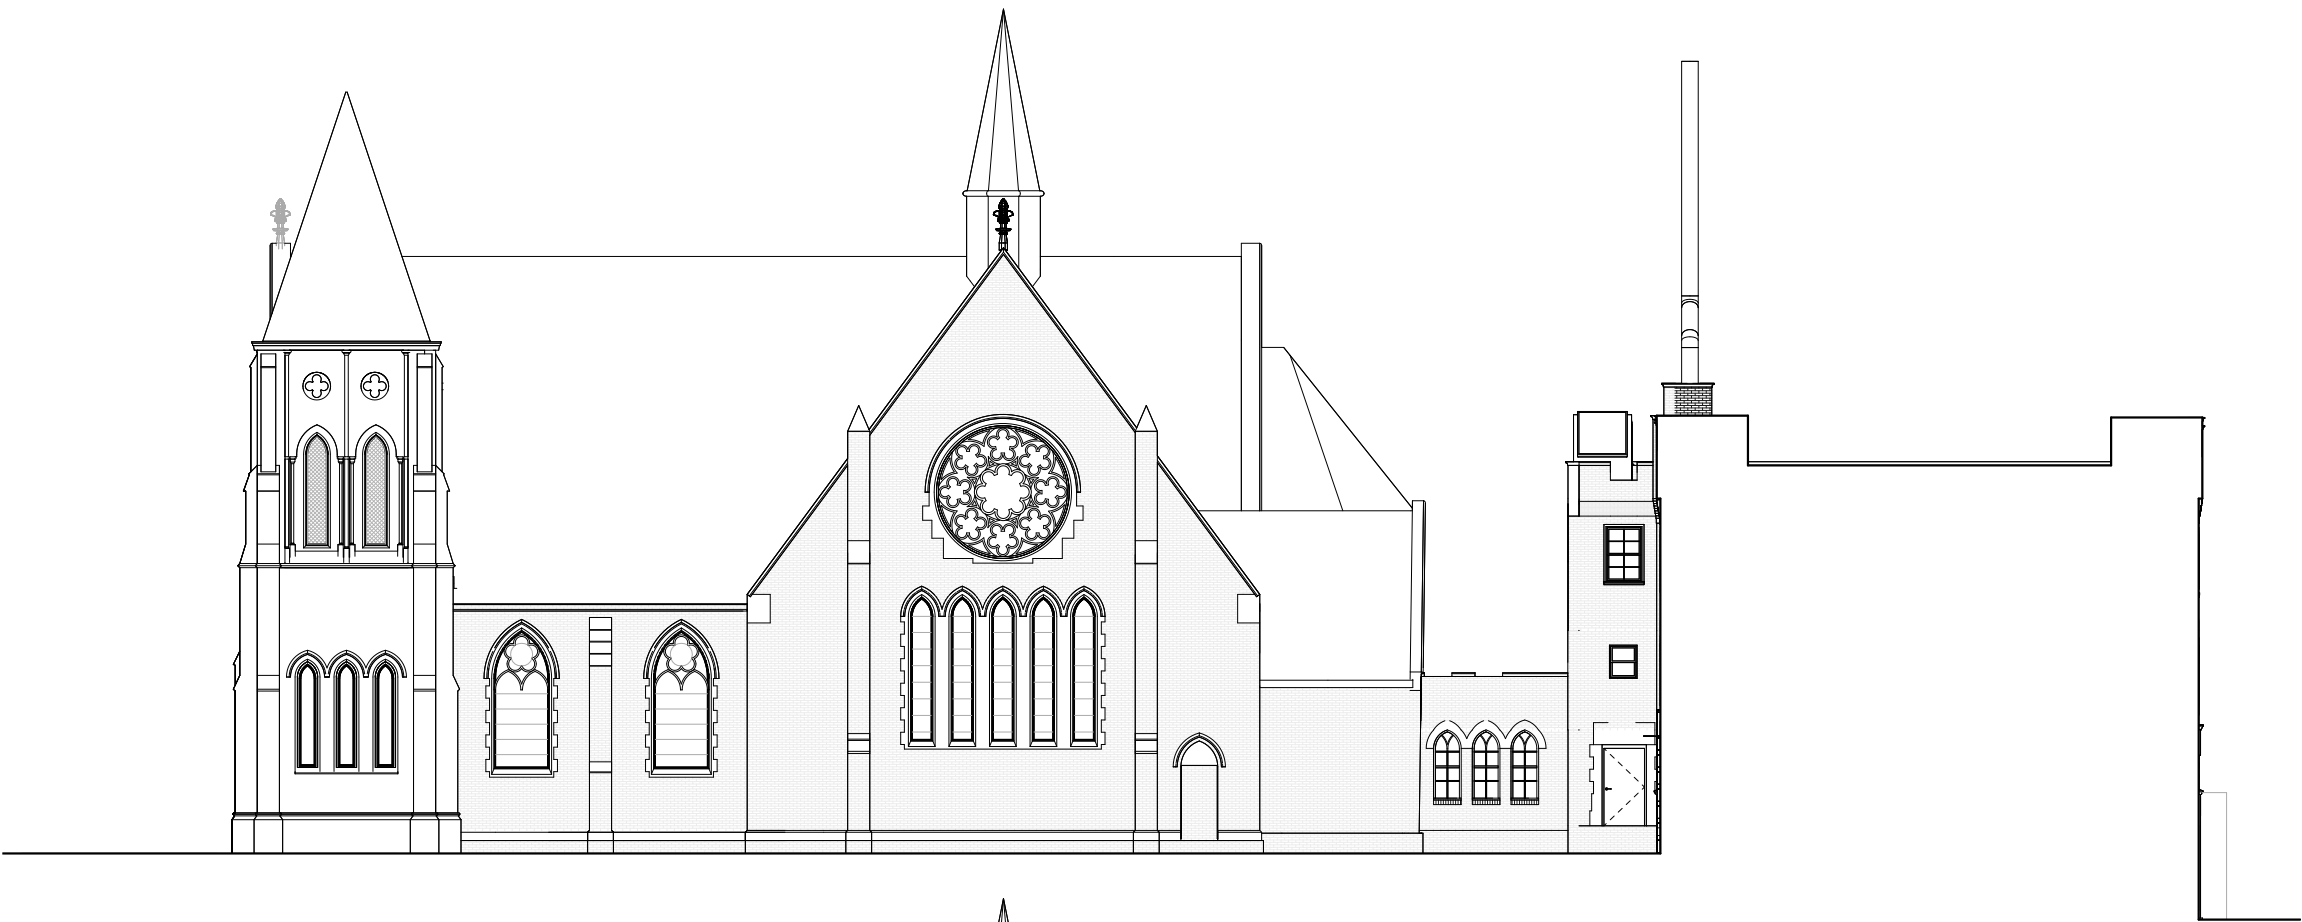
SOUTH ELEVATION

EXISTING

PROPOSED

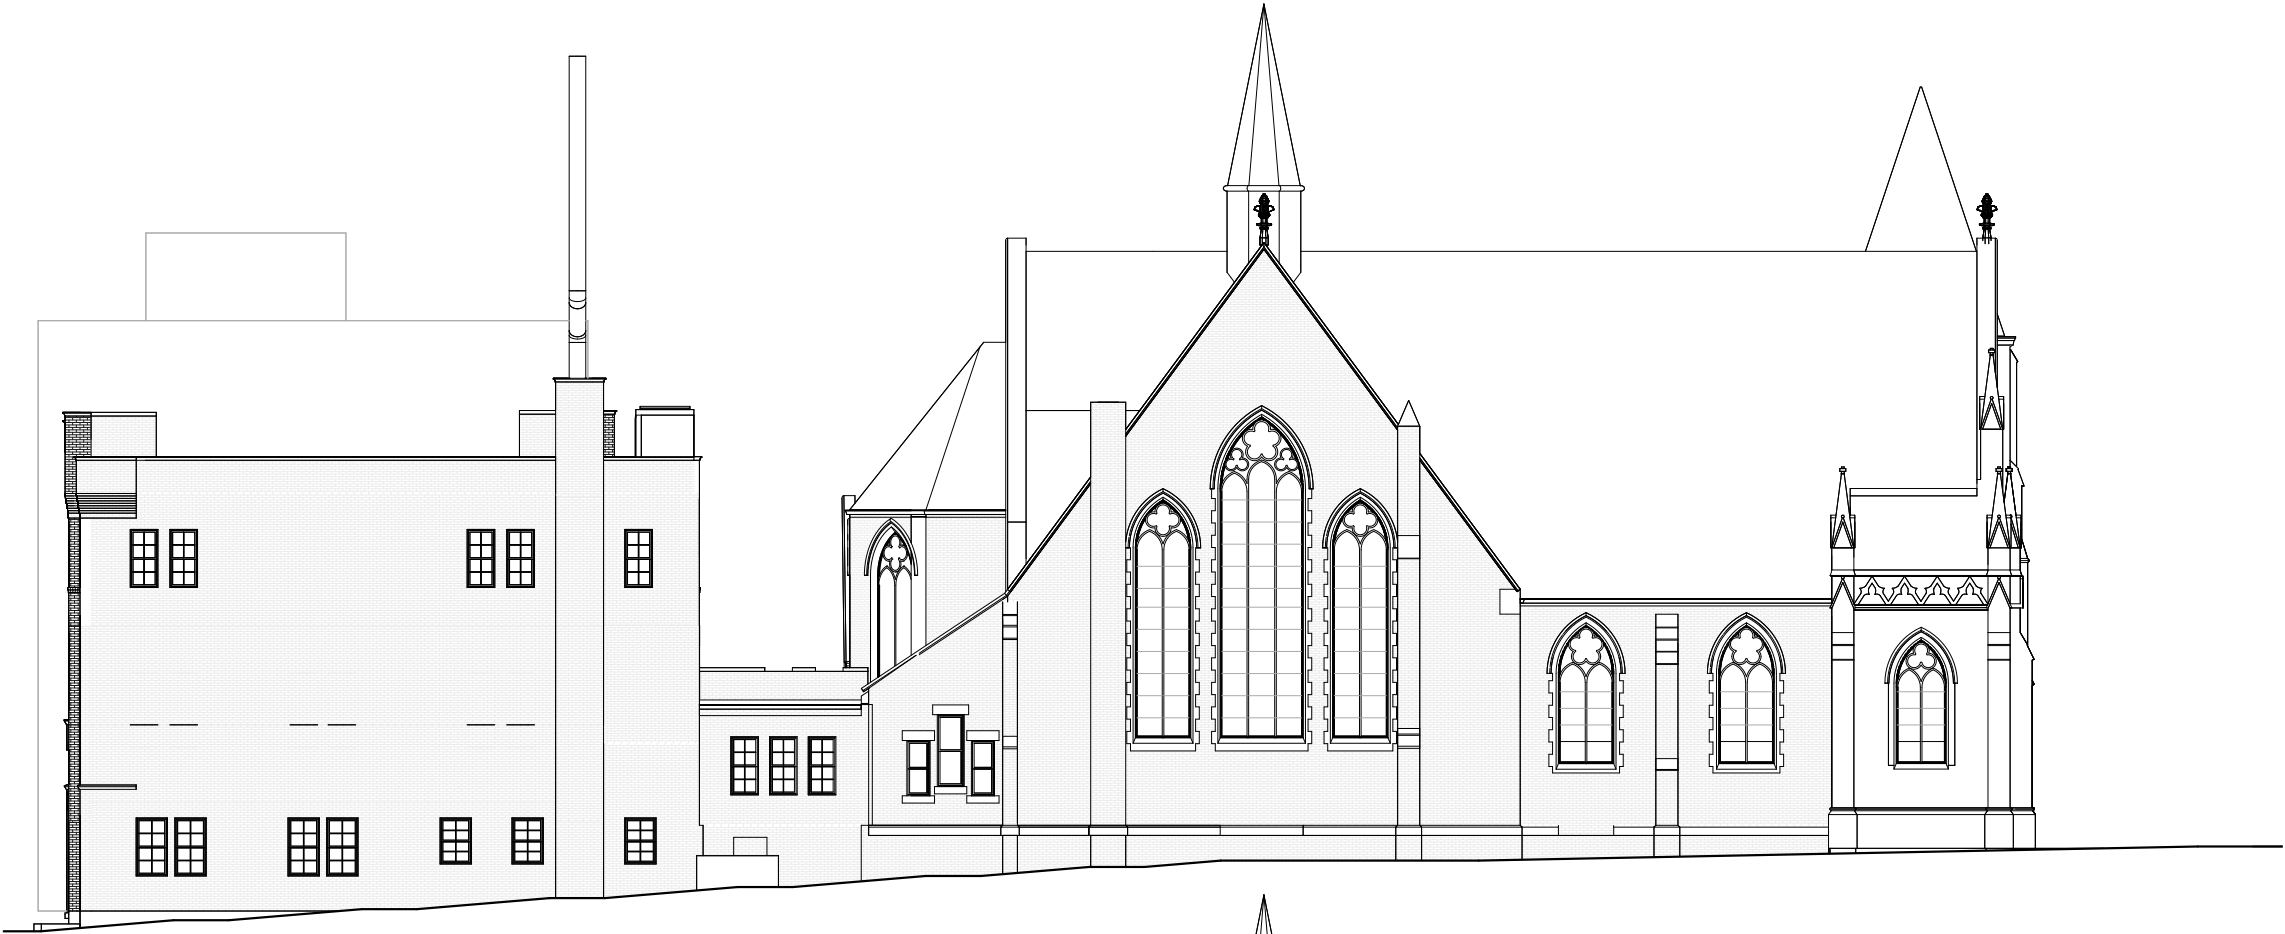
NORTH ELEVATION

EXISTING

PROPOSED

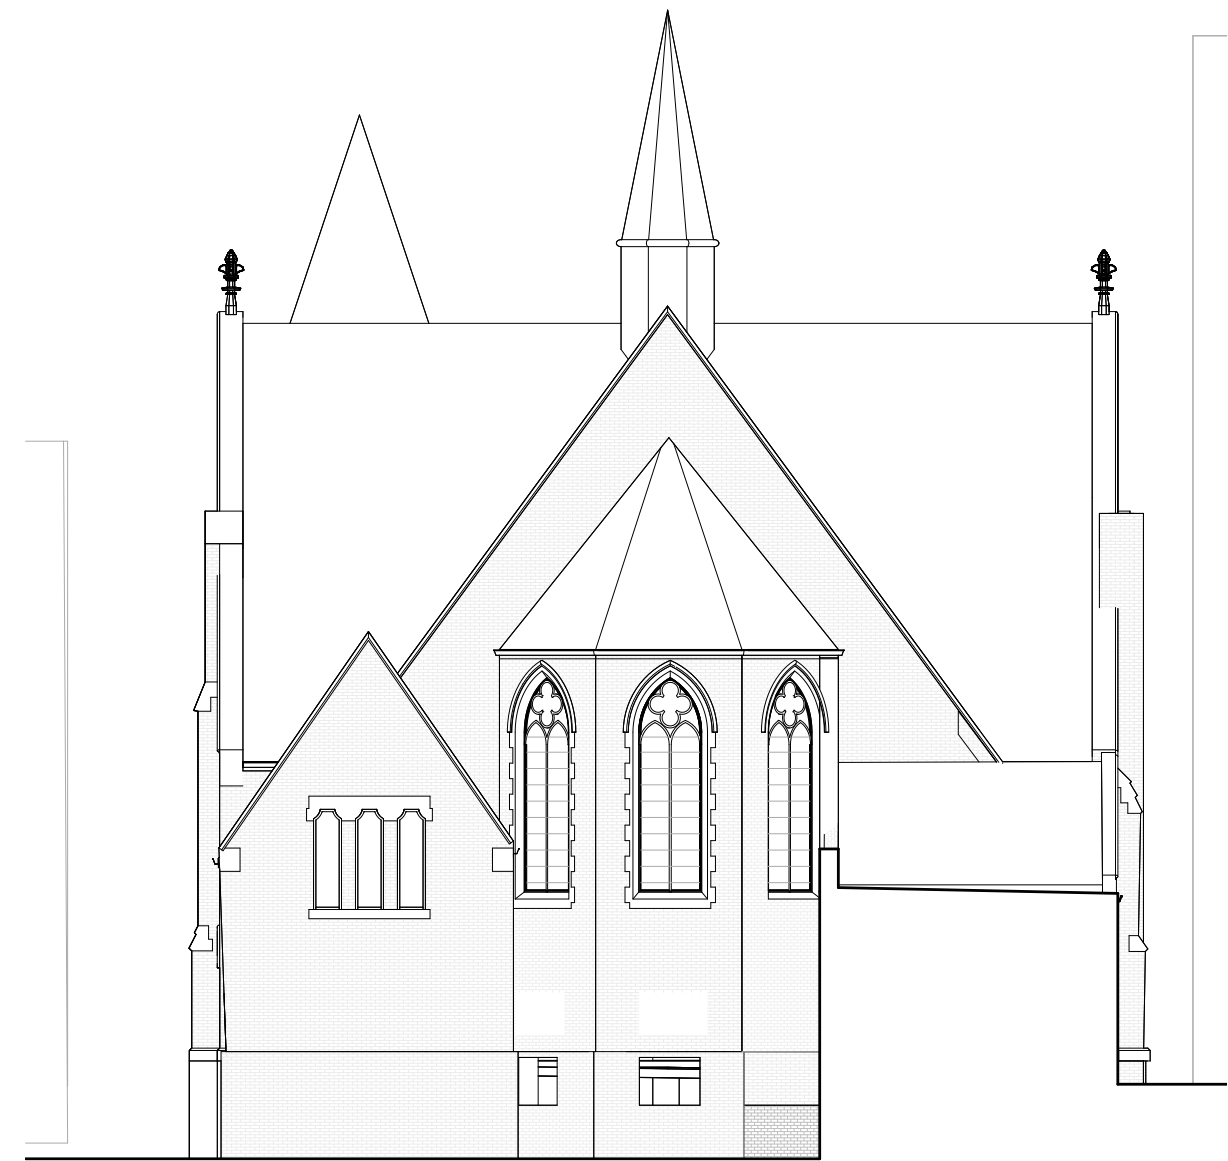
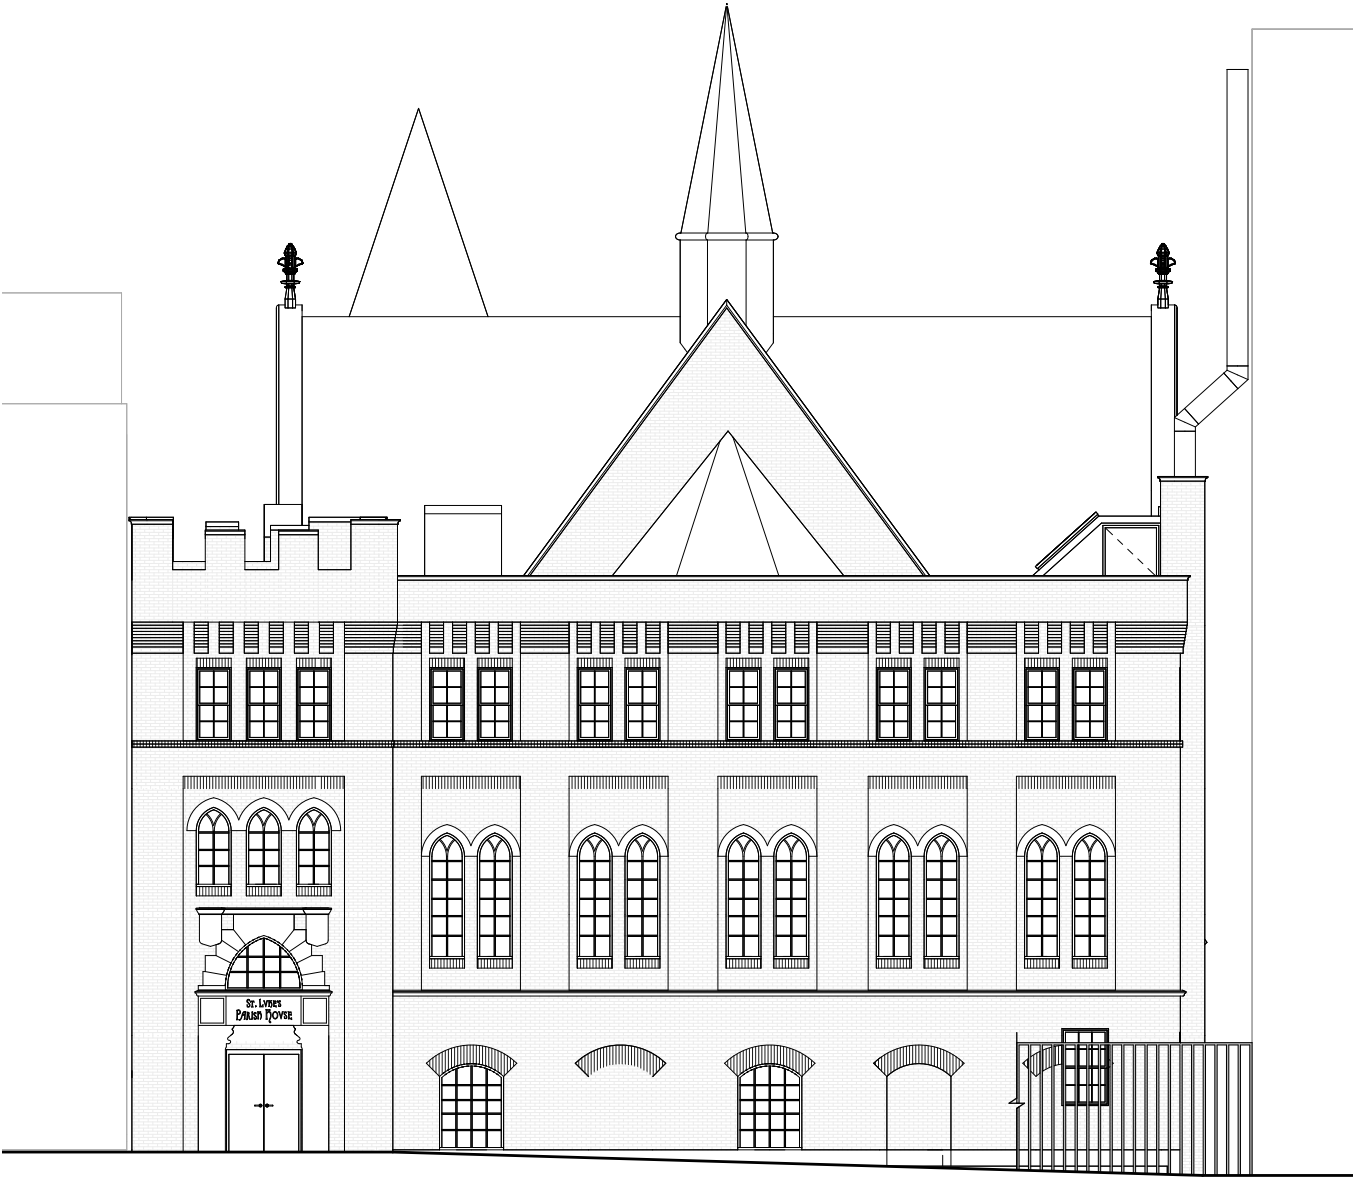
HALL STREET ELEVATION

EXISTING

PROPOSED

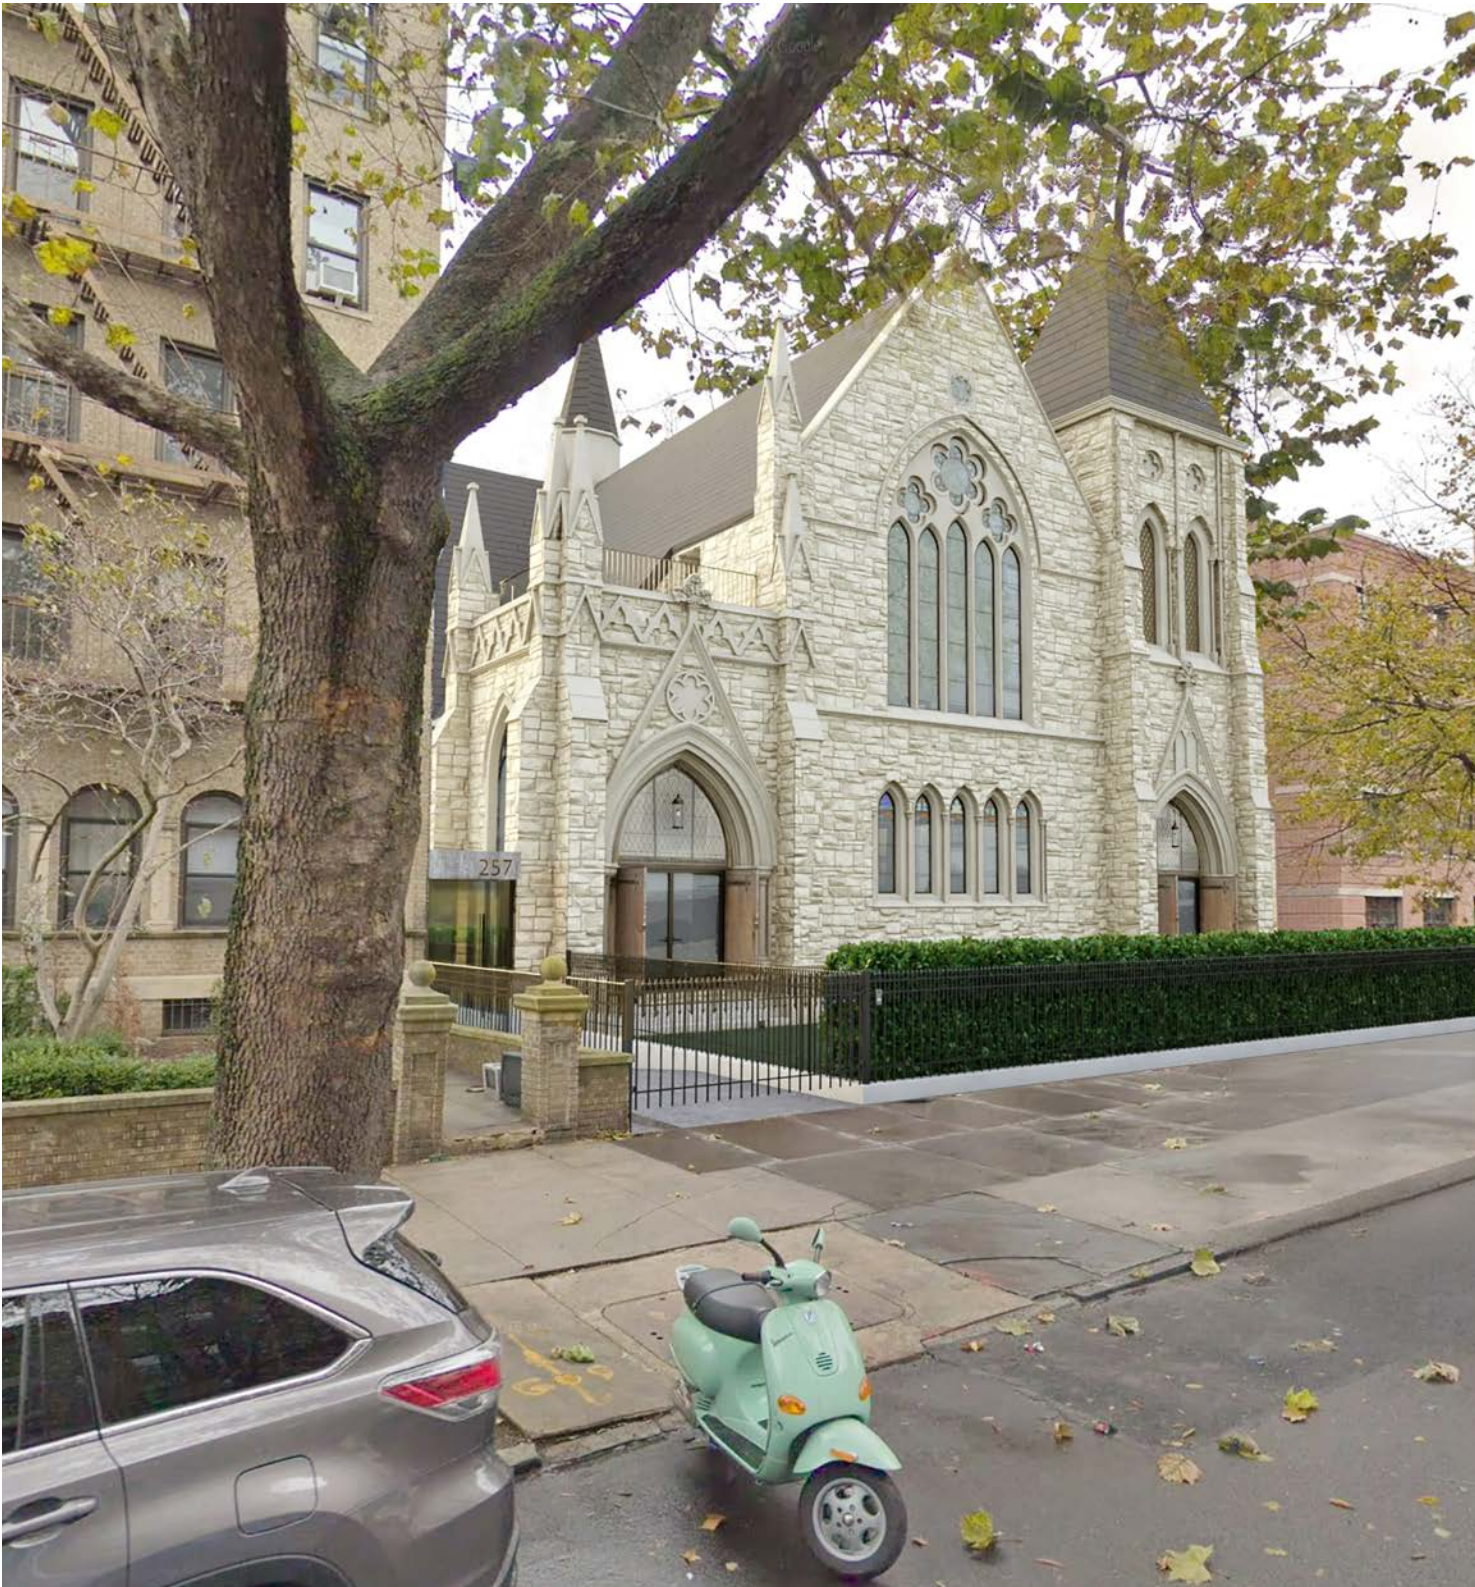
WASHINGTON AVENUE

PROPOSED MATERIALS PALETTE - CHURCH ROOF

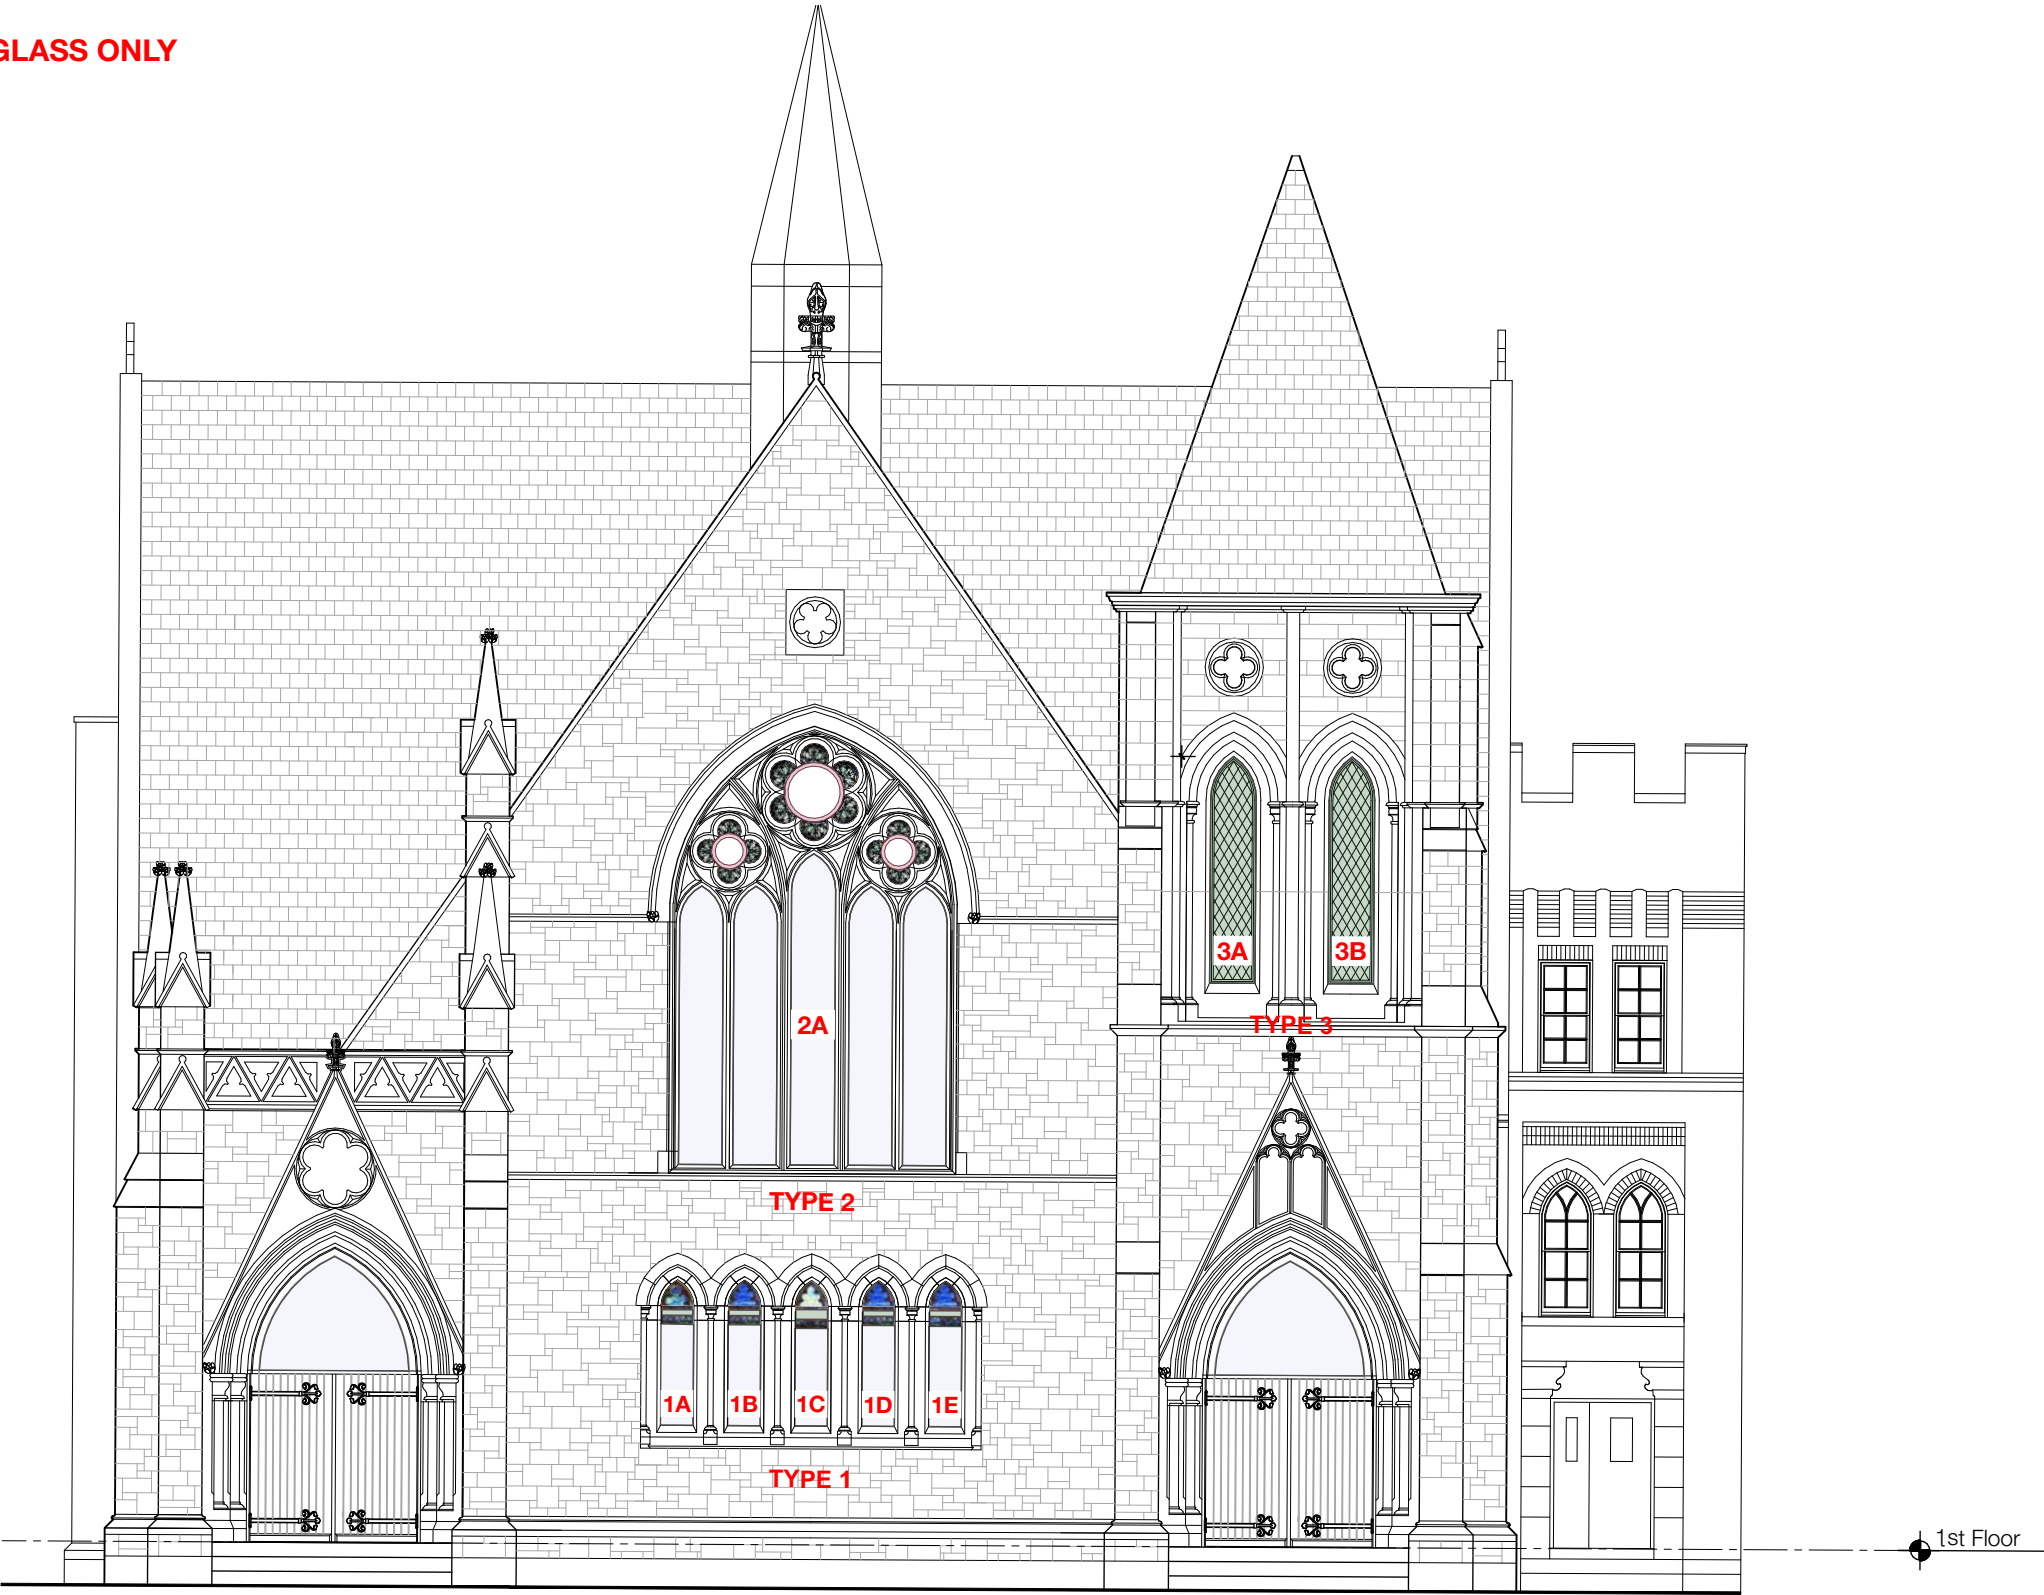
West Facade Elevation - Proposed Stained Glass Window Scheme

- RESTORED PATTERNED STAINED GLASS ONLY
NO RELIGIOUS ICONOGRAPHY
- NEW CLEAR GLASS
- NEW STAINED GLASS
- NEW WOOD TRACERY
FASTENED TO ALUMINUM FRAME
- STONE TRACERY TO REMAIN
- ALUMINUM FRAME

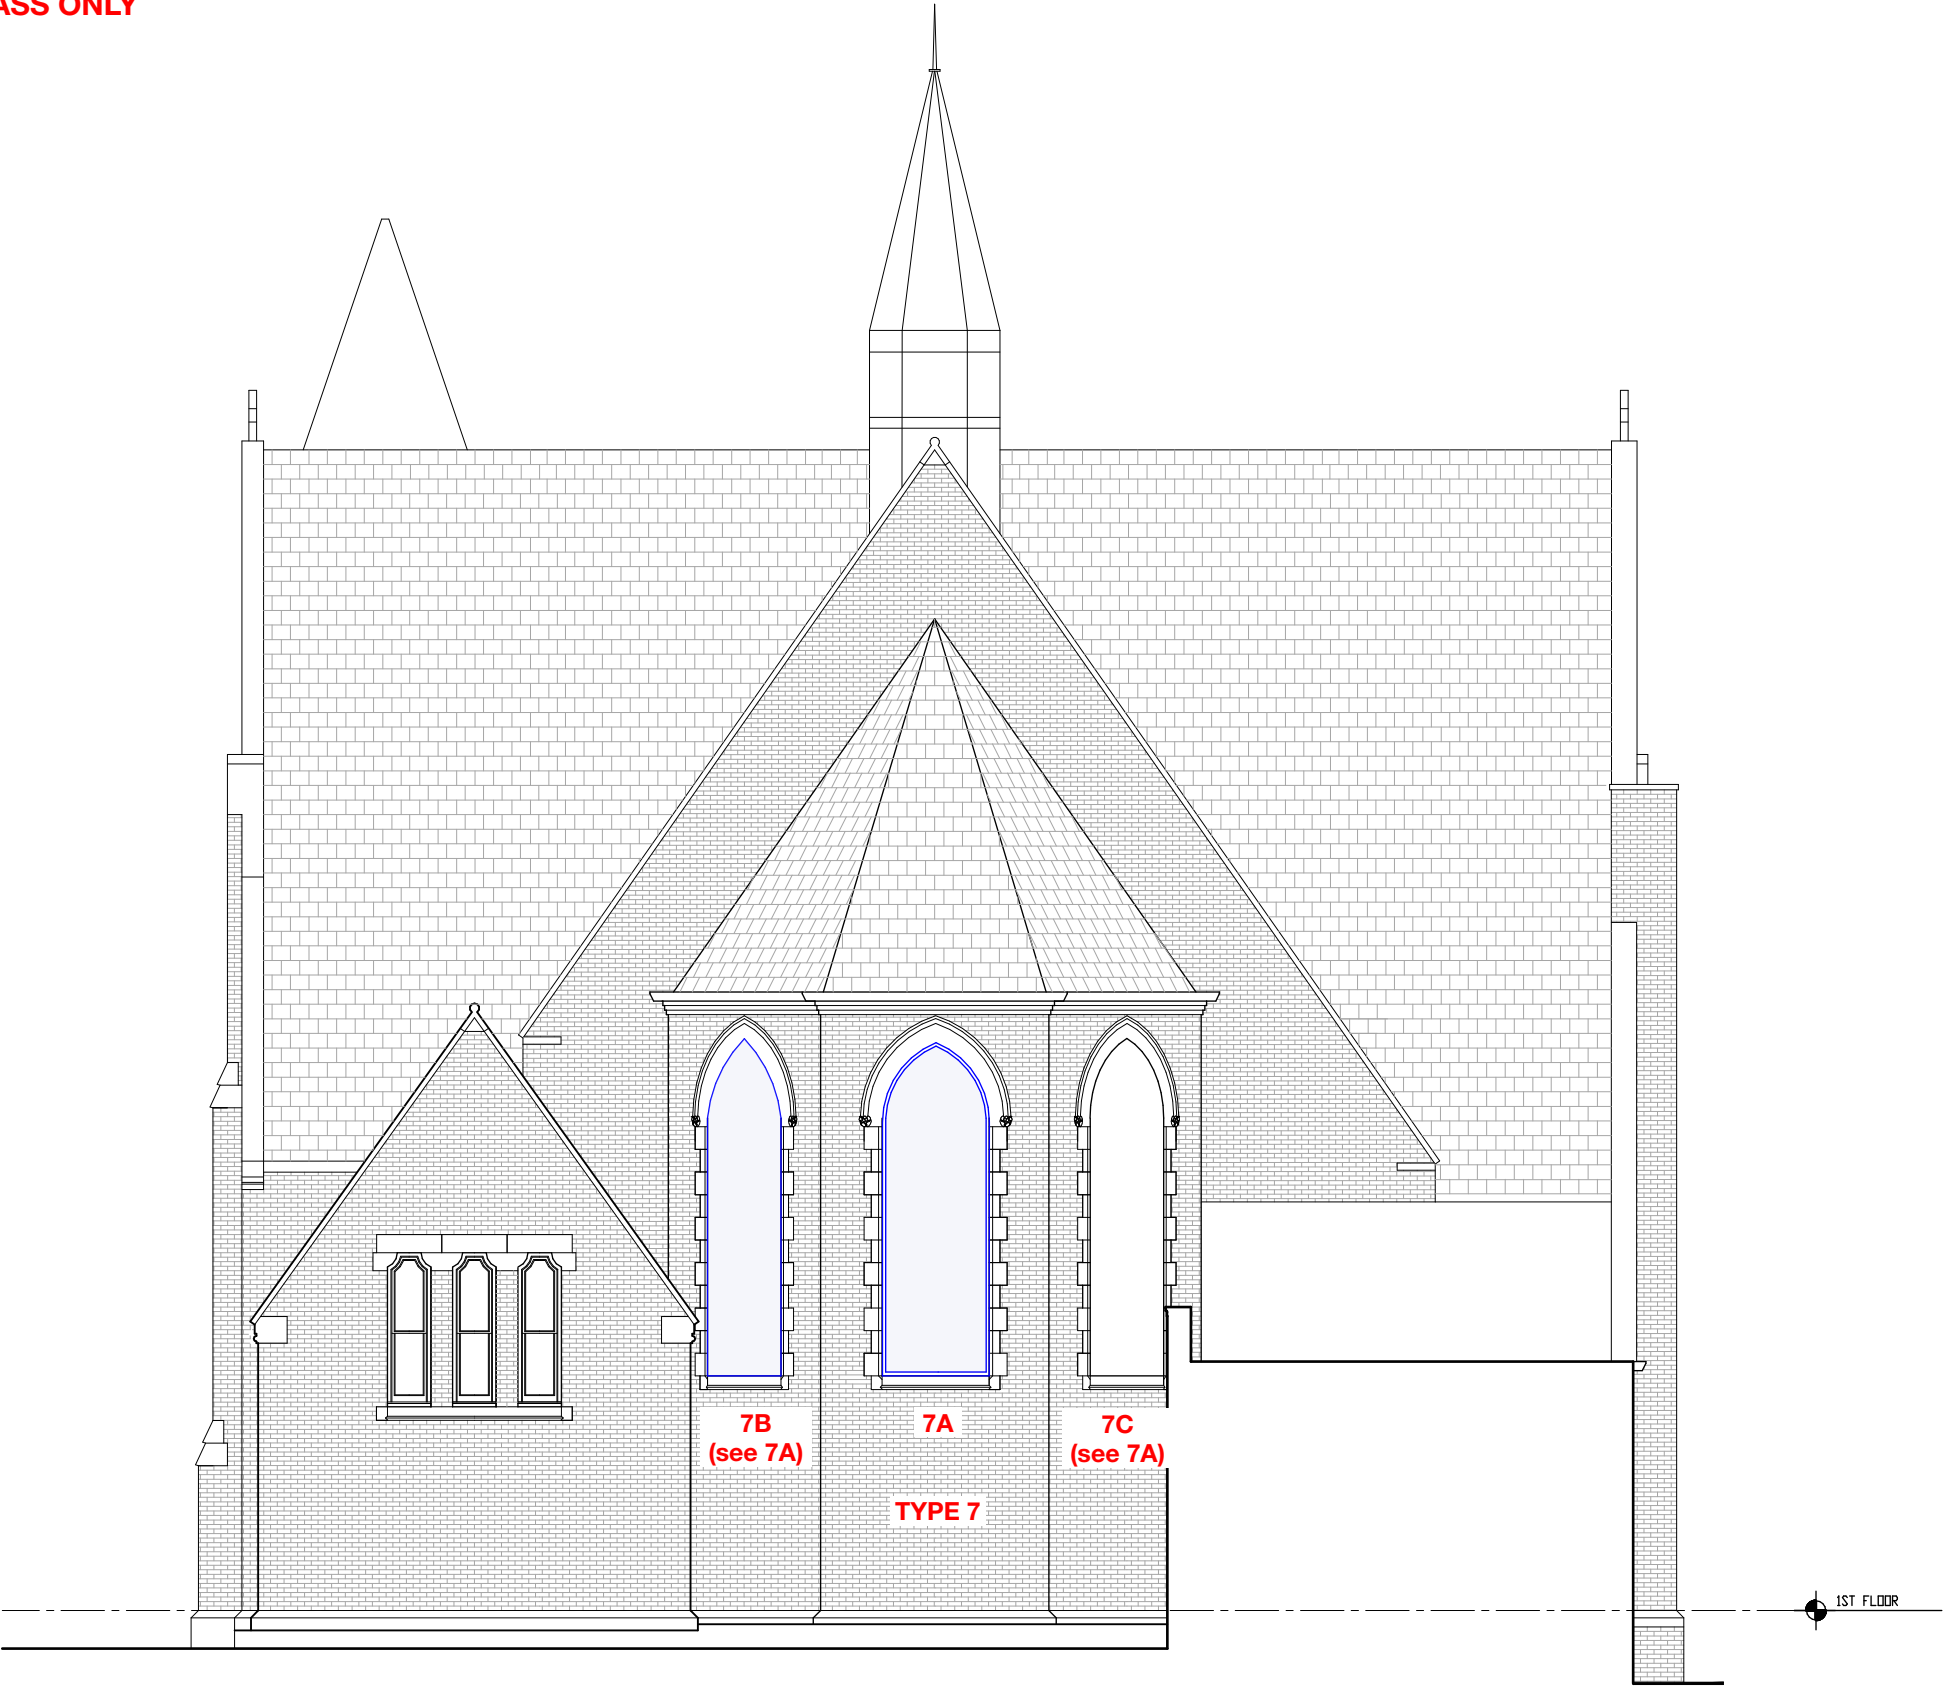
East Facade Elevation - Proposed Stained Glass Window Scheme

- RESTORED PATTERNED STAINED GLASS ONLY
NO RELIGIOUS ICONOGRAPHY
- NEW CLEAR GLASS
- NEW WOOD TRACERY
FASTENED TO ALUMINUM FRAME
- STONE TRACERY TO REMAIN
- ALUMINUM FRAME

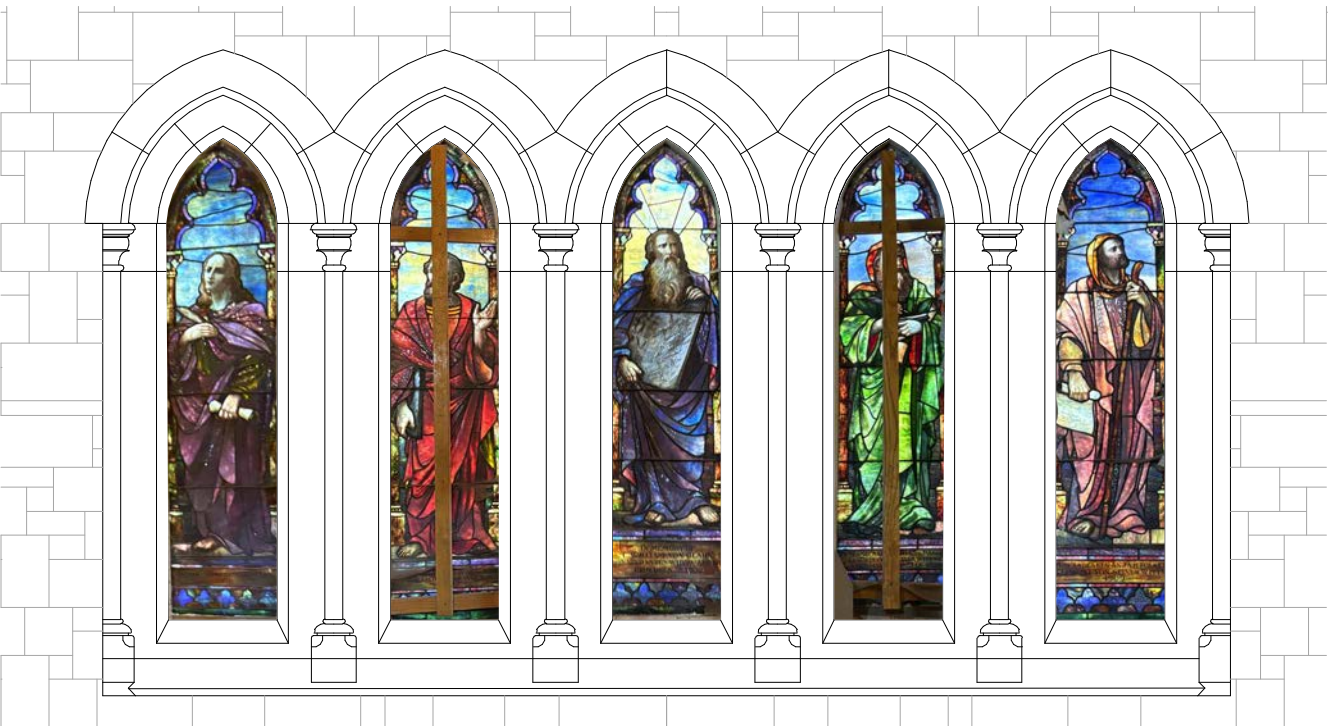
Window 1A-1E - Existing
Interior View Mirrored to Exterior

- Stained glass is in good condition, coming in good condition.
- Exterior finish in good condition
- No evidence of famous maker provenance
- The window is fixed

Type 1 - Set of five (5) lancet, non-operable lites, frameless with stained glass depicting religious iconography.
