Preservation Department – Item 6, LPC-25-11198

**257-263 Washington Avenue and 230-236 Hall Street –
Clinton Hill Historic District
Borough of Brooklyn**

APPLICATION TO THE NYC LANDMARKS PRESERVATION COMMISSION
257 WASHINGTON AVE, BOROUGH OF BROOKLYN

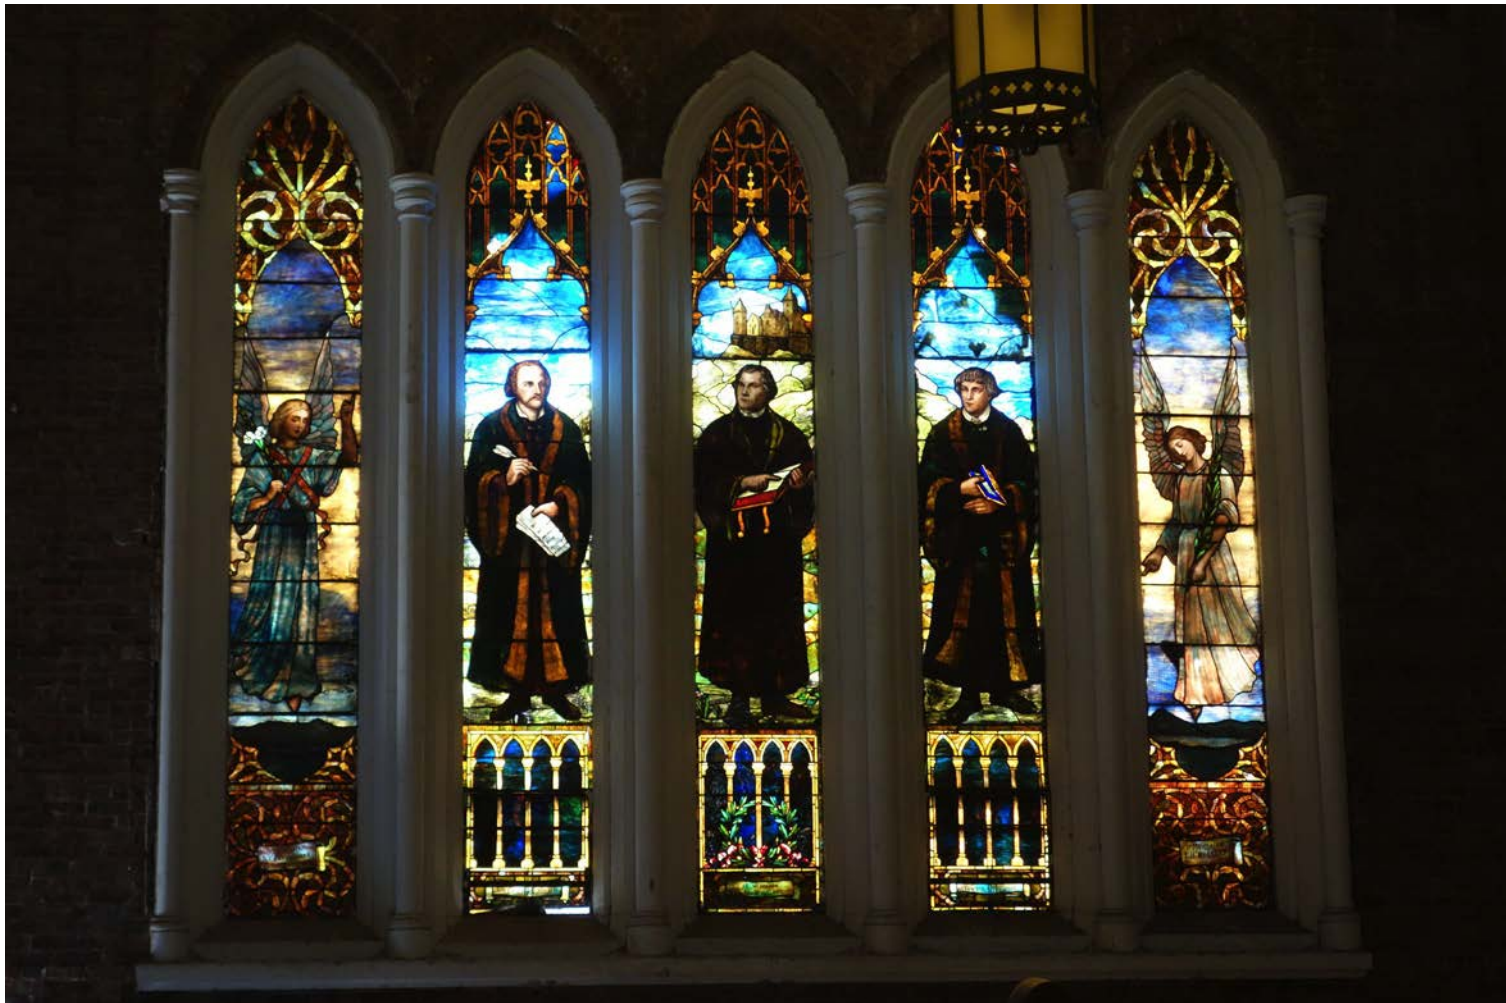
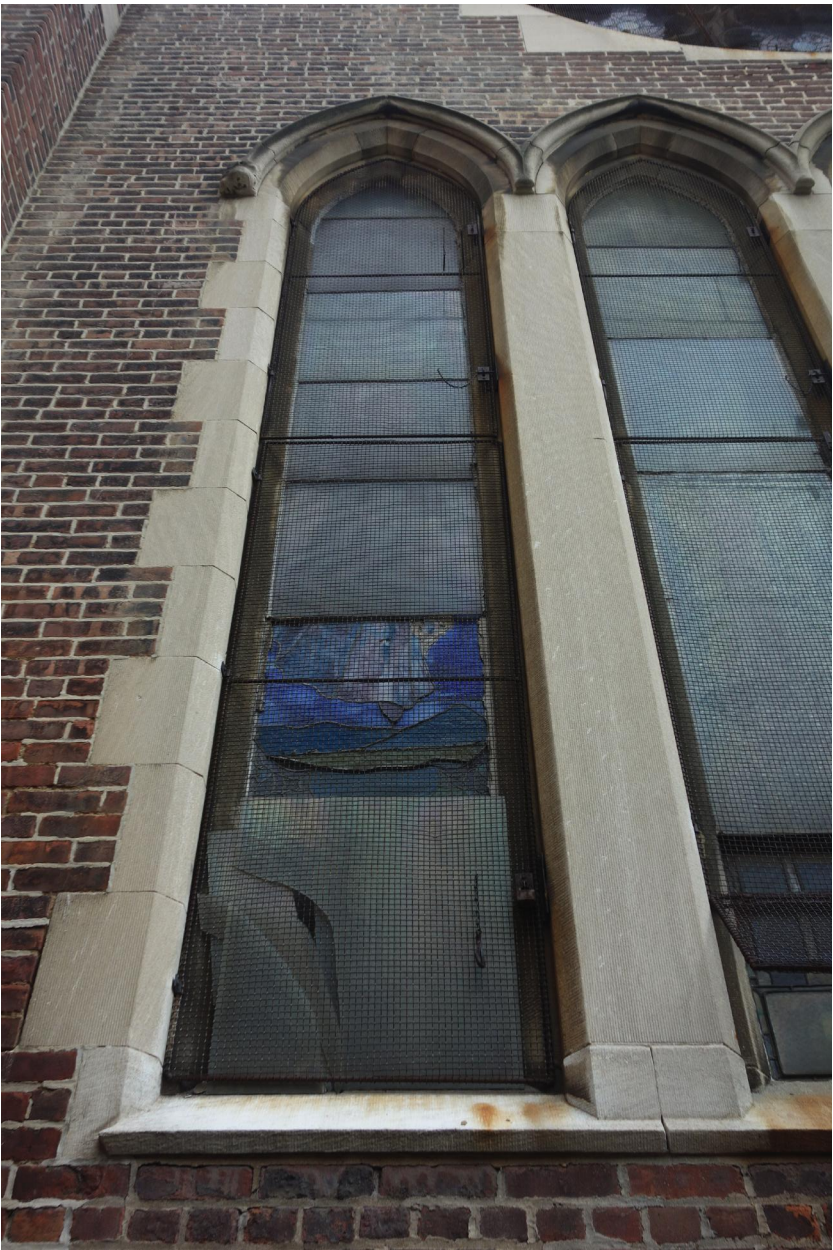
Window Type 6 - Photos

Windows 6B, 6C, & 6D - (Secondary Facade / Not Visible from Street)

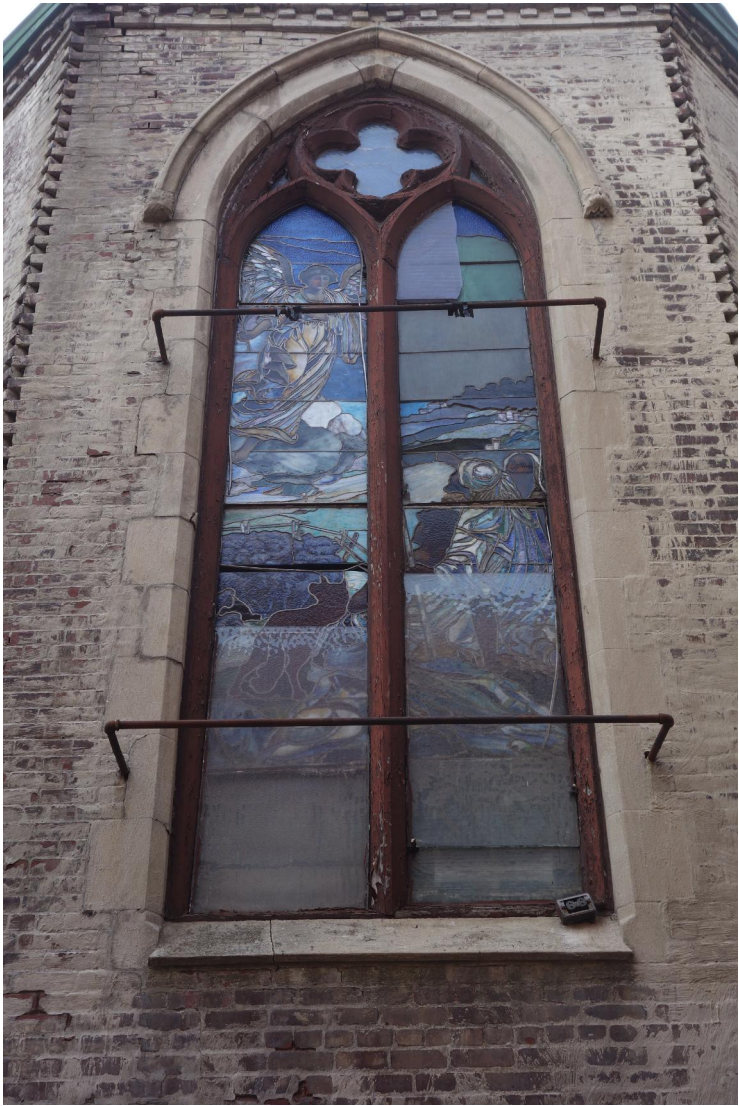
Window Type 7 - Photos

Windows 7A-7C - (Secondary Facade / Not Visible from Street)

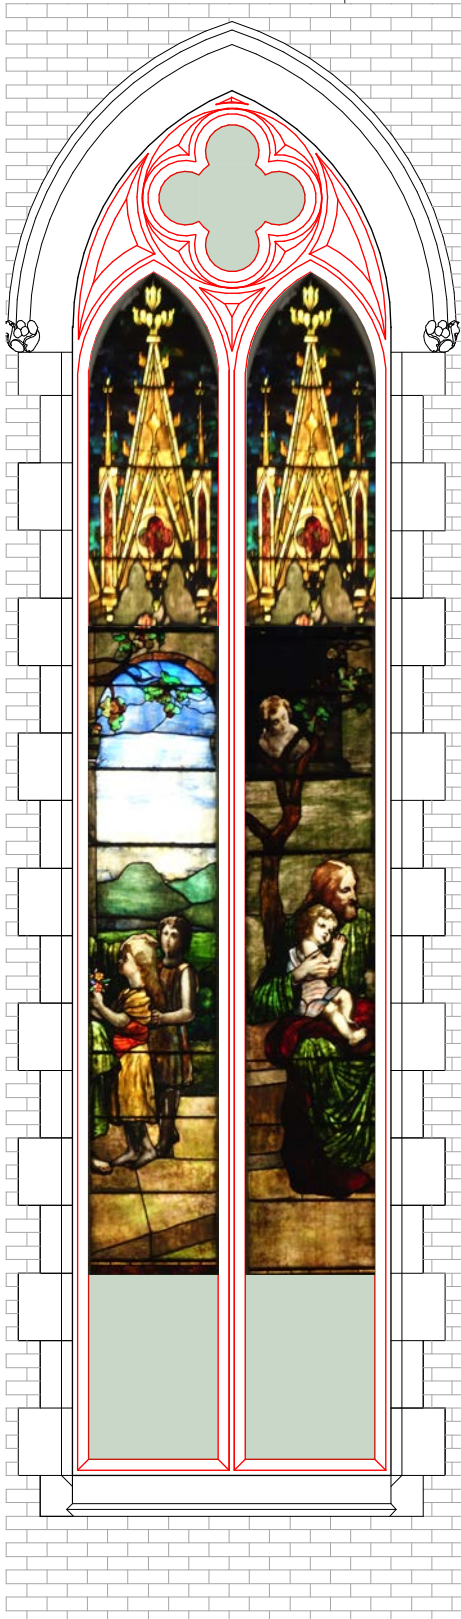
Window 8B - Proposed

- Remove existing stained glass.
- Remove damaged wood framing
- Supply and install new aluminum frame, J. Sussman, Inc #6400 series or equivalent frame into entire opening. New frame to be split into lites mimicking existing wood frame.
- Install restored lite 8B.3 into new aluminum frame.
- Supply and install one inch insulated clear glass in all aluminum frame lites.

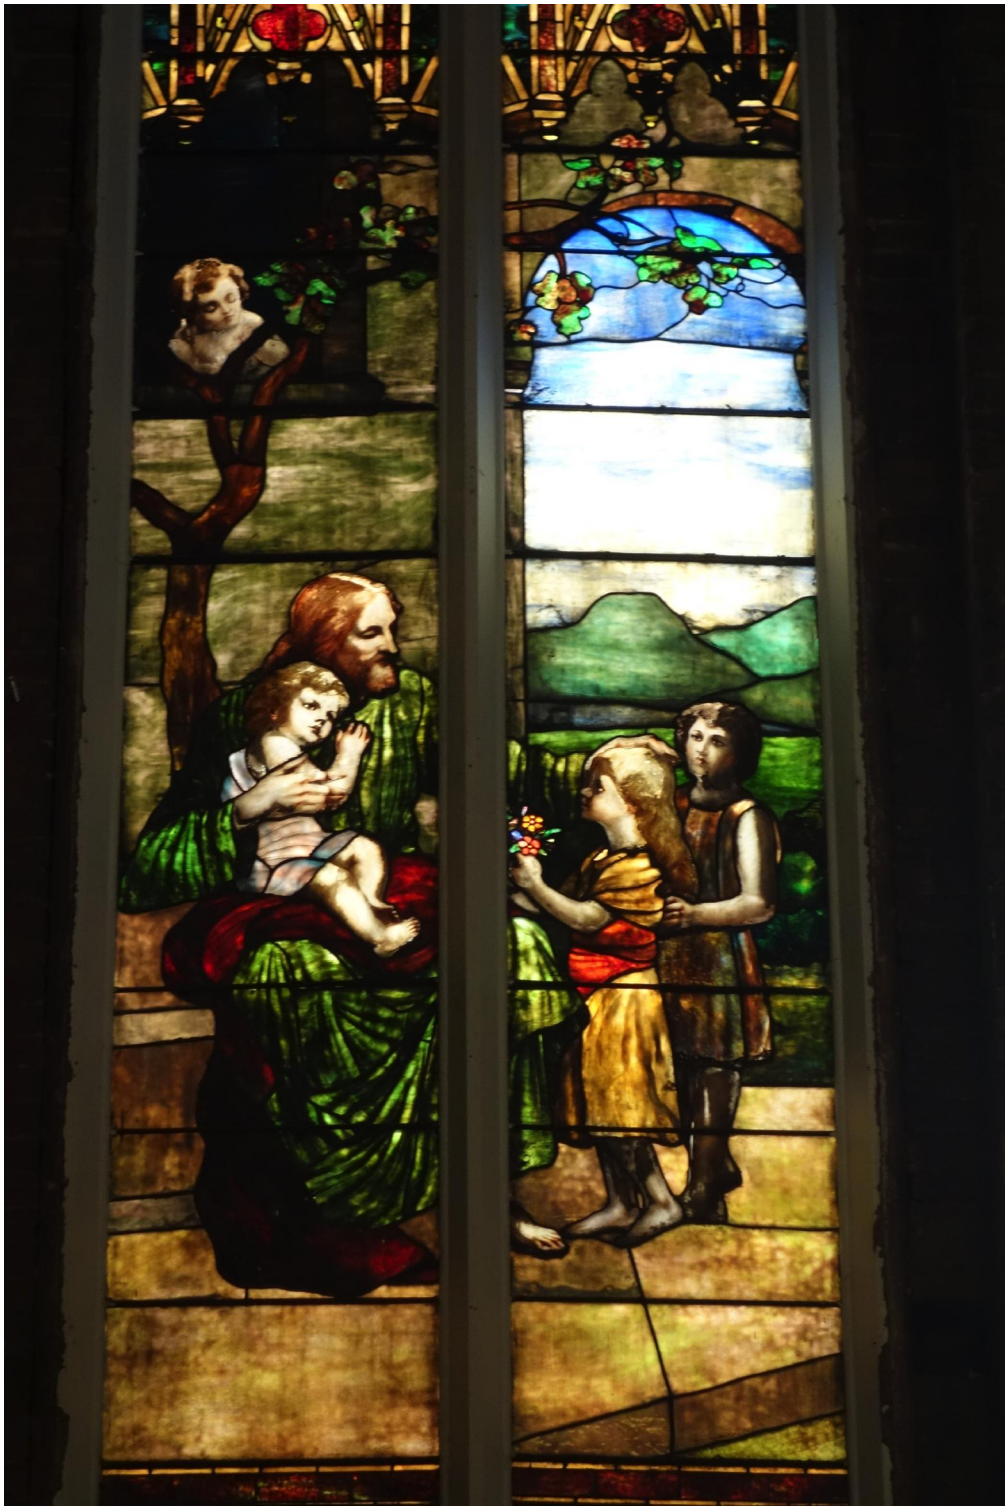
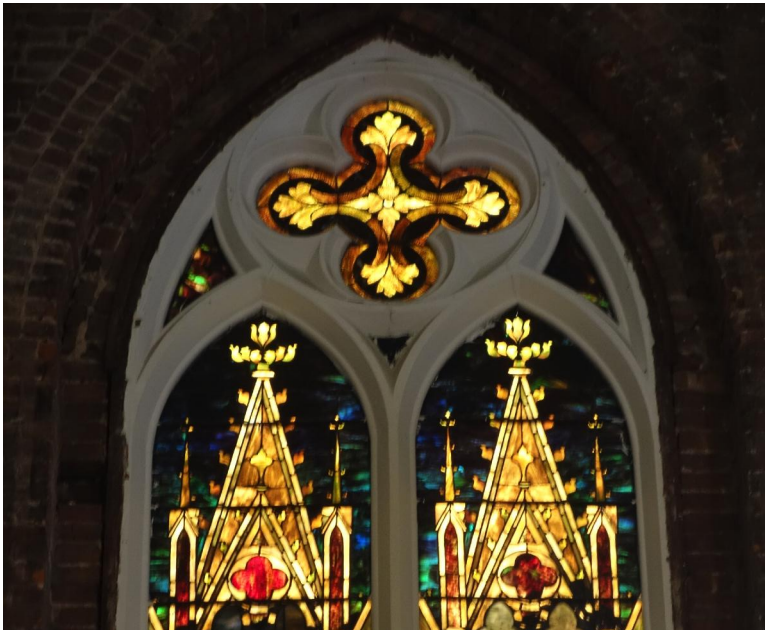
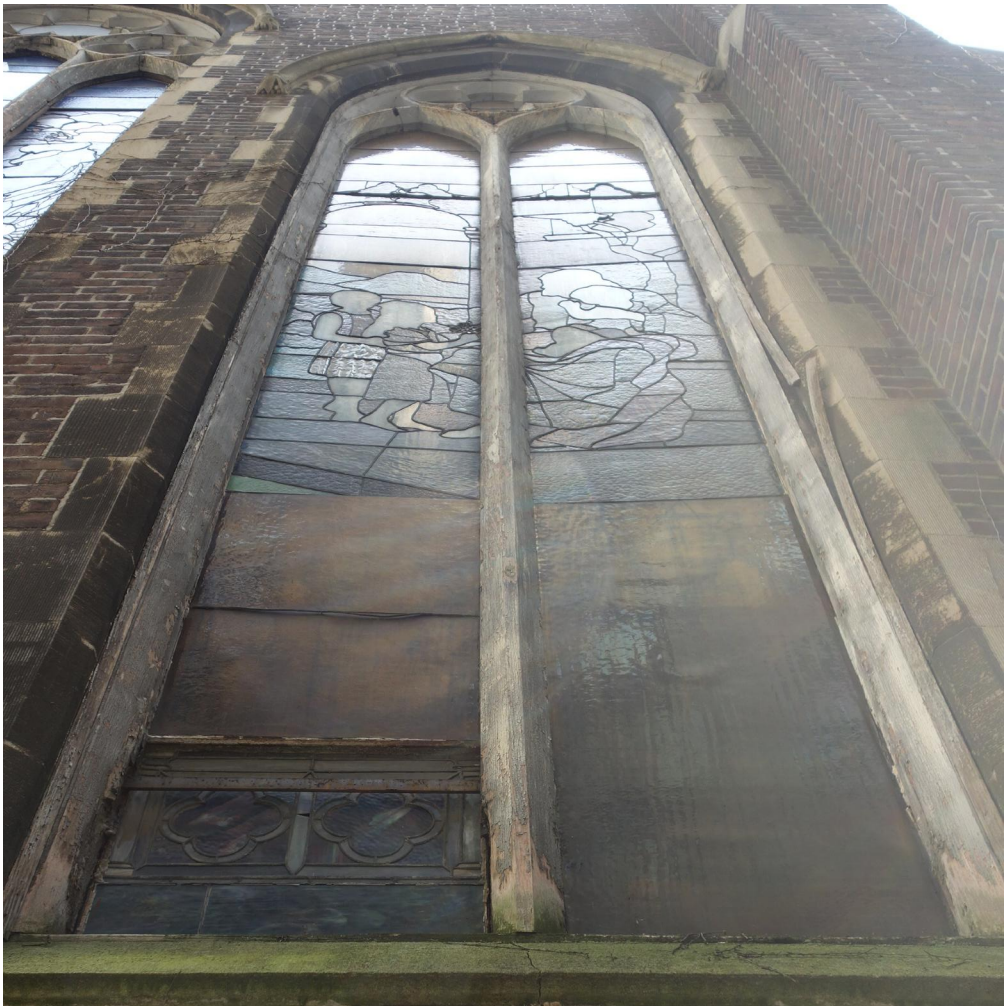
Window Type 8 - Photos
Window 8B - Lites 8B.1-8B.3 - (Secondary Facade / Not Visible from Street)

- Exterior frame in very poor condition; wood is exposed showing rot.
- Interior frame showing noticeable cracking
- Stained glass is in good condition, few panes cracked, coming in good condition.
- No evidence of famous maker provenance
- The window is fixed

Existing wood has been left exposed to the elements and has deteriorated. Frame is not stable and would need to be removed. Religious iconography makes windows not appropriate for building conversion.

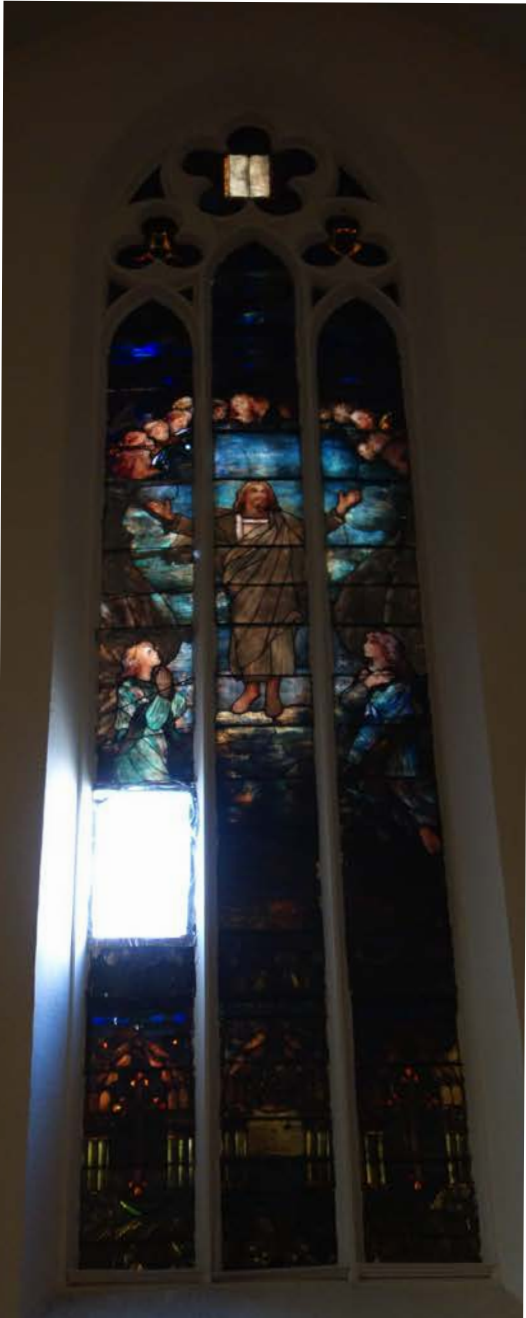
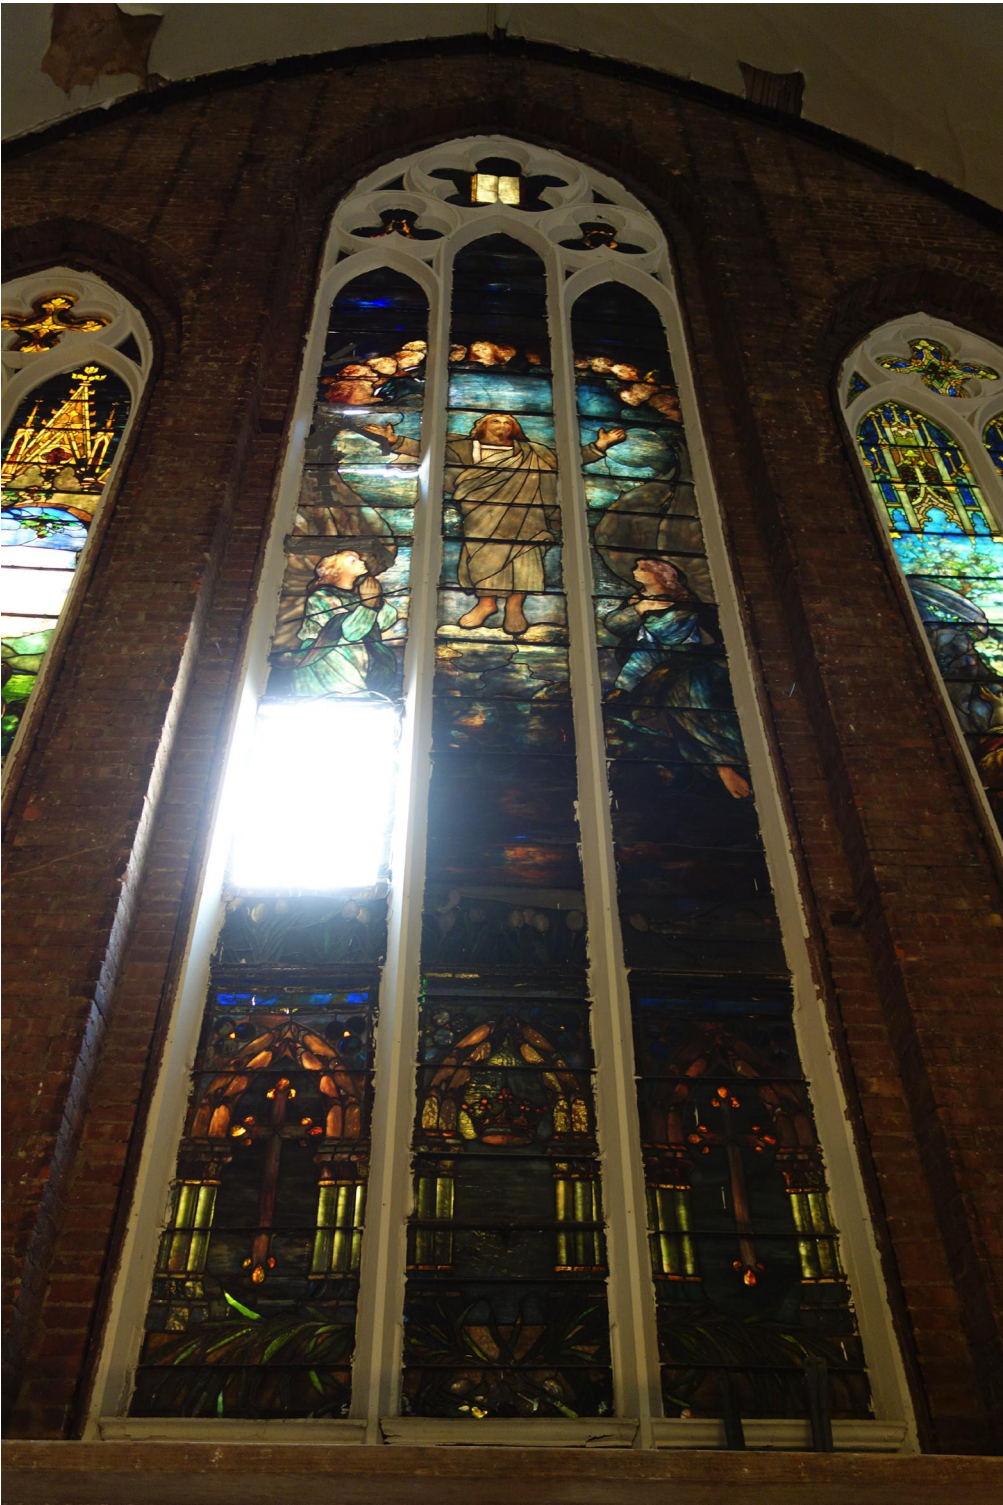
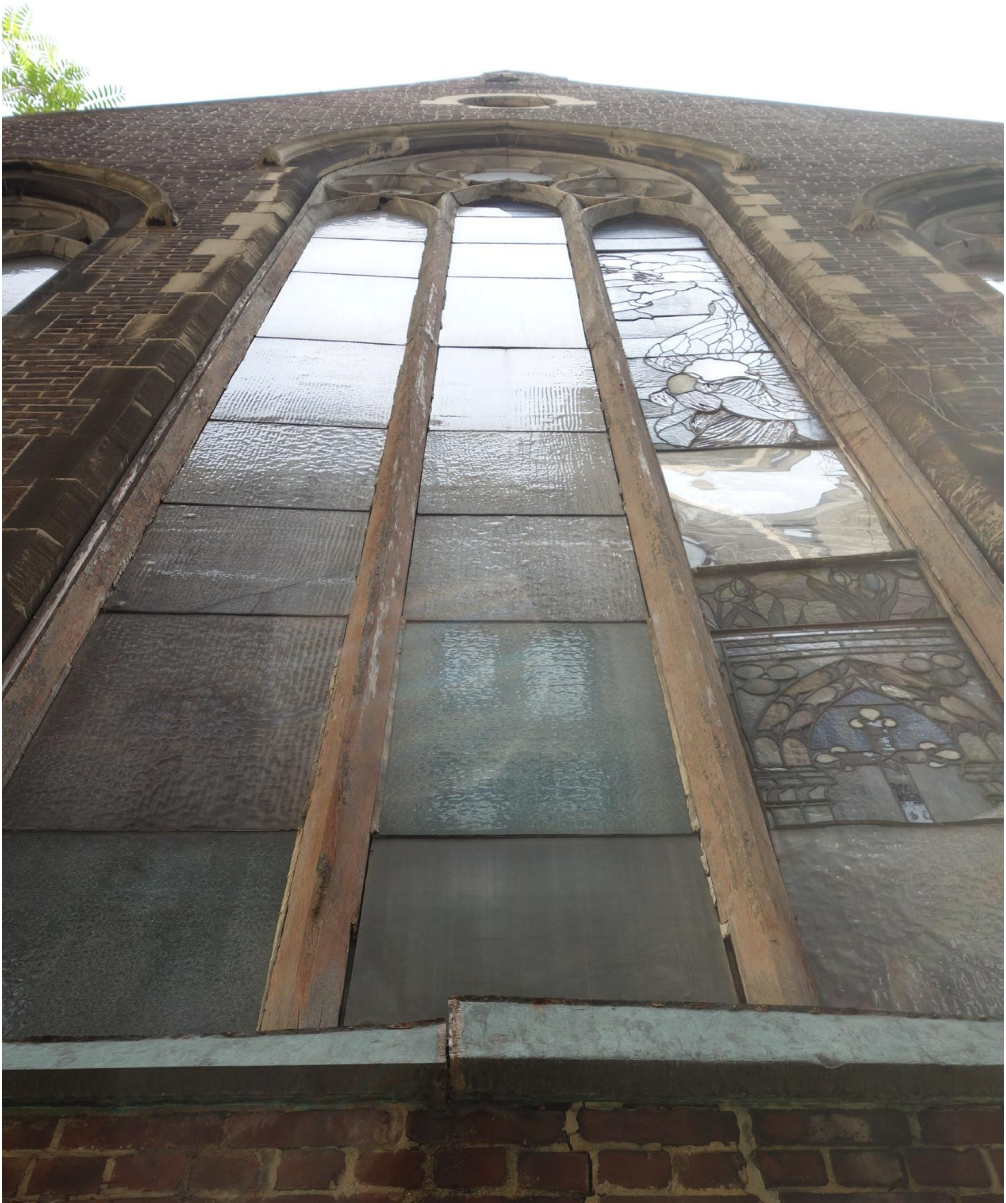
Window Type 9 - Condition & Preservation Narrative
Window 9A - Lites 9A.1-9A.6 - (Secondary Facade / Not Visible from Street)

- Exterior frame in very poor condition; wood is exposed showing rot.
- Interior frame showing noticeable cracking
- Stained glass is in good condition, few panes cracked, coming in good condition.
- No evidence of famous maker provenance
- The window is fixed

Existing wood has been left exposed to the elements and has deteriorated. Frame is not stable and would need to be removed. Religious iconography makes windows not appropriate for building conversion.

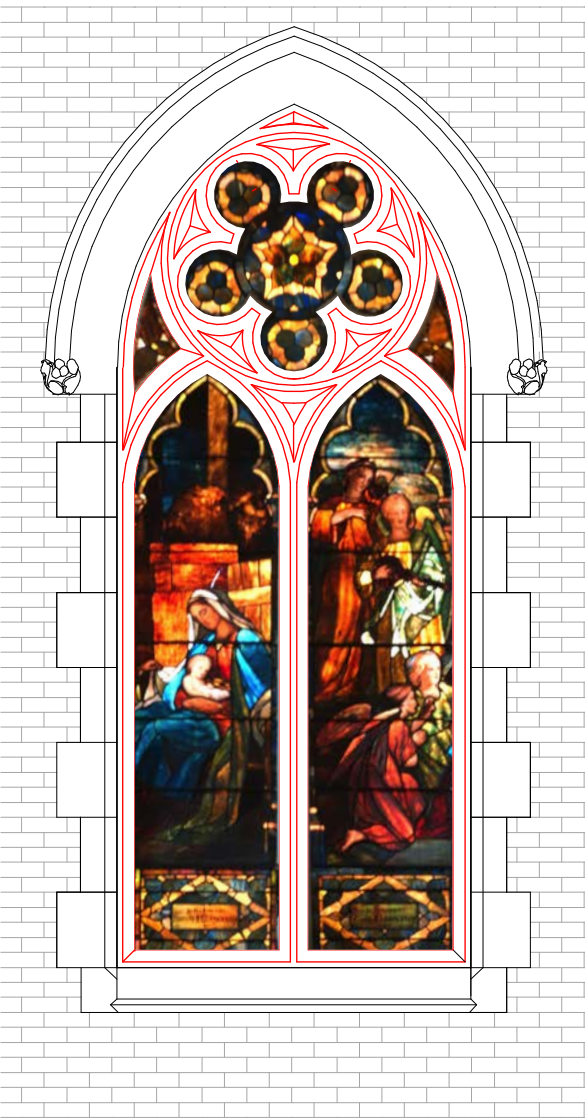
Window 10A - Proposed

- Remove existing stained glass.
- Remove damaged wood framing
- Restore stained glass in hexafoil and two kites (10A.2-4)
- Supply and install new aluminum frame, J. Sussman, Inc #6400 series or equivalent frame into entire opening. New frame to be split into lites mimicking existing wood frame.
- Install restored stained glass lites into new aluminum frame in lites 10B.2-4
- Operable units to be project-in bottom ventilators with screens.
- Supply and install one inch insulated clear glass in all aluminum frame lites.
- Supply and install custom wood trim applied to both exterior and interior faces of the aluminum frame matching the profile of the existing wood tracery.

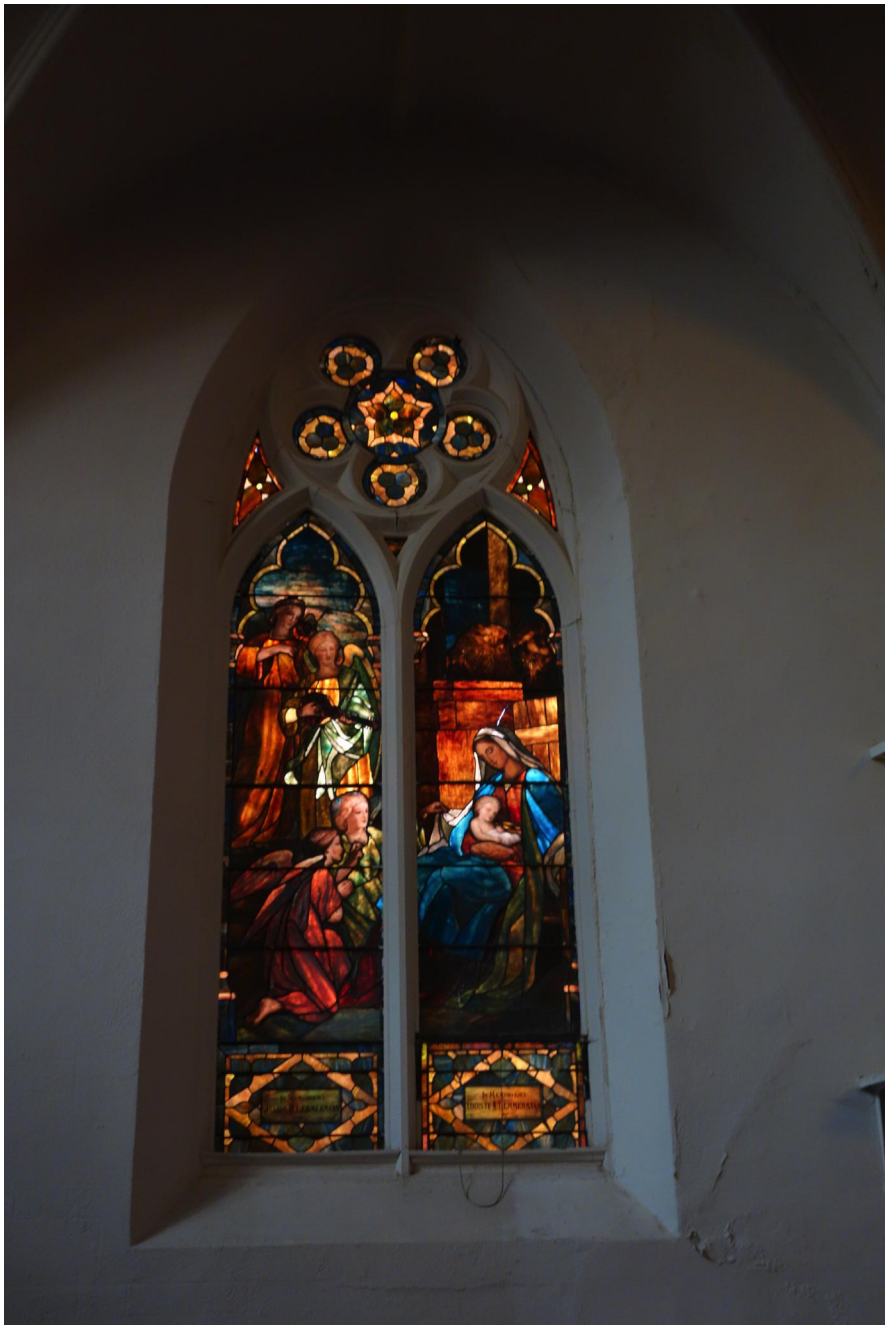
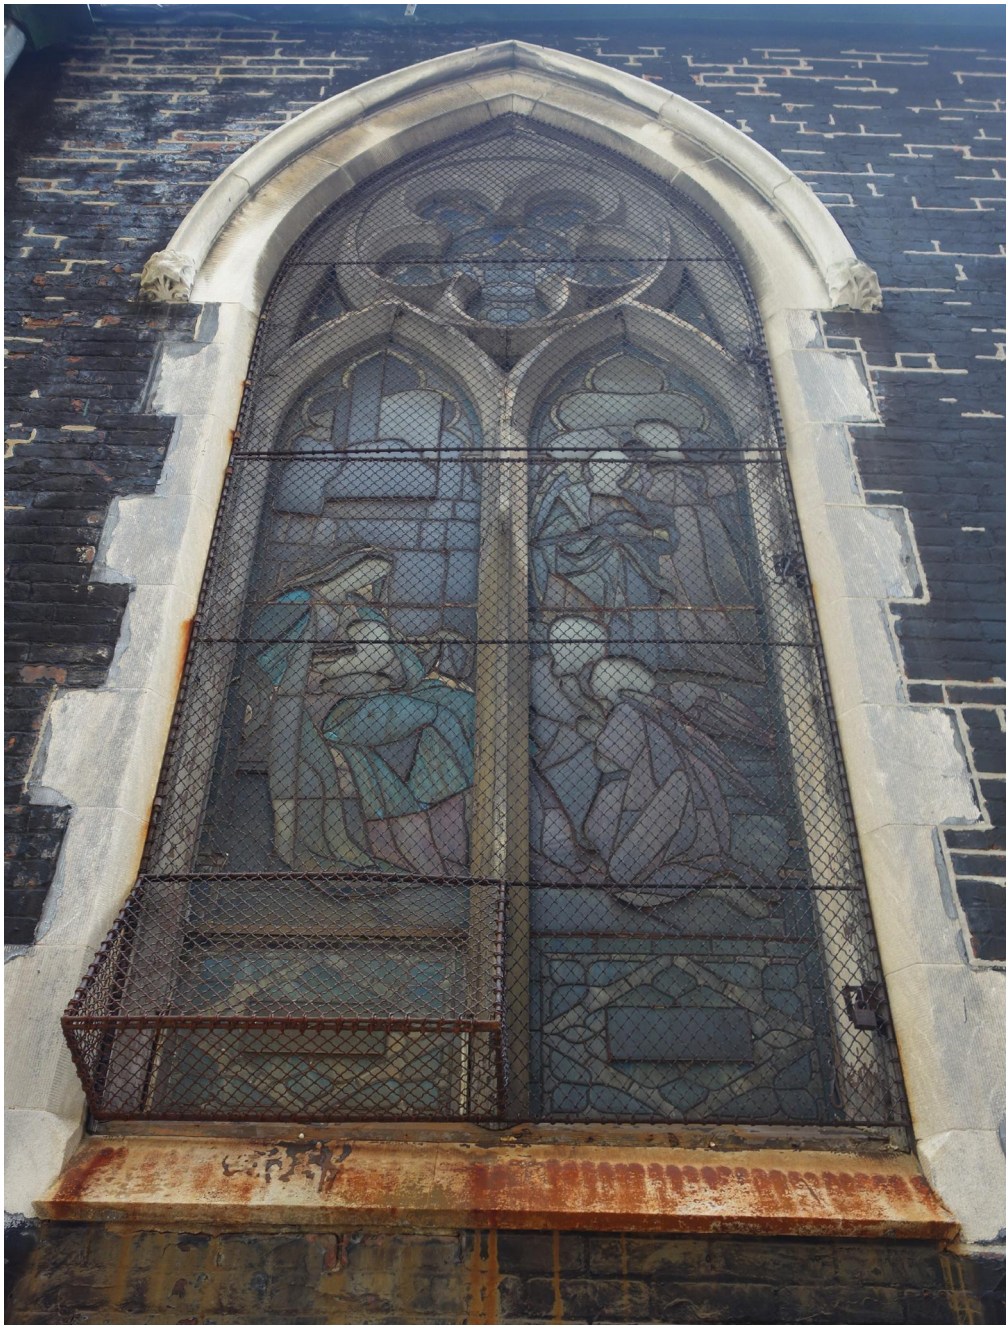
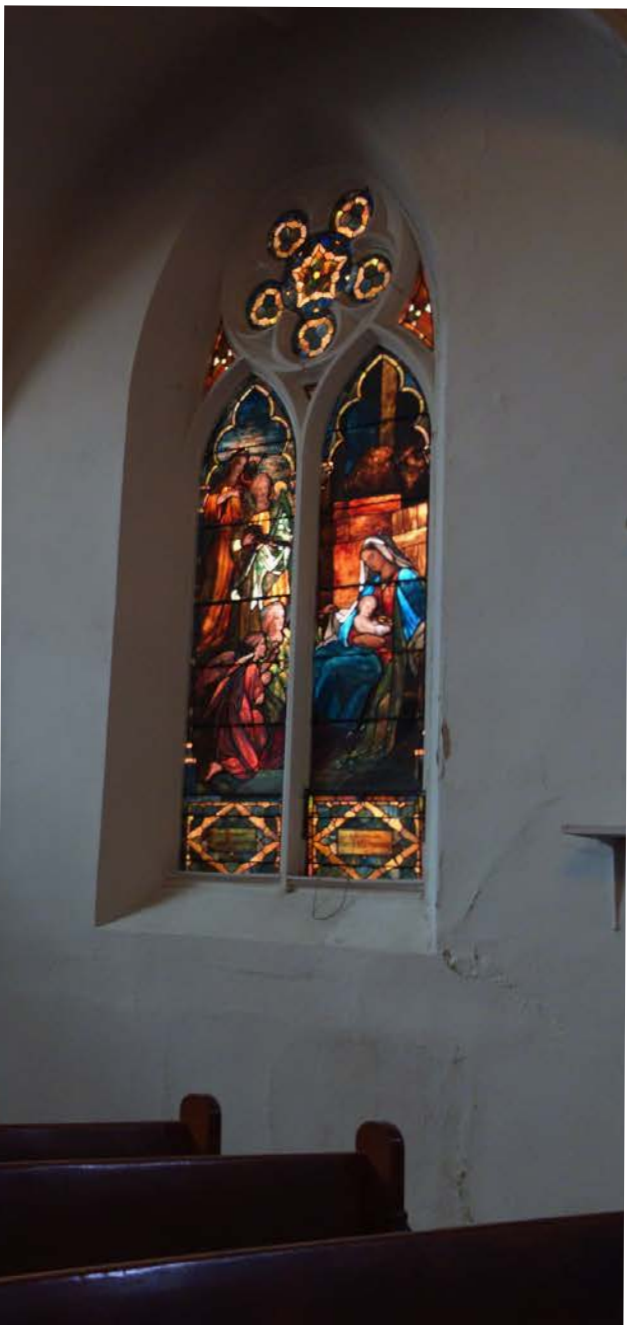
Window Type 10 - Photos
Window 10A - Lites 10A.1-10A.4 - (Secondary Facade)

- Exterior frame in very poor condition; wood is exposed showing rot.
- Stained glass is in good condition, few panes cracked, coming in good condition.
- Interior frame showing noticeable cracking
- No sign of famous maker provenance
- The window is operable, the bottom pane is awing

- Existing wood has been left exposed to the elements and has deteriorated. Frame is not stable and would need to be removed. religious iconography in lights makes windows not appropriate for building conversion.

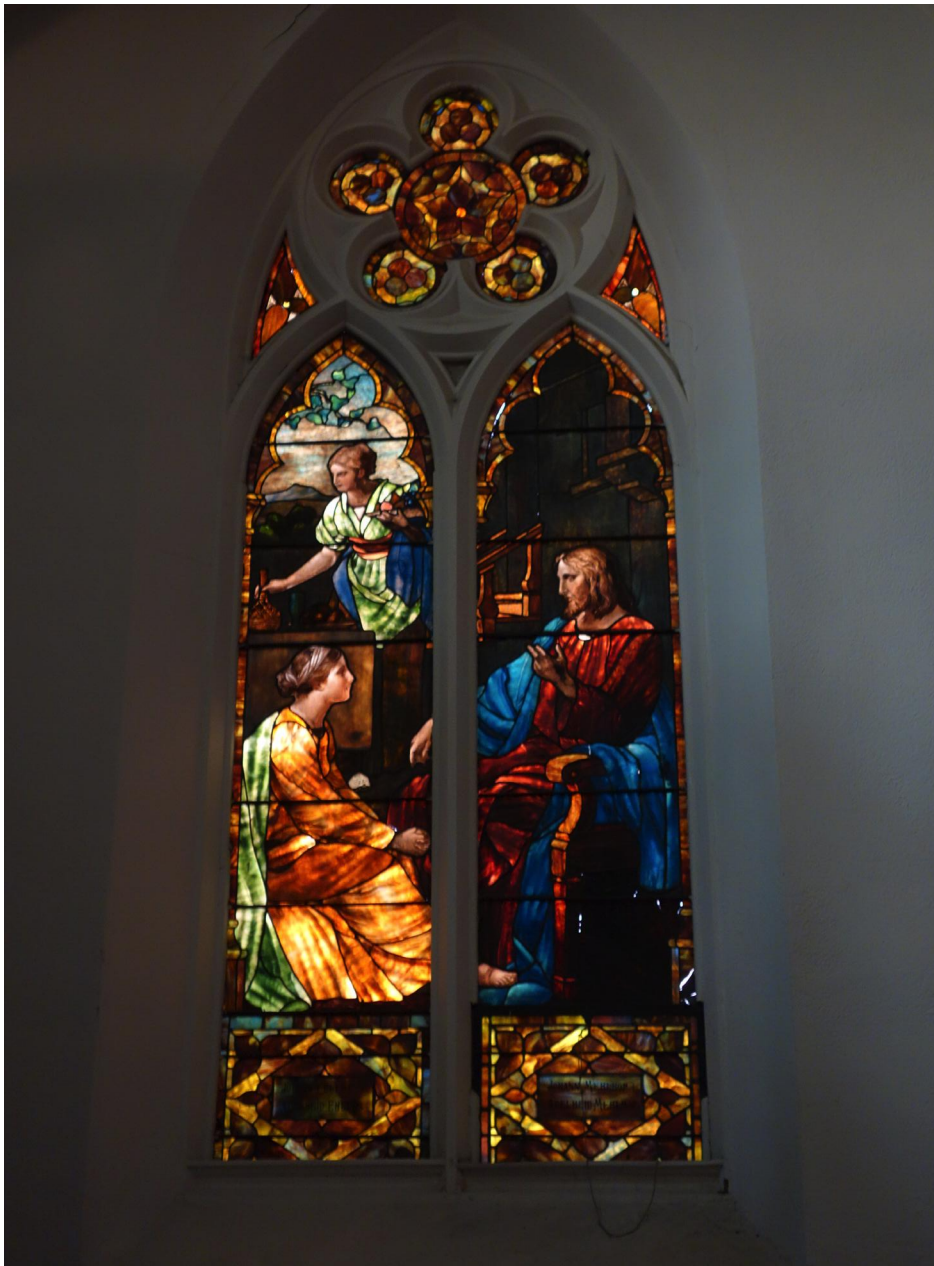
Window 10B - Lites 10B.1-10B.4 - (Secondary Facade)

- Exterior frame in very poor condition; wood is exposed showing rot.
- Stained glass is in good condition, few panes cracked, coming in good condition.
- Interior frame showing noticeable cracking
- No sign of famous maker provenance
- The window is operable, the bottom pane is awing

- Existing wood has been left exposed to the elements and has deteriorated. Frame is not stable and would need to be removed. religious iconography in lights makes windows not appropriate for building conversion.

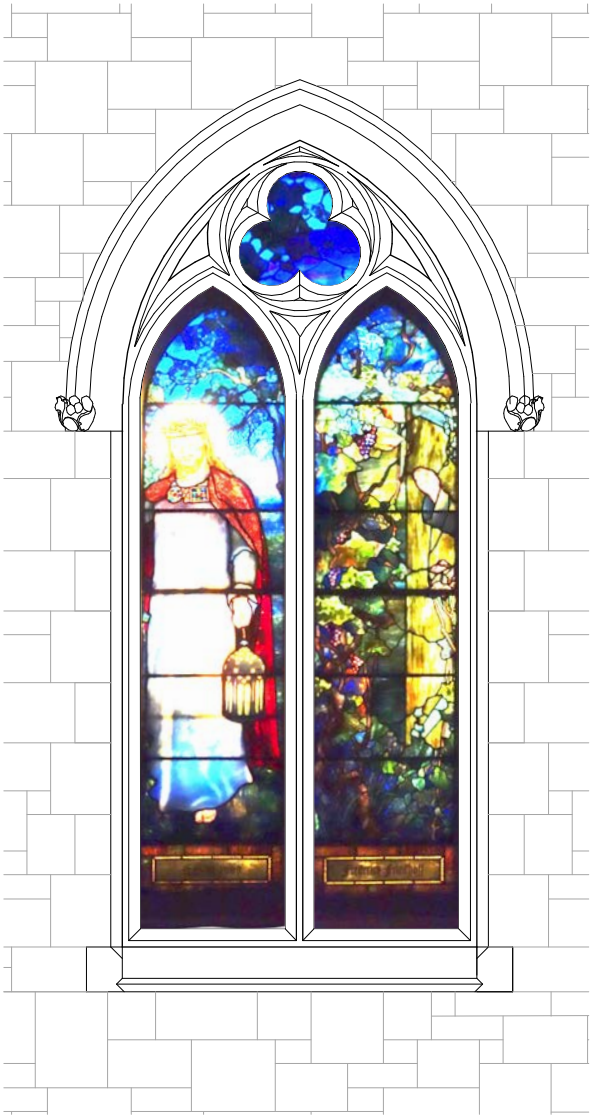
Window 11A - Proposed

- Remove existing stained glass.
- Remove existing framing
- Supply and install new aluminum frame, J. Sussman, Inc #4200 series or equivalent frame into entire opening.
- Supply and install one inch insulated clear glass in all aluminum frame lites.

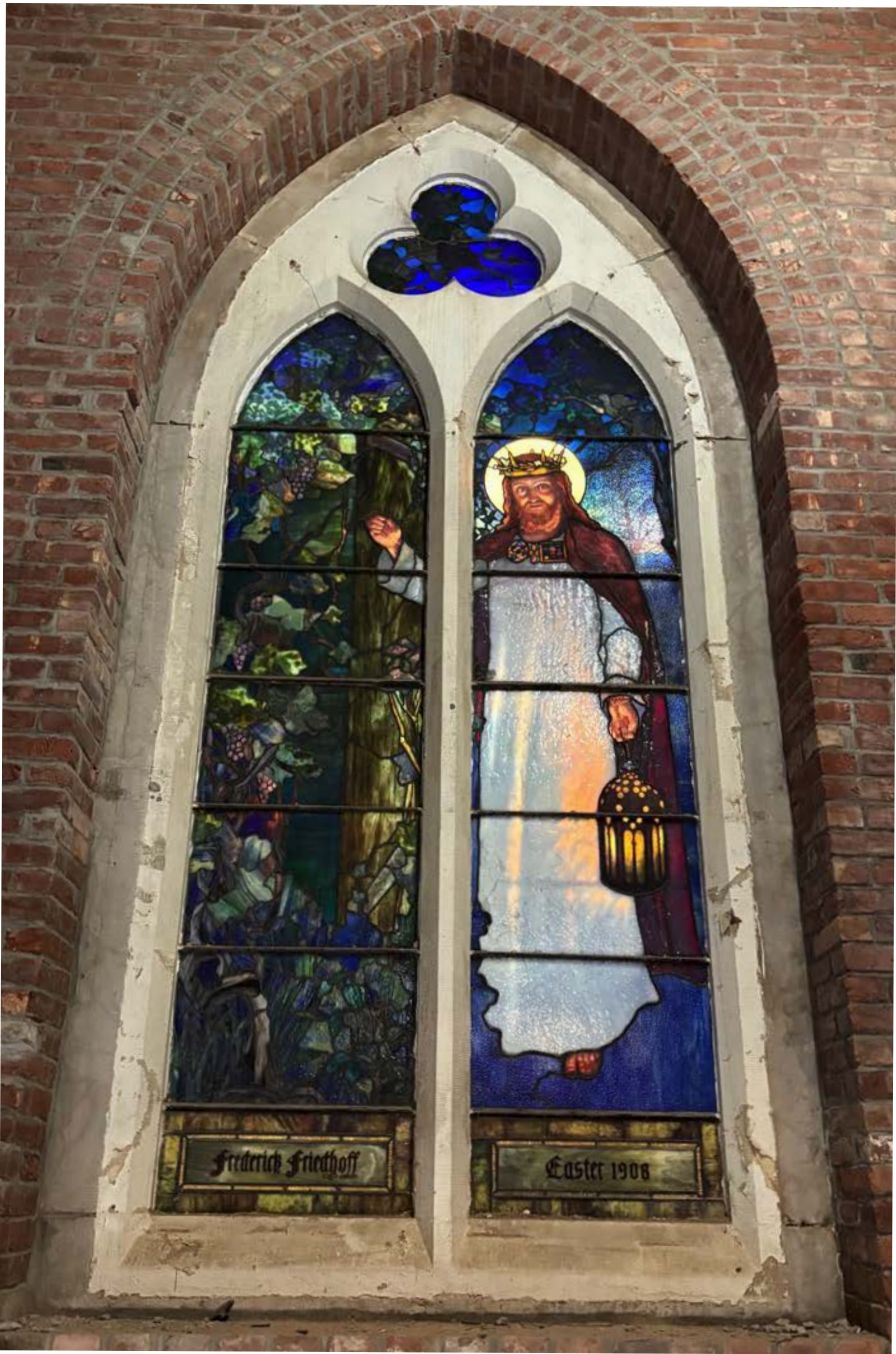
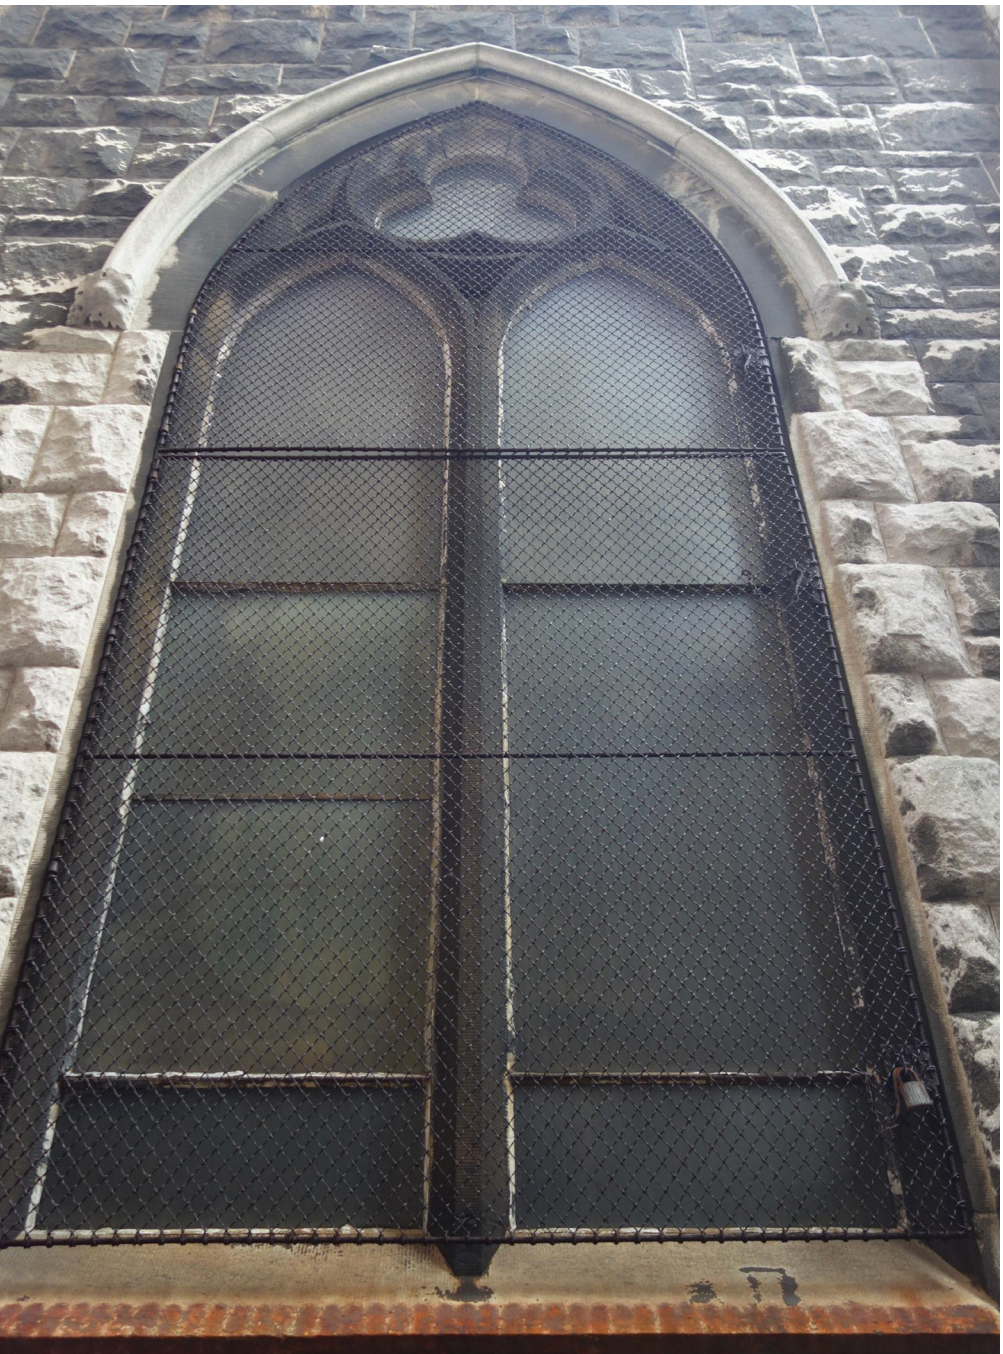
Window 11A - Lites 11A.1-11A.3 - (Secondary Facade / Visible from Street)

- Freidhoff Memorial Window, "Light of the World." by Tiffany Studios [Tiffany 1910] and [Duncan 1980]
- Exterior stone tracery in good condition
- Stained glass is in good condition, coming in good condition.

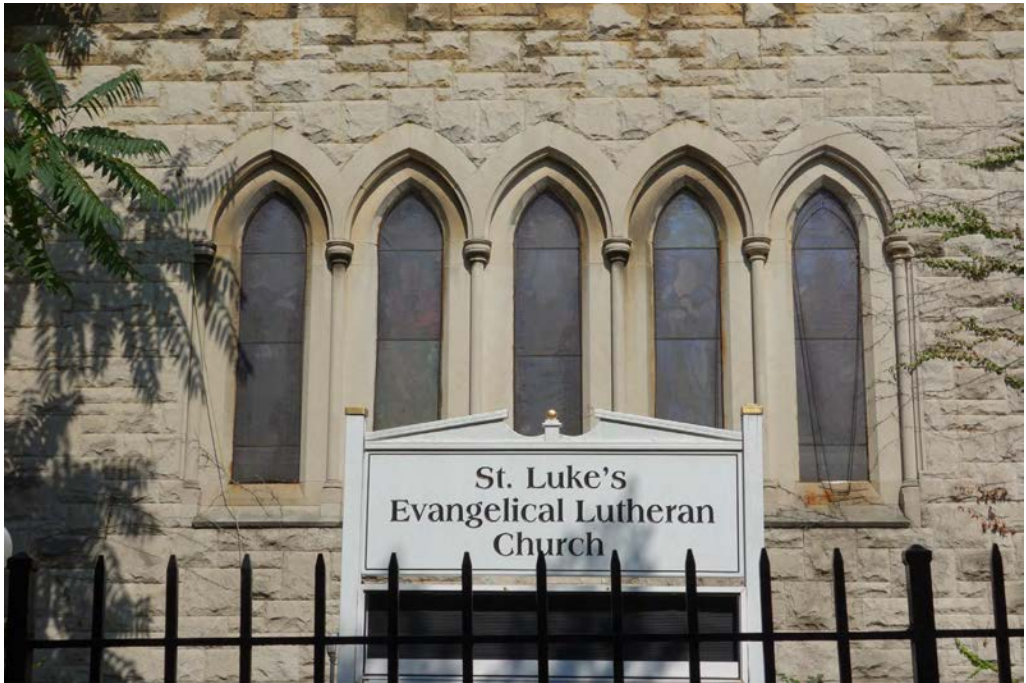
CHURCH STREET FACADE - CENTRAL GABLE STAINED GLASS MASONRY OPENINGS (LOWER LEVEL), TYPE 1 EXTERIOR VIEW

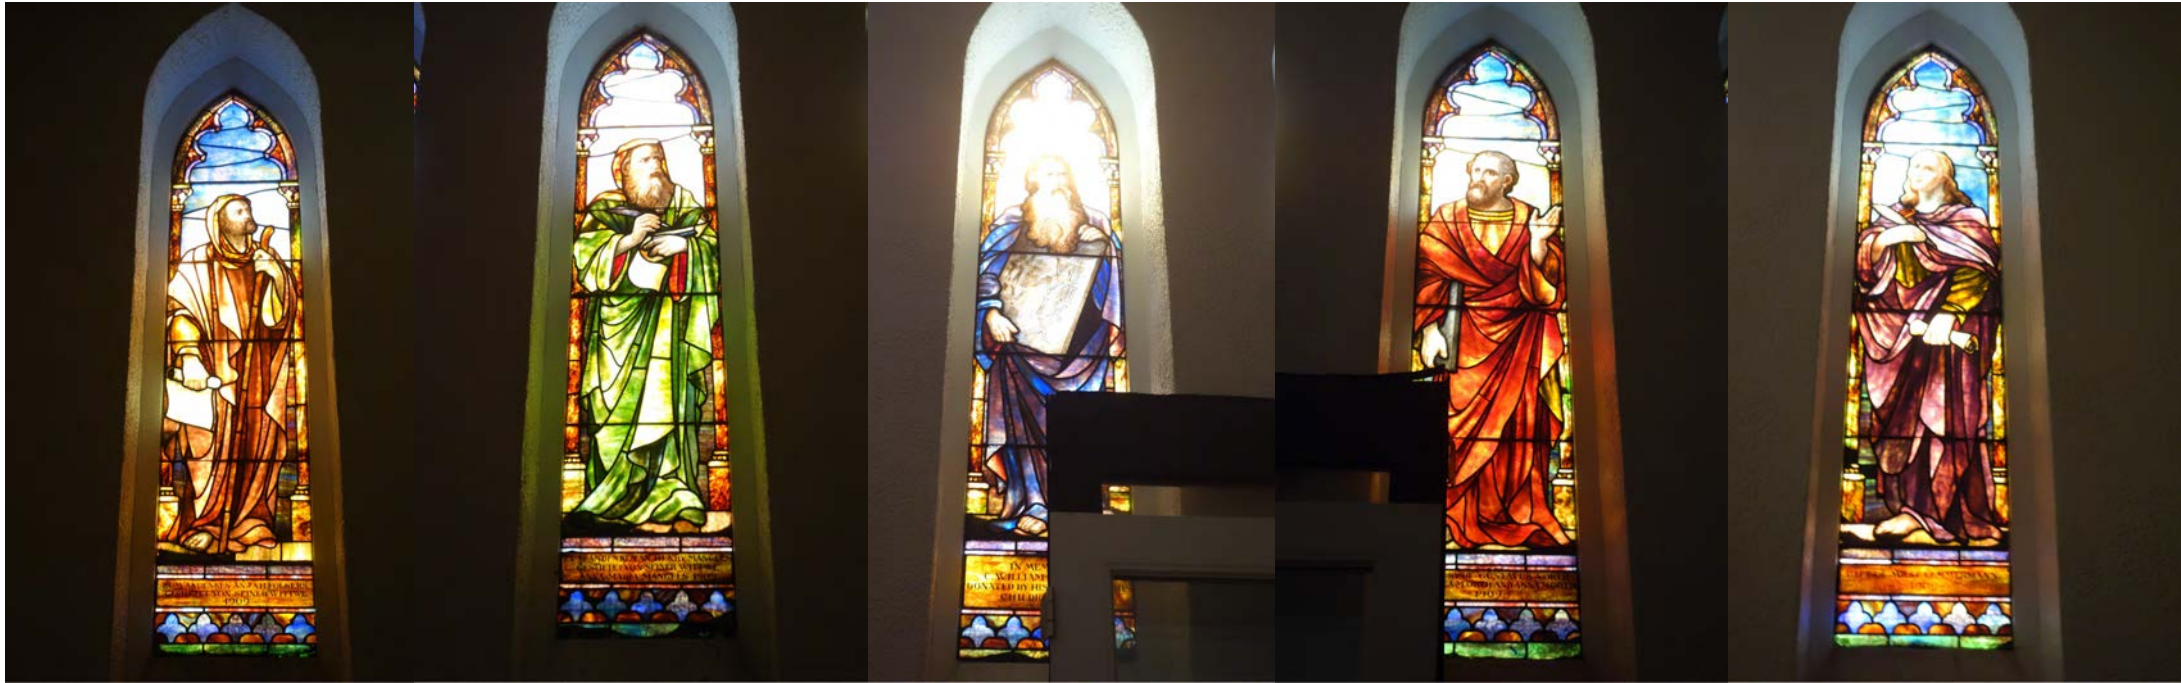
CHURCH STREET FACADE - CENTRAL GABLE STAINED GLASS (LOWER LEVEL), TYPE 1 INTERIOR VIEW

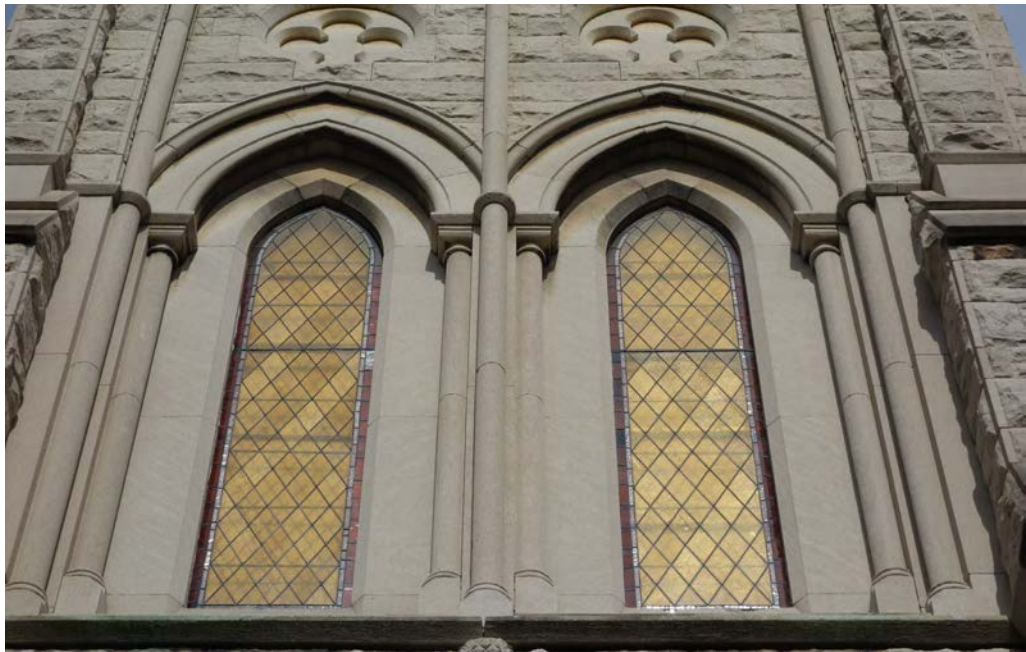
CHURCH STREET FACADE - TOWER STAINED GLASS MASONRY OPENINGS, TYPE 3 EXTERIOR VIEW
