Preservation Department – Item 6, LPC-25-11198

**257-263 Washington Avenue and 230-236 Hall Street –
Clinton Hill Historic District
Borough of Brooklyn**

APPLICATION TO THE NYC LANDMARKS PRESERVATION COMMISSION
257 WASHINGTON AVE, BOROUGH OF BROOKLYN

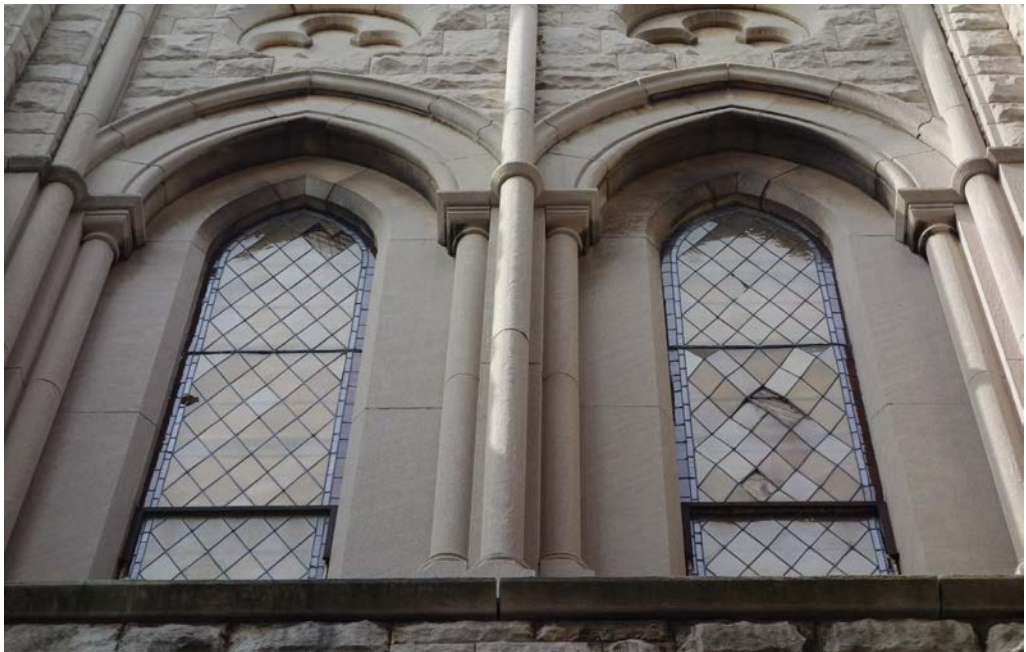
CHURCH SOUTH FACADE - TOWER STAINED GLASS MASONRY OPENINGS (UPPER LEVEL), TYPE 3 EXTERIOR VIEW

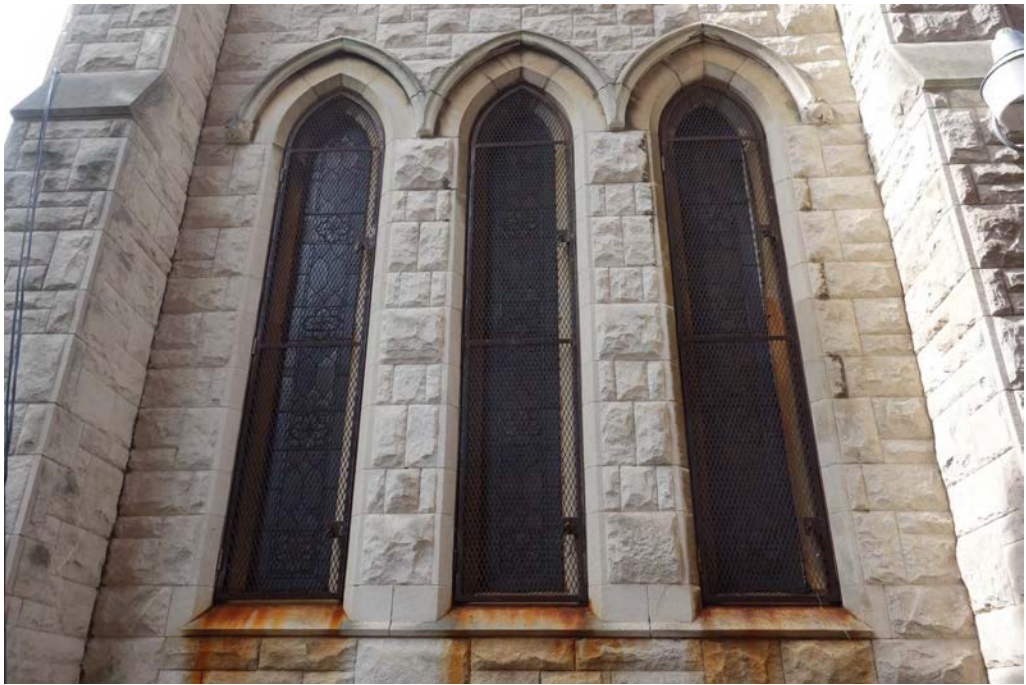
CHURCH SOUTH FACADE - TOWER STAINED GLASS MASONRY OPENINGS (LOWER LEVEL), TYPE 4 EXTERIOR VIEW

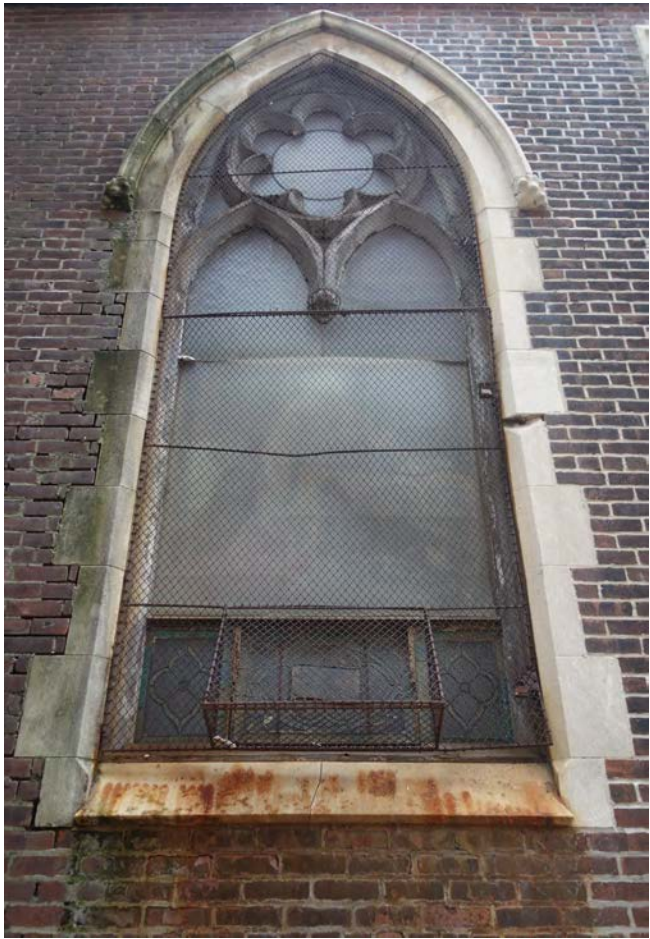
CHURCH SOUTH FACADE - NAVE MASONRY OPENING AND WOOD TRACERY (TYP. OF 2), EXT.

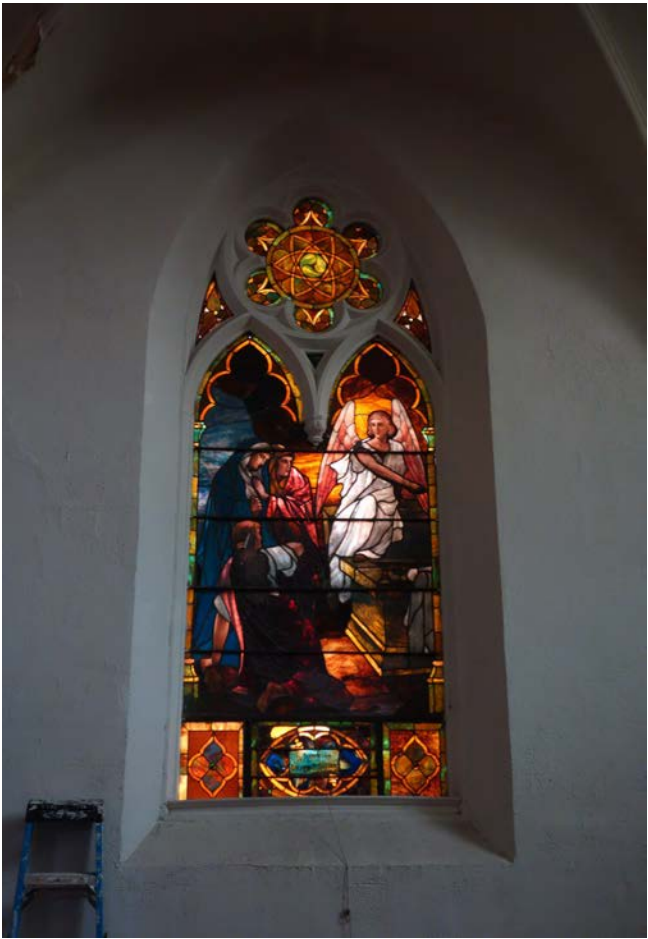
S2. CHURCH SOUTH FACADE - NAVE STAINED GLASS, TYPE 5 INTERIOR VIEW

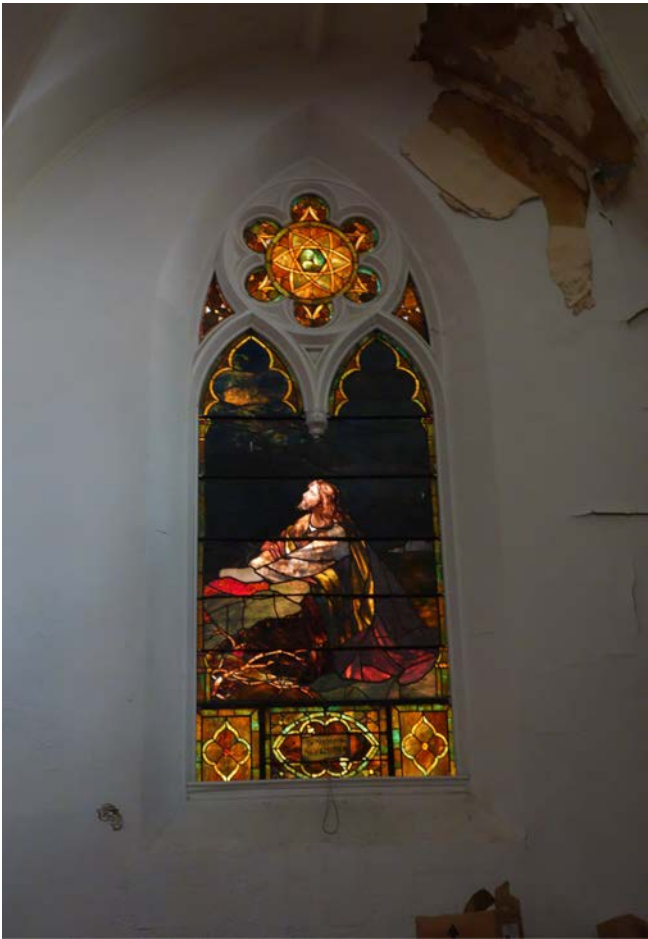
S1. CHURCH SOUTH FACADE - NAVE STAINED GLASS, TYPE 5 INTERIOR VIEW

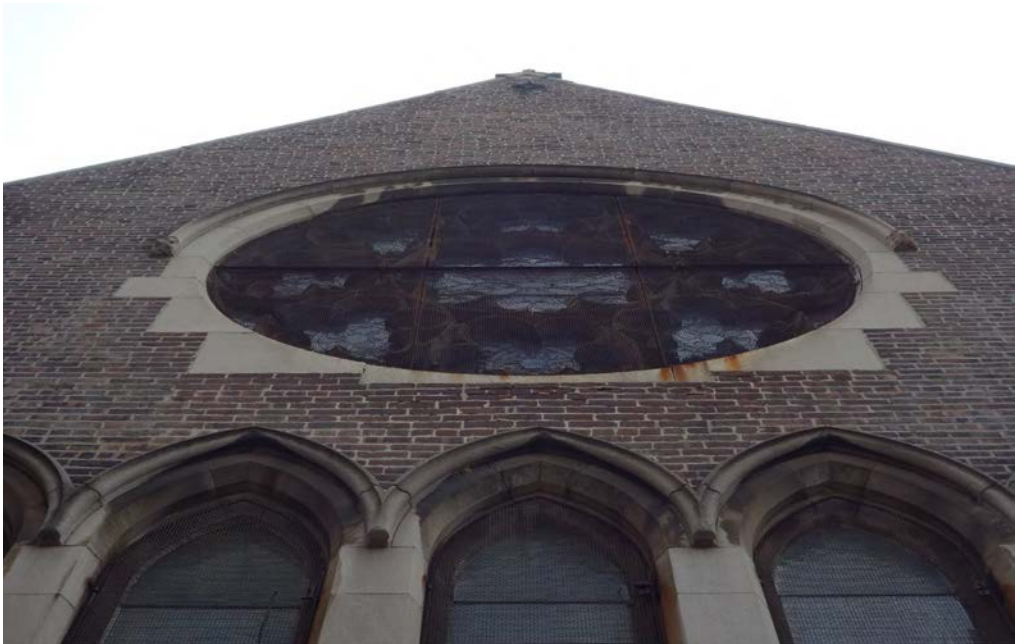
CHURCH SOUTH FACADE - TRANSEPT ROSE MASONRY OPENING AND WOOD TRACERY, TYPE 7 EXTERIOR VIEW

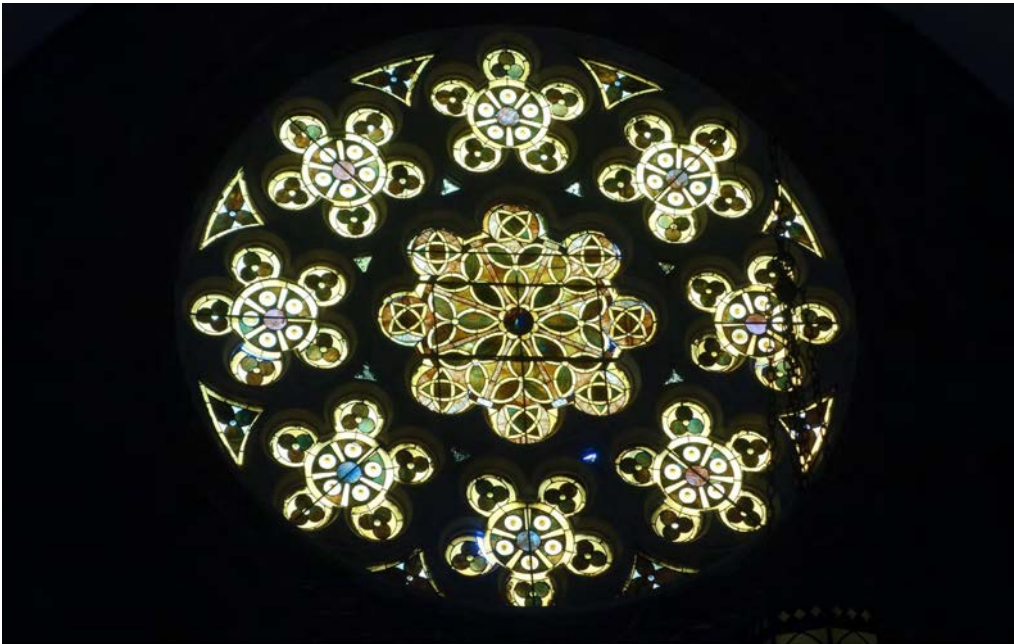
CHURCH SOUTH FACADE - TRANSEPT ROSE STAINED GLASS, TYPE 7 INTERIOR VIEW

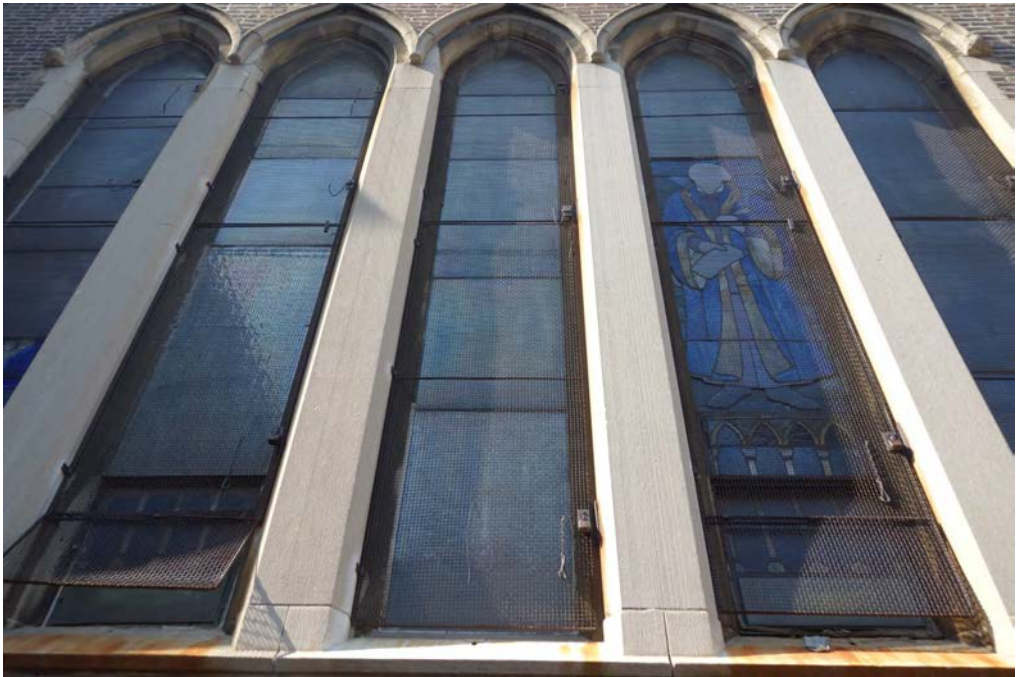
CHURCH SOUTH FACADE - TRANSEPT STAINED GLASS MASONRY OPENINGS, TYPE 6 EXTERIOR VIEW

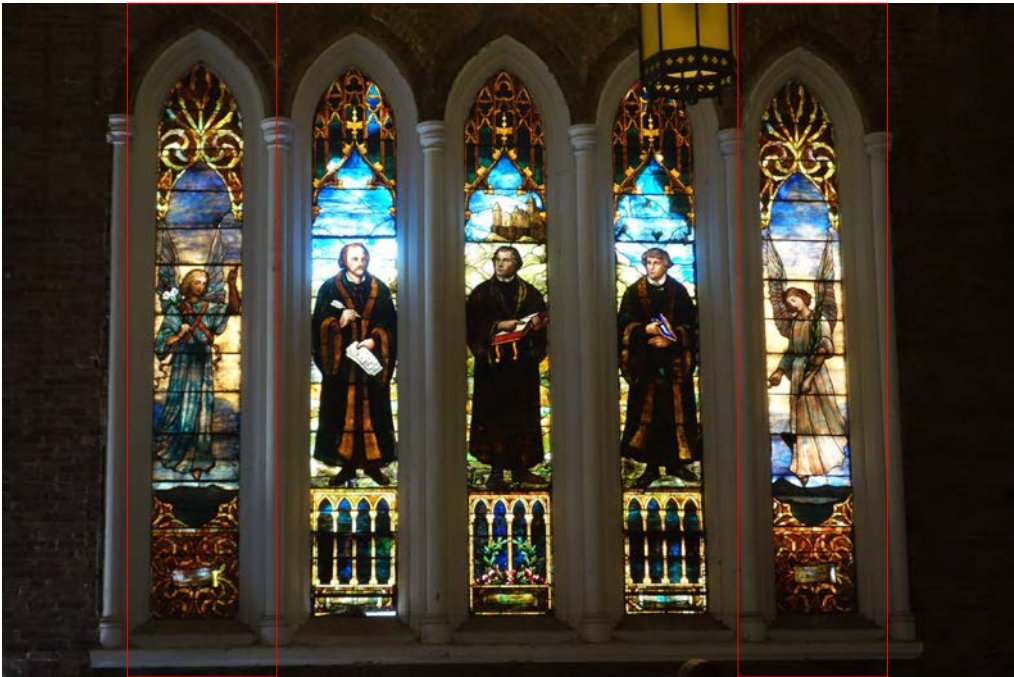
CHURCH SOUTH FACADE - TRANSEPT STAINED GLASS, ANGELS BY TIFFANY STUDIOS, TYPE 6 INTERIOR VIEW

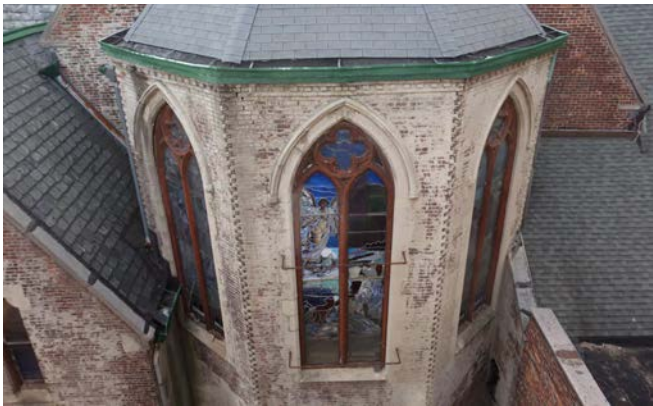
CHURCH REAR FACADE - APSE STAINED GLASS MASONRY OPENINGS AND WOOD TRACERY, EXT.

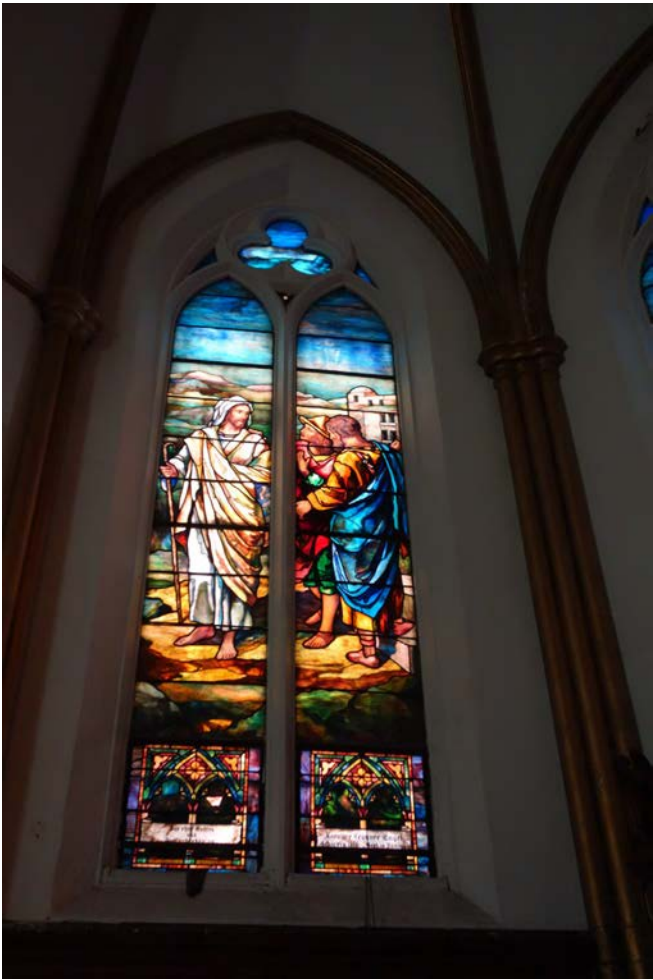
3. CHURCH REAR FACADE - APSE STAINED GLASS BY J&R LAMB, TYPE 8 INTERIOR VIEW

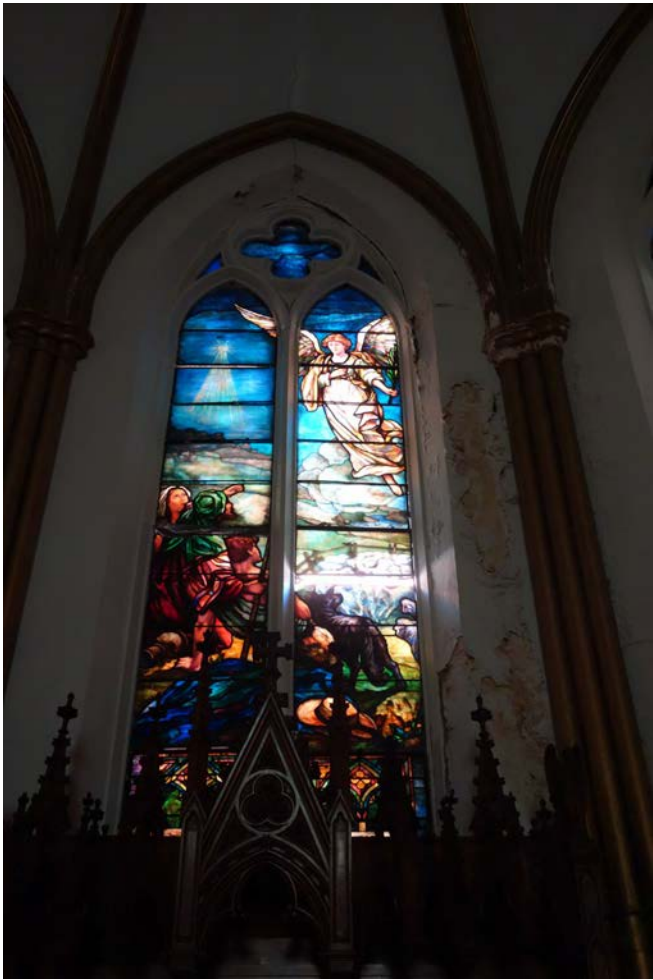
2. CHURCH REAR FACADE - APSE STAINED GLASS BY J&R LAMB, TYPE 8 INTERIOR VIEW

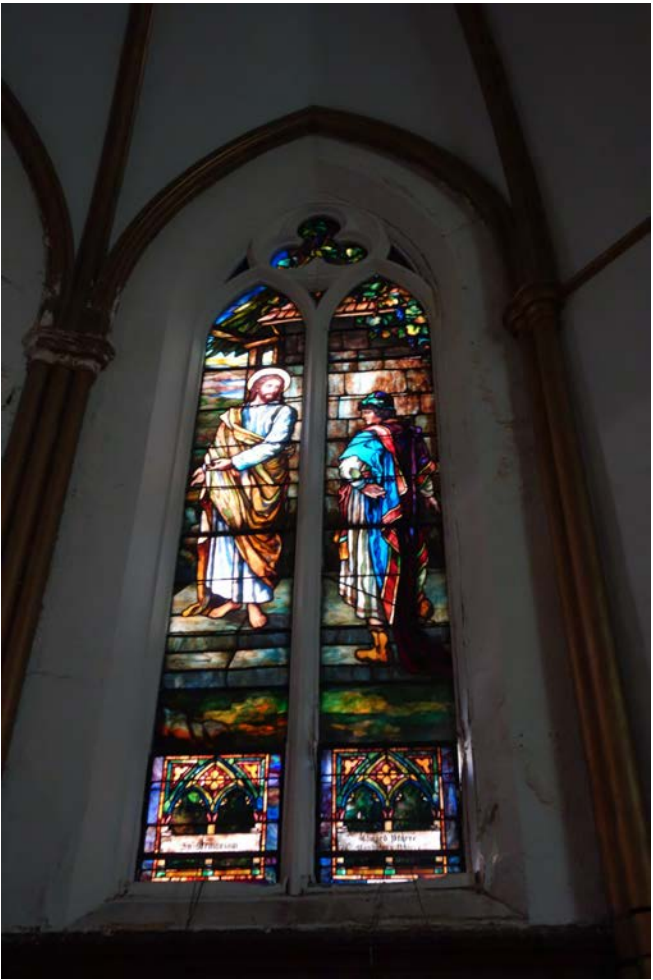
1. CHURCH REAR FACADE - APSE STAINED GLASS BY J&R LAMB, TYPE 8 INTERIOR VIEW

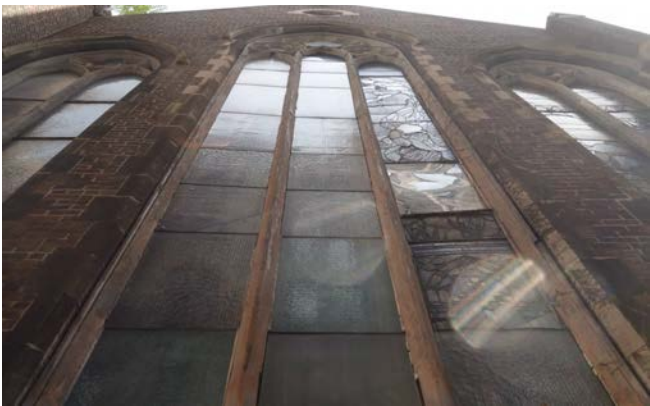
CHURCH NORTH FACADE - TRANSEPT STAINED GLASS MASONRY OPENINGS AND WOOD TRACERY

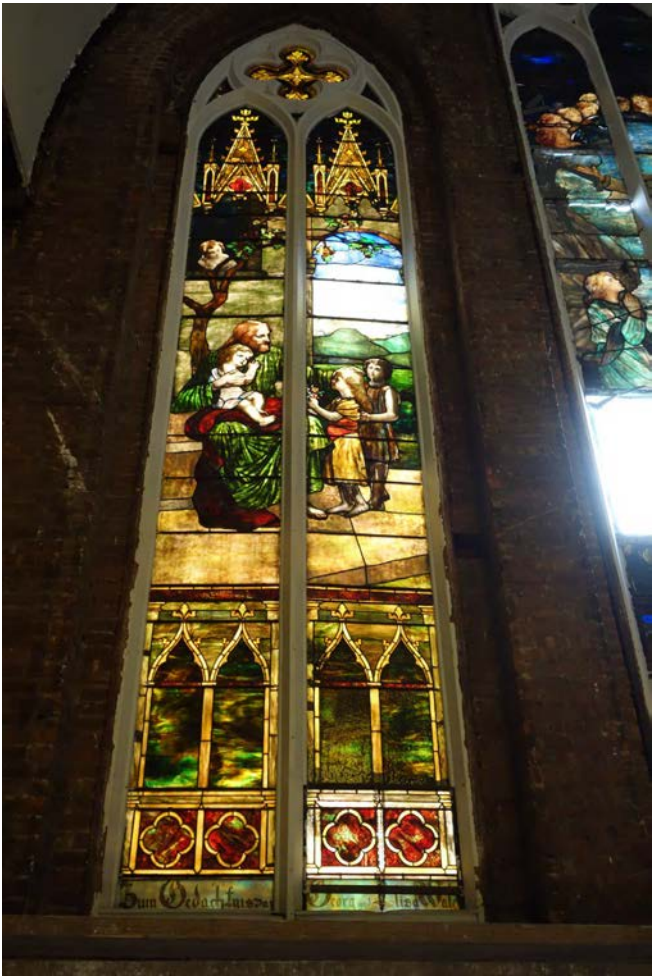
CHURCH NORTH FACADE - TRANSEPT STAINED GLASS, TYPE 9 INTERIOR VIEW

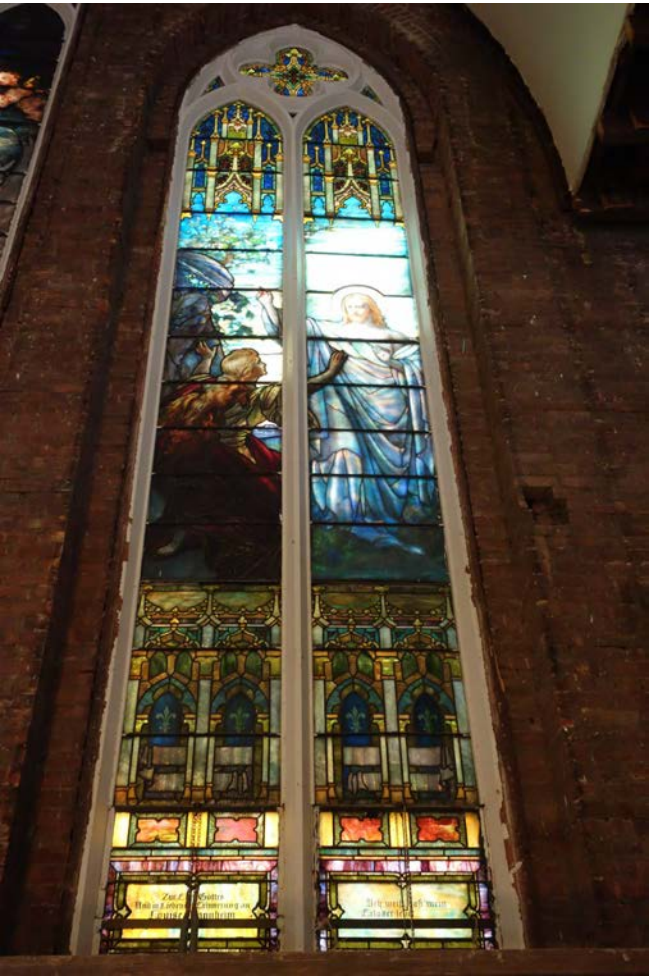
CHURCH NORTH FACADE - TRANSEPT STAINED GLASS BY TIFFANY STUDIOS, TYPE 9 INT.

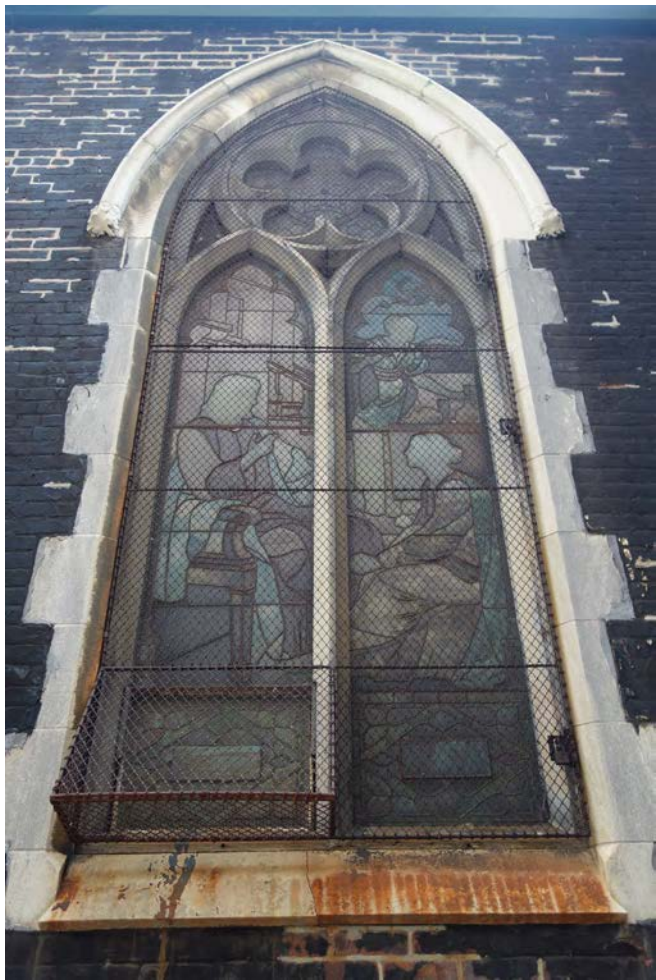
CHURCH NORTH FACADE - NAVE STAINED GLASS MASONRY OPENING AND WOOD TRACERY, EXT.

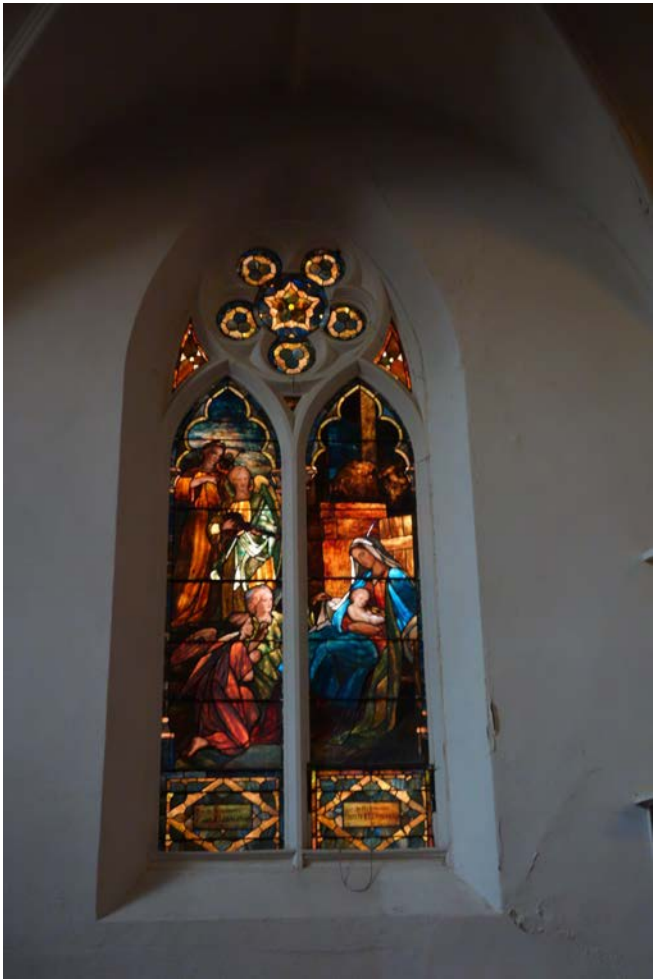
N2. CHURCH NORTH FACADE - NAVE STAINED GLASS, TYPE 5 INTERIOR VIEW

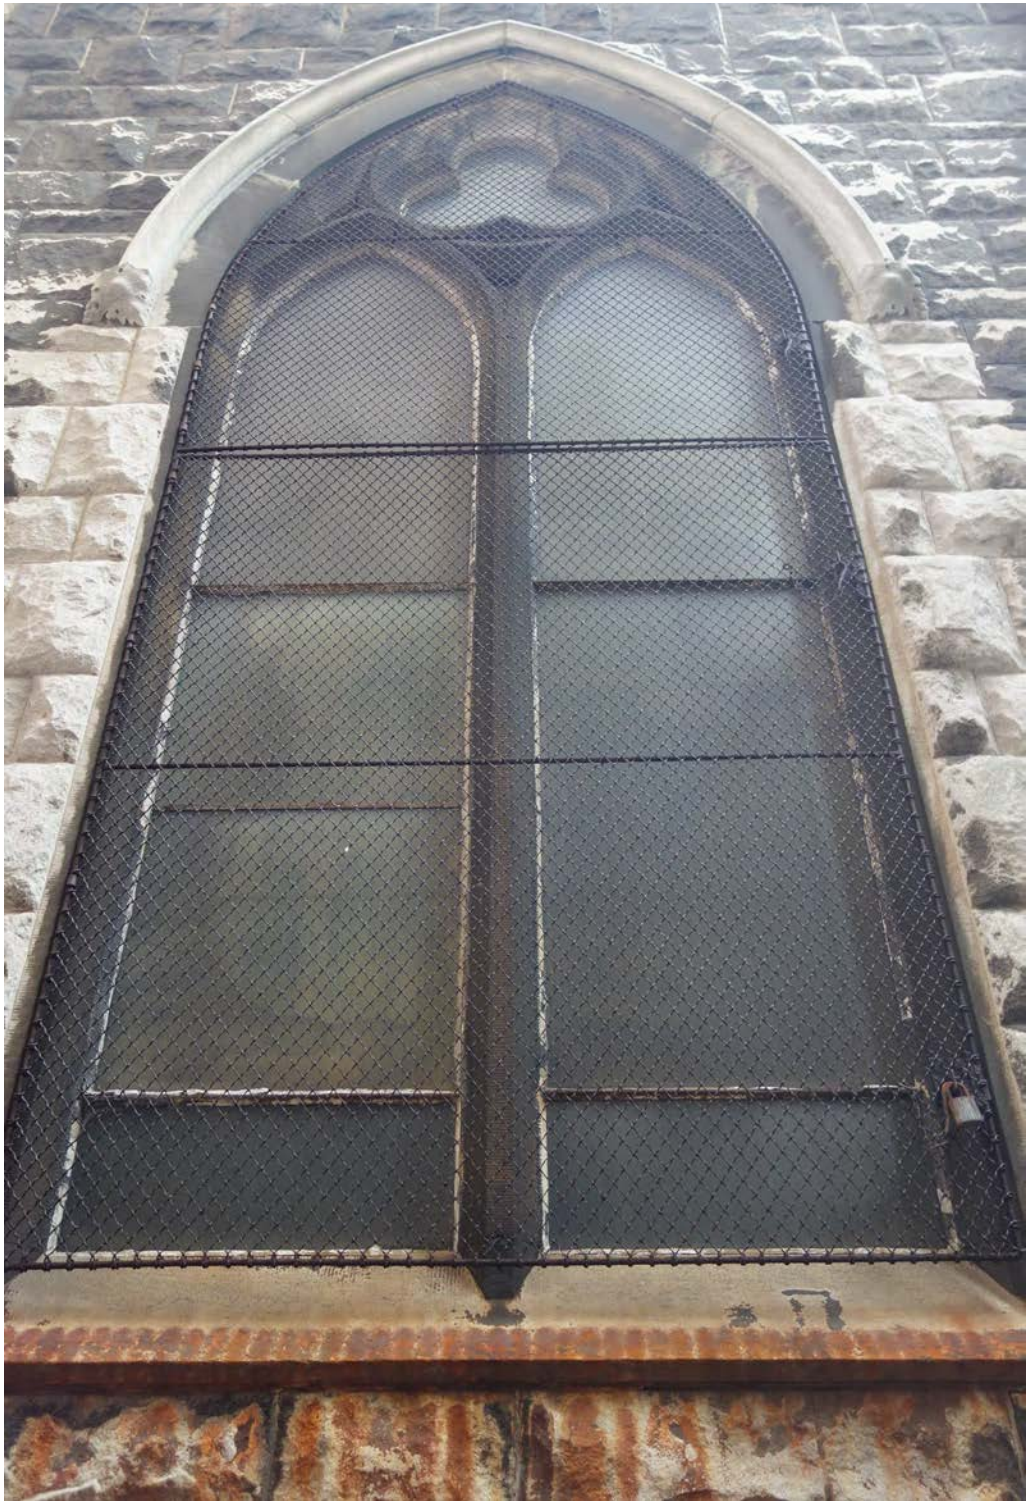
CHURCH NORTH FACADE - PORCH STAINED GLASS MASONRY OPENING AND TRACERY, TYPE 10 EXTERIOR VIEW

- Exterior frame in very poor condition; wood is exposed showing rot.
- Stained glass is in good condition, few panes cracked, coming in good condition.
- Interior frame showing noticeable cracking
- No sign of famous maker provenance
- The window is operable, the bottom pane is awing

- Existing wood has been left exposed to the elements and has deteriorated. Frame is not stable and would need to be removed. religious iconography in lights makes windows not appropriate for building conversion.

- Remove existing stained glass.
- Remove damaged wood framing
- Restore stained glass in hexafoil and two kites (10A.2-4)
- Supply and install new aluminum frame, J. Sussman, Inc #6400 series or equivalent frame into entire opening. New frame to be split into lites mimicking existing wood frame.
- Install restored stained glass lites into new aluminum frame in lites 10B.2-4
- Operable units to be project-in bottom ventilators with screens.
- Supply and install one inch insulated clear glass in all aluminum frame lites.
- Supply and install custom wood trim applied to both exterior and interior faces of the aluminum frame matching the profile of the existing wood tracery.

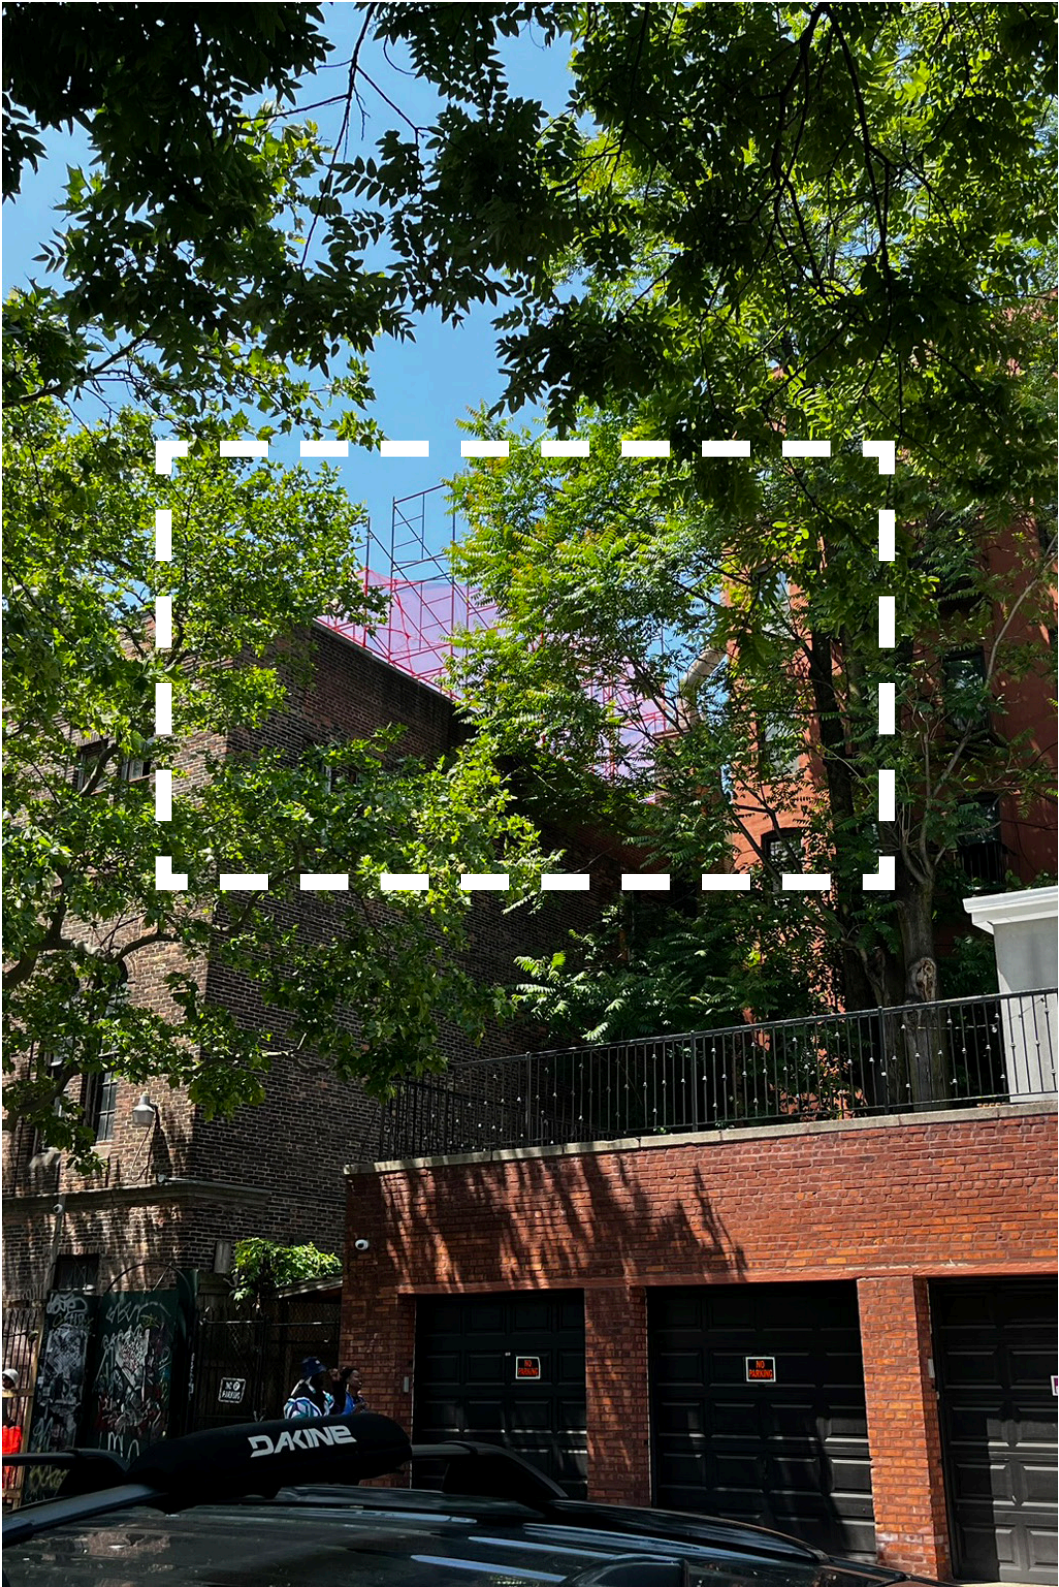
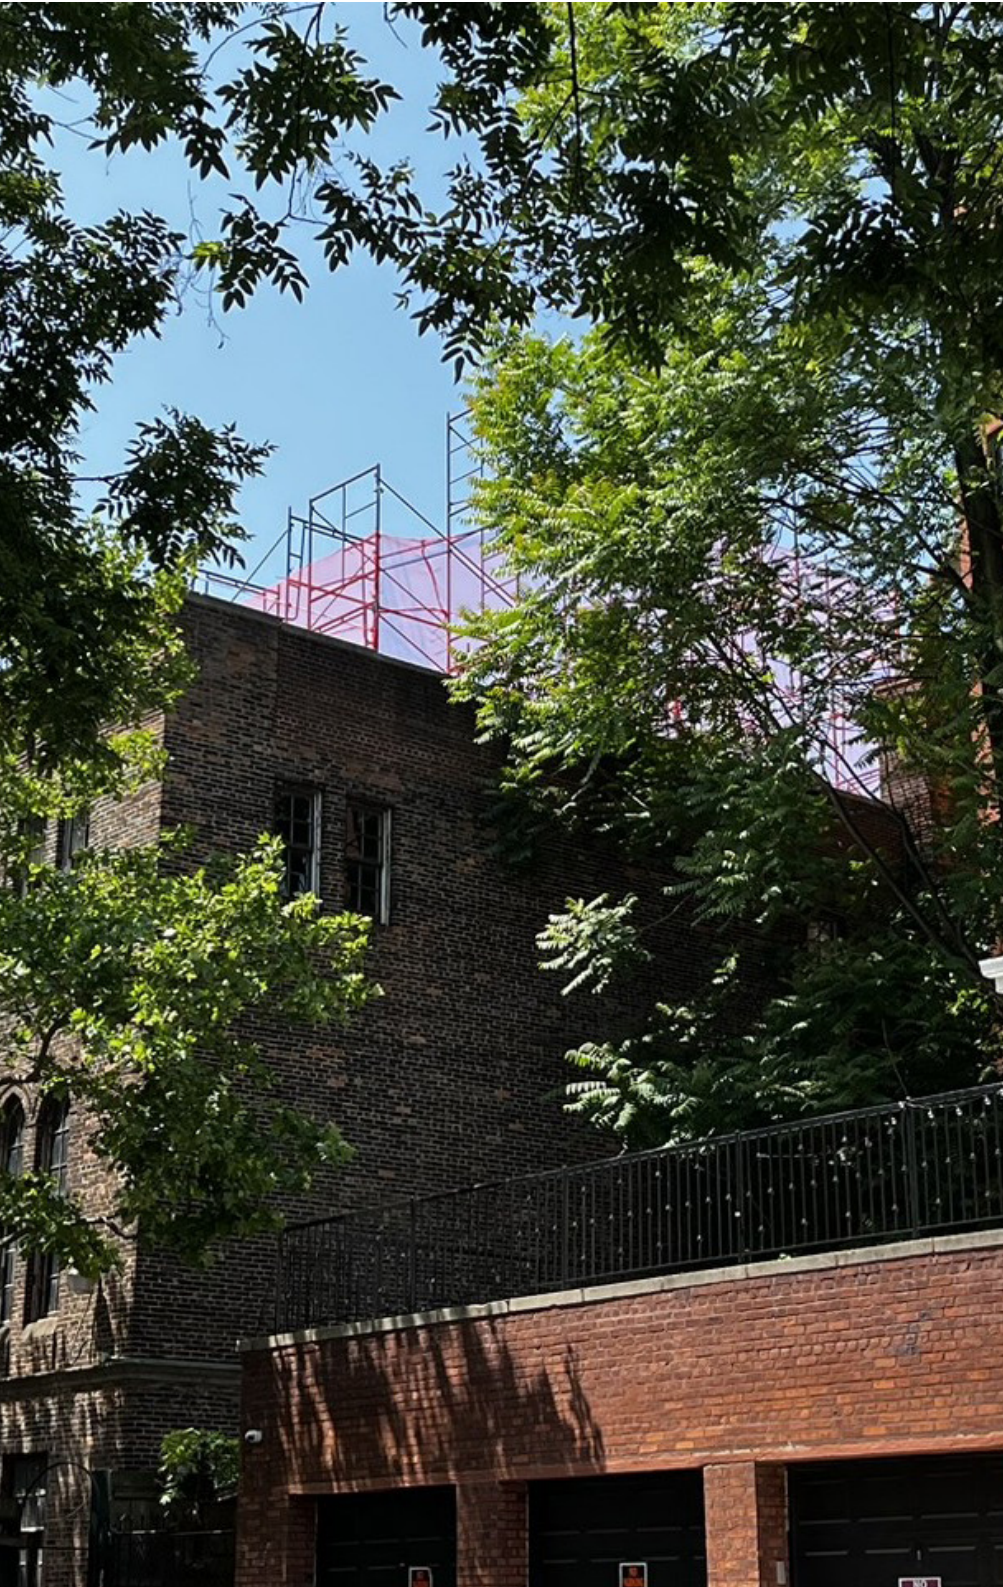
1.

HALL ST. - PENTHOUSE MOCKUP

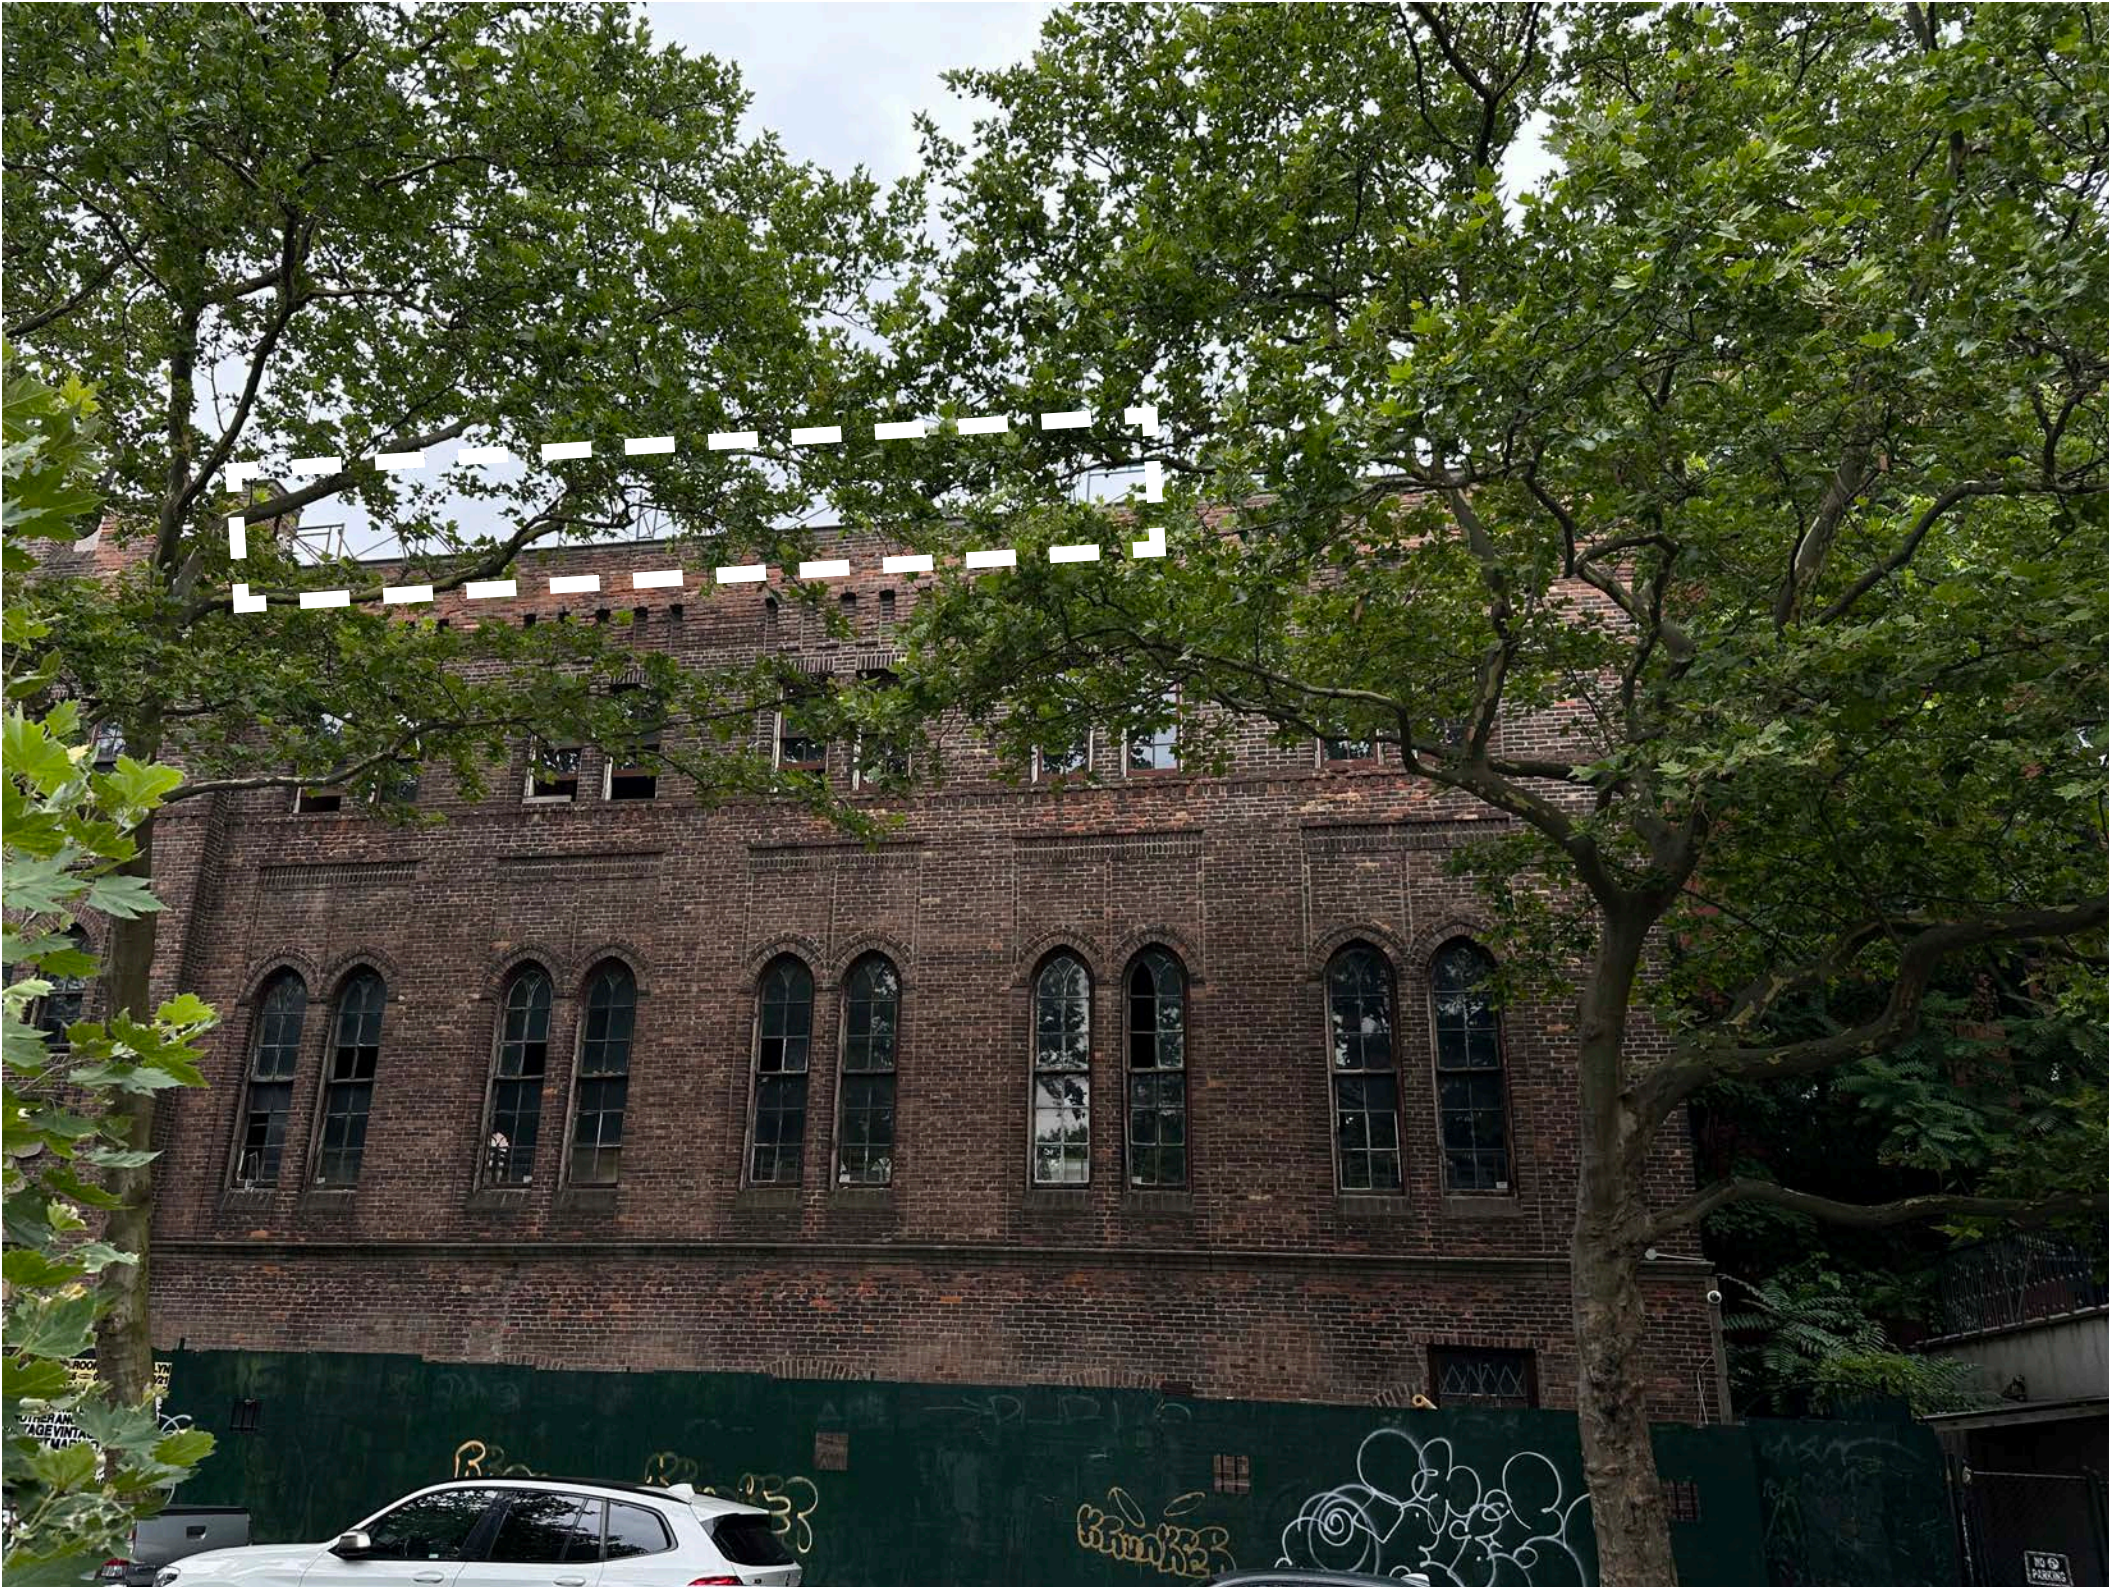
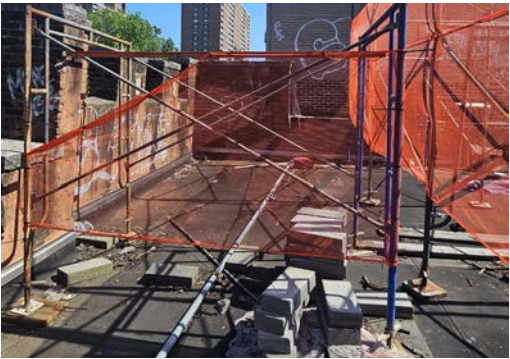
FENCE MOCKUP
ADJUSTED
TO REDUCE
VISIBILITY

3. HALL ST. - PENTHOUSE + TERRACE FENCE MOCKUPS - NO VISIBILITY
