Preservation Department – Item 6, LPC-25-11198

**257-263 Washington Avenue and 230-236 Hall Street –
Clinton Hill Historic District
Borough of Brooklyn**

APPLICATION TO THE NYC LANDMARKS PRESERVATION COMMISSION
257 WASHINGTON AVE, BOROUGH OF BROOKLYN

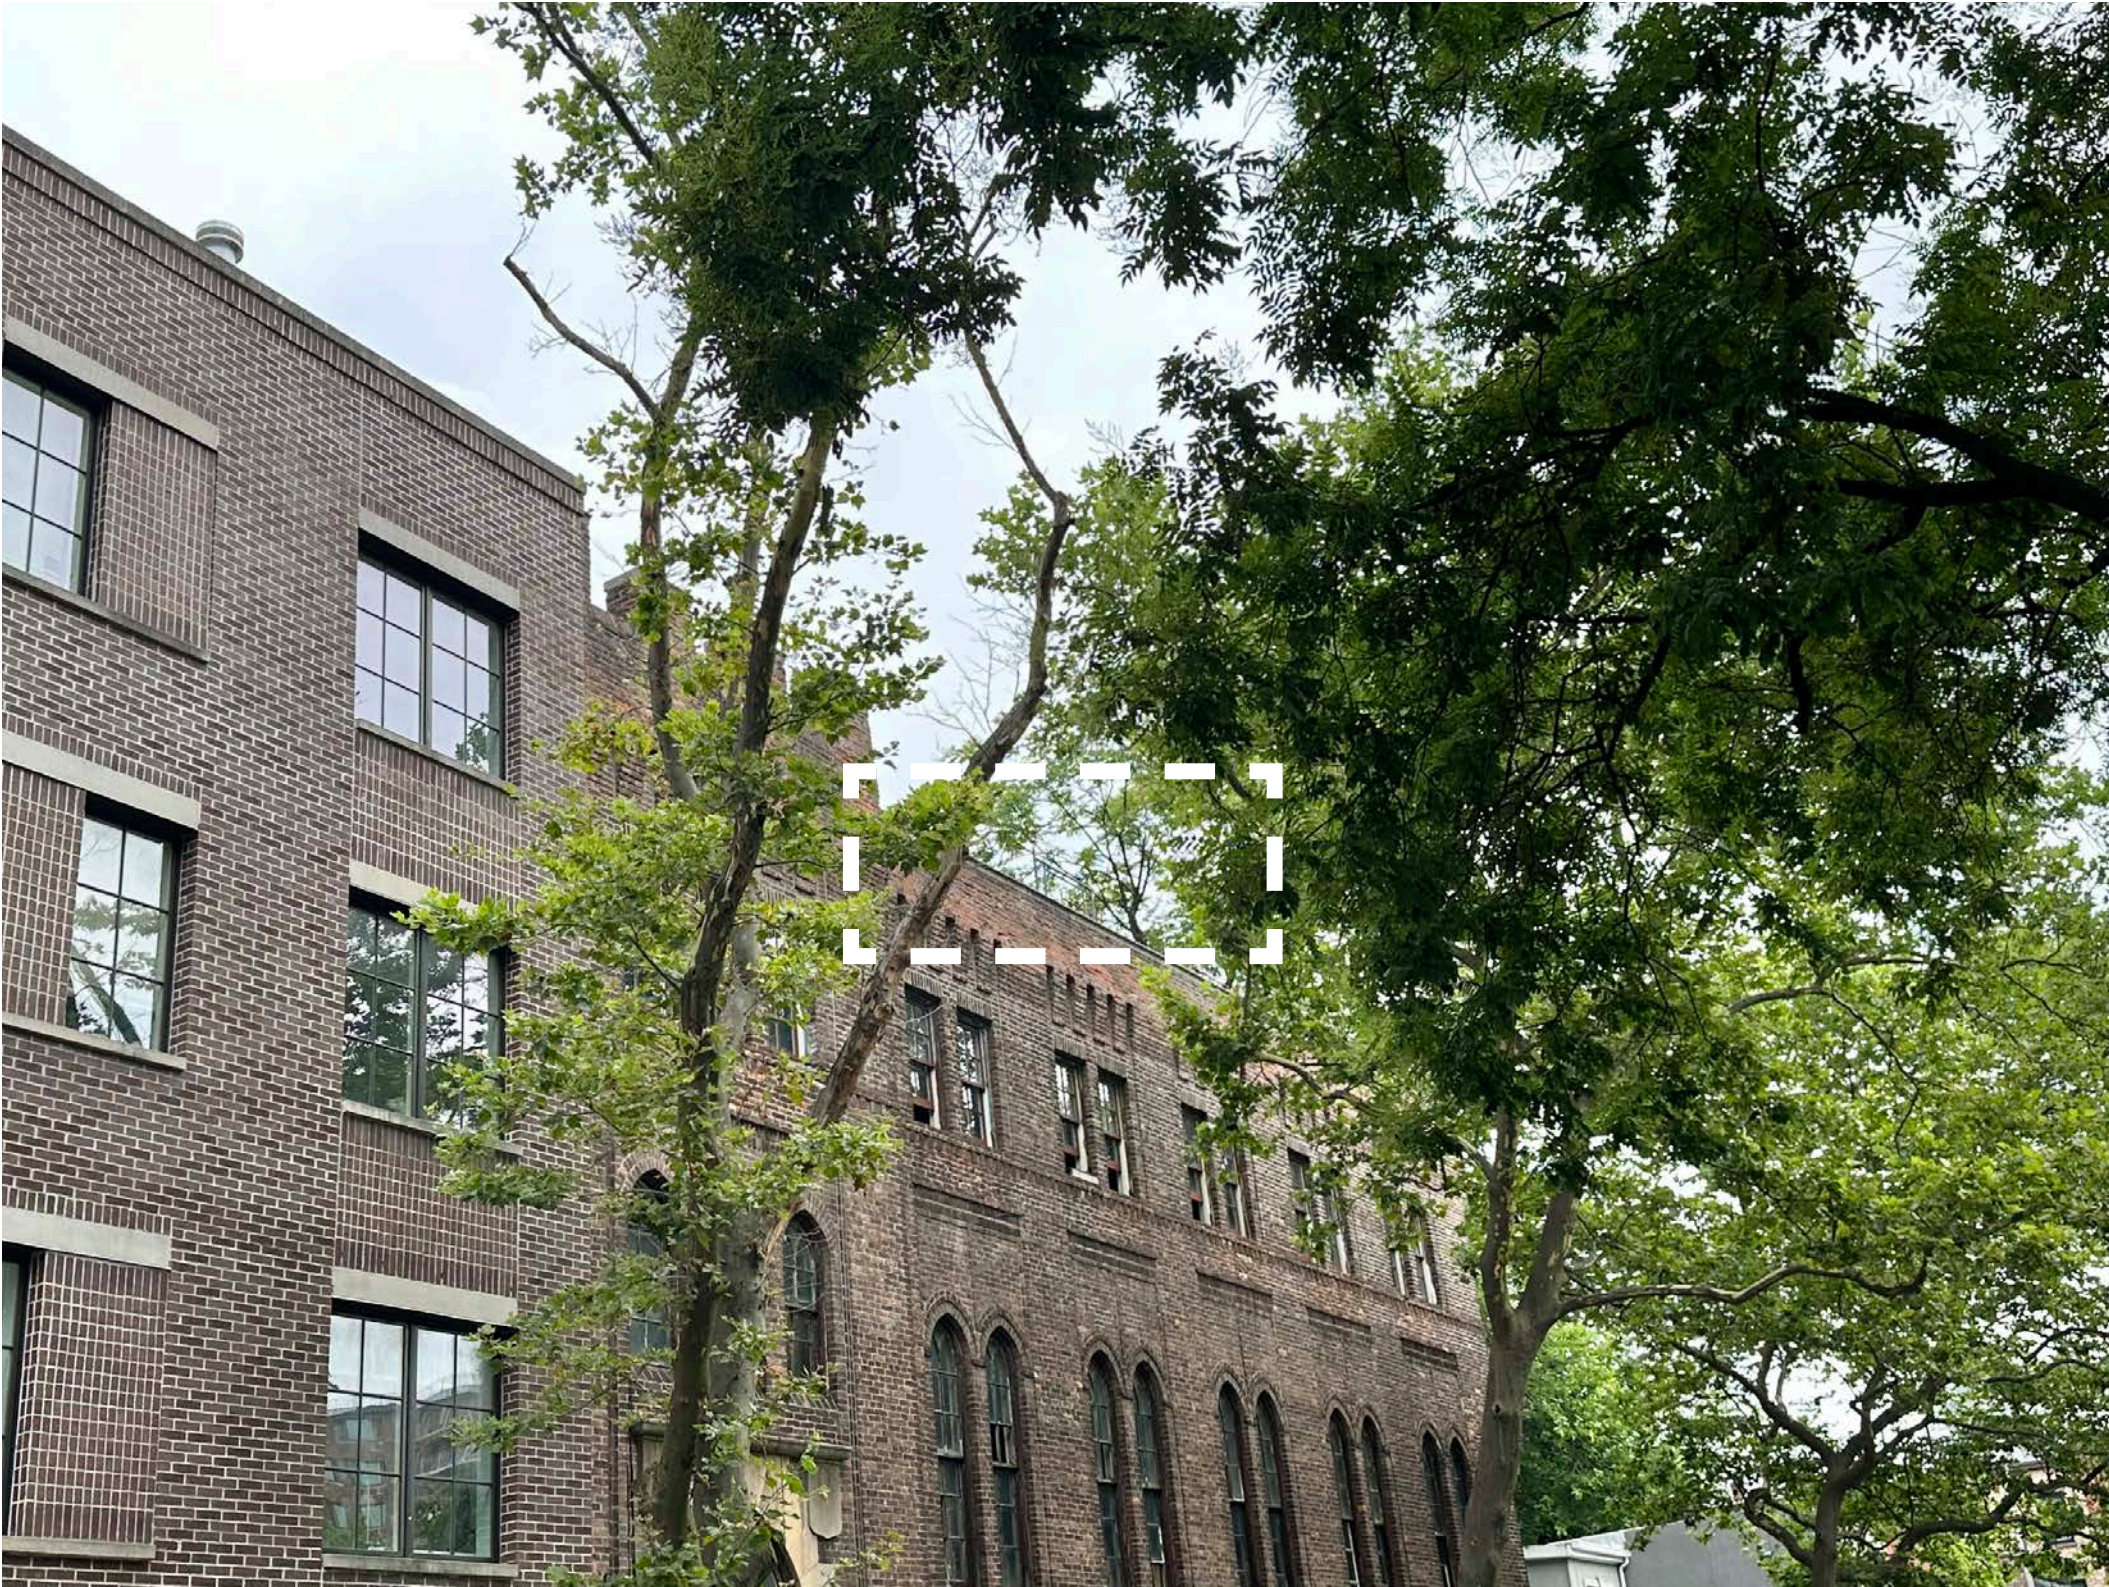
FENCE MOCKUP
ADJUSTED
TO REDUCE
VISIBILITY

4. HALL ST. - PENTHOUSE + TERRACE FENCE MOCKUPS - NO VISIBILITY

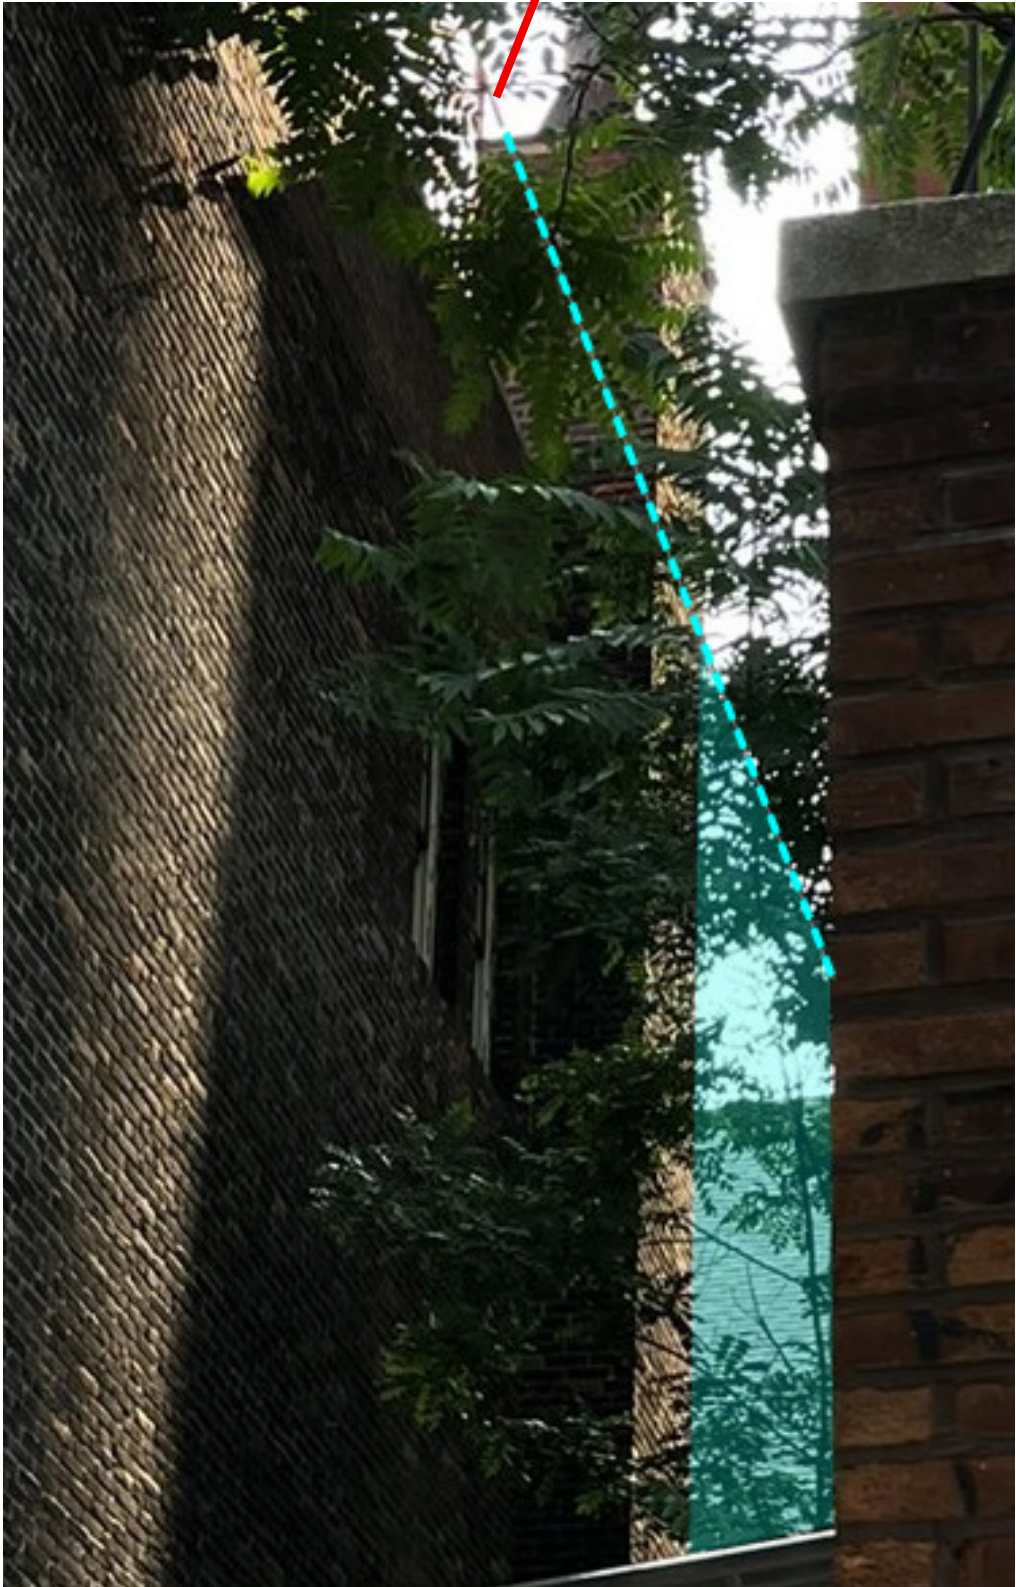
6.

HALL ST. - CONNECTOR DIGITAL MOCKUP - MIN. VISIBILITY

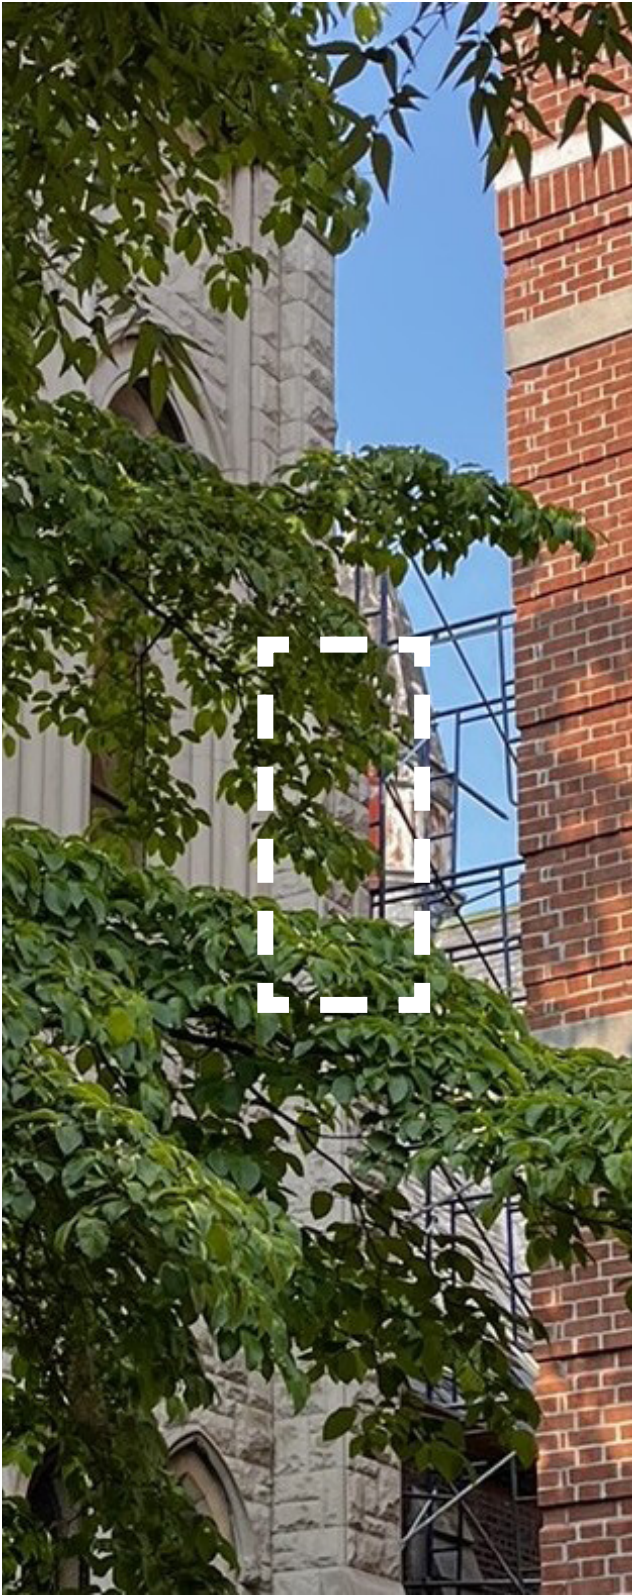
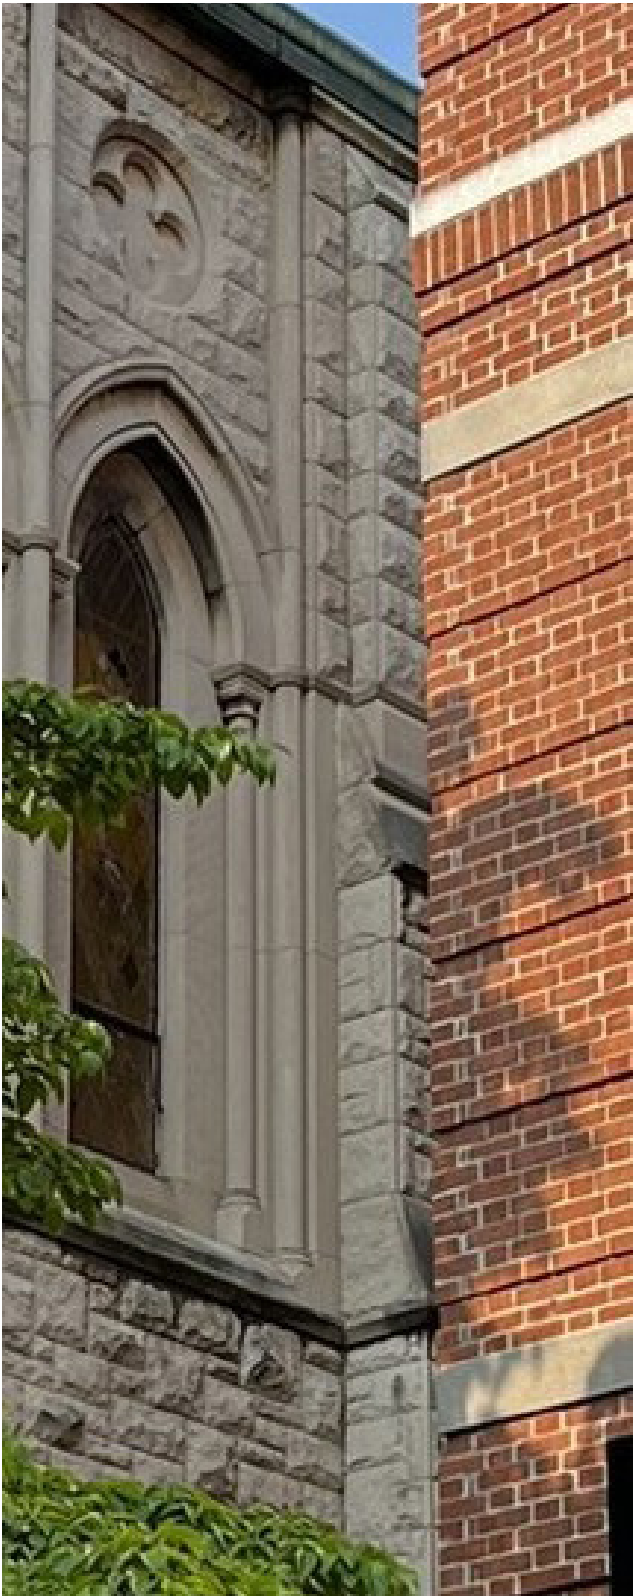
9. WASH. AVE. - DORMER
MOCKUP - MIN. VISIBILITY
- NO VISIBILITY

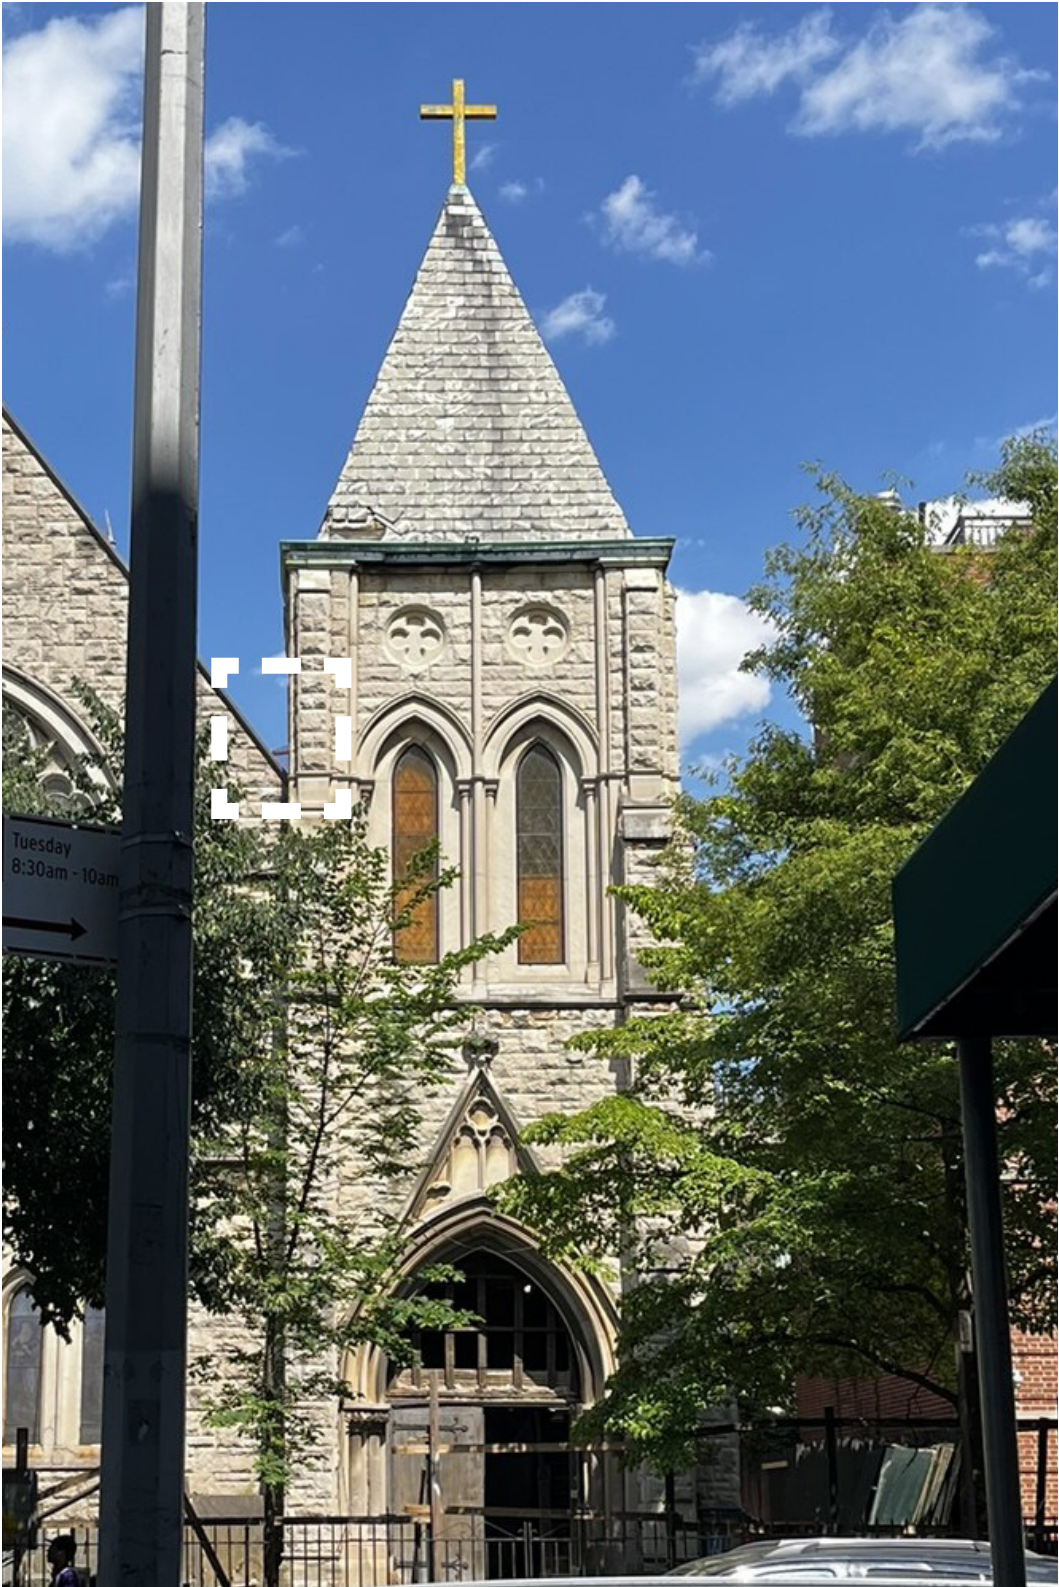
10.

WASH. AVE. - DORMER MOCKUP - MIN. VISIBILITY

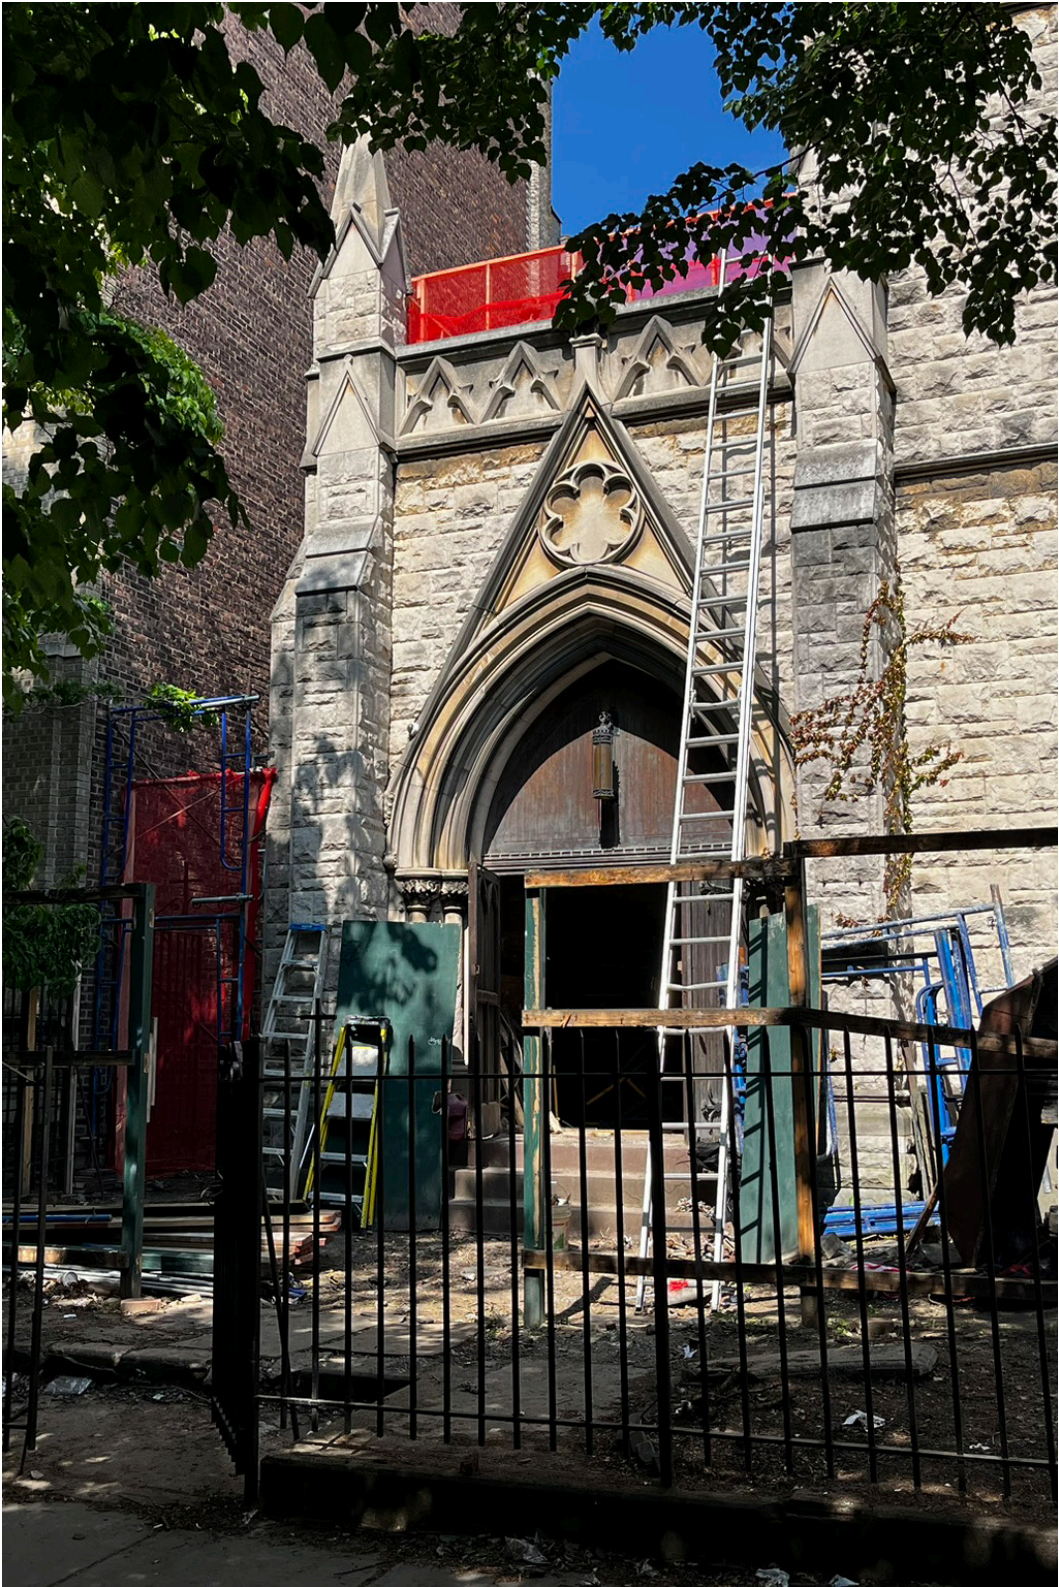
11.

12. WASH. AVE. - TERRACE RAILING & NEW ENTRY

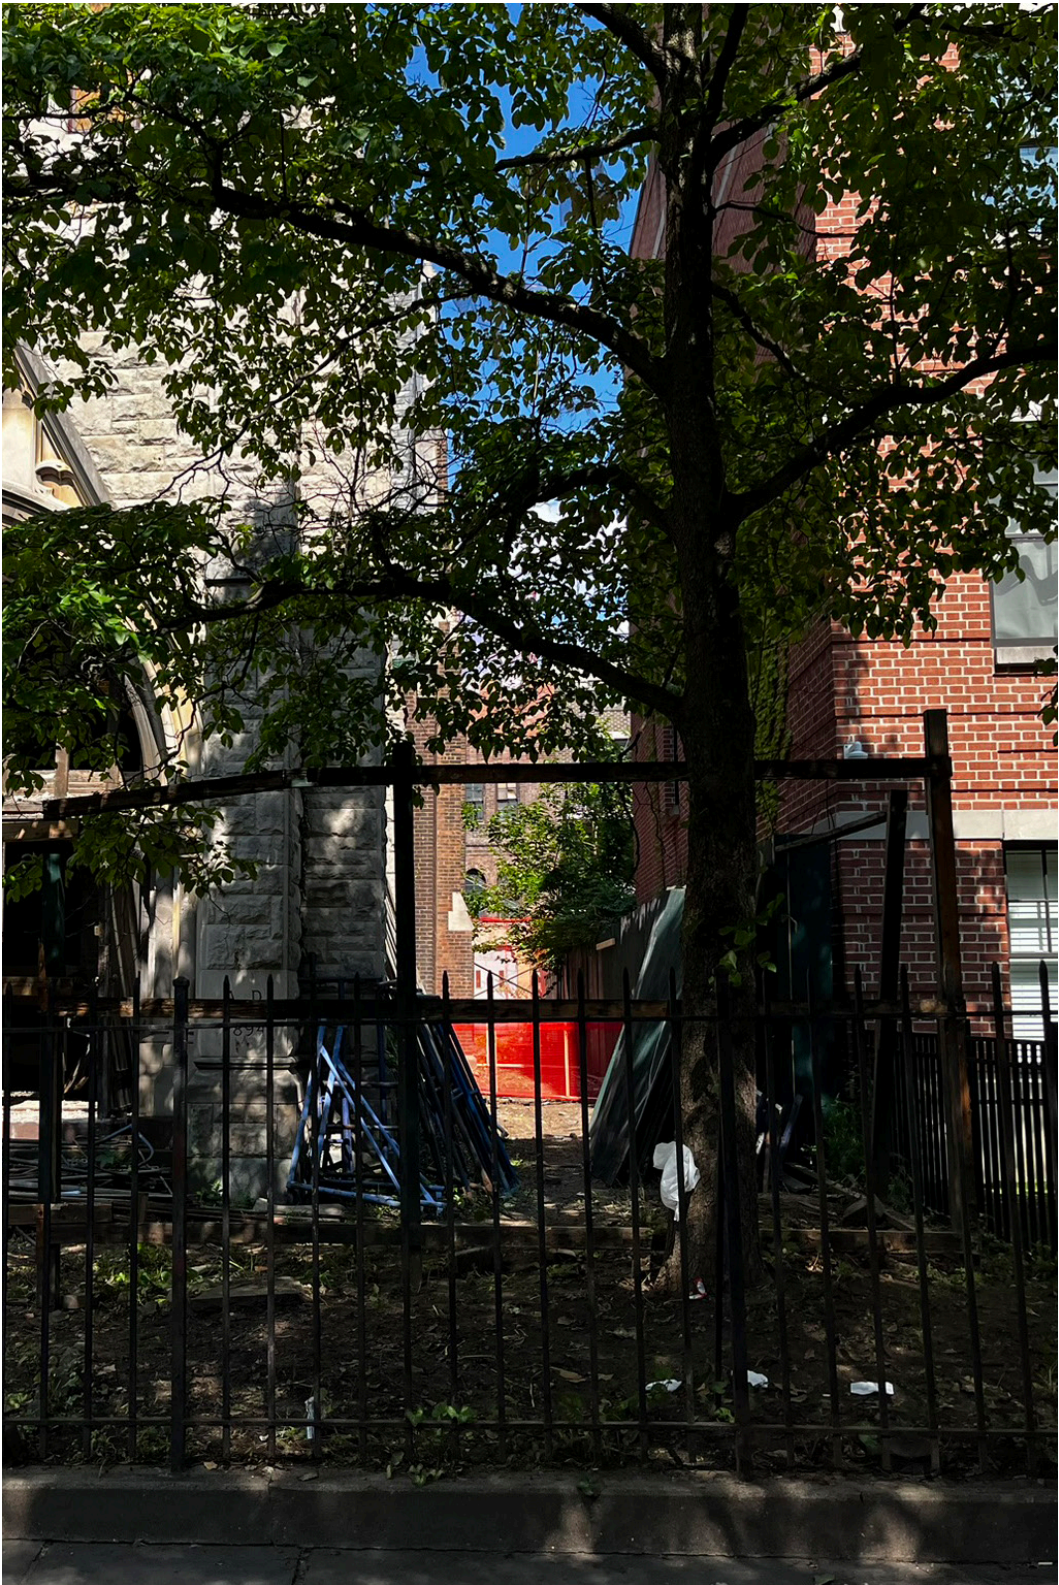
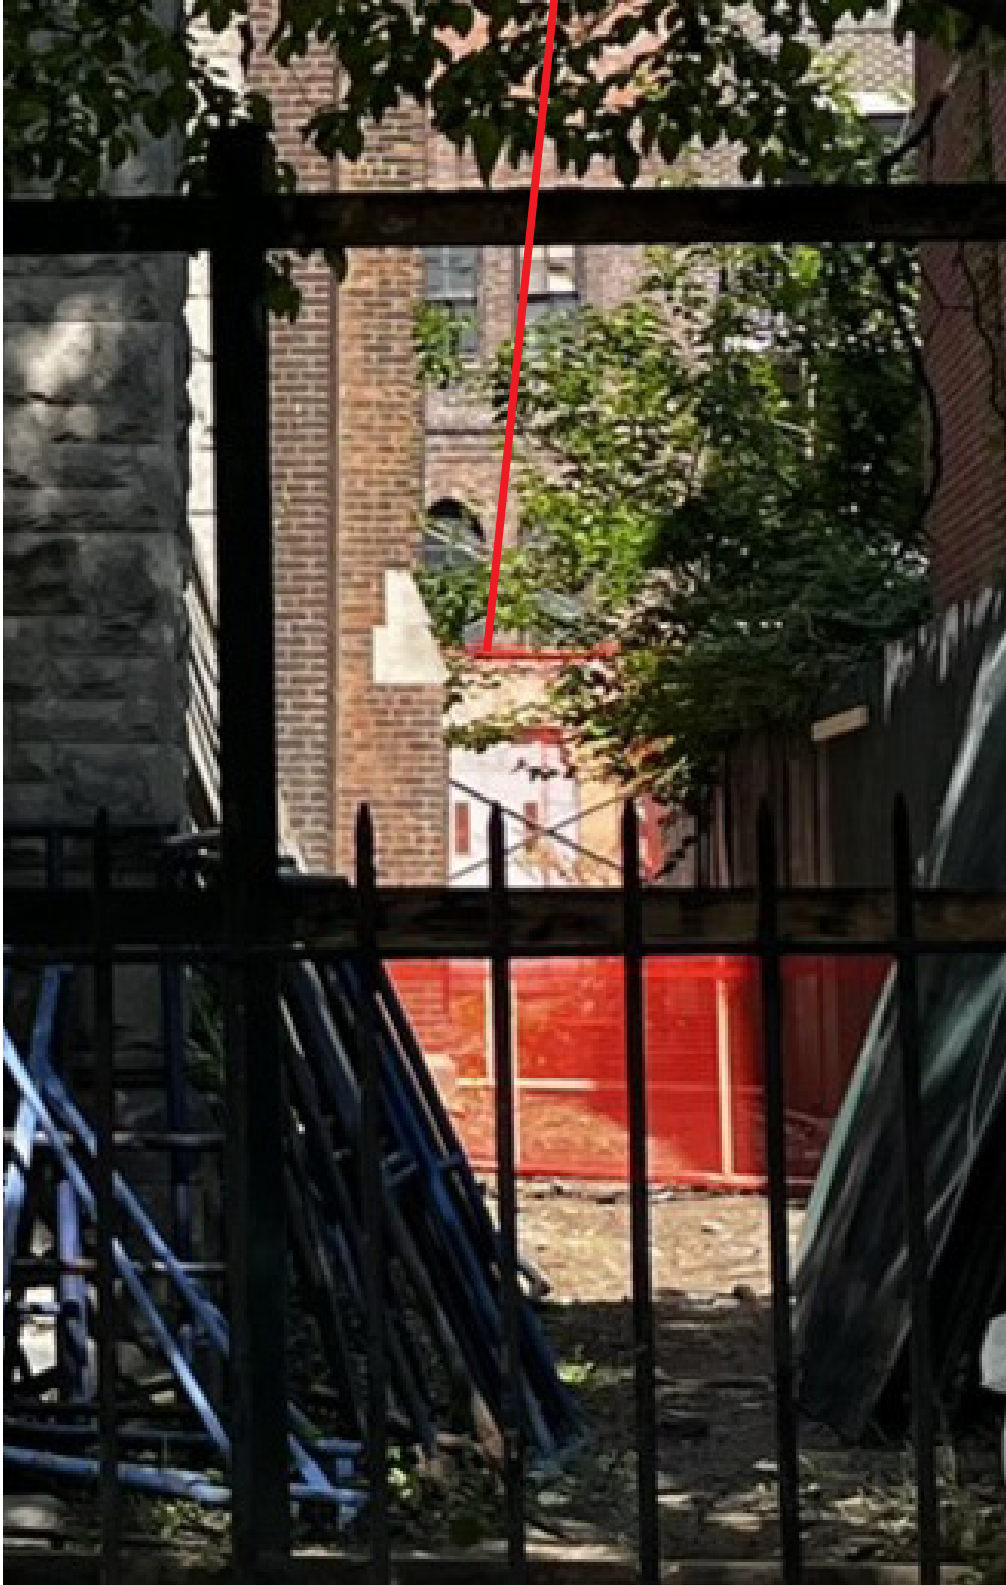
13.

PHYSICAL MOCKUP
PROPOSED 1 STORY
MASSING

WASH. AVE. - SIDEYARD FENCES & 1 STORY MASSING

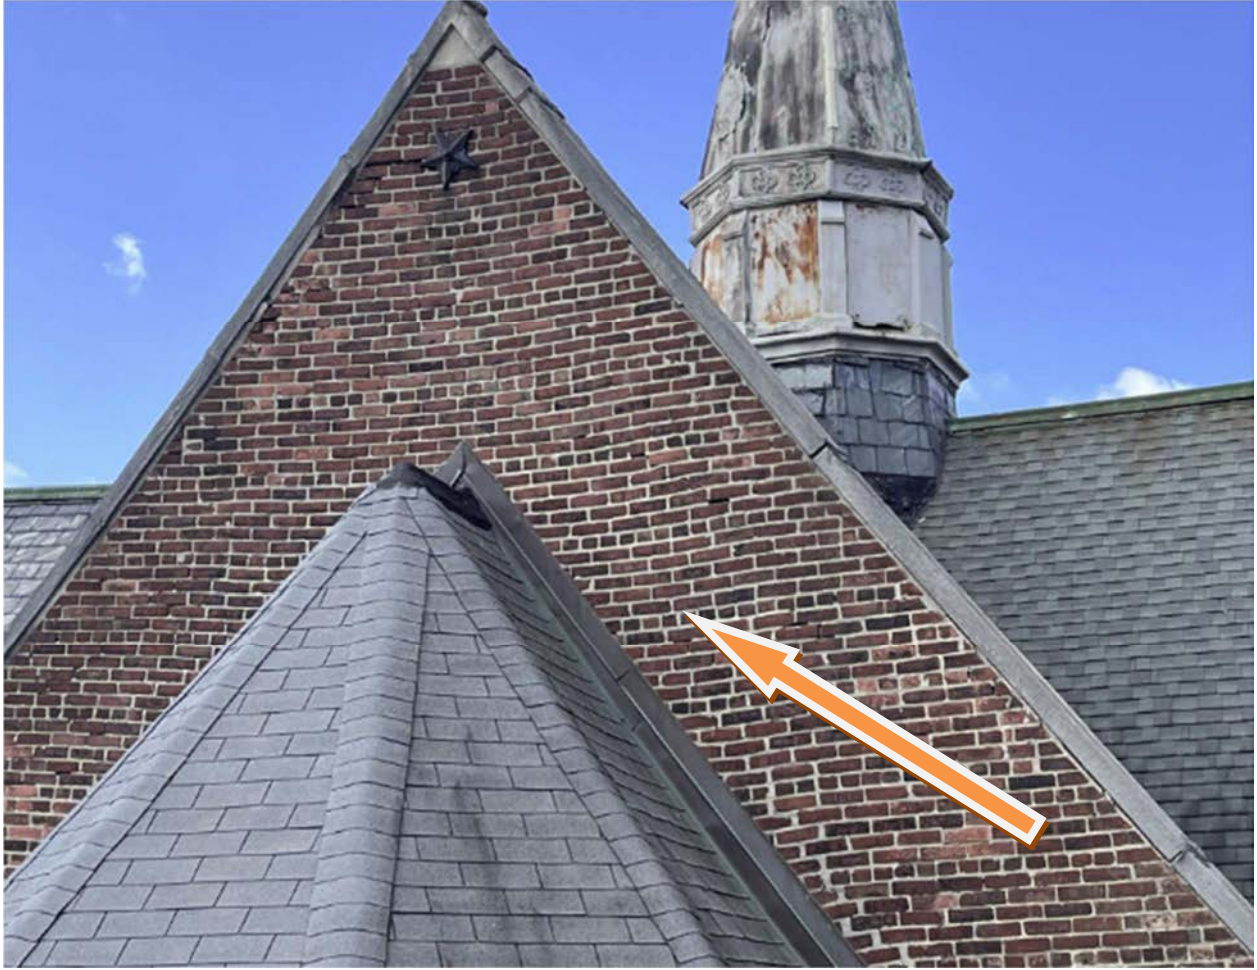
PHOTOGRAPH 4: Rear Brick Church Wall Settlement. Note: hidden causes possible behind plaster/ceiling

- **Church Rear Brick Wall Settlement (See Photographs 3 and 4)**- A noticeable overall settlement of rear church wall can be observed from the exterior view. The same wall is hidden from the interior view by the remaining plaster and ceiling profile. JAG would recommend that the removal of the interior finishes be completed to expose the wall in question. Further evaluation of the wall would be needed to conclude the next steps including the needed repairs.

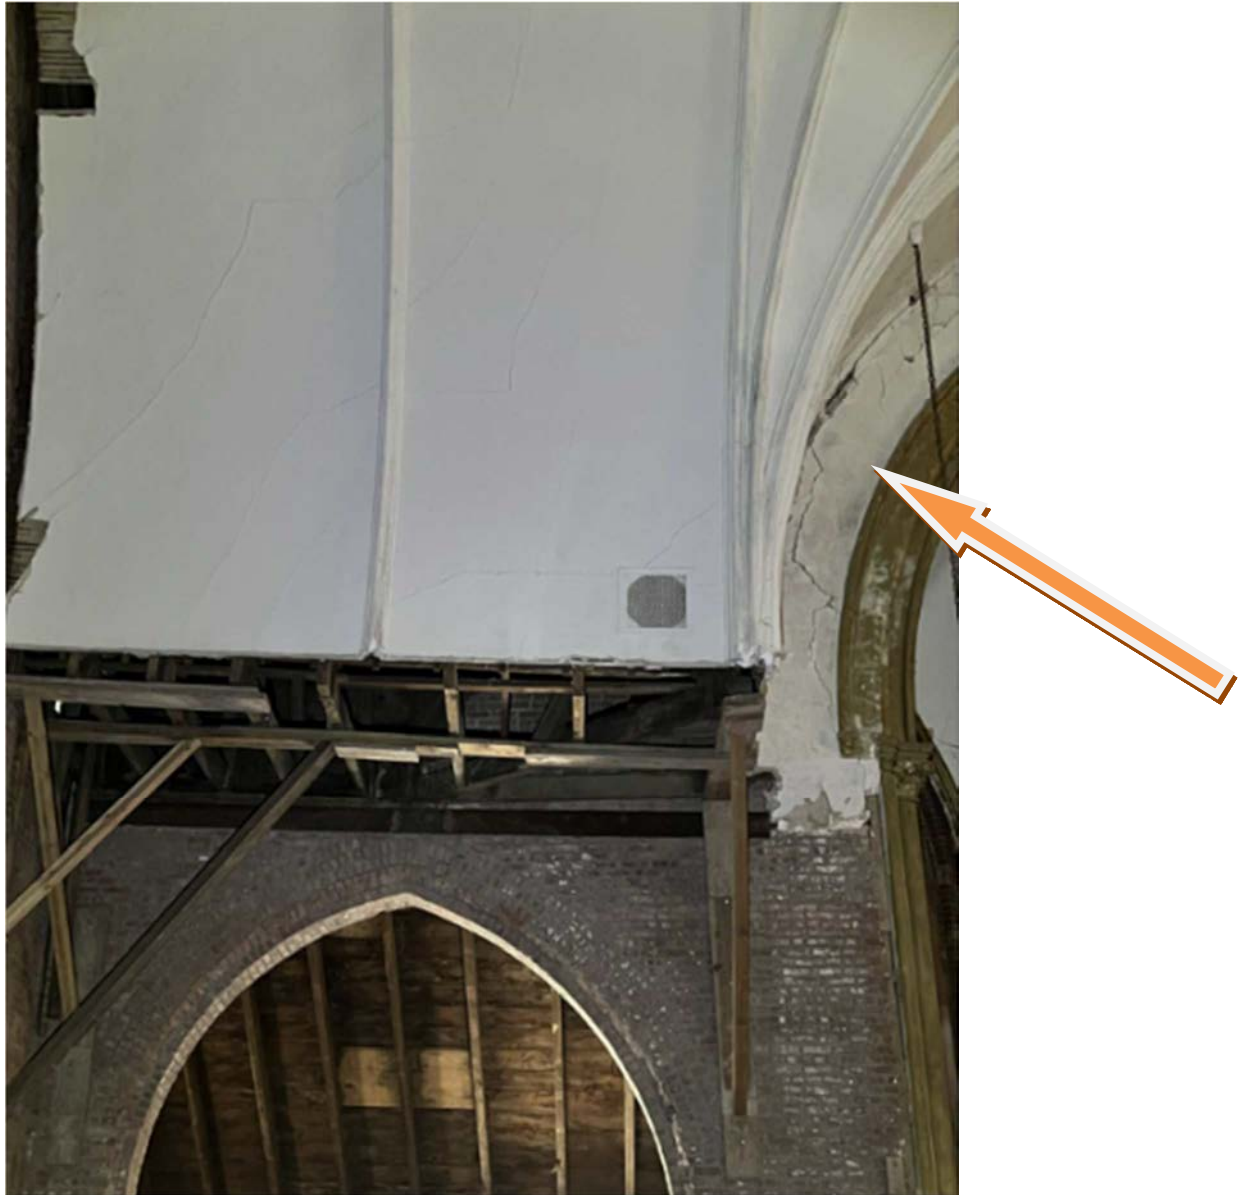
PHOTOGRAPH 5: View of unknown condition of church roof joists

- **Church Roof Joists (See Photographs 5 and 6)**- The existing church joists are currently hidden from view due to the church ceiling construction. Long term water intrusion is occurring at the roof due to a deteriorated exterior roofing. There is a strong possibility that roof joist construction has been compromised in areas where water intrusion has been occurring. JAG would recommend that the removal of the interior finishes be completed to expose the church joists in question. Further evaluation of the joists would be needed to conclude the next steps including the need for repairs and/or replacement.

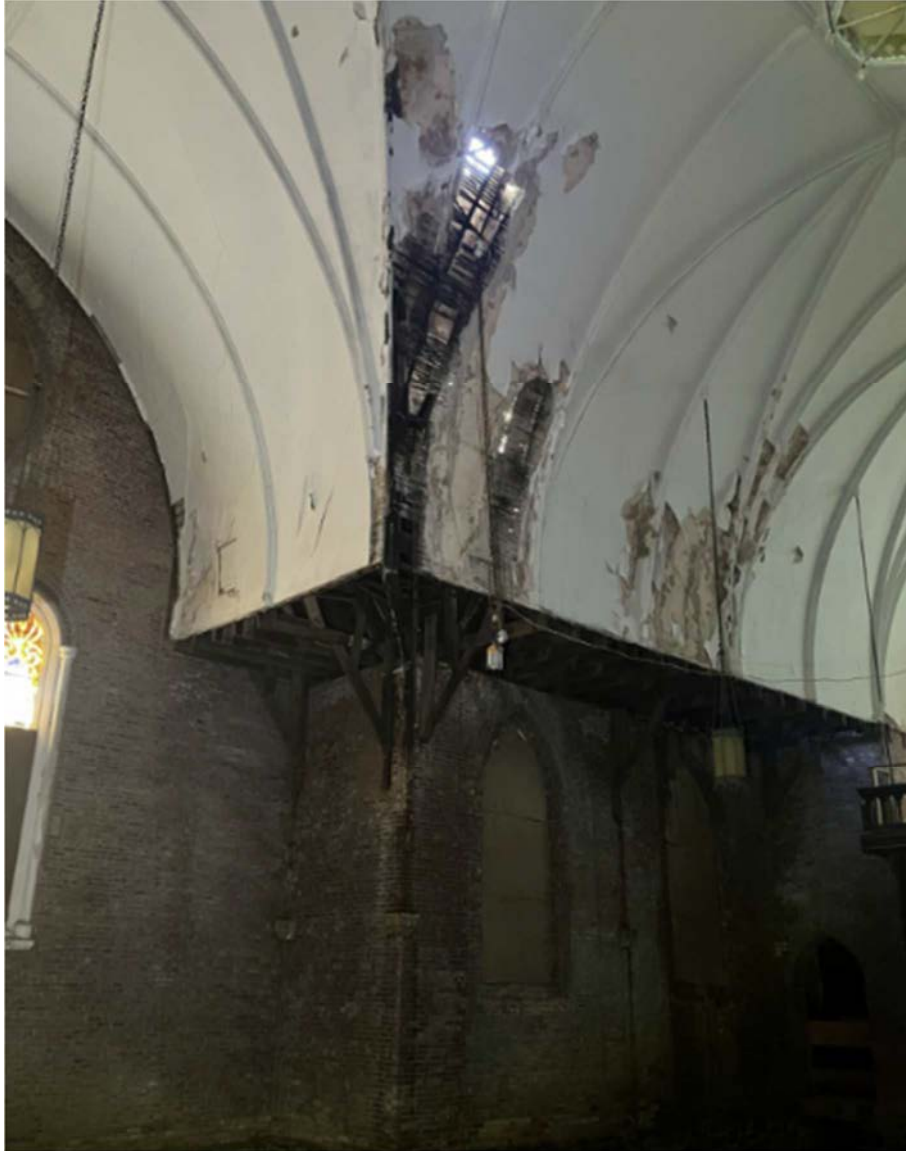
PHOTOGRAPH 6: View of unknown condition of church roof joists

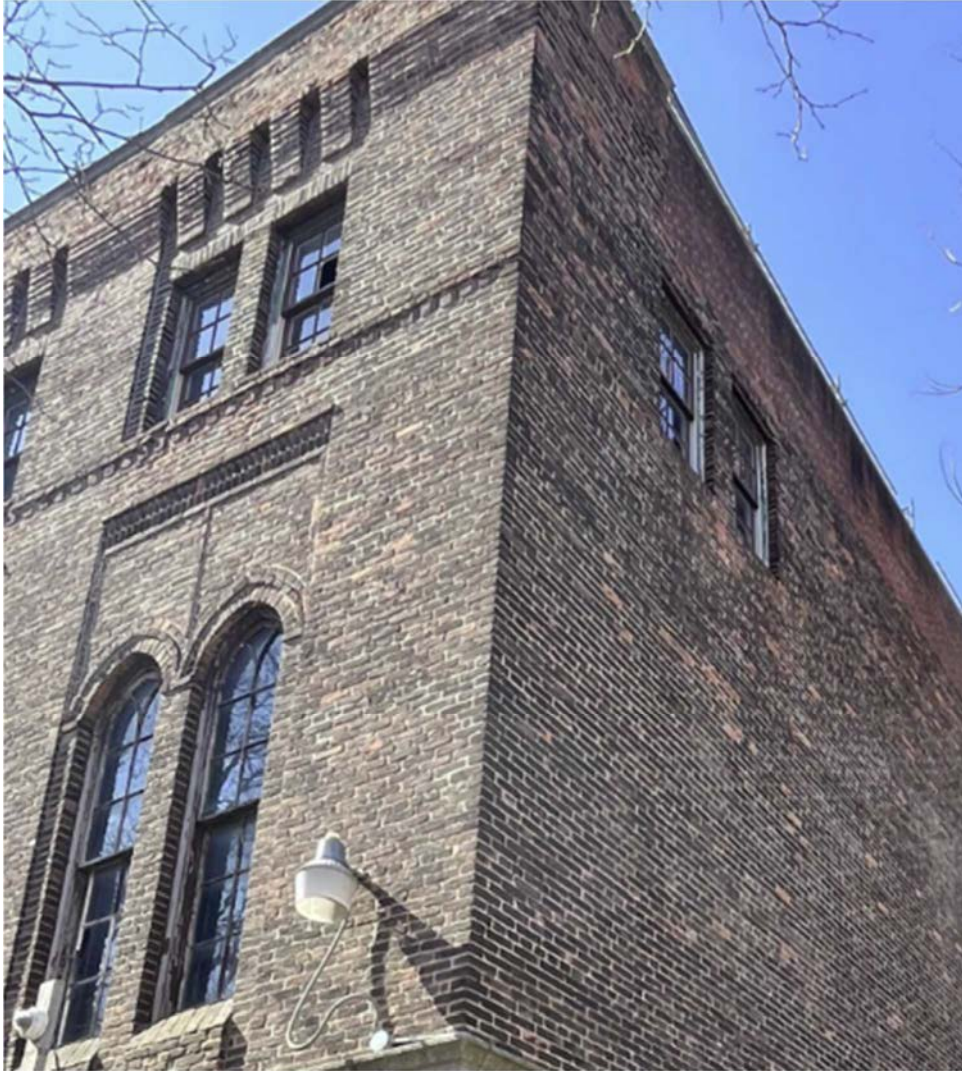
PHOTOGRAPH 8: View of existing parish perimeter wall construction

- **Brick Pointing at Parish Building (See Photographs 7 and 8)**- The exposed perimeter walls of the parish building include an exterior layer of unreinforced brick. Both the brick-and-mortar joints are weathered and concaved throughout. JAG would recommend that these perimeter walls be routed and pointed to extend the lifespan of the original construction.

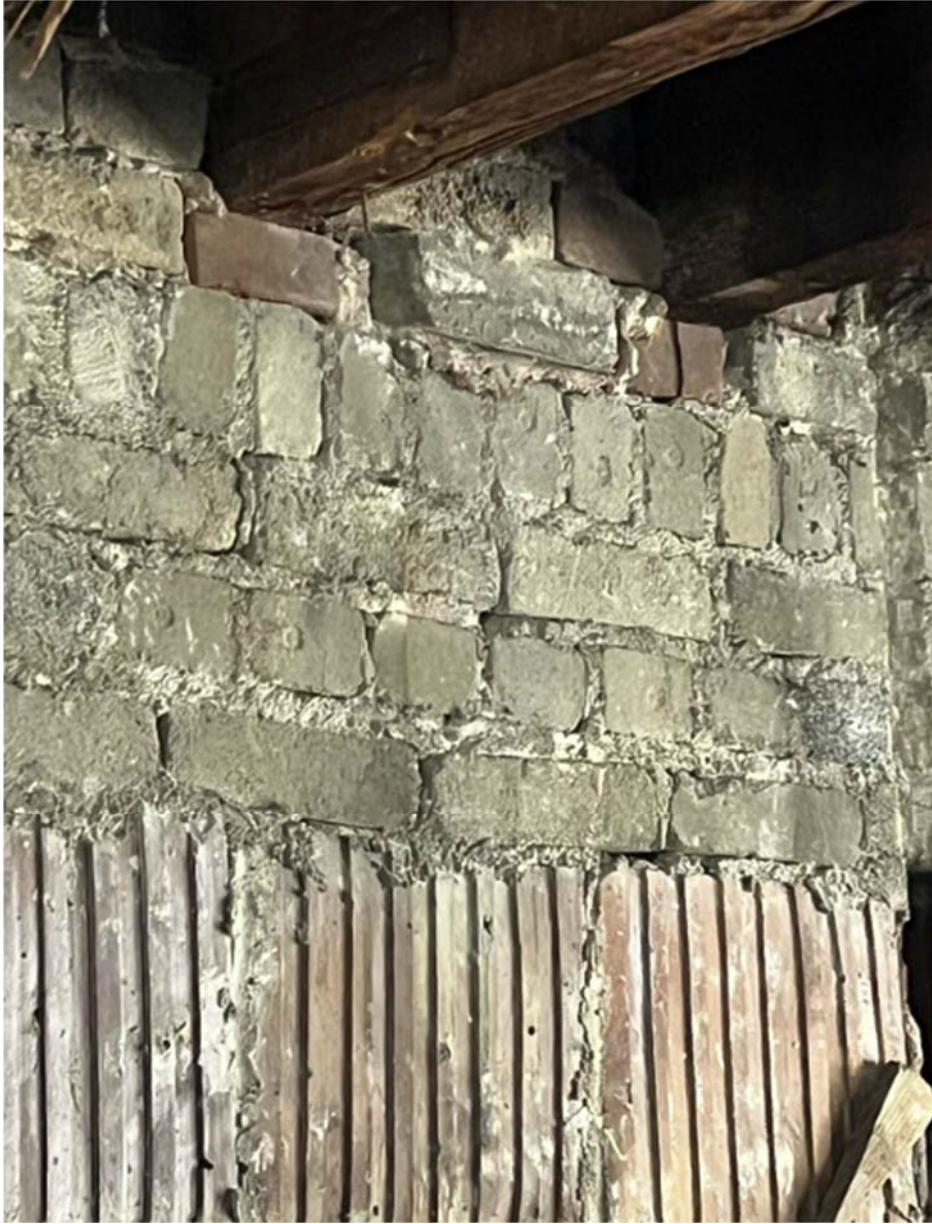
PHOTOGRAPH 9: View of existing roof leaks

- **Roof Leaks (See Photographs 9 and 10)**- There are multiple locations on all slopes on both the church and parish roofs that water entry was confirmed. JAG would recommend that the existing roofs be removed and replaced to extend the lifespan of the original construction.

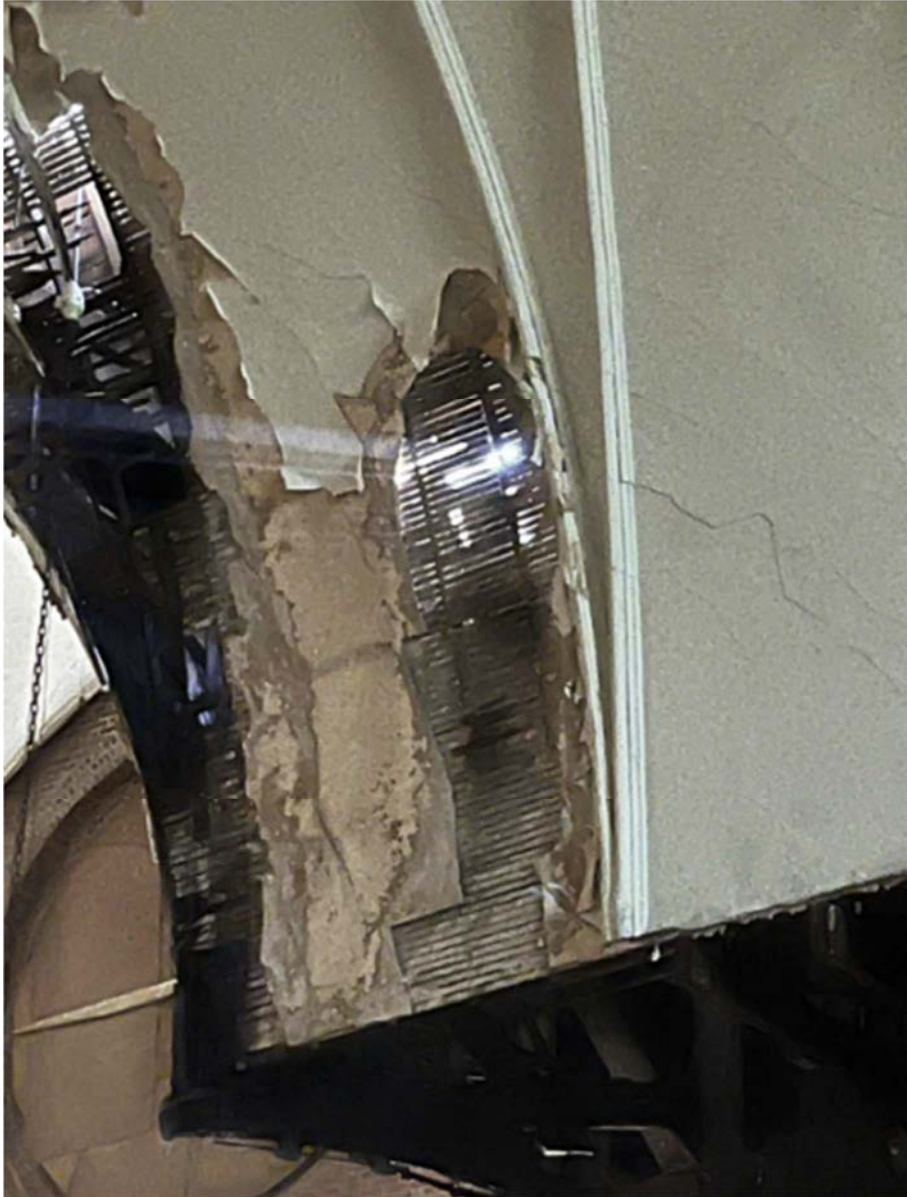
PHOTOGRAPH 10: View of existing roof leaks

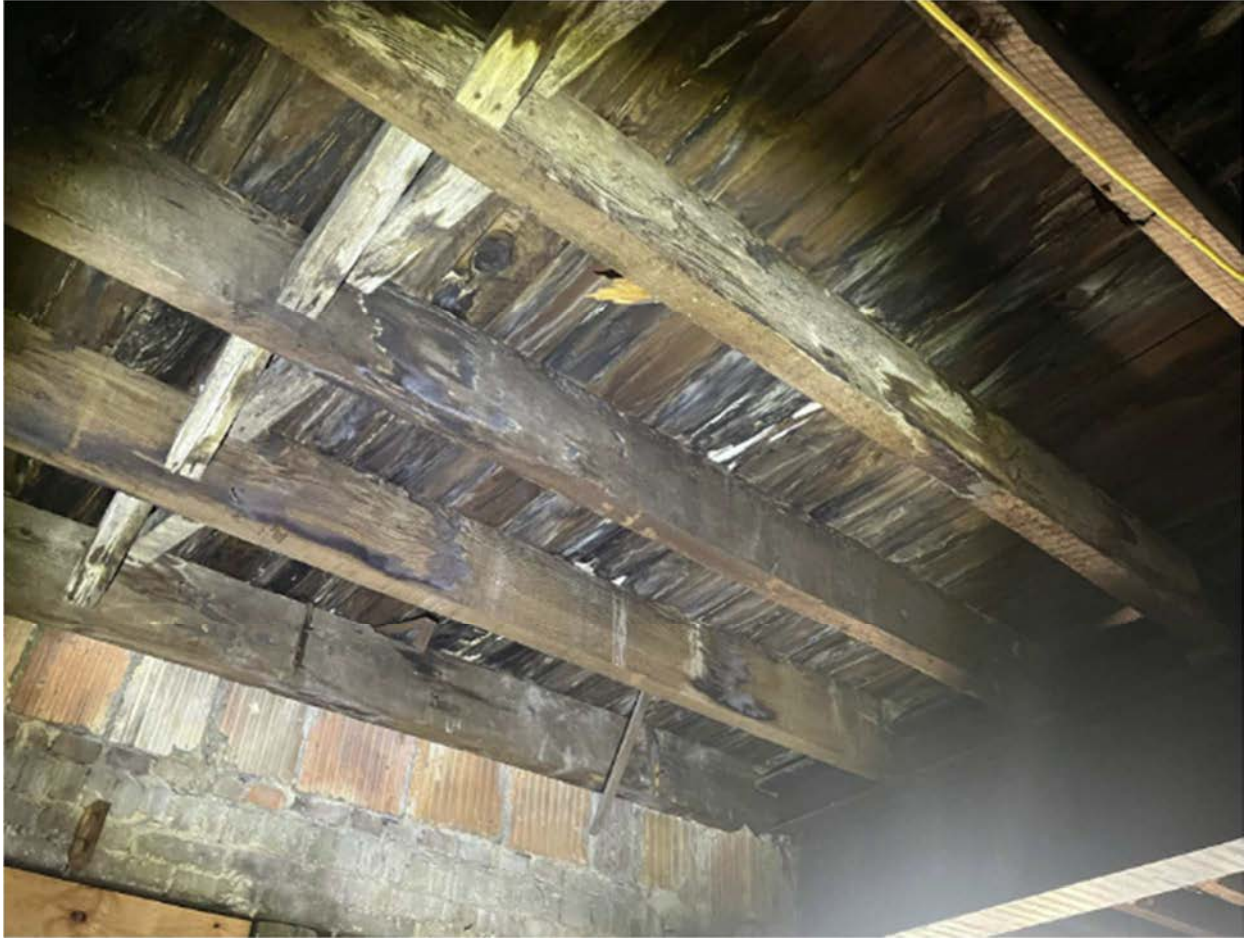
PHOTOGRAPH 11: View of installed concrete underpinning

- Existing as-built underpinning (See Photographs 11 and 12)- Underpinning of the existing church foundation is in place and there are no noticeable defects. Due to the complexity of underpinning and large extent of underpinning work further evaluation would be recommended. JAG would recommend that further evaluation, including destructive testing and probing of the installed underpinning, be completed to ensure adequate and appropriate construction.
- Lateral Bracing of Parish perimeter walls (See Photographs 13 and 14)- As-built conditions include double height spaces where previous flooring has been removed. This creates a double height unbraced wall condition. JAG would recommend that further evaluation of the unbraced walls be completed, and appropriate temporary bracing be installed until proposed new floor elevations can be established.
