Preservation Department – Item 6, LPC-25-11198

**257-263 Washington Avenue and 230-236 Hall Street –
Clinton Hill Historic District
Borough of Brooklyn**

APPLICATION TO THE NYC LANDMARKS PRESERVATION COMMISSION
257 WASHINGTON AVE, BOROUGH OF BROOKLYN

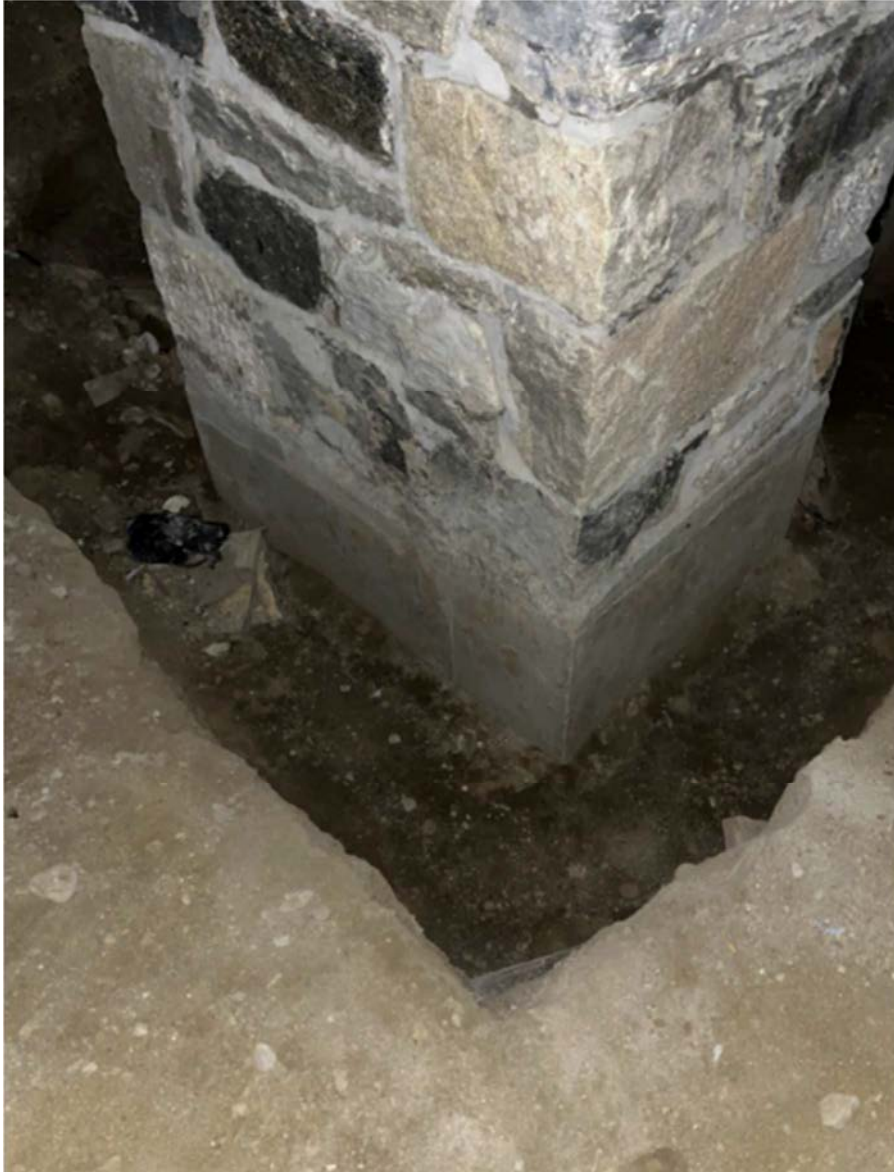
PHOTOGRAPH 12: View of installed concrete underpinning

- Existing as-built underpinning (See Photographs 11 and 12)- Underpinning of the existing church foundation is in place and there are no noticeable defects. Due to the complexity of underpinning and large extent of underpinning work further evaluation would be recommended. JAG would recommend that further evaluation, including destructive testing and probing of the installed underpinning, be completed to ensure adequate and appropriate construction.
- Lateral Bracing of Parish perimeter walls (See Photographs 13 and 14)- As-built conditions include double height spaces where previous flooring has been removed. This creates a double height unbraced wall condition. JAG would recommend that further evaluation of the unbraced walls be completed, and appropriate temporary bracing be installed until proposed new floor elevations can be established.

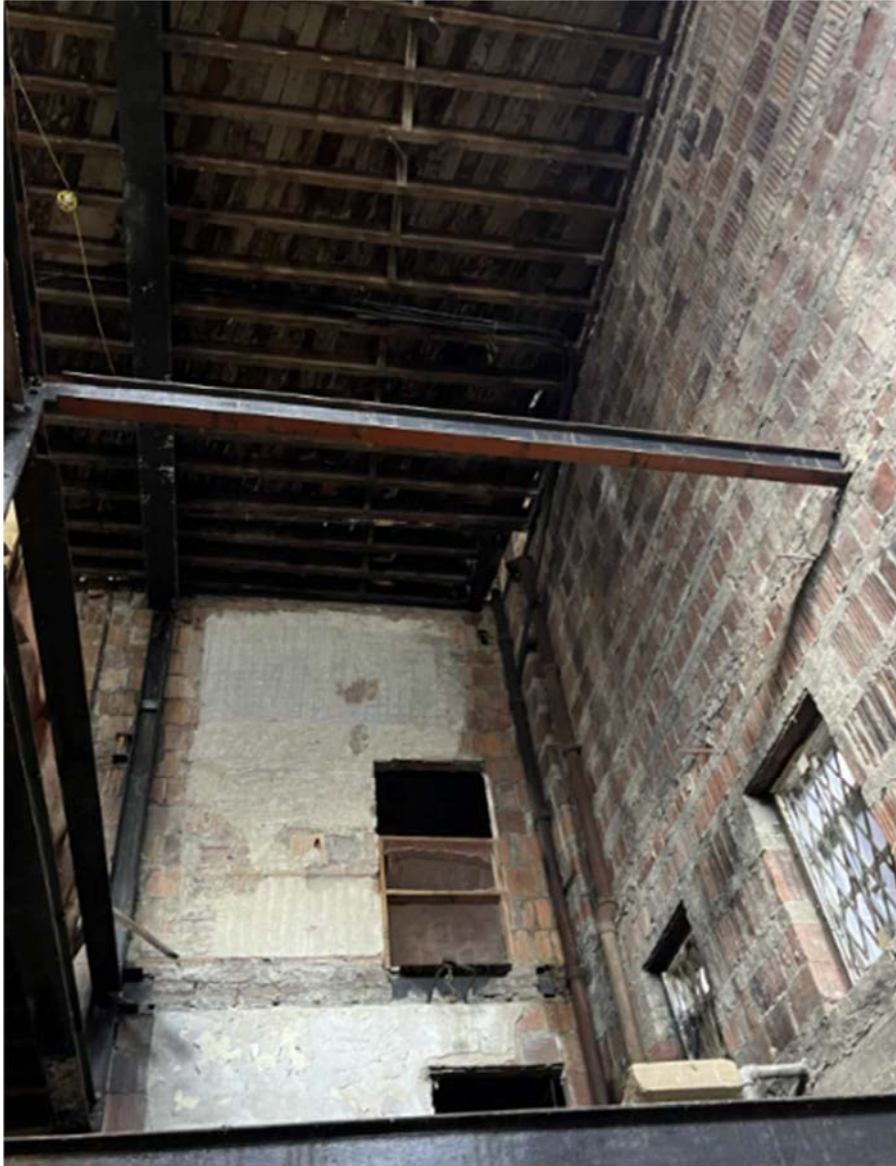
PHOTOGRAPH 13: View of Parish Perimeter Wall

- 1) Evaluation of the completed foundation wall underpinning of the church building.
- 2) Evaluation of the lateral bracing of the perimeter walls of the parish building.

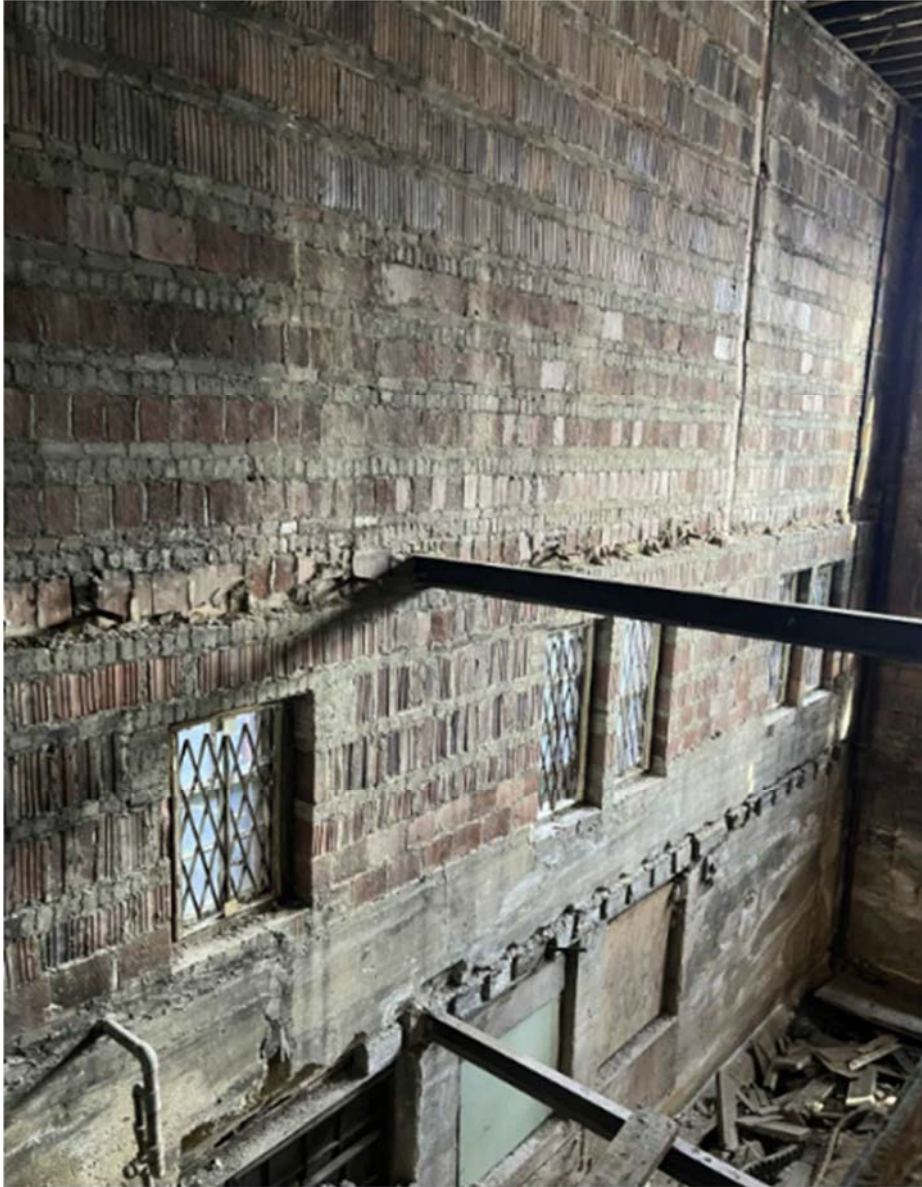
PHOTOGRAPH 14: View of Parish Perimeter Wall
