**Preservation Department – Item 1, LPC-26-03280**

**138-154 St. Felix Street, aka 11-21 Hanson Place –  
Brooklyn Academy of Music Historic District  
Borough of Brooklyn**

# **144 ST. FELIX STREET**

## **ADAPTIVE-REUSE & ENLARGEMENT**

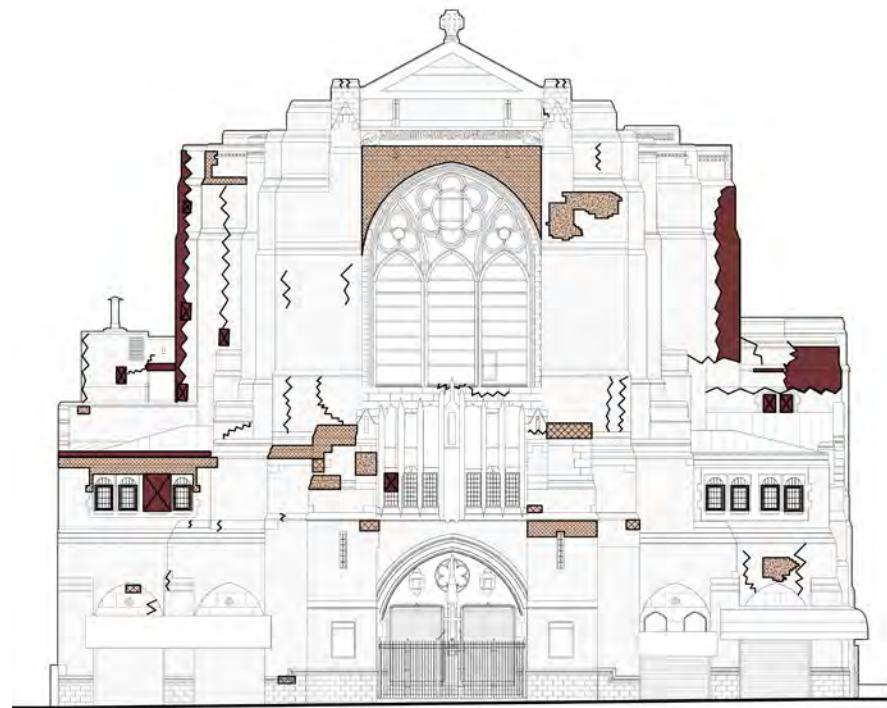
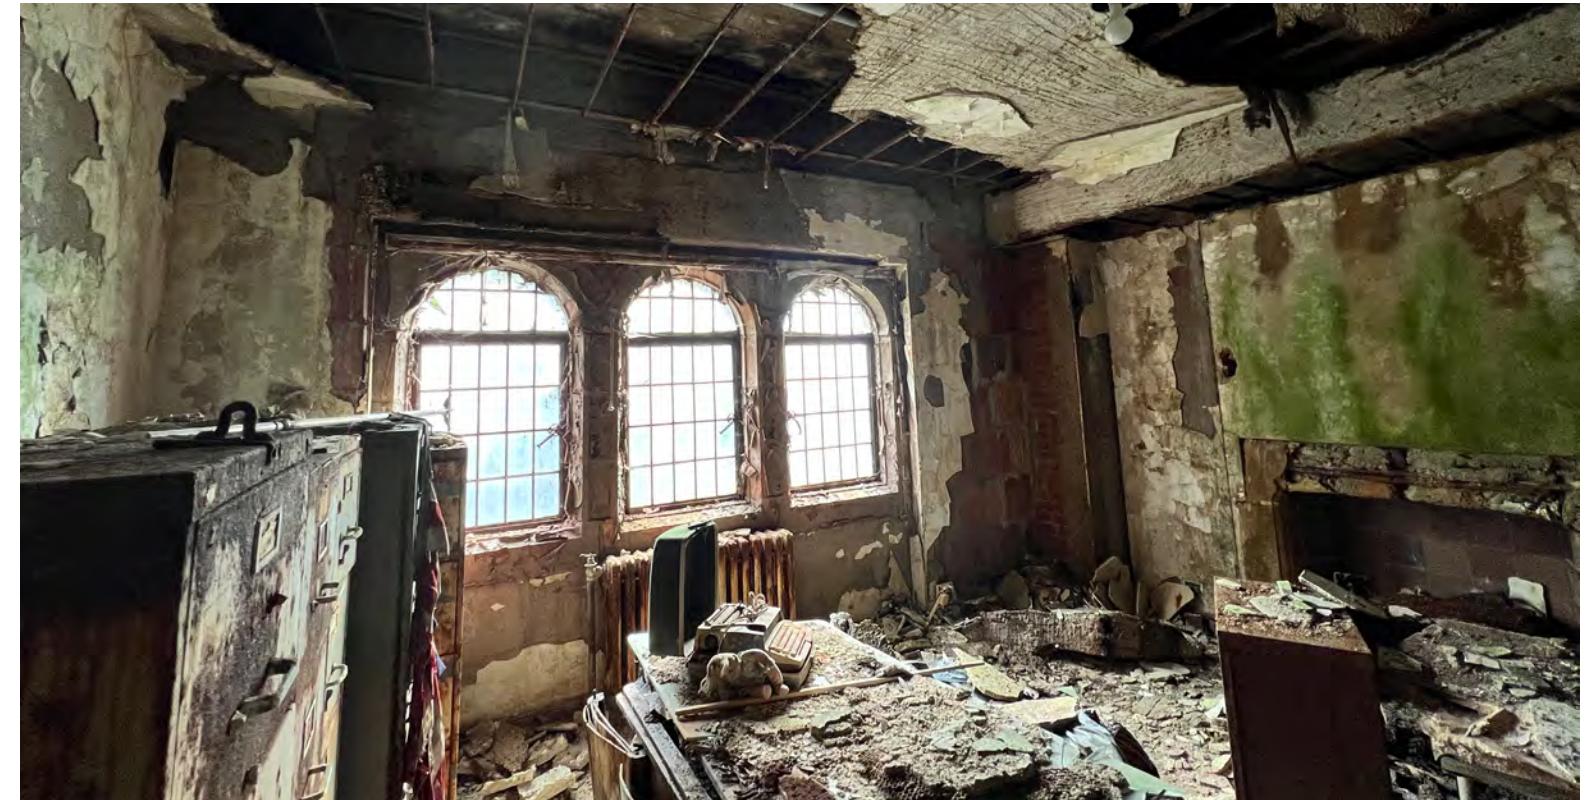
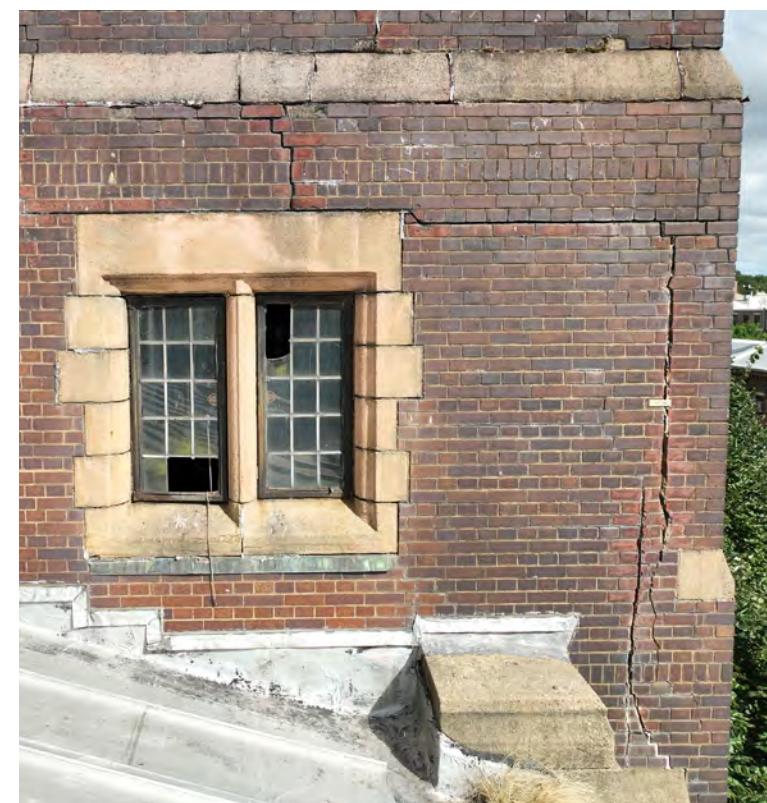
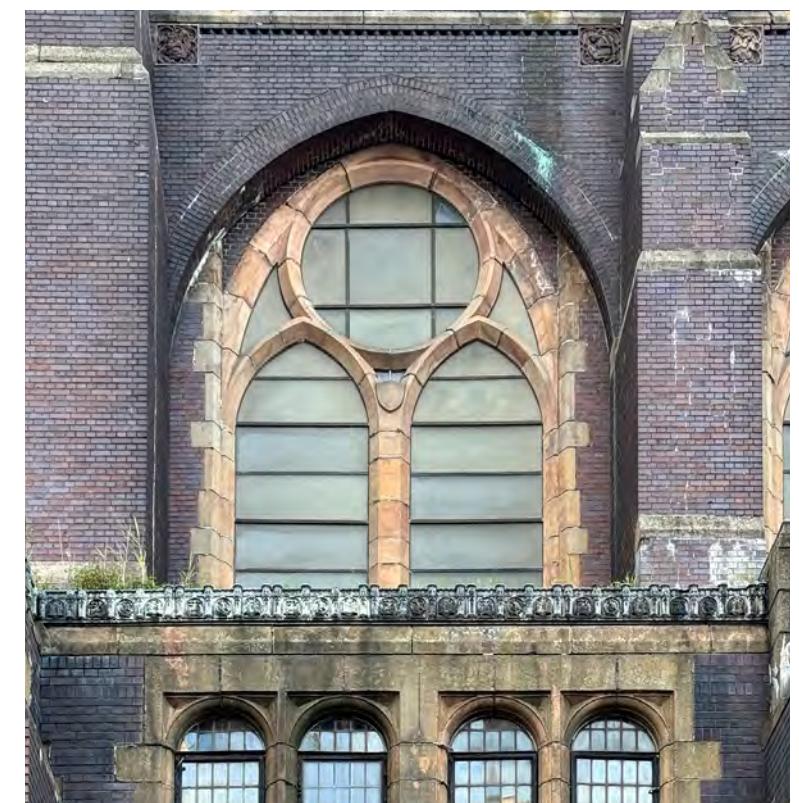
# Dire Condition of the Church Is Well-Documented

- Cherry-picked interior photographs cannot negate two decades of documented deterioration.
- Commissioners have personally toured the church building and observed its condition first-hand.
- Structural distress, water infiltration, and material failure are extensively recorded.

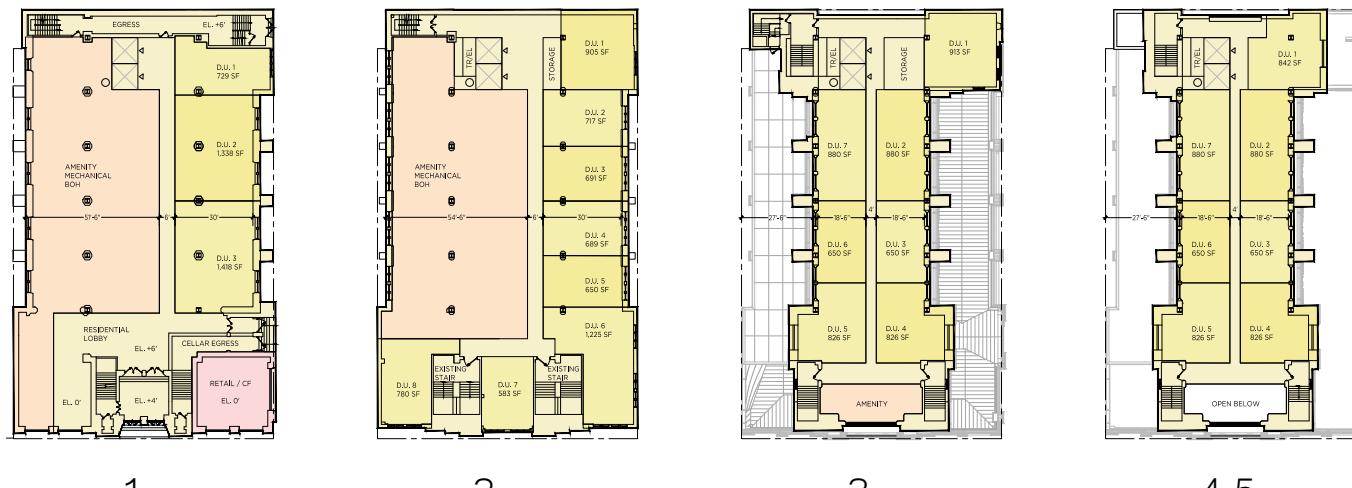
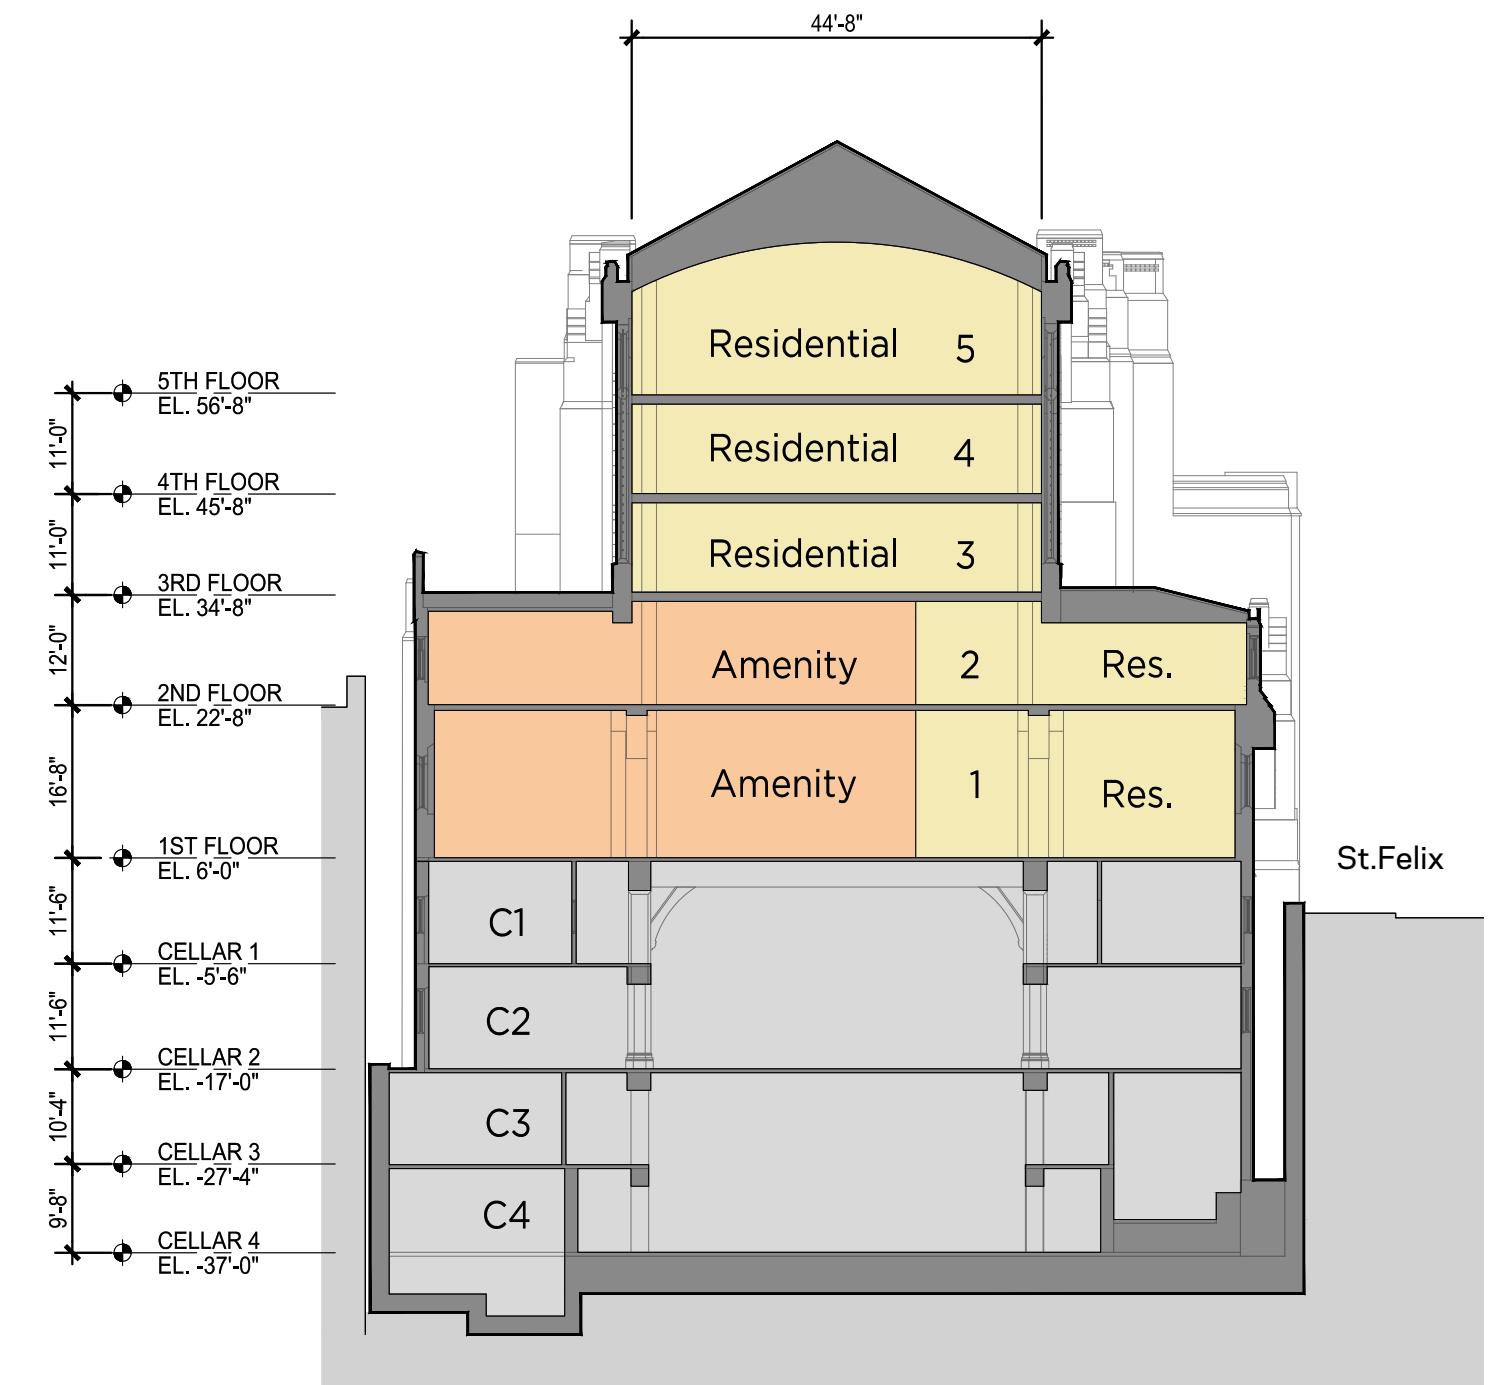
Adaptive Reuse Scheme

# Adaptive Reuse is not Feasible without an Enlargement

- Residential reuse solely yields minimal usable floor area and unit count: approximately **26,500 SF** for **32 units** and an efficiency of **26%** ( vs. 70-80% for new development).
- A decade of marketing did not attract a commercial or community facility user.
- Church footprint and configuration limits residential design and access to light and air.

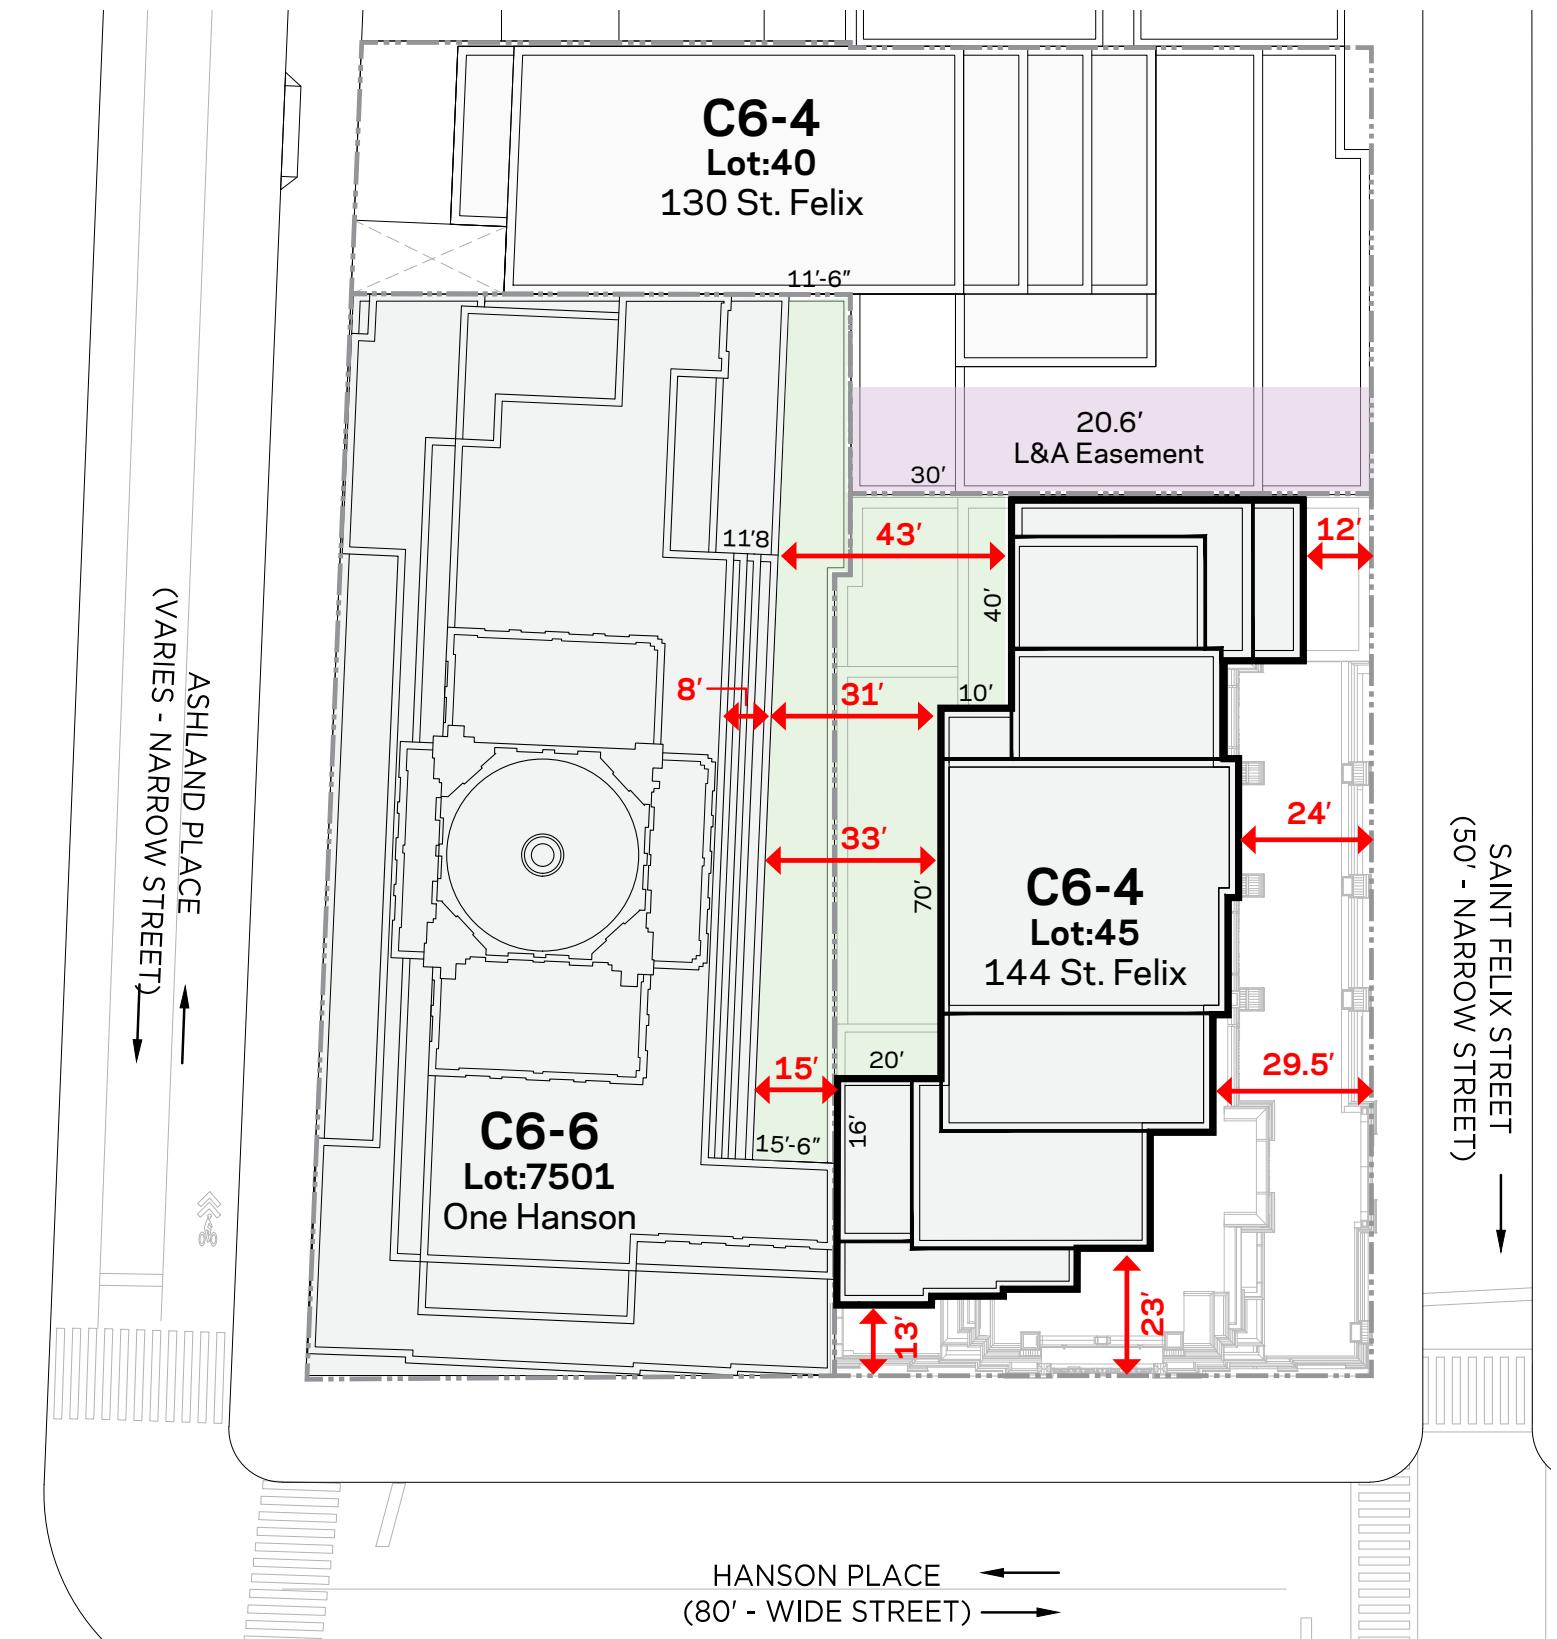
# Respectful Relationship to Williamsburg Savings Bank

- At approximately 300 feet, the proposed building is more than 200 feet shorter than the 512-foot WSB.
- The WSB clock tower remains visible and continues to define the skyline and neighborhood identity.
- The proposed building sets back at Hanson Place and Rear Lot Line.

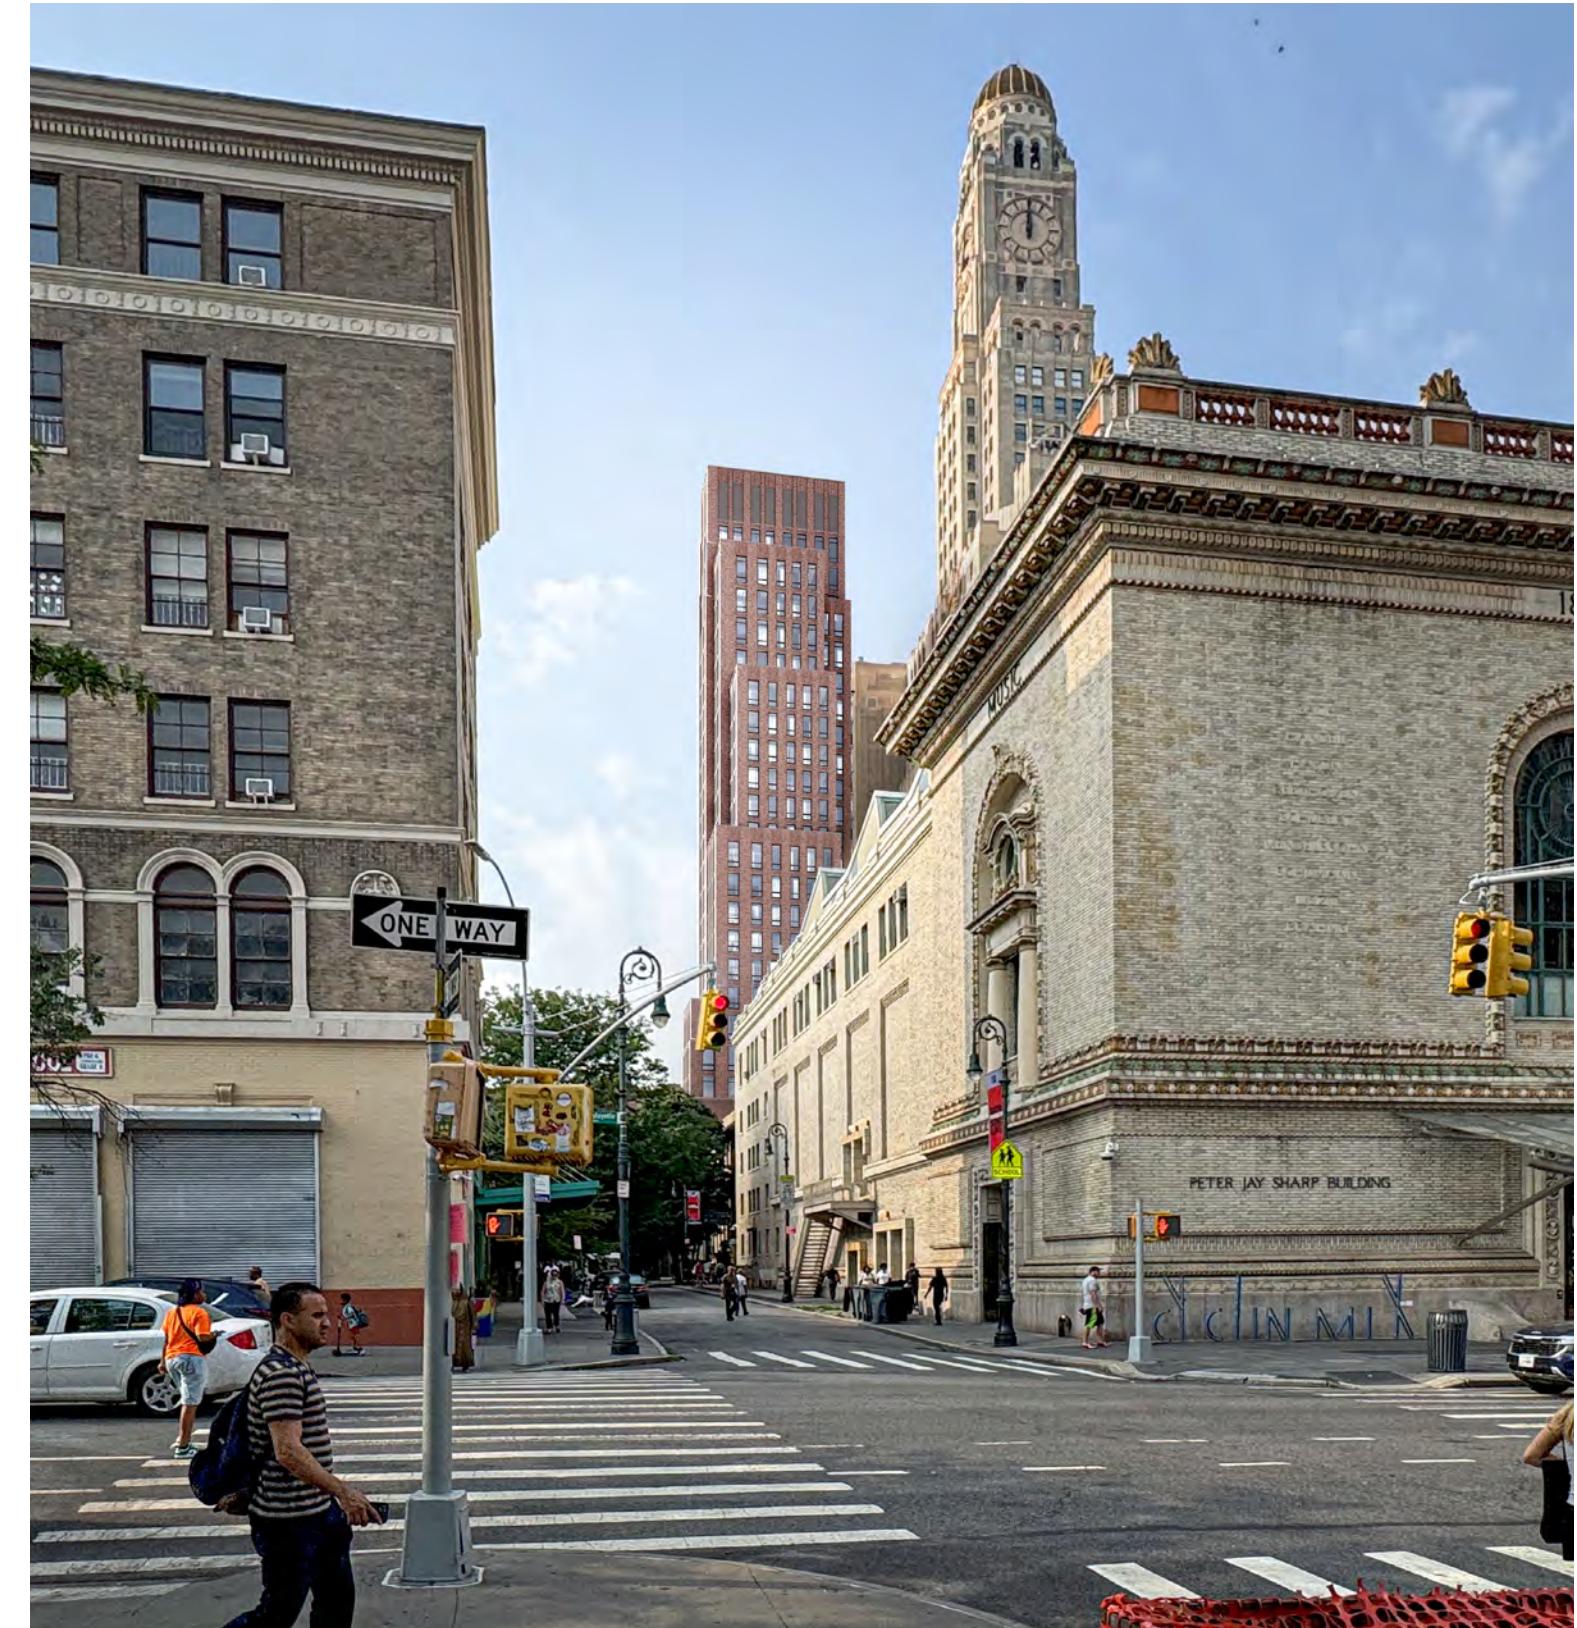
# Respectful Relationship to Williamsburg Savings Bank

- The proposed design avoids competition through careful proportioned setbacks and differentiated materiality.
- A sculpted and articulated top provides a dignified termination and an independent identity, reinforcing WSB's unique profile without imitation or rivalry.
- A flat-roofed alternative would diminish the landmark's presence by creating an abrupt and visually unresolved silhouette.

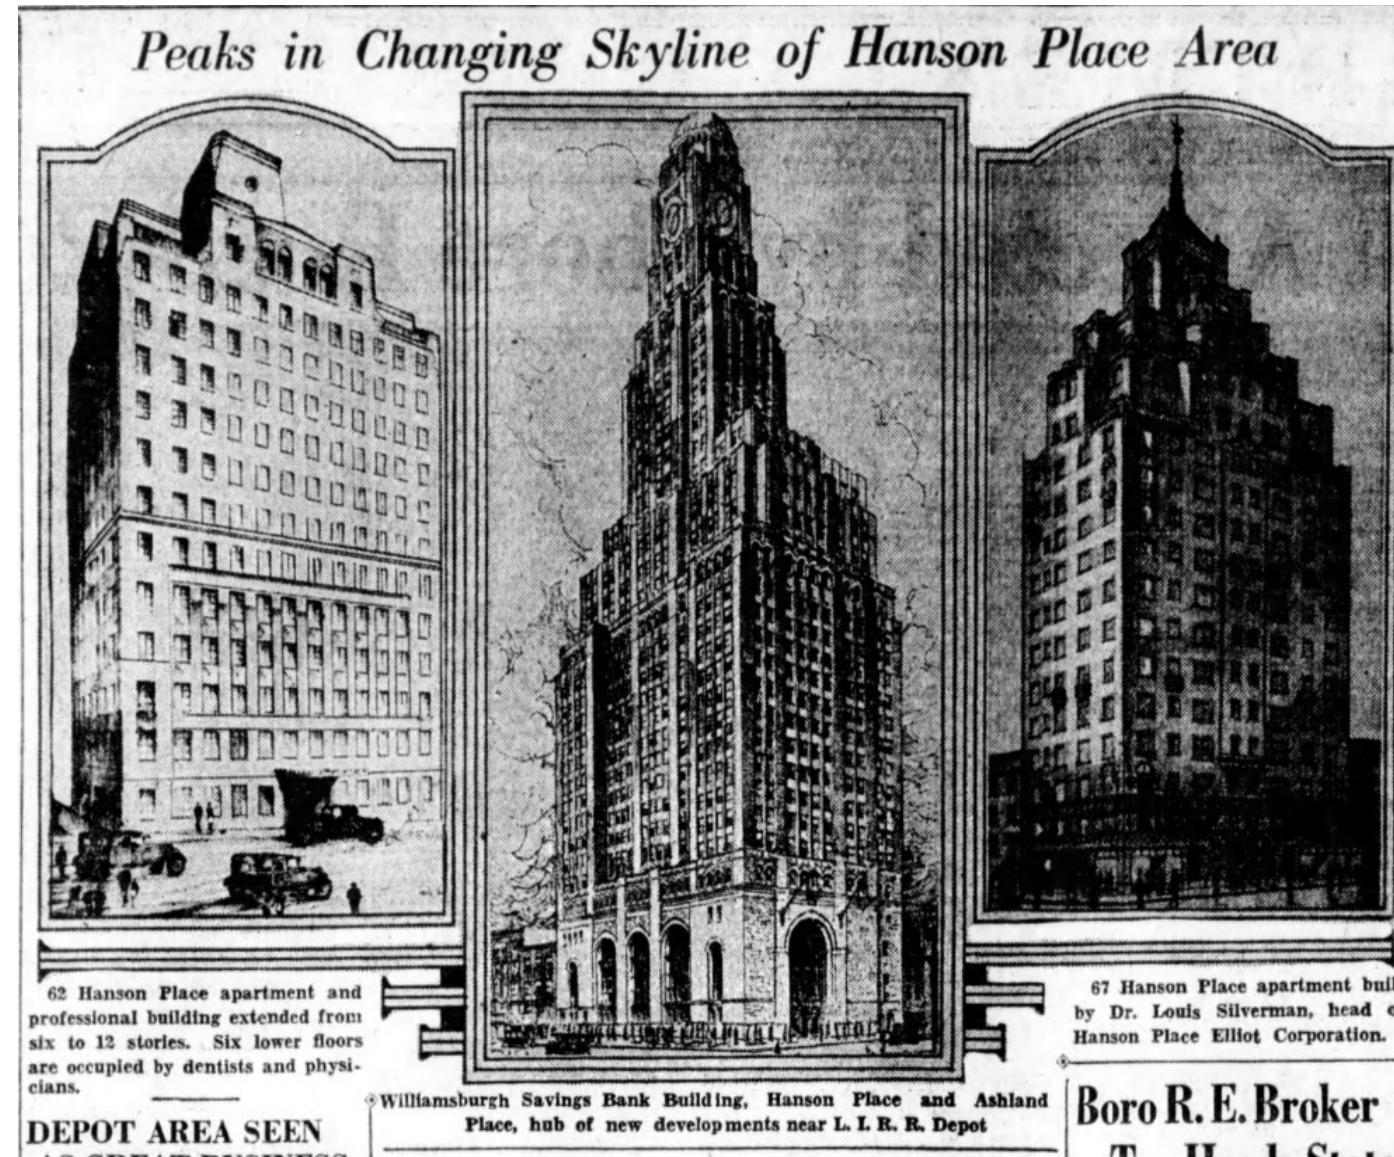
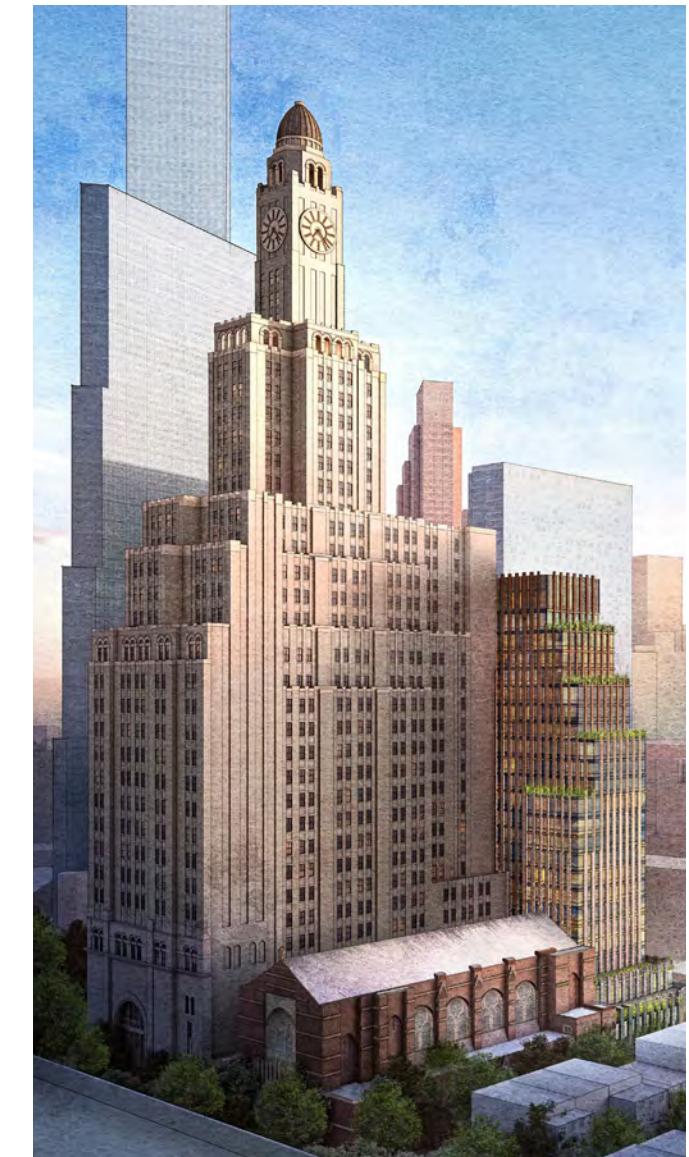
# The Scale and Height are Appropriate to this Historic District

- Height and Density is intrinsic to this prominent and unique block within the historic district.
- Block 2111 is characterized by mix of medium- and large-scale institutional, commercial buildings and future residential at 130 St. Felix.
- Hanson Place has a concentration of taller buildings.

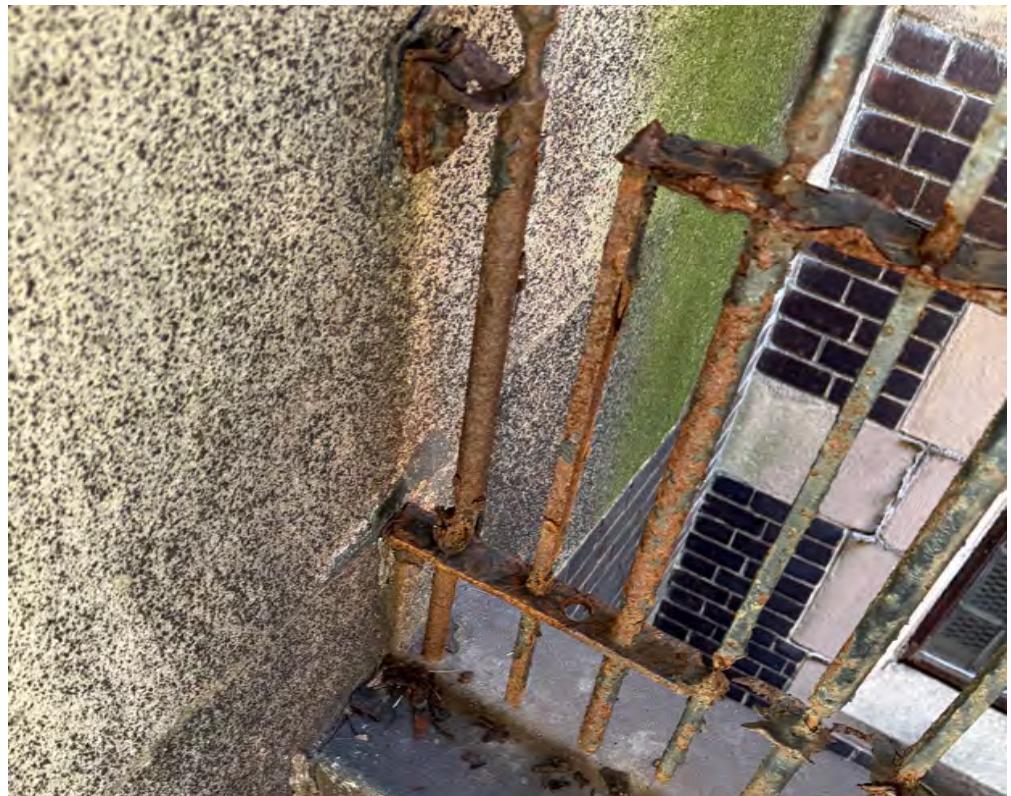
Corroded metal railing

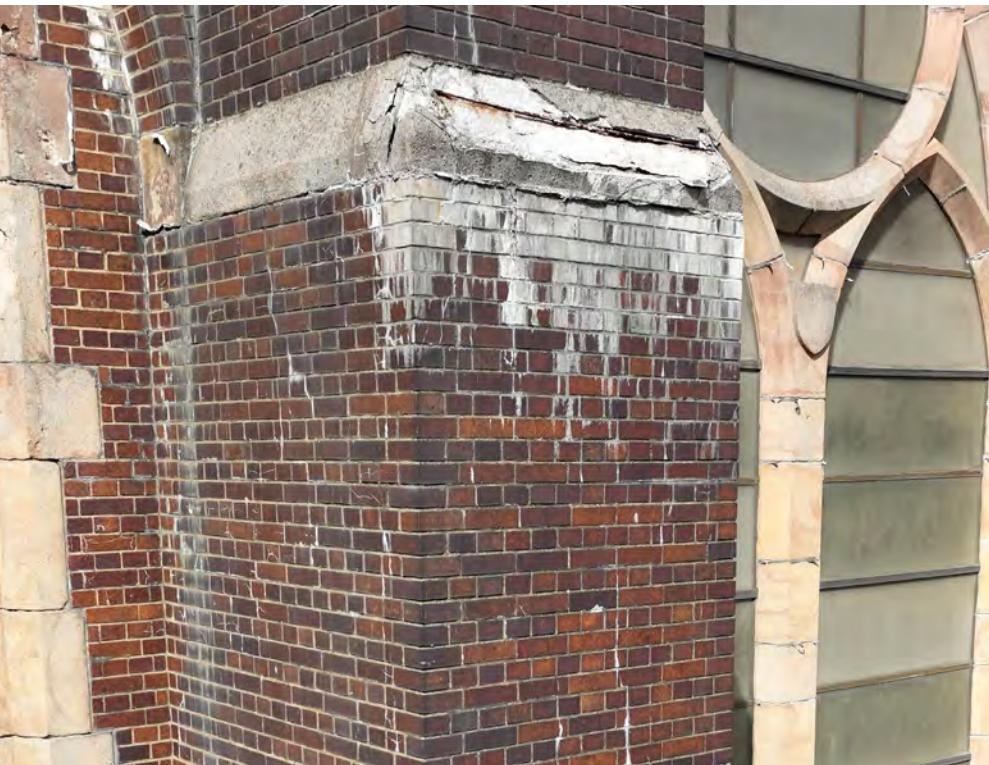
Spalling cast stone

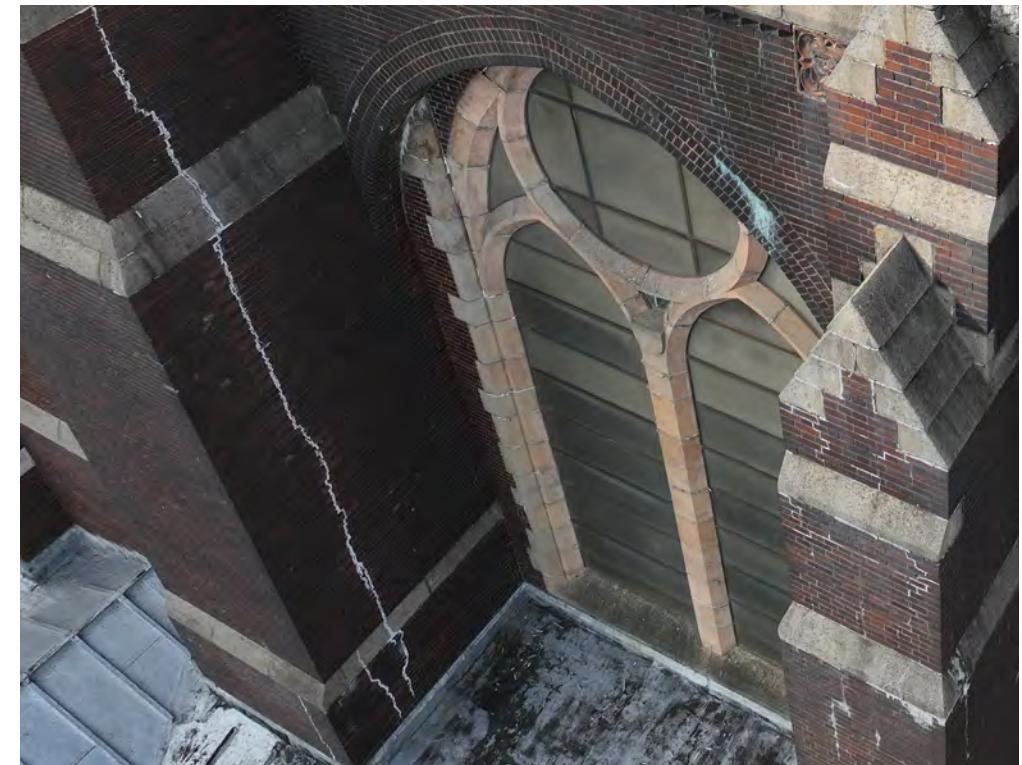
Major brick cracking

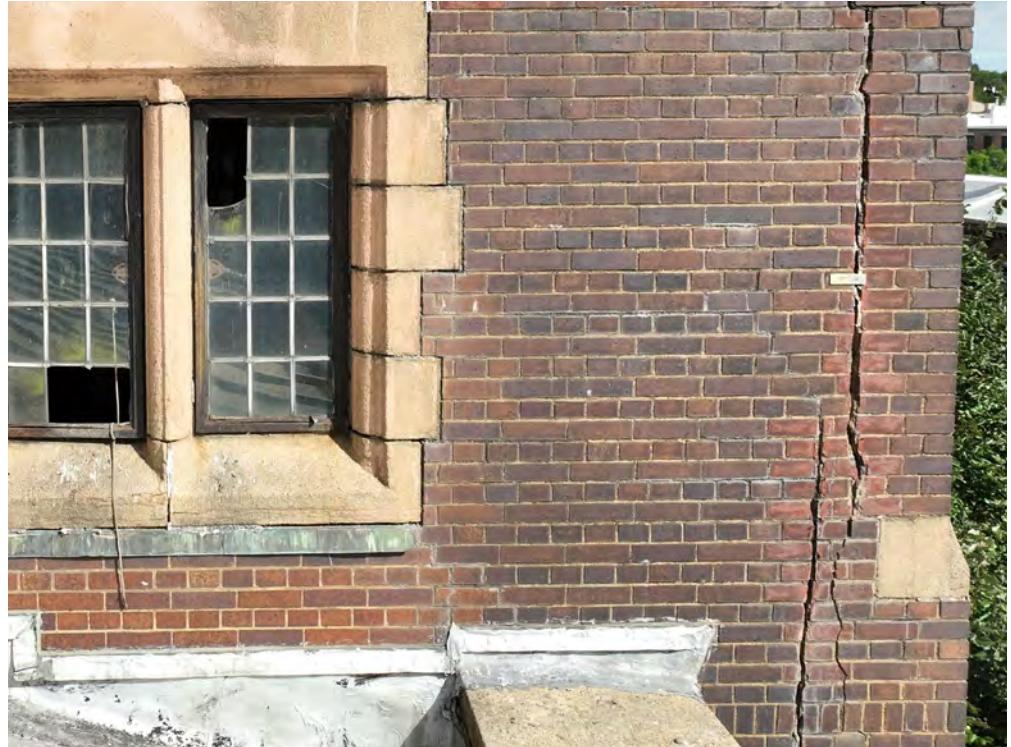
Brick cracking & leaking at underlying steel structure

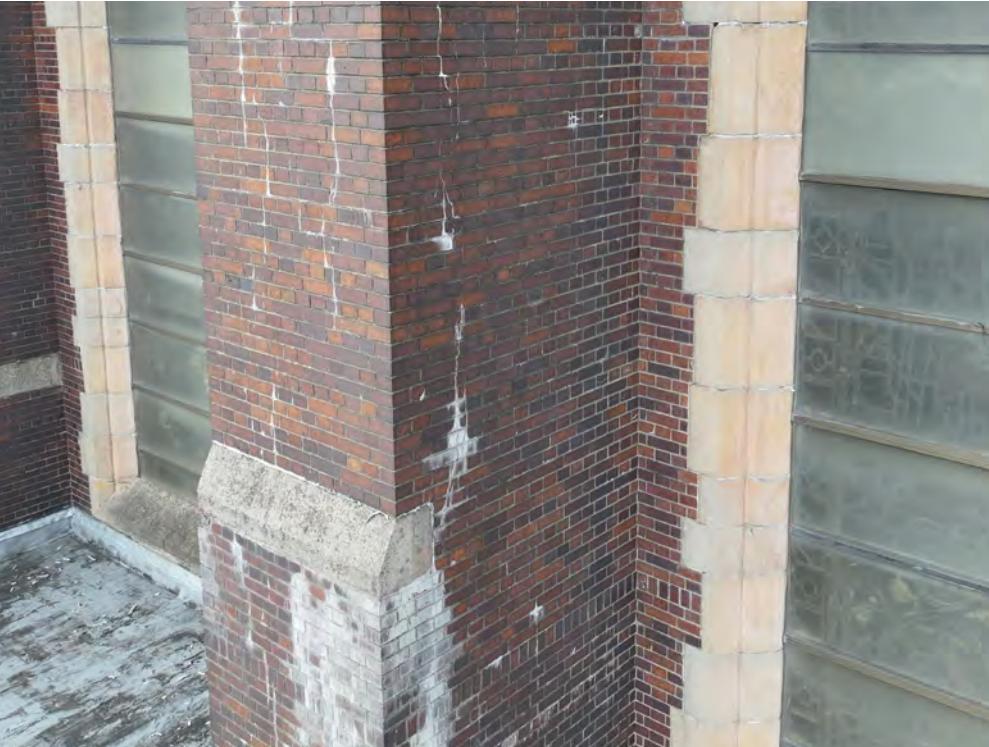
Brick cracking and major efflorescence

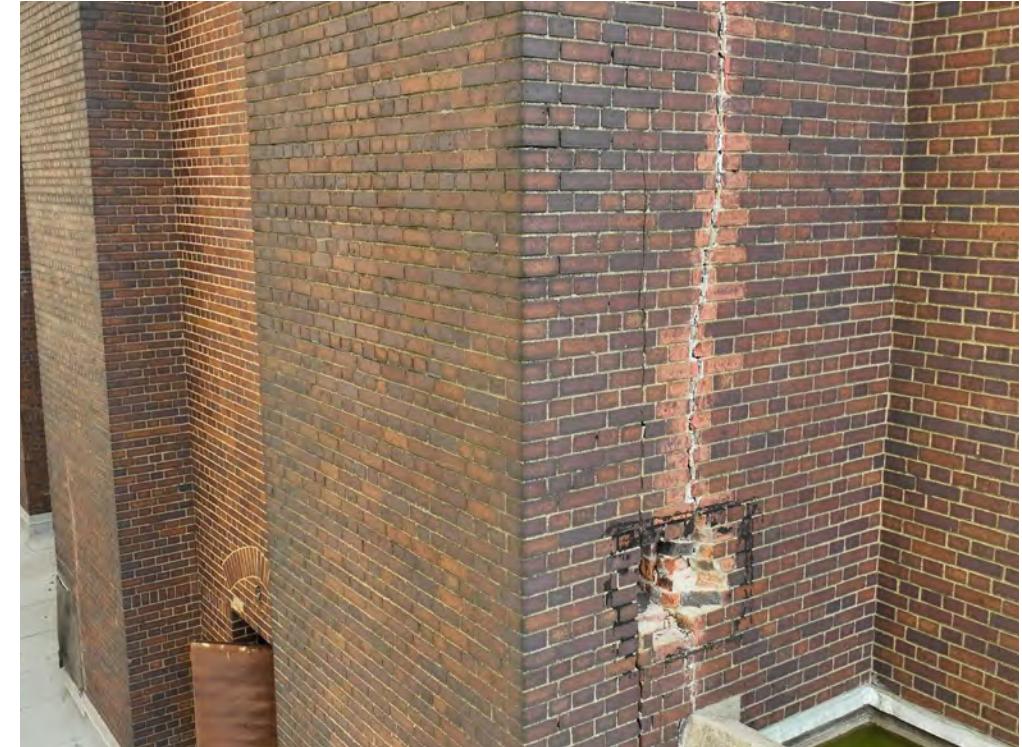
Missing brick and exposed steel structure

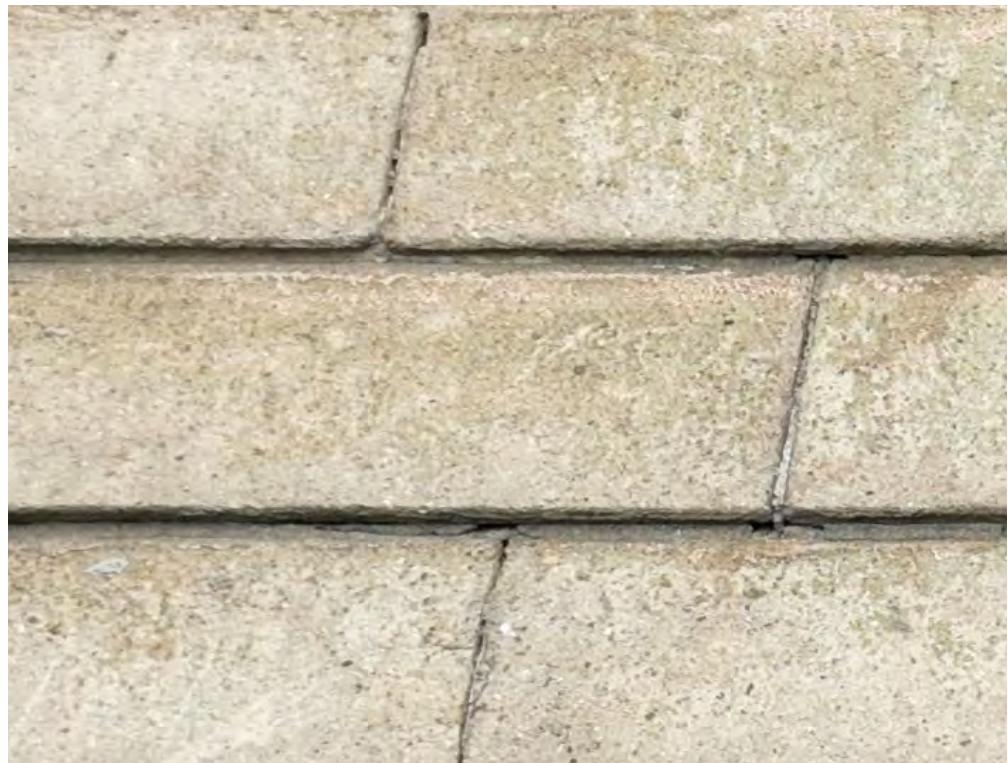
Limestone type cast stone bands

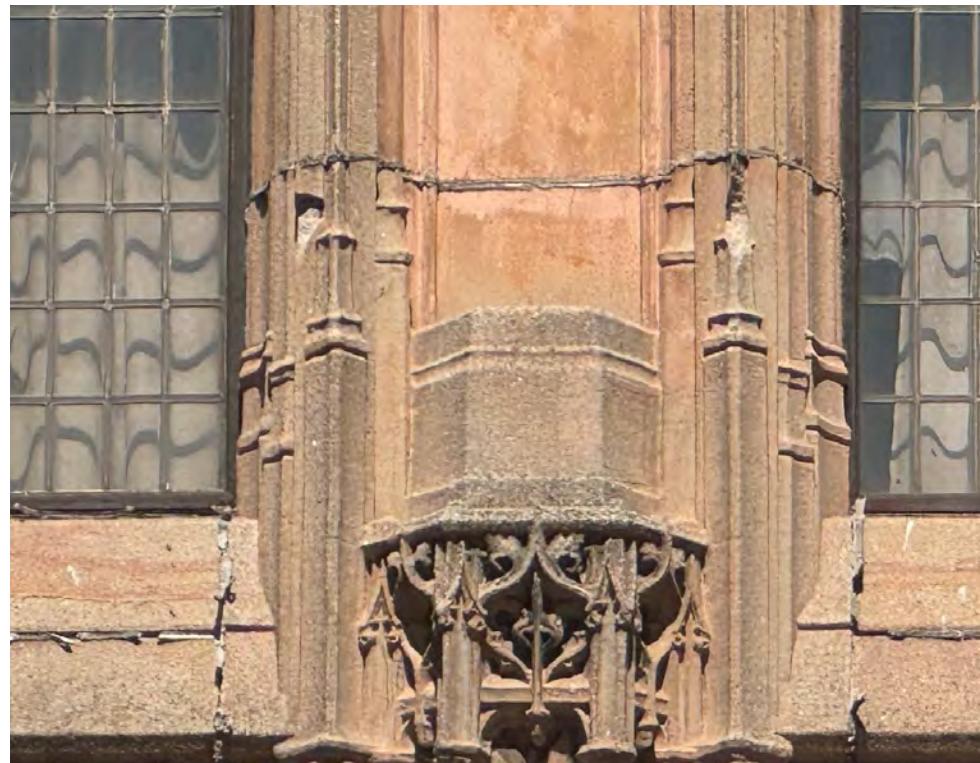
Terracotta type cast stone

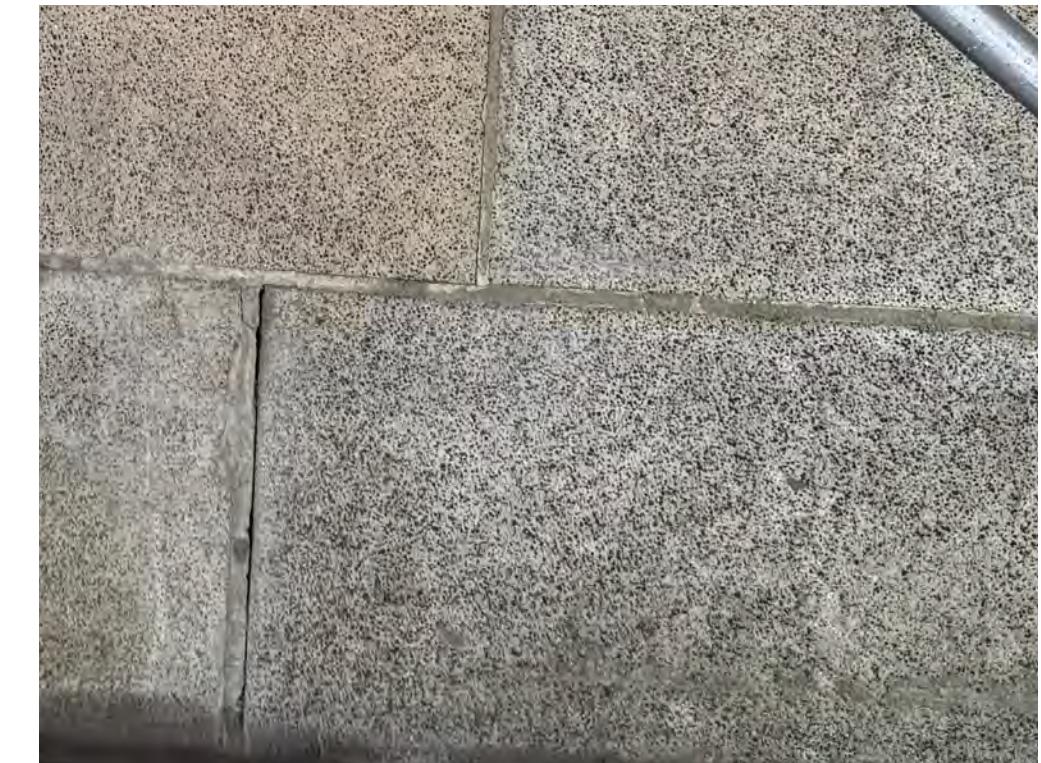
Granite type cast stone base

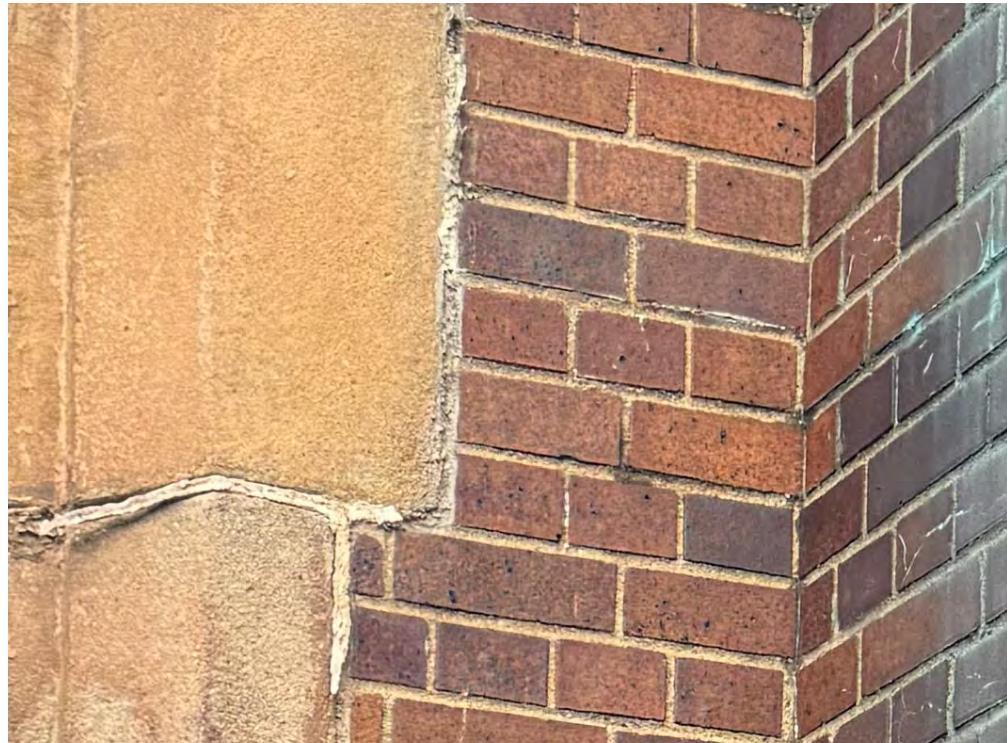
Protected brick

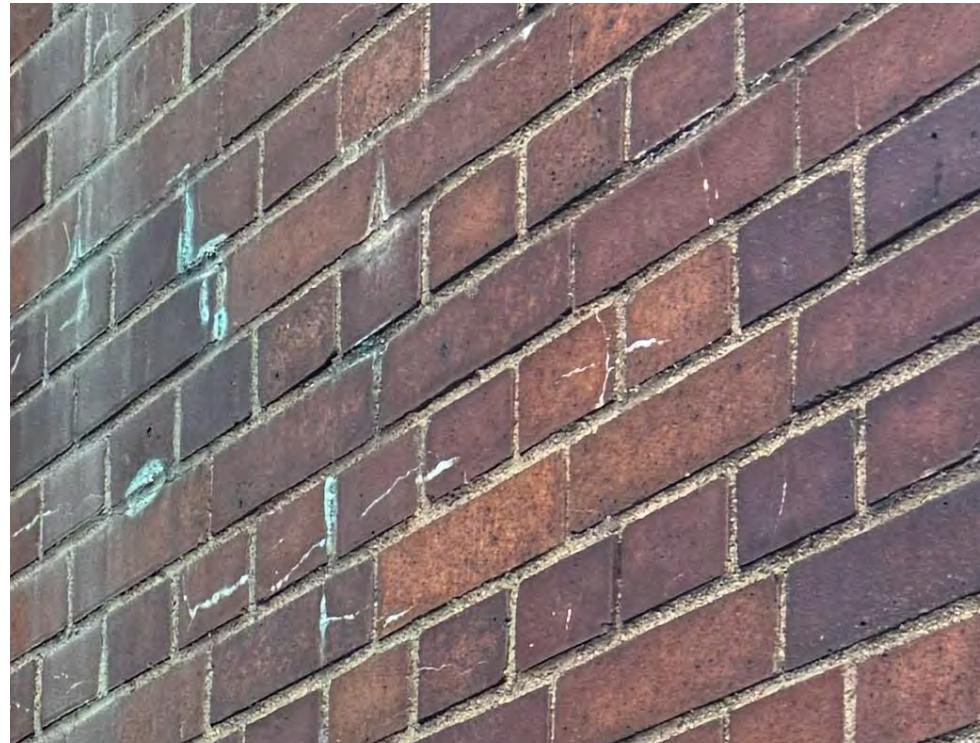
Weathered brick

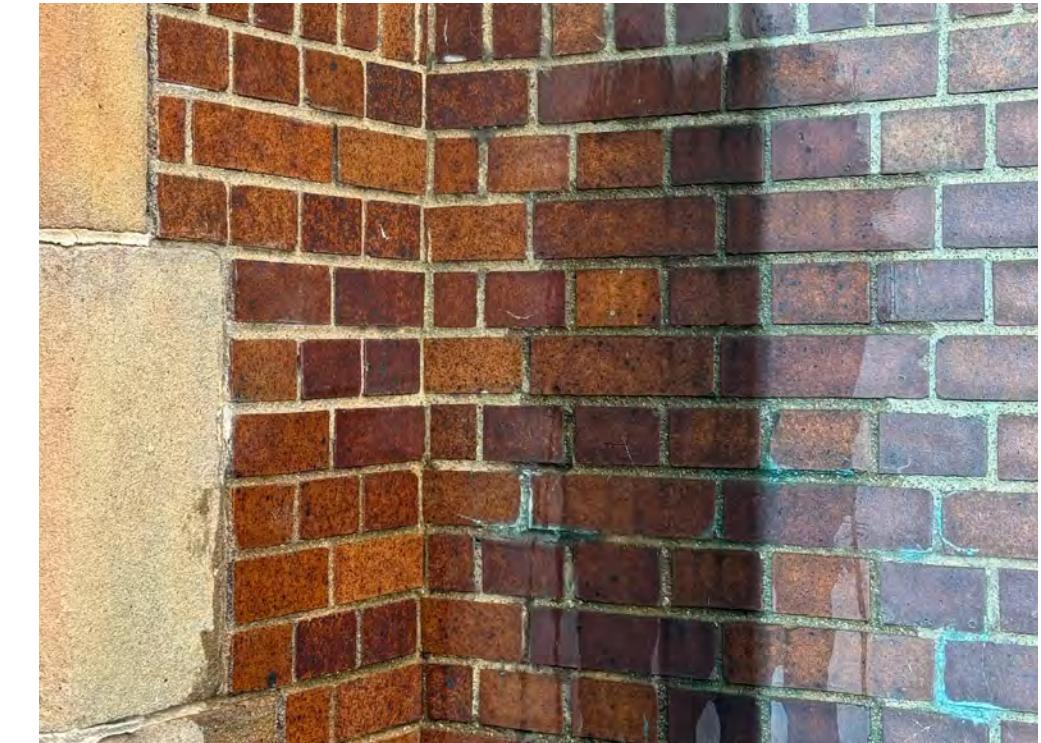
Brick color comparison
