**Preservation Department – Item 1, LPC-26-03280**

**138-154 St. Felix Street, aka 11-21 Hanson Place –  
Brooklyn Academy of Music Historic District  
Borough of Brooklyn**

# **144 ST. FELIX STREET**

## **ADAPTIVE-REUSE & ENLARGEMENT**

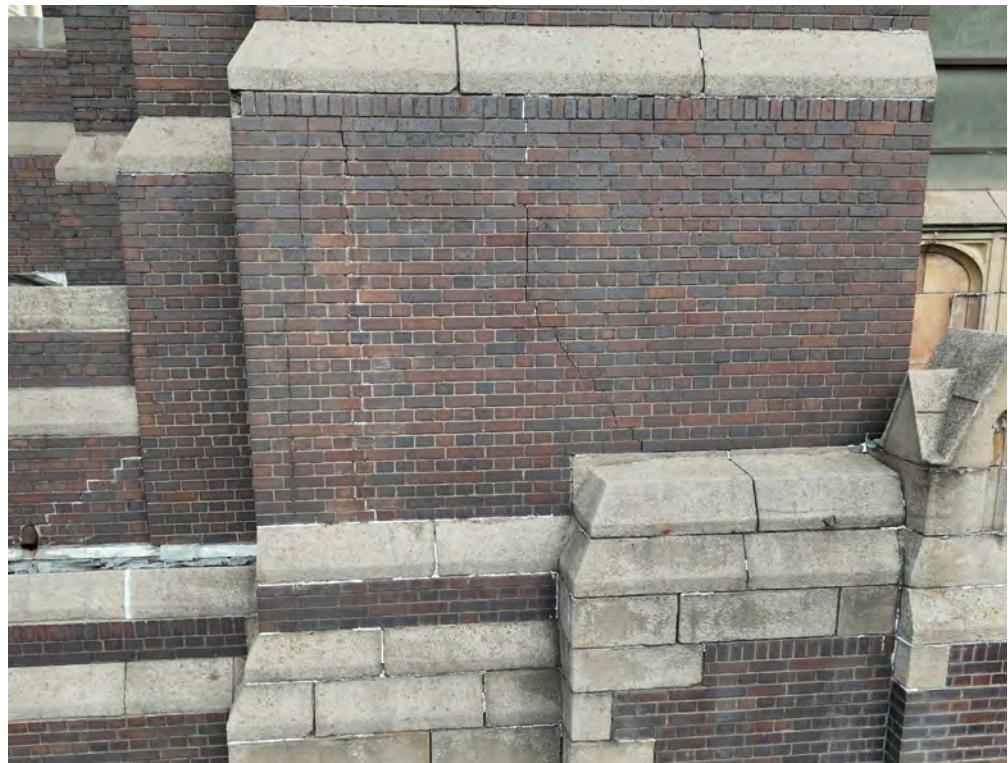
Limestone type cast stone bands

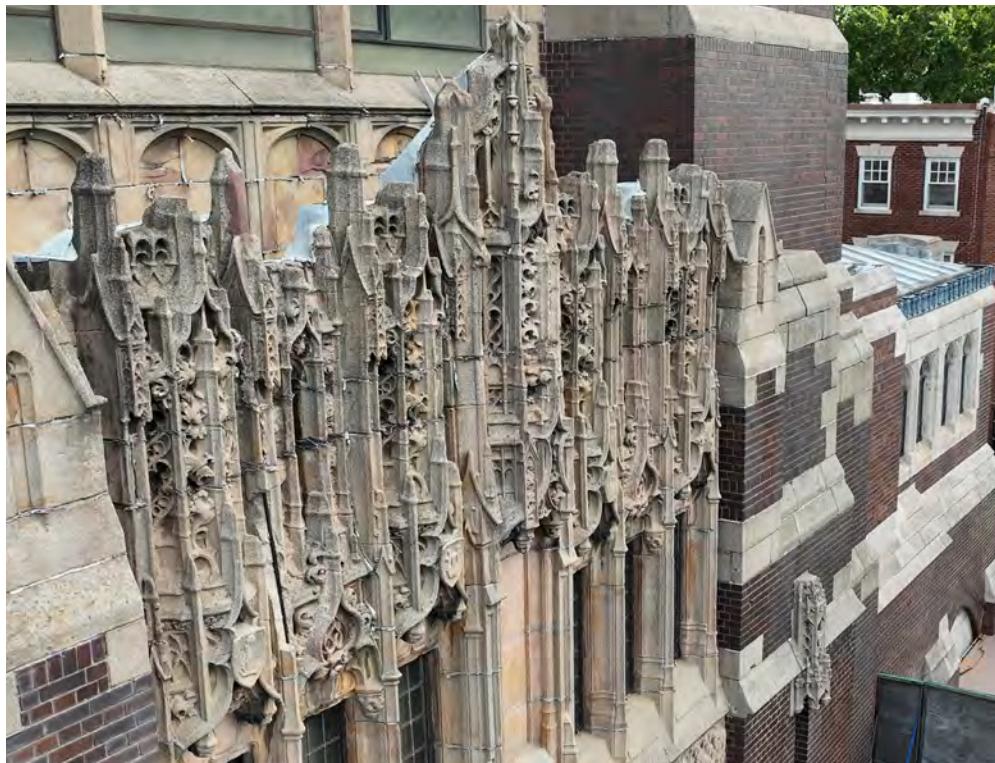
Terra cotta type cast stone tracery

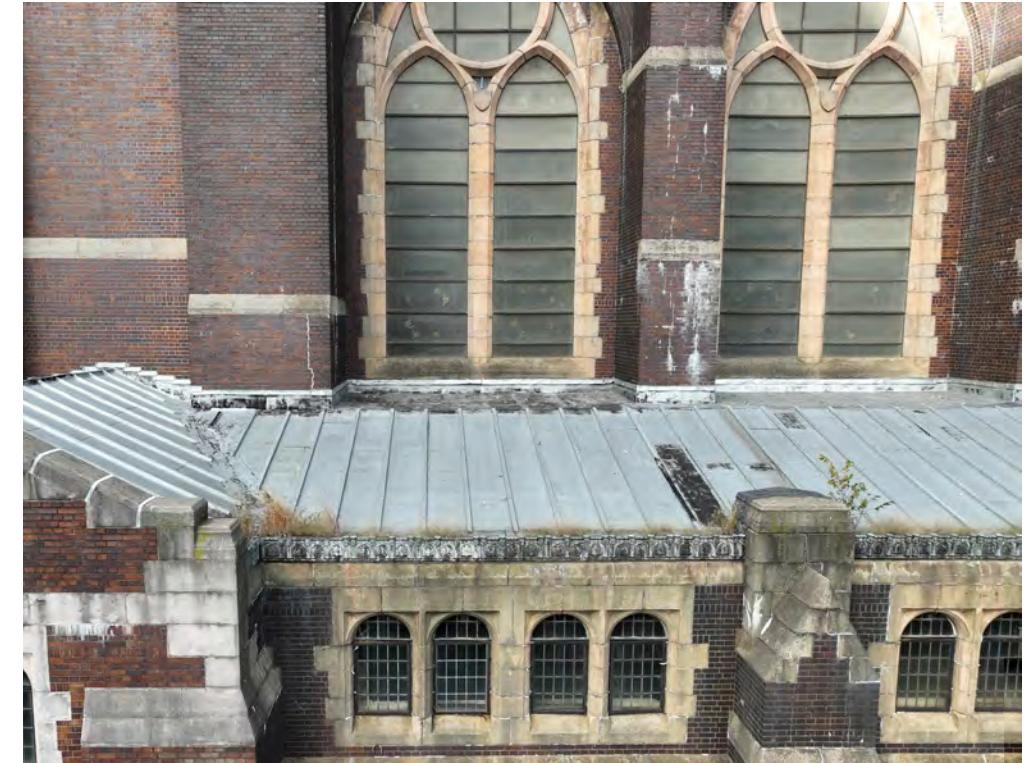
Terra cotta type cast stone tracery

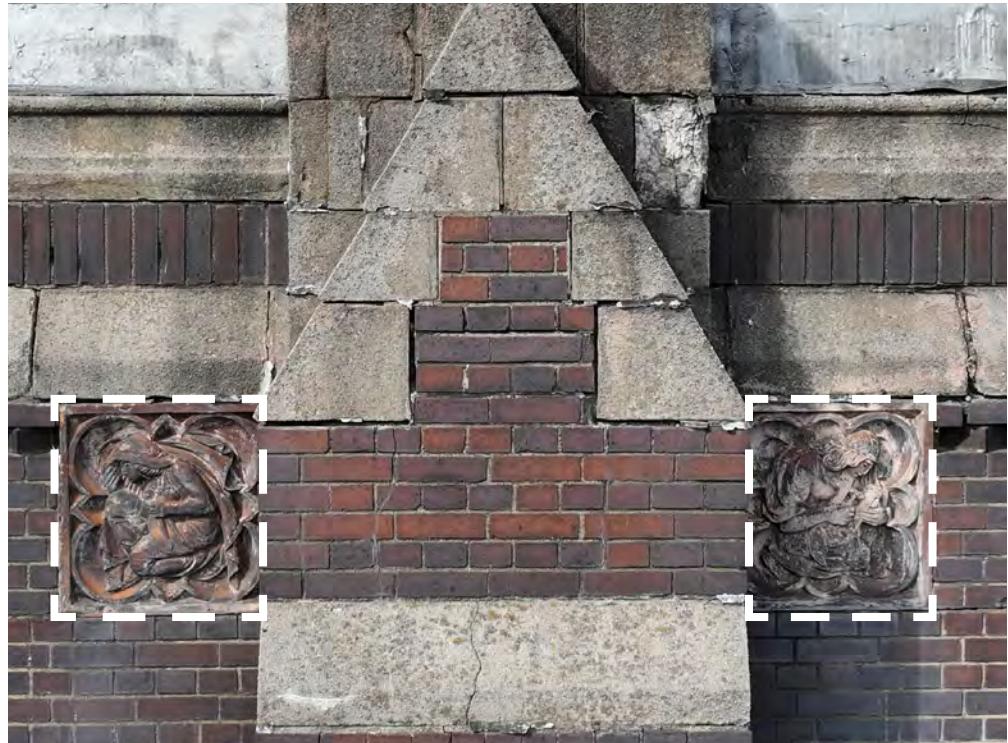
Terra cotta type cast stone plaques

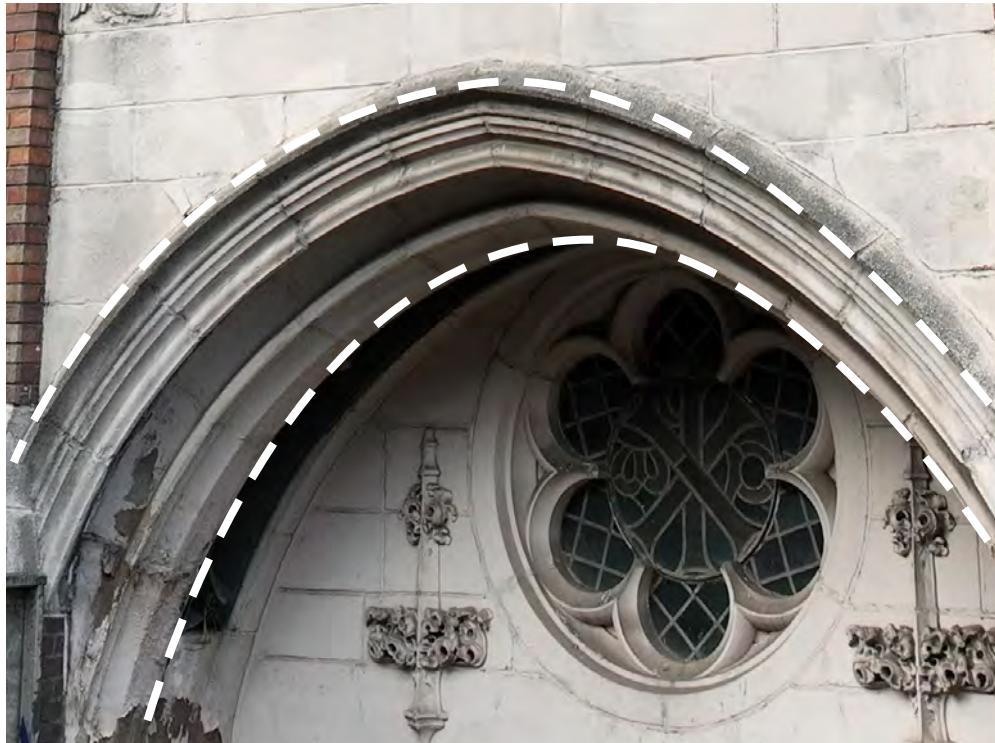
Intricate carved canopies

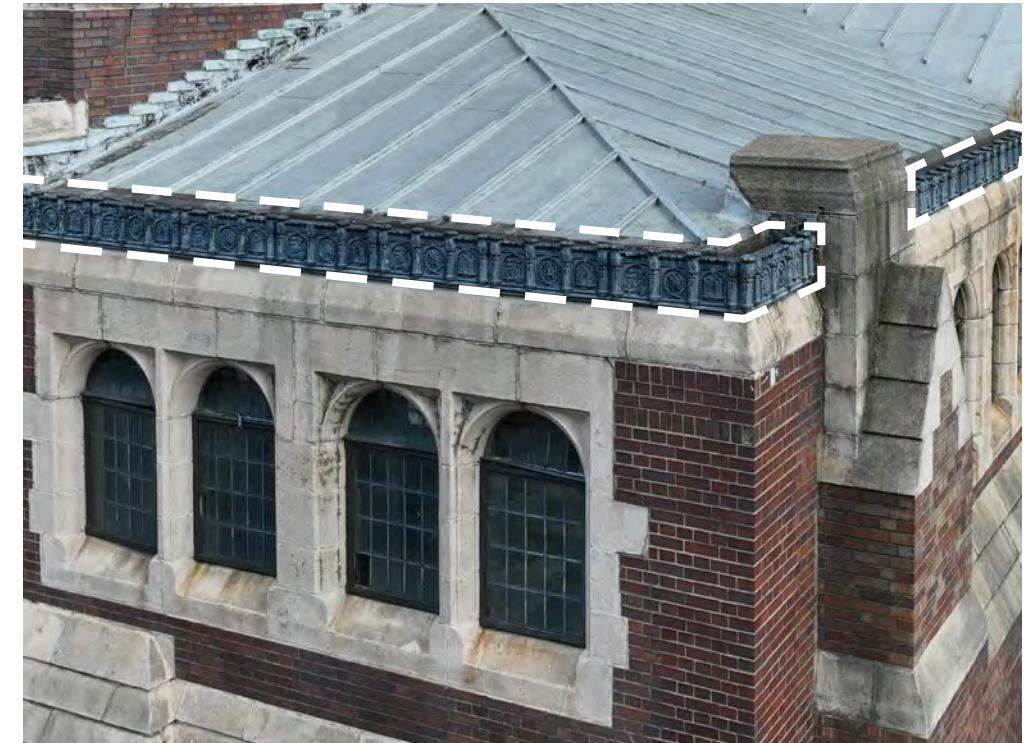
Lead gutter with emblems

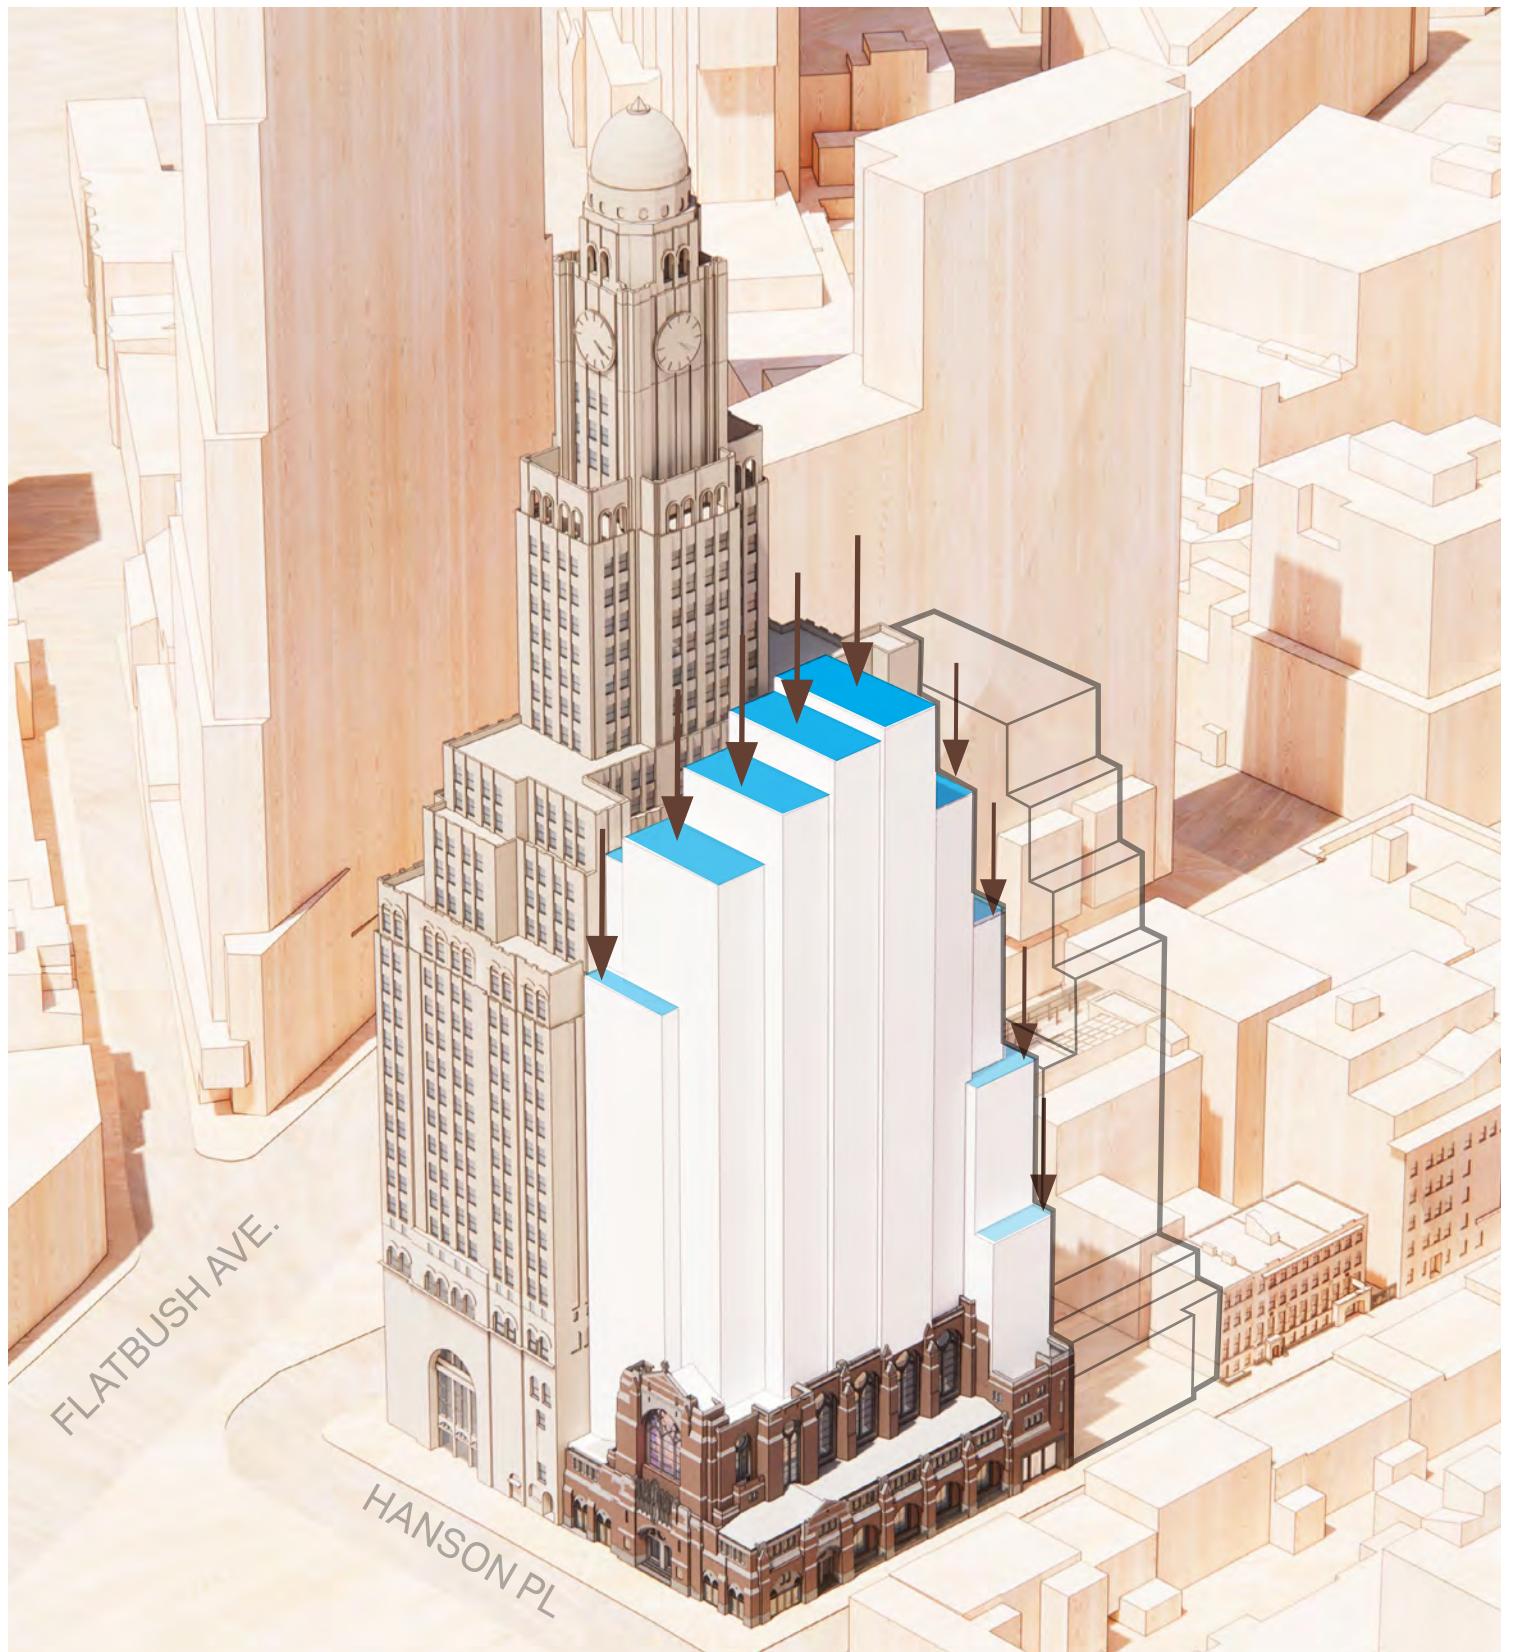
AXON LOOKING NORTHWEST

## Tower Massing Sets Back

to respond to adjacent neighbors

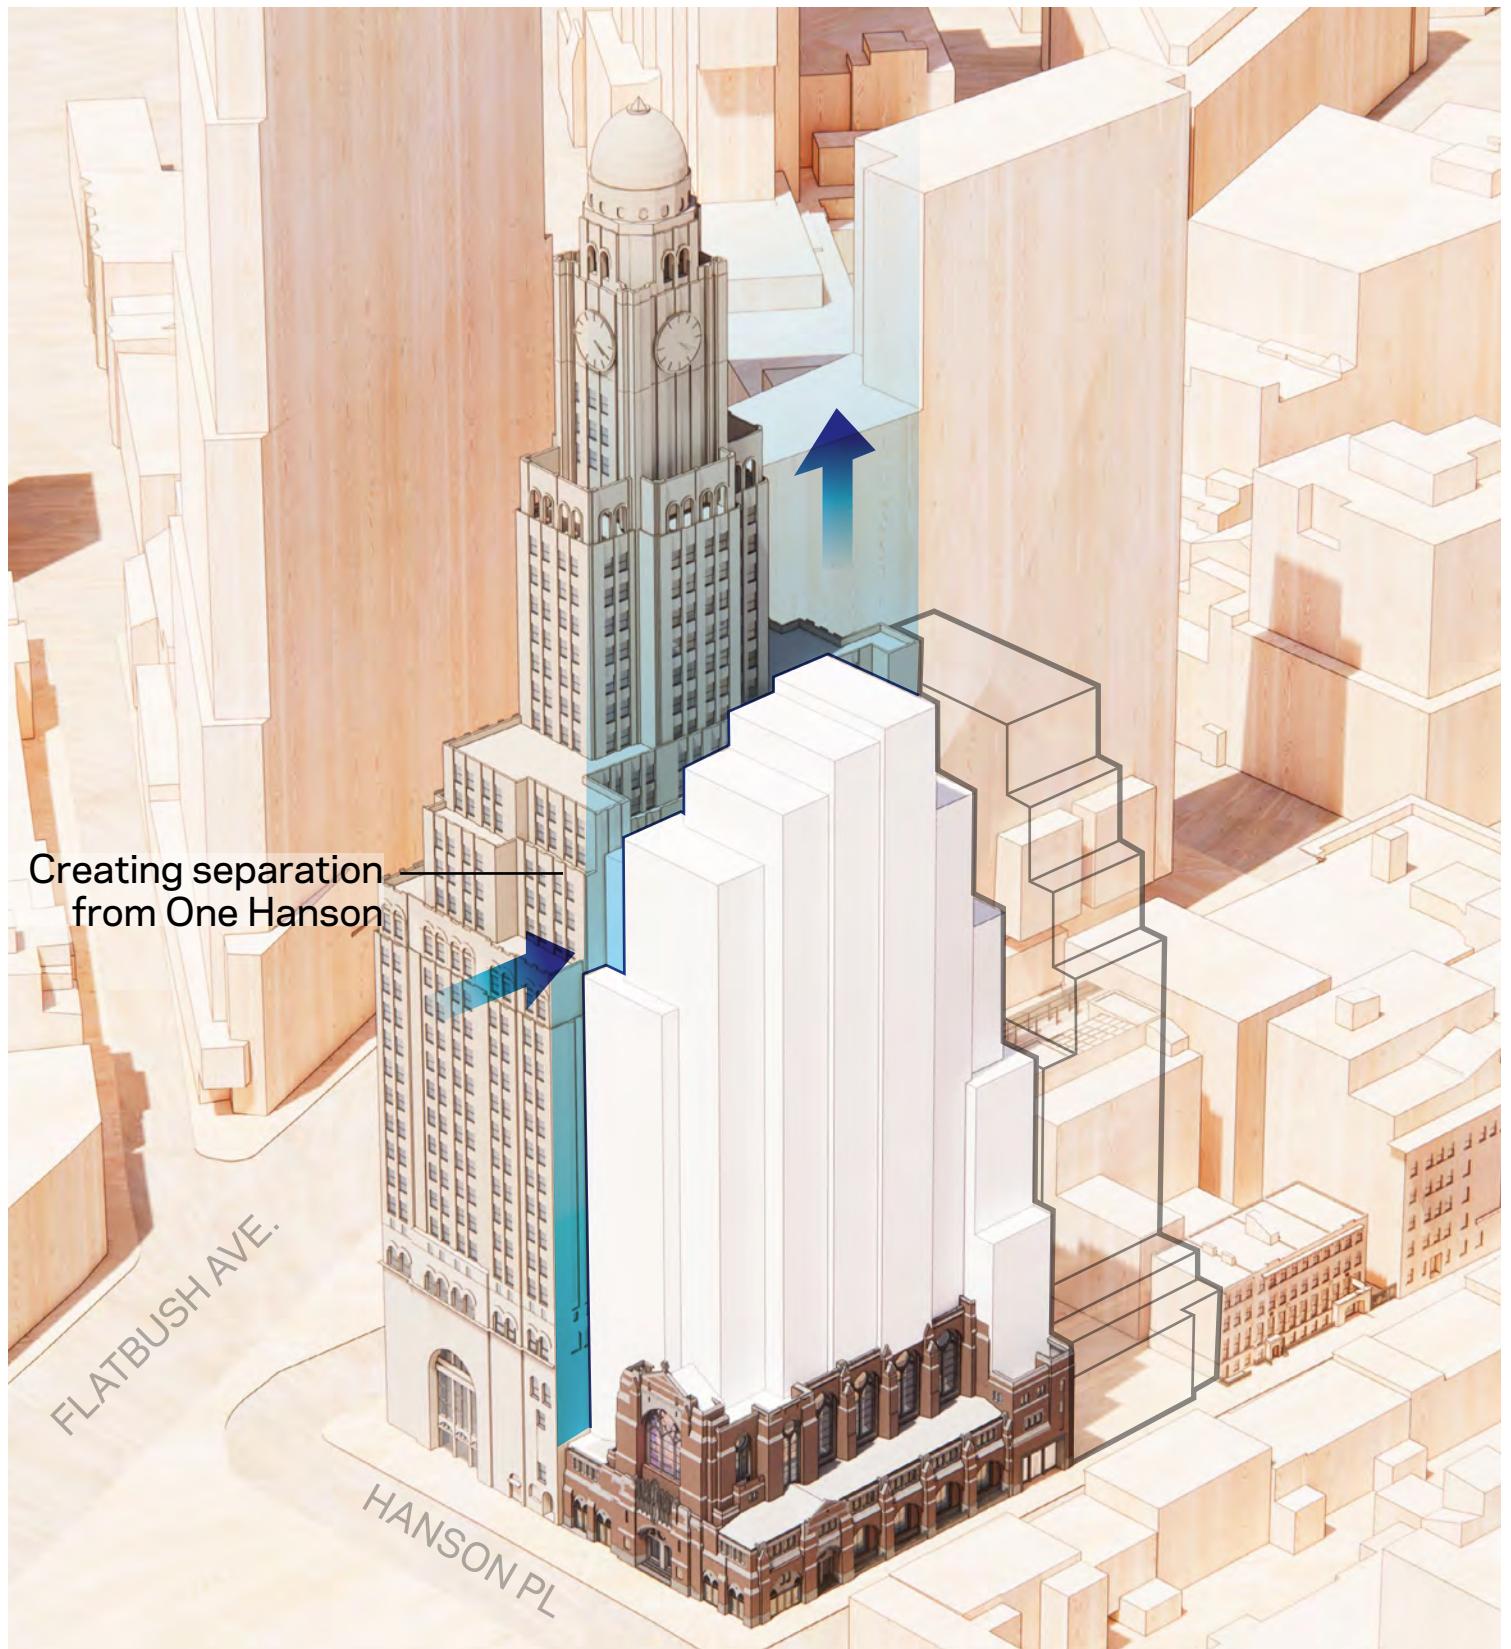
AXON LOOKING NORTHWEST

**Terracing Creates a Sculpted Expression**  
to provide identity and top culmination

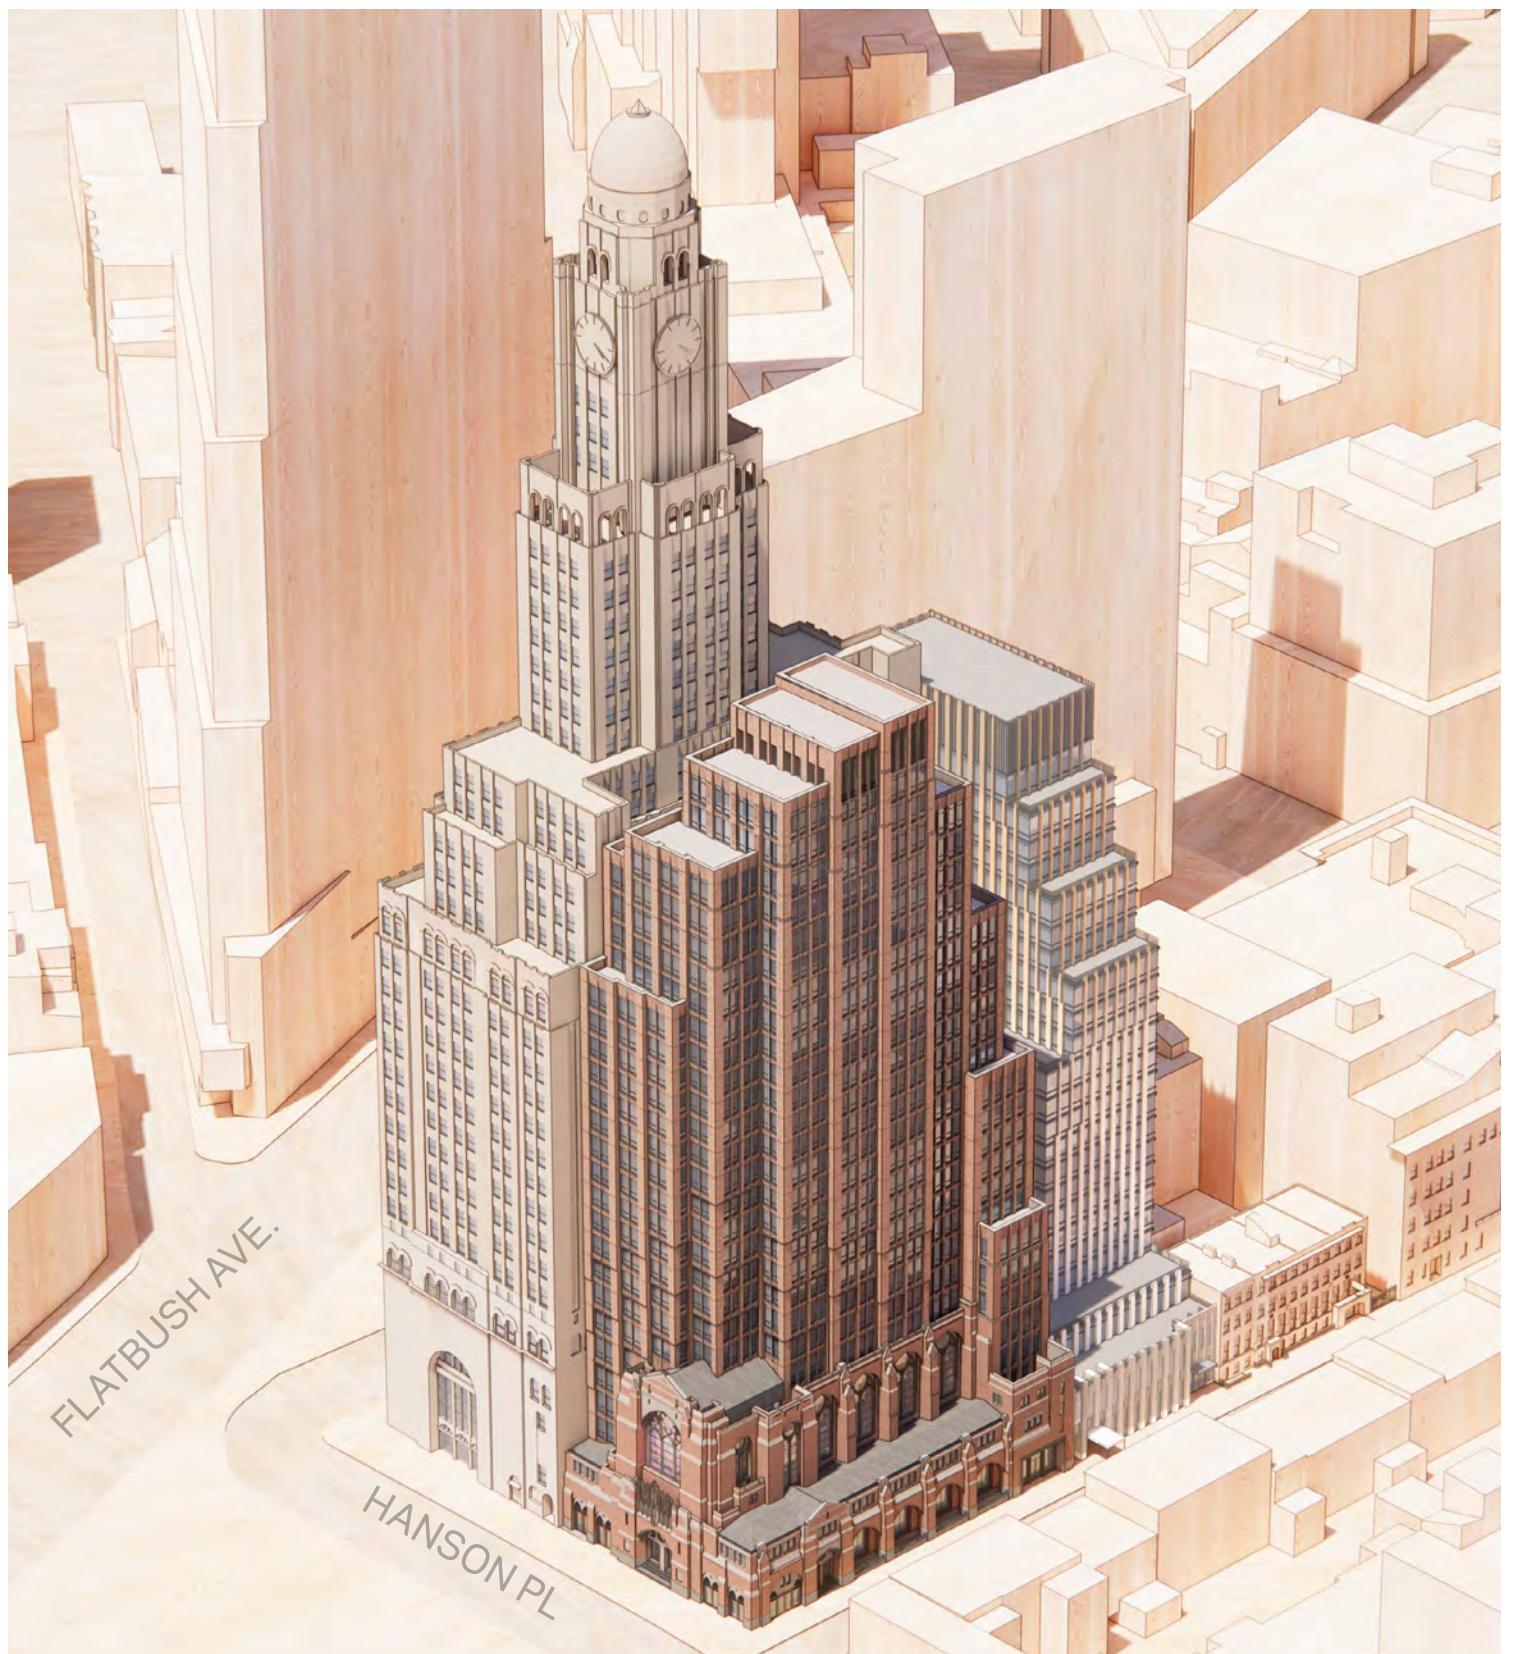
AXON LOOKING NORTHWEST

**Base of Tower Corbels Inward**  
to soften transition into Church Building

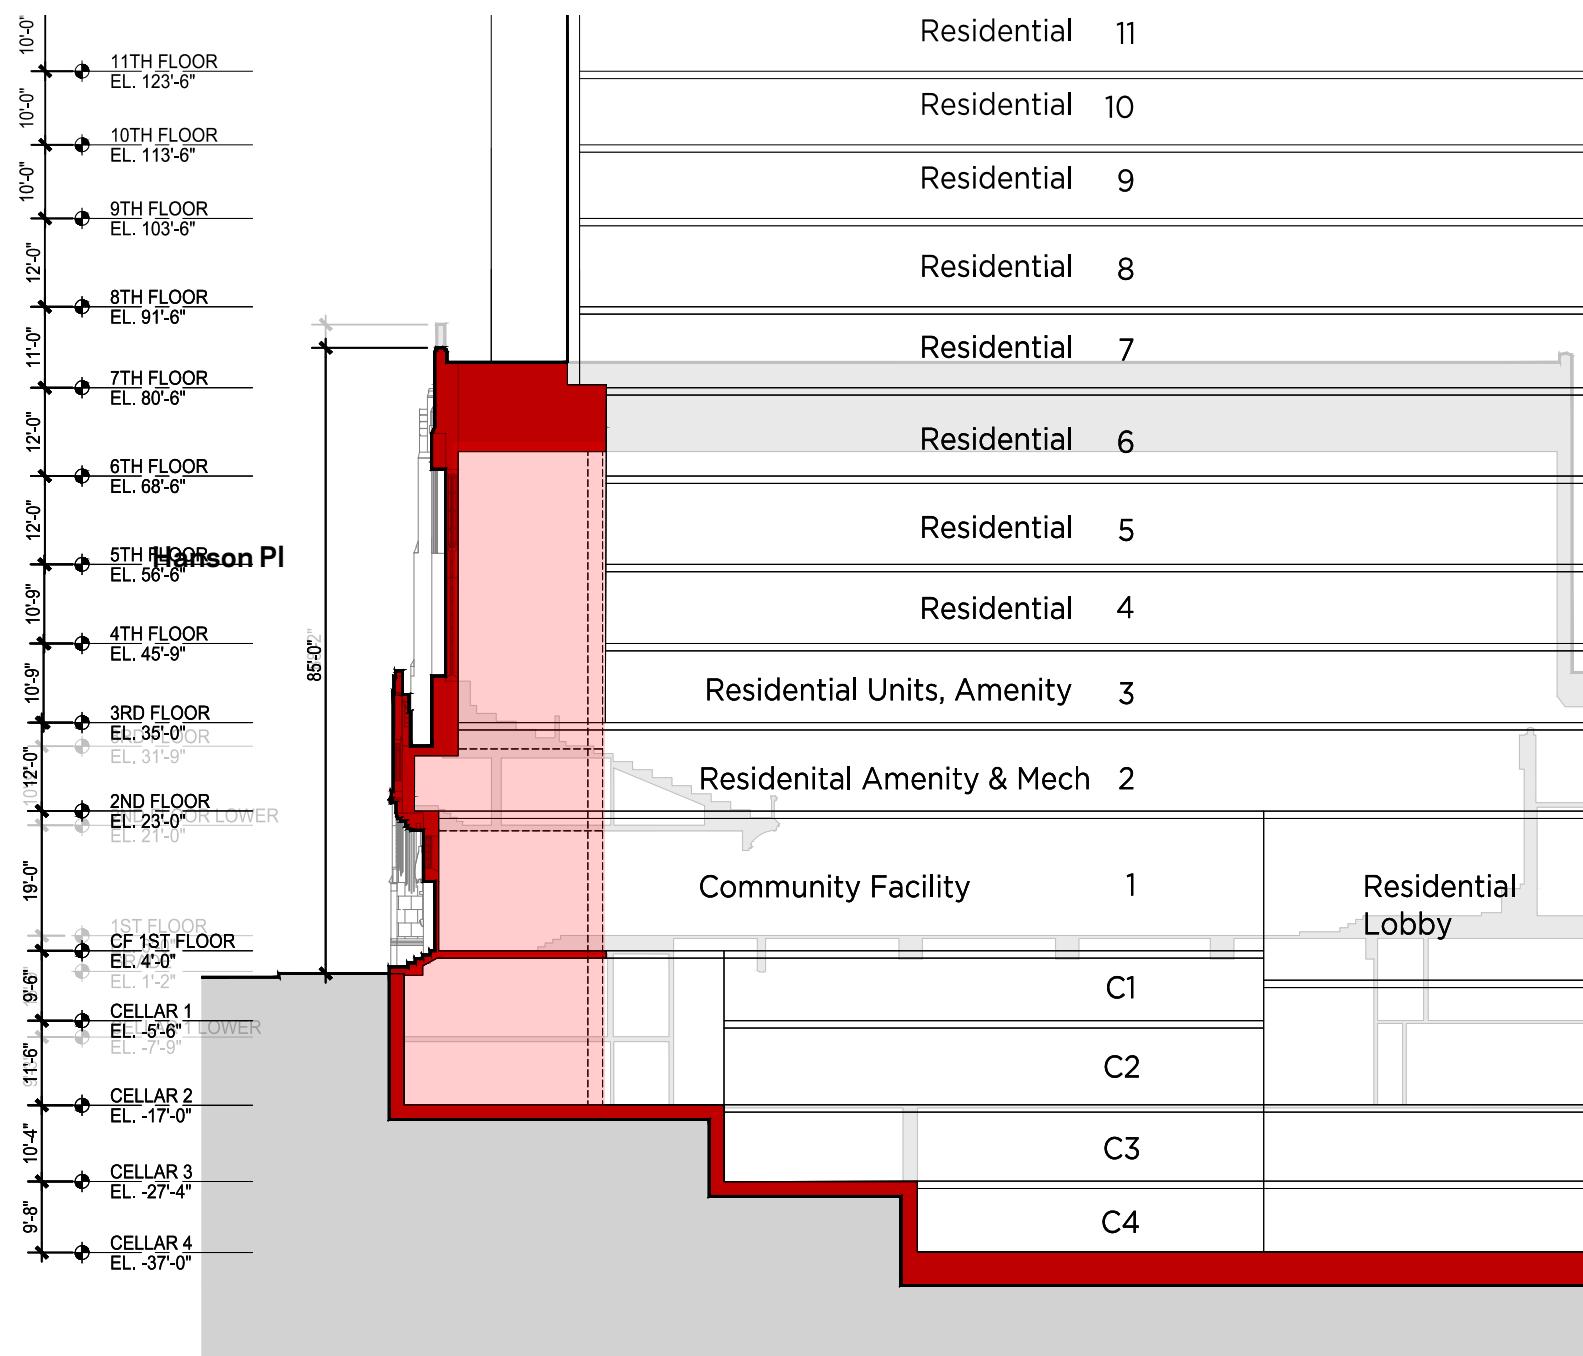
North-South Section

## Proposed Residential Adaptive Reuse

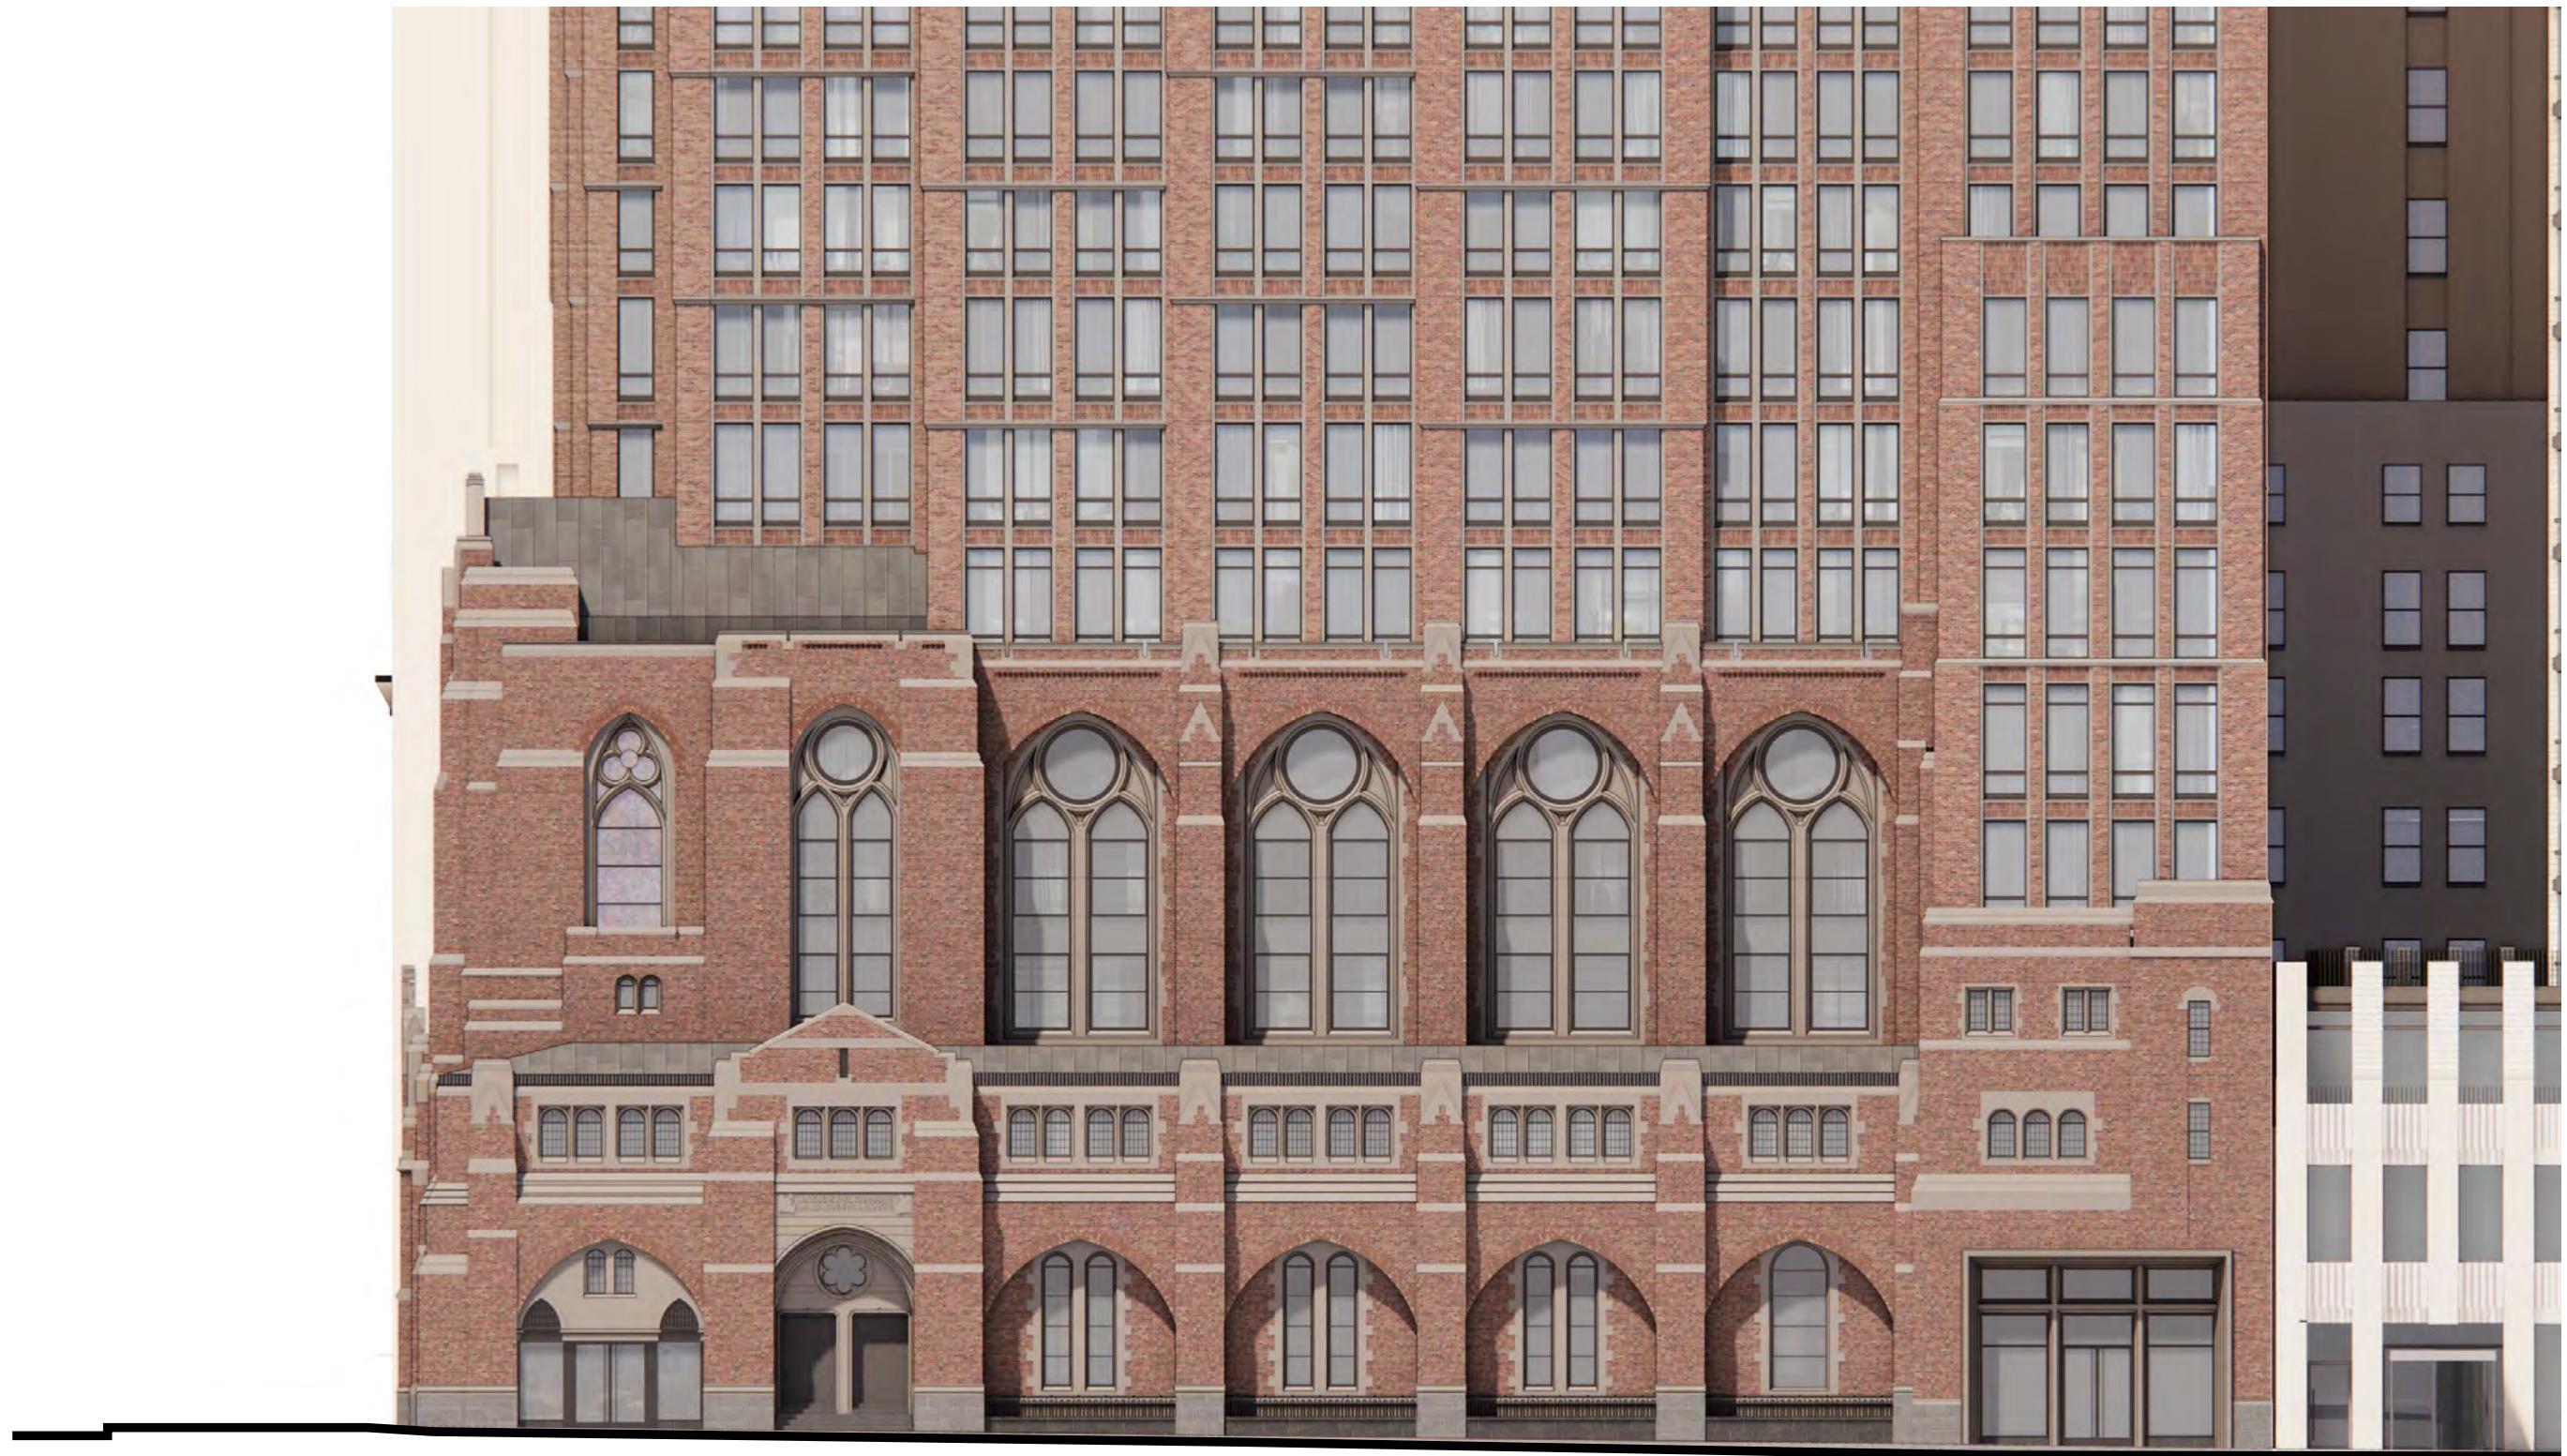
## PRIMARY FACADES

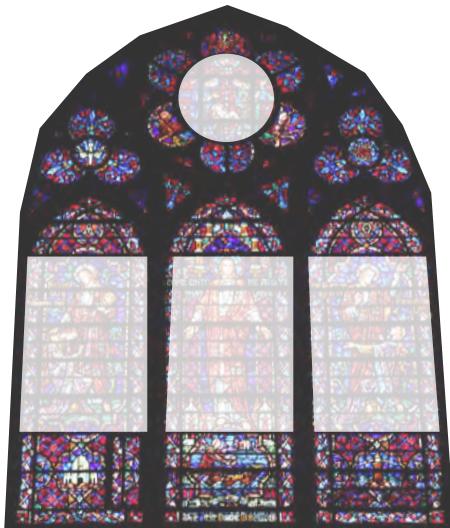
Relocate secular panes from West facade, return religious panes to Church Parish  
Infill at South facade Rosette window

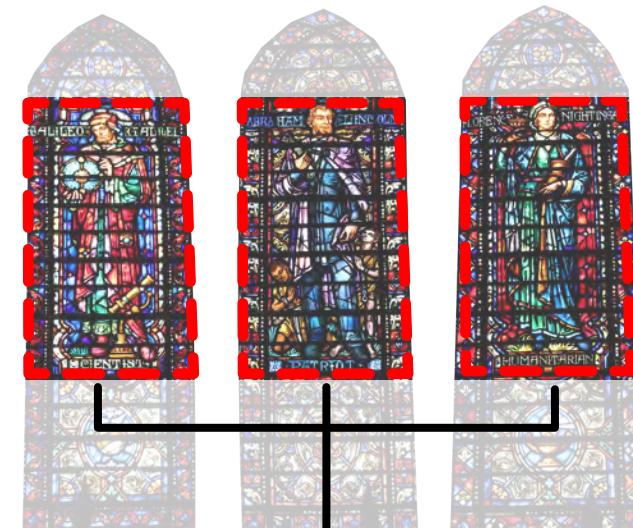
Infill at East facade new window

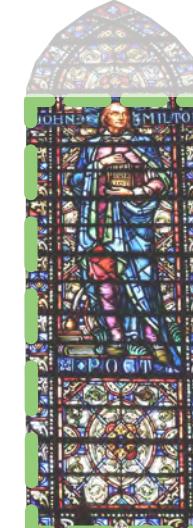
Relocate from North facade lot line to interior of new residential lobby

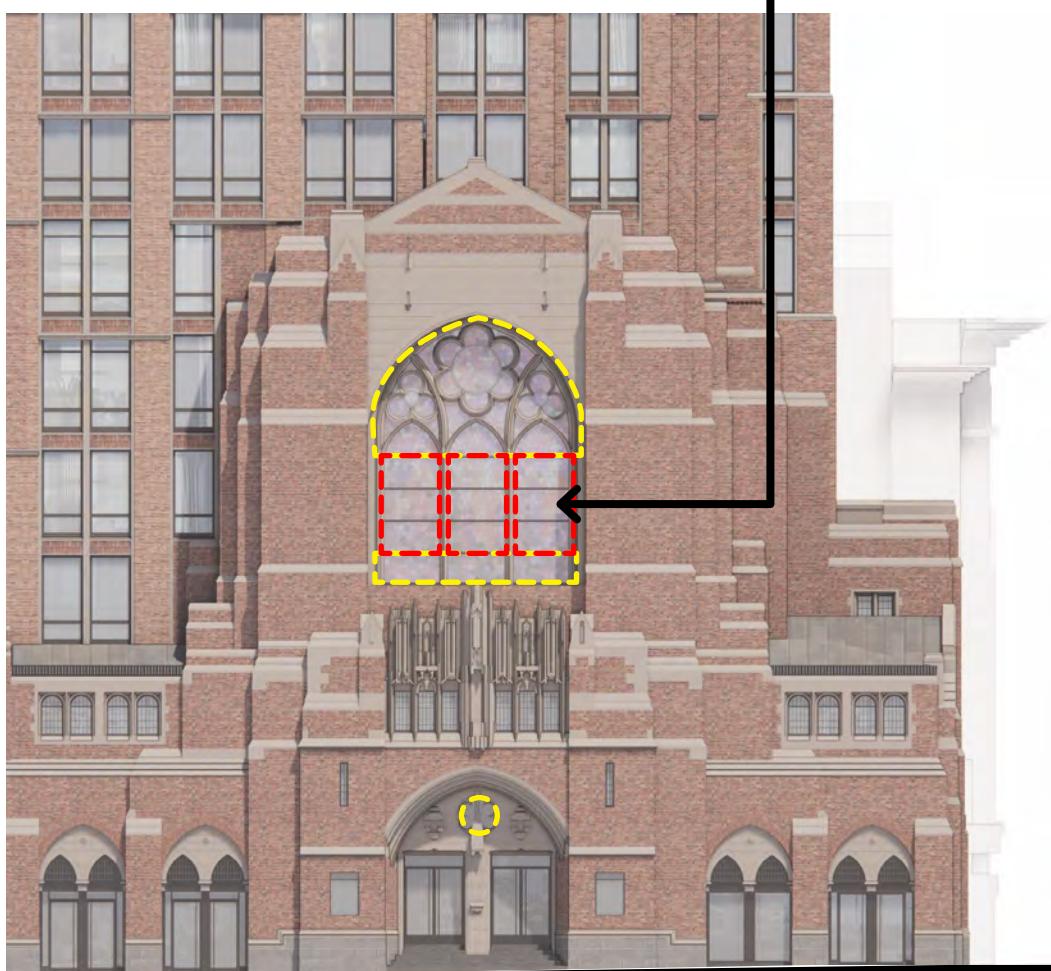
South Facade

- Restore existing in place
- Relocate existing stained glass
- Replace with clear operable glazing
- Replace with clear operable glazing, lower sill
- Relocate stained glass for new window

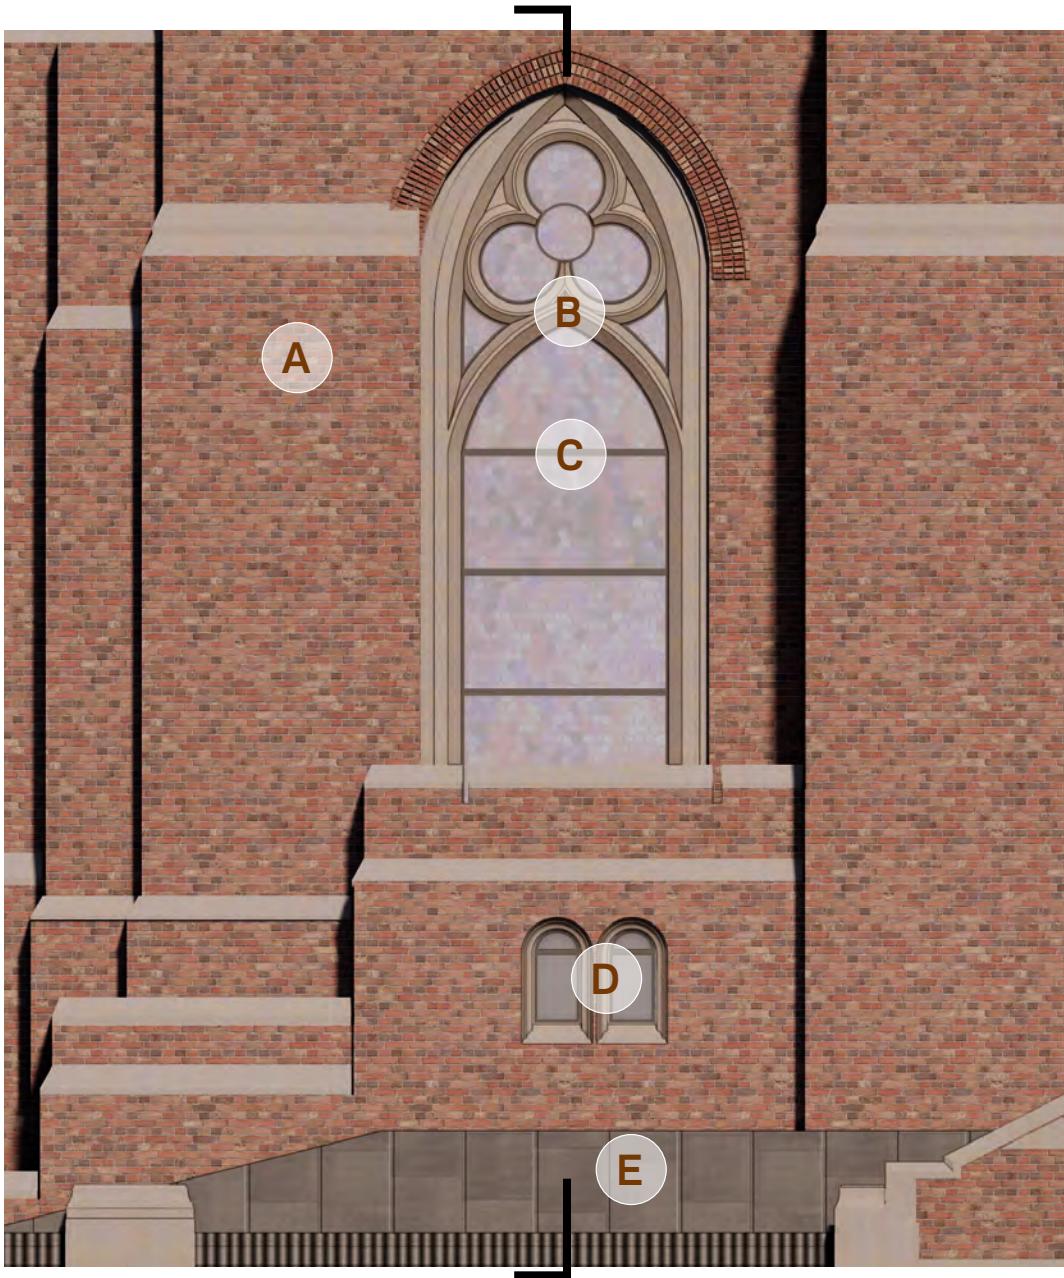
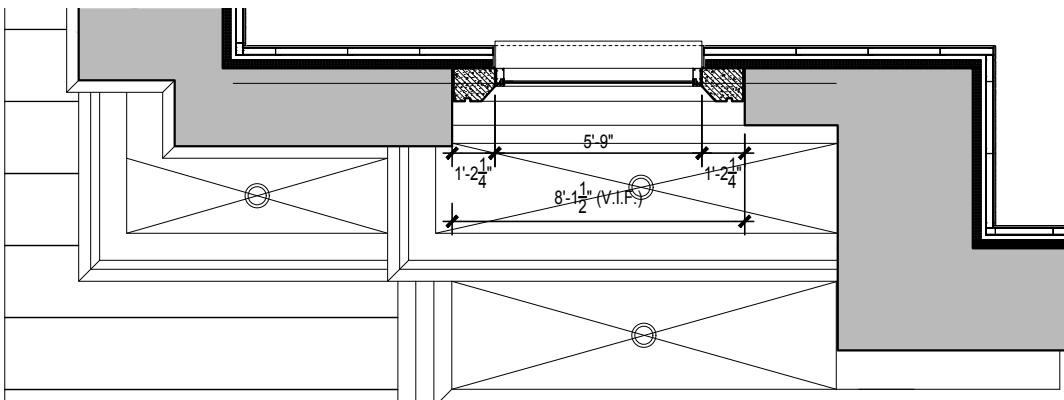
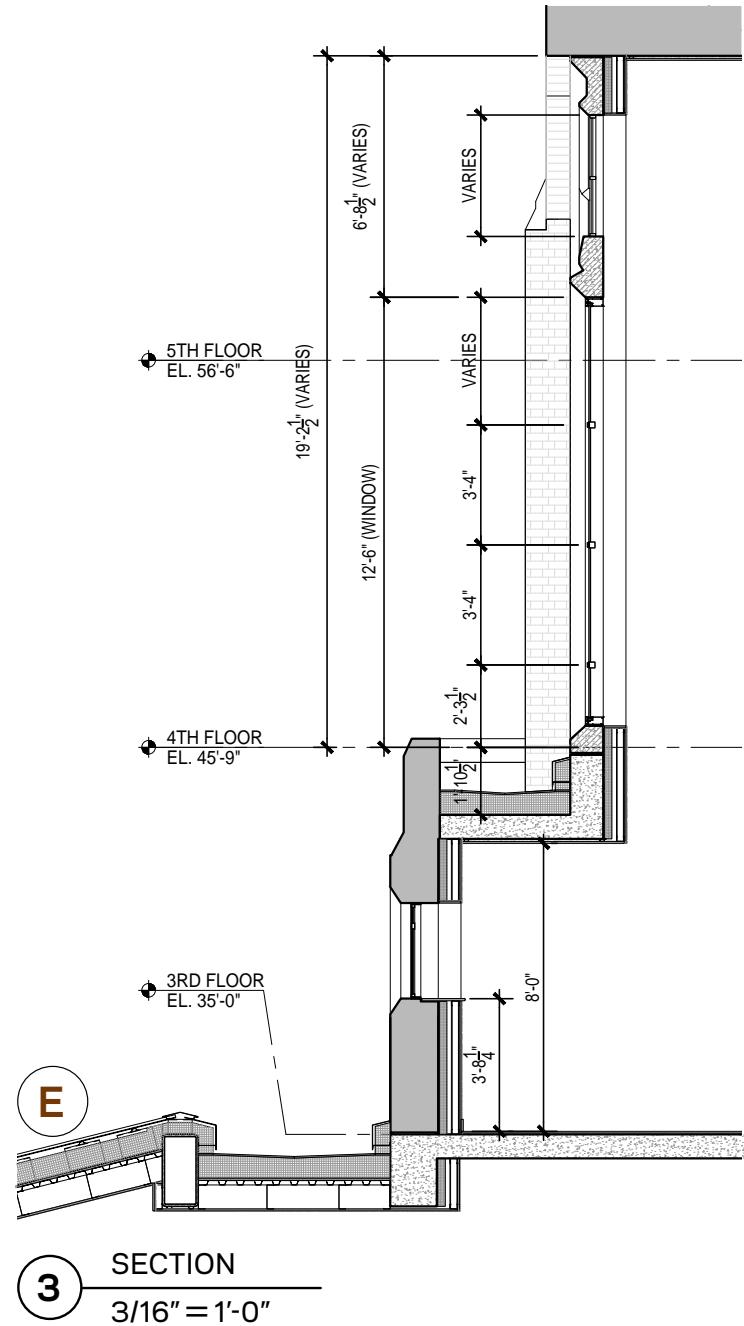
2 ELEVATION  
3/16" = 1'-0"

1 PLAN  
3/16" = 1'-0"

3 SECTION  
3/16" = 1'-0"

- A** Restored Existing Brick English Bond
- B** Precast Concrete w/ a Limestone Finish
- C** High Performance Painted Aluminum Curtain Wall w/ Relocated Stained Glass
- D** Replaced Existing Windows
- E** Standing Seam Roof w/ Integrated Skylights & Drainage
