**Preservation Department – Item 1, LPC-26-03280**

**138-154 St. Felix Street, aka 11-21 Hanson Place –  
Brooklyn Academy of Music Historic District  
Borough of Brooklyn**

# **144 ST. FELIX STREET**

## **ADAPTIVE-REUSE & ENLARGEMENT**

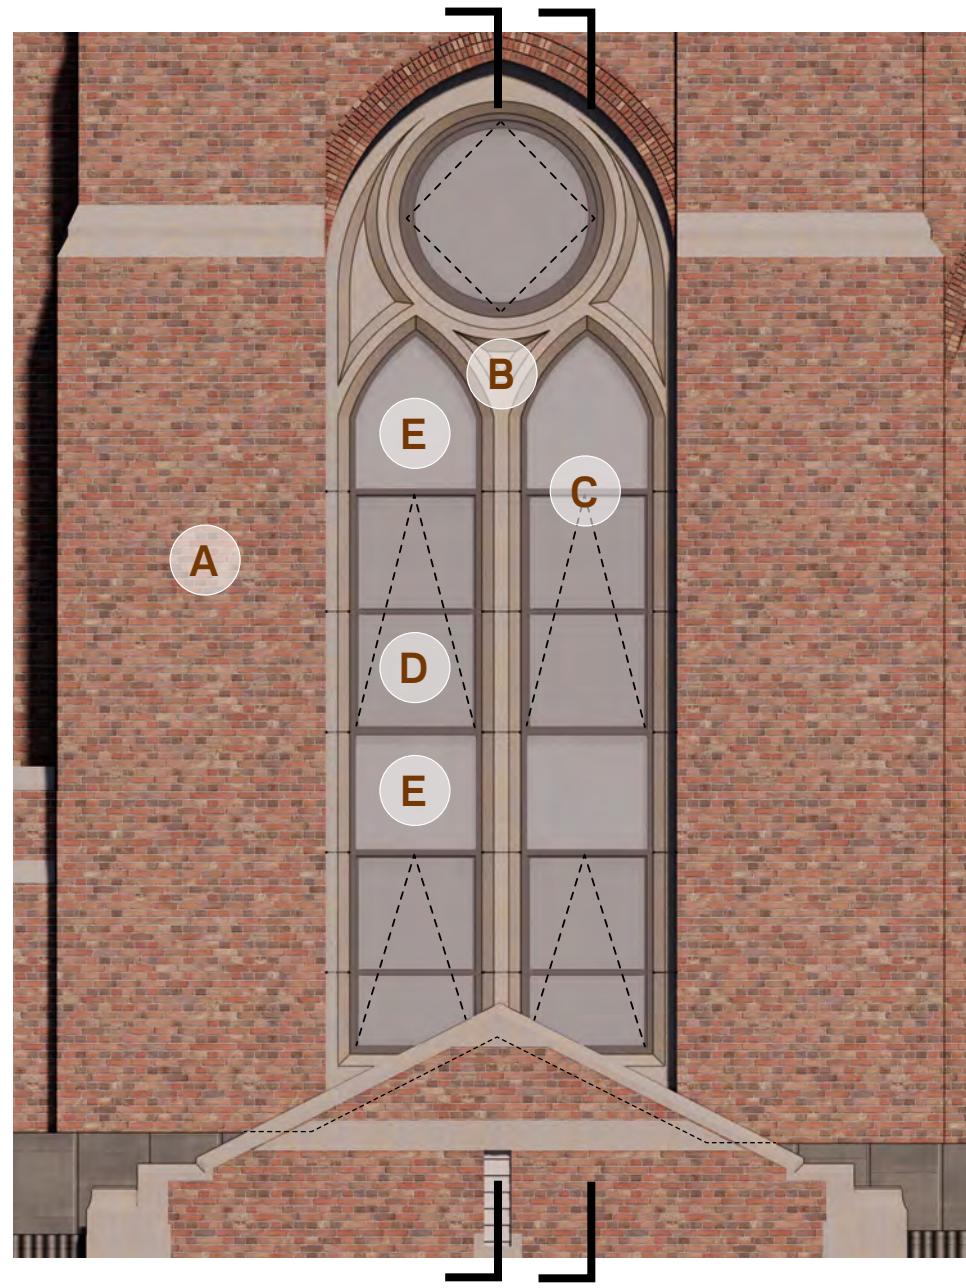
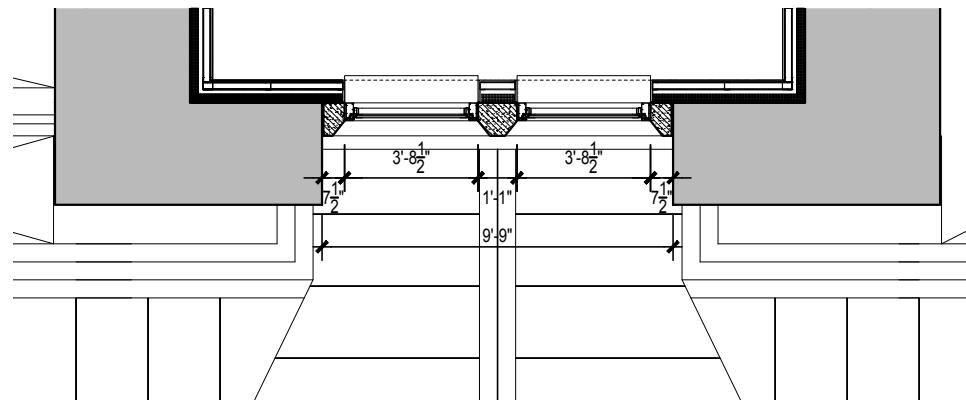
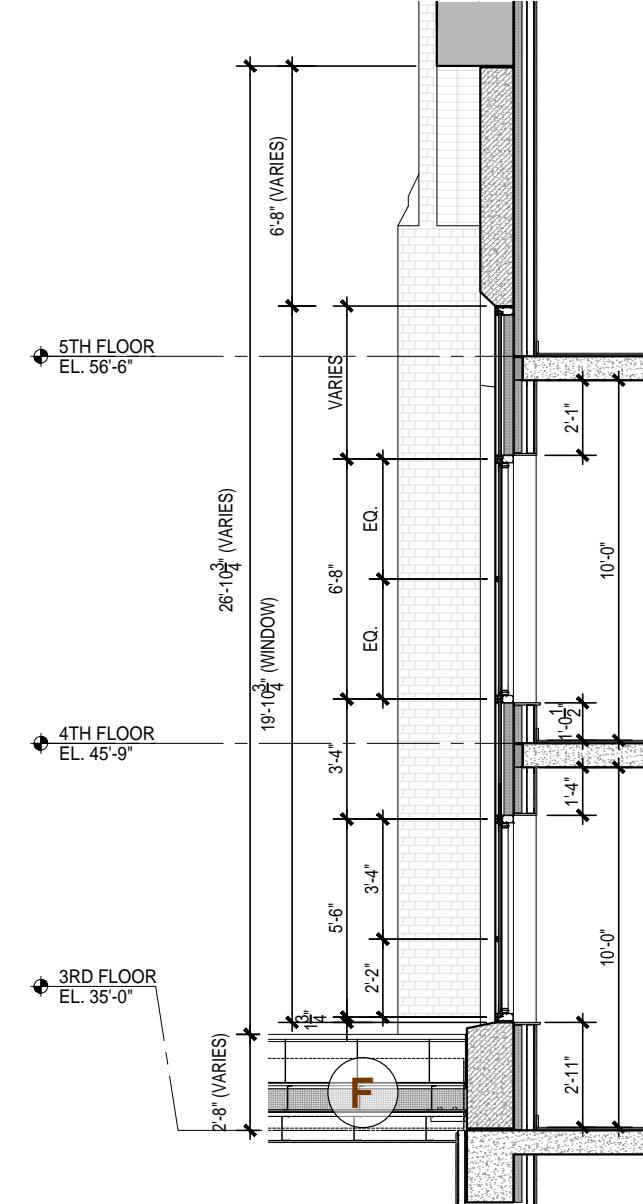
**2** ELEVATION  
3/16" = 1'-0"

**1** PLAN  
3/16" = 1'-0"

**3** SECTION  
3/16" = 1'-0"

- A** Restored Existing Brick English Bond
- B** Precast Concrete w/ a Limestone Finish
- C** High Performance Painted Aluminum Curtain Wall w/ SSG Mullion Option
- D** Thermally Broken Painted Aluminum Awning Windows
- E** Insulated Glass Shadow Box
- F** Standing Seam Roof w/ Integrated Skylights & Drainage

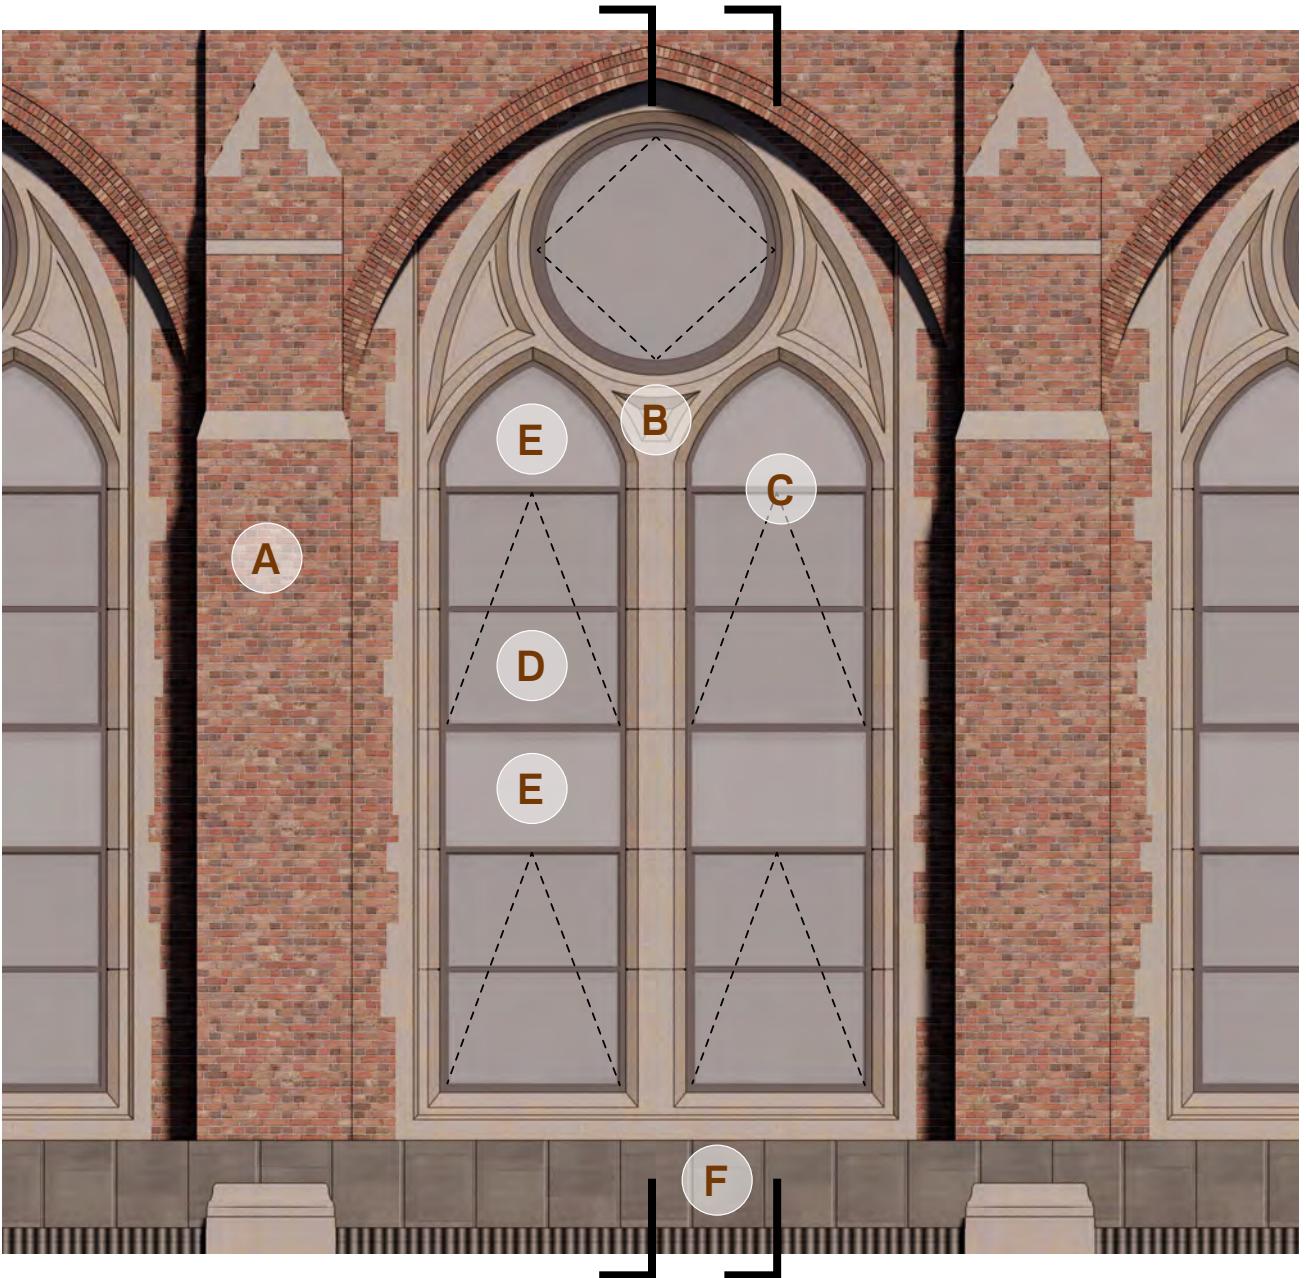
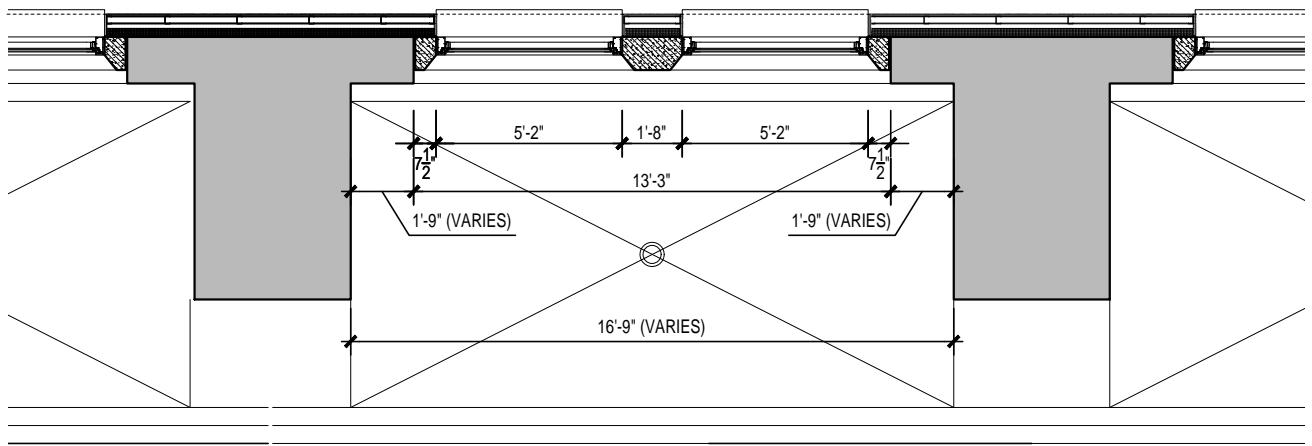
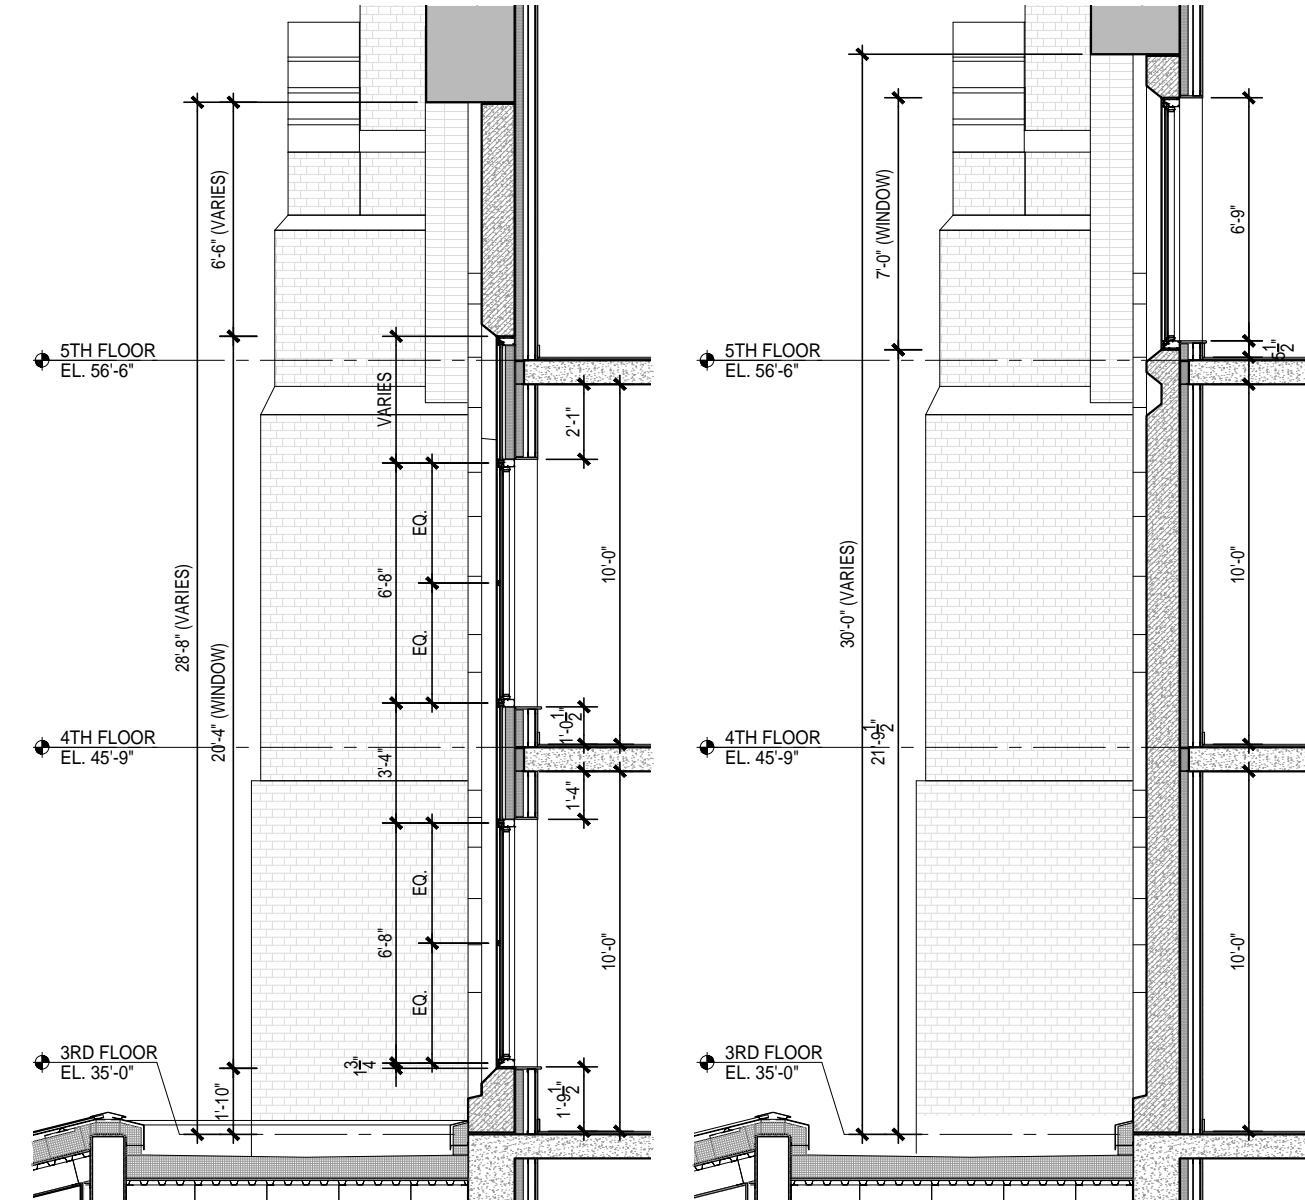
**2** ELEVATION  
3/16" = 1'-0"

**1** PLAN  
3/16" = 1'-0"

**3** SECTION  
3/16" = 1'-0"

- A** Restored Existing Brick English Bond
- B** Precast Concrete w/ a Limestone Finish
- C** High Performance Painted Aluminum Curtain Wall w/ SSG Mullion Option
- D** Thermally Broken Painted Aluminum Awning Windows
- E** Insulated Glass Shadow Box
- F** Standing Seam Roof w/ Integrated Skylights & Drainage

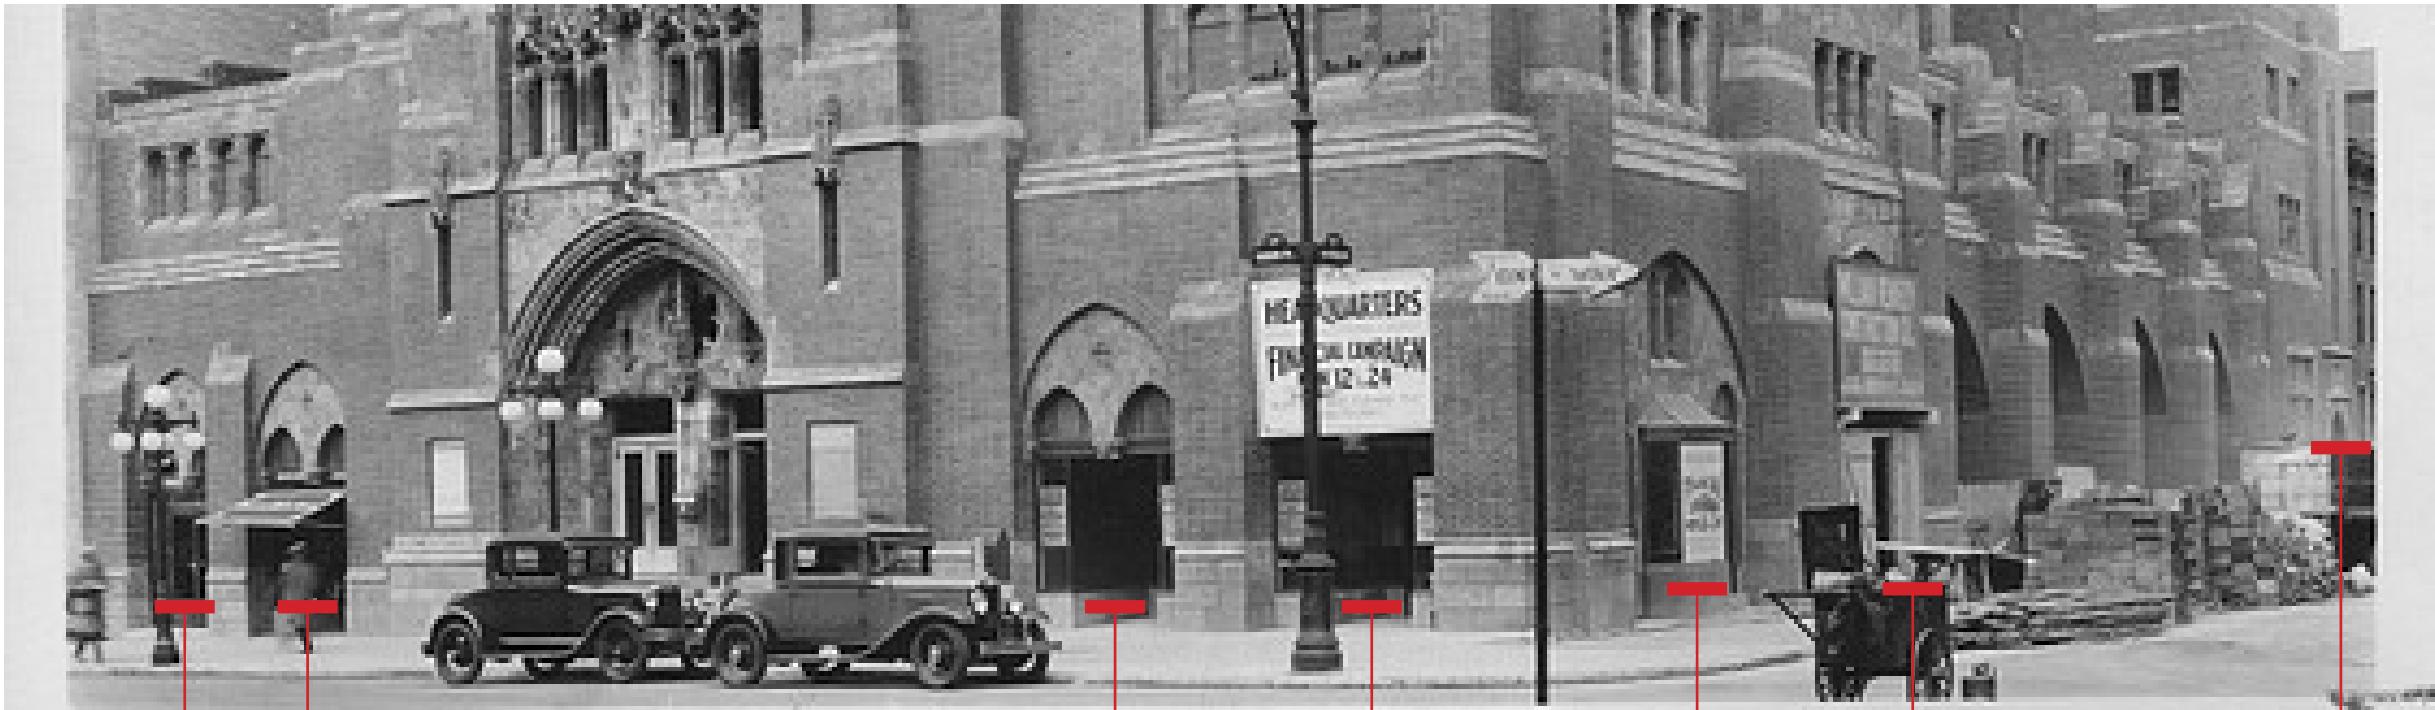
South Facade, Entry Doors

ca. 1930, near end of construction

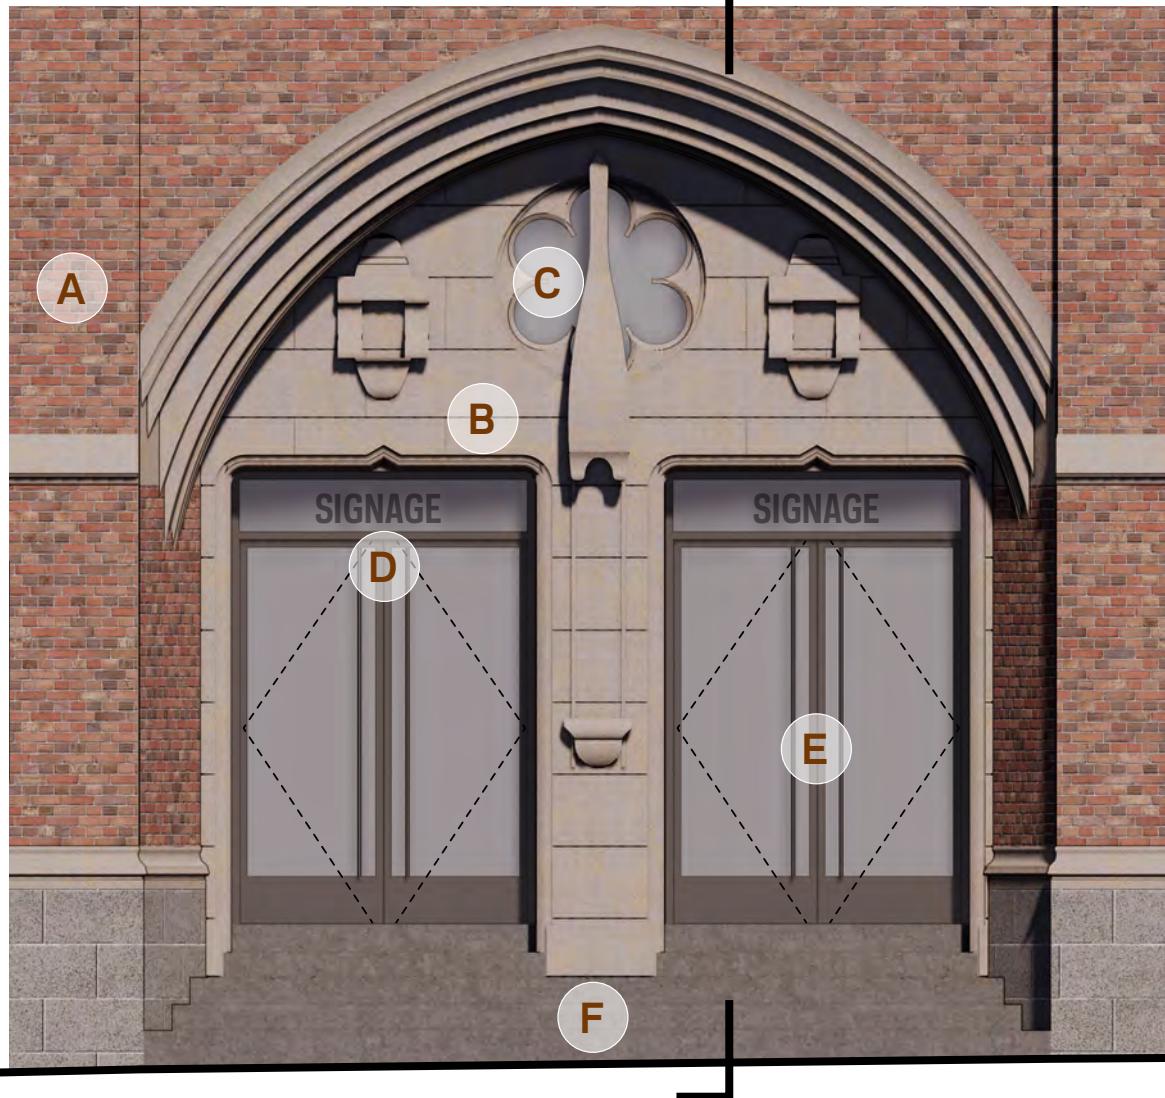
2 ELEVATION  
1/4" = 1'-0"

- A** Restored Existing Brick English Bond
- B** Restored Existing Masonry Cladding
- C** Restored Existing Windows
- D** High Performance Painted Aluminum Storefront w/ Custom Mullion Caps
- E** Thermally Broken Painted Aluminum Storefront Door w/ IGU
- F** Granite Reclad Stair

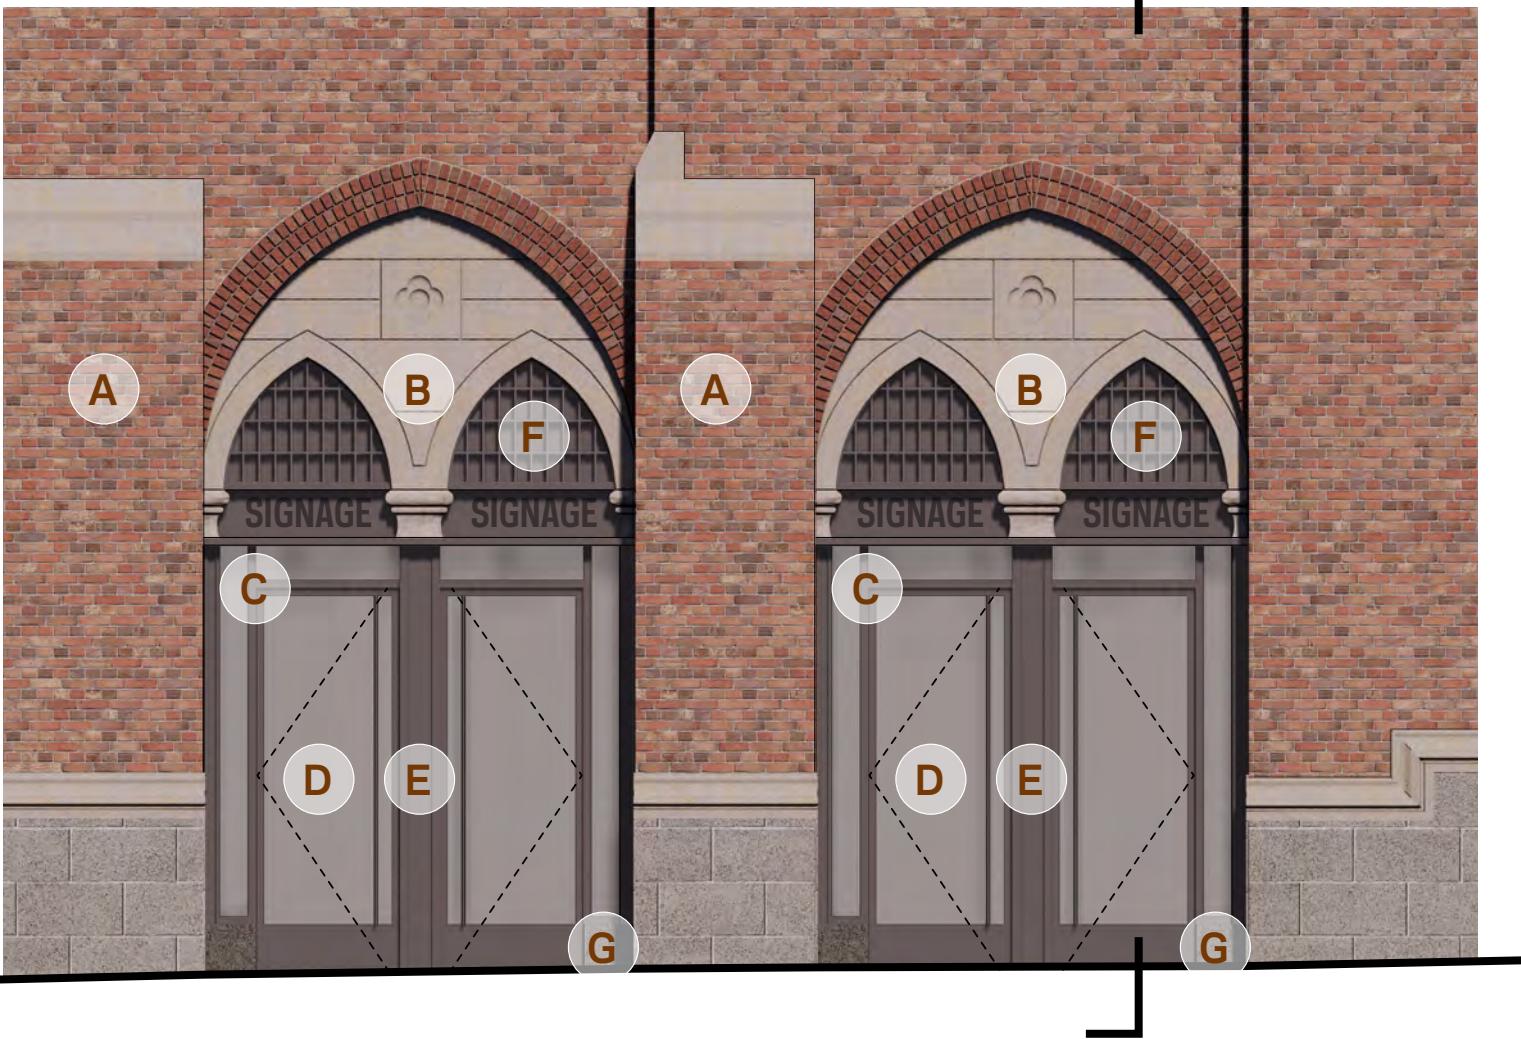
2 ELEVATION  
1/4" = 1'-0"

- A** Restored Existing Brick English Bond
- B** Restored Existing Masonry Cladding
- C** High Performance Painted Aluminum Storefront w/ Custom Mullion Caps
- D** Thermally Broken Painted Aluminum Storefront Door w/ IGU
- E** Painted Aluminum Piers
- F** Decorative Painted Aluminum Ventilation Screen
- G** Granite Base & Pavers

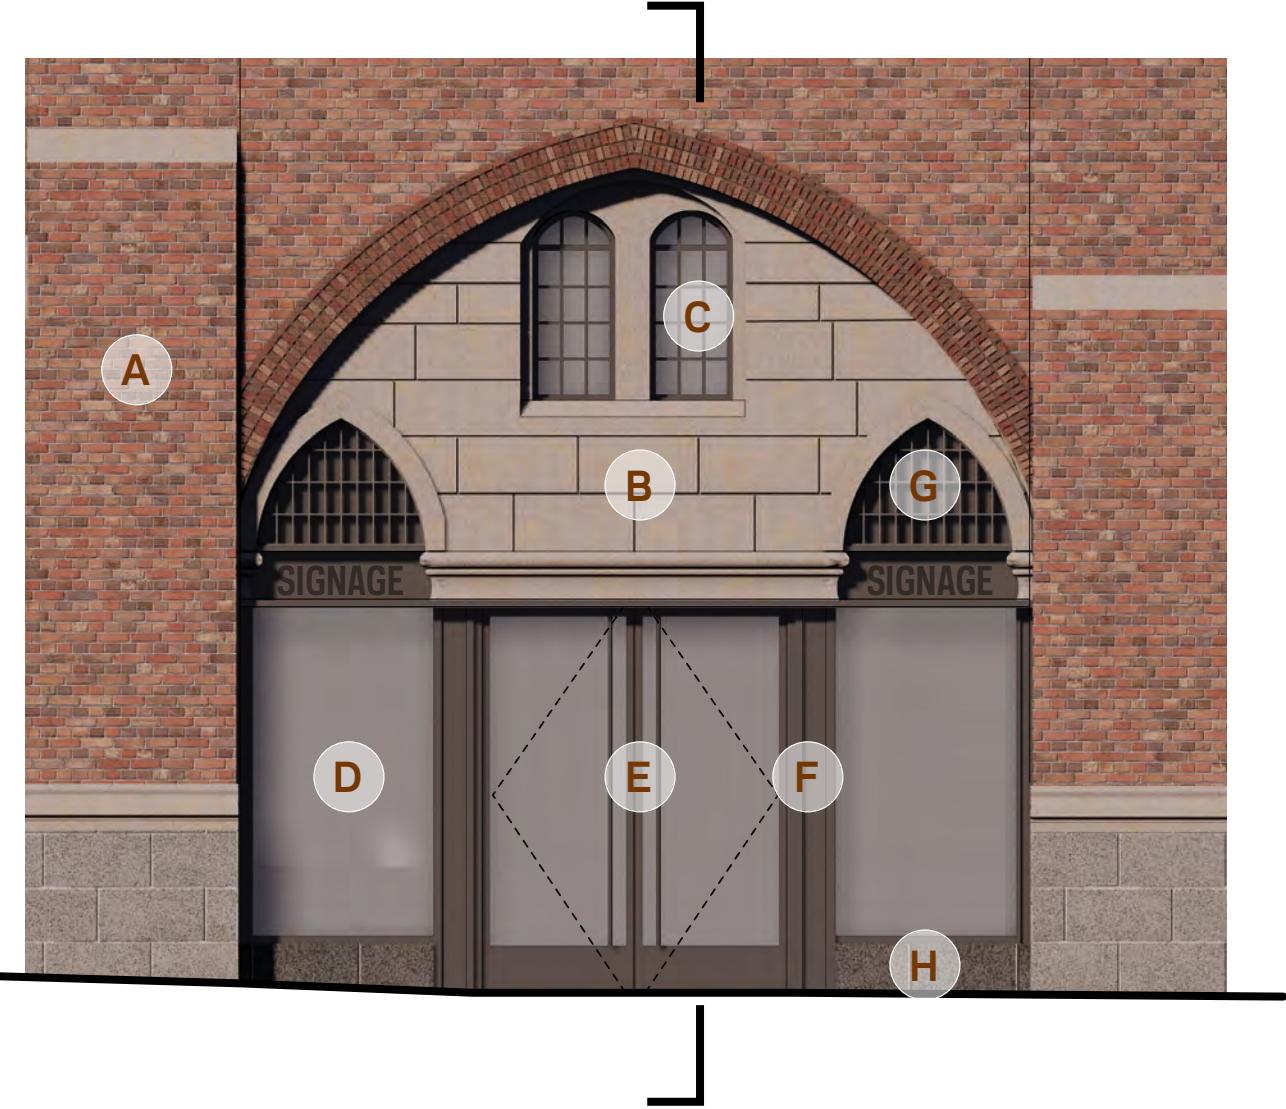
2 ELEVATION  
1/4" = 1'-0"

- A** Restored Existing Brick English Bond
- B** Restored Existing Masonry Cladding
- C** Replaced Existing Windows
- D** High Performance Painted Aluminum Storefront w/ Custom Mullion Caps
- E** Thermally Broken Painted Aluminum Storefront Door w/ IGU
- F** Painted Aluminum Piers
- G** Decorative Painted Aluminum Ventilation Screen
- H** Granite Base & Pavers

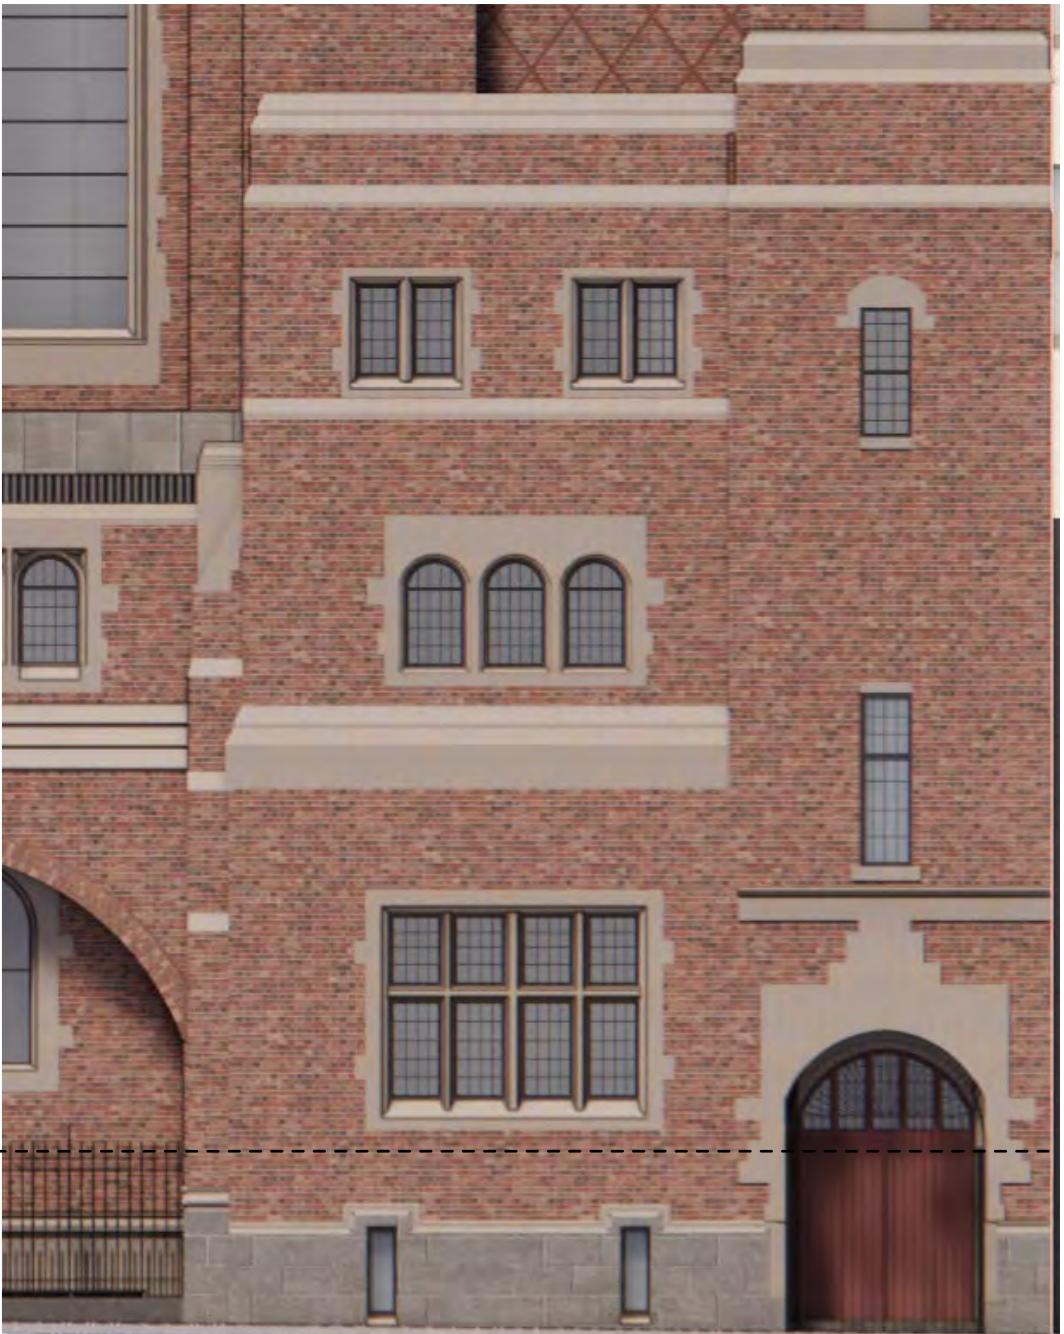
EXISTING

FIRST FLOOR  
BEYOND VESTIBULE

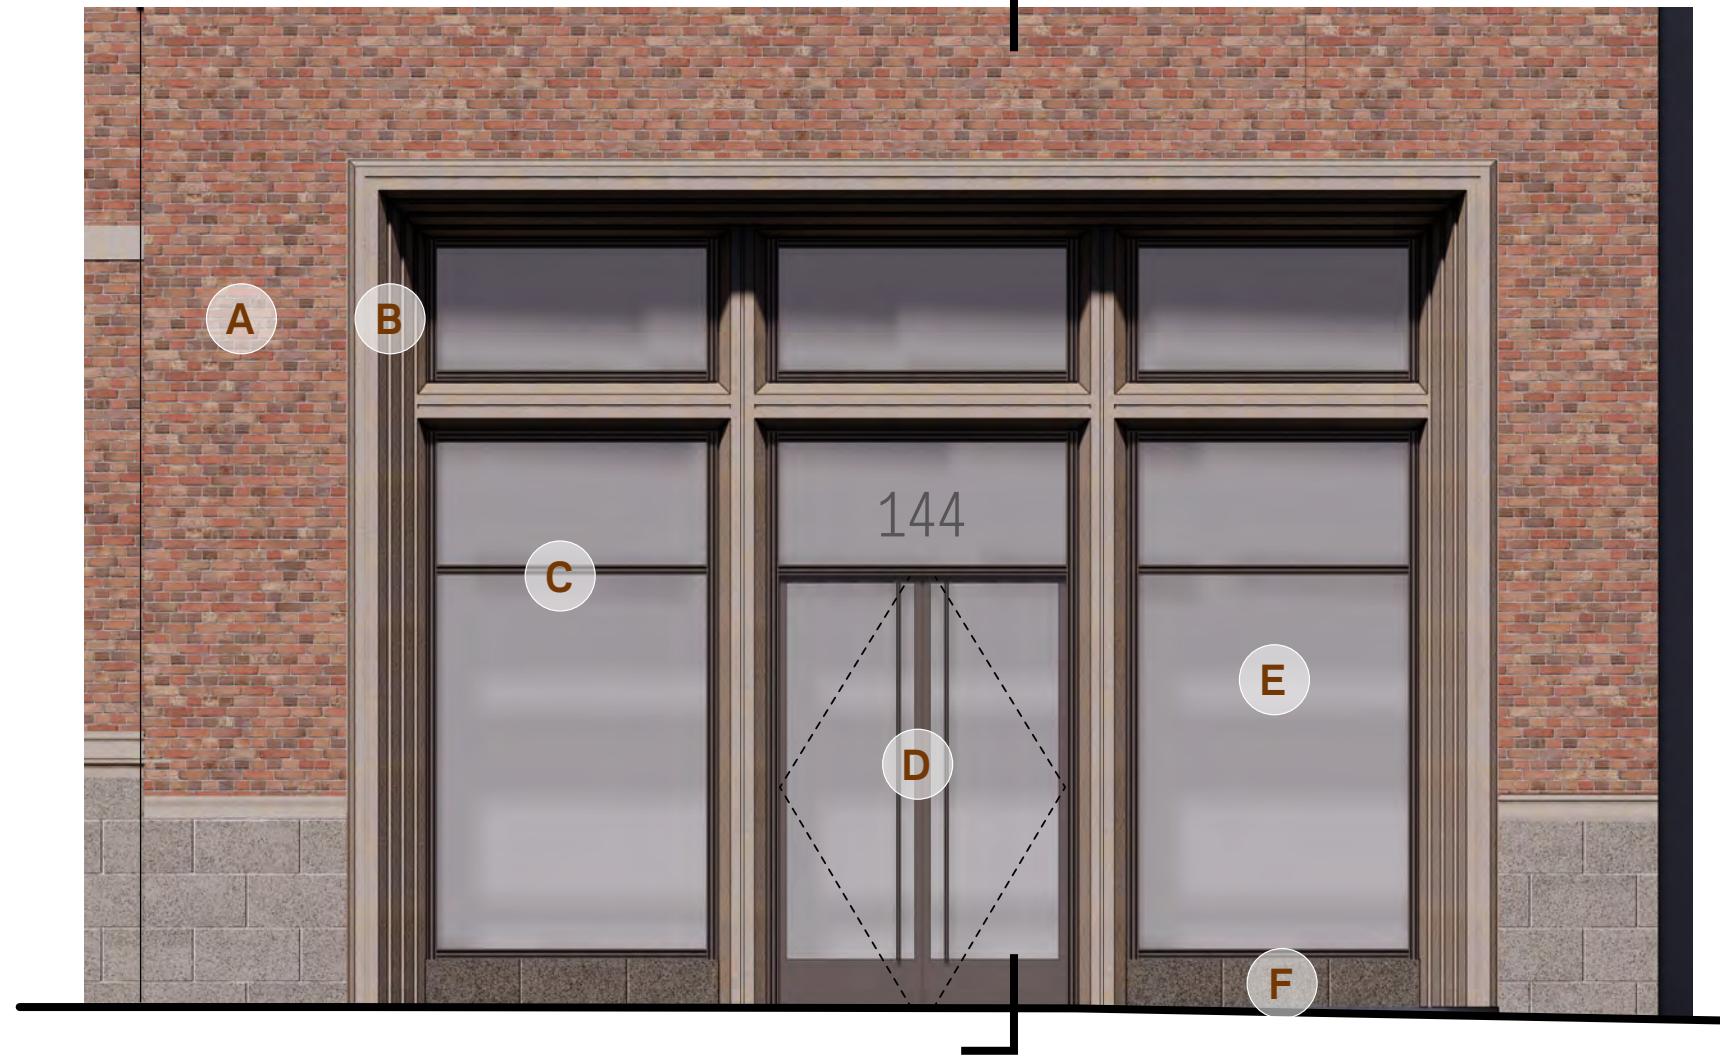
2 ELEVATION  
1/4" = 1'-0"

- A** Restored Existing Brick English Bond
- B** Cast stone w/ Limestone Finish to match existing
- C** High Performance Painted Aluminum Storefront w/ Custom Mullion Caps
- D** Thermally Broken Painted Aluminum Storefront Door w/ IGU
- E** Bird-safe Glass
- F** Granite Base and Pavers

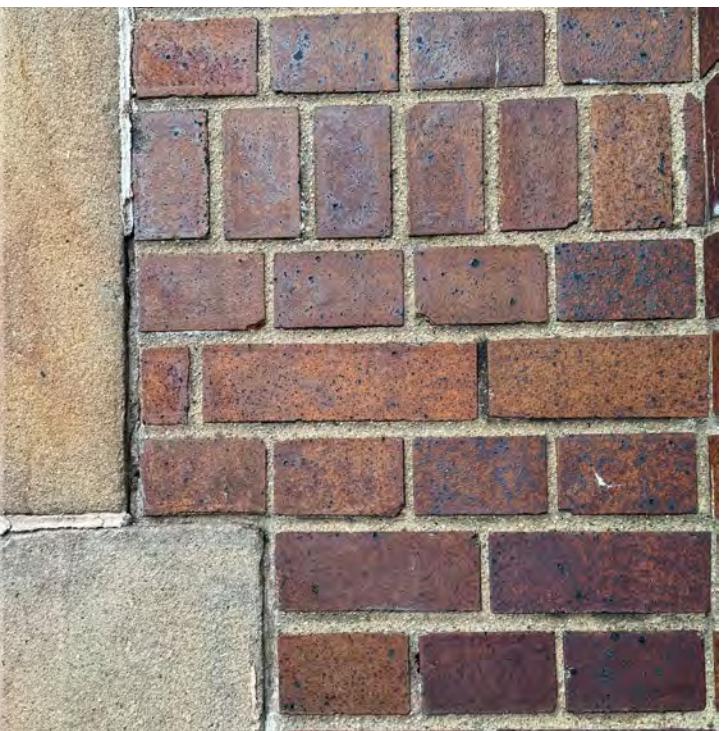
Weathered Condition

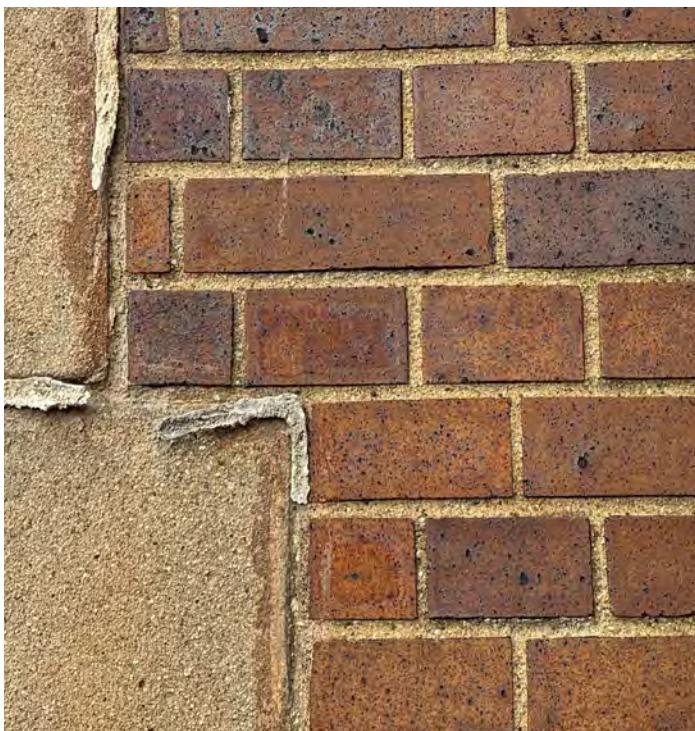
Protected Condition

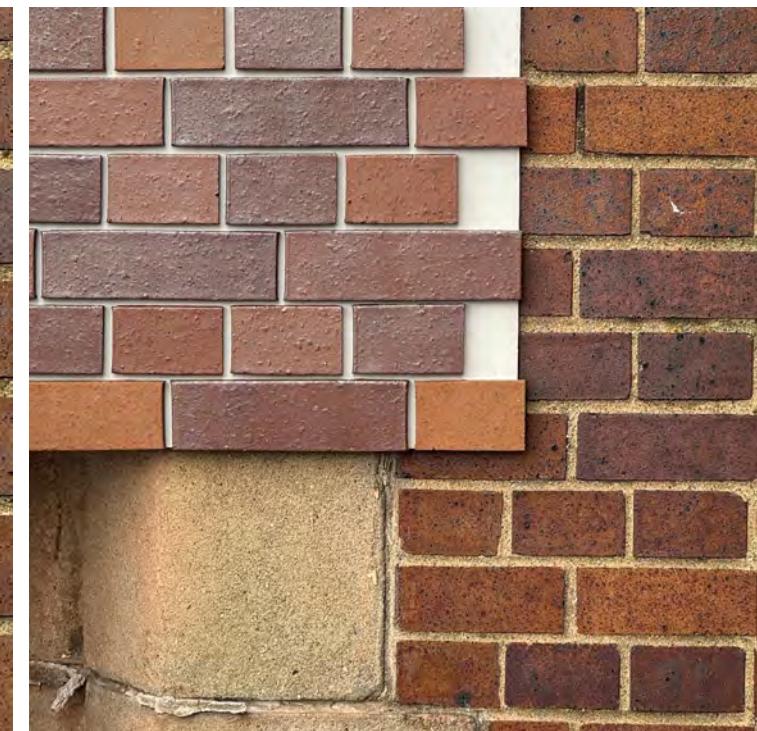
Matching Process

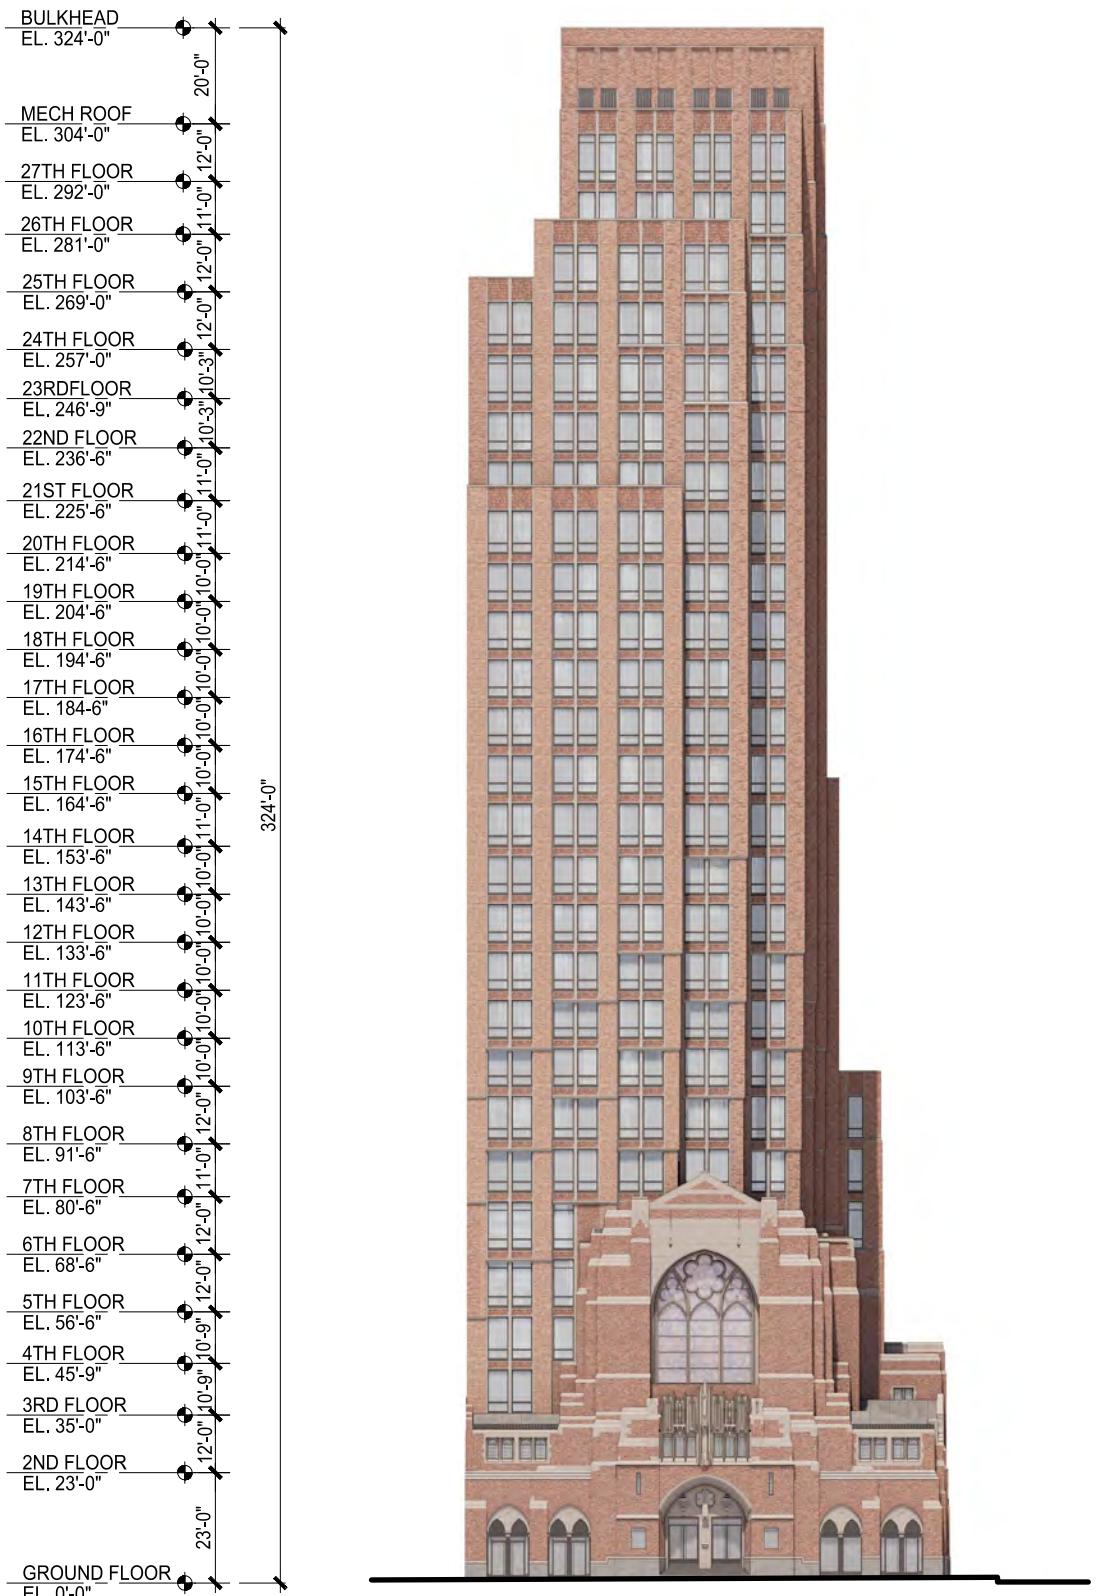
South

## Building Elevations

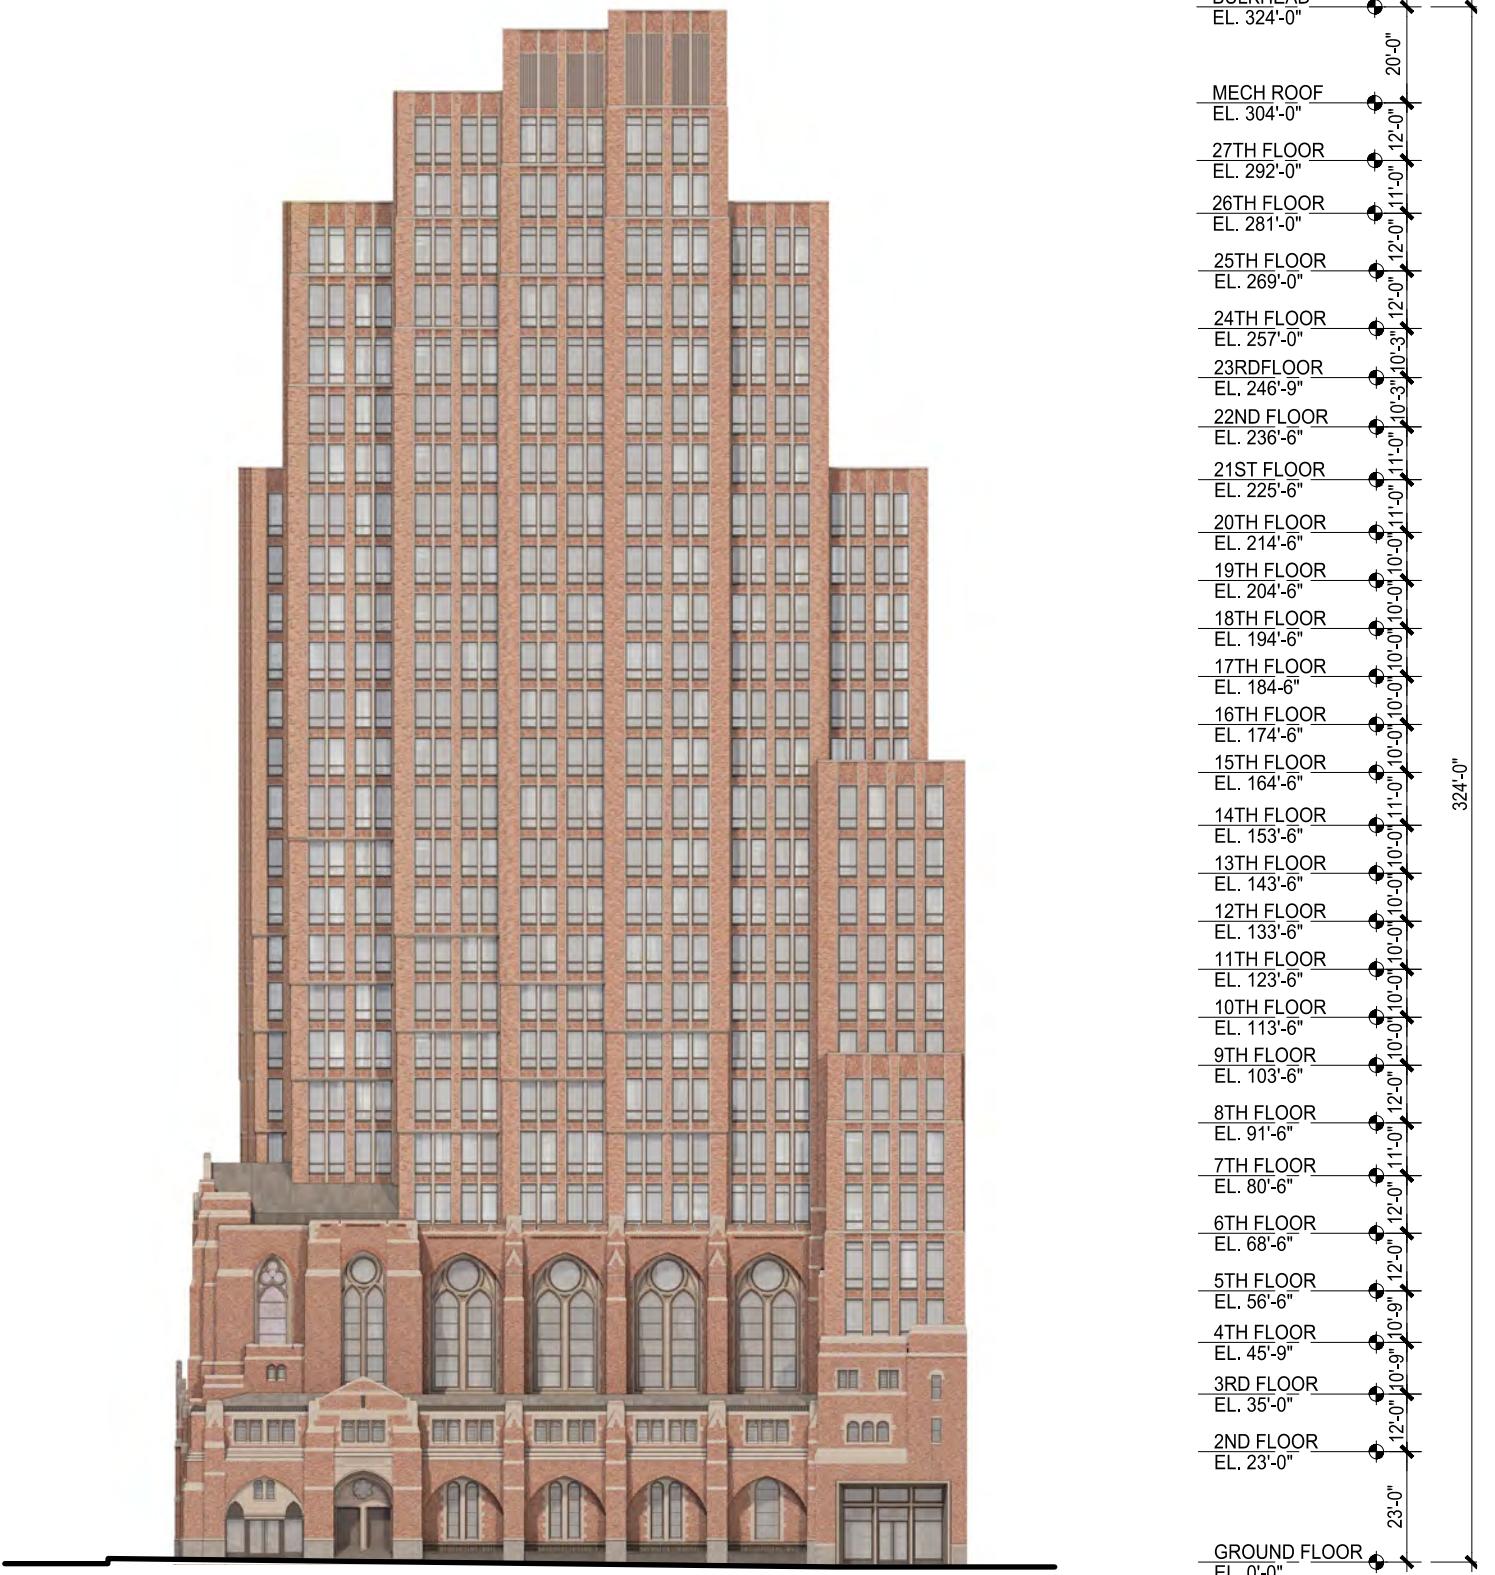
East

SCALE : 1 / 40 " = 1' - 0"
